# IndianOil

## JOURNEY RISK MANAGEMENT (JRM) STUDY

### Salem Terminal to PRANAV AGENCY UNIT II

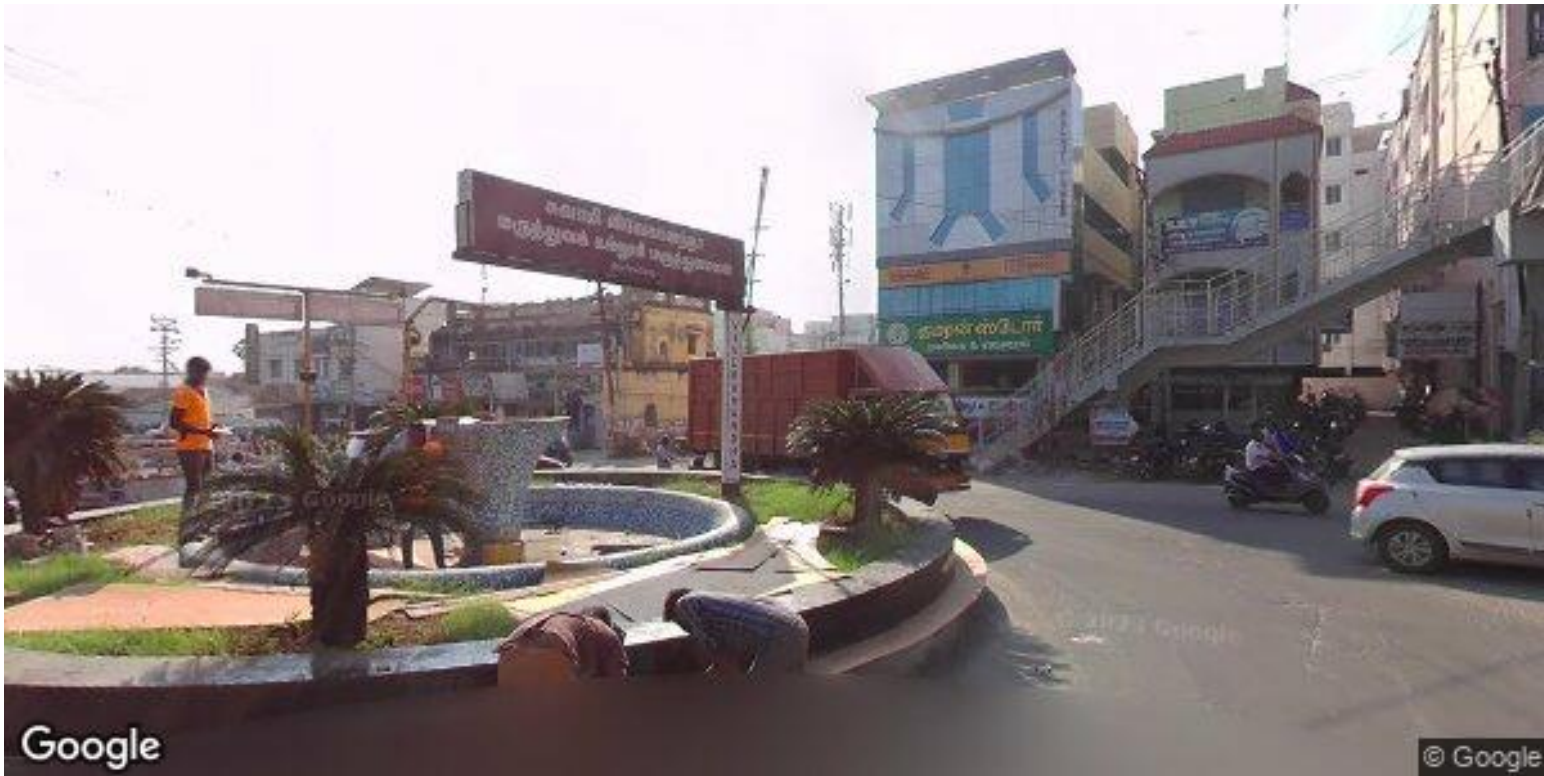
**Coordinates:** 11.38395, 77.89480

**Risk Type:** Roundabout

**Risk Level:** High

**Speed Limit:** 15 KM/Hr

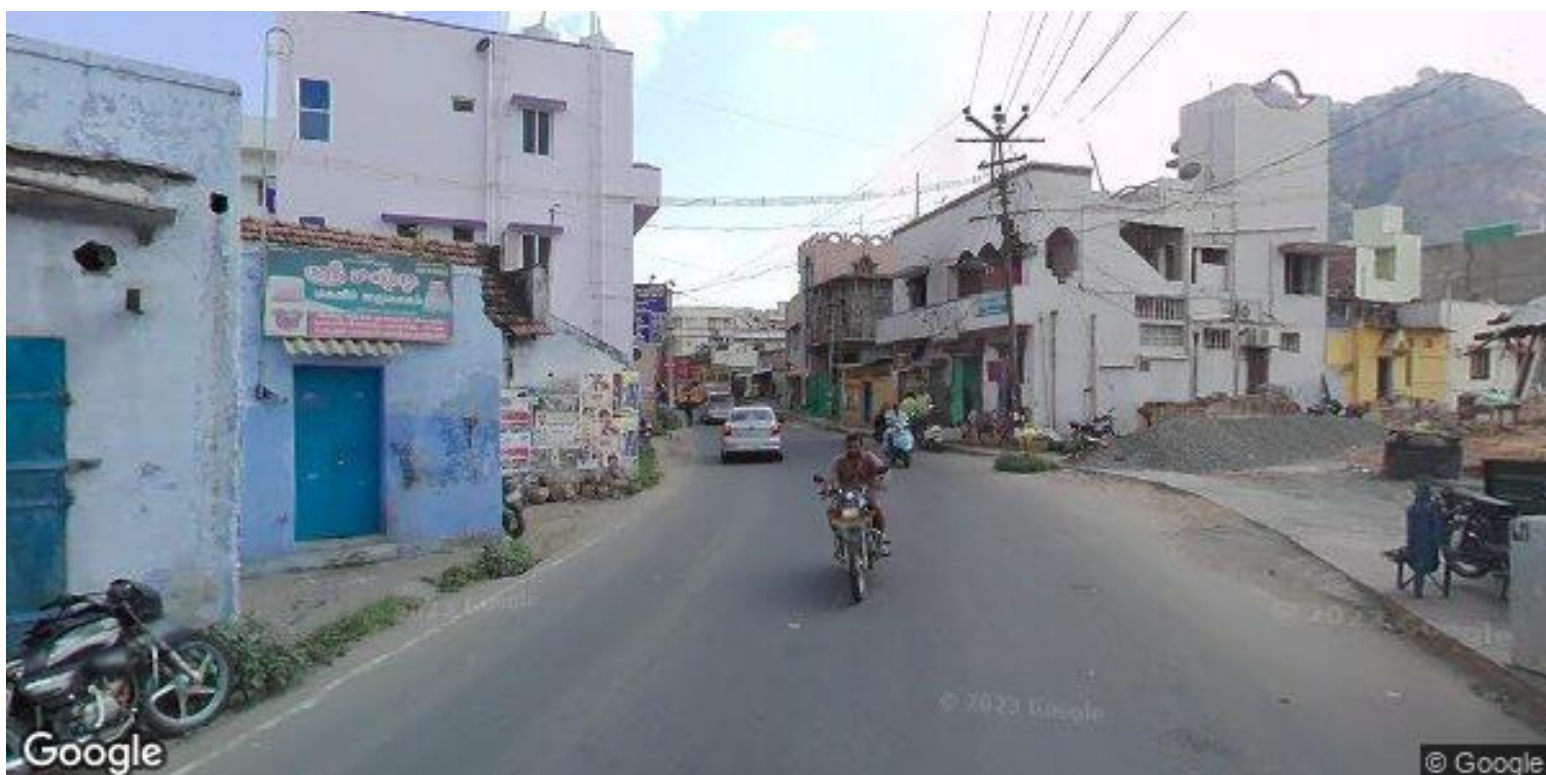
**Coordinates:** 11.38302, 77.89995

**Risk Type:** Turn

**Risk Level:** Medium

**Speed Limit:** 30 KM/Hr

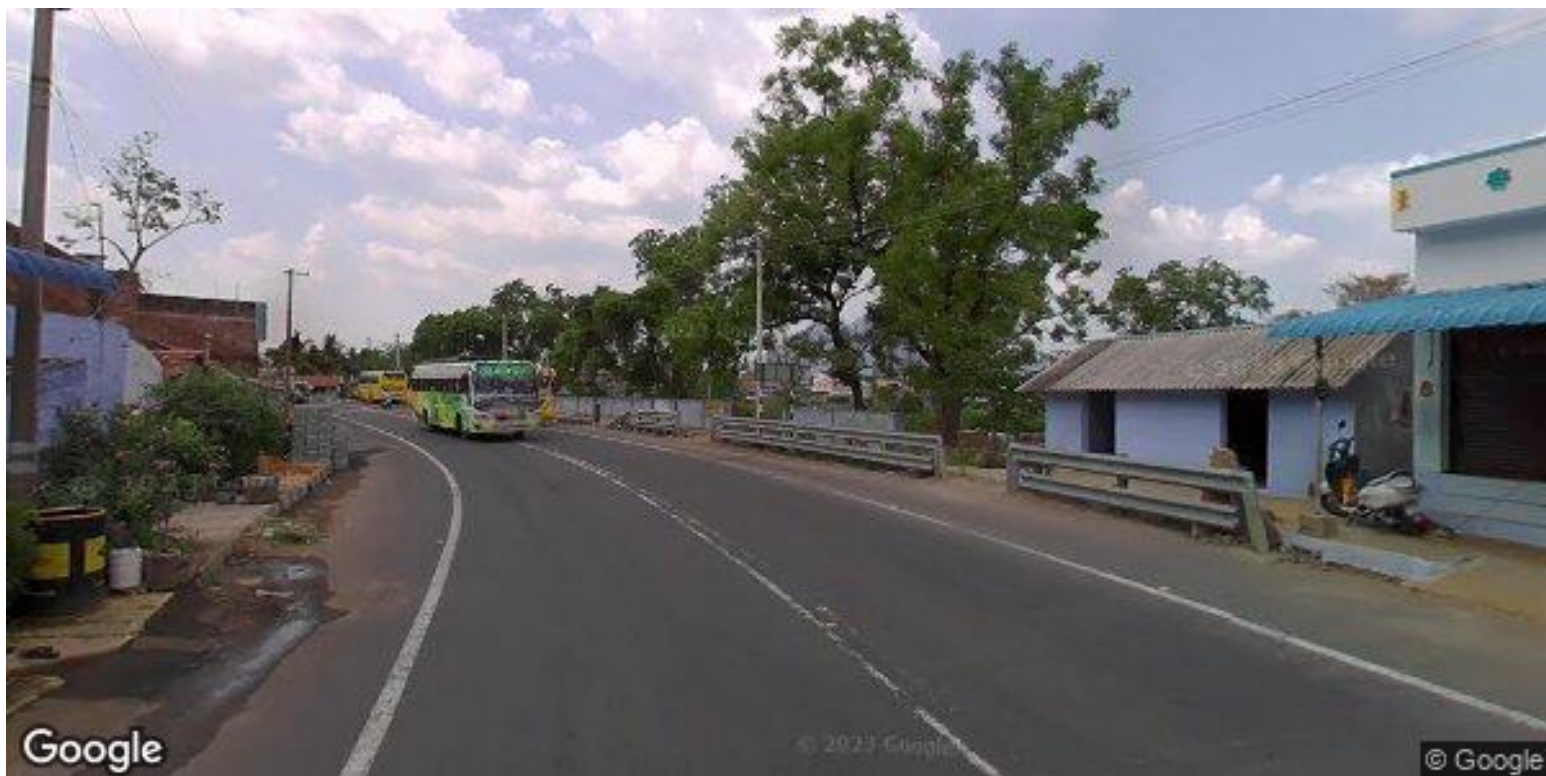
**Coordinates:** 11.41332, 78.08072

**Risk Type:** Turn

**Risk Level:** Medium

**Speed Limit:** 30 KM/Hr

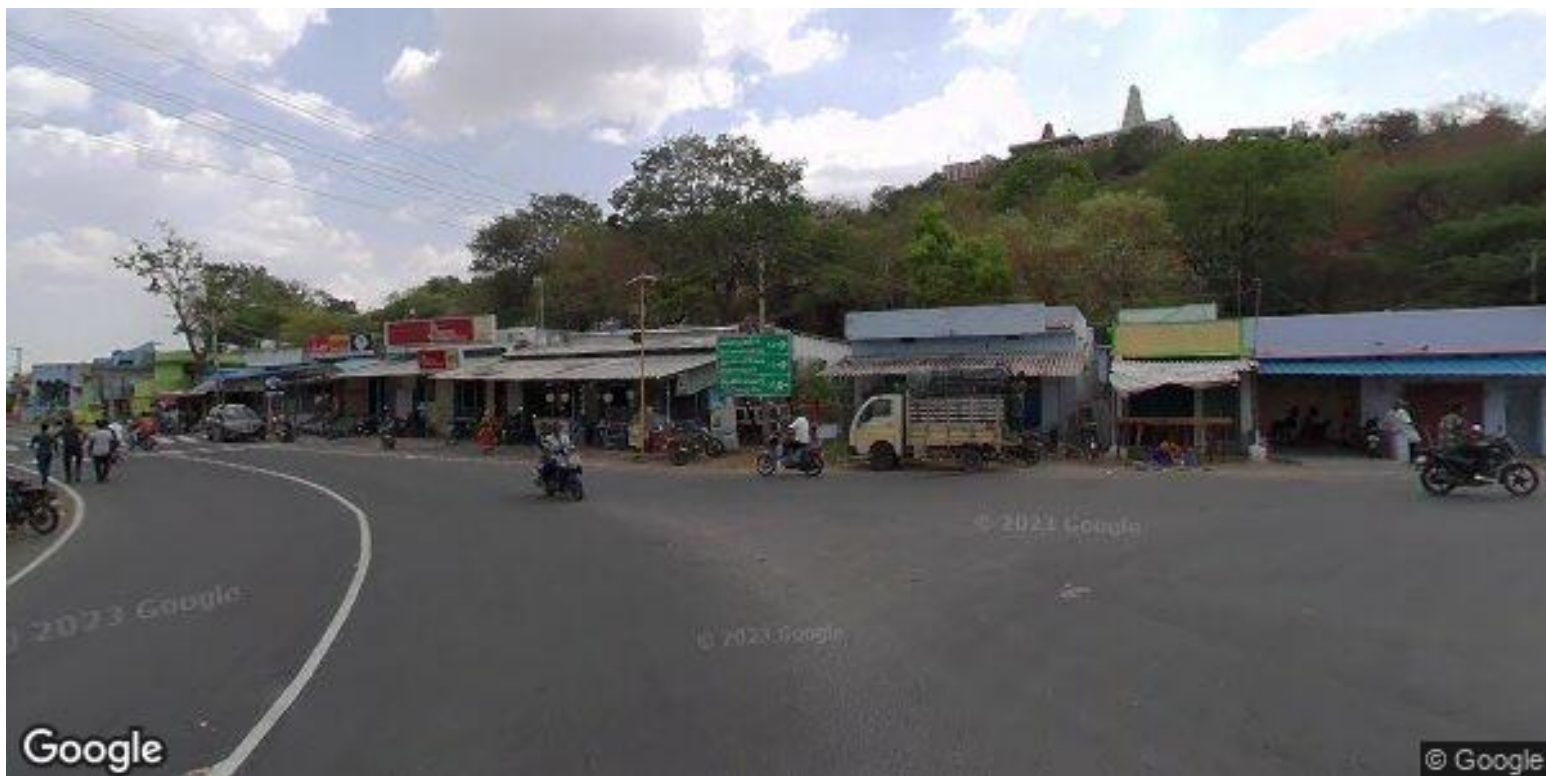
**Risk Type:** Turn  
**Risk Level:** High  
**Speed Limit:** 15 KM/Hr  
**Coordinates:** 11.41463, 78.08067

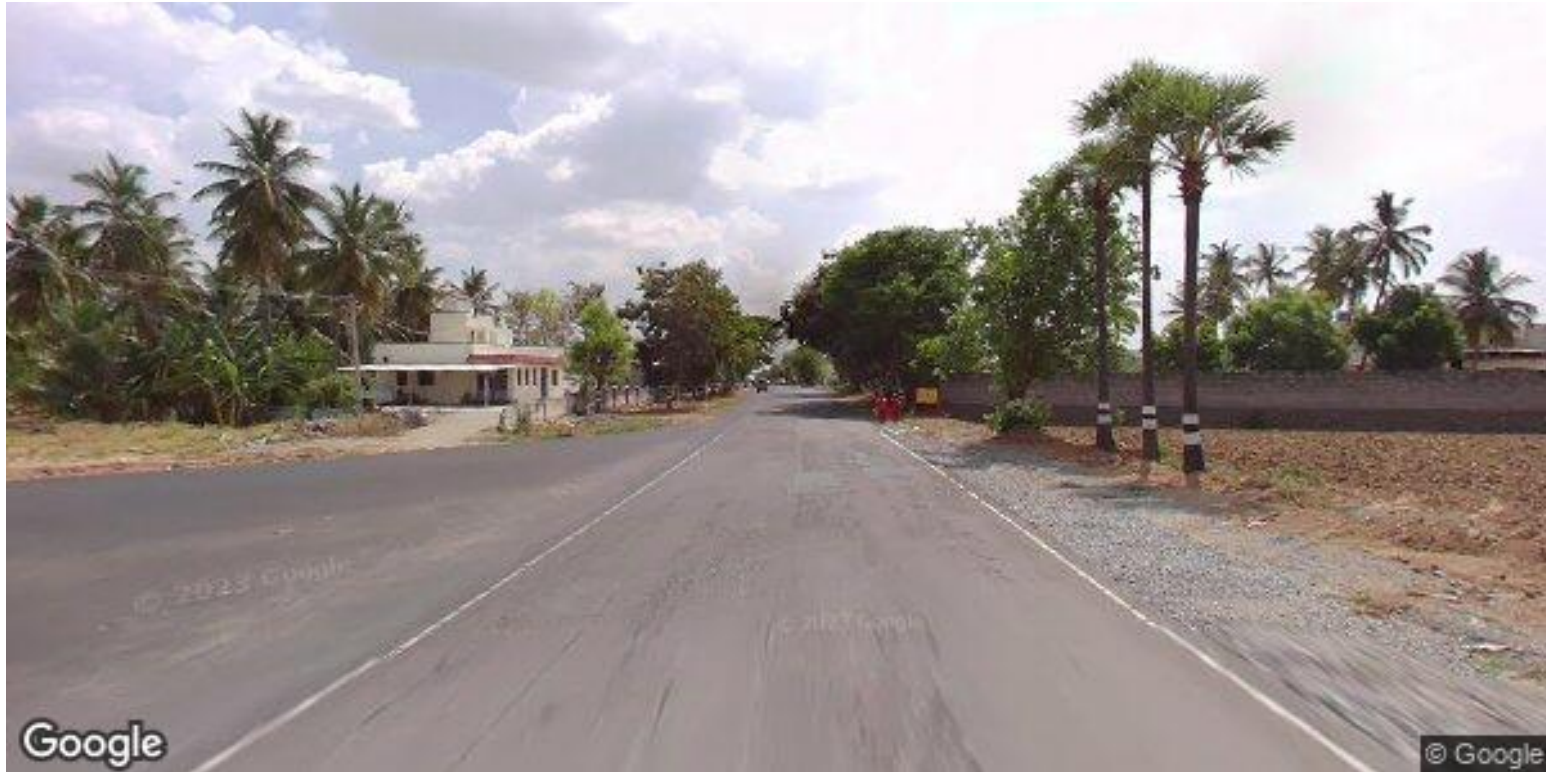
**Risk Type:** Turn  
**Risk Level:** High  
**Speed Limit:** 15 KM/Hr  
**Coordinates:** 11.42964, 78.11587

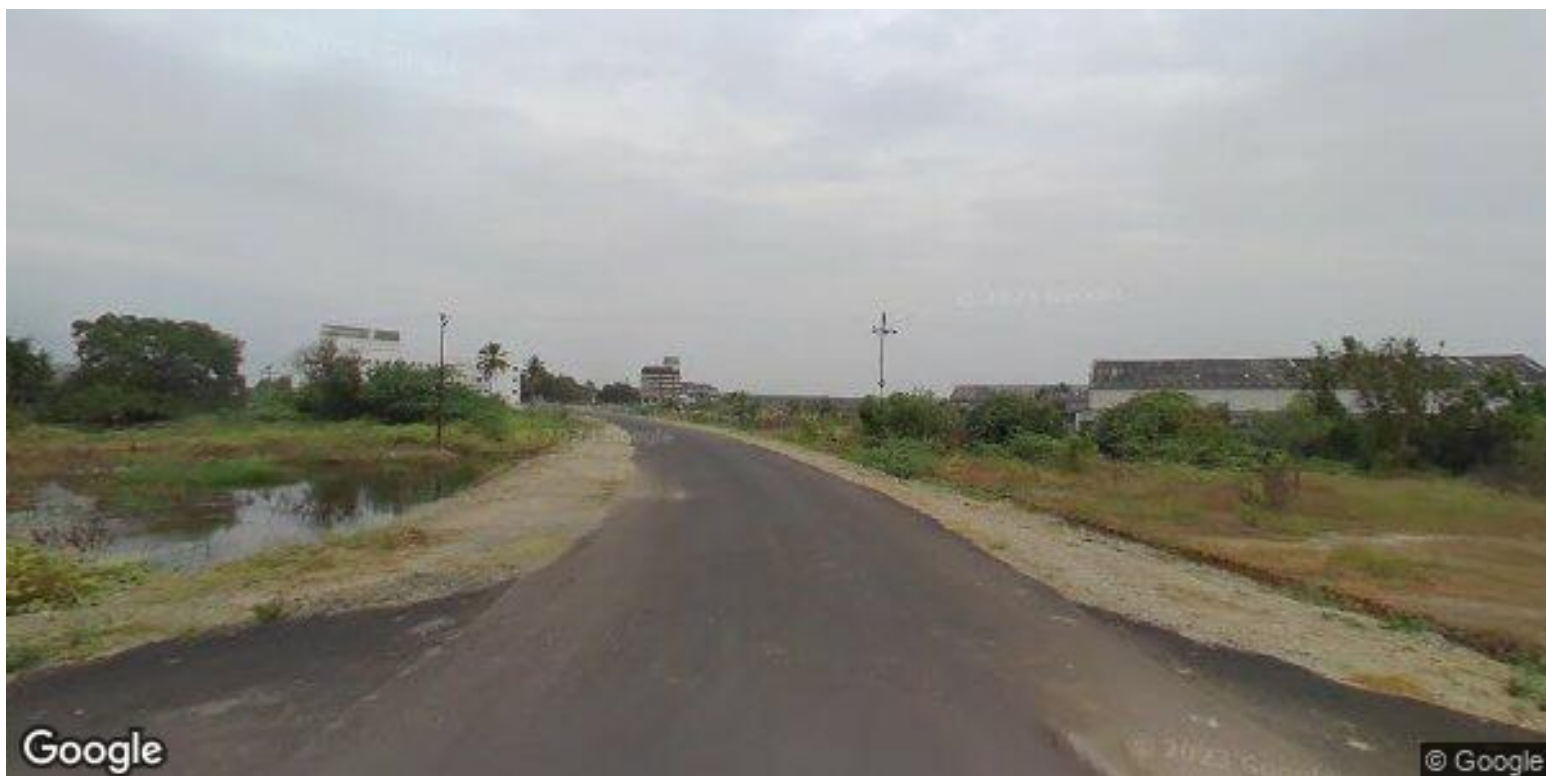
**Risk Type:** Turn  
**Risk Level:** Medium  
**Speed Limit:** 30 KM/Hr  
**Coordinates:** 11.42454, 78.15291

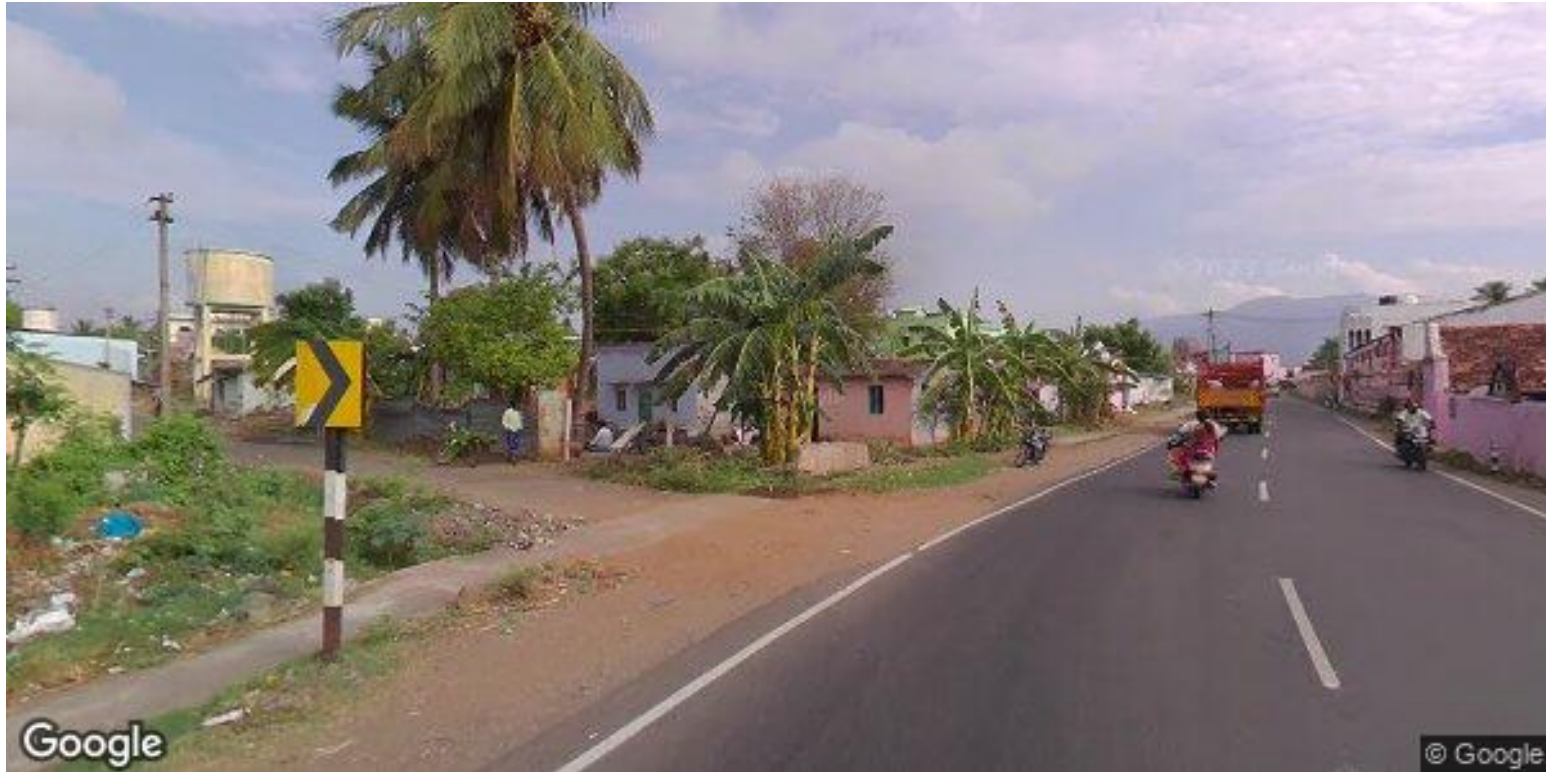
**Risk Type:** Turn  
**Risk Level:** Medium  
**Speed Limit:** 30 KM/Hr  
**Coordinates:** 11.44813, 78.22305

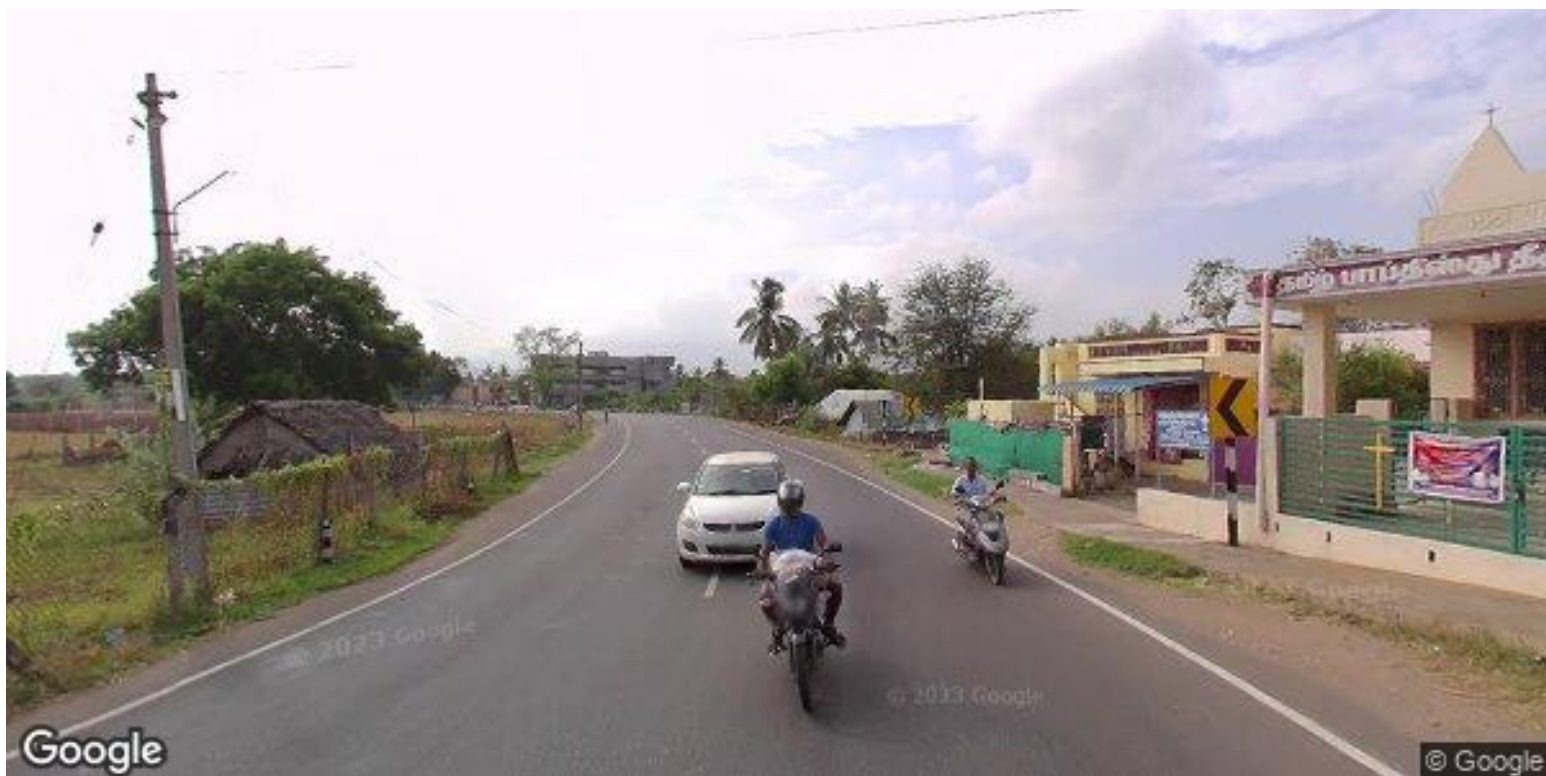
**Risk Type:** Turn  
**Risk Level:** Medium  
**Speed Limit:** 30 KM/Hr  
**Coordinates:** 11.44793, 78.22320

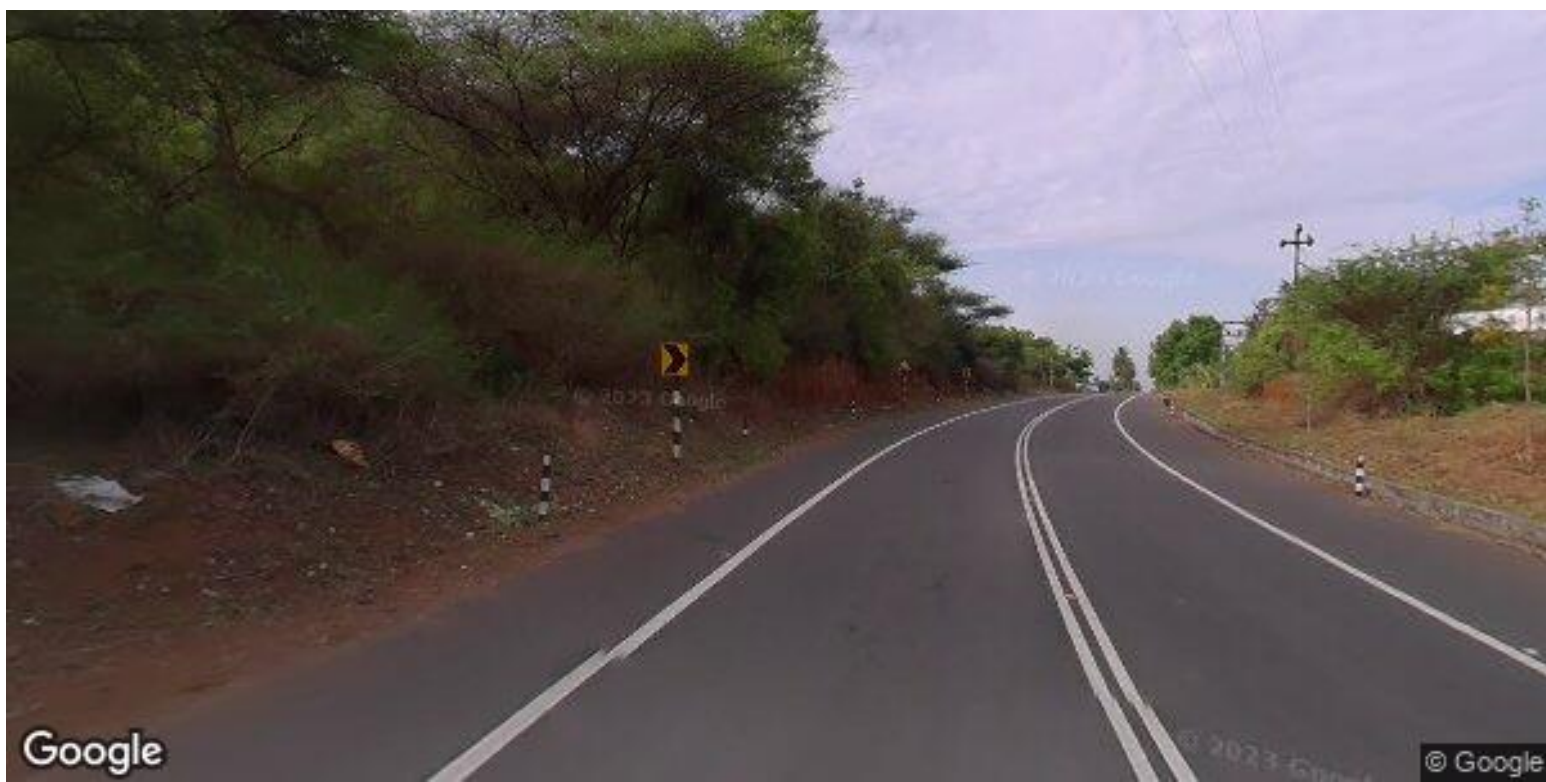
**Coordinates:** 11.49628, 78.32342

**Risk Type:** Turn

**Risk Level:** Medium

**Speed Limit:** 30 KM/Hr

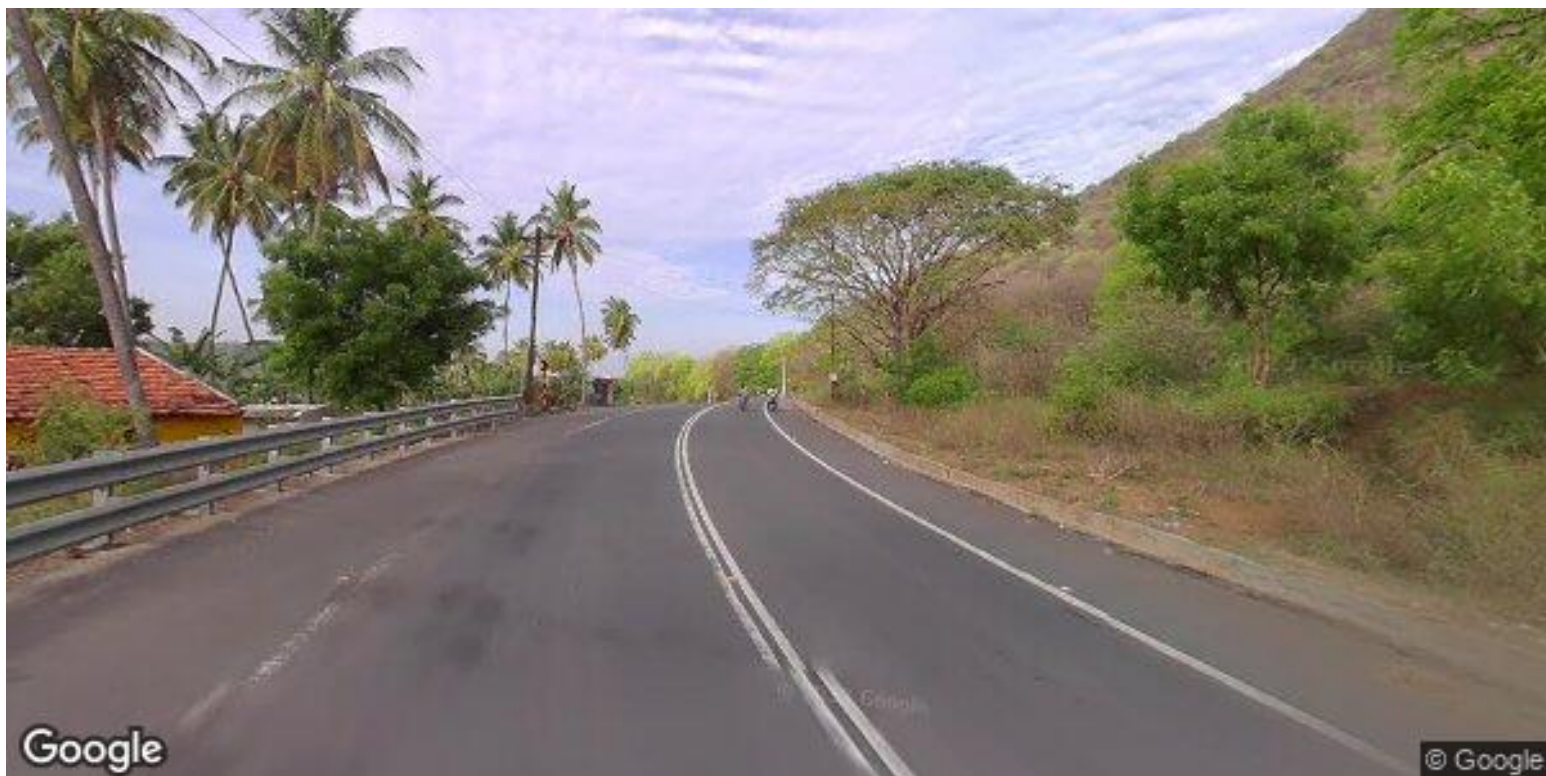
**Coordinates:** 11.50497, 78.33079

**Risk Type:** Turn

**Risk Level:** Medium

**Speed Limit:** 30 KM/Hr

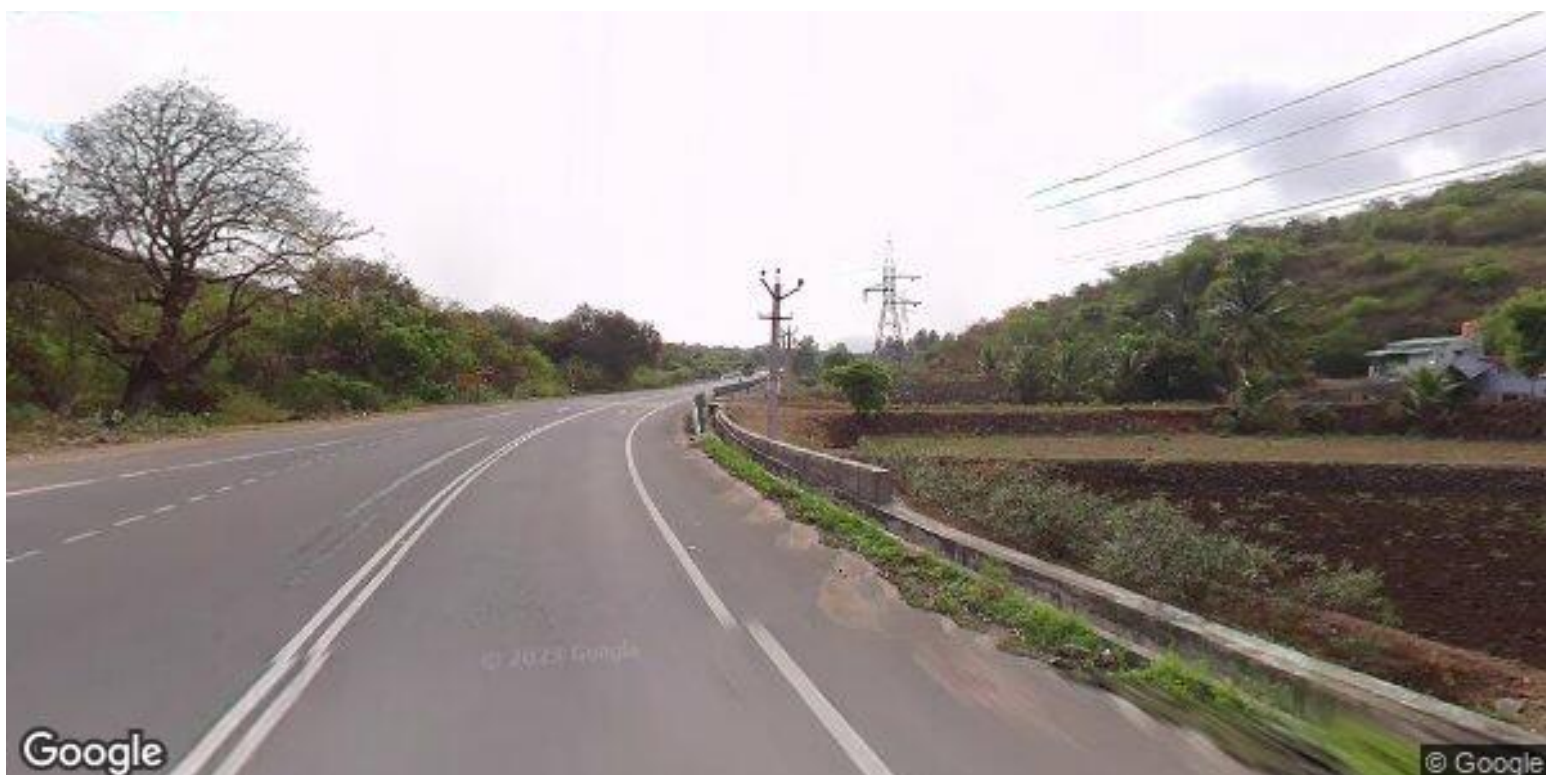
**Risk Type:** Turn  
**Risk Level:** Medium  
**Speed Limit:** 30 KM/Hr  
**Coordinates:** 11.50769, 78.33291

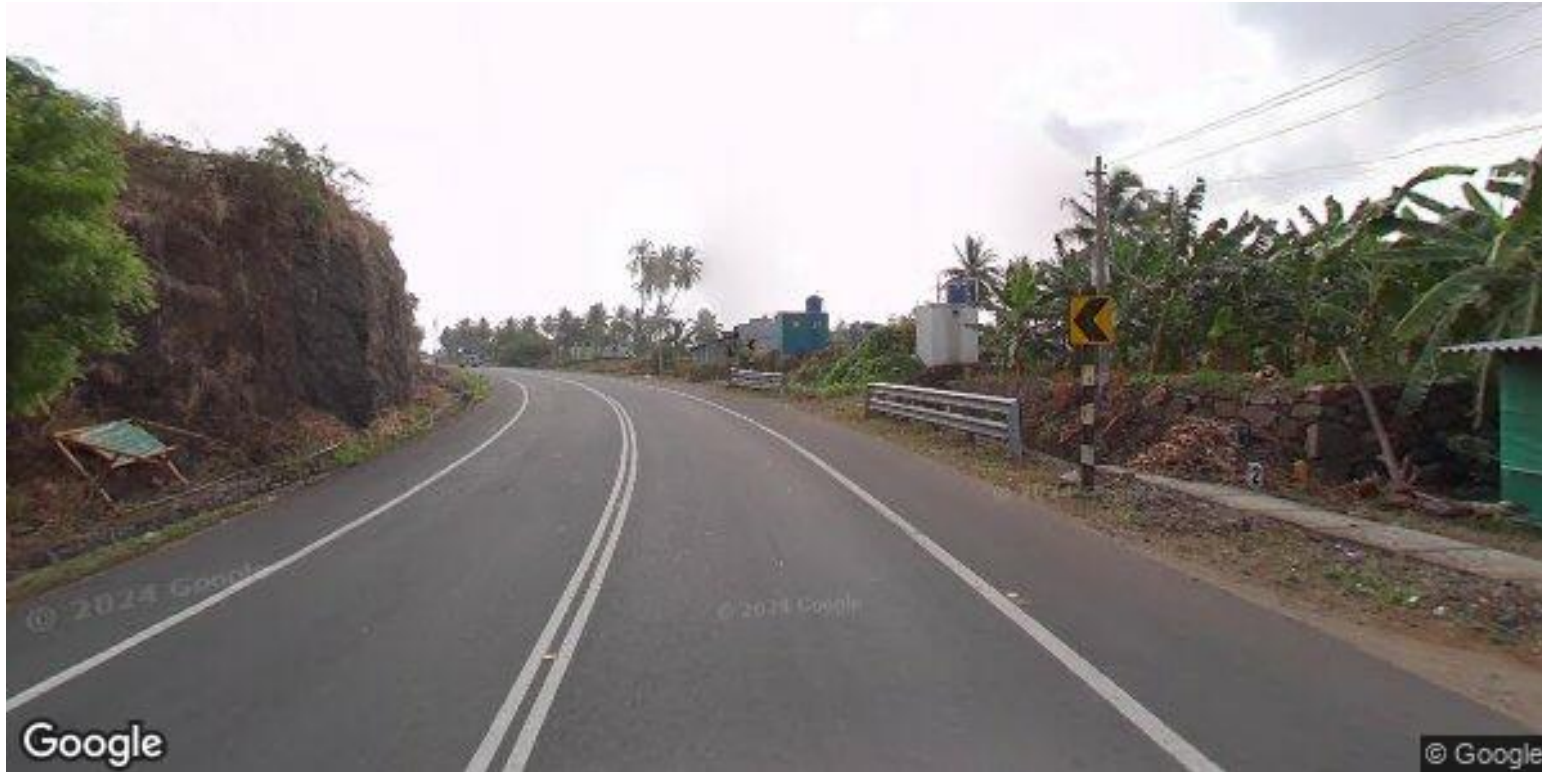
**Risk Type:** Turn  
**Risk Level:** Medium  
**Speed Limit:** 30 KM/Hr  
**Coordinates:** 11.50860, 78.33951

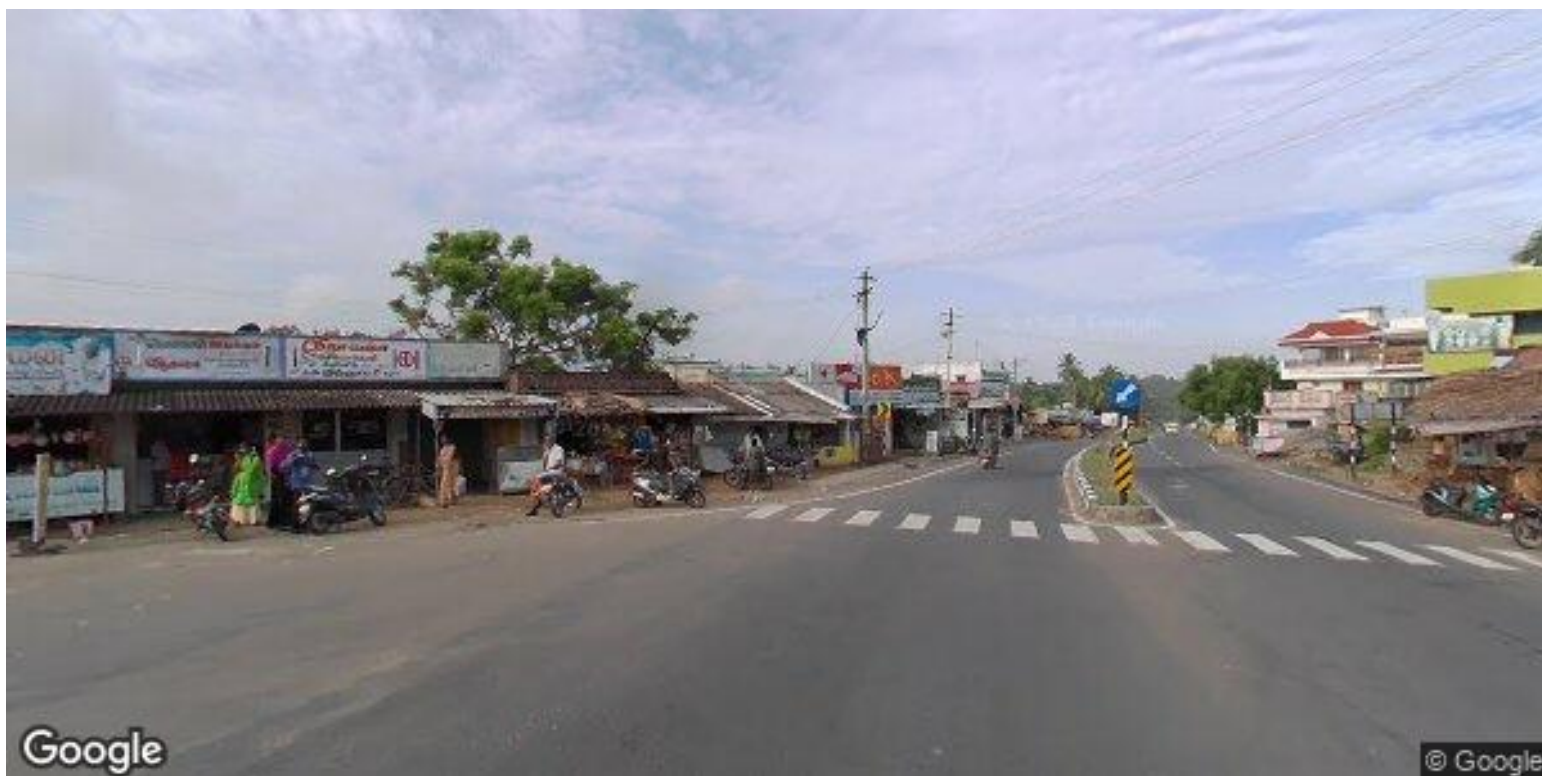
**Risk Type:** Turn  
**Risk Level:** High  
**Speed Limit:** 15 KM/Hr  
**Coordinates:** 11.51180, 78.34422
