# IndianOil

## JOURNEY RISK MANAGEMENT (JRM) STUDY

### Salem Terminal to N.P.AGENCY

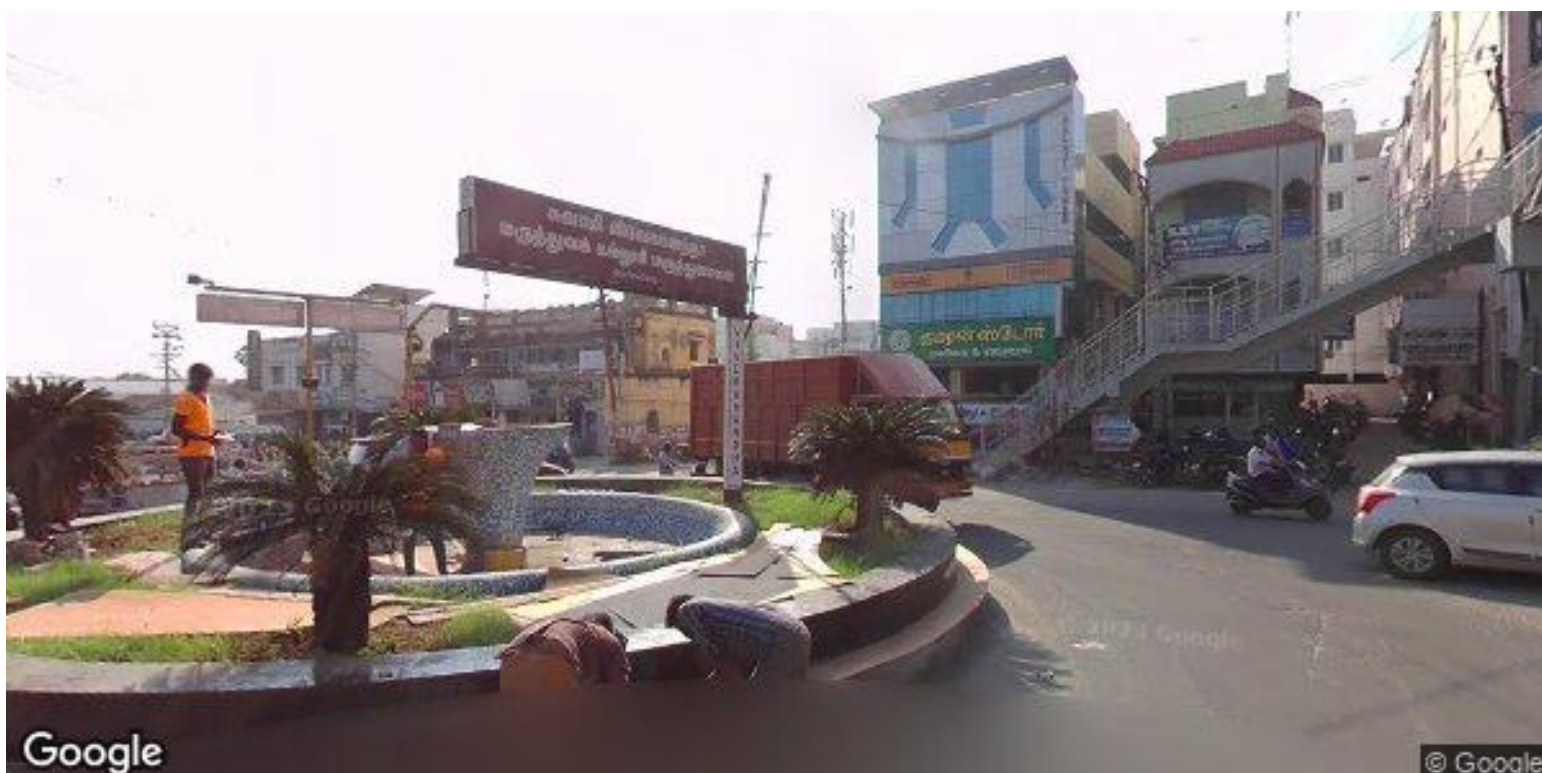
**Risk Type:** Roundabout

**Risk Level:** High

**Speed Limit: 15 KM/Hr**  
**Coordinates: 11.38395, 77.89480**

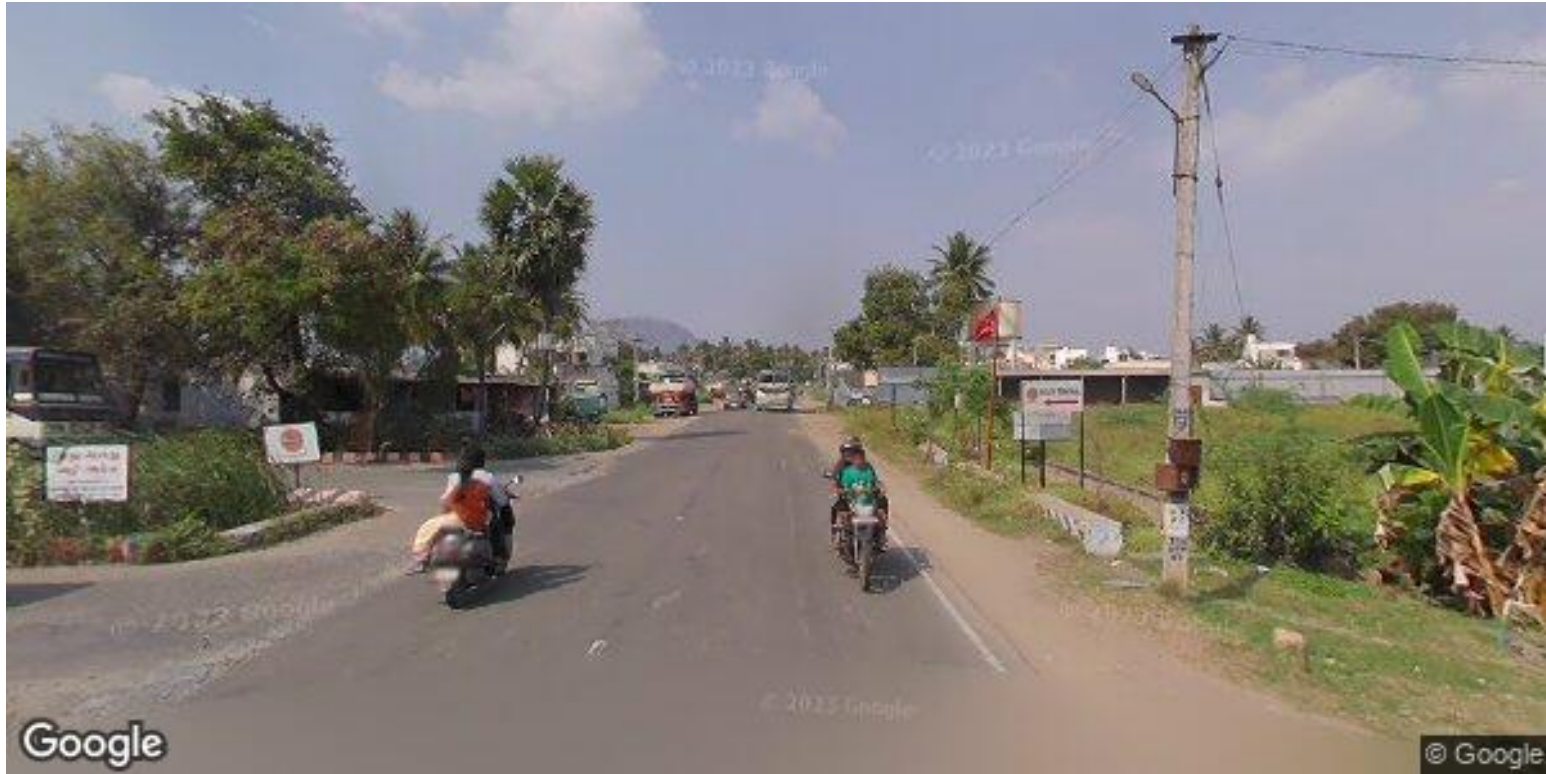
**Risk Type: Turn**  
**Risk Level: High**  
**Speed Limit: 15 KM/Hr**  
**Coordinates: 11.44019, 77.87547**

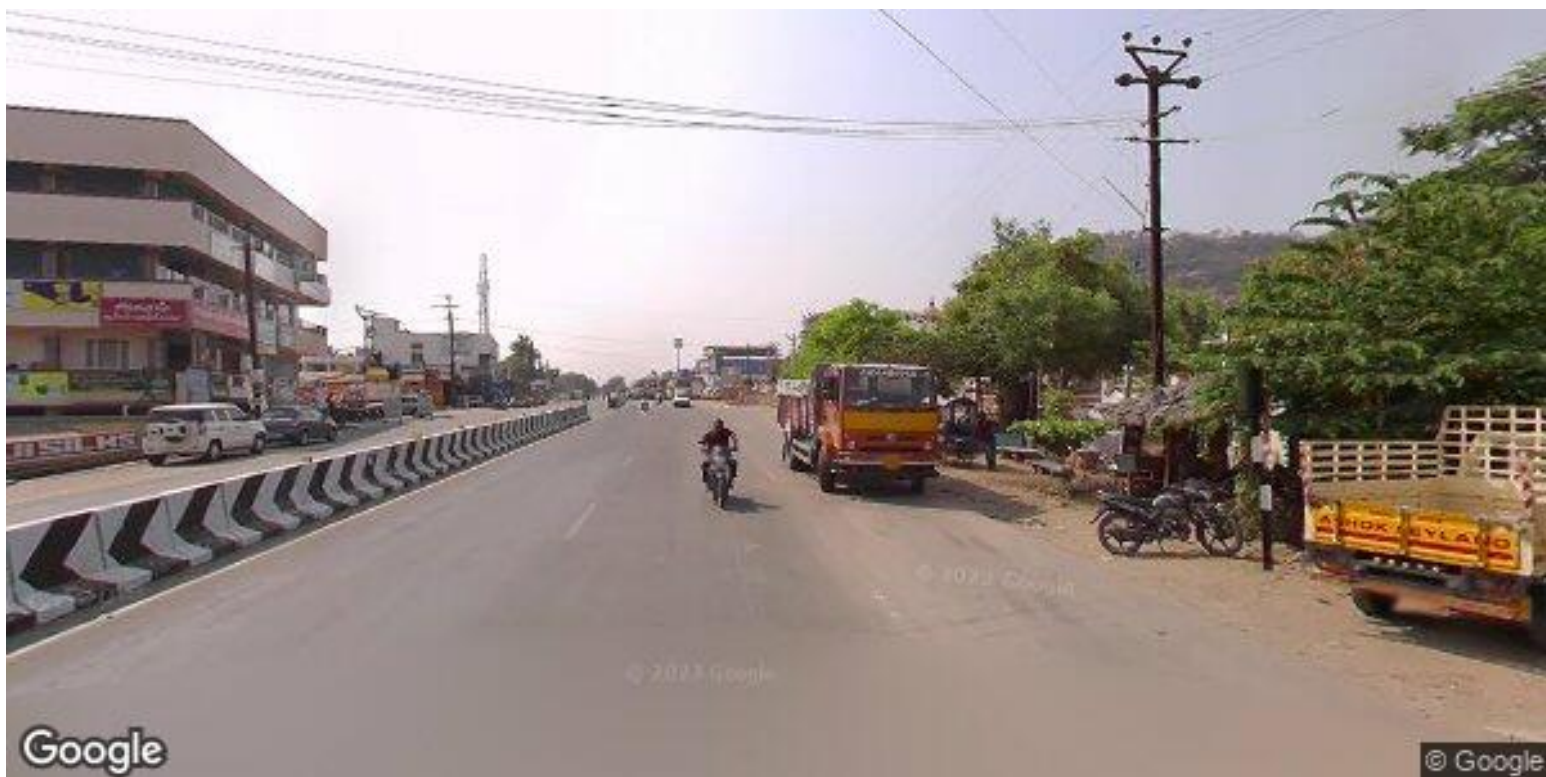
**Risk Type: Turn**  
**Risk Level: Medium**  
**Speed Limit: 30 KM/Hr**  
**Coordinates: 11.39685, 77.88861**

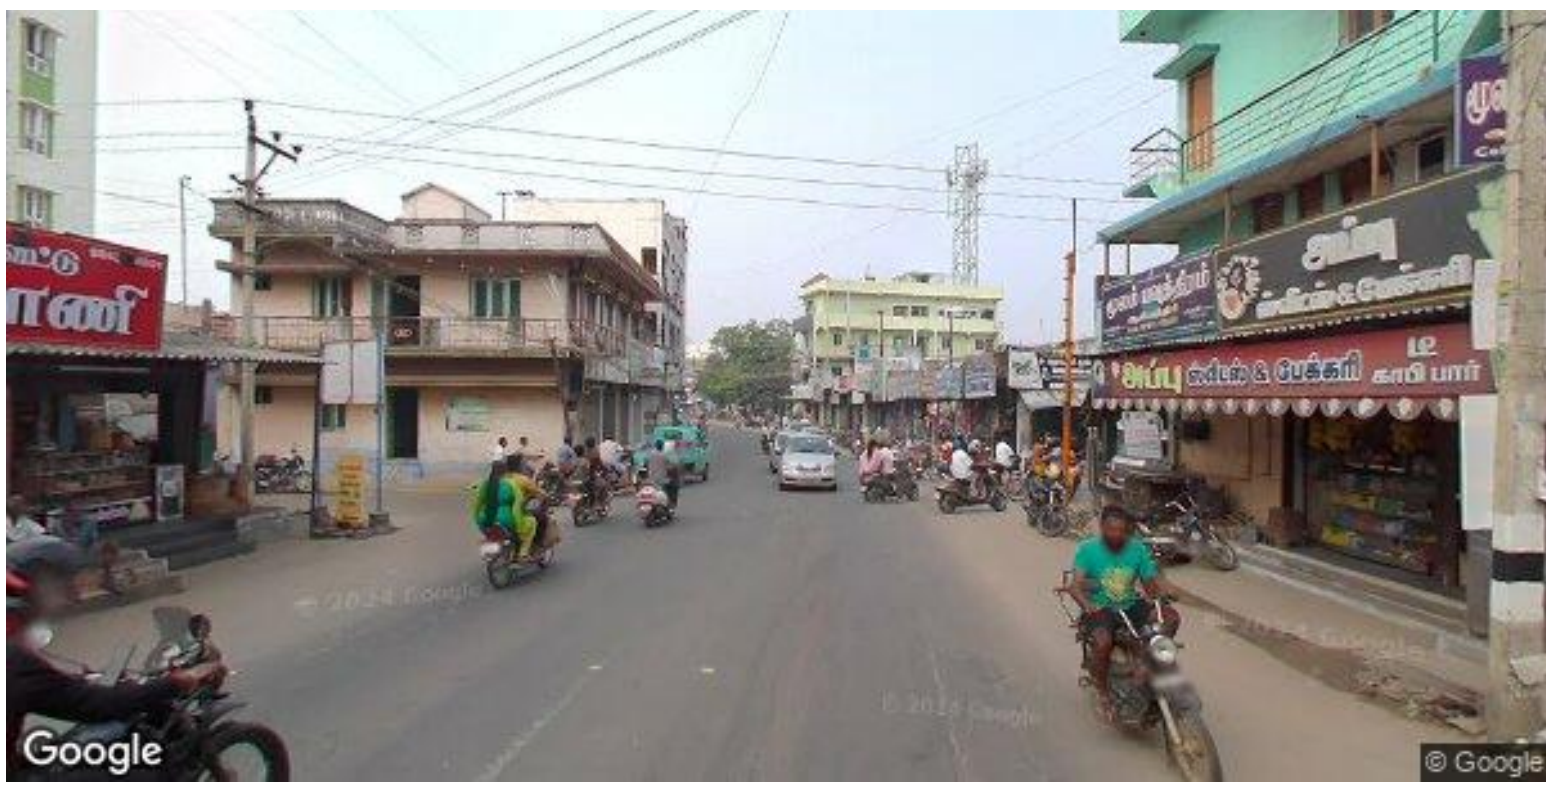
**Risk Type:** Turn

**Risk Level:** Medium

**Speed Limit:** 30 KM/Hr

**Coordinates:** 11.38376, 77.89914

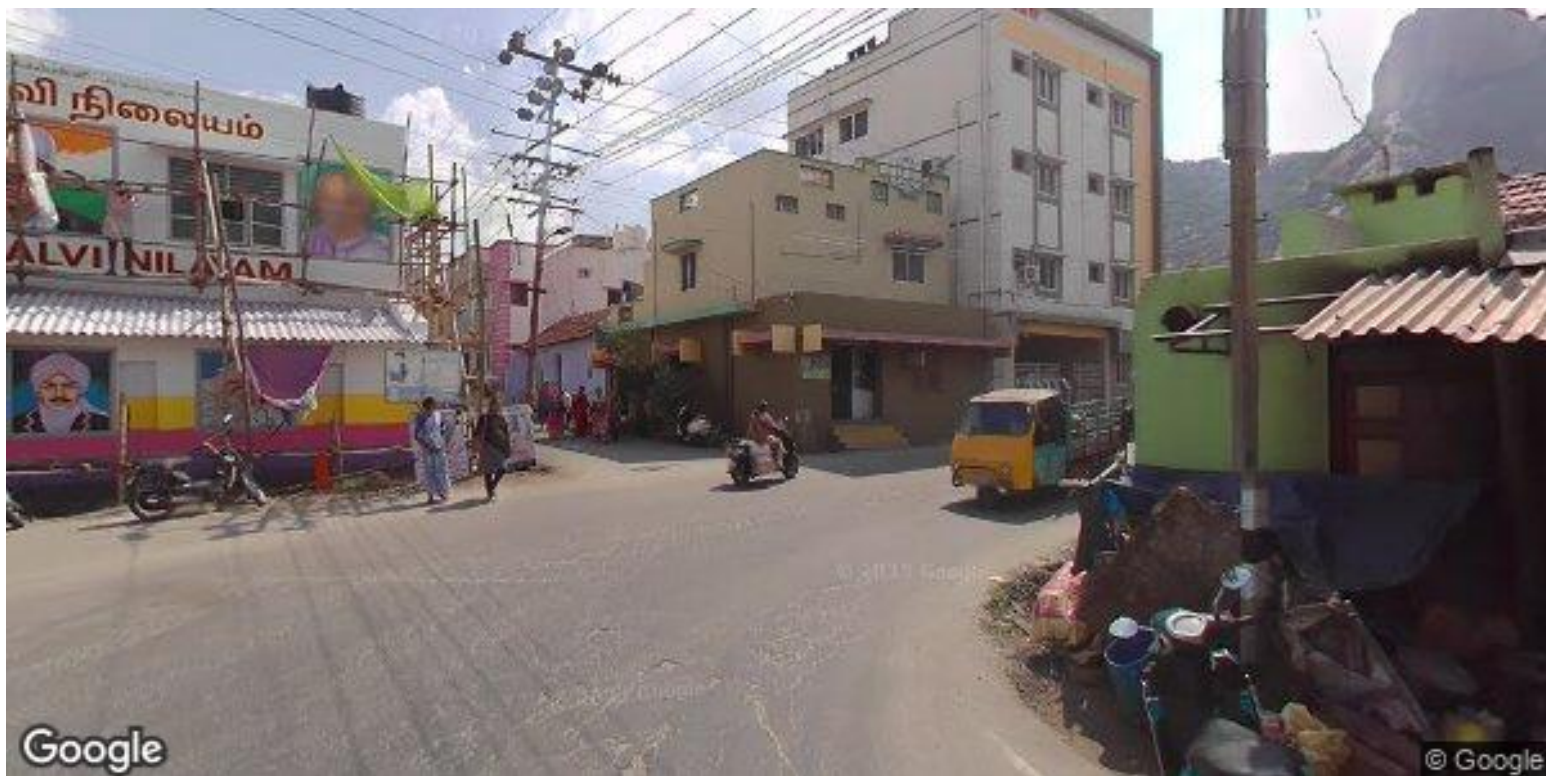
**Risk Type:** Turn

**Risk Level:** High

**Speed Limit:** 15 KM/Hr

**Coordinates:** 11.38186, 77.90258

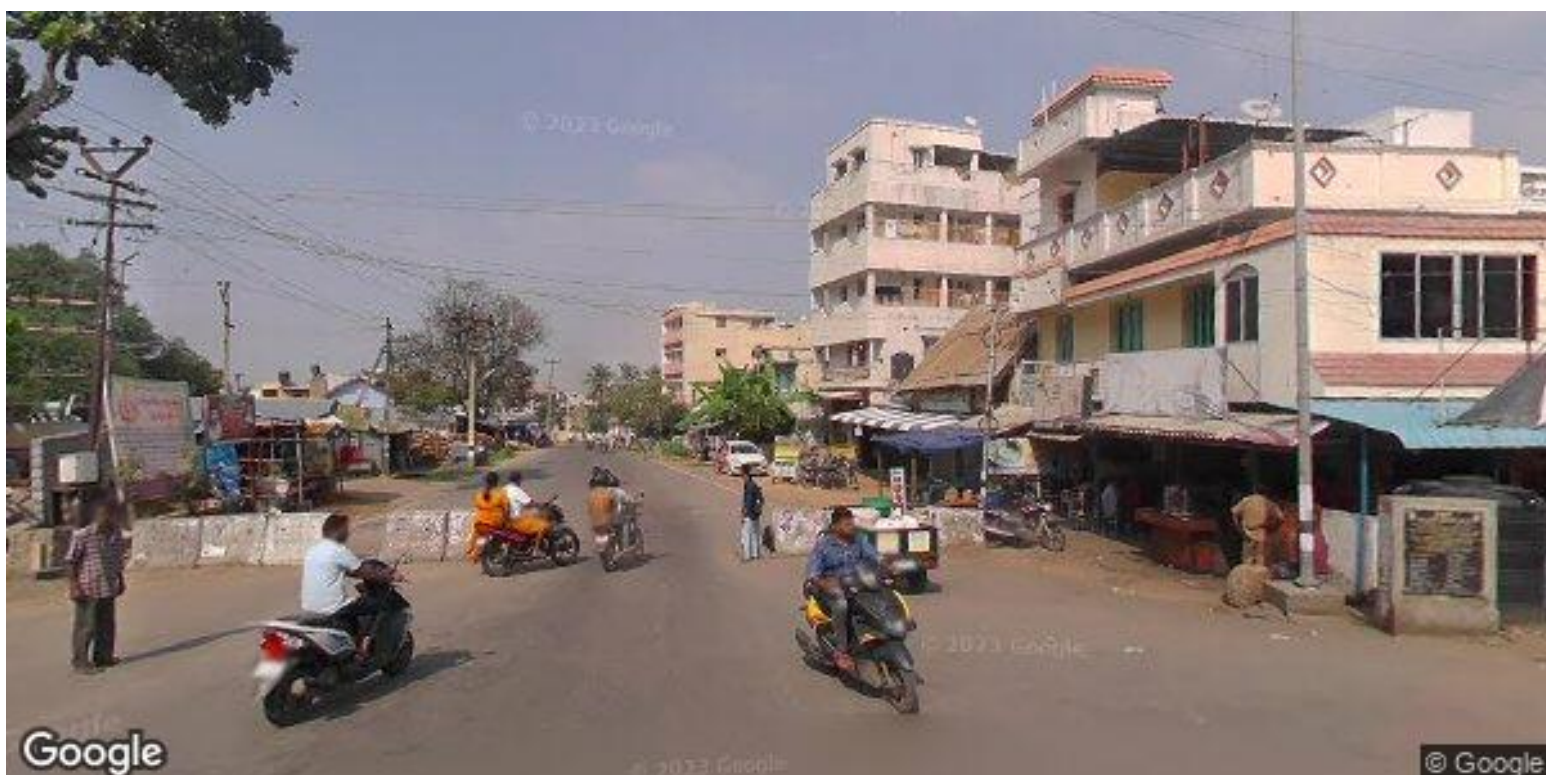
**Risk Type:** Blind Spot  
**Risk Level:** Blind Spot  
**Speed Limit:** 10 KM/Hr  
**Coordinates:** 11.37841, 77.90140

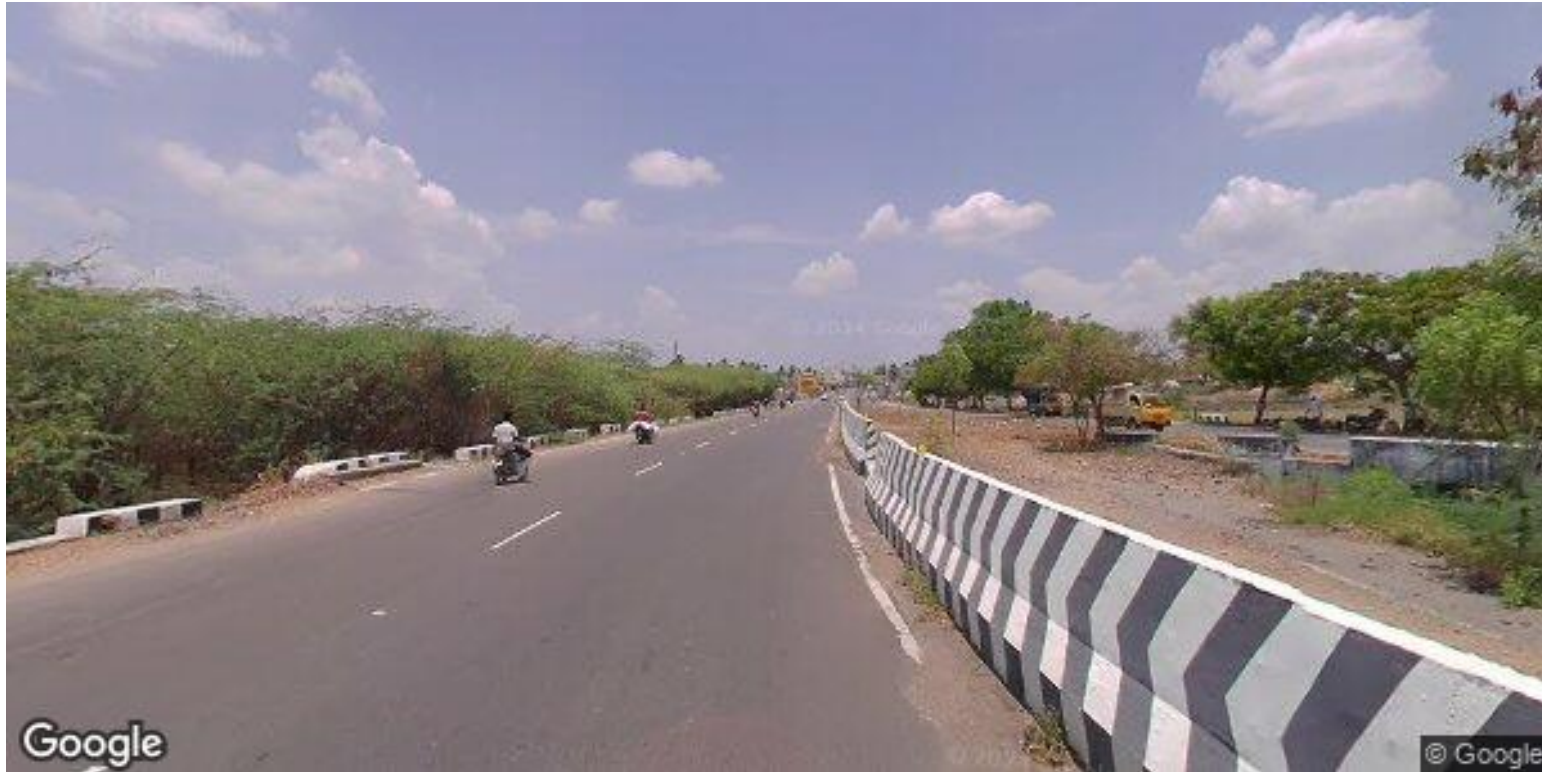
**Risk Type:** Turn  
**Risk Level:** Medium  
**Speed Limit:** 30 KM/Hr  
**Coordinates:** 11.33425, 78.00843

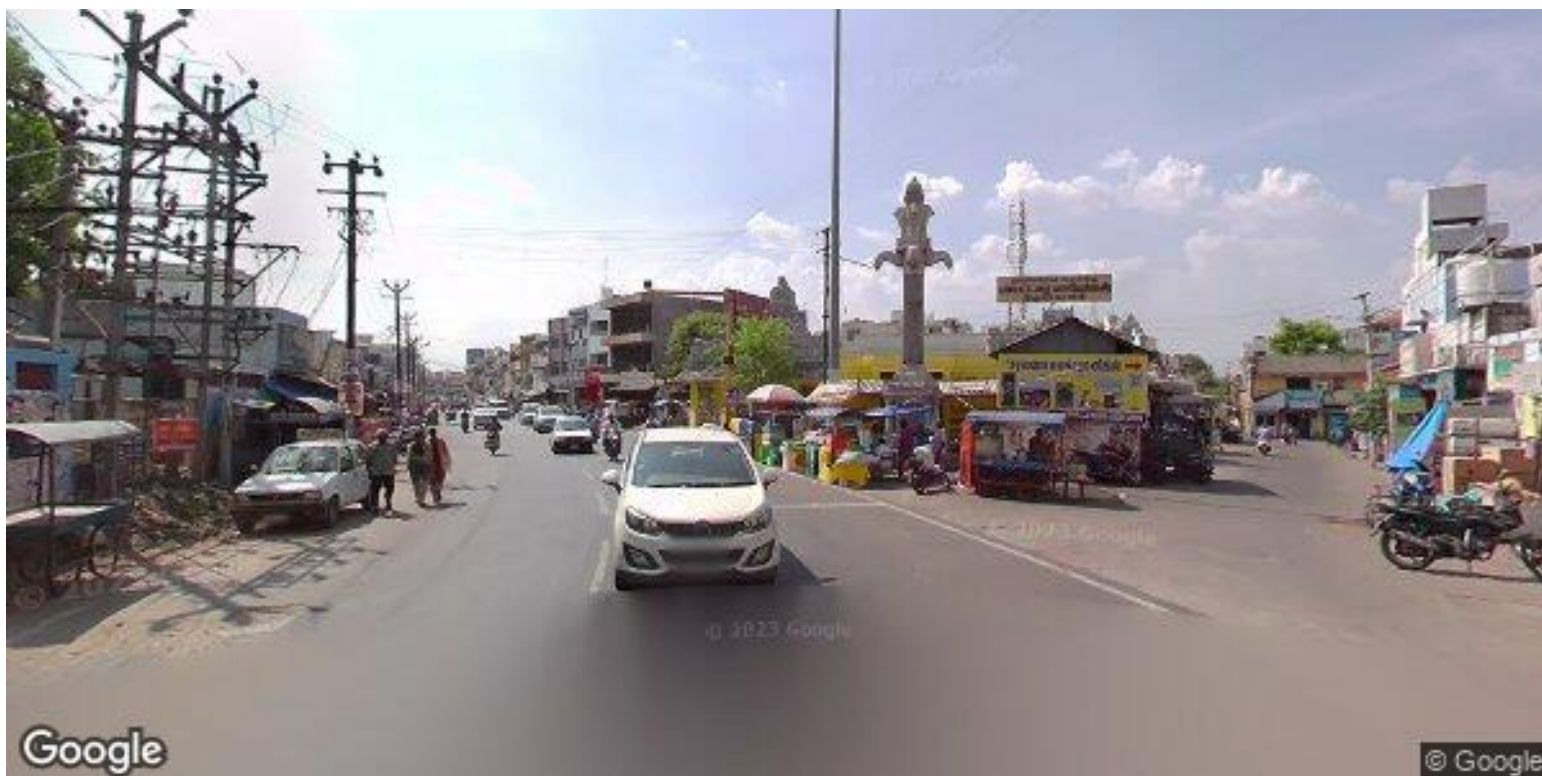
**Risk Type:** Turn  
**Risk Level:** Medium  
**Speed Limit:** 30 KM/Hr  
**Coordinates:** 11.22411, 78.16637

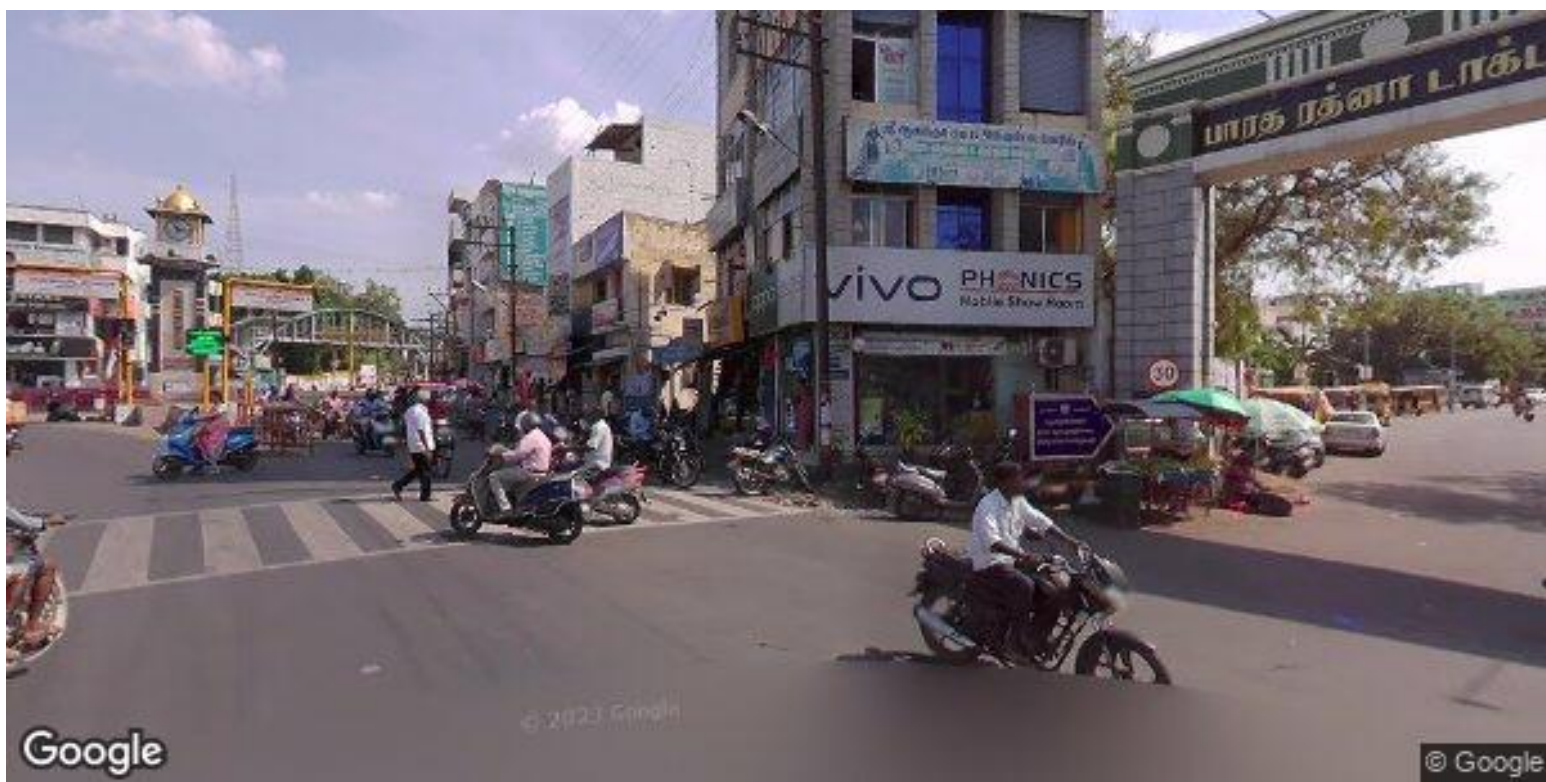
**Risk Type:** Turn

**Risk Level:** Medium

**Speed Limit:** 30 KM/Hr

**Coordinates:** 11.21992, 78.16759

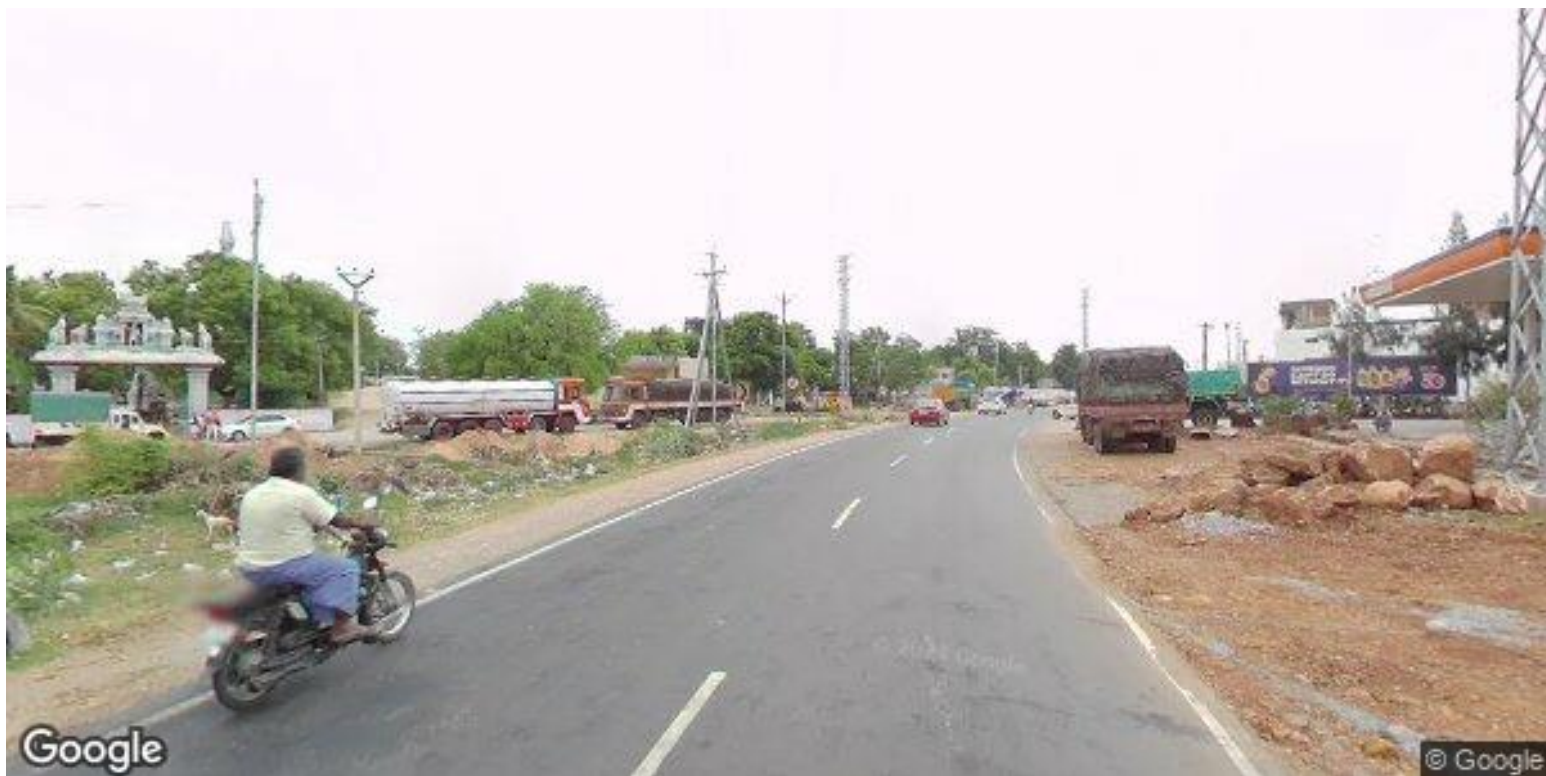
**Risk Type:** Turn

**Risk Level:** Medium

**Speed Limit:** 30 KM/Hr

**Coordinates:** 11.12316, 78.23249

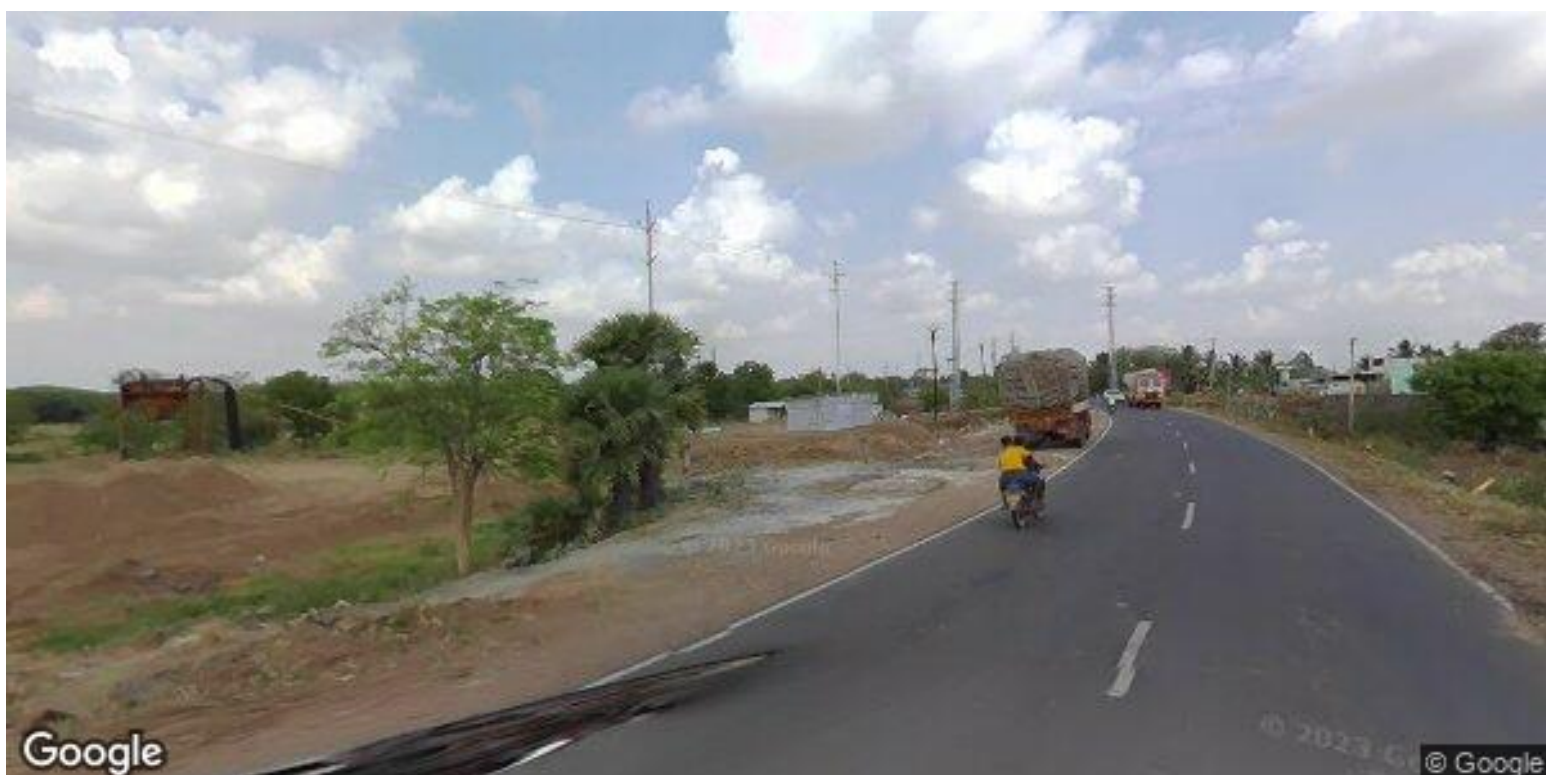
**Risk Type:** Turn

**Risk Level:** Medium

**Speed Limit:** 30 KM/Hr

**Coordinates:** 11.12001, 78.23557

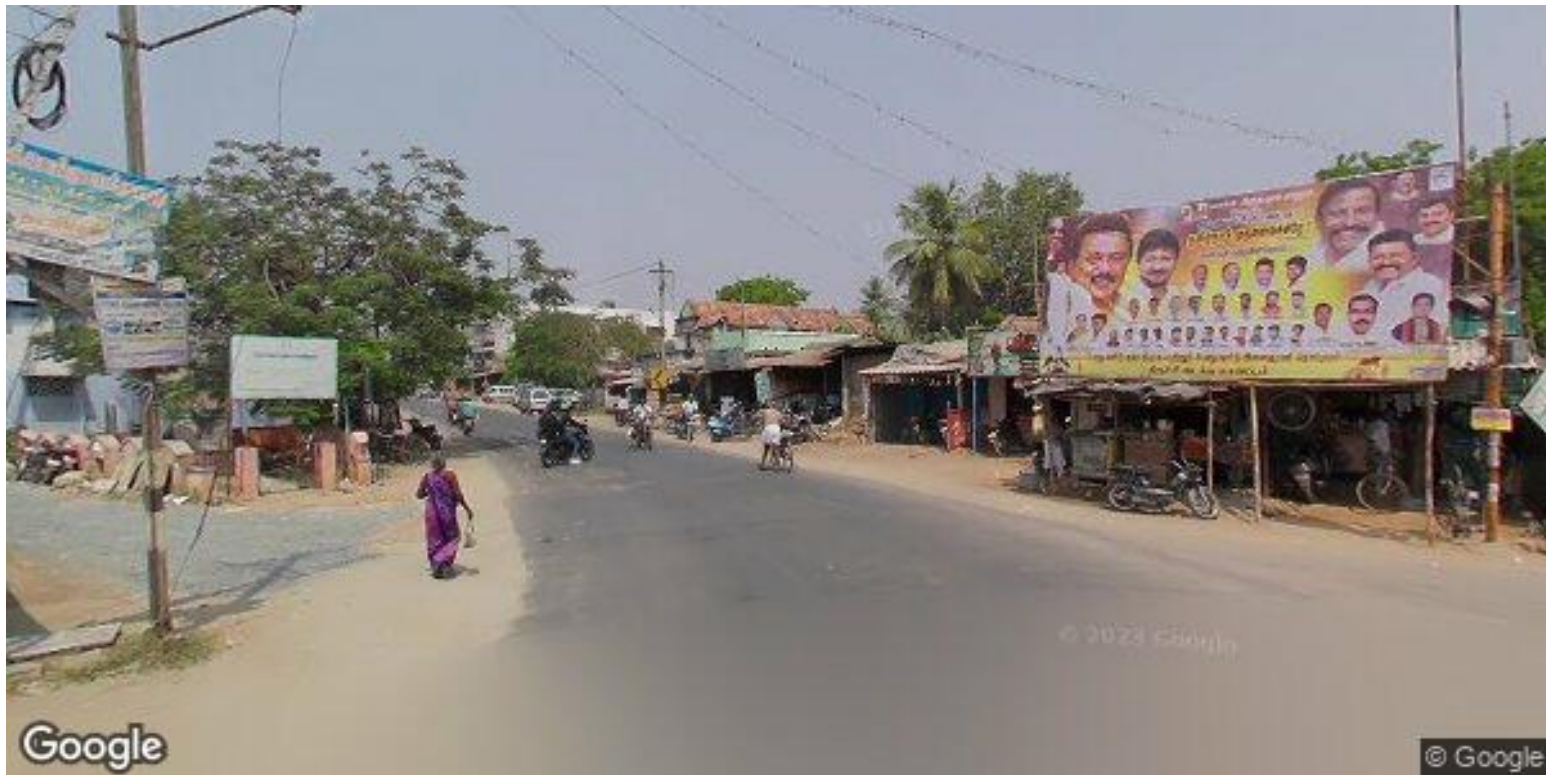
**Risk Type:** Turn

**Risk Level:** Medium

**Speed Limit:** 30 KM/Hr

**Coordinates:** 10.98686, 78.33767

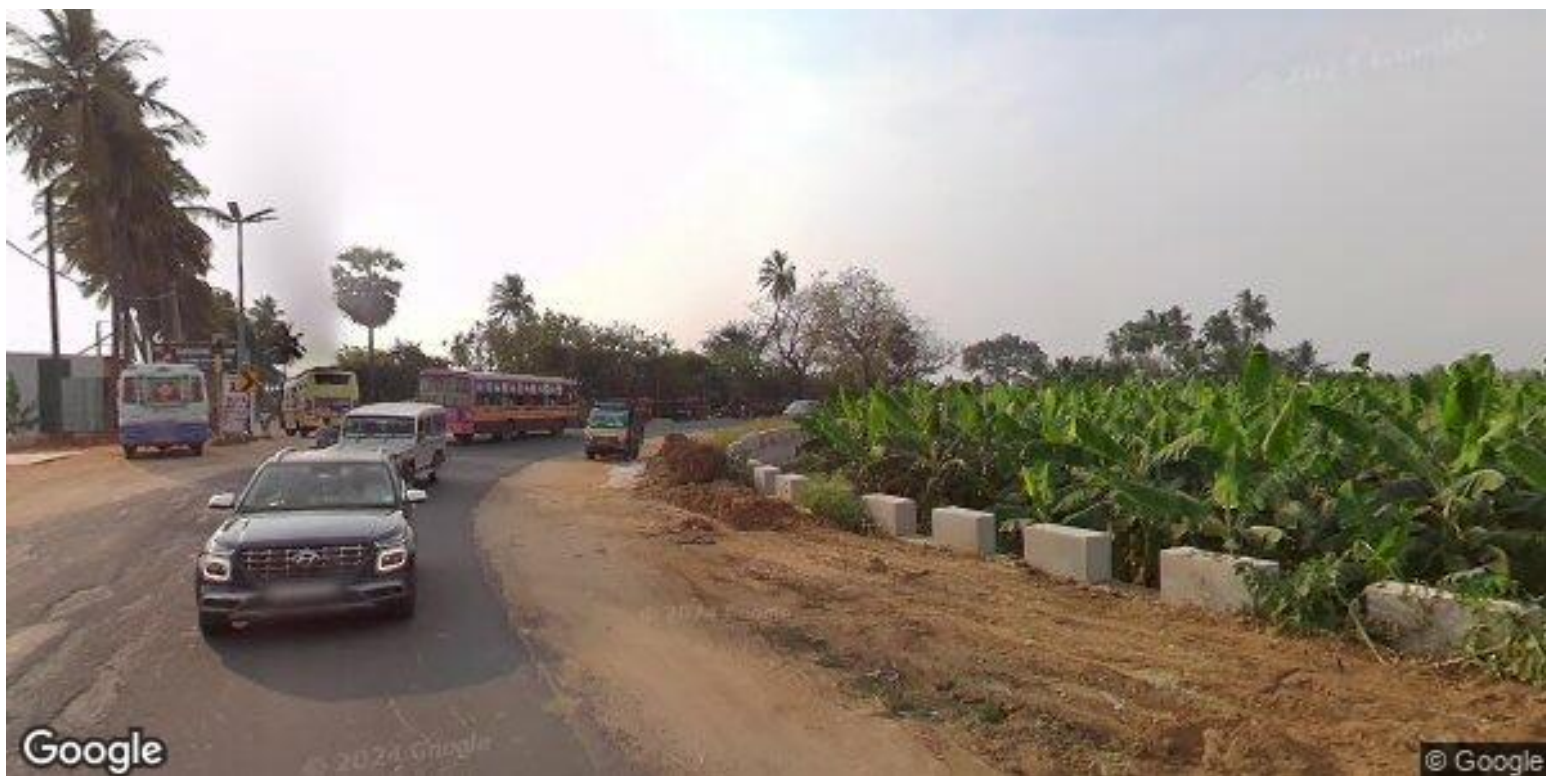
**Risk Type:** Turn

**Risk Level:** Medium

**Speed Limit:** 30 KM/Hr

**Coordinates:** 10.97256, 78.34408

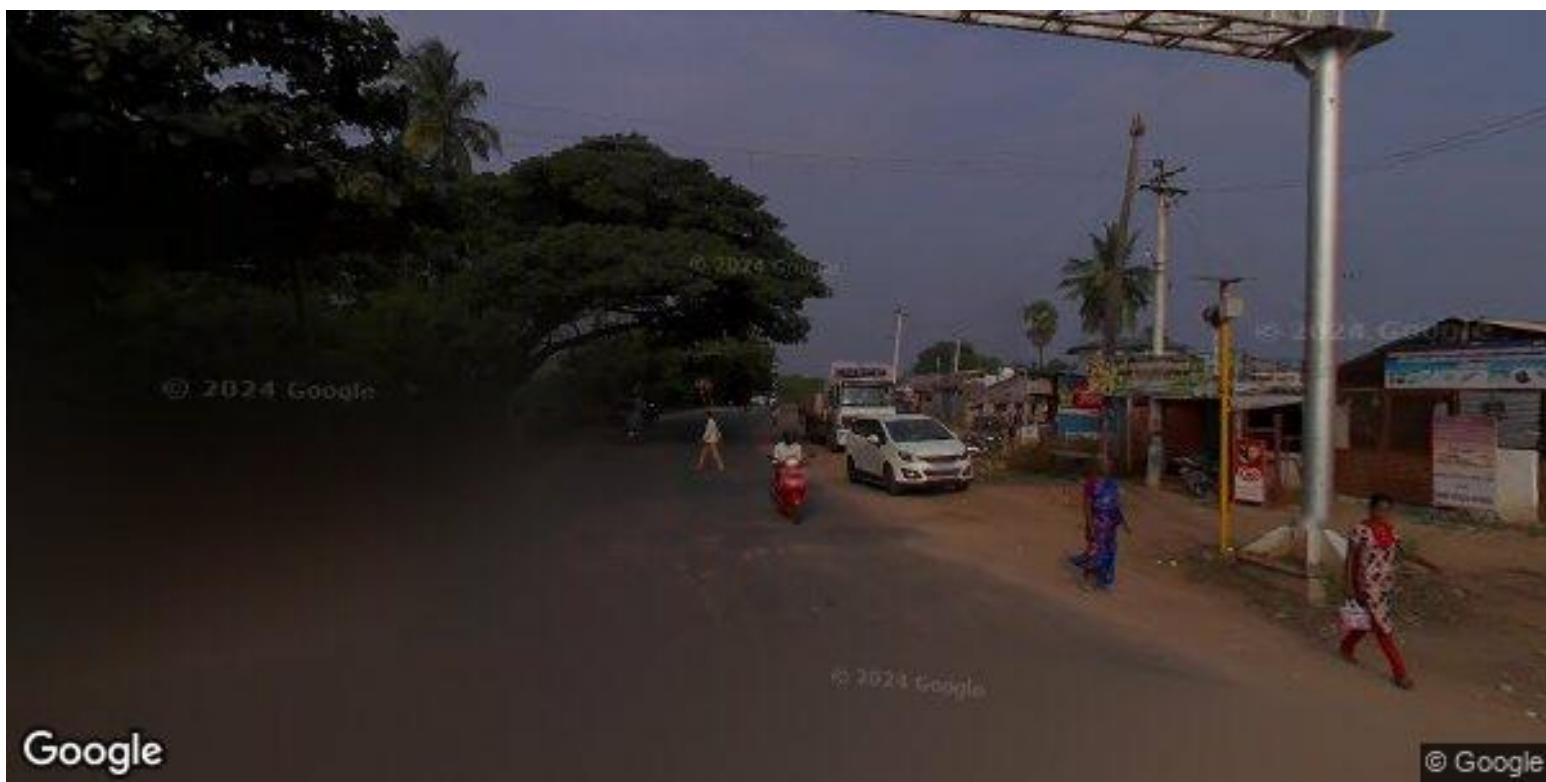
**Risk Type:** Turn

**Risk Level:** High

**Speed Limit:** 15 KM/Hr

**Coordinates:** 10.96031, 78.42222

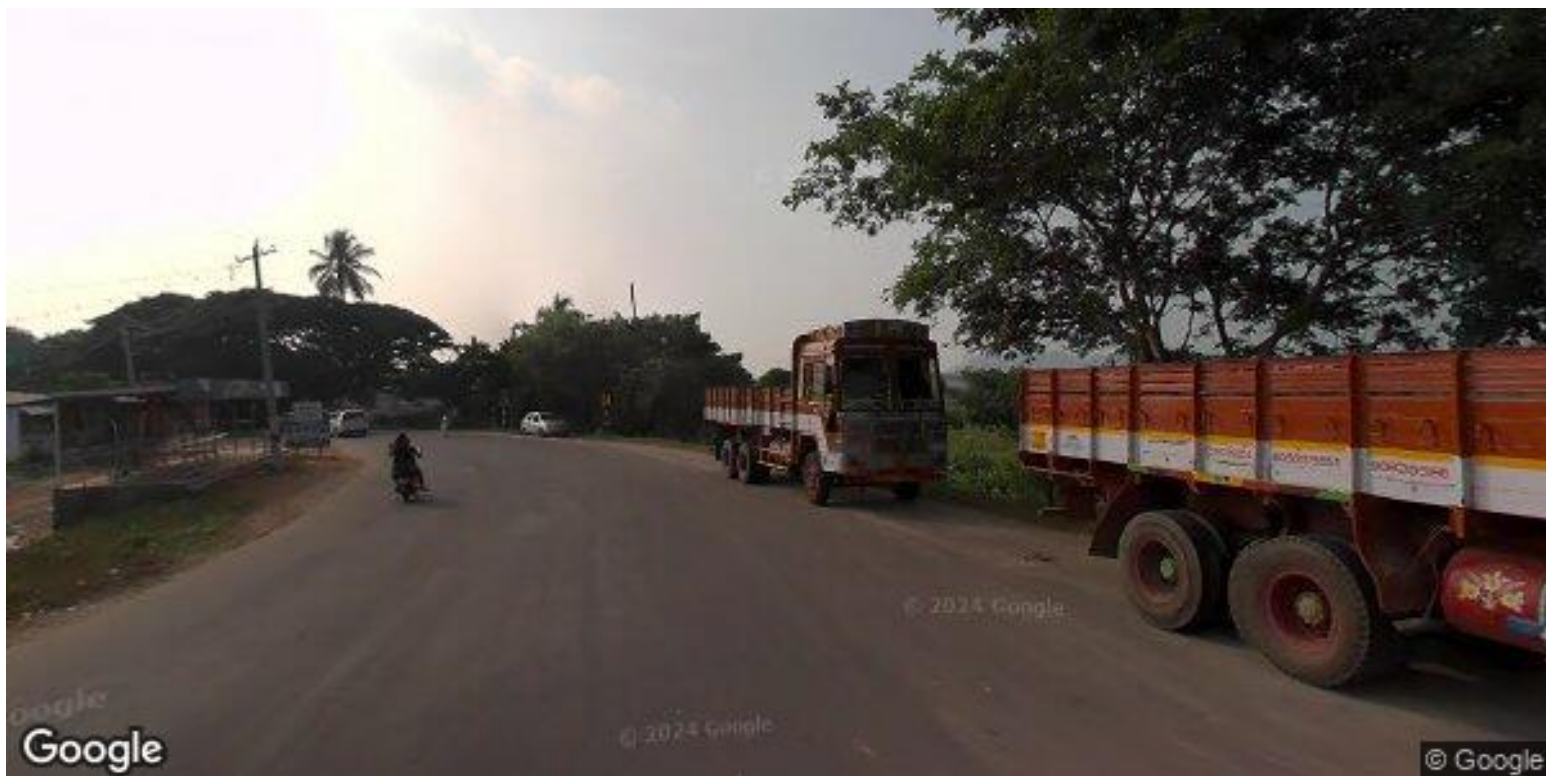
**Risk Type:** Turn

**Risk Level:** High

**Speed Limit:** 15 KM/Hr

**Coordinates:** 10.96084, 78.42307

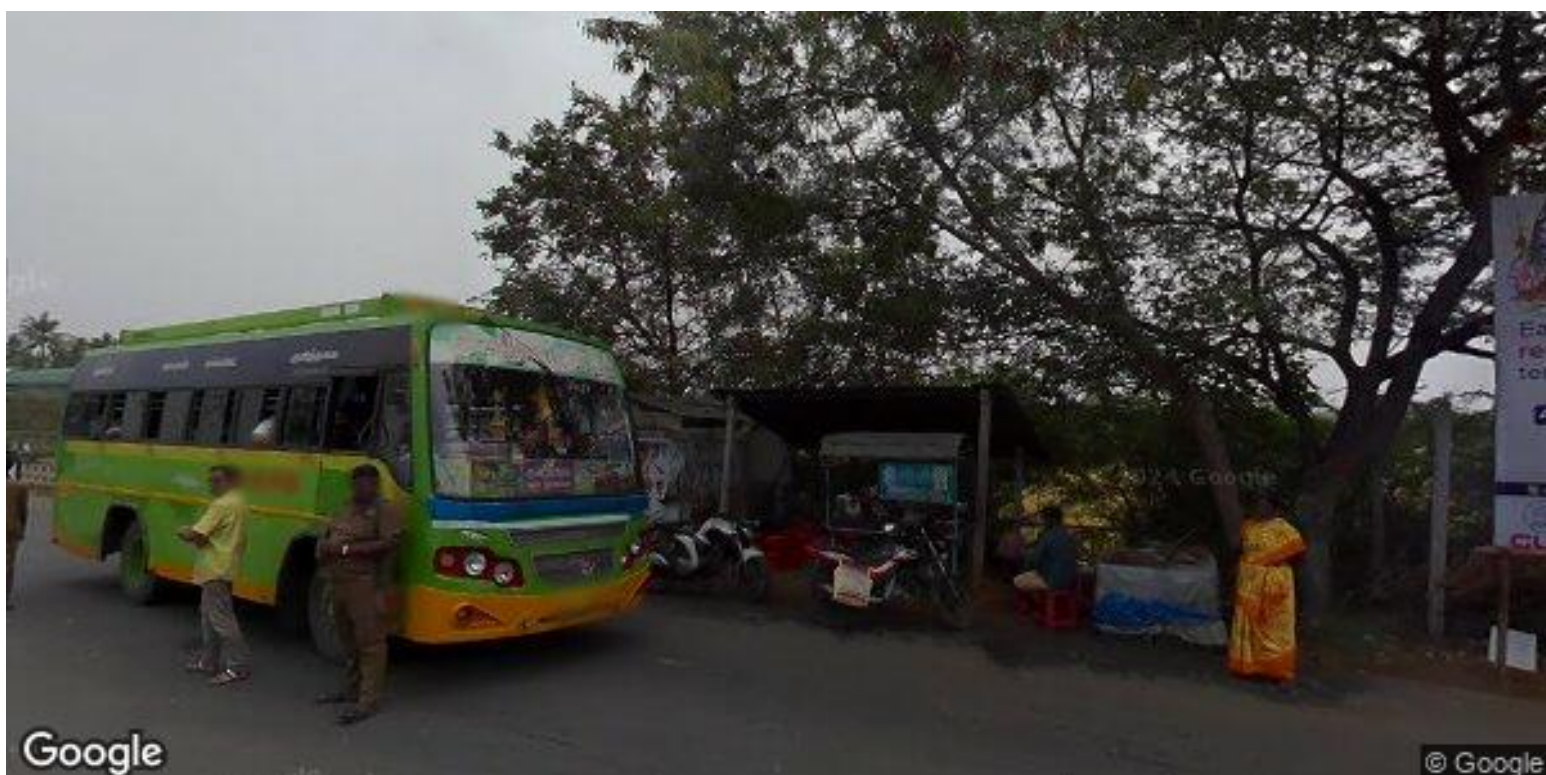
**Risk Type:** Blind Spot  
**Risk Level:** Blind Spot  
**Speed Limit:** 10 KM/Hr  
**Coordinates:** 10.96050, 78.42371

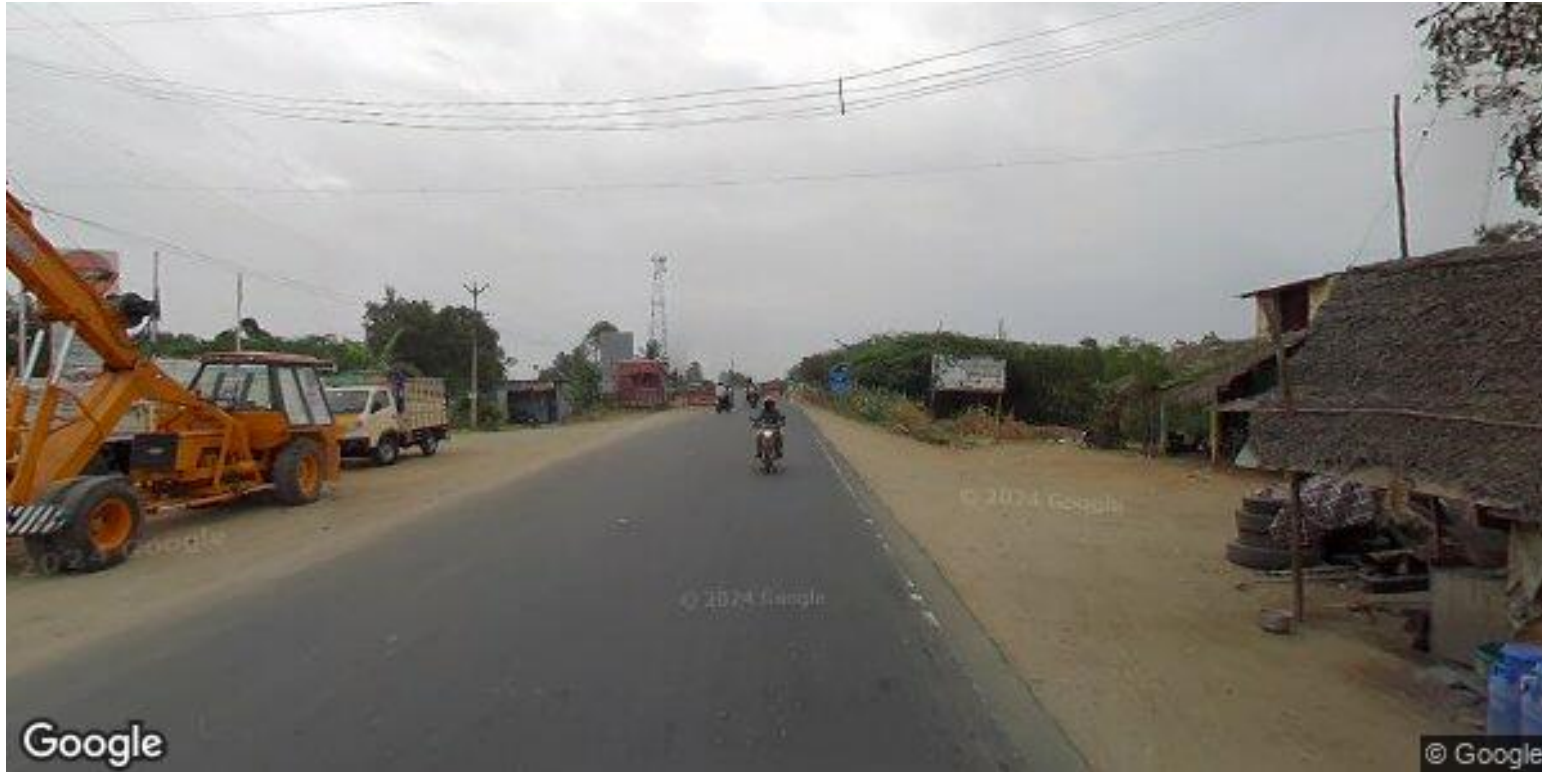
**Risk Type:** Blind Spot  
**Risk Level:** Blind Spot  
**Speed Limit:** 10 KM/Hr  
**Coordinates:** 10.94455, 78.41419

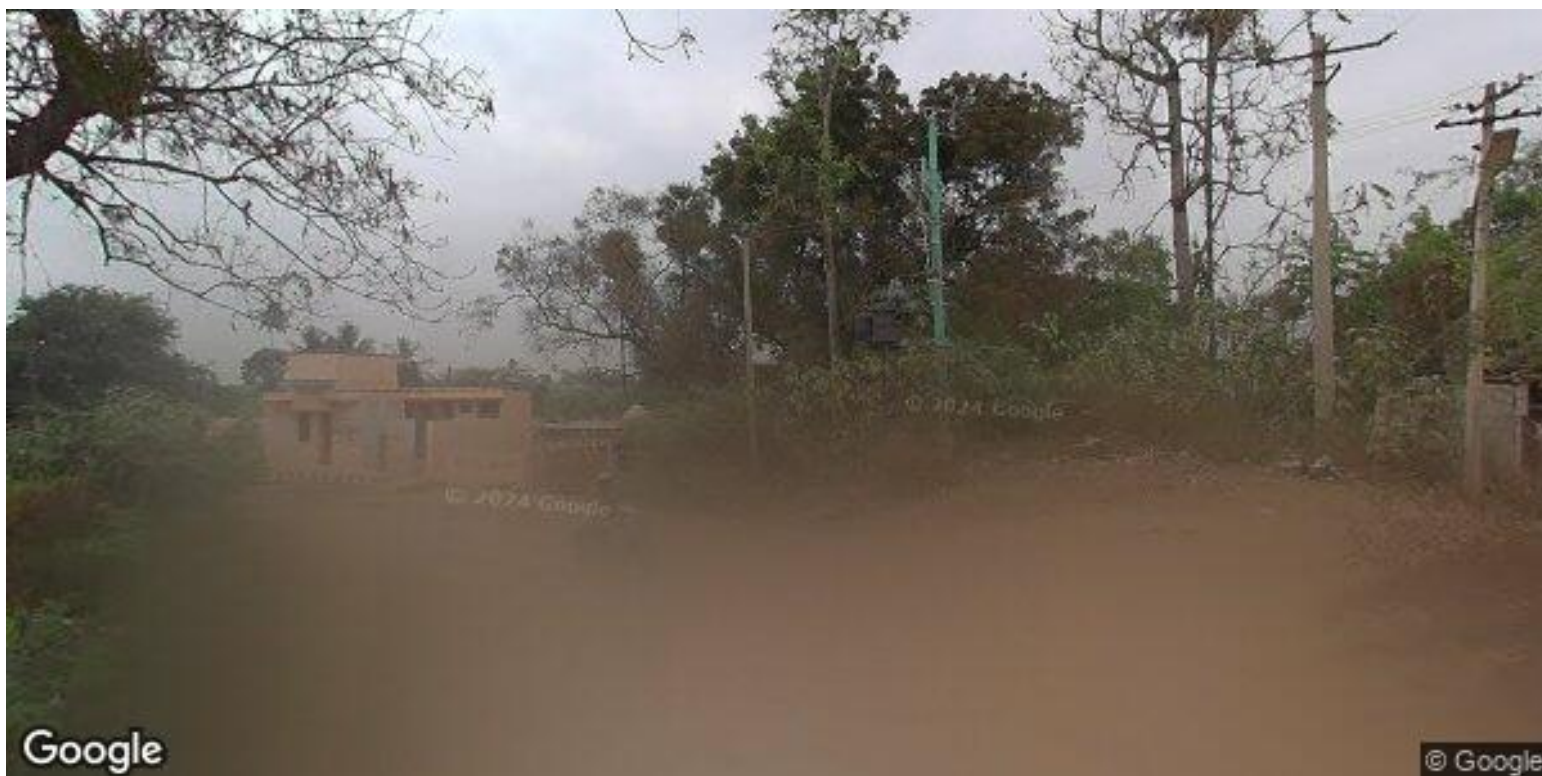
**Risk Type:** Turn  
**Risk Level:** High  
**Speed Limit:** 15 KM/Hr  
**Coordinates:** 10.94435, 78.41548

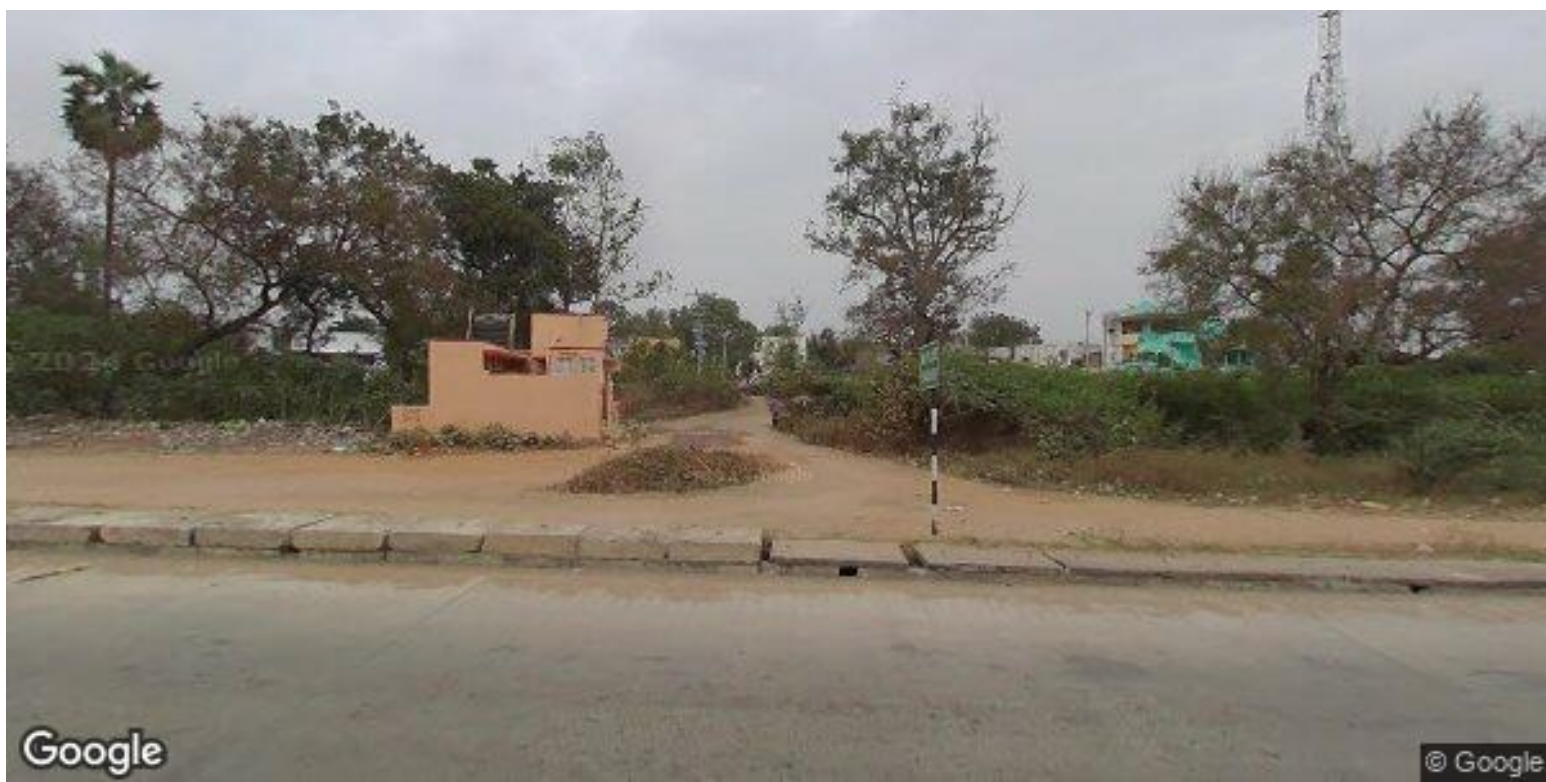
**Risk Type:** Turn

**Risk Level:** Medium

**Speed Limit:** 30 KM/Hr

**Coordinates:** 10.94465, 78.41565
