# IndianOil

## JOURNEY RISK MANAGEMENT (JRM) STUDY

### Salem Terminal to N.P.AGENCY

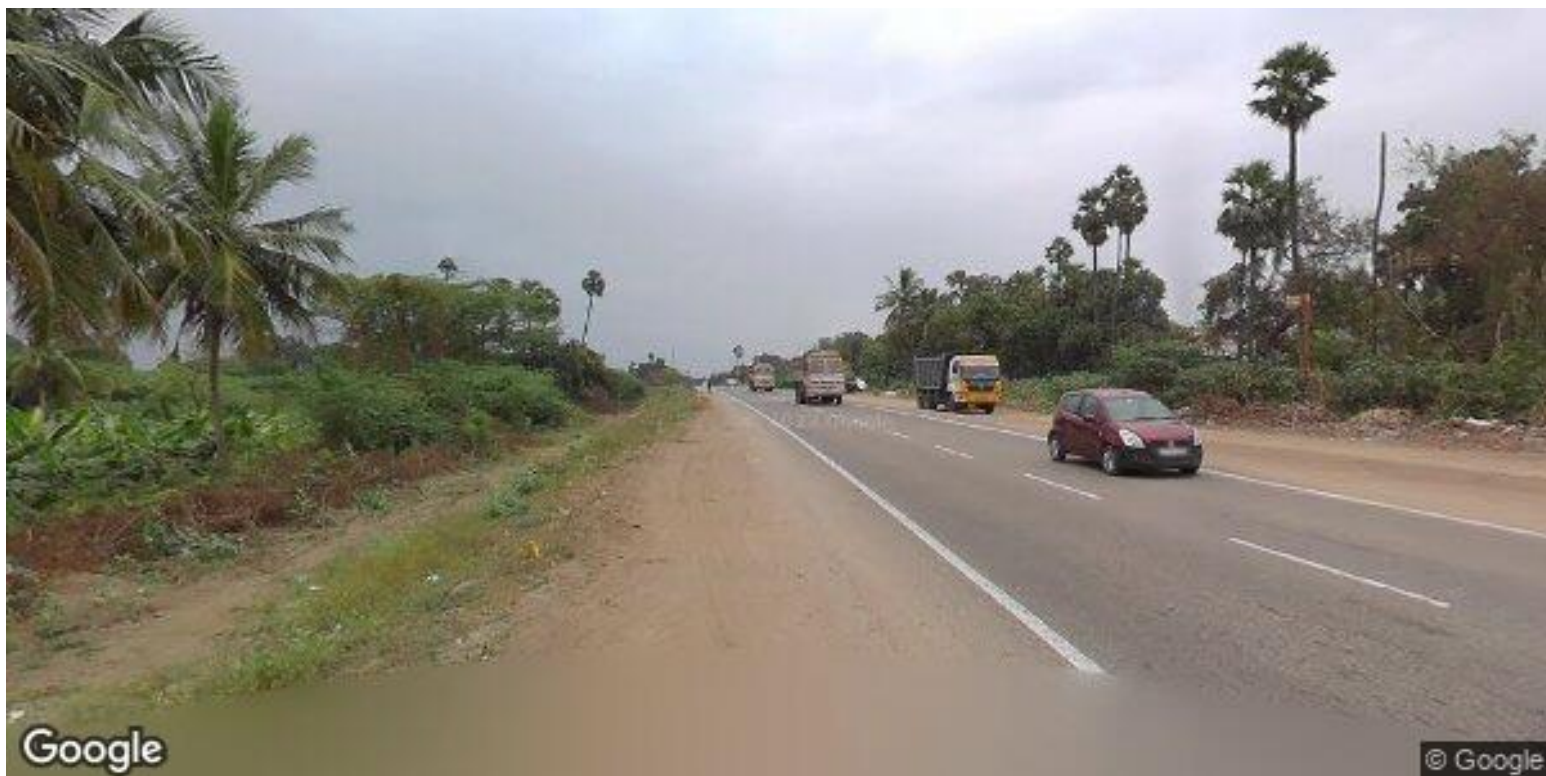
**Risk Type:** Turn

**Risk Level:** Medium

**Speed Limit:** 30 KM/Hr

**Coordinates:** 10.94478, 78.41595

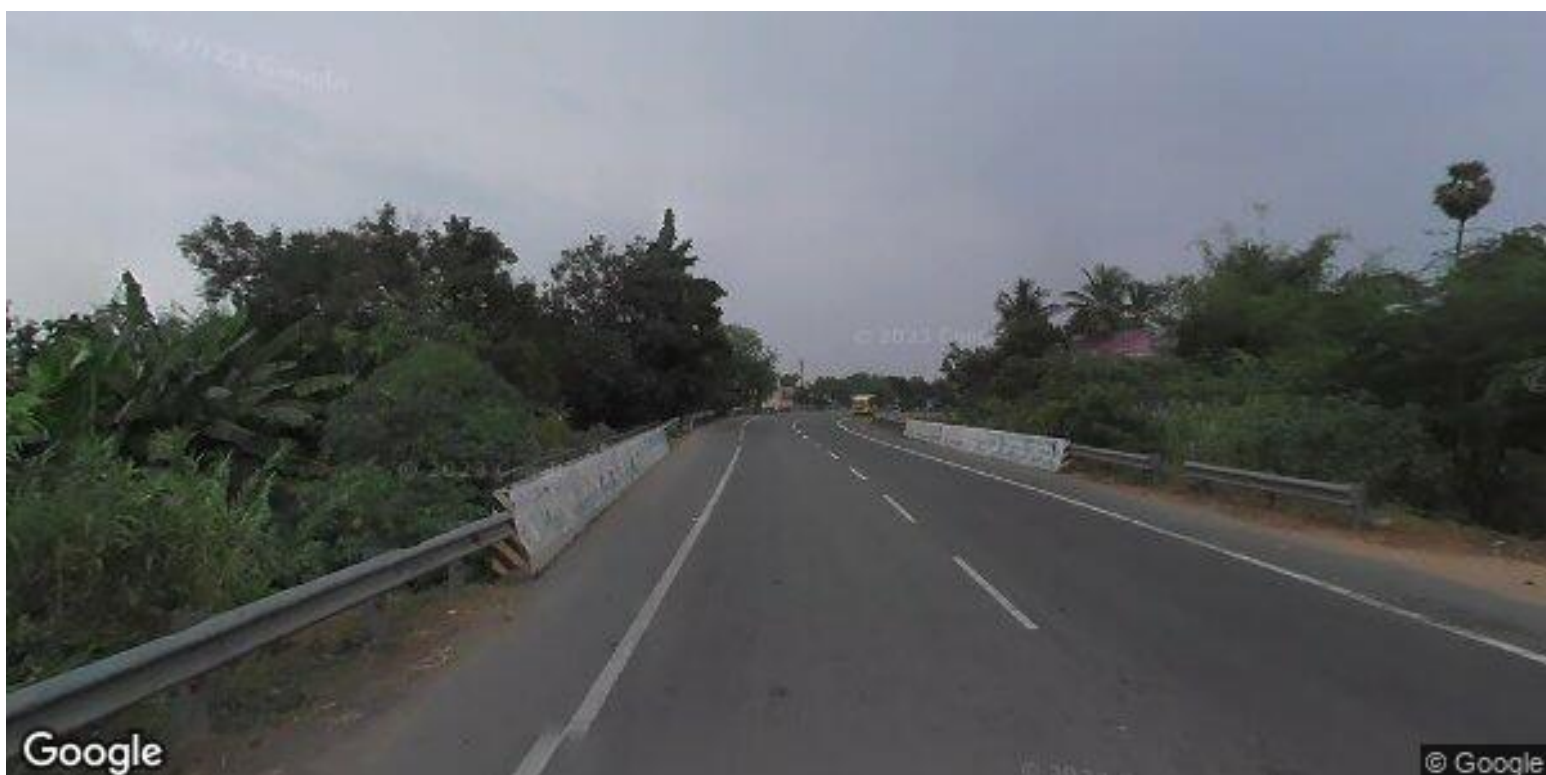
**Risk Type:** Turn  
**Risk Level:** Medium  
**Speed Limit:** 30 KM/Hr  
**Coordinates:** 10.89656, 78.52077

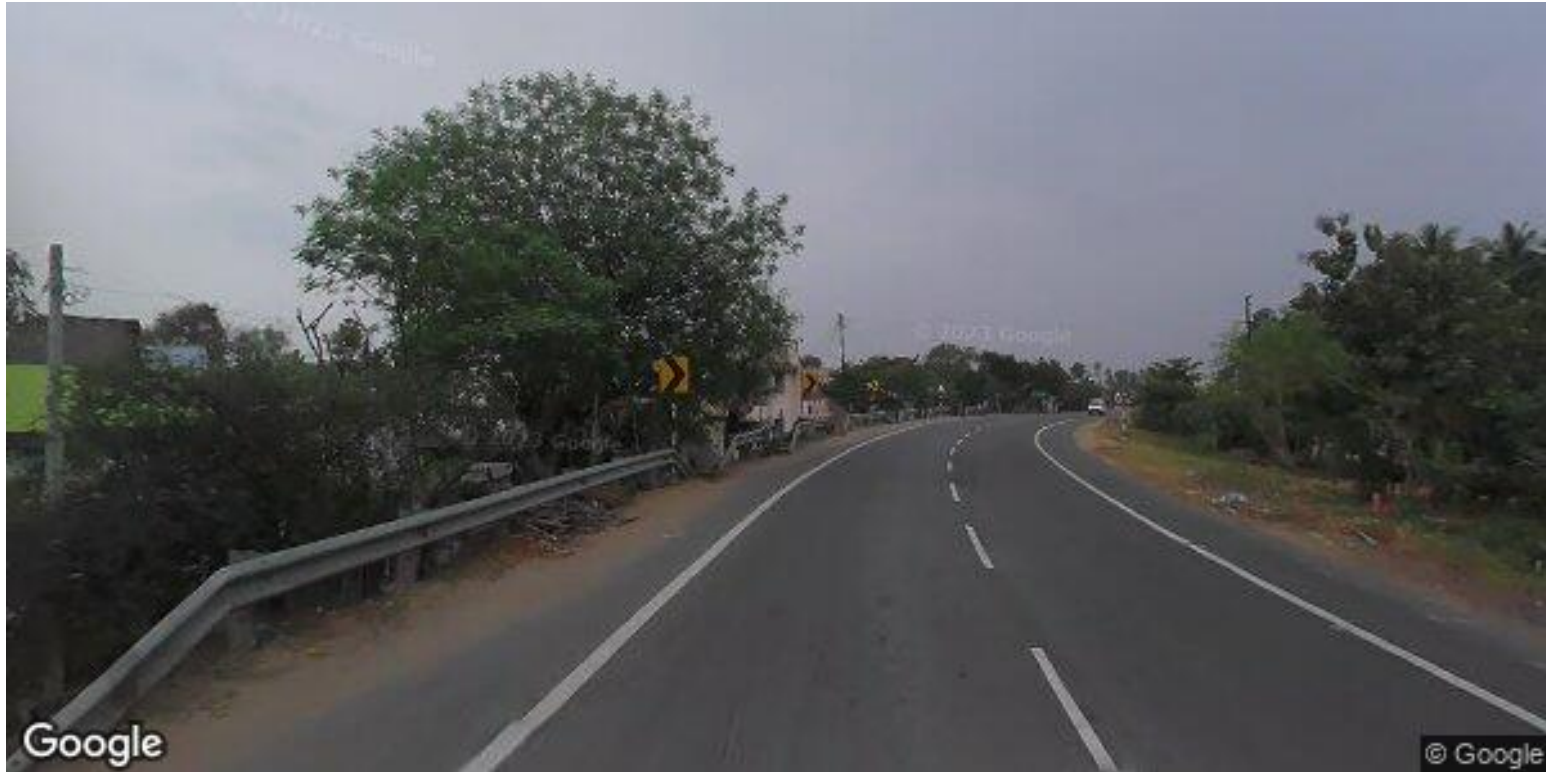
**Risk Type:** Turn  
**Risk Level:** Medium  
**Speed Limit:** 30 KM/Hr  
**Coordinates:** 10.89694, 78.52119

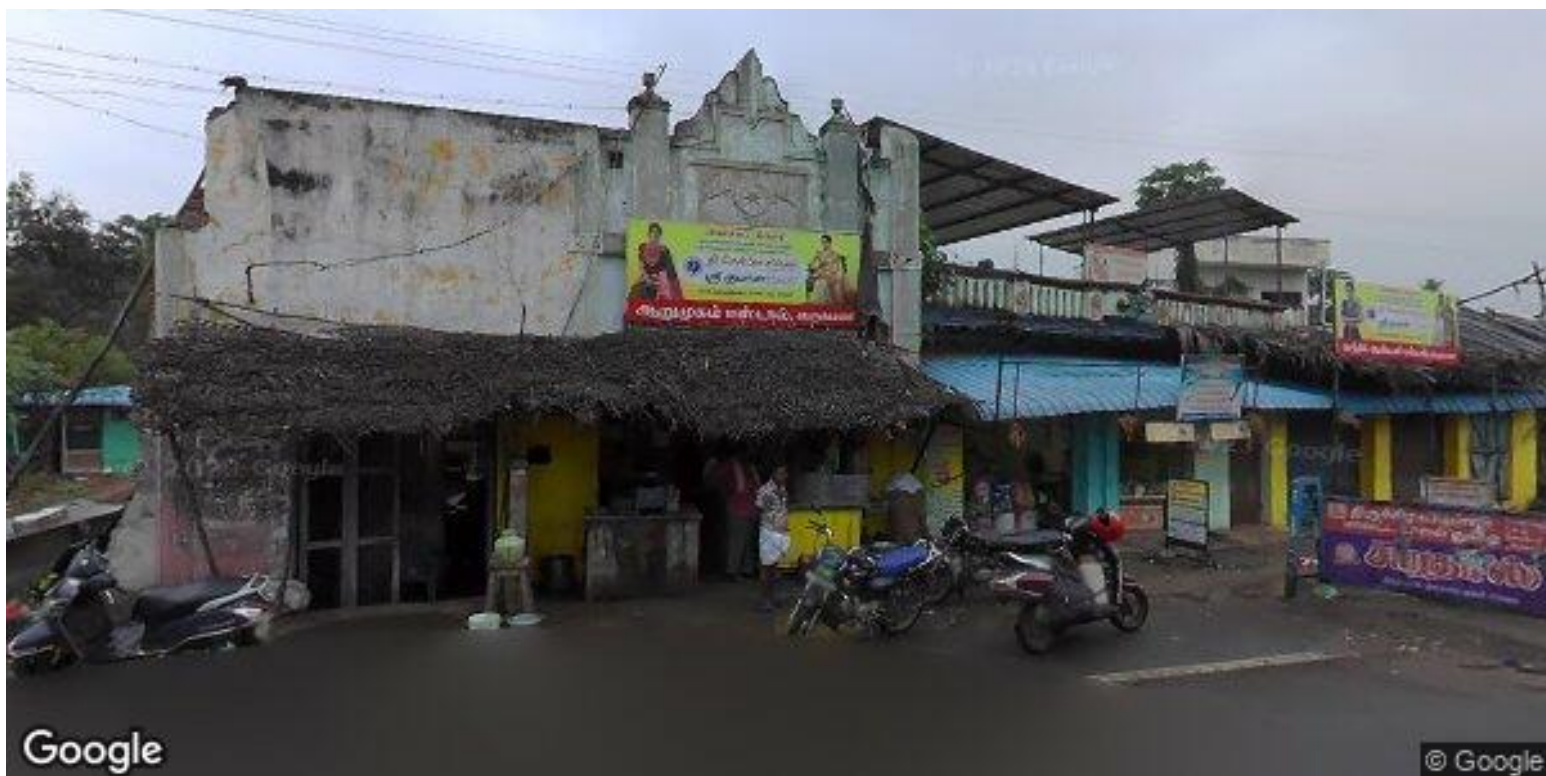
**Risk Type:** Blind Spot  
**Risk Level:** Blind Spot  
**Speed Limit:** 10 KM/Hr  
**Coordinates:** 10.88965, 78.54586

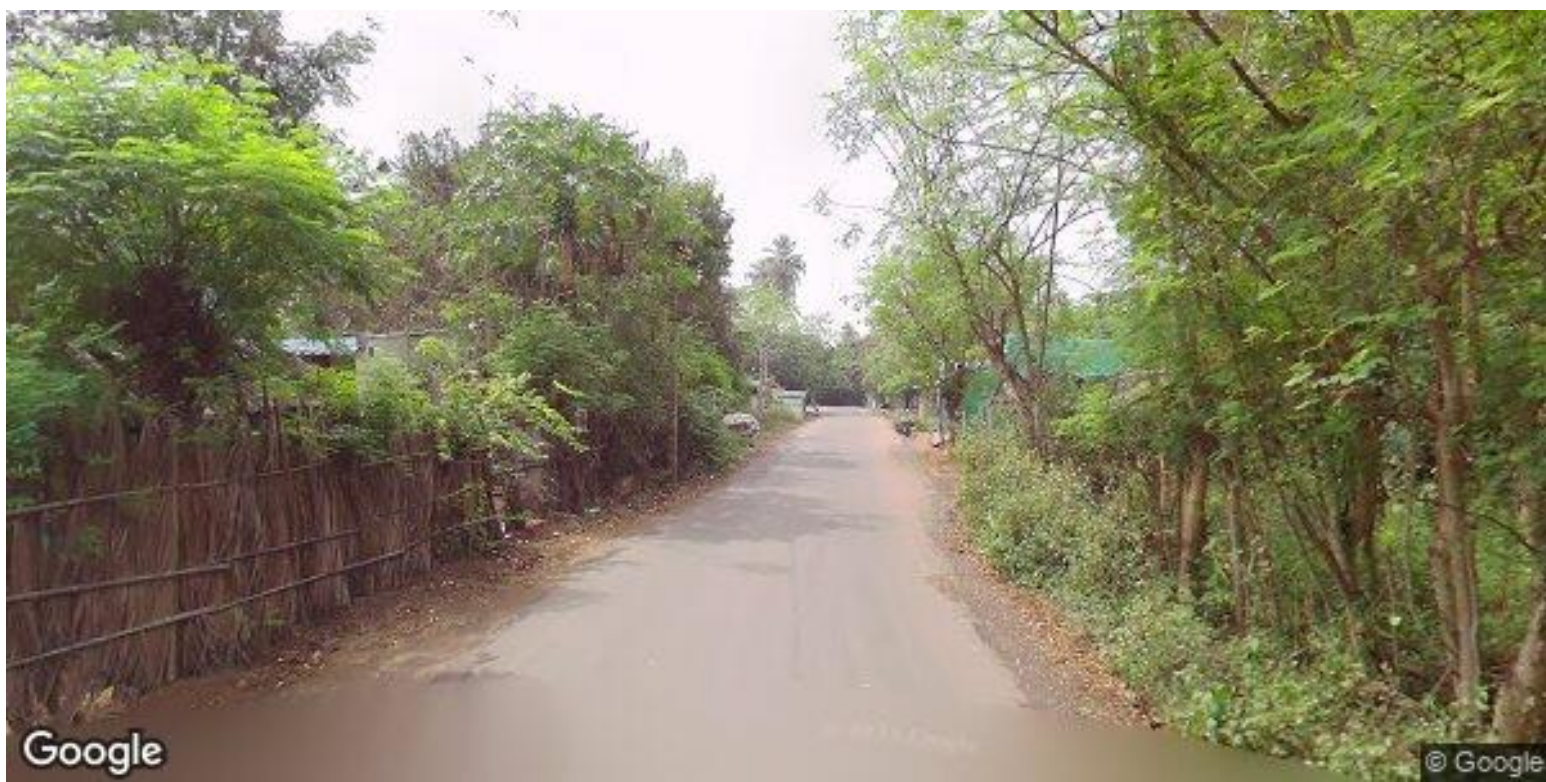
**Risk Type:** Turn

**Risk Level:** High

**Speed Limit:** 15 KM/Hr

**Coordinates:** 10.88043, 78.54458

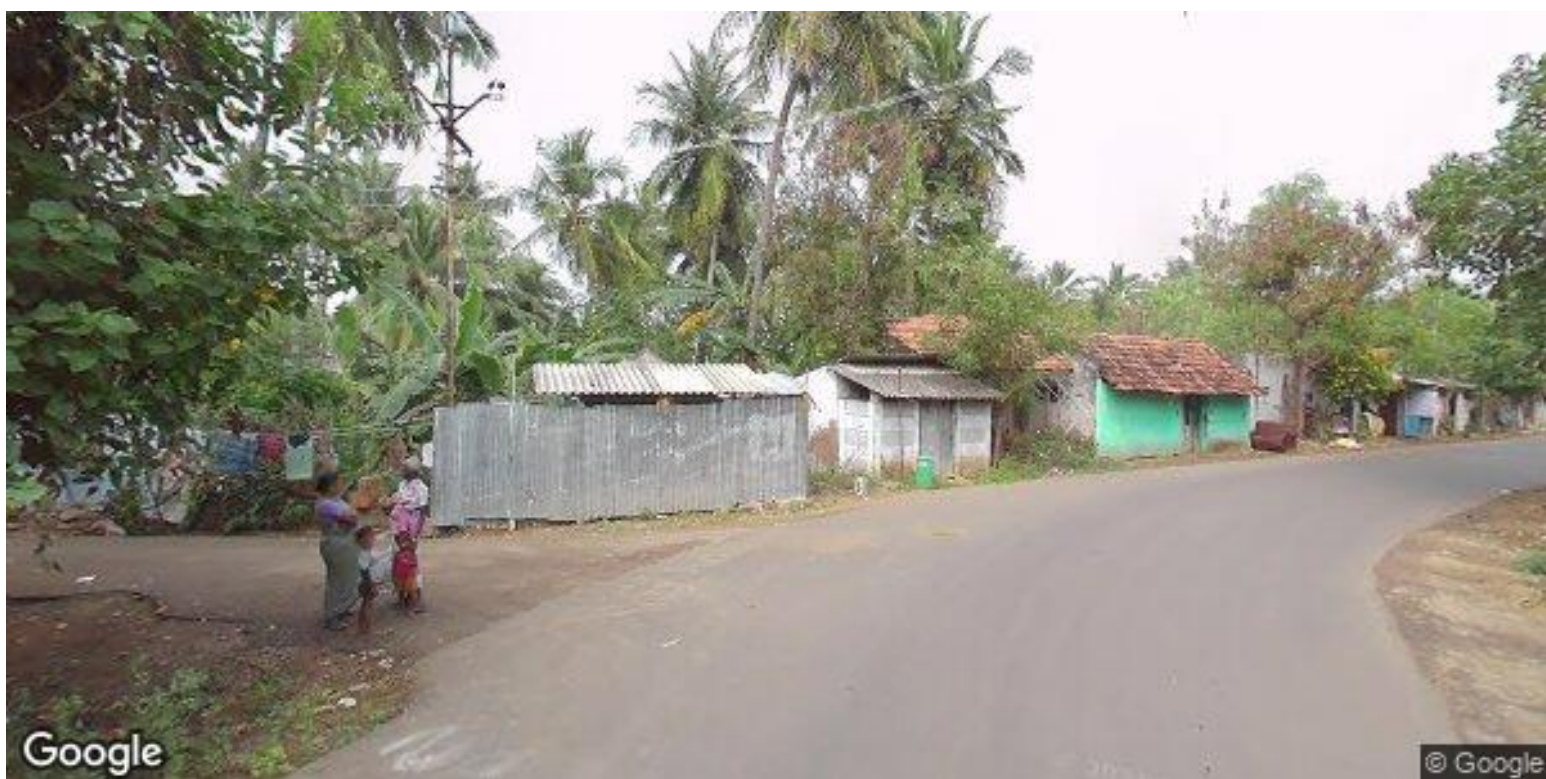
**Risk Type:** Turn

**Risk Level:** High

**Speed Limit:** 15 KM/Hr

**Coordinates:** 10.88035, 78.54354

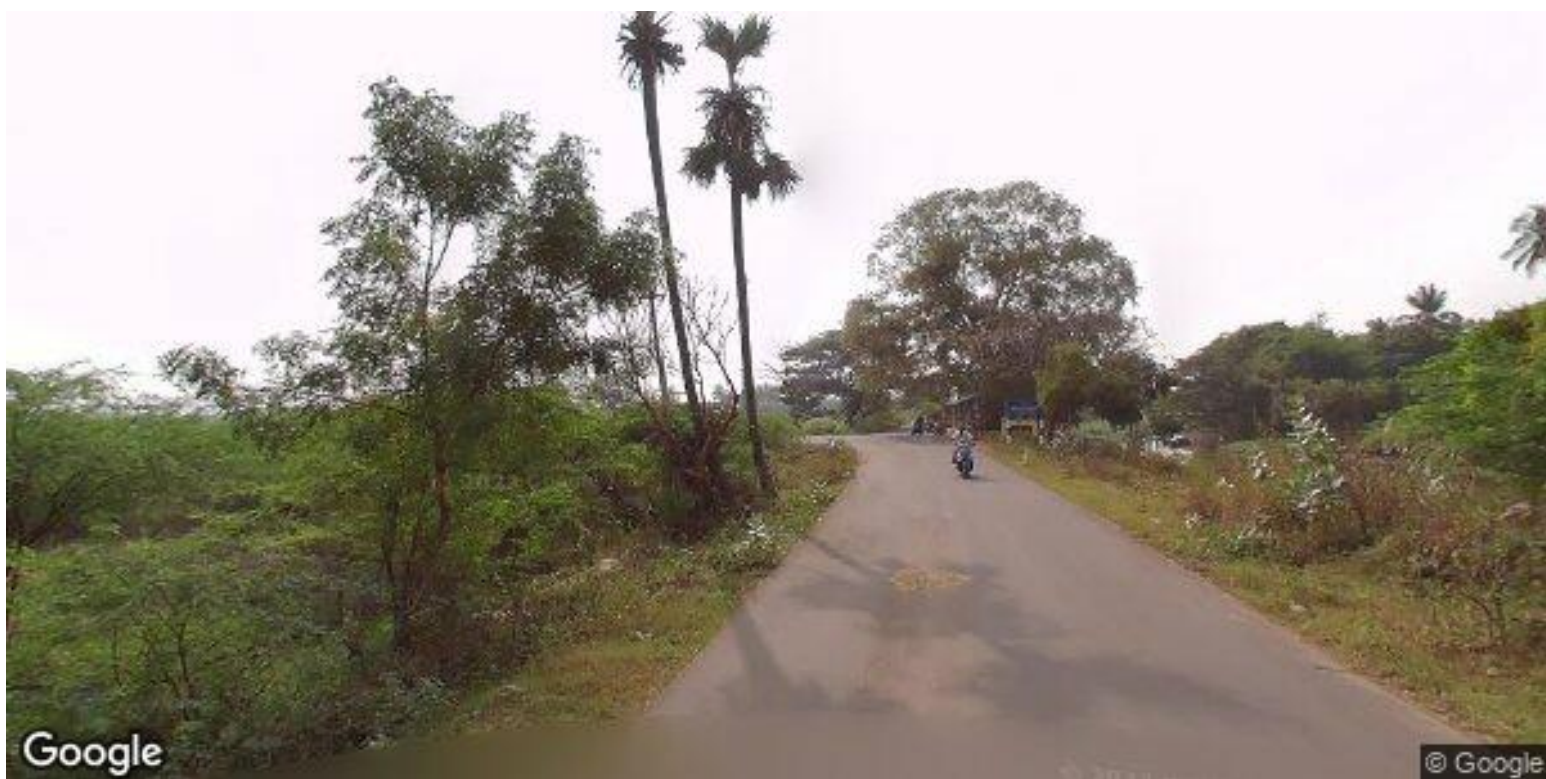
**Risk Type:** Turn  
**Risk Level:** High  
**Speed Limit:** 15 KM/Hr  
**Coordinates:** 10.87949, 78.54326

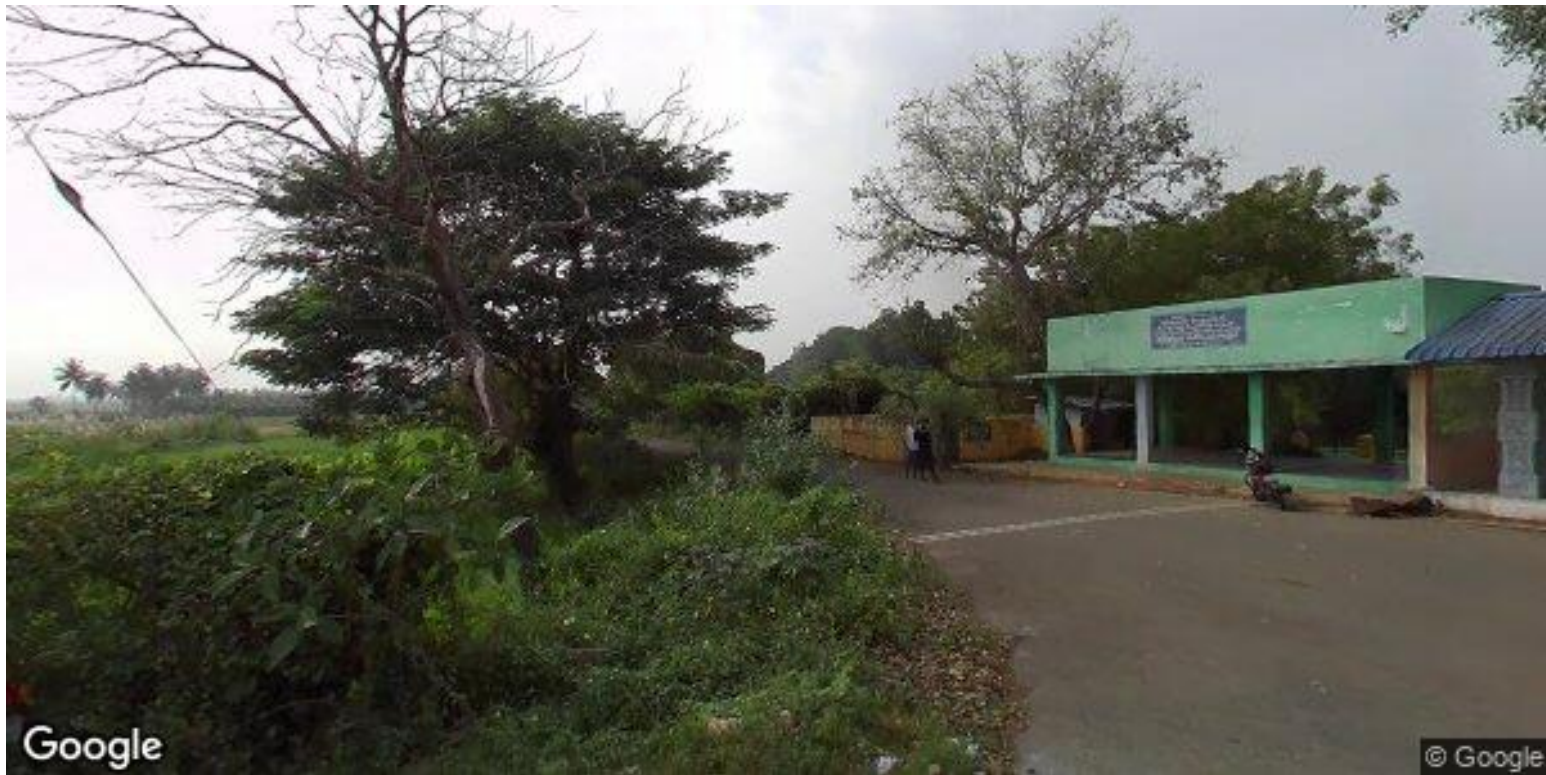
**Risk Type:** Turn  
**Risk Level:** High  
**Speed Limit:** 15 KM/Hr  
**Coordinates:** 10.87931, 78.54275

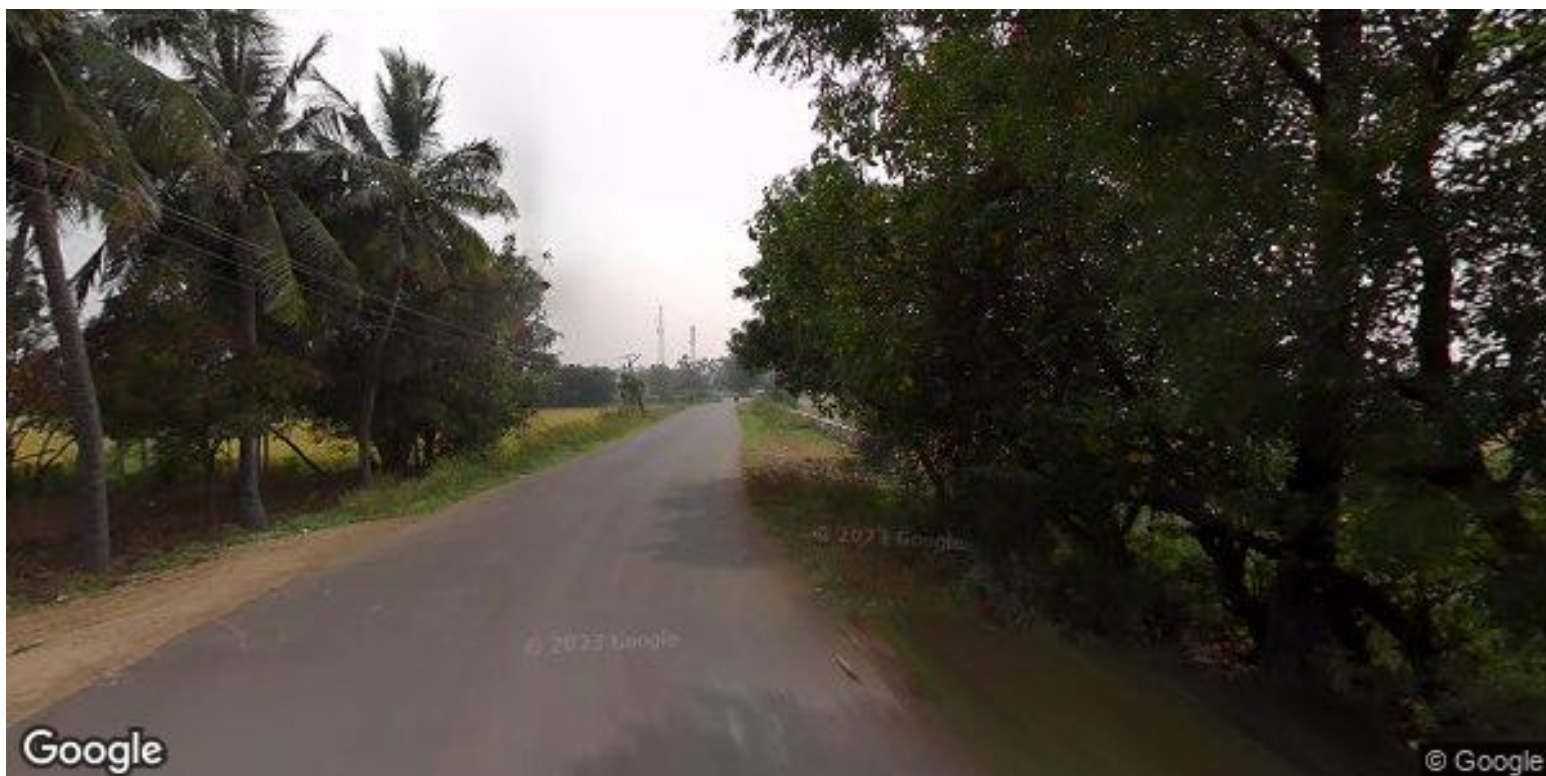
**Risk Type:** Turn  
**Risk Level:** Medium  
**Speed Limit:** 30 KM/Hr  
**Coordinates:** 10.87339, 78.54096

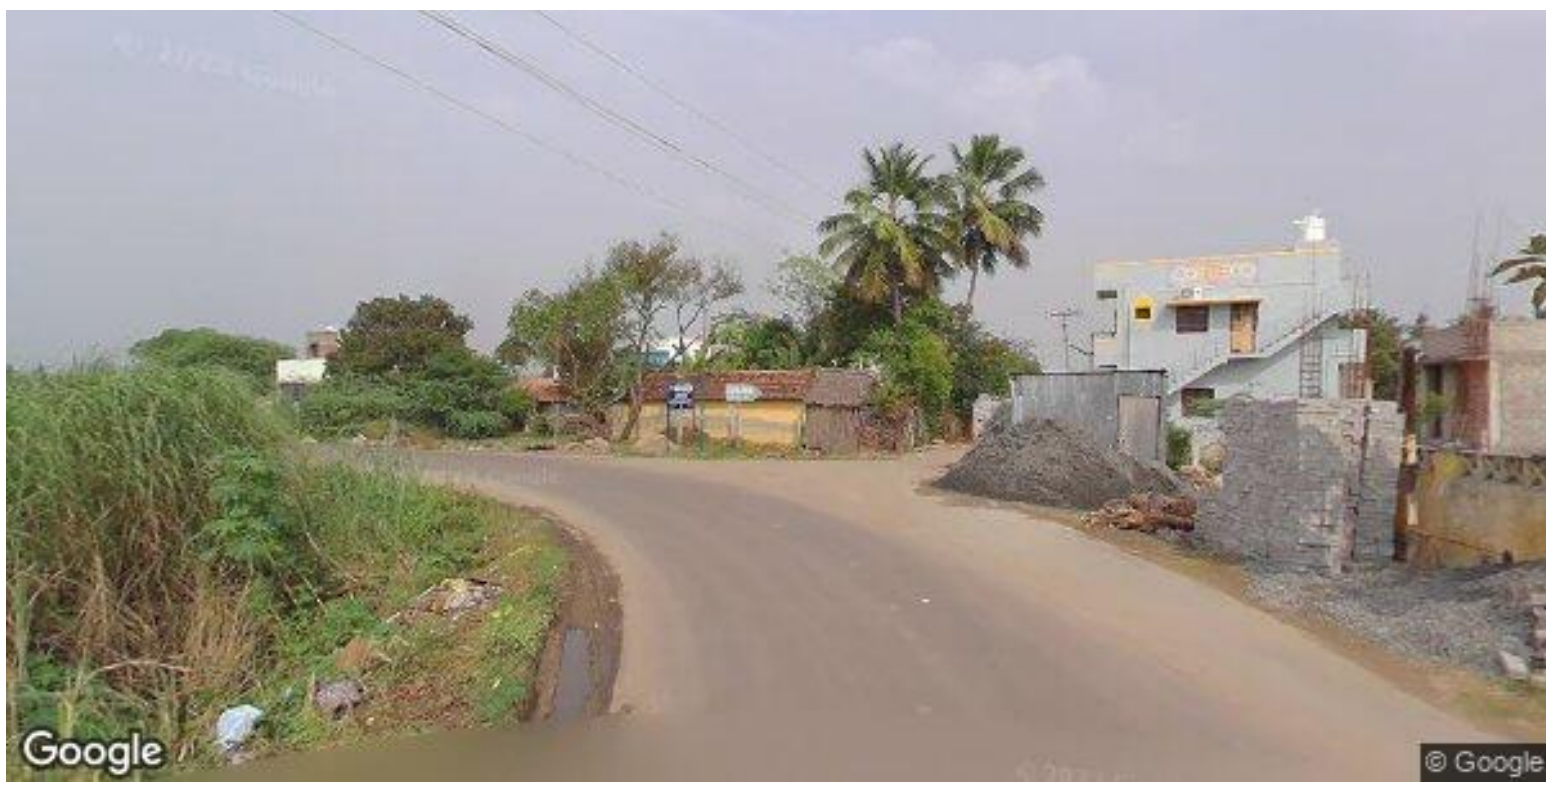
**Risk Type:** Turn

**Risk Level:** Medium

**Speed Limit:** 30 KM/Hr

**Coordinates:** 10.87090, 78.53973

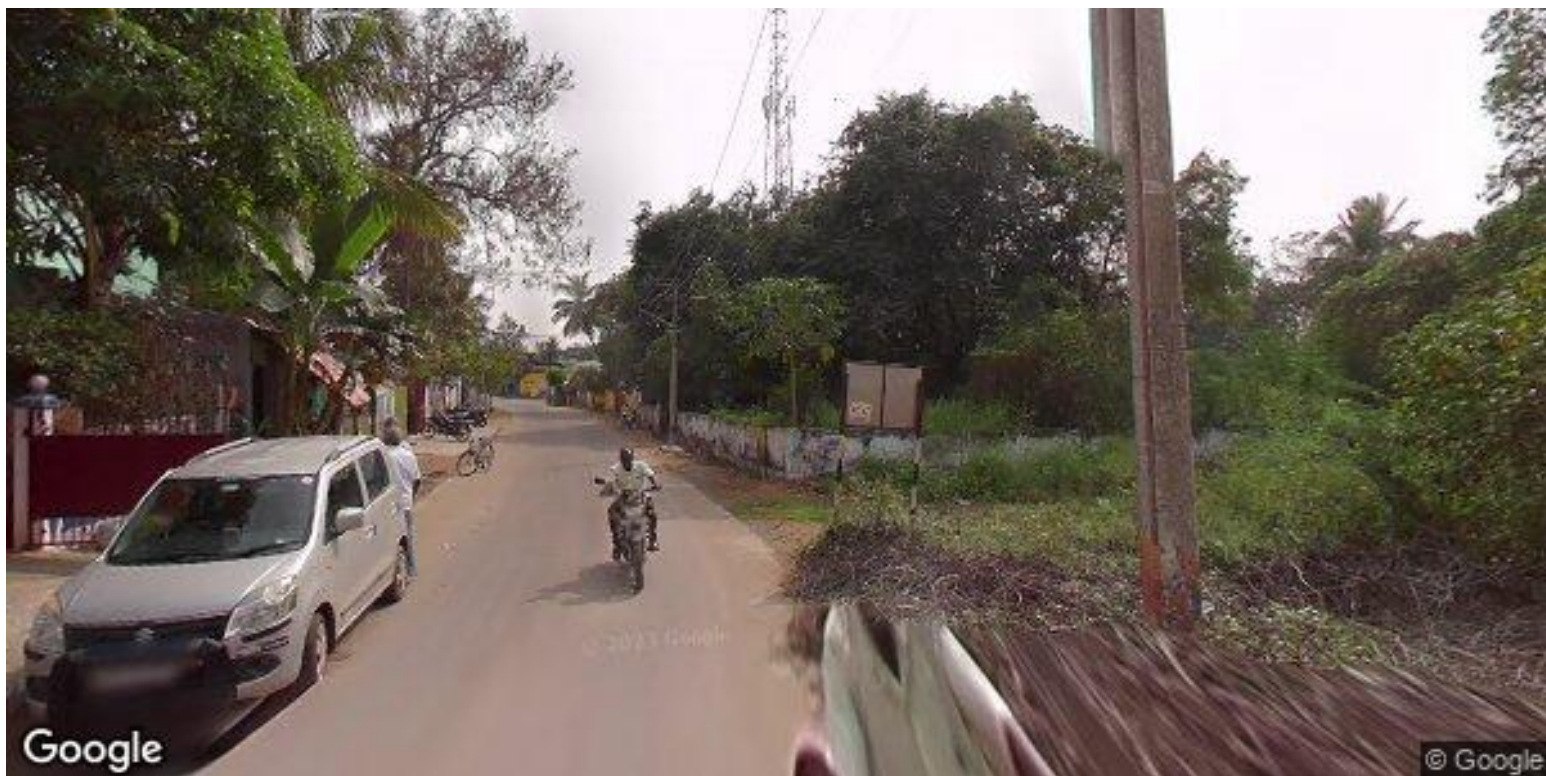
**Risk Type:** Turn

**Risk Level:** High

**Speed Limit:** 15 KM/Hr

**Coordinates:** 10.87065, 78.53930

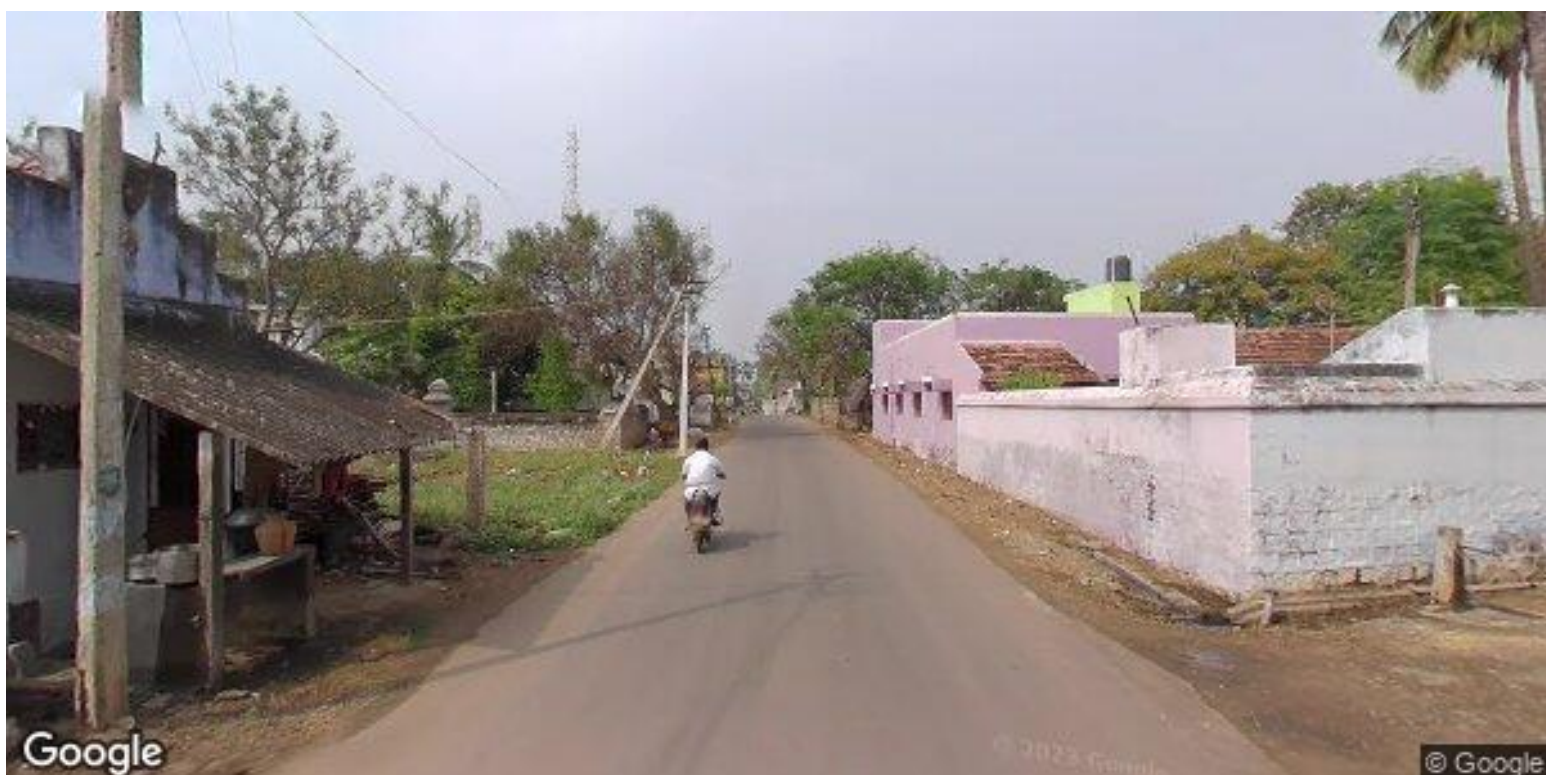
**Risk Type:** Turn

**Risk Level:** Medium

**Speed Limit:** 30 KM/Hr

**Coordinates:** 10.86866, 78.53904

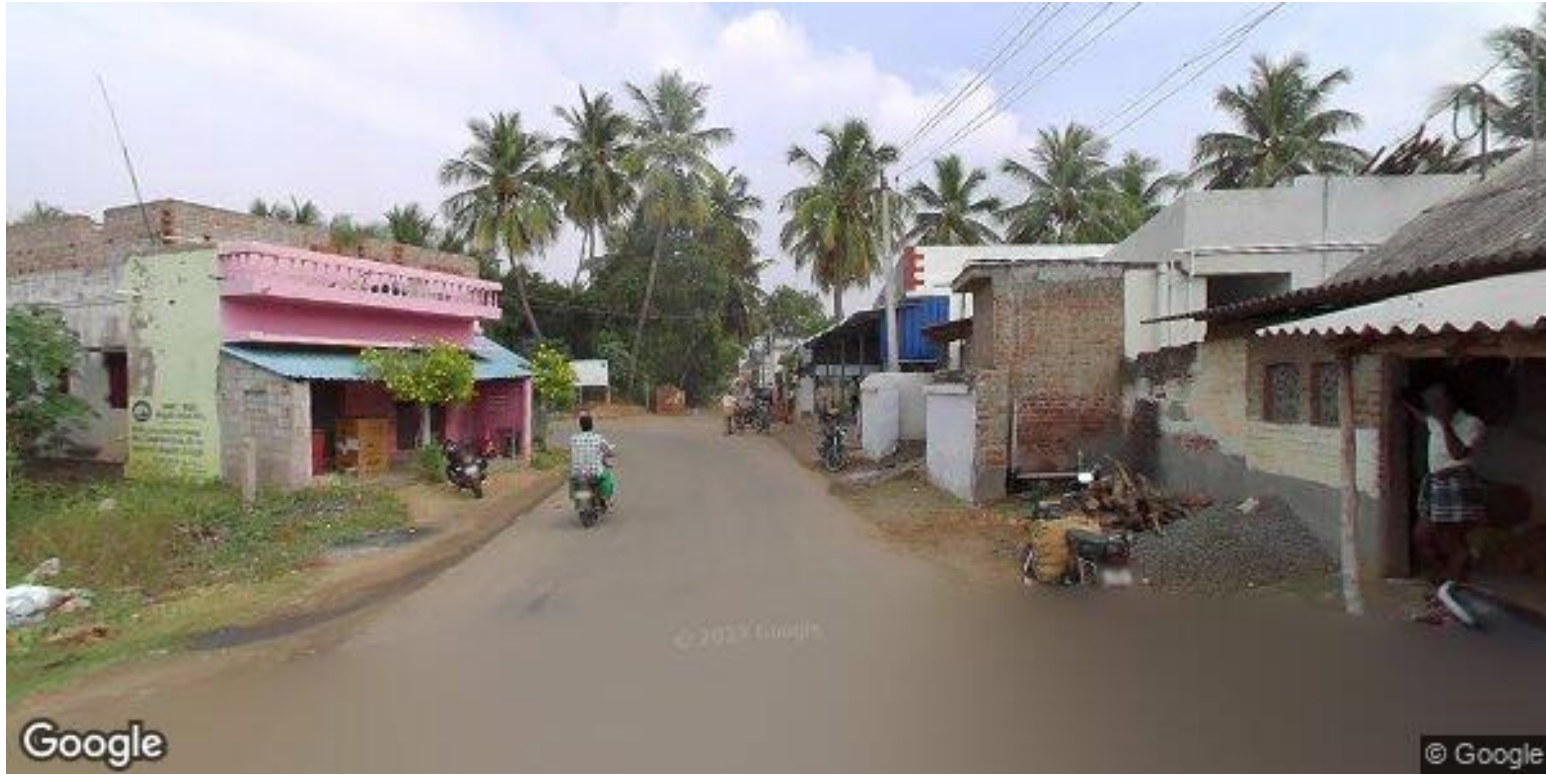
**Risk Type:** Turn

**Risk Level:** High

**Speed Limit:** 15 KM/Hr

**Coordinates:** 10.86817, 78.53870

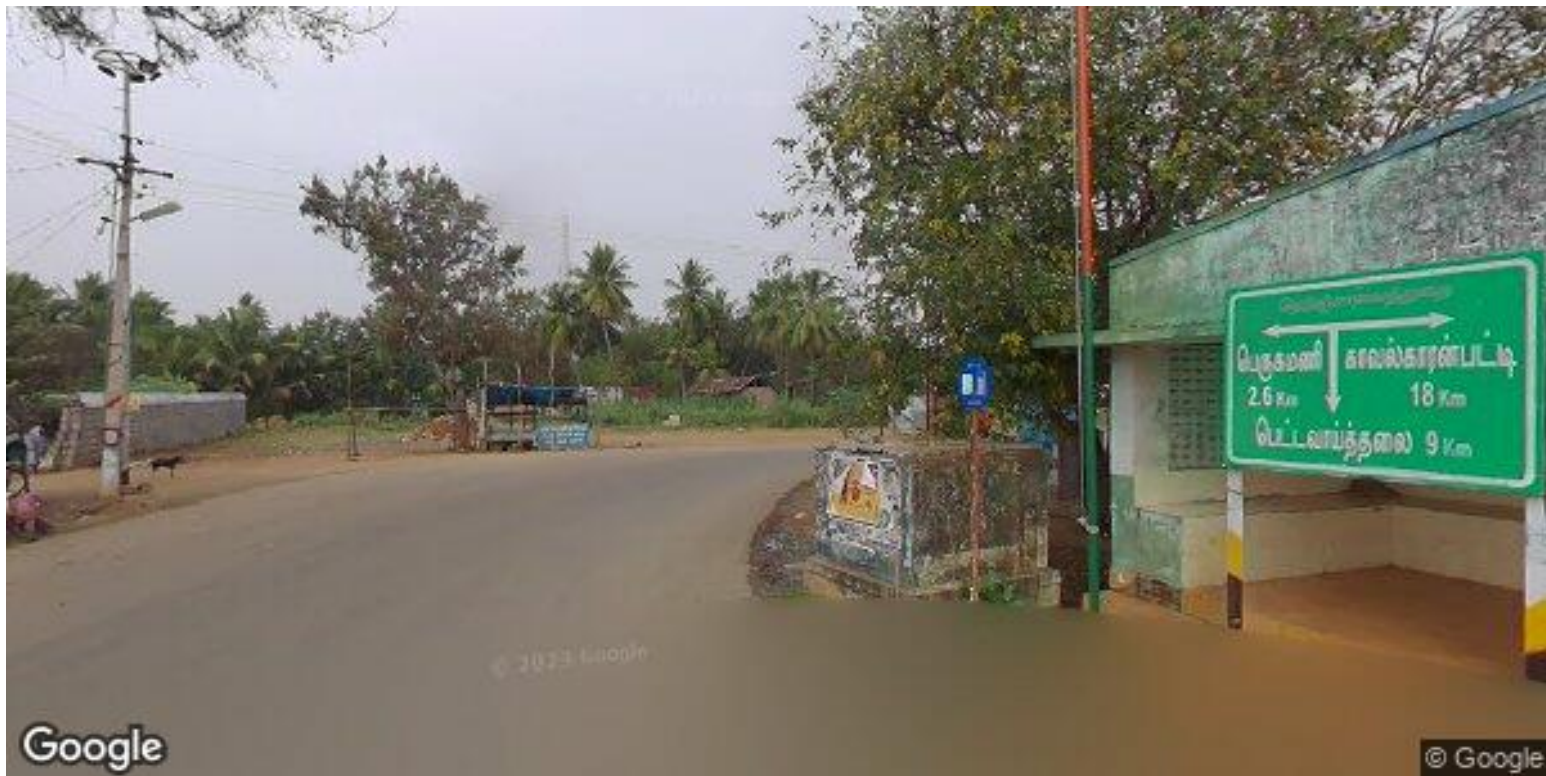
**Risk Type:** Turn

**Risk Level:** High

**Speed Limit:** 15 KM/Hr

**Coordinates:** 10.86814, 78.53816

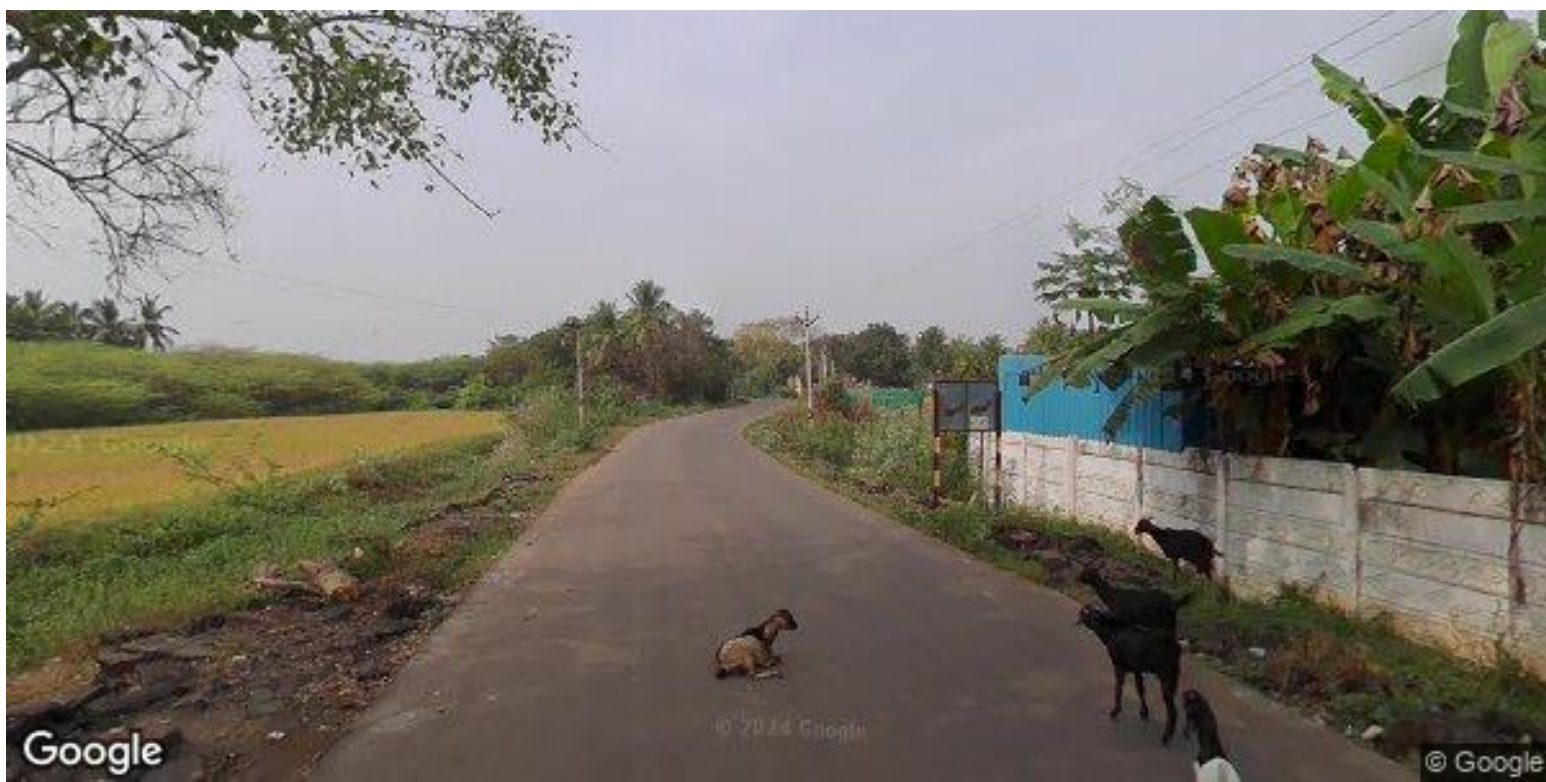
**Risk Type:** Turn

**Risk Level:** High

**Speed Limit:** 15 KM/Hr

**Coordinates:** 10.86518, 78.53852

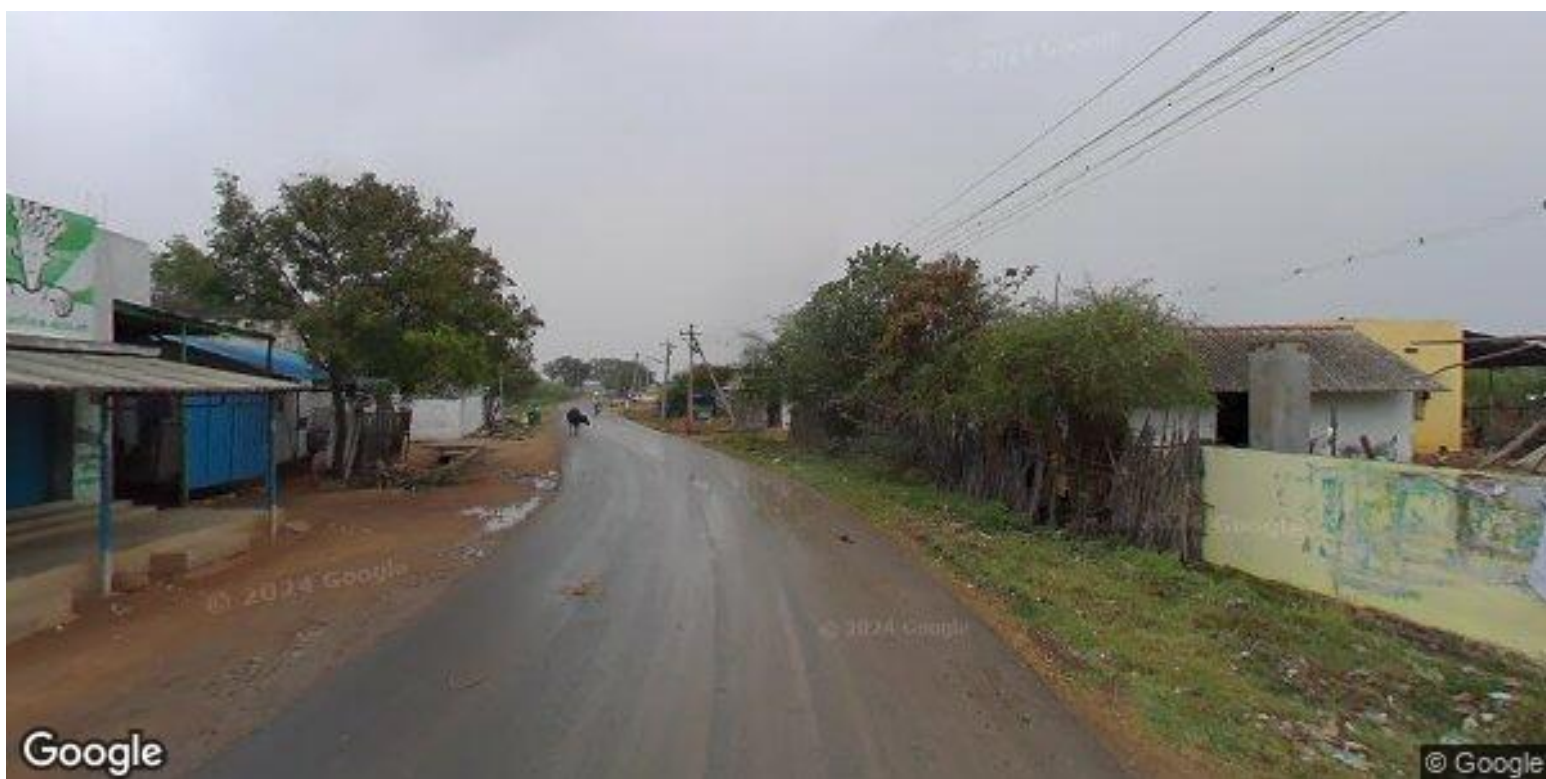
**Risk Type:** Turn

**Risk Level:** Medium

**Speed Limit:** 30 KM/Hr

**Coordinates:** 10.86079, 78.53641

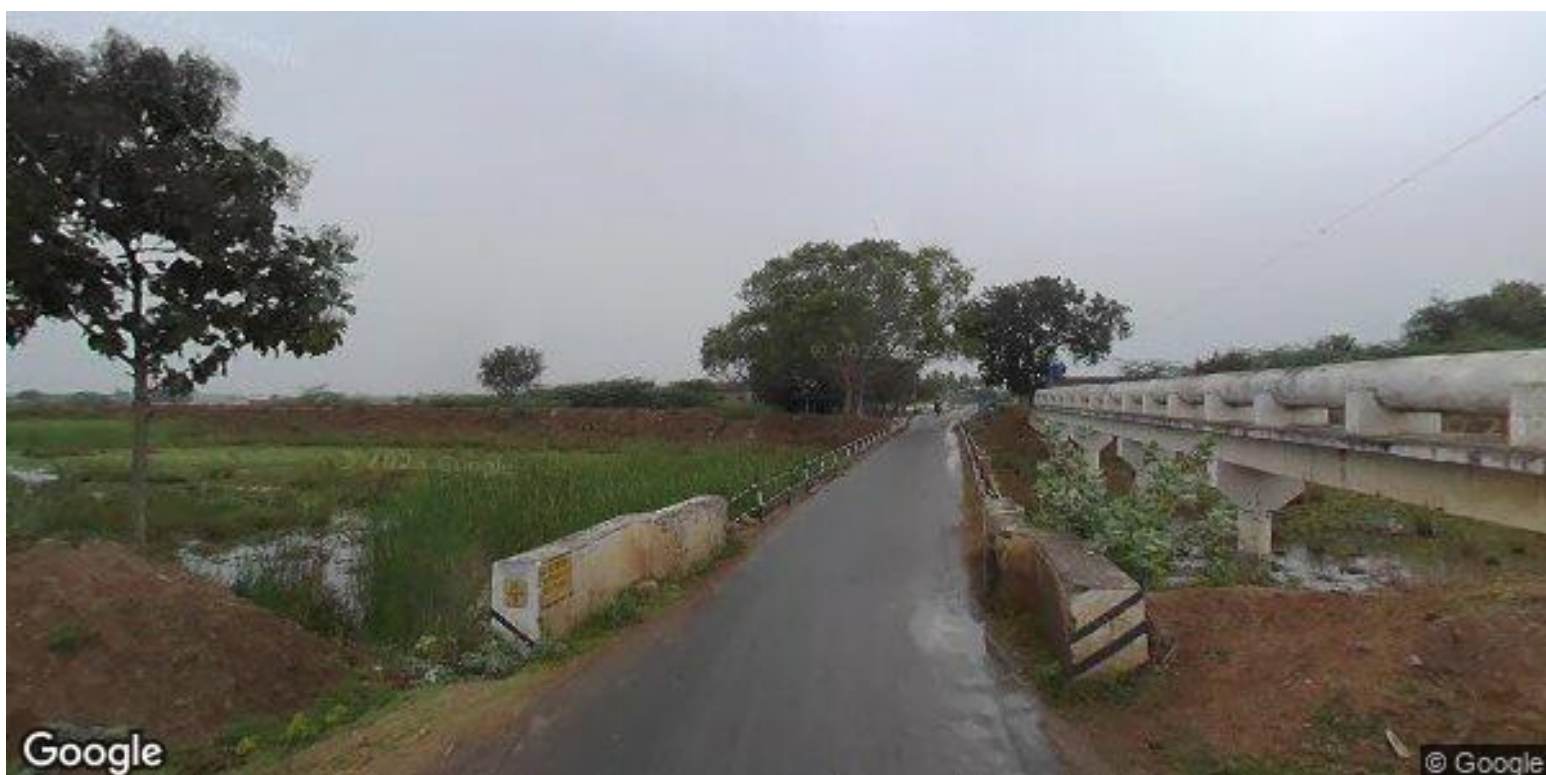
**Risk Type:** Turn  
**Risk Level:** Medium  
**Speed Limit:** 30 KM/Hr  
**Coordinates:** 10.85759, 78.53682

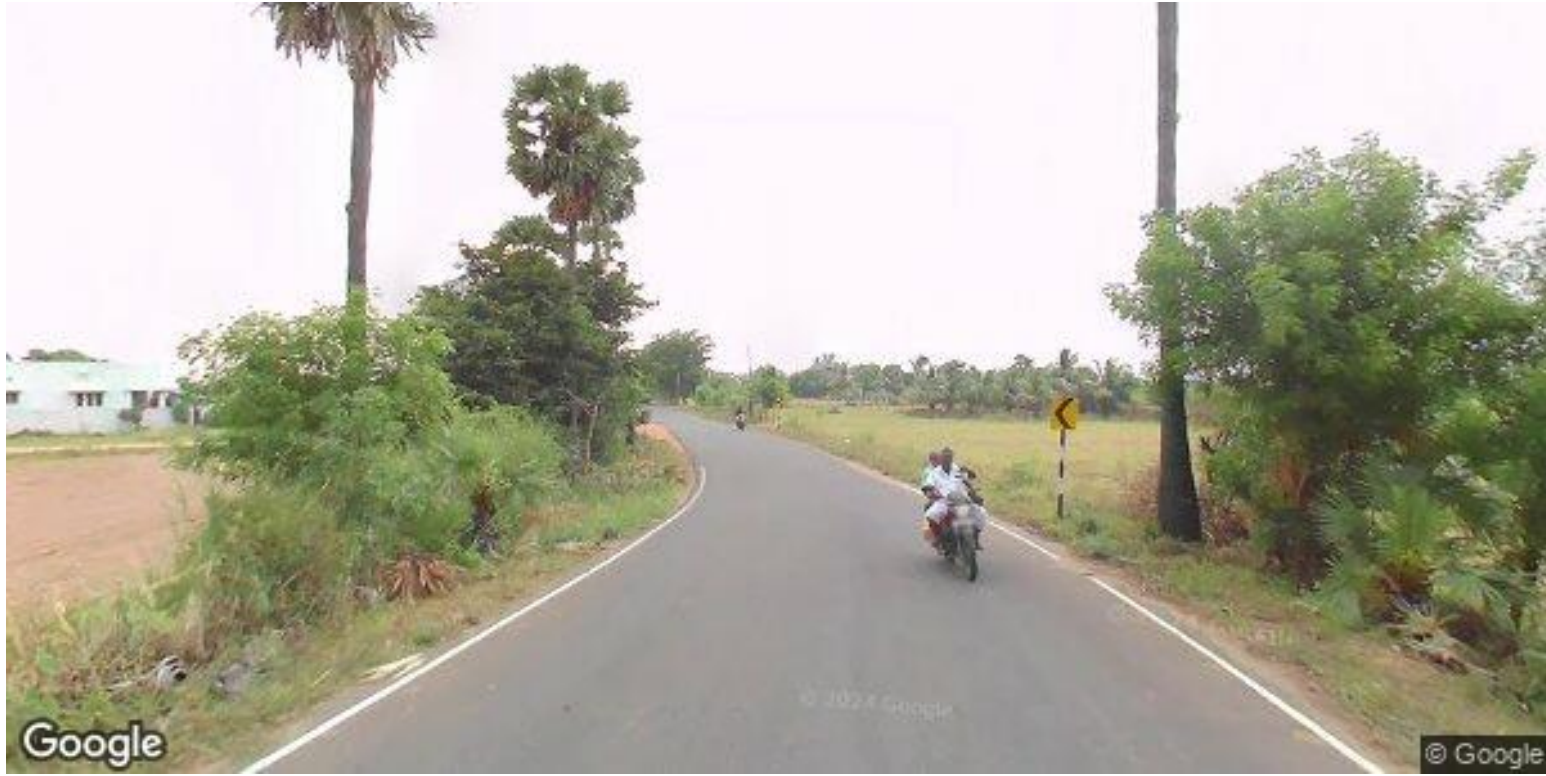
**Risk Type:** Turn  
**Risk Level:** Medium  
**Speed Limit:** 30 KM/Hr  
**Coordinates:** 10.85289, 78.54270
