# IndianOil

## JOURNEY RISK MANAGEMENT (JRM) STUDY

### Salem Terminal to N.P.AGENCY

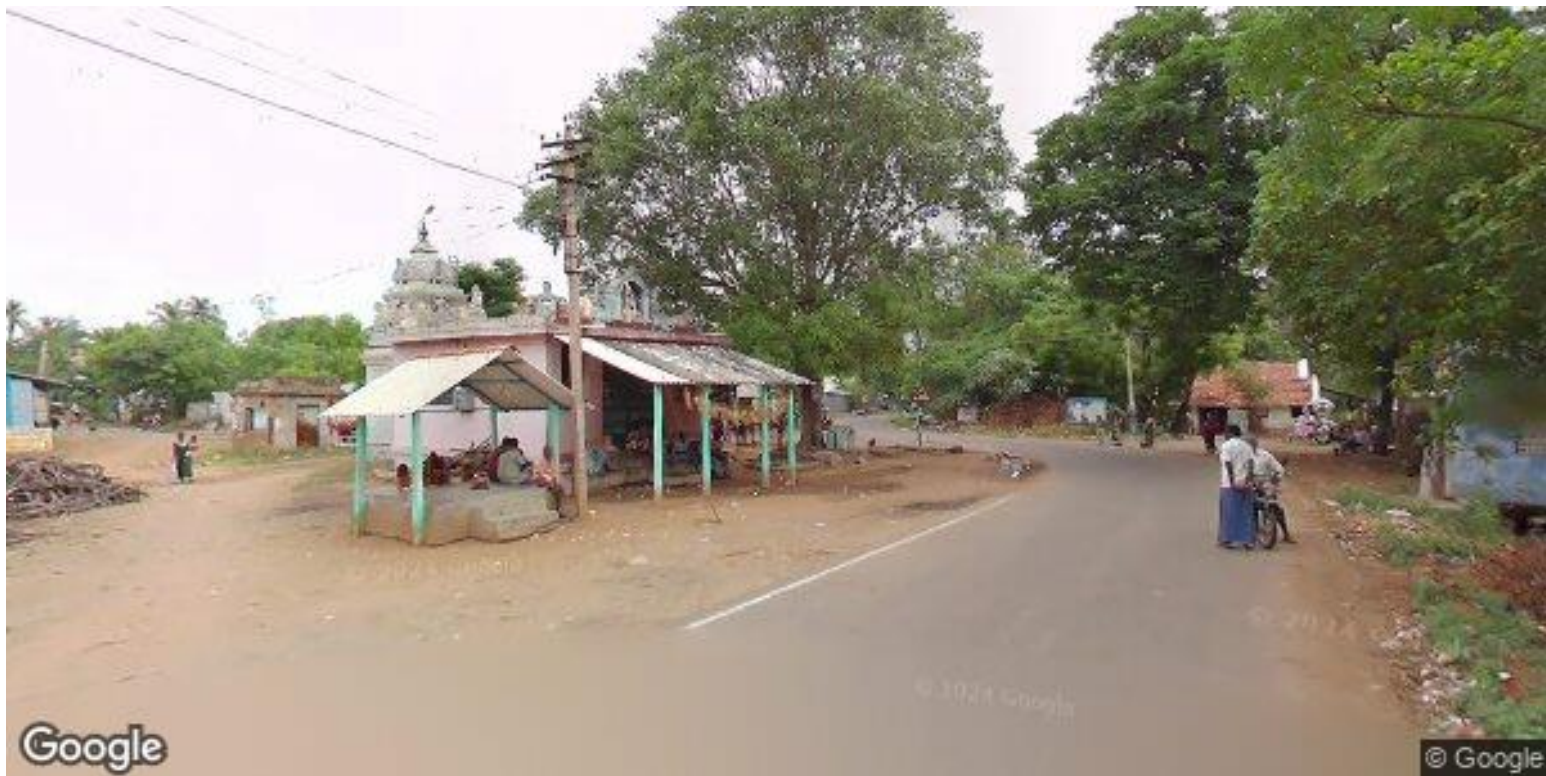
**Risk Type:** Turn  
**Risk Level:** Medium  
**Speed Limit:** 30 KM/Hr  
**Coordinates:** 10.83579, 78.54689

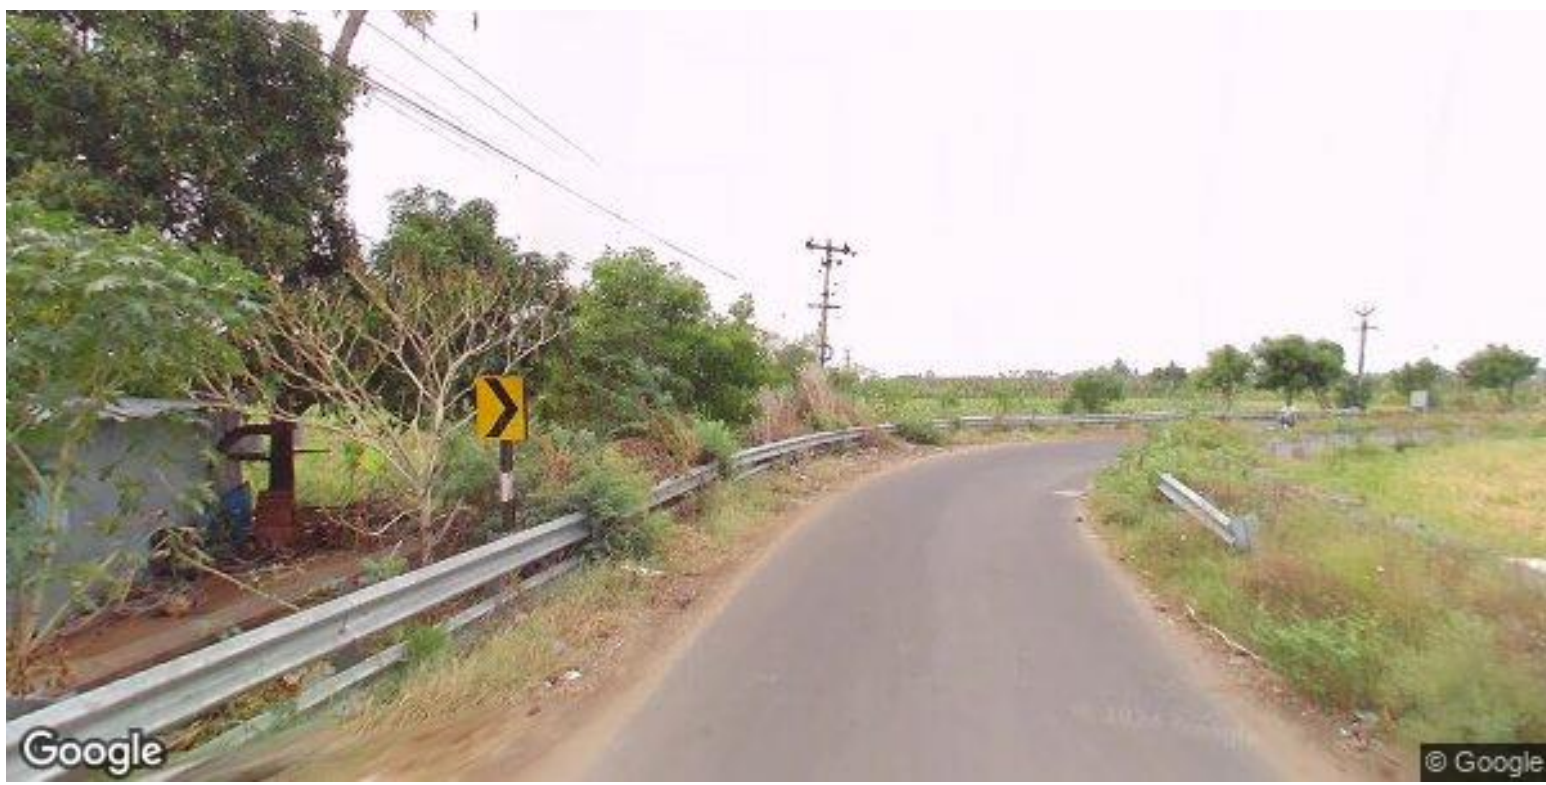
**Risk Type:** Turn

**Risk Level:** High
