# IndianOil

## JOURNEY RISK MANAGEMENT (JRM) STUDY

### Salem Terminal TO PONNI SERVICE STATION UNIT II

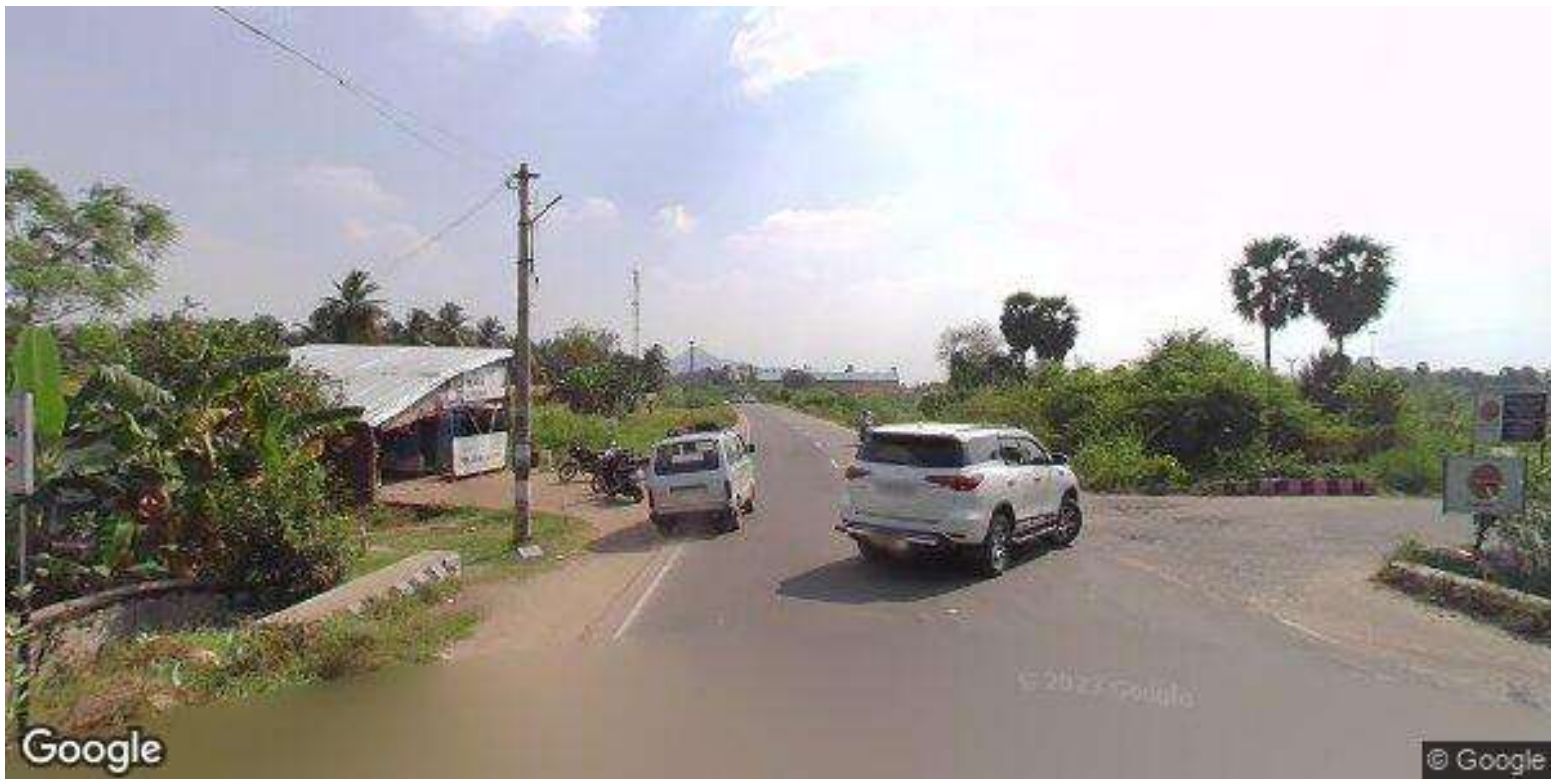
**Risk Type:** Blind Spot  
**Risk Level:** Blind Spot  
**Speed Limit:** 10 KM/Hr  
**Coordinates:** 11.44029, 77.87544

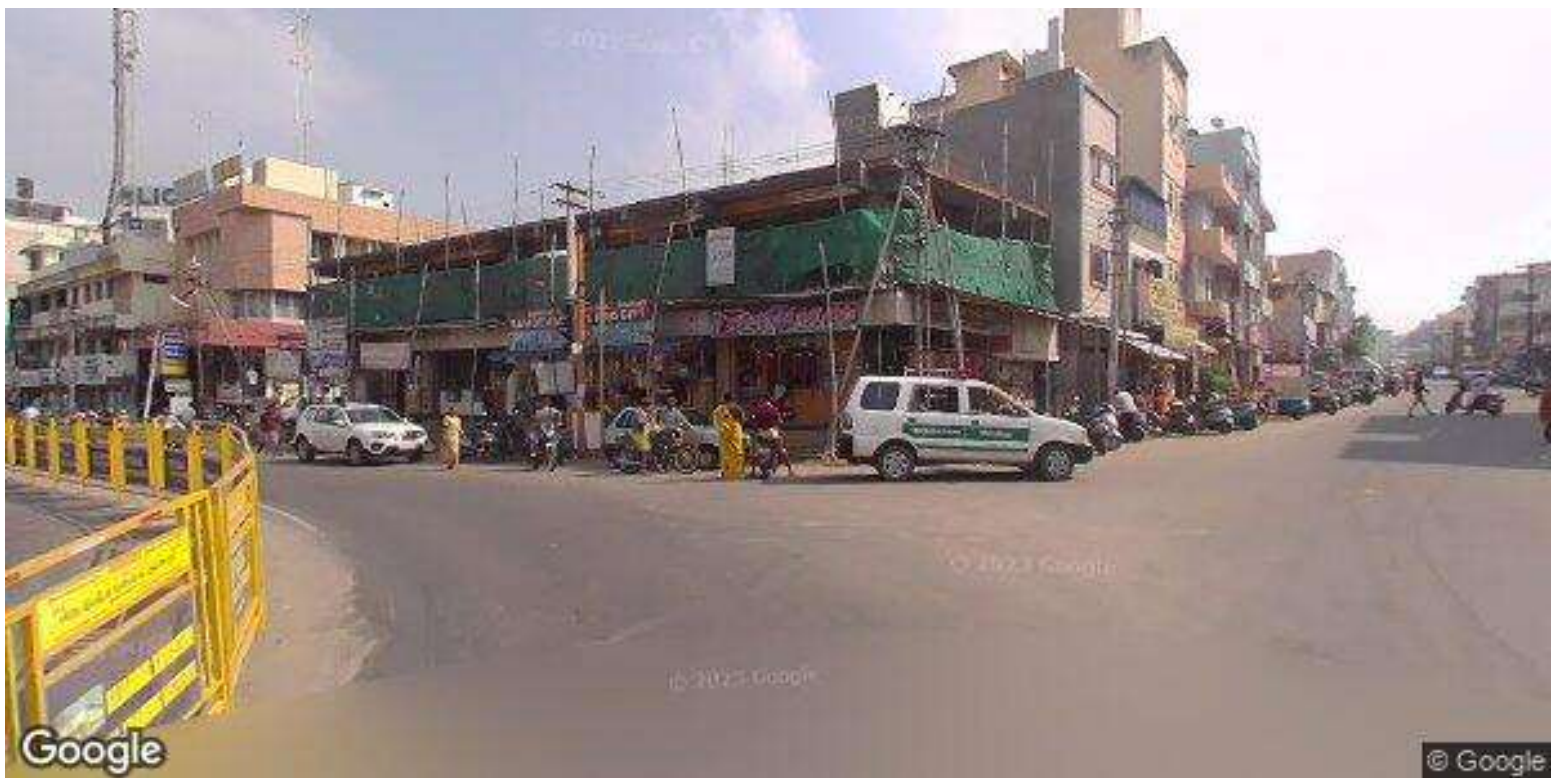
**Risk Type:** Turn  
**Risk Level:** High  
**Speed Limit:** 15 KM/Hr  
**Coordinates:** 11.37868, 77.89498

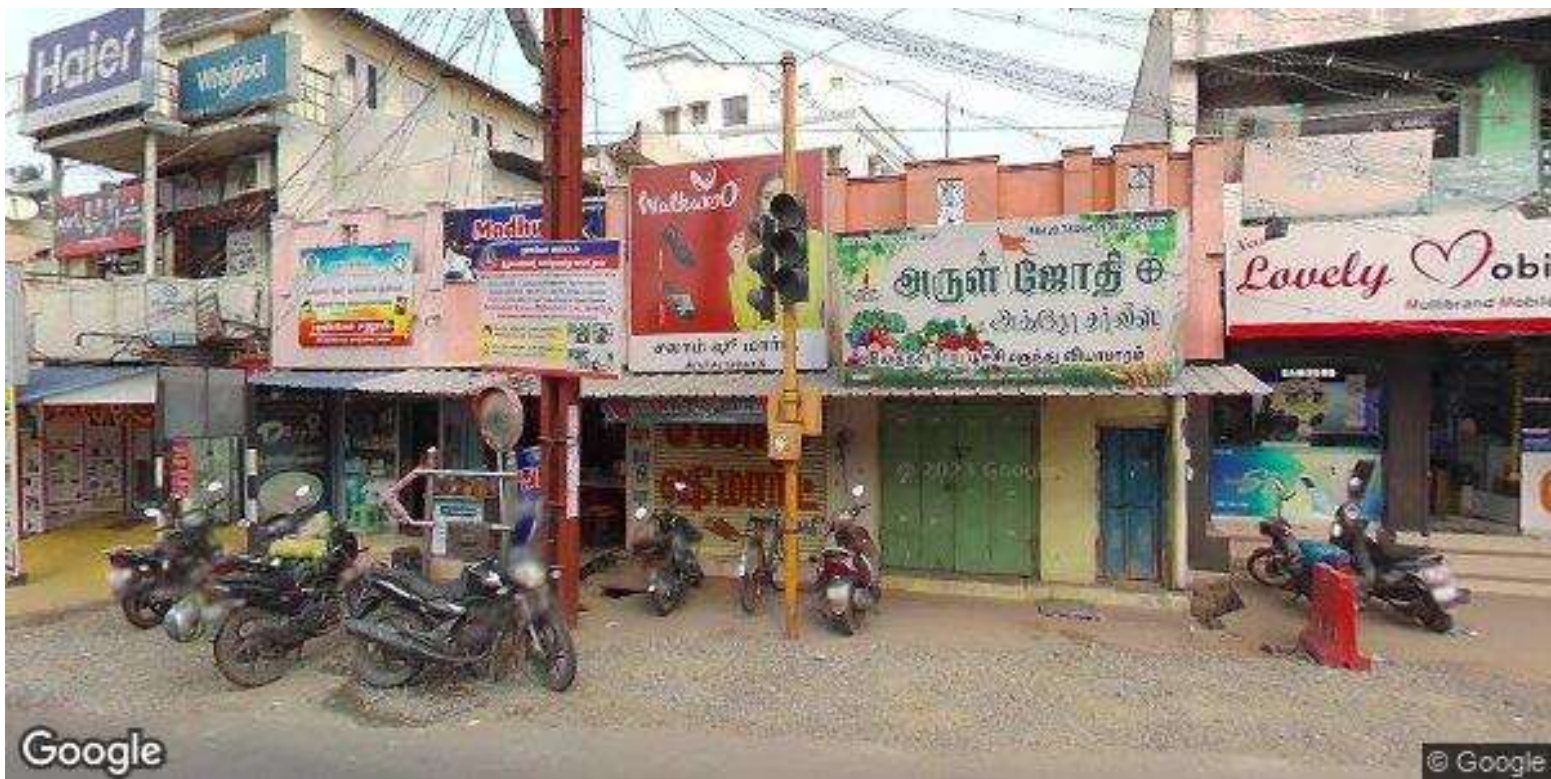
**Risk Type:** Turn  
**Risk Level:** High  
**Speed Limit:** 15 KM/Hr  
**Coordinates:** 11.37850, 77.89453

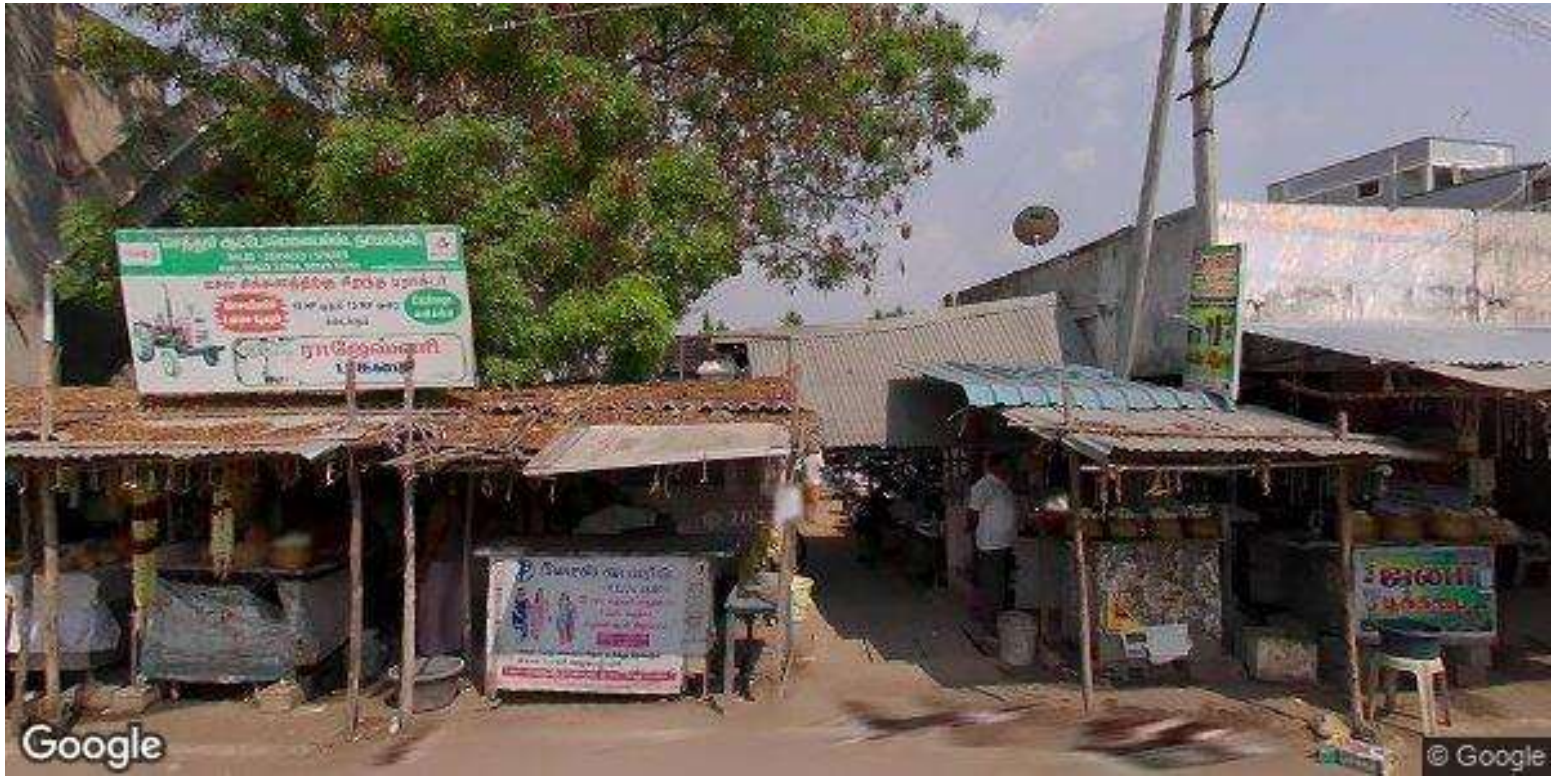
**Risk Type:** Blind Spot  
**Risk Level:** Blind Spot  
**Speed Limit:** 10 KM/Hr  
**Coordinates:** 11.15573, 78.02176

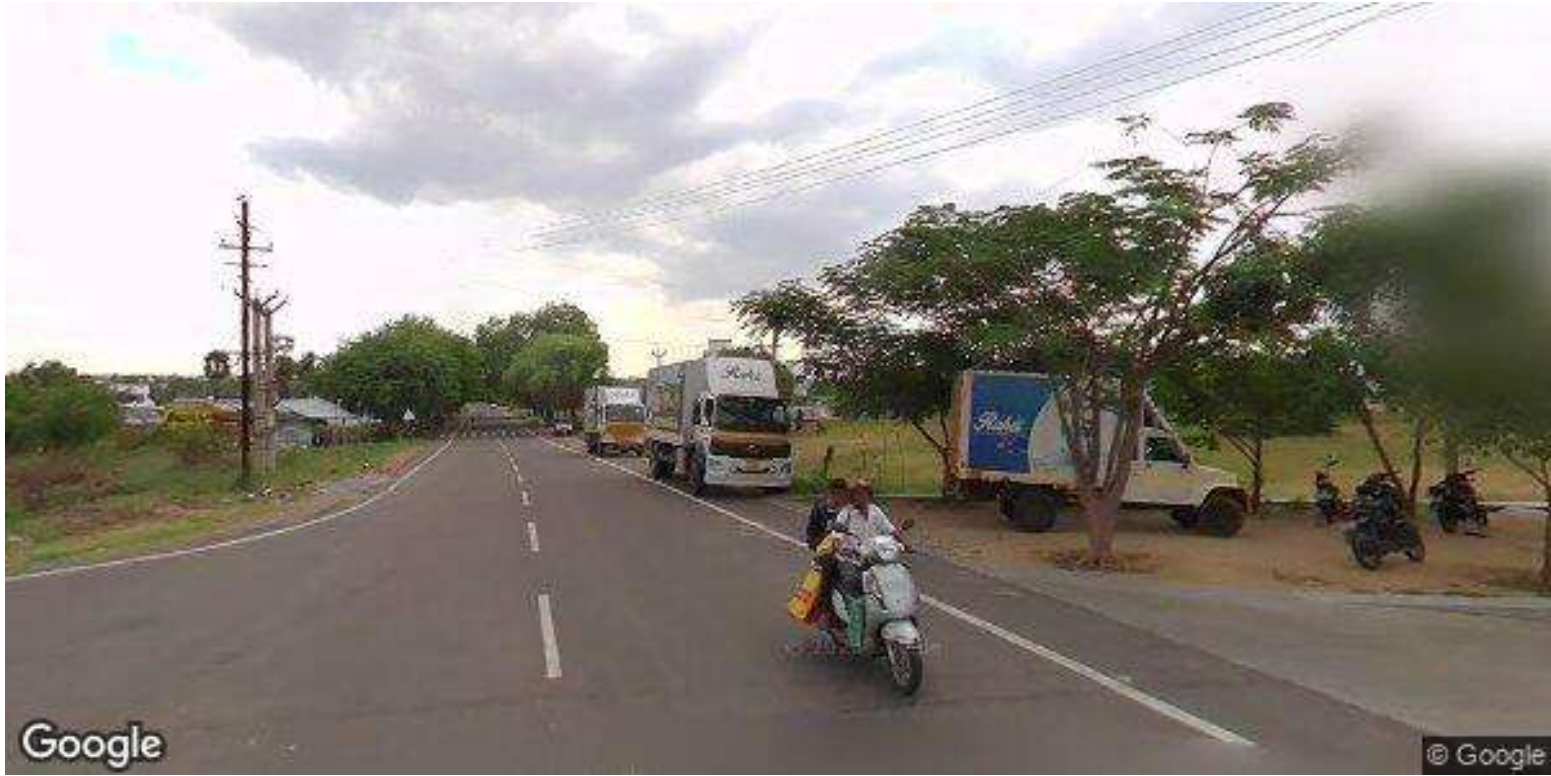
**Risk Type:** Turn  
**Risk Level:** Medium  
**Speed Limit:** 30 KM/Hr  
**Coordinates:** 11.16243, 78.02715

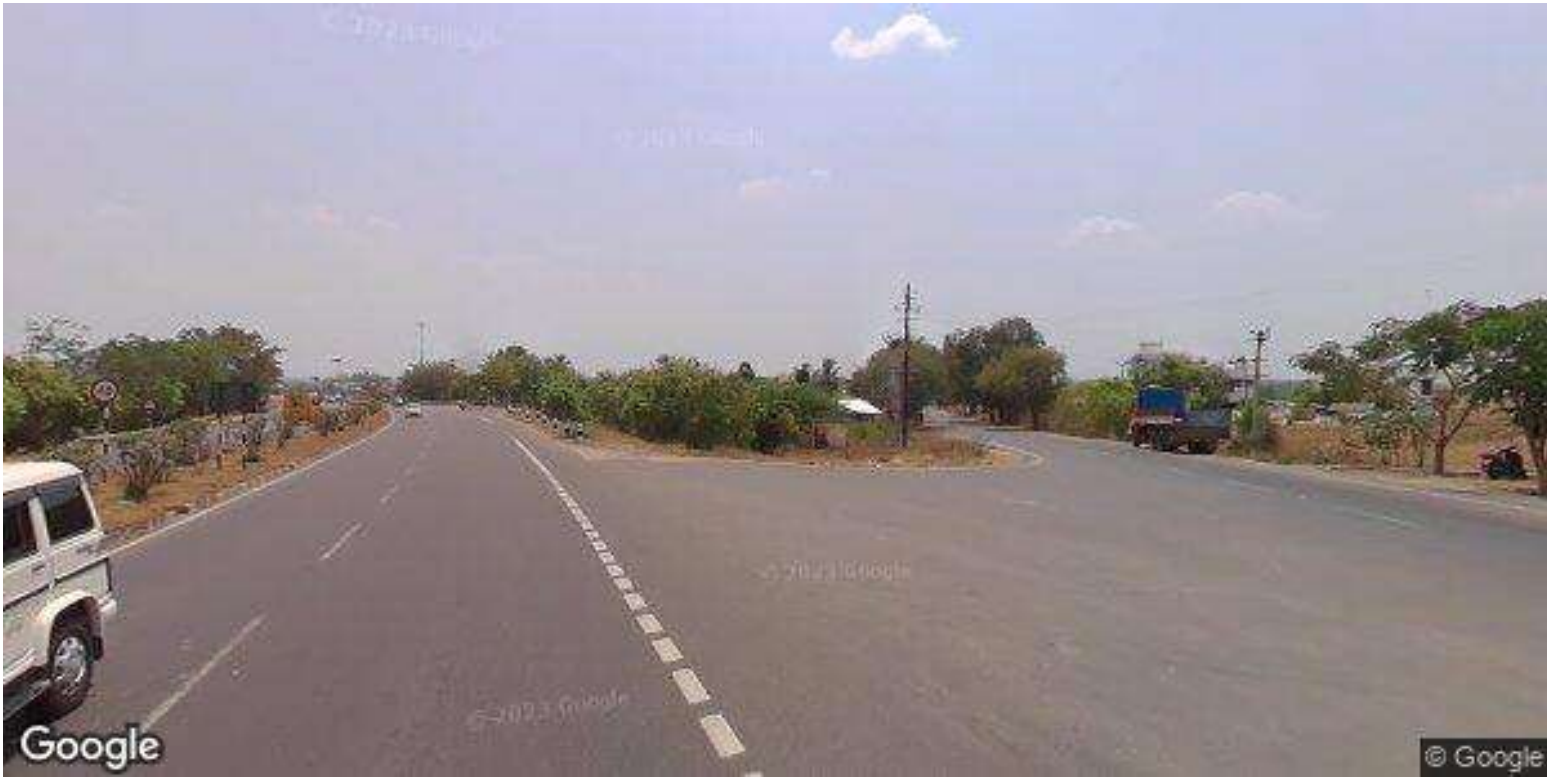
**Coordinates:** 11.16241, 78.02729

**Risk Type:** Turn

**Risk Level:** High

**Speed Limit:** 15 KM/Hr
