# IndianOil

## JOURNEY RISK MANAGEMENT (JRM) STUDY

### Salem Terminal to ADVG AGENCIES

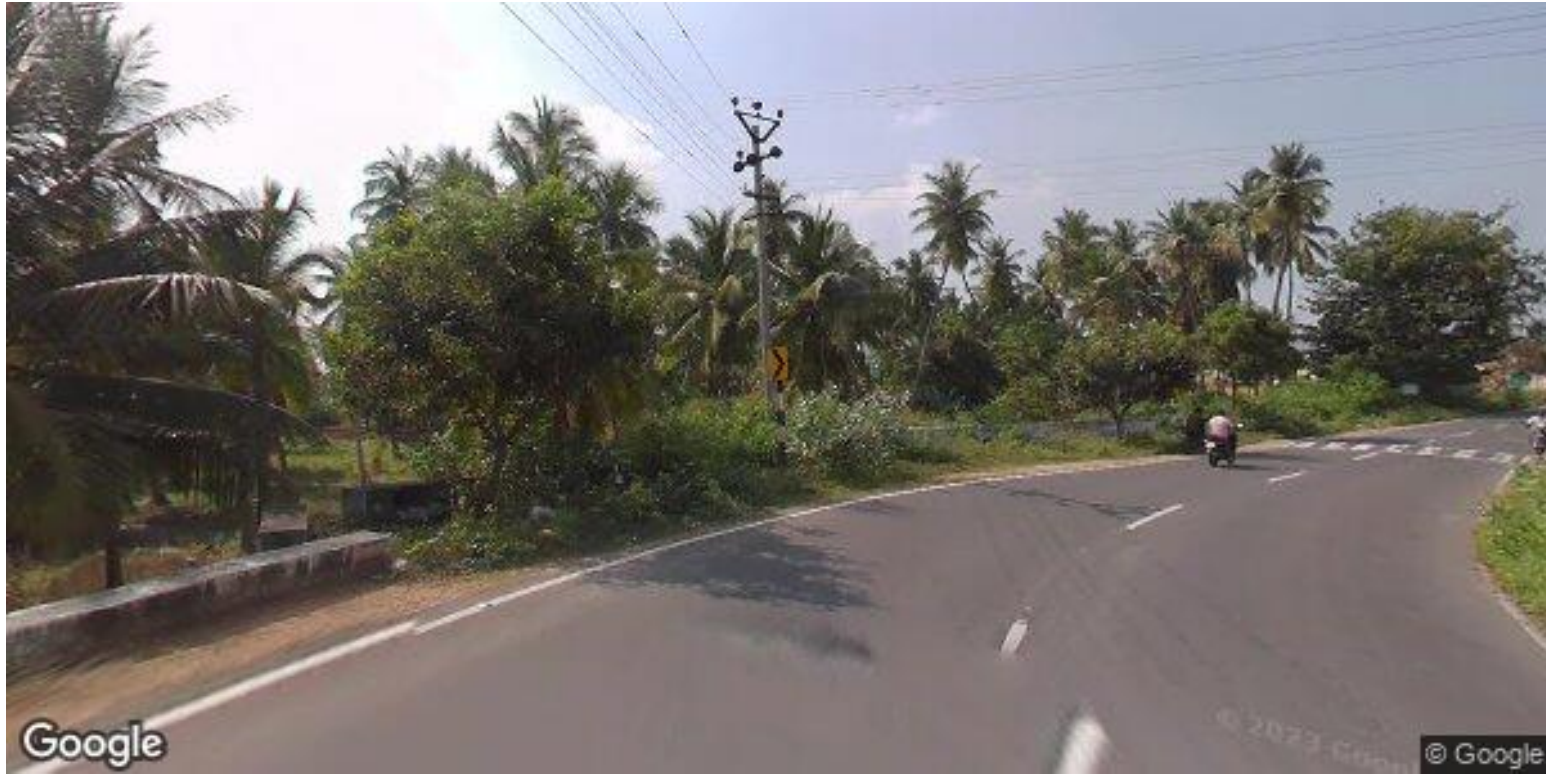
**Risk Type:** Turn  
**Risk Level:** Medium  
**Speed Limit:** 30 KM/Hr  
**Coordinates:** 11.45348, 77.85706

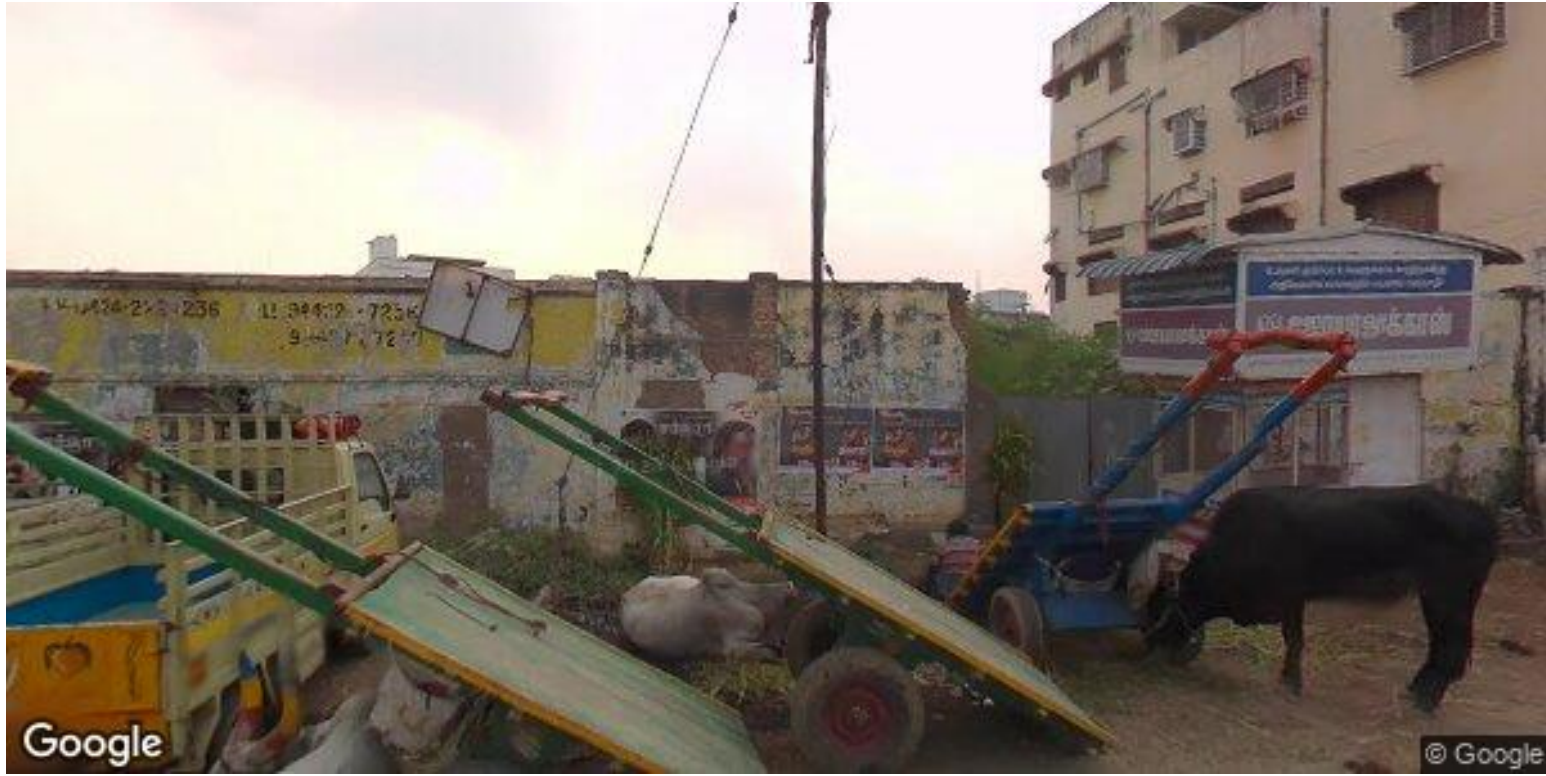
**Coordinates: 11.34678, 77.72581**

**Risk Type: Turn**

**Risk Level: High**

**Speed Limit: 15 KM/Hr**

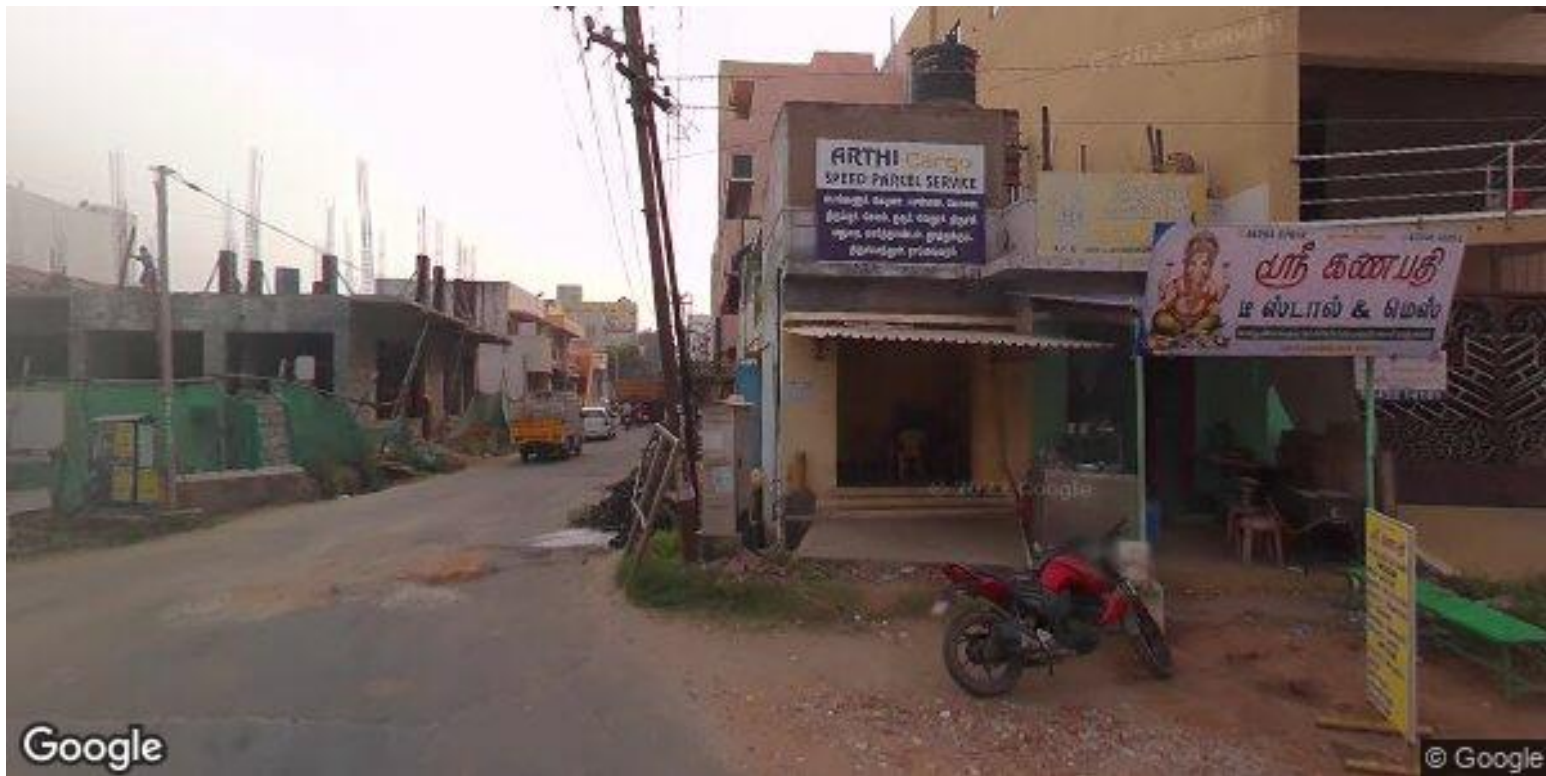
**Coordinates: 11.34803, 77.72478**

**Risk Type: Blind Spot**

**Risk Level: Blind Spot**

**Speed Limit: 10 KM/Hr**

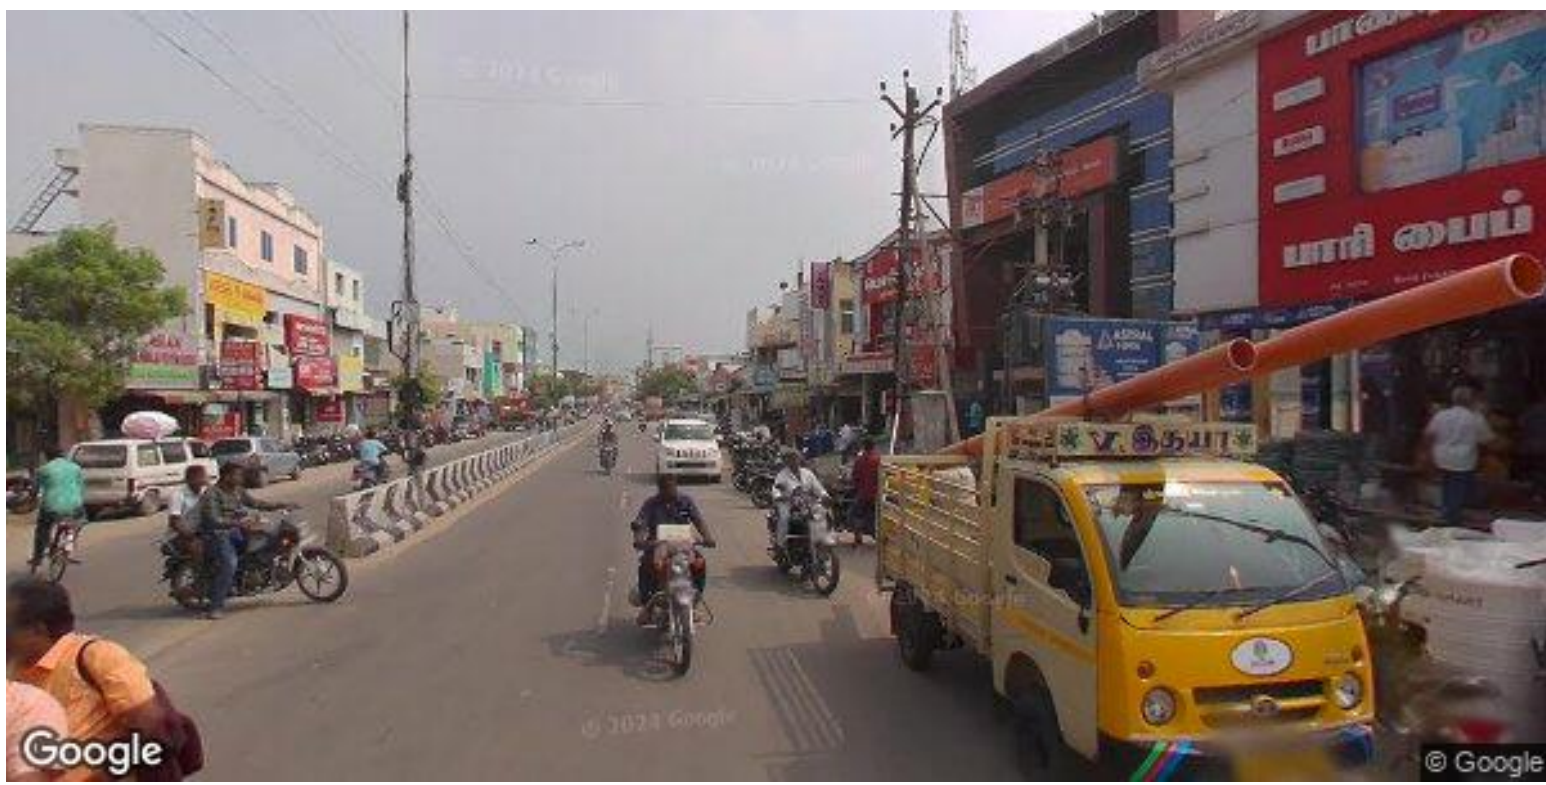
**Coordinates:** 11.34625, 77.72392

**Risk Type:** Blind Spot

**Risk Level:** Blind Spot

**Speed Limit:** 10 KM/Hr

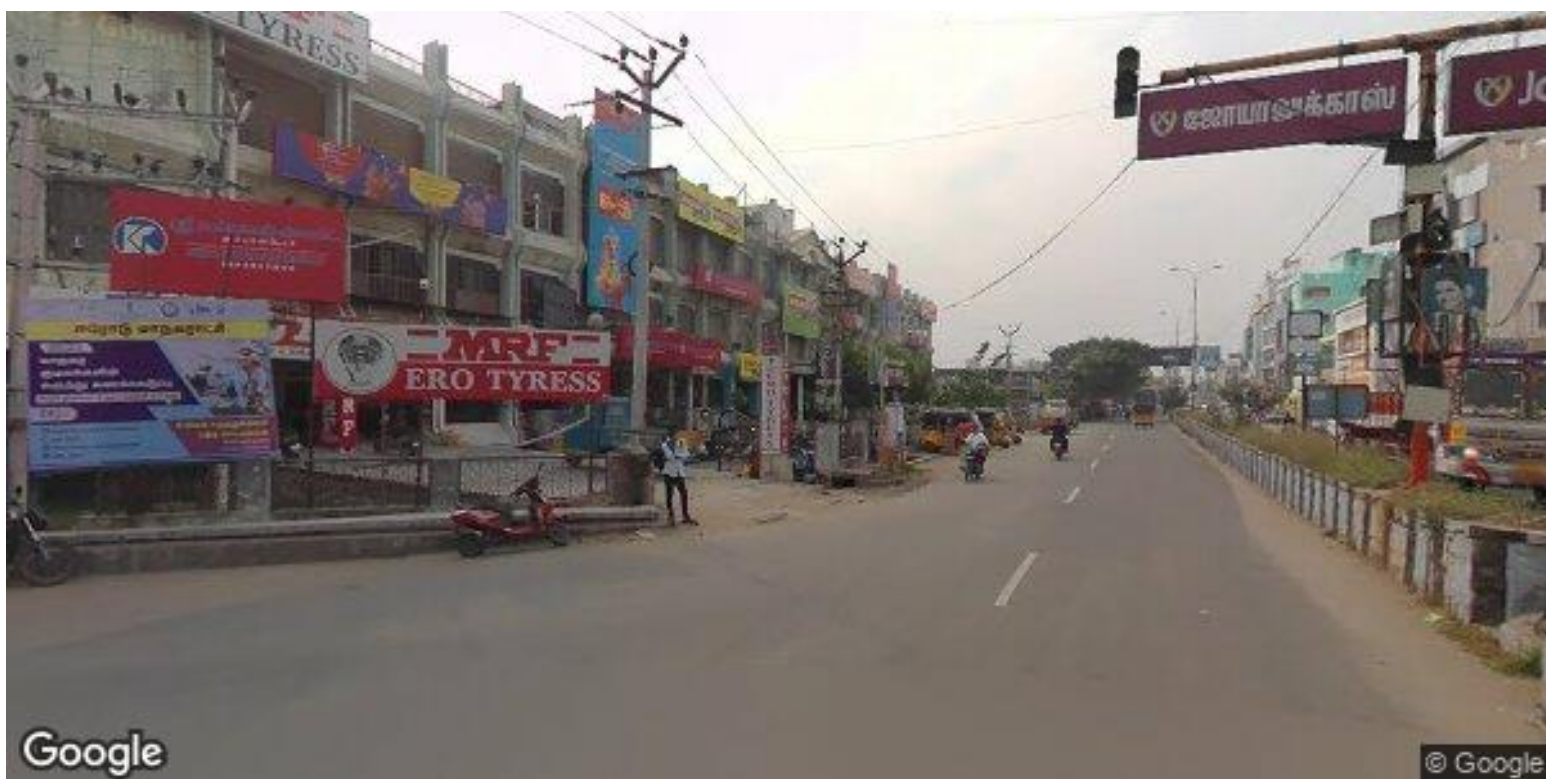
**Coordinates:** 11.34727, 77.72138

**Risk Type:** Turn

**Risk Level:** High

**Speed Limit:** 15 KM/Hr
