# IndianOil

## JOURNEY RISK MANAGEMENT (JRM) STUDY

### Salem Terminal to KAVIRAJ AGENCY

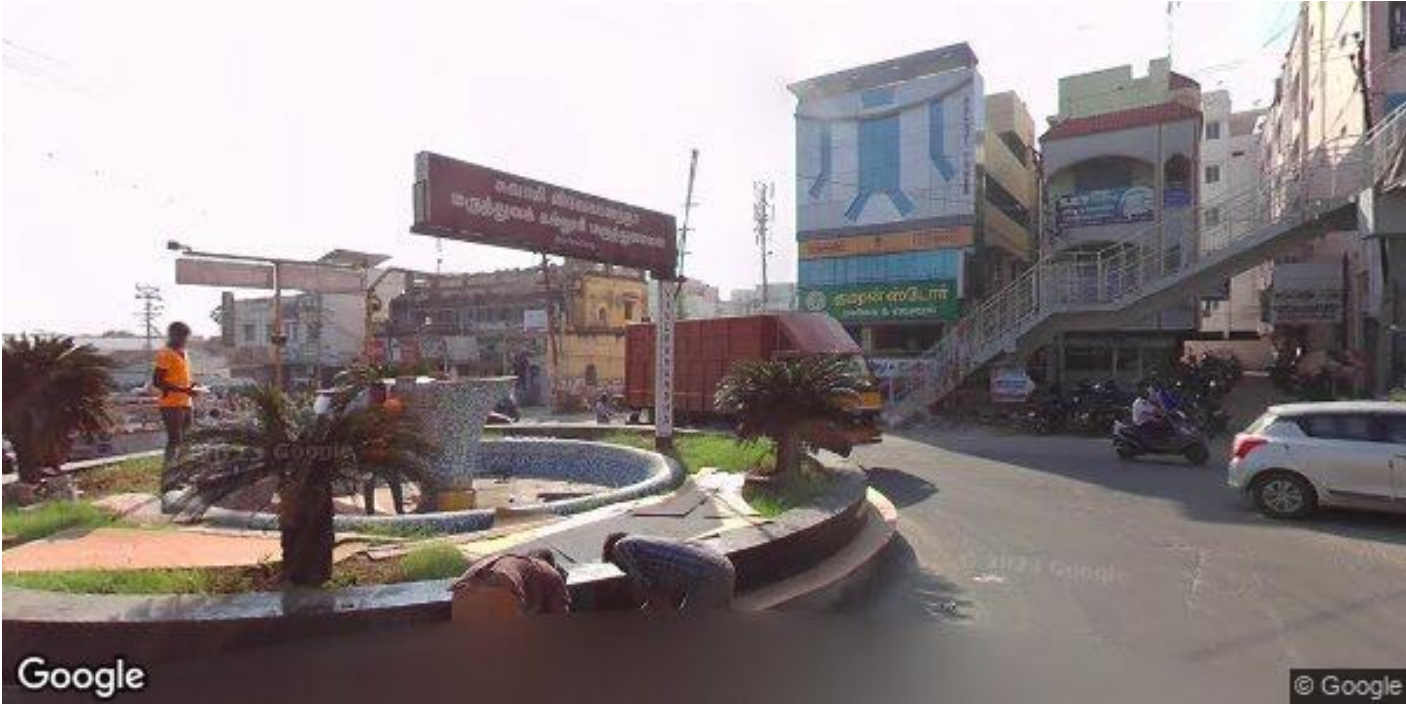
Coordinates: 11.38395, 77.89480

Risk Type: Roundabout

Risk Level: High

Speed Limit: 15 KM/Hr

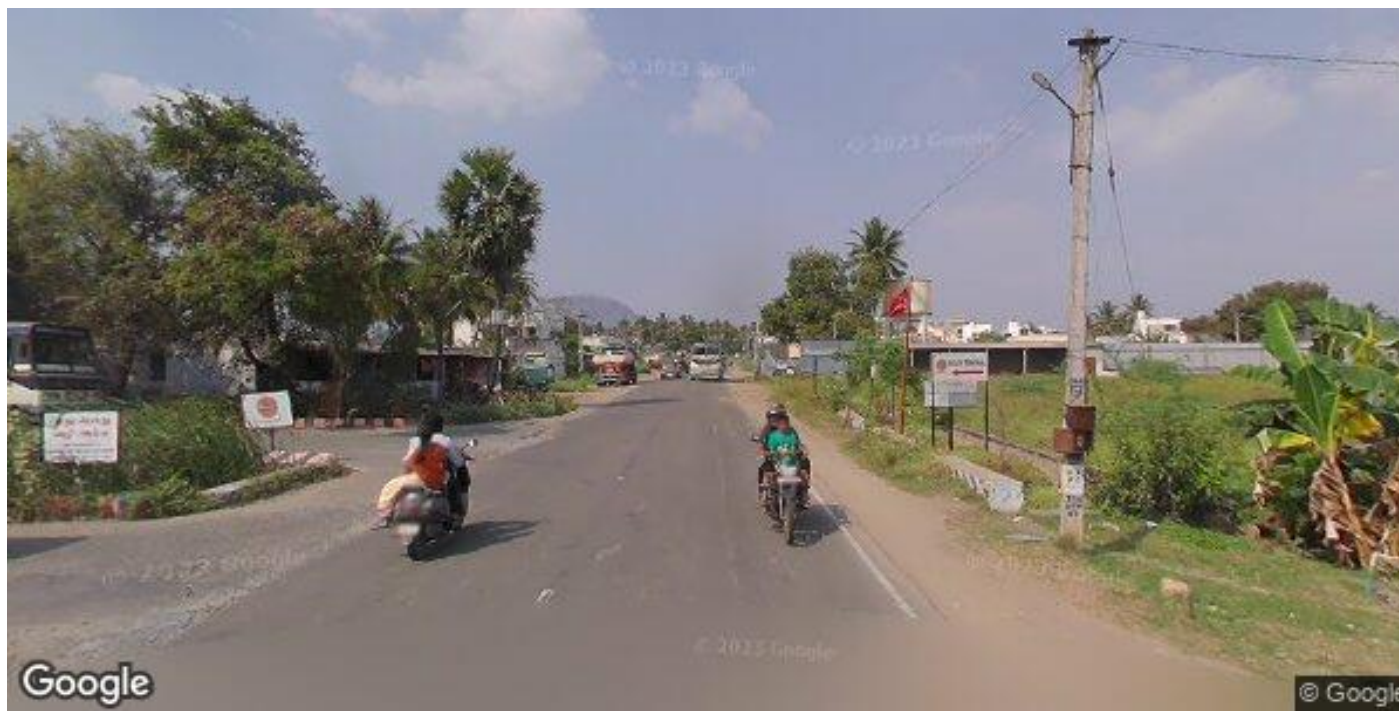
**Risk Type:** Turn  
**Risk Level:** High  
**Speed Limit:** 15 KM/Hr  
**Coordinates:** 11.44019, 77.87547

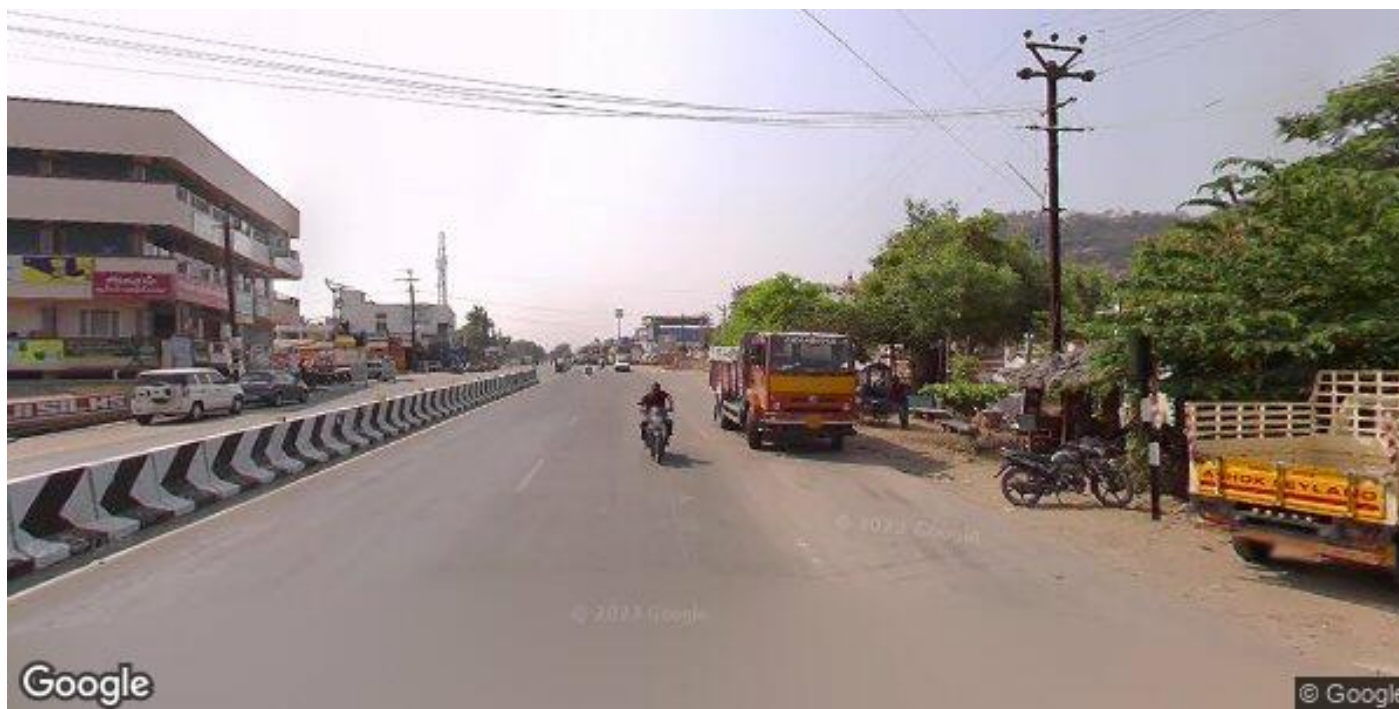
**Risk Type:** Turn  
**Risk Level:** Medium  
**Speed Limit:** 30 KM/Hr  
**Coordinates:** 11.39685, 77.88861

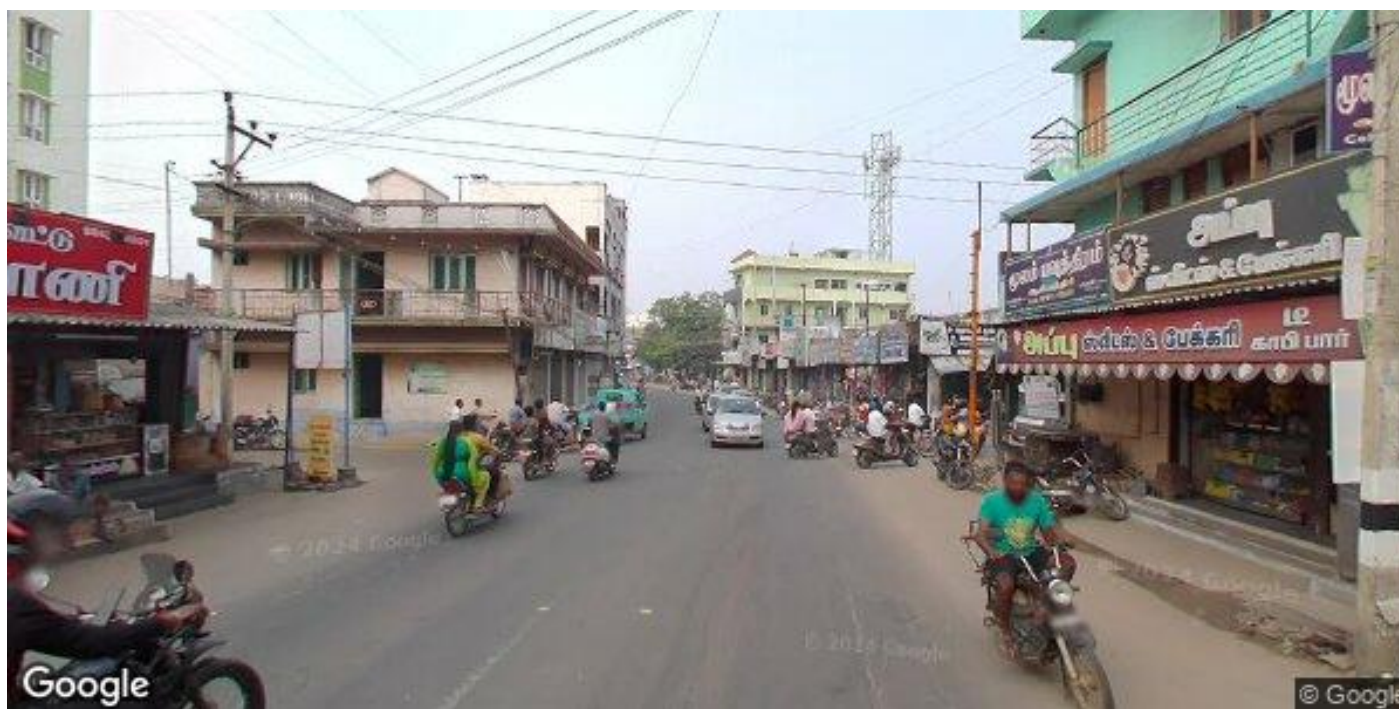
**Risk Type:** Turn  
**Risk Level:** Medium  
**Speed Limit:** 30 KM/Hr  
**Coordinates:** 11.38376, 77.89914

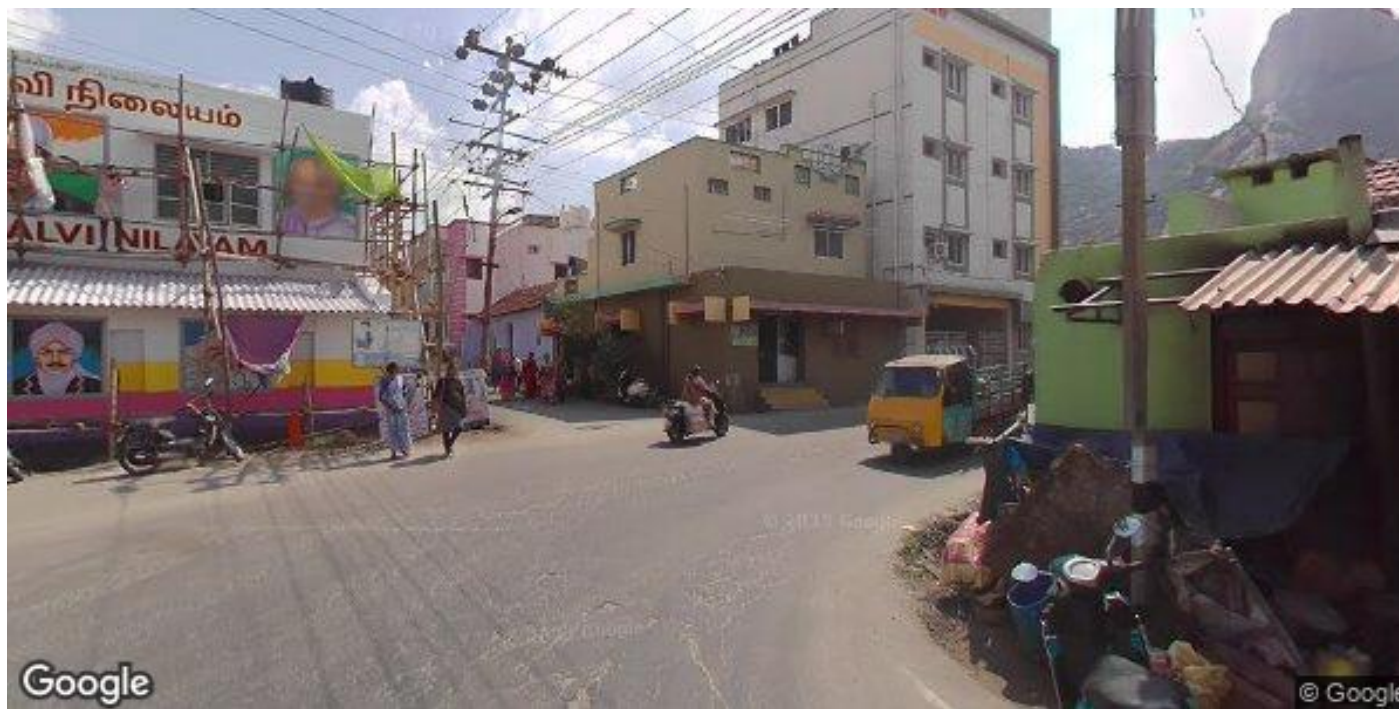
**Risk Type:** Turn  
**Risk Level:** High  
**Speed Limit:** 15 KM/Hr  
**Coordinates:** 11.38186, 77.90258

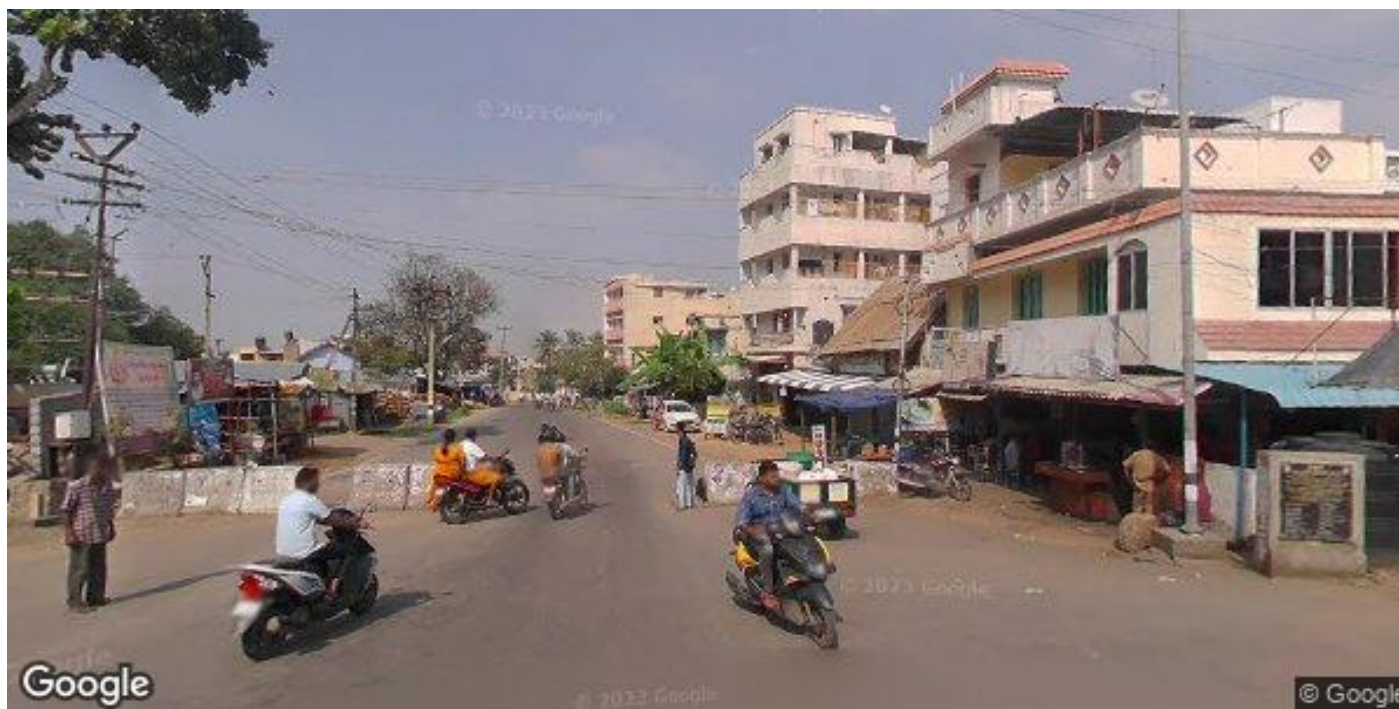
**Risk Type:** Blind Spot  
**Risk Level:** Blind Spot  
**Speed Limit:** 10 KM/Hr  
**Coordinates:** 11.37841, 77.90140

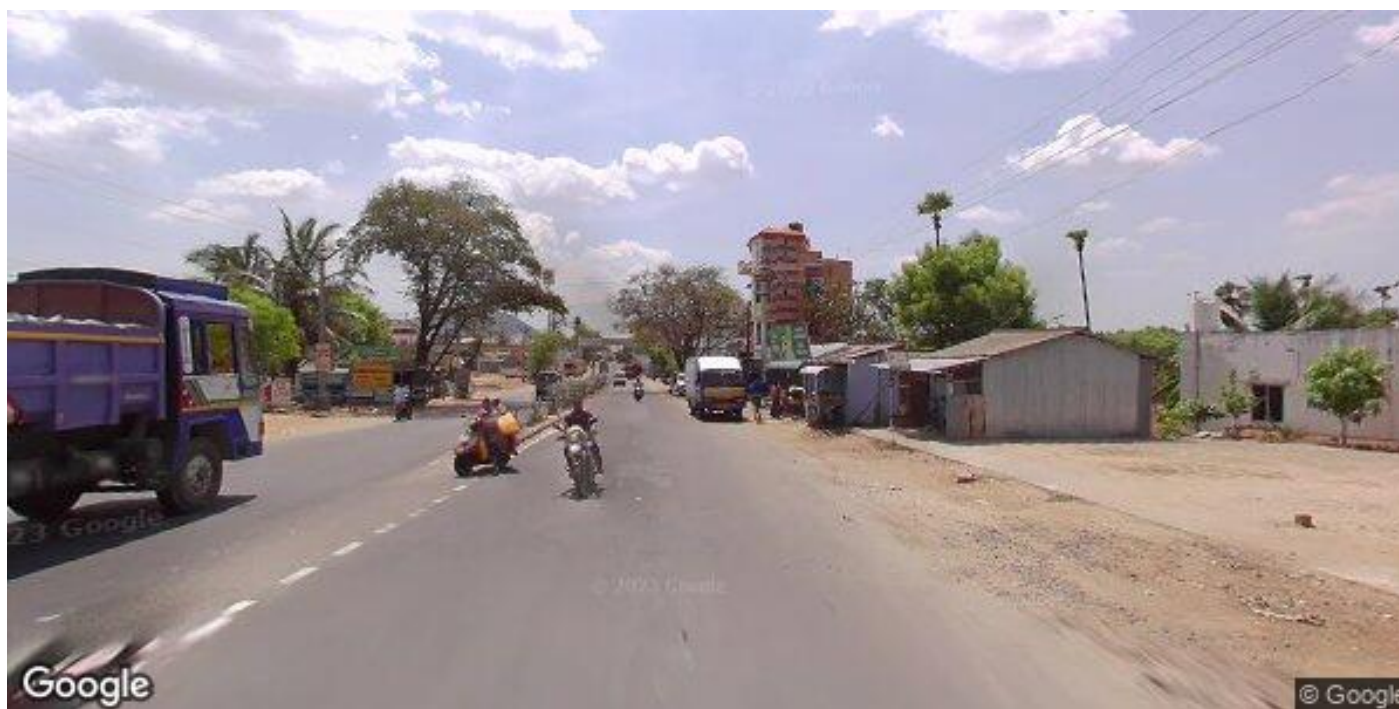
**Risk Type:** Turn  
**Risk Level:** Medium  
**Speed Limit:** 30 KM/Hr  
**Coordinates:** 11.36754, 77.93919

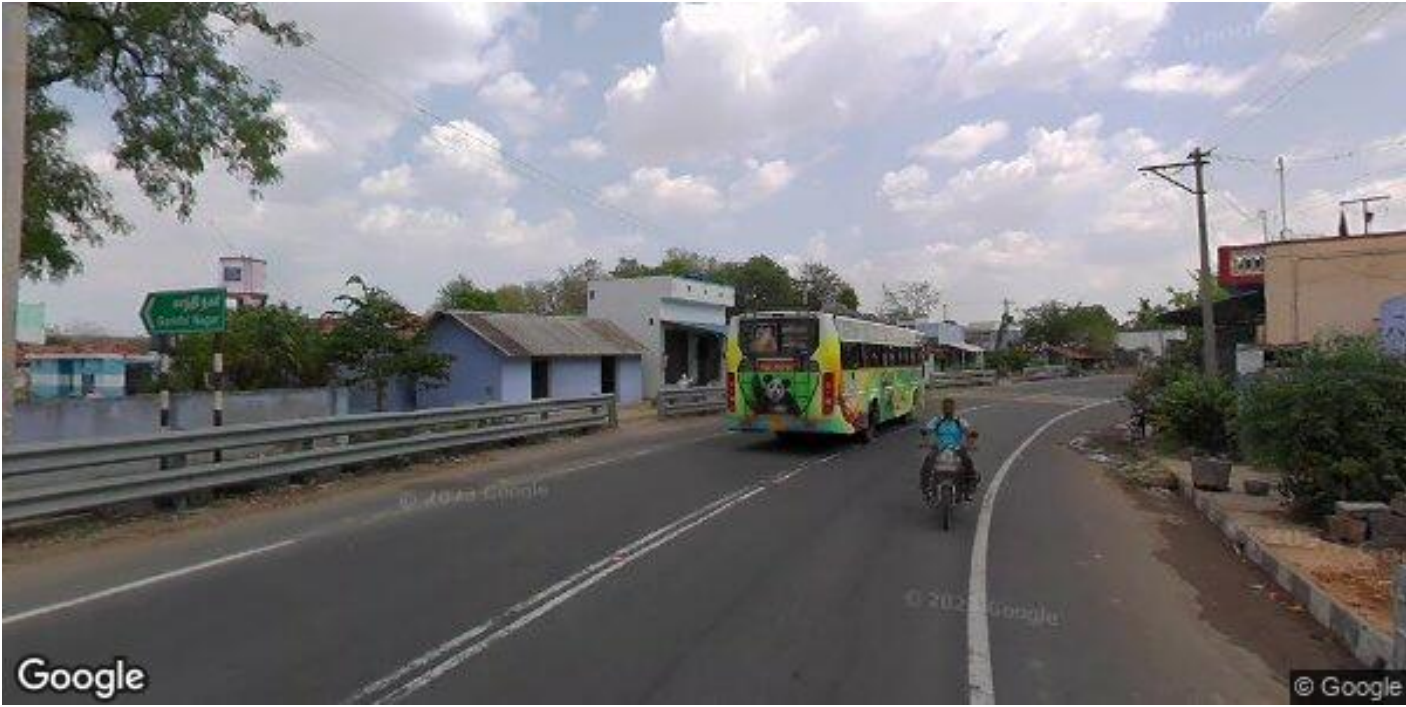
**Risk Type:** Turn  
**Risk Level:** Medium  
**Speed Limit:** 30 KM/Hr  
**Coordinates:** 11.41354, 78.08075

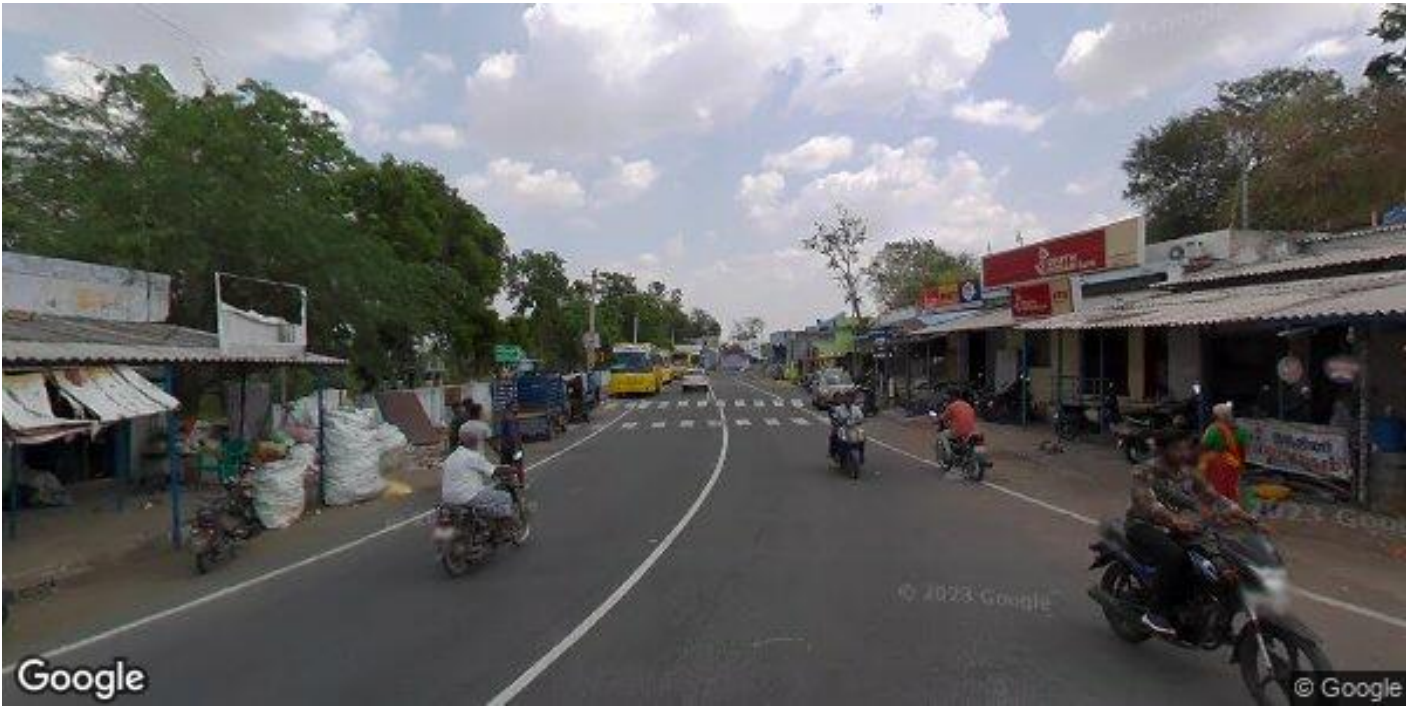
**Risk Type:** Turn  
**Risk Level:** High  
**Speed Limit:** 15 KM/Hr  
**Coordinates:** 11.41447, 78.08063

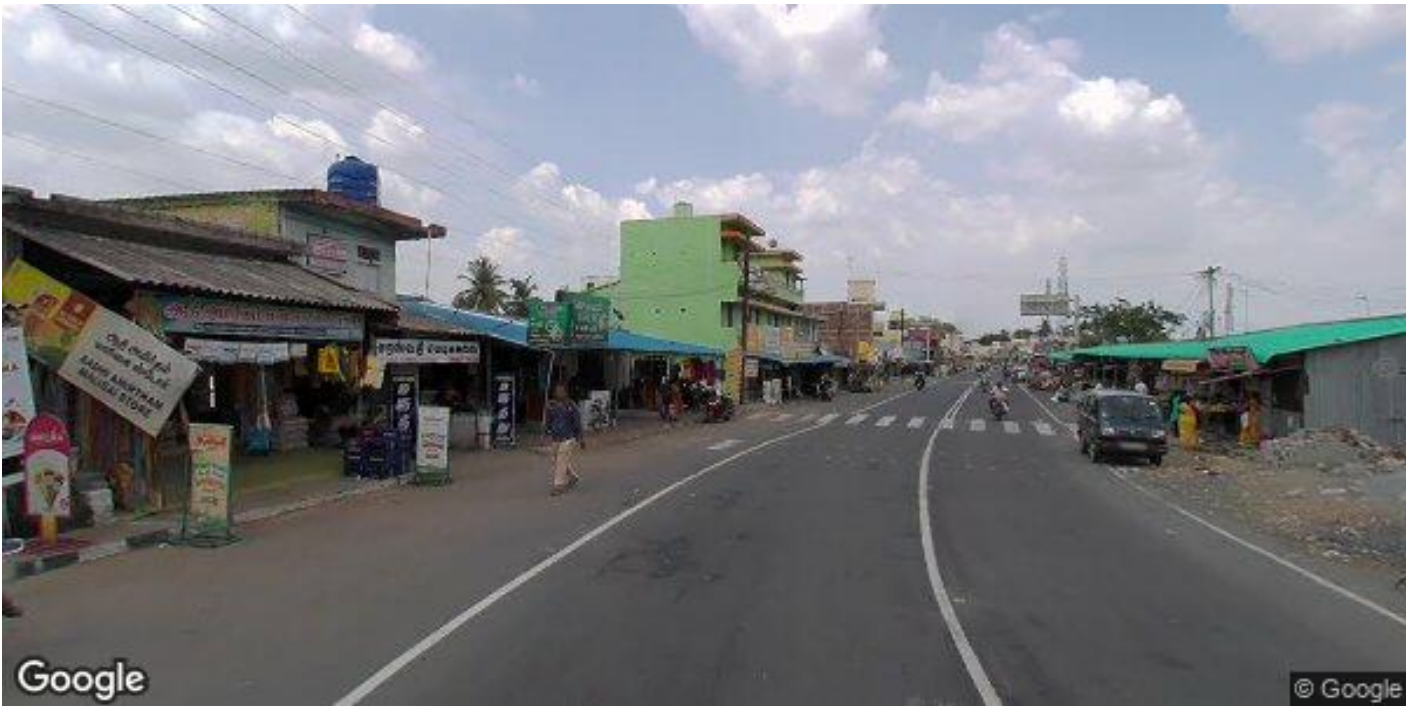
**Risk Type:** Turn  
**Risk Level:** High  
**Speed Limit:** 15 KM/Hr  
**Coordinates:** 11.41475, 78.08087

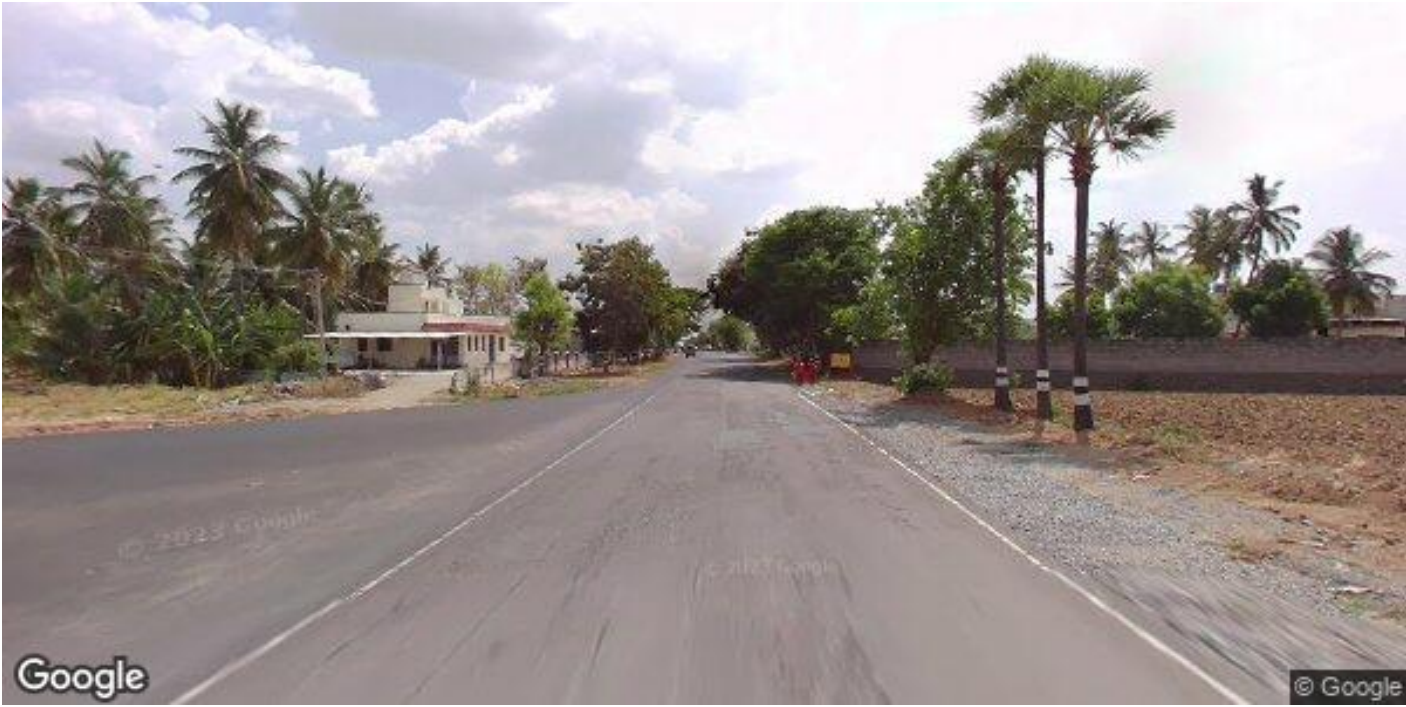
**Risk Type:** Turn  
**Risk Level:** High  
**Speed Limit:** 15 KM/Hr  
**Coordinates:** 11.42964, 78.11587

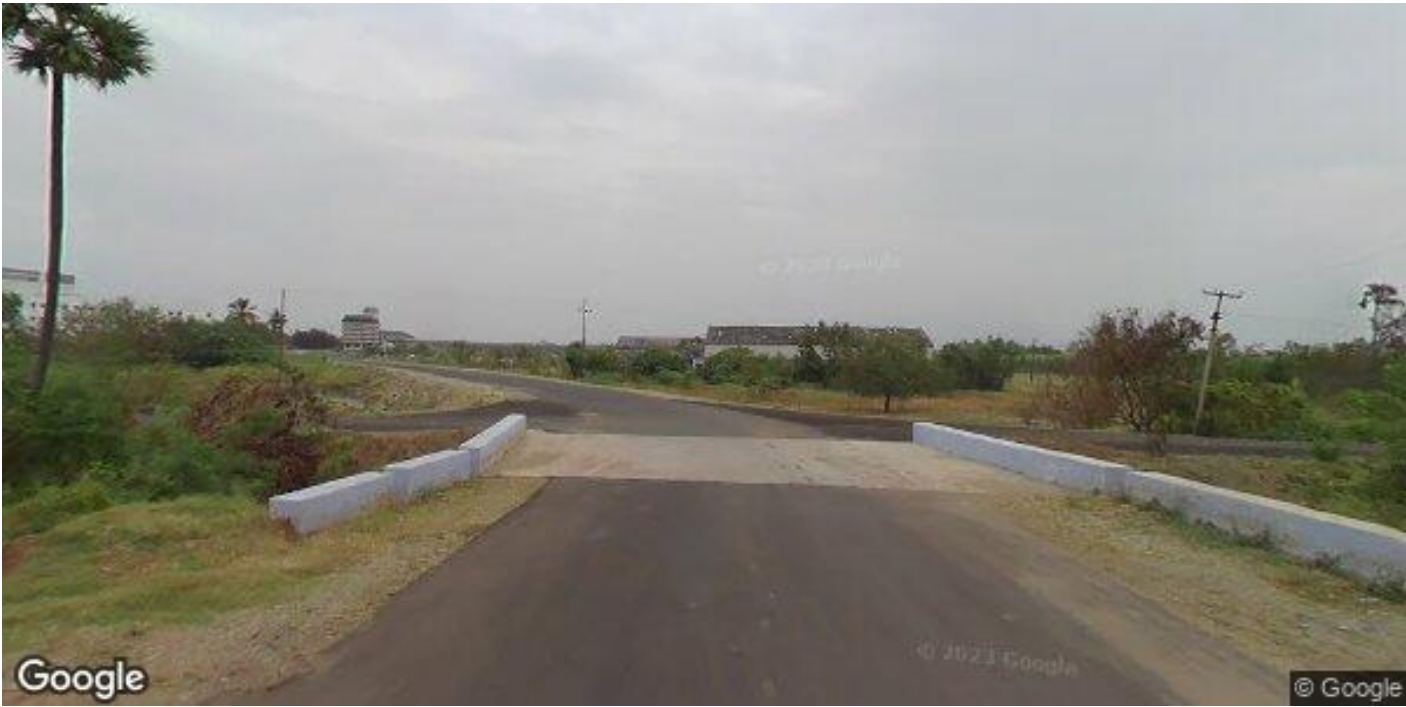
**Risk Type:** Turn  
**Risk Level:** Medium  
**Speed Limit:** 30 KM/Hr  
**Coordinates:** 11.42447, 78.15264

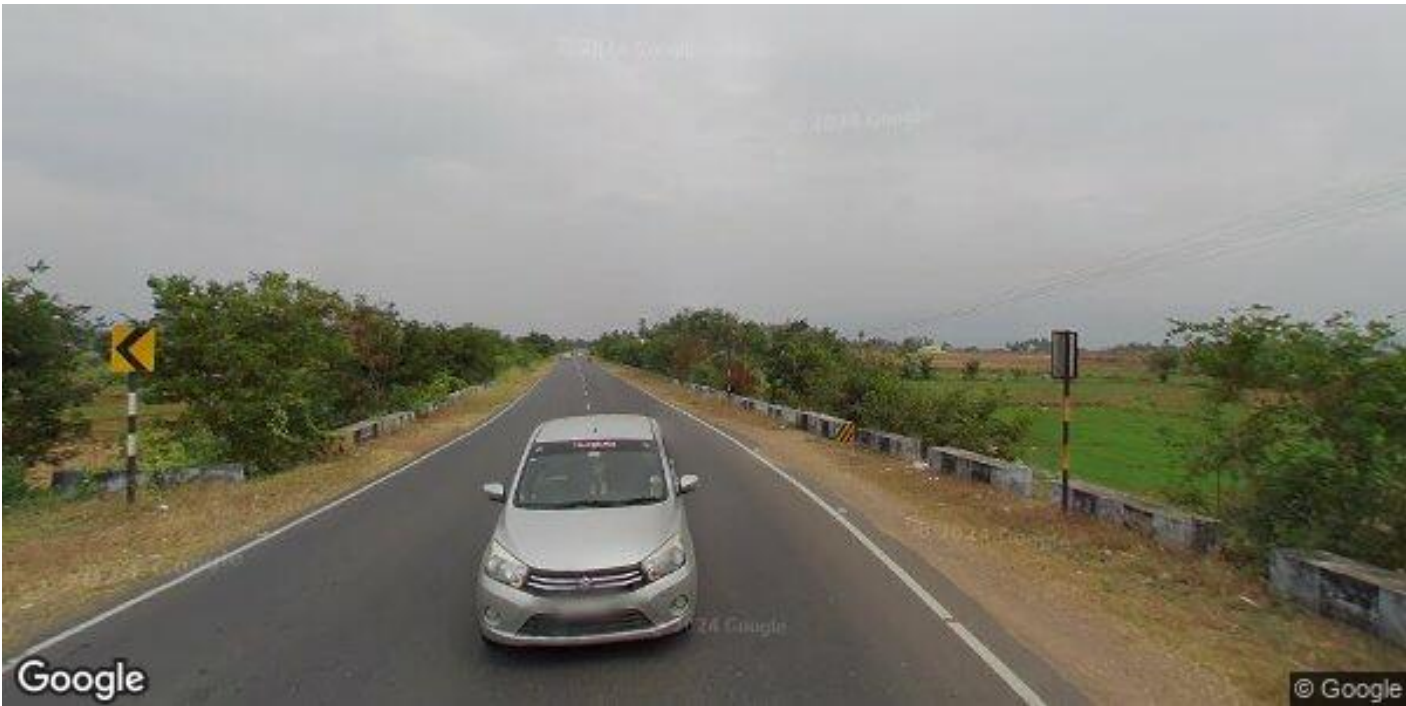
**Risk Type:** Turn  
**Risk Level:** Medium  
**Speed Limit:** 30 KM/Hr  
**Coordinates:** 11.43142, 78.18808

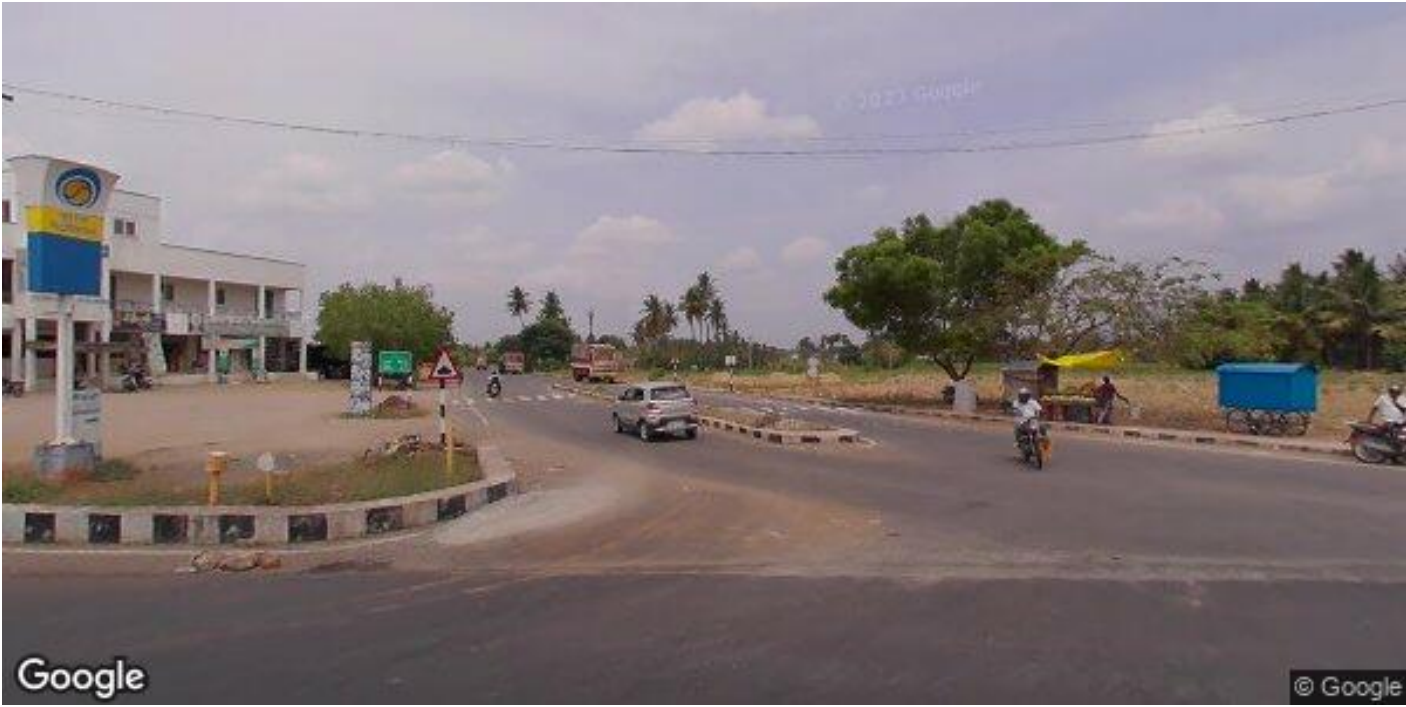
**Risk Type:** Turn  
**Risk Level:** Medium  
**Speed Limit:** 30 KM/Hr  
**Coordinates:** 11.43521, 78.20729

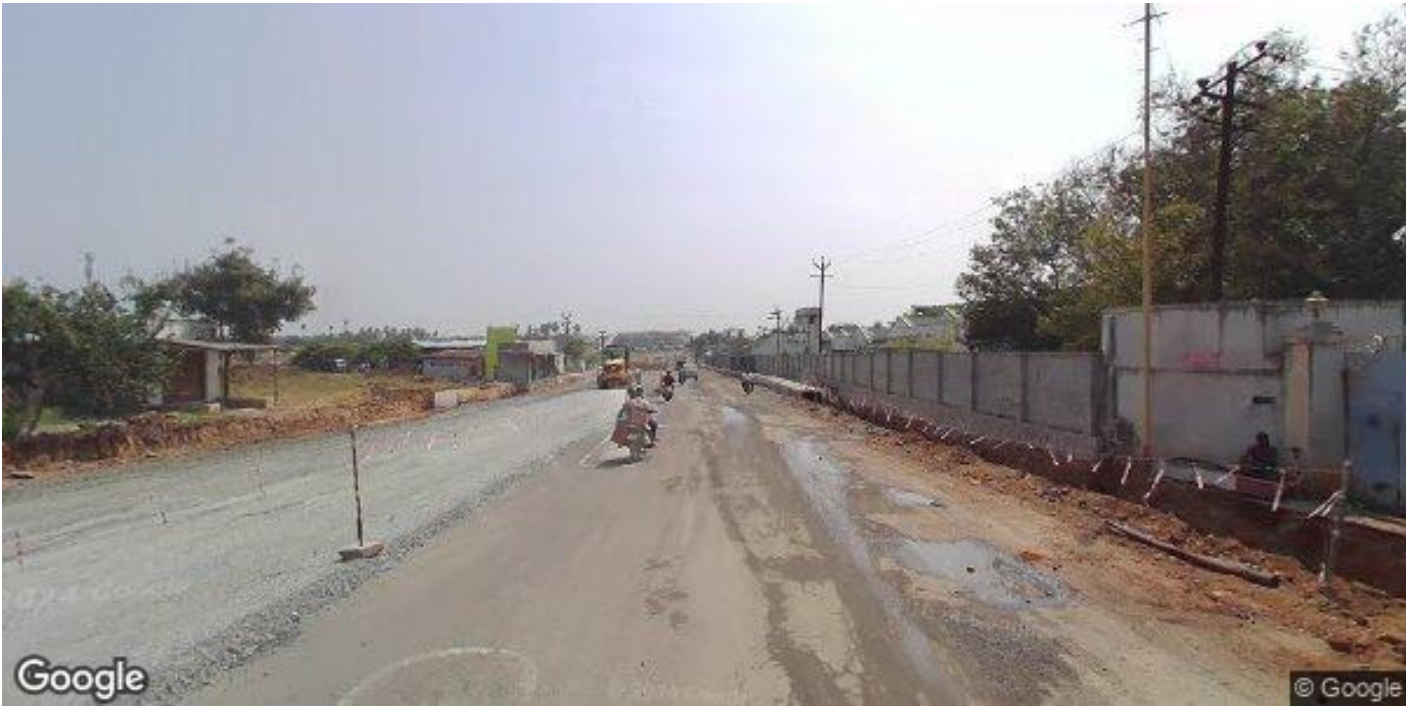
**Risk Type:** Turn  
**Risk Level:** High  
**Speed Limit:** 15 KM/Hr  
**Coordinates:** 11.45070, 78.20393

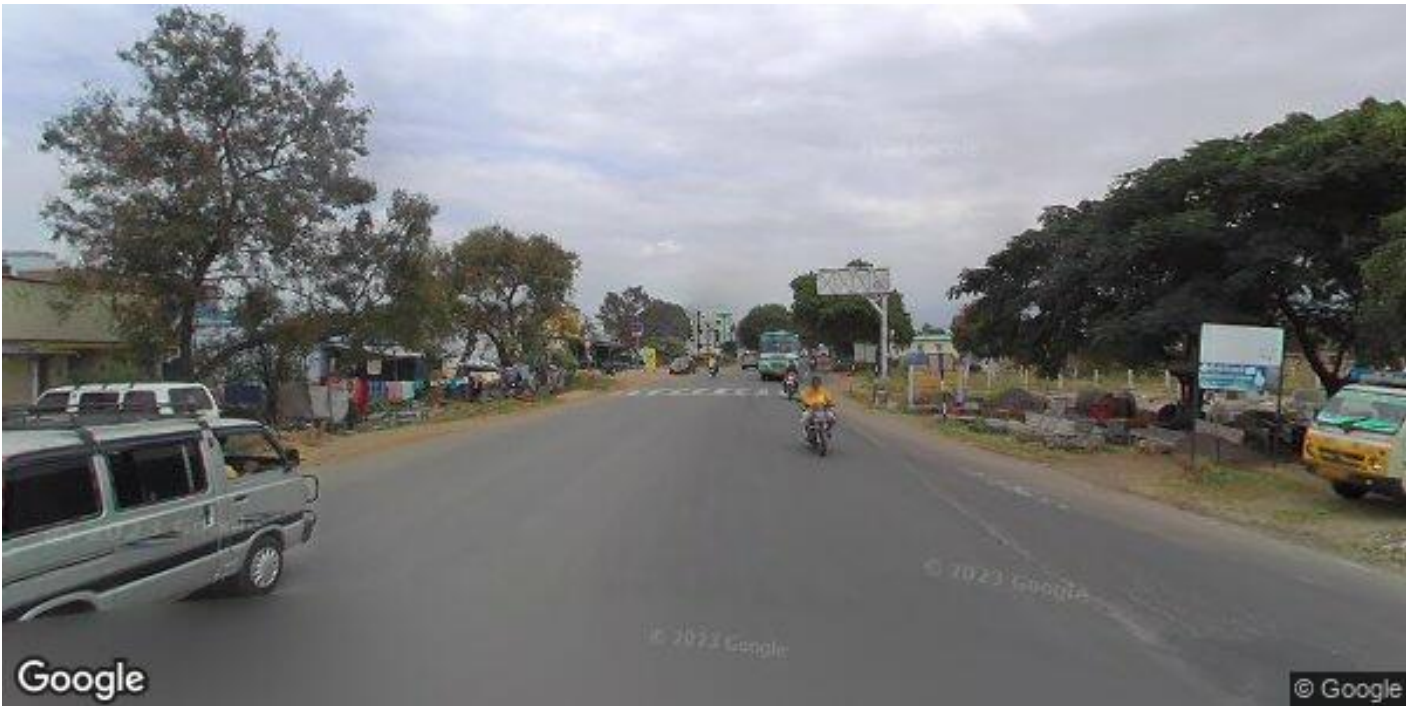
**Risk Type:** Turn  
**Risk Level:** High  
**Speed Limit:** 15 KM/Hr  
**Coordinates:** 11.45098, 78.20412

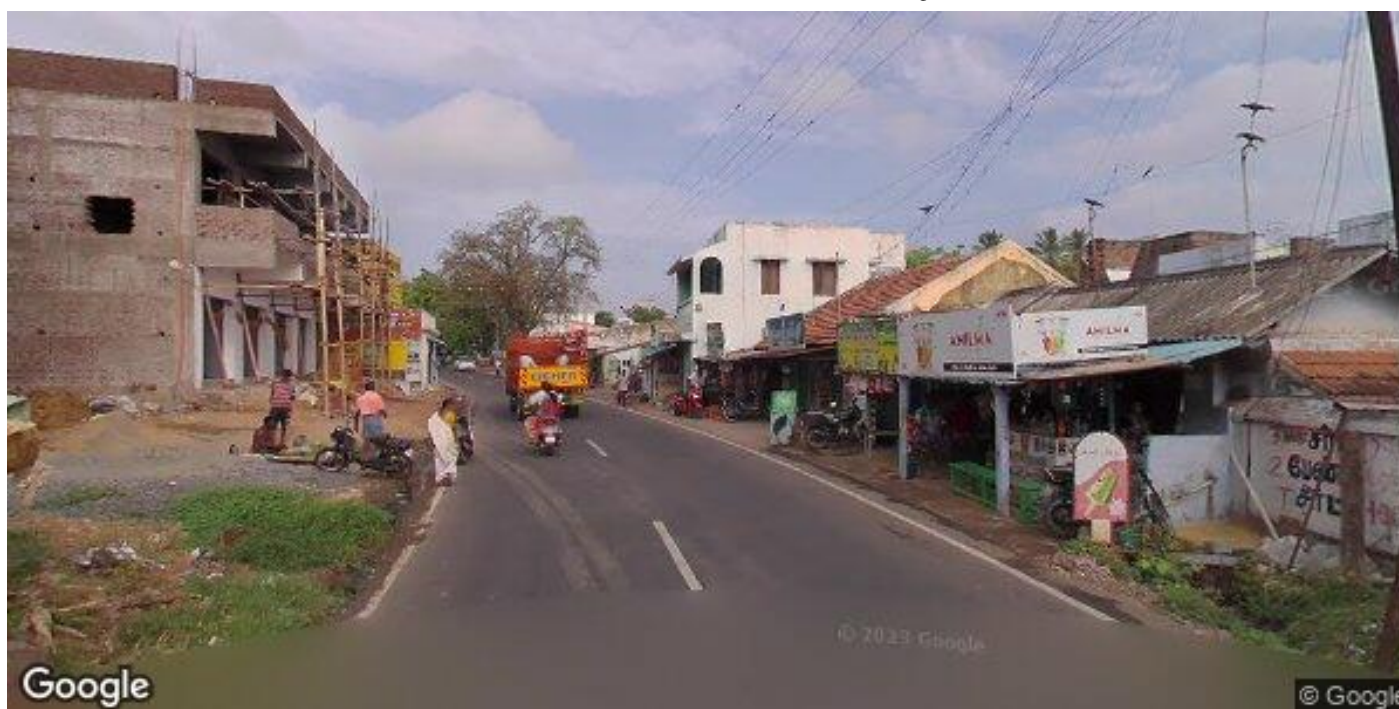
**Risk Type:** Turn  
**Risk Level:** Medium  
**Speed Limit:** 30 KM/Hr  
**Coordinates:** 11.44993, 78.22152

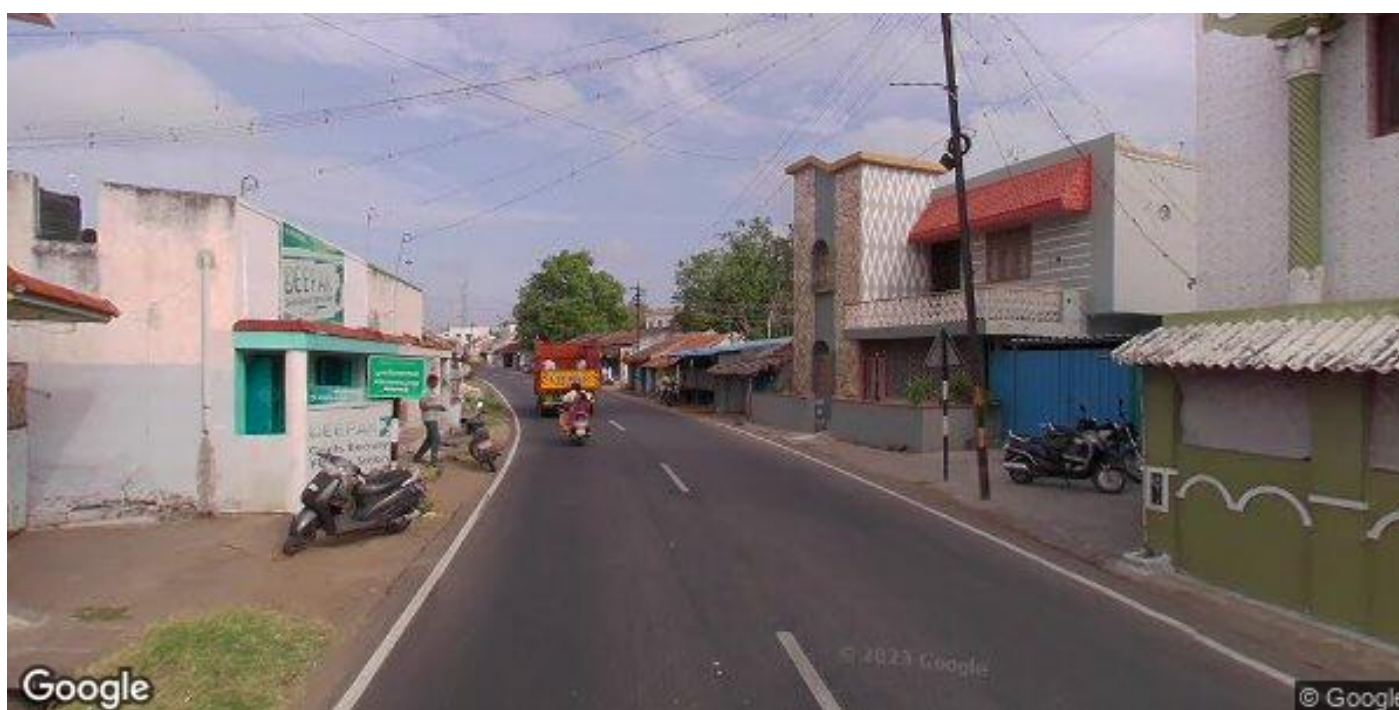
**Risk Type:** Turn  
**Risk Level:** High  
**Speed Limit:** 15 KM/Hr  
**Coordinates:** 11.44951, 78.22263

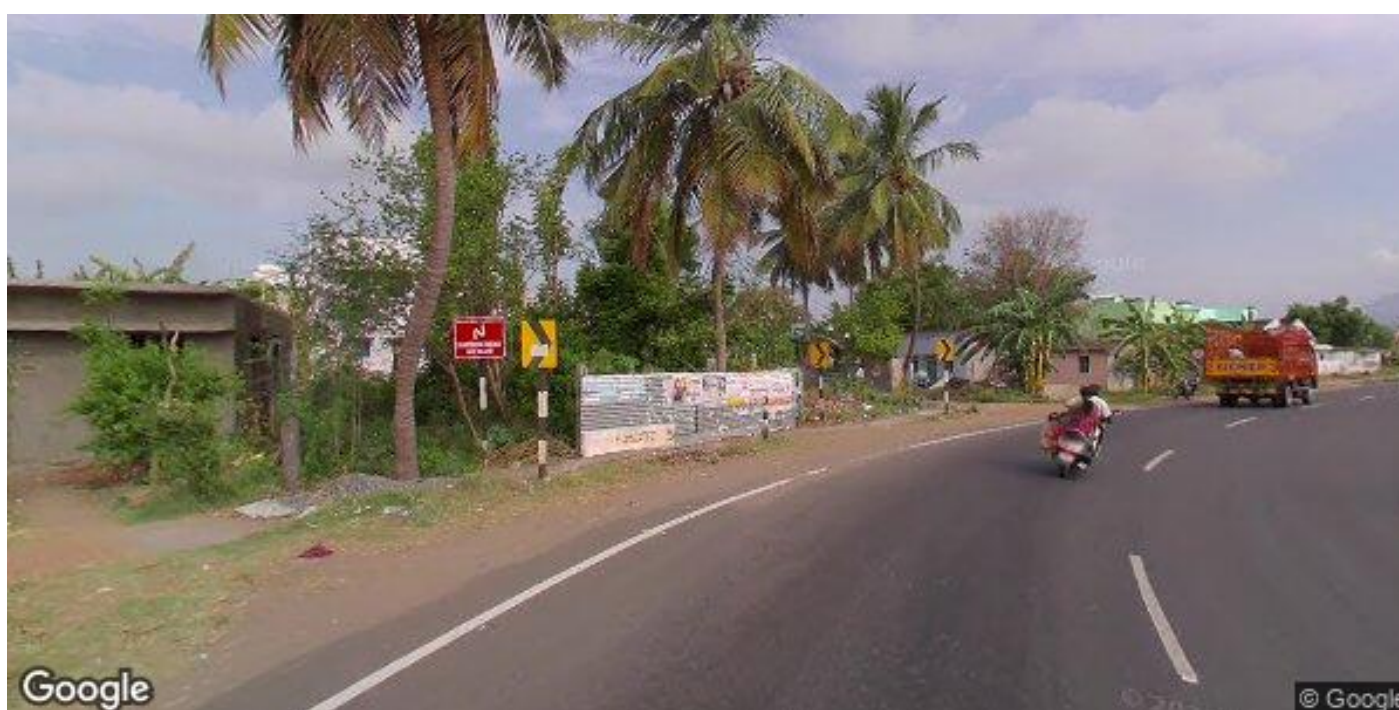
**Risk Type:** Turn  
**Risk Level:** High  
**Speed Limit:** 15 KM/Hr  
**Coordinates:** 11.44797, 78.22314

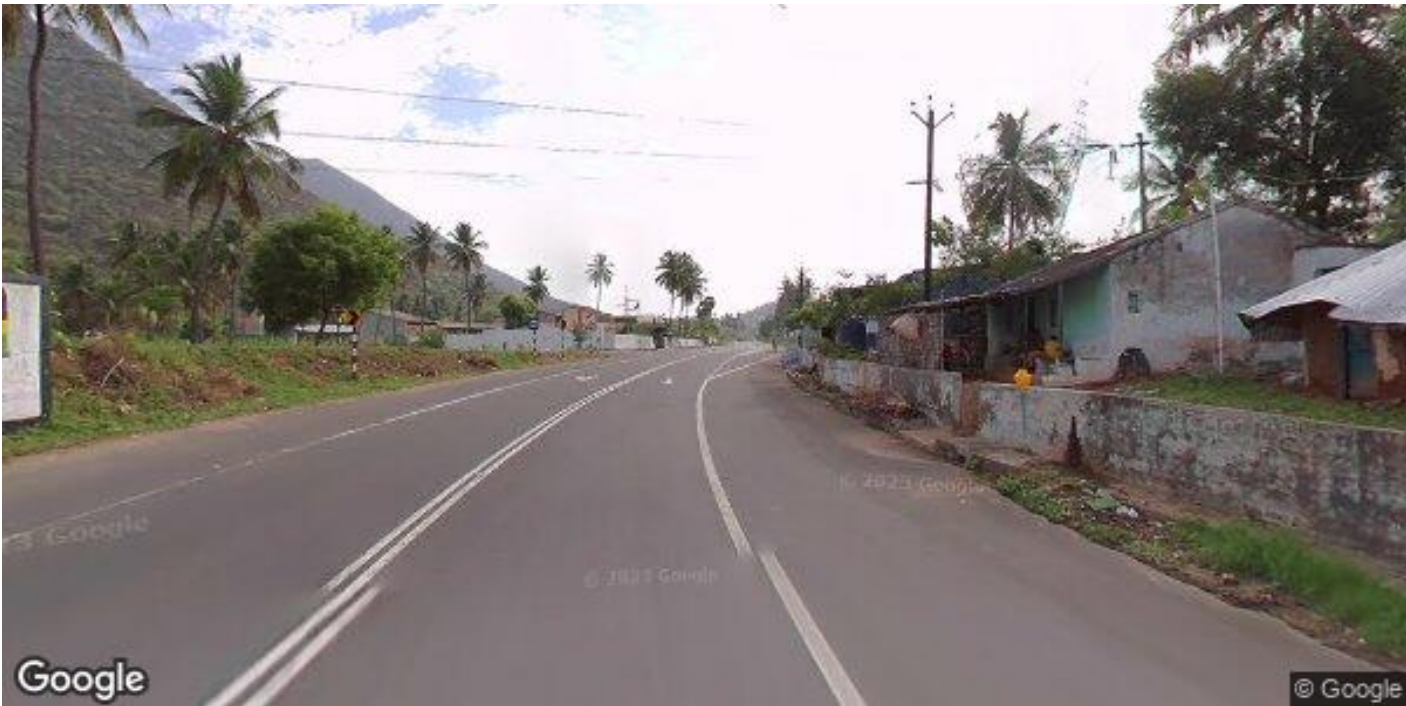
**Risk Type:** Turn  
**Risk Level:** Medium  
**Speed Limit:** 30 KM/Hr  
**Coordinates:** 11.49835, 78.32417

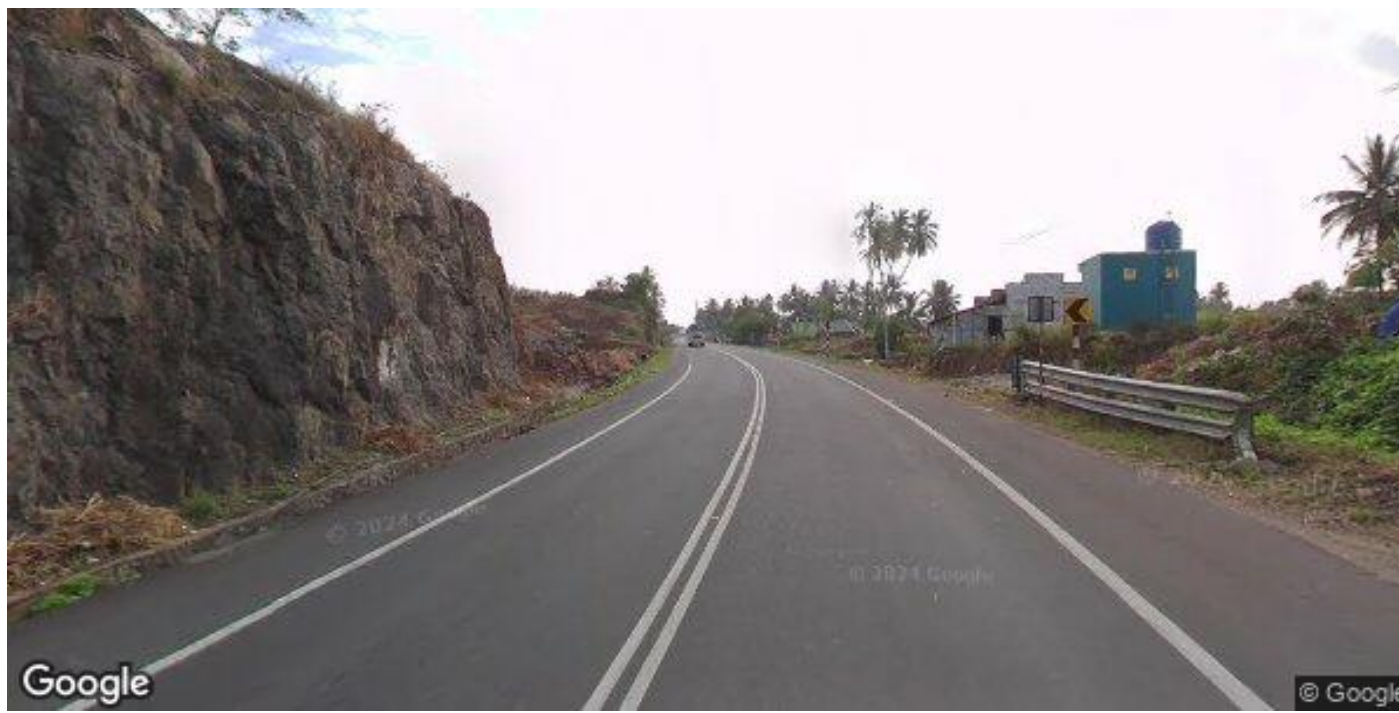
**Coordinates:** 11.50865, 78.33966

**Risk Type:** Turn

**Risk Level:** Medium

**Speed Limit:** 30 KM/Hr

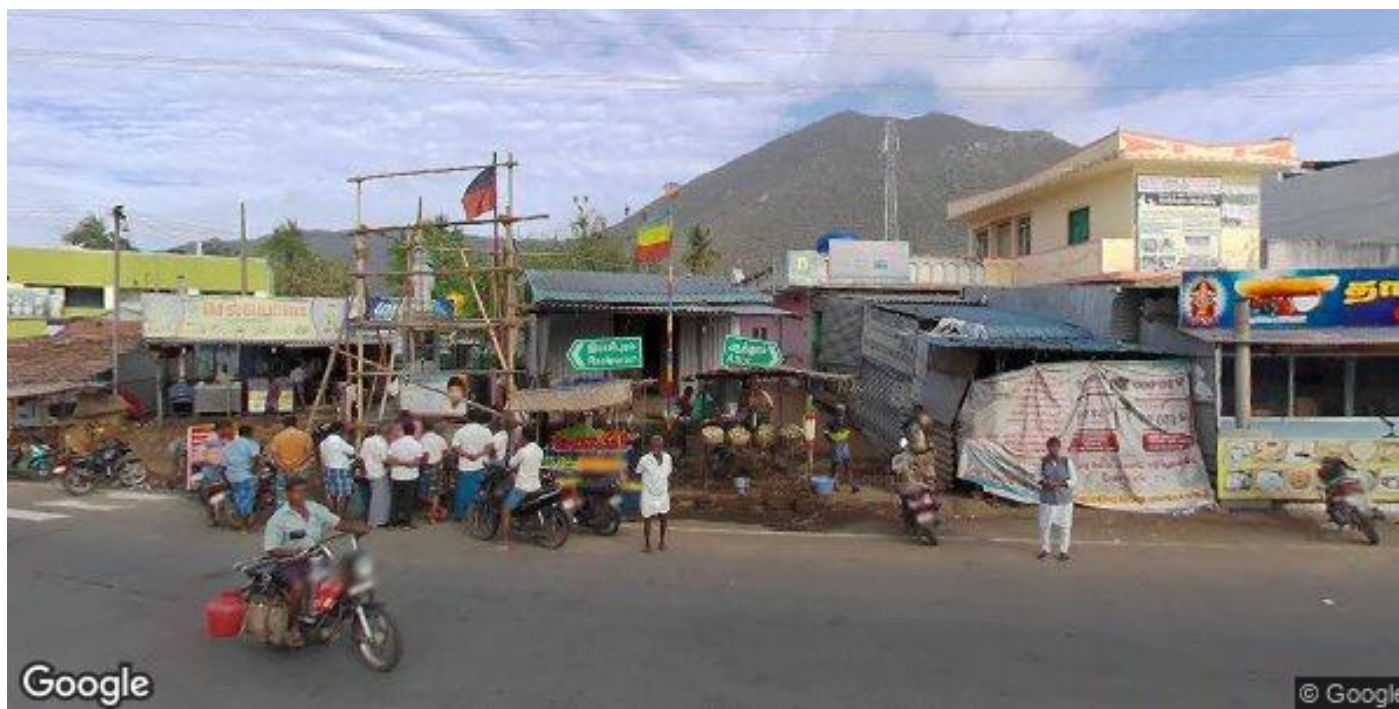
**Coordinates:** 11.51183, 78.34416

**Risk Type:** Turn

**Risk Level:** High

**Speed Limit:** 15 KM/Hr
