# IndianOil

## JOURNEY RISK MANAGEMENT (JRM) STUDY

### Salem Terminal to KAVIRAJ AGENCY

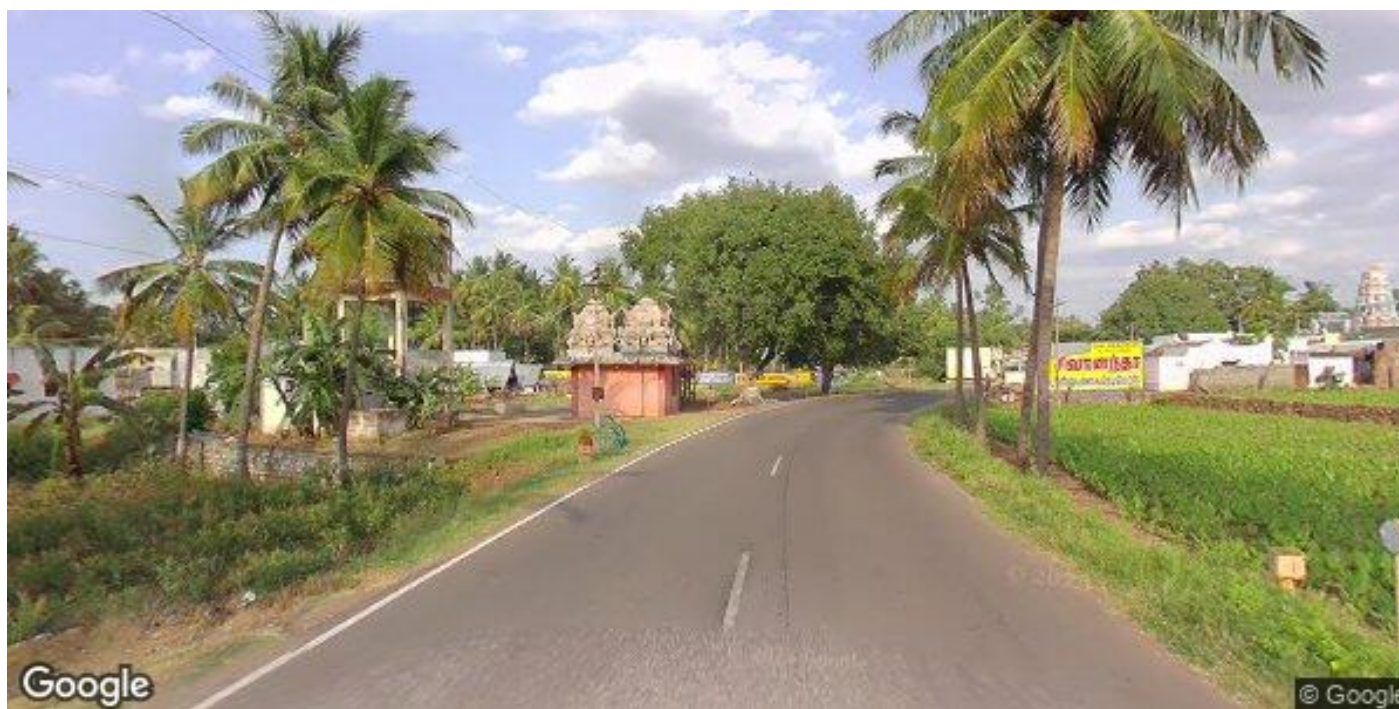
**Coordinates:** 11.51042, 78.34865

**Risk Type:** Turn

**Risk Level:** Medium

**Speed Limit:** 30 KM/Hr

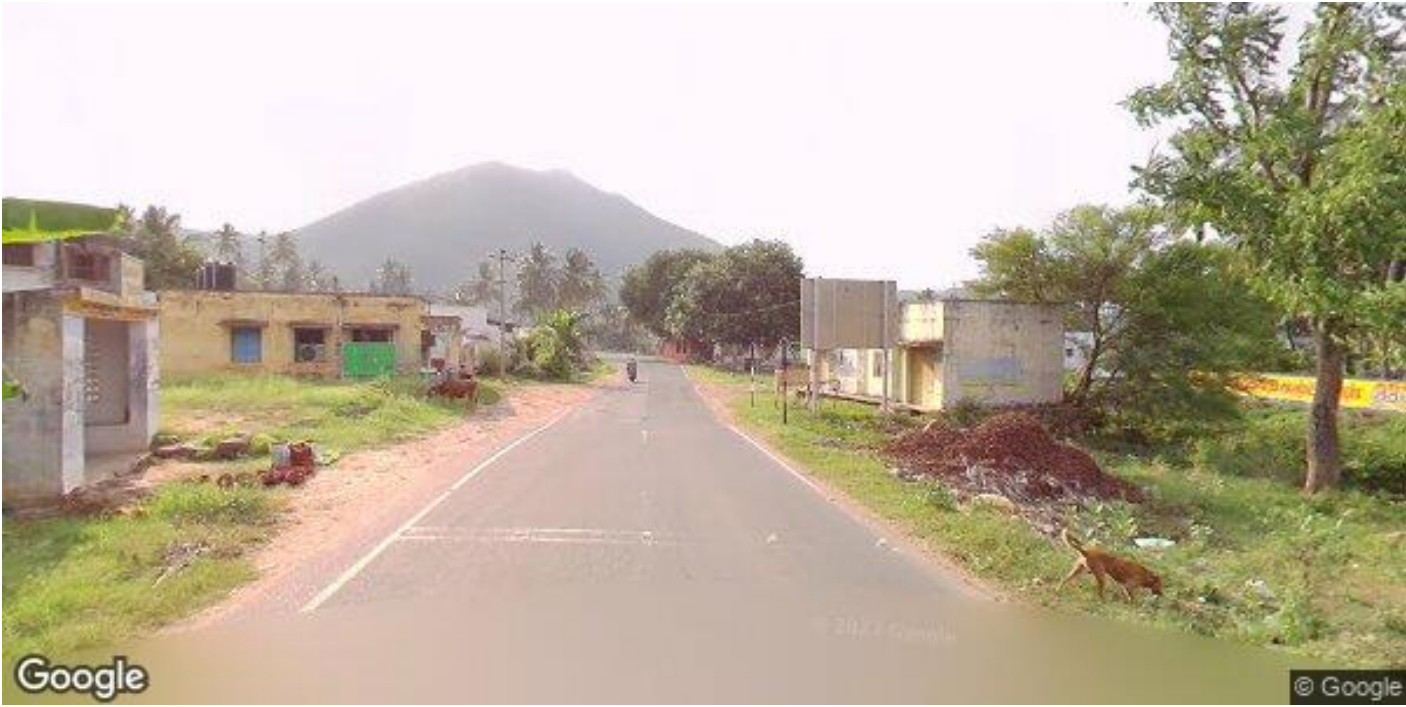
**Risk Type:** Turn  
**Risk Level:** Medium  
**Speed Limit:** 30 KM/Hr  
**Coordinates:** 11.50973, 78.34962

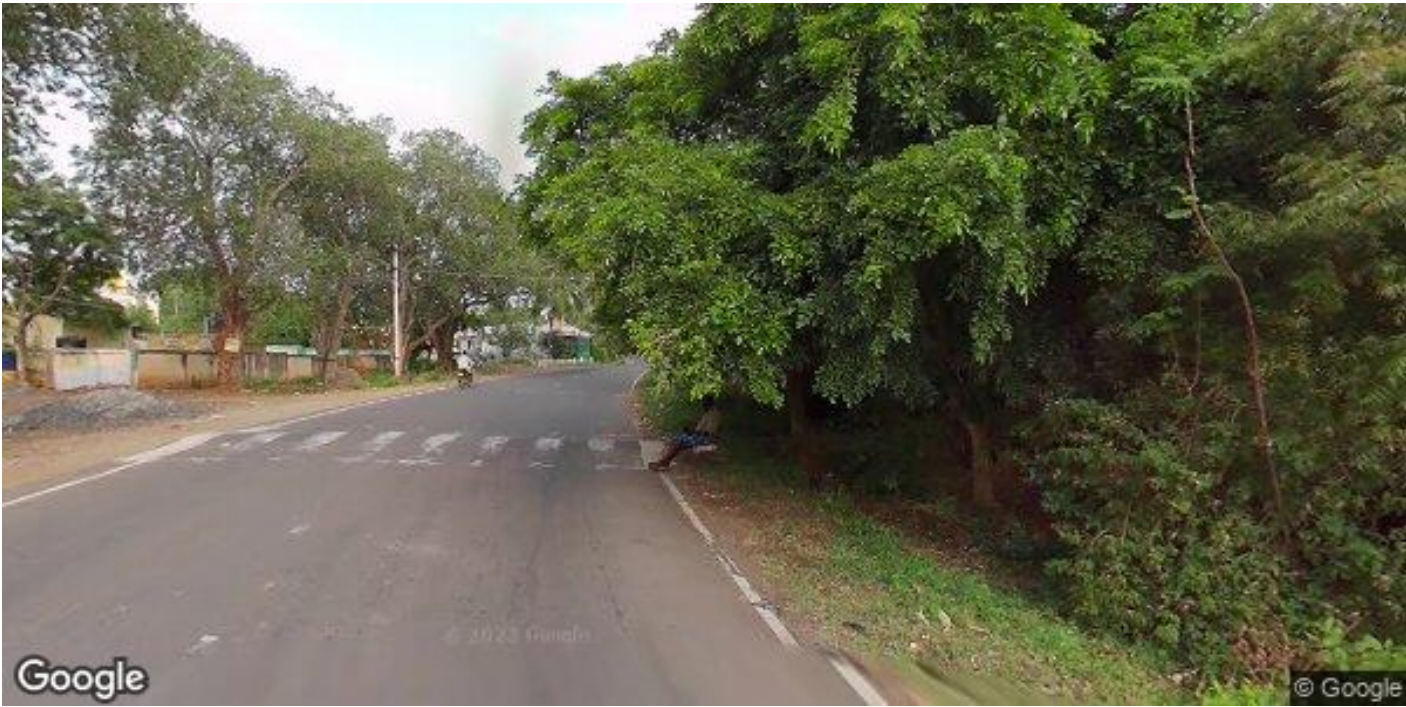
**Risk Type:** Turn  
**Risk Level:** Medium  
**Speed Limit:** 30 KM/Hr  
**Coordinates:** 11.50909, 78.35278

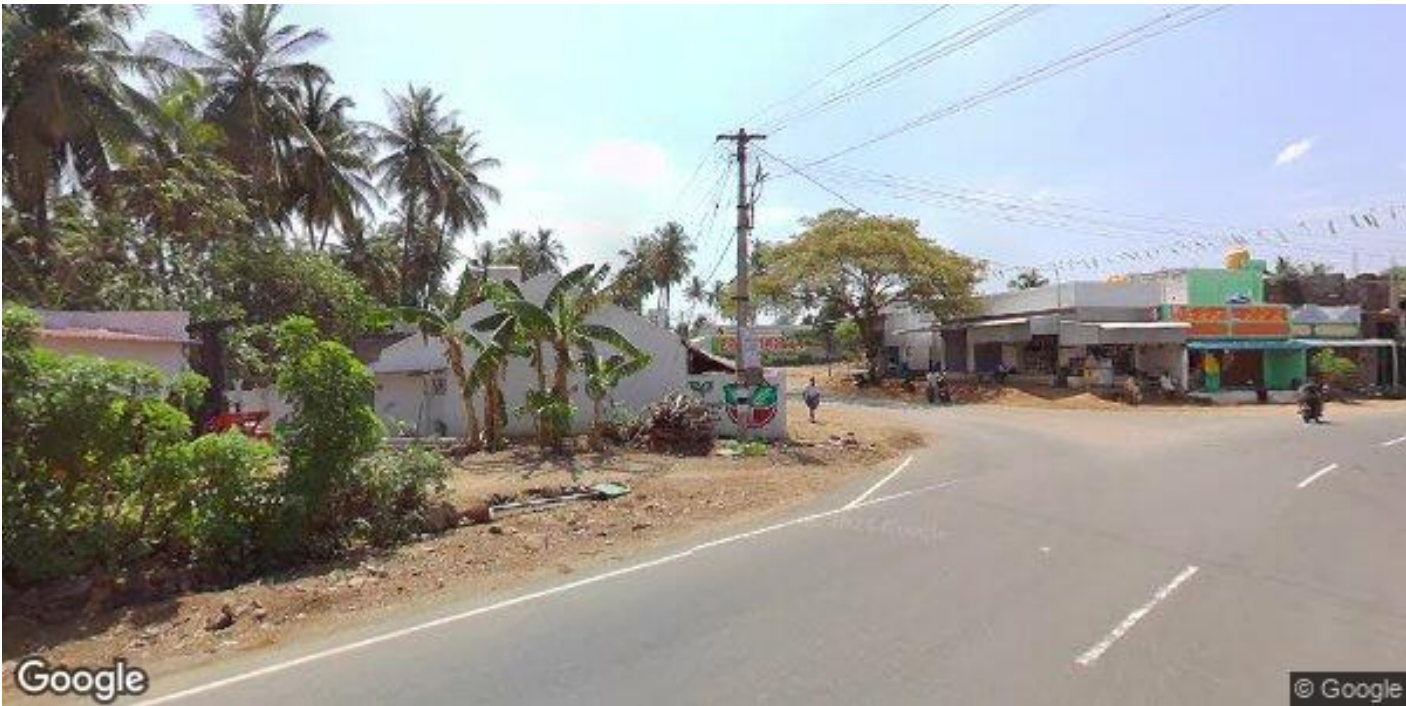
**Risk Type:** Turn  
**Risk Level:** Medium  
**Speed Limit:** 30 KM/Hr  
**Coordinates:** 11.47991, 78.38028

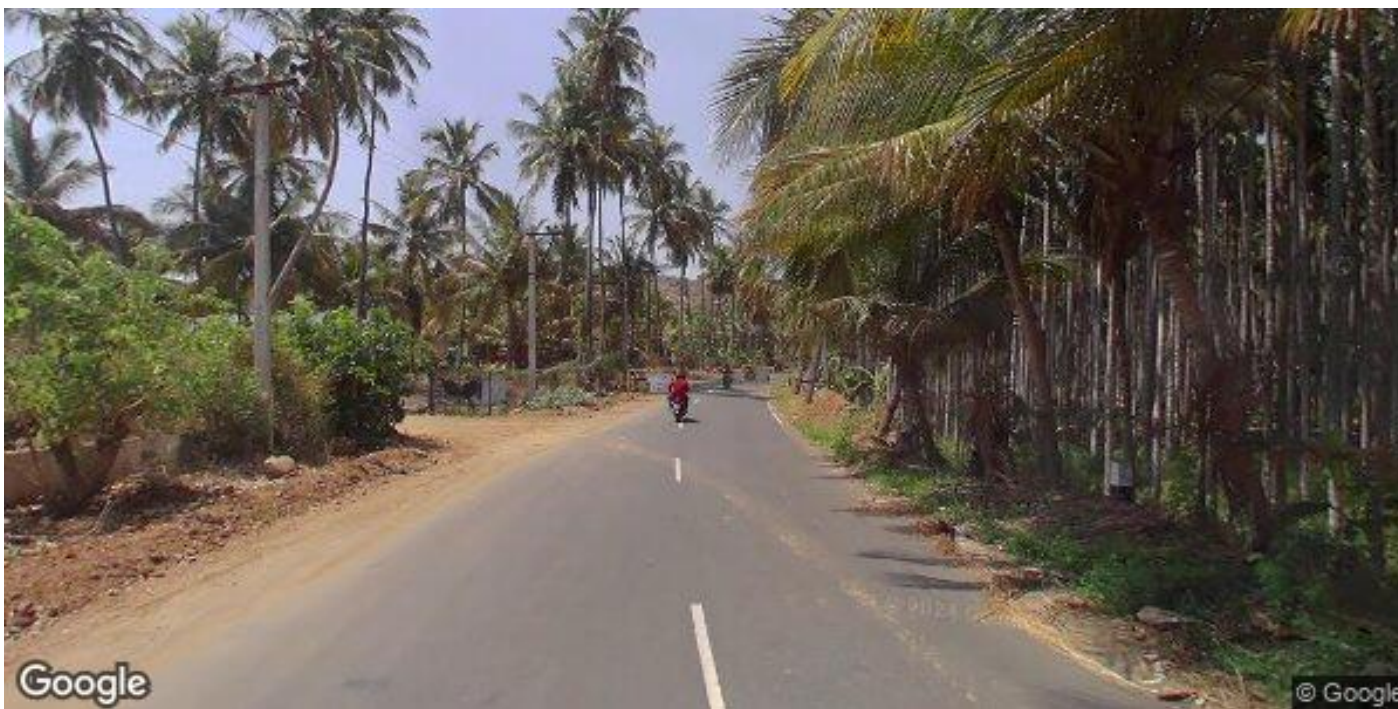
**Risk Type:** Turn  
**Risk Level:** Medium  
**Speed Limit:** 30 KM/Hr  
**Coordinates:** 11.46964, 78.39358

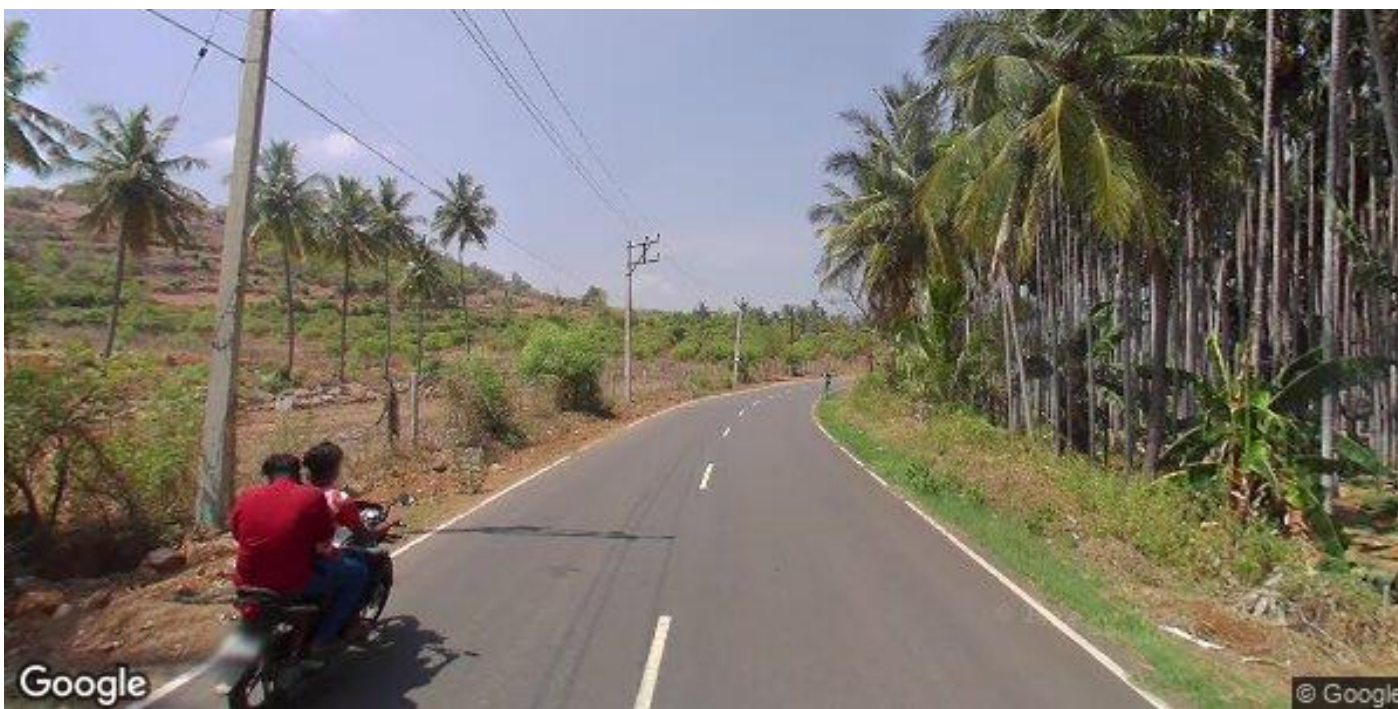
**Risk Type:** Turn  
**Risk Level:** Medium  
**Speed Limit:** 30 KM/Hr  
**Coordinates:** 11.46790, 78.39420

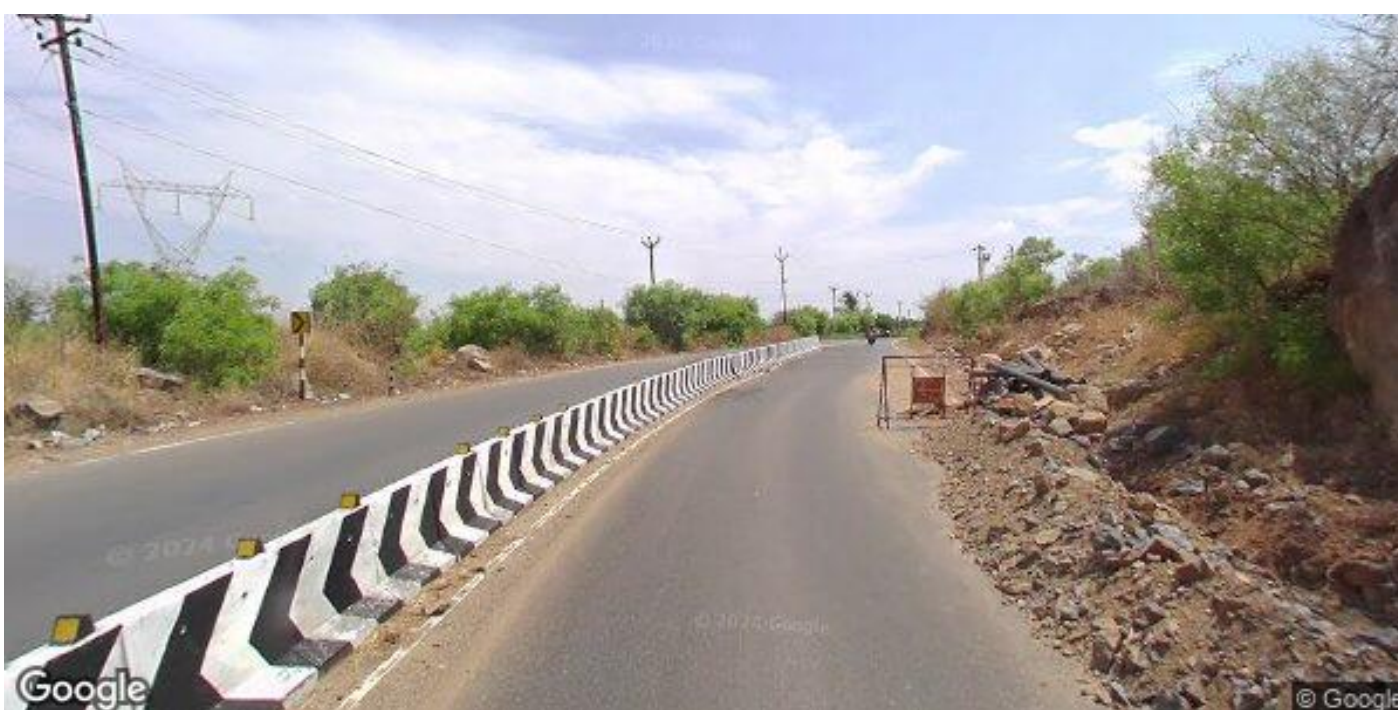
**Risk Type:** Turn  
**Risk Level:** High  
**Speed Limit:** 15 KM/Hr  
**Coordinates:** 11.46466, 78.39289

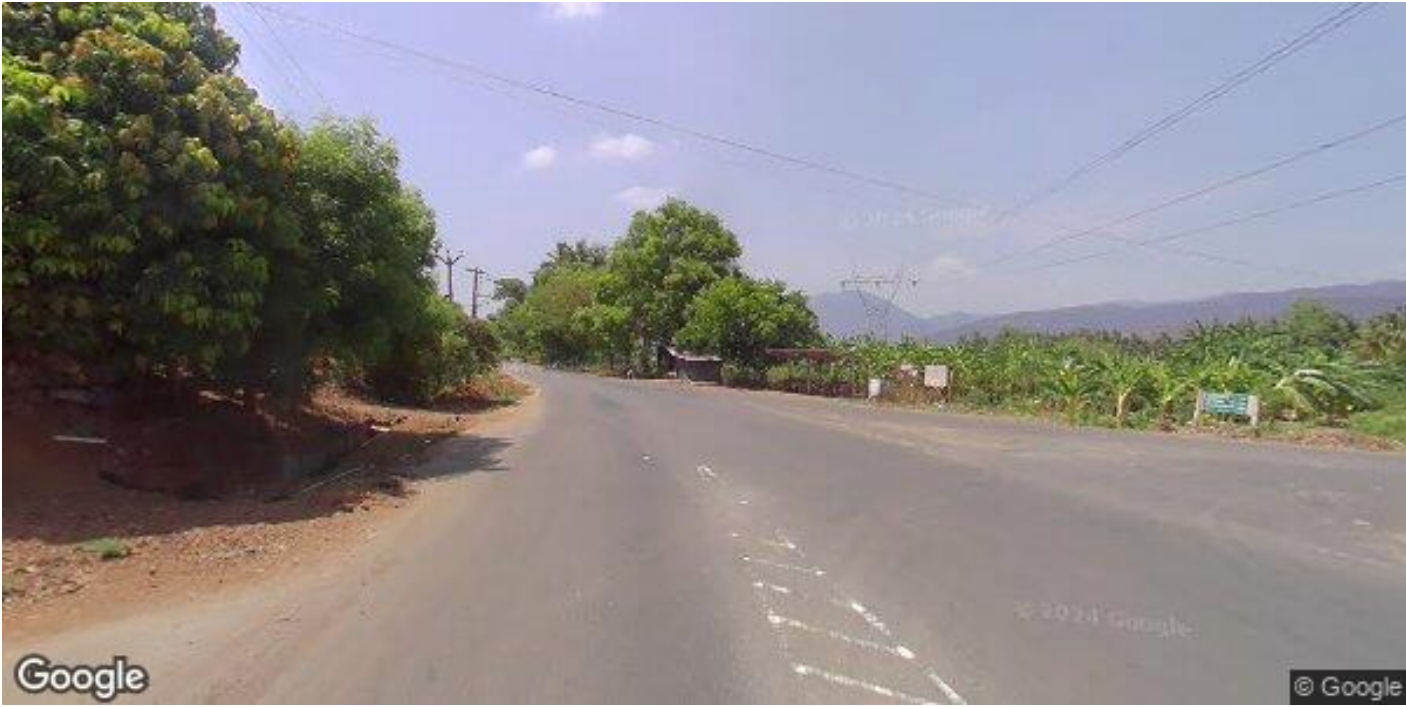
**Risk Type:** Turn  
**Risk Level:** Medium  
**Speed Limit:** 30 KM/Hr  
**Coordinates:** 11.46410, 78.39311

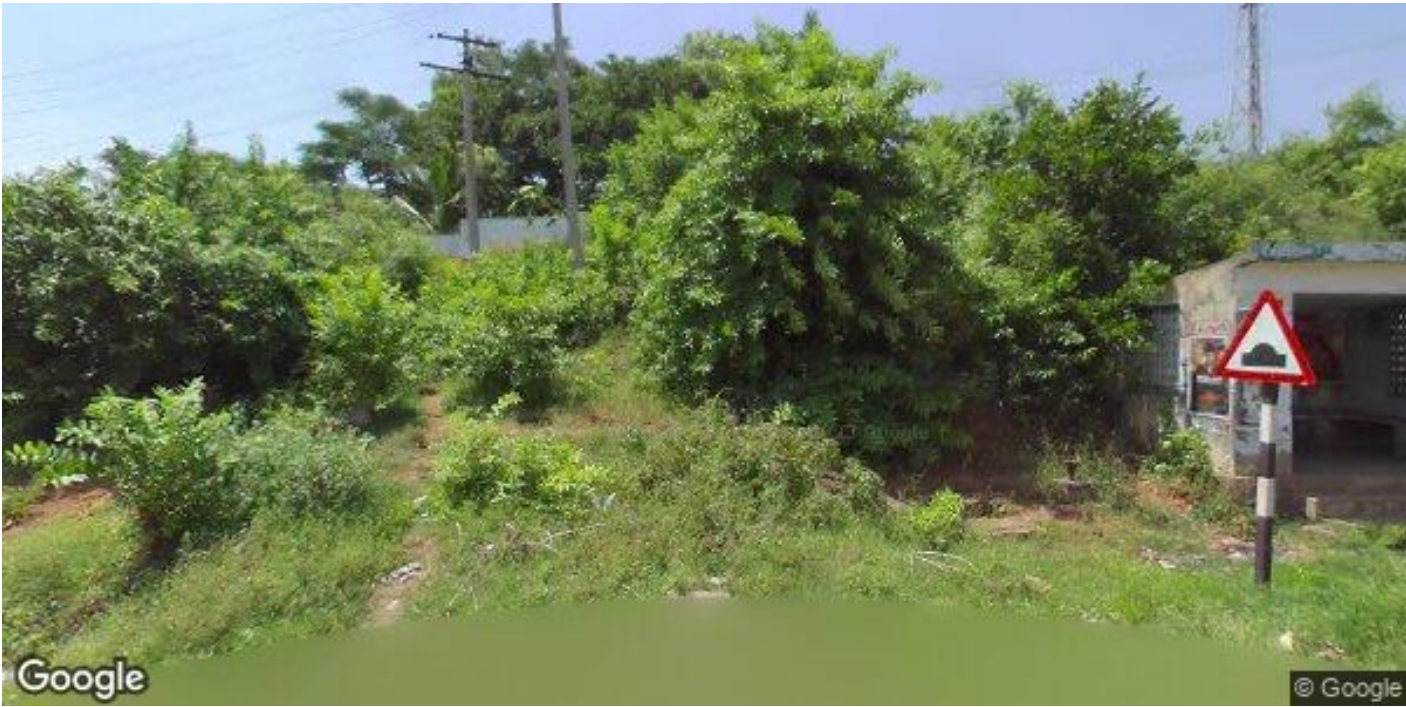
**Risk Type:** Turn  
**Risk Level:** High  
**Speed Limit:** 15 KM/Hr  
**Coordinates:** 11.45597, 78.40096

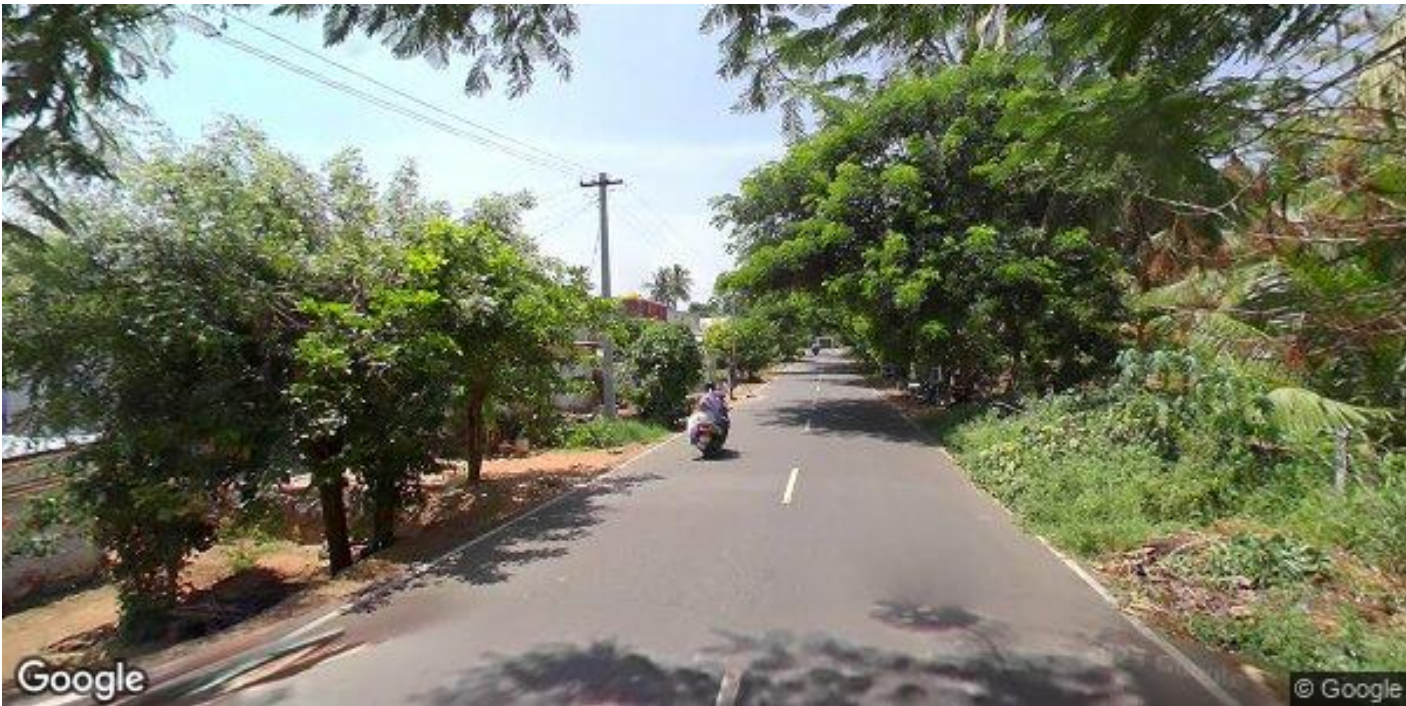
**Risk Type:** Turn  
**Risk Level:** Medium  
**Speed Limit:** 30 KM/Hr  
**Coordinates:** 11.45563, 78.40251

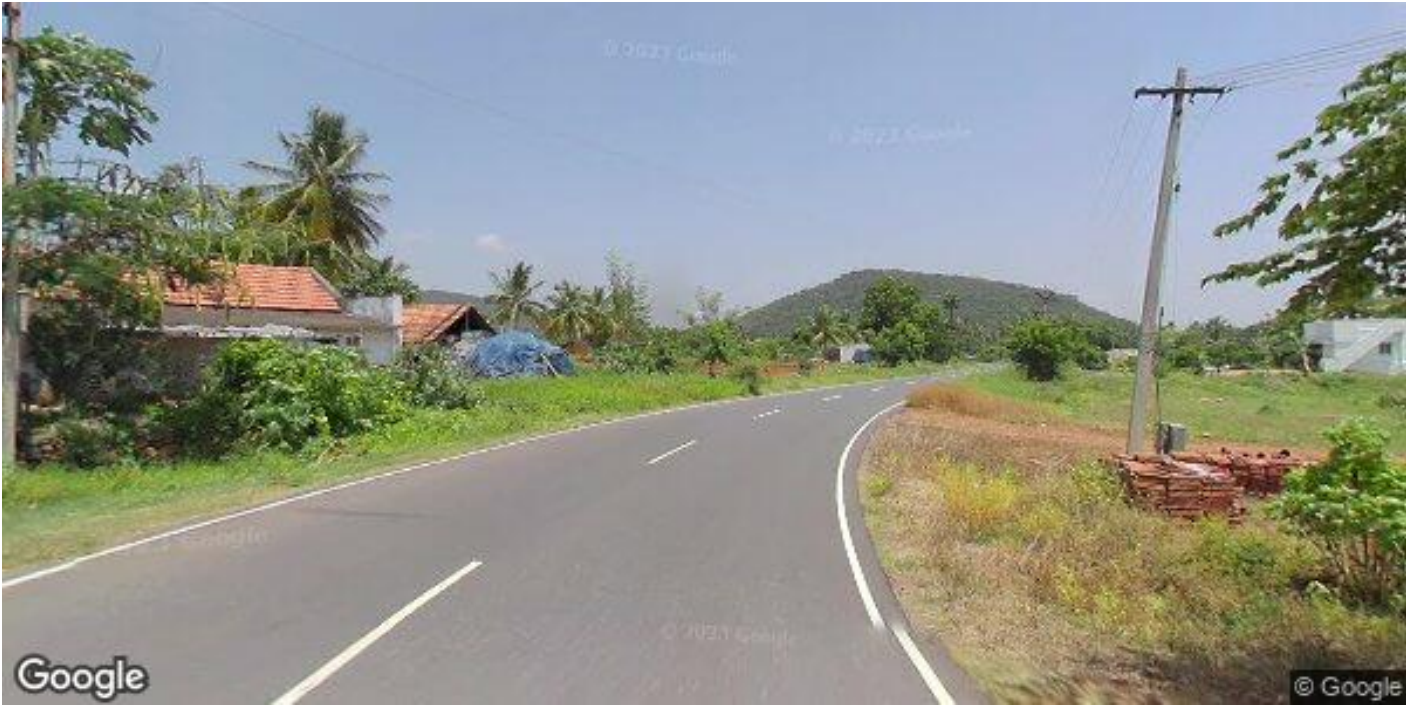
**Risk Type:** Turn  
**Risk Level:** Medium  
**Speed Limit:** 30 KM/Hr  
**Coordinates:** 11.45658, 78.40441

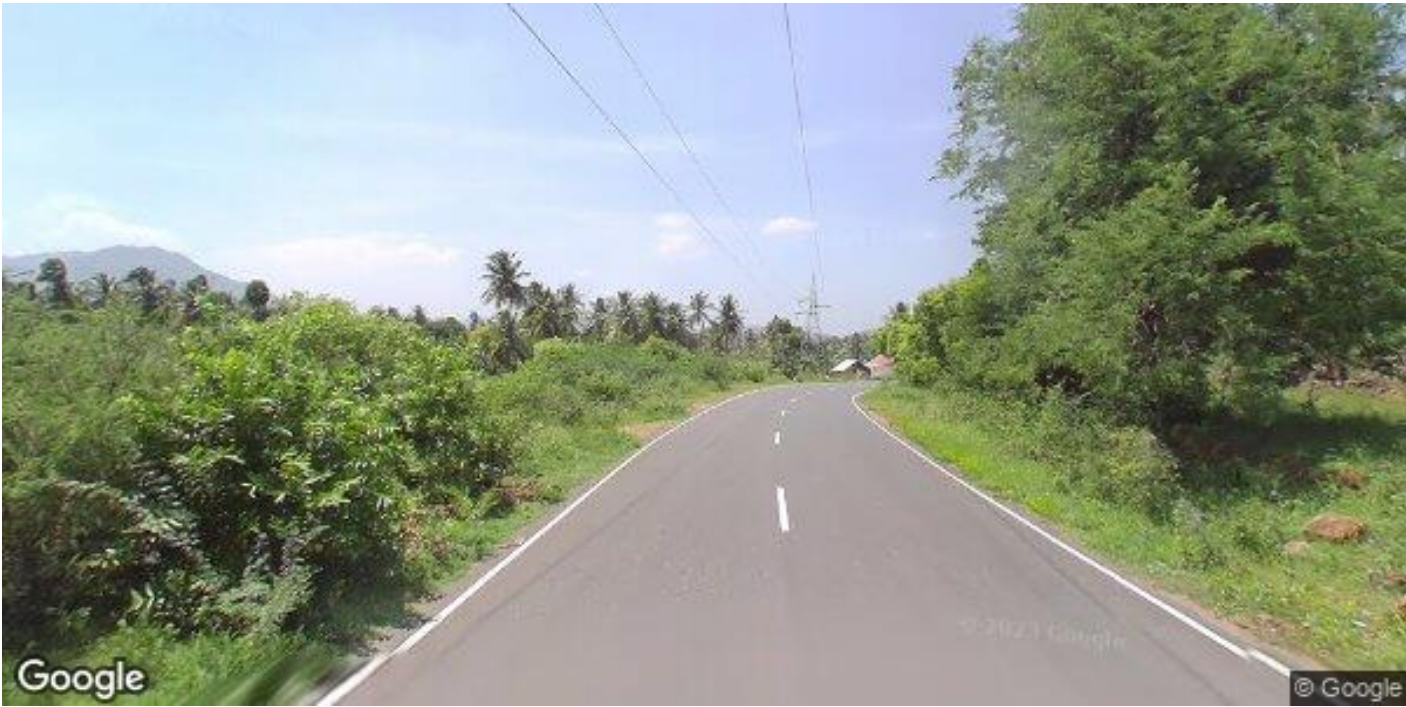
**Risk Type:** Turn  
**Risk Level:** Medium  
**Speed Limit:** 30 KM/Hr  
**Coordinates:** 11.45458, 78.40886

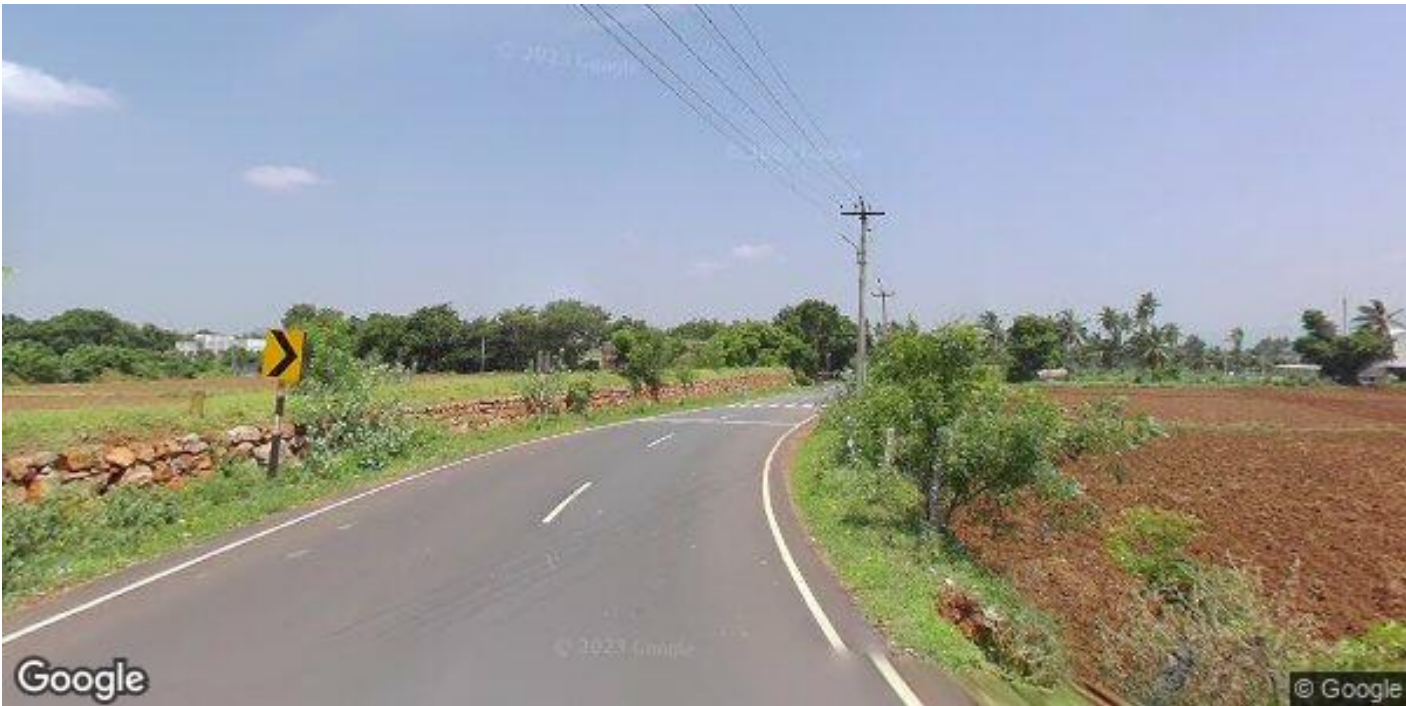
**Risk Type:** Turn  
**Risk Level:** Medium  
**Speed Limit:** 30 KM/Hr  
**Coordinates:** 11.46740, 78.45082

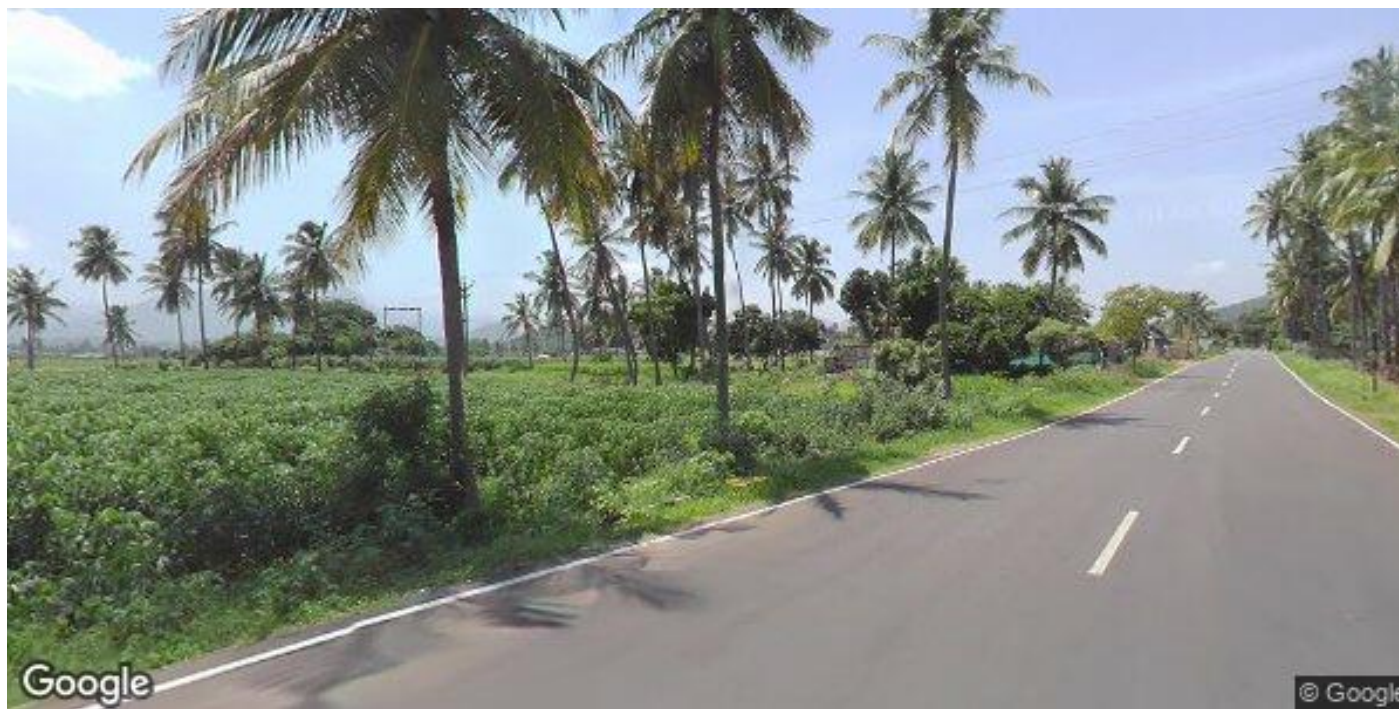
**Risk Type:** Turn  
**Risk Level:** Medium  
**Speed Limit:** 30 KM/Hr  
**Coordinates:** 11.46728, 78.45442

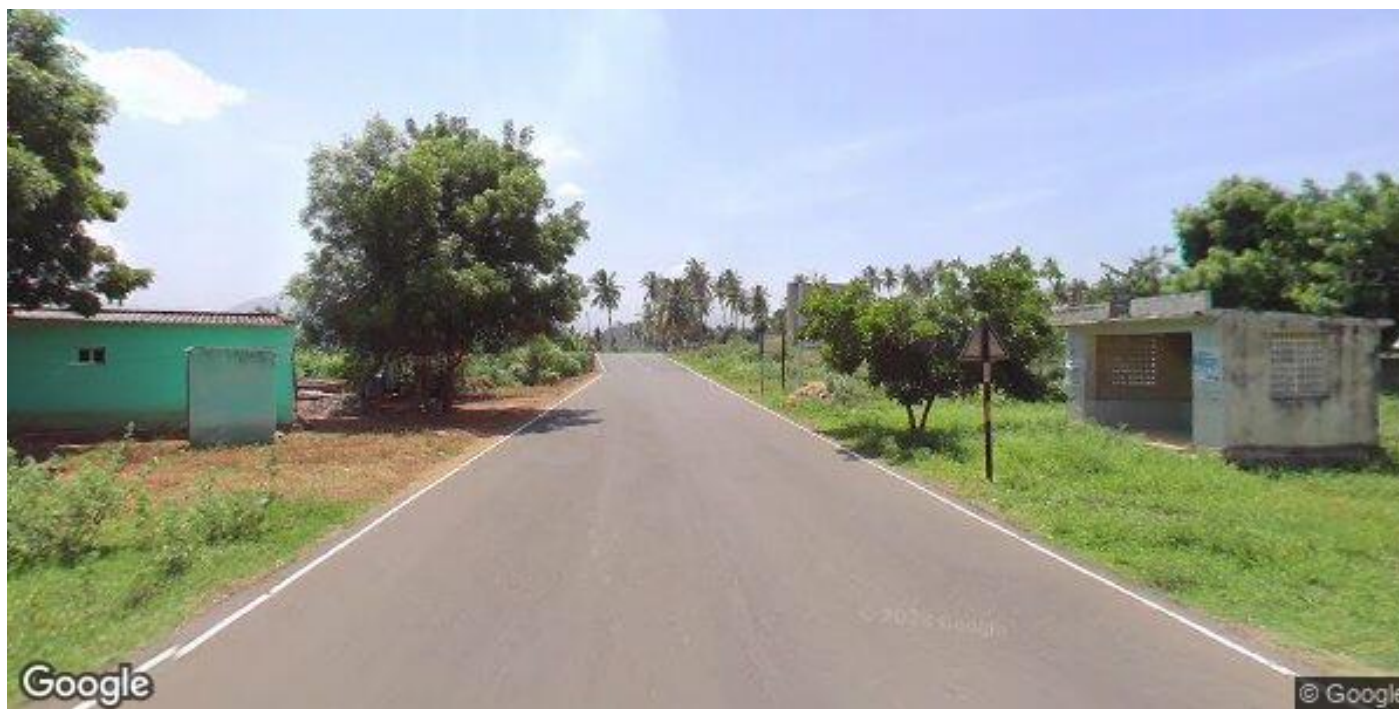
**Risk Type:** Turn  
**Risk Level:** Medium  
**Speed Limit:** 30 KM/Hr  
**Coordinates:** 11.46798, 78.45523

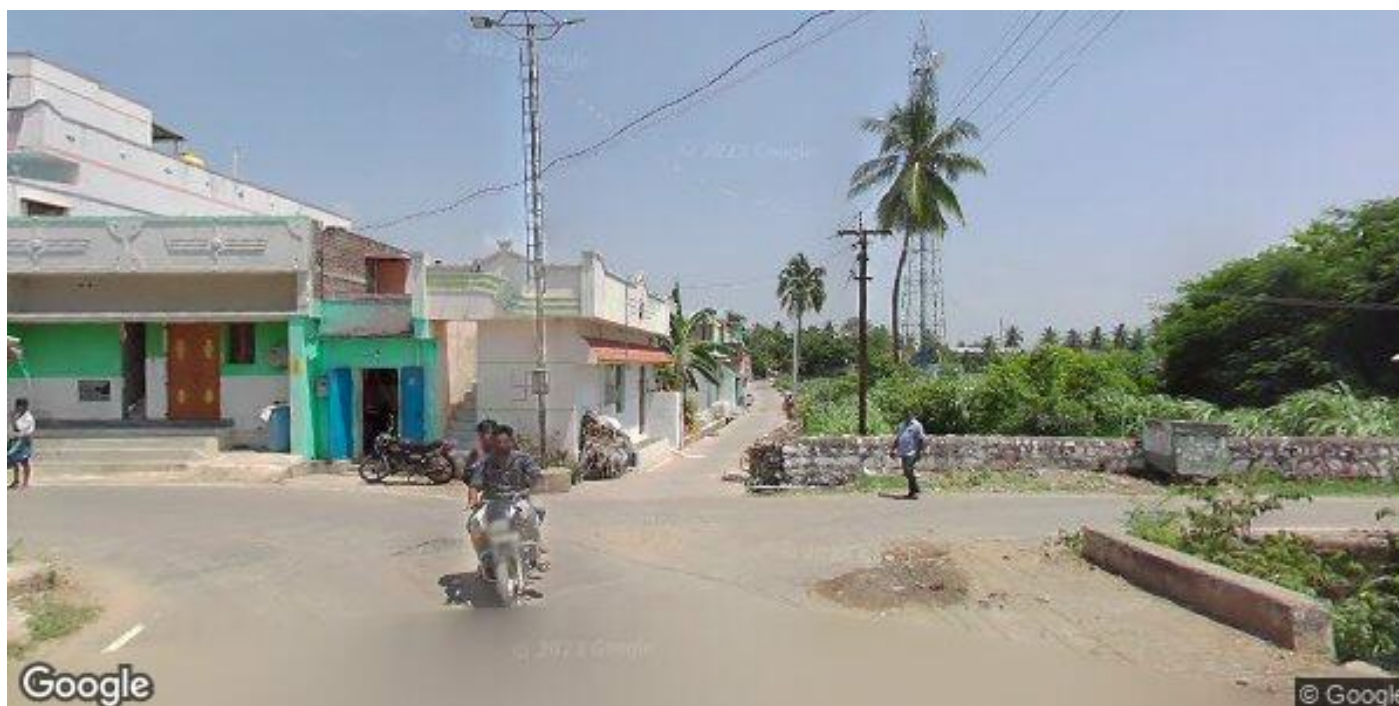
**Risk Type:** Turn  
**Risk Level:** High  
**Speed Limit:** 15 KM/Hr  
**Coordinates:** 11.46798, 78.45844

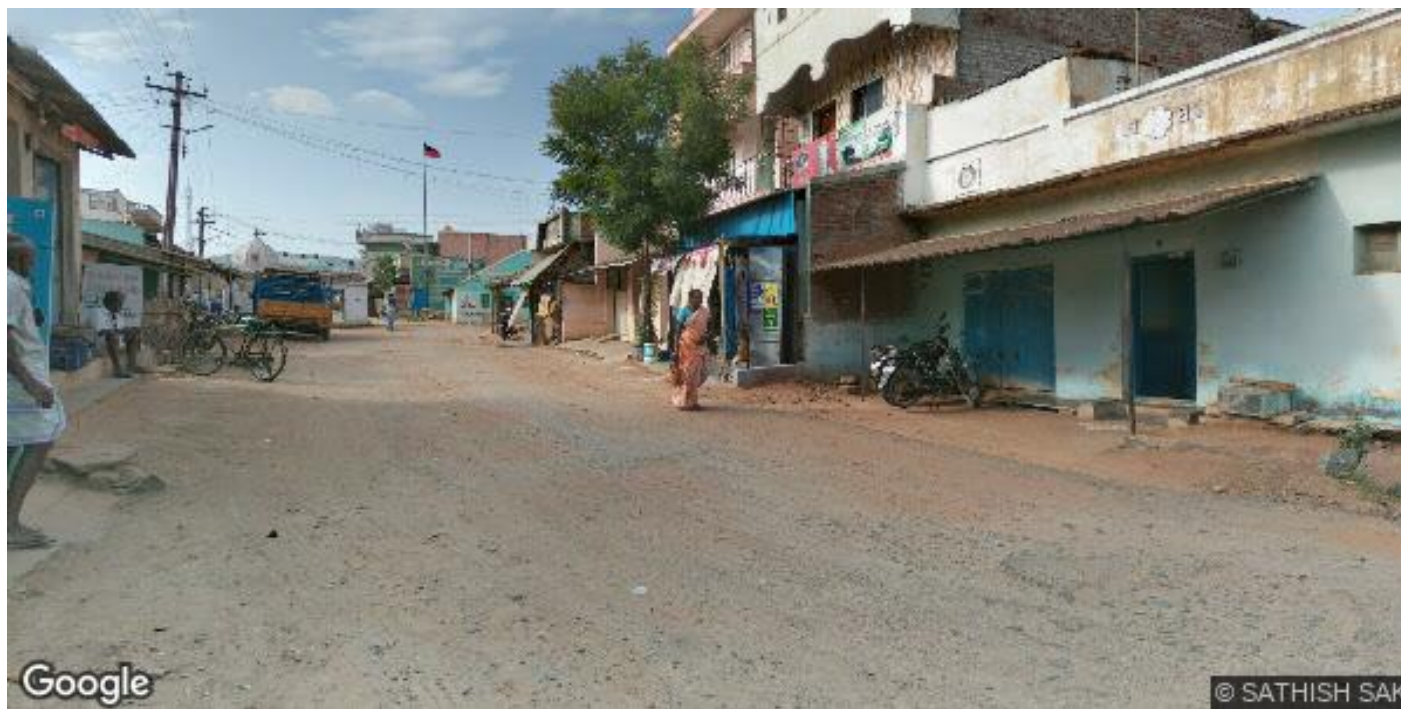
**Risk Type:** Blind Spot  
**Risk Level:** Blind Spot  
**Speed Limit:** 10 KM/Hr  
**Coordinates:** 11.46857, 78.45844

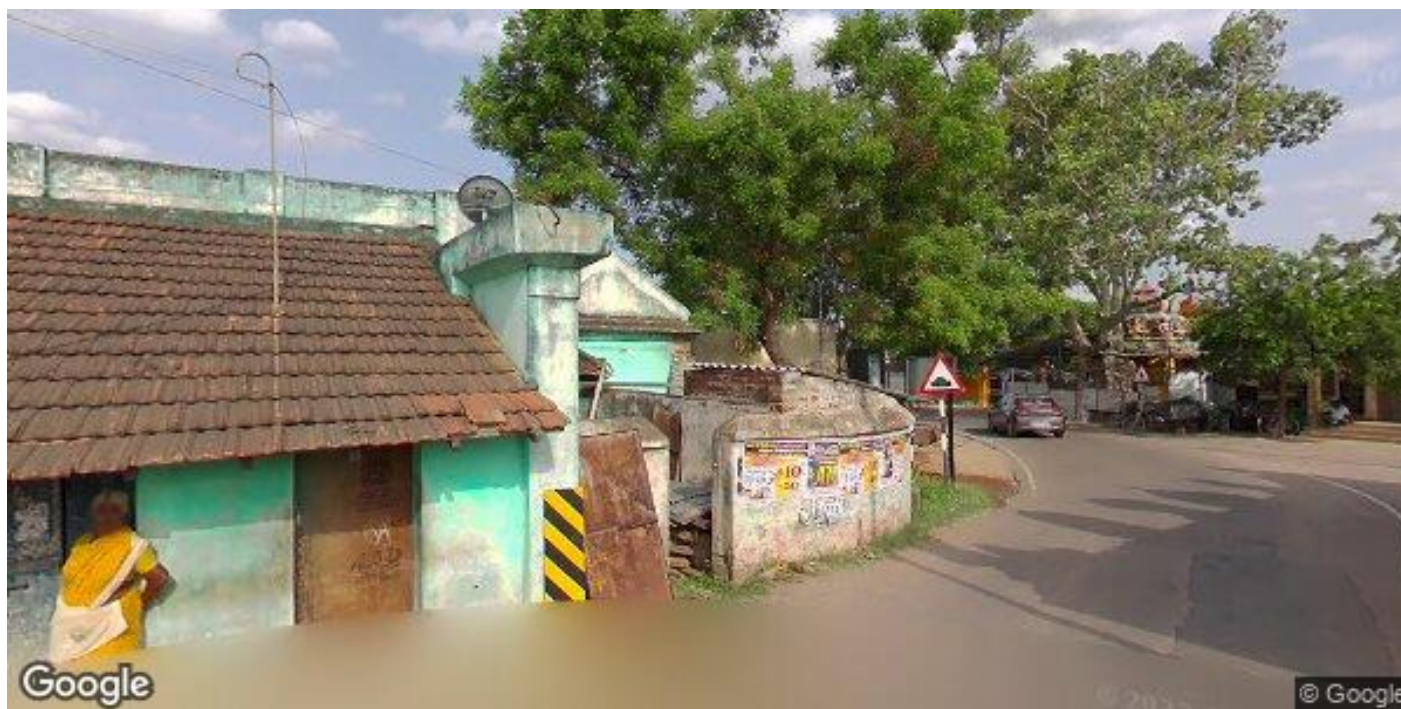
**Risk Type:** Turn  
**Risk Level:** Medium  
**Speed Limit:** 30 KM/Hr  
**Coordinates:** 11.46835, 78.45959

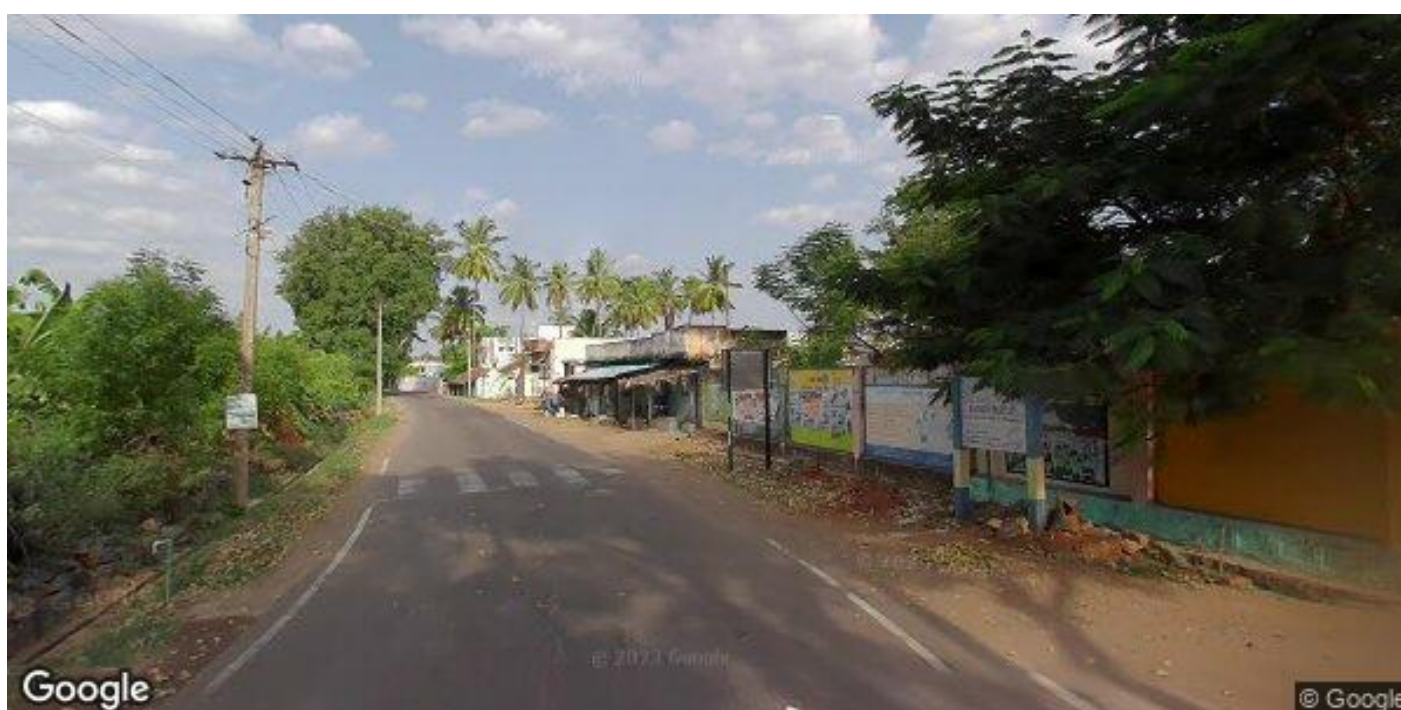
**Risk Type:** Turn  
**Risk Level:** High  
**Speed Limit:** 15 KM/Hr  
**Coordinates:** 11.46800, 78.45987

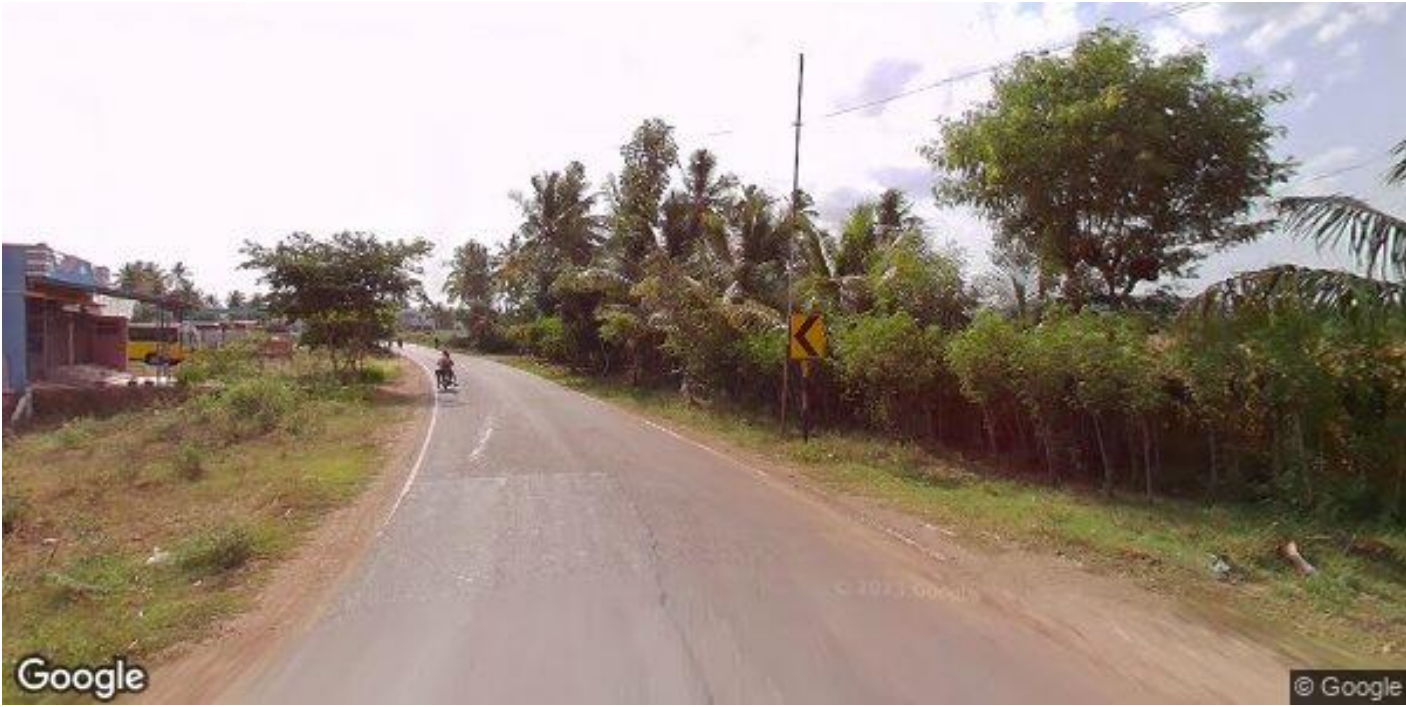
**Risk Type:** Turn  
**Risk Level:** Medium  
**Speed Limit:** 30 KM/Hr  
**Coordinates:** 11.46461, 78.47397

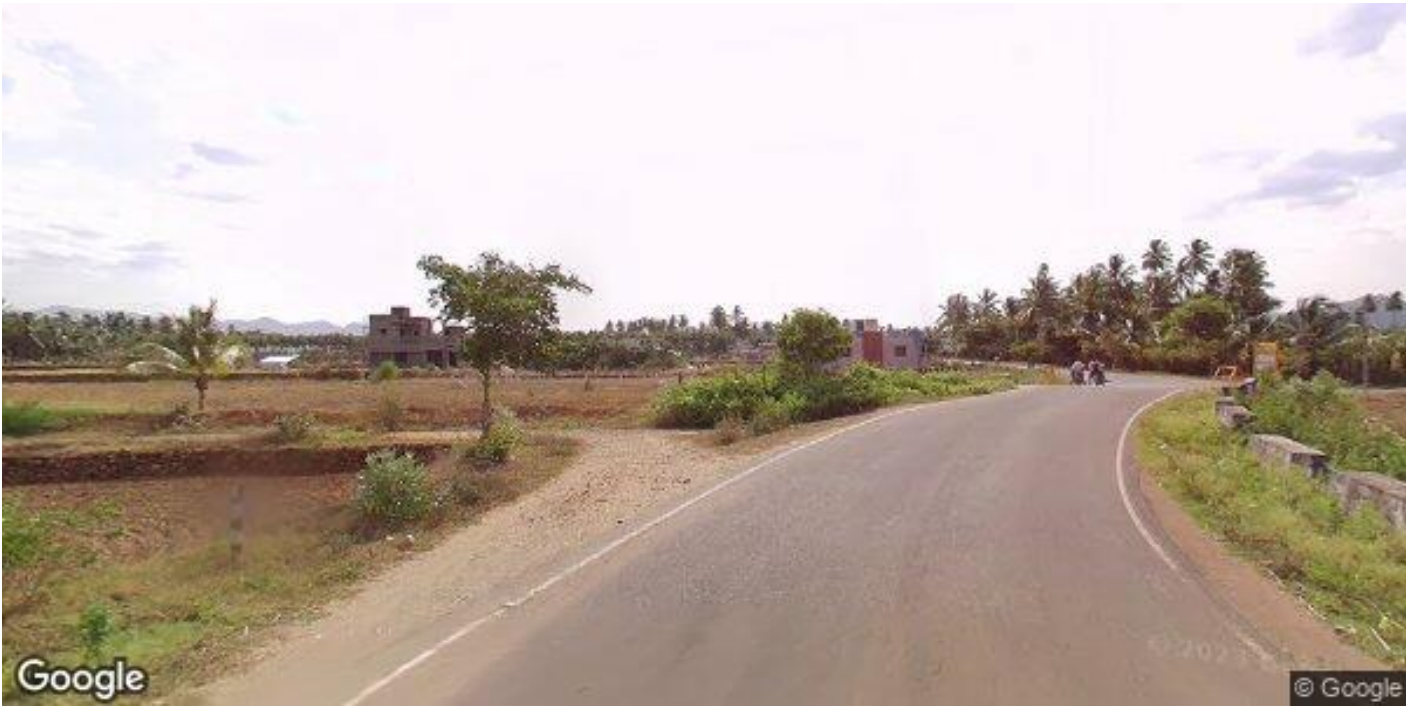
**Risk Type:** Turn  
**Risk Level:** Medium  
**Speed Limit:** 30 KM/Hr  
**Coordinates:** 11.46419, 78.47445

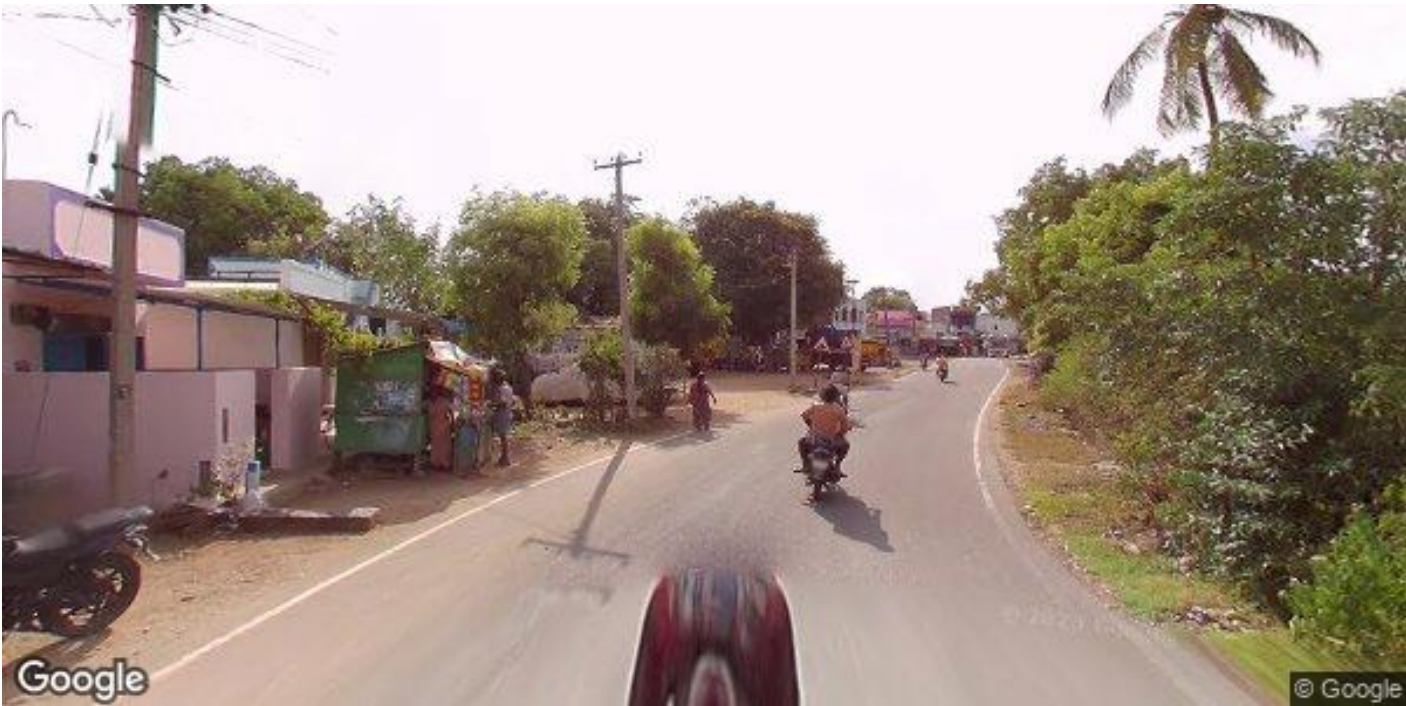
**Risk Type:** Turn  
**Risk Level:** Medium  
**Speed Limit:** 30 KM/Hr  
**Coordinates:** 11.46211, 78.48159
