# IndianOil

## JOURNEY RISK MANAGEMENT (JRM) STUDY

### Salem Terminal to KAVIRAJ AGENCY

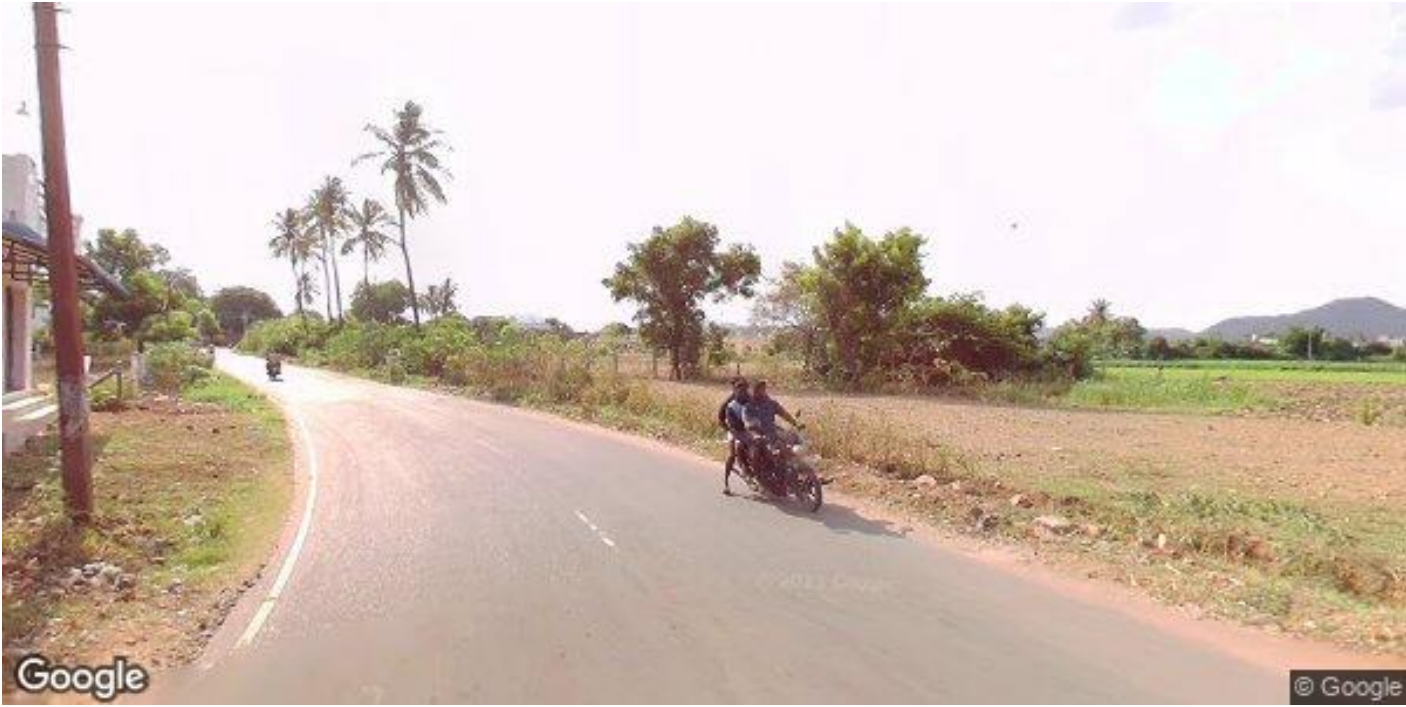
**Risk Type:** Turn  
**Risk Level:** Medium  
**Speed Limit:** 30 KM/Hr  
**Coordinates:** 11.46184, 78.48270

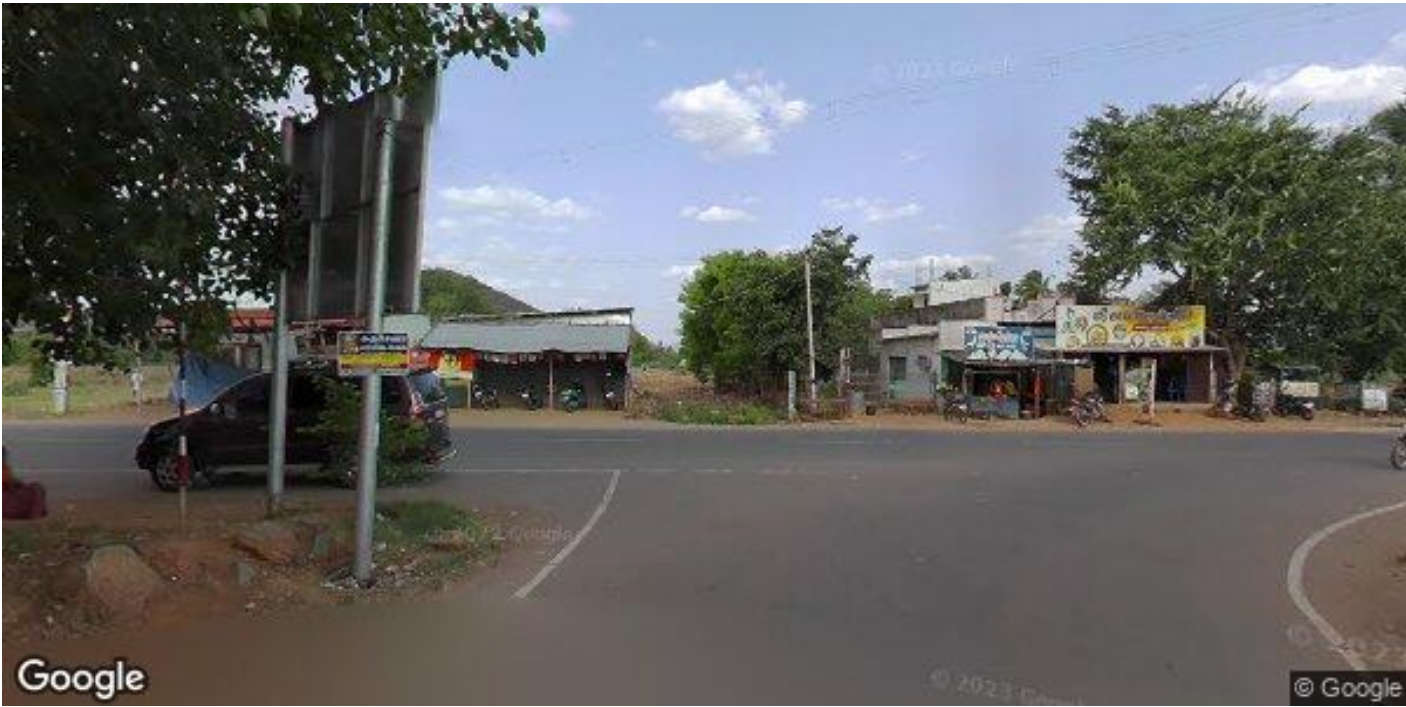
**Risk Type:** Turn  
**Risk Level:** Medium  
**Speed Limit:** 30 KM/Hr  
**Coordinates:** 11.46106, 78.48357

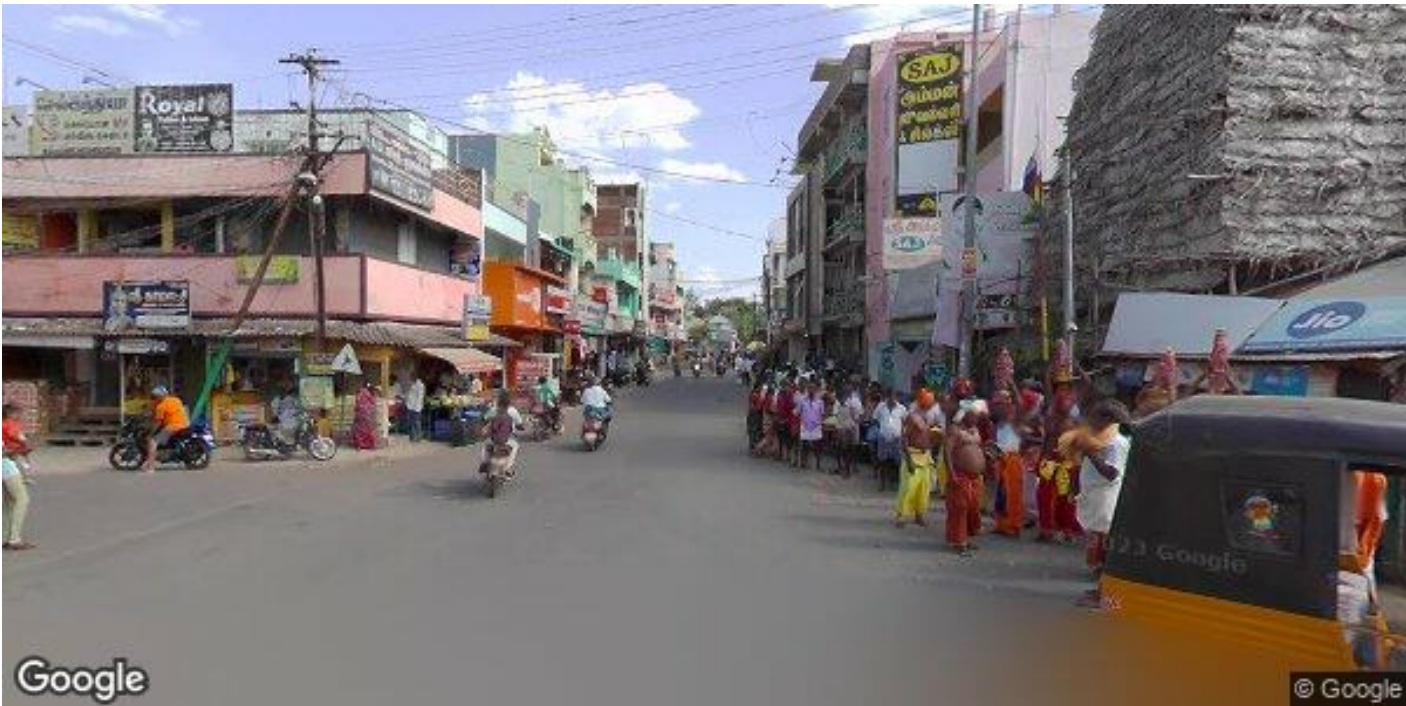
**Risk Type:** Blind Spot  
**Risk Level:** Blind Spot  
**Speed Limit:** 10 KM/Hr  
**Coordinates:** 11.44233, 78.48592

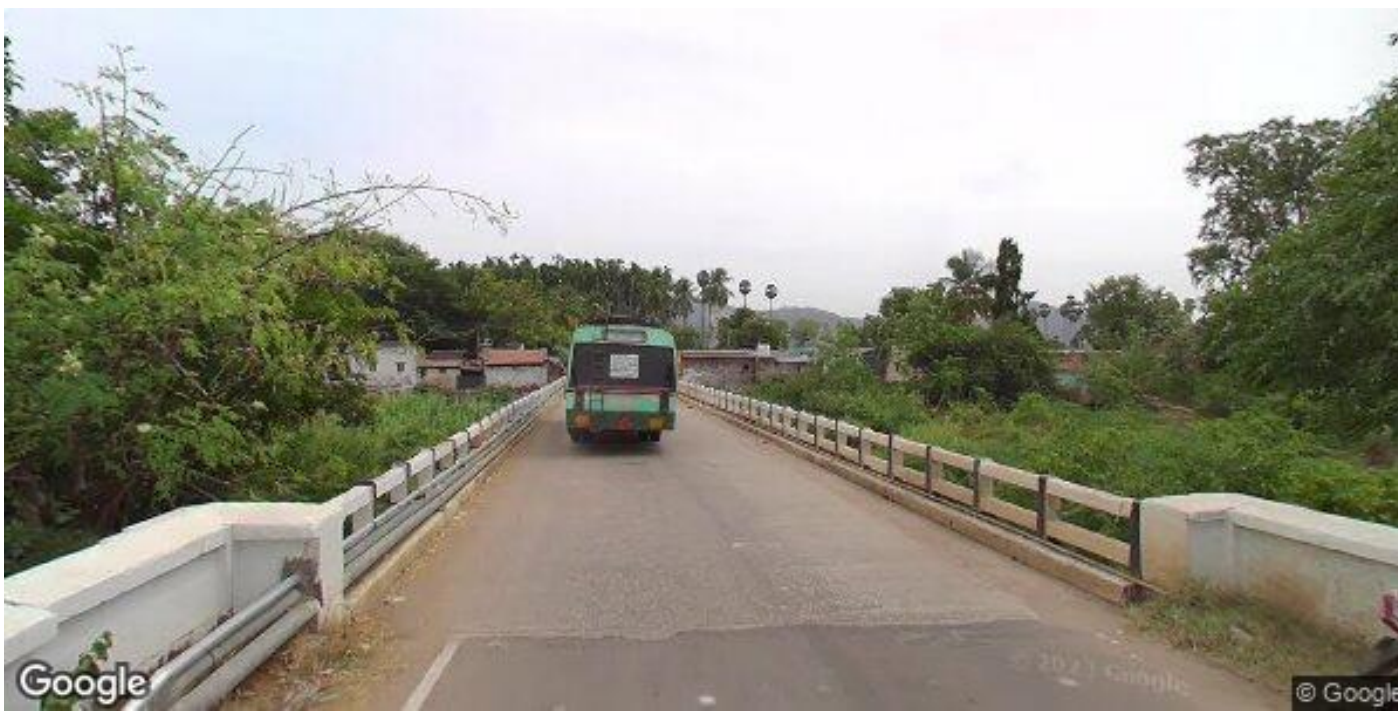
**Risk Type:** Turn  
**Risk Level:** High  
**Speed Limit:** 15 KM/Hr  
**Coordinates:** 11.45641, 78.52757

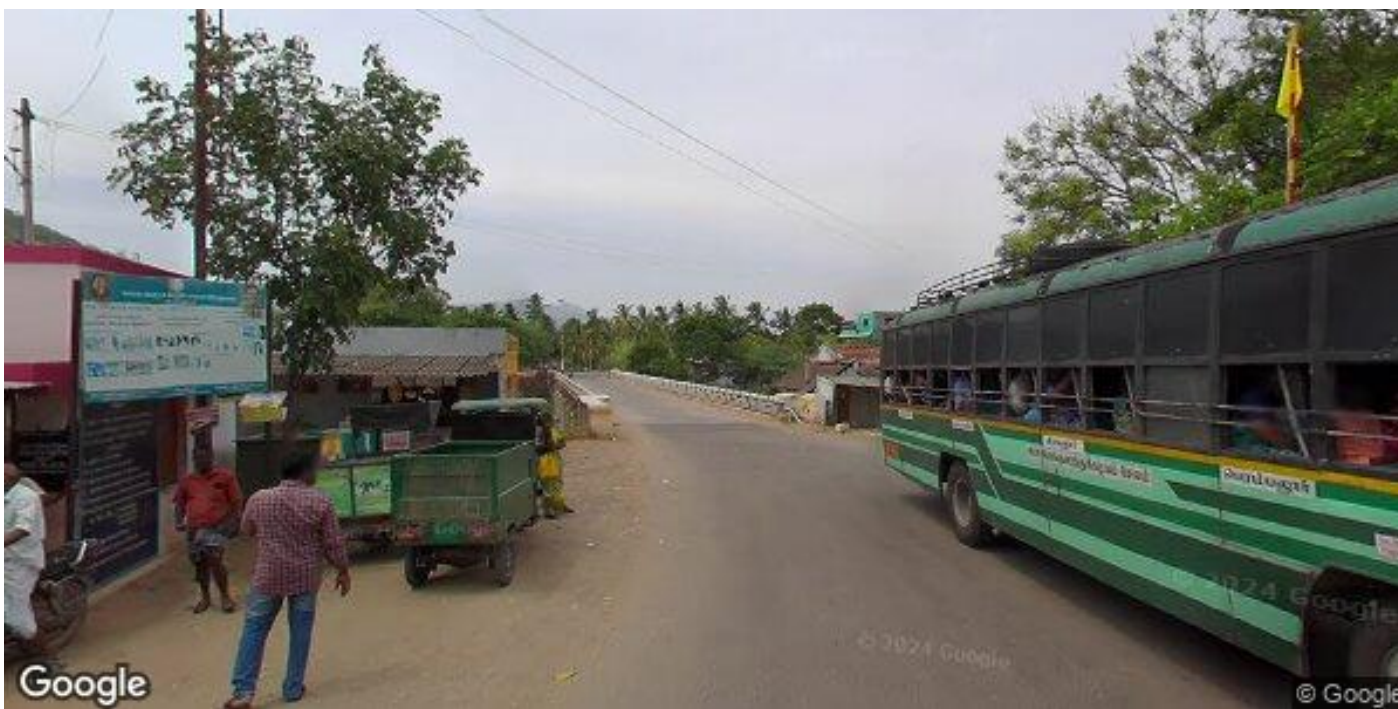
**Risk Type:** Turn  
**Risk Level:** High  
**Speed Limit:** 15 KM/Hr  
**Coordinates:** 11.45723, 78.52761

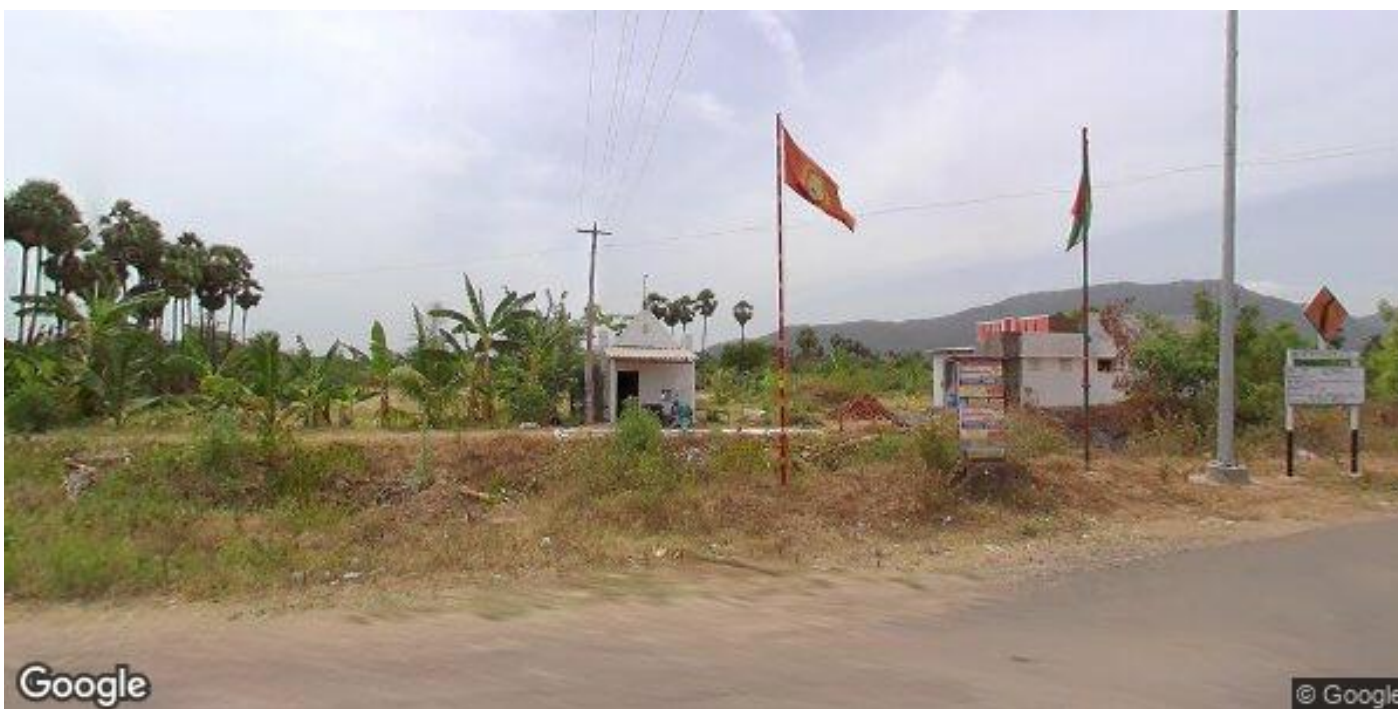
**Risk Type:** Turn  
**Risk Level:** Medium  
**Speed Limit:** 30 KM/Hr  
**Coordinates:** 11.48770, 78.63405

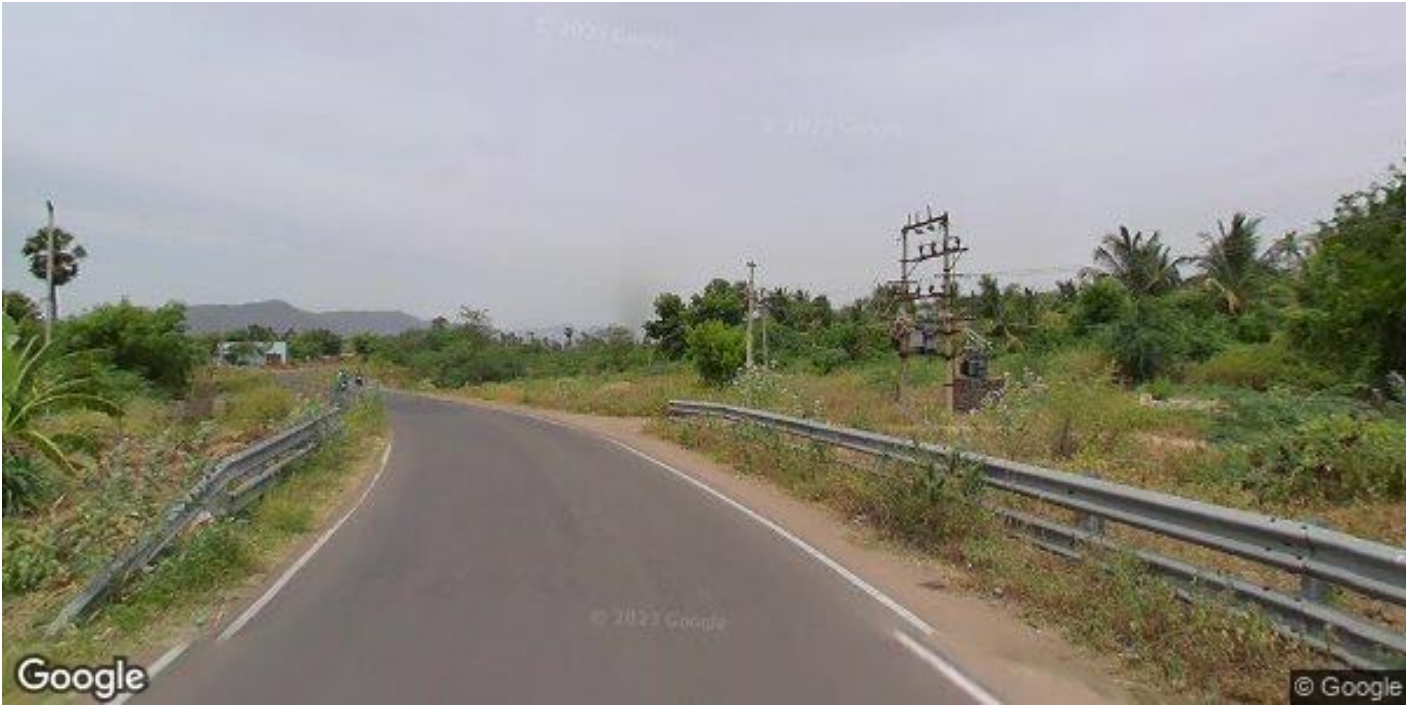
**Risk Type:** Turn  
**Risk Level:** High  
**Speed Limit:** 15 KM/Hr  
**Coordinates:** 11.48870, 78.63452

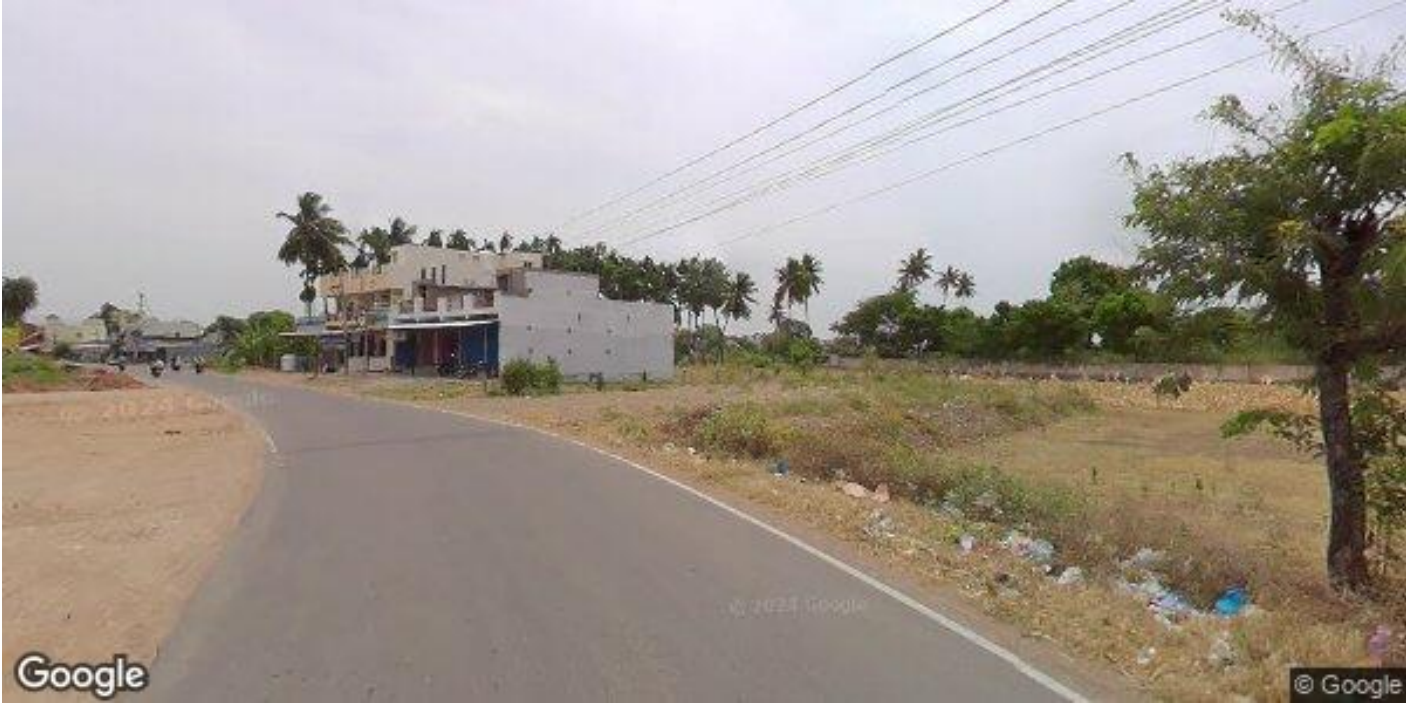
**Risk Type:** Turn  
**Risk Level:** Medium  
**Speed Limit:** 30 KM/Hr  
**Coordinates:** 11.49431, 78.64705

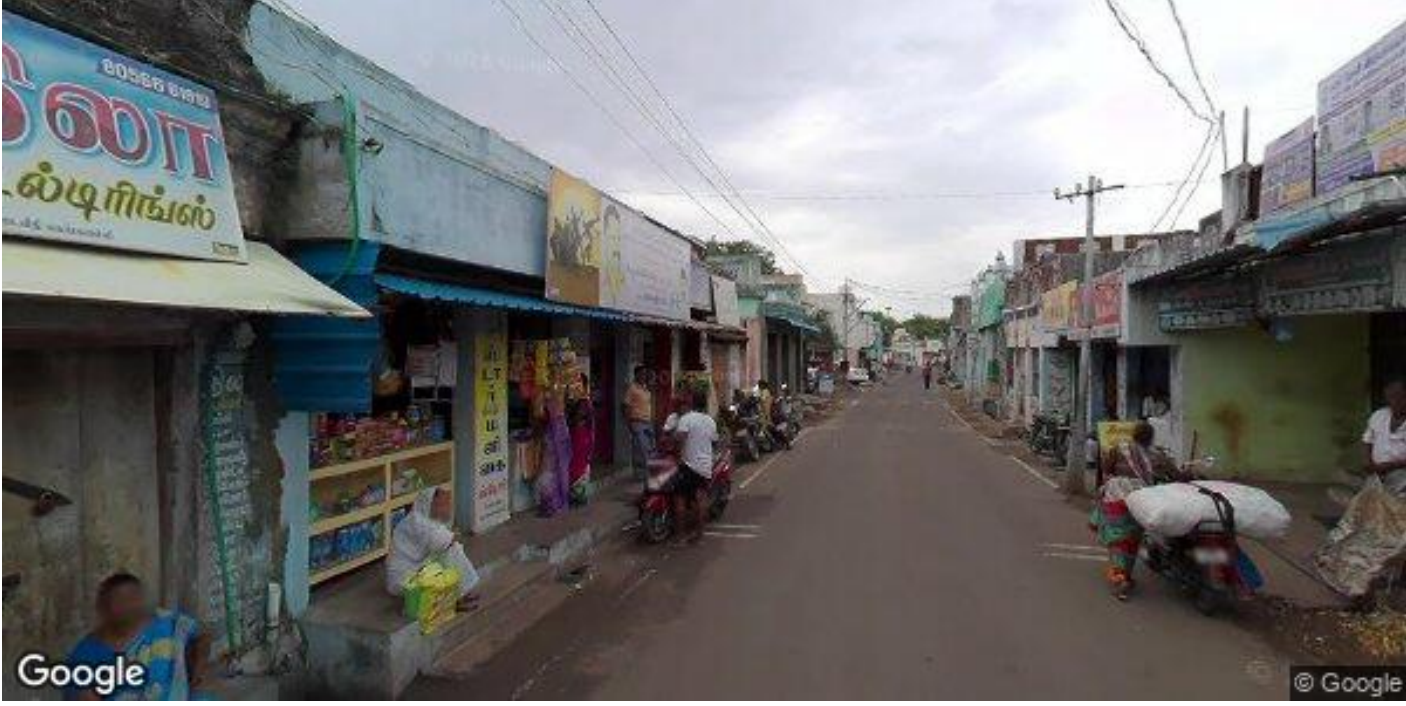
**Risk Type:** Turn  
**Risk Level:** High  
**Speed Limit:** 15 KM/Hr  
**Coordinates:** 11.49697, 78.64738
