# IndianOil

## JOURNEY RISK MANAGEMENT (JRM) STUDY

### Salem Terminal TO SWAGAT COCO NAMAKKAL

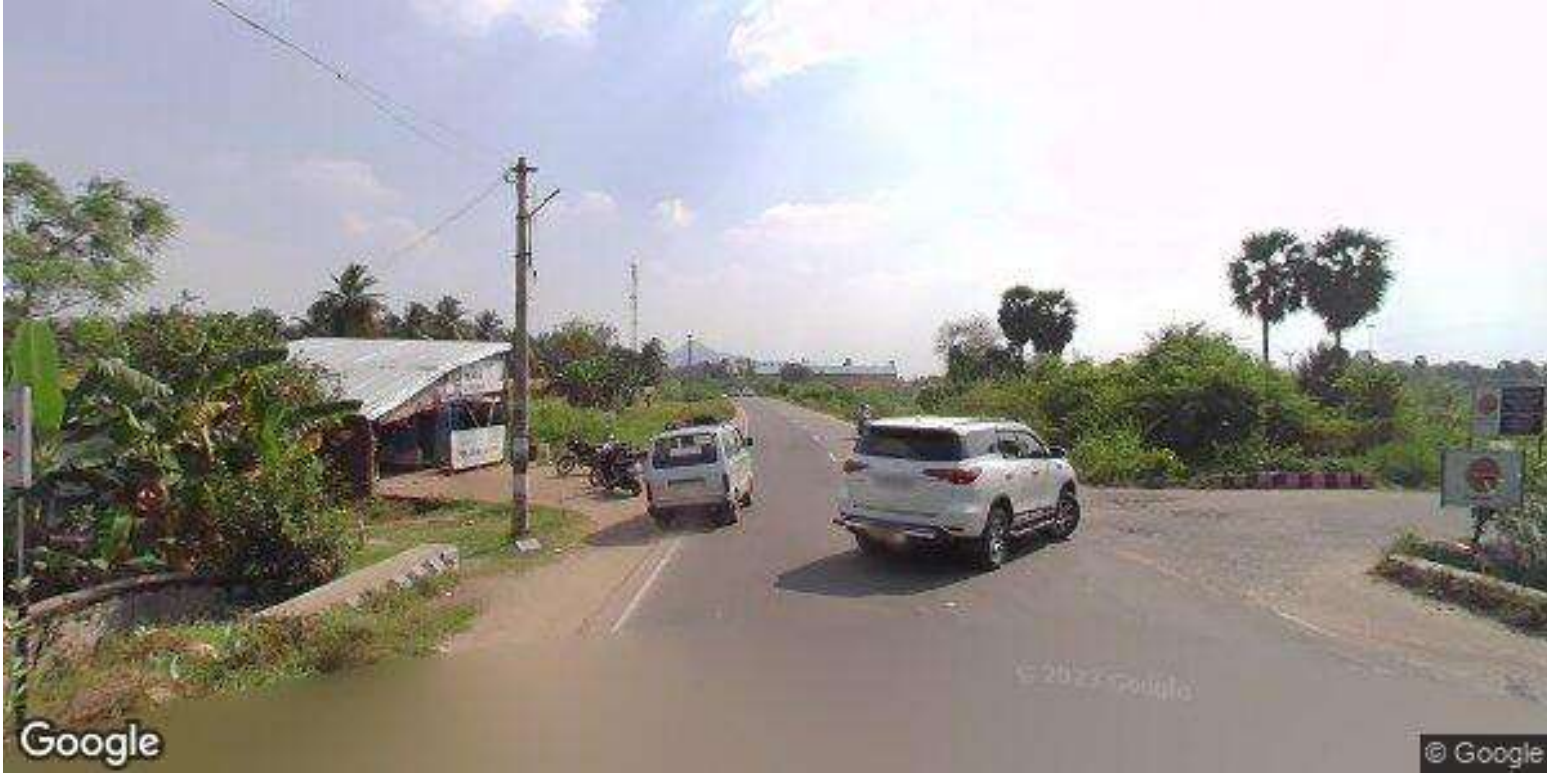
| | Risk Type | Risk Level | Coordinates | Speed Limit |
|---|---|---|---|---|
| 4 | Blind Spot | Blind Spot | 11.44029, 77.87544 | 10 KM/Hr |

Risk Type: Blind Spot  
Risk Level: Blind Spot  
Speed Limit: 10 KM/Hr  
Coordinates: 11.44029, 77.87544

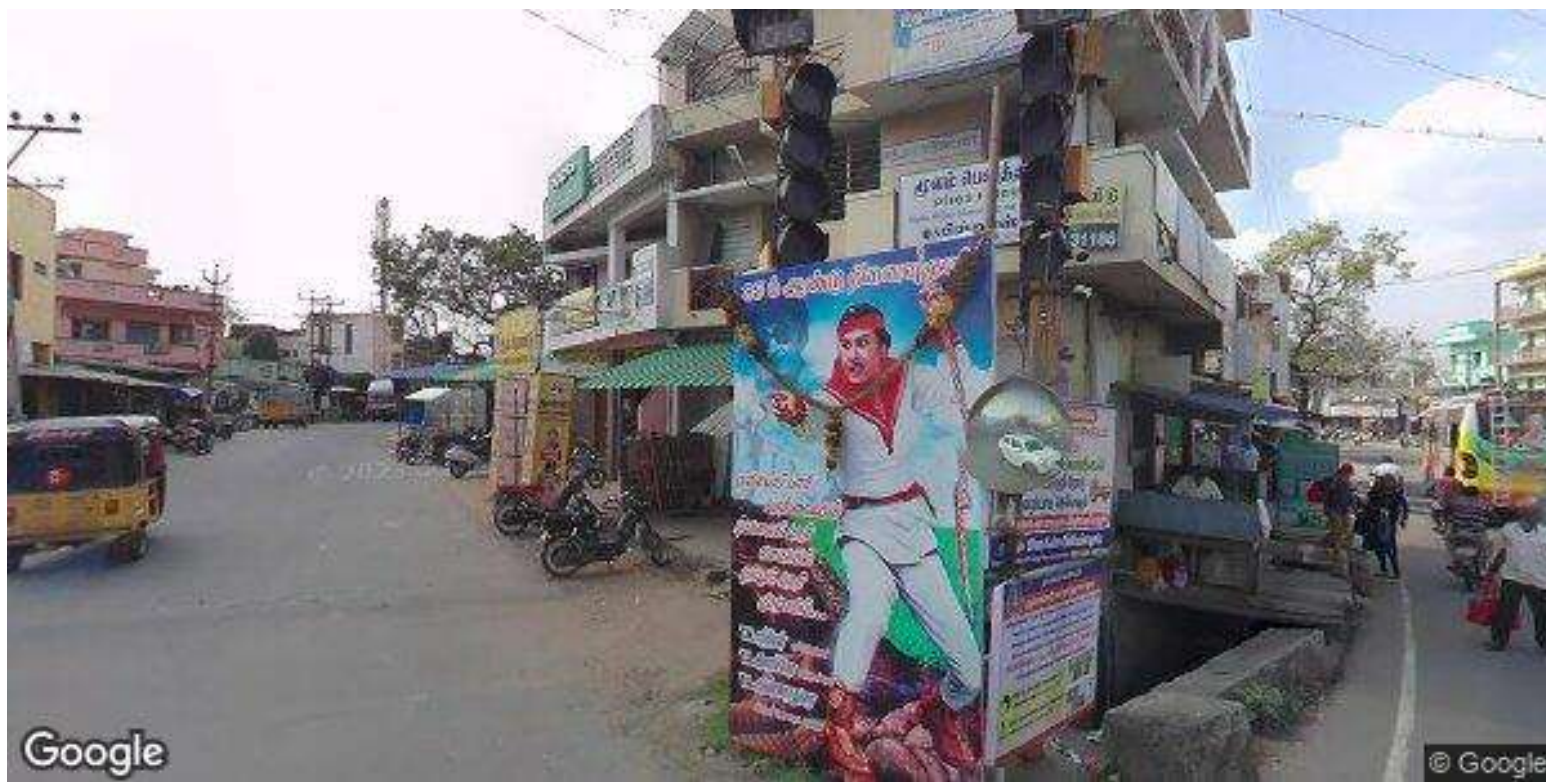
**Coordinates:** 11.38342, 77.89975

| | Risk Type | Risk Level | Coordinates | Speed Limit |
|---|---|---|---|---|
| 5 | Turn | Medium | 11.38342, 77.89975 | 30 KM/Hr |

**Risk Type:** Turn

**Risk Level:** Medium

**Speed Limit:** 30 KM/Hr

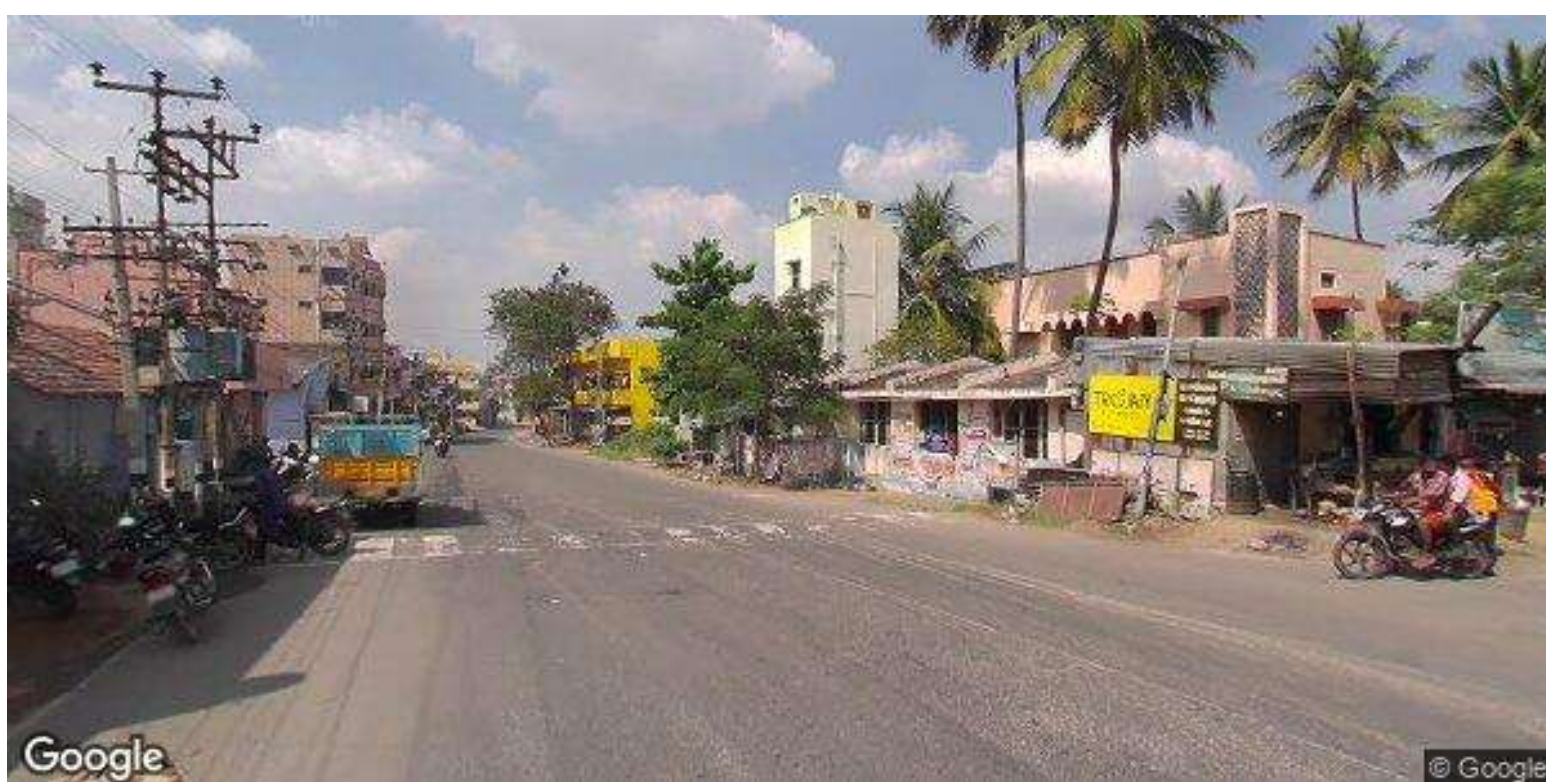
**Coordinates:** 11.38190, 77.90254

| | Risk Type | Risk Level | Coordinates | Speed Limit |
|---|---|---|---|---|
| 6 | Turn | Medium | 11.38190, 77.90254 | 30 KM/Hr |

**Risk Type:** Turn

**Risk Level:** Medium

**Speed Limit:** 30 KM/Hr

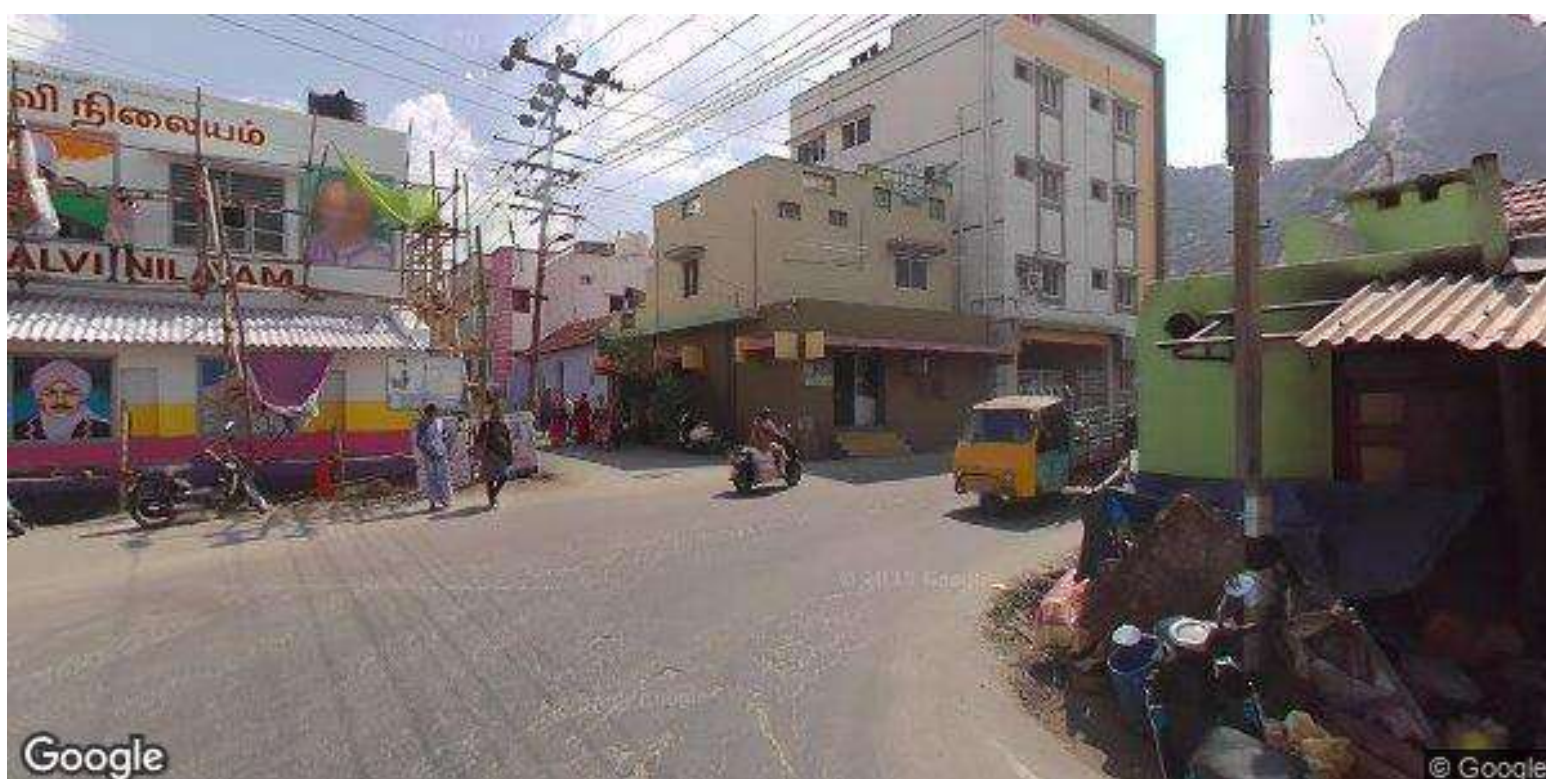
**Coordinates: 11.38186, 77.90258**

| | Risk Type | Risk Level | Coordinates | Speed Limit |
|---|---|---|---|---|
| 7 | Turn | High | 11.38186, 77.90258 | 15 KM/Hr |

**Risk Type: Turn**

**Risk Level: High**

**Speed Limit: 15 KM/Hr**

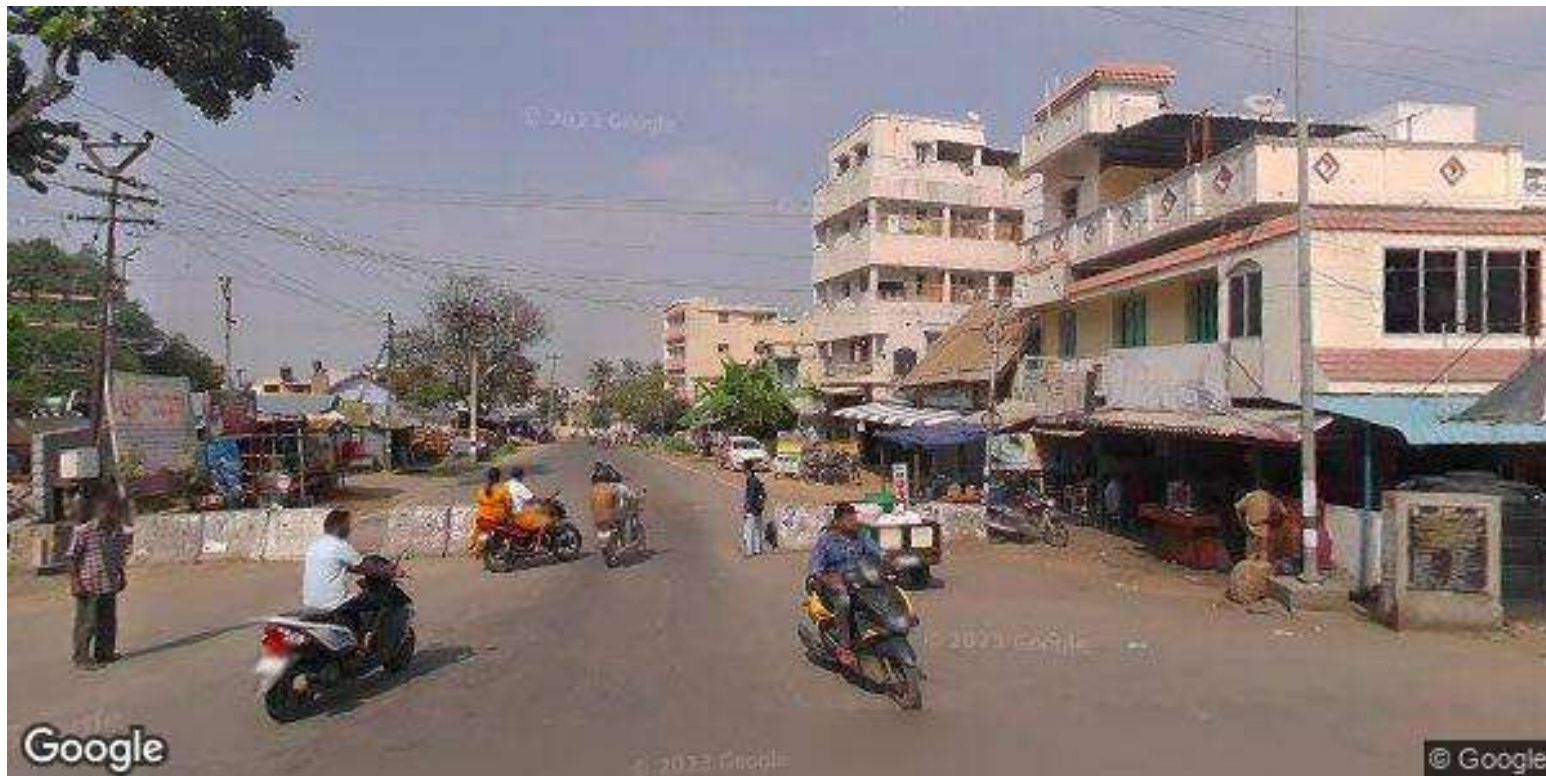
**Coordinates: 11.37841, 77.90140**

| | Risk Type | Risk Level | Coordinates | Speed Limit |
|---|---|---|---|---|
| 8 | Blind Spot | Blind Spot | 11.37841, 77.90140 | 10 KM/Hr |

**Risk Type: Blind Spot**

**Risk Level: Blind Spot**

**Speed Limit: 10 KM/Hr**

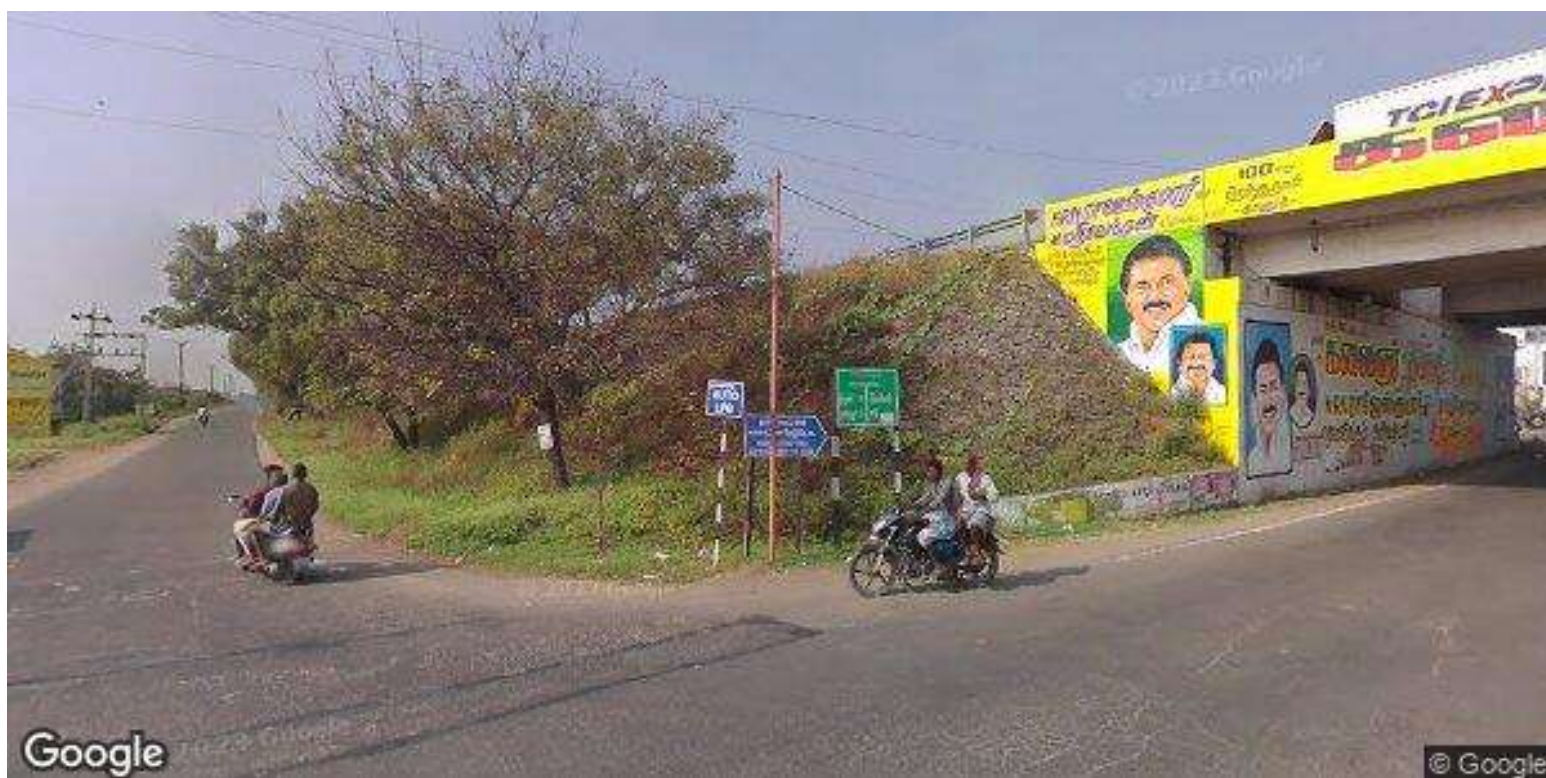
**Coordinates: 11.23936, 78.14267**

| | Risk Type | Risk Level | Coordinates | Speed Limit |
|---|---|---|---|---|
| 9 | Blind Spot | Blind Spot | 11.23936, 78.14267 | 10 KM/Hr |

**Risk Type: Blind Spot**

**Risk Level: Blind Spot**

**Speed Limit: 10 KM/Hr**

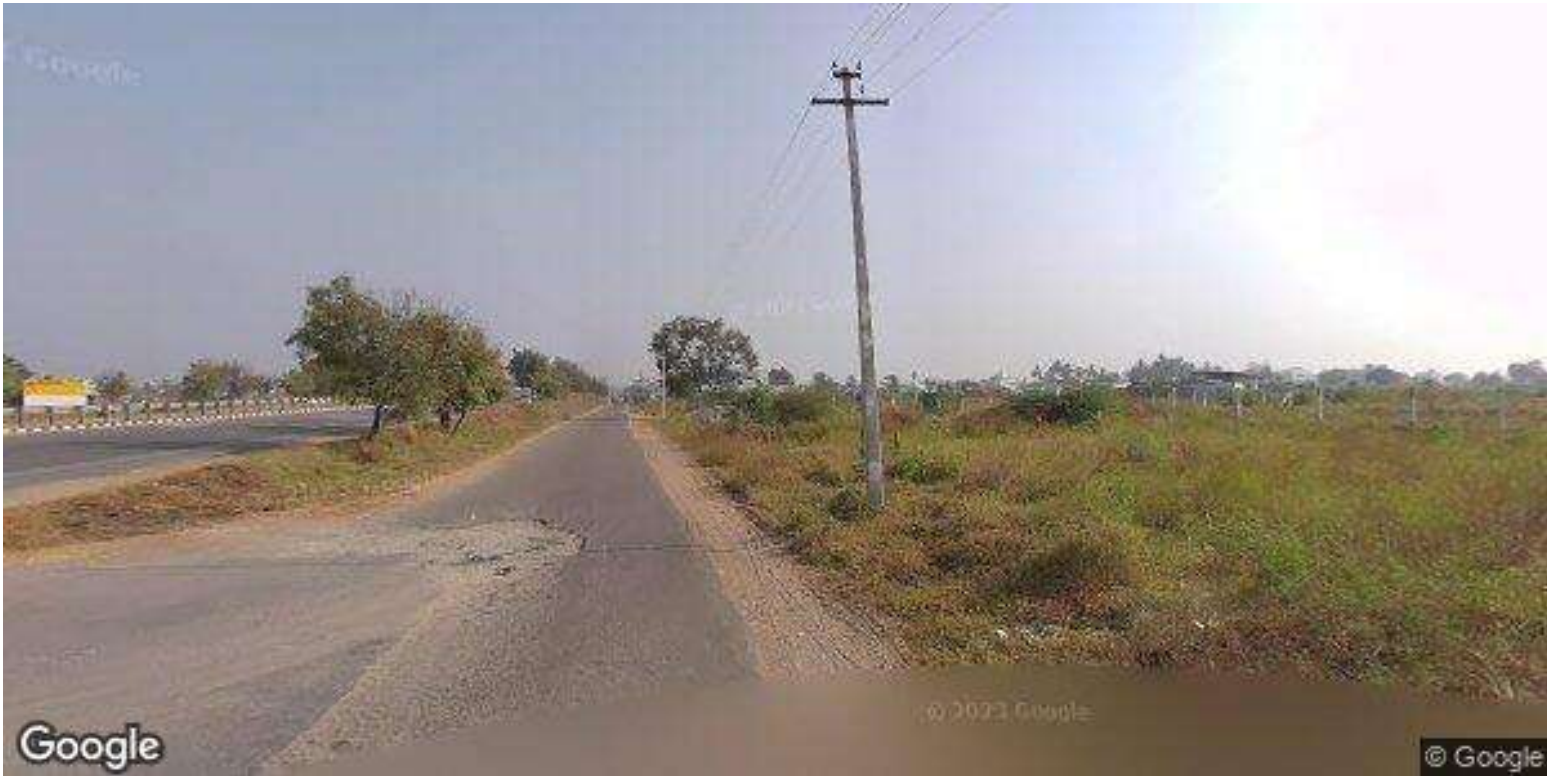
| | Risk Type | Risk Level | Coordinates | Speed Limit |
|---|---|---|---|---|
| 10 | Turn | High | 11.22817, 78.13576 | 15 KM/Hr |

**Risk Type:** Turn  
**Risk Level:** High  
**Speed Limit:** 15 KM/Hr  
**Coordinates:** 11.22817, 78.13576
