# IndianOil

## JOURNEY RISK MANAGEMENT (JRM) STUDY

### Salem Terminal TO SAI FUEL AGENCY

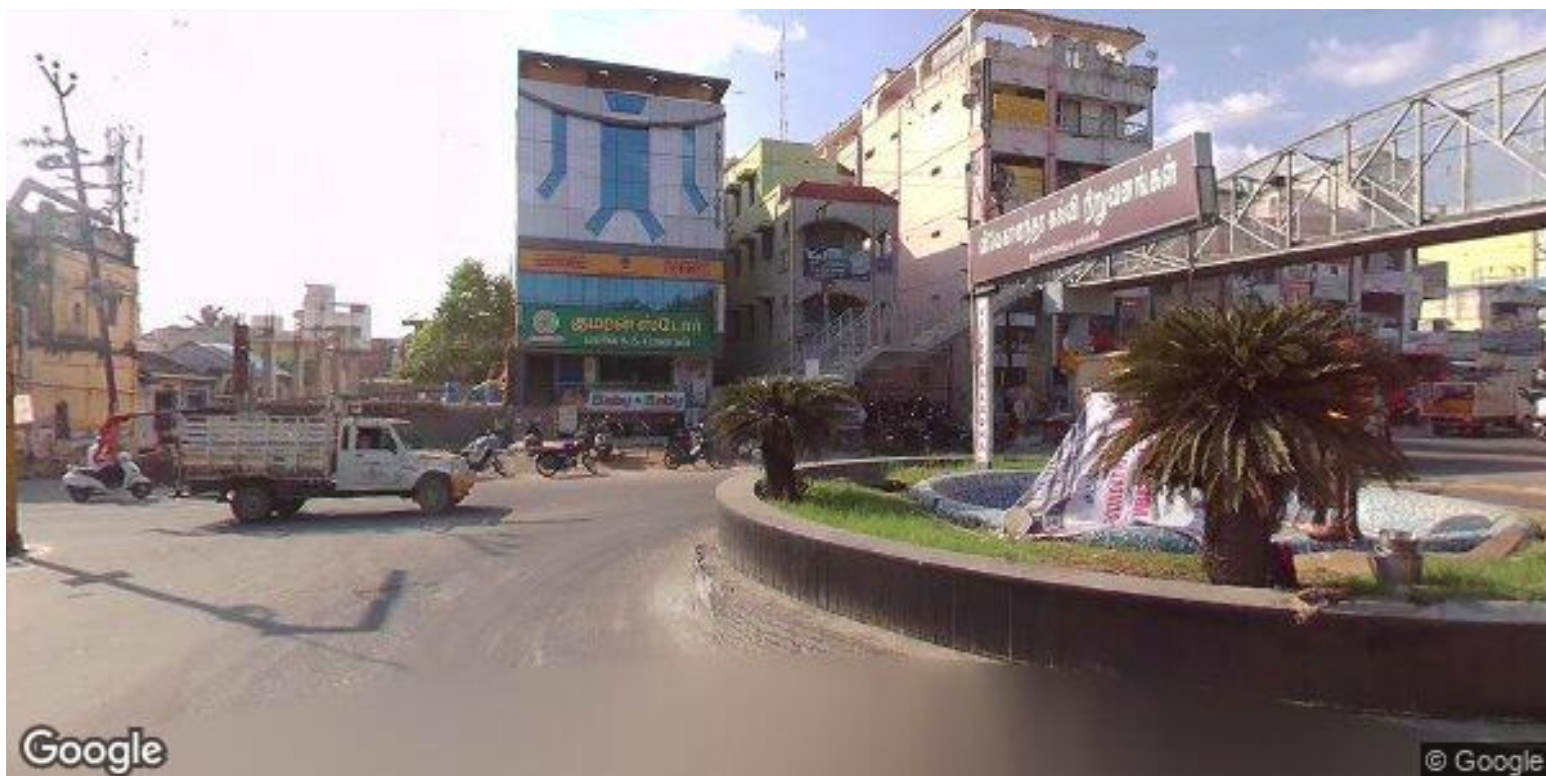
**Risk Type:** Roundabout

**Risk Level:** High

**Speed Limit: 15 KM/Hr**  
**Coordinates: 11.38386, 77.89482**

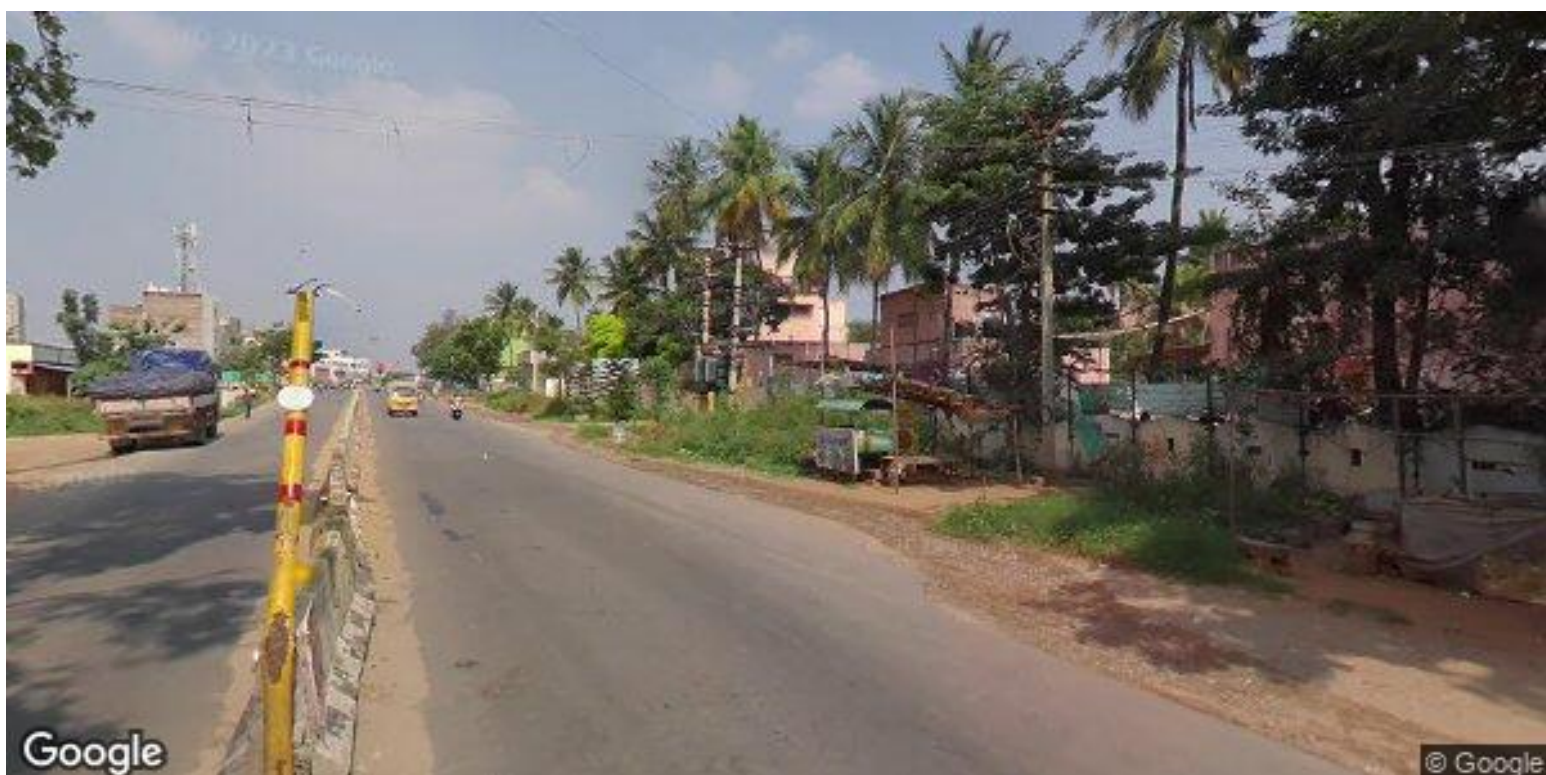
**Risk Type:** Turn  
**Risk Level:** Medium  
**Speed Limit:** 30 KM/Hr  
**Coordinates:** 11.36439, 77.88943

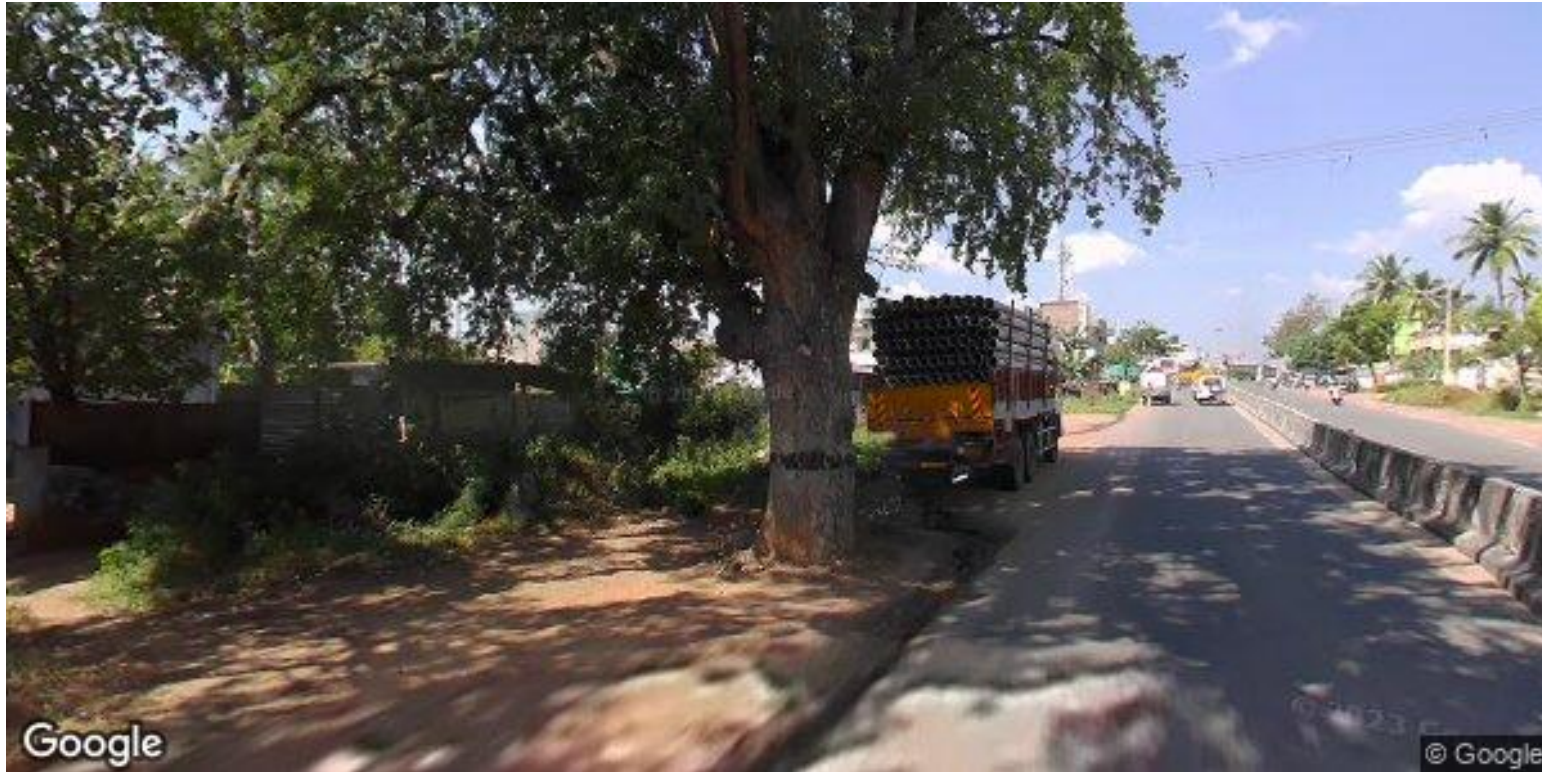
**Risk Type:** Turn  
**Risk Level:** Medium  
**Speed Limit:** 30 KM/Hr  
**Coordinates:** 11.36434, 77.88942

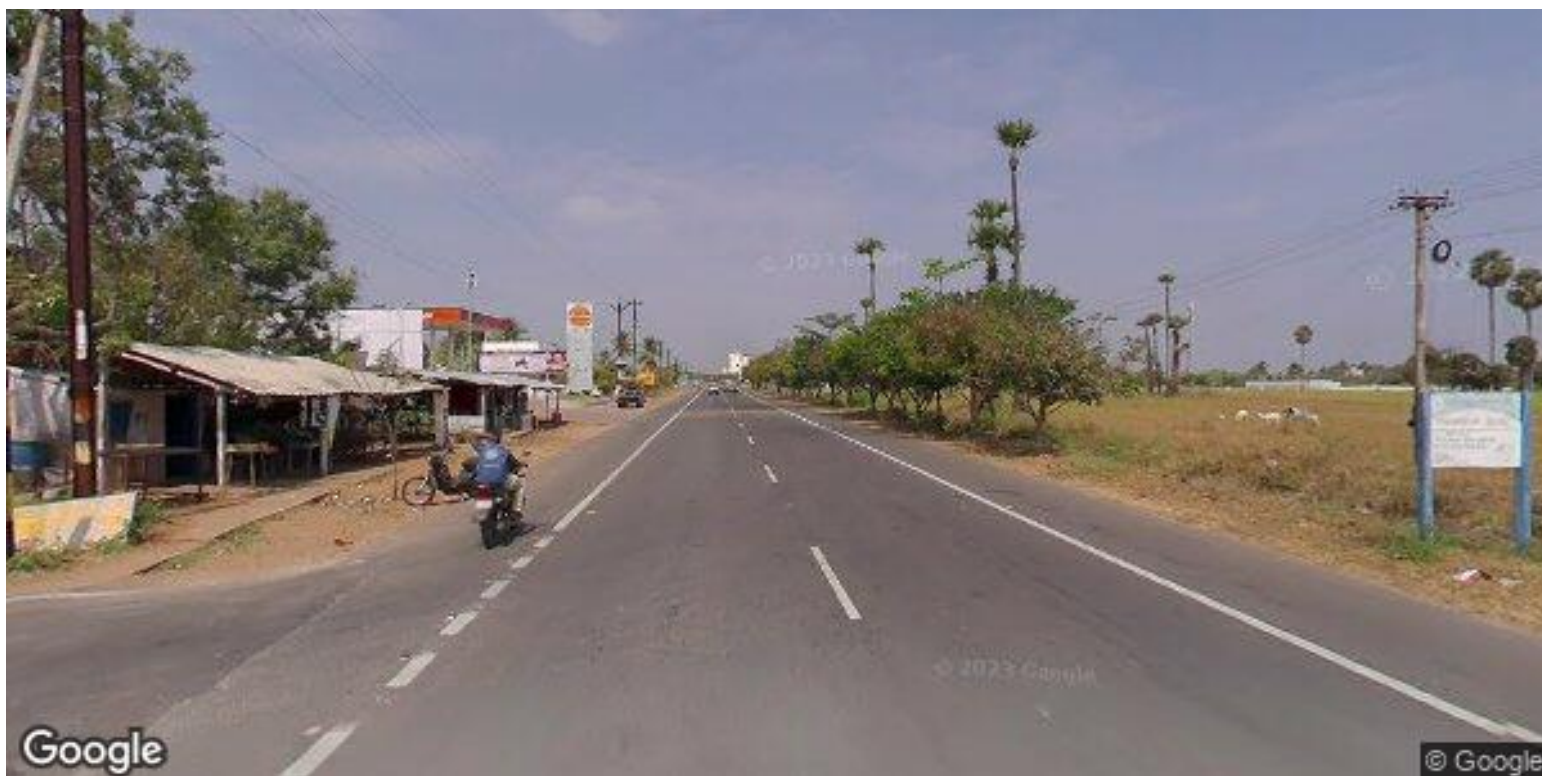
**Risk Type:** Blind Spot  
**Risk Level:** Blind Spot  
**Speed Limit:** 10 KM/Hr  
**Coordinates:** 11.28479, 77.94438

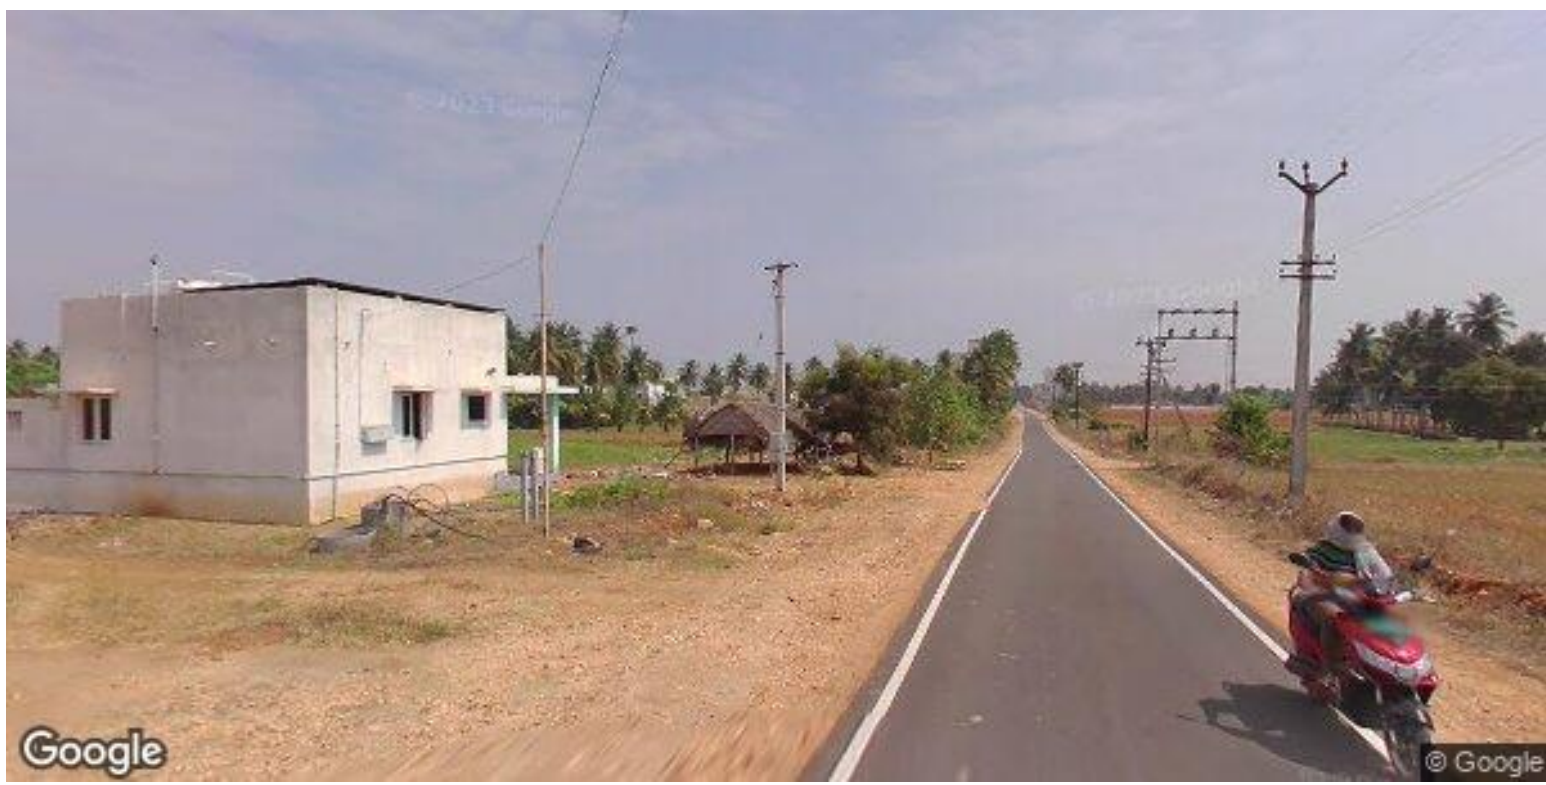
**Coordinates:** 11.28476, 77.94029

**Risk Type:** Turn

**Risk Level:** High

**Speed Limit:** 15 KM/Hr
