# IndianOil

## JOURNEY RISK MANAGEMENT (JRM) STUDY

### Salem Terminal to SREE VENKATESHWARA FUEL STATION

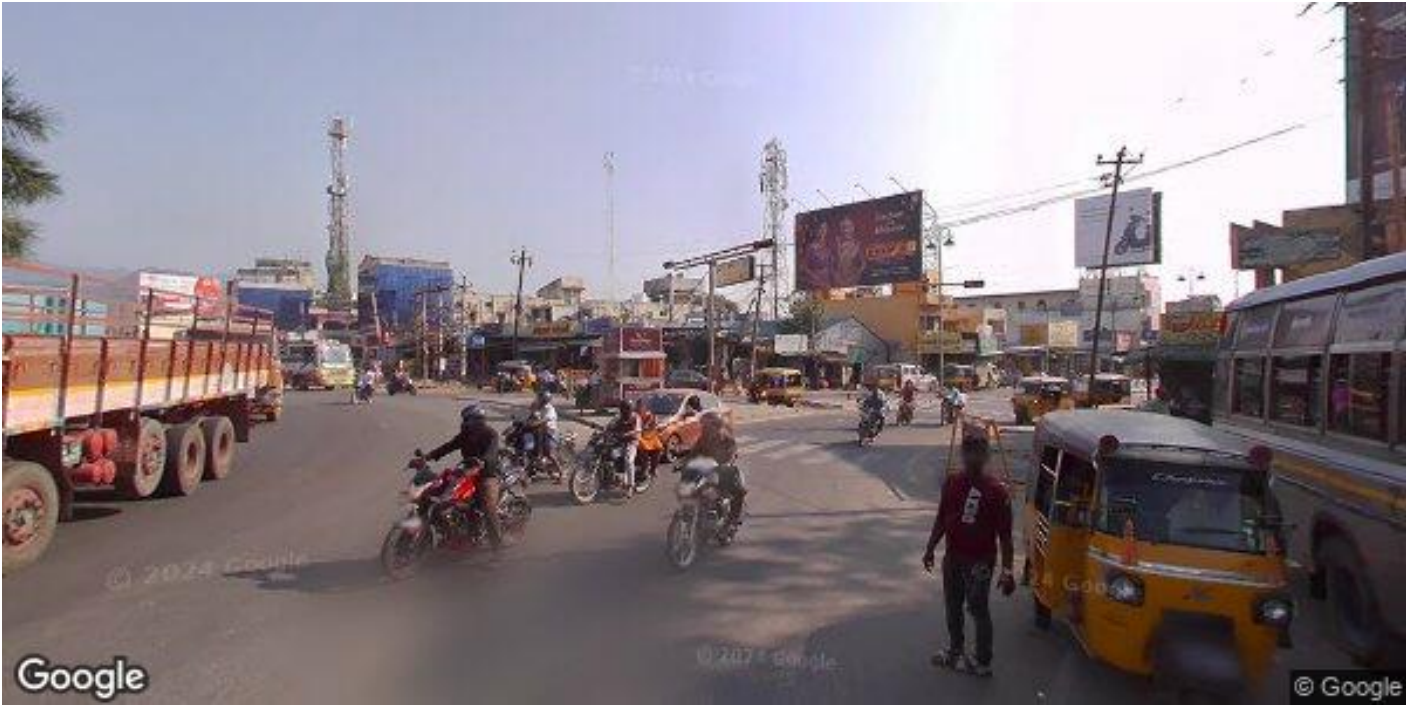
Risk Type: Roundabout  
Risk Level: High  
Speed Limit: 15 KM/Hr  
Coordinates: 11.63266, 78.12699

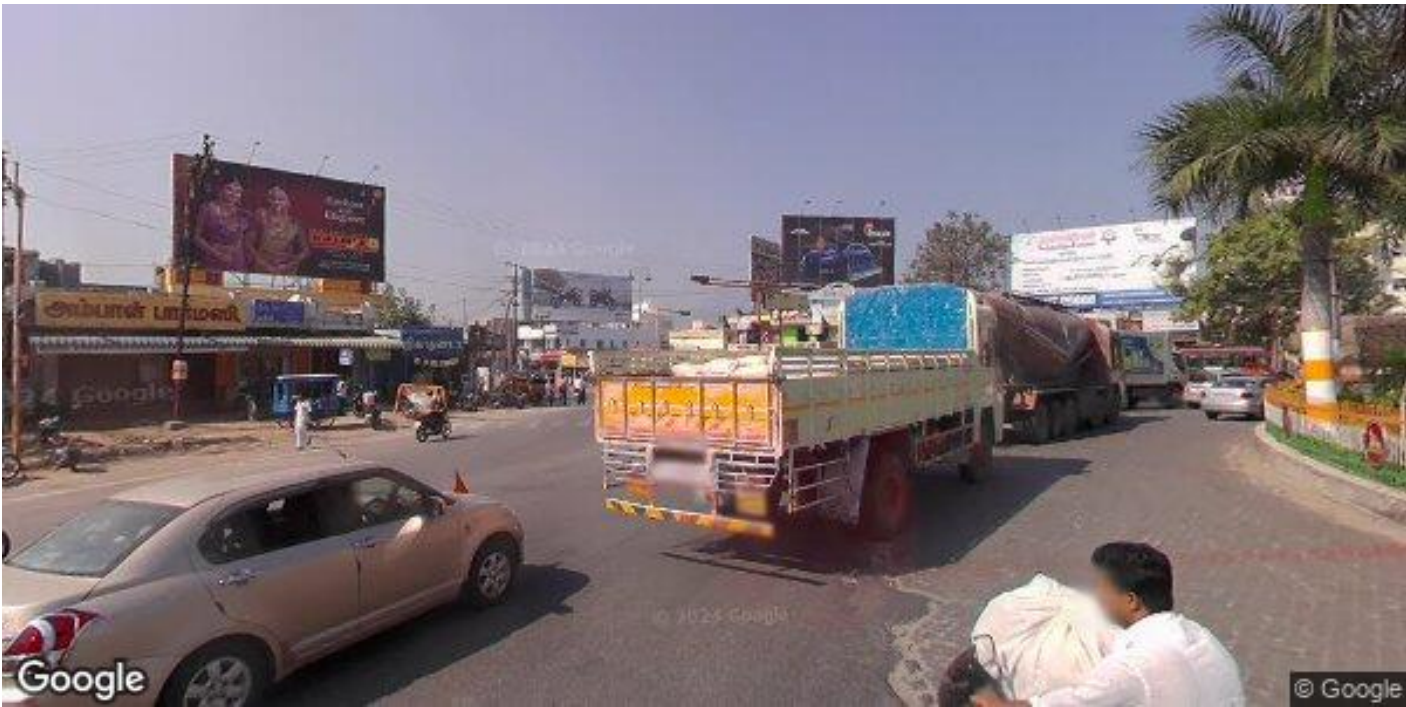
Risk Type: Roundabout  
Risk Level: High

**Speed Limit: 15 KM/Hr**  
**Coordinates: 11.63247, 78.12734**

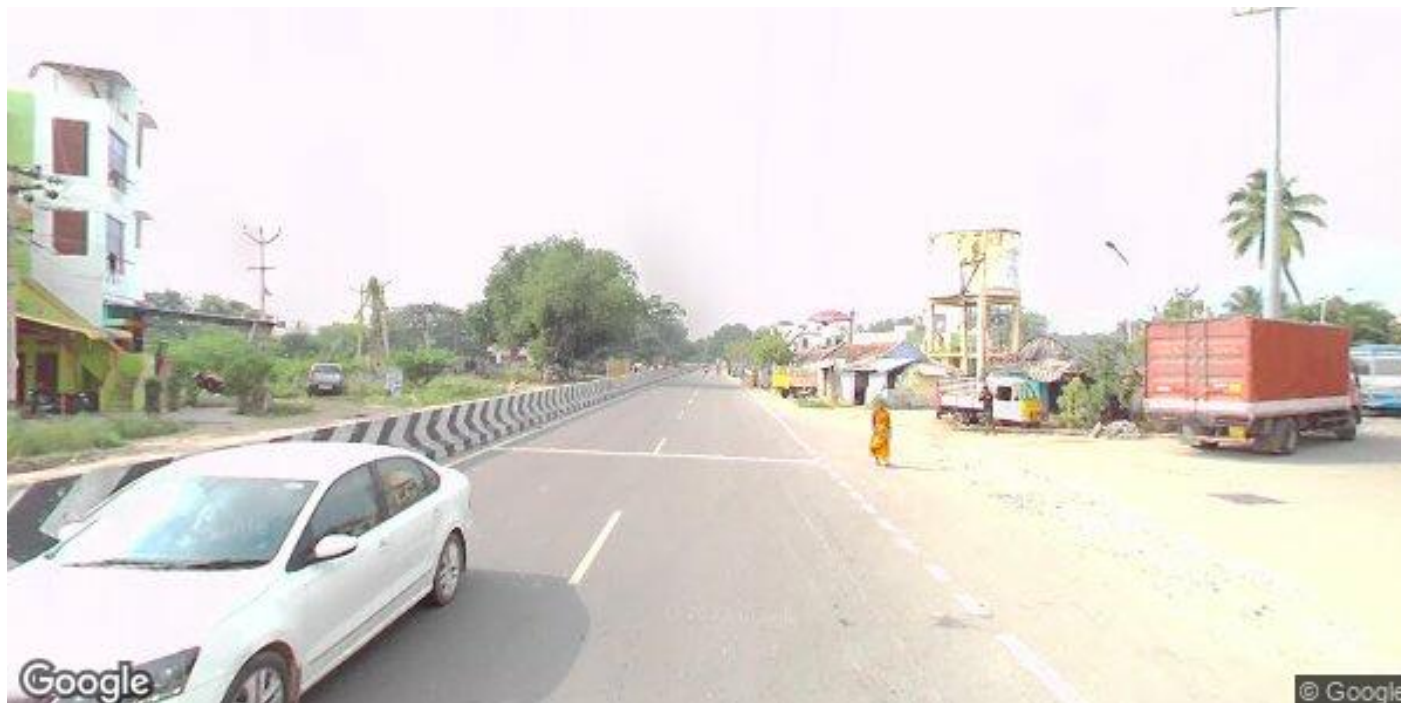
**Risk Type: U-Turn**  
**Risk Level: High**  
**Speed Limit: 10 KM/Hr**  
**Coordinates: 11.6193714, 78.1124012**

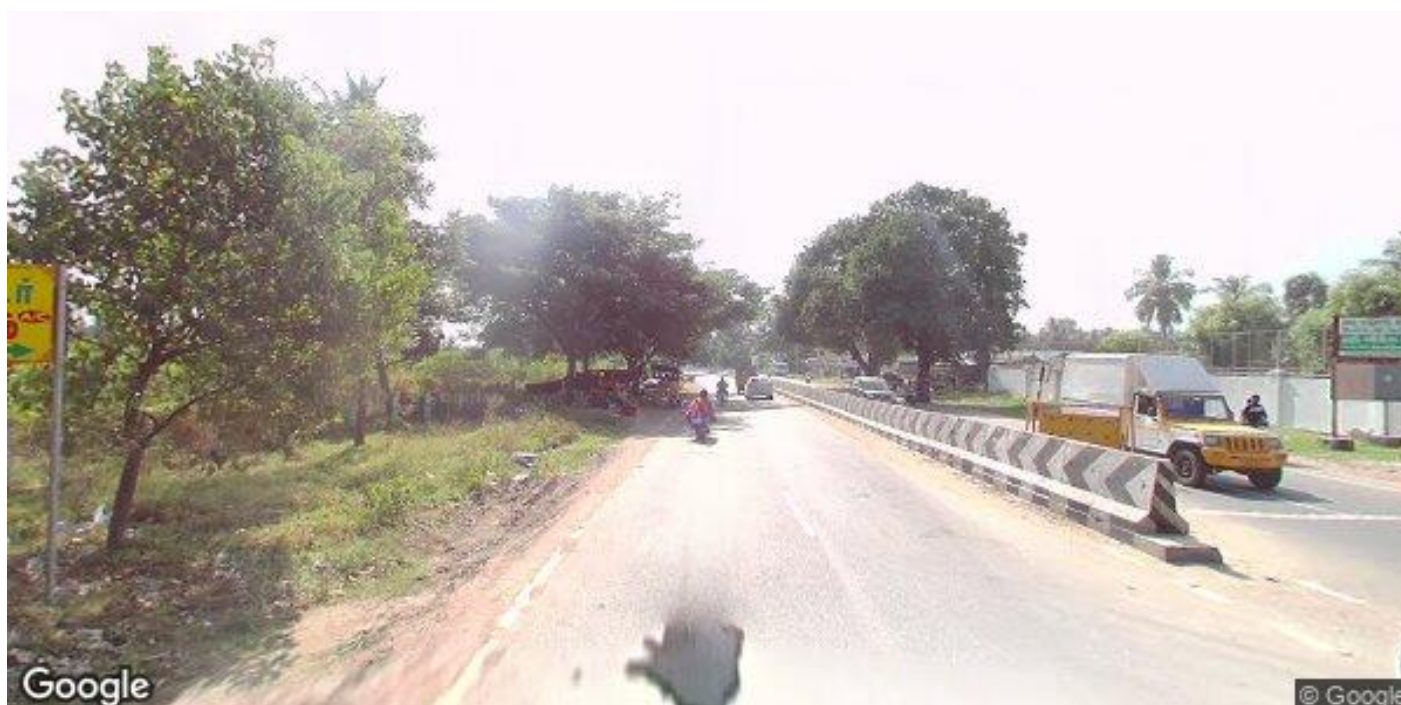
**Risk Type: U-Turn**  
**Risk Level: High**  
**Speed Limit: 10 KM/Hr**  
**Coordinates: 11.618013, 78.1109532**

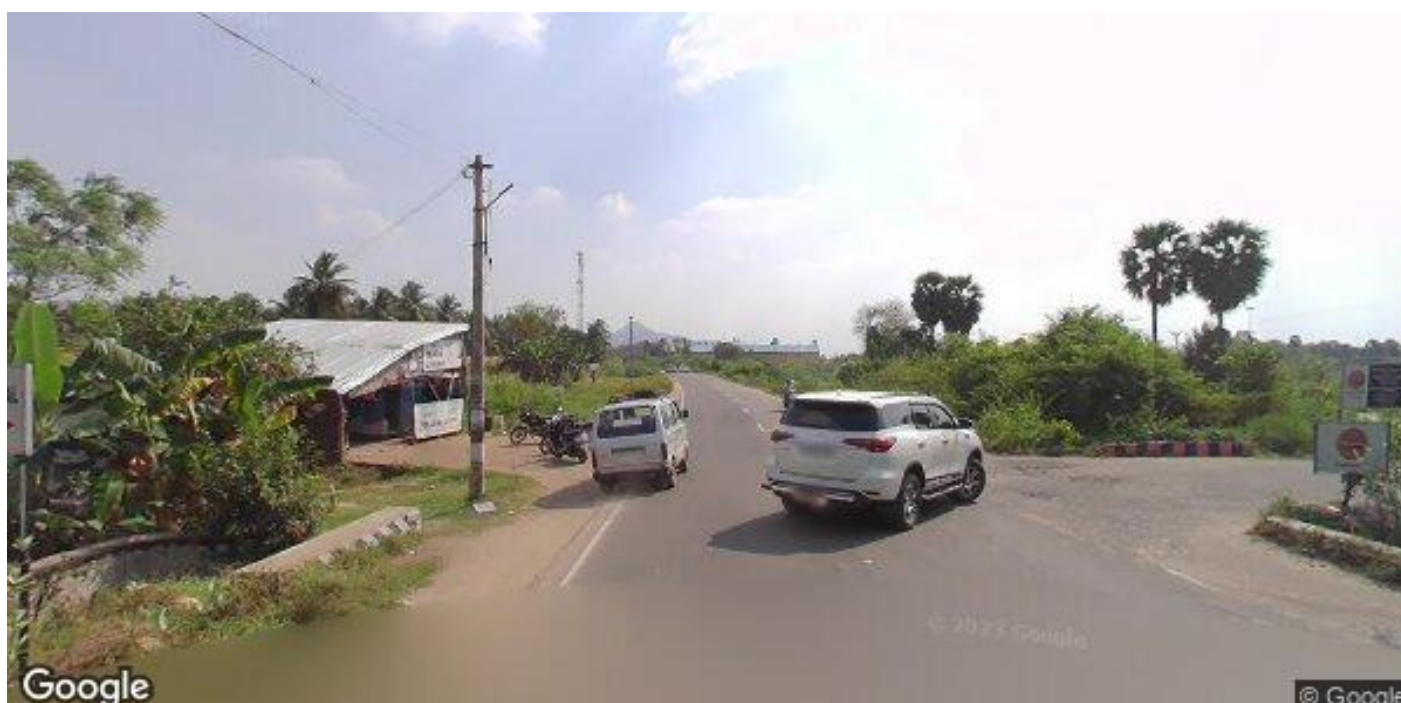
**Risk Type:** Turn  
**Risk Level:** High  
**Speed Limit:** 15 KM/Hr  
**Coordinates:** 11.44029, 77.87544

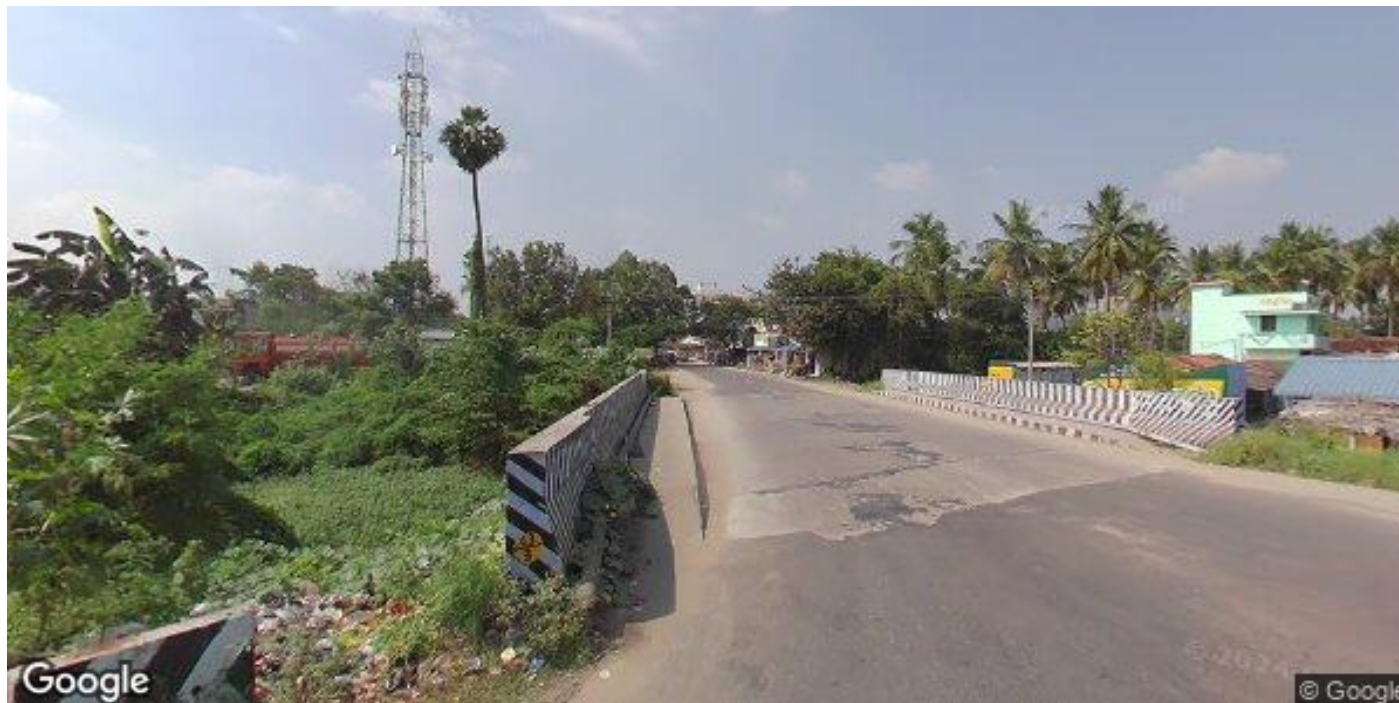
**Risk Type:** Turn  
**Risk Level:** Medium  
**Speed Limit:** 30 KM/Hr  
**Coordinates:** 11.44900, 77.87406

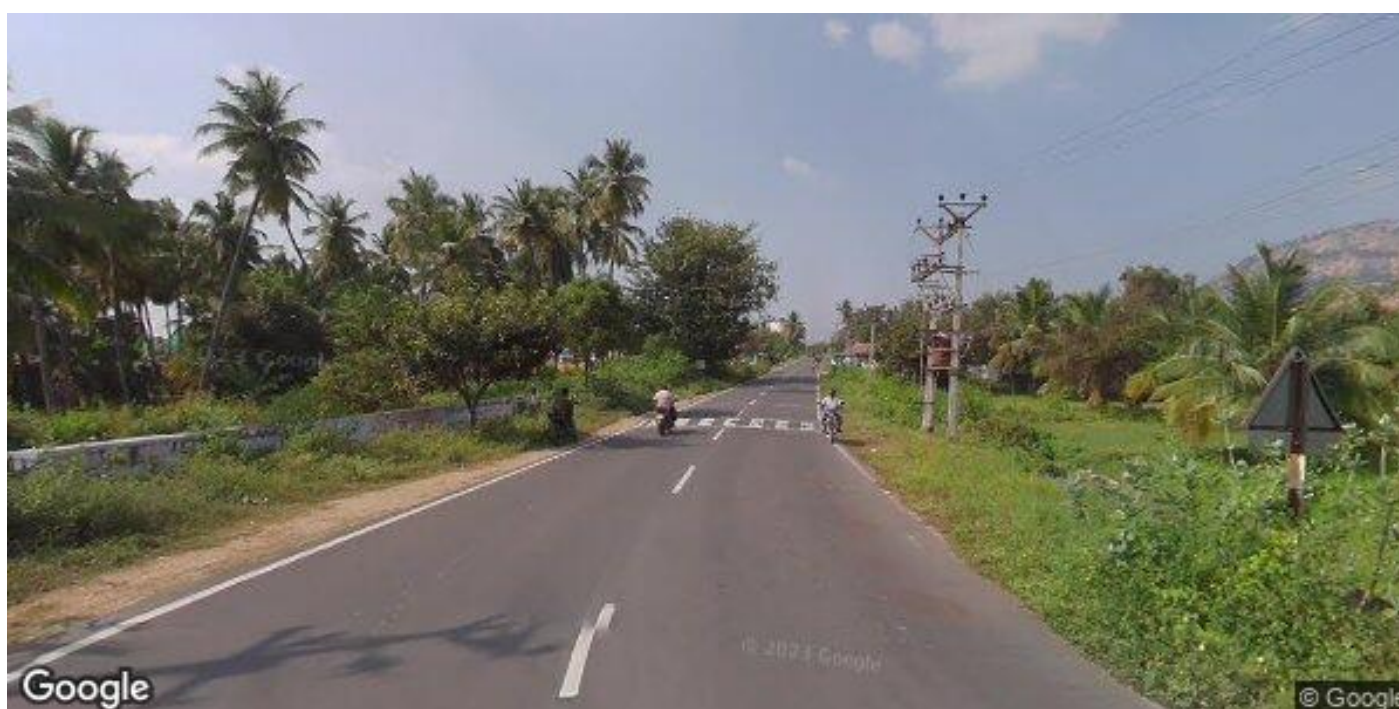
**Risk Type:** Turn  
**Risk Level:** High  
**Speed Limit:** 15 KM/Hr  
**Coordinates:** 11.45353, 77.85697

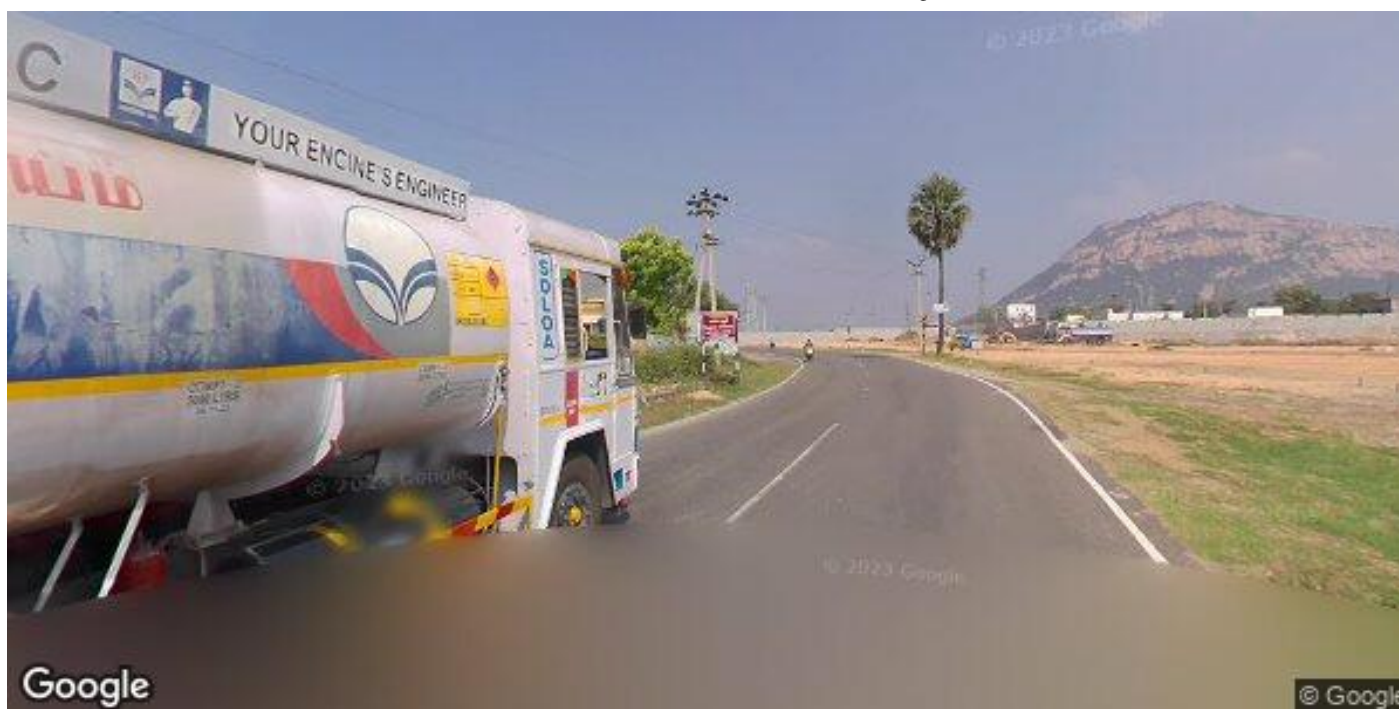
**Risk Type:** Turn  
**Risk Level:** Medium  
**Speed Limit:** 30 KM/Hr  
**Coordinates:** 11.45853, 77.85139

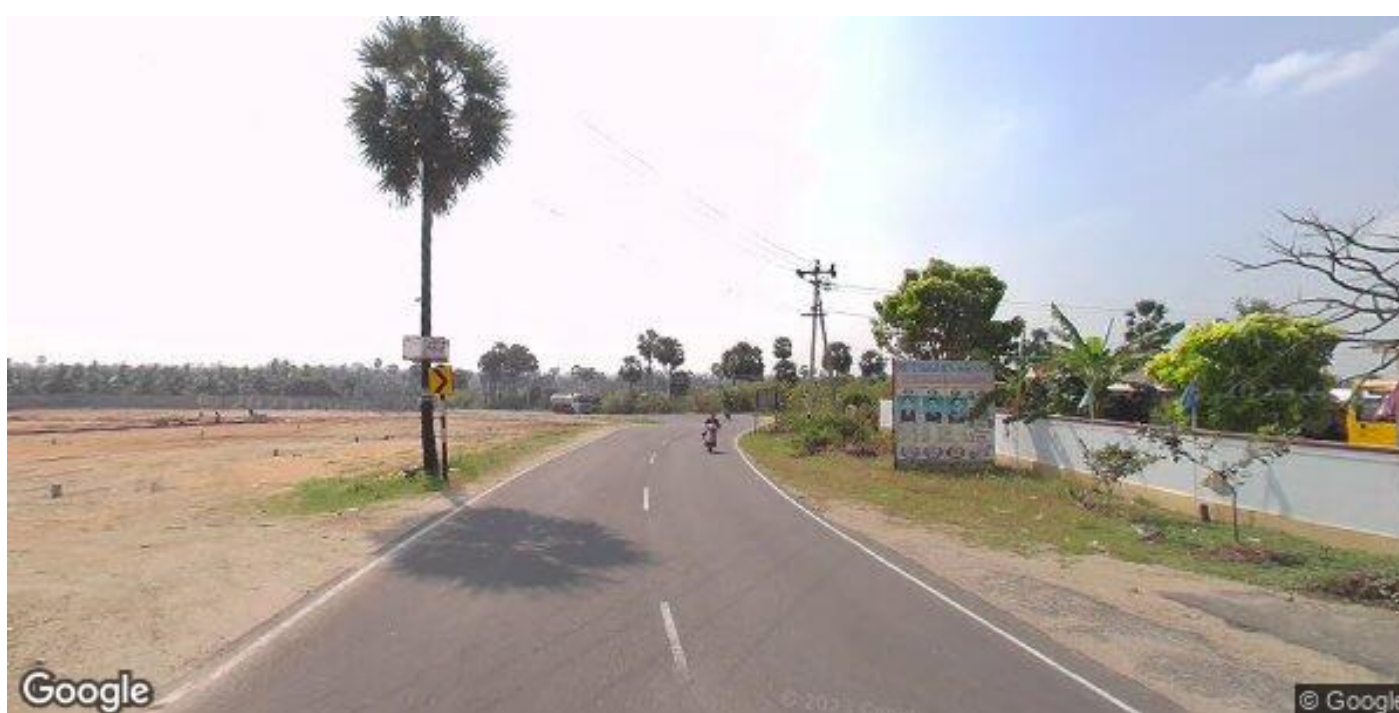
**Risk Type:** Turn  
**Risk Level:** Medium  
**Speed Limit:** 30 KM/Hr  
**Coordinates:** 11.45906, 77.85132

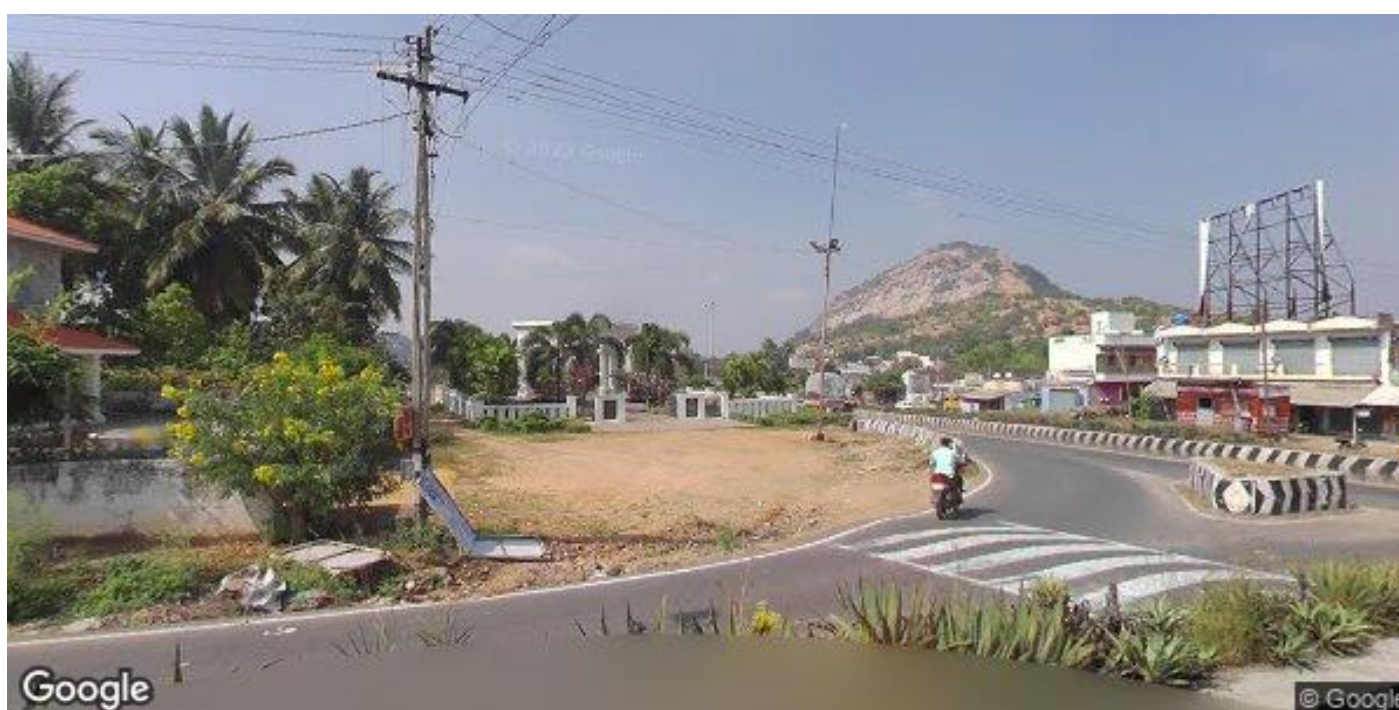
**Risk Type:** Turn  
**Risk Level:** High  
**Speed Limit:** 15 KM/Hr  
**Coordinates:** 11.46307, 77.84941

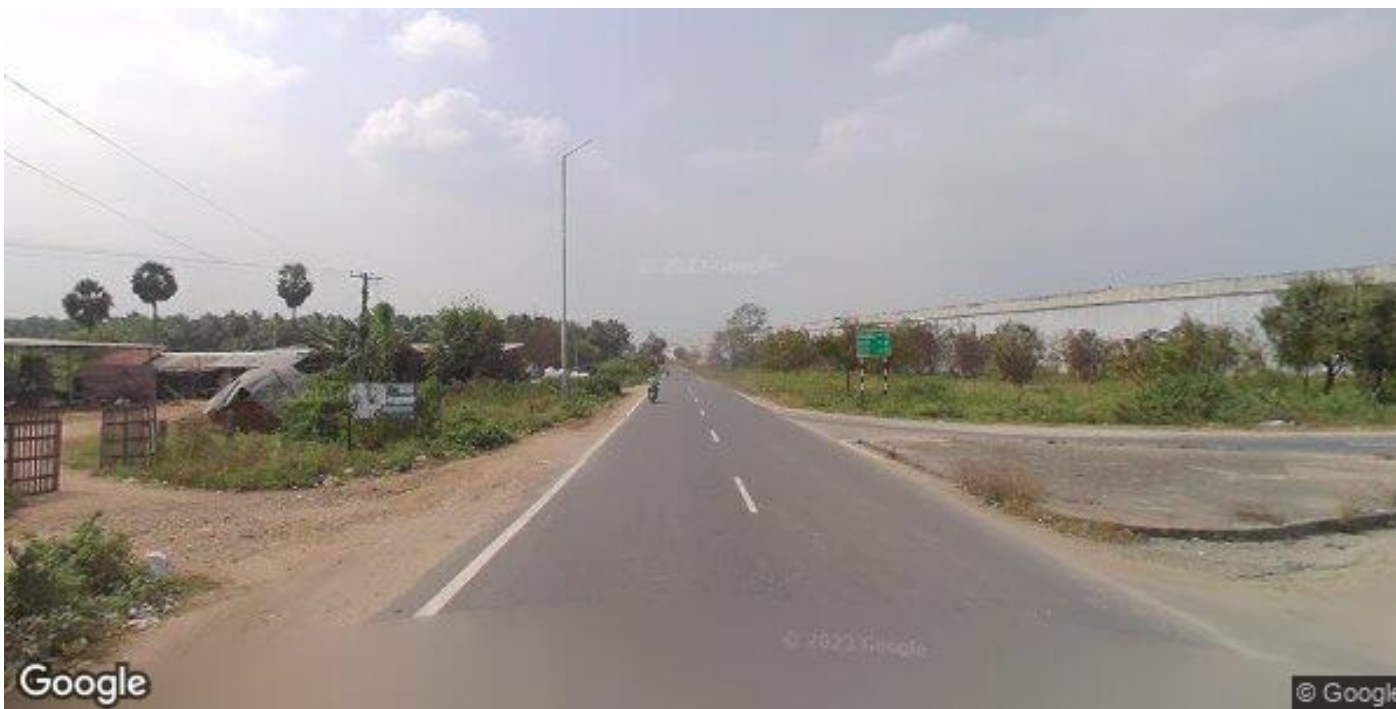
**Risk Type:** Turn  
**Risk Level:** High  
**Speed Limit:** 15 KM/Hr  
**Coordinates:** 11.45542, 77.81725

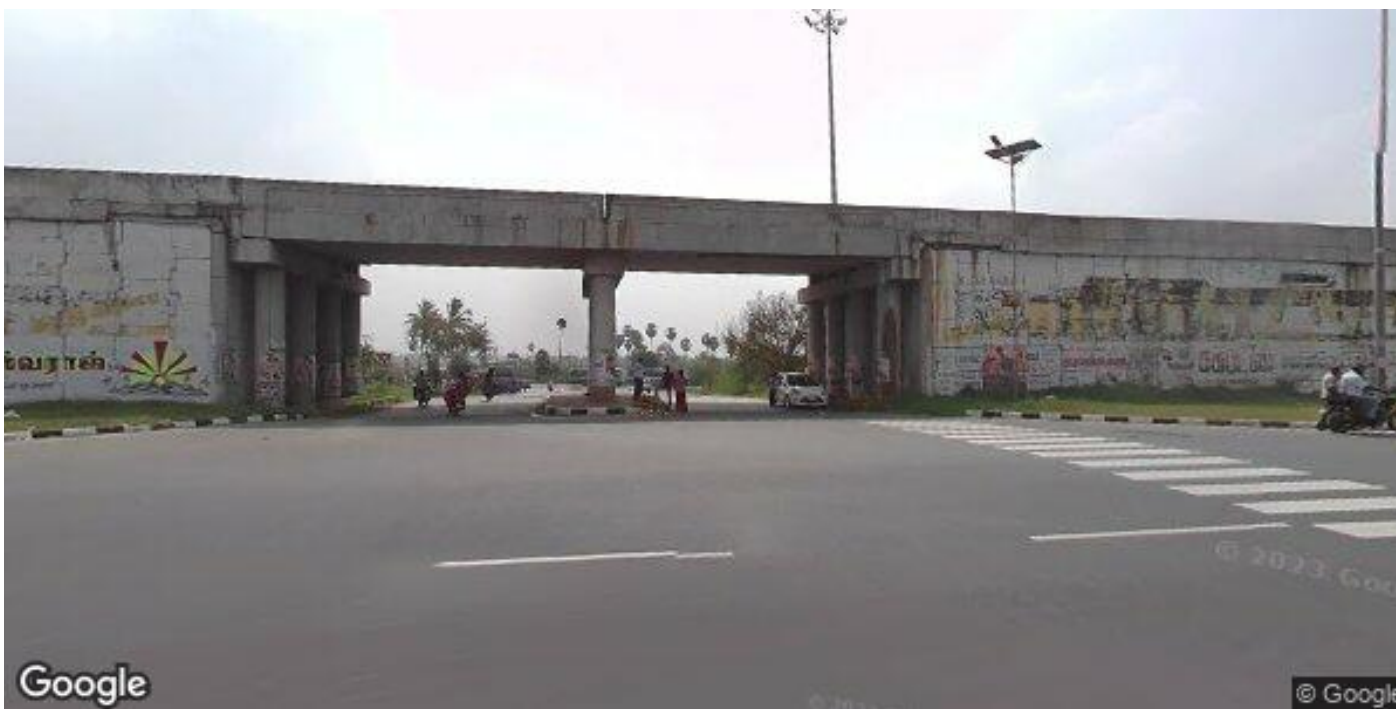
**Risk Type:** Turn  
**Risk Level:** High  
**Speed Limit:** 15 KM/Hr  
**Coordinates:** 11.45636, 77.81678

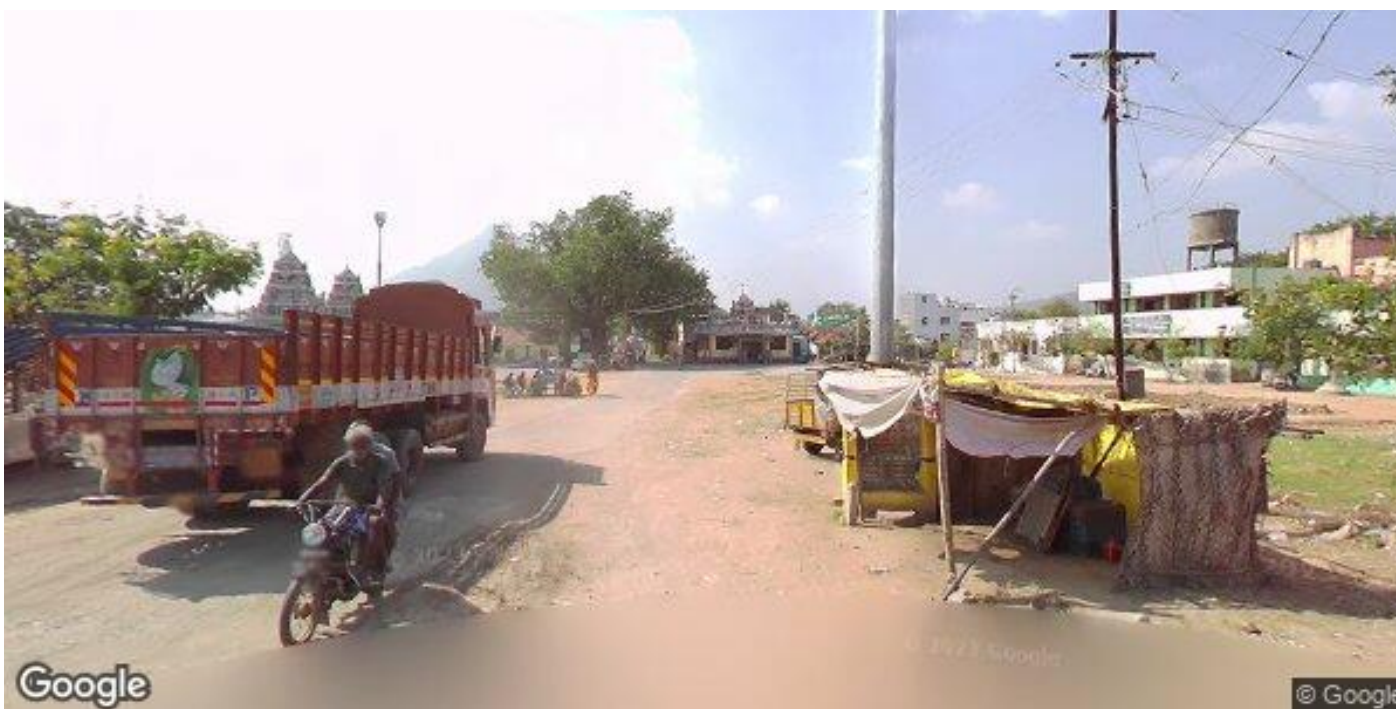
**Risk Type:** Blind Spot  
**Risk Level:** Blind Spot  
**Speed Limit:** 10 KM/Hr  
**Coordinates:** 11.62145, 78.10740

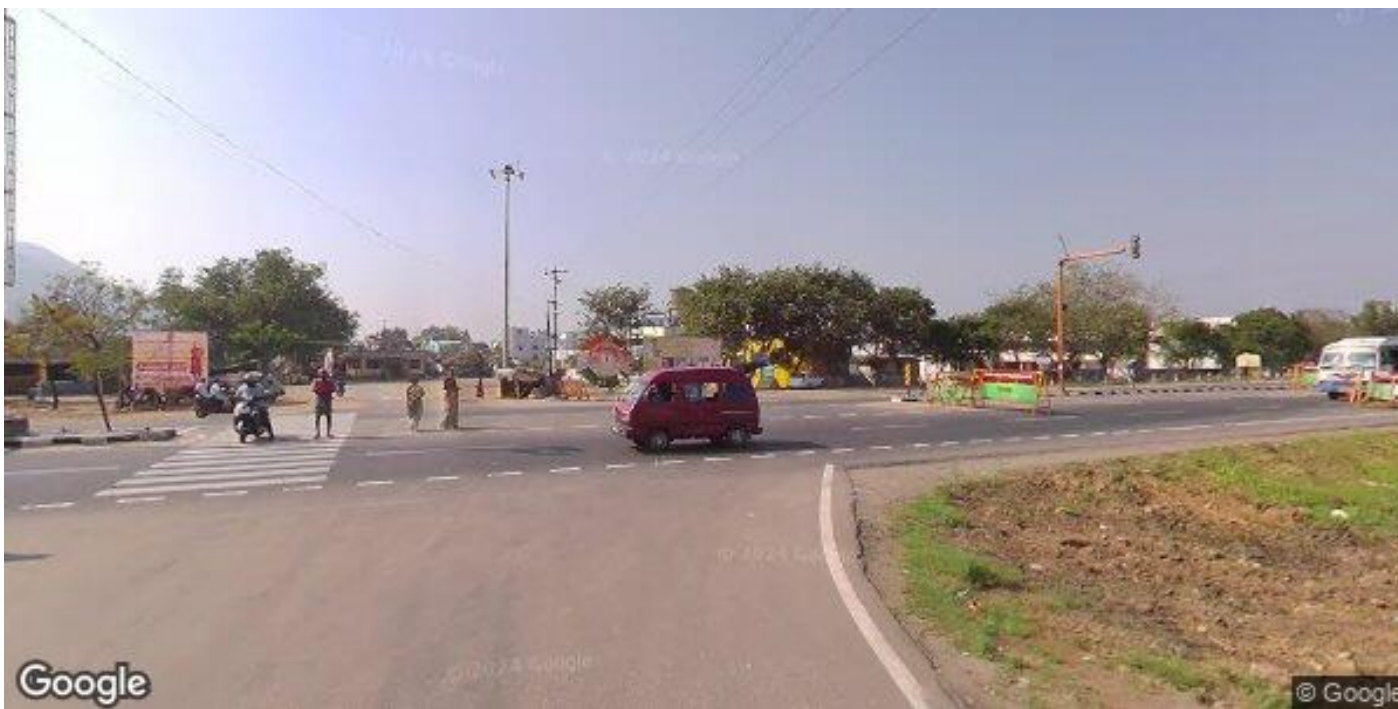
**Risk Type:** Turn  
**Risk Level:** High  
**Speed Limit:** 15 KM/Hr  
**Coordinates:** 11.62130, 78.10776

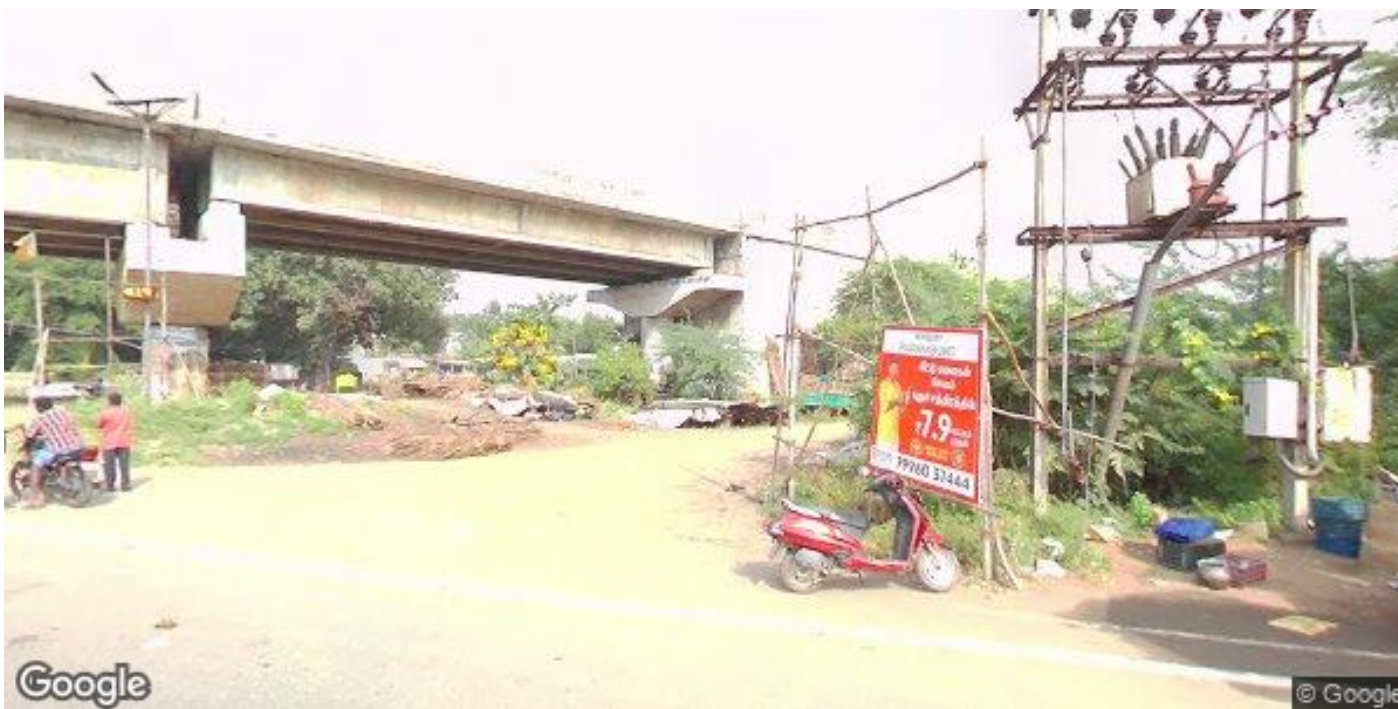
**Risk Type:** Blind Spot  
**Risk Level:** Blind Spot  
**Speed Limit:** 10 KM/Hr  
**Coordinates:** 11.61235, 78.10438

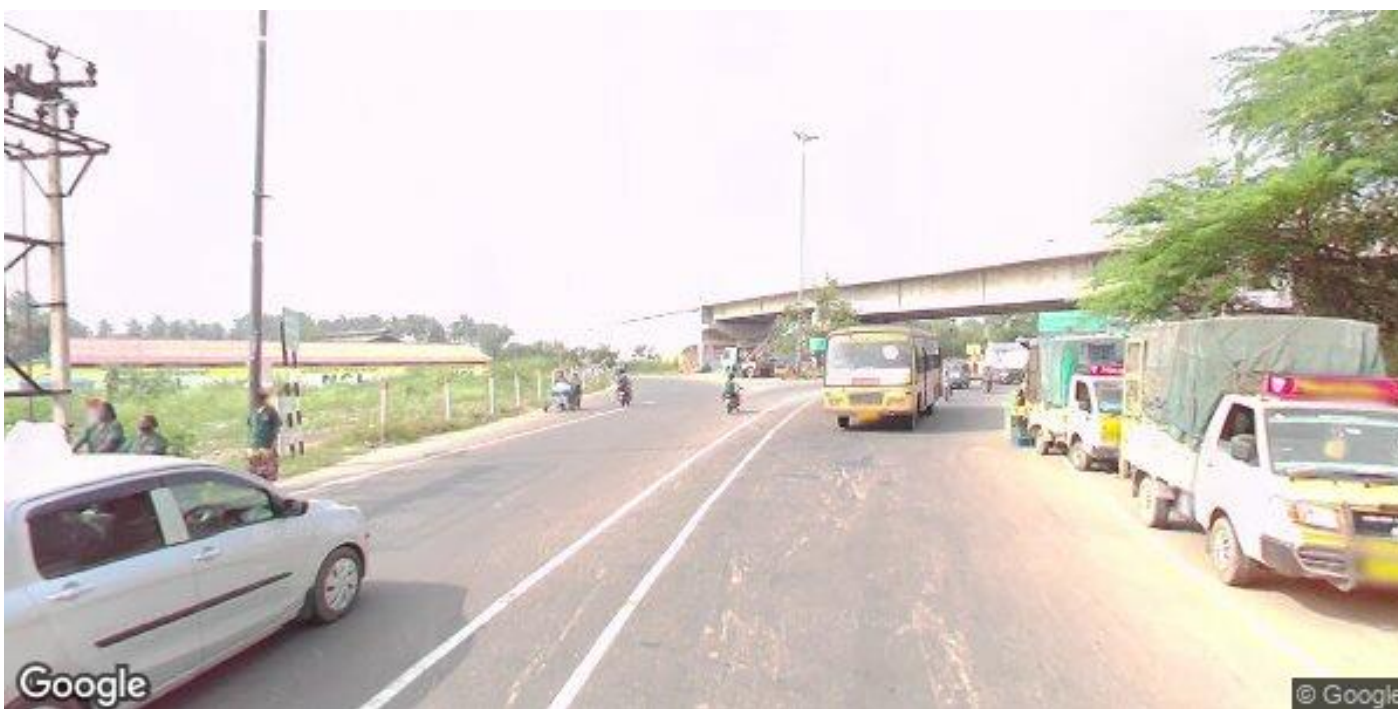
**Risk Type:** Turn  
**Risk Level:** Medium  
**Speed Limit:** 30 KM/Hr  
**Coordinates:** 11.61224, 78.10469

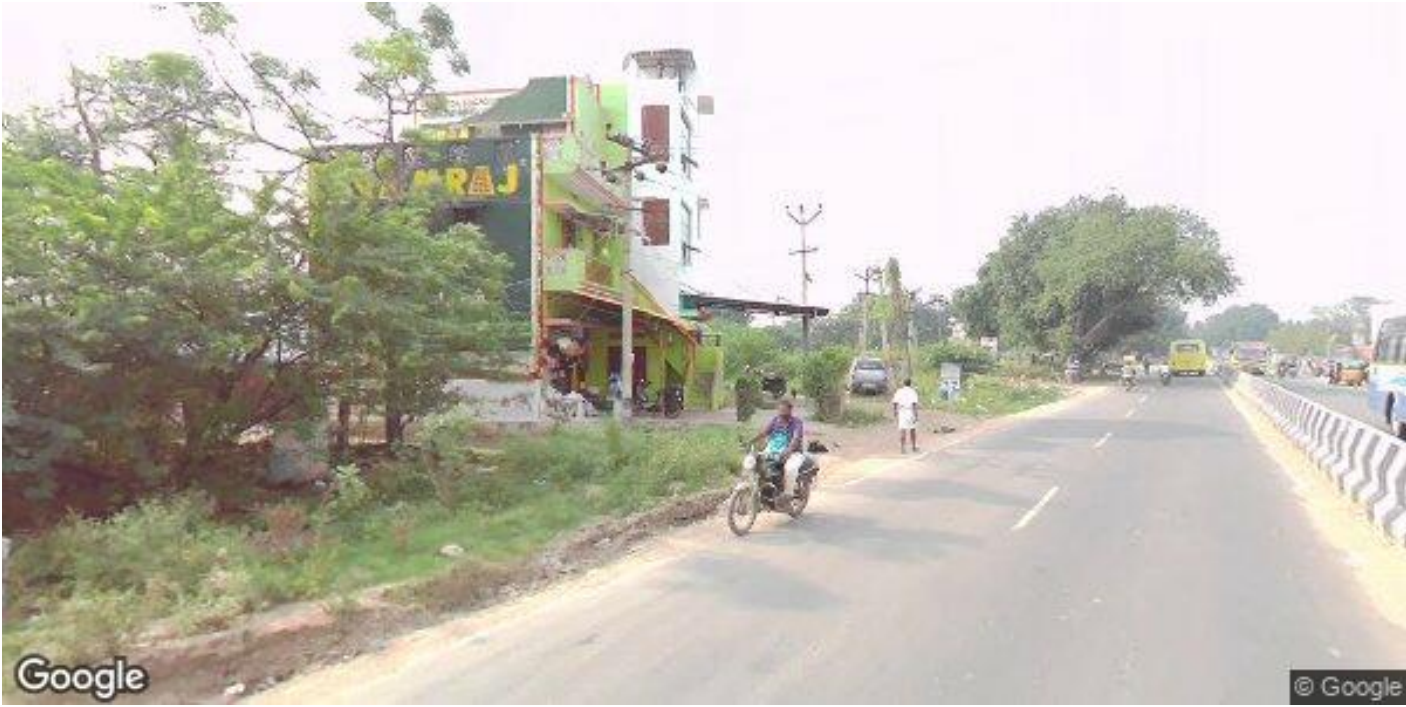
**Risk Type:** Blind Spot  
**Risk Level:** Blind Spot  
**Speed Limit:** 10 KM/Hr  
**Coordinates:** 11.61928, 78.11242

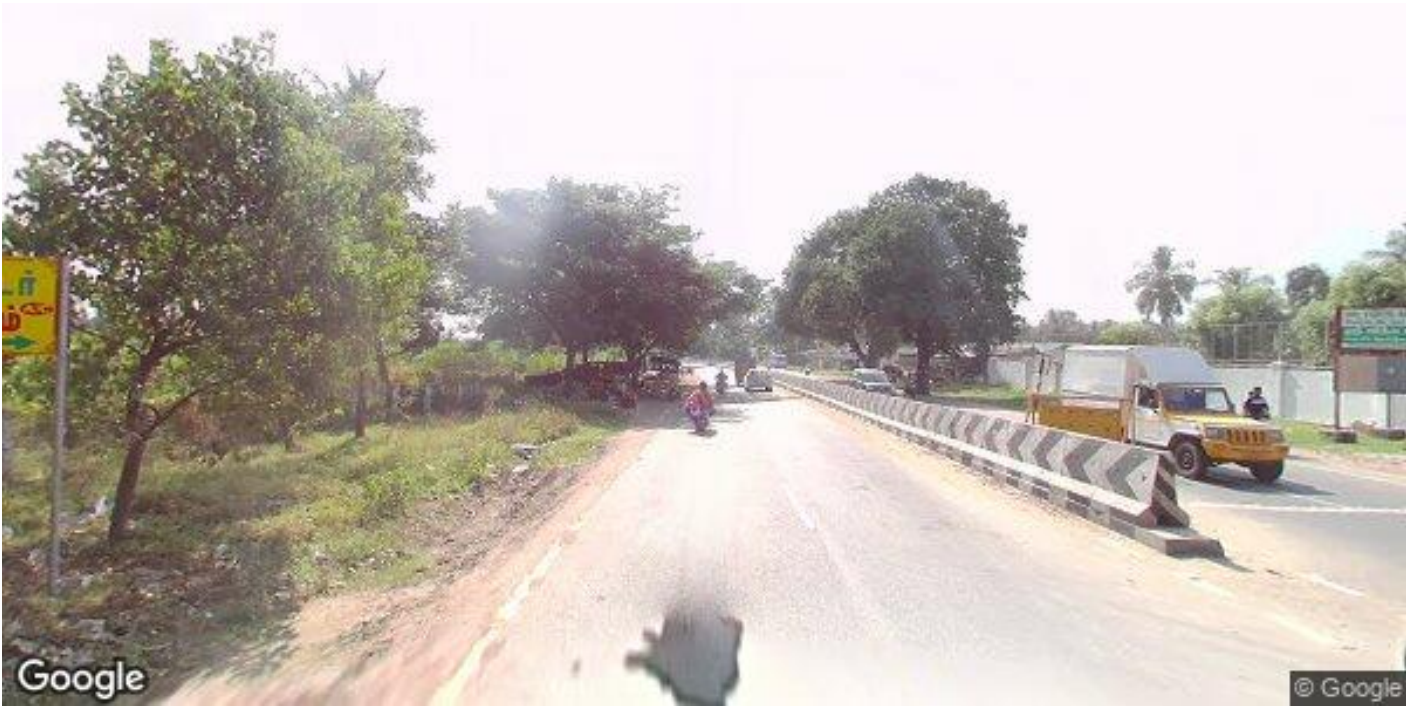
**Risk Type:** Blind Spot  
**Risk Level:** Blind Spot  
**Speed Limit:** 10 KM/Hr  
**Coordinates:** 11.61801, 78.11095

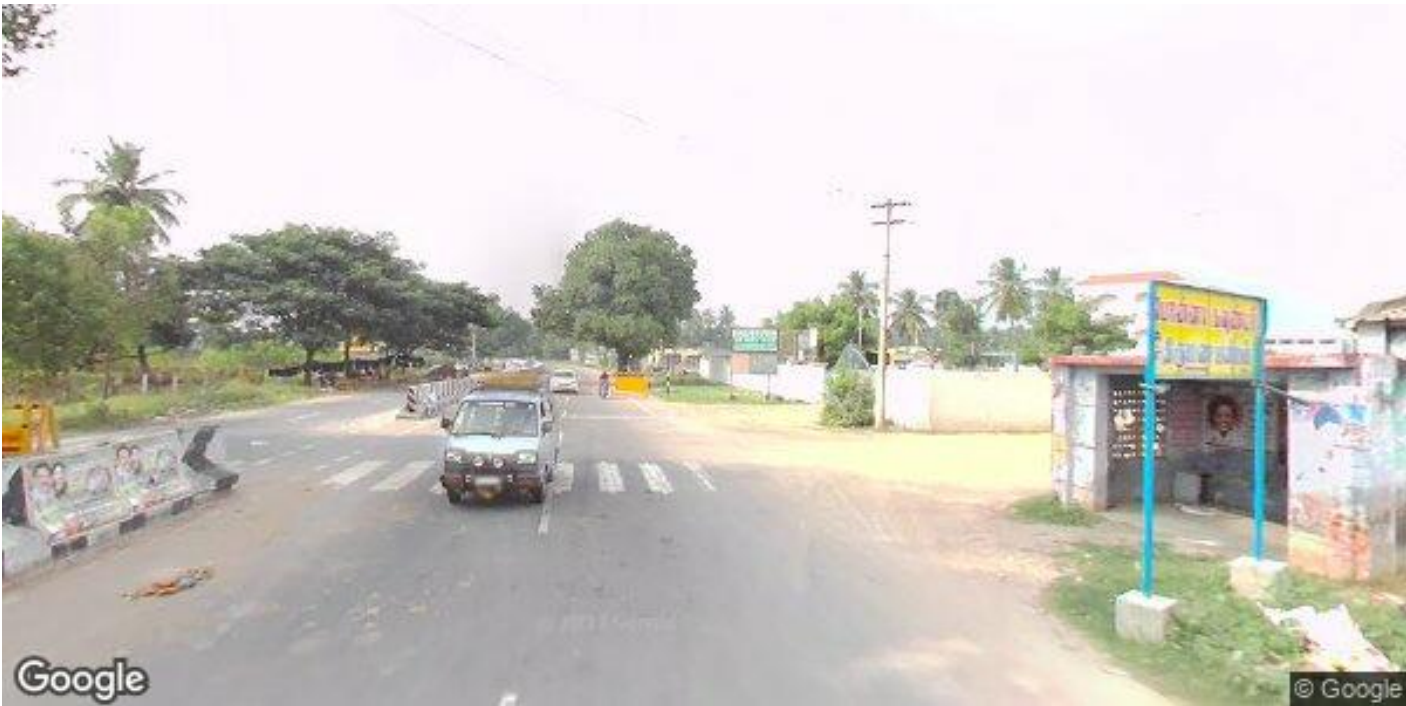
**Risk Type:** Turn  
**Risk Level:** Medium  
**Speed Limit:** 30 KM/Hr  
**Coordinates:** 11.61817, 78.11102

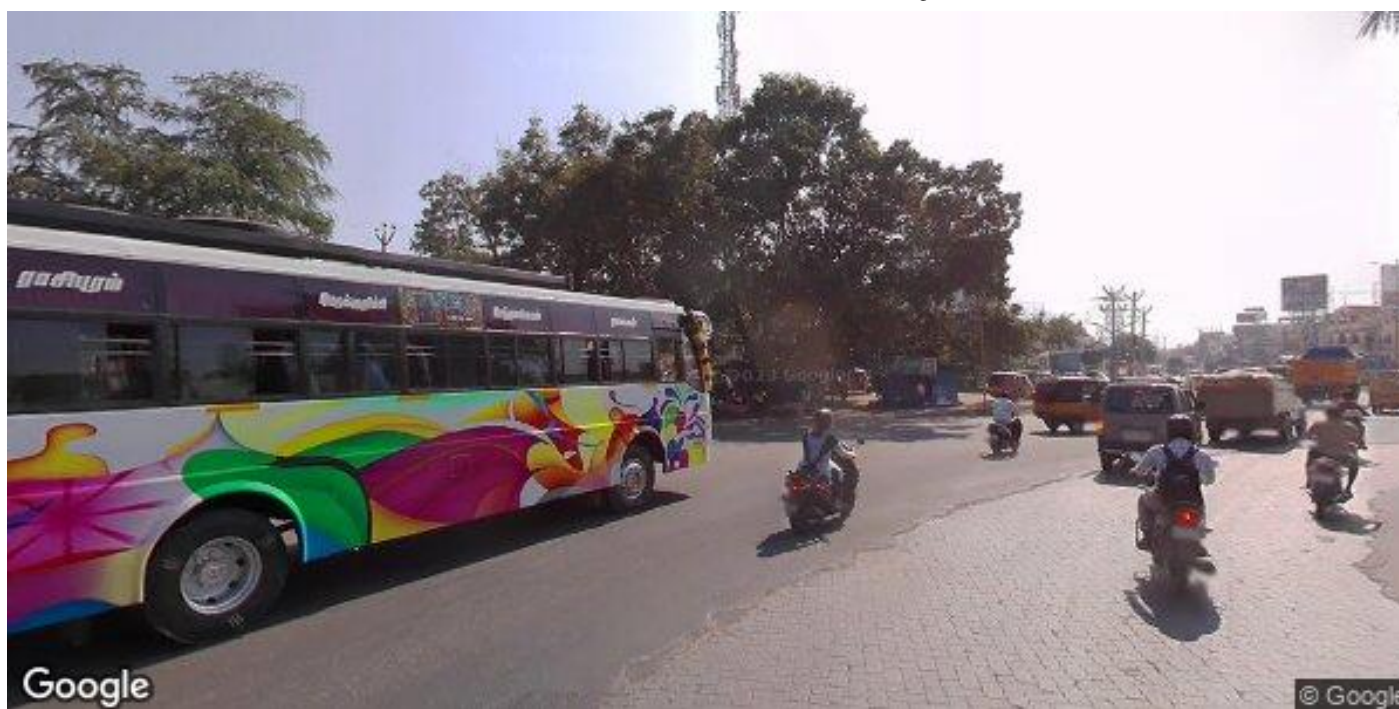
**Risk Type:** Turn  
**Risk Level:** High  
**Speed Limit:** 15 KM/Hr  
**Coordinates:** 11.63300, 78.12746

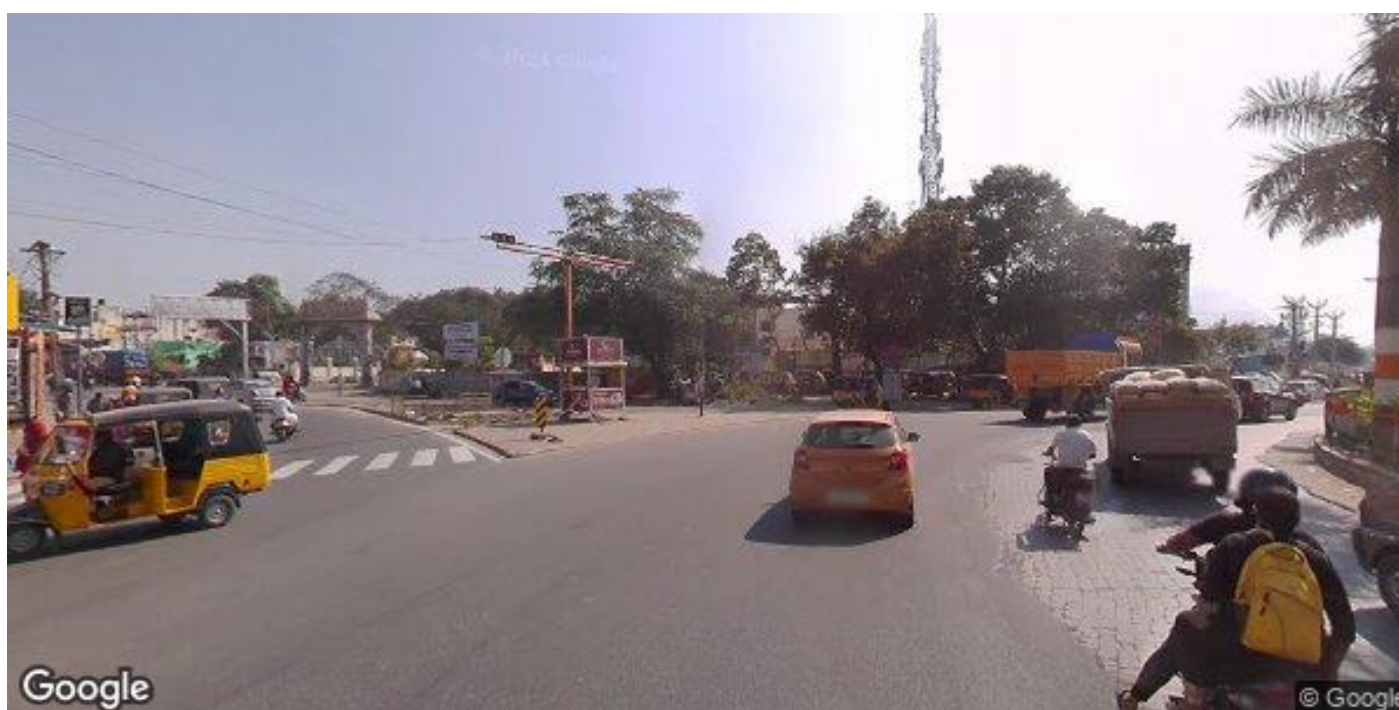
**Risk Type:** Turn  
**Risk Level:** High  
**Speed Limit:** 15 KM/Hr  
**Coordinates:** 11.63306, 78.12731

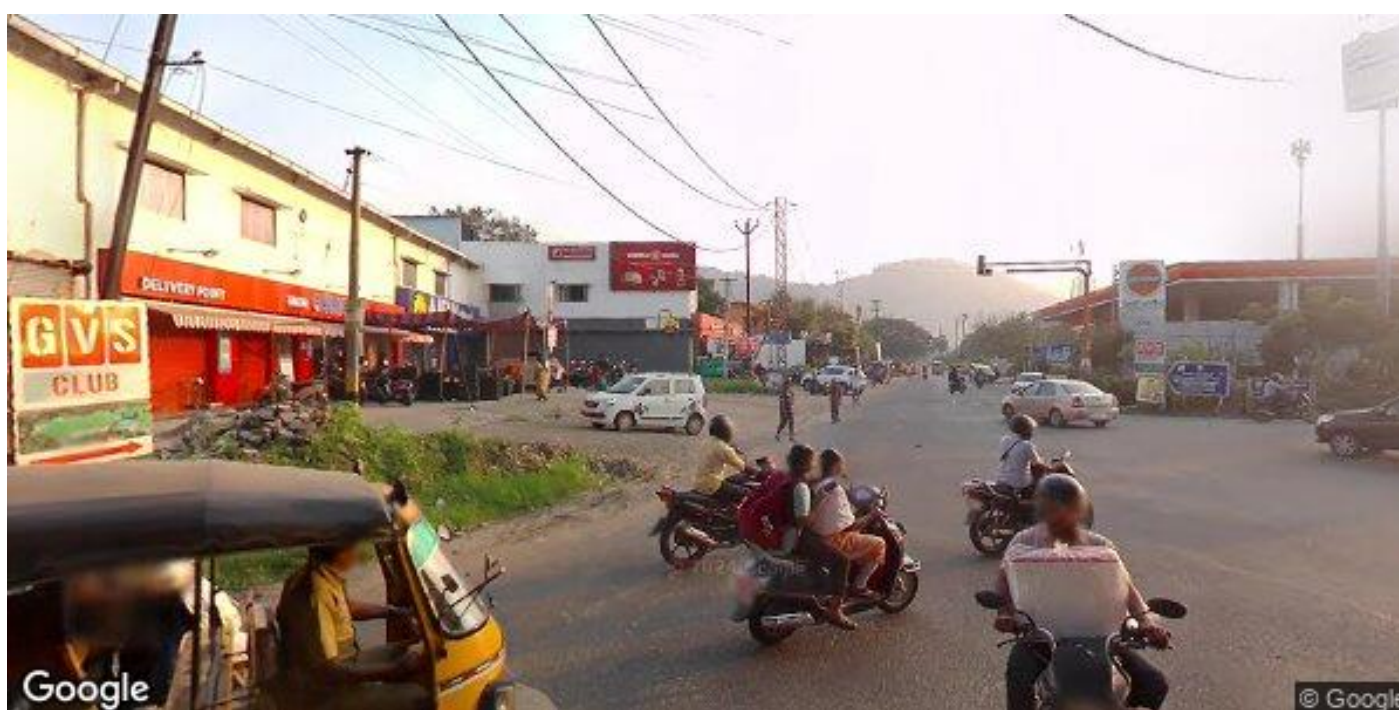
**Risk Type:** Turn  
**Risk Level:** Medium  
**Speed Limit:** 30 KM/Hr  
**Coordinates:** 11.66372, 78.20649
