# IndianOil

## JOURNEY RISK MANAGEMENT (JRM) STUDY

### Salem Terminal to SREE VENKATESHWARA FUEL STATION

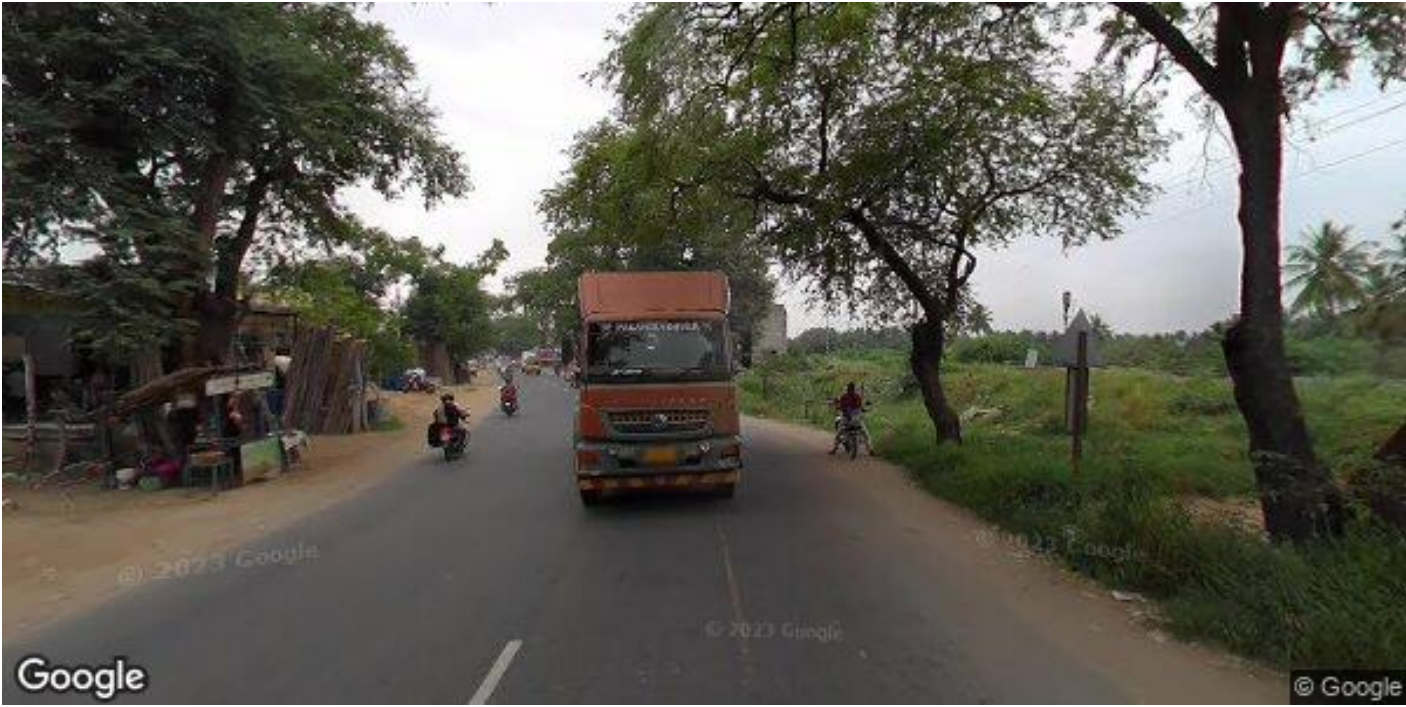
**Risk Type:** Turn  
**Risk Level:** Medium  
**Speed Limit:** 30 KM/Hr  
**Coordinates:** 11.67130, 78.22990

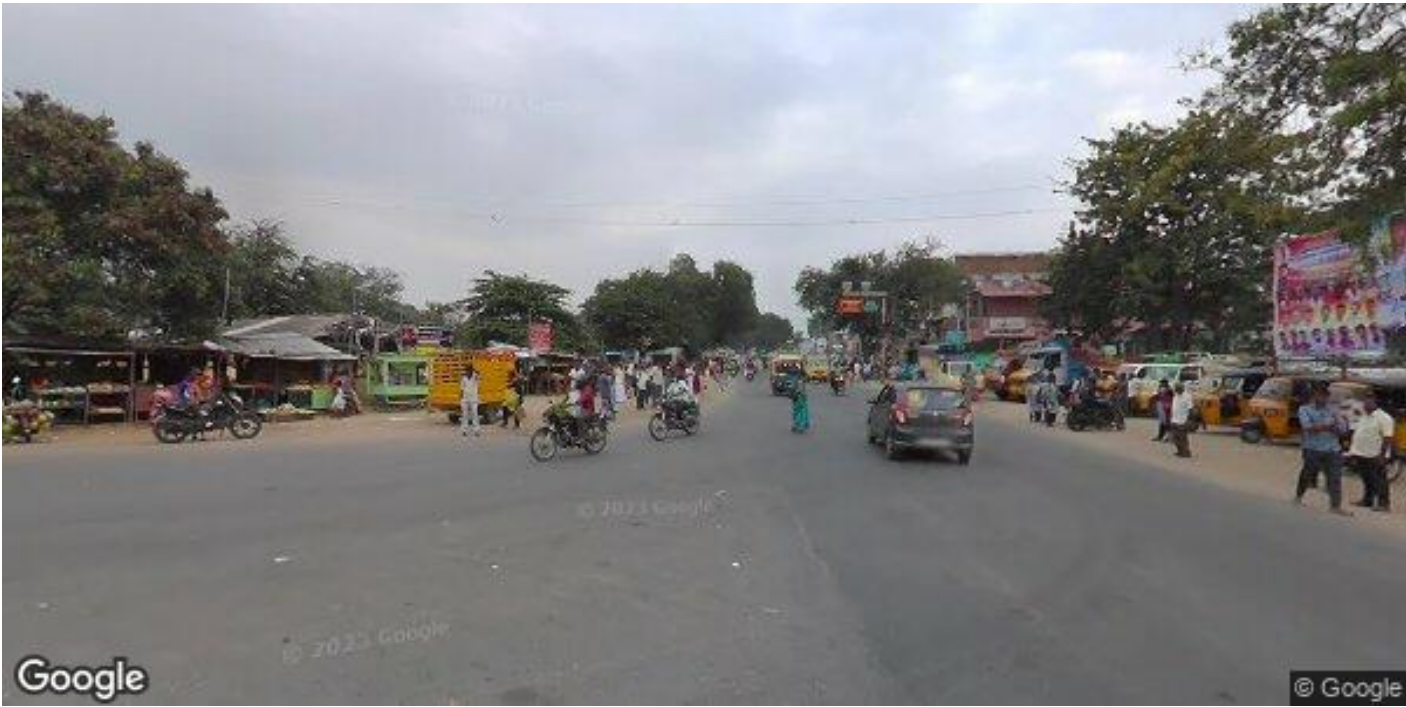
**Risk Type:** Blind Spot  
**Risk Level:** Blind Spot  
**Speed Limit:** 10 KM/Hr  
**Coordinates:** 11.67111, 78.23134

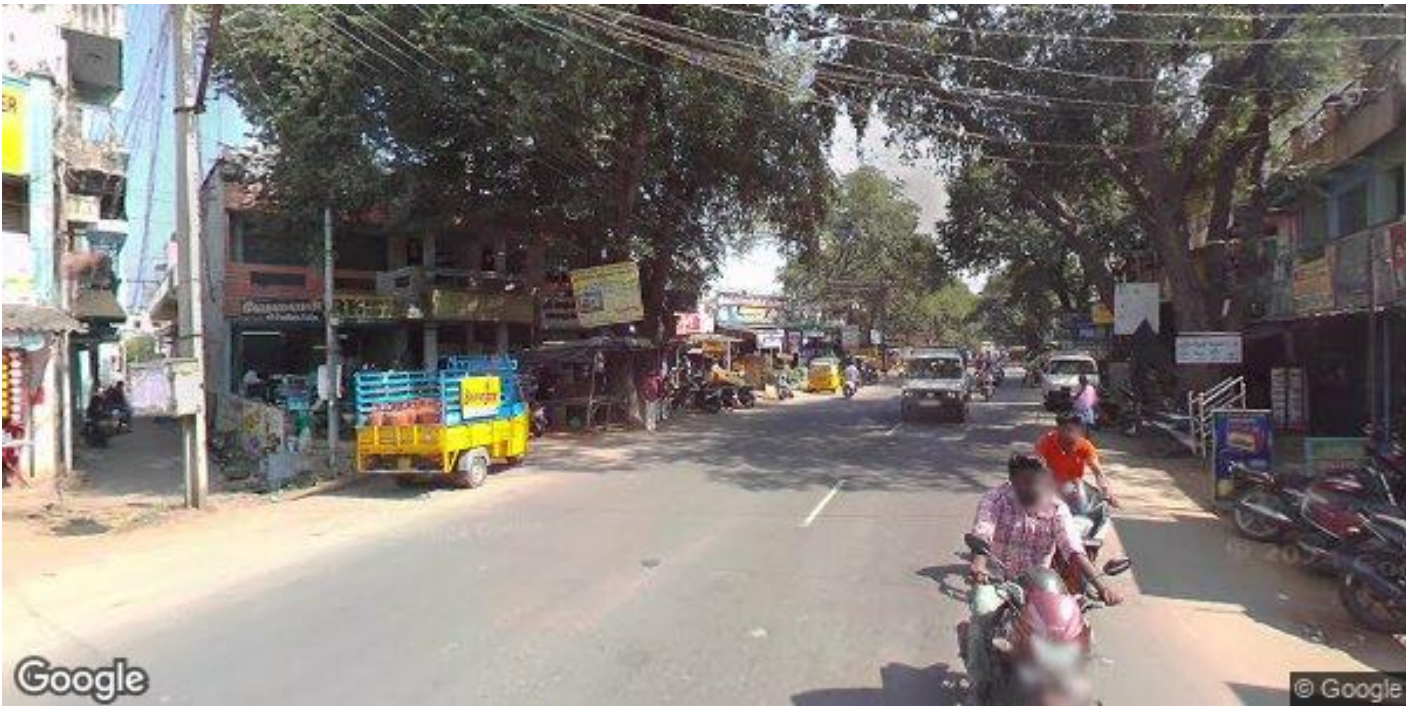
**Risk Type:** Turn  
**Risk Level:** High  
**Speed Limit:** 15 KM/Hr  
**Coordinates:** 11.67203, 78.23152

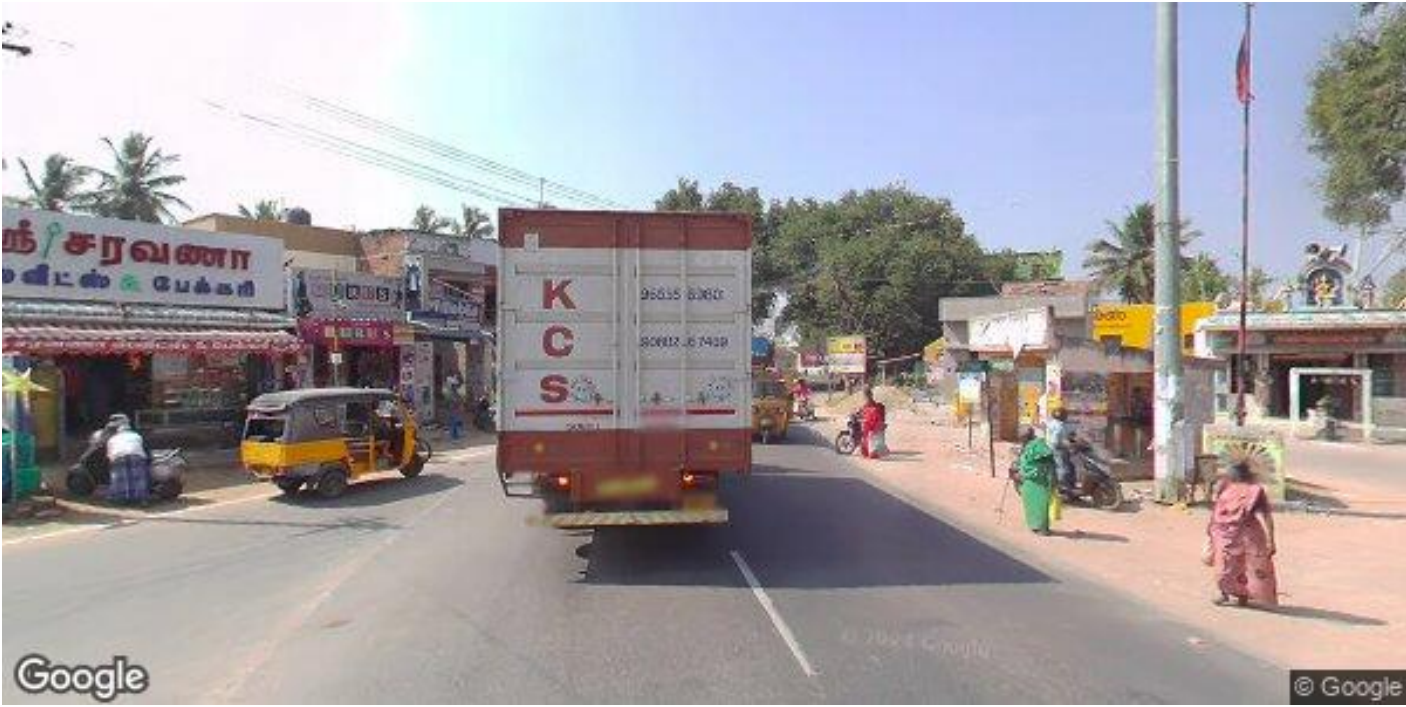
**Risk Type:** Turn  
**Risk Level:** Medium  
**Speed Limit:** 30 KM/Hr  
**Coordinates:** 11.67445, 78.23920

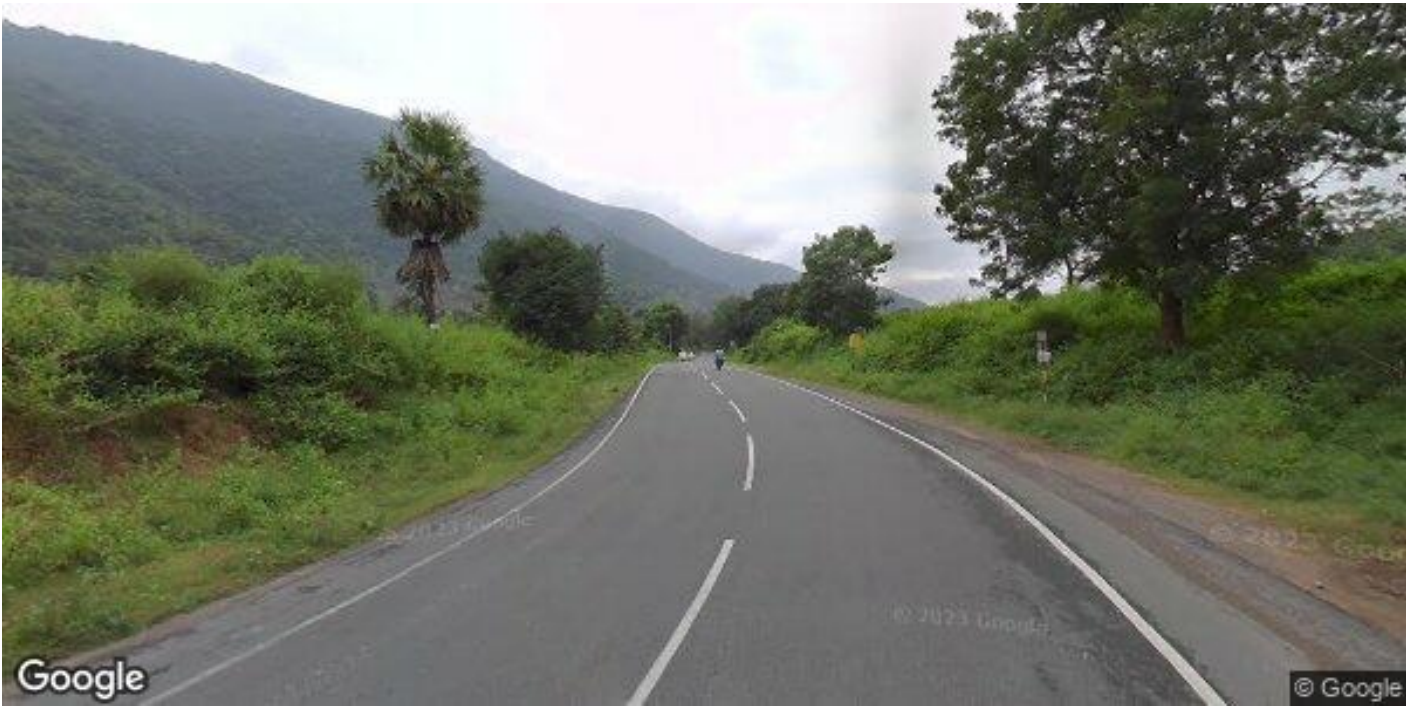
**Risk Type:** Turn  
**Risk Level:** Medium  
**Speed Limit:** 30 KM/Hr  
**Coordinates:** 11.80448, 78.33329

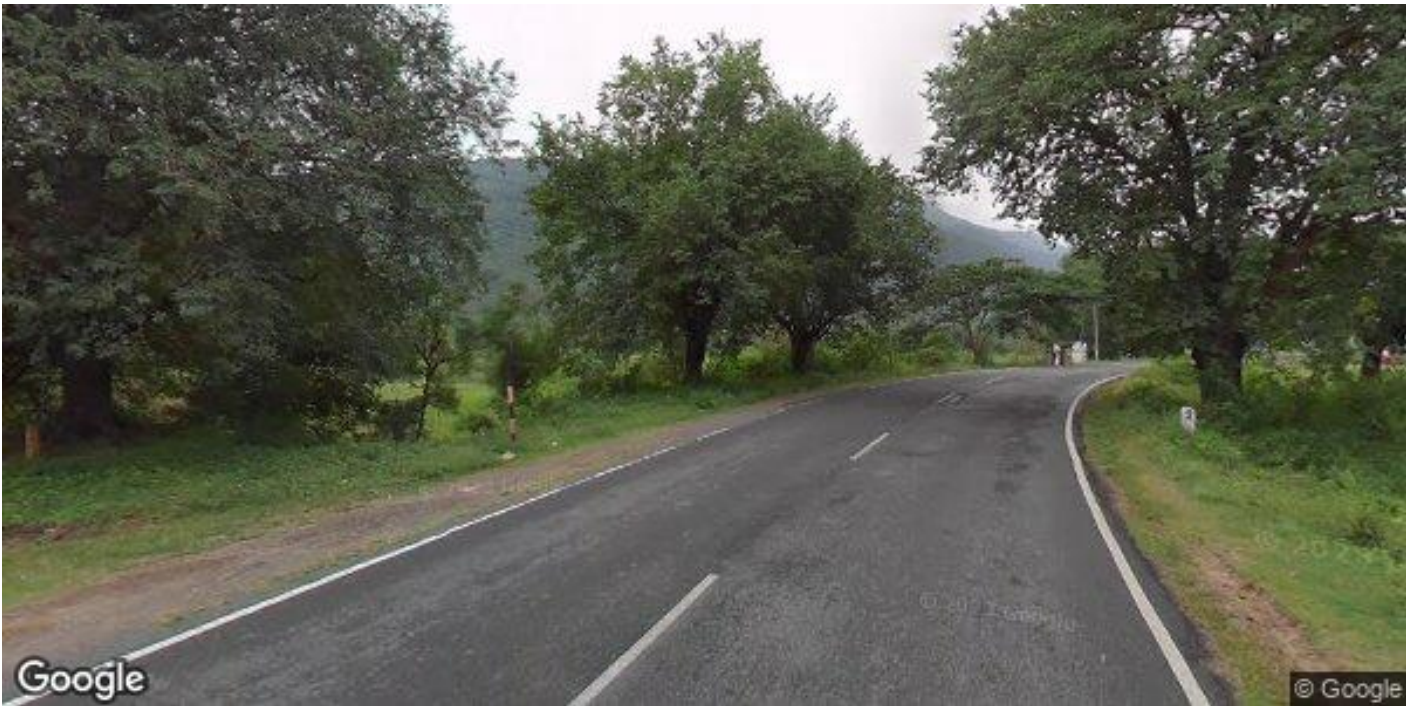
**Risk Type:** Turn  
**Risk Level:** Medium  
**Speed Limit:** 30 KM/Hr  
**Coordinates:** 11.81243, 78.34087

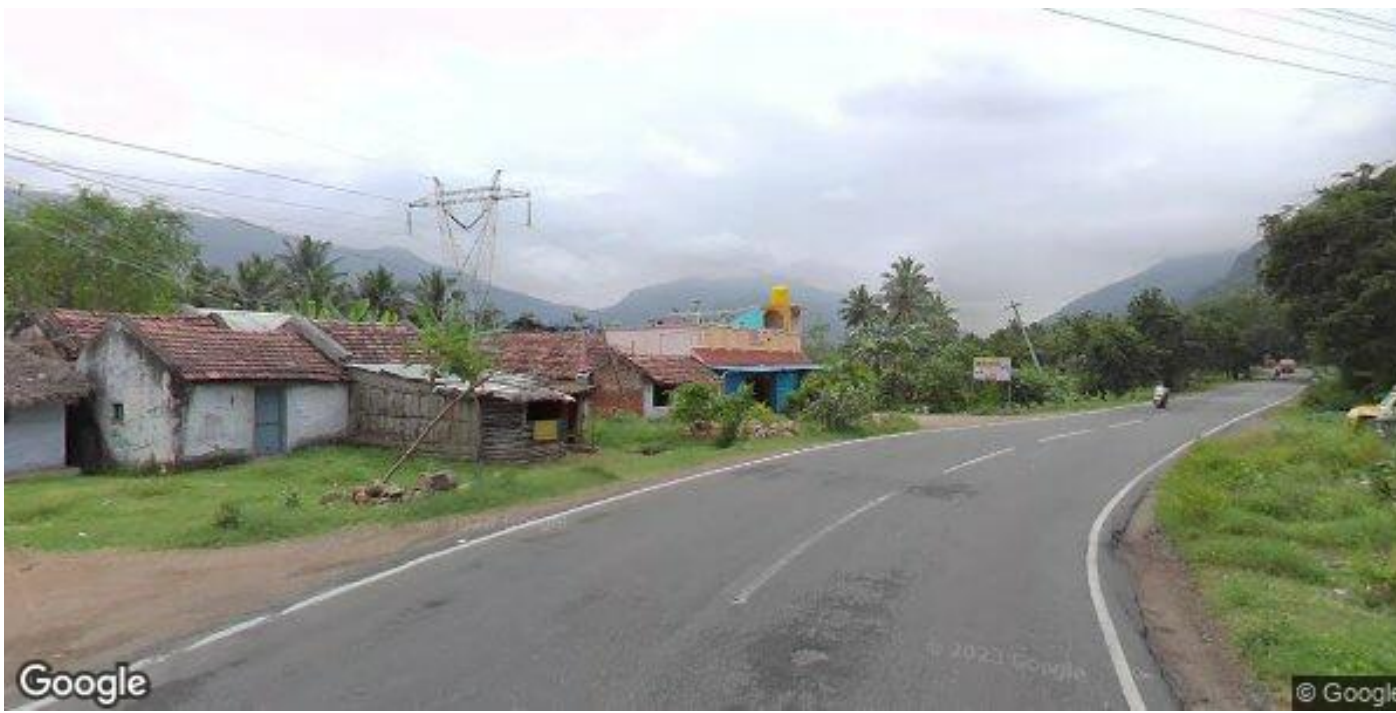
**Risk Type:** Turn  
**Risk Level:** Medium  
**Speed Limit:** 30 KM/Hr  
**Coordinates:** 11.83483, 78.35295

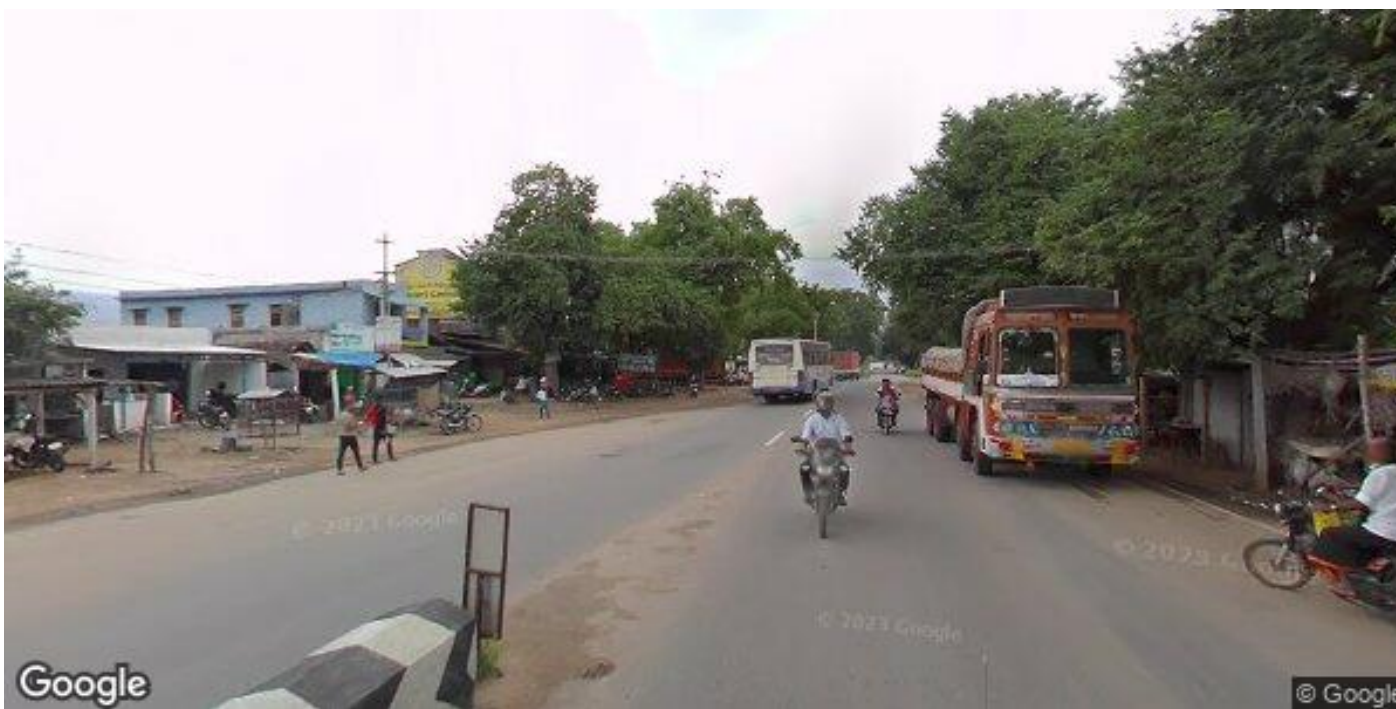
**Risk Type:** Turn  
**Risk Level:** Medium  
**Speed Limit:** 30 KM/Hr  
**Coordinates:** 11.88901, 78.37646

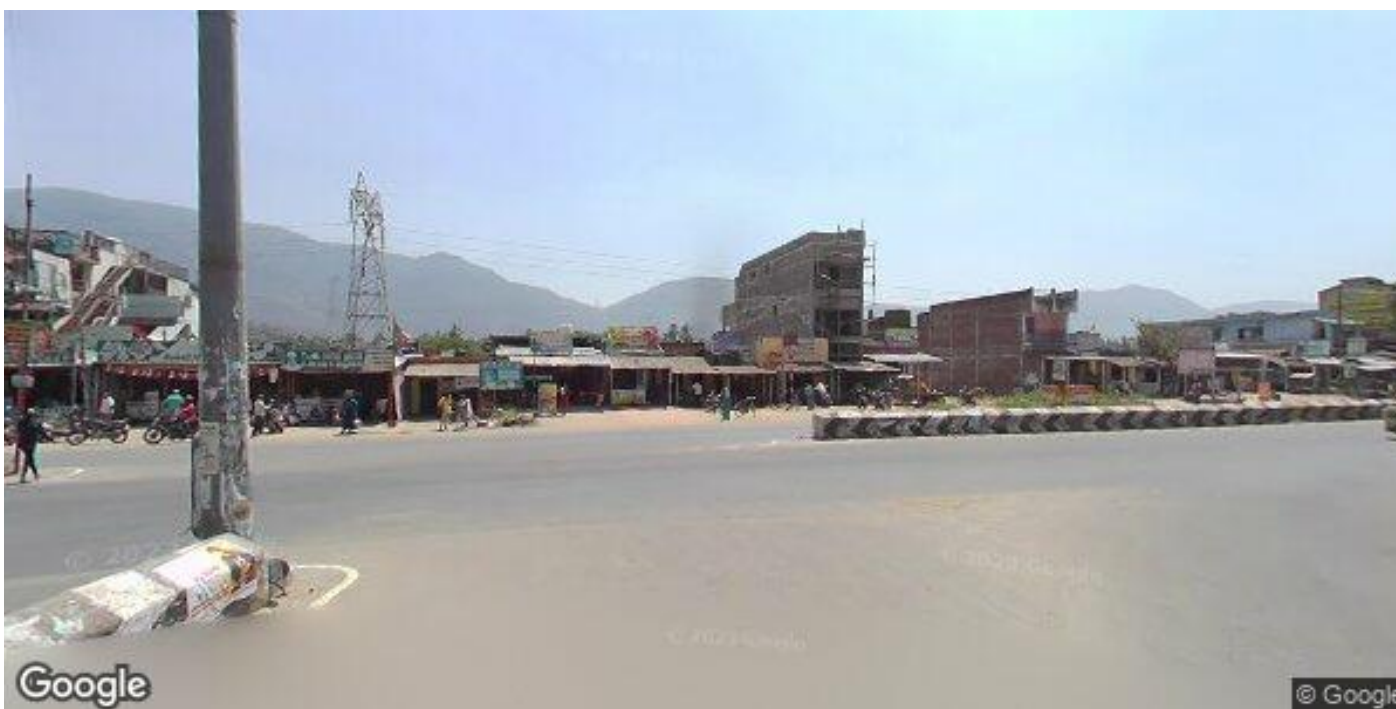
**Risk Type:** Turn  
**Risk Level:** Medium  
**Speed Limit:** 30 KM/Hr  
**Coordinates:** 11.88930, 78.37653
