# IndianOil

## JOURNEY RISK MANAGEMENT (JRM) STUDY

### Salem Terminal TO SRI AYYAPPA AGENCIES

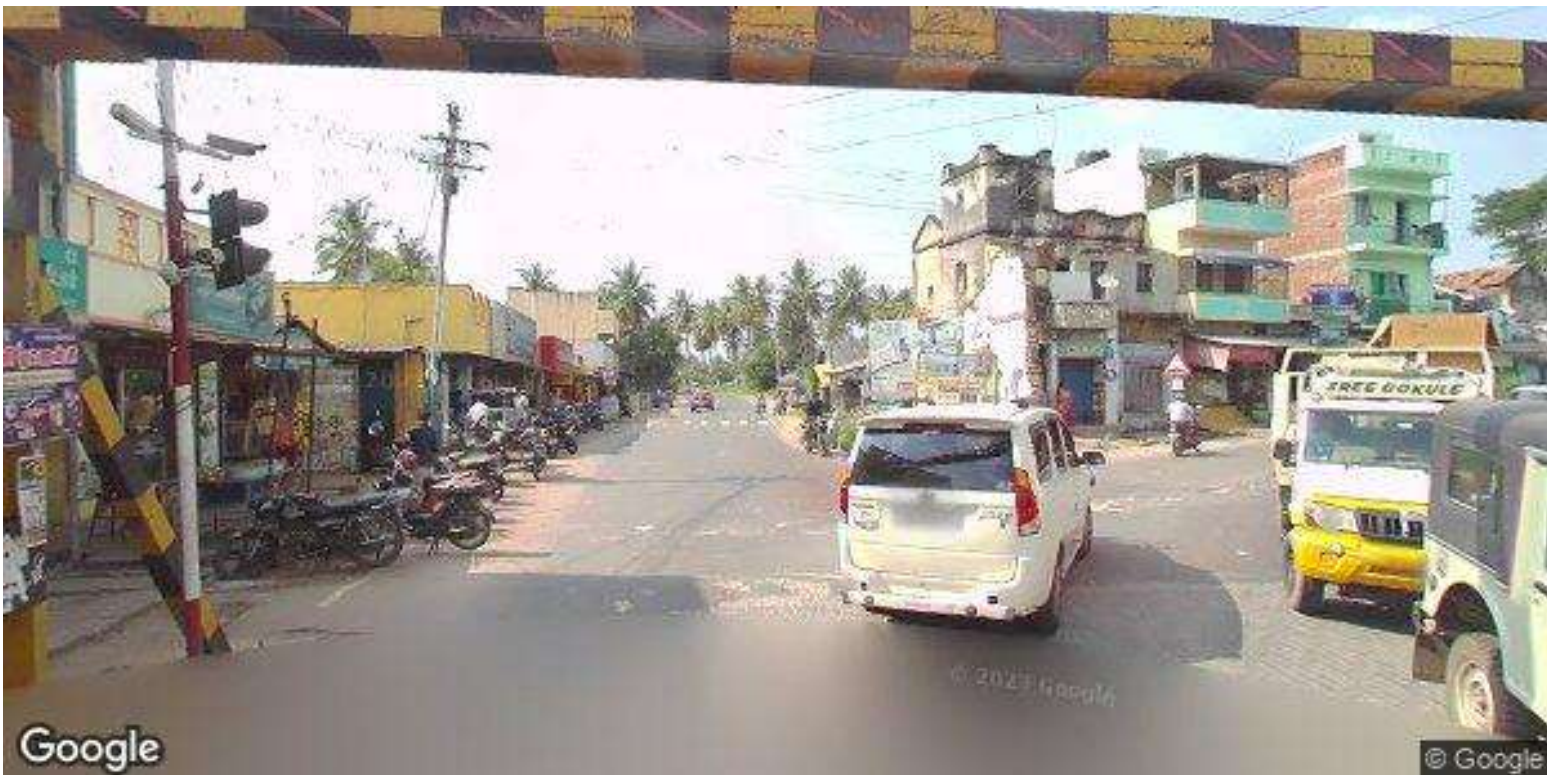
Coordinates: 11.45004, 77.87206

Risk Type: Turn

Risk Level: High

Speed Limit: 15 KM/Hr

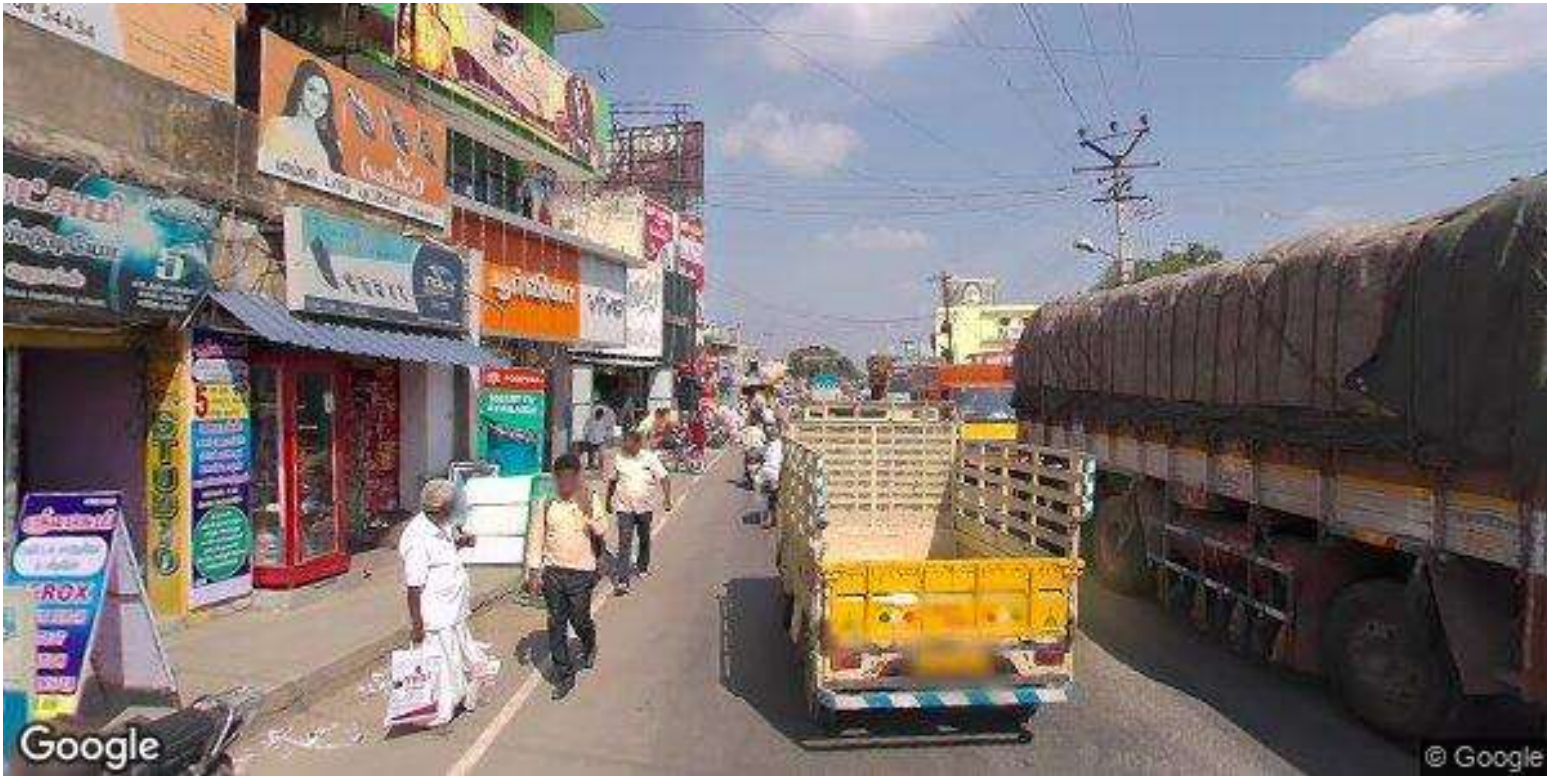
**Risk Type:** Turn  
**Risk Level:** Medium  
**Speed Limit:** 30 KM/Hr  
**Coordinates:** 11.47410, 77.86845

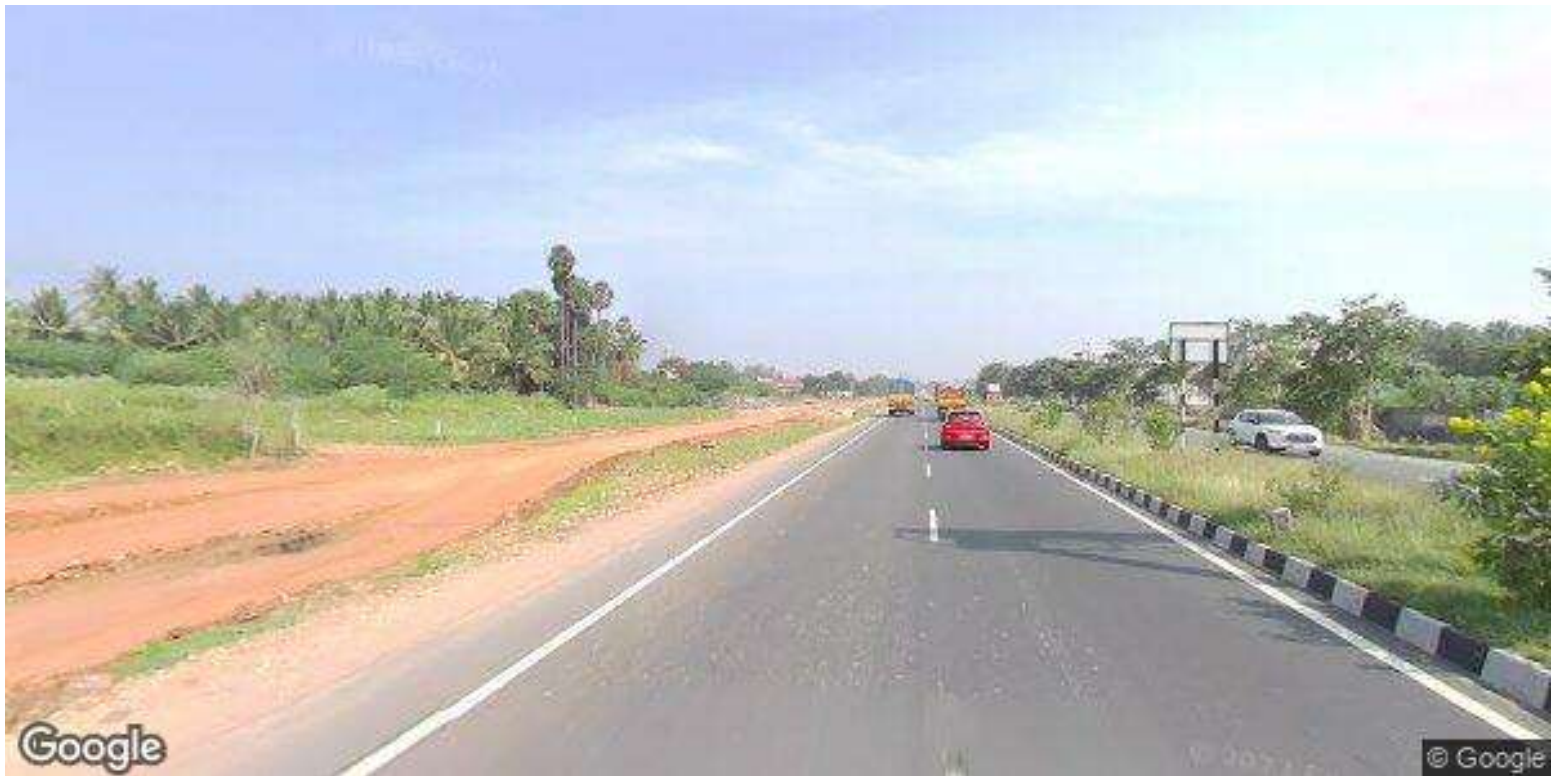
**Risk Type:** Turn  
**Risk Level:** Medium  
**Speed Limit:** 30 KM/Hr  
**Coordinates:** 11.61753, 78.10608

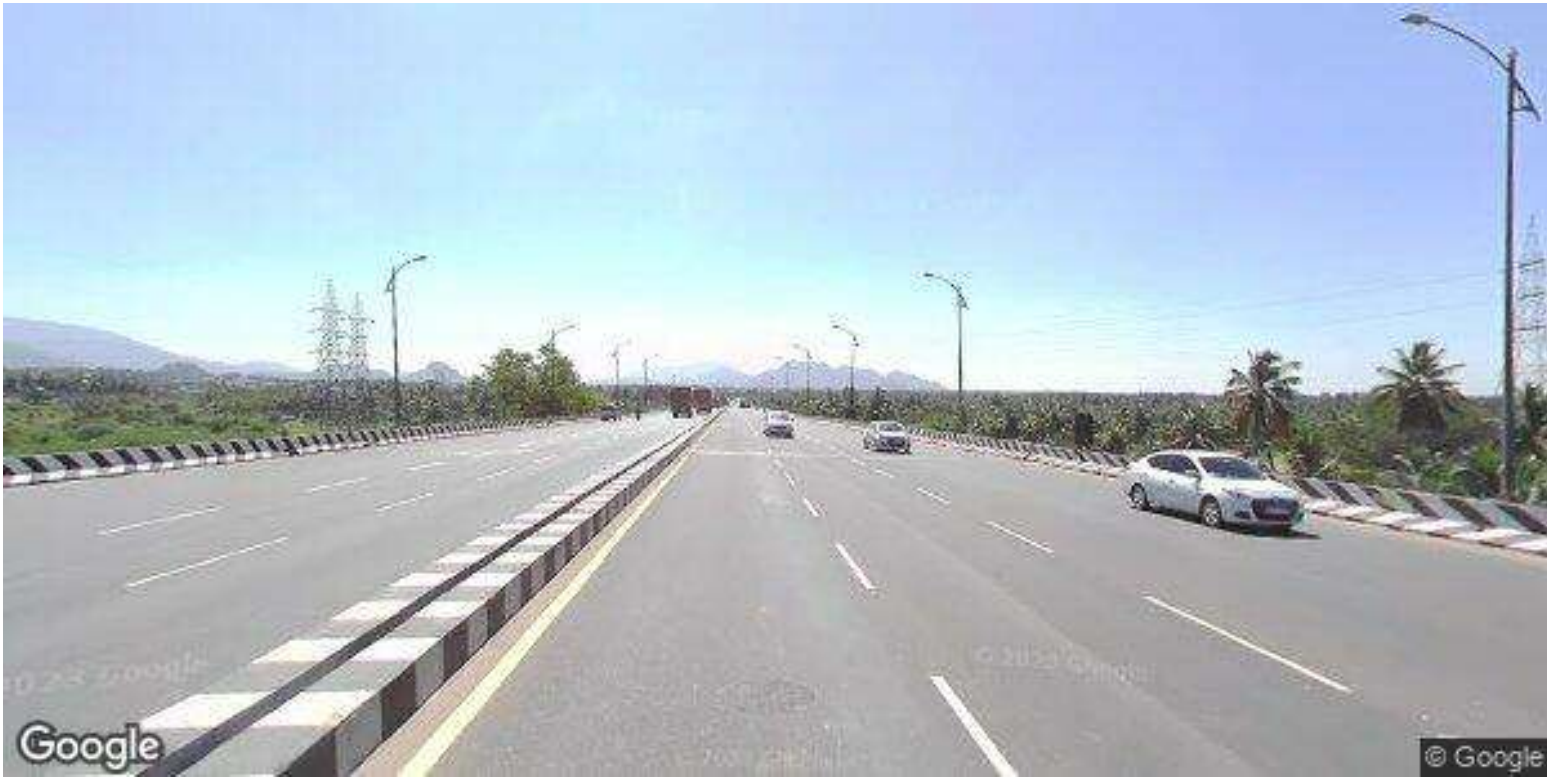
**Risk Type:** Turn  
**Risk Level:** Medium  
**Speed Limit:** 30 KM/Hr  
**Coordinates:** 11.64007, 78.11794

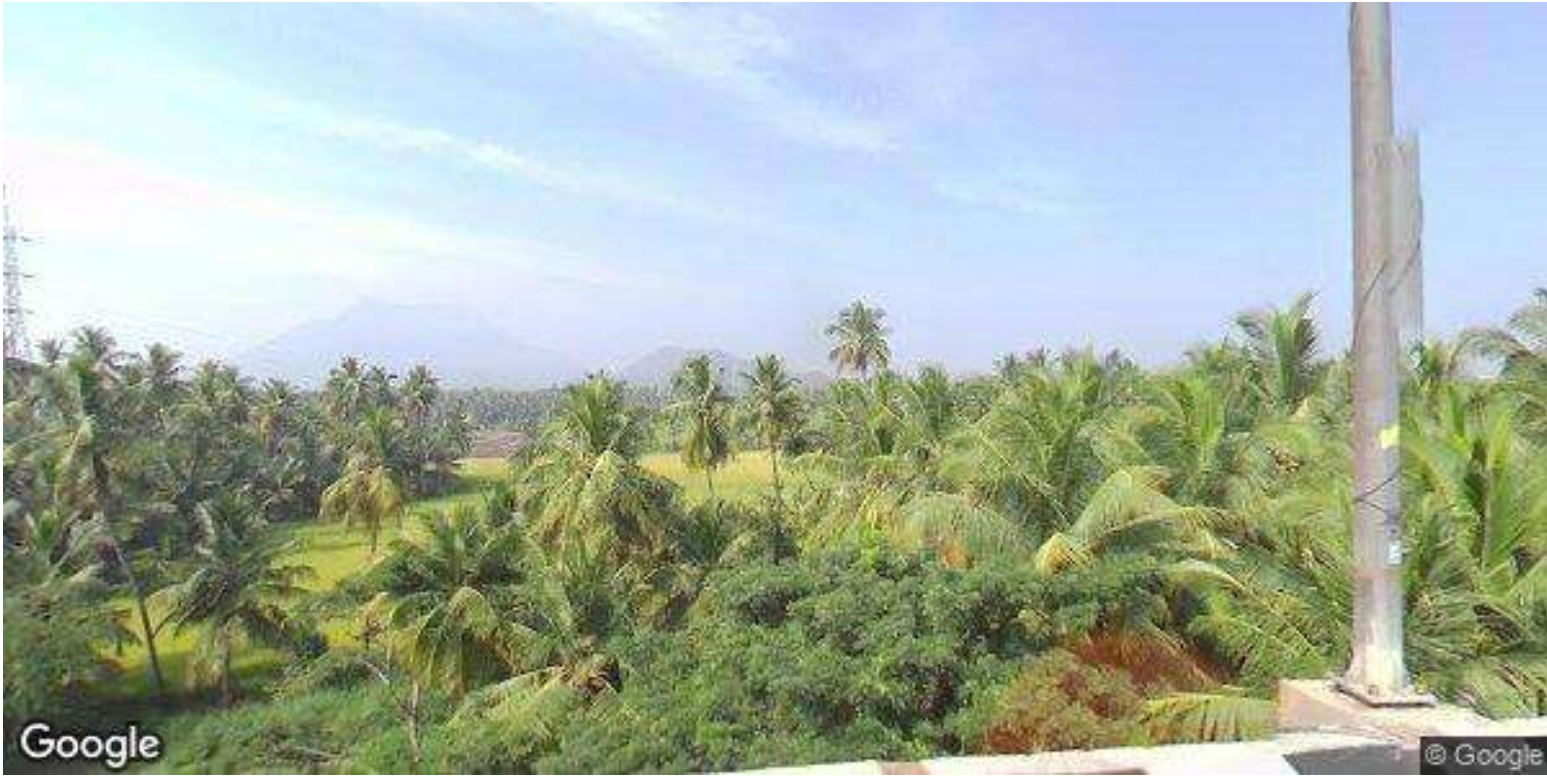
**Risk Type:** Turn  
**Risk Level:** Medium  
**Speed Limit:** 30 KM/Hr  
**Coordinates:** 11.64020, 78.11786

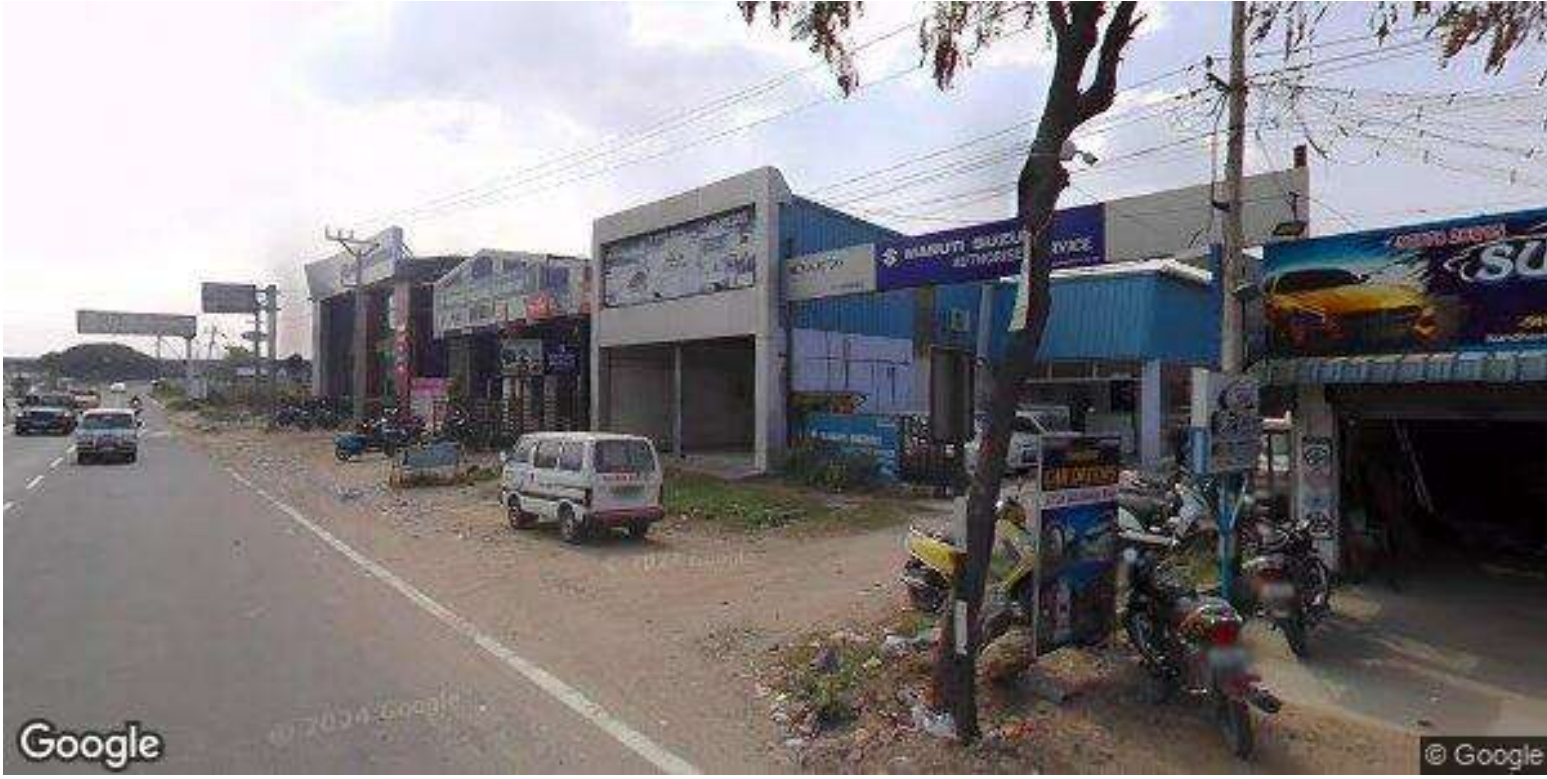
**Risk Type:** Turn  
**Risk Level:** Medium  
**Speed Limit:** 30 KM/Hr  
**Coordinates:** 11.64497, 78.12028

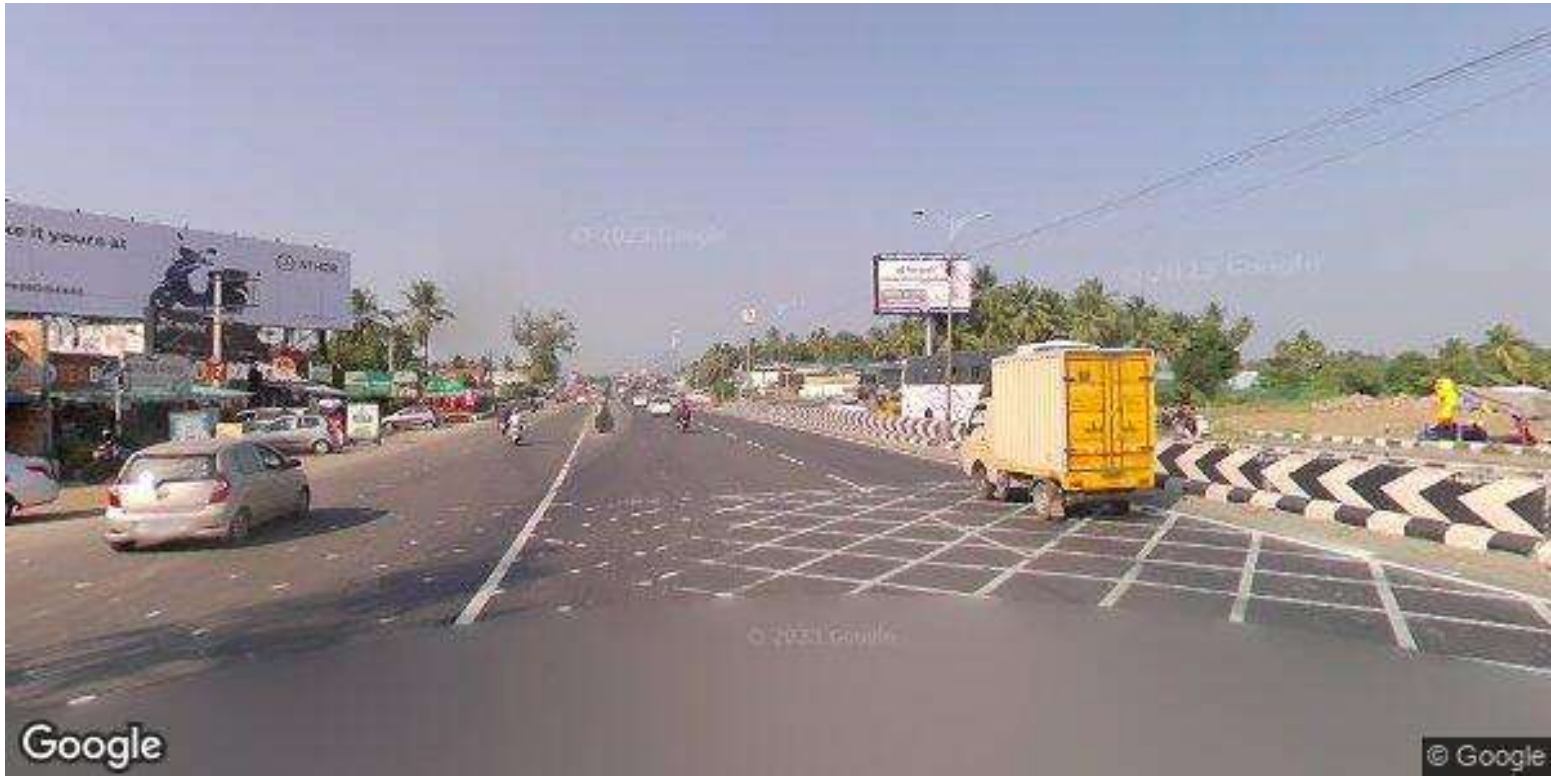
**Risk Type:** Turn  
**Risk Level:** Medium  
**Speed Limit:** 30 KM/Hr  
**Coordinates:** 11.64503, 78.12034

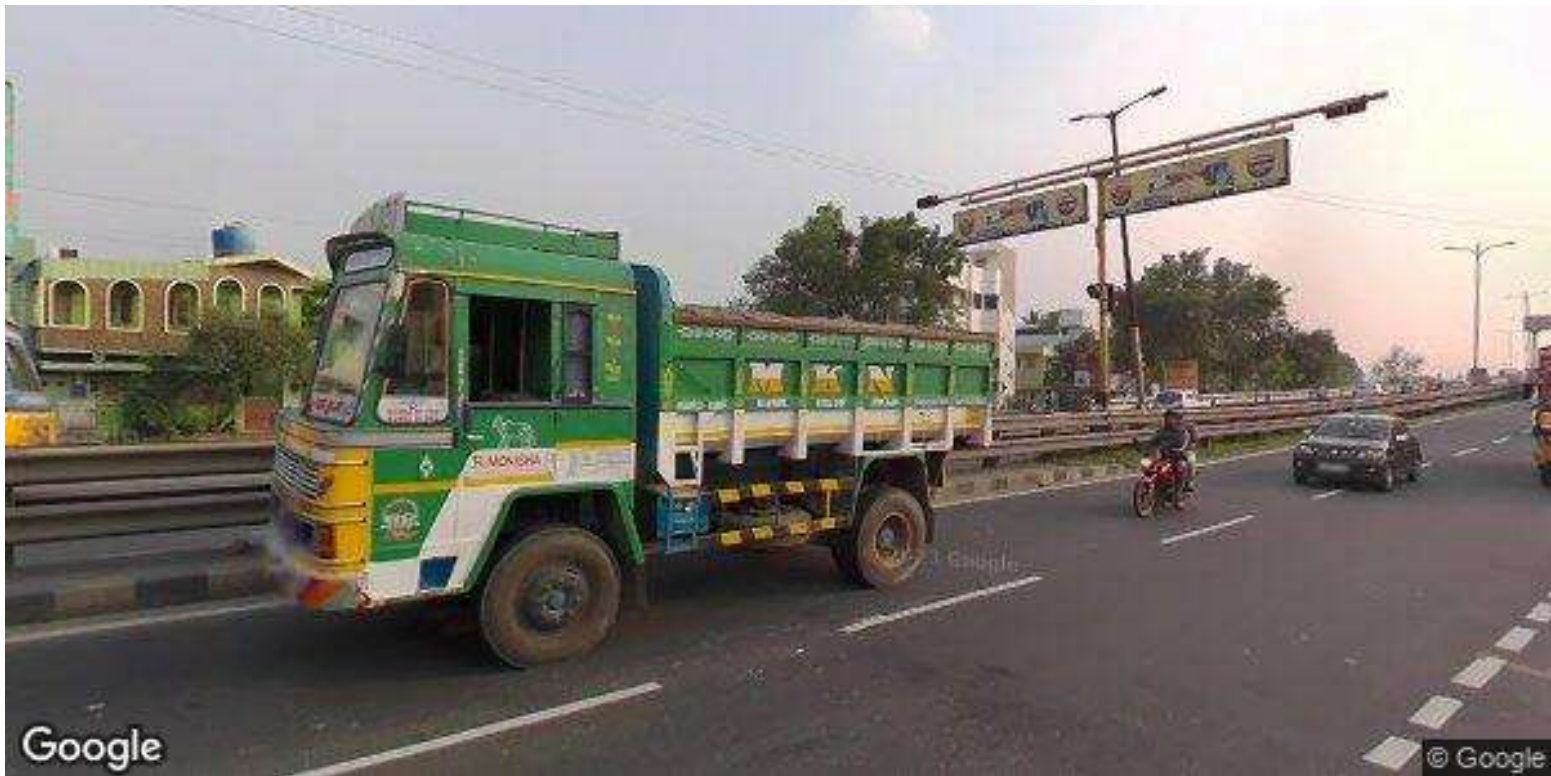
**Risk Type:** Turn  
**Risk Level:** High  
**Speed Limit:** 15 KM/Hr  
**Coordinates:** 11.66458, 78.12303

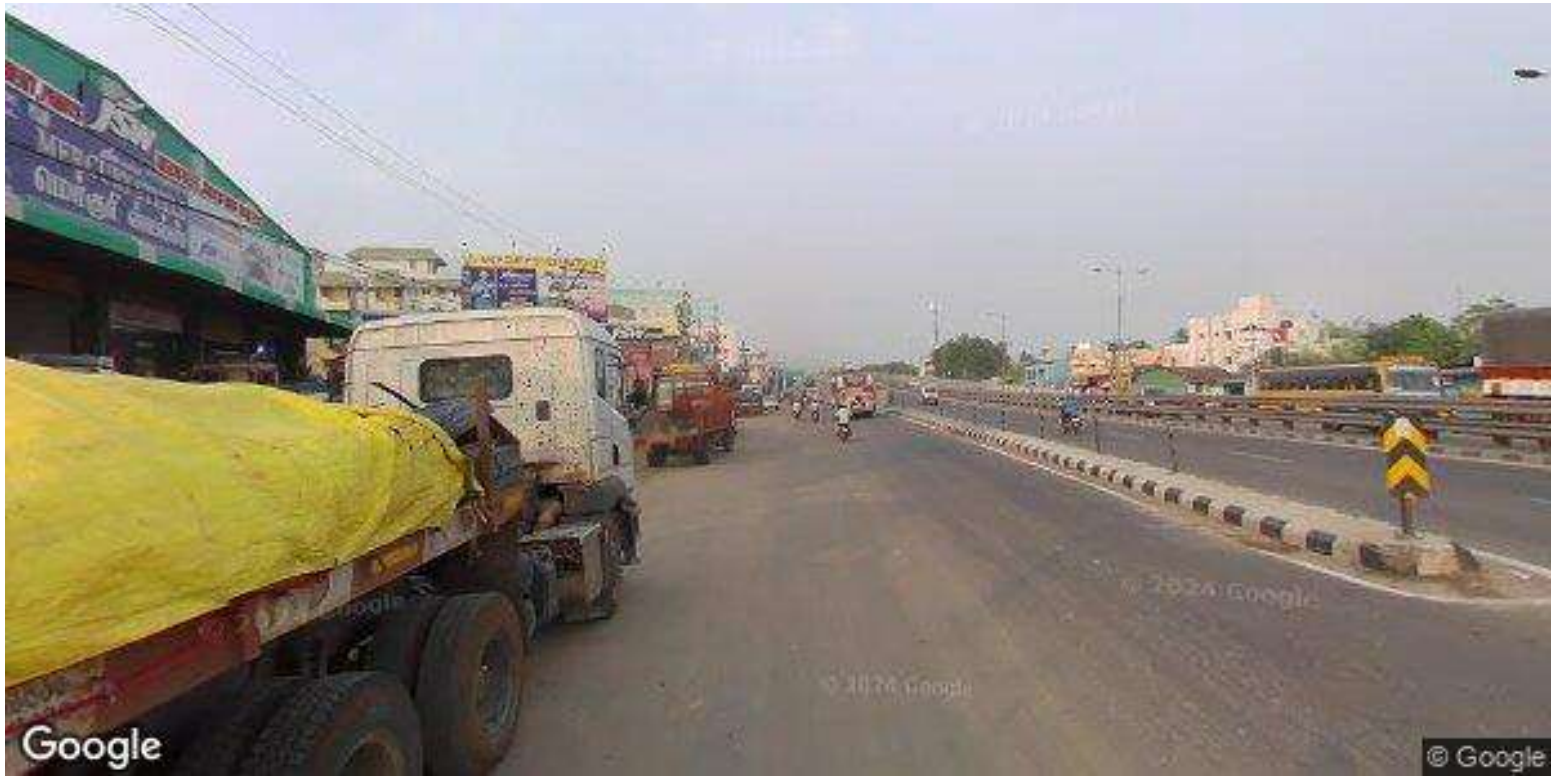
Risk Type: Turn  
Risk Level: High  
Speed Limit: 15 KM/Hr  
Coordinates: 11.66477, 78.12298

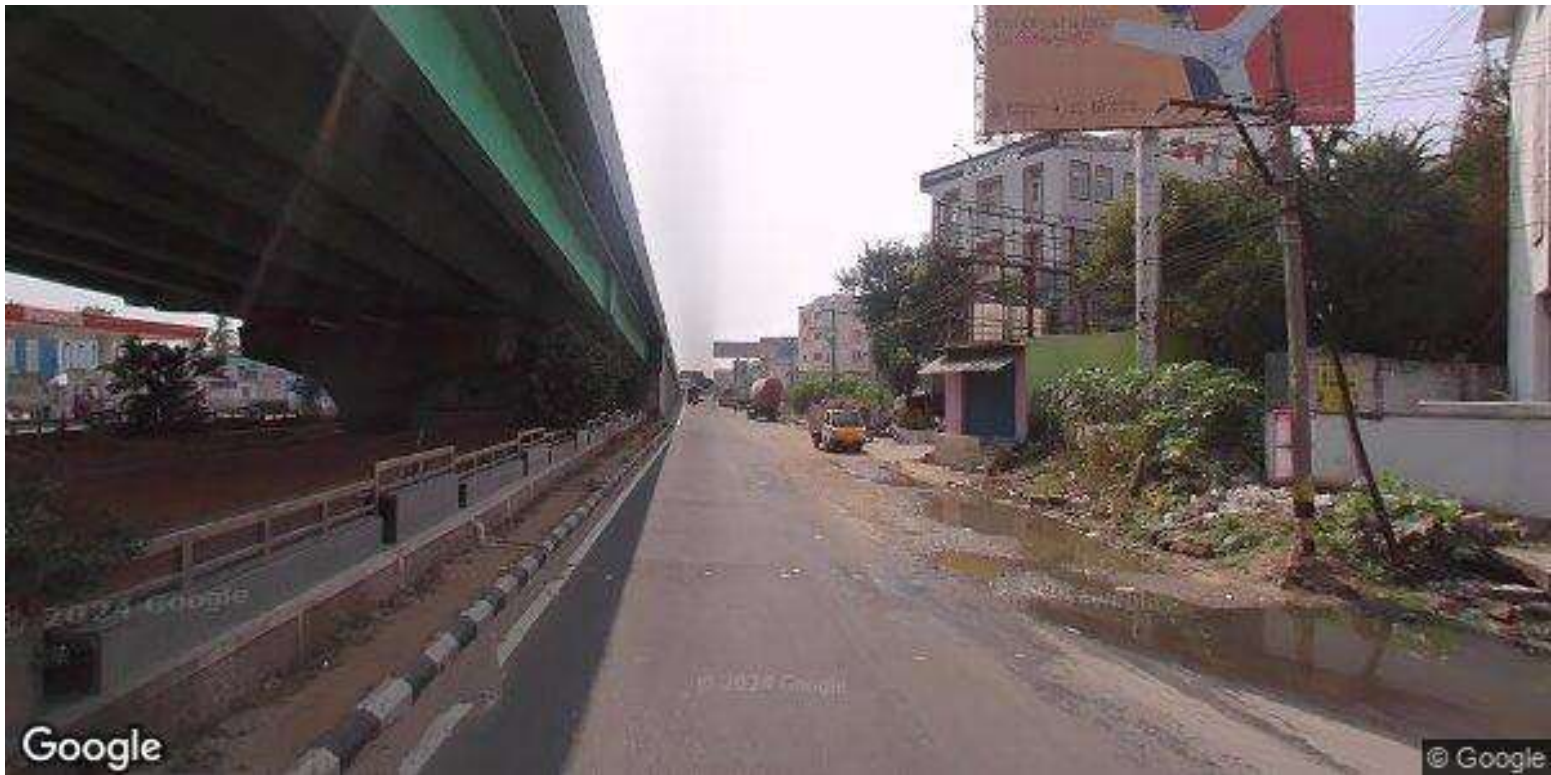
Risk Type: Turn  
Risk Level: High  
Speed Limit: 15 KM/Hr  
Coordinates: 11.66719, 78.12442

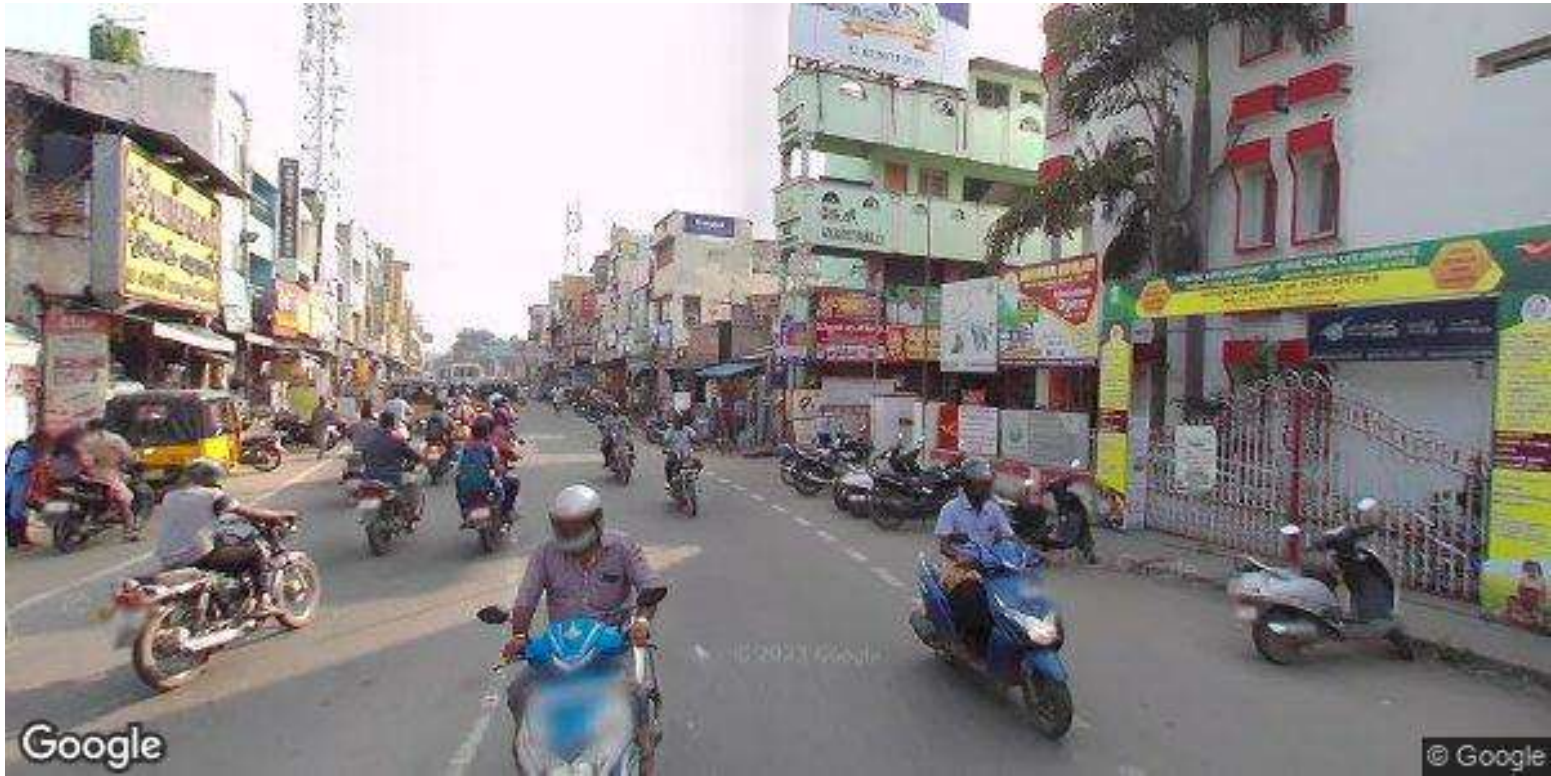
**Risk Type:** Turn  
**Risk Level:** Medium  
**Speed Limit:** 30 KM/Hr  
**Coordinates:** 11.67015, 78.11449

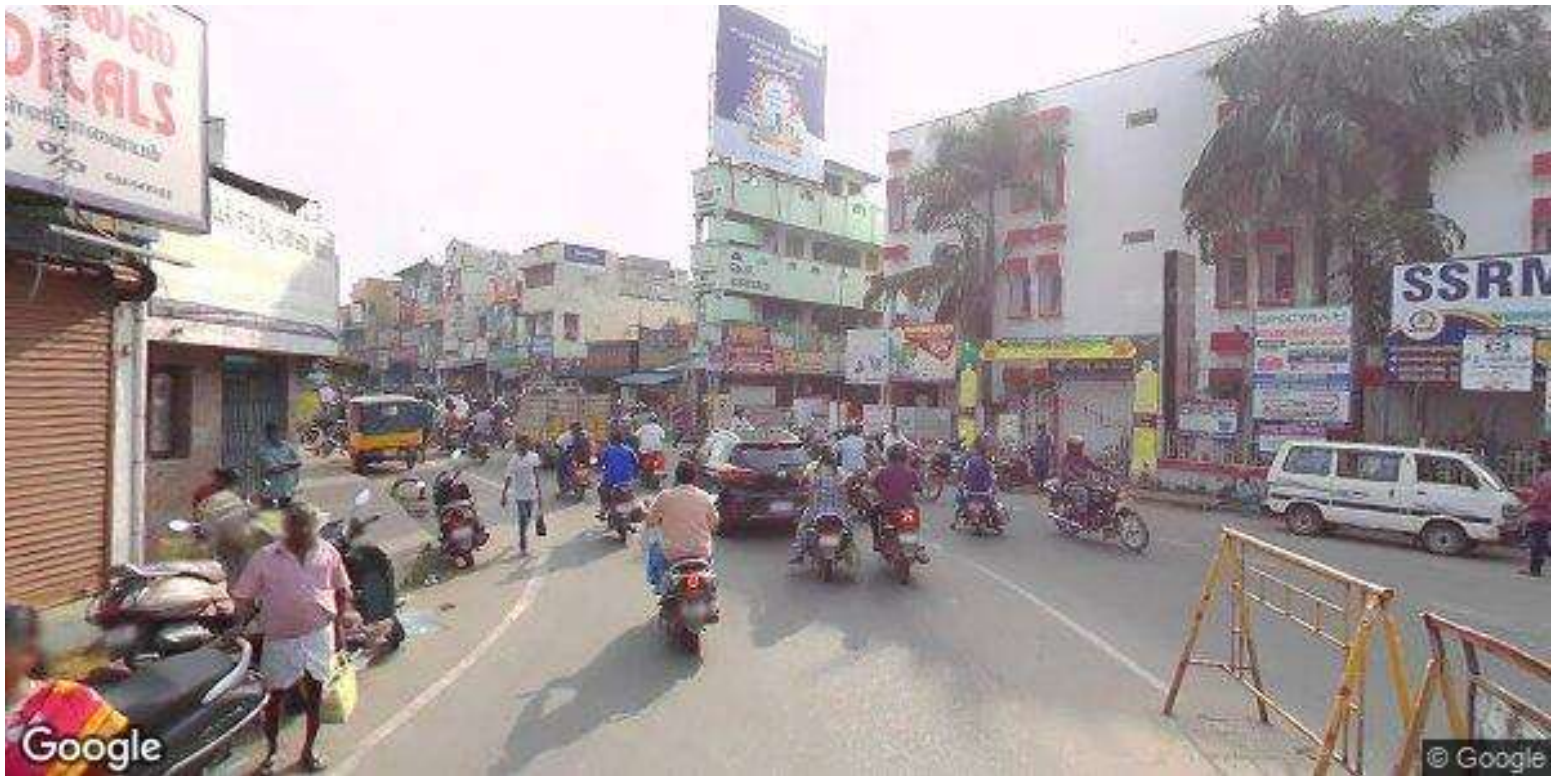
**Risk Type:** Turn  
**Risk Level:** Medium  
**Speed Limit:** 30 KM/Hr  
**Coordinates:** 11.67016, 78.11440

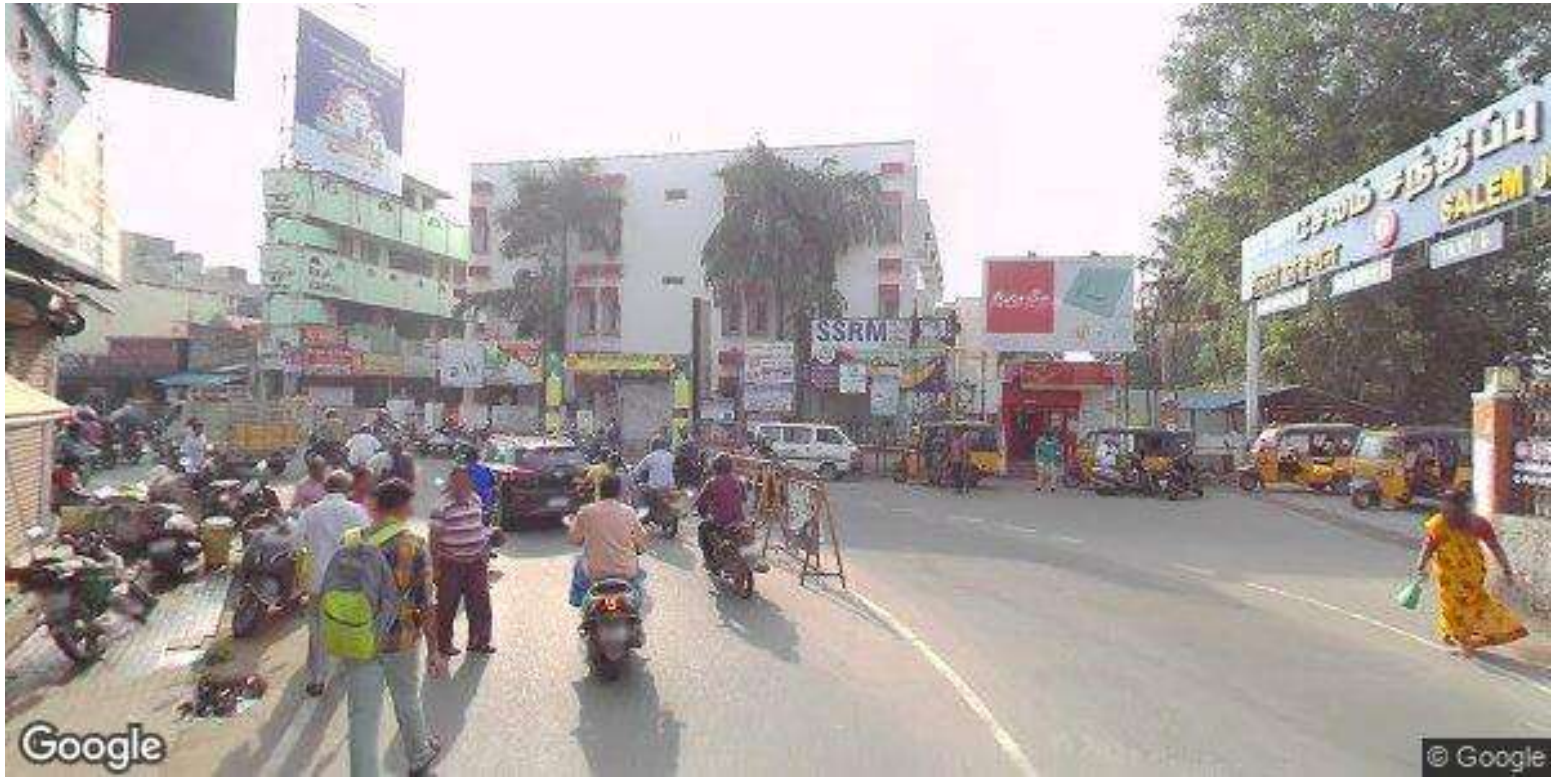
**Risk Type:** Turn  
**Risk Level:** Medium  
**Speed Limit:** 30 KM/Hr  
**Coordinates:** 11.67023, 78.11431

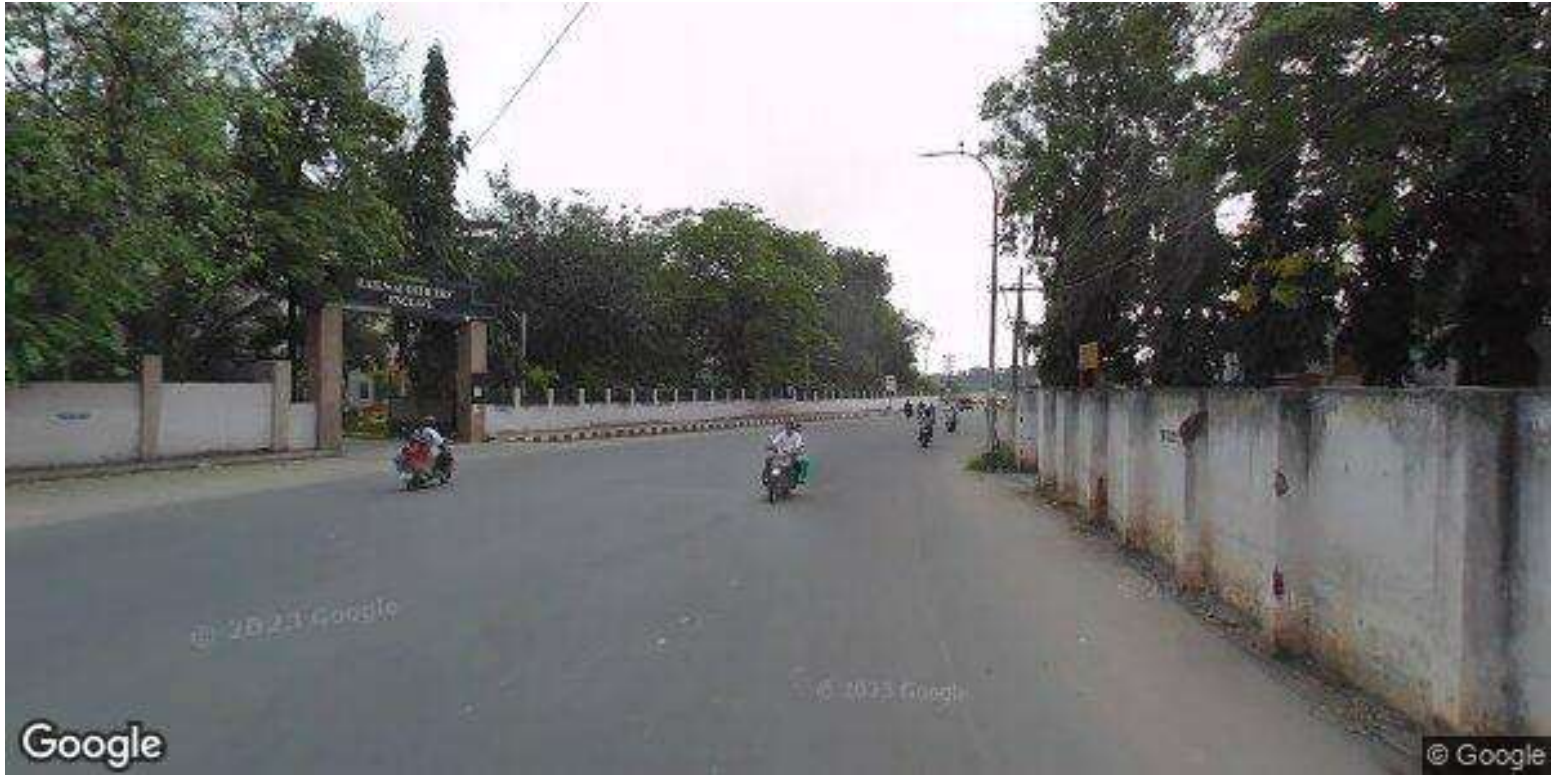
**Risk Type:** Turn  
**Risk Level:** Medium  
**Speed Limit:** 30 KM/Hr  
**Coordinates:** 11.67664, 78.11117

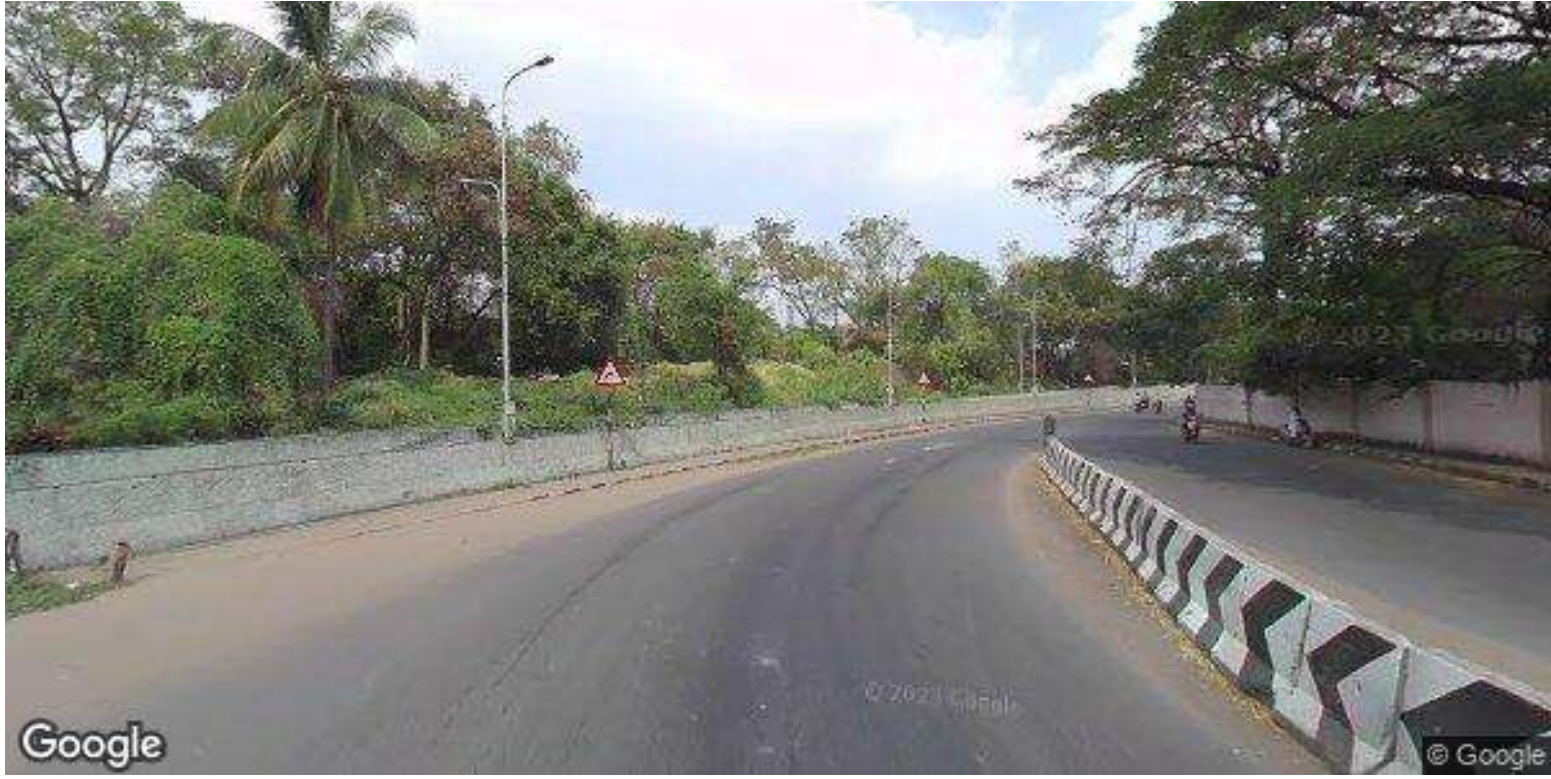
**Risk Type:** Turn  
**Risk Level:** Medium  
**Speed Limit:** 30 KM/Hr  
**Coordinates:** 11.67716, 78.11079

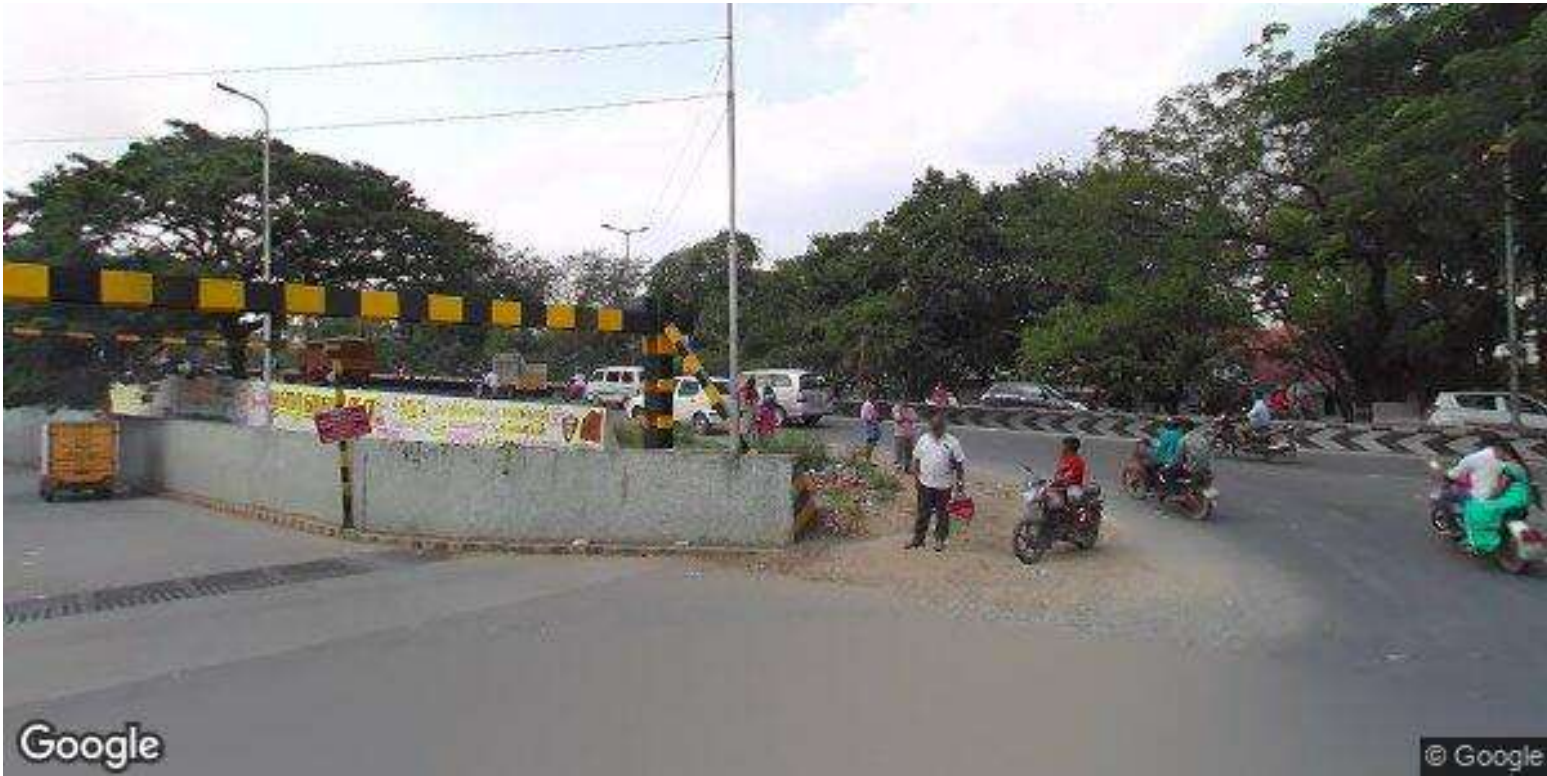
**Risk Type:** Turn  
**Risk Level:** High  
**Speed Limit:** 15 KM/Hr  
**Coordinates:** 11.67840, 78.11186

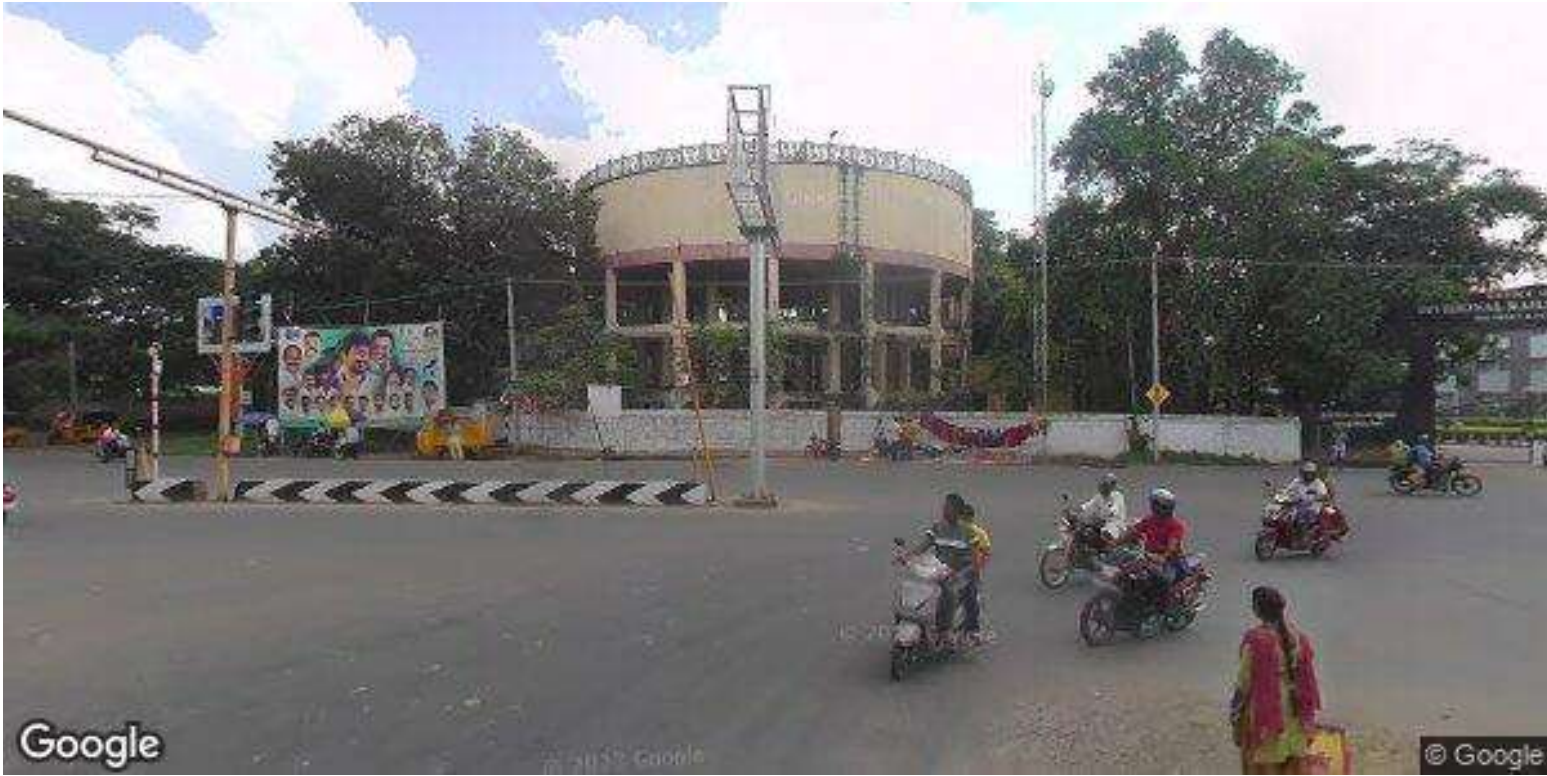
**Risk Type:** Turn  
**Risk Level:** Medium  
**Speed Limit:** 30 KM/Hr  
**Coordinates:** 11.67849, 78.11179

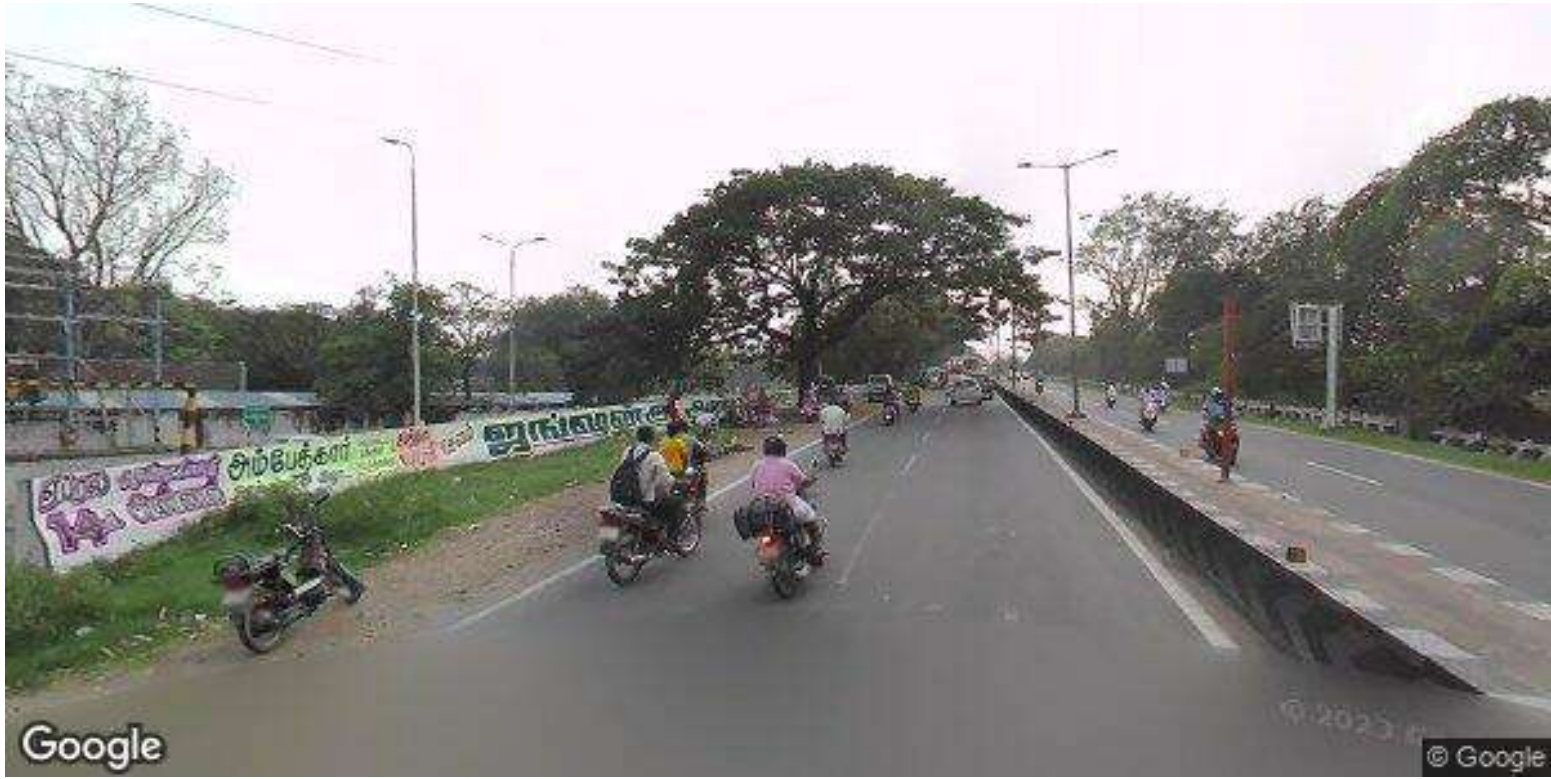
**Risk Type:** Turn  
**Risk Level:** High  
**Speed Limit:** 15 KM/Hr  
**Coordinates:** 11.67851, 78.11172
