# IndianOil

## JOURNEY RISK MANAGEMENT (JRM) STUDY

### Salem Terminal TO SRI AYYAPPA AGENCIES

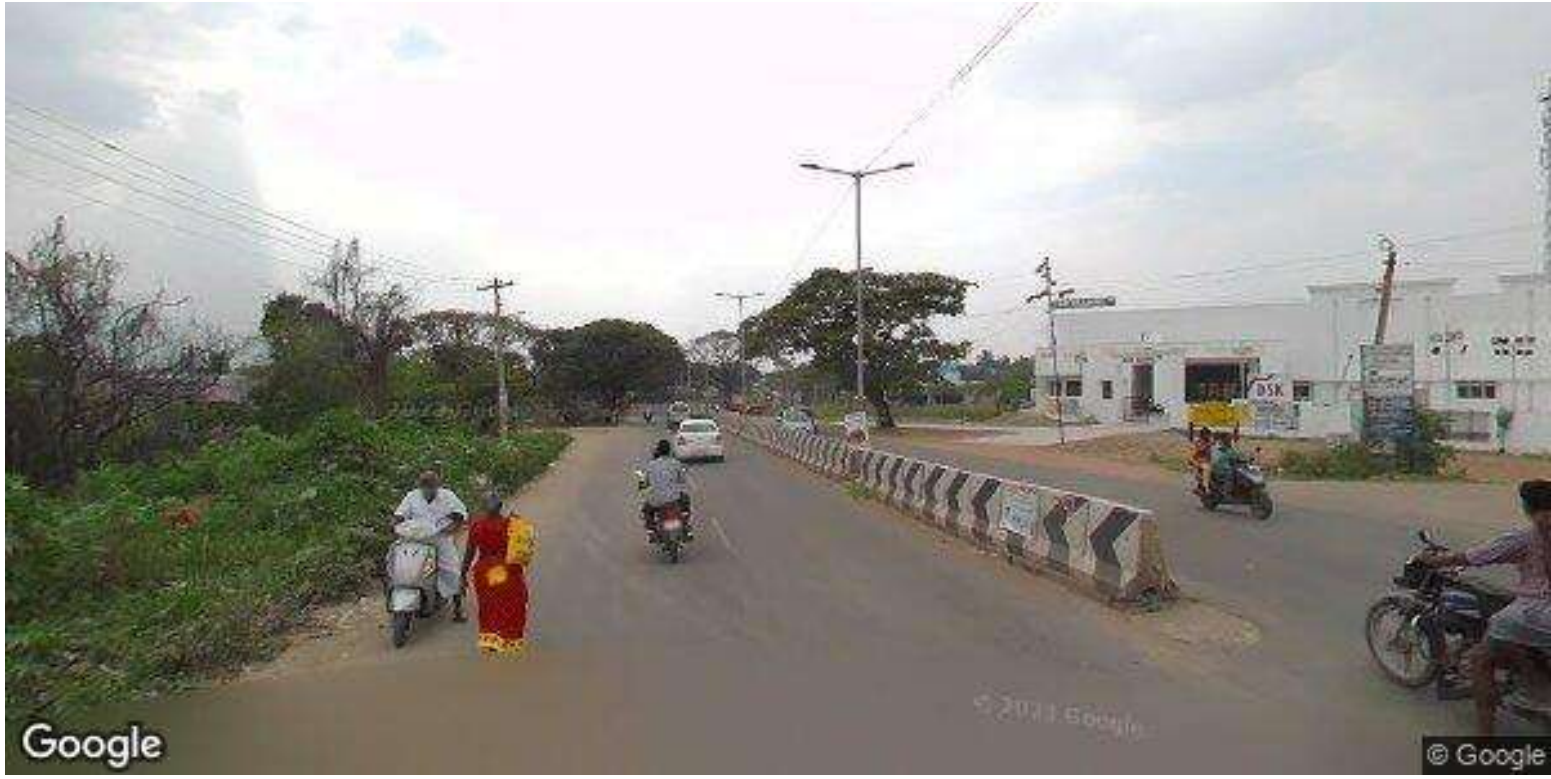
**Risk Type:** Blind Spot  
**Risk Level:** Blind Spot  
**Speed Limit:** 10 KM/Hr  
**Coordinates:** 11.67153, 78.09716
