## JOURNEY RISK MANAGEMENT (JRM) STUDY

### Salem Terminal to SRS FUELS

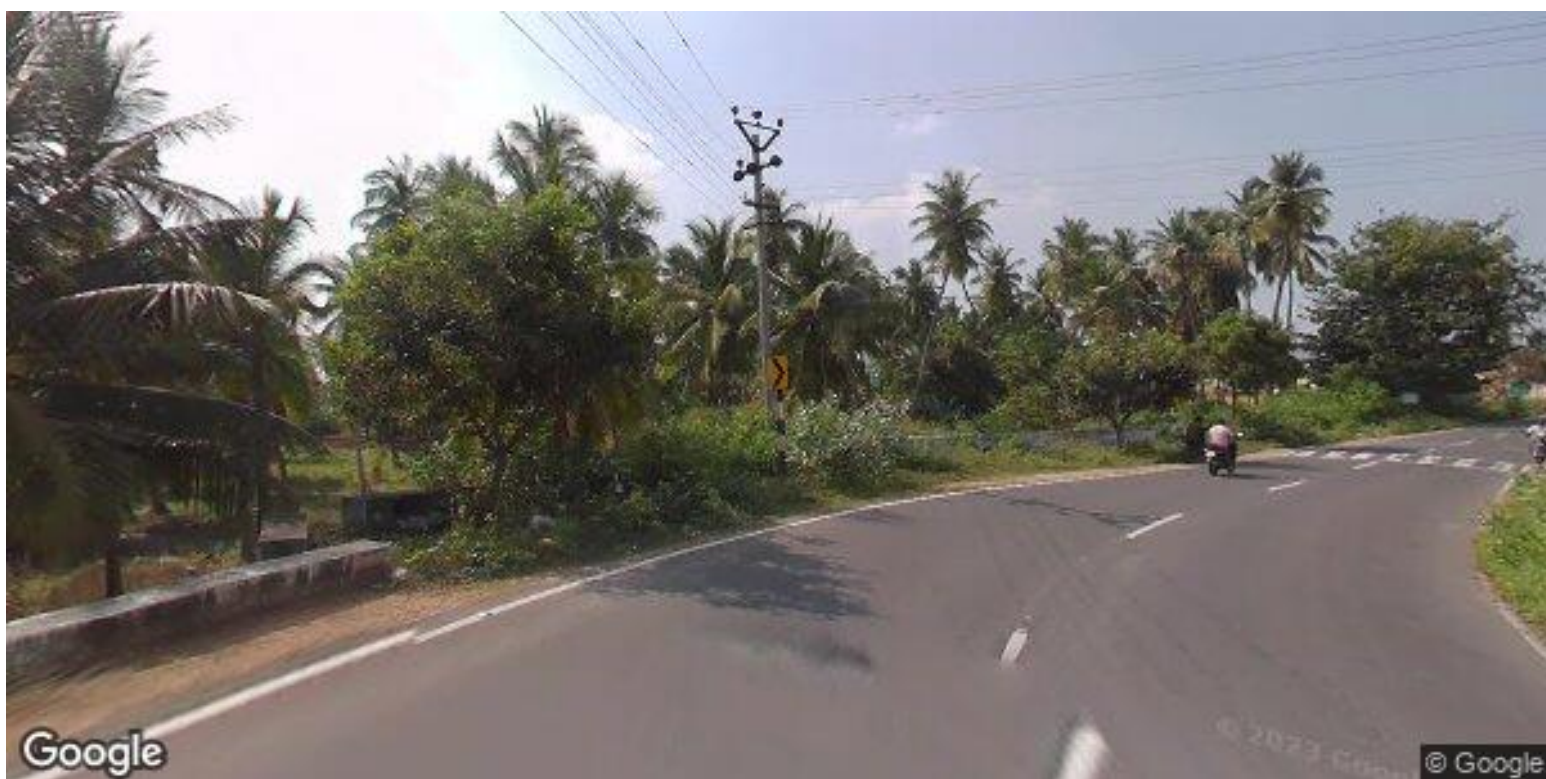
**Coordinates:** 11.45348, 77.85706

**Risk Type:** Turn

**Risk Level:** Medium

**Speed Limit:** 30 KM/Hr

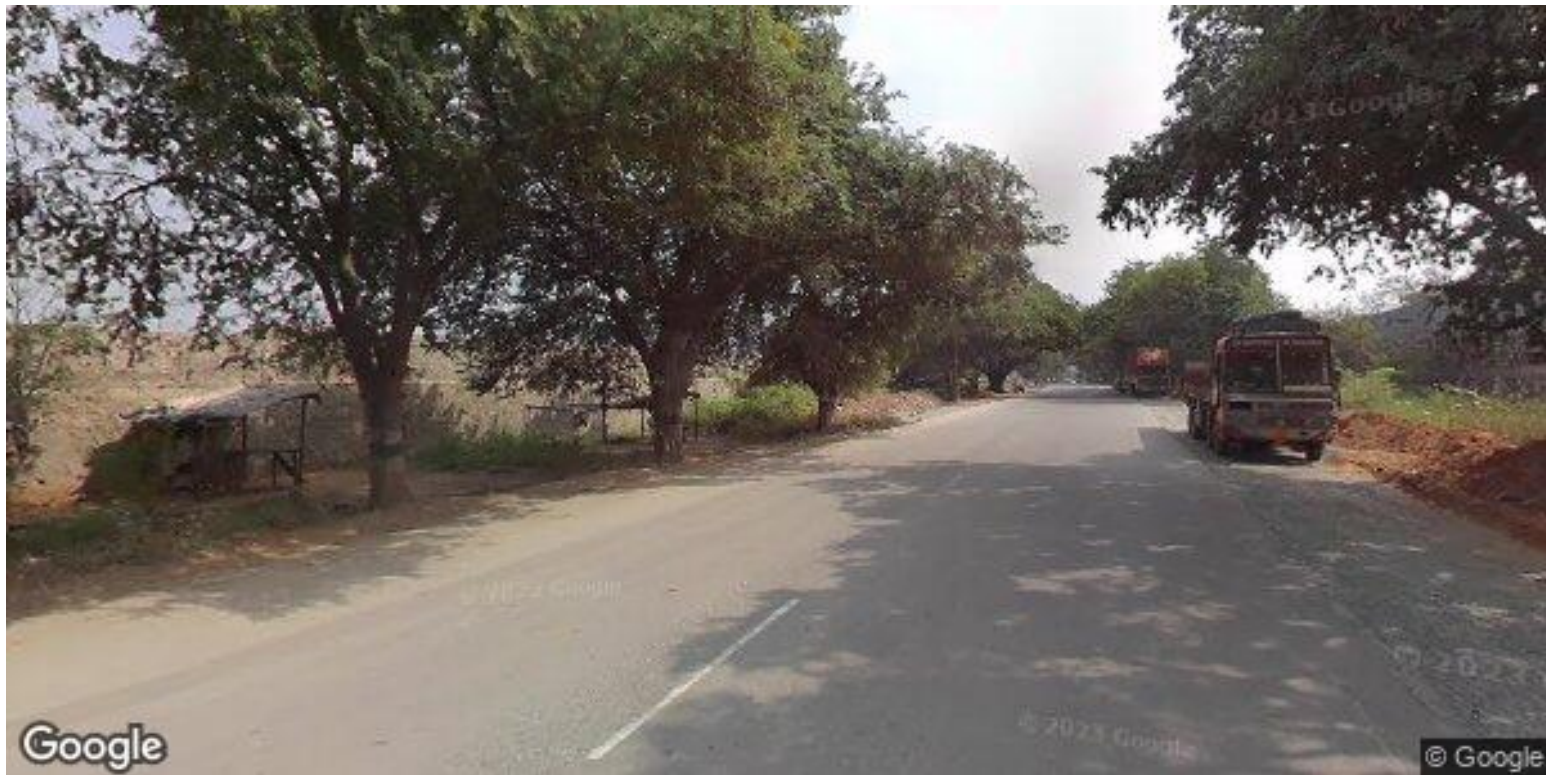
**Risk Type:** Turn  
**Risk Level:** Medium  
**Speed Limit:** 30 KM/Hr  
**Coordinates:** 11.45697, 77.82719

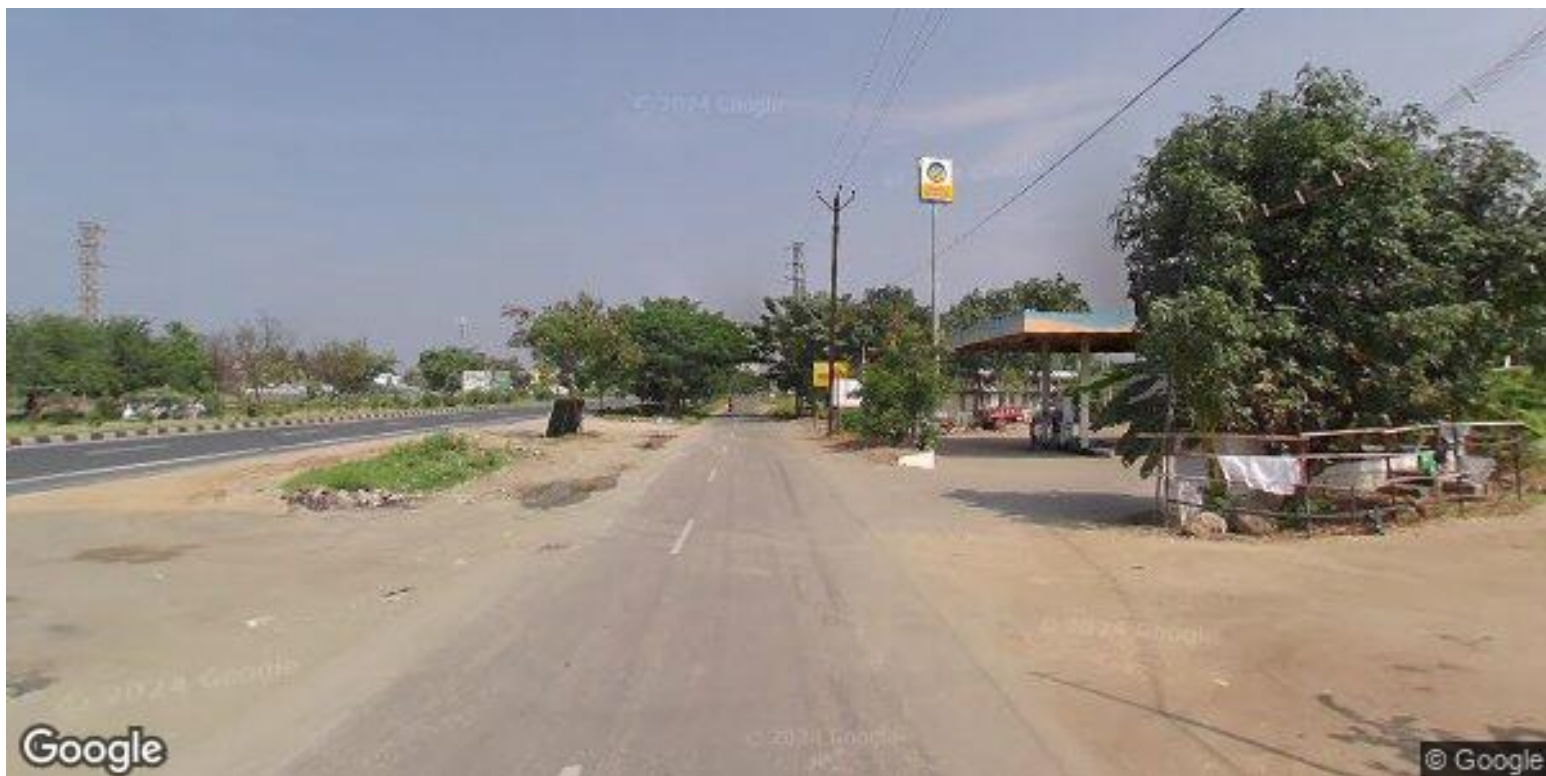
**Coordinates:** 11.43994, 77.71111

**Risk Type:** Turn

**Risk Level:** Medium

**Speed Limit:** 30 KM/Hr

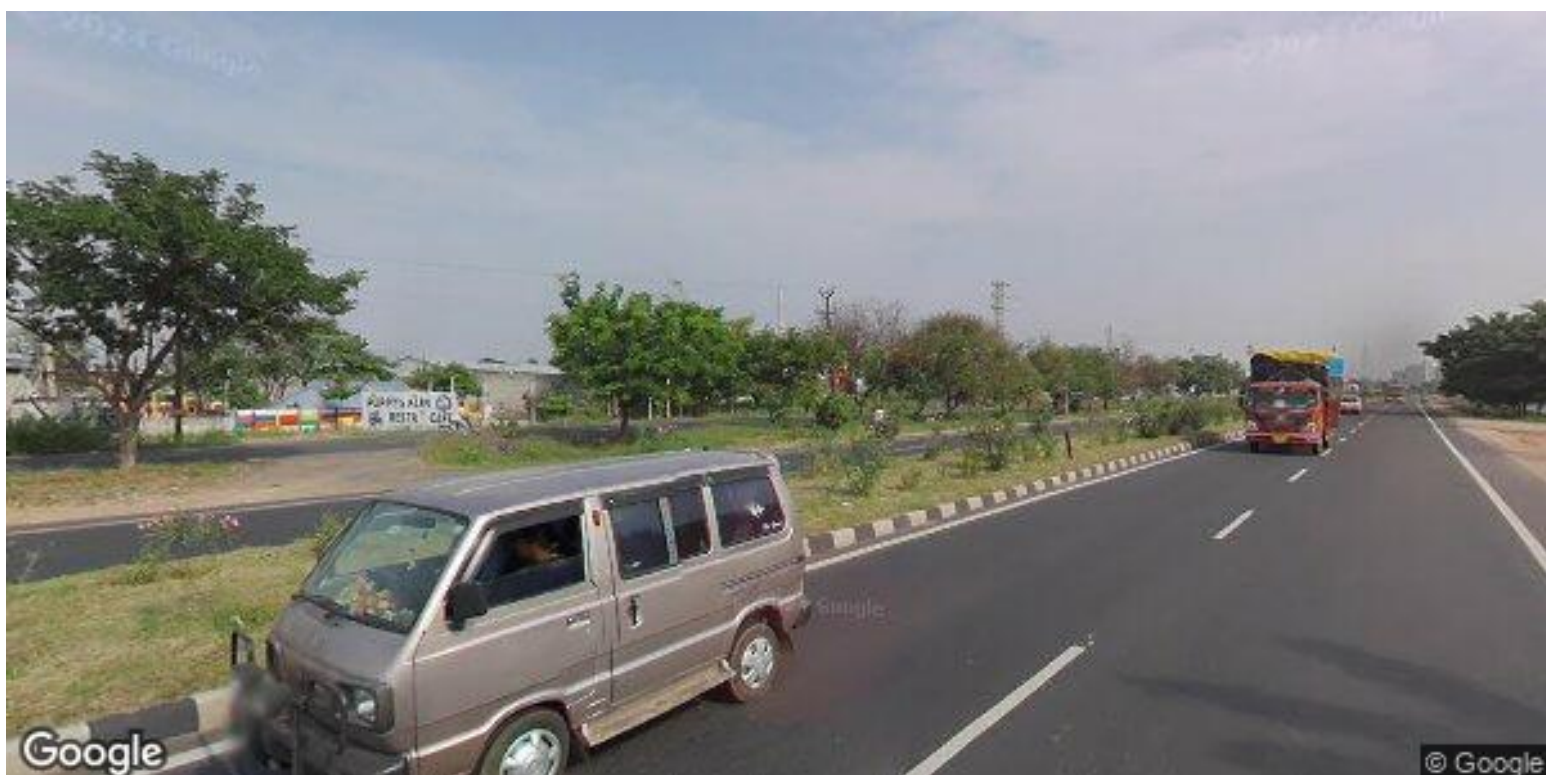
**Risk Type:** Turn  
**Risk Level:** Medium  
**Speed Limit:** 30 KM/Hr  
**Coordinates:** 11.43982, 77.71084

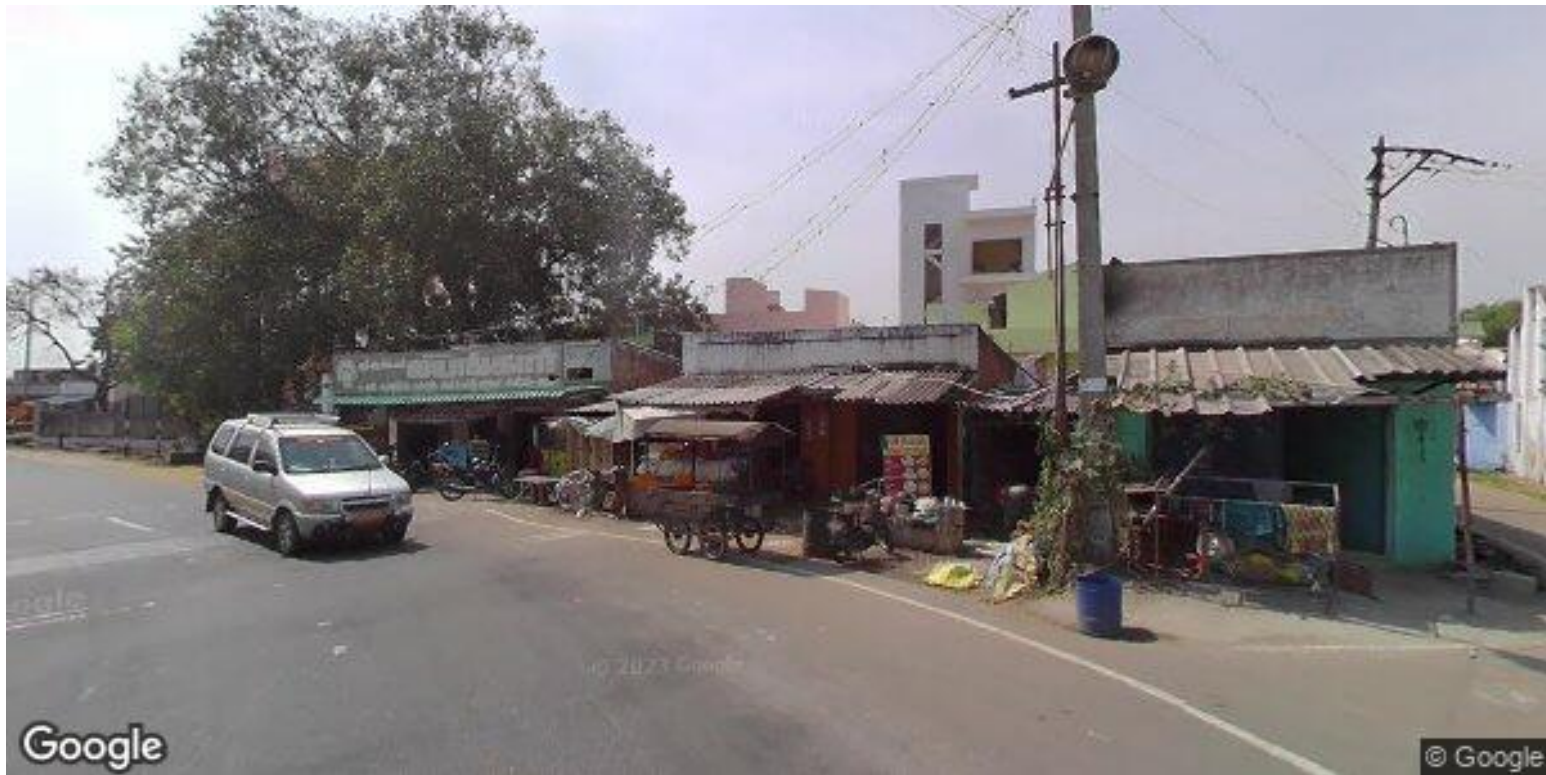
**Risk Type:** Turn  
**Risk Level:** Medium  
**Speed Limit:** 30 KM/Hr  
**Coordinates:** 11.44107, 77.68189

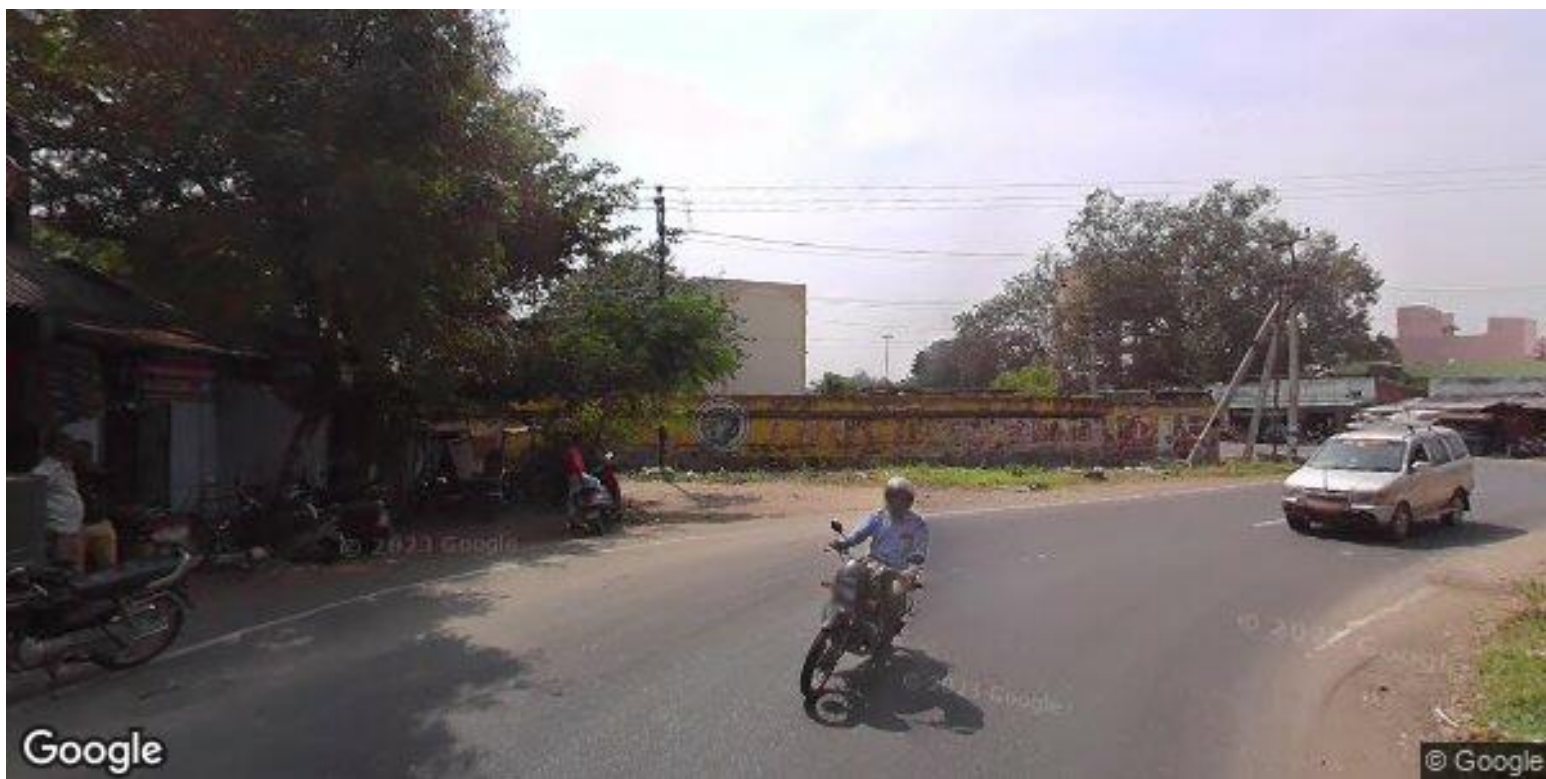
**Risk Type:** Turn  
**Risk Level:** Medium  
**Speed Limit:** 30 KM/Hr  
**Coordinates:** 11.44122, 77.68219

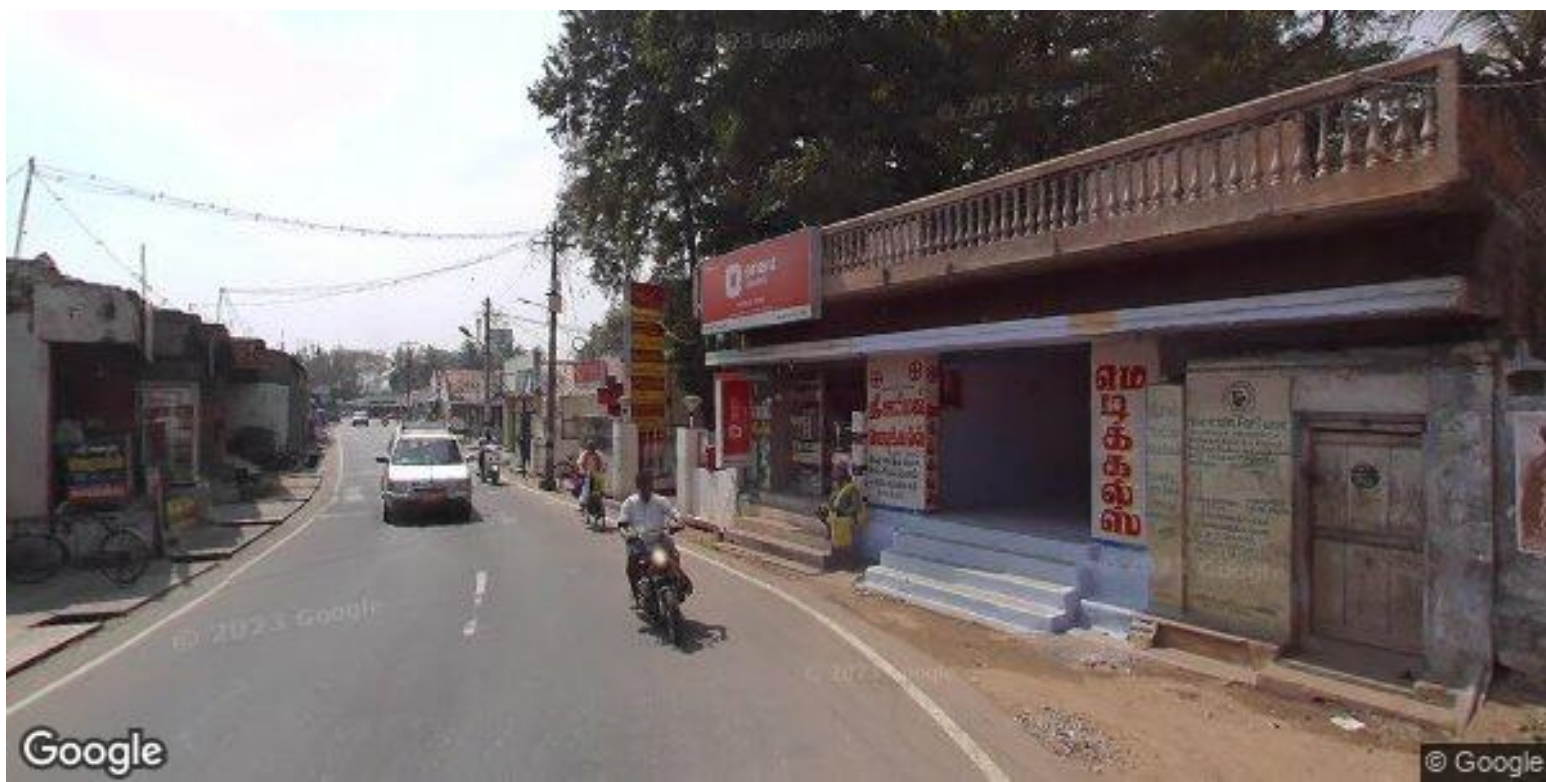
**Coordinates:** 11.44291, 77.68256

**Risk Type:** Turn

**Risk Level:** Medium

**Speed Limit:** 30 KM/Hr

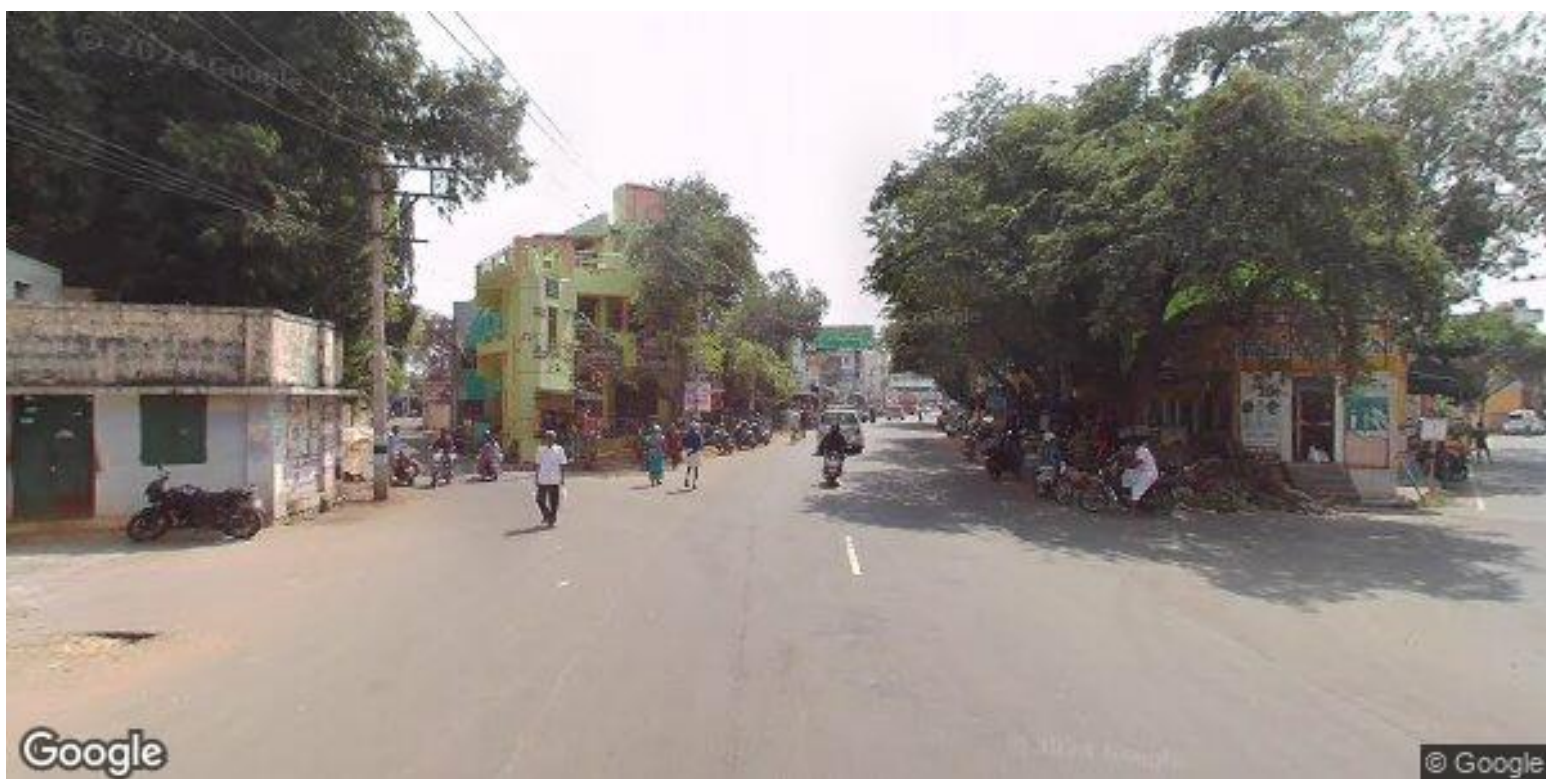
**Coordinates:** 11.44858, 77.68333

**Risk Type:** Turn

**Risk Level:** High

**Speed Limit:** 15 KM/Hr

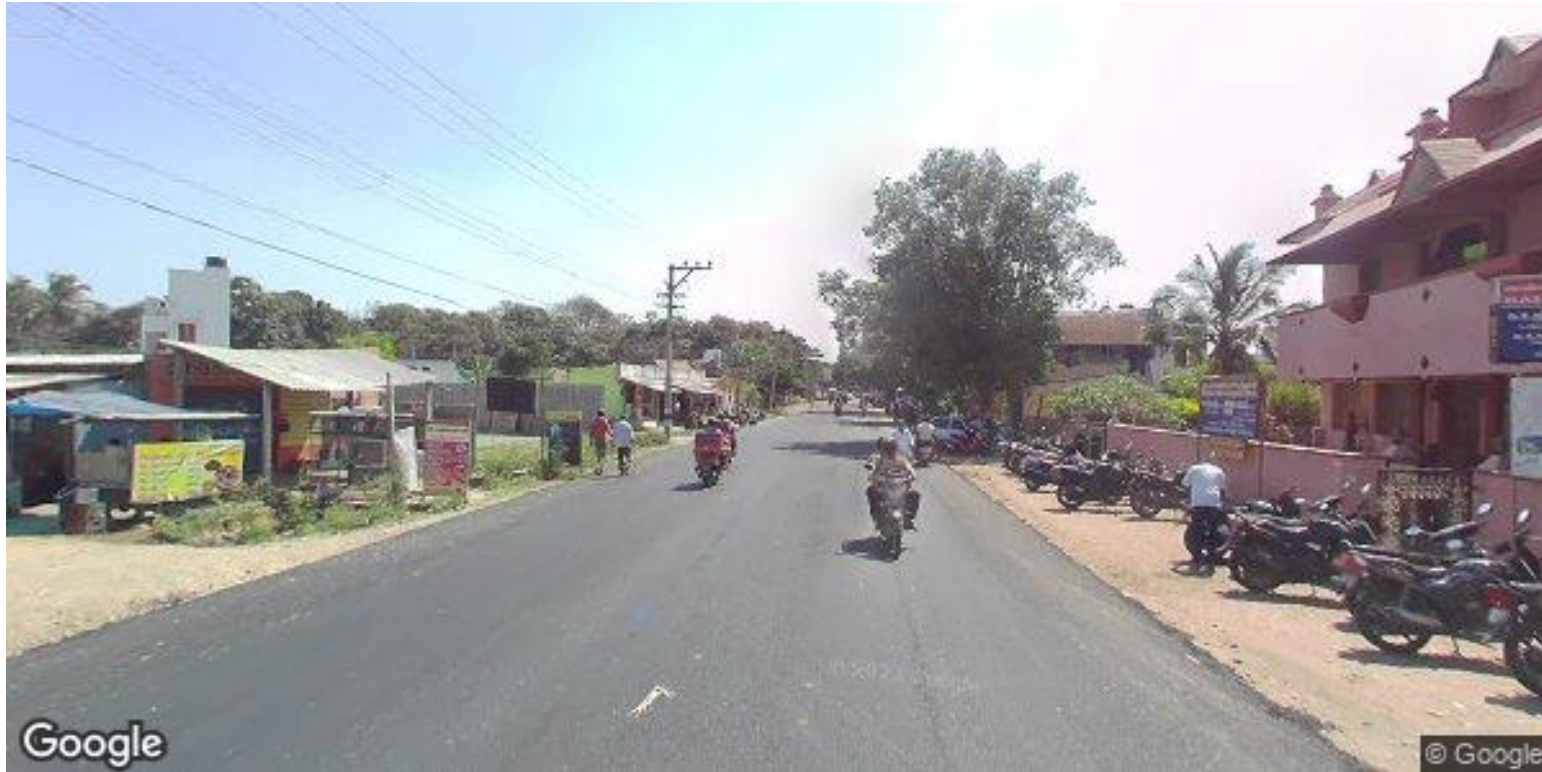
**Coordinates:** 11.45231, 77.68109

**Risk Type:** Turn

**Risk Level:** High

**Speed Limit:** 15 KM/Hr
