# IndianOil

## JOURNEY RISK MANAGEMENT (JRM) STUDY

### Salem Terminal to SUBRAMANYAA FUELS

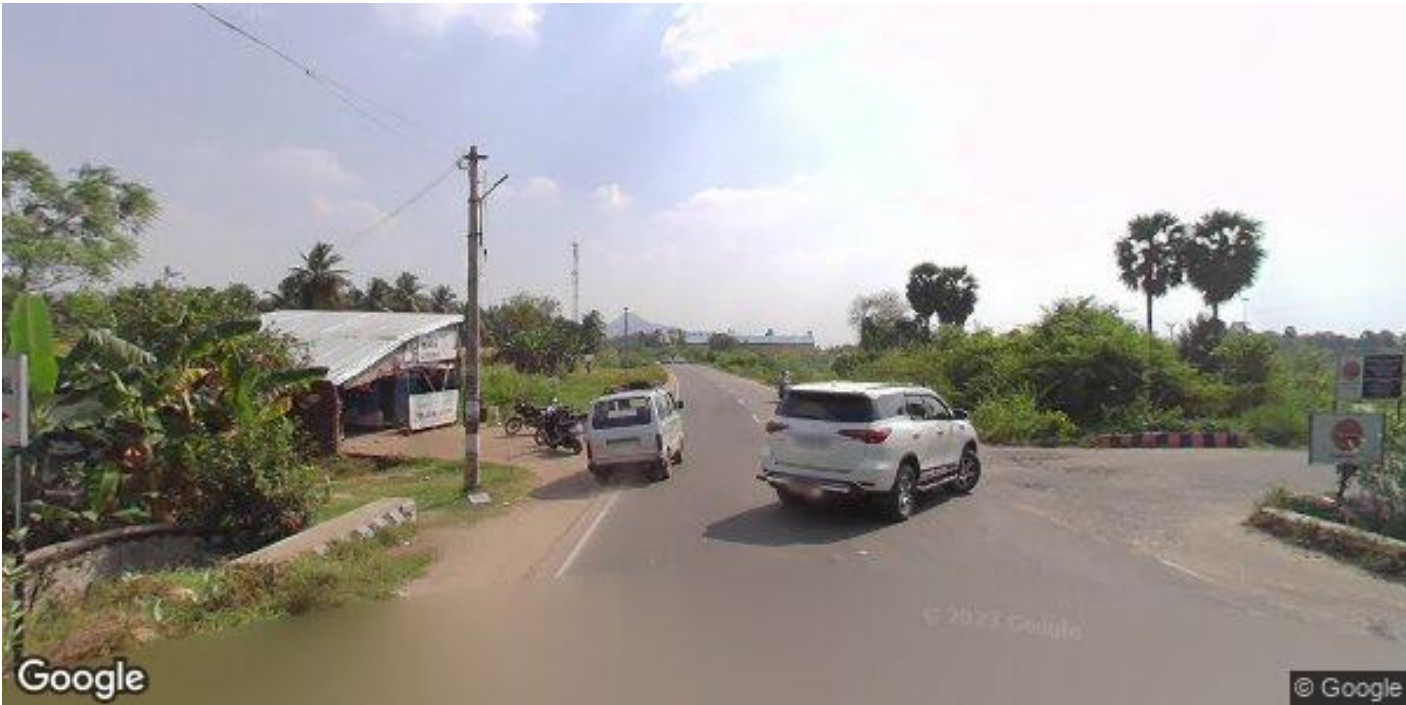
Risk Type: Turn

Risk Level: High

**Speed Limit: 15 KM/Hr**  
**Coordinates: 11.44029, 77.87544**

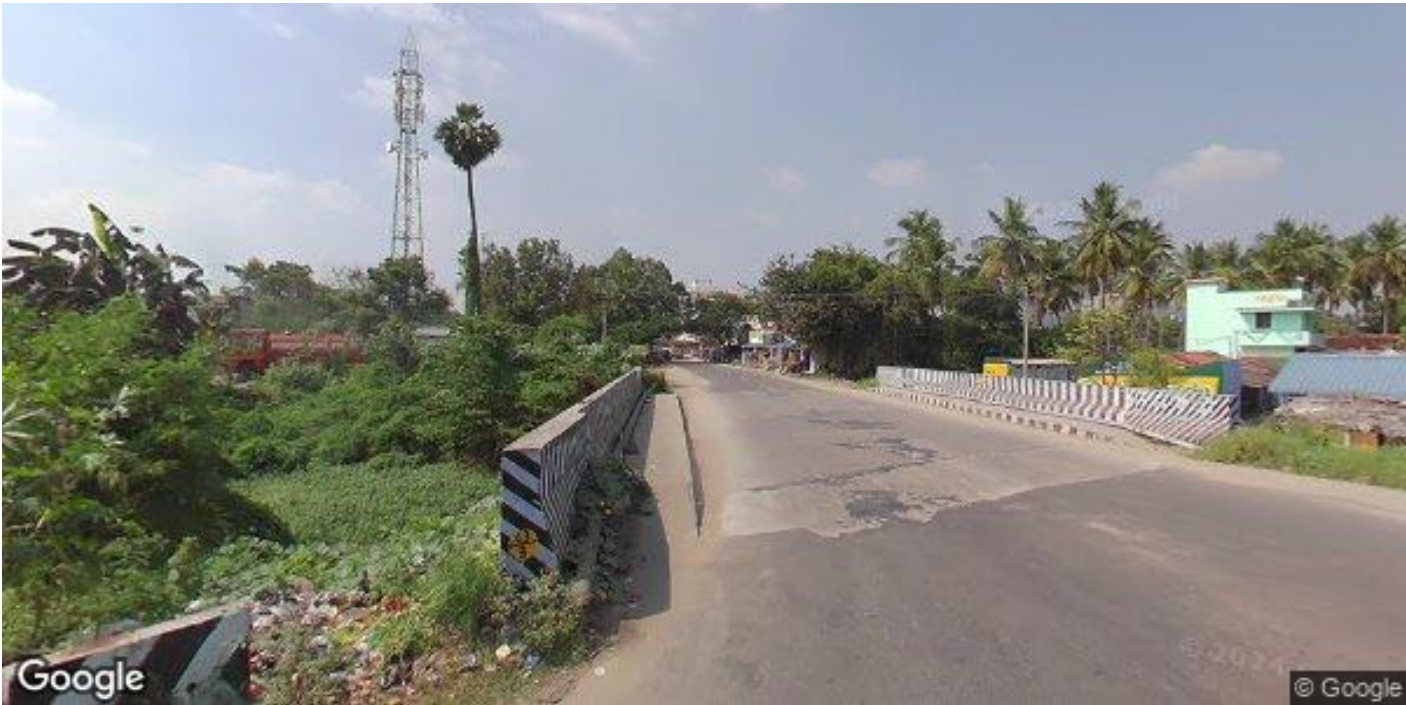
**Risk Type: Turn**  
**Risk Level: High**  
**Speed Limit: 15 KM/Hr**  
**Coordinates: 11.44900, 77.87406**

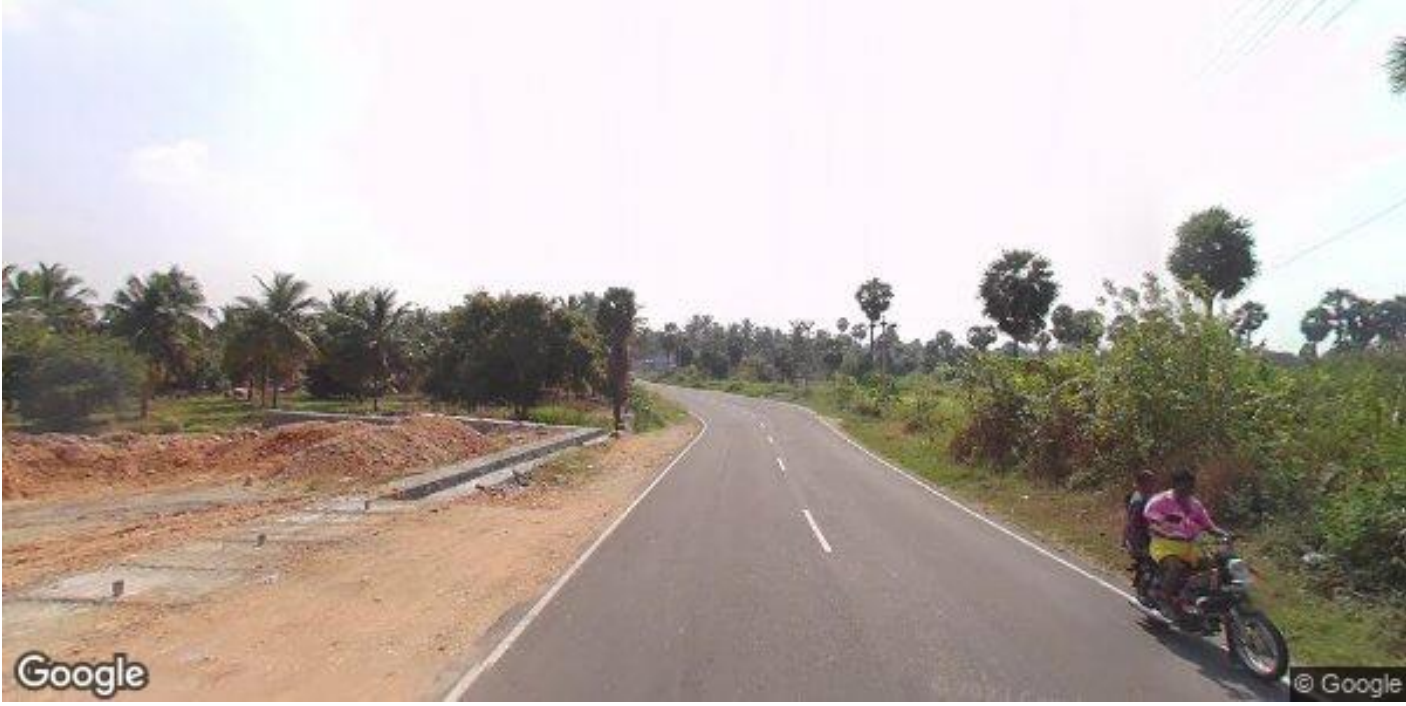
**Risk Type:** Turn  
**Risk Level:** Medium  
**Speed Limit:** 30 KM/Hr  
**Coordinates:** 11.45781, 77.85203

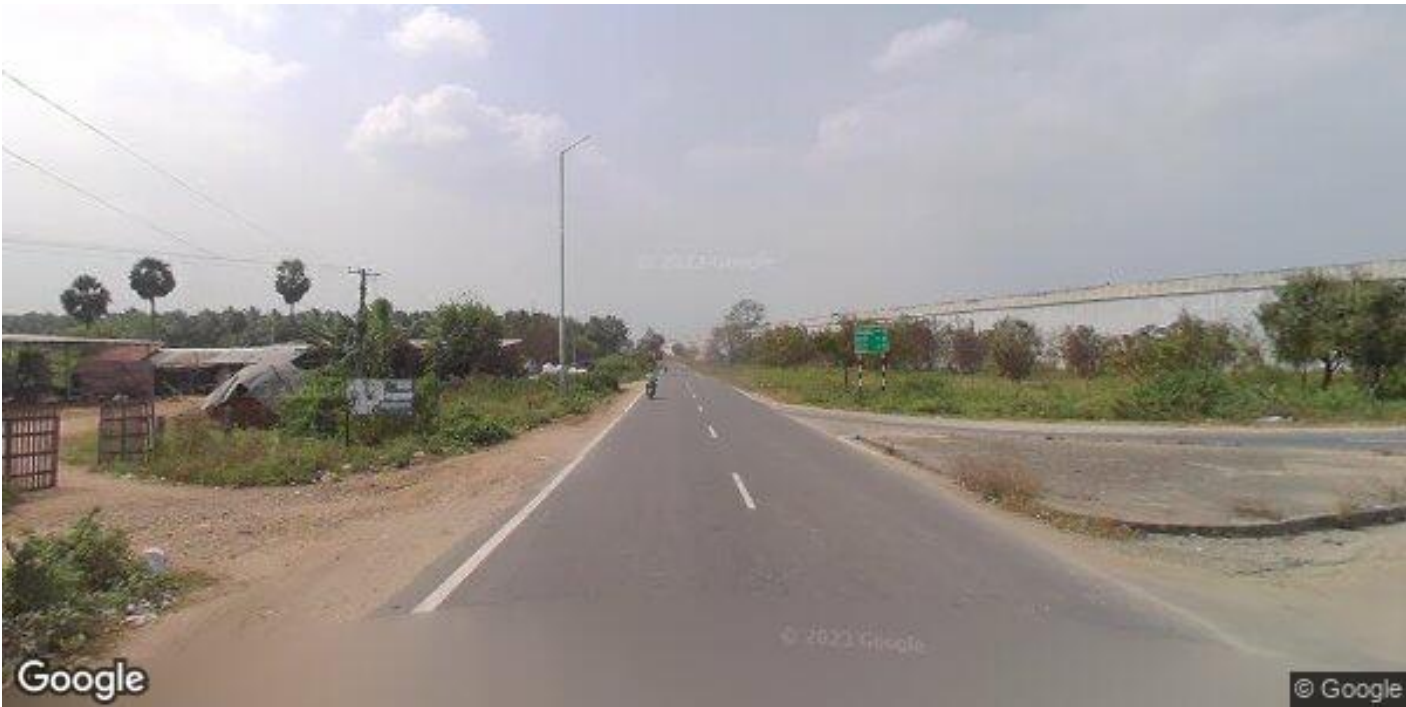
**Risk Type:** Turn  
**Risk Level:** High  
**Speed Limit:** 15 KM/Hr  
**Coordinates:** 11.45542, 77.81725

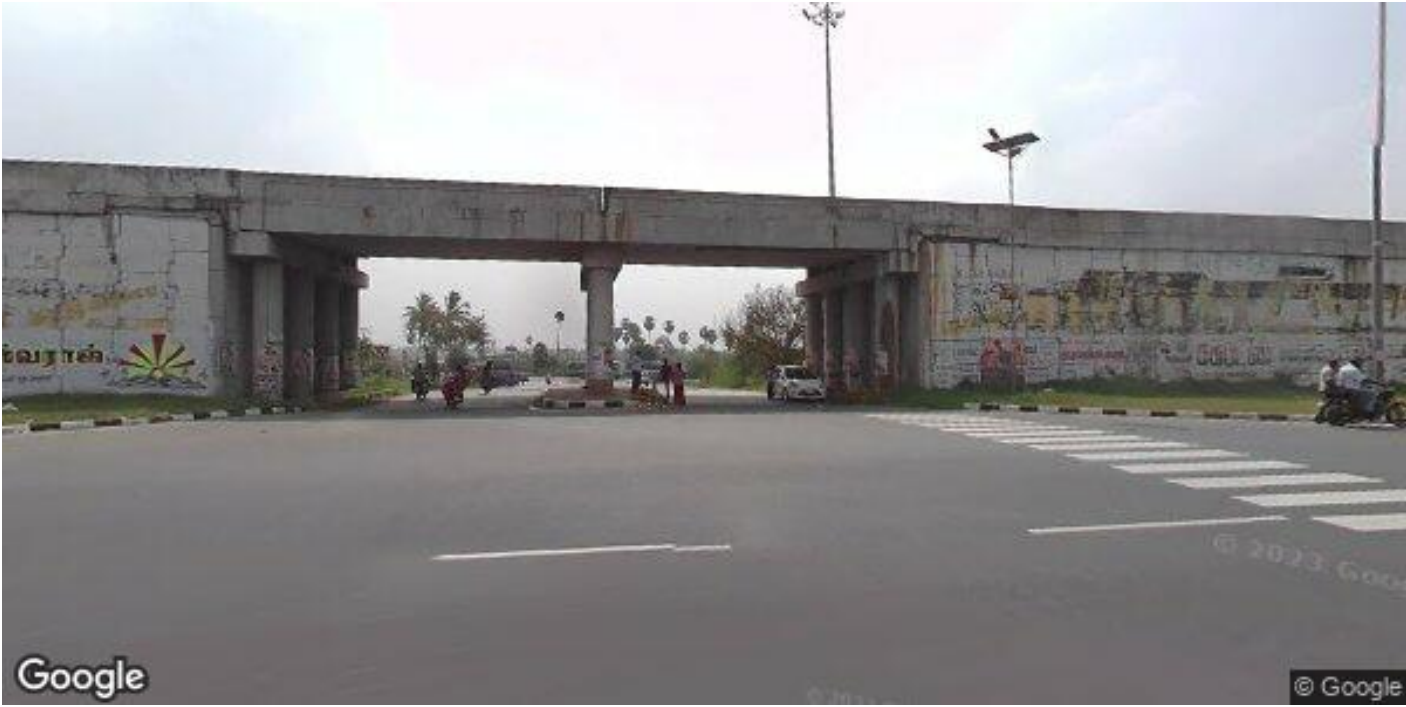
**Risk Type:** Turn  
**Risk Level:** High  
**Speed Limit:** 15 KM/Hr  
**Coordinates:** 11.45636, 77.81678

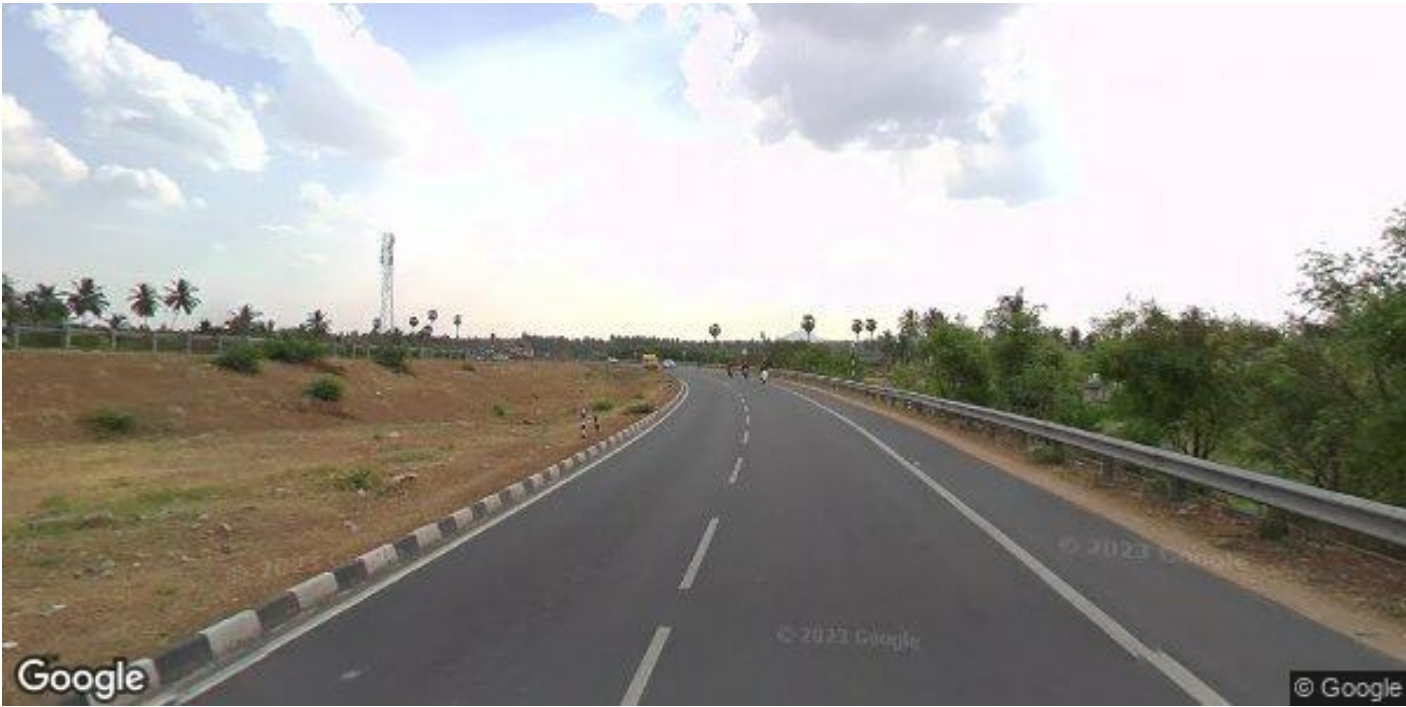
**Risk Type:** Turn  
**Risk Level:** Medium  
**Speed Limit:** 30 KM/Hr  
**Coordinates:** 11.53573, 77.95794

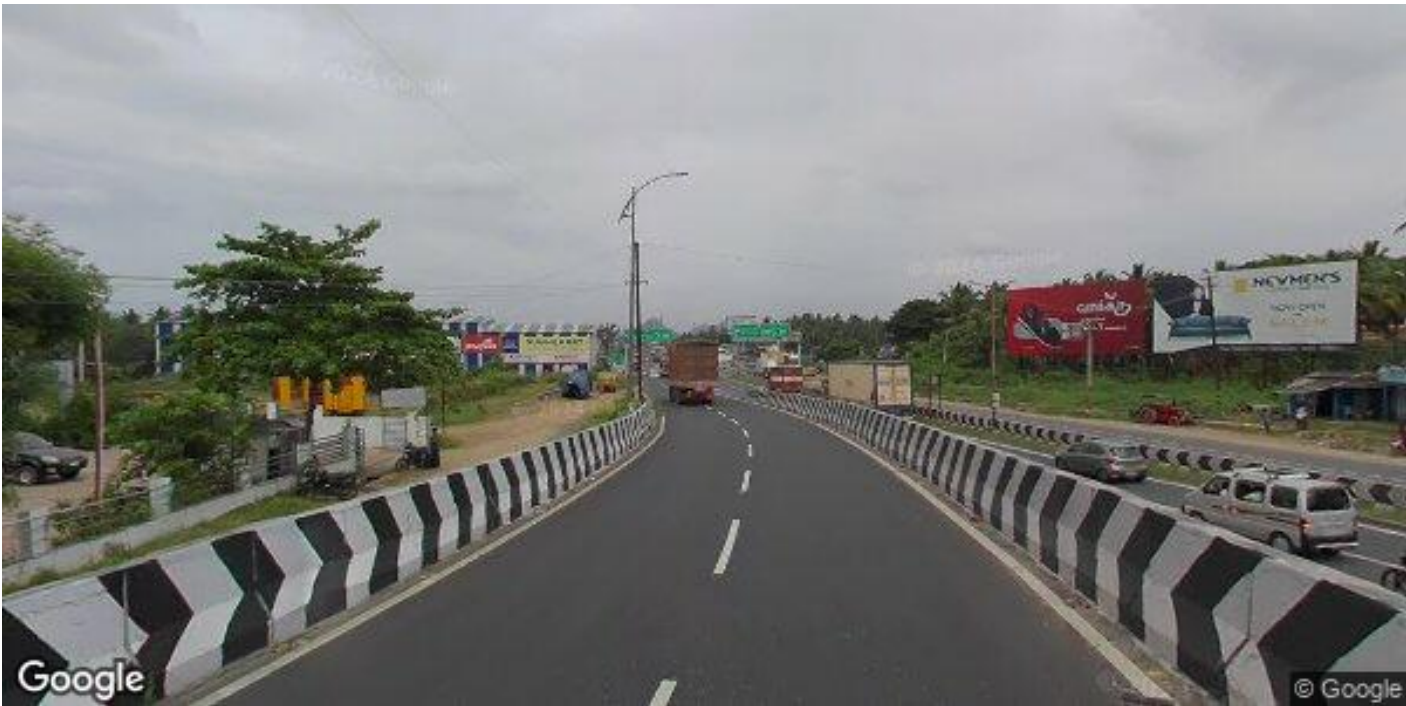
**Risk Type:** Turn  
**Risk Level:** Medium  
**Speed Limit:** 30 KM/Hr  
**Coordinates:** 11.64338, 78.11998

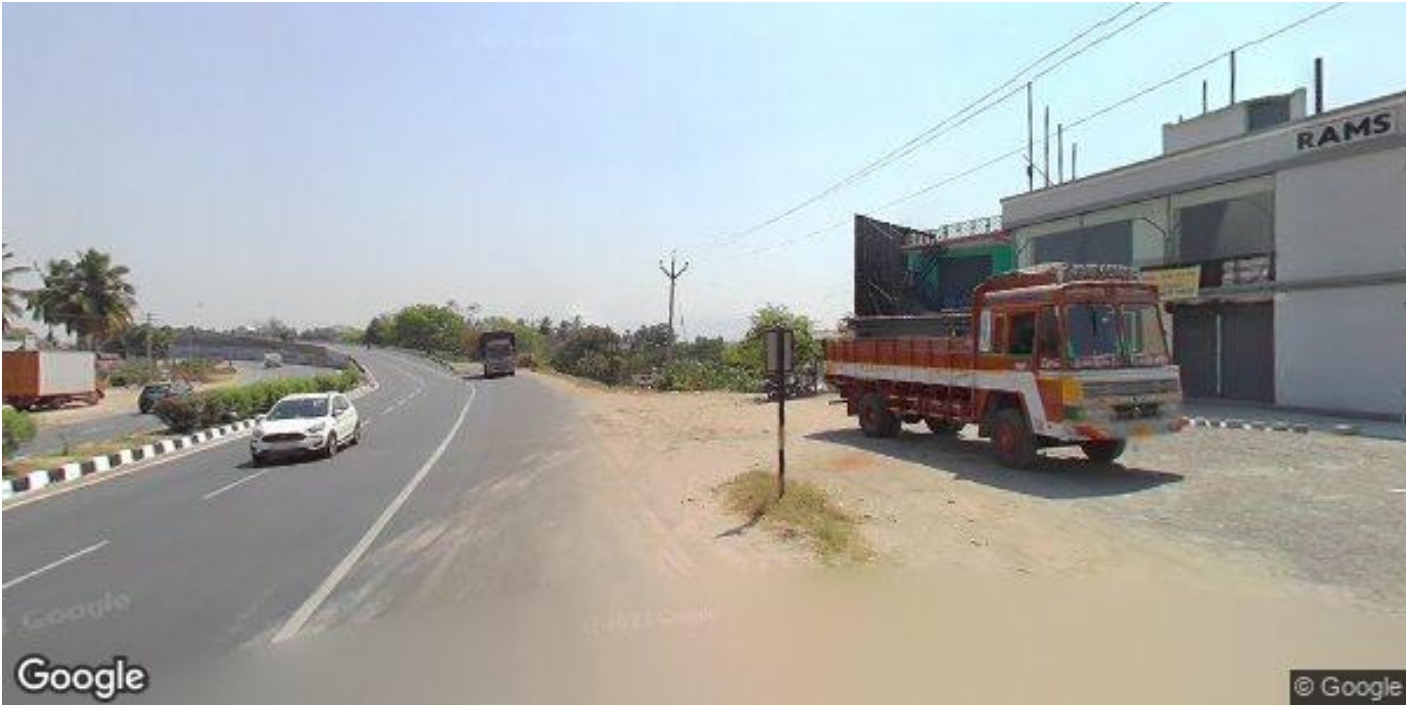
**Risk Type:** Turn  
**Risk Level:** Medium  
**Speed Limit:** 30 KM/Hr  
**Coordinates:** 11.74068, 78.05047

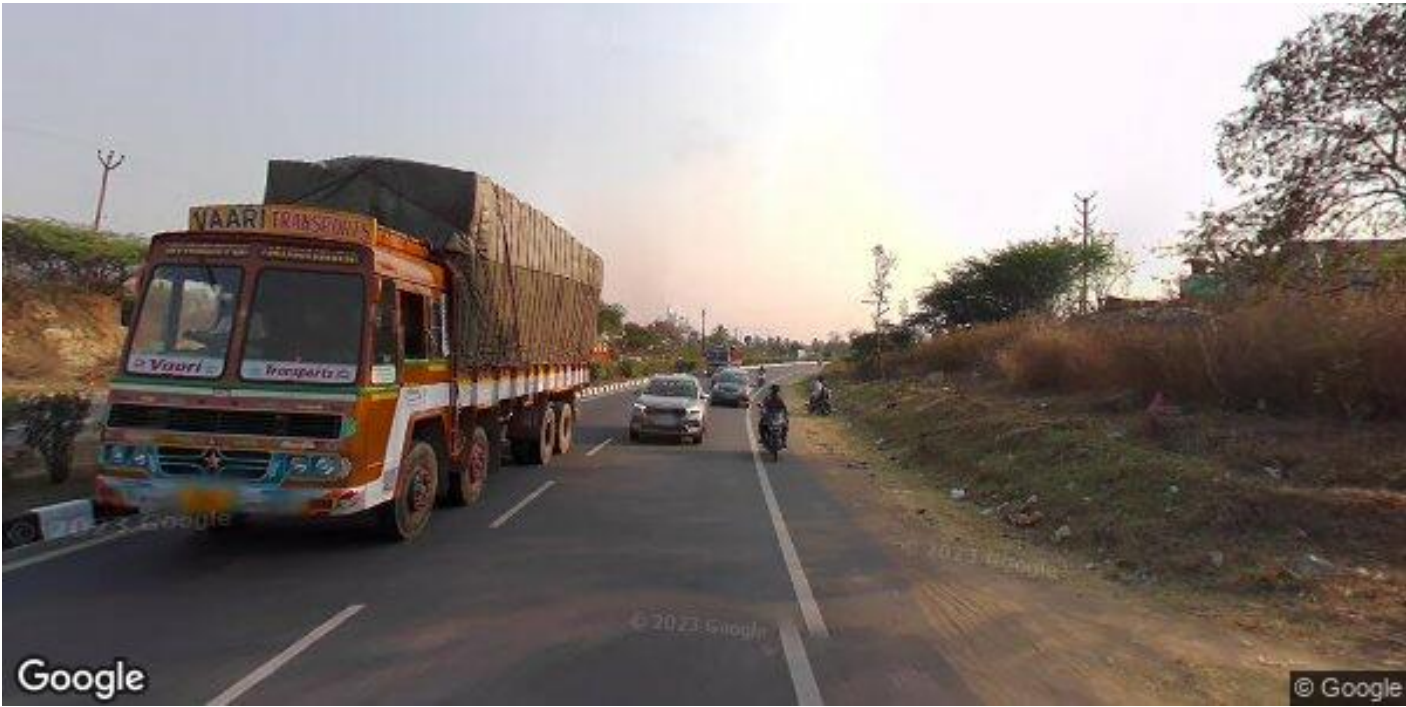
**Risk Type:** Turn  
**Risk Level:** Medium  
**Speed Limit:** 30 KM/Hr  
**Coordinates:** 11.78039, 78.05792

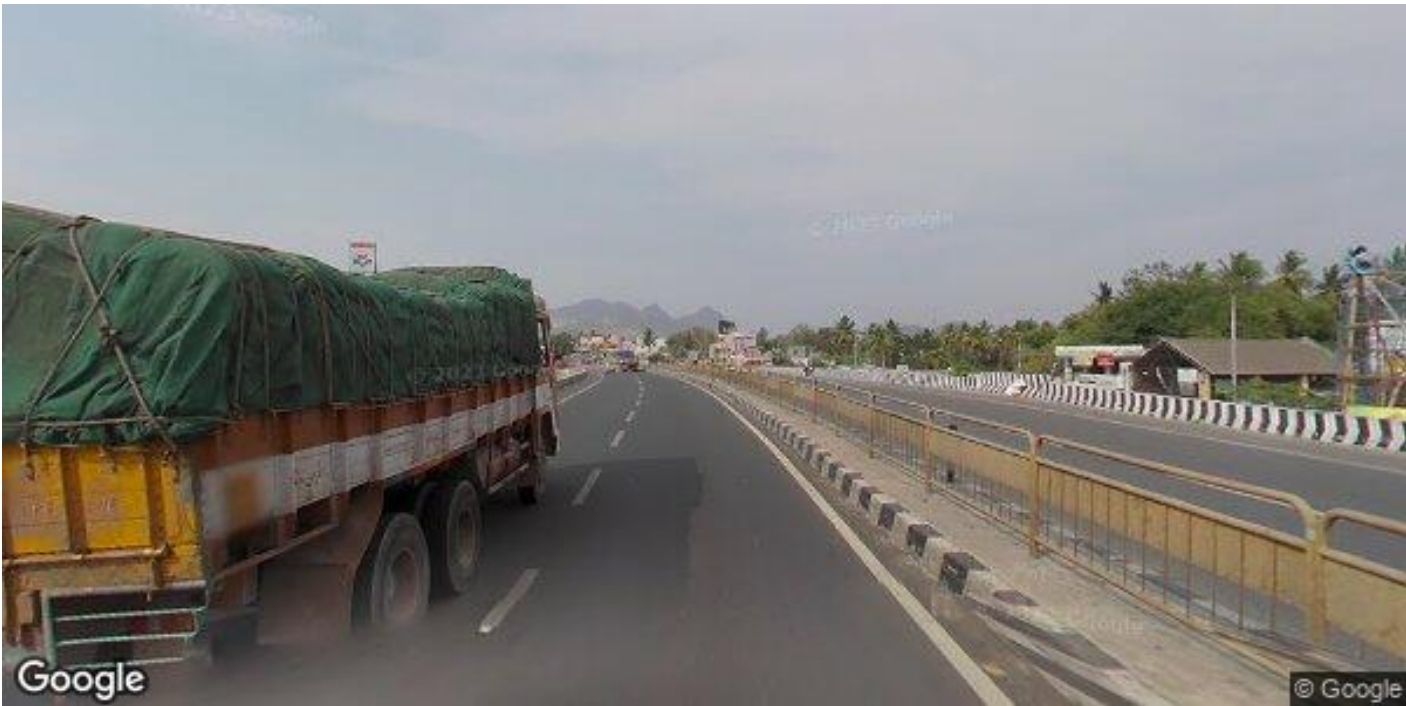
**Risk Type:** Turn  
**Risk Level:** Medium  
**Speed Limit:** 30 KM/Hr  
**Coordinates:** 11.86753, 78.08331

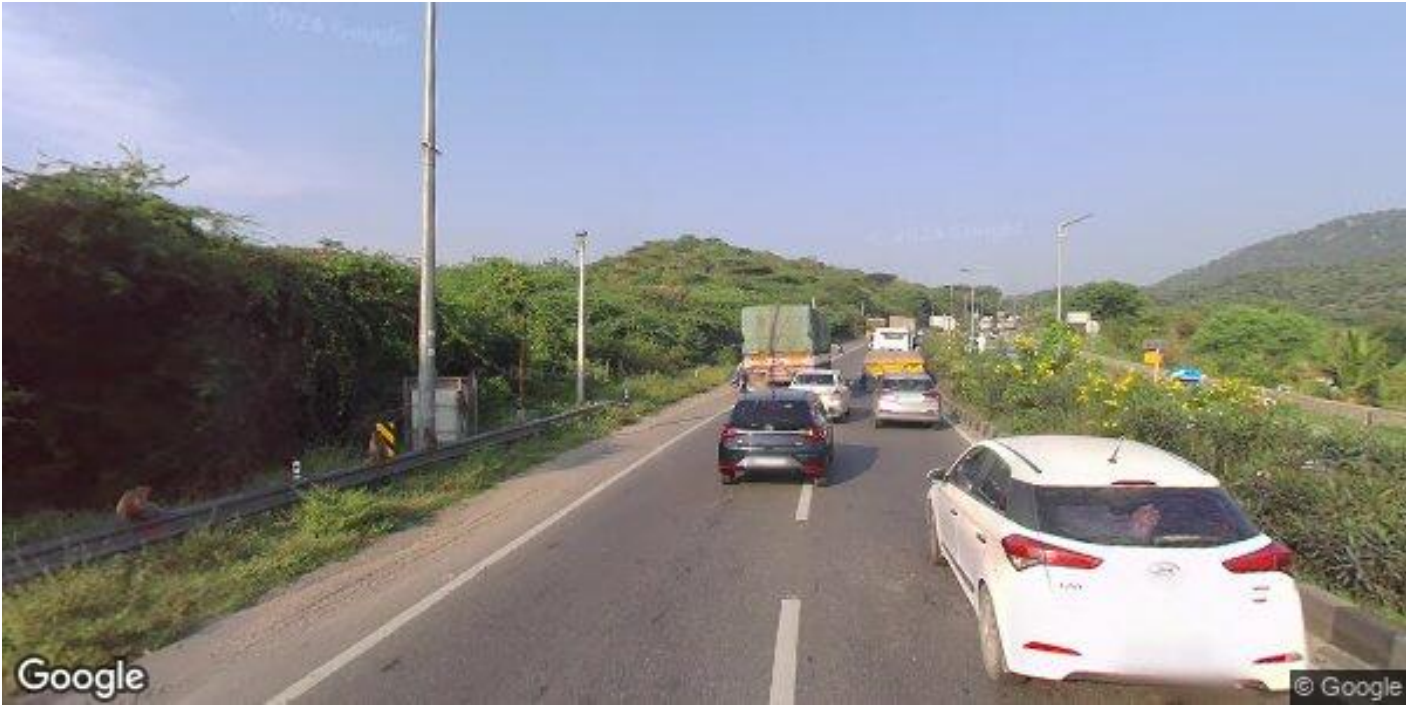
**Risk Type:** Turn  
**Risk Level:** Medium  
**Speed Limit:** 30 KM/Hr  
**Coordinates:** 11.95625, 78.04748

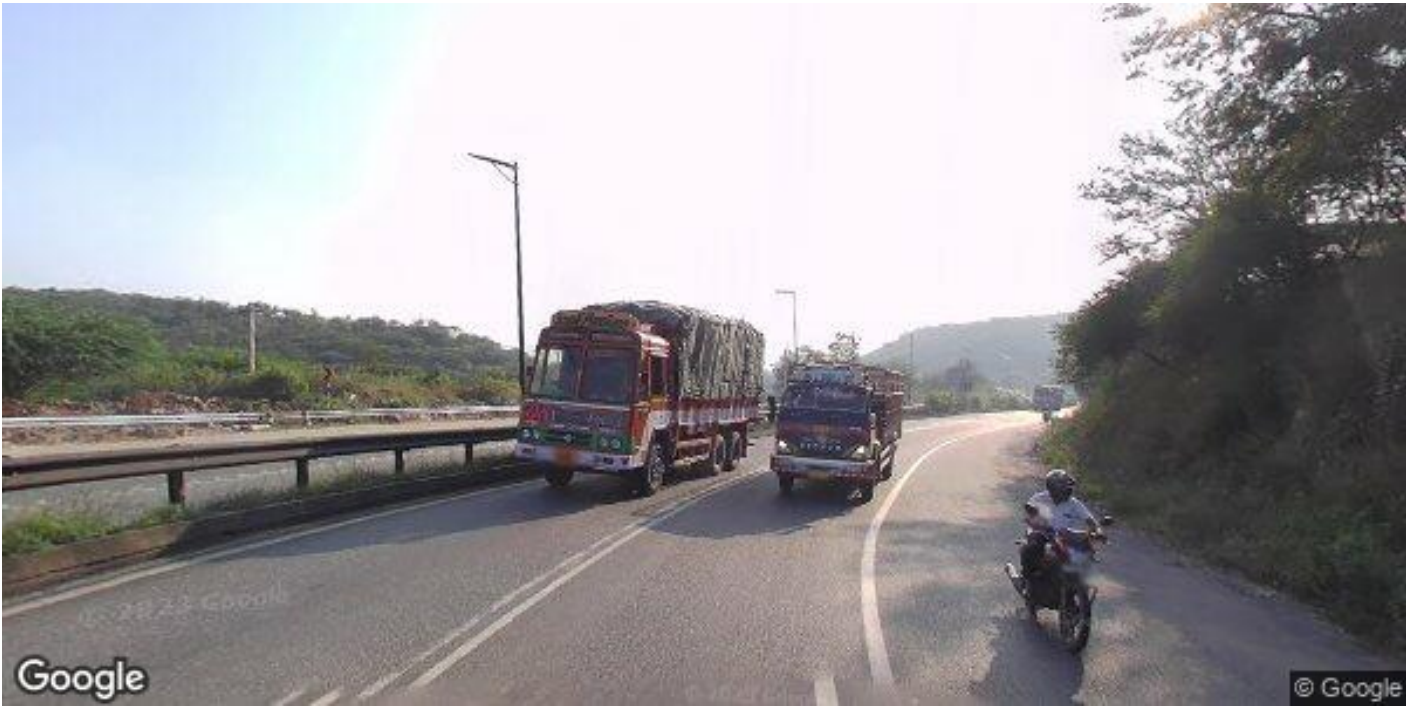
**Risk Type:** Turn  
**Risk Level:** High  
**Speed Limit:** 15 KM/Hr  
**Coordinates:** 11.95824, 78.04981

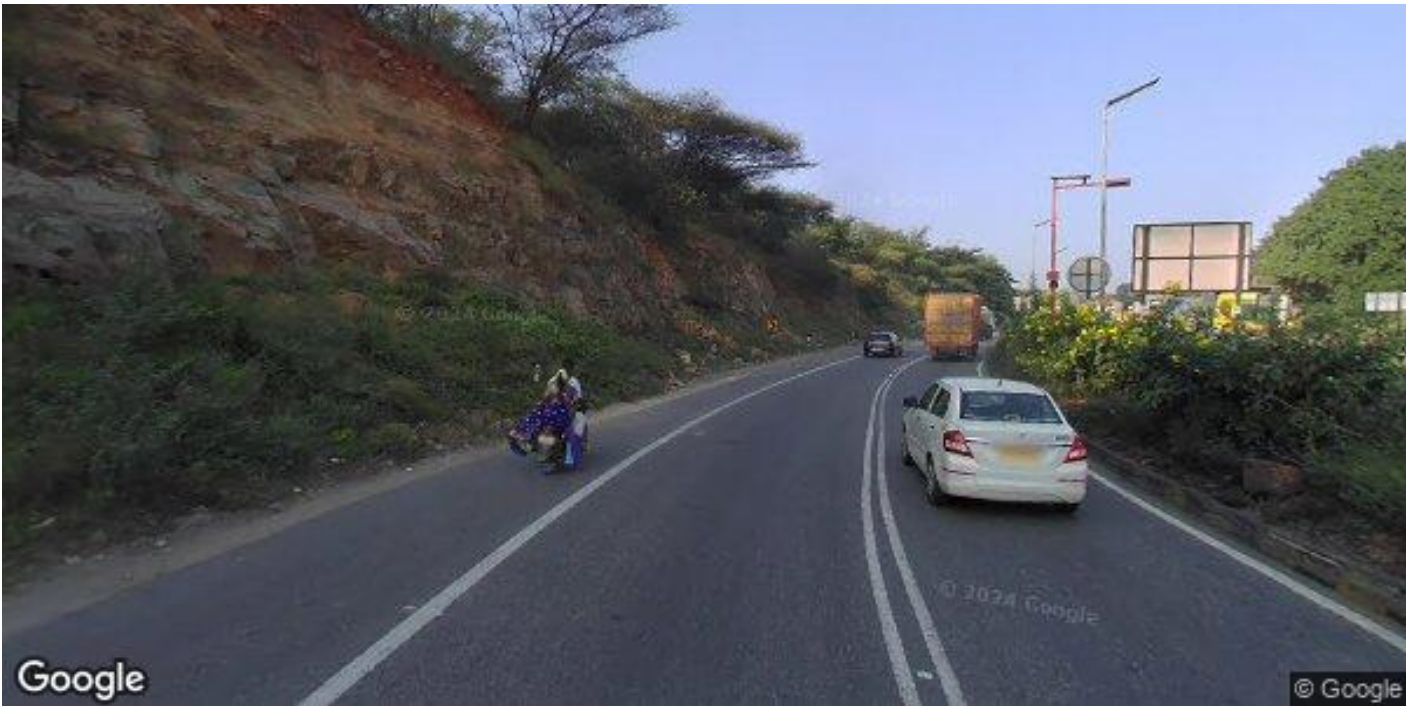
**Risk Type:** Turn  
**Risk Level:** High  
**Speed Limit:** 15 KM/Hr  
**Coordinates:** 11.96040, 78.04947

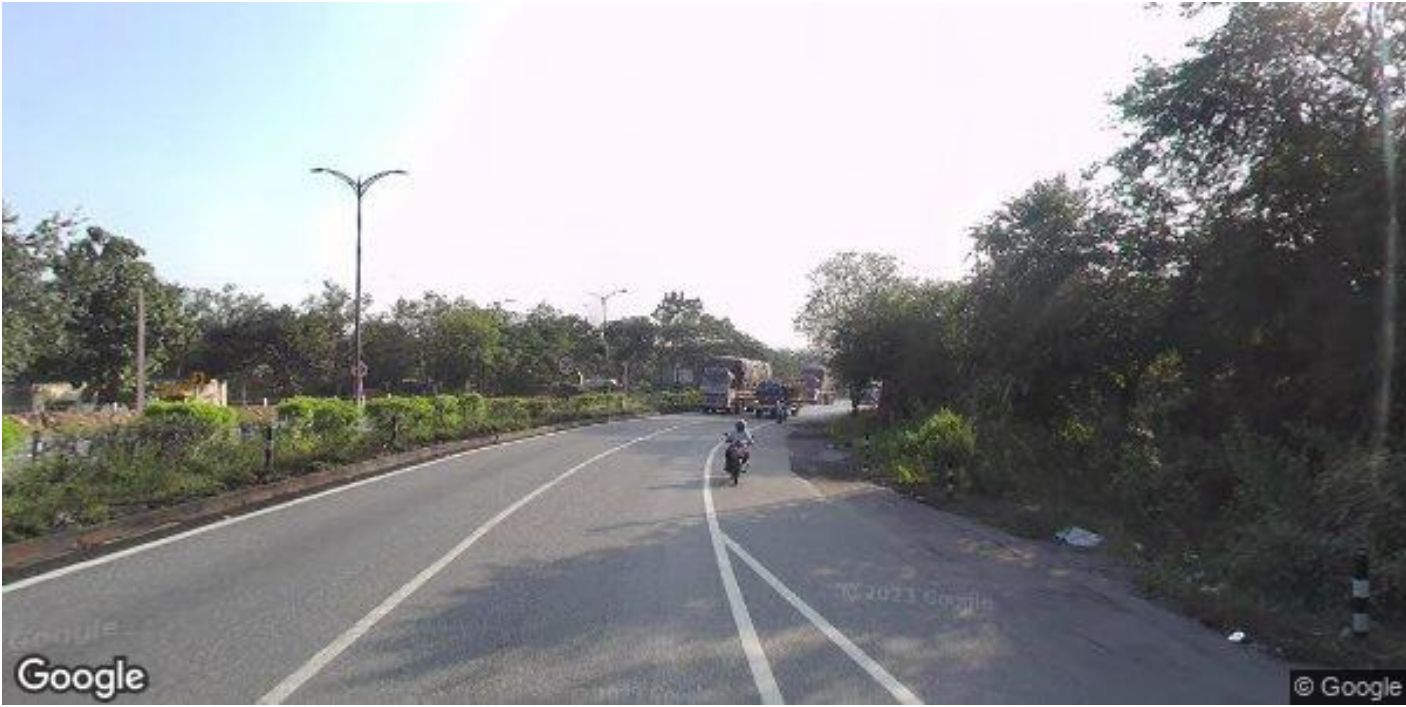
**Risk Type:** Turn  
**Risk Level:** Medium  
**Speed Limit:** 30 KM/Hr  
**Coordinates:** 11.96320, 78.05139

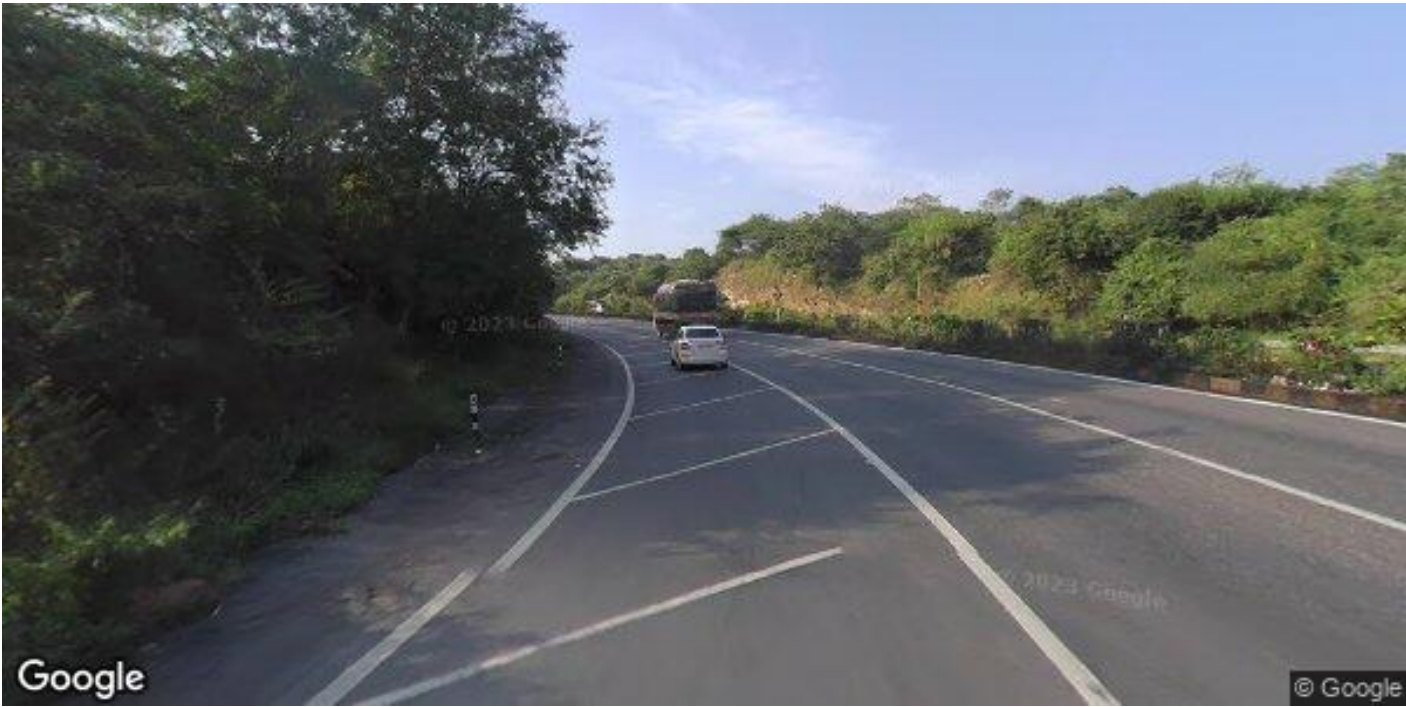
**Risk Type:** Turn  
**Risk Level:** Medium  
**Speed Limit:** 30 KM/Hr  
**Coordinates:** 11.96401, 78.05134

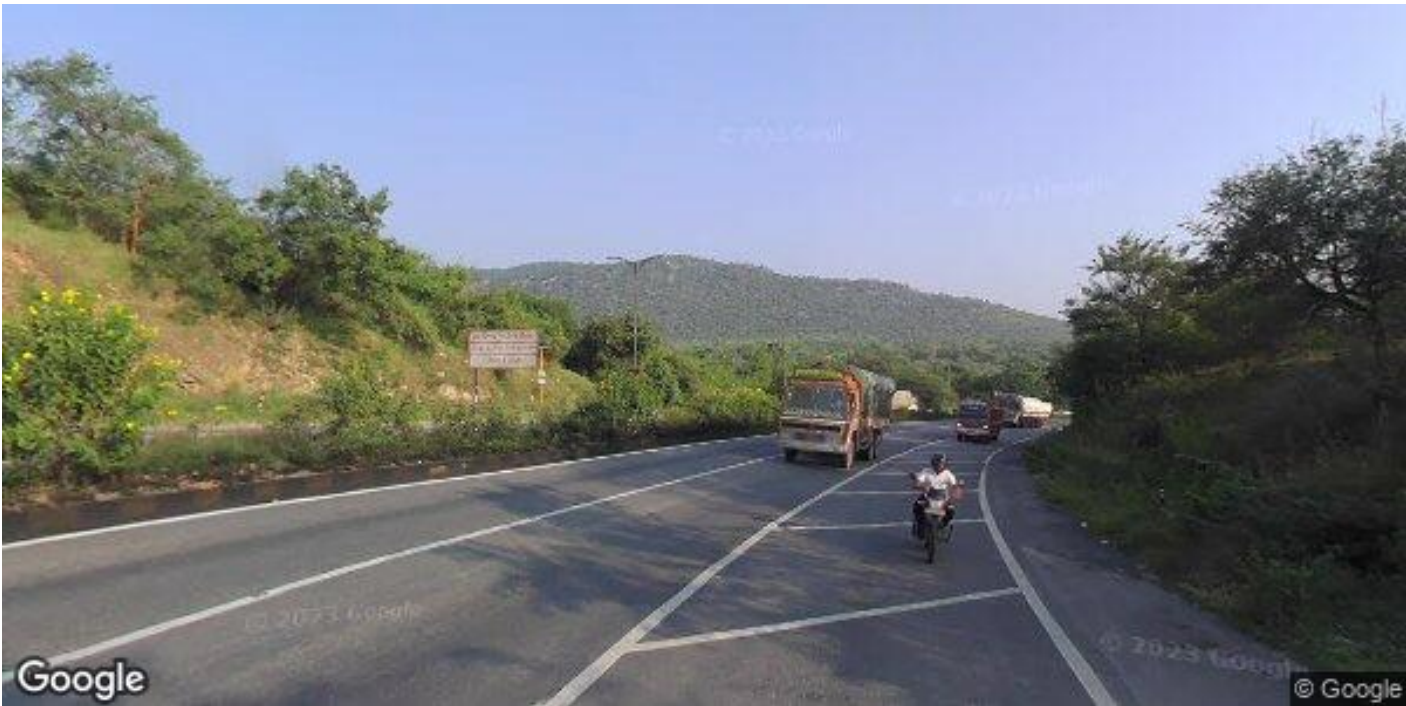
**Risk Type:** Turn  
**Risk Level:** Medium  
**Speed Limit:** 30 KM/Hr  
**Coordinates:** 11.96463, 78.05077

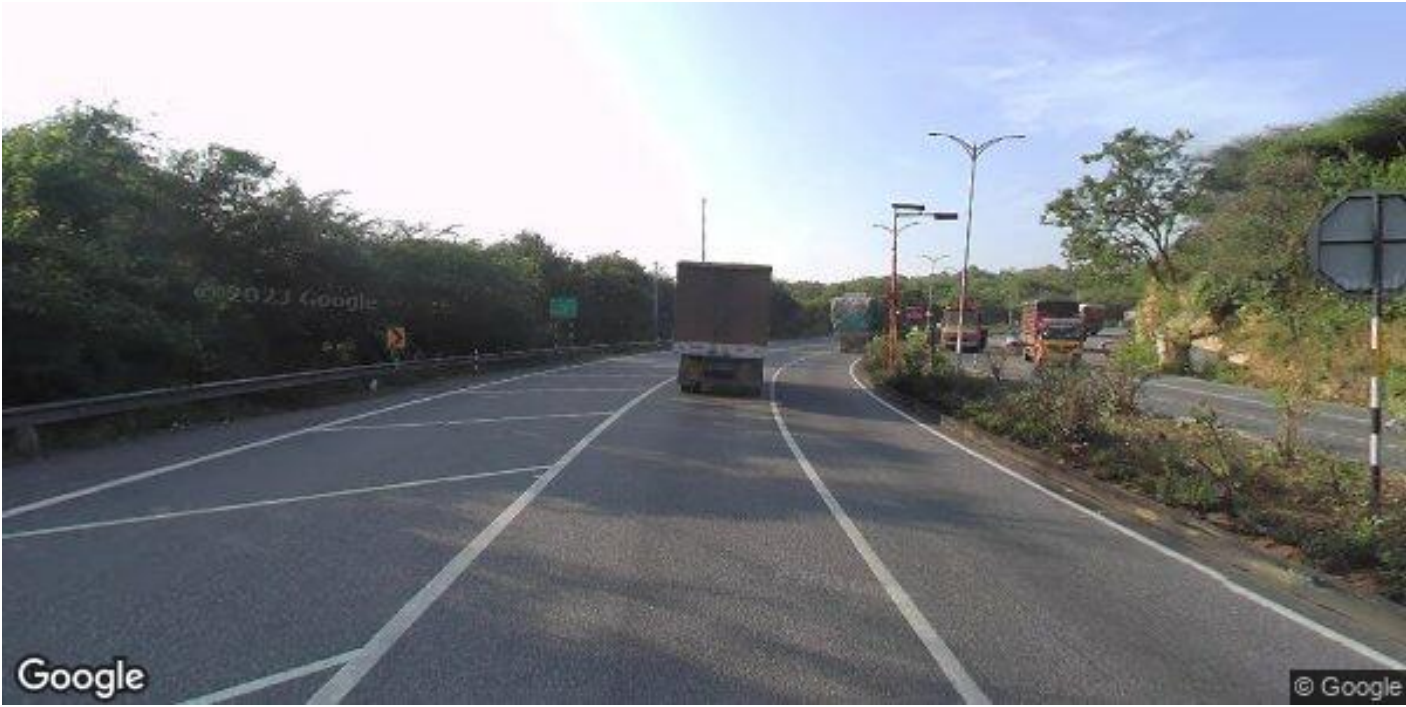
**Risk Type:** Turn  
**Risk Level:** Medium  
**Speed Limit:** 30 KM/Hr  
**Coordinates:** 11.96504, 78.04975

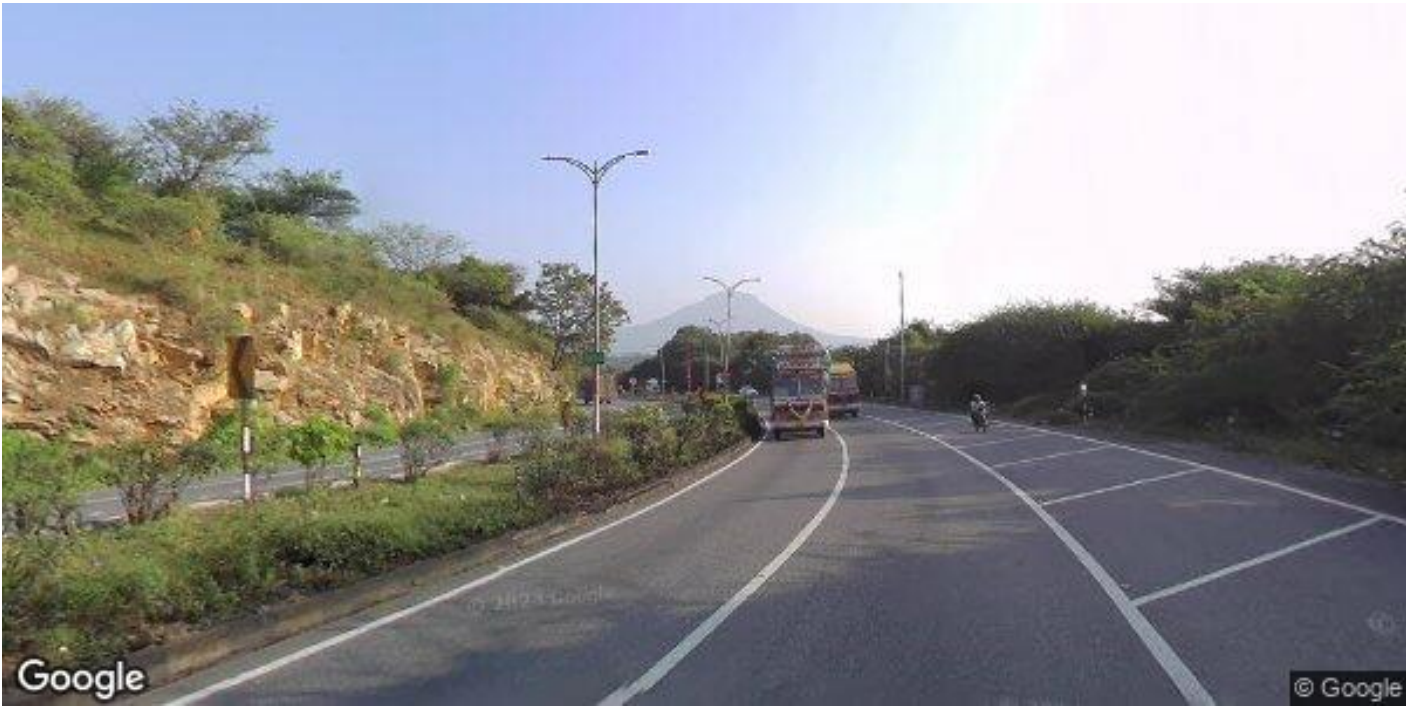
**Risk Type:** Turn  
**Risk Level:** High  
**Speed Limit:** 15 KM/Hr  
**Coordinates:** 11.96597, 78.04920

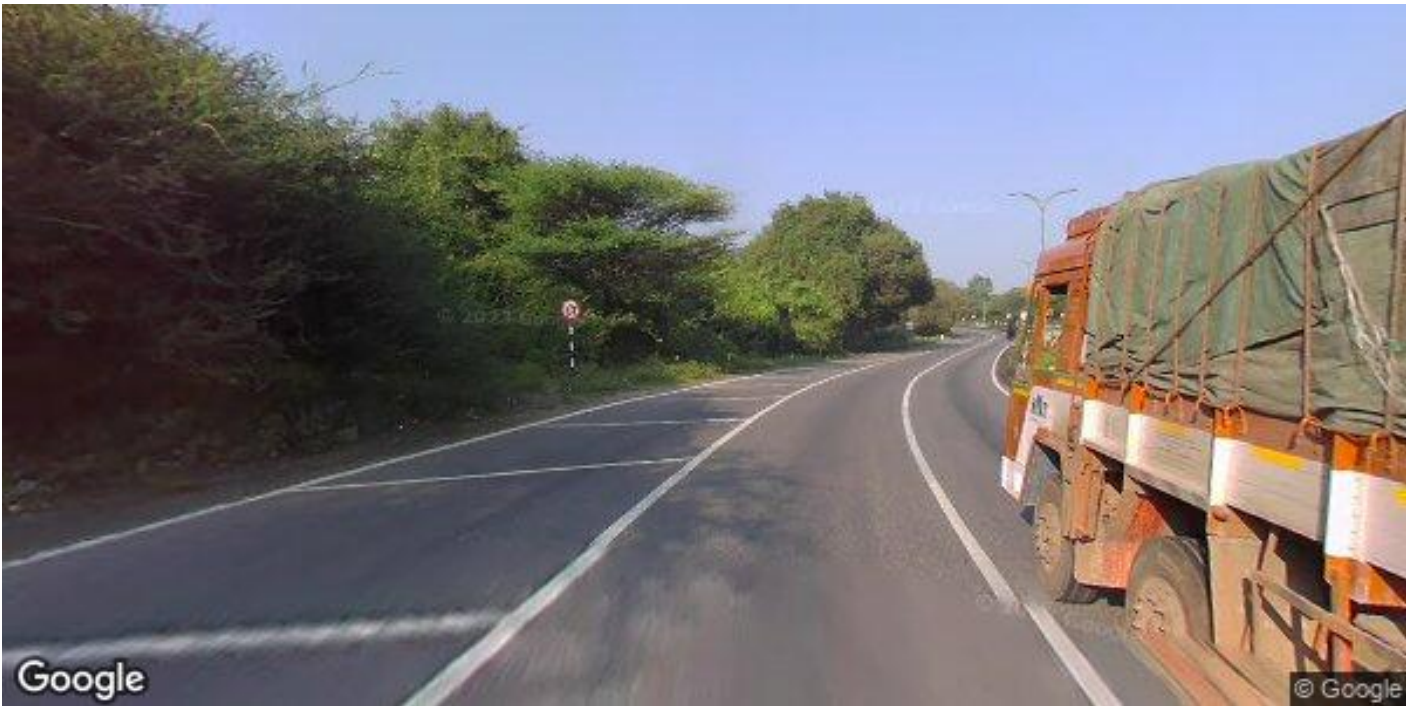
**Risk Type:** Turn  
**Risk Level:** Medium  
**Speed Limit:** 30 KM/Hr  
**Coordinates:** 11.96679, 78.04942

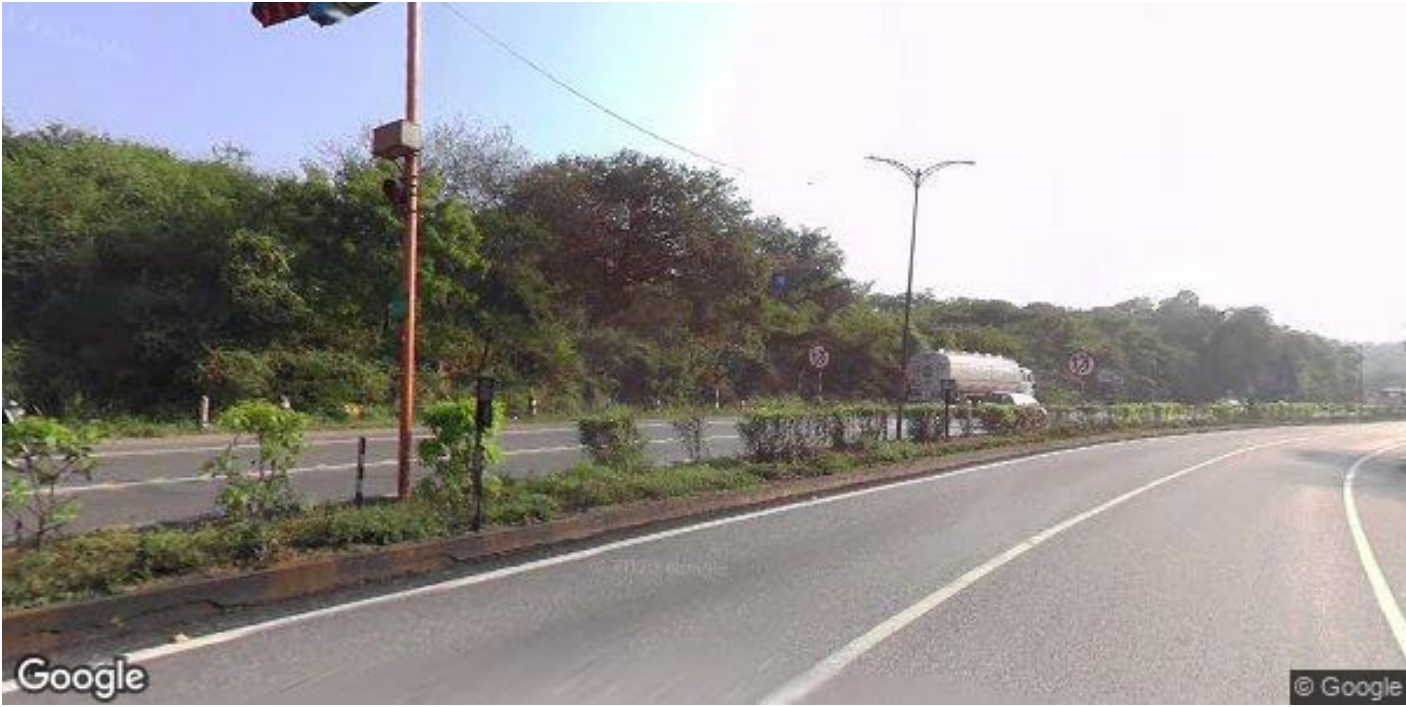
**Risk Type:** Turn  
**Risk Level:** Medium  
**Speed Limit:** 30 KM/Hr  
**Coordinates:** 11.96804, 78.05080

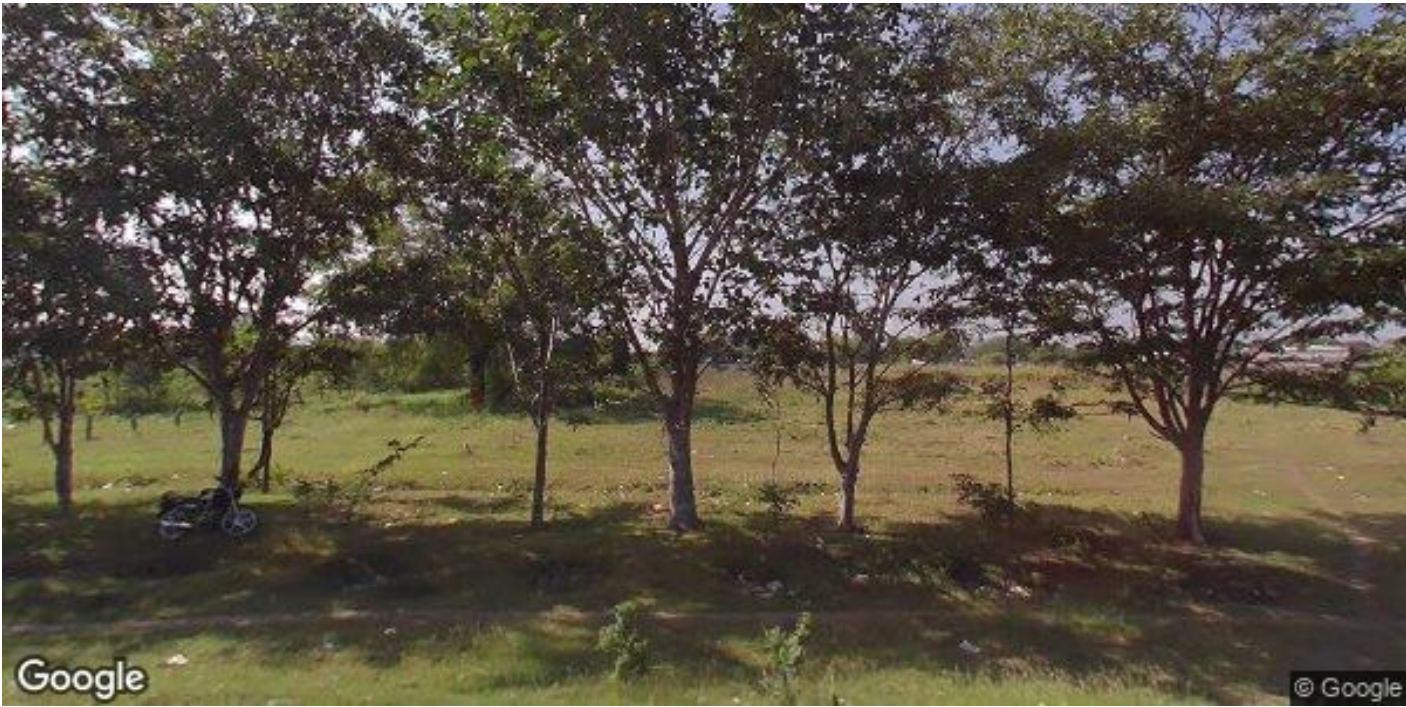
**Risk Type:** Turn  
**Risk Level:** Medium  
**Speed Limit:** 30 KM/Hr  
**Coordinates:** 12.12067, 78.13281

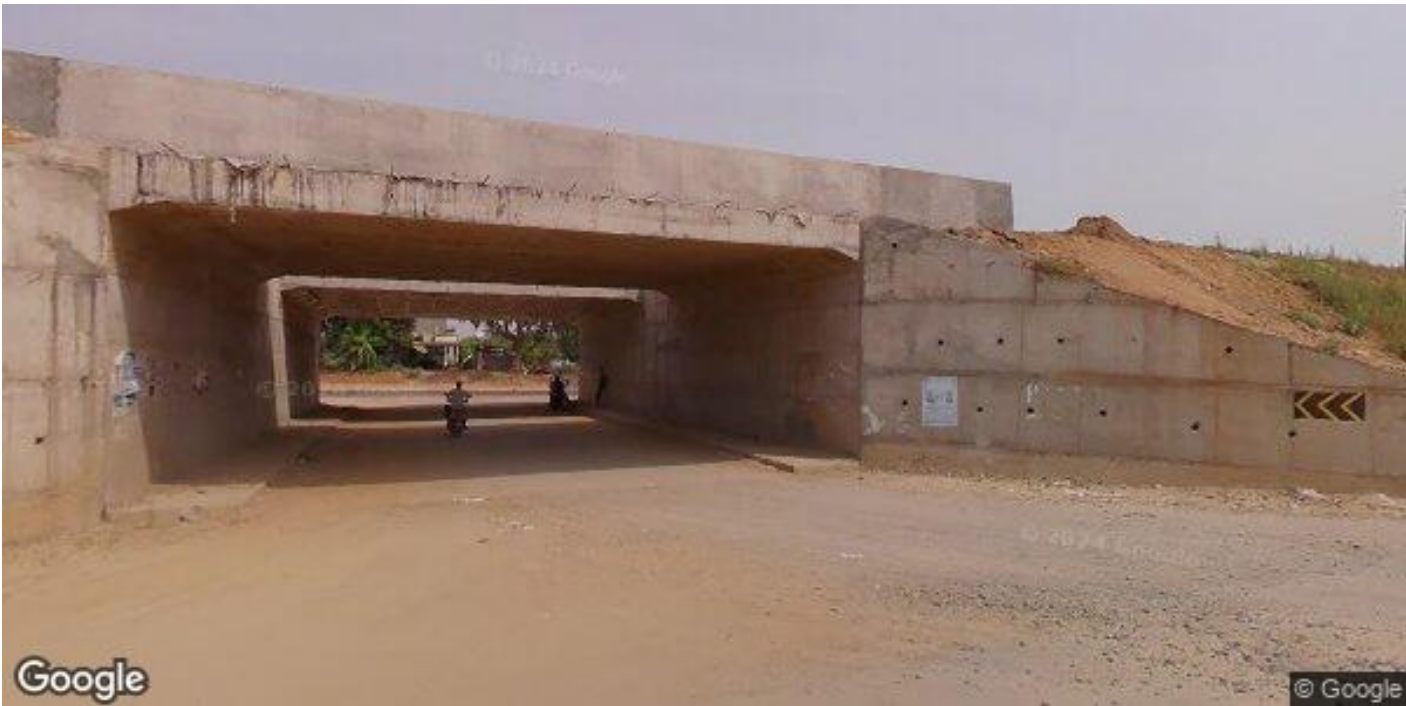
**Risk Type:** Turn  
**Risk Level:** High  
**Speed Limit:** 15 KM/Hr  
**Coordinates:** 12.26532, 78.08427
