# IndianOil

## JOURNEY RISK MANAGEMENT (JRM) STUDY

### Salem Terminal to SUBRAMANYAA FUELS

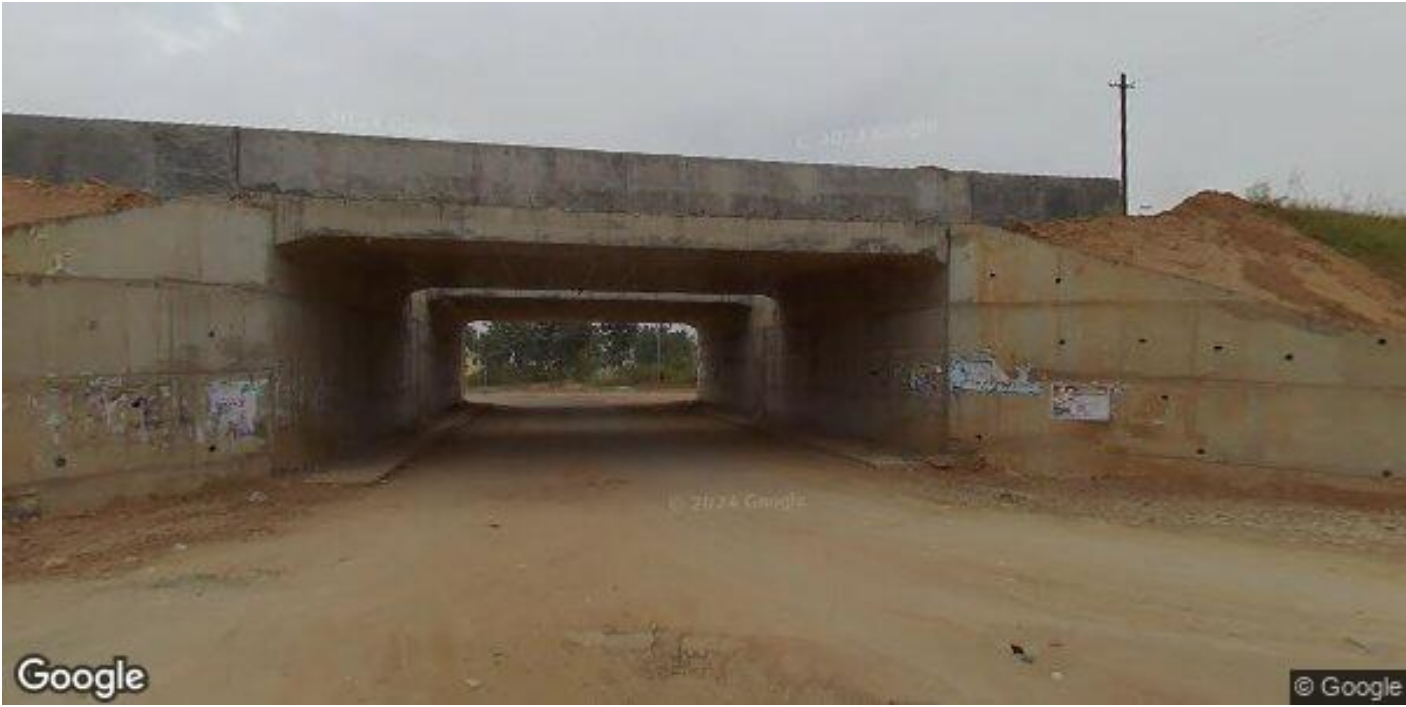
**Risk Type:** Turn  
**Risk Level:** High  
**Speed Limit:** 15 KM/Hr  
**Coordinates:** 12.26548, 78.08438

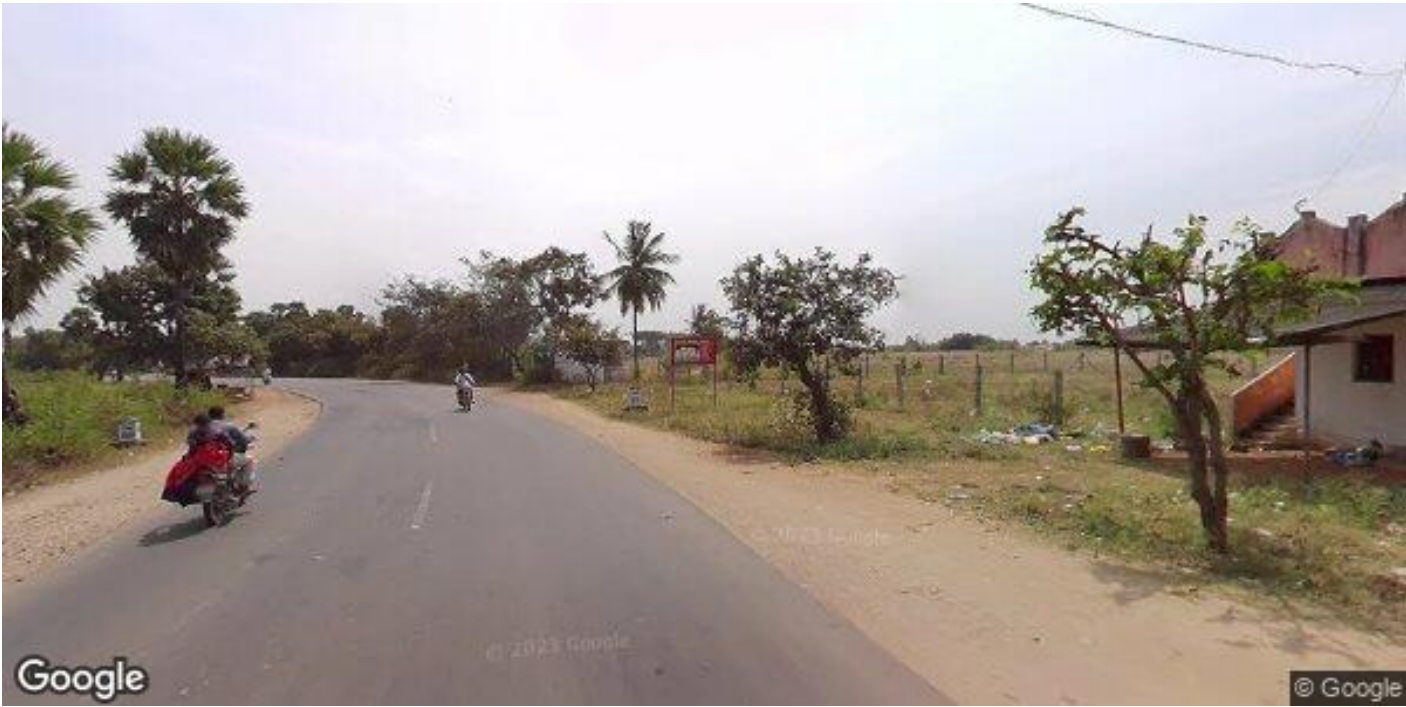
**Risk Type:** Turn  
**Risk Level:** Medium  
**Speed Limit:** 30 KM/Hr  
**Coordinates:** 12.27200, 78.08089

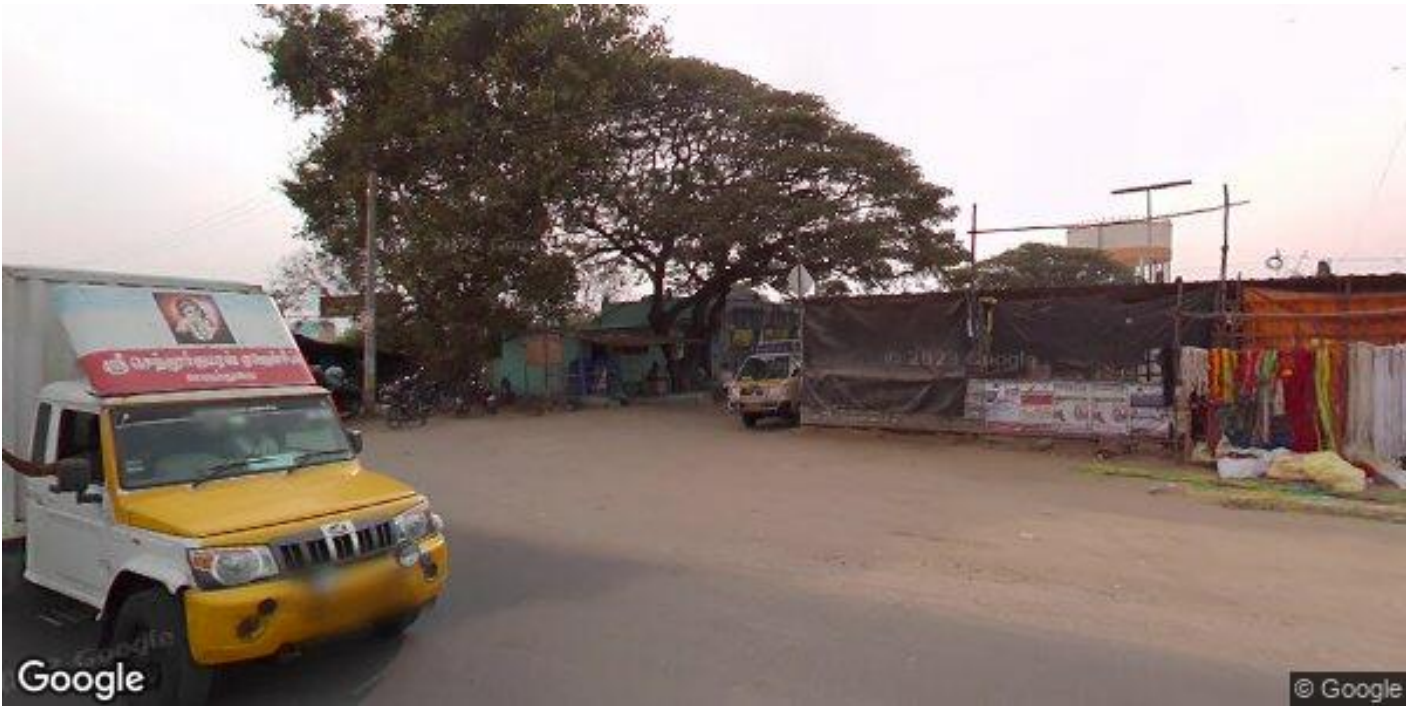
**Risk Type:** Turn  
**Risk Level:** High  
**Speed Limit:** 15 KM/Hr  
**Coordinates:** 12.29579, 78.07370

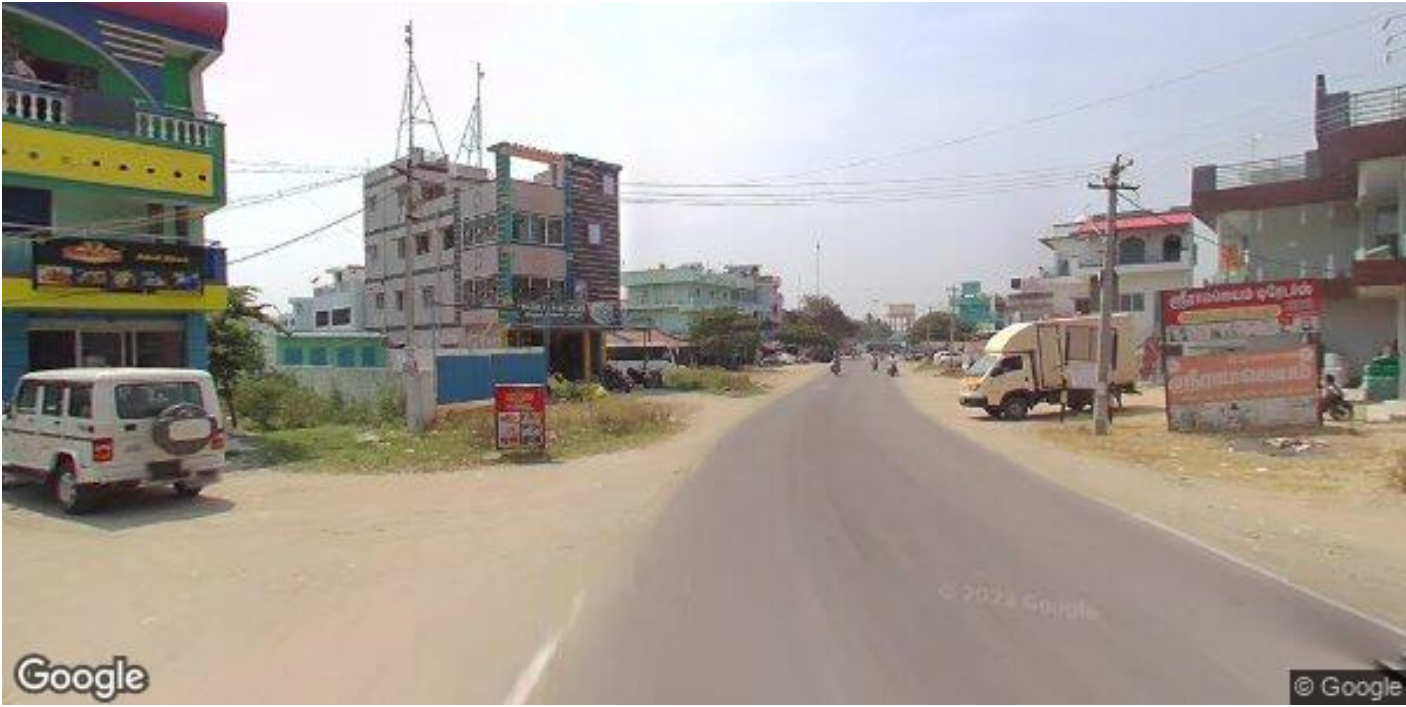
**Risk Type:** Turn  
**Risk Level:** High  
**Speed Limit:** 15 KM/Hr  
**Coordinates:** 12.29649, 78.07542
