# IndianOil

## **JOURNEY RISK MANAGEMENT (JRM) STUDY**

**Salem Terminal to ADITYA TRADERS IOC DEALERS  
NH-7**

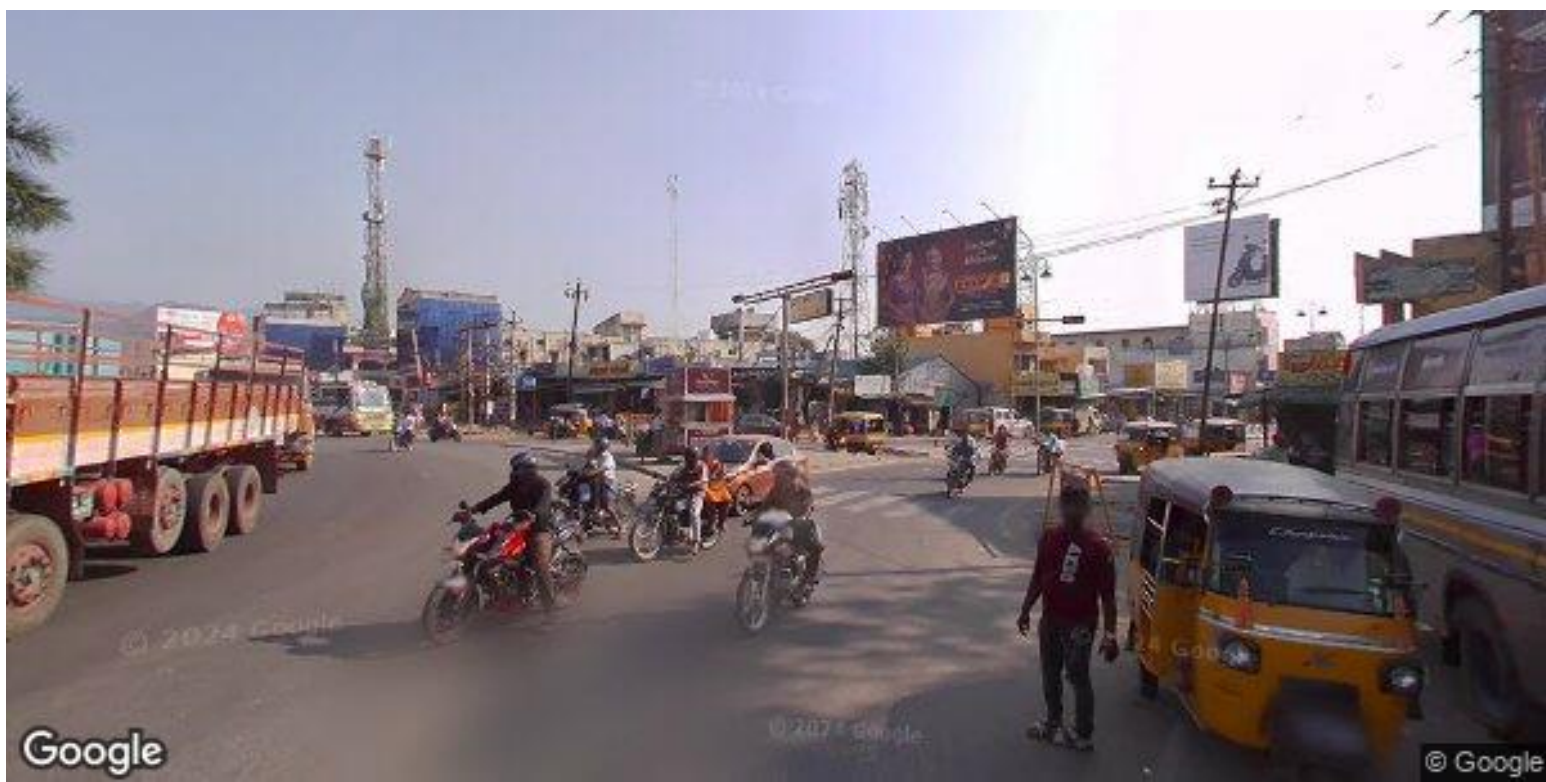
**Coordinates:** 11.63266, 78.12699

**Risk Type:** Roundabout

**Risk Level:** High

**Speed Limit:** 15 KM/Hr

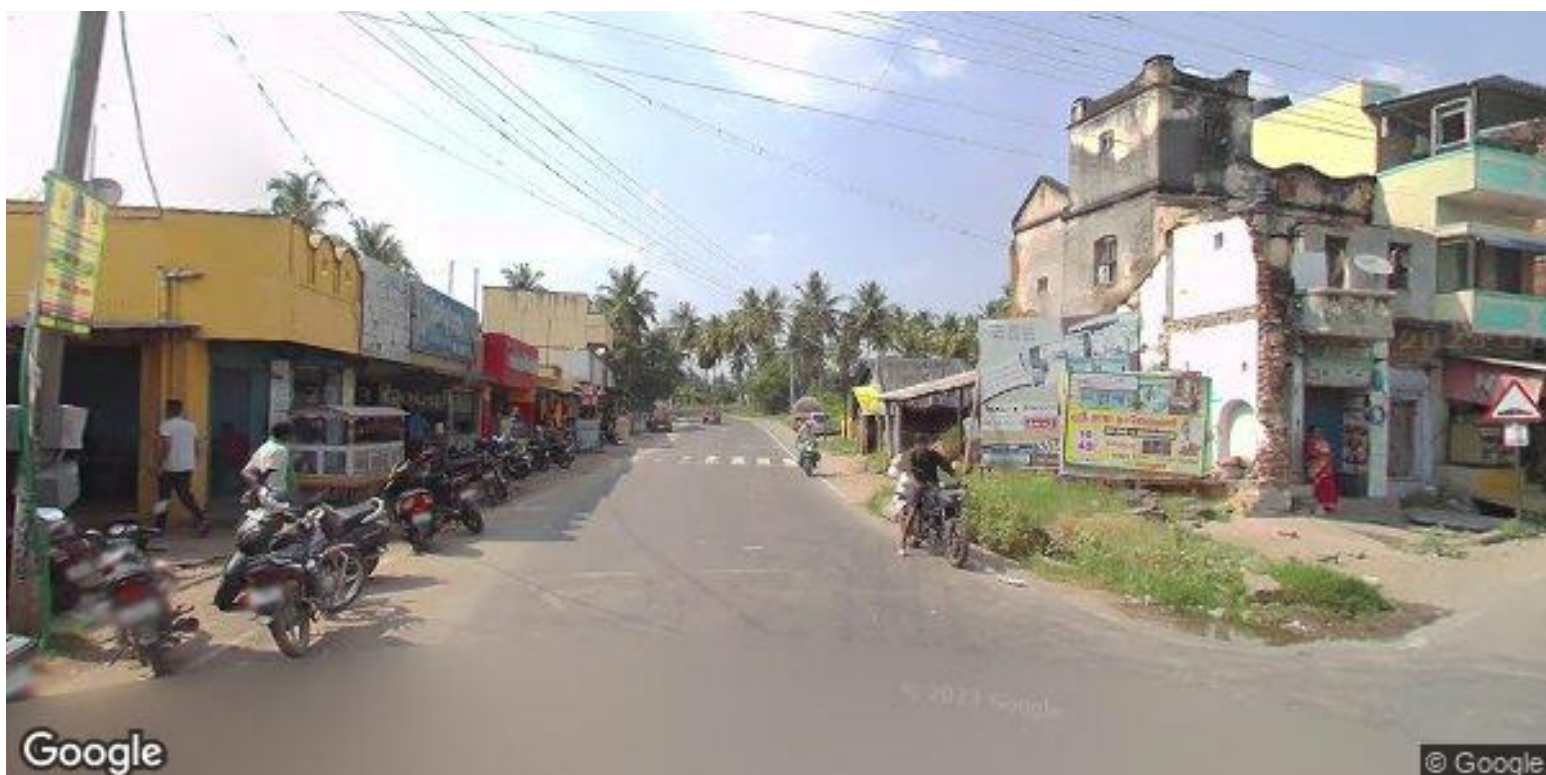
**Coordinates: 11.45007, 77.87201**

**Risk Type: Turn**

**Risk Level: High**

**Speed Limit: 15 KM/Hr**

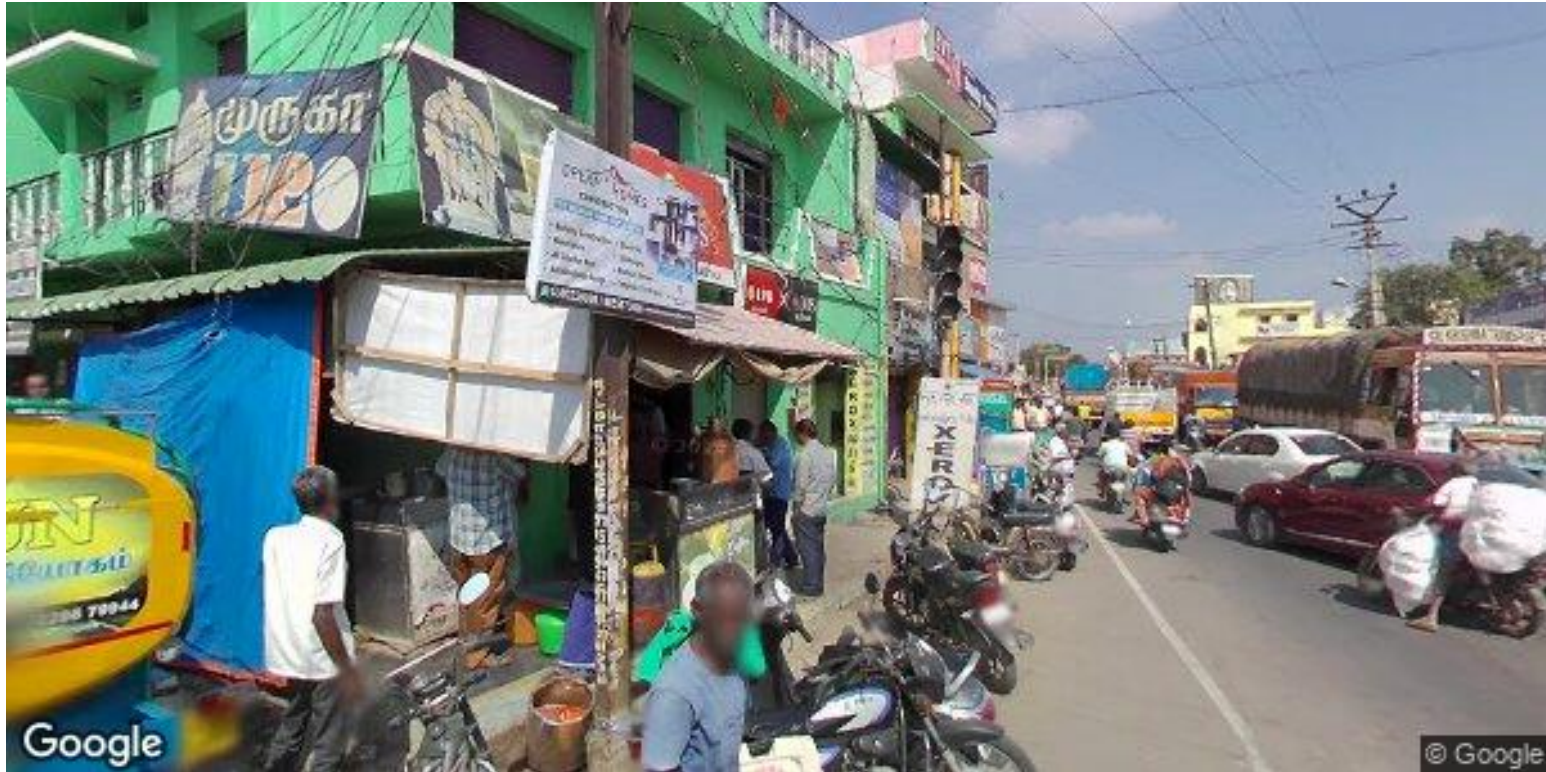
**Coordinates: 11.47407, 77.86839**

**Risk Type: Turn**

**Risk Level: High**

**Speed Limit: 15 KM/Hr**

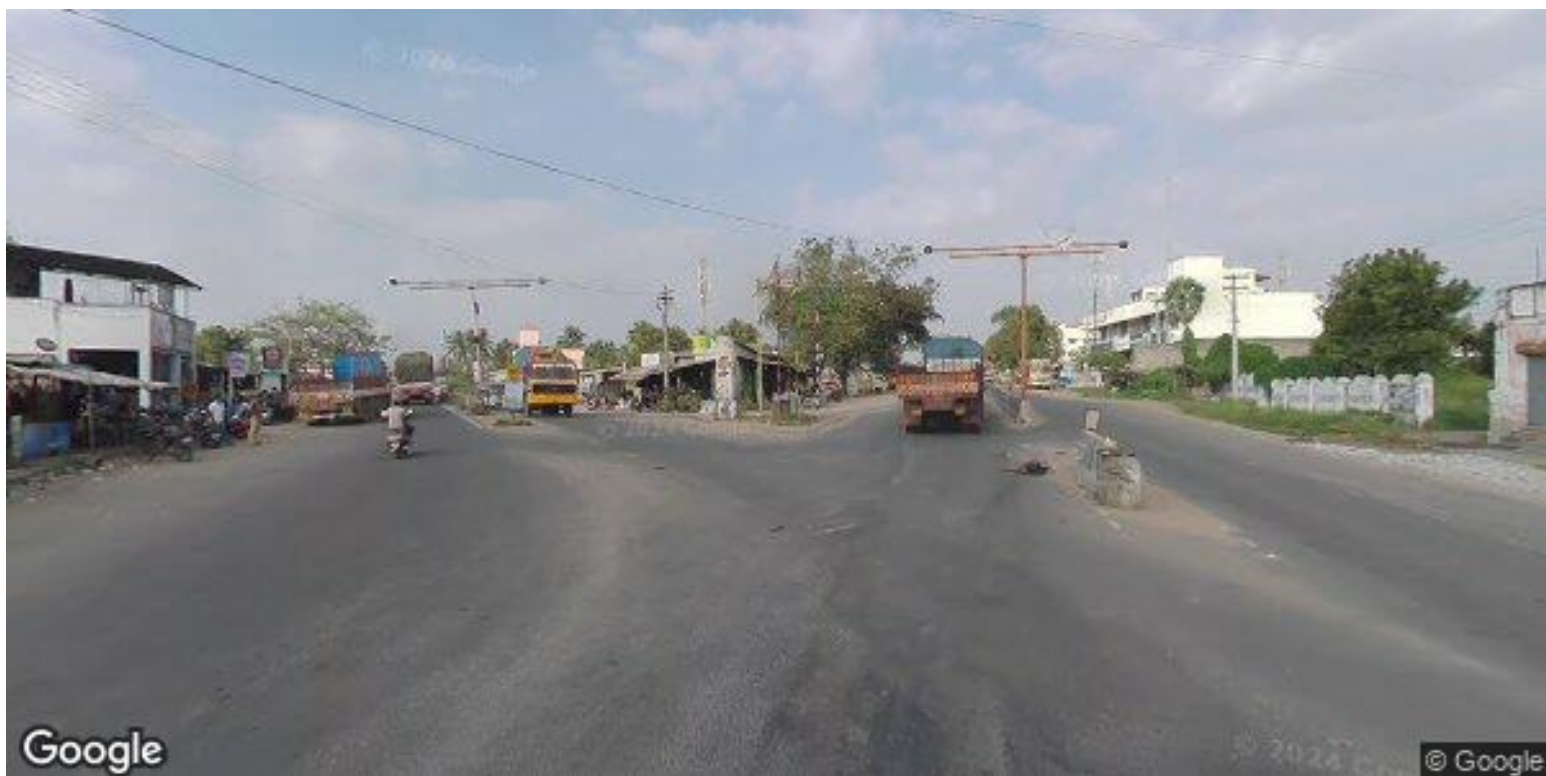
**Coordinates: 11.48366, 77.88781**

**Risk Type: Turn**

**Risk Level: Medium**

**Speed Limit: 30 KM/Hr**

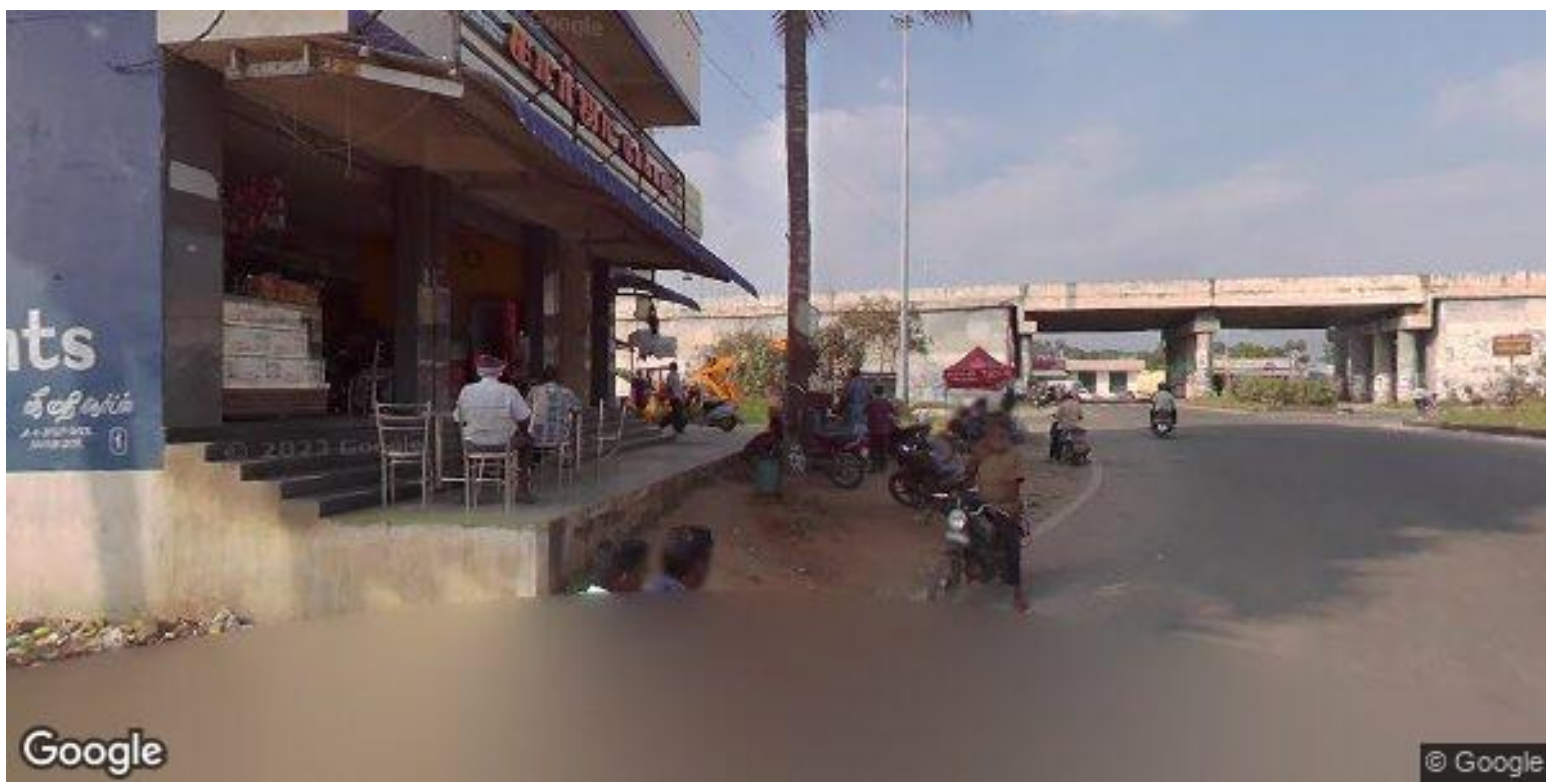
Coordinates: 11.49149, 77.89601

Risk Type: Turn

Risk Level: High

Speed Limit: 15 KM/Hr

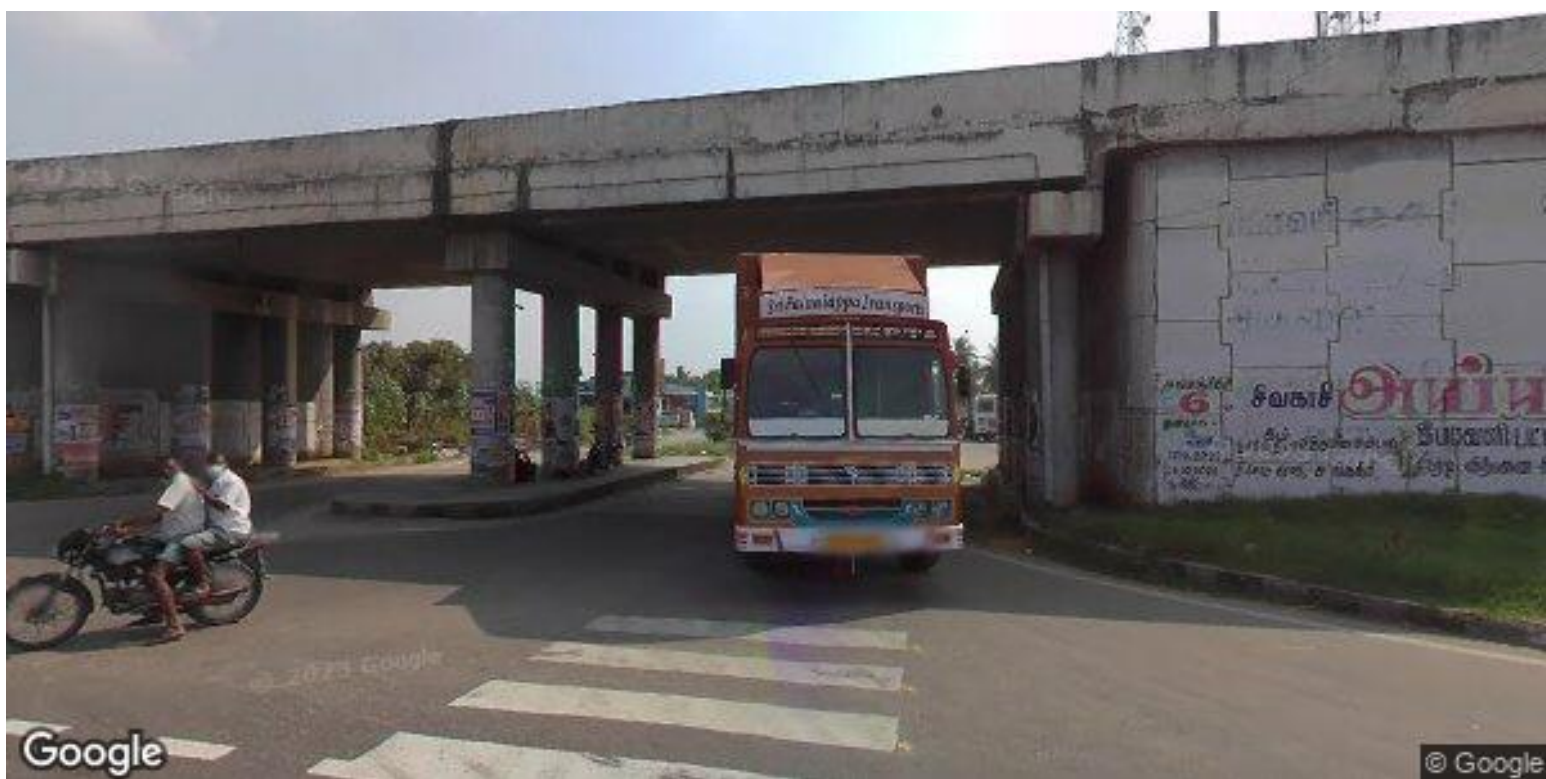
Coordinates: 11.49224, 77.89601

Risk Type: Turn

Risk Level: High

Speed Limit: 15 KM/Hr

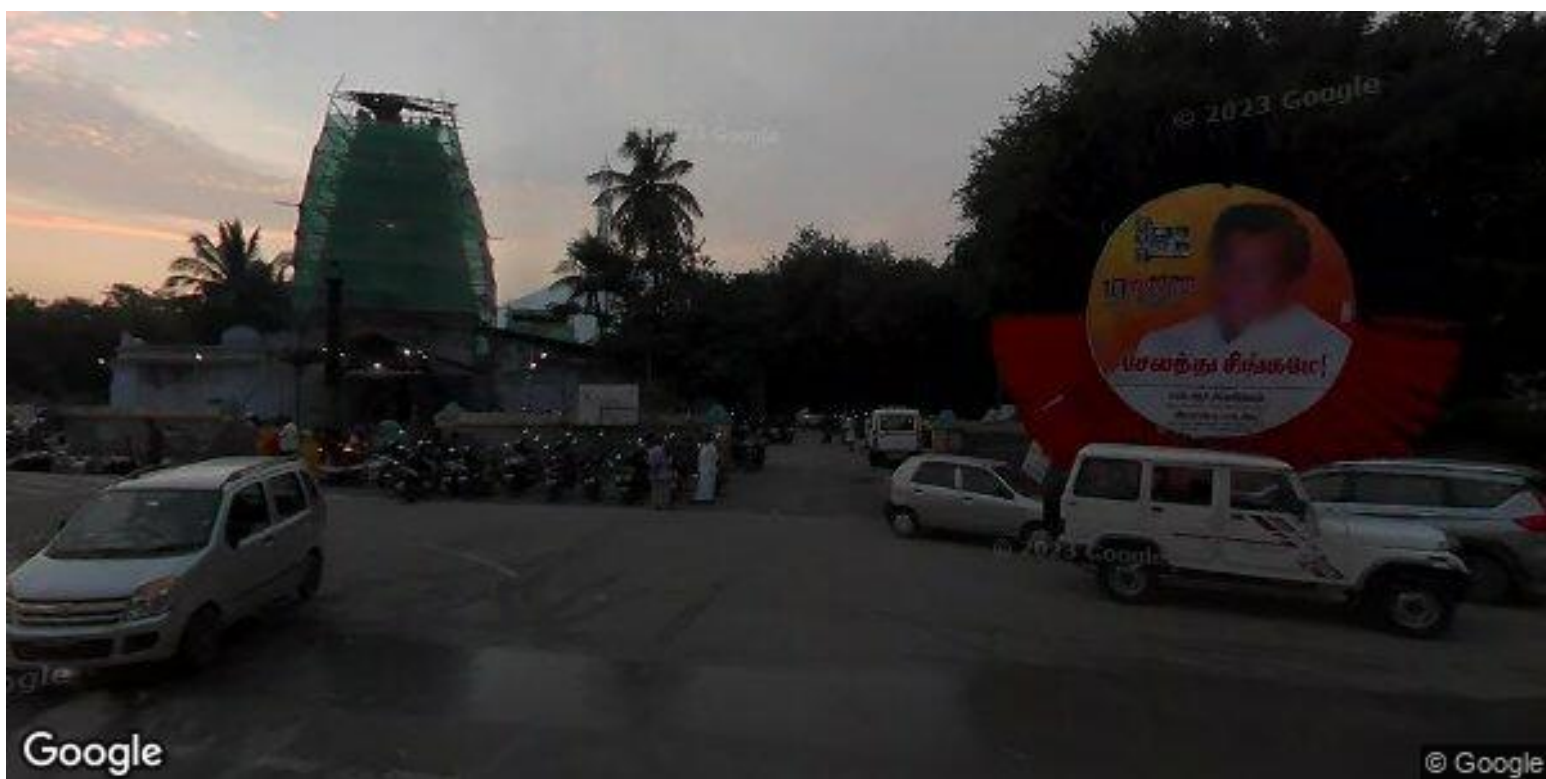
**Risk Type:** Turn  
**Risk Level:** High  
**Speed Limit:** 15 KM/Hr  
**Coordinates:** 11.61233, 78.10397

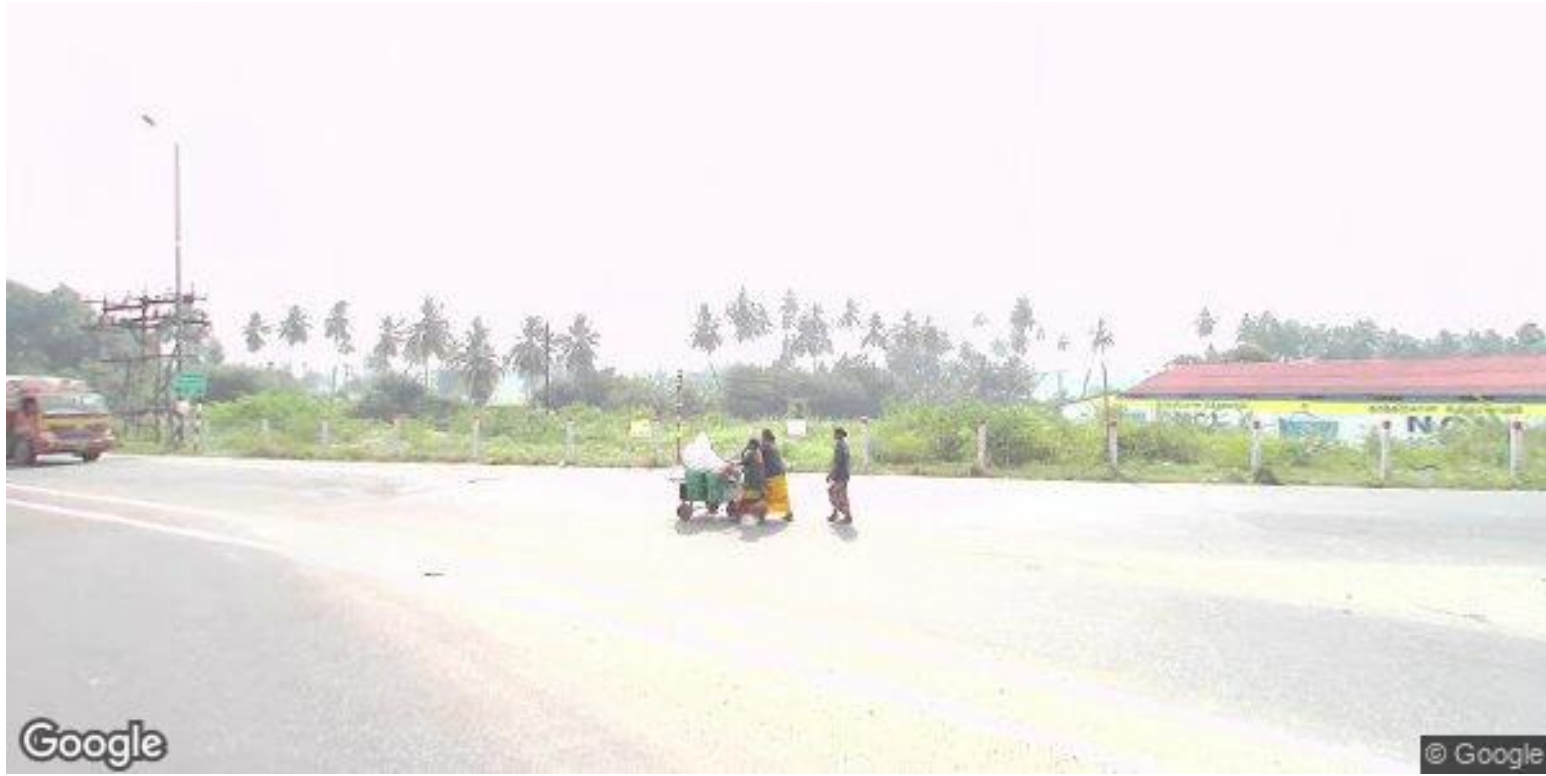
**Risk Type:** Turn  
**Risk Level:** High  
**Speed Limit:** 15 KM/Hr  
**Coordinates:** 11.61216, 78.10423

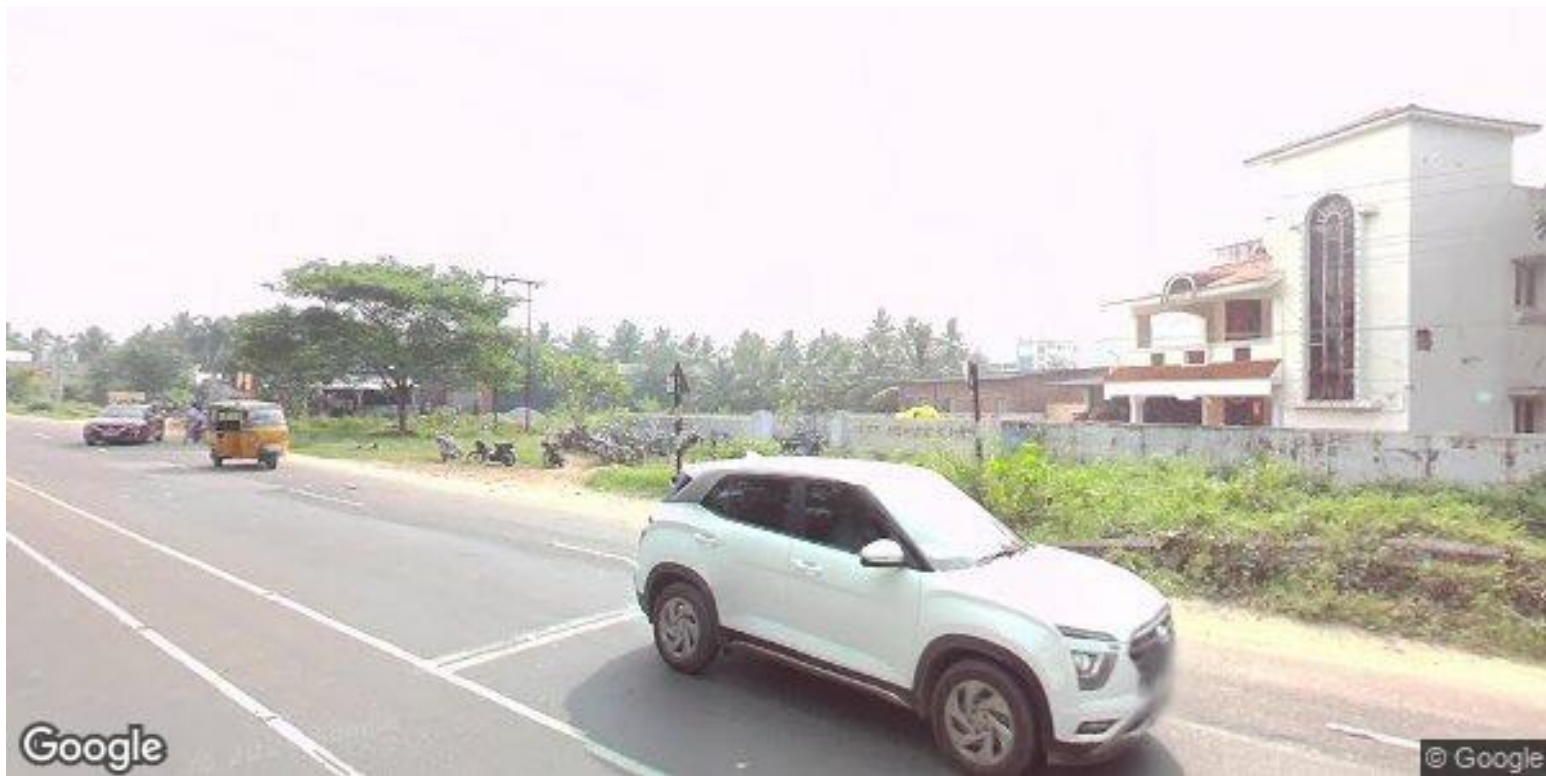
**Risk Type:** Turn  
**Risk Level:** Medium  
**Speed Limit:** 30 KM/Hr  
**Coordinates:** 11.61284, 78.10600

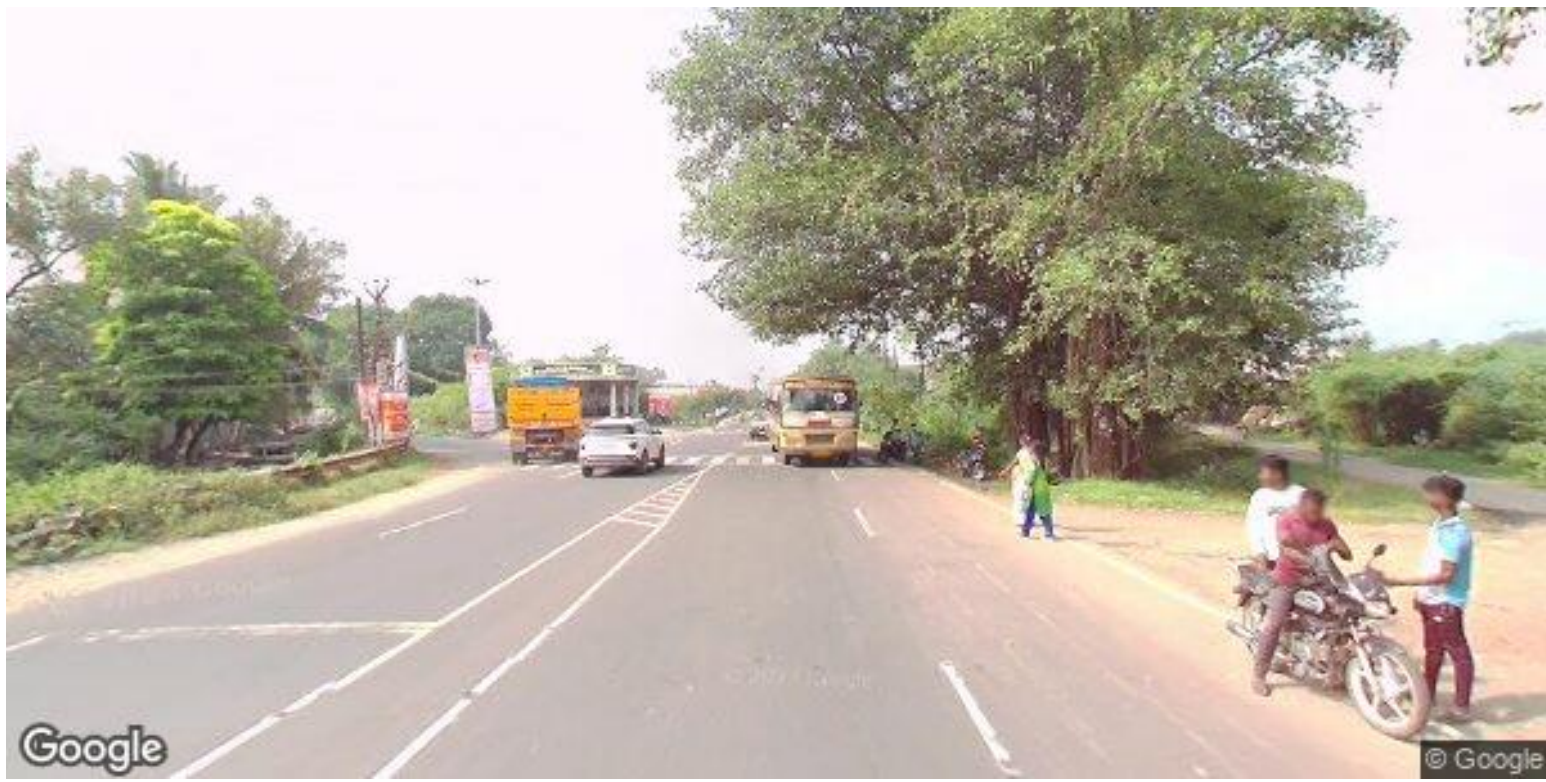
**Coordinates:** 11.61292, 78.10606

**Risk Type:** Turn

**Risk Level:** Medium

**Speed Limit:** 30 KM/Hr

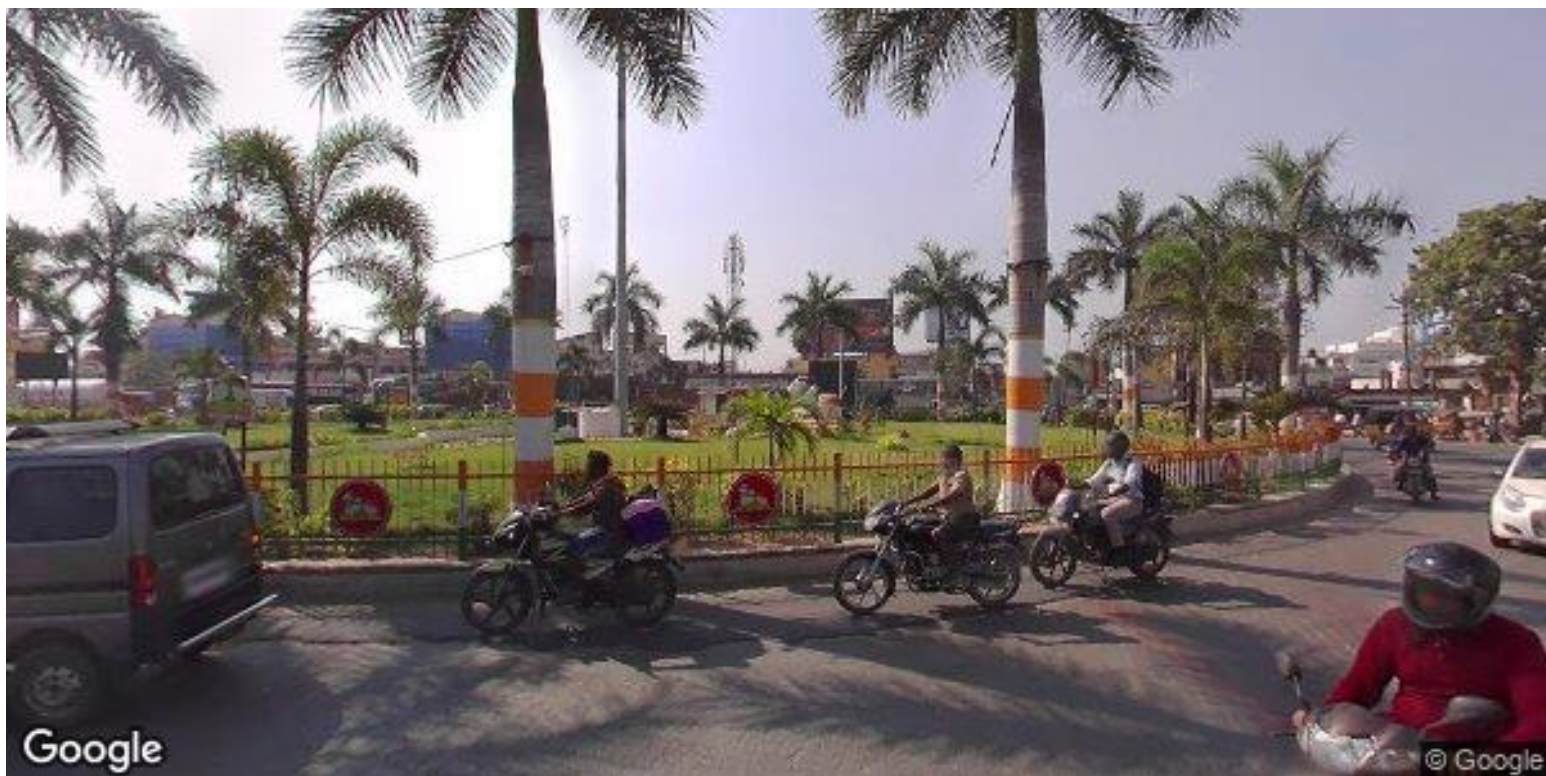
**Coordinates:** 11.63306, 78.12728

**Risk Type:** Turn

**Risk Level:** Medium

**Speed Limit:** 30 KM/Hr

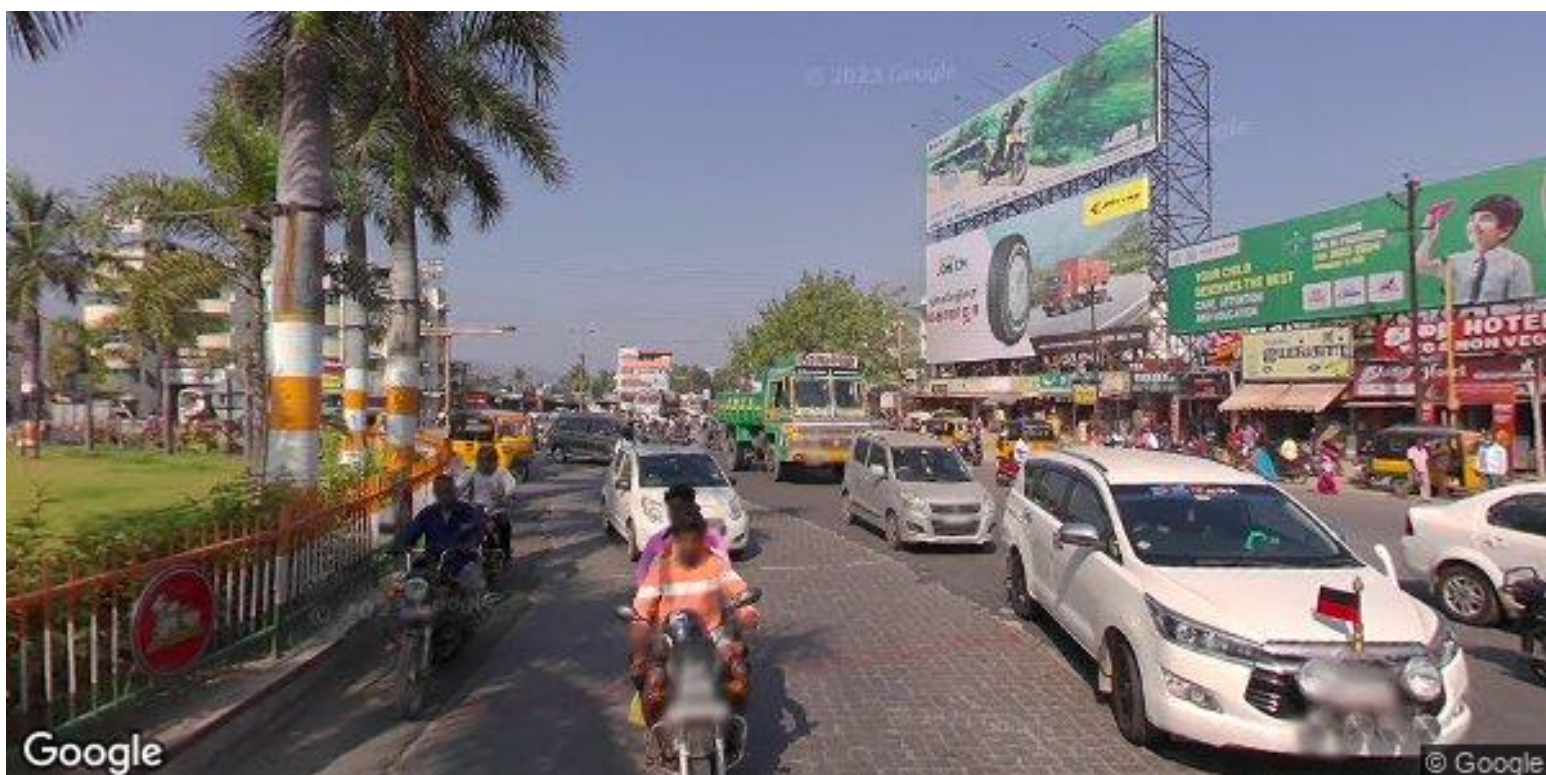
**Coordinates:** 11.63302, 78.12742

**Risk Type:** Turn

**Risk Level:** Medium

**Speed Limit:** 30 KM/Hr

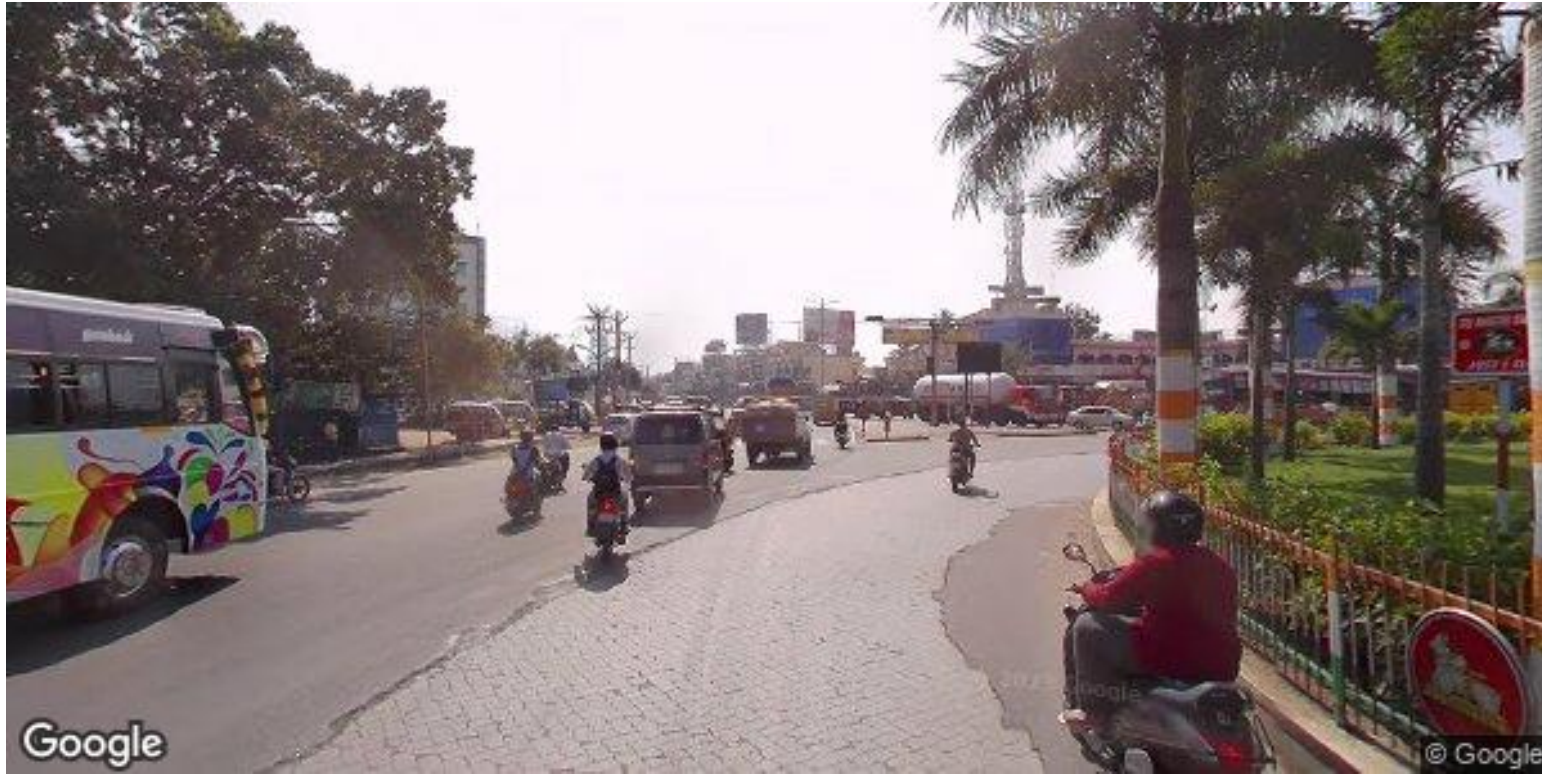
**Coordinates:** 11.63292, 78.12753

**Risk Type:** Turn

**Risk Level:** Medium

**Speed Limit:** 30 KM/Hr
