# IndianOil

## JOURNEY RISK MANAGEMENT (JRM) STUDY

### Salem Terminal to SELVAM FUELS IOC DEALERS

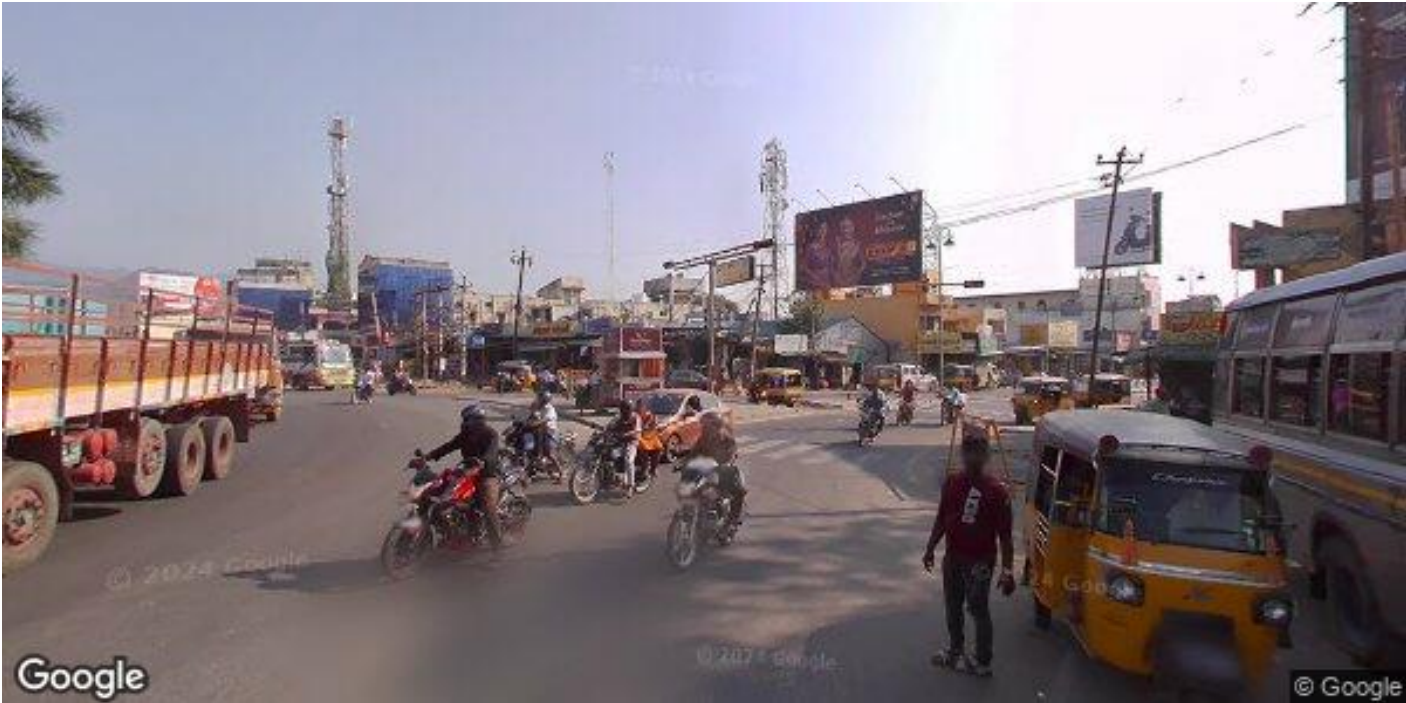
**Risk Type:** Roundabout  
**Risk Level:** High  
**Speed Limit:** 15 KM/Hr  
**Coordinates:** 11.63266, 78.12699

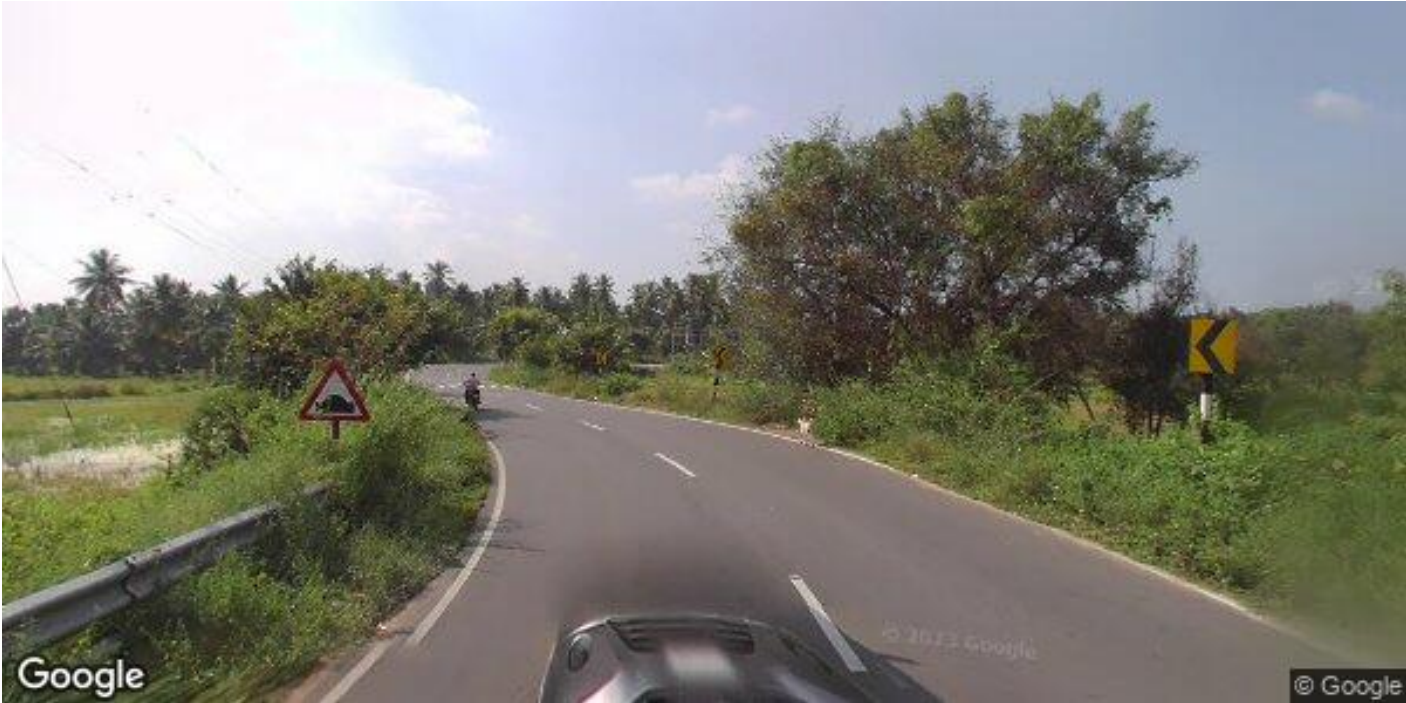
**Risk Type:** Turn  
**Risk Level:** Medium  
**Speed Limit:** 30 KM/Hr  
**Coordinates:** 11.45358, 77.85781

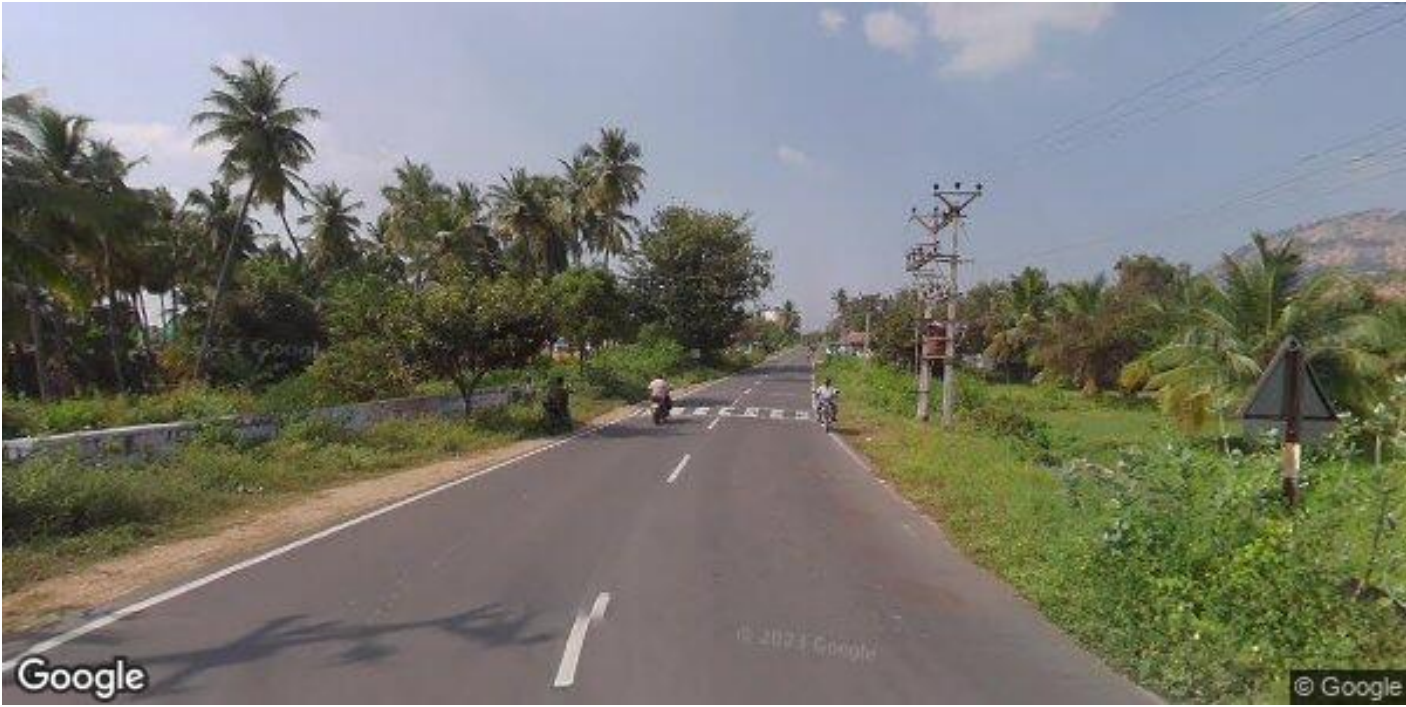
**Risk Type:** Turn  
**Risk Level:** Medium  
**Speed Limit:** 30 KM/Hr  
**Coordinates:** 11.45353, 77.85697

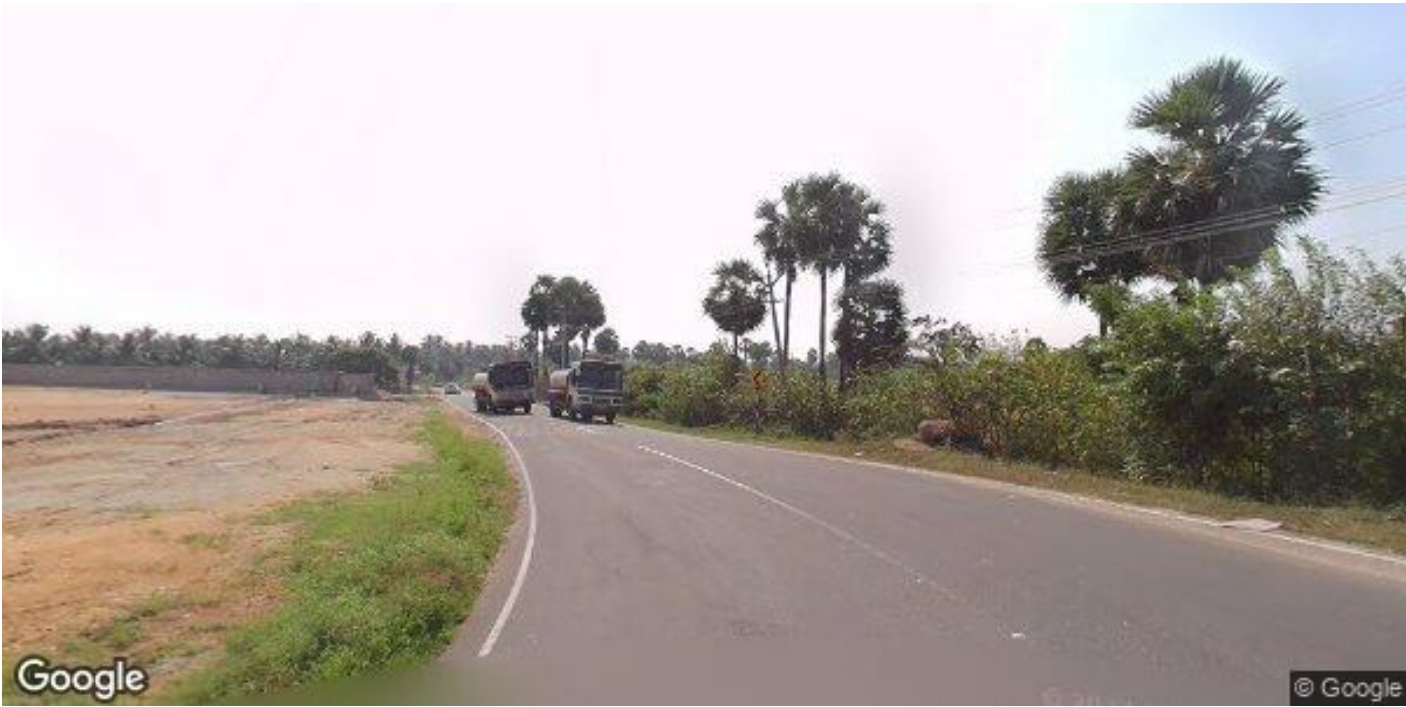
**Risk Type:** Turn  
**Risk Level:** Medium  
**Speed Limit:** 30 KM/Hr  
**Coordinates:** 11.45839, 77.85143

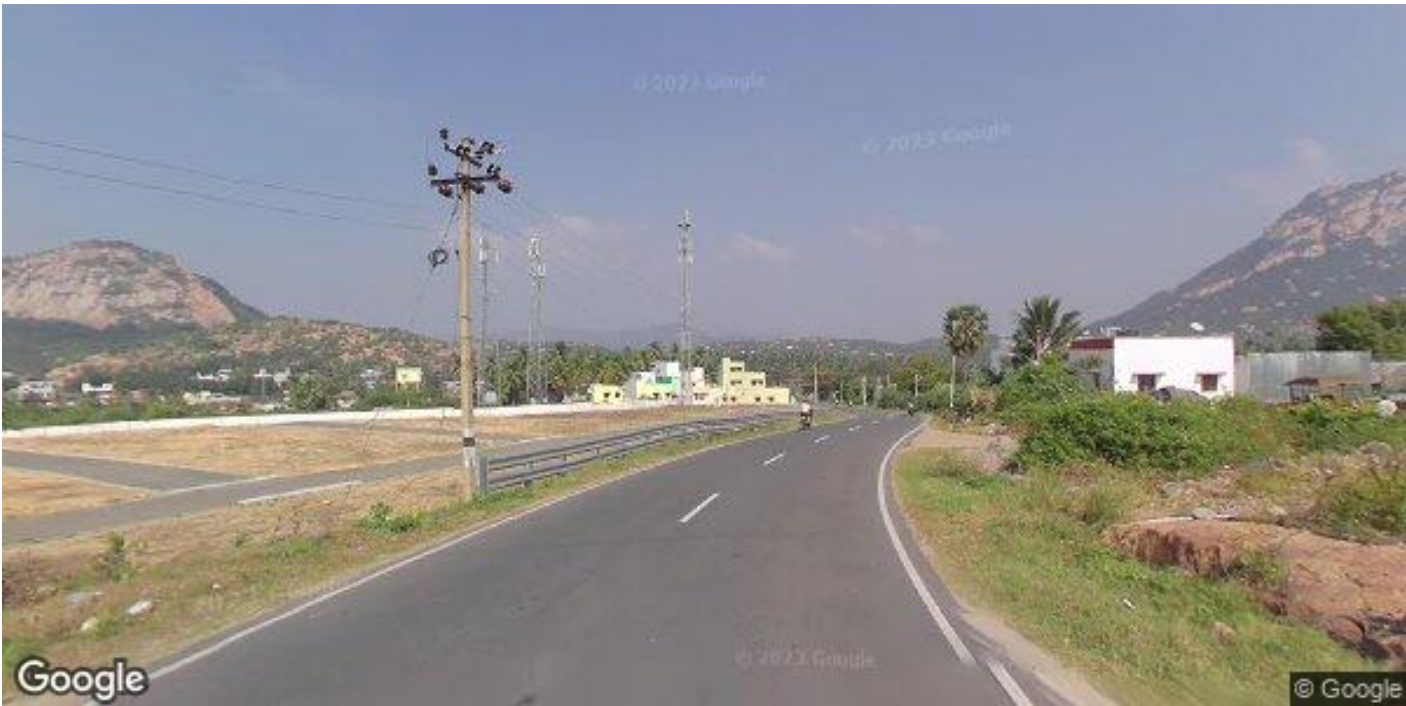
**Risk Type:** Turn  
**Risk Level:** Medium  
**Speed Limit:** 30 KM/Hr  
**Coordinates:** 11.46053, 77.85034

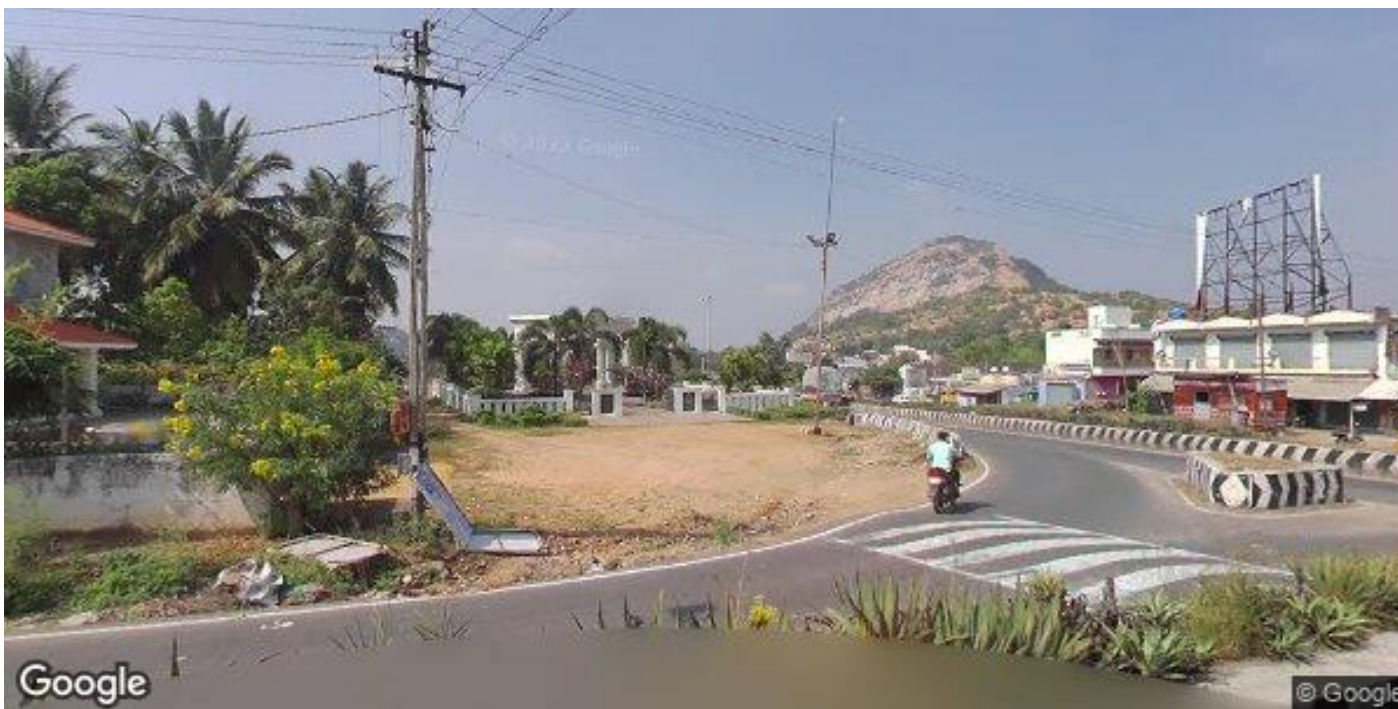
**Risk Type:** Turn  
**Risk Level:** Medium  
**Speed Limit:** 30 KM/Hr  
**Coordinates:** 11.46307, 77.84941

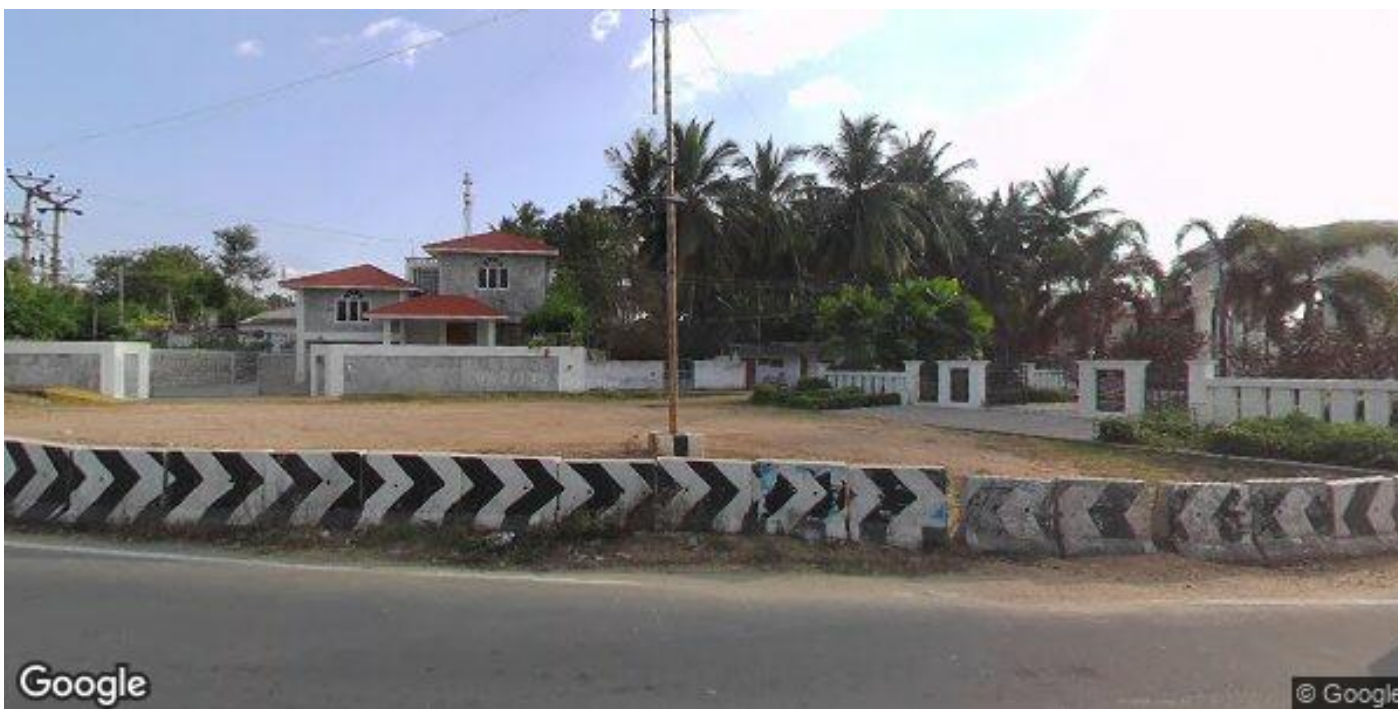
**Risk Type:** Turn  
**Risk Level:** Medium  
**Speed Limit:** 30 KM/Hr  
**Coordinates:** 11.46316, 77.84921

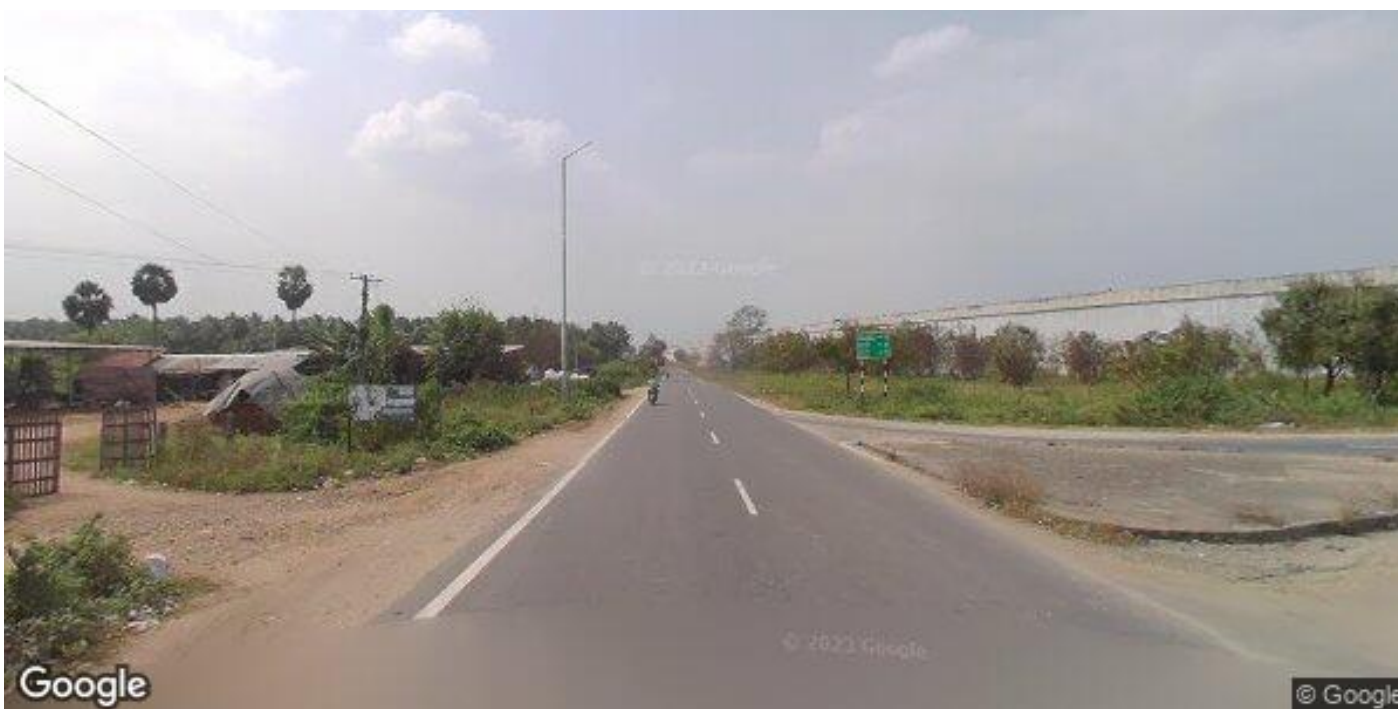
**Risk Type:** Turn  
**Risk Level:** High  
**Speed Limit:** 15 KM/Hr  
**Coordinates:** 11.45542, 77.81725

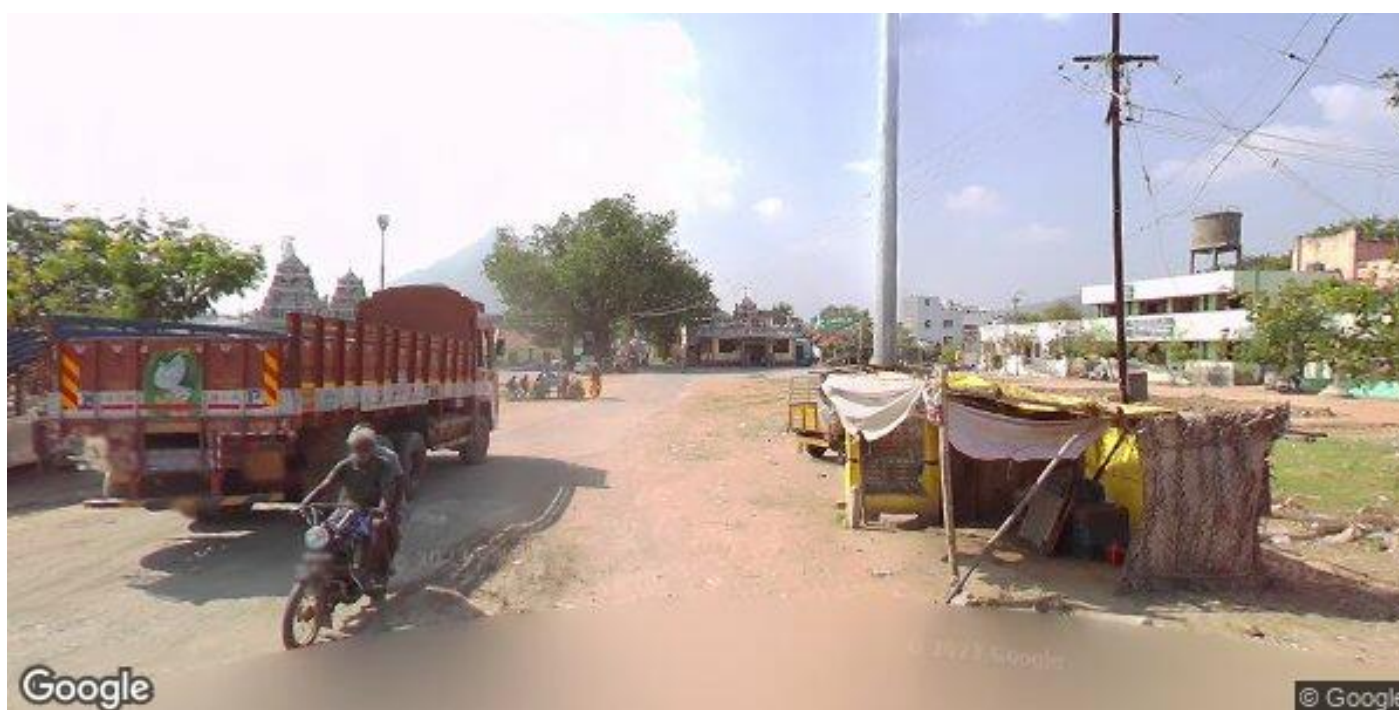
**Risk Type:** Blind Spot  
**Risk Level:** Blind Spot  
**Speed Limit:** 10 KM/Hr  
**Coordinates:** 11.62145, 78.10740

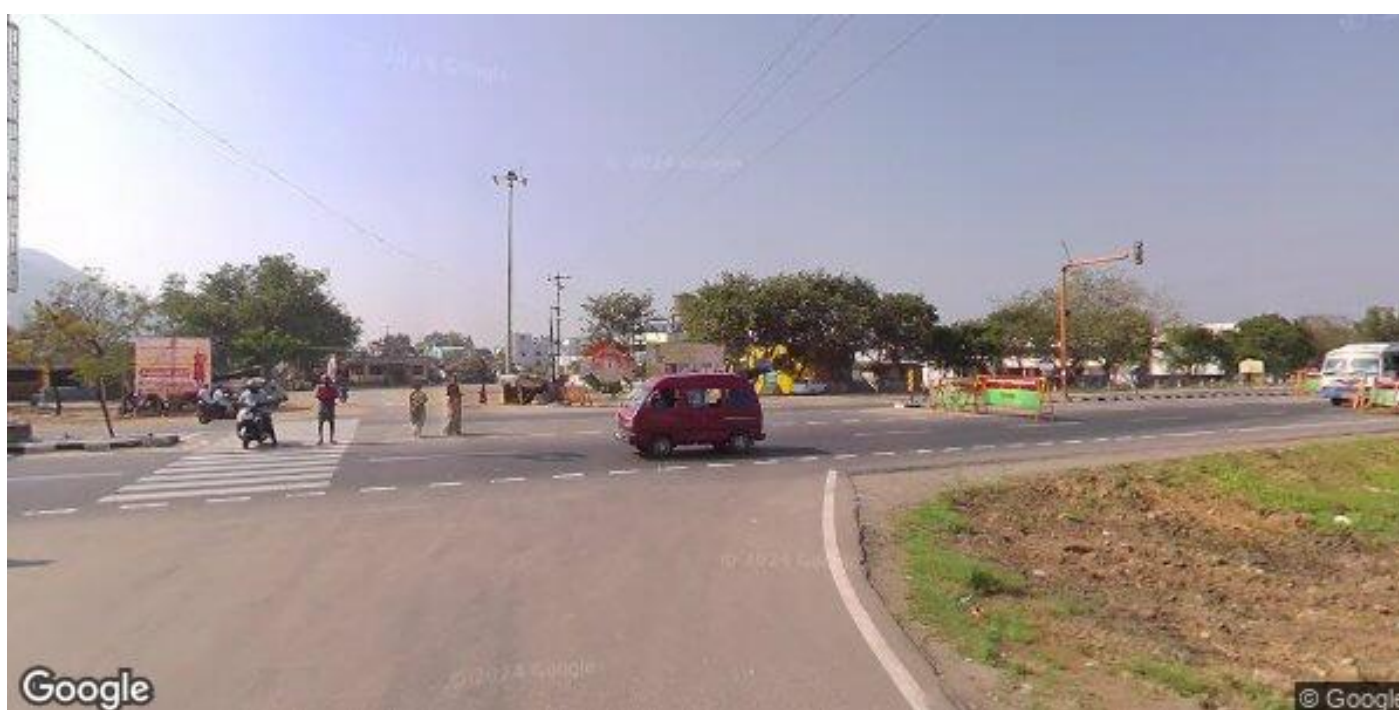
**Risk Type:** Turn  
**Risk Level:** High  
**Speed Limit:** 15 KM/Hr  
**Coordinates:** 11.62130, 78.10776

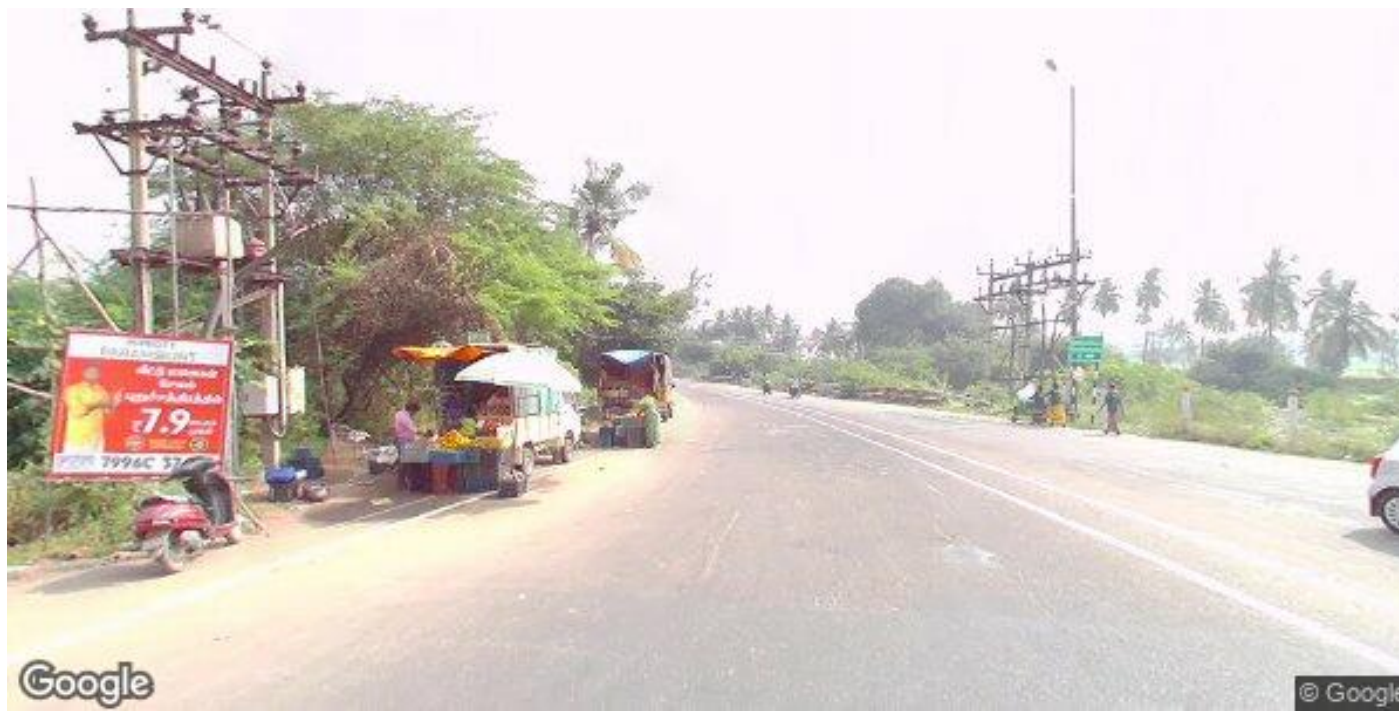
**Risk Type:** Blind Spot  
**Risk Level:** Blind Spot  
**Speed Limit:** 10 KM/Hr  
**Coordinates:** 11.61217, 78.10439

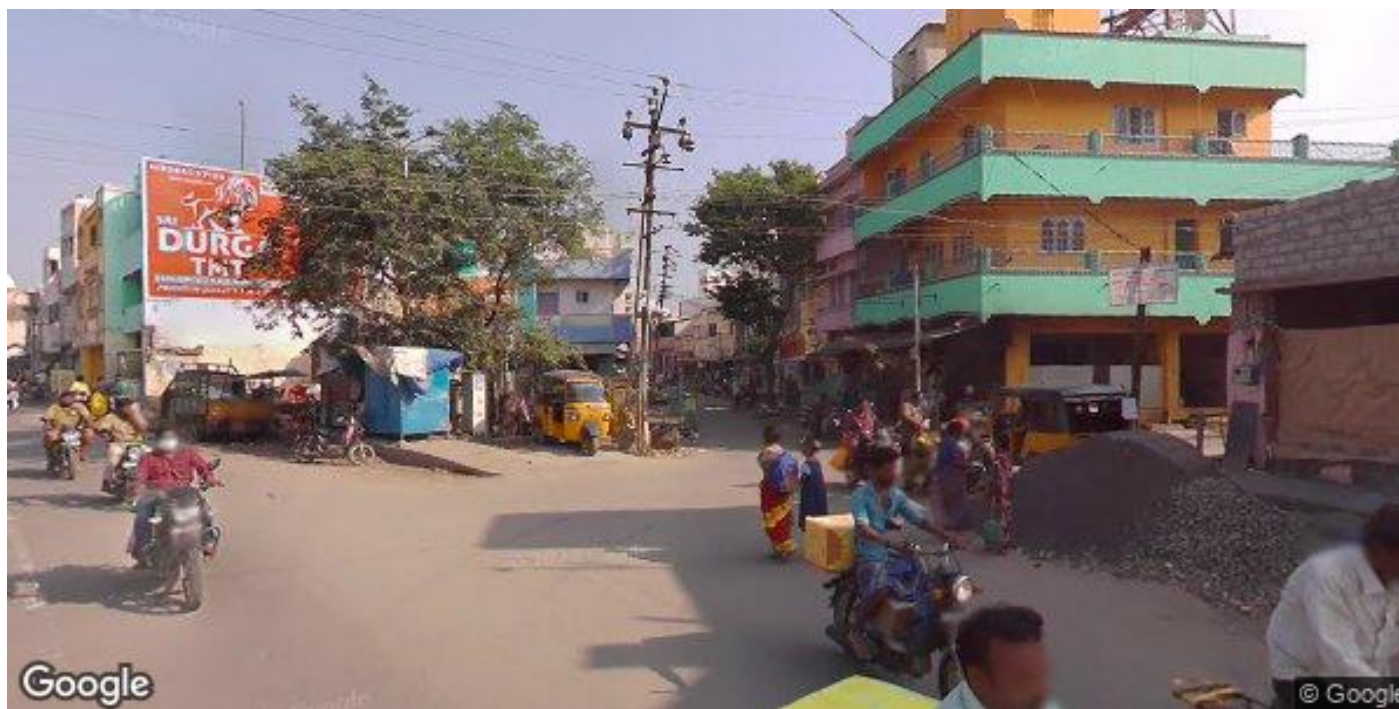
**Risk Type:** Turn  
**Risk Level:** Medium  
**Speed Limit:** 30 KM/Hr  
**Coordinates:** 11.64844, 78.14338

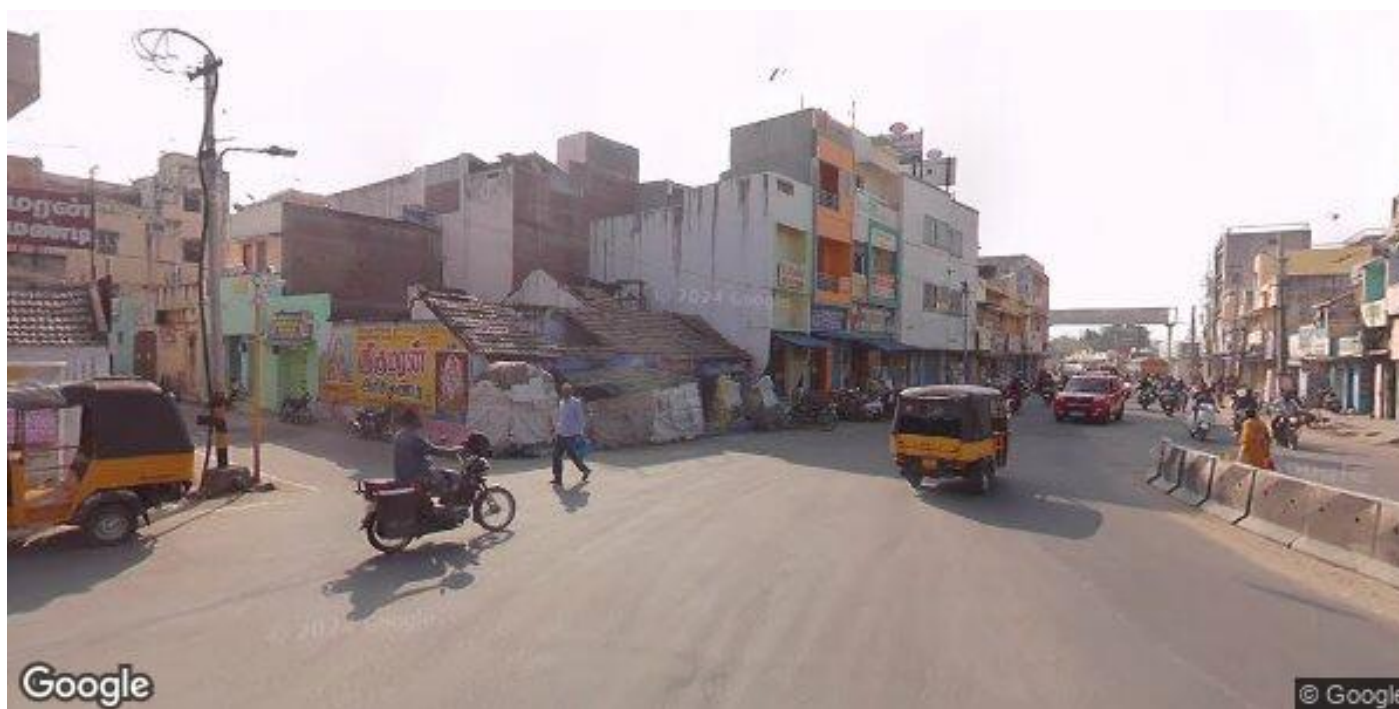
**Risk Type:** Turn  
**Risk Level:** Medium  
**Speed Limit:** 30 KM/Hr  
**Coordinates:** 11.65152, 78.14229

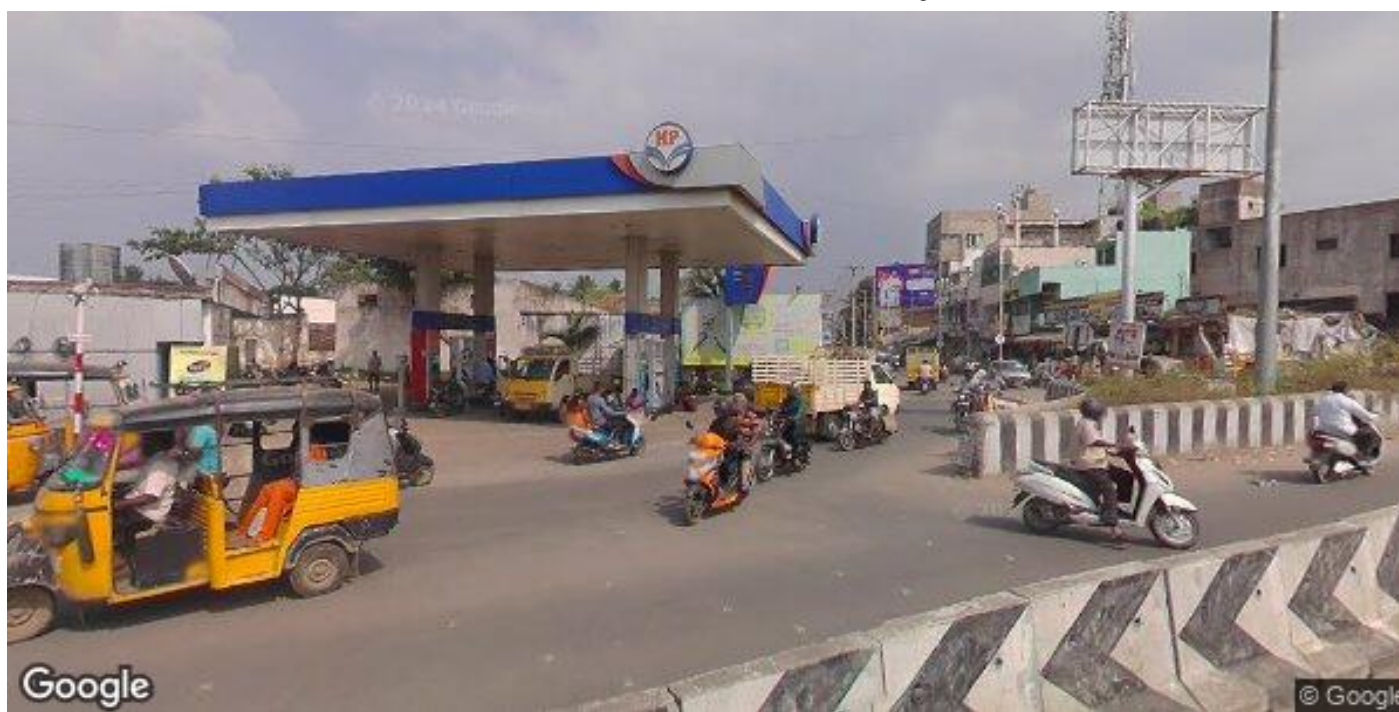
**Risk Type:** Blind Spot  
**Risk Level:** Blind Spot  
**Speed Limit:** 10 KM/Hr  
**Coordinates:** 11.65573, 78.13972

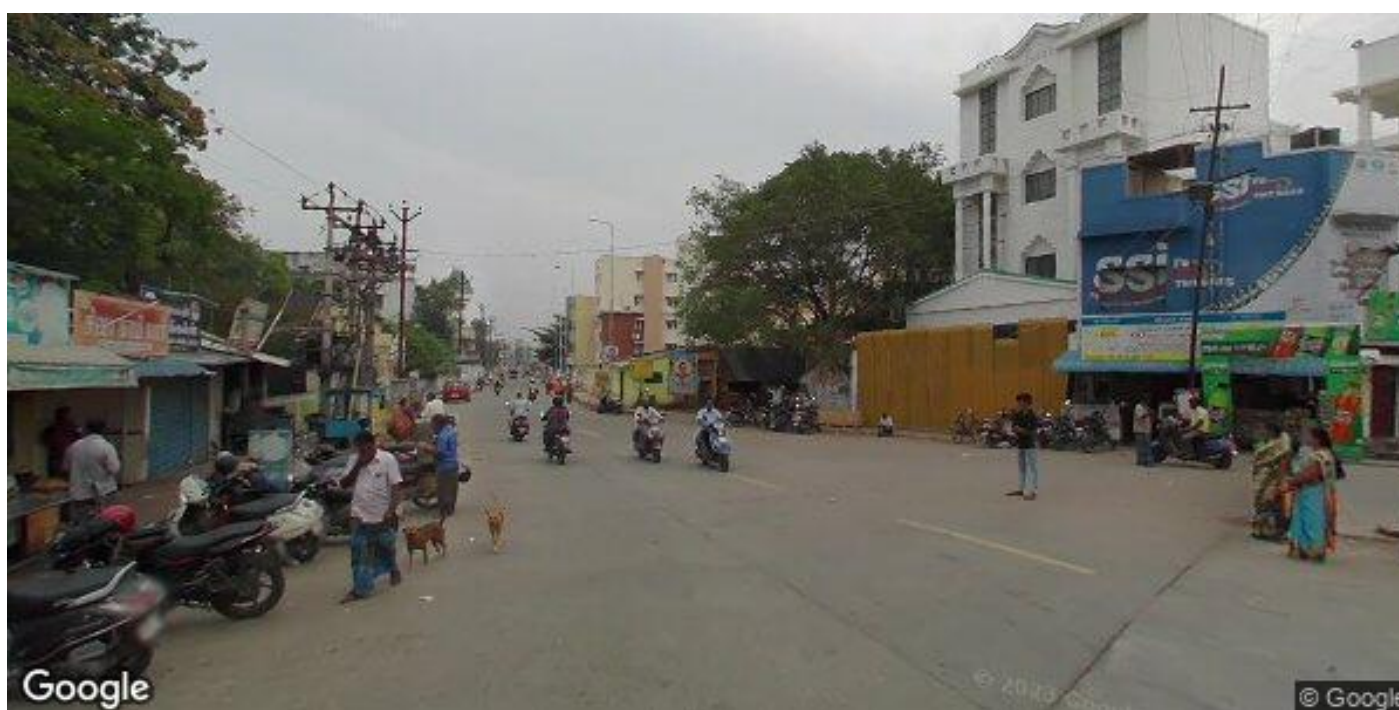
**Risk Type:** Turn  
**Risk Level:** Medium  
**Speed Limit:** 30 KM/Hr  
**Coordinates:** 11.65678, 78.14605

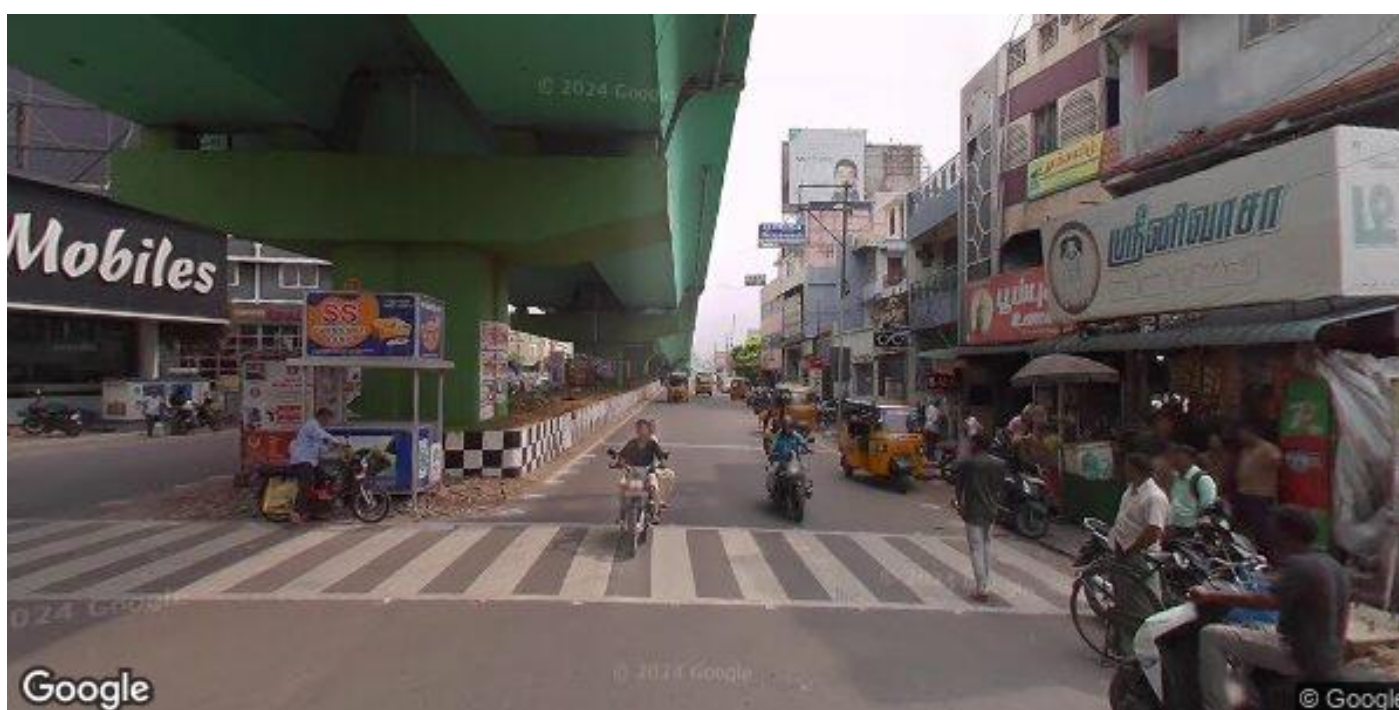
**Risk Type:** Turn  
**Risk Level:** High  
**Speed Limit:** 15 KM/Hr  
**Coordinates:** 11.66305, 78.14758
