# IndianOil

## JOURNEY RISK MANAGEMENT (JRM) STUDY

### Salem Terminal TO GUBER AGENCY IOC DEALERS

**Route Analysis: CVQF+23W, Sangagiri to 14, Pallipalayam - Sankari Rd, Tamil Nadu**

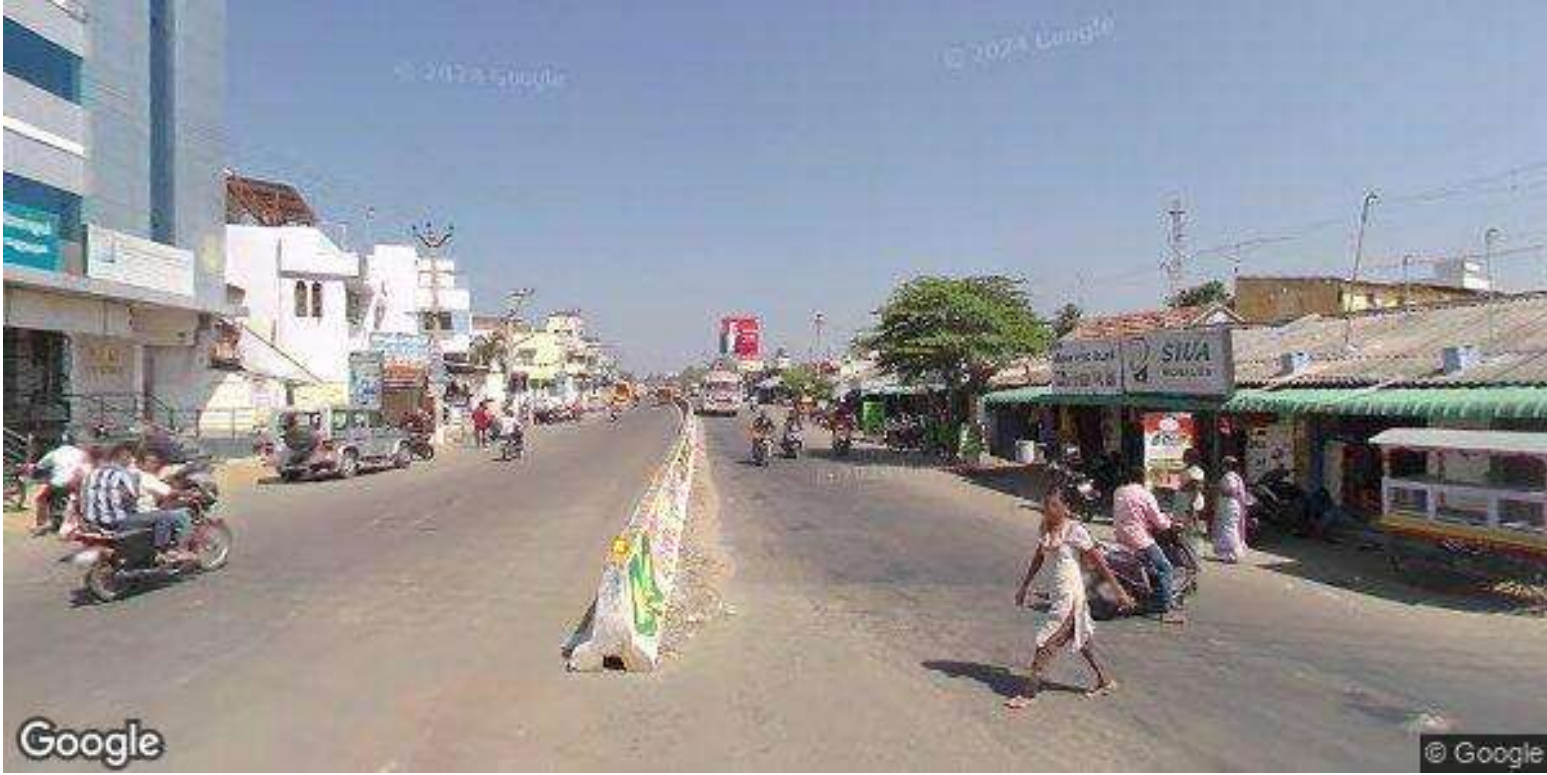
Coordinates: 11.37086, 77.74828

Risk Type: Roundabout

Risk Level: High

Speed Limit: 15 KM/Hr

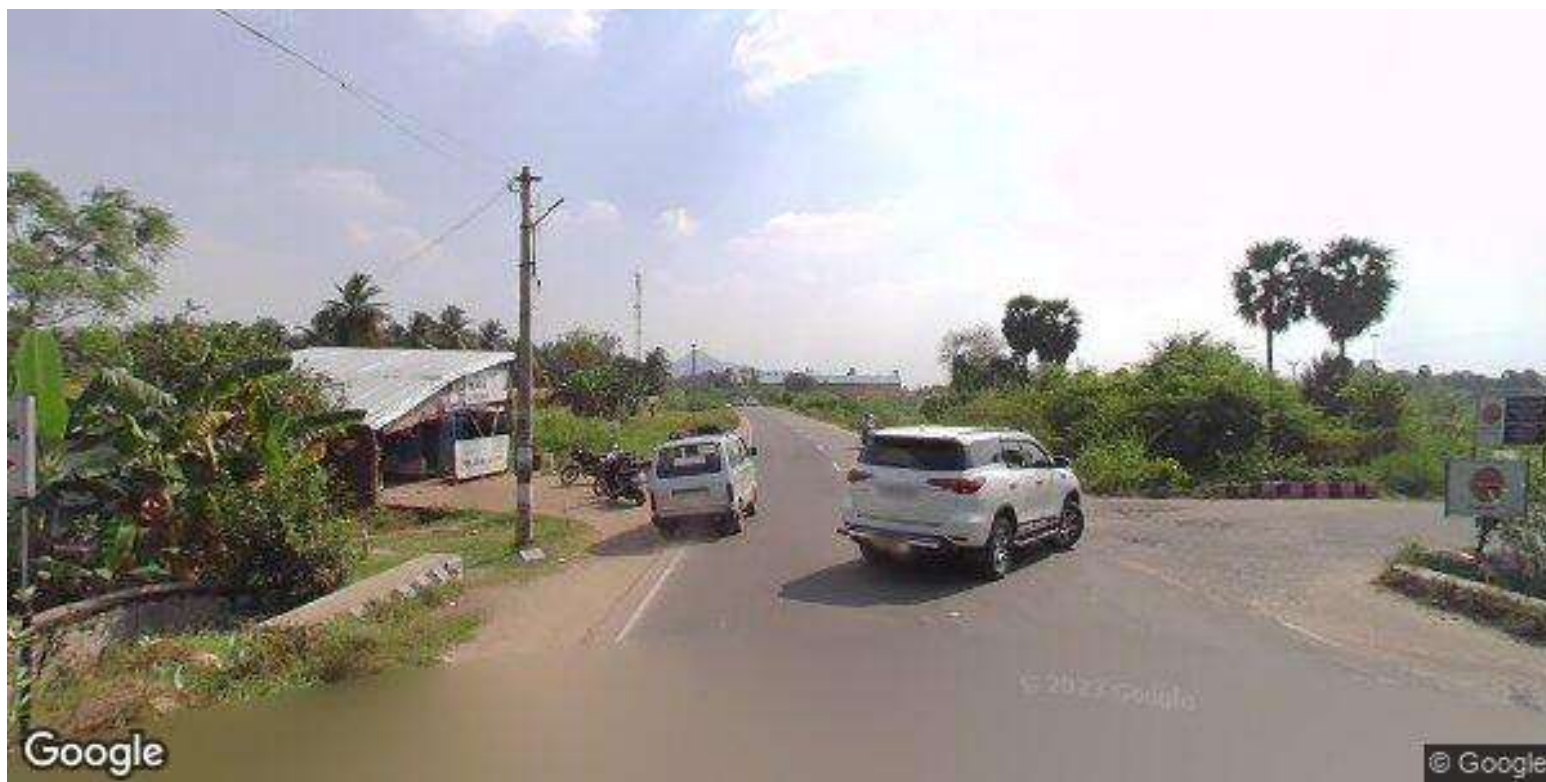
**Coordinates:** 11.44029, 77.87544

**Risk Type:** Turn

**Risk Level:** High

**Speed Limit:** 15 KM/Hr

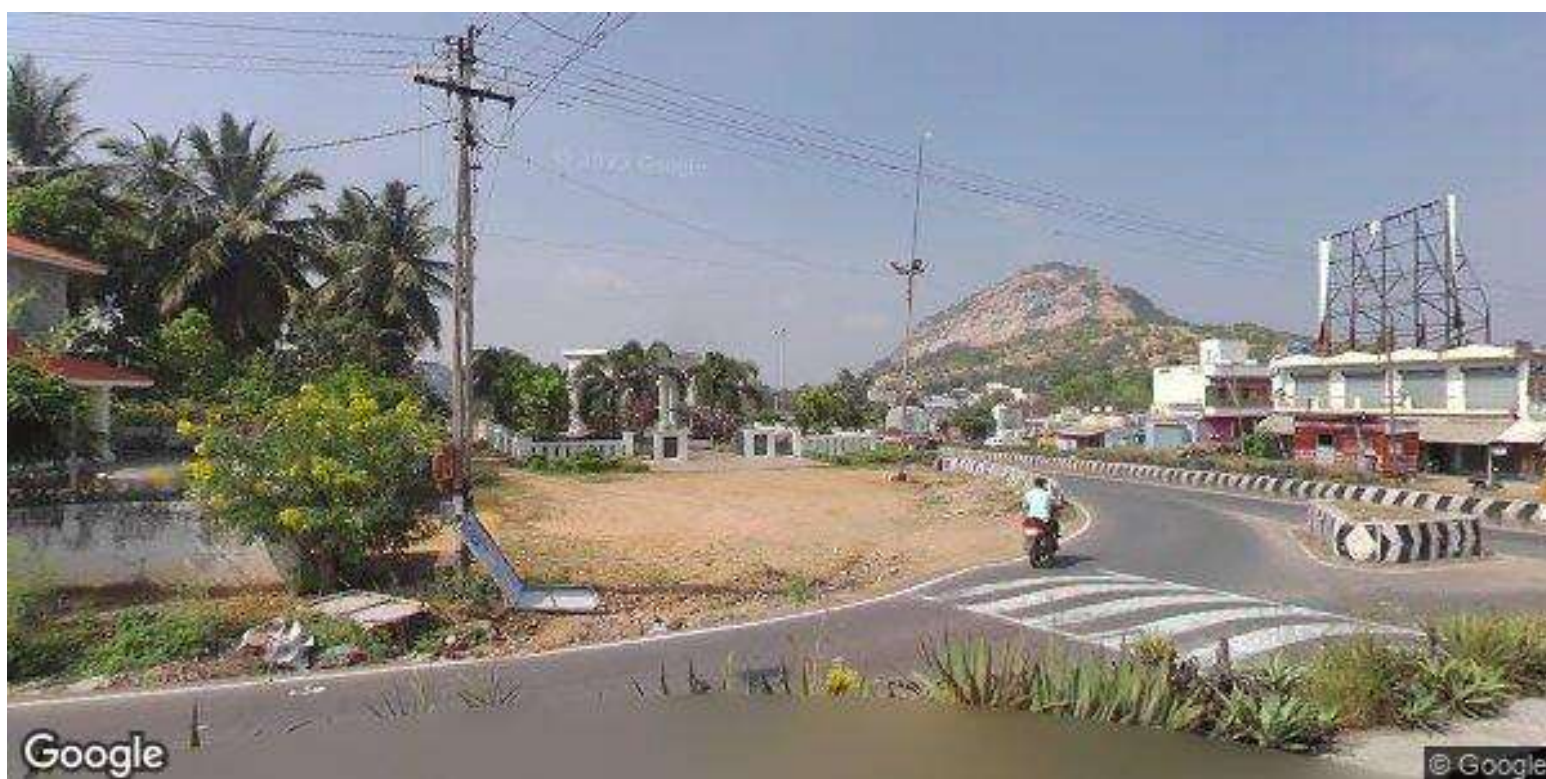
**Coordinates:** 11.46307, 77.84941

**Risk Type:** Turn

**Risk Level:** Medium

**Speed Limit:** 30 KM/Hr

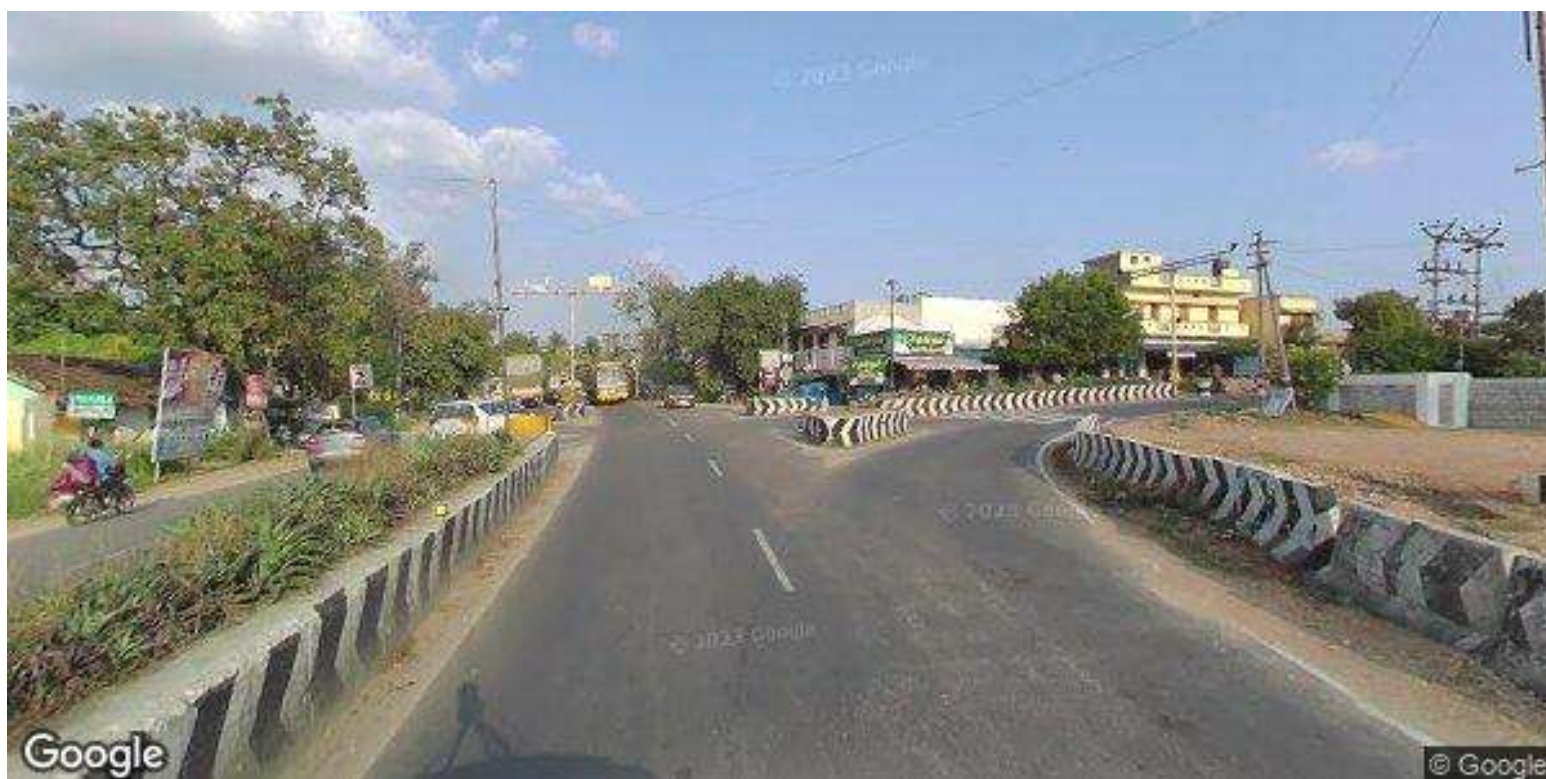
**Coordinates: 11.46318, 77.84913**

**Risk Type: Turn**

**Risk Level: Medium**

**Speed Limit: 30 KM/Hr**

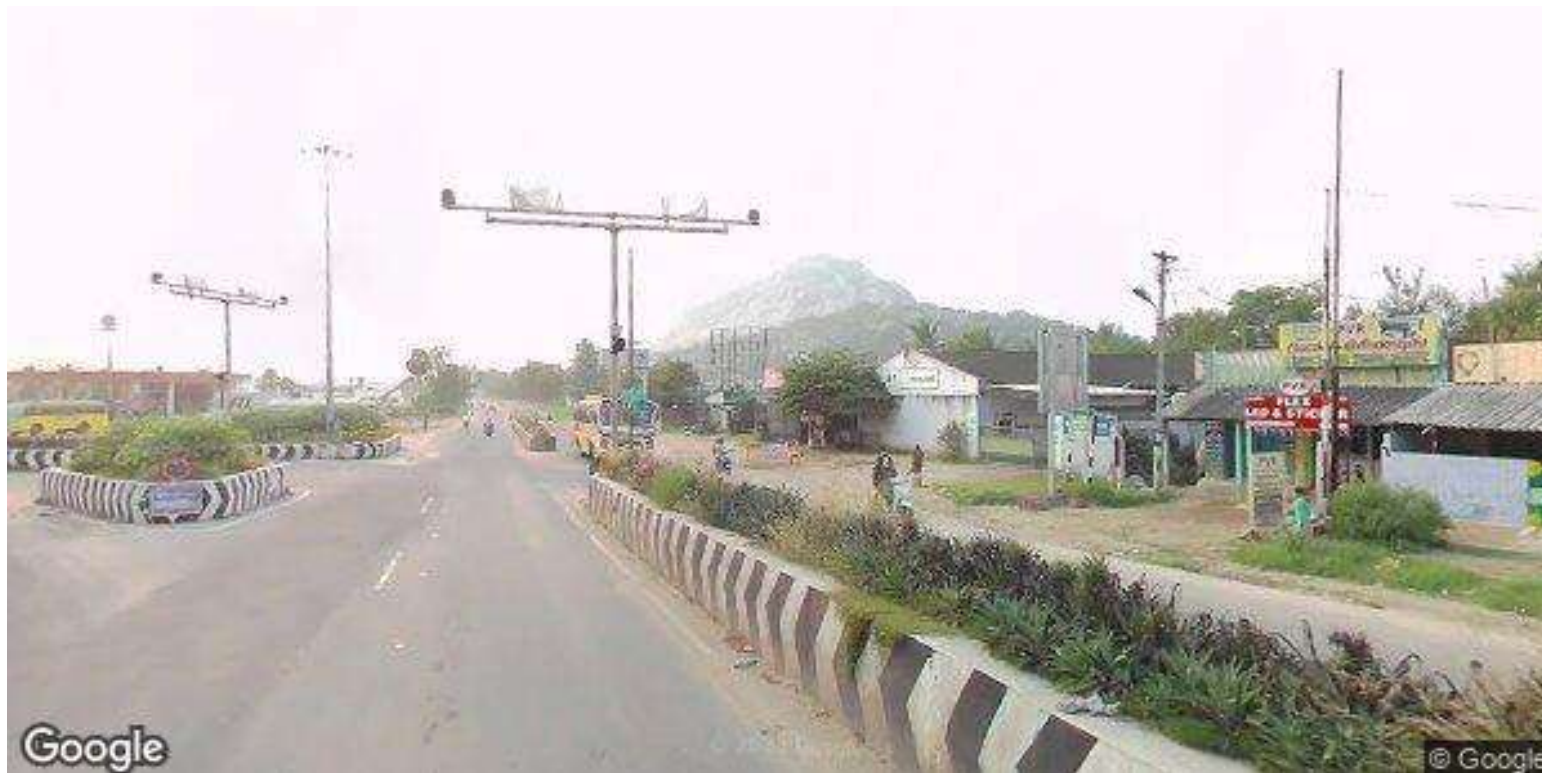
**Coordinates: 11.46312, 77.84886**

**Risk Type: Turn**

**Risk Level: Medium**

**Speed Limit: 30 KM/Hr**

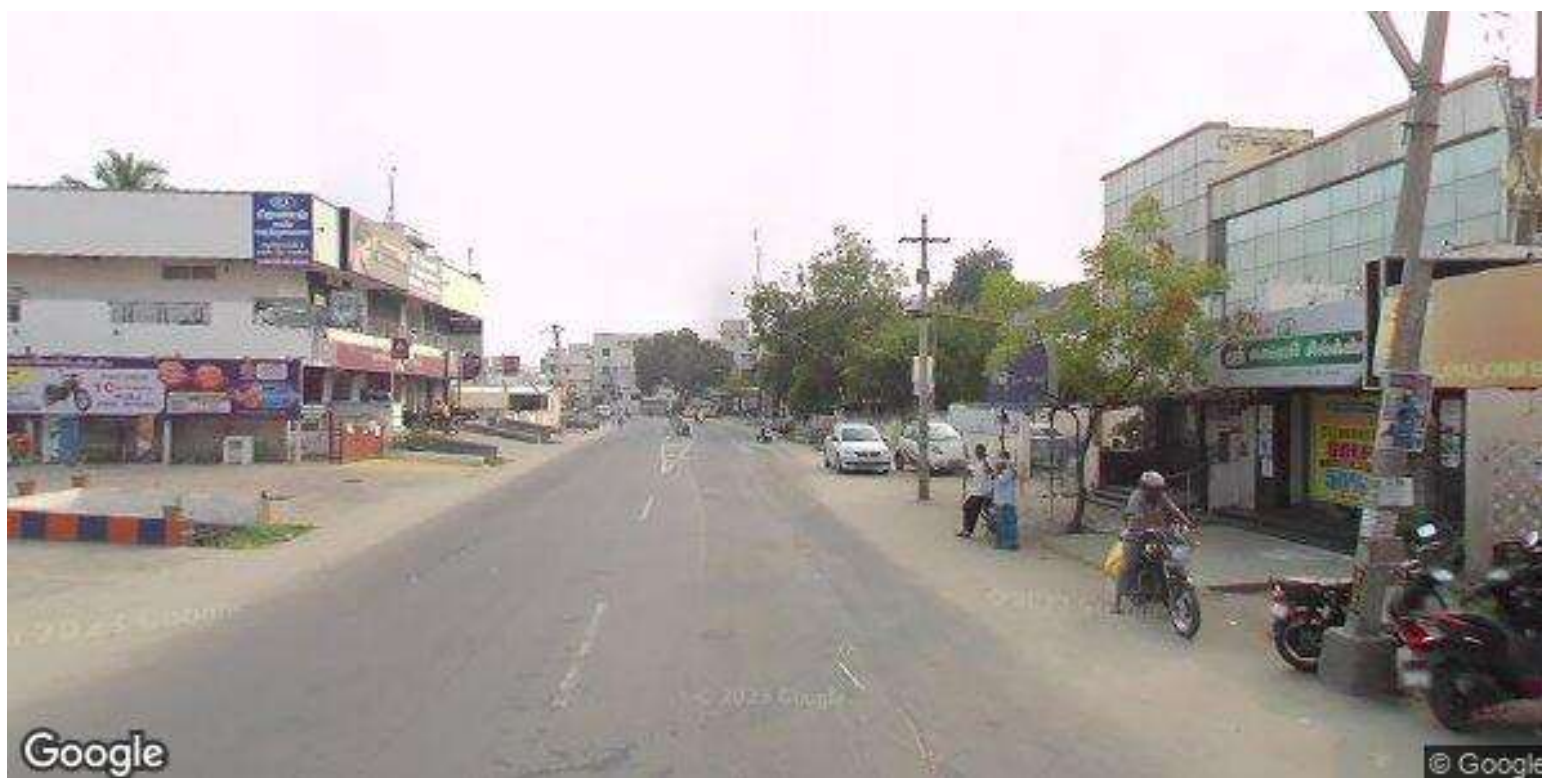
**Coordinates: 11.36696, 77.74794**

**Risk Type: Turn**

**Risk Level: High**

**Speed Limit: 15 KM/Hr**

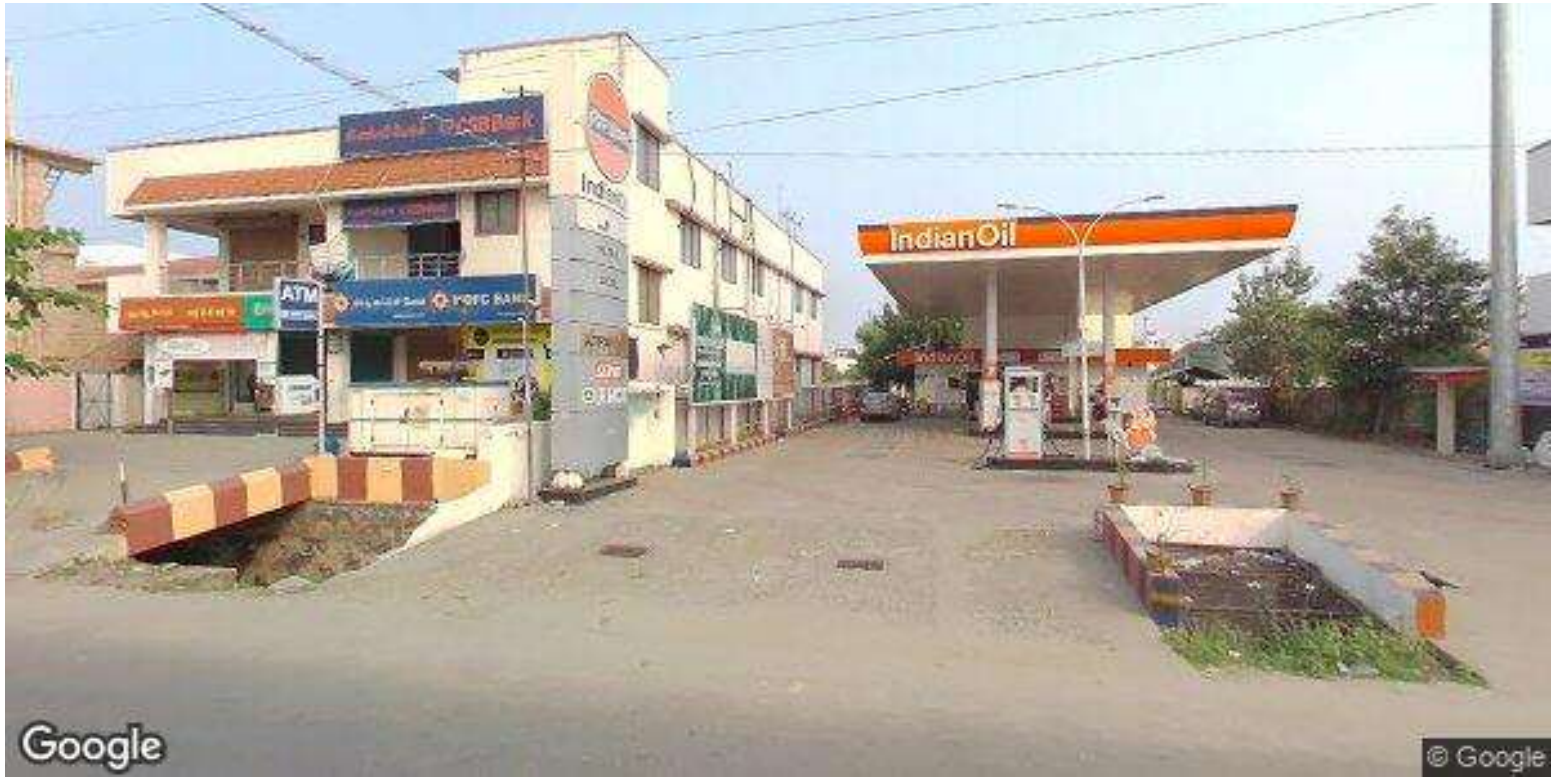
**Risk Type:** Turn  
**Risk Level:** Medium  
**Speed Limit:** 30 KM/Hr  
**Coordinates:** 11.36692, 77.74807

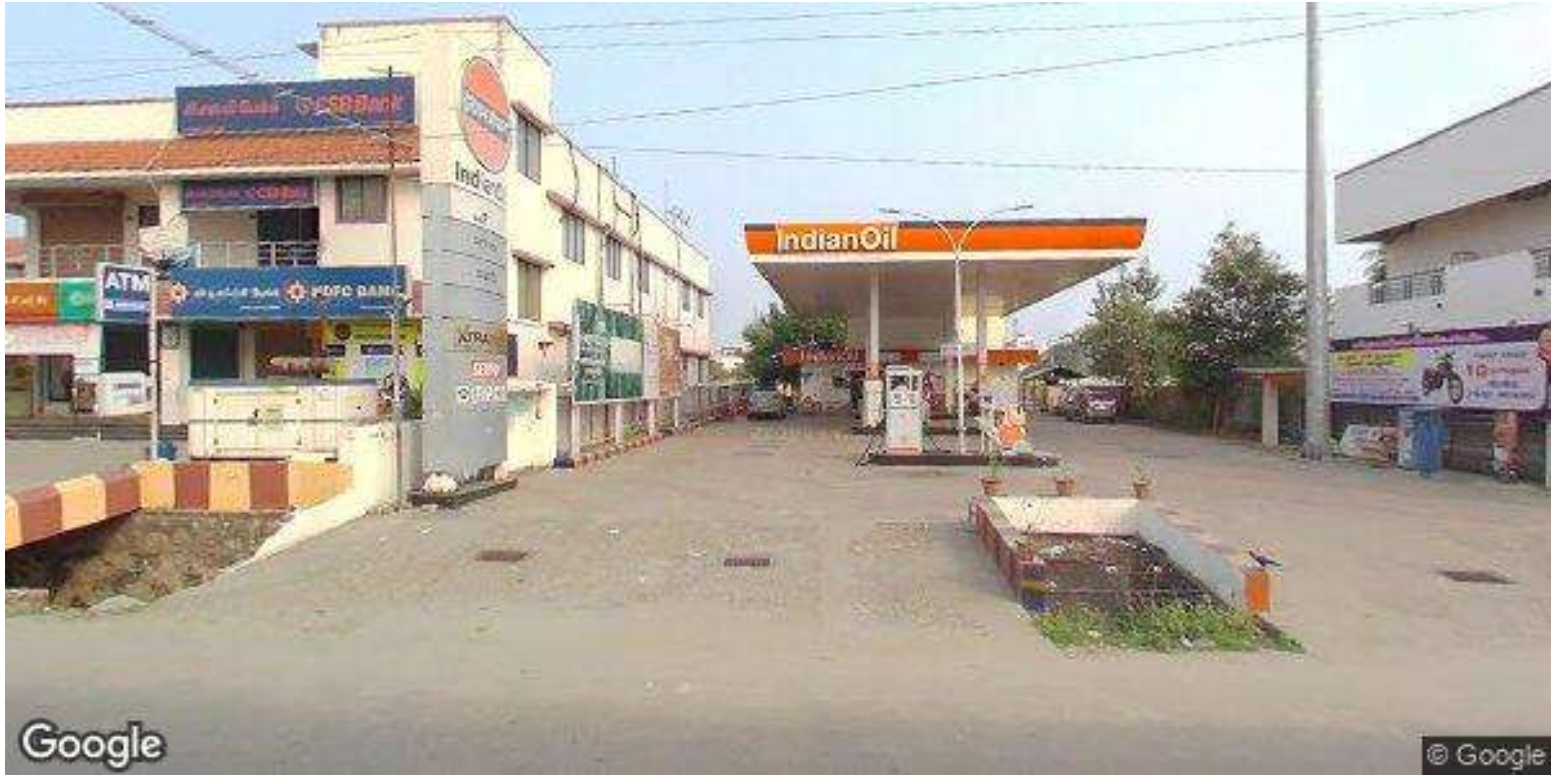
**Risk Type:** Turn  
**Risk Level:** High  
**Speed Limit:** 15 KM/Hr  
**Coordinates:** 11.36690, 77.74809
