## **JOURNEY RISK MANAGEMENT (JRM) STUDY**

### **Salem Terminal TO SHRI MARUTHI AGENCIES IOC DEALERS**

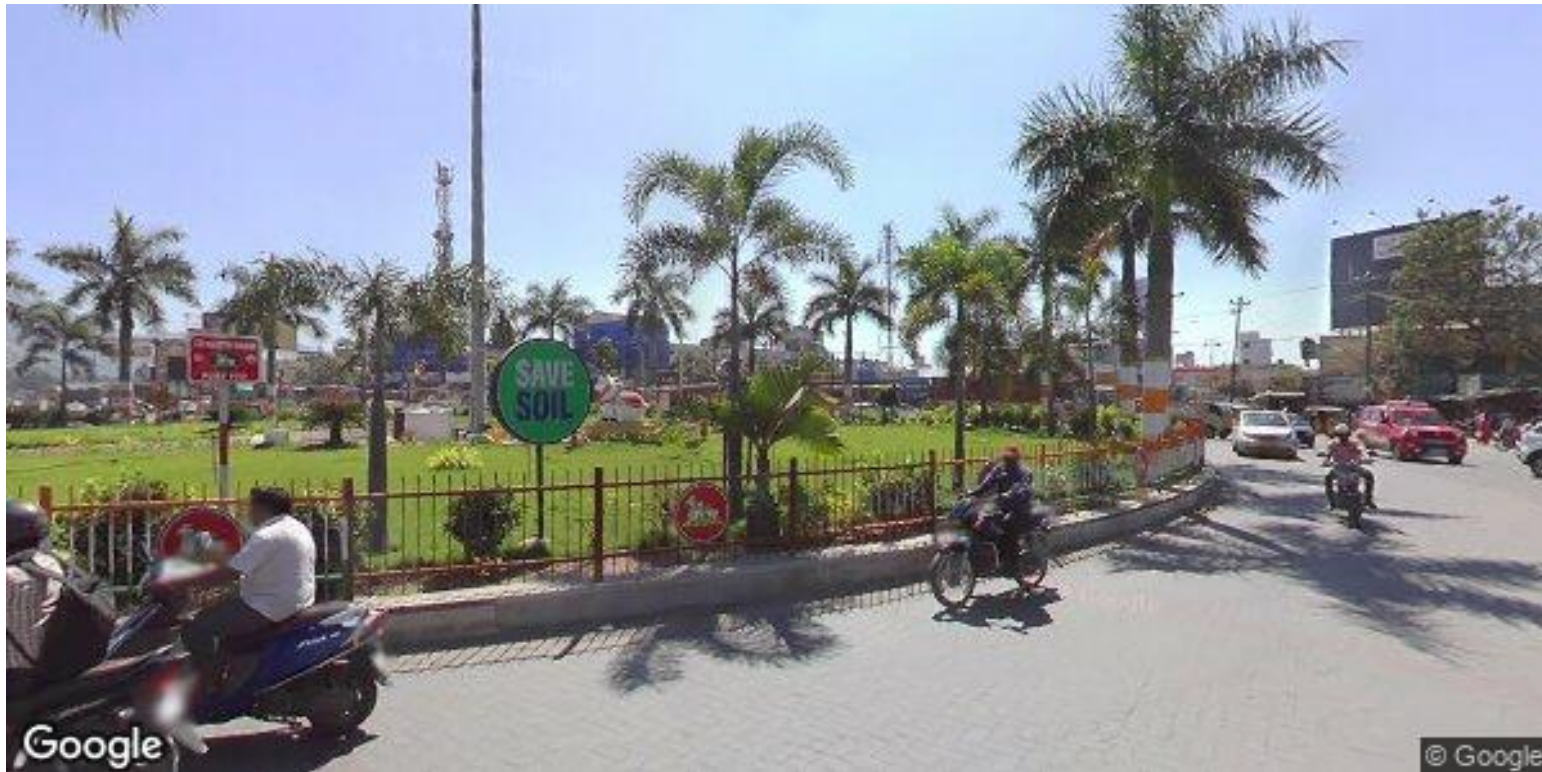
**Coordinates:** 11.63303, 78.12713

**Risk Type:** Roundabout

**Risk Level:** High

**Speed Limit:** 15 KM/Hr

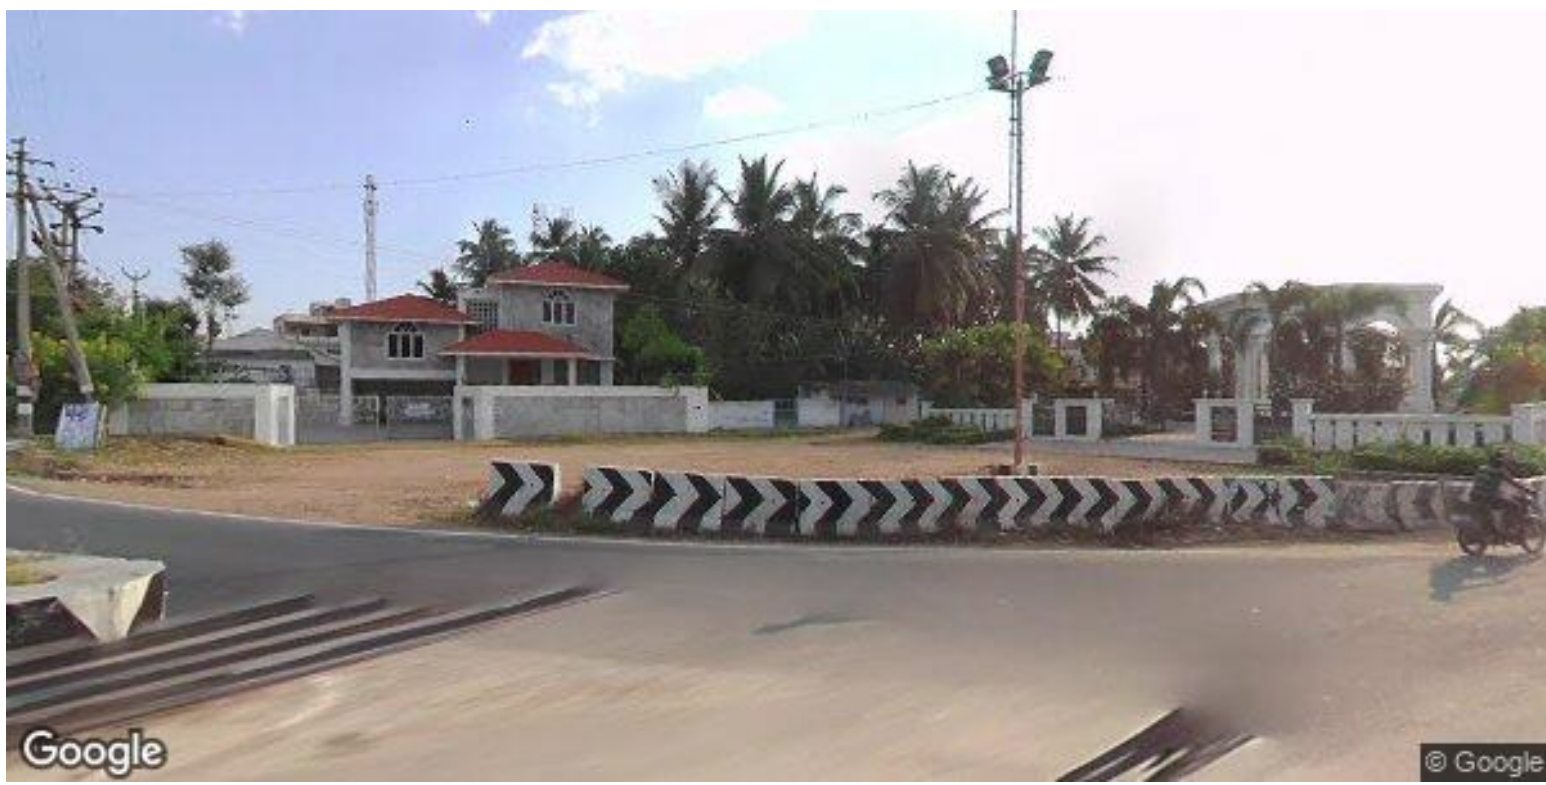
**Coordinates:** 11.46314, 77.84928

**Risk Type:** Turn

**Risk Level:** Medium

**Speed Limit:** 30 KM/Hr

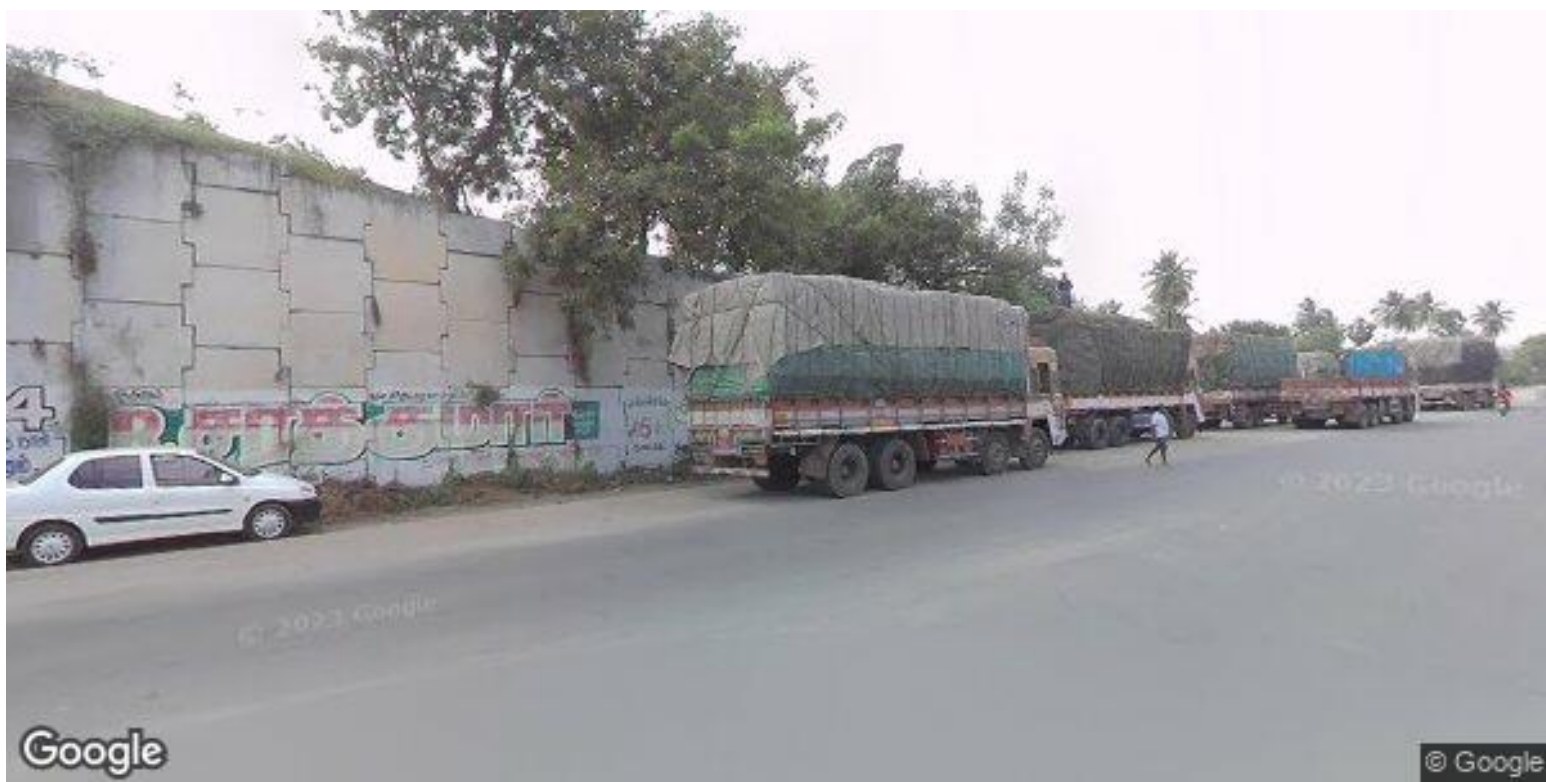
**Coordinates:** 11.49365, 77.88596

**Risk Type:** Turn

**Risk Level:** Medium

**Speed Limit:** 30 KM/Hr

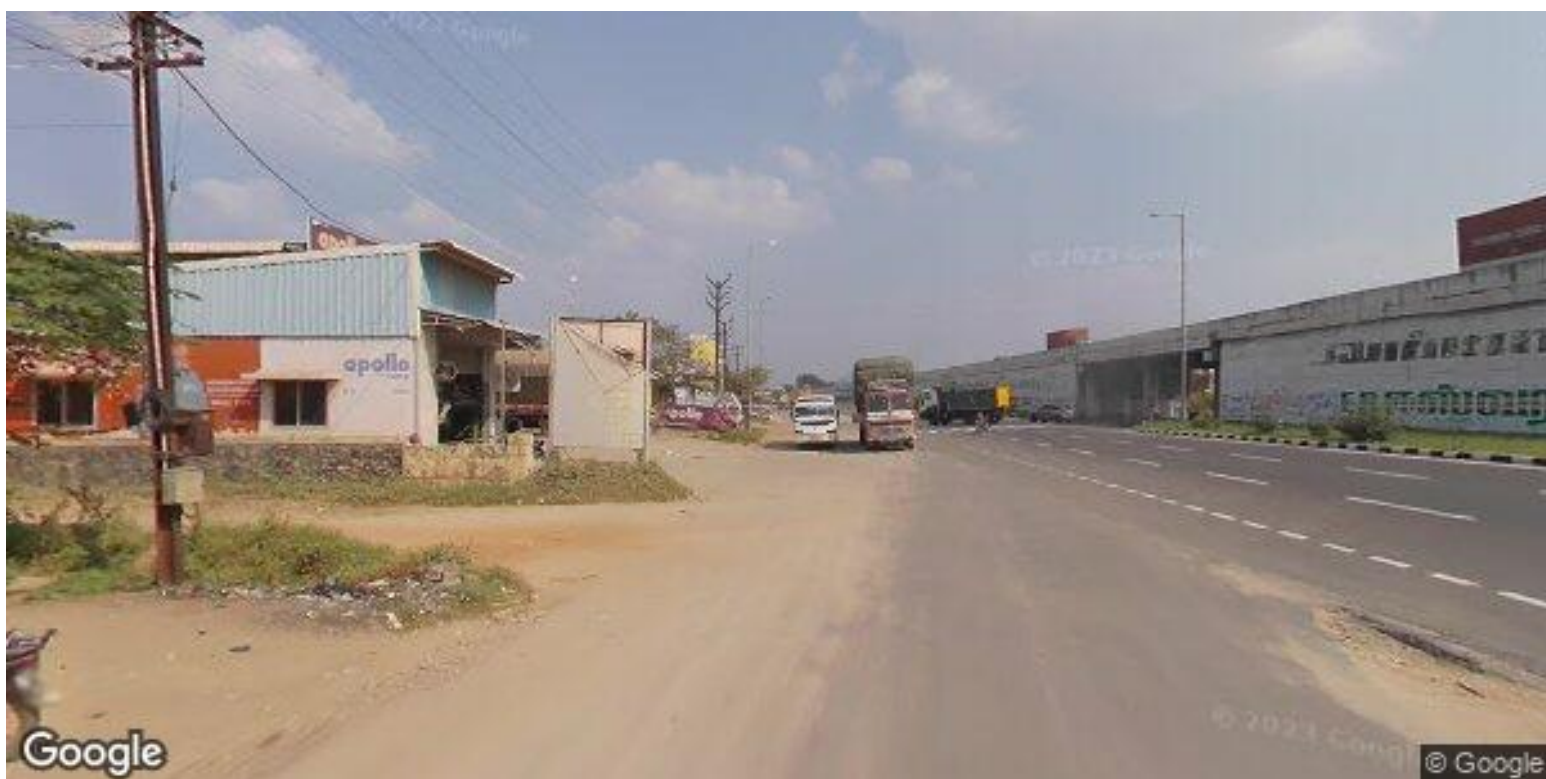
**Coordinates:** 11.49236, 77.89552

**Risk Type:** Turn

**Risk Level:** High

**Speed Limit:** 15 KM/Hr

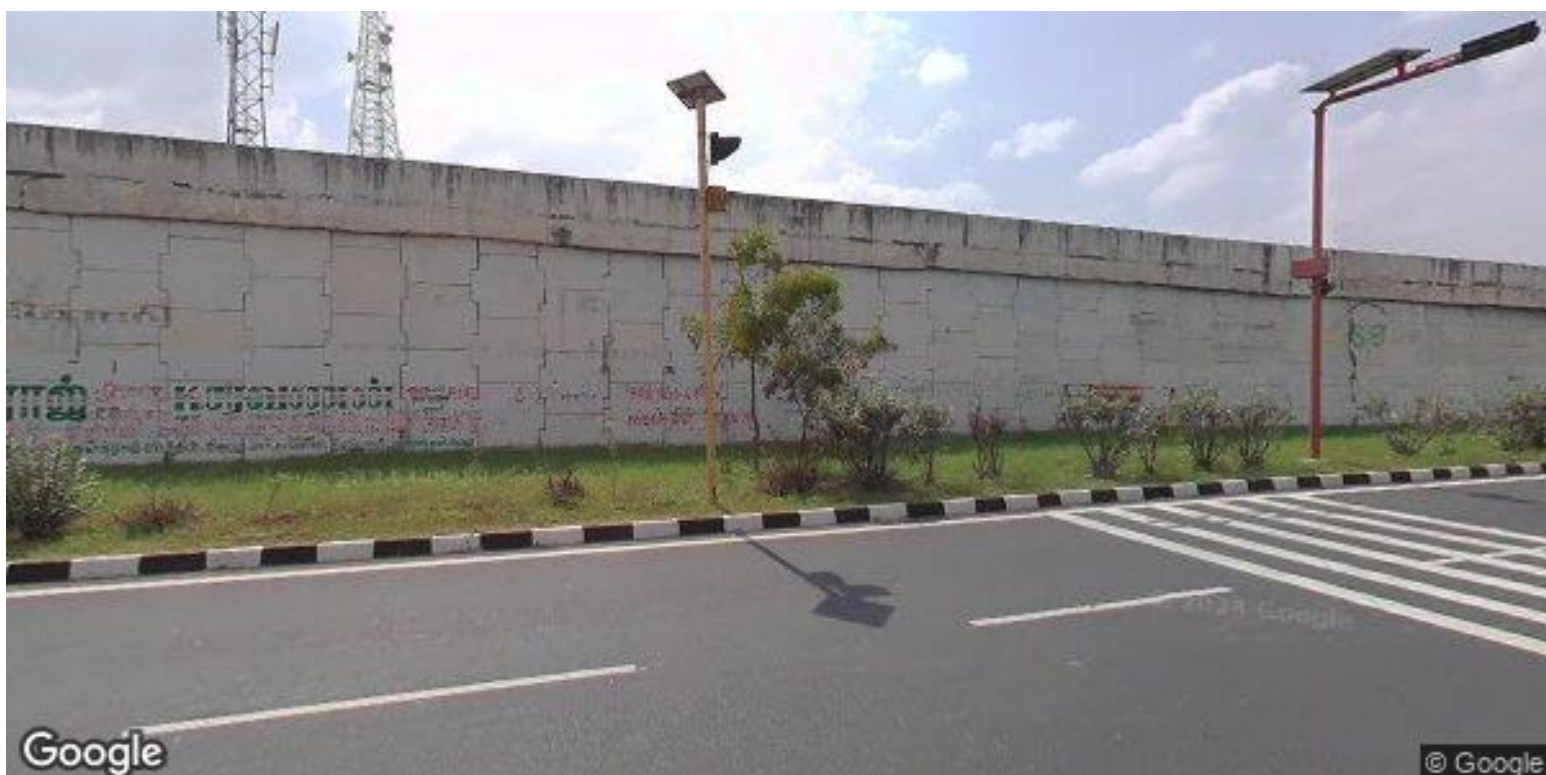
**Risk Type:** Turn  
**Risk Level:** High  
**Speed Limit:** 15 KM/Hr  
**Coordinates:** 11.49225, 77.89560

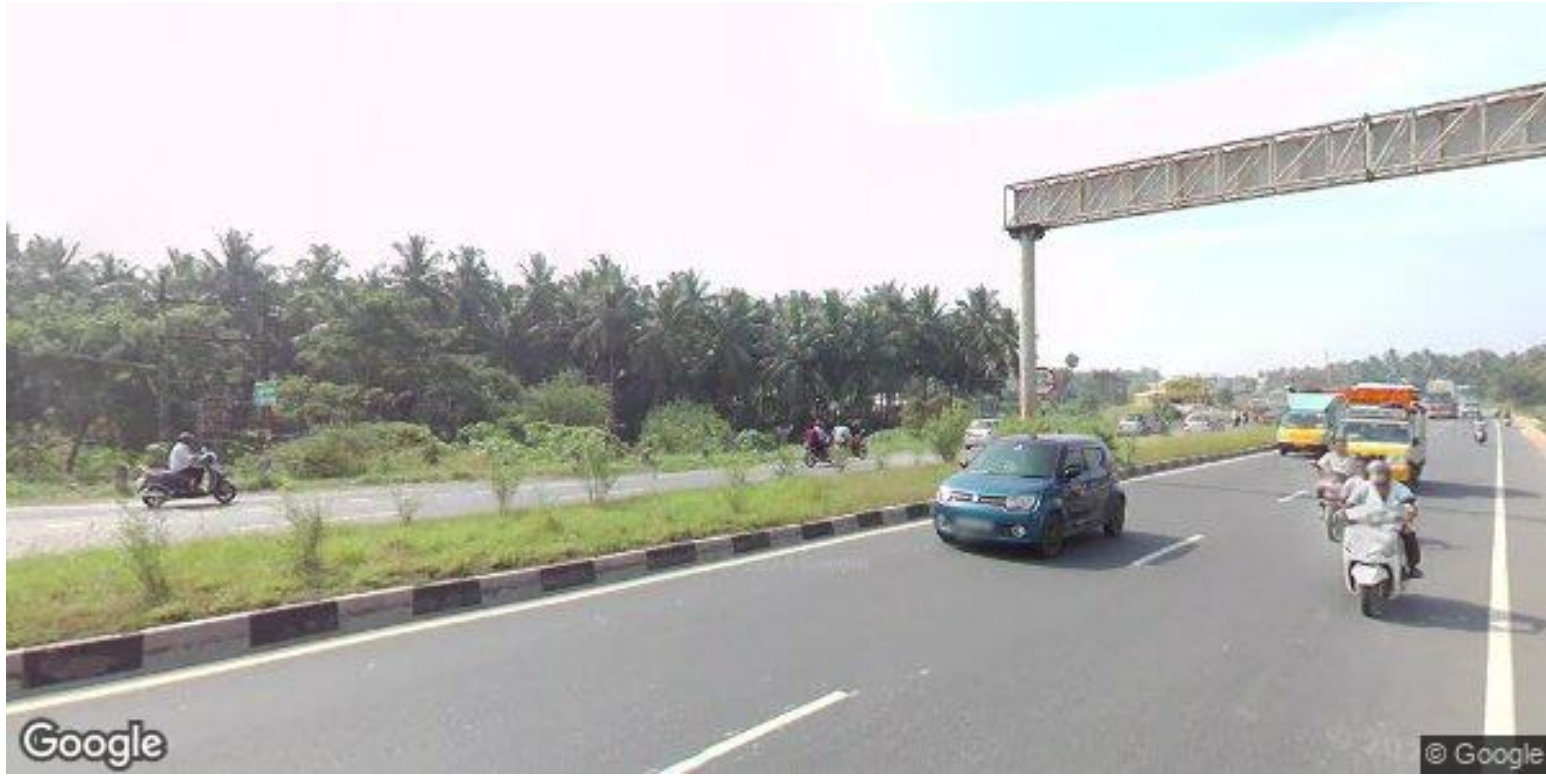
**Risk Type:** Turn  
**Risk Level:** Medium  
**Speed Limit:** 30 KM/Hr  
**Coordinates:** 11.60942, 78.10056

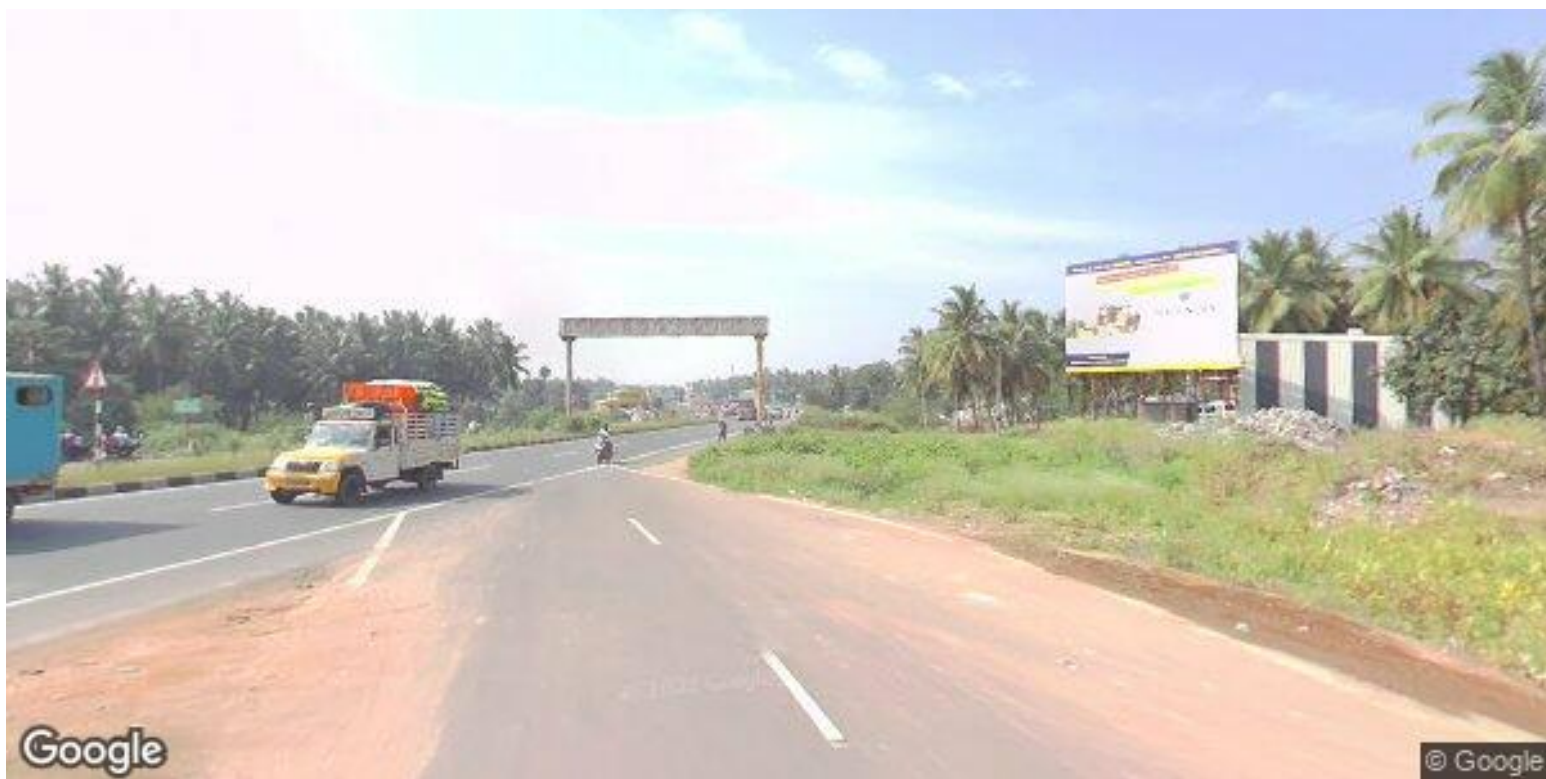
**Risk Type:** Turn  
**Risk Level:** Medium  
**Speed Limit:** 30 KM/Hr  
**Coordinates:** 11.60965, 78.10070

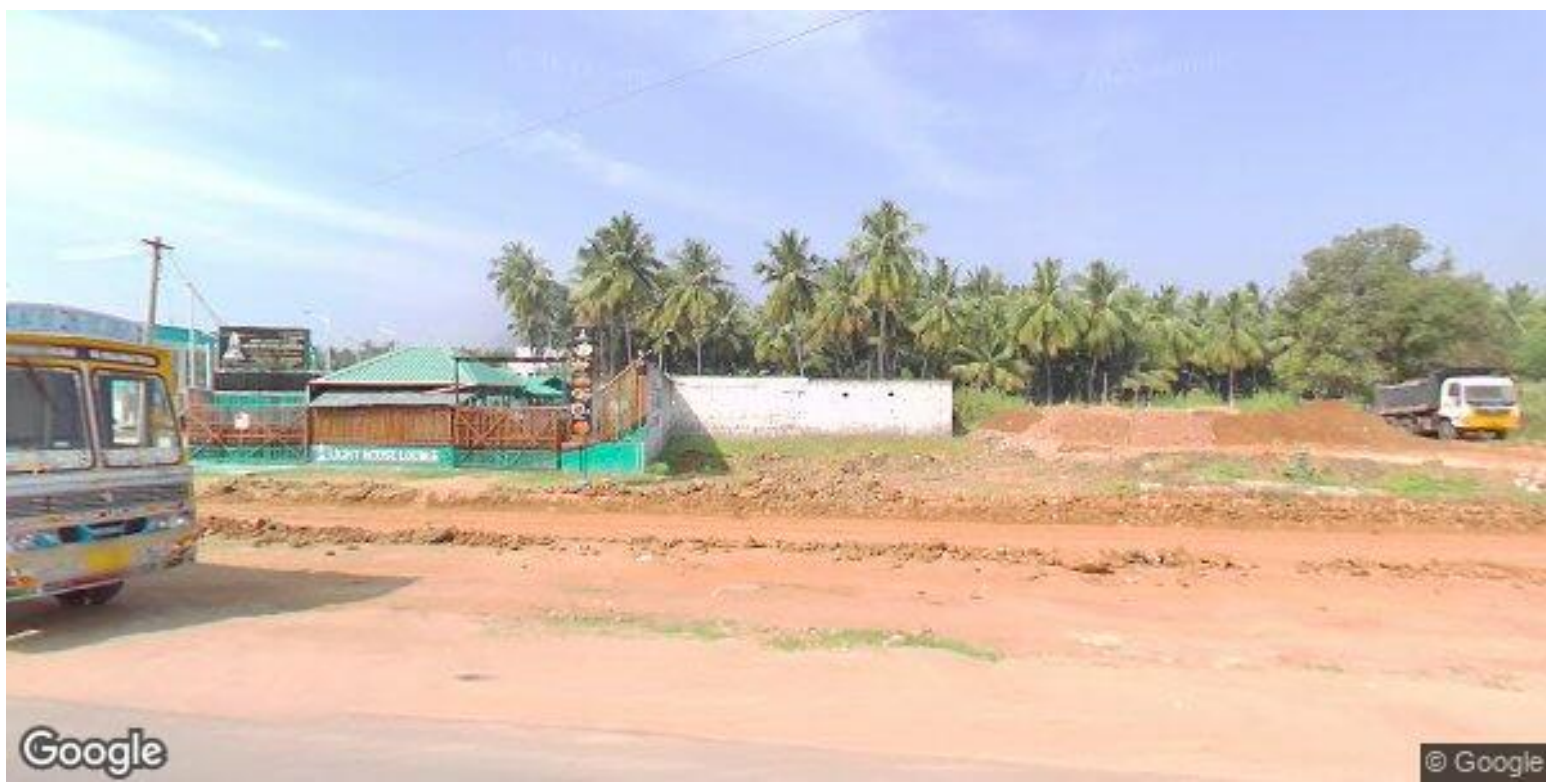
**Coordinates:** 11.61736, 78.10588

**Risk Type:** Turn

**Risk Level:** Medium

**Speed Limit:** 30 KM/Hr

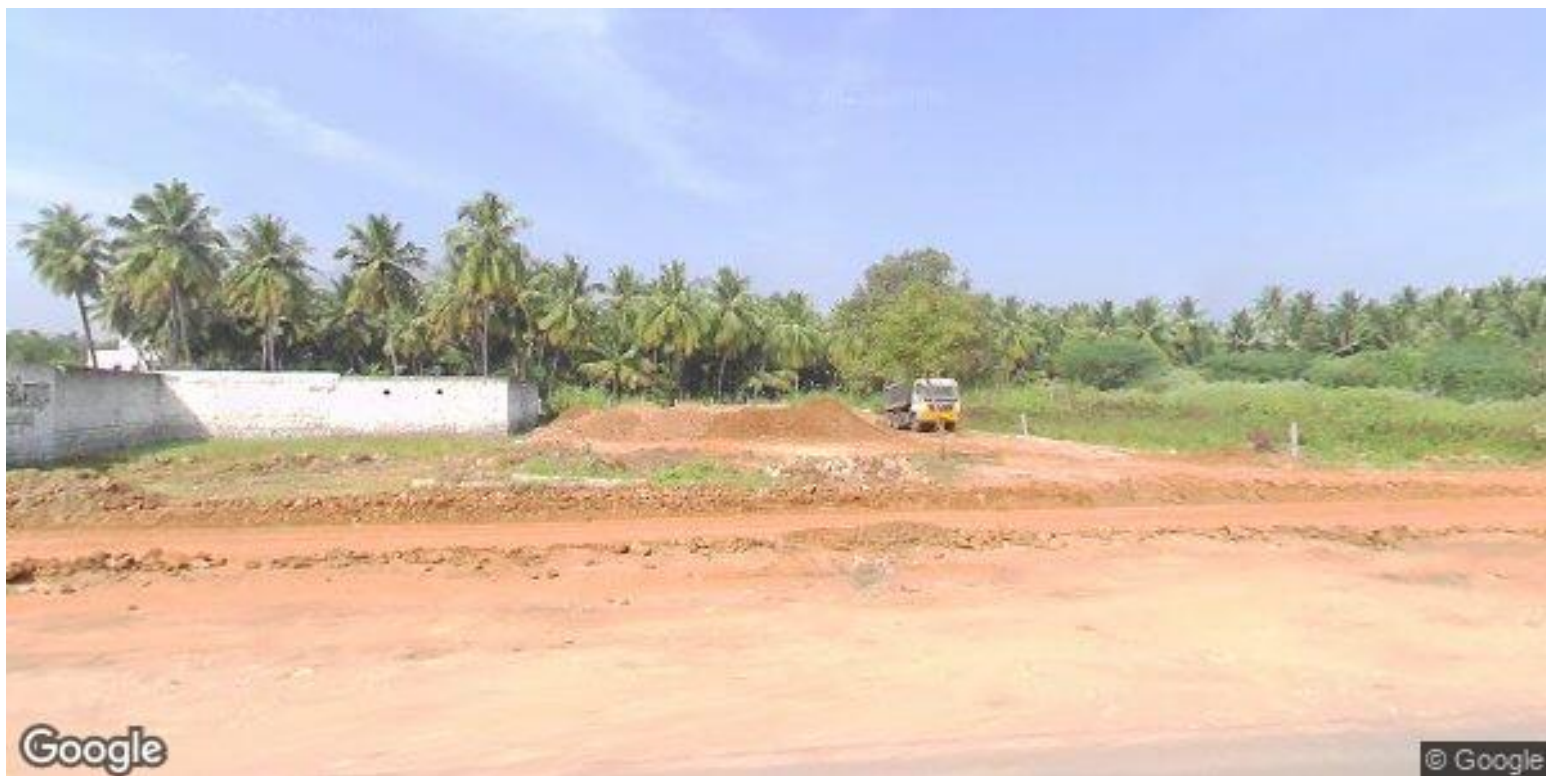
**Coordinates:** 11.61745, 78.10601

**Risk Type:** Turn

**Risk Level:** Medium

**Speed Limit:** 30 KM/Hr

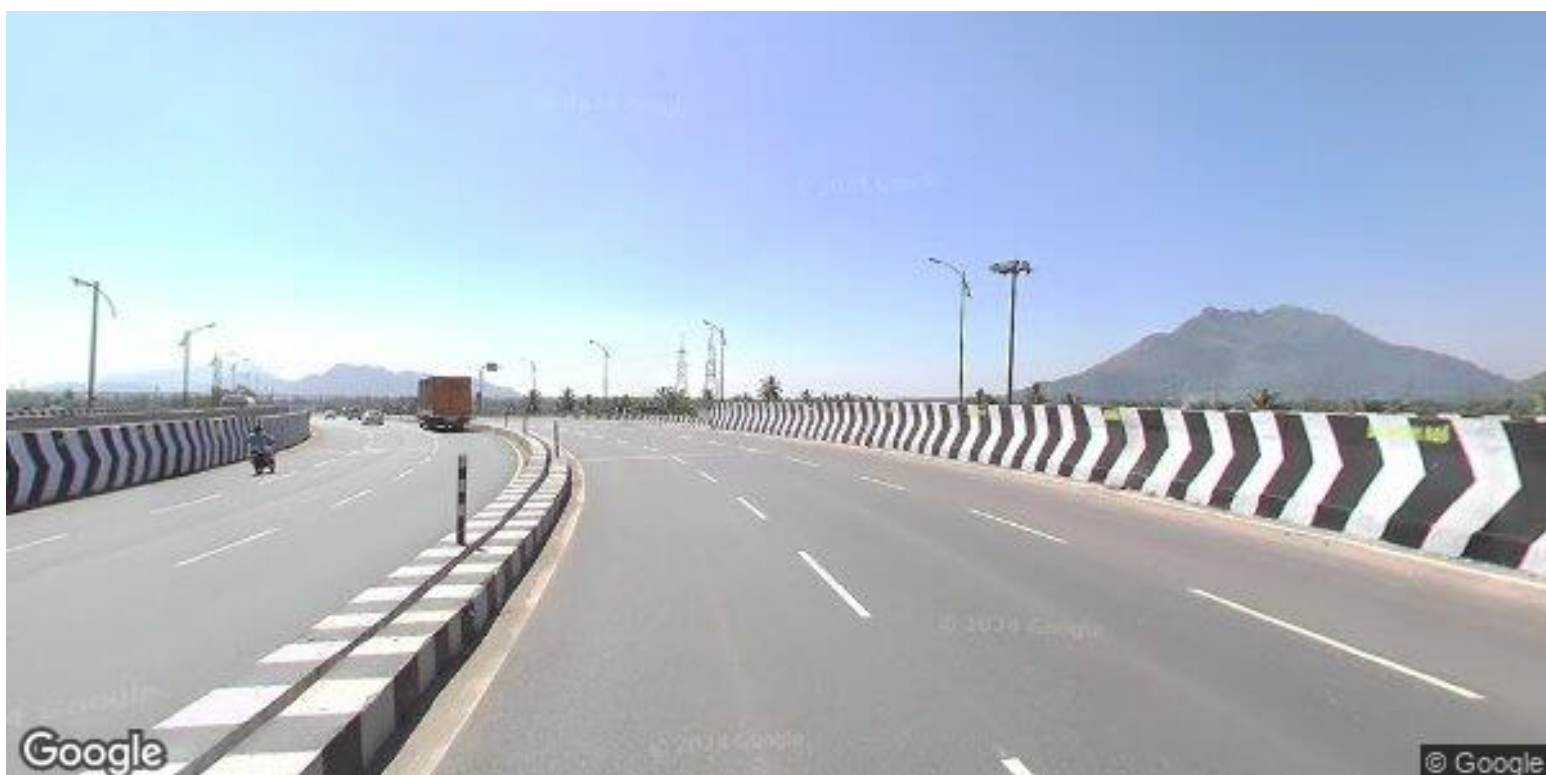
**Risk Type:** Turn  
**Risk Level:** Medium  
**Speed Limit:** 30 KM/Hr  
**Coordinates:** 11.64158, 78.11808

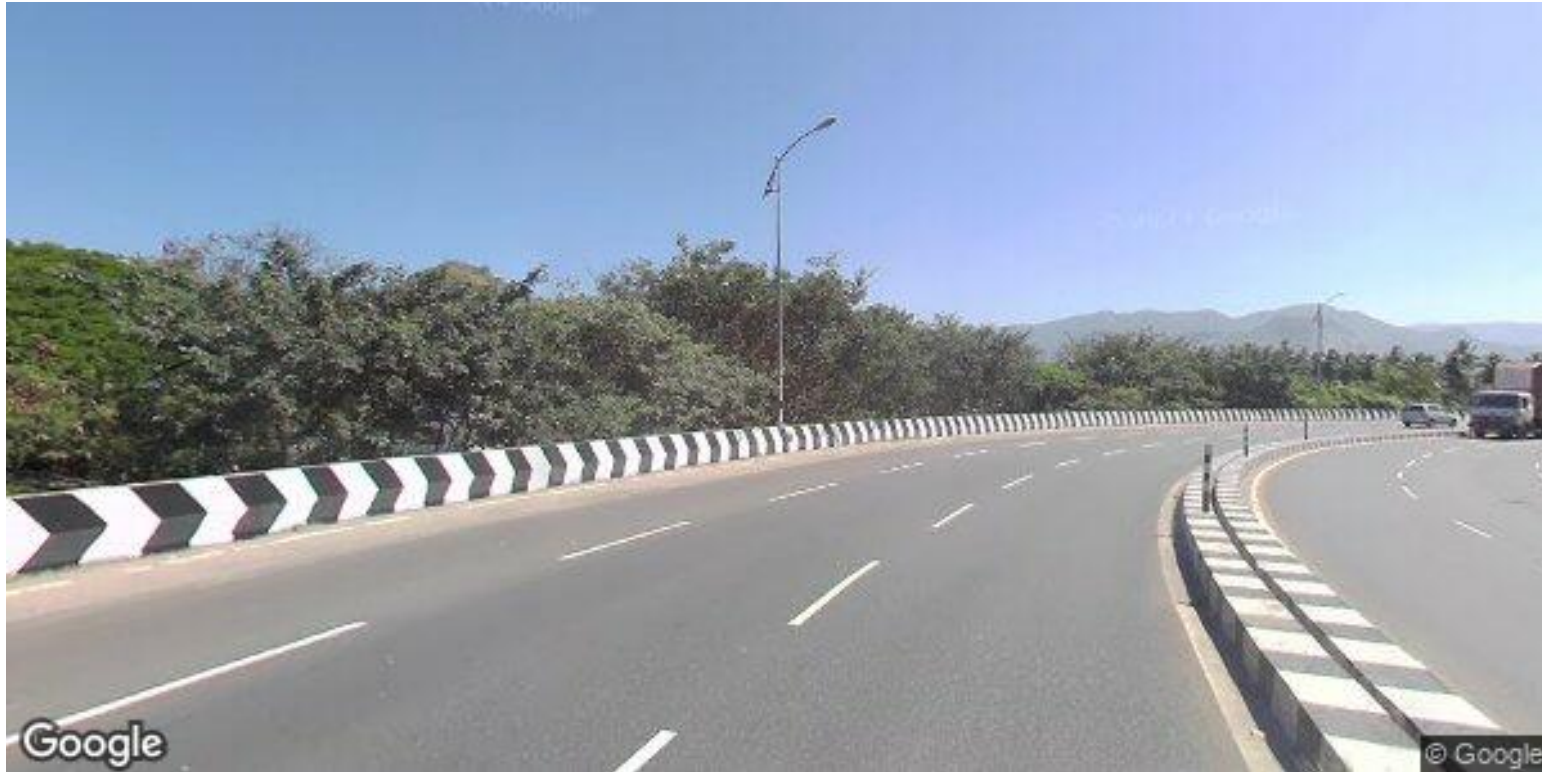
**Risk Type:** Turn  
**Risk Level:** Medium  
**Speed Limit:** 30 KM/Hr  
**Coordinates:** 11.64200, 78.12120

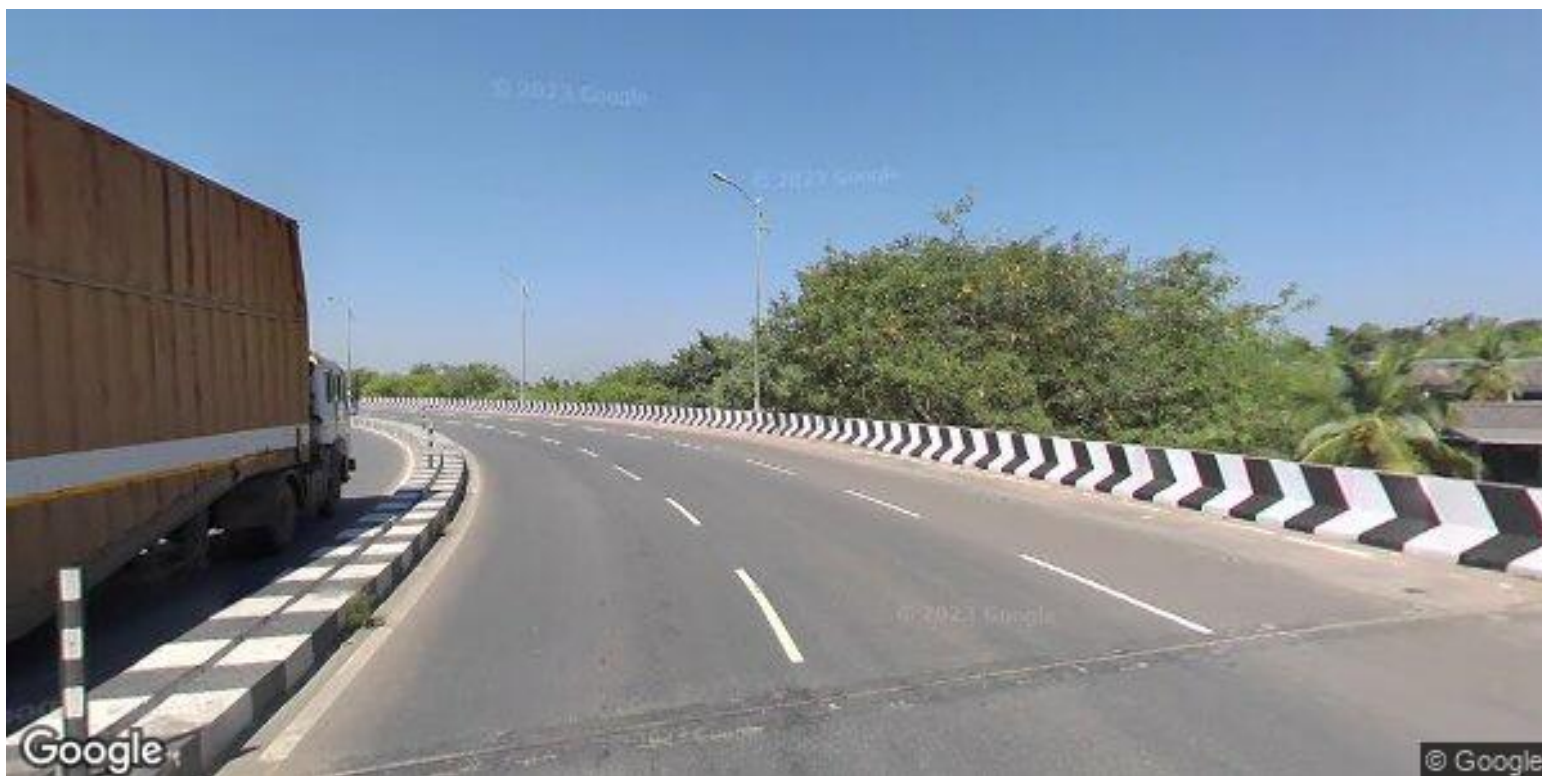
**Risk Type:** Turn  
**Risk Level:** Medium  
**Speed Limit:** 30 KM/Hr  
**Coordinates:** 11.64172, 78.12154

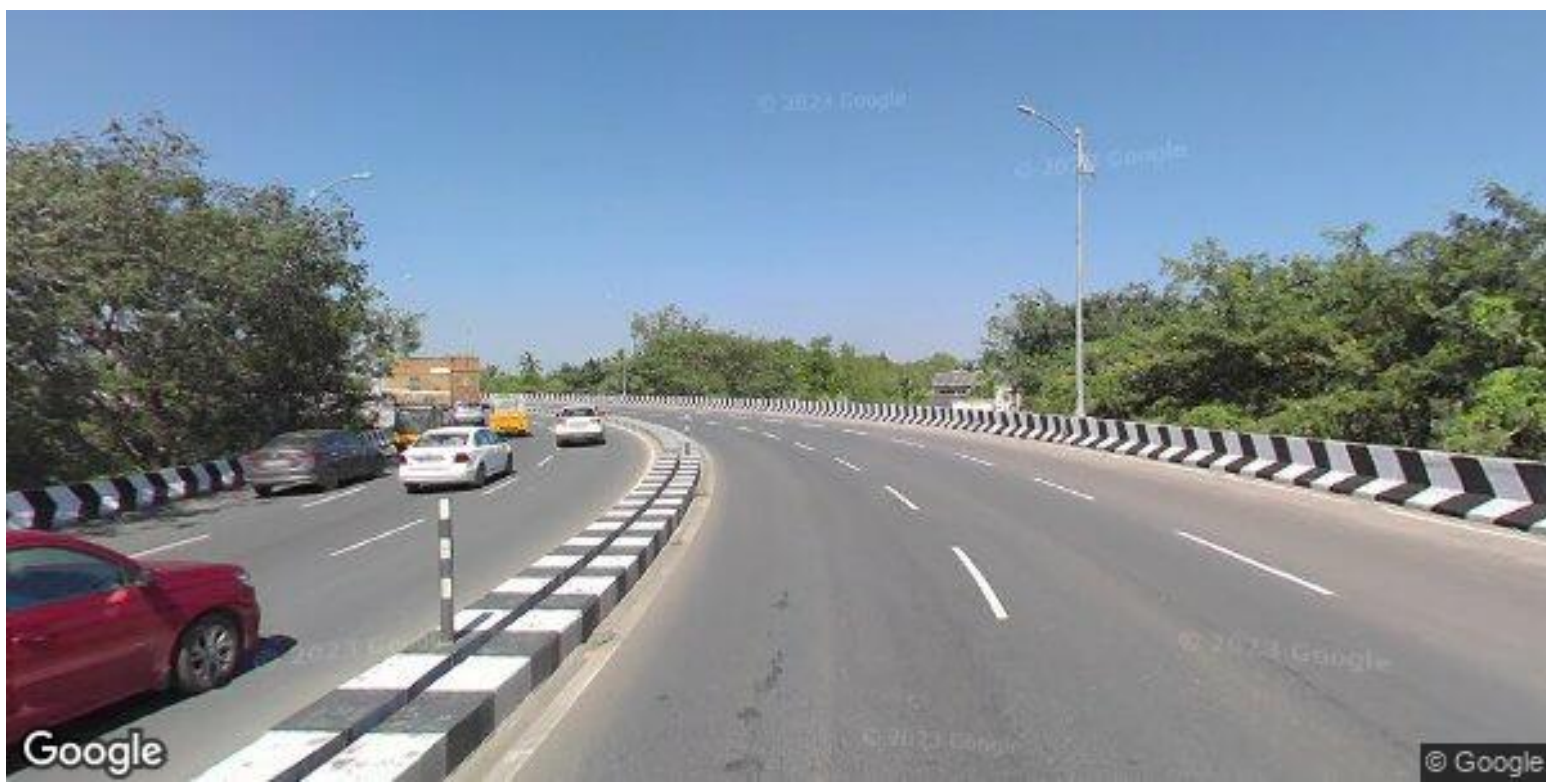
**Coordinates:** 11.64128, 78.12168

**Risk Type:** Turn

**Risk Level:** Medium

**Speed Limit:** 30 KM/Hr

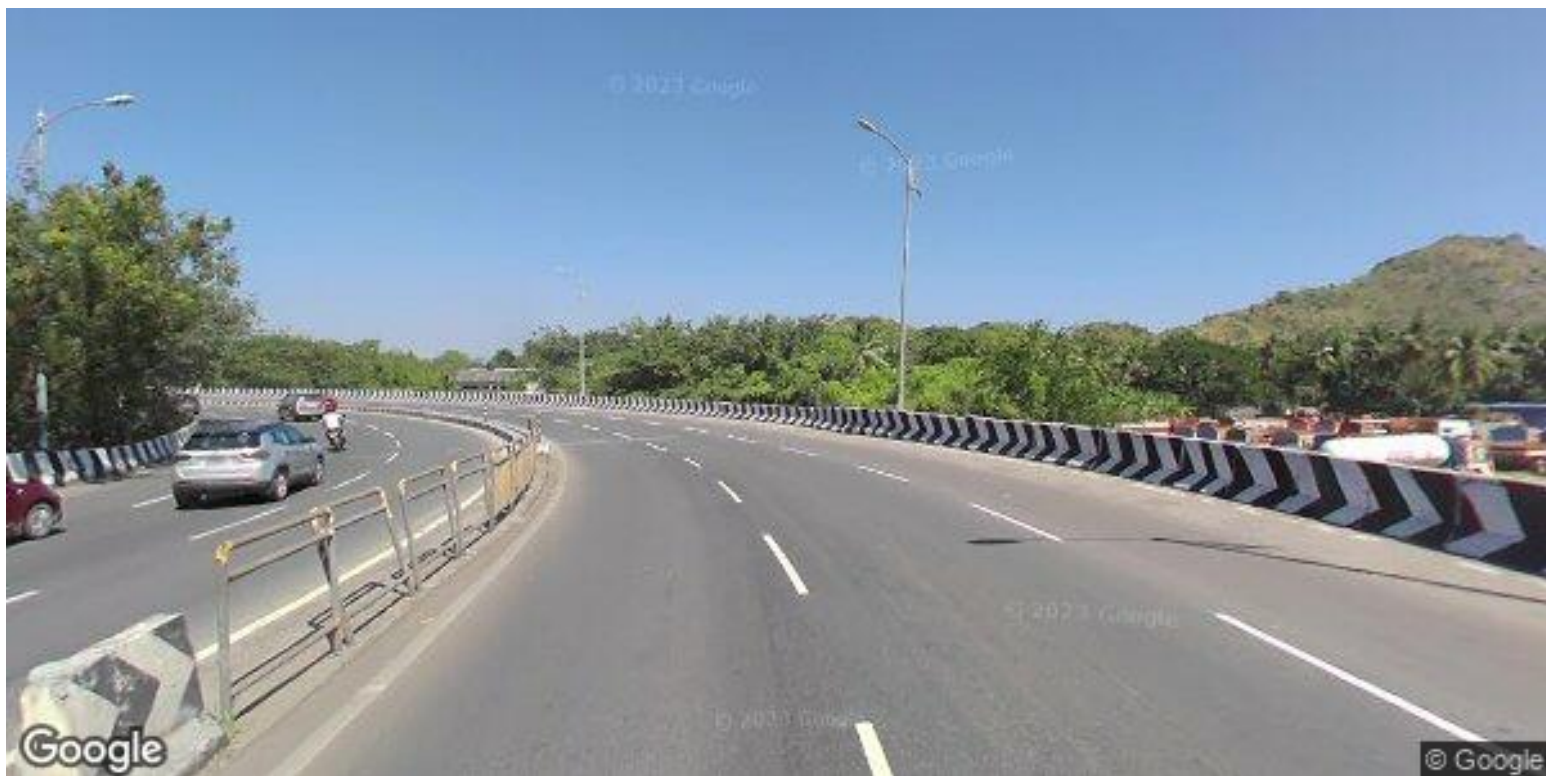
**Coordinates:** 11.64098, 78.12163

**Risk Type:** Turn

**Risk Level:** Medium

**Speed Limit:** 30 KM/Hr

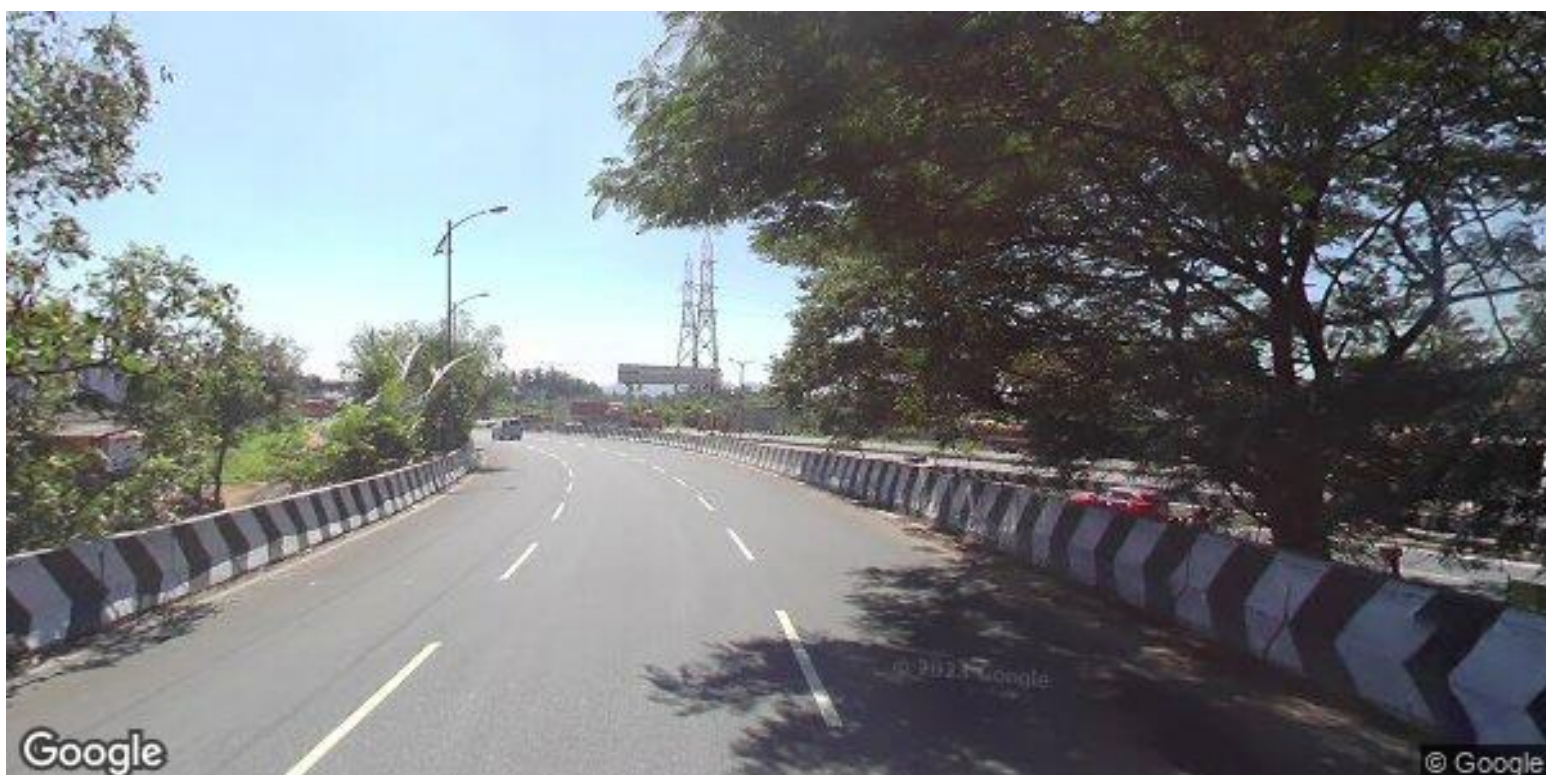
**Coordinates:** 11.63972, 78.12083

**Risk Type:** Turn

**Risk Level:** Medium

**Speed Limit:** 30 KM/Hr

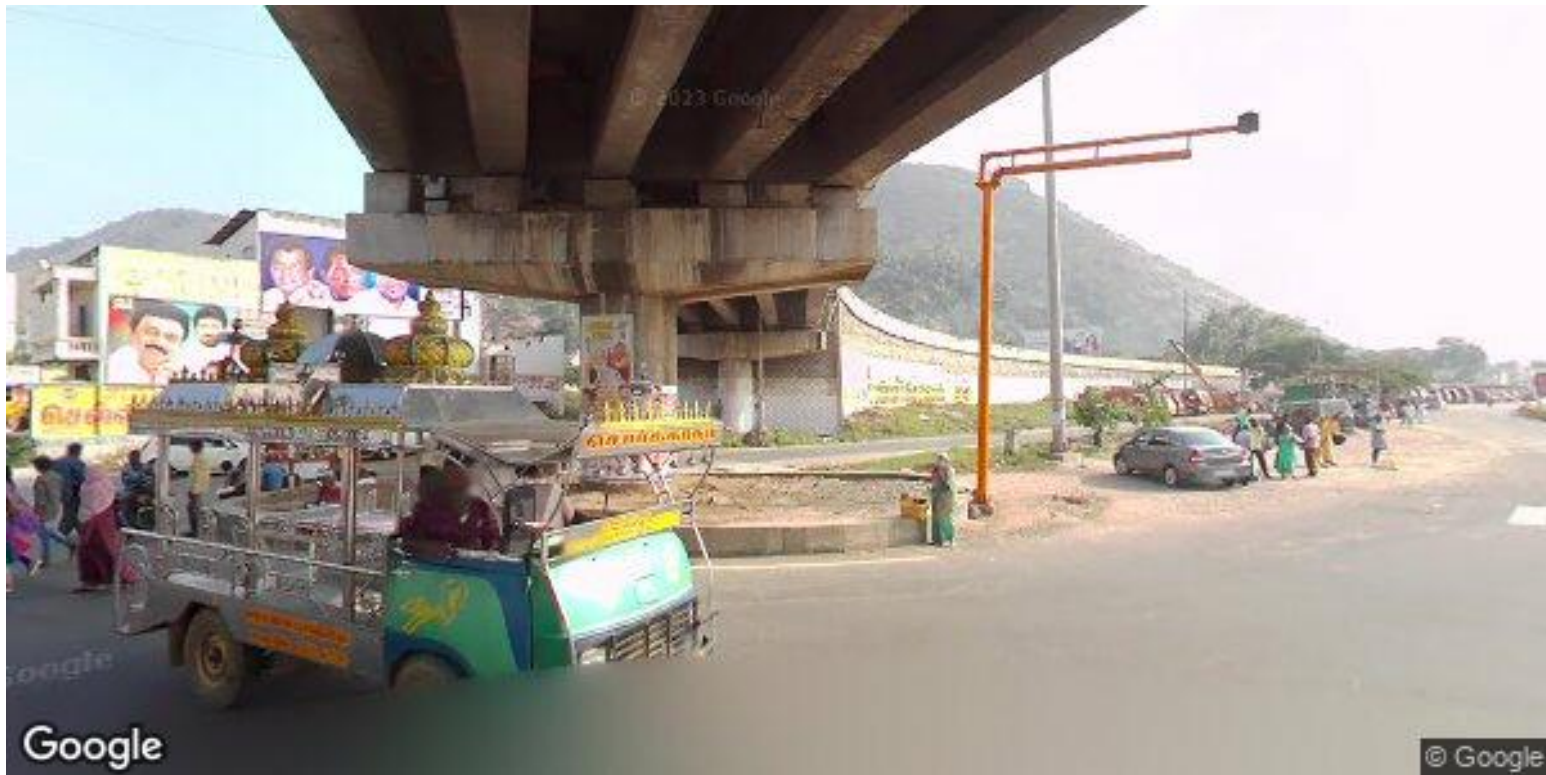
**Coordinates:** 11.62509, 78.14758

**Risk Type:** Turn

**Risk Level:** Medium

**Speed Limit:** 30 KM/Hr

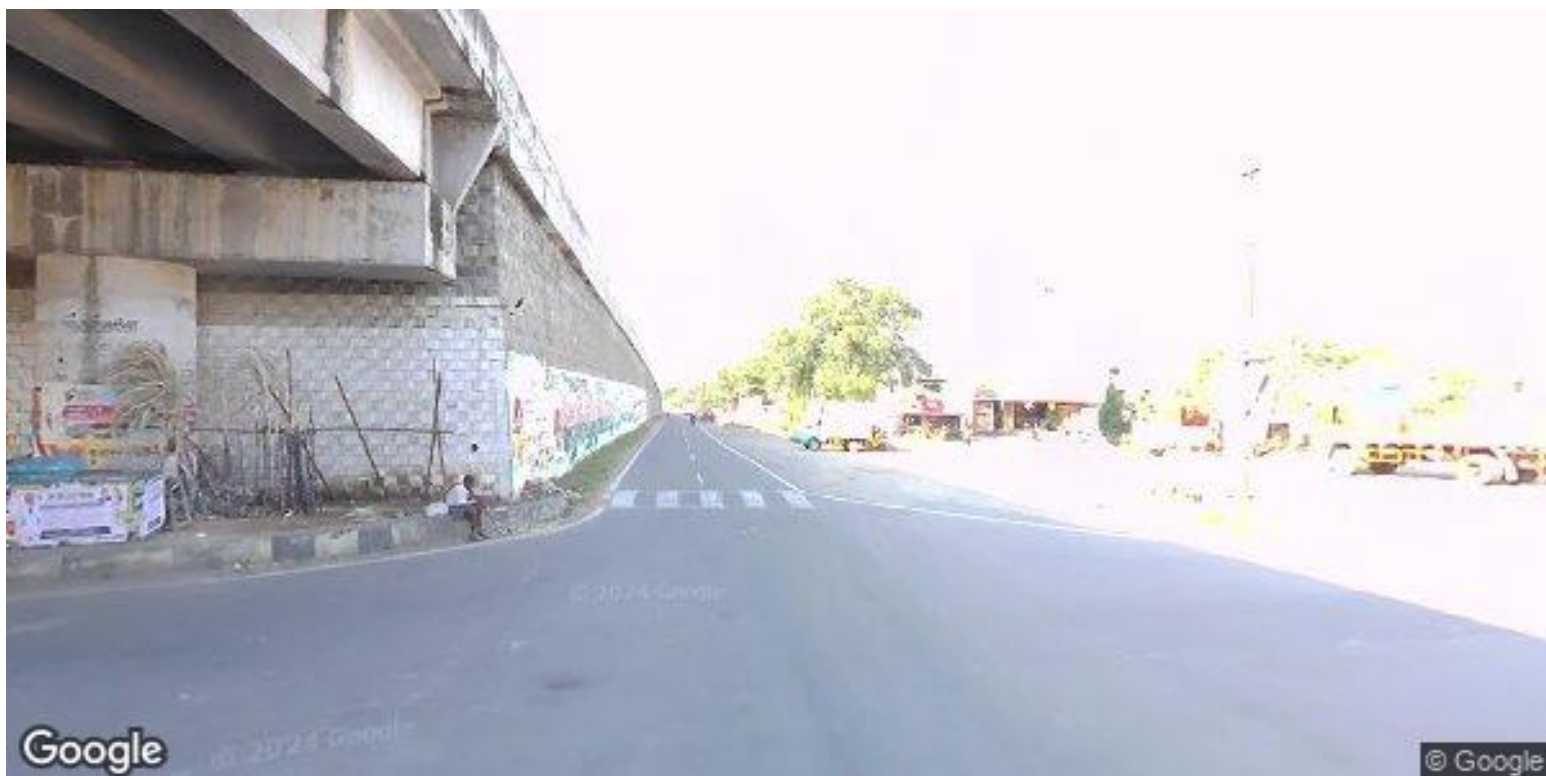
**Coordinates:** 11.58757, 78.14819

**Risk Type:** Blind Spot

**Risk Level:** Blind Spot

**Speed Limit:** 10 KM/Hr

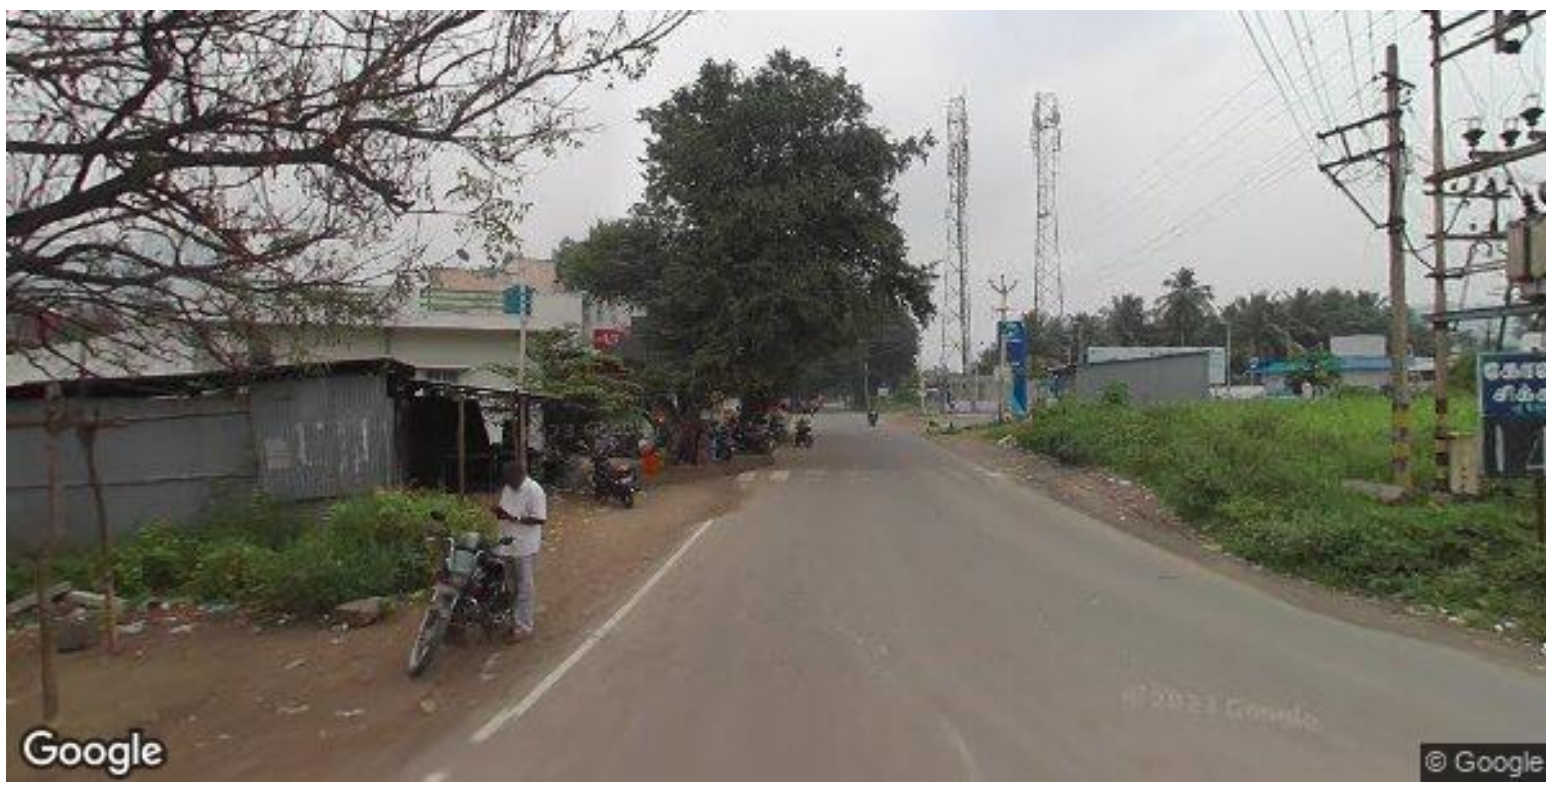
**Coordinates:** 11.58771, 78.14873

**Risk Type:** Turn

**Risk Level:** High

**Speed Limit:** 15 KM/Hr
