# IndianOil

## **JOURNEY RISK MANAGEMENT (JRM) STUDY**

### **Salem Terminal to SRI SIVASAKTHI AGENCY**

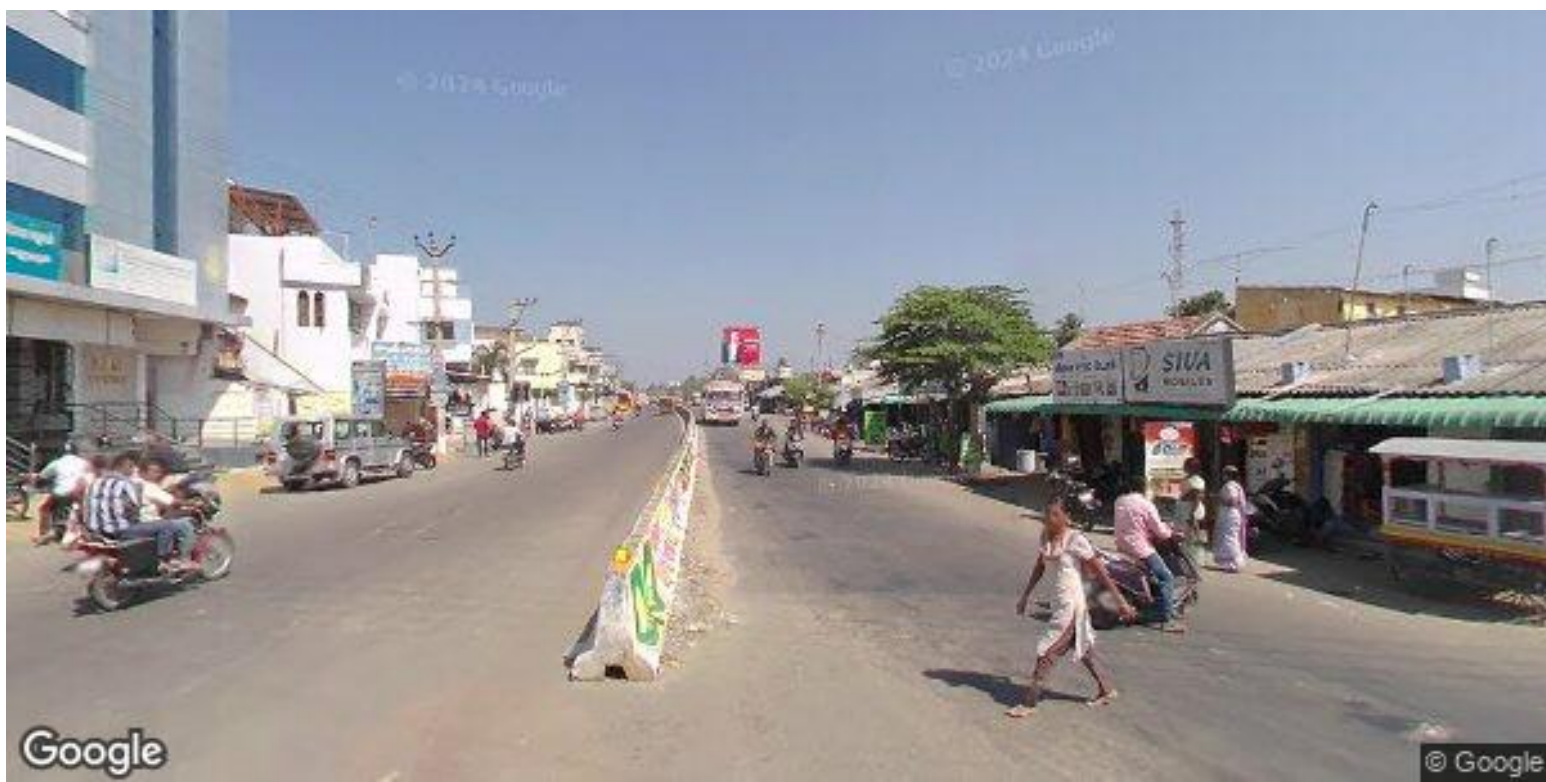
**Coordinates:** 11.37086, 77.74828

**Risk Type:** Roundabout

**Risk Level:** High

**Speed Limit:** 15 KM/Hr

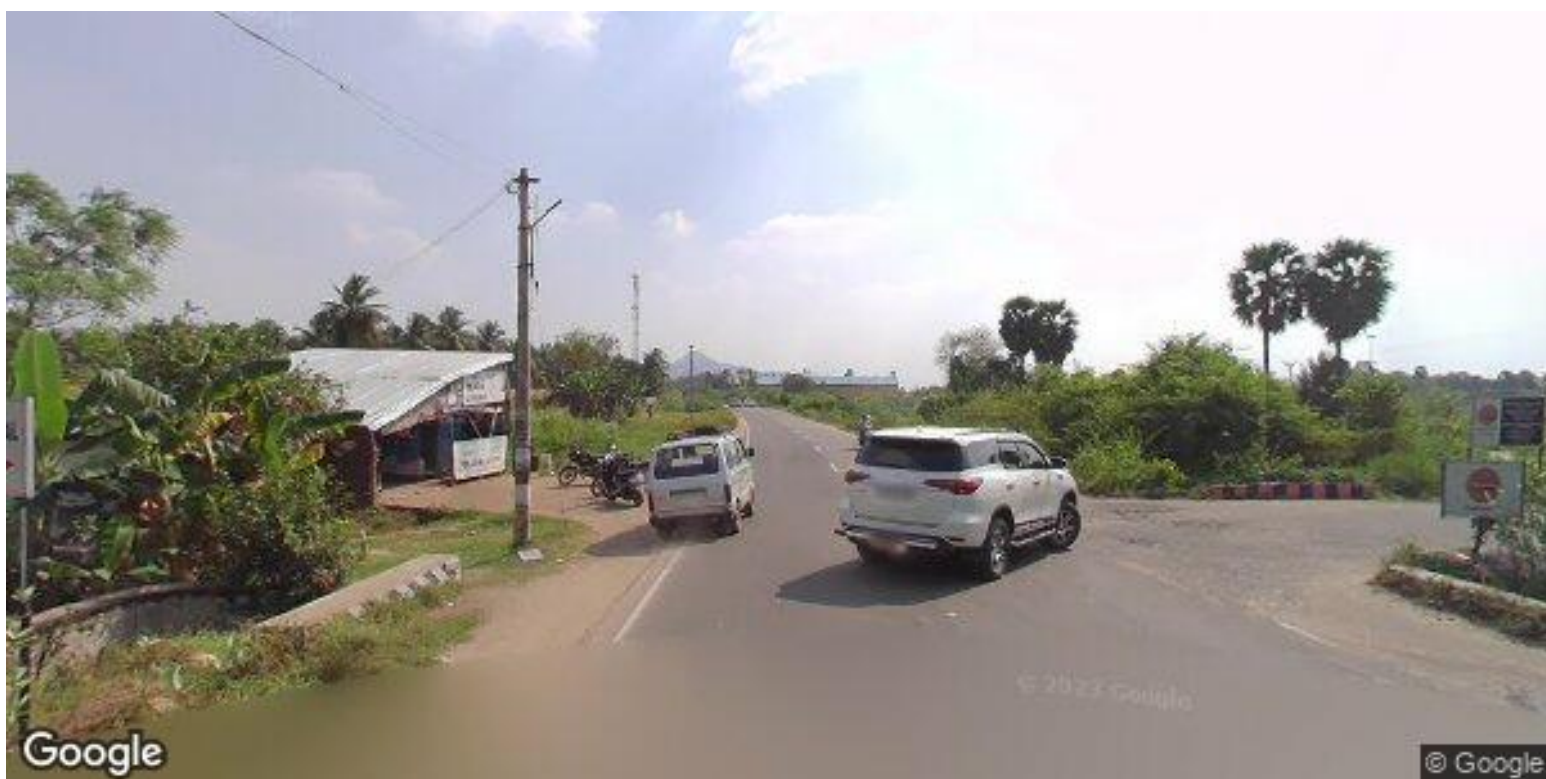
**Coordinates:** 11.44029, 77.87544

**Risk Type:** Turn

**Risk Level:** High

**Speed Limit:** 15 KM/Hr

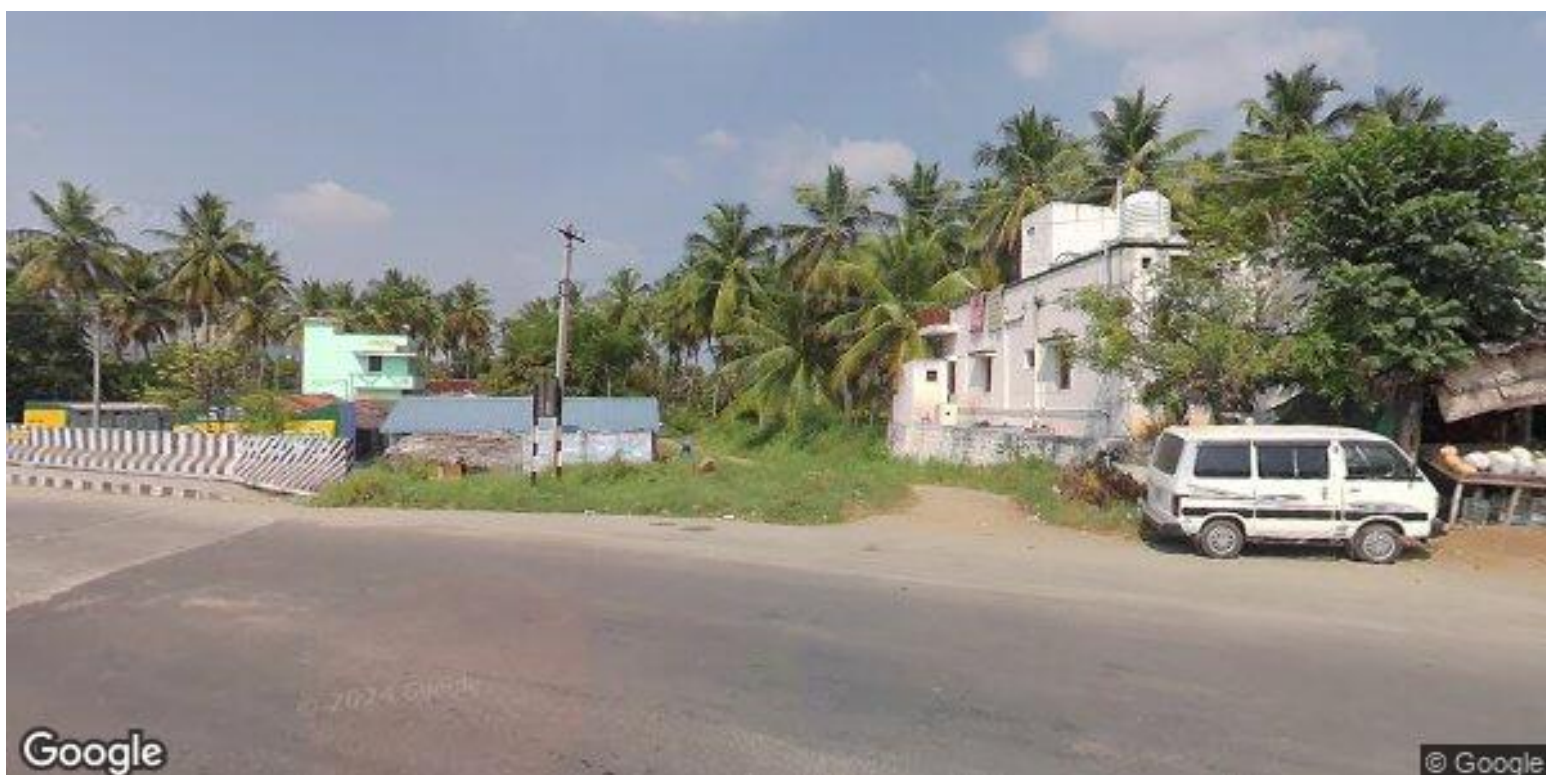
**Risk Type:** Turn  
**Risk Level:** Medium  
**Speed Limit:** 30 KM/Hr  
**Coordinates:** 11.44898, 77.87410

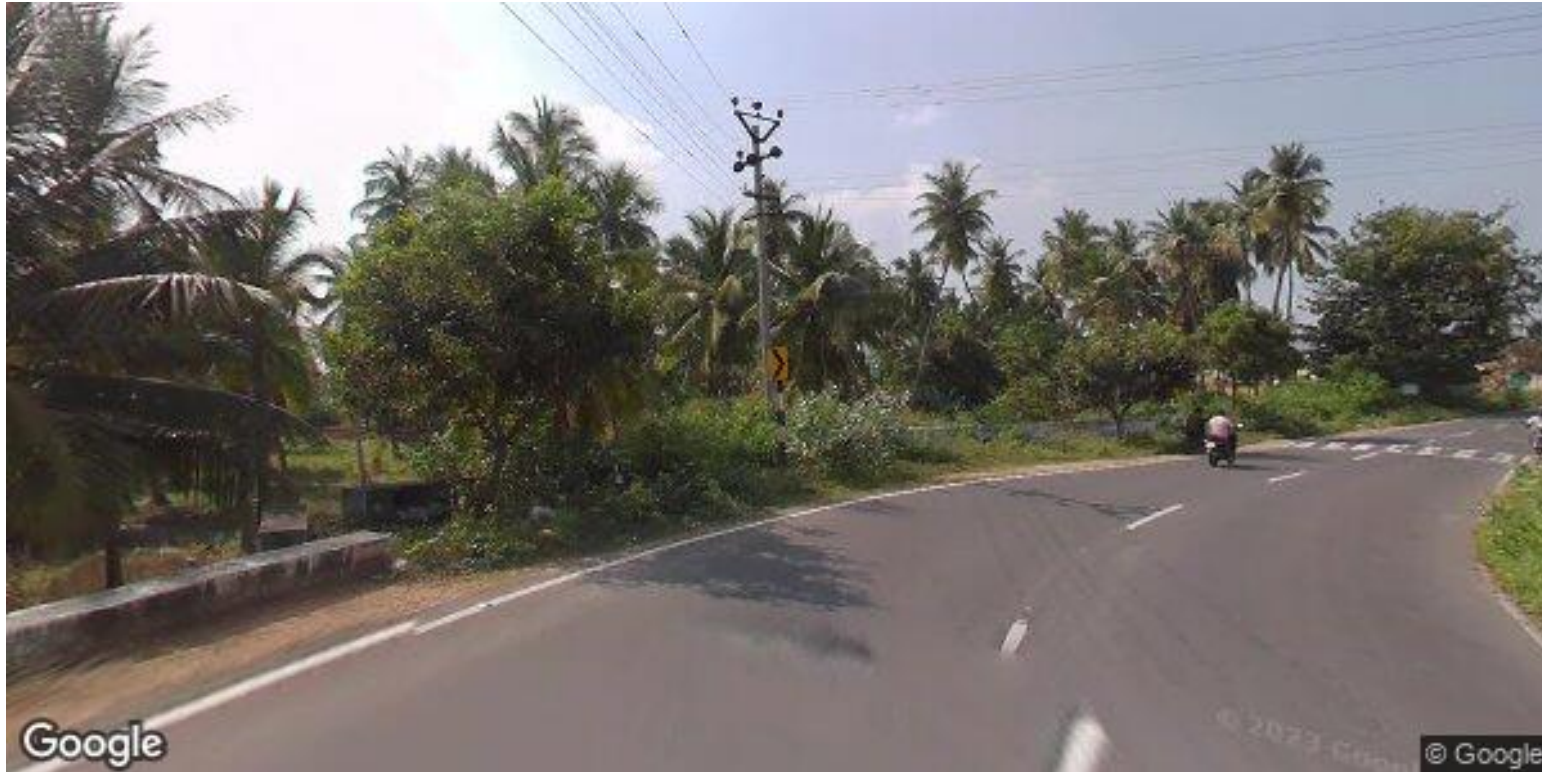
**Risk Type:** Turn  
**Risk Level:** Medium  
**Speed Limit:** 30 KM/Hr  
**Coordinates:** 11.45348, 77.85706

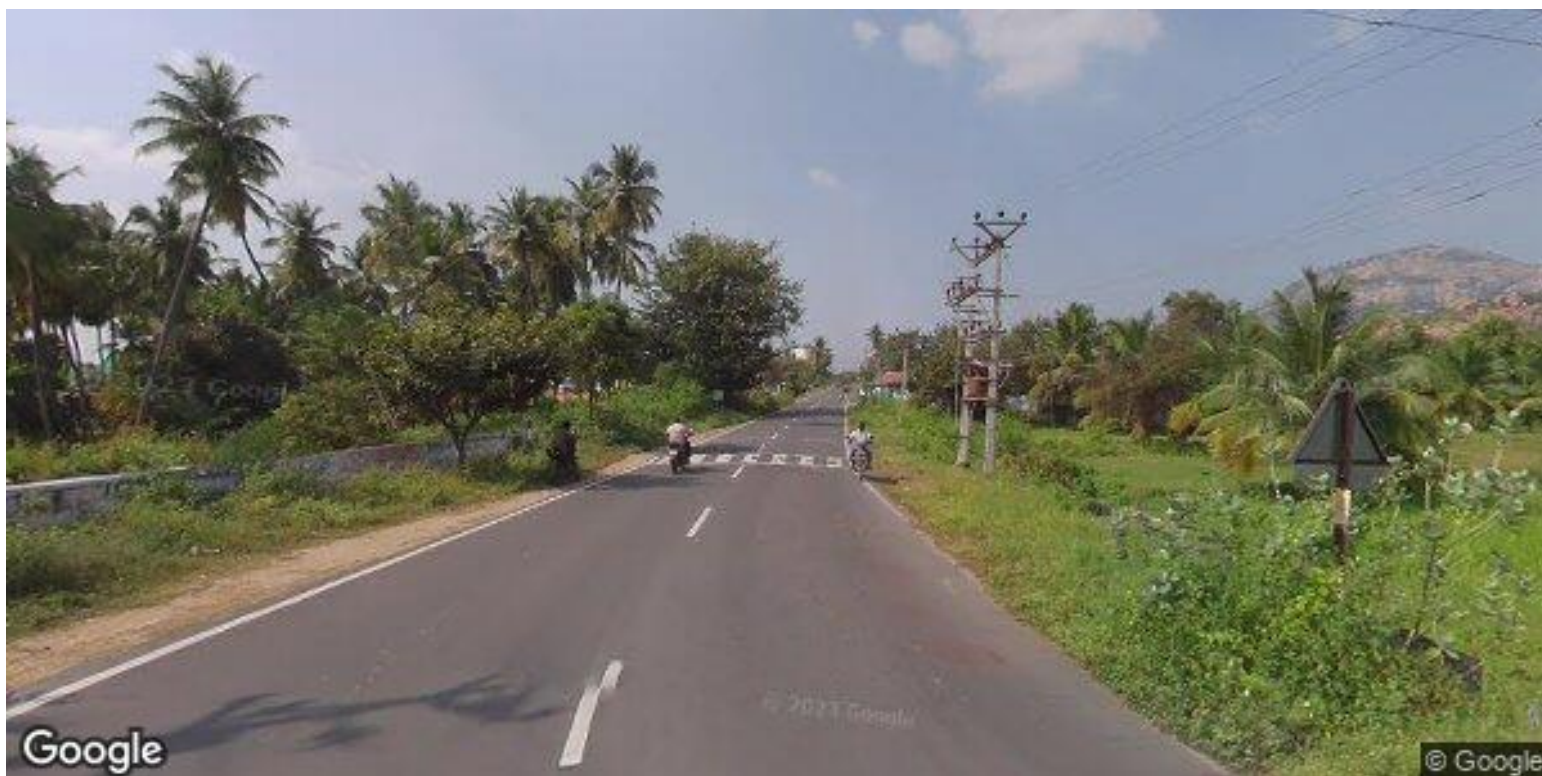
**Risk Type:** Turn  
**Risk Level:** Medium  
**Speed Limit:** 30 KM/Hr  
**Coordinates:** 11.45352, 77.85698

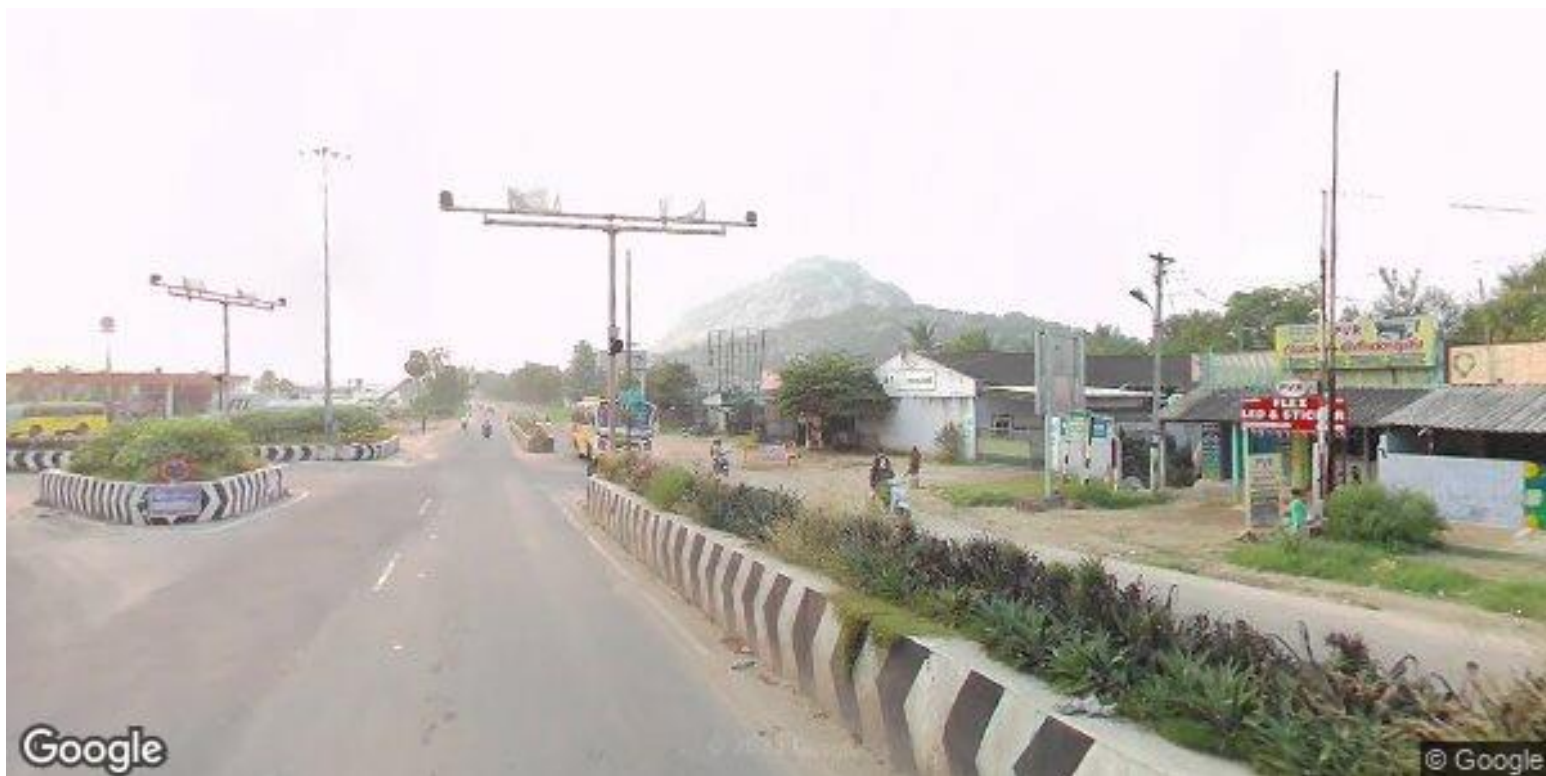
**Coordinates:** 11.46312, 77.84886

**Risk Type:** Turn

**Risk Level:** Medium

**Speed Limit:** 30 KM/Hr

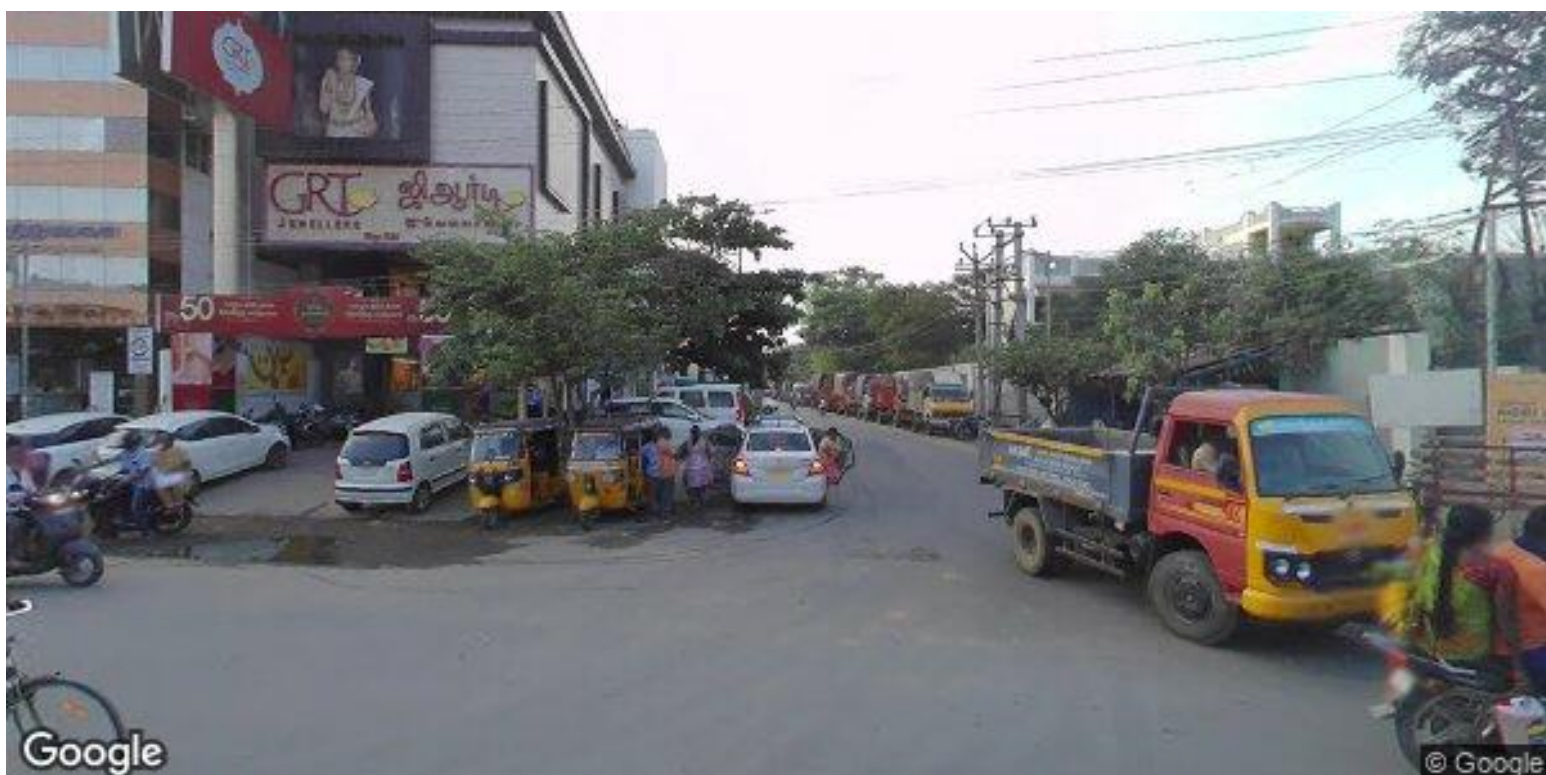
**Risk Type:** Turn  
**Risk Level:** High  
**Speed Limit:** 15 KM/Hr  
**Coordinates:** 11.34678, 77.73104

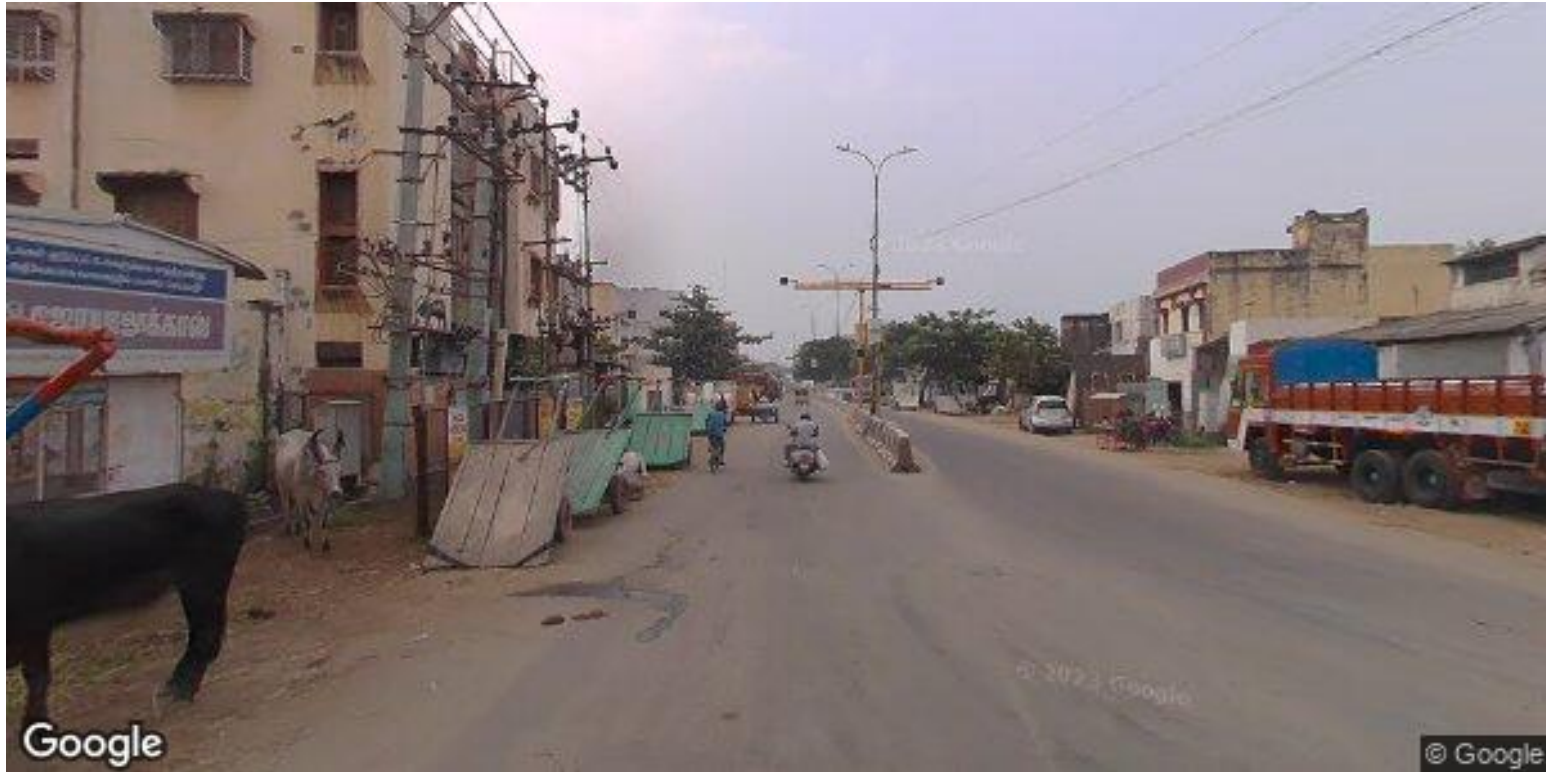
**Risk Type:** Blind Spot  
**Risk Level:** Blind Spot  
**Speed Limit:** 10 KM/Hr  
**Coordinates:** 11.34680, 77.72584

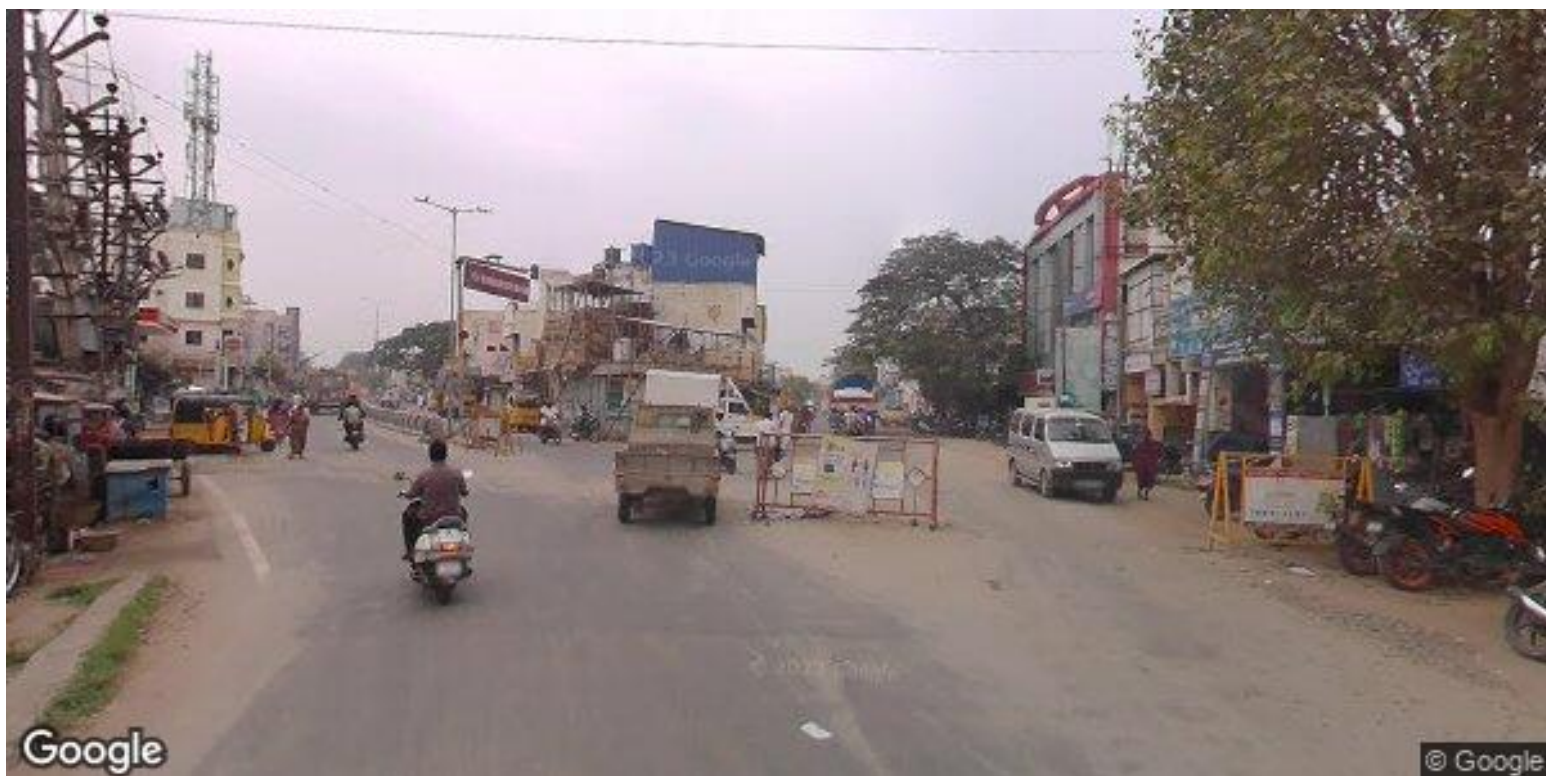
**Risk Type:** Blind Spot  
**Risk Level:** Blind Spot  
**Speed Limit:** 10 KM/Hr  
**Coordinates:** 11.34492, 77.72706

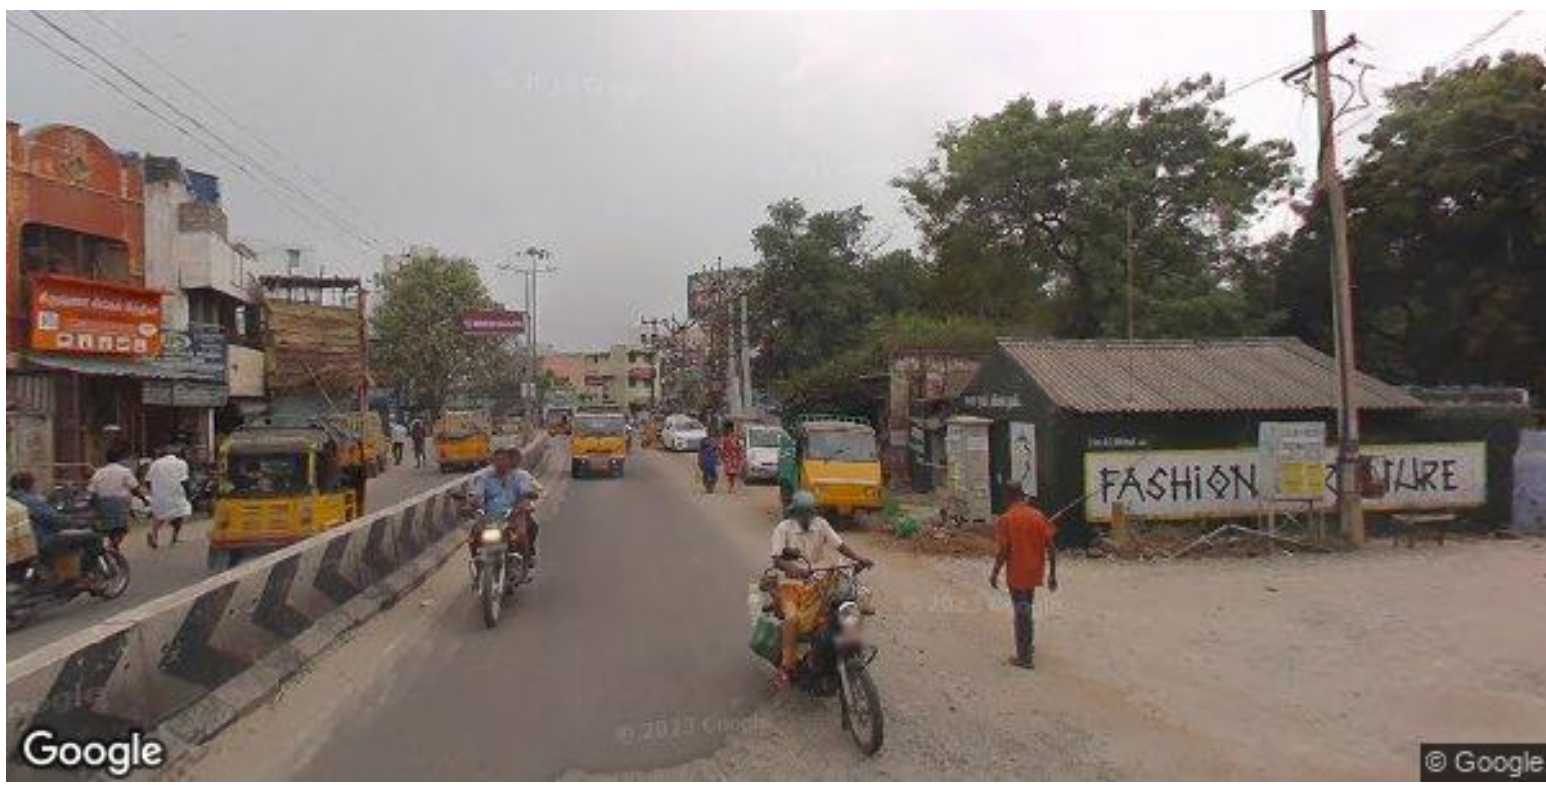
**Coordinates:** 11.34508, 77.72653

**Risk Type:** Turn

**Risk Level:** High

**Speed Limit:** 15 KM/Hr
