## JOURNEY RISK MANAGEMENT (JRM) STUDY

### Salem Terminal TO KARUR TALUK LORRY OWNERS ASSOC

**Route Safety Analysis Report**

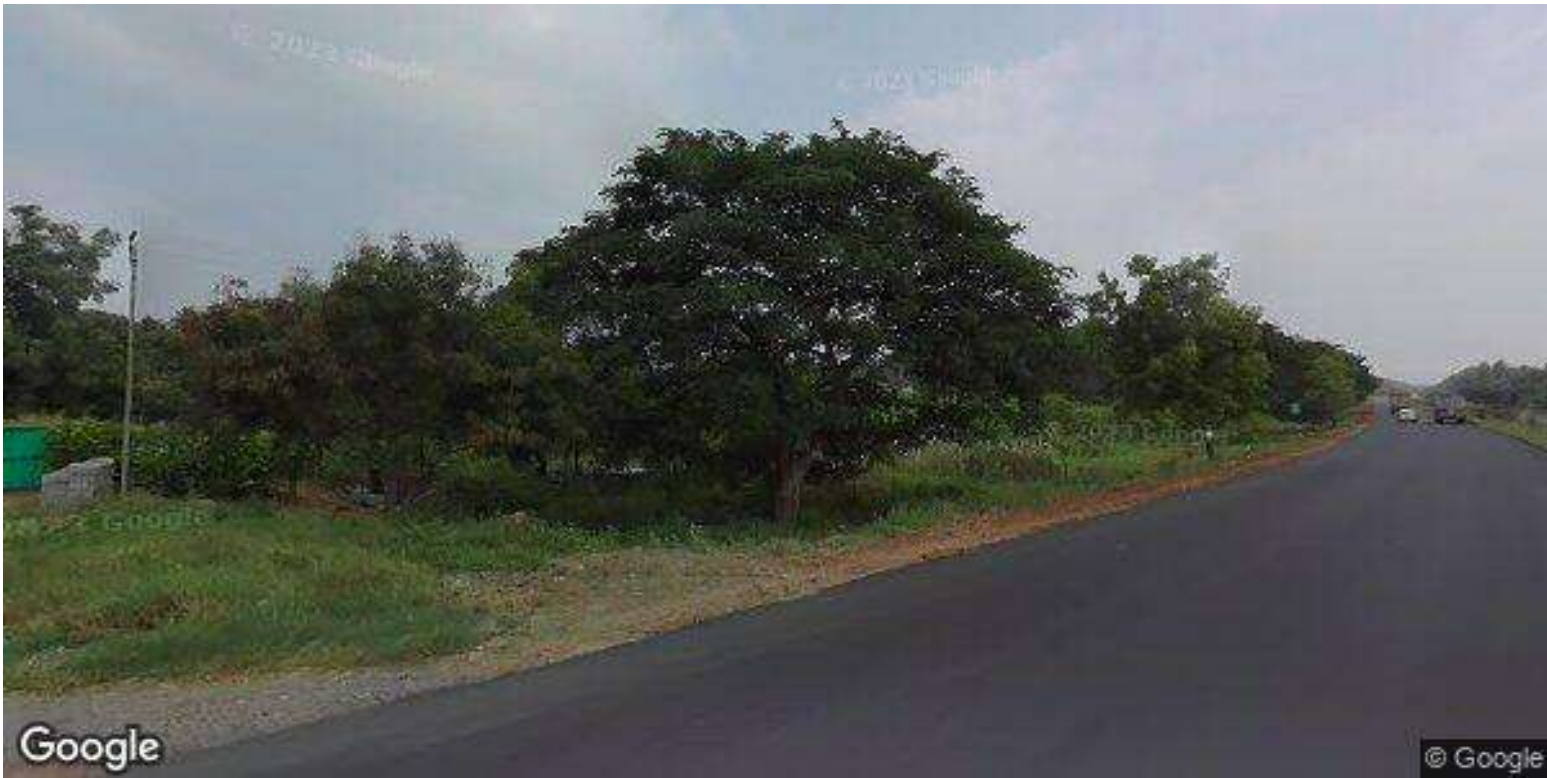
**Risk Type:** Blind Spot  
**Risk Level:** Blind Spot  
**Speed Limit:** 10 KM/Hr  
**Coordinates:** 11.06358, 78.01751

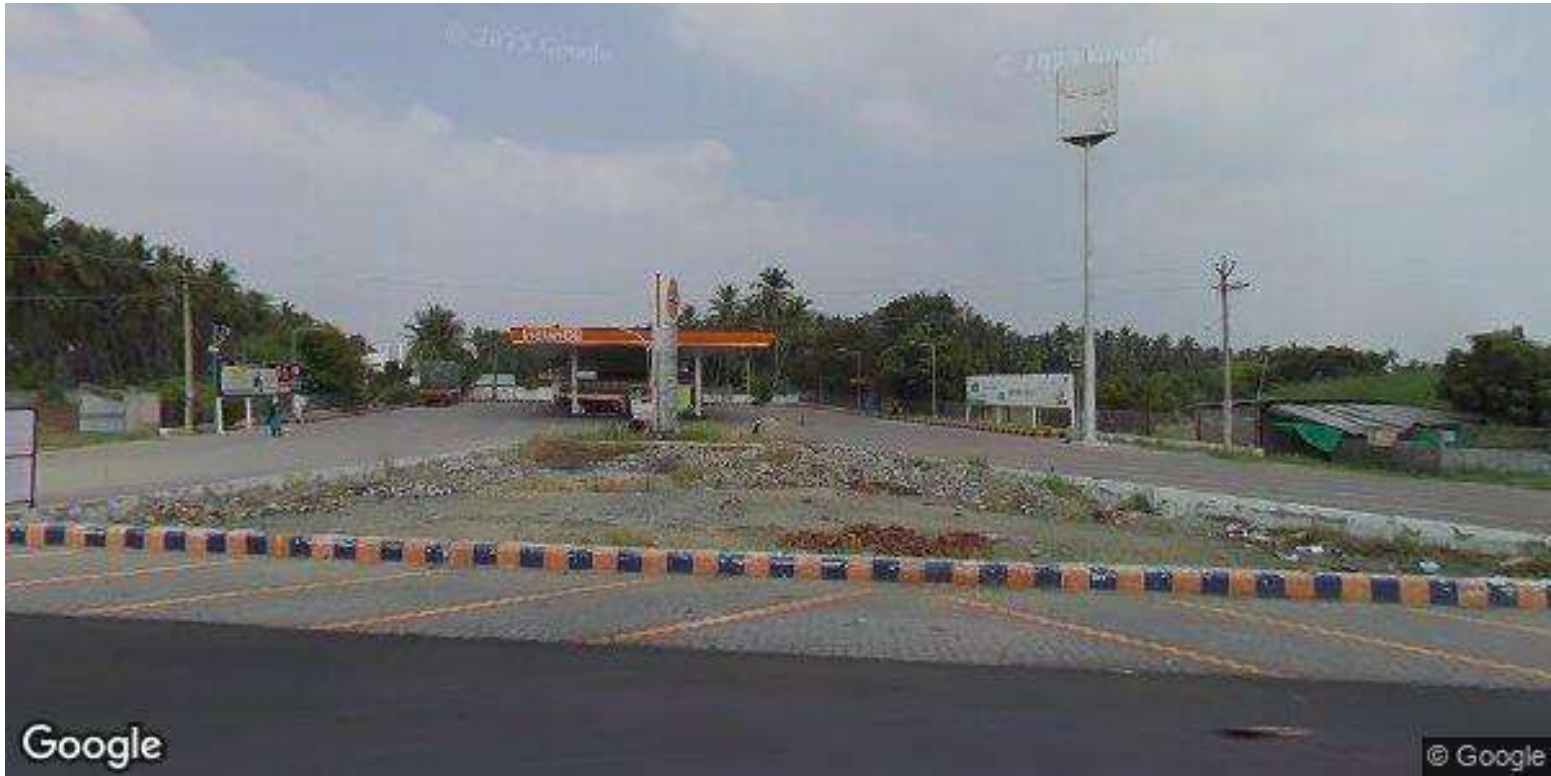
**Risk Type:** Turn  
**Risk Level:** High  
**Speed Limit:** 15 KM/Hr  
**Coordinates:** 11.06408, 78.01744
