# IndianOil

## **JOURNEY RISK MANAGEMENT (JRM) STUDY**

### **Salem Terminal to SRI SARAVANA AGENCIES PUDUPAI**

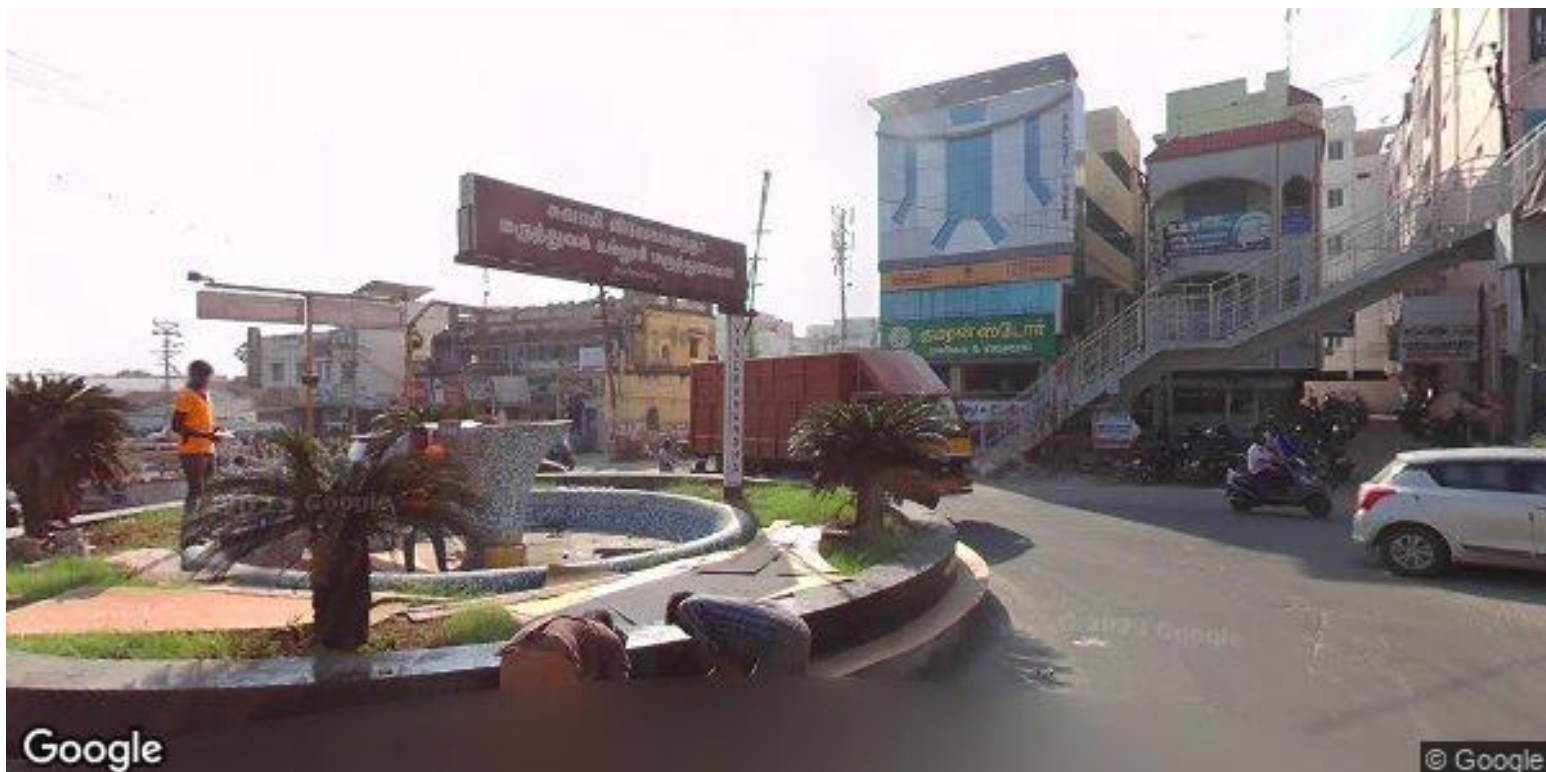
**Risk Type:** Roundabout  
**Risk Level:** High  
**Speed Limit:** 15 KM/Hr  
**Coordinates:** 11.38395, 77.89480

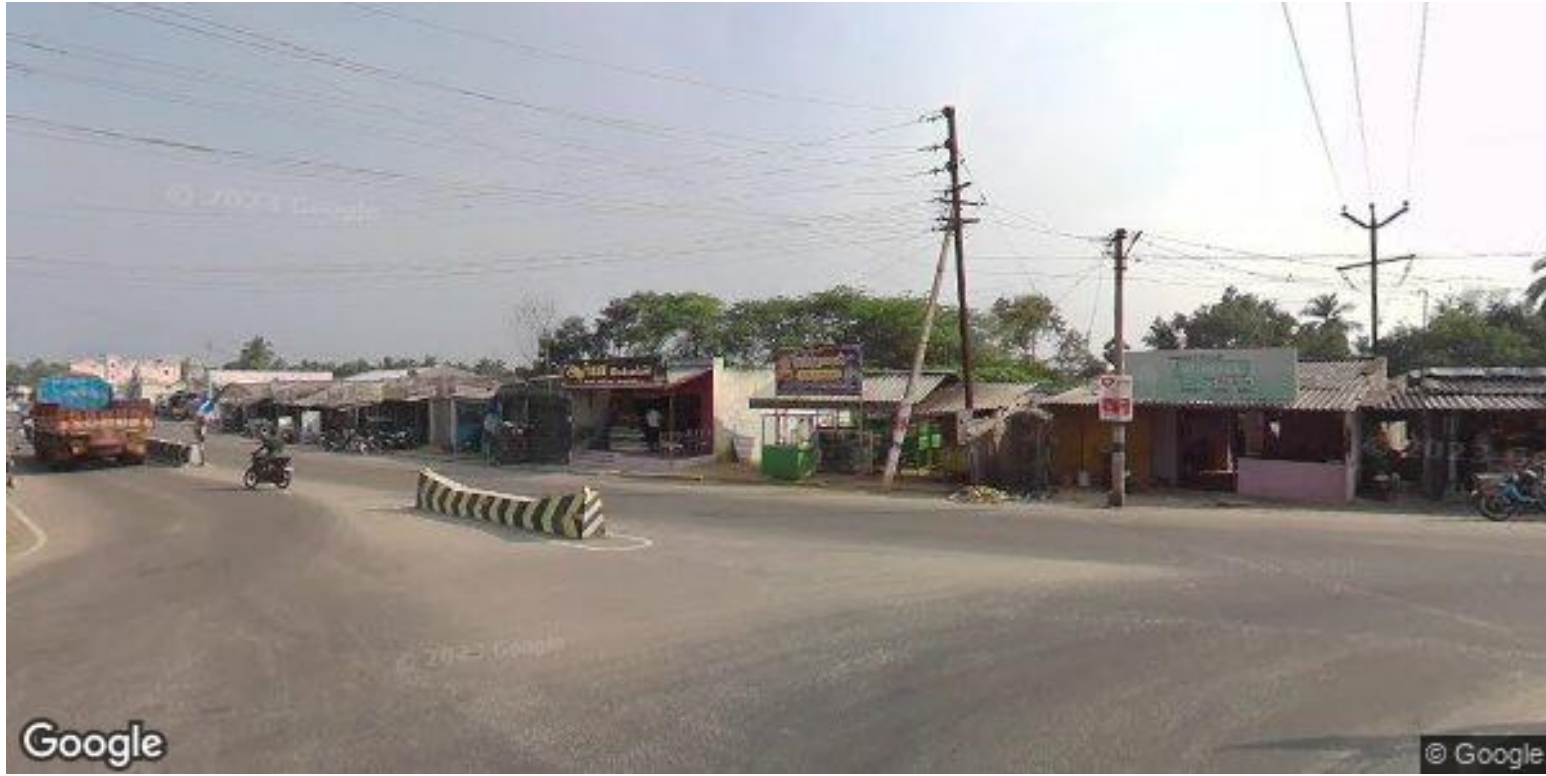
**Risk Type:** Roundabout  
**Risk Level:** High  
**Speed Limit:** 15 KM/Hr  
**Coordinates:** 11.04637, 77.73761

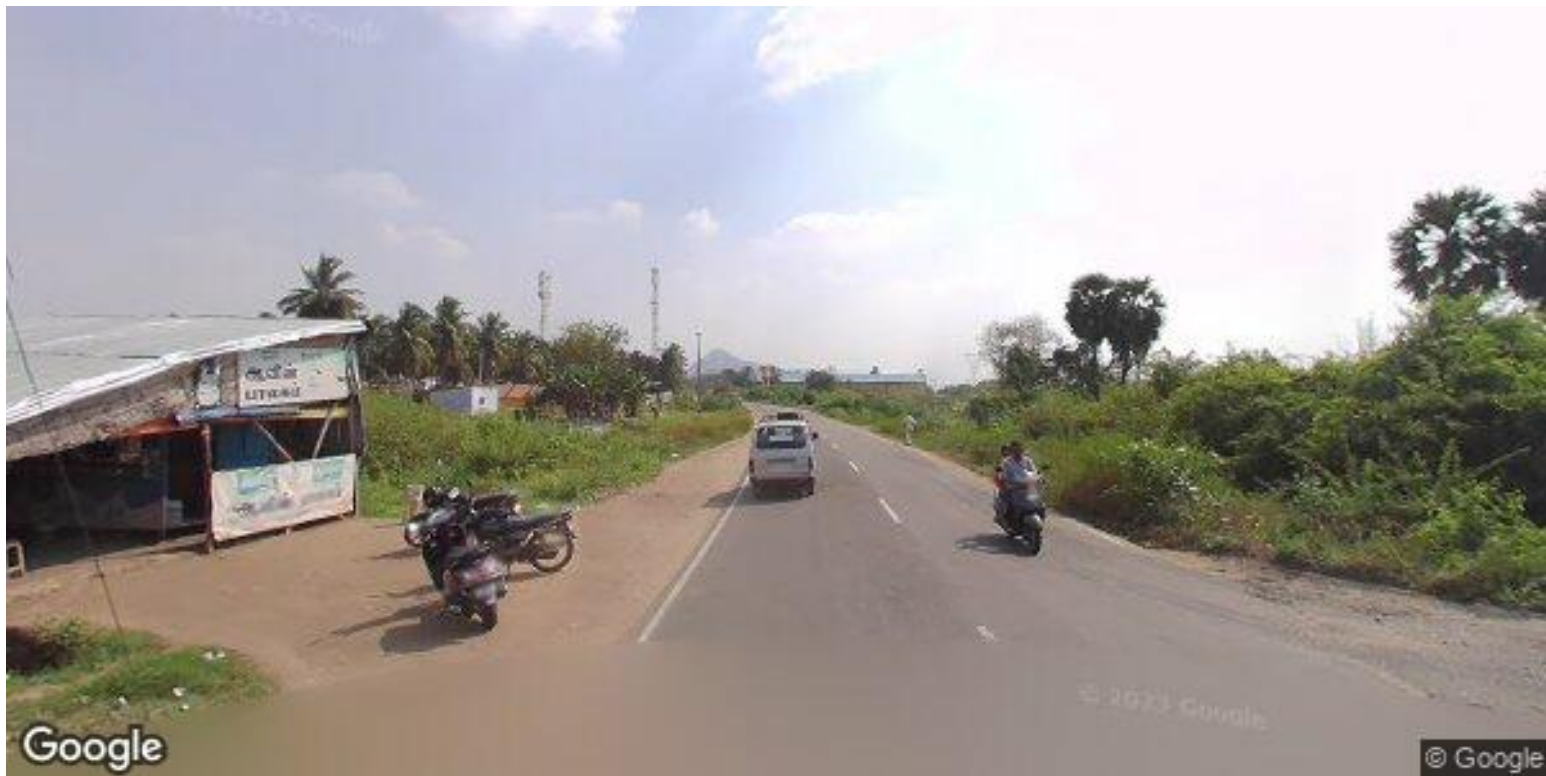
**Risk Type:** Turn  
**Risk Level:** High  
**Speed Limit:** 15 KM/Hr  
**Coordinates:** 11.44022, 77.87546

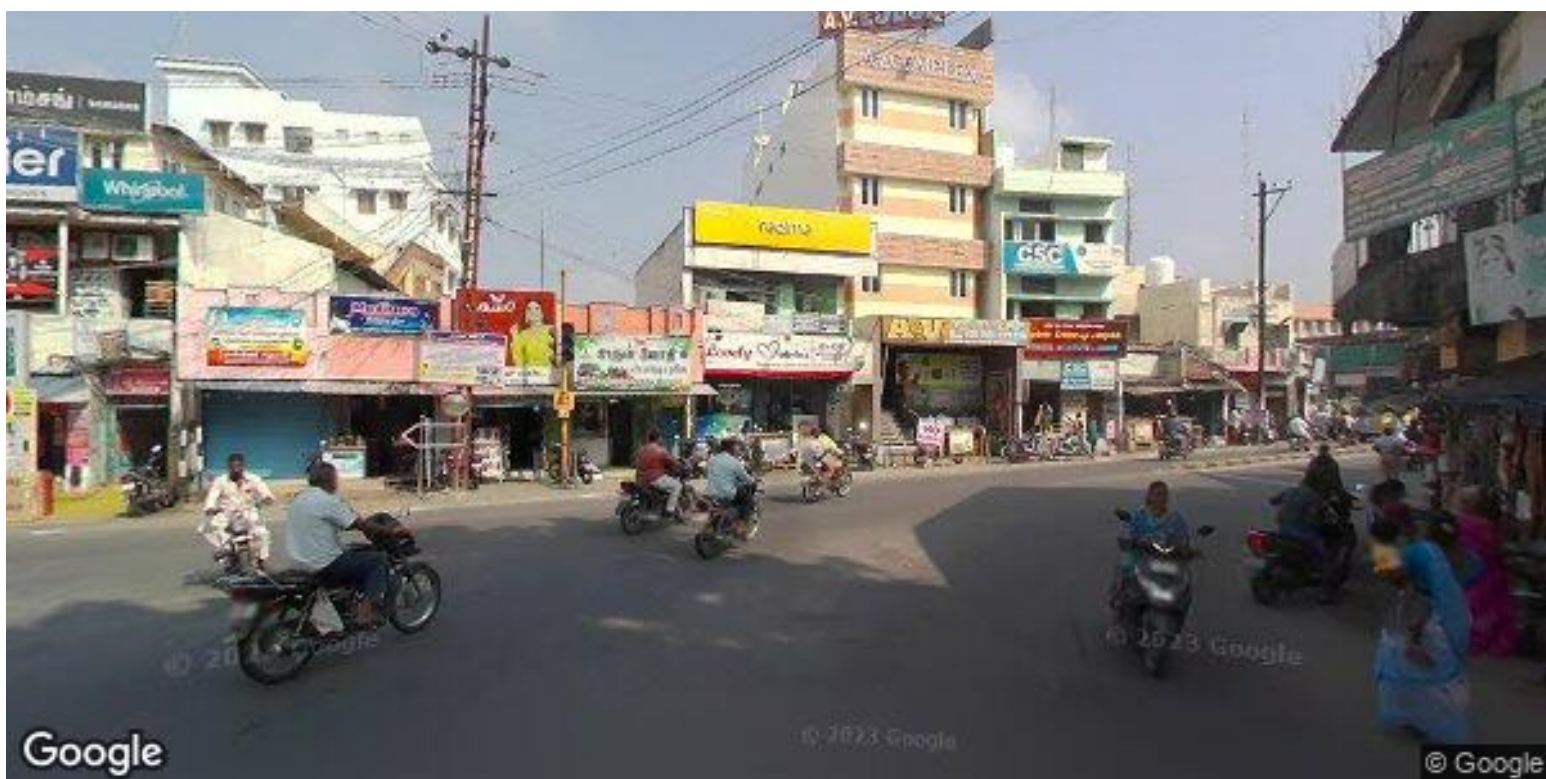
**Coordinates:** 11.37842, 77.89452

**Risk Type:** Turn

**Risk Level:** Medium

**Speed Limit:** 30 KM/Hr

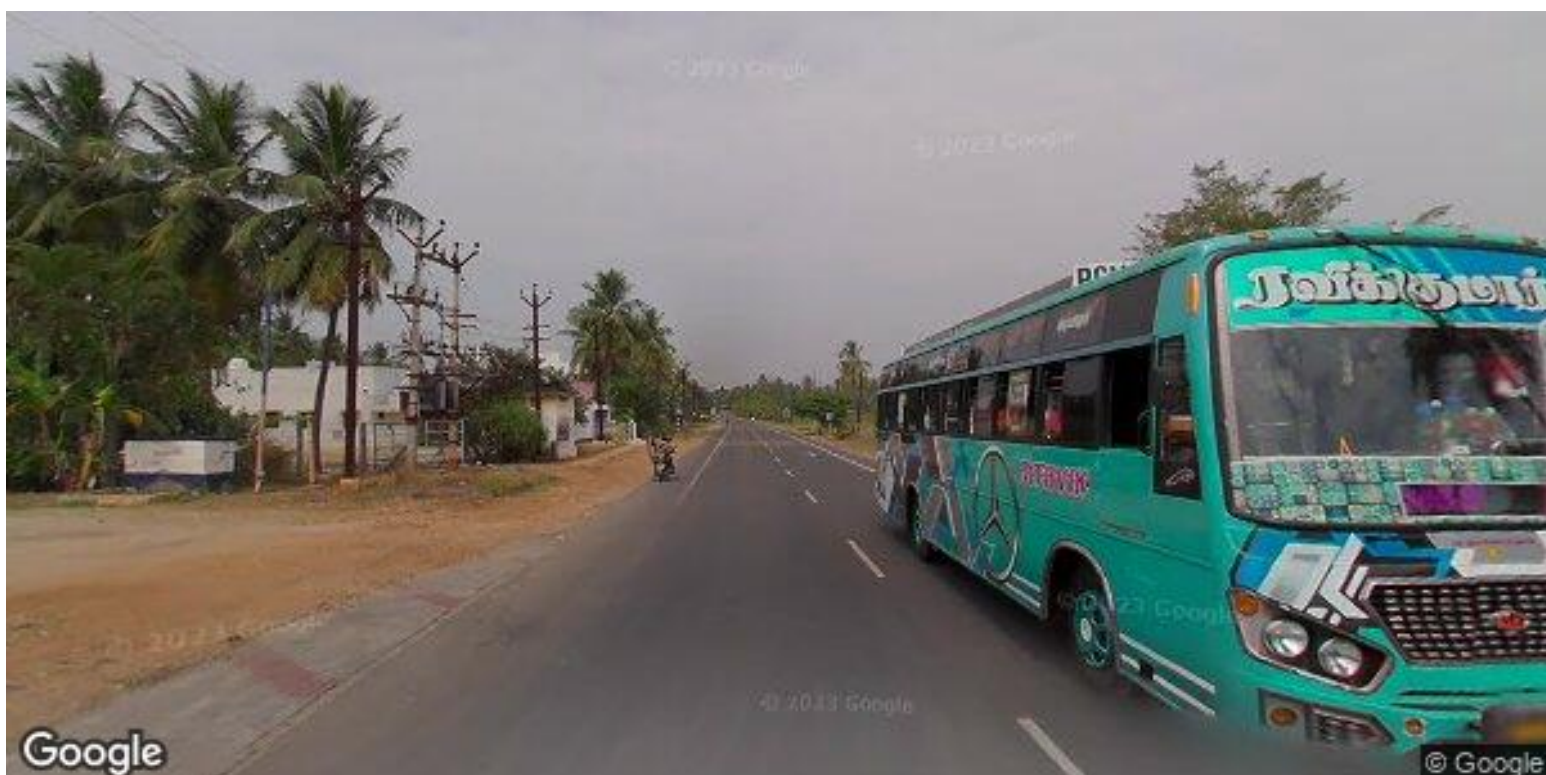
**Coordinates:** 11.30869, 77.92911

**Risk Type:** Turn

**Risk Level:** Medium

**Speed Limit:** 30 KM/Hr

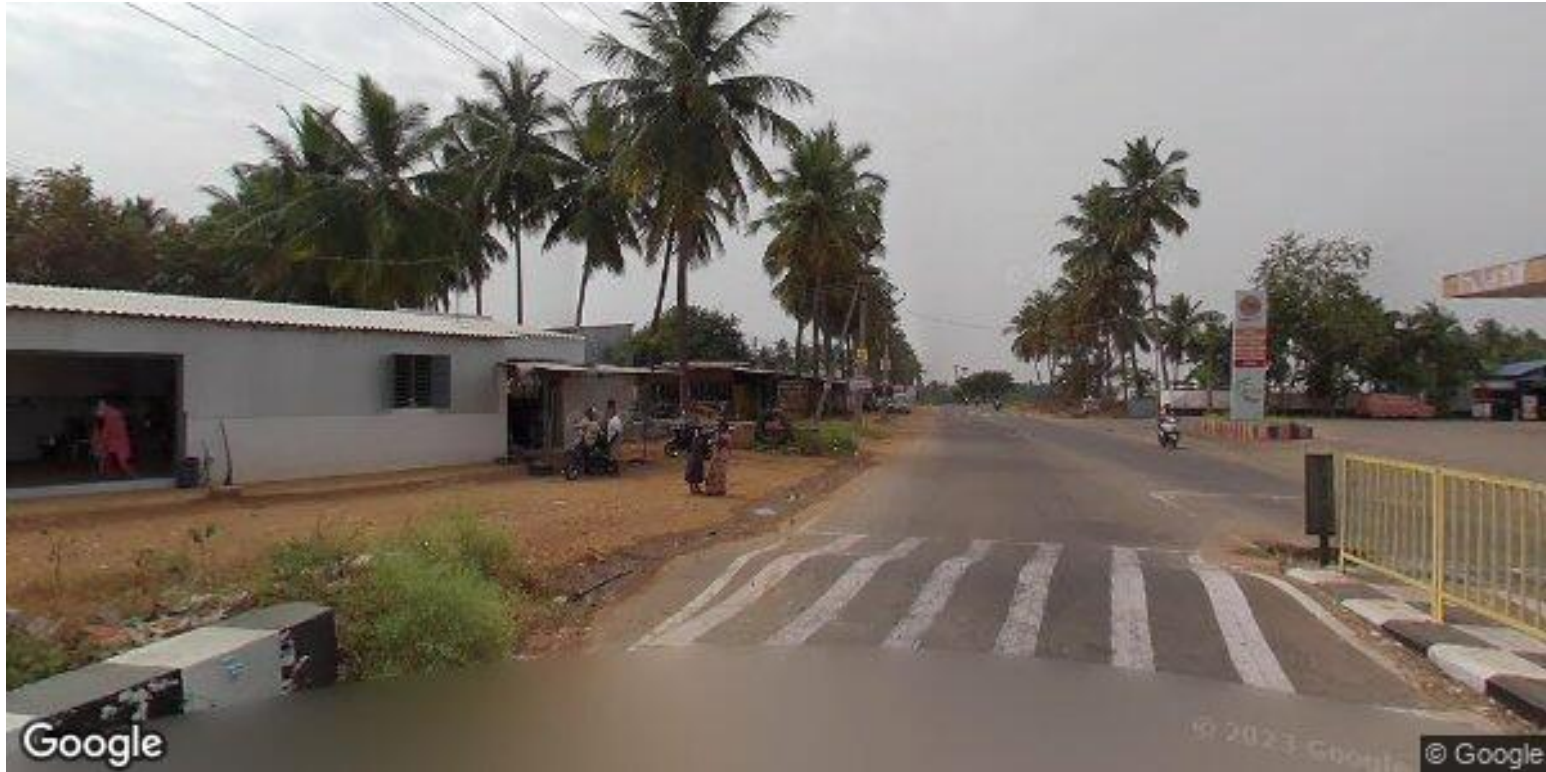
**Coordinates:** 11.30849, 77.92910

**Risk Type:** Turn

**Risk Level:** Medium

**Speed Limit:** 30 KM/Hr

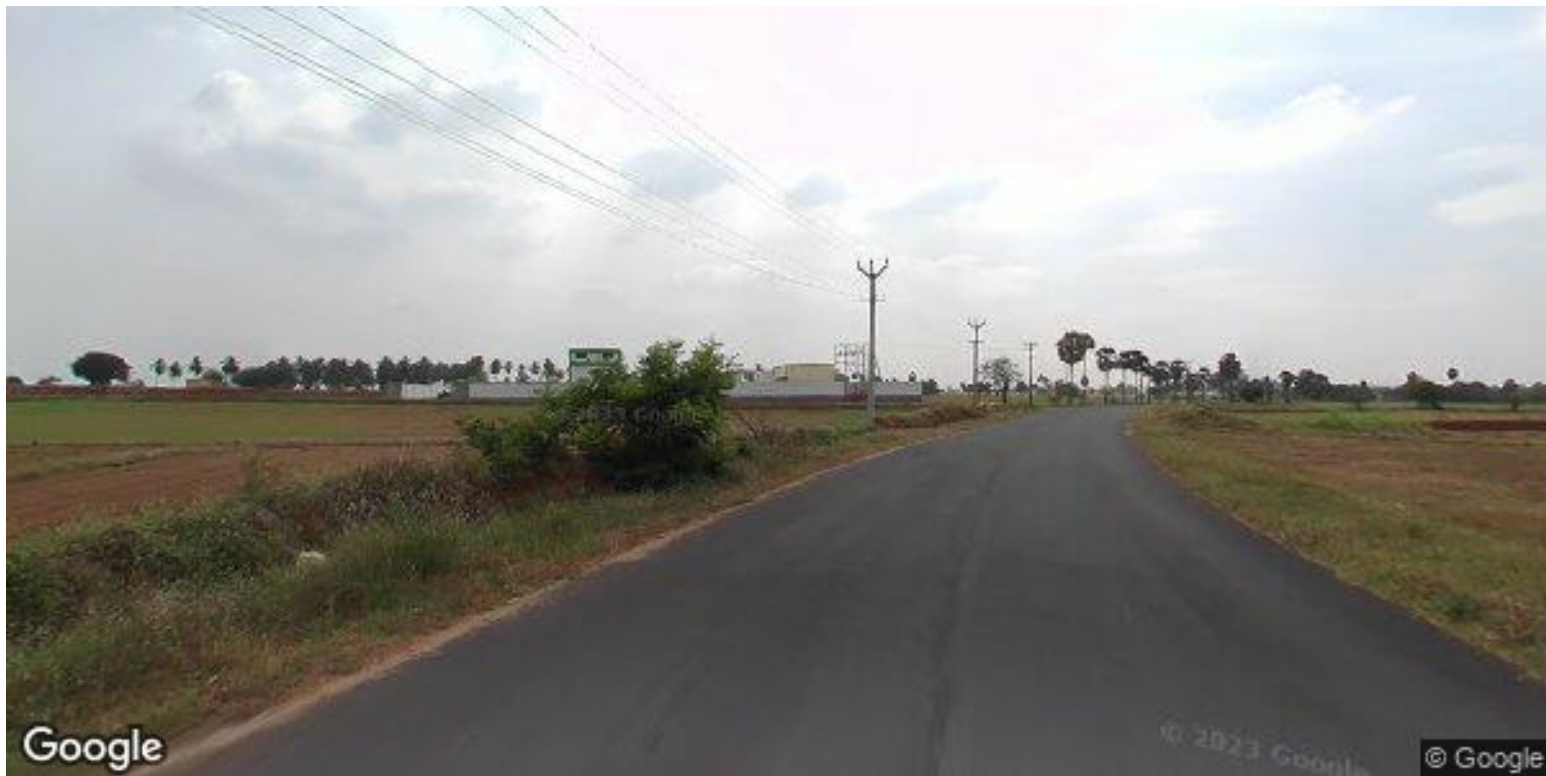
**Coordinates:** 11.27840, 77.91284

**Risk Type:** Turn

**Risk Level:** Medium

**Speed Limit:** 30 KM/Hr

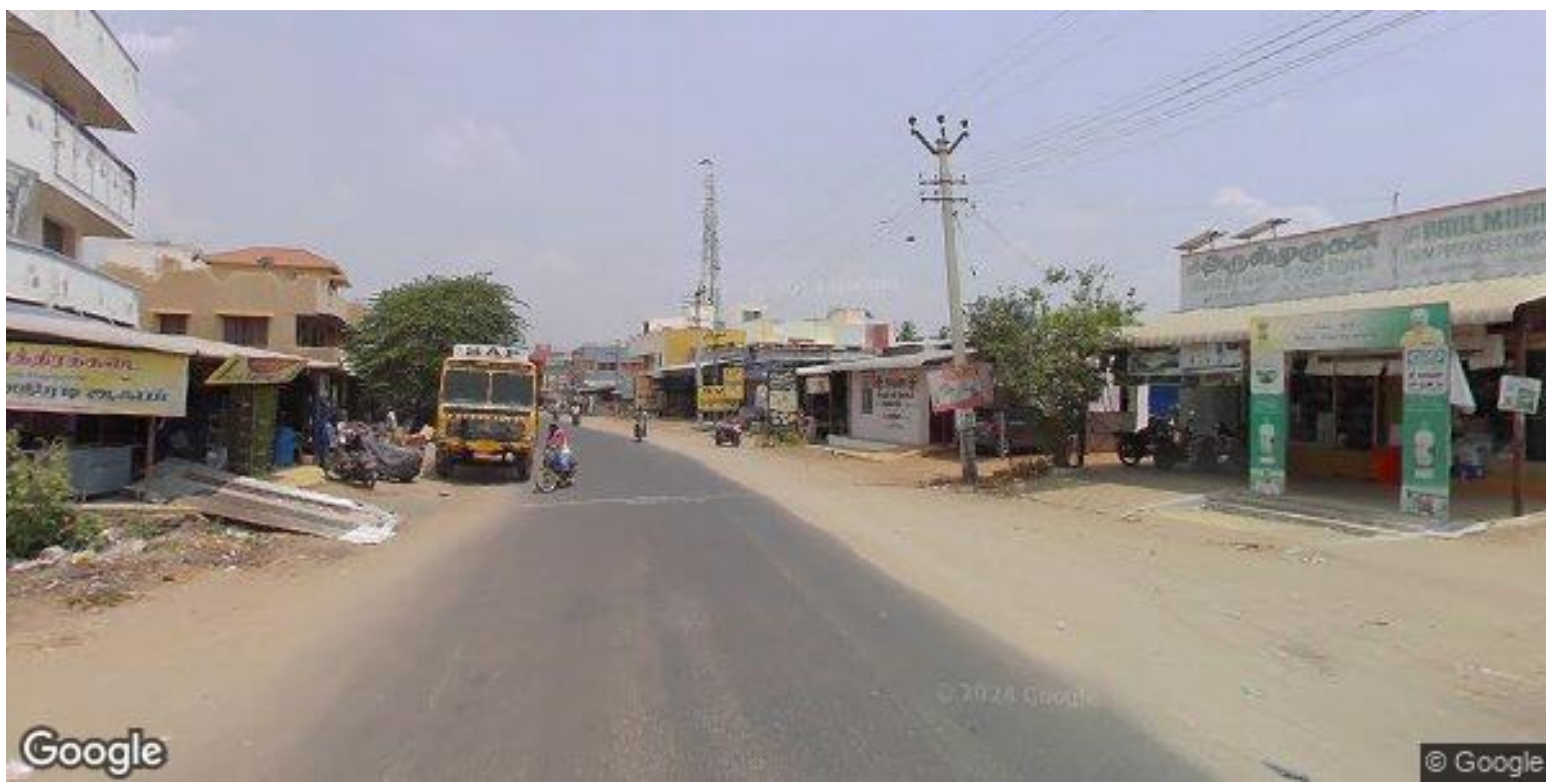
**Coordinates:** 11.24172, 77.87357

**Risk Type:** Turn

**Risk Level:** Medium

**Speed Limit:** 30 KM/Hr

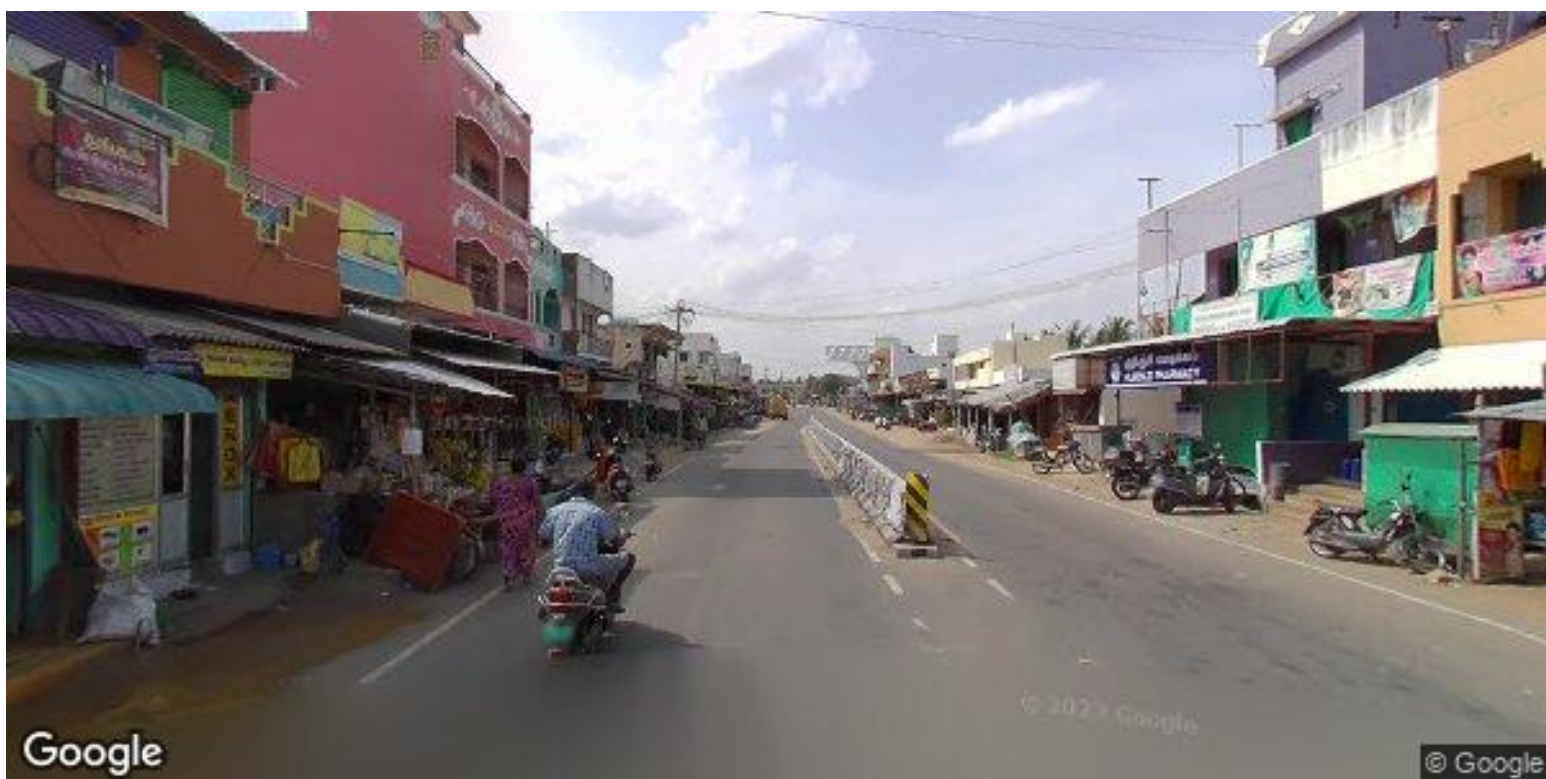
**Coordinates:** 11.24000, 77.87363

**Risk Type:** Turn

**Risk Level:** High

**Speed Limit:** 15 KM/Hr

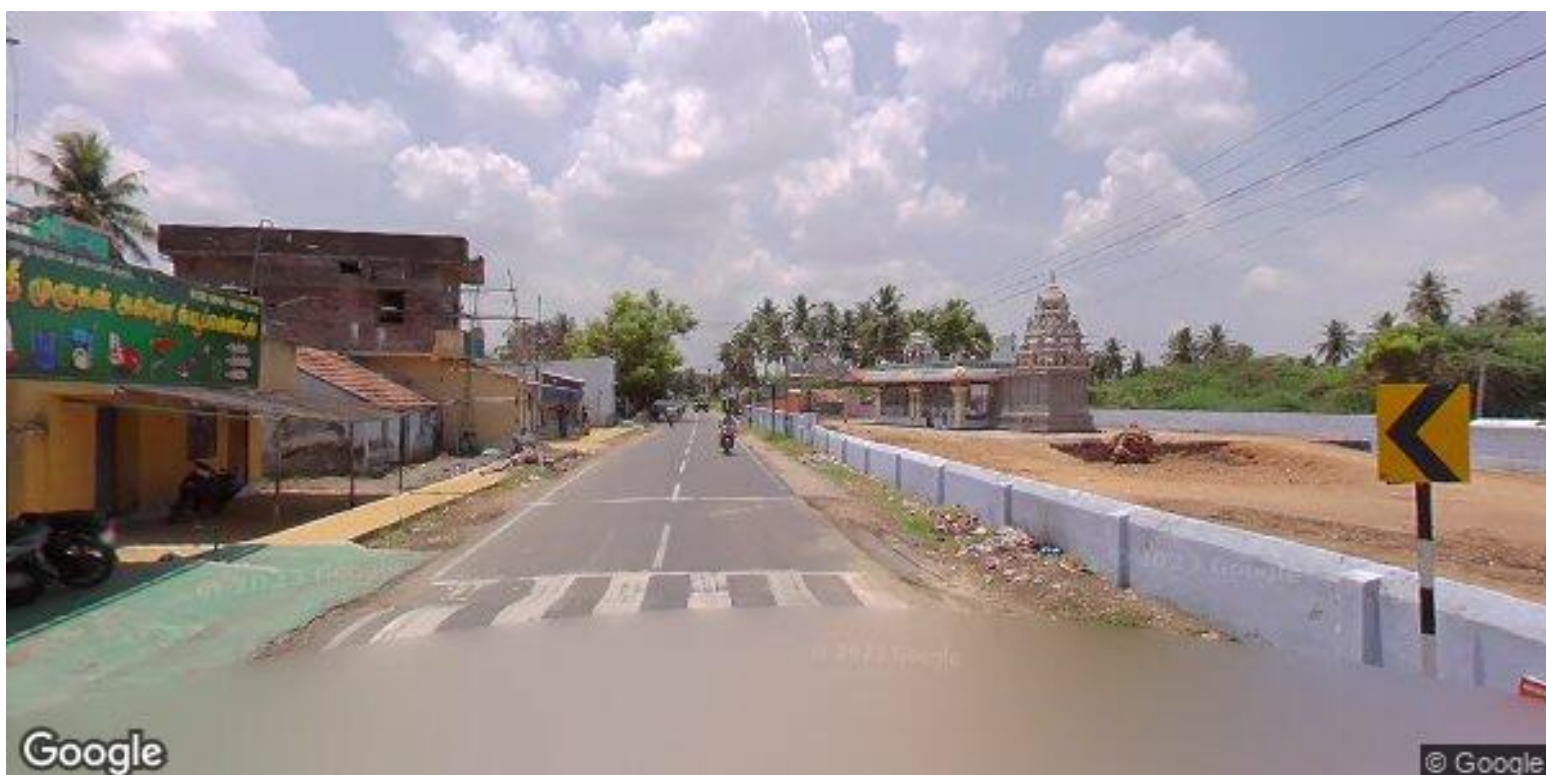
**Coordinates:** 11.24041, 77.86919

**Risk Type:** Turn

**Risk Level:** Medium

**Speed Limit:** 30 KM/Hr

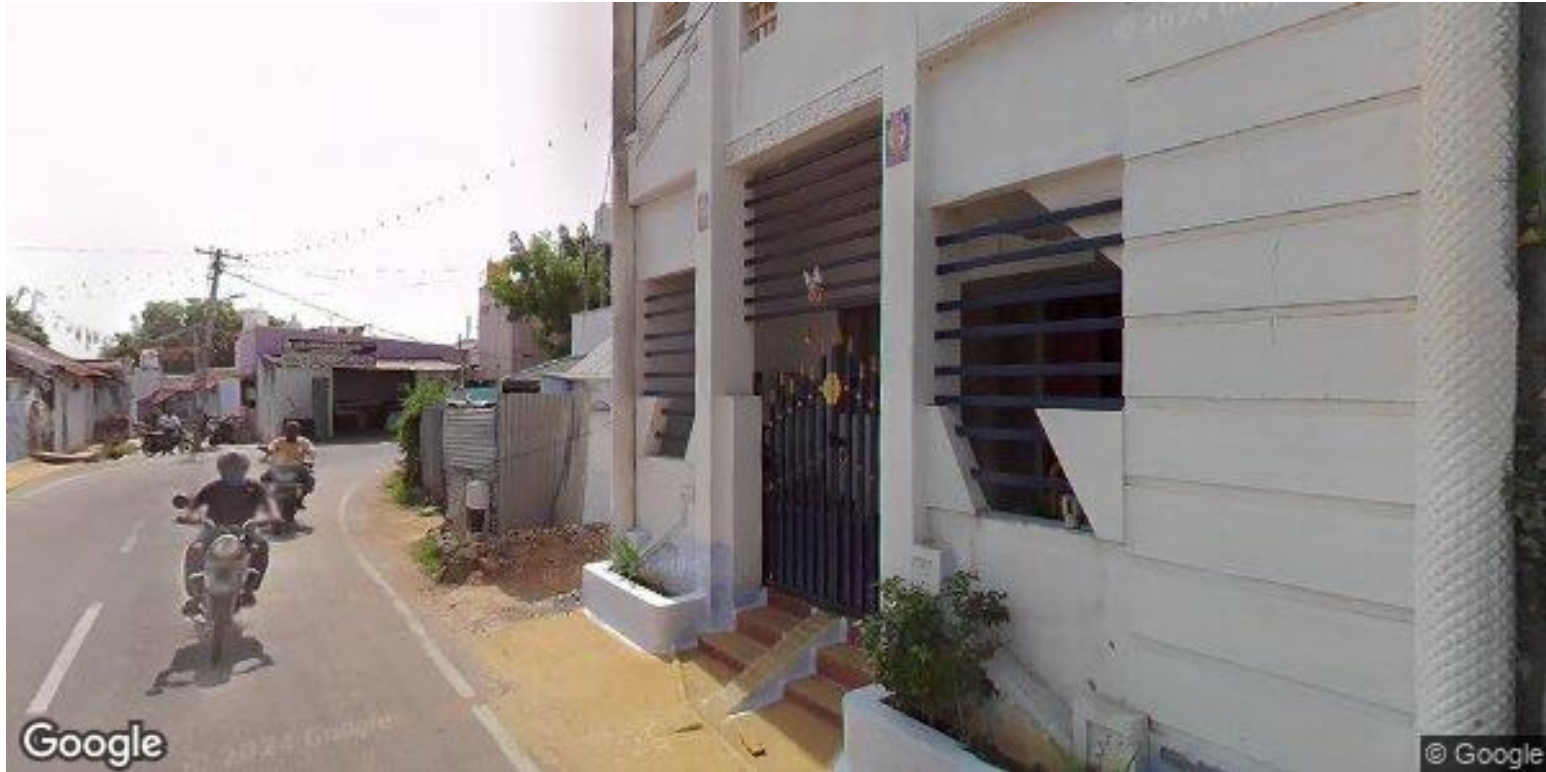
**Coordinates:** 11.24159, 77.86874

**Risk Type:** Turn

**Risk Level:** High

**Speed Limit:** 15 KM/Hr

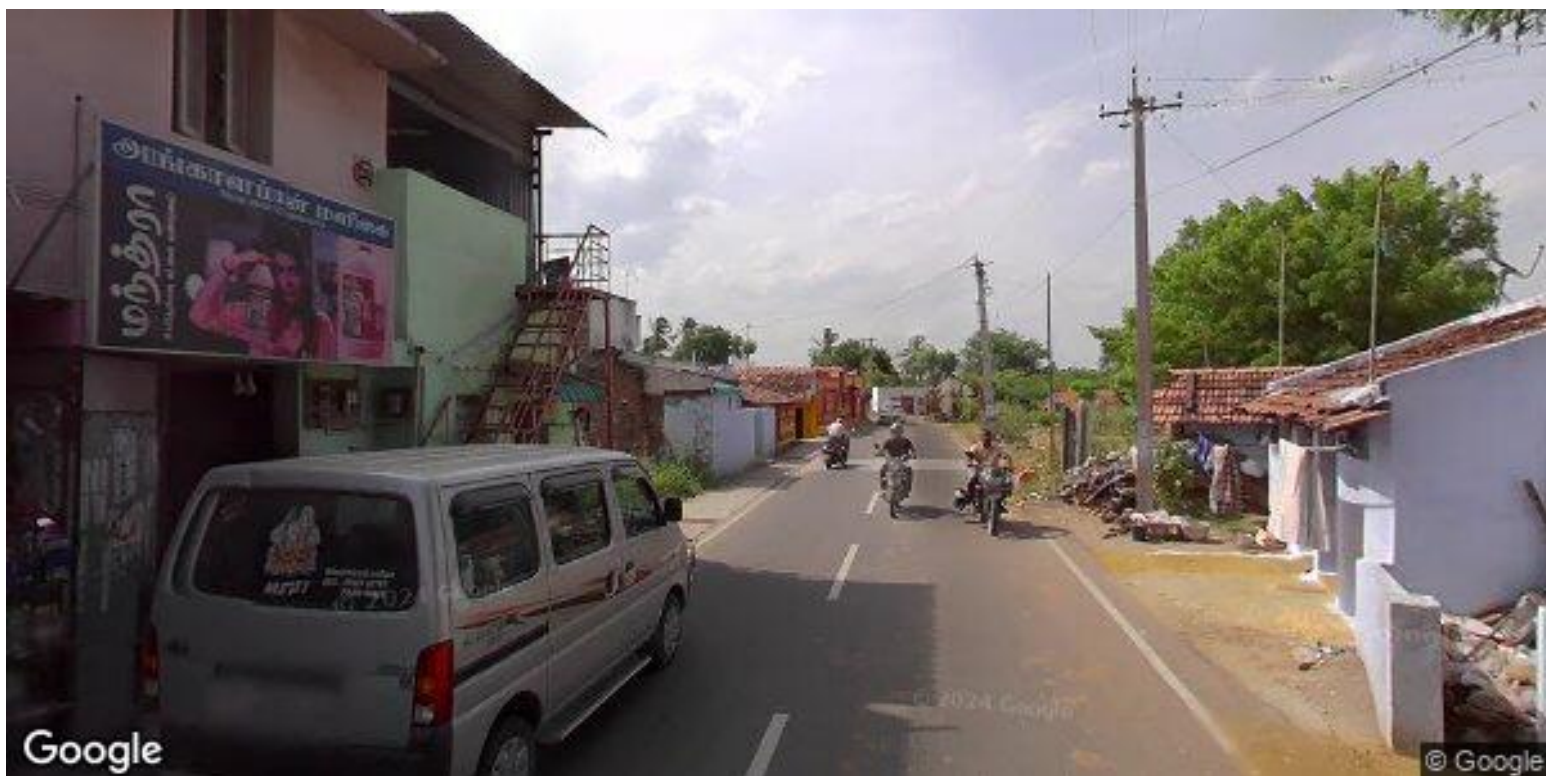
**Coordinates:** 11.24170, 77.86842

**Risk Type:** Turn

**Risk Level:** High

**Speed Limit:** 15 KM/Hr

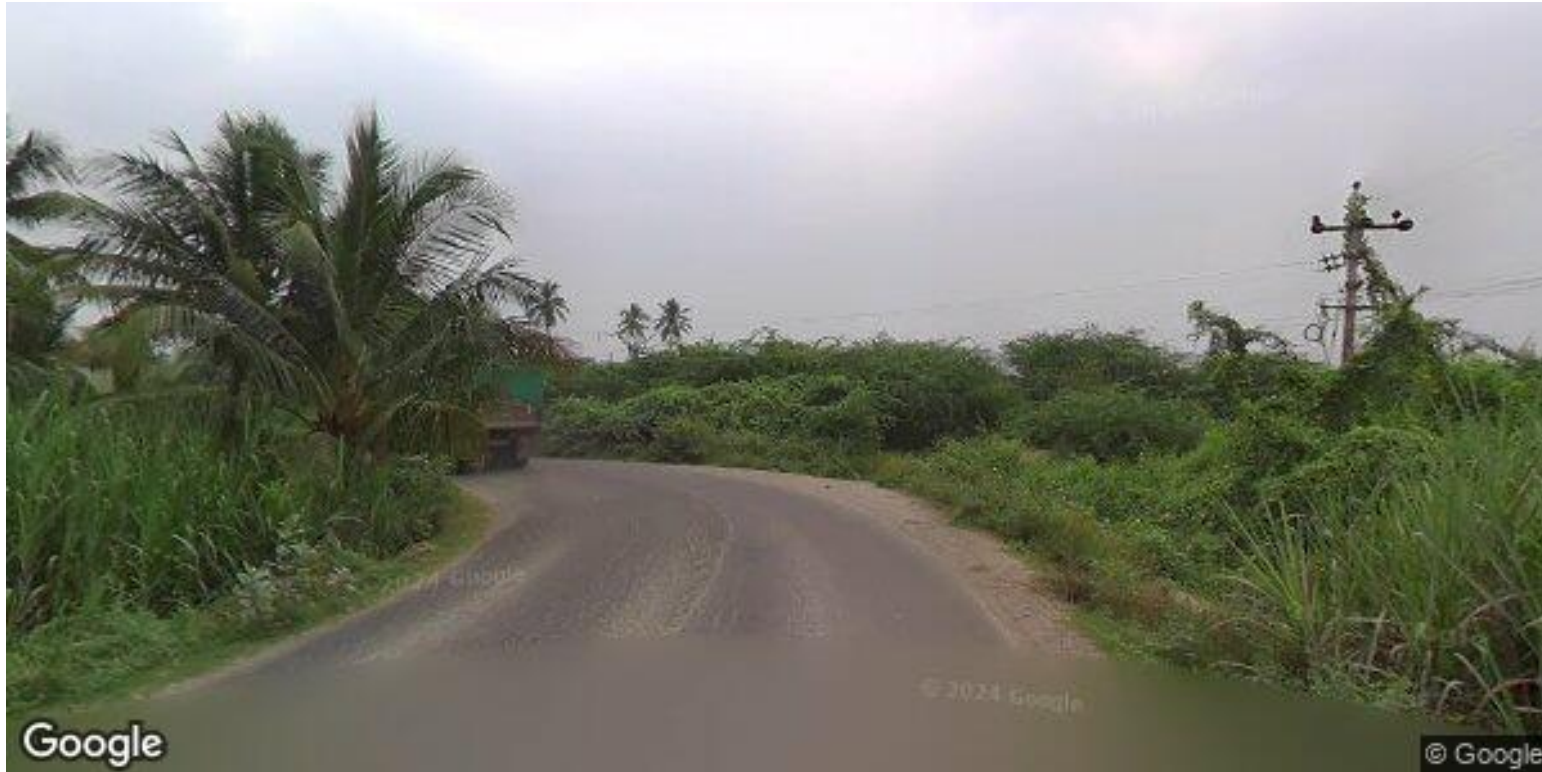
**Risk Type:** Turn  
**Risk Level:** High  
**Speed Limit:** 15 KM/Hr  
**Coordinates:** 11.24103, 77.86020

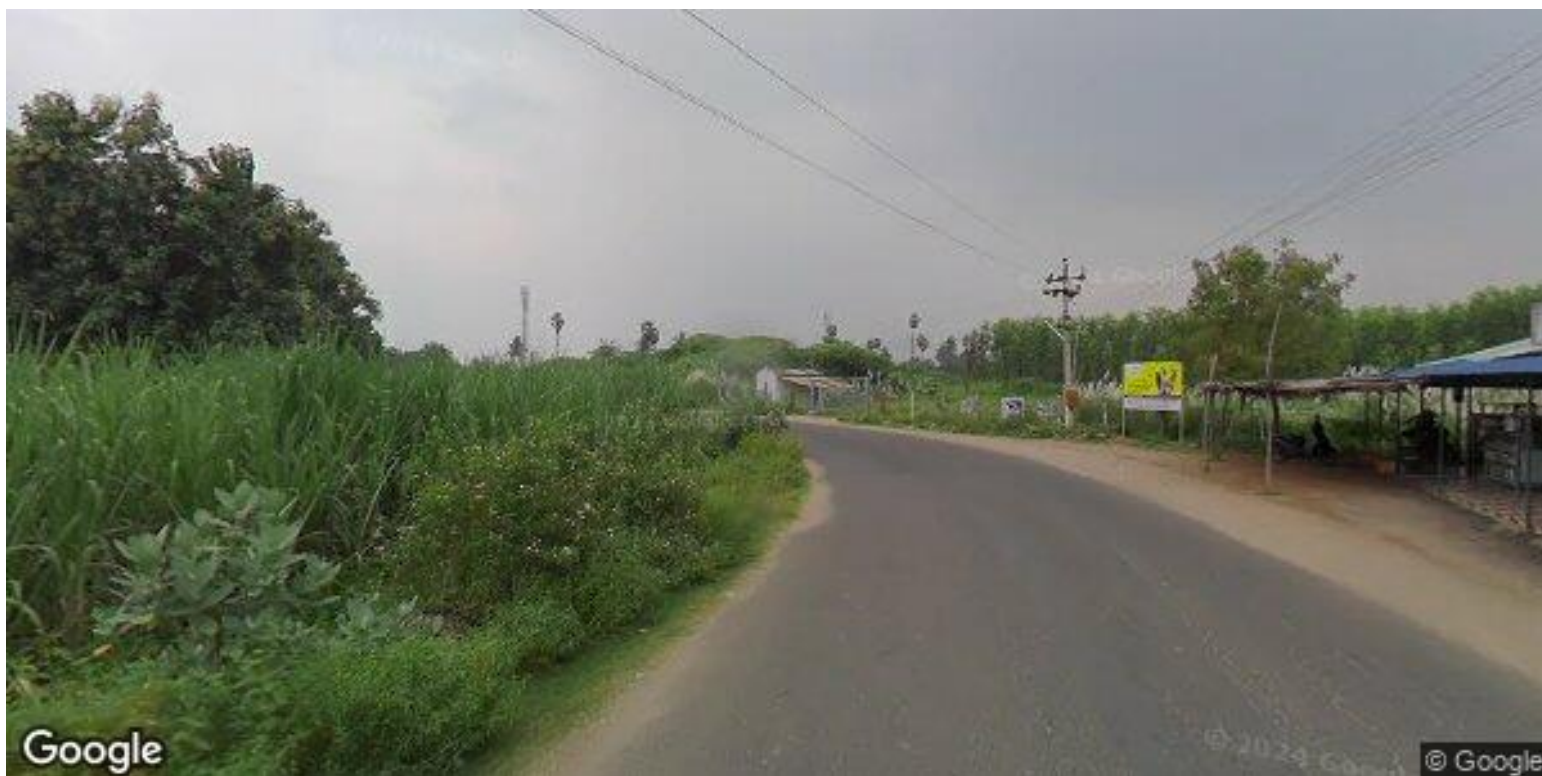
**Risk Type:** Turn  
**Risk Level:** High  
**Speed Limit:** 15 KM/Hr  
**Coordinates:** 11.24200, 77.85882

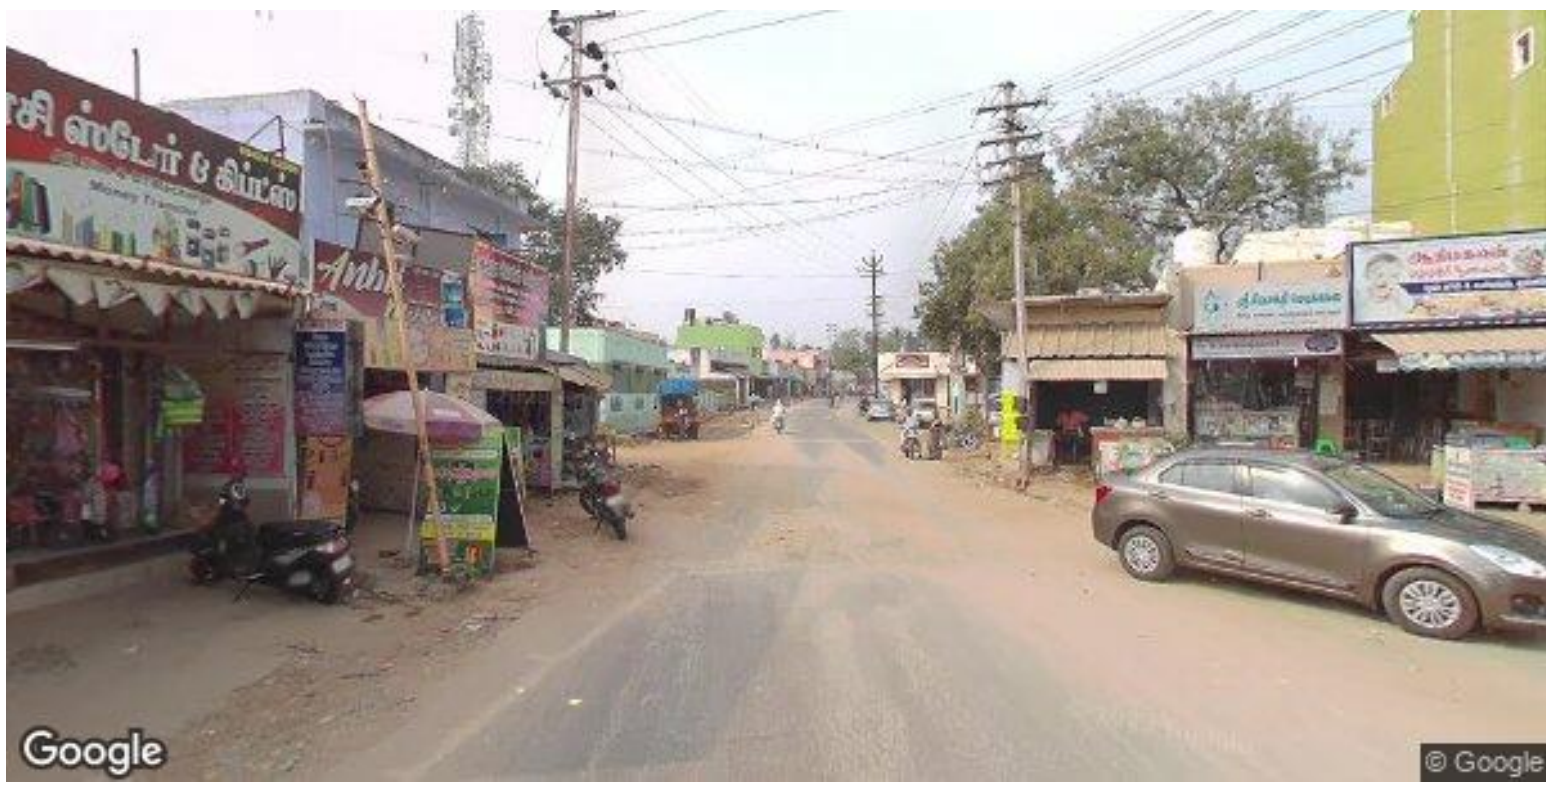
**Coordinates:** 11.18856, 77.77110

**Risk Type:** Turn

**Risk Level:** High

**Speed Limit:** 15 KM/Hr

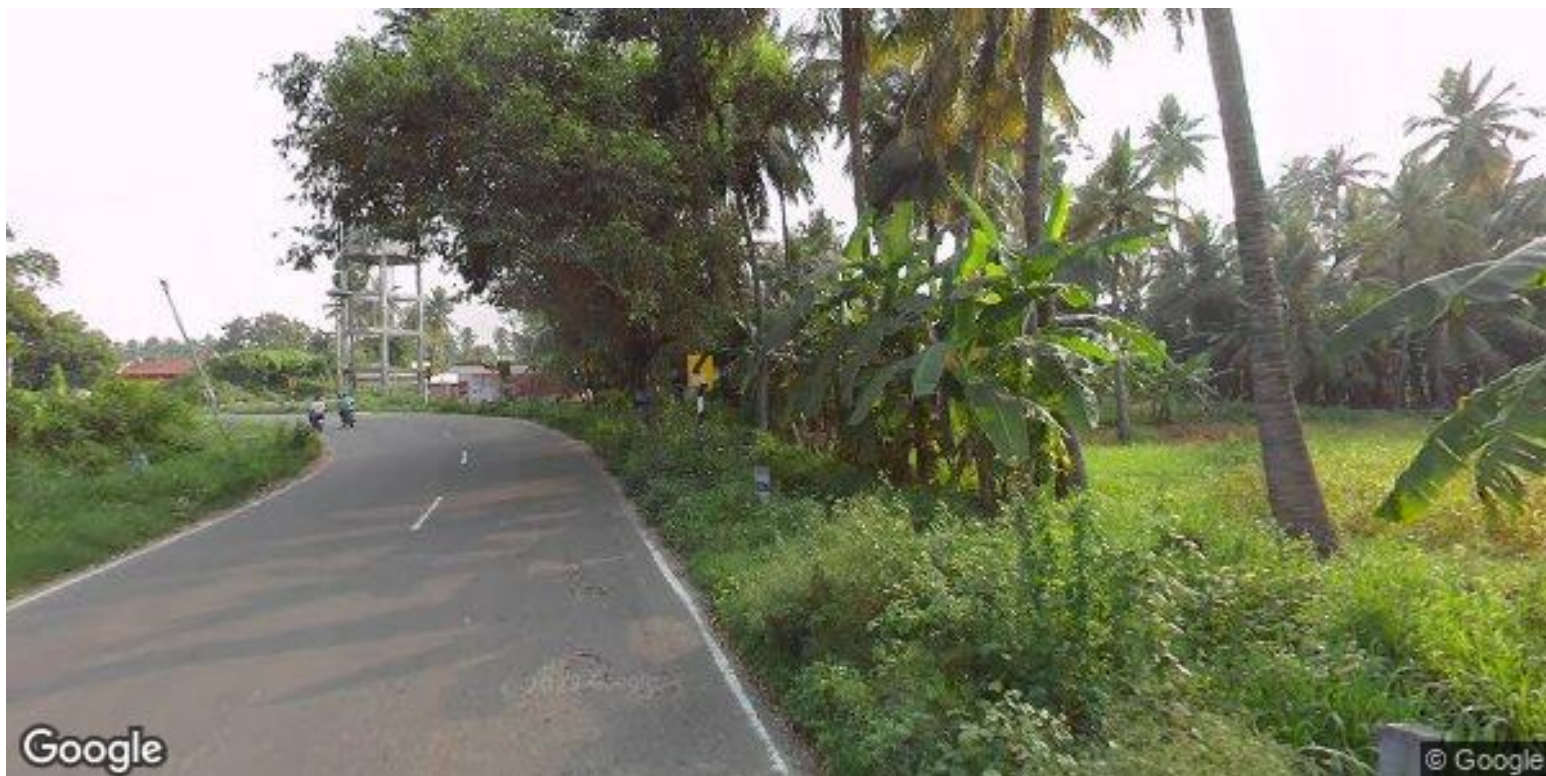
**Coordinates:** 11.16441, 77.77358

**Risk Type:** Turn

**Risk Level:** Medium

**Speed Limit:** 30 KM/Hr

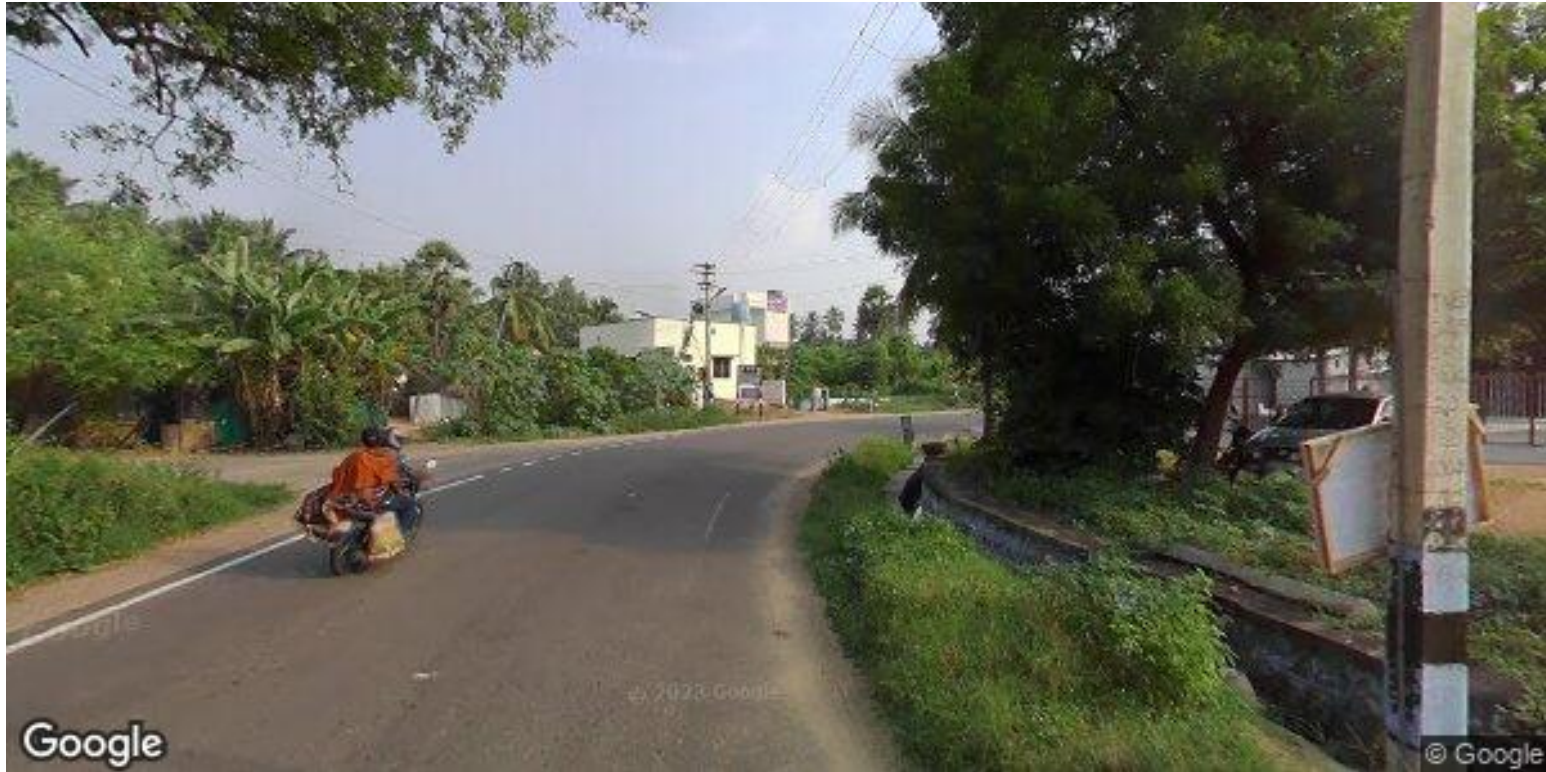
**Coordinates:** 11.16377, 77.77421

**Risk Type:** Turn

**Risk Level:** High

**Speed Limit:** 15 KM/Hr

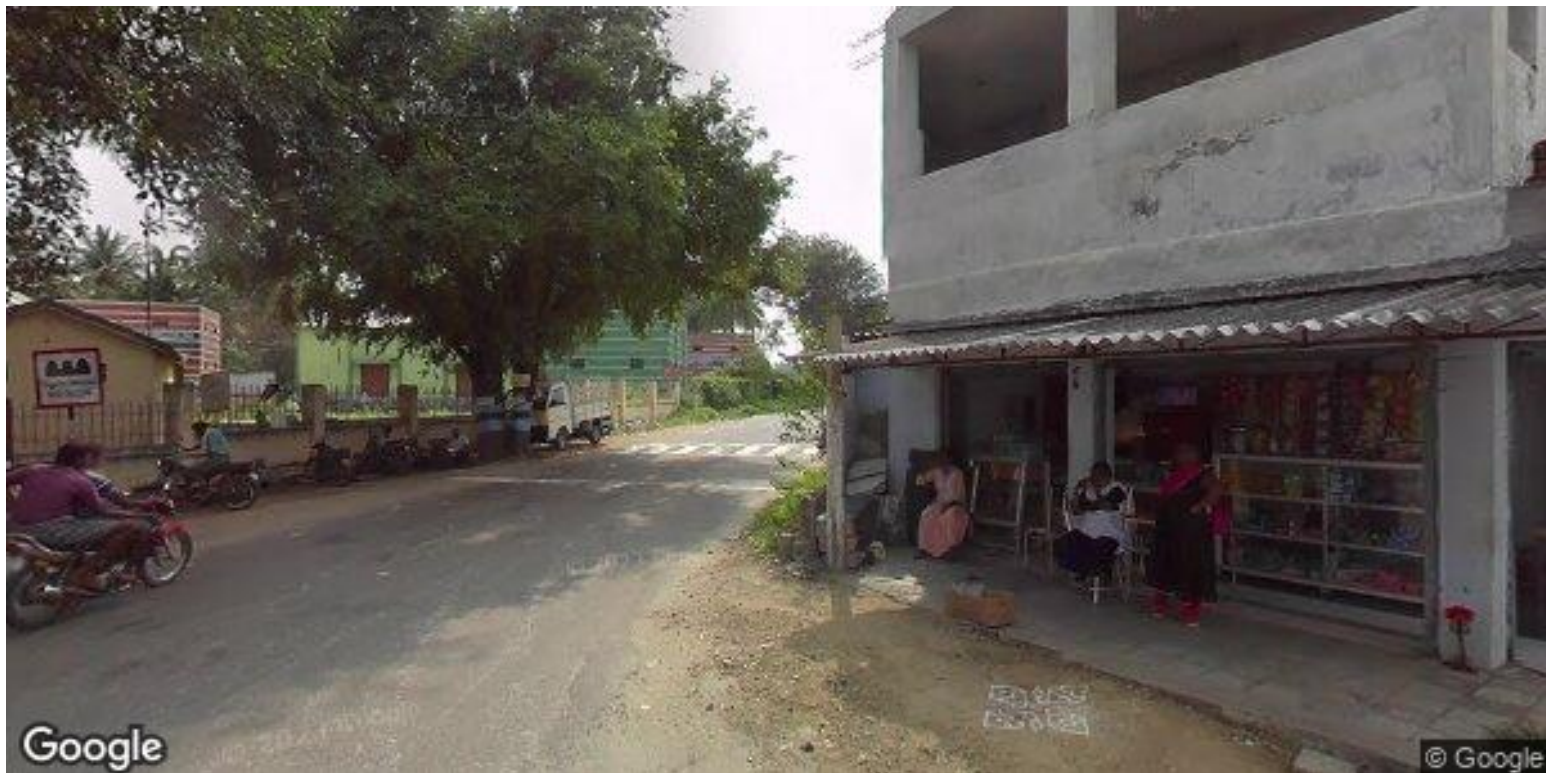
**Coordinates:** 11.13664, 77.76524

**Risk Type:** Turn

**Risk Level:** Medium

**Speed Limit:** 30 KM/Hr

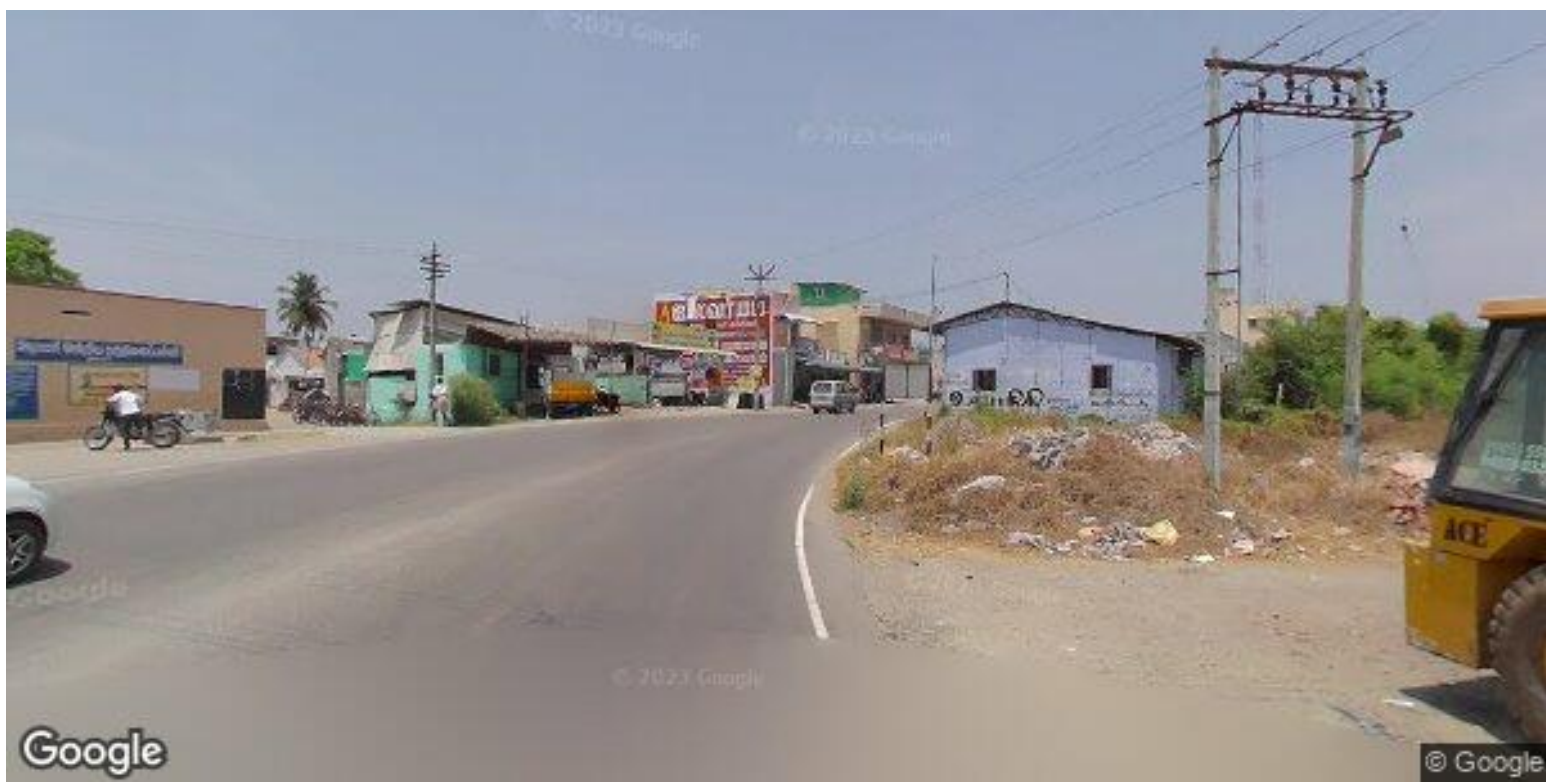
**Coordinates:** 11.04699, 77.73747

**Risk Type:** Turn

**Risk Level:** Medium

**Speed Limit:** 30 KM/Hr
