# IndianOil

## **JOURNEY RISK MANAGEMENT (JRM) STUDY**

### **Salem Terminal to SRI SARAVANA AGENCIES PUDUPAI**

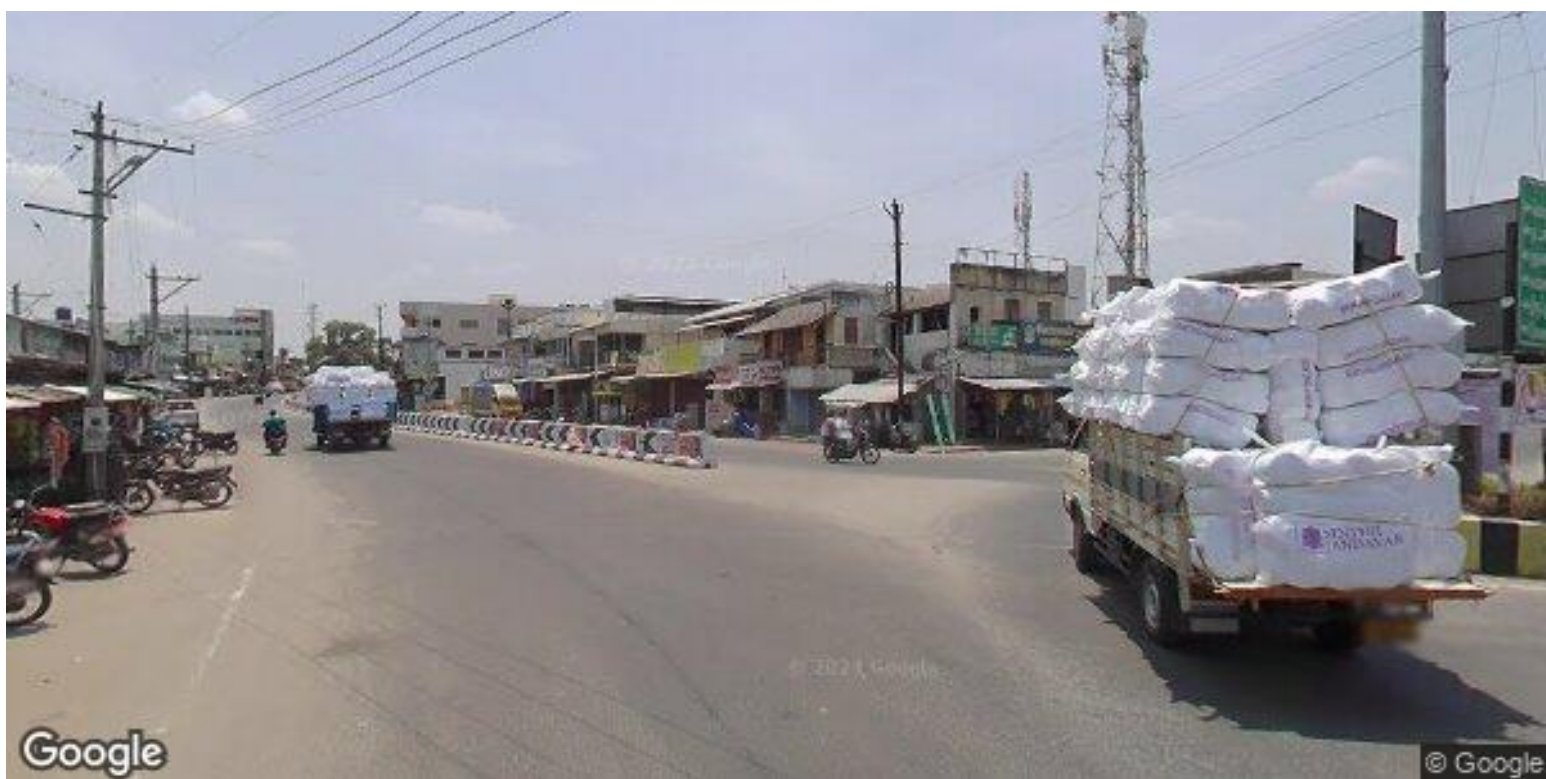
**Coordinates:** 11.04515, 77.73621

**Risk Type:** Turn

**Risk Level:** High

**Speed Limit:** 15 KM/Hr

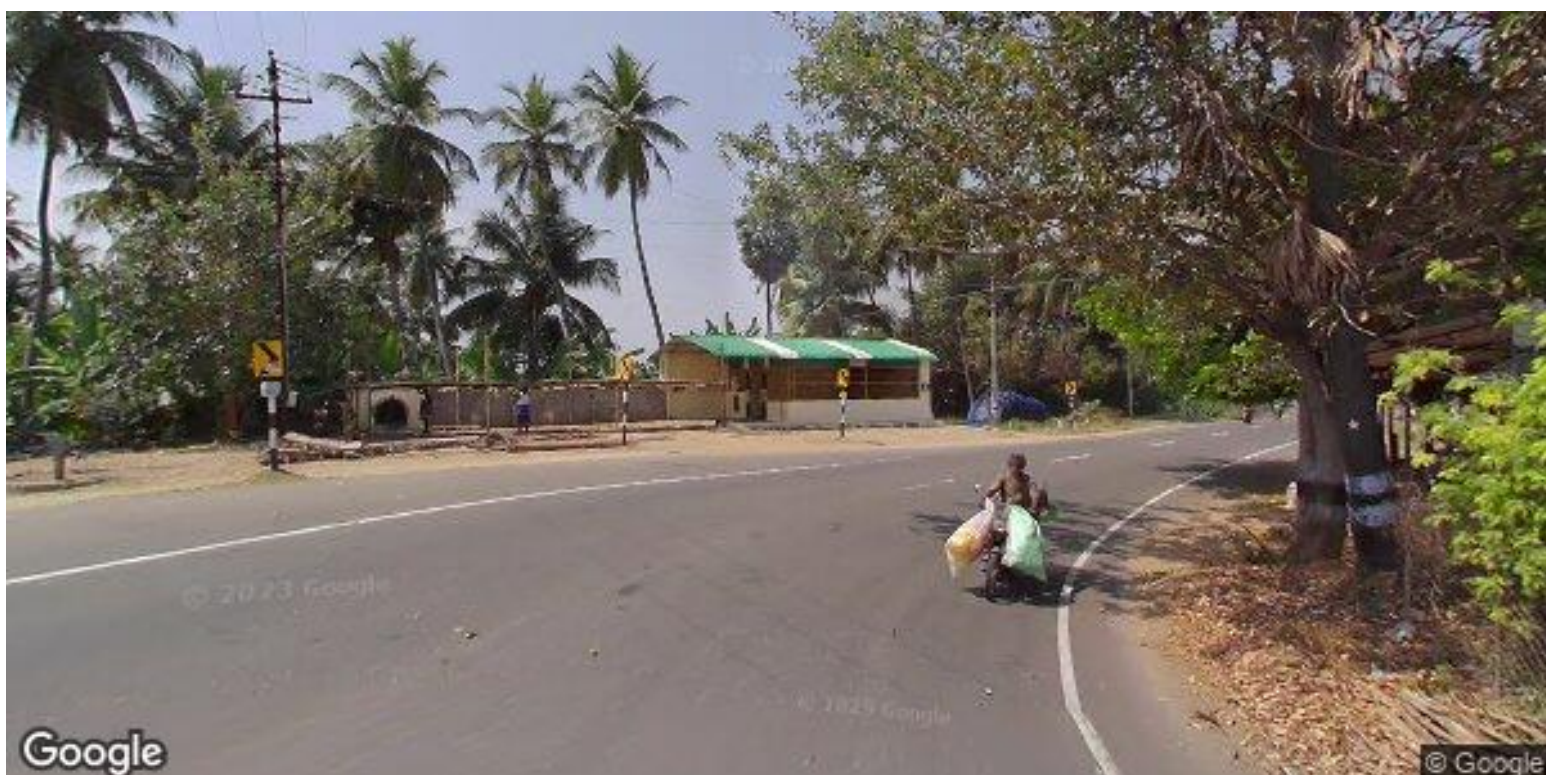
**Risk Type:** Turn  
**Risk Level:** High  
**Speed Limit:** 15 KM/Hr  
**Coordinates:** 10.99026, 77.72511

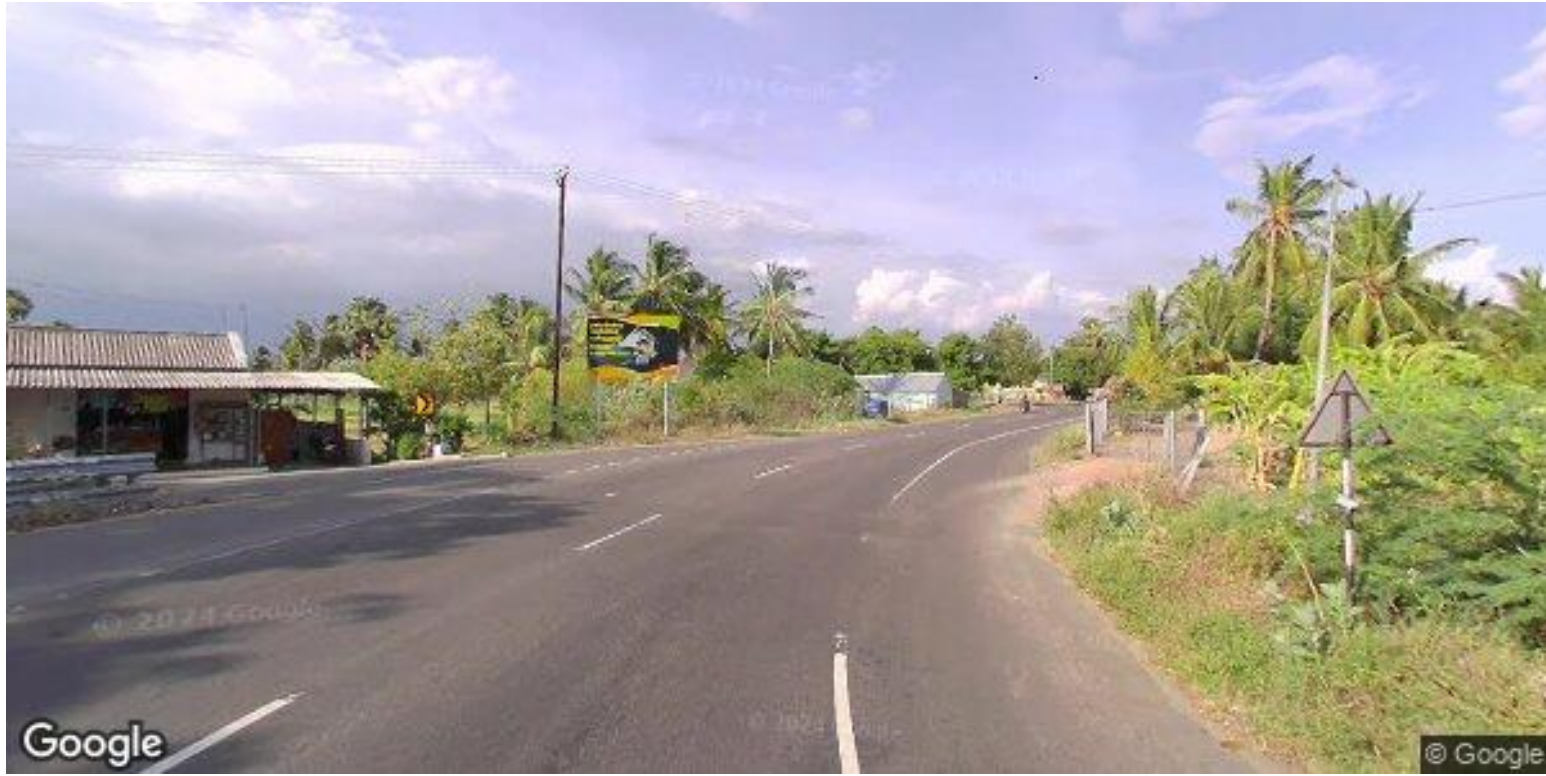
**Risk Type:** Turn  
**Risk Level:** High  
**Speed Limit:** 15 KM/Hr  
**Coordinates:** 10.98974, 77.72388

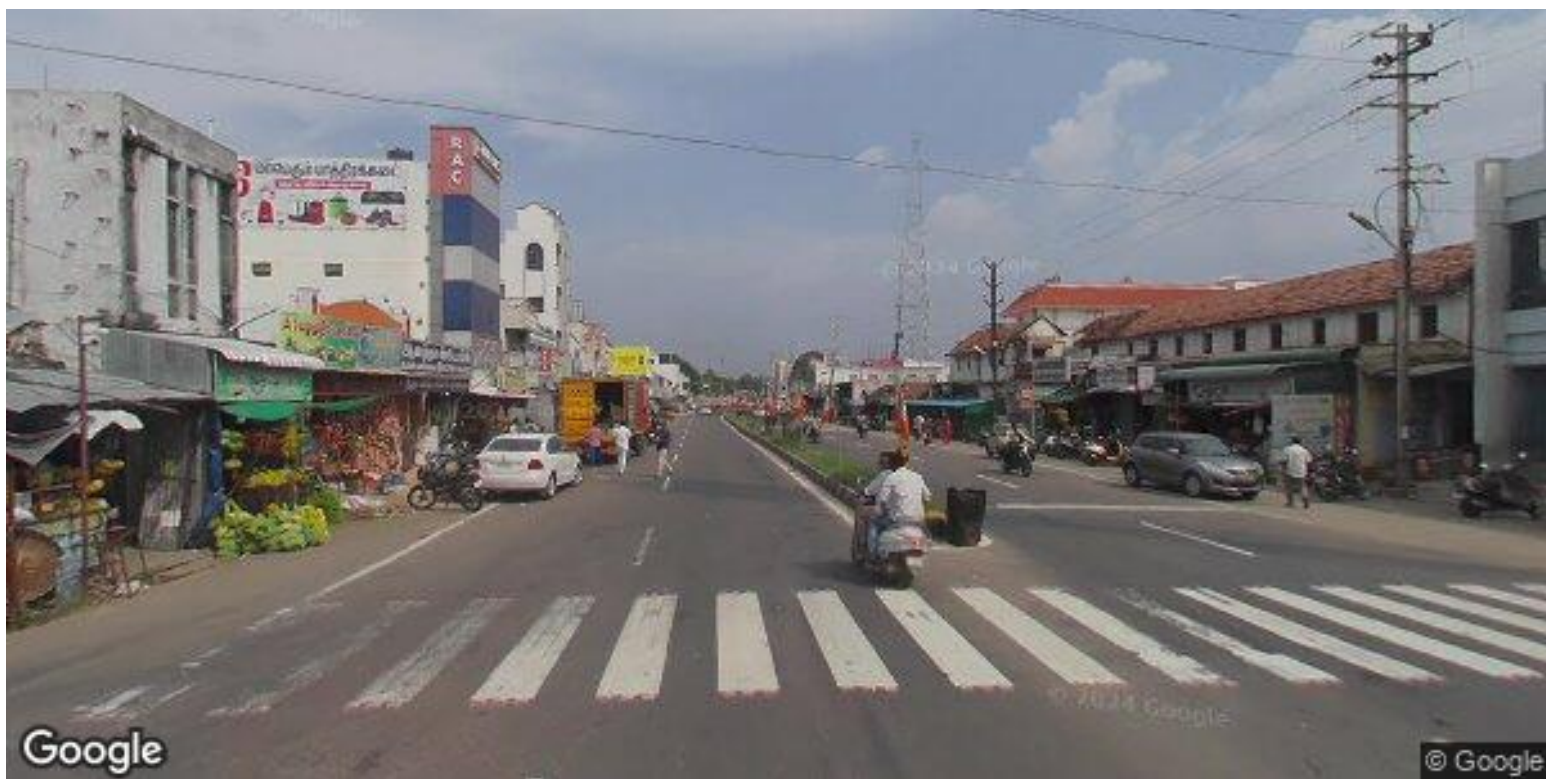
**Risk Type:** Blind Spot  
**Risk Level:** Blind Spot  
**Speed Limit:** 10 KM/Hr  
**Coordinates:** 10.94597, 77.71319

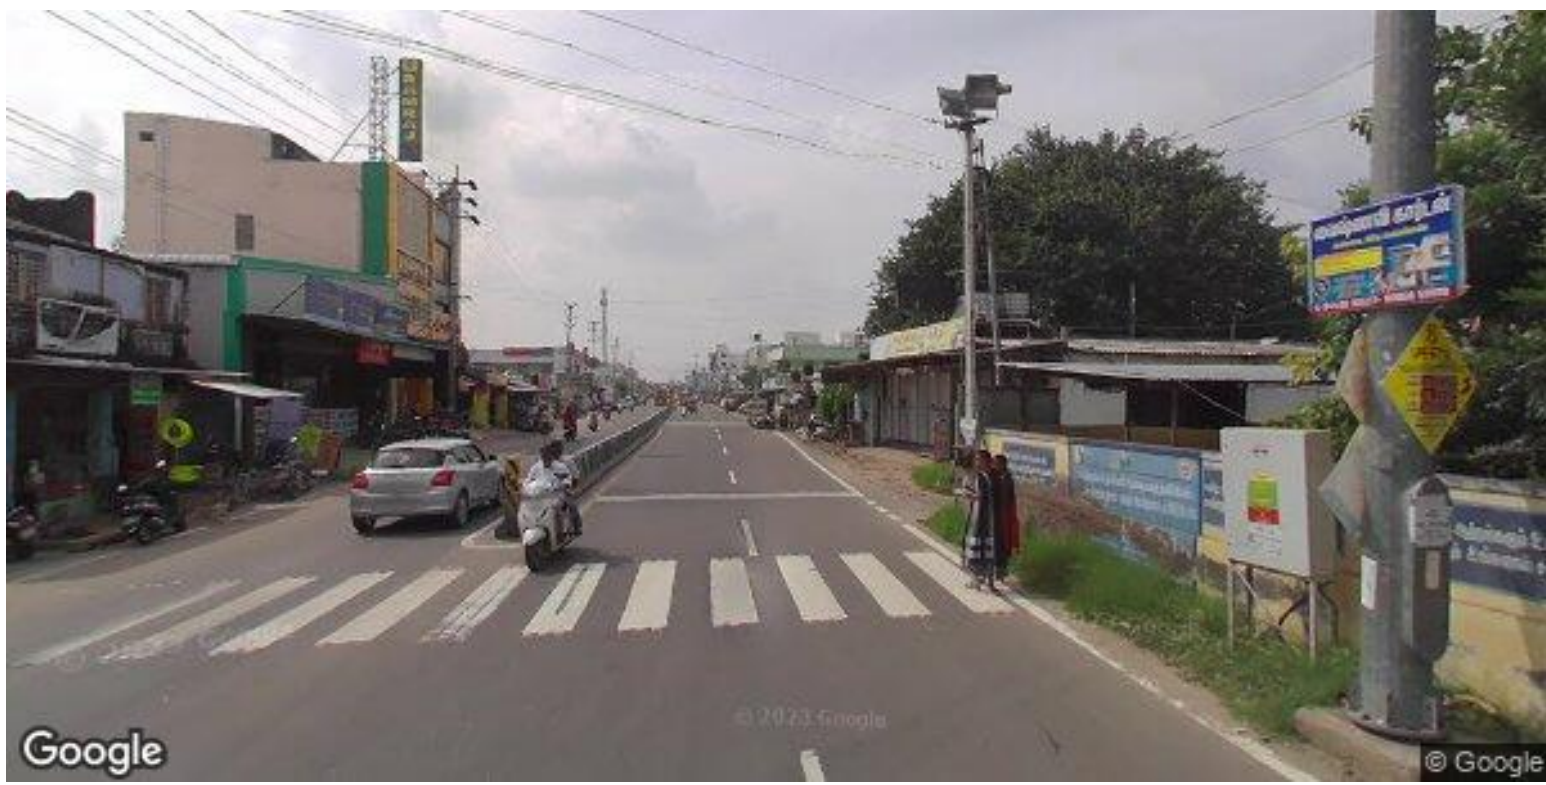
**Coordinates:** 10.94571, 77.71574

**Risk Type:** Turn

**Risk Level:** High

**Speed Limit:** 15 KM/Hr

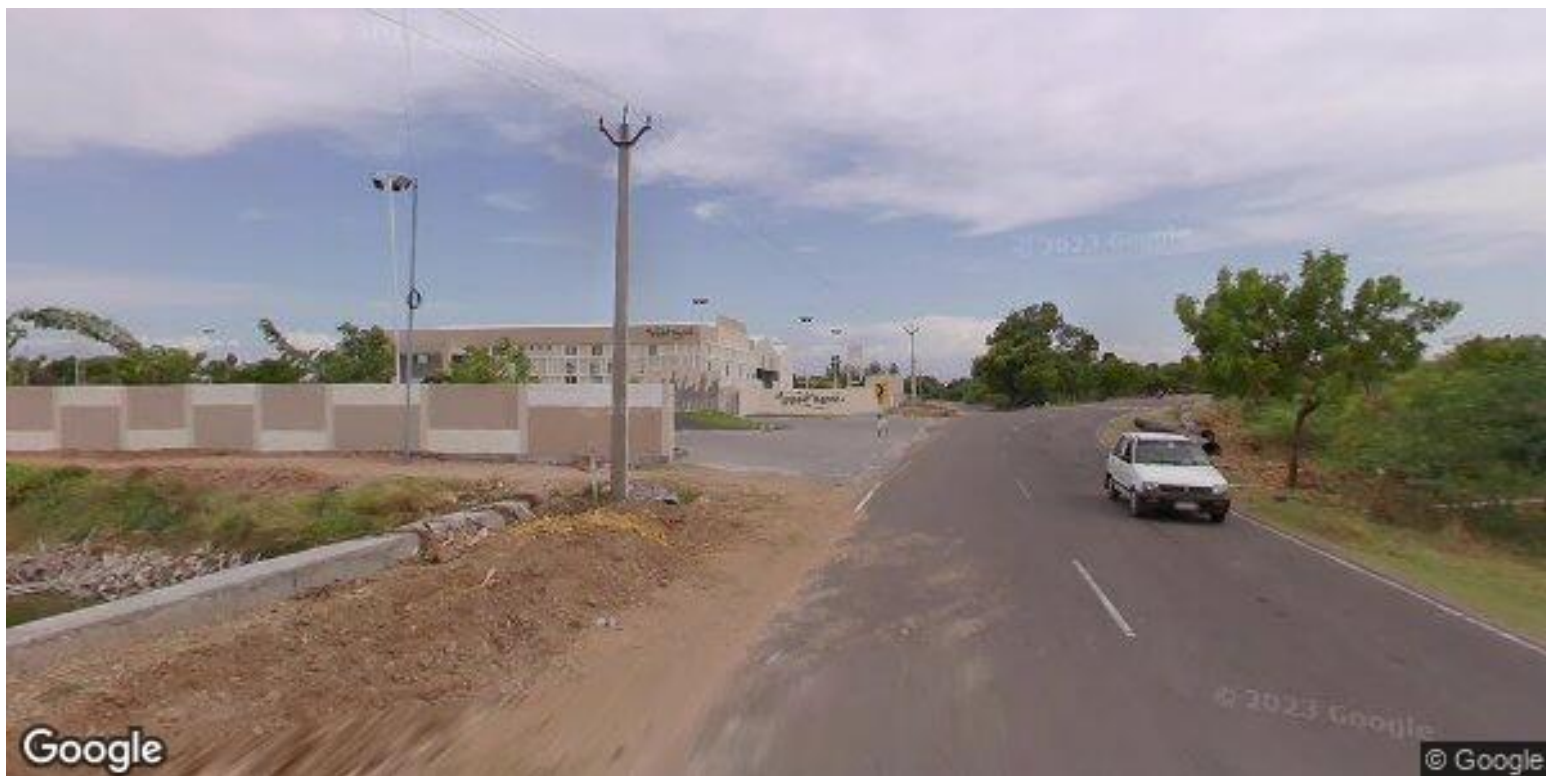
**Coordinates:** 10.92251, 77.72391

**Risk Type:** Turn

**Risk Level:** Medium

**Speed Limit:** 30 KM/Hr

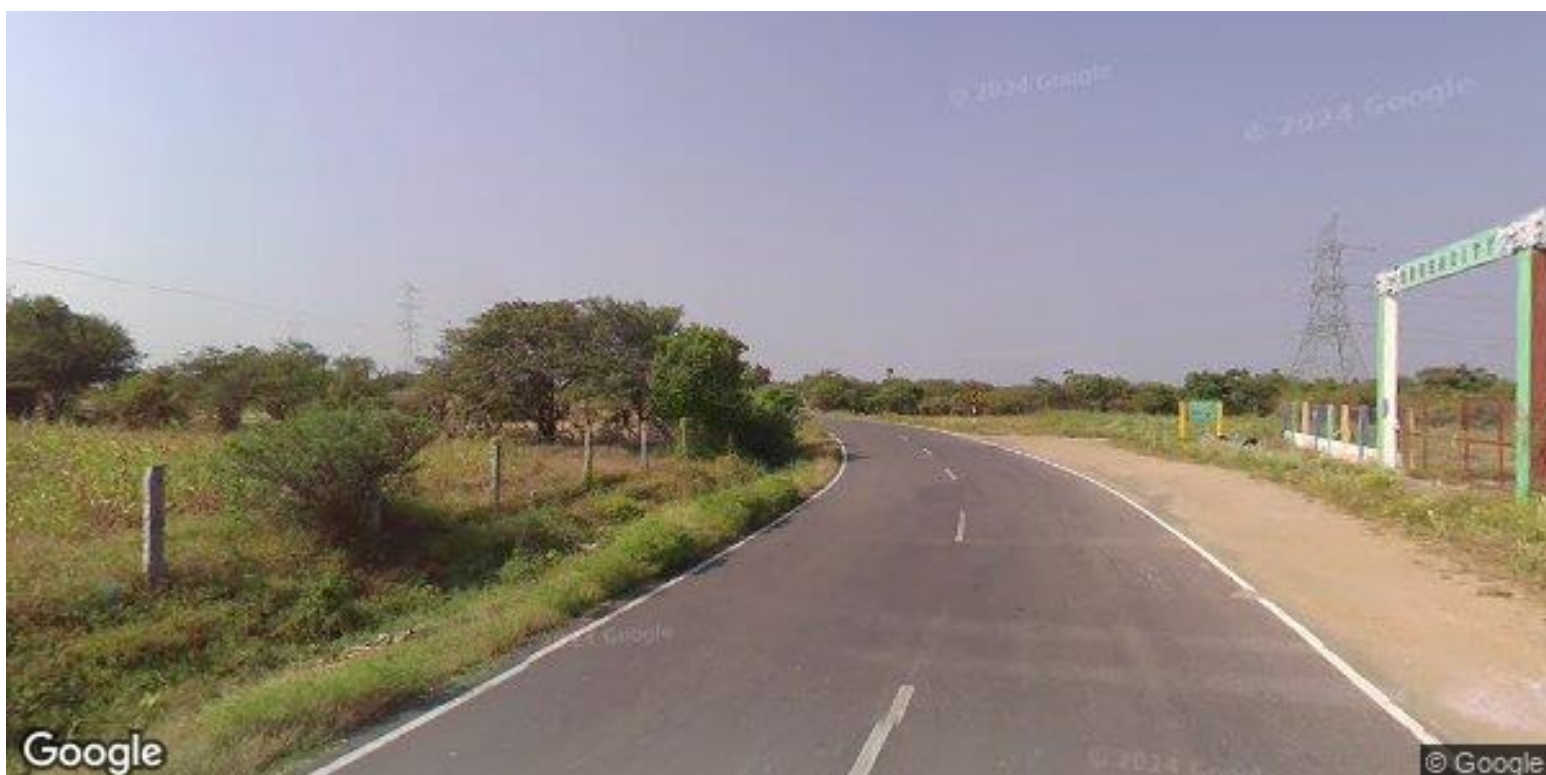
**Coordinates:** 10.87191, 77.72259

**Risk Type:** Turn

**Risk Level:** Medium

**Speed Limit:** 30 KM/Hr
