## JOURNEY RISK MANAGEMENT (JRM) STUDY

### Salem Terminal TO VENKATESWARA AUTO SERVICE

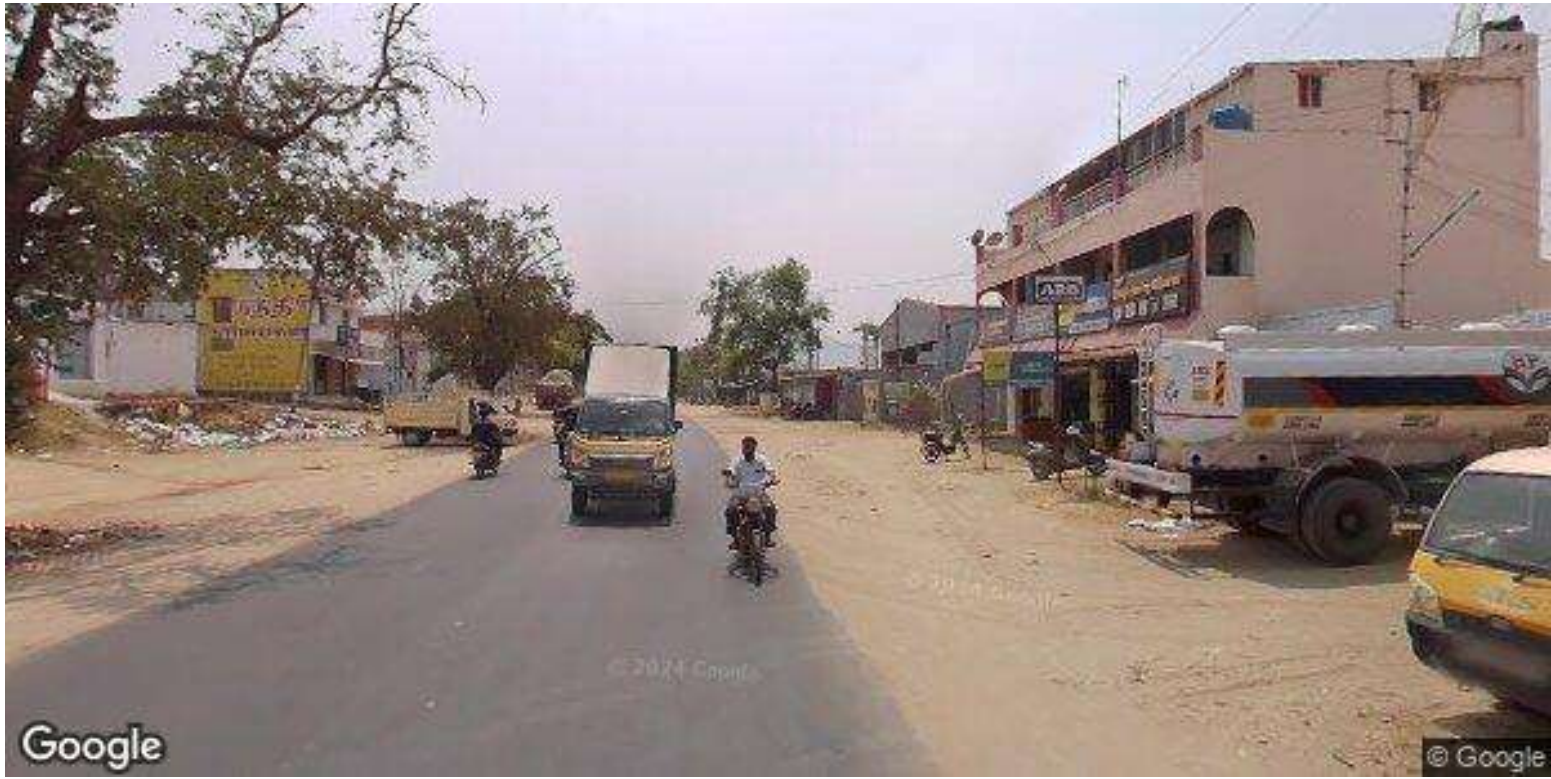
**Risk Type:** Turn  
**Risk Level:** Medium  
**Speed Limit:** 30 KM/Hr  
**Coordinates:** 11.39976, 77.88382

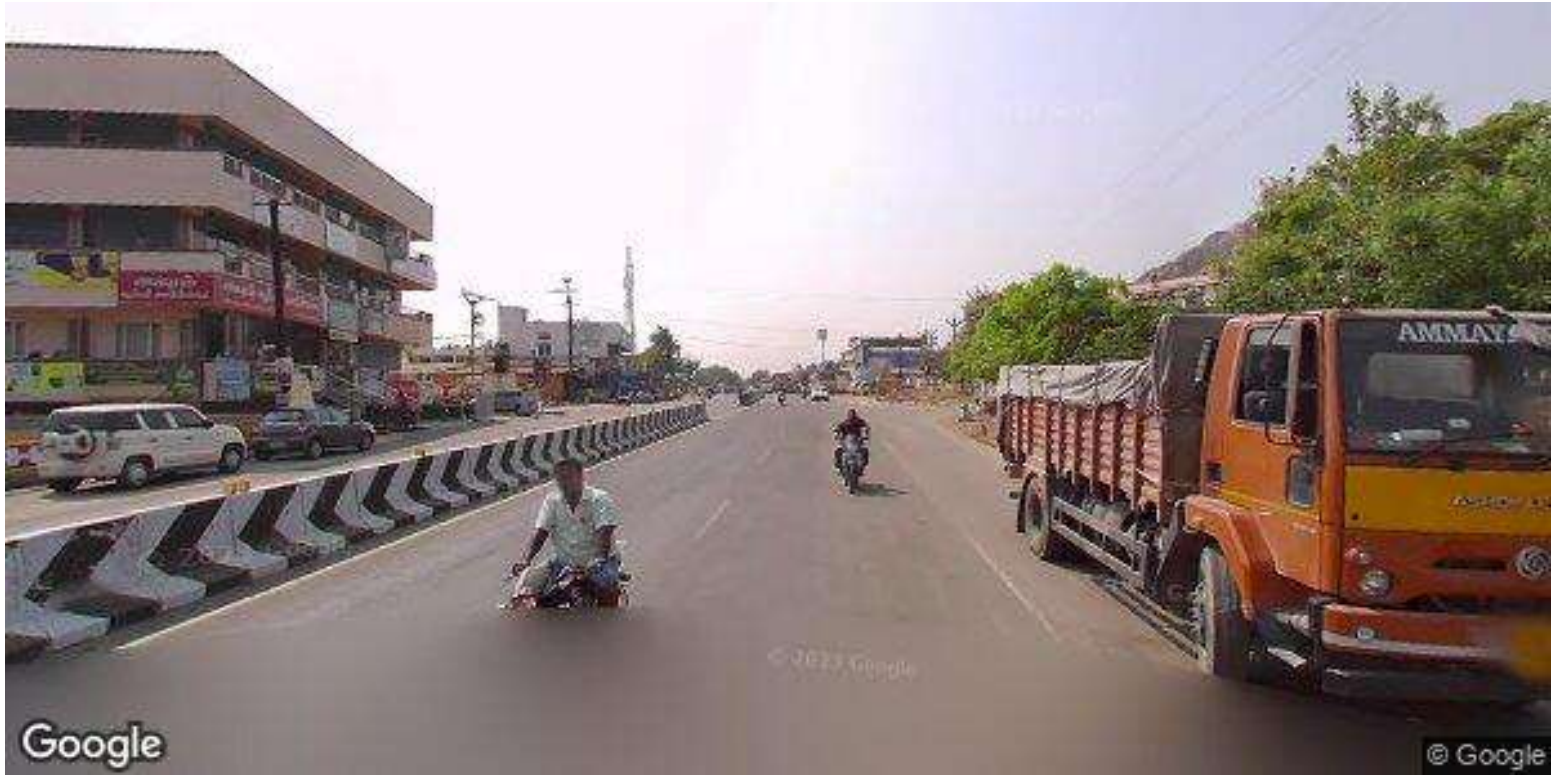
**Risk Type:** Turn  
**Risk Level:** Medium  
**Speed Limit:** 30 KM/Hr  
**Coordinates:** 11.39690, 77.88852

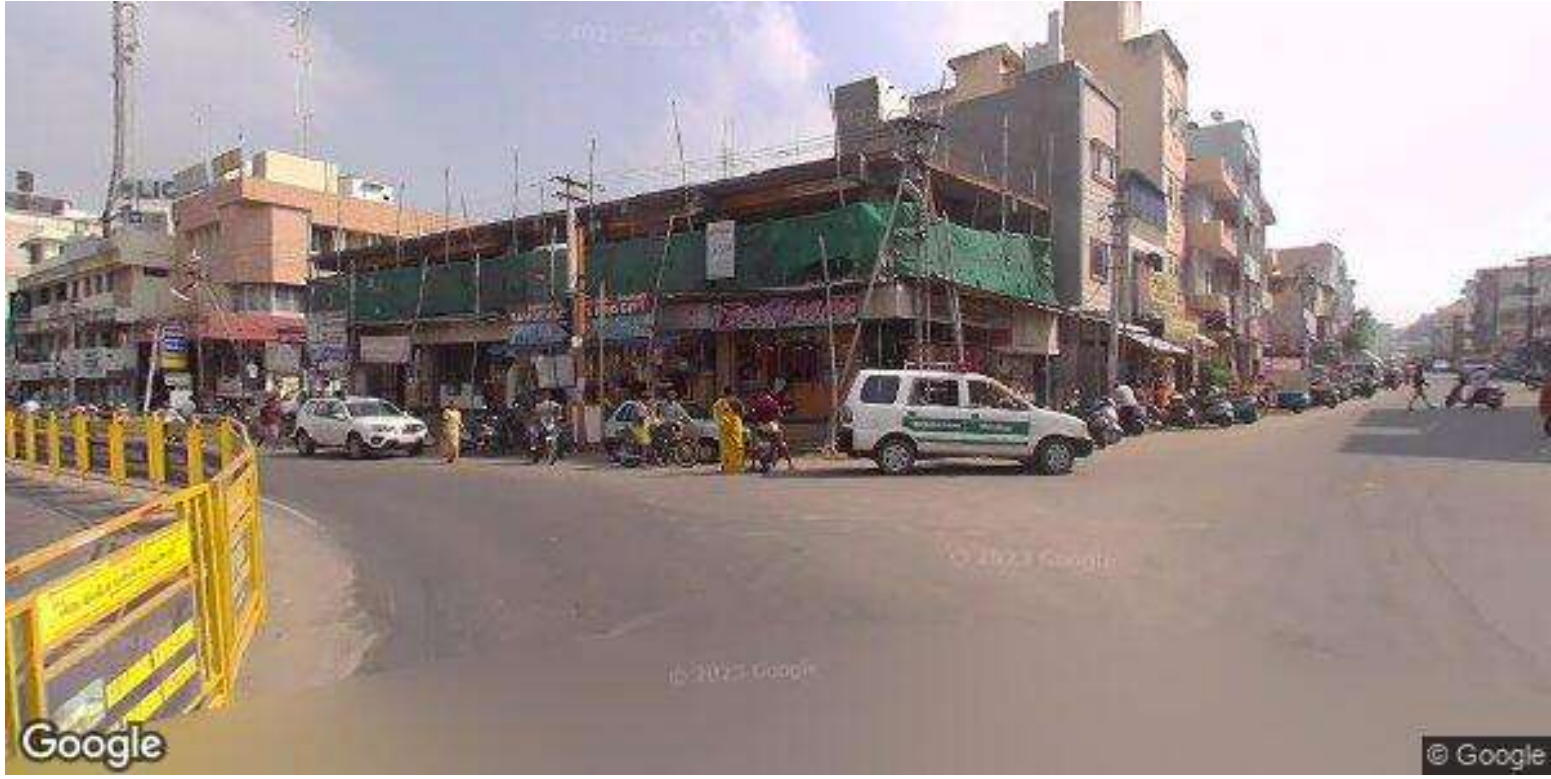
**Risk Type:** Turn  
**Risk Level:** High  
**Speed Limit:** 15 KM/Hr  
**Coordinates:** 11.37868, 77.89498

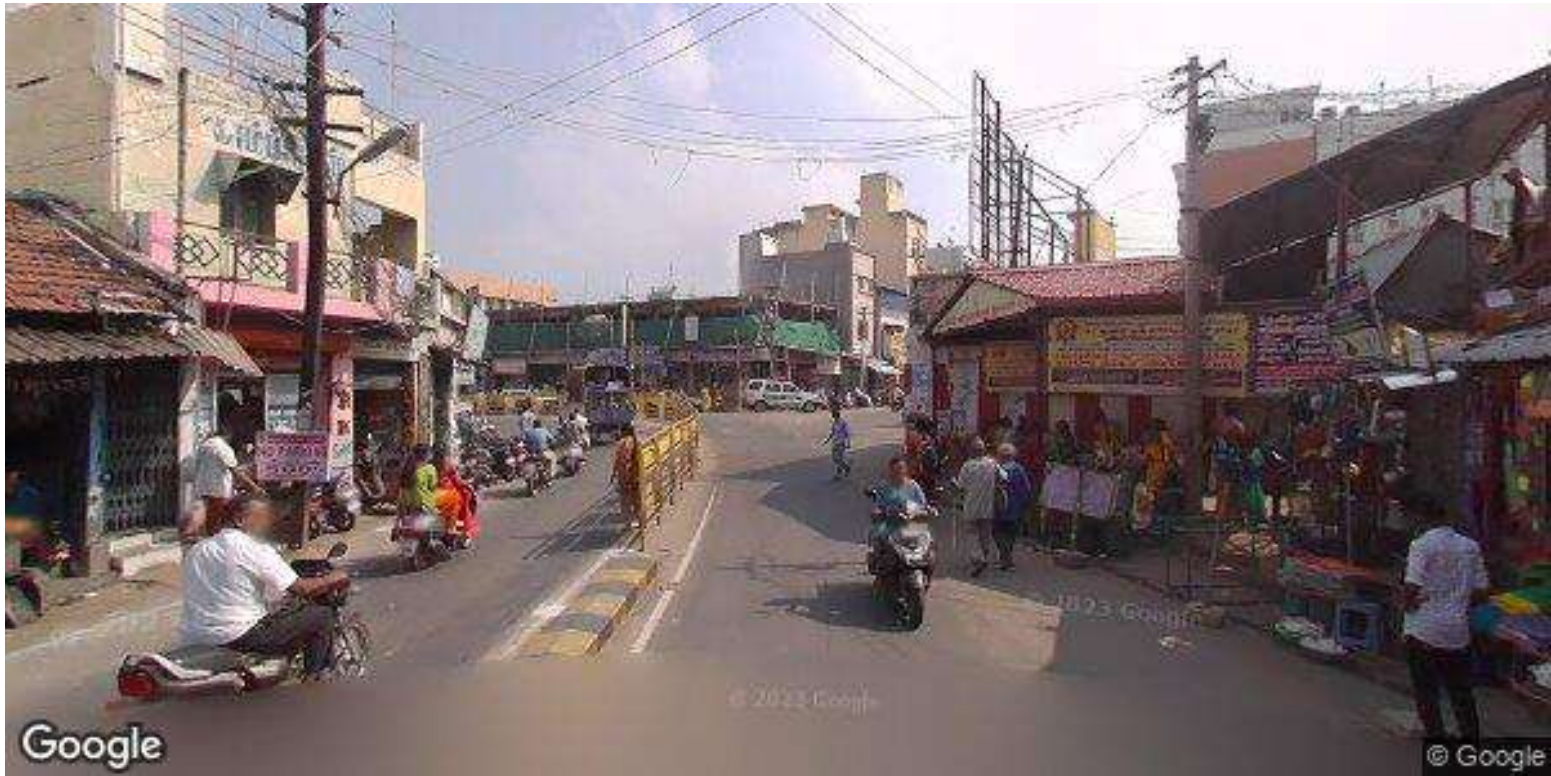
**Risk Type:** Turn  
**Risk Level:** Medium  
**Speed Limit:** 30 KM/Hr  
**Coordinates:** 11.37857, 77.89473

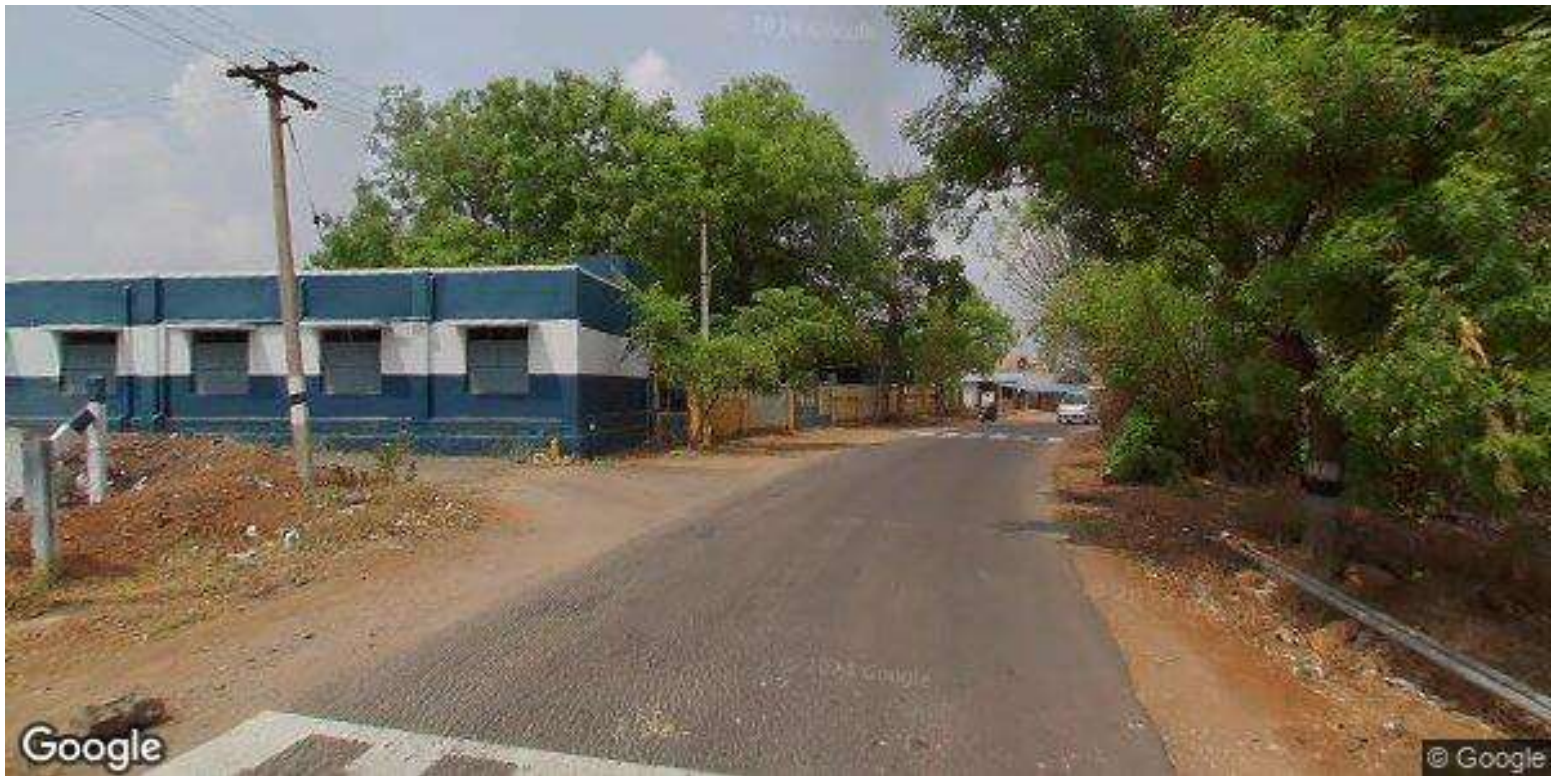
**Risk Type:** Turn  
**Risk Level:** High  
**Speed Limit:** 15 KM/Hr  
**Coordinates:** 11.33268, 77.88827

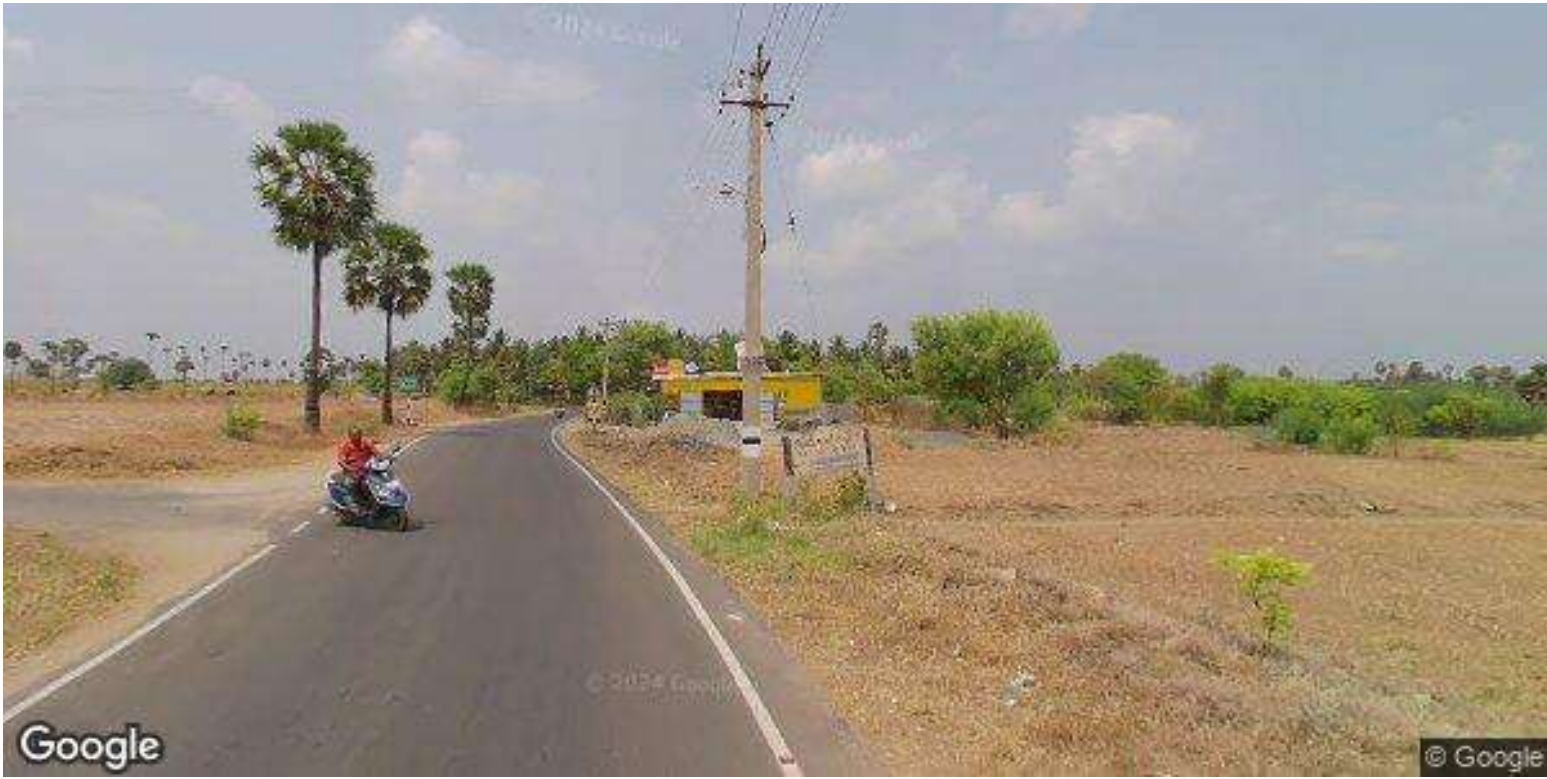
**Risk Type:** Turn  
**Risk Level:** Medium  
**Speed Limit:** 30 KM/Hr  
**Coordinates:** 11.33165, 77.88697

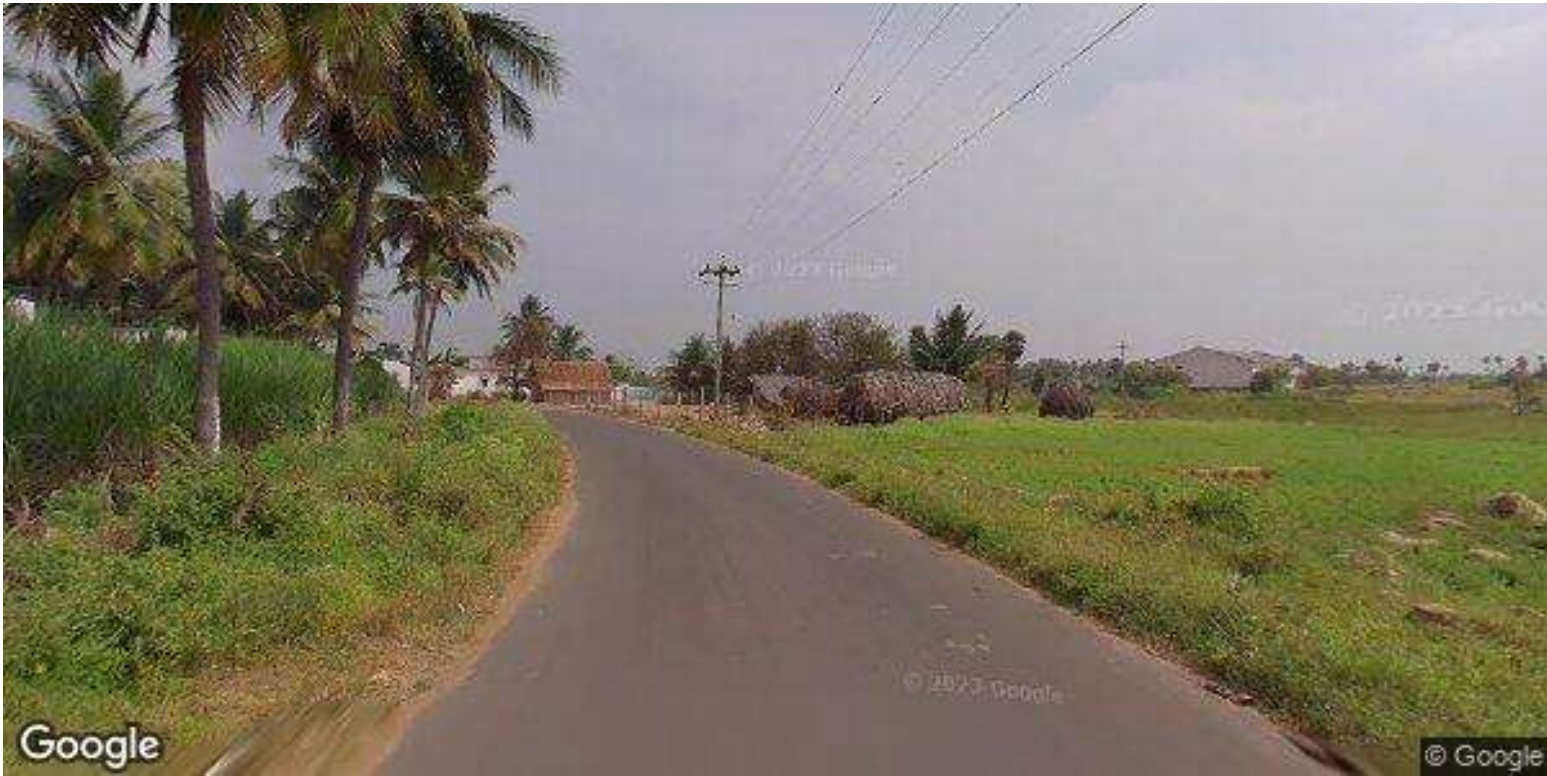
**Risk Type:** Turn  
**Risk Level:** Medium  
**Speed Limit:** 30 KM/Hr  
**Coordinates:** 11.31183, 77.88094

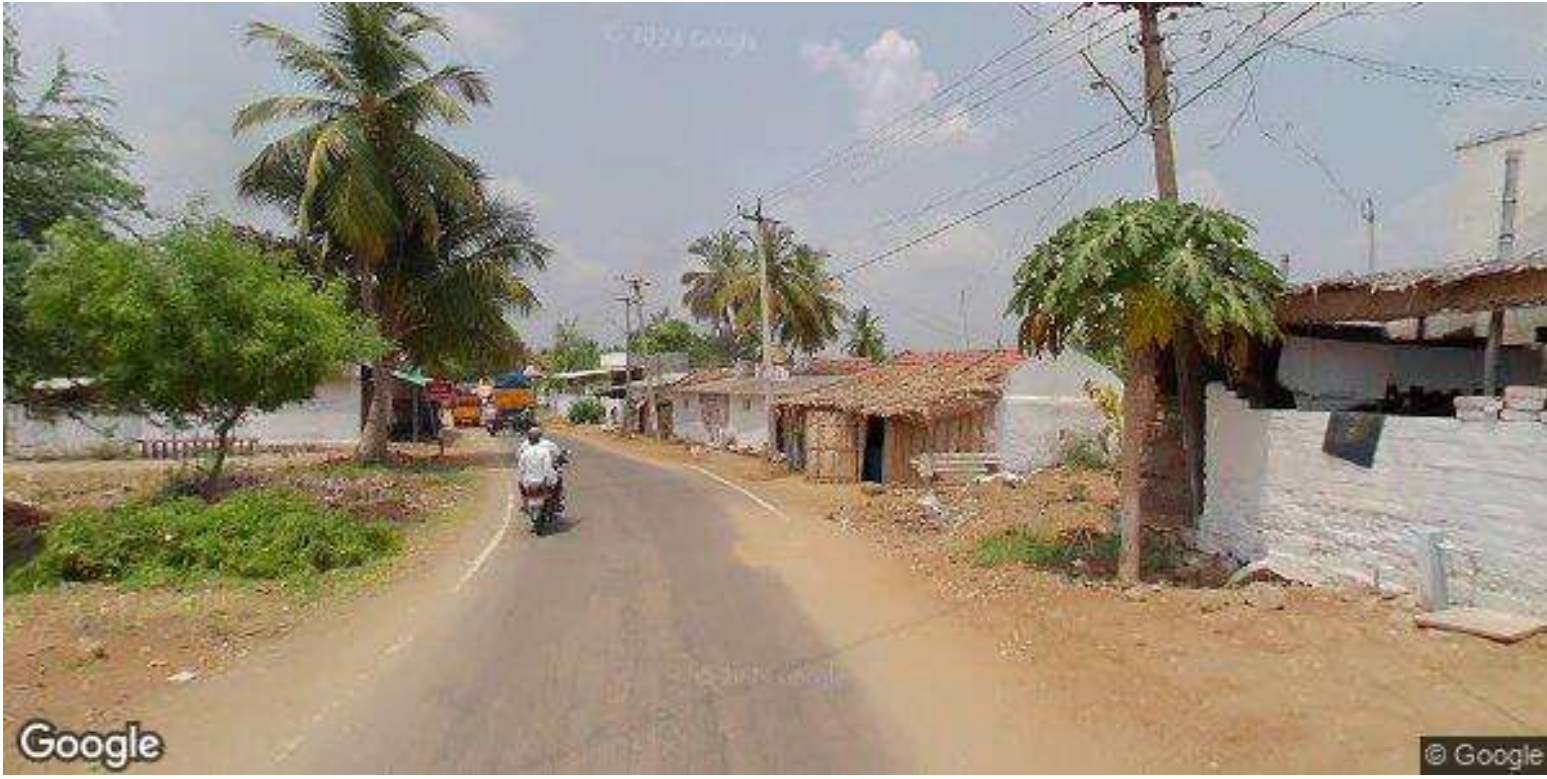
**Risk Type:** Turn  
**Risk Level:** Medium  
**Speed Limit:** 30 KM/Hr  
**Coordinates:** 11.30625, 77.87776

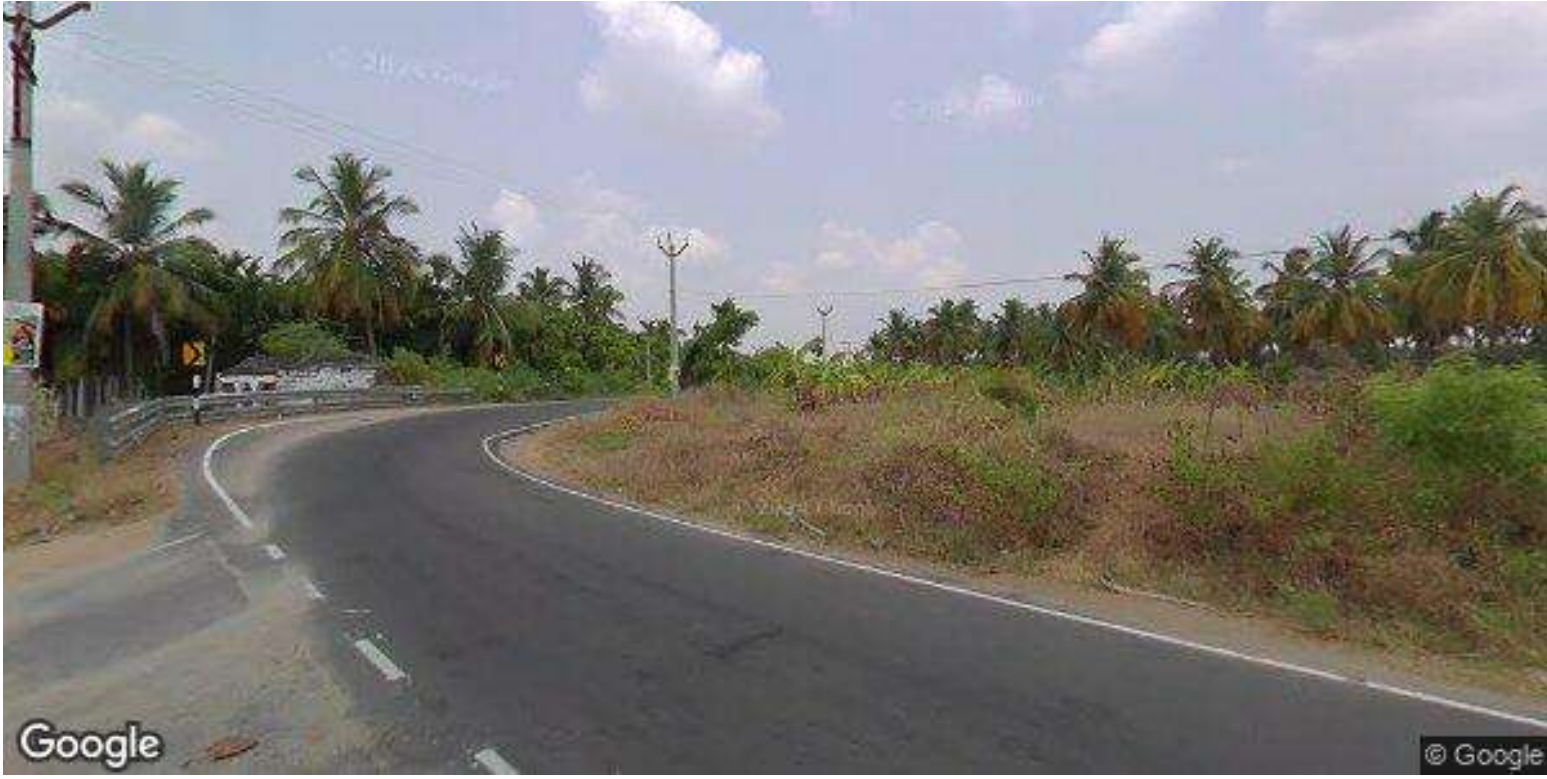
**Risk Type:** Turn  
**Risk Level:** High  
**Speed Limit:** 15 KM/Hr  
**Coordinates:** 11.29763, 77.87710

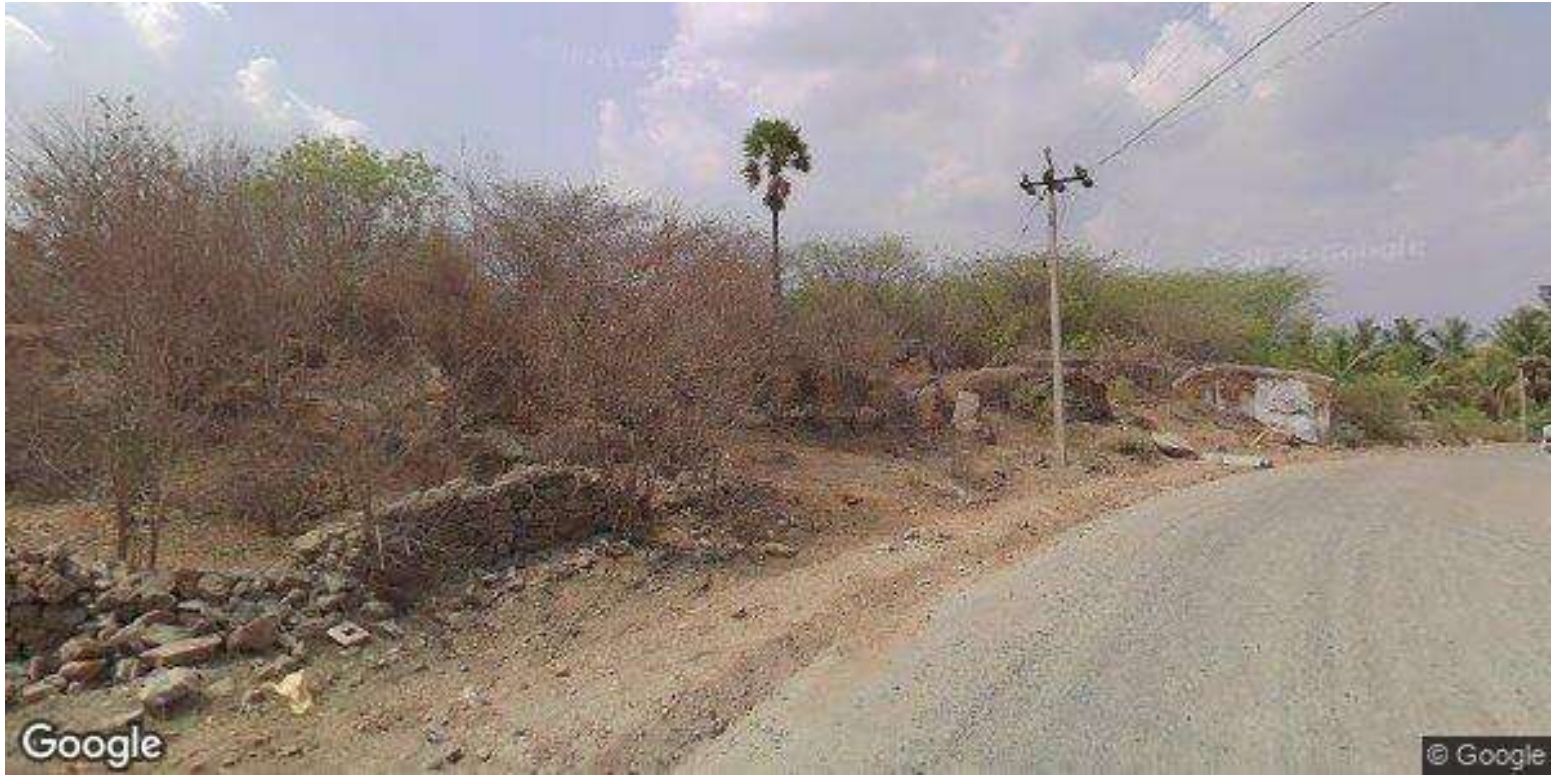
**Risk Type:** Turn  
**Risk Level:** Medium  
**Speed Limit:** 30 KM/Hr  
**Coordinates:** 11.27057, 77.86827

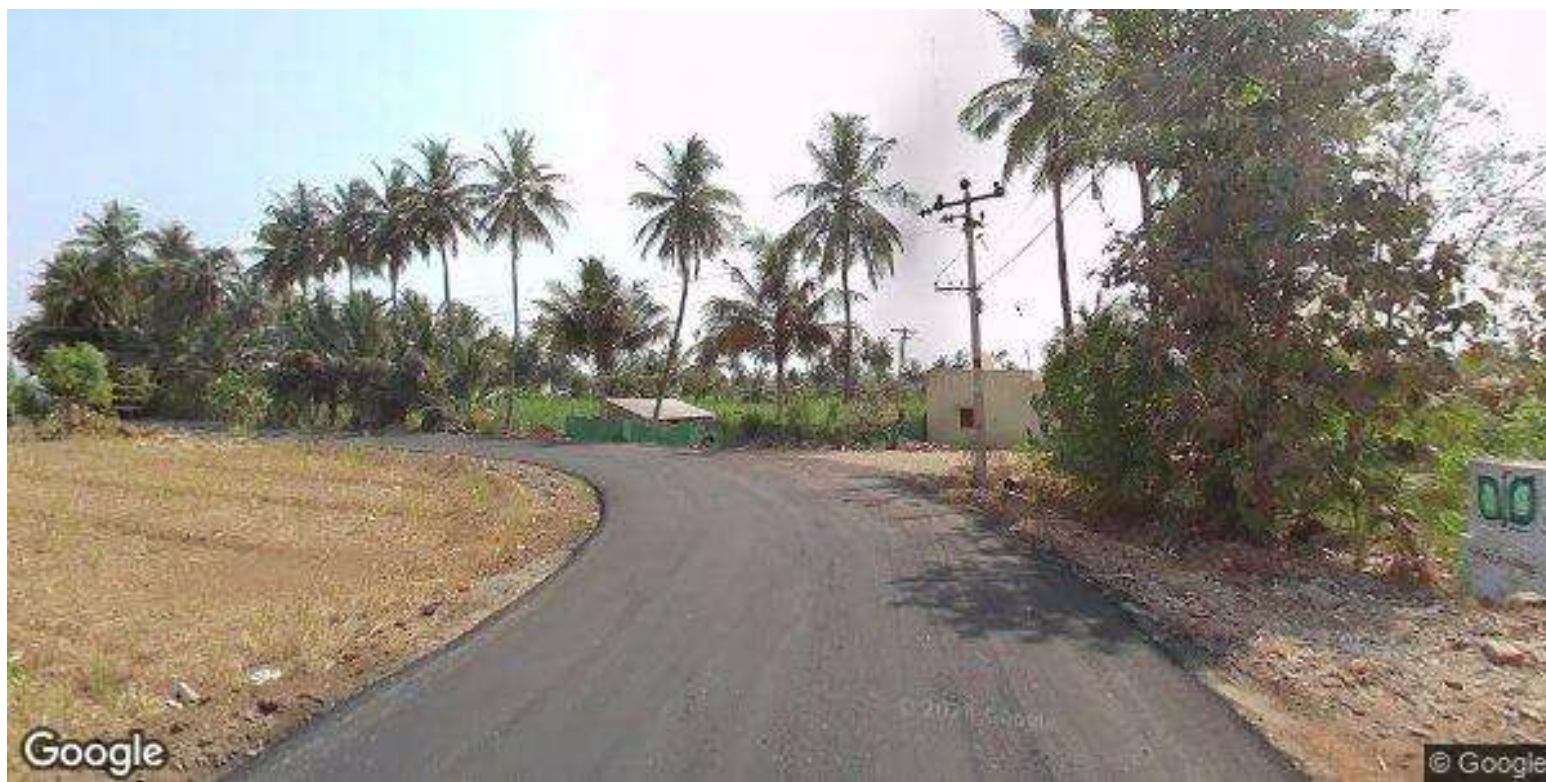
**Risk Type: Turn**

**Risk Level: High**

**Speed Limit: 15 KM/Hr**

**Coordinates: 11.26028, 77.85633**

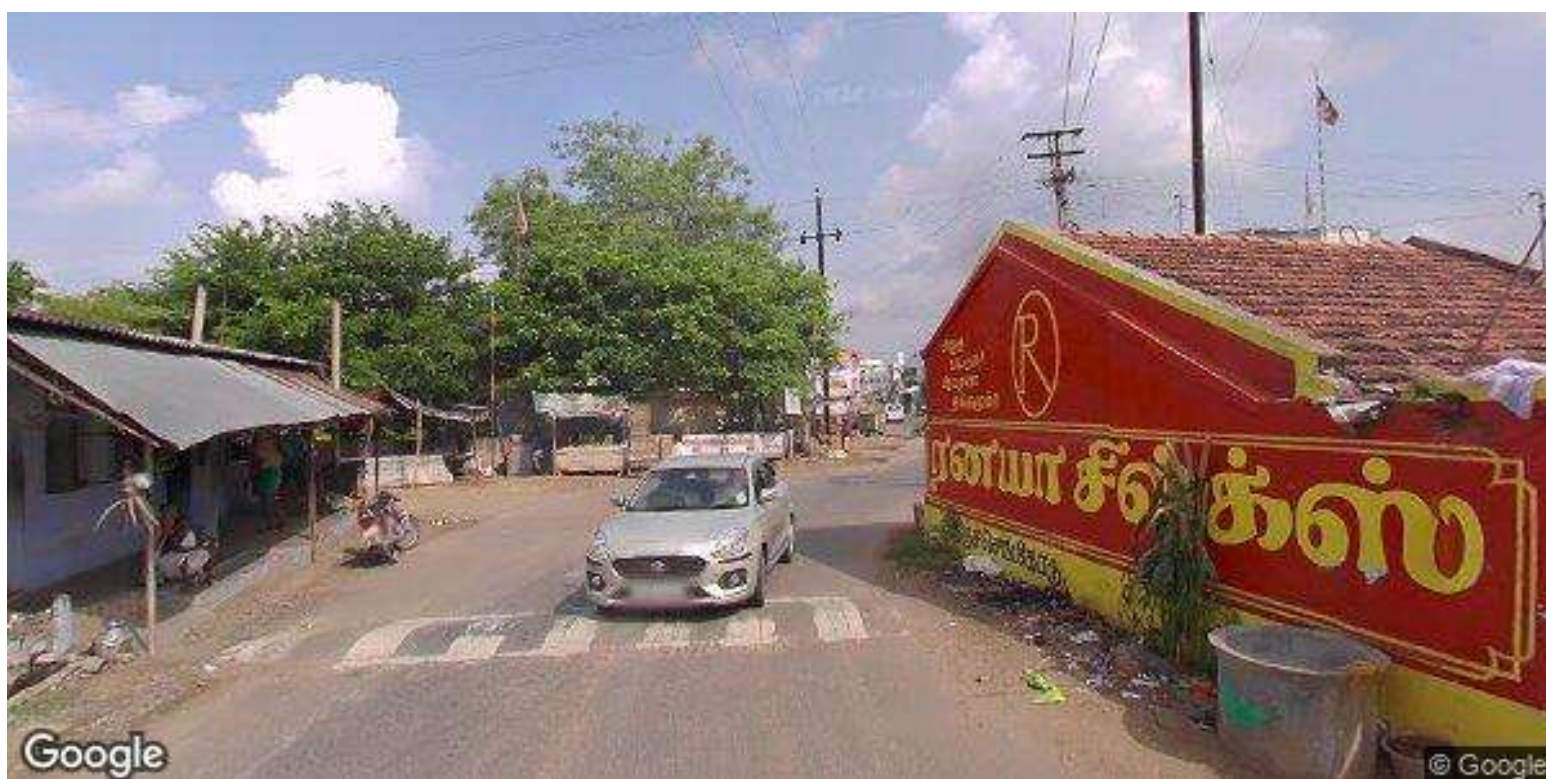
**Risk Type: Turn**

**Risk Level: High**

**Speed Limit: 15 KM/Hr**

**Coordinates: 11.25791, 77.85522**

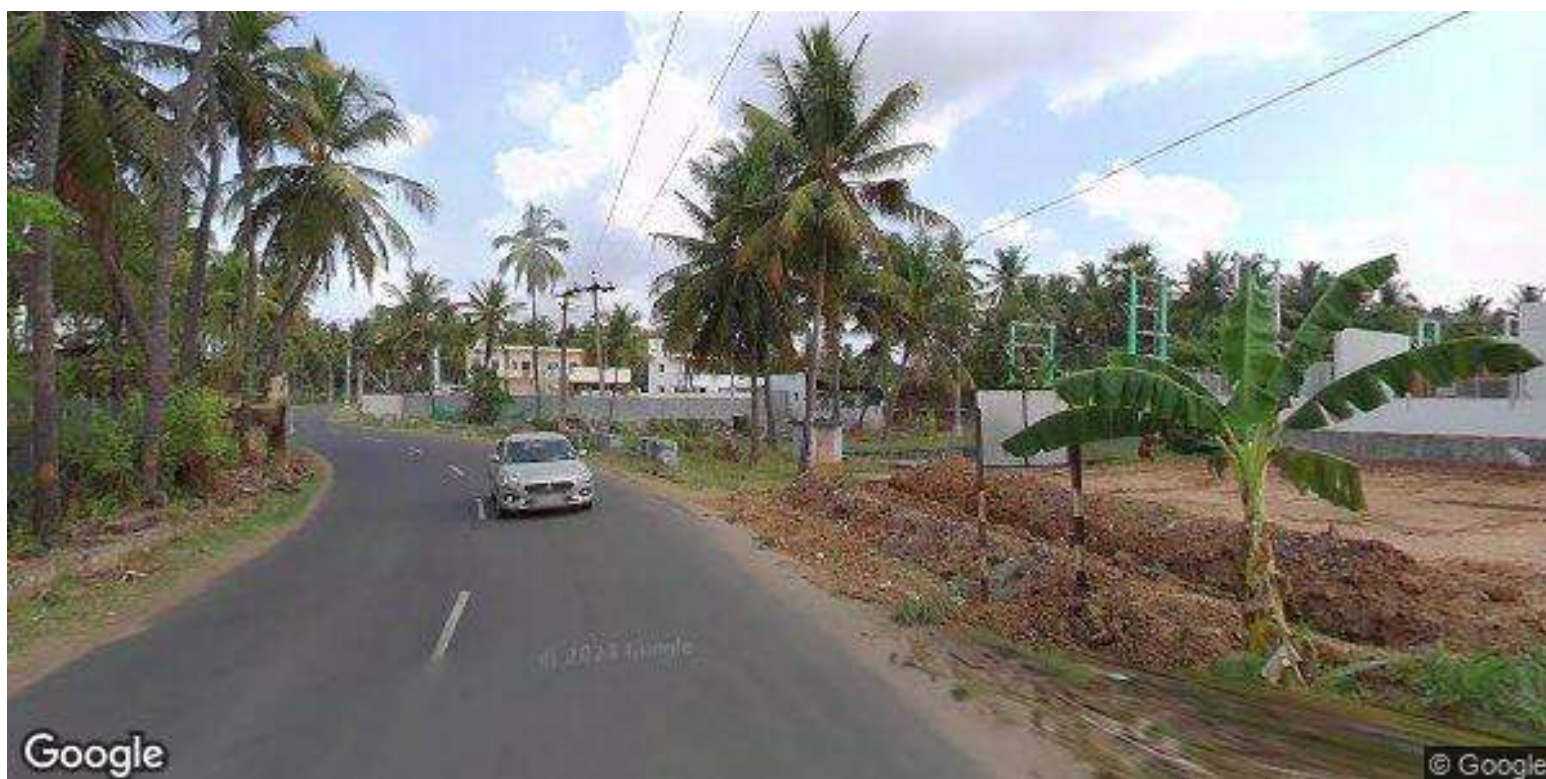
**Risk Type:** Turn  
**Risk Level:** Medium  
**Speed Limit:** 30 KM/Hr  
**Coordinates:** 11.25287, 77.86220

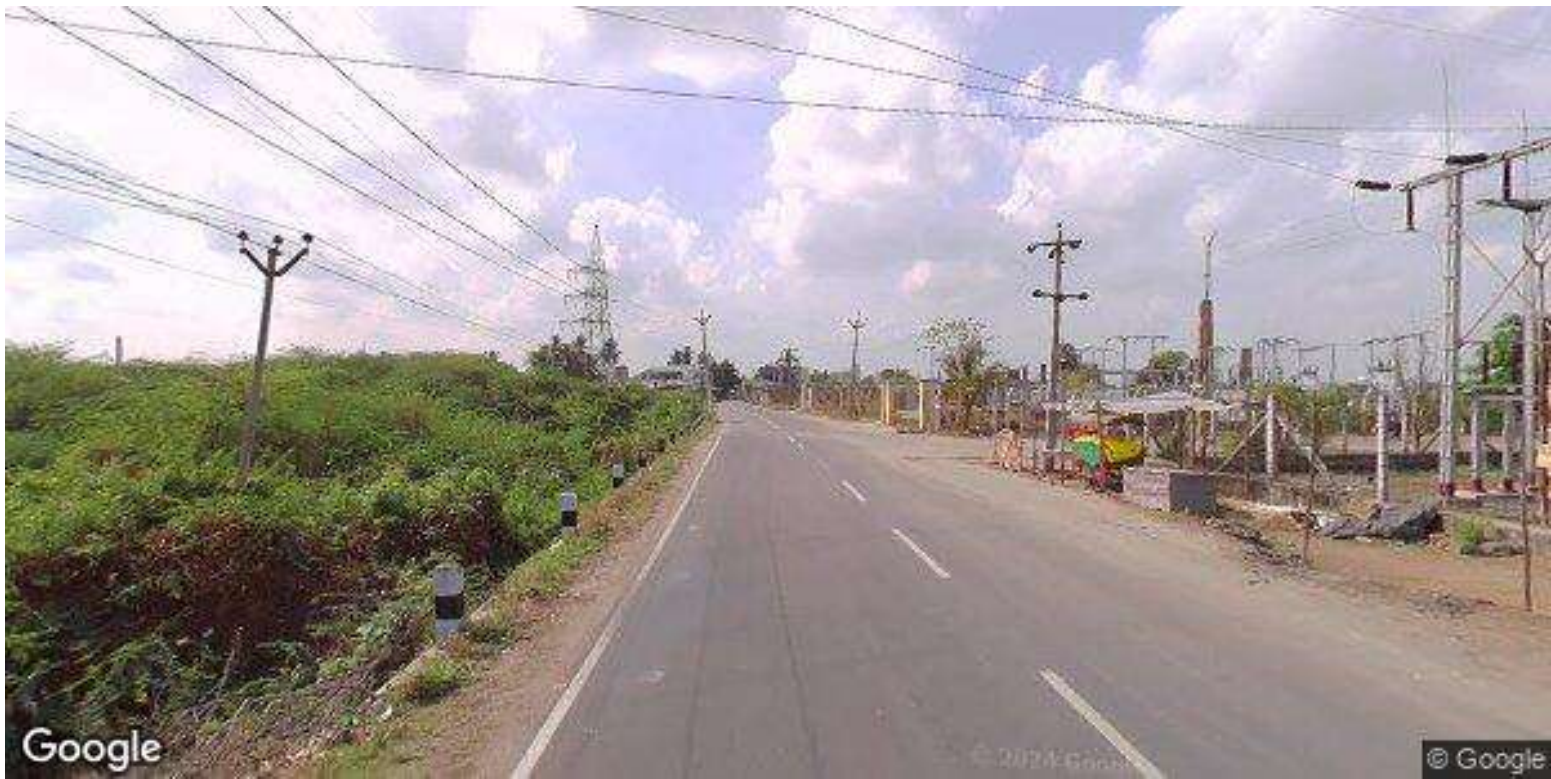
**Risk Type:** Turn  
**Risk Level:** Medium  
**Speed Limit:** 30 KM/Hr  
**Coordinates:** 11.24410, 77.86671

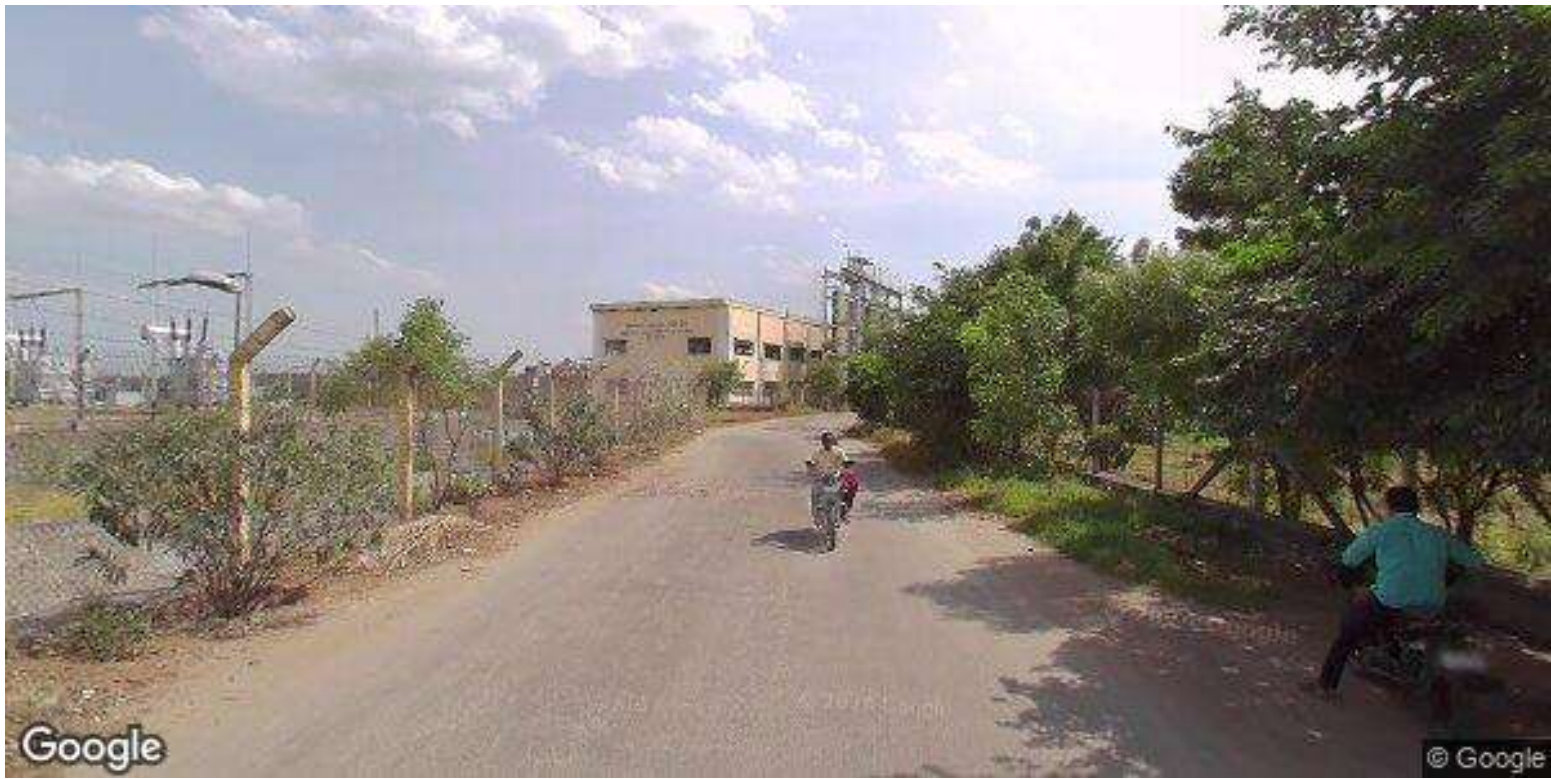
**Risk Type:** Turn  
**Risk Level:** High  
**Speed Limit:** 15 KM/Hr  
**Coordinates:** 11.24365, 77.86668

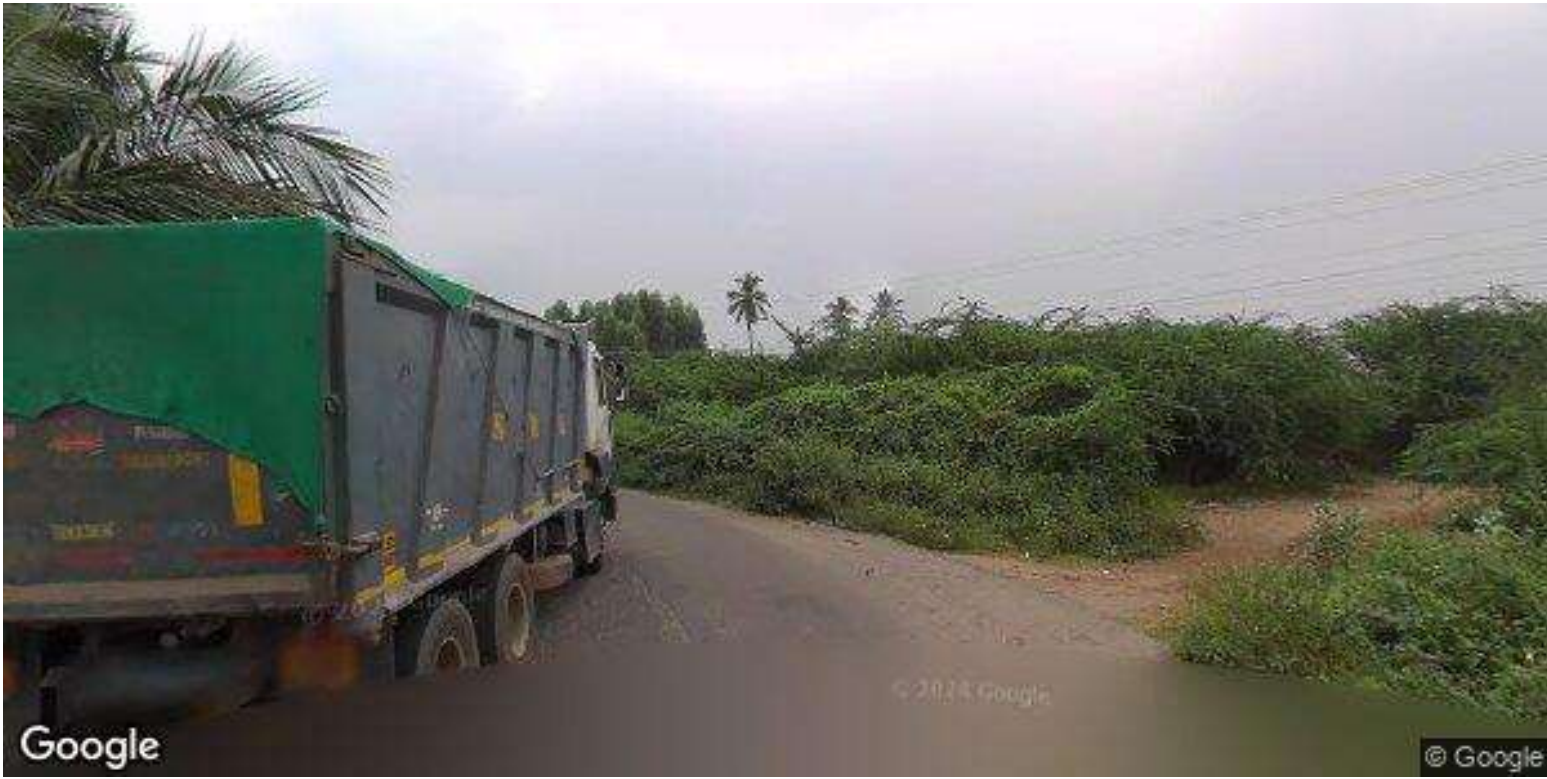
**Risk Type:** Turn  
**Risk Level:** High  
**Speed Limit:** 15 KM/Hr  
**Coordinates:** 11.24100, 77.86030

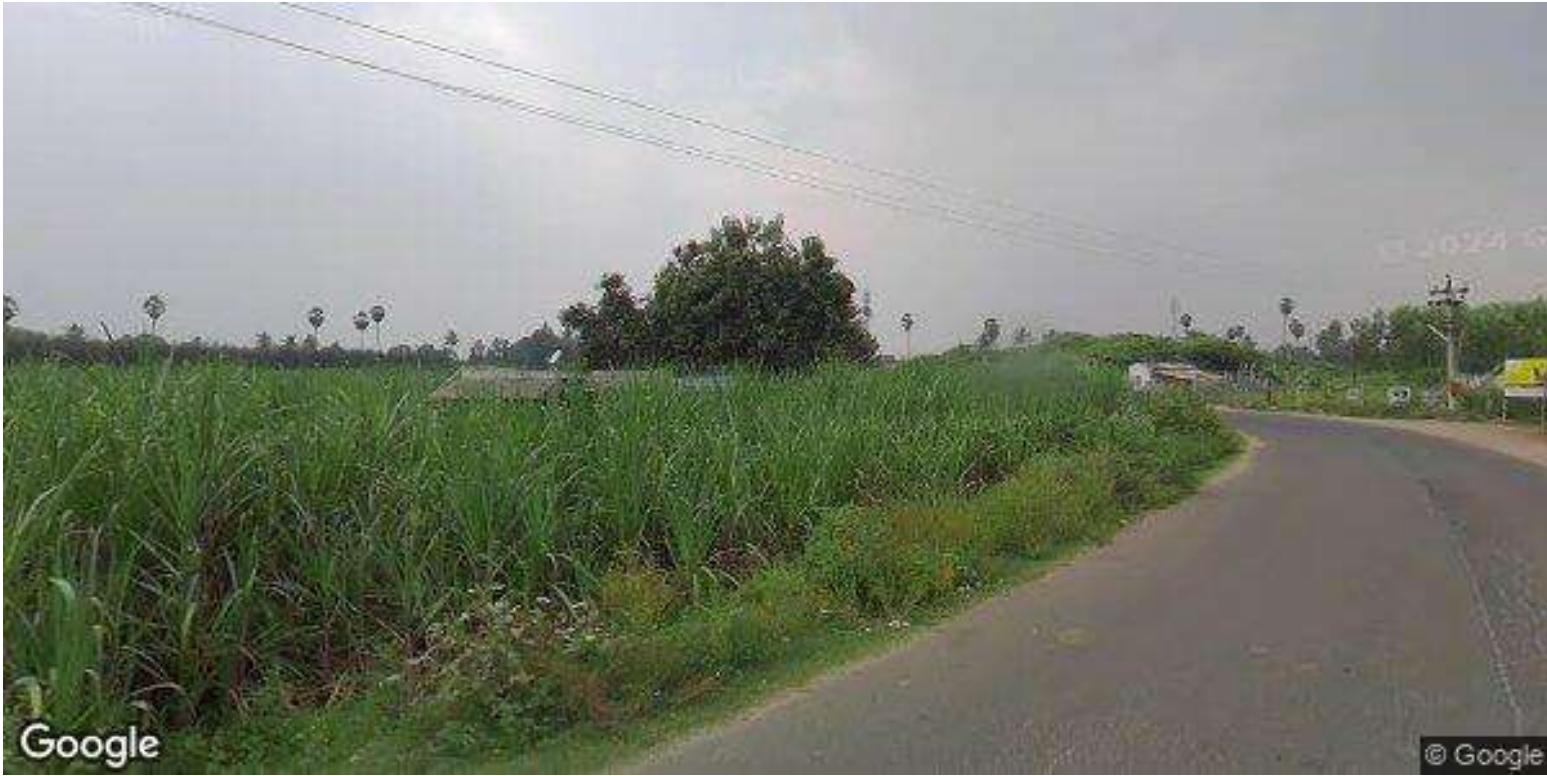
**Risk Type:** Turn  
**Risk Level:** Medium  
**Speed Limit:** 30 KM/Hr  
**Coordinates:** 11.24196, 77.85902

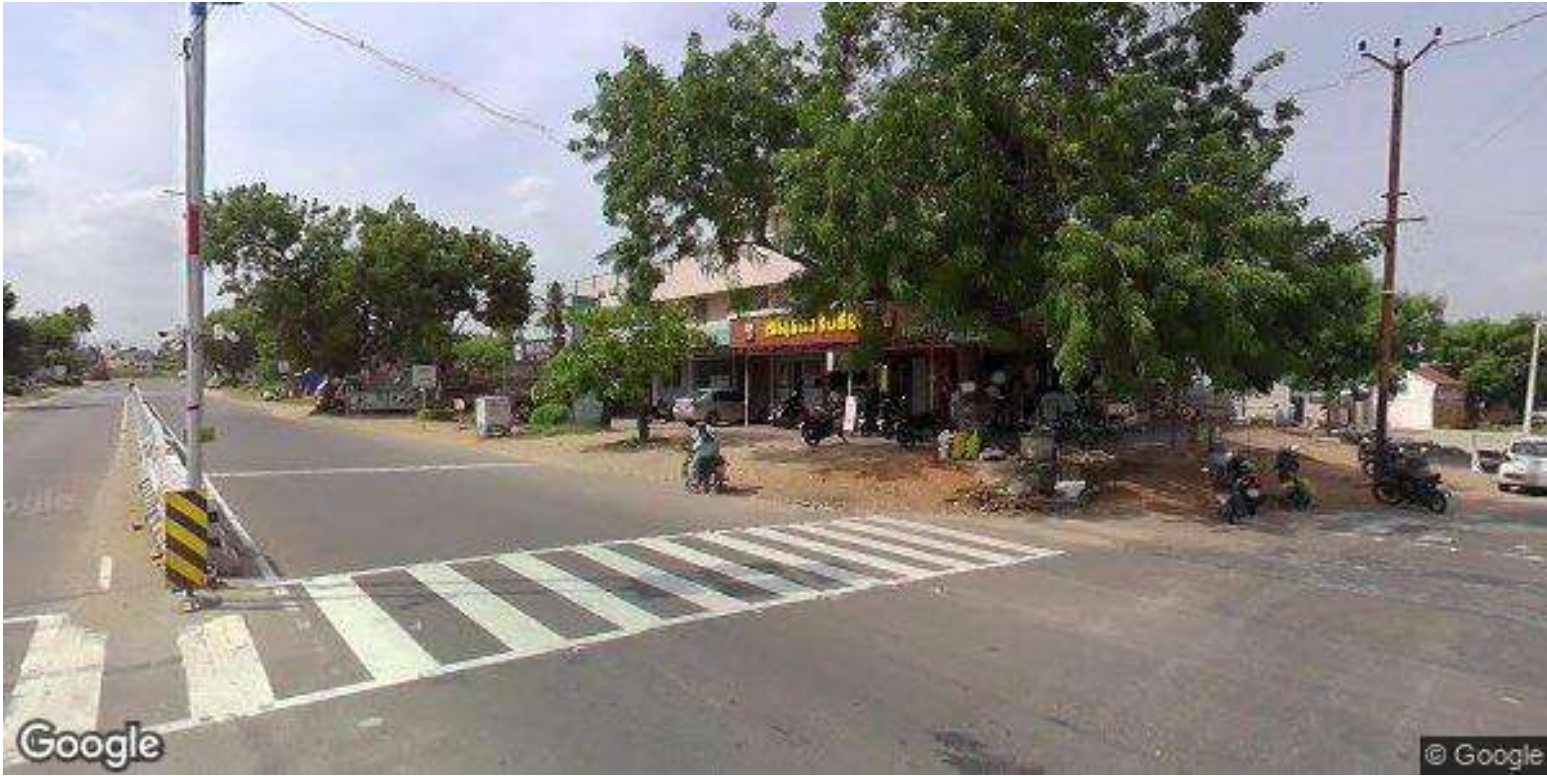
**Risk Type:** Turn  
**Risk Level:** High  
**Speed Limit:** 15 KM/Hr  
**Coordinates:** 11.22377, 77.83980
