## JOURNEY RISK MANAGEMENT (JRM) STUDY

### Salem Terminal TO VENKATESWARA AUTO SERVICE

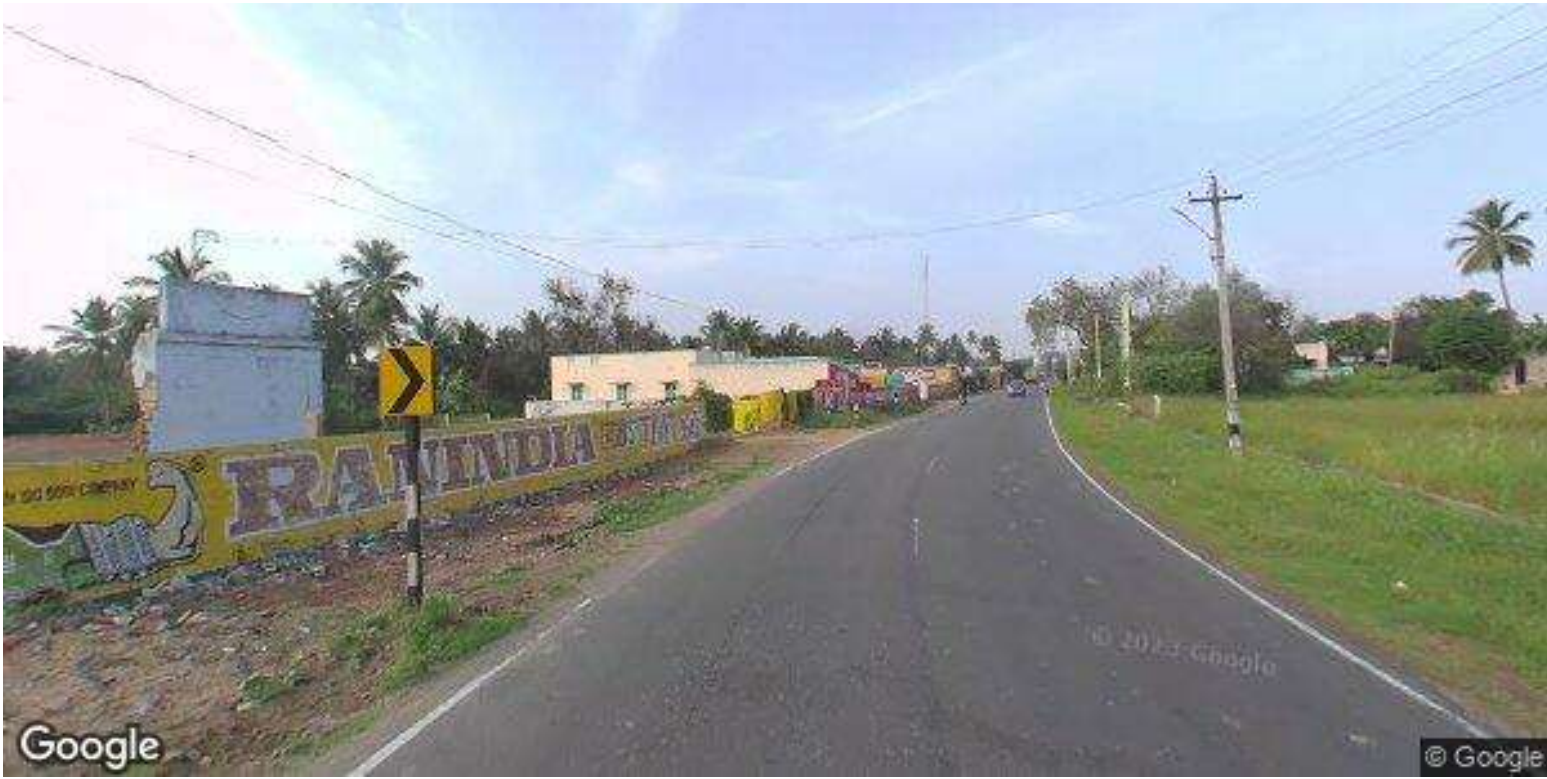
**Risk Type:** Turn  
**Risk Level:** Medium  
**Speed Limit:** 30 KM/Hr  
**Coordinates:** 11.14595, 77.84958

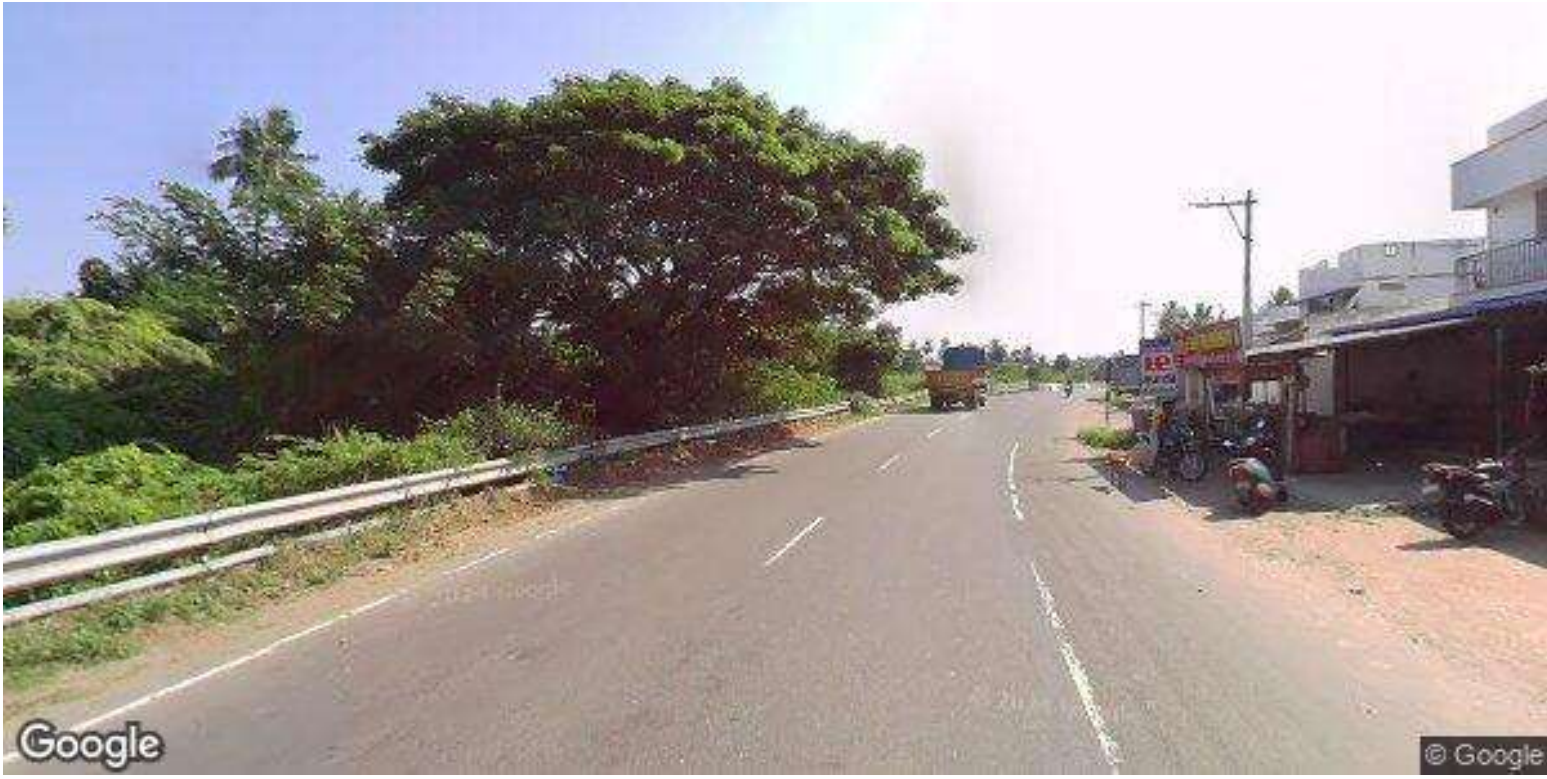
**Risk Type:** Turn  
**Risk Level:** Medium  
**Speed Limit:** 30 KM/Hr  
**Coordinates:** 11.12977, 77.85502

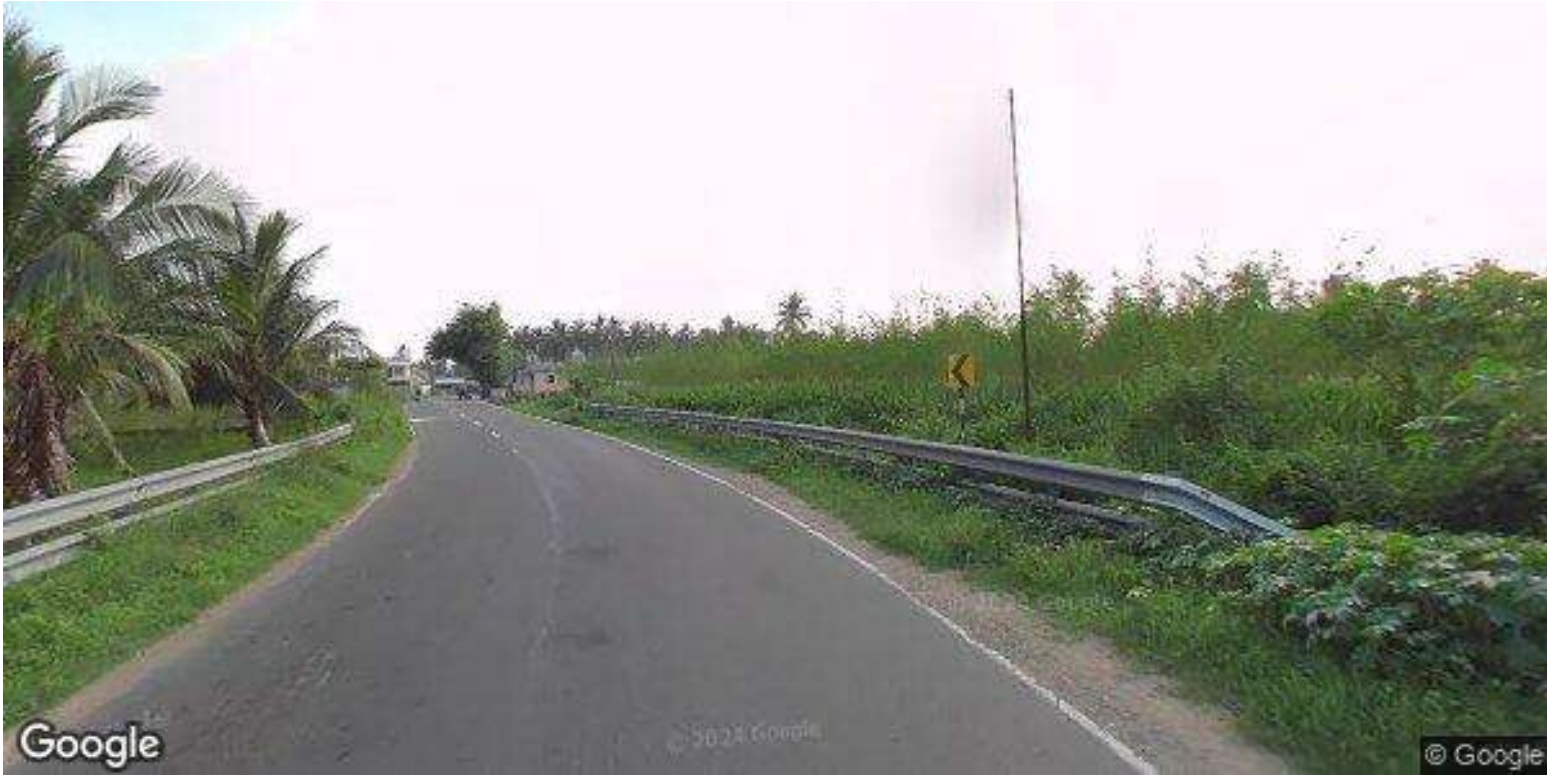
**Risk Type:** Turn  
**Risk Level:** Medium  
**Speed Limit:** 30 KM/Hr  
**Coordinates:** 11.12714, 77.85403

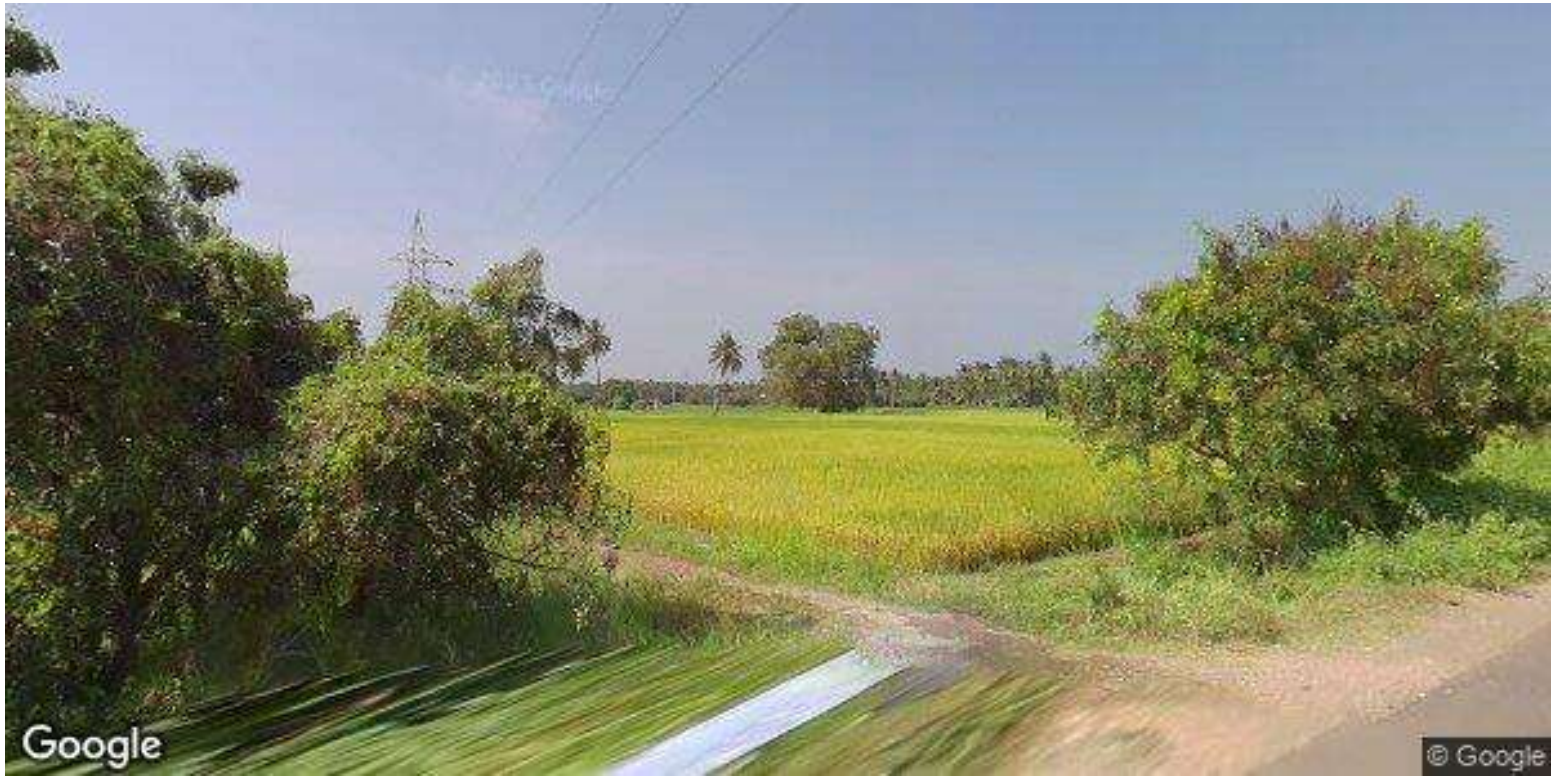
**Risk Type:** Turn  
**Risk Level:** Medium  
**Speed Limit:** 30 KM/Hr  
**Coordinates:** 11.05412, 77.87969

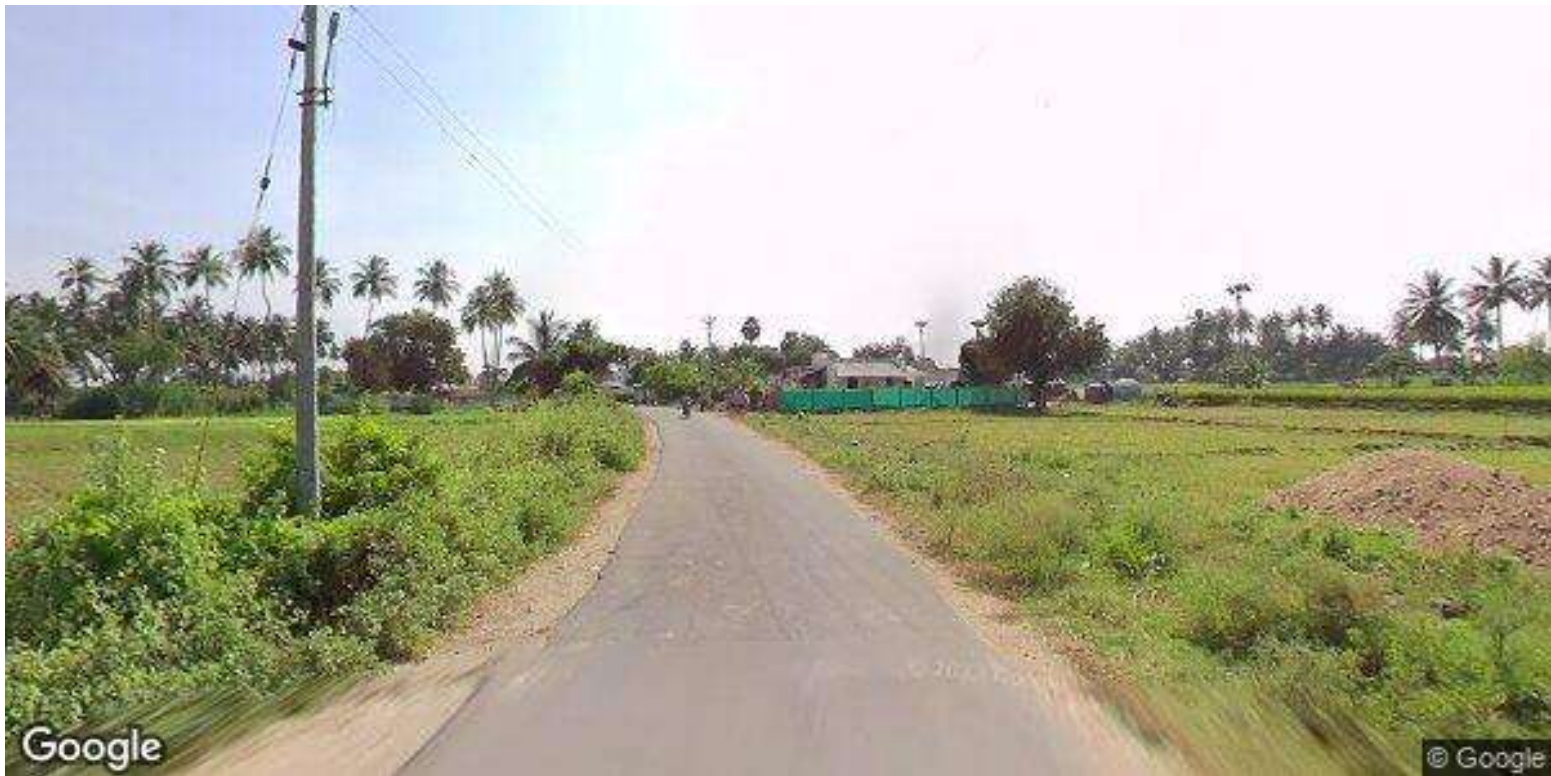
**Risk Type:** Turn  
**Risk Level:** Medium  
**Speed Limit:** 30 KM/Hr  
**Coordinates:** 11.04059, 77.87686

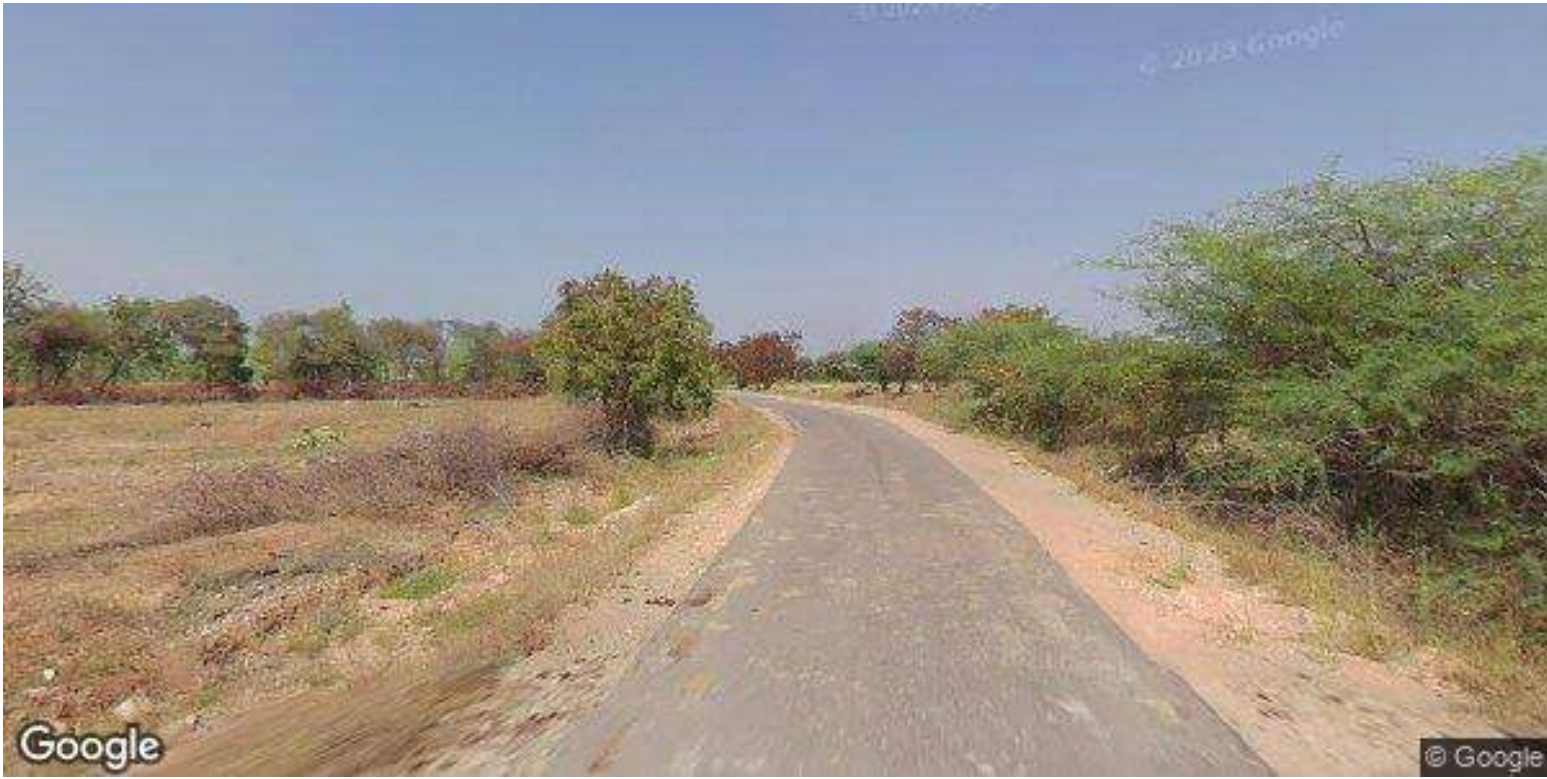
**Risk Type:** Turn  
**Risk Level:** Medium  
**Speed Limit:** 30 KM/Hr  
**Coordinates:** 11.02806, 77.87663

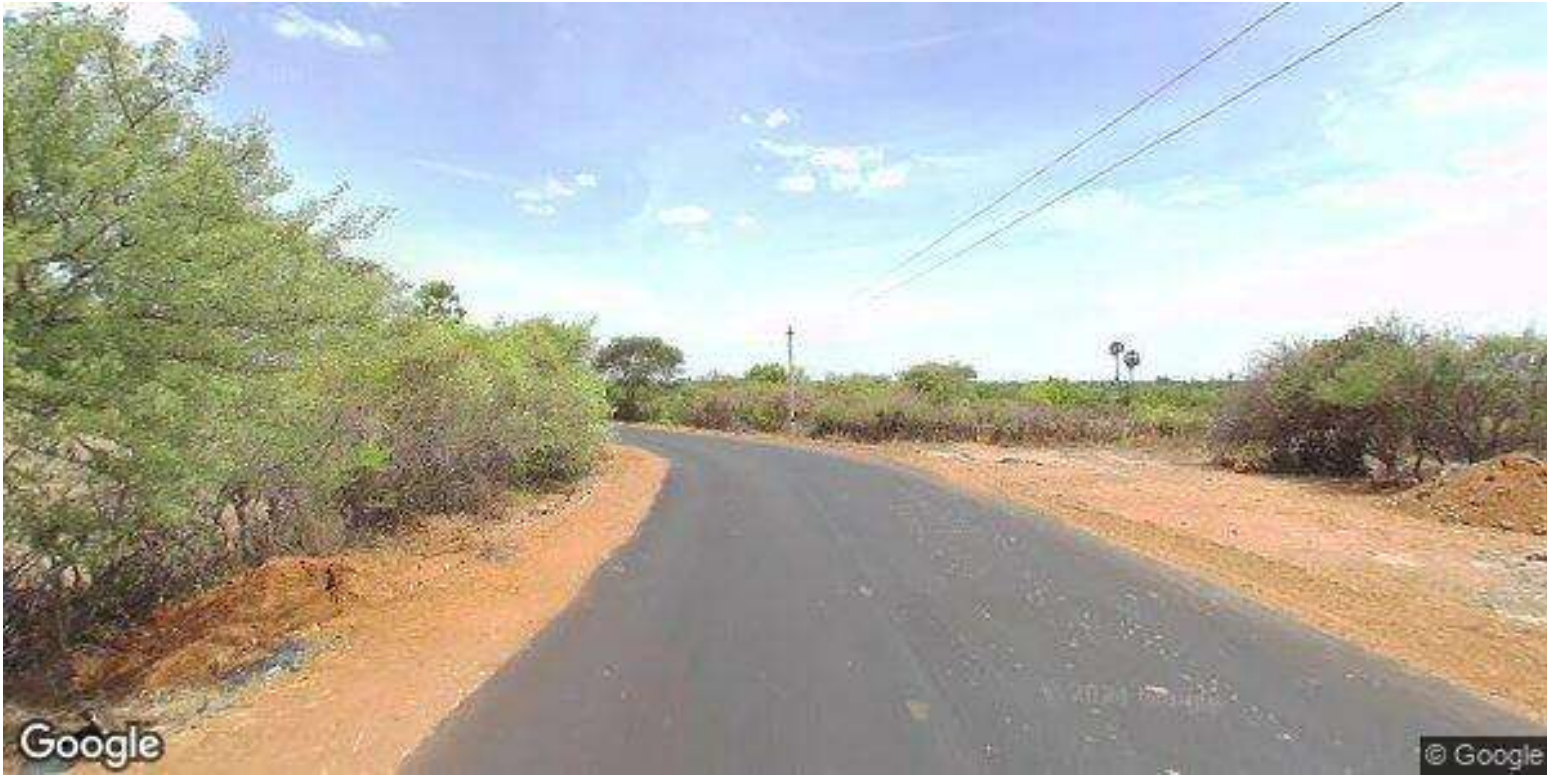
**Risk Type:** Turn  
**Risk Level:** Medium  
**Speed Limit:** 30 KM/Hr  
**Coordinates:** 11.00834, 77.85882

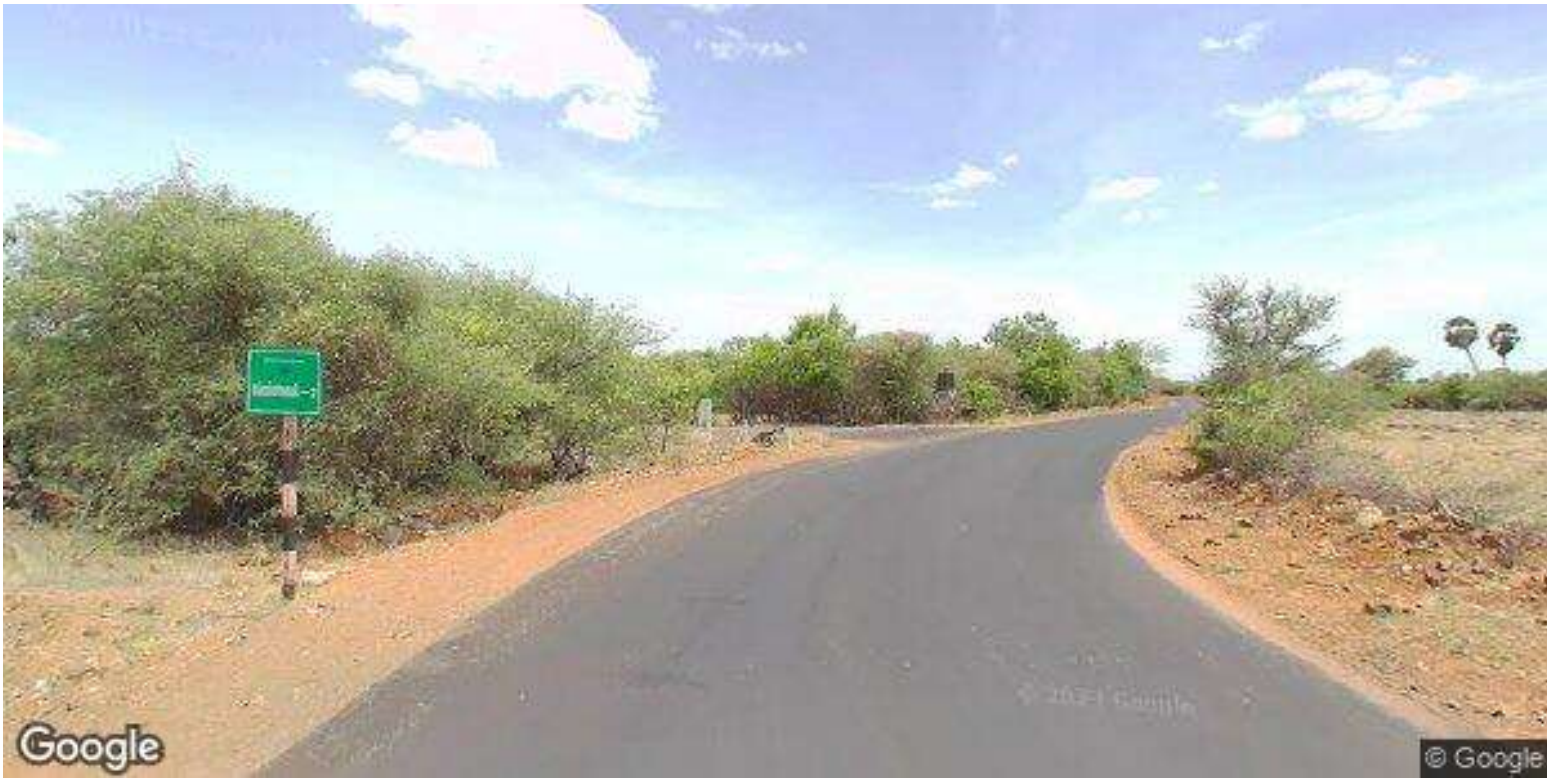
**Risk Type:** Turn  
**Risk Level:** Medium  
**Speed Limit:** 30 KM/Hr  
**Coordinates:** 11.00475, 77.85797

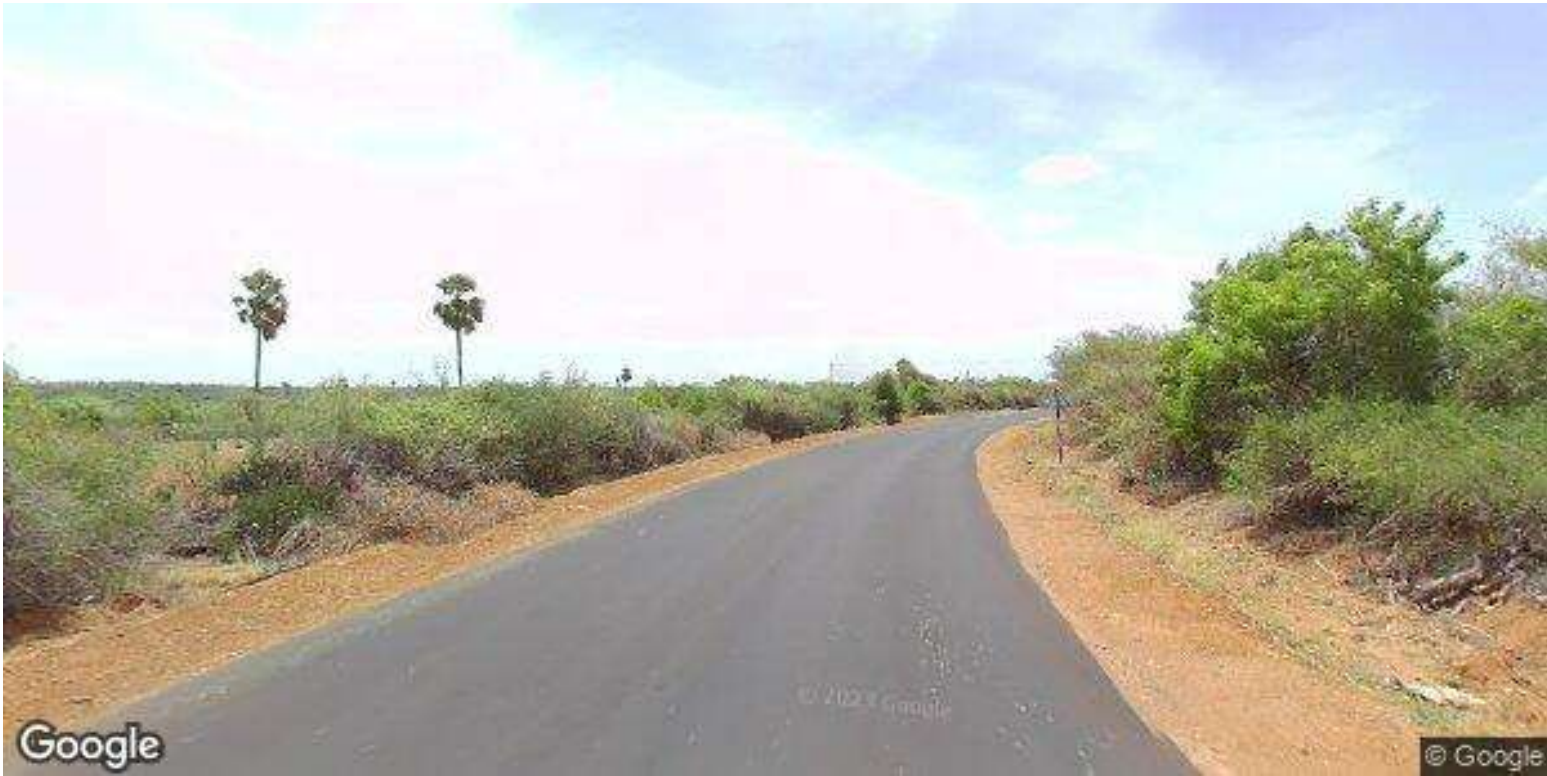
**Risk Type:** Turn  
**Risk Level:** Medium  
**Speed Limit:** 30 KM/Hr  
**Coordinates:** 11.00360, 77.85683

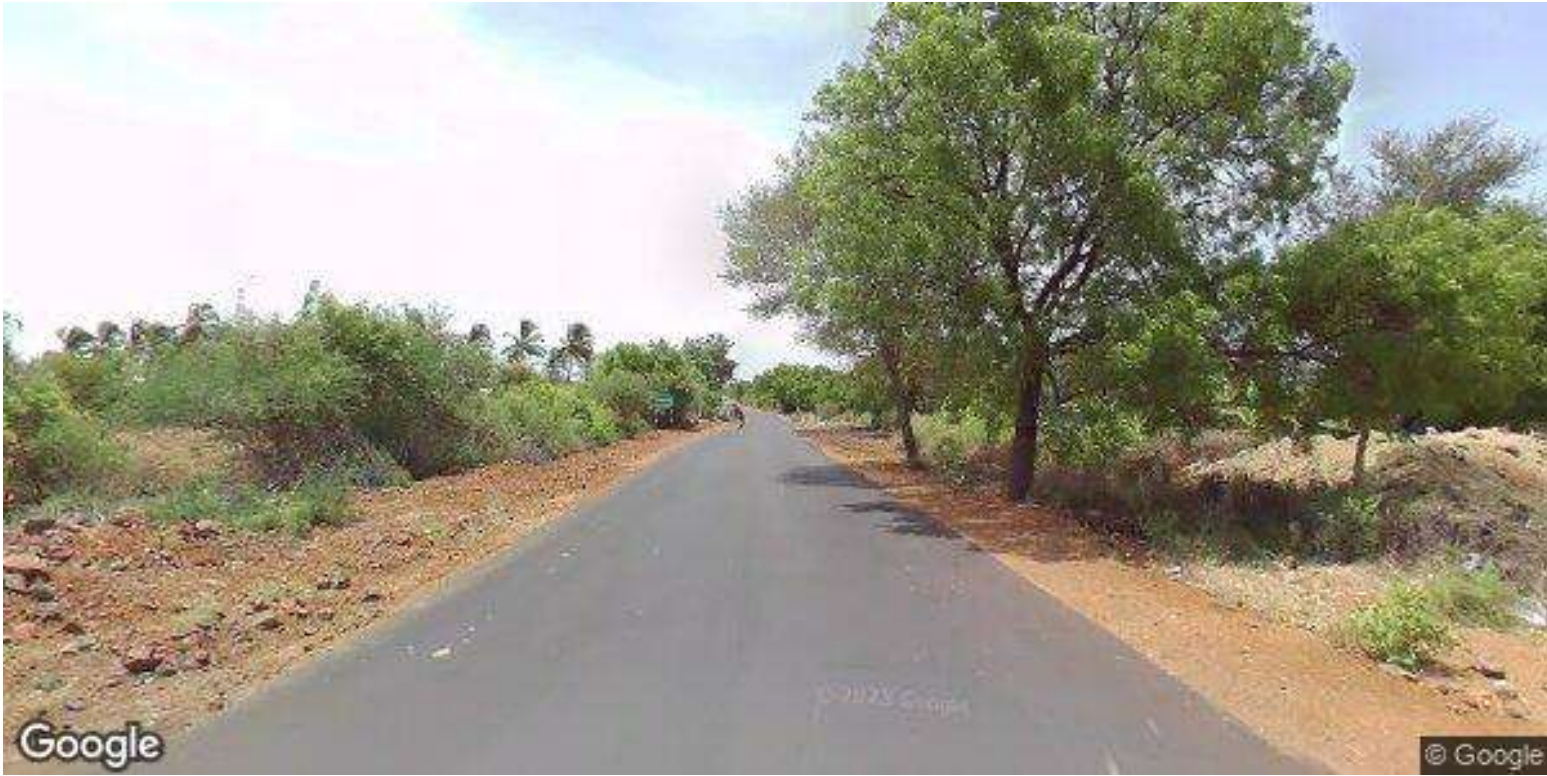
**Risk Type:** Turn  
**Risk Level:** Medium  
**Speed Limit:** 30 KM/Hr  
**Coordinates:** 10.99820, 77.85581

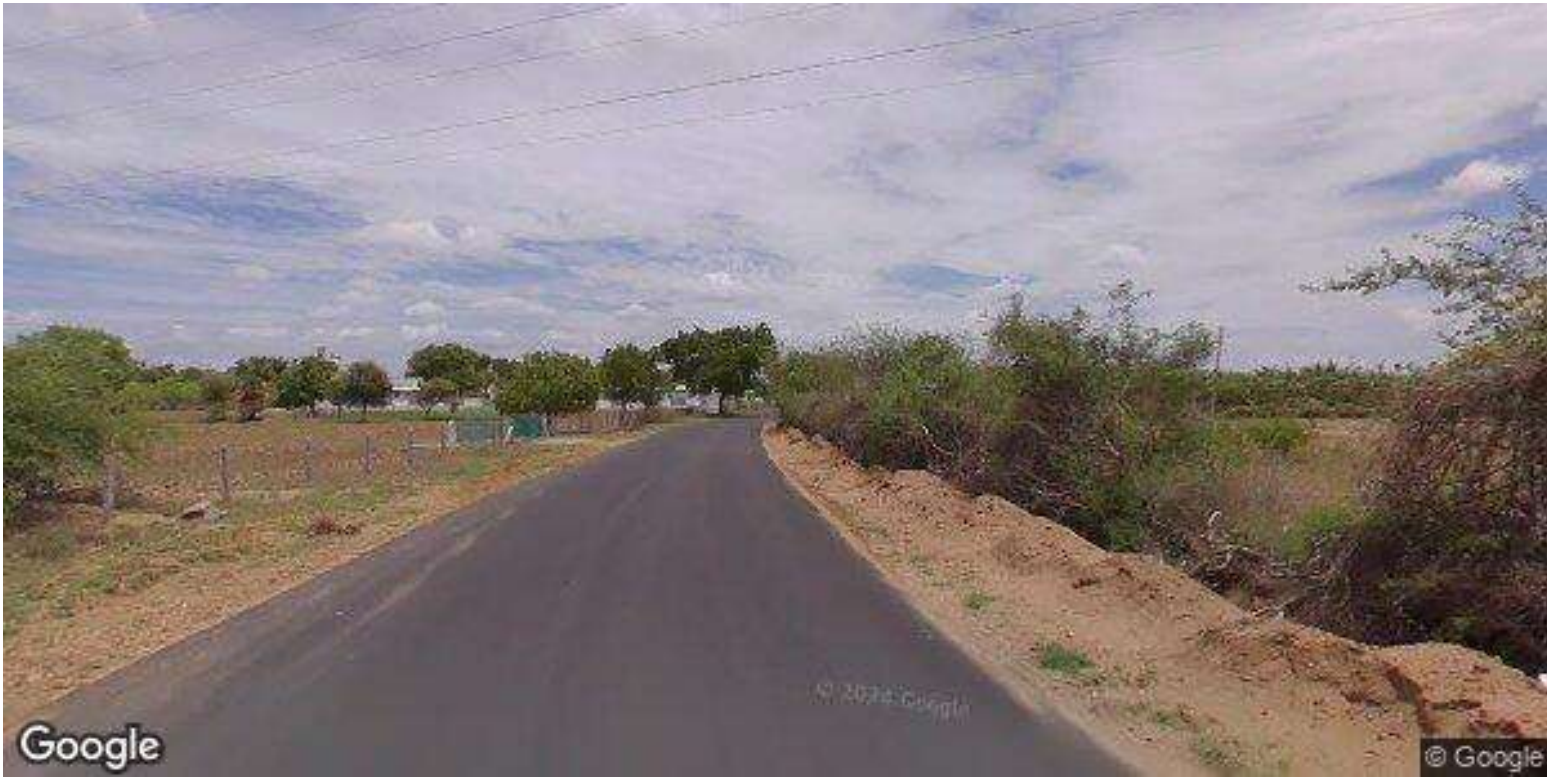
**Risk Type:** Turn  
**Risk Level:** Medium  
**Speed Limit:** 30 KM/Hr  
**Coordinates:** 10.96483, 77.83744

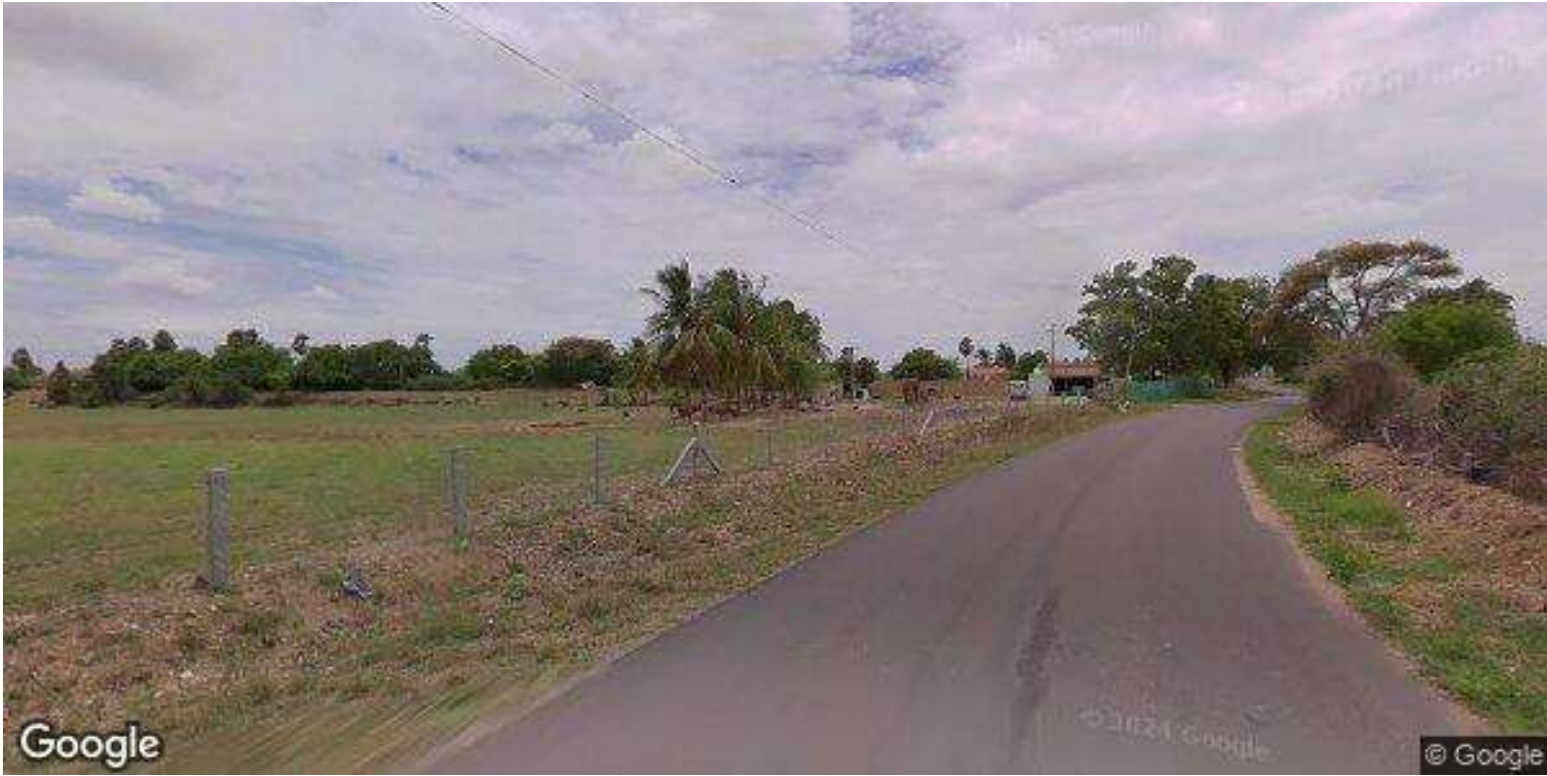
**Risk Type:** Turn  
**Risk Level:** Medium  
**Speed Limit:** 30 KM/Hr  
**Coordinates:** 10.95683, 77.83813

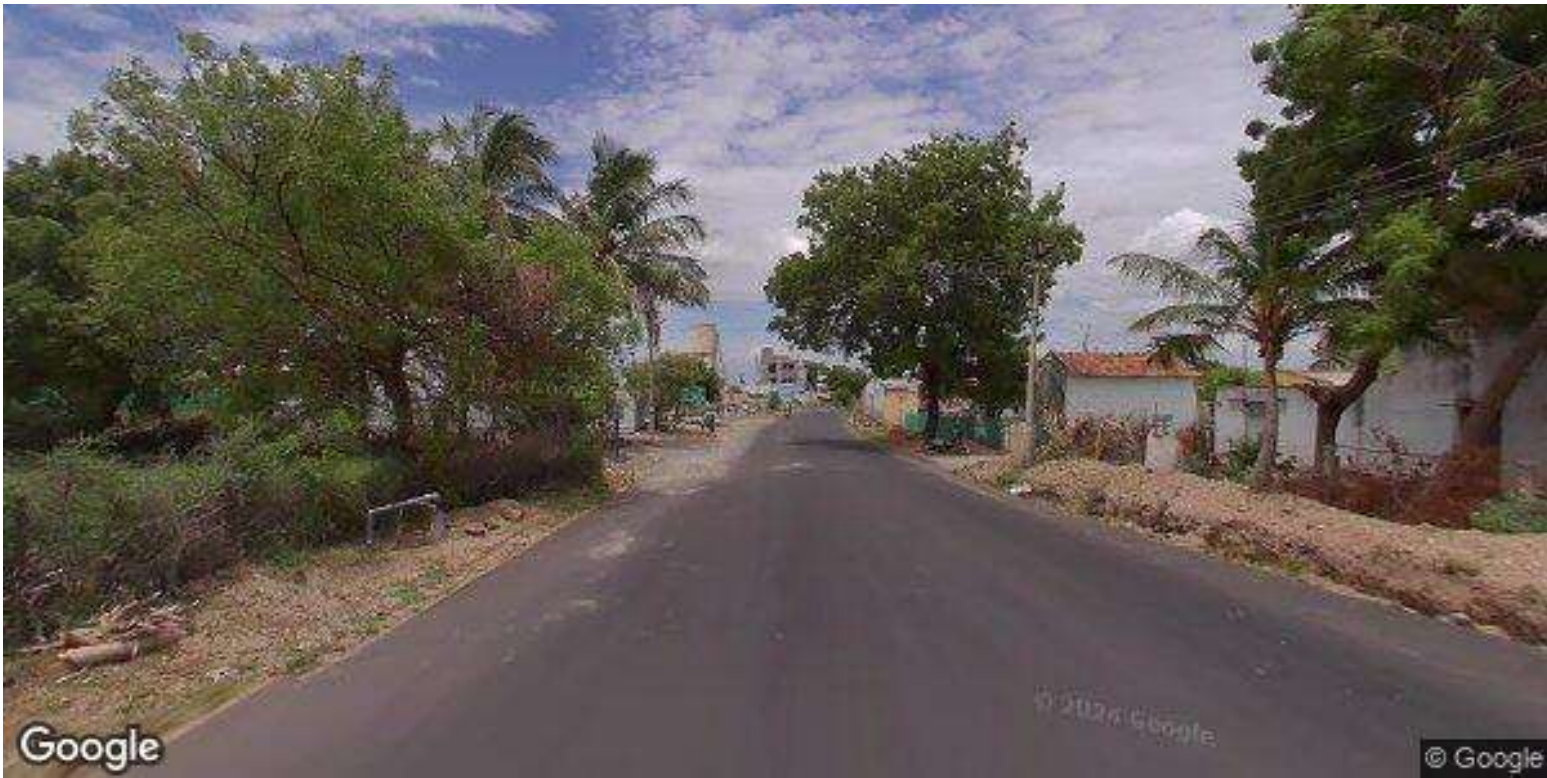
**Risk Type:** Turn  
**Risk Level:** Medium  
**Speed Limit:** 30 KM/Hr  
**Coordinates:** 10.95401, 77.83691

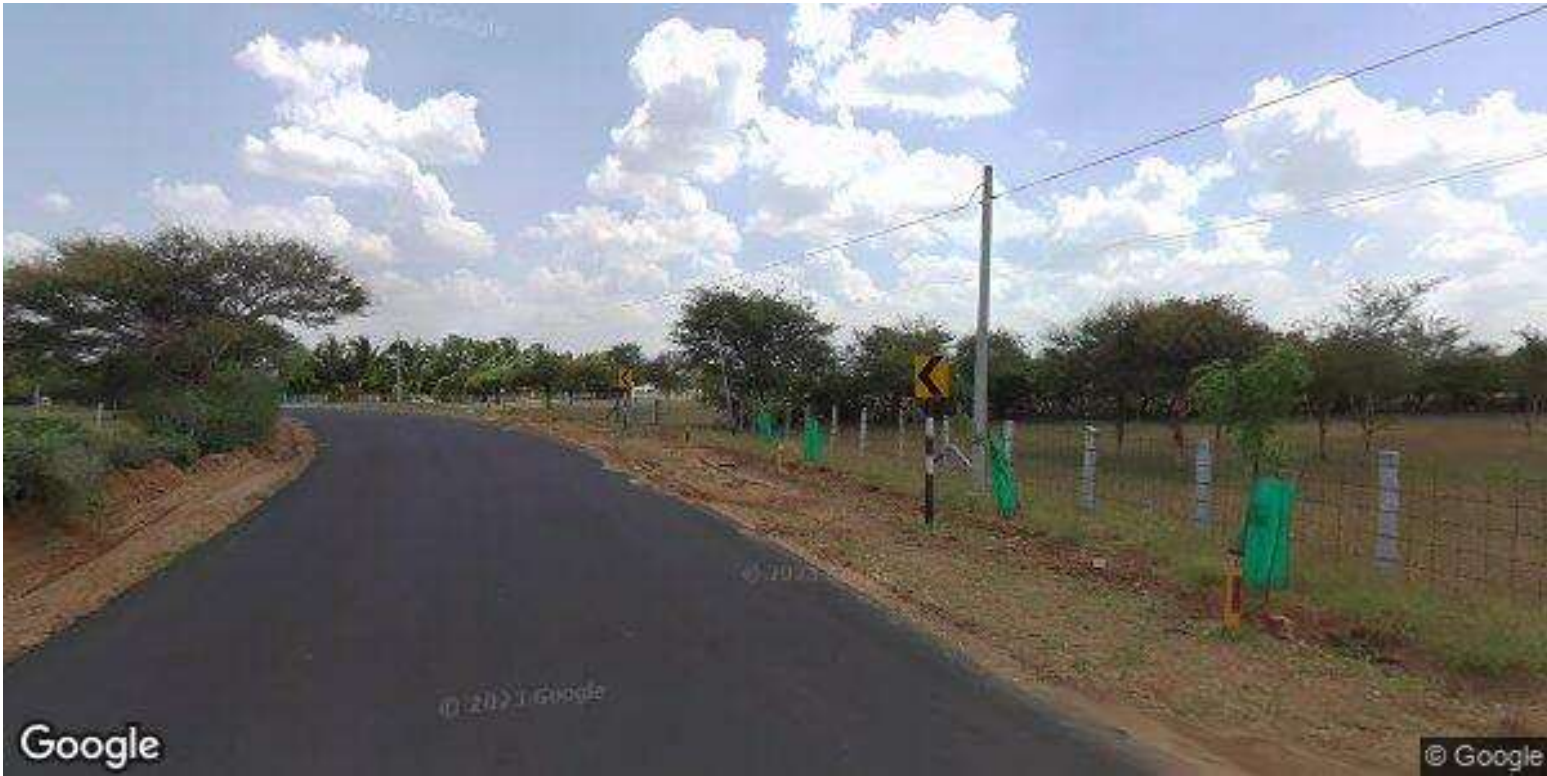
**Risk Type:** Turn  
**Risk Level:** Medium  
**Speed Limit:** 30 KM/Hr  
**Coordinates:** 10.89518, 77.83562

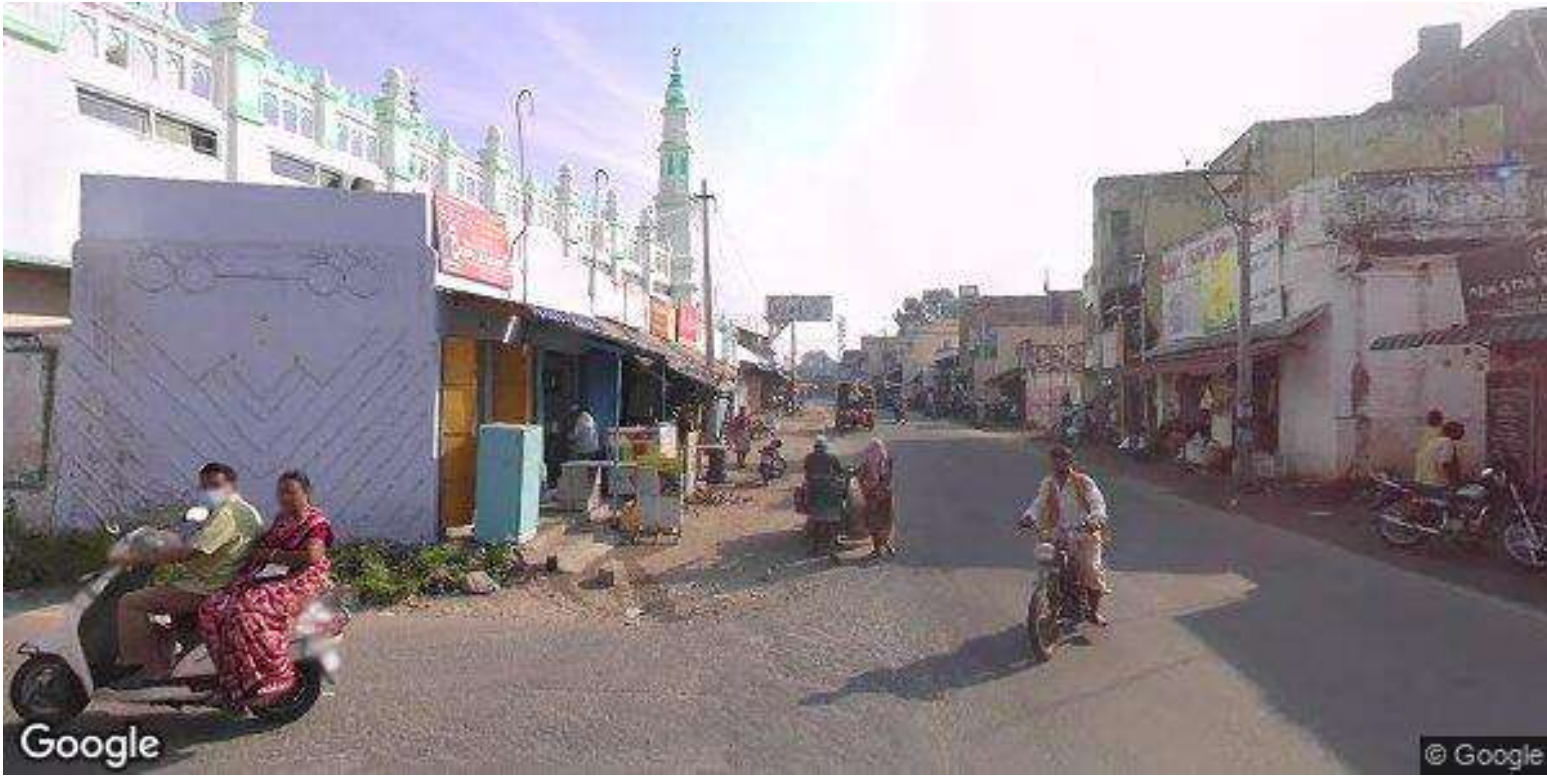
**Risk Type:** Blind Spot  
**Risk Level:** Blind Spot  
**Speed Limit:** 10 KM/Hr  
**Coordinates:** 10.85240, 77.85000

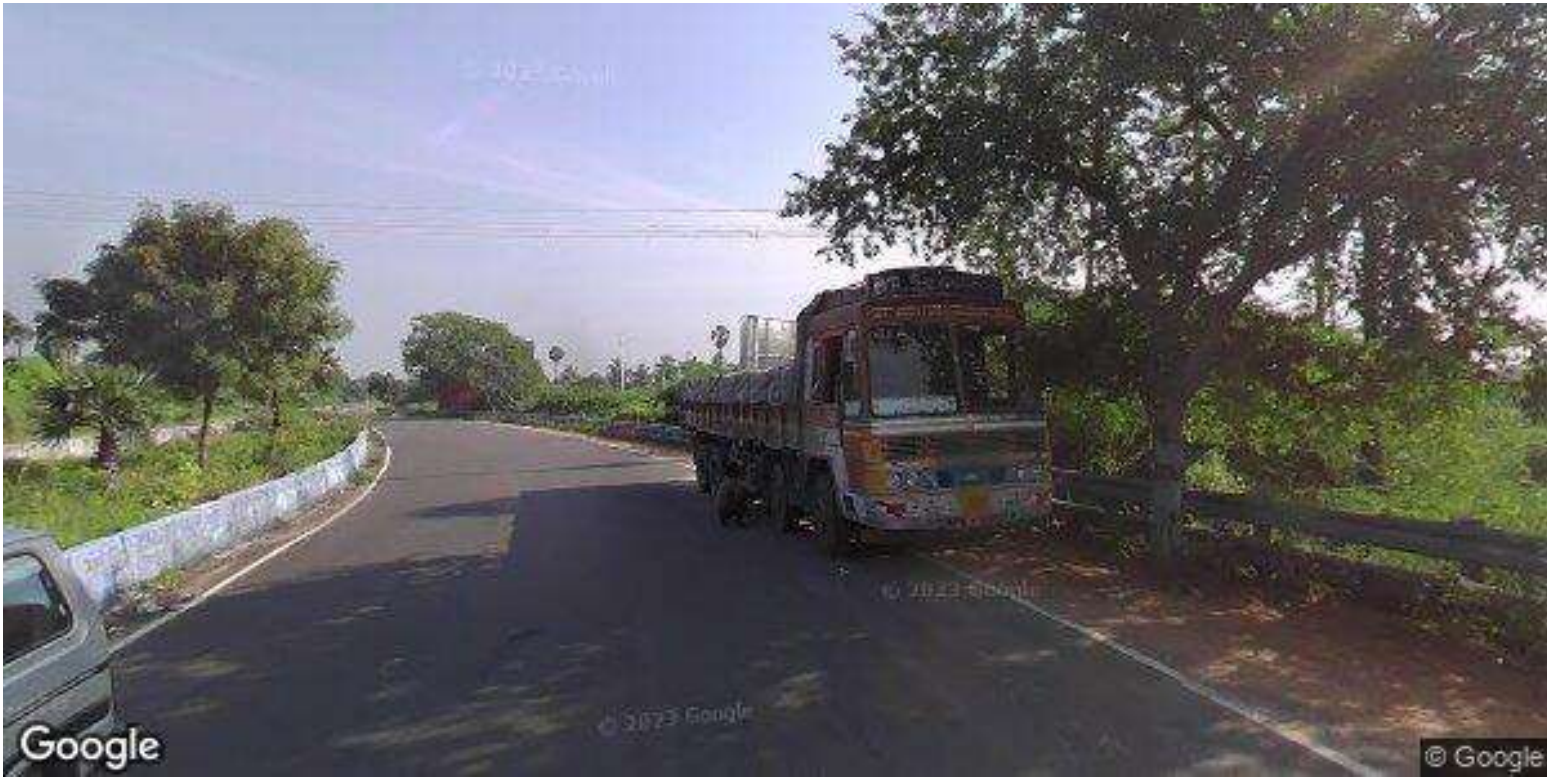
**Risk Type:** Turn  
**Risk Level:** High  
**Speed Limit:** 15 KM/Hr  
**Coordinates:** 10.81414, 77.79125

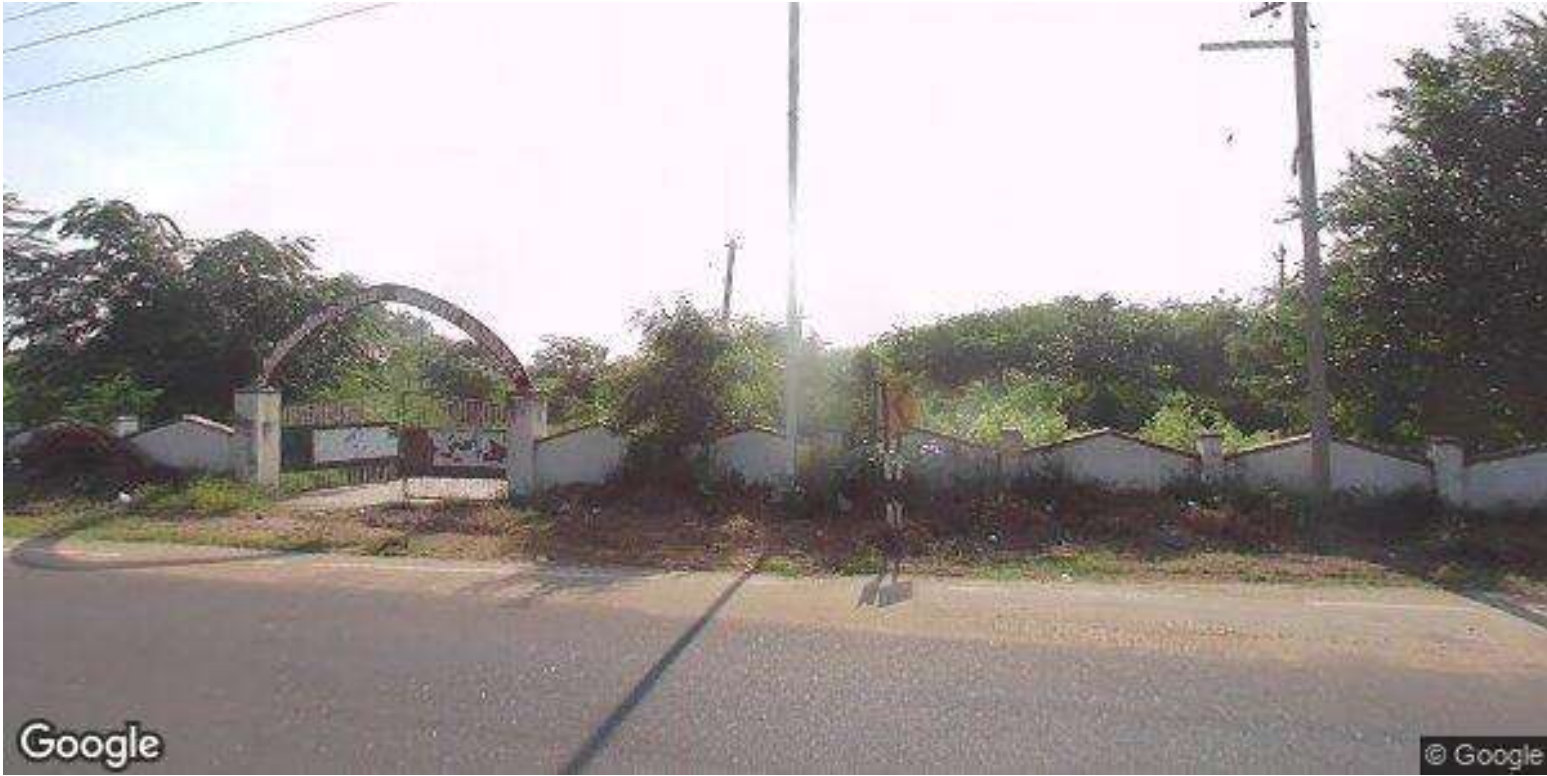
**Risk Type:** Turn  
**Risk Level:** Medium  
**Speed Limit:** 30 KM/Hr  
**Coordinates:** 10.81215, 77.78718

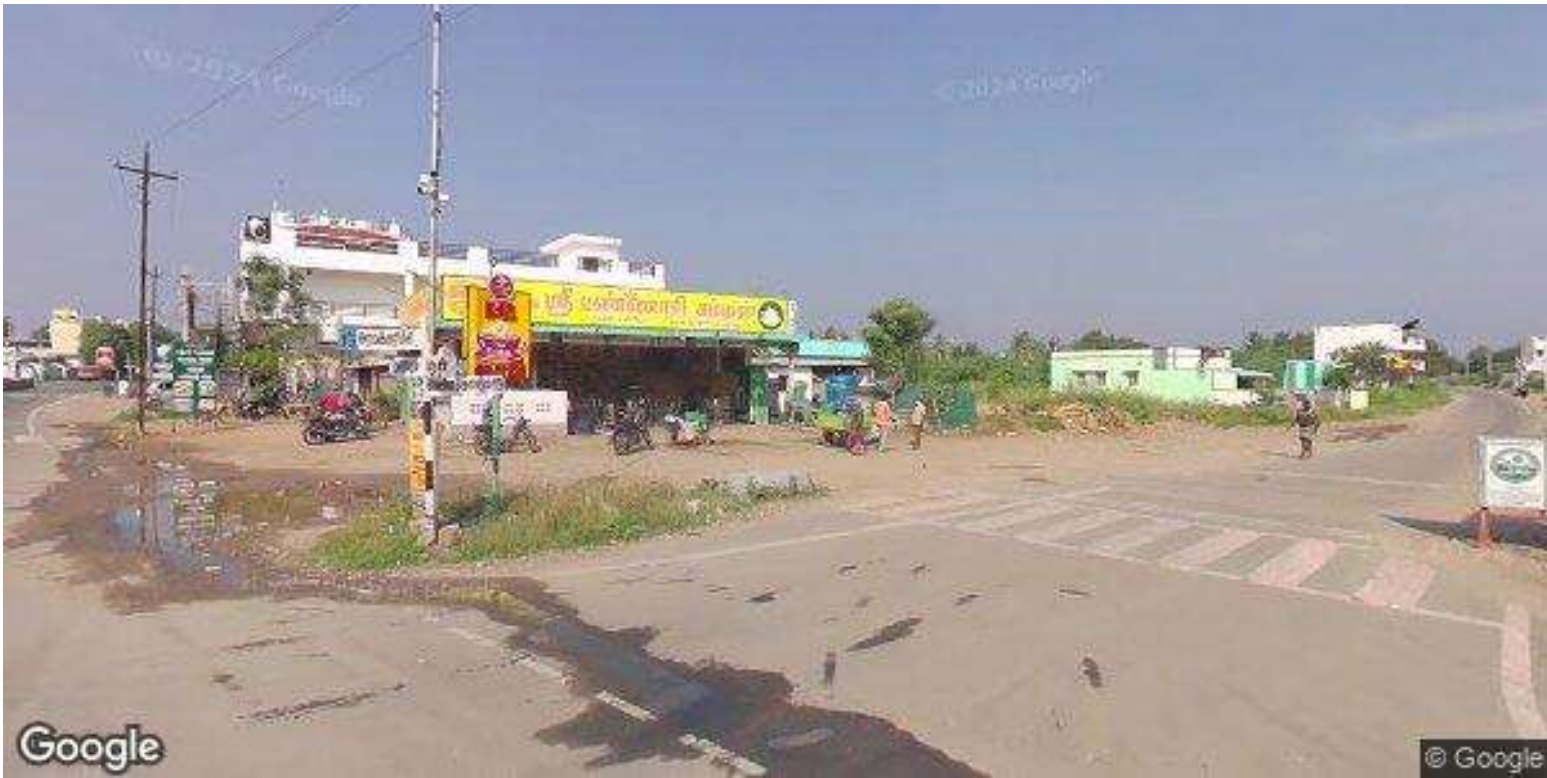
**Risk Type:** Turn

**Risk Level:** High

**Speed Limit:** 15 KM/Hr

**Coordinates:** 10.81177, 77.78603
