## **JOURNEY RISK MANAGEMENT (JRM) STUDY**

### **Salem Terminal To SRI CHELLANDI AMMAN AGENCIES**

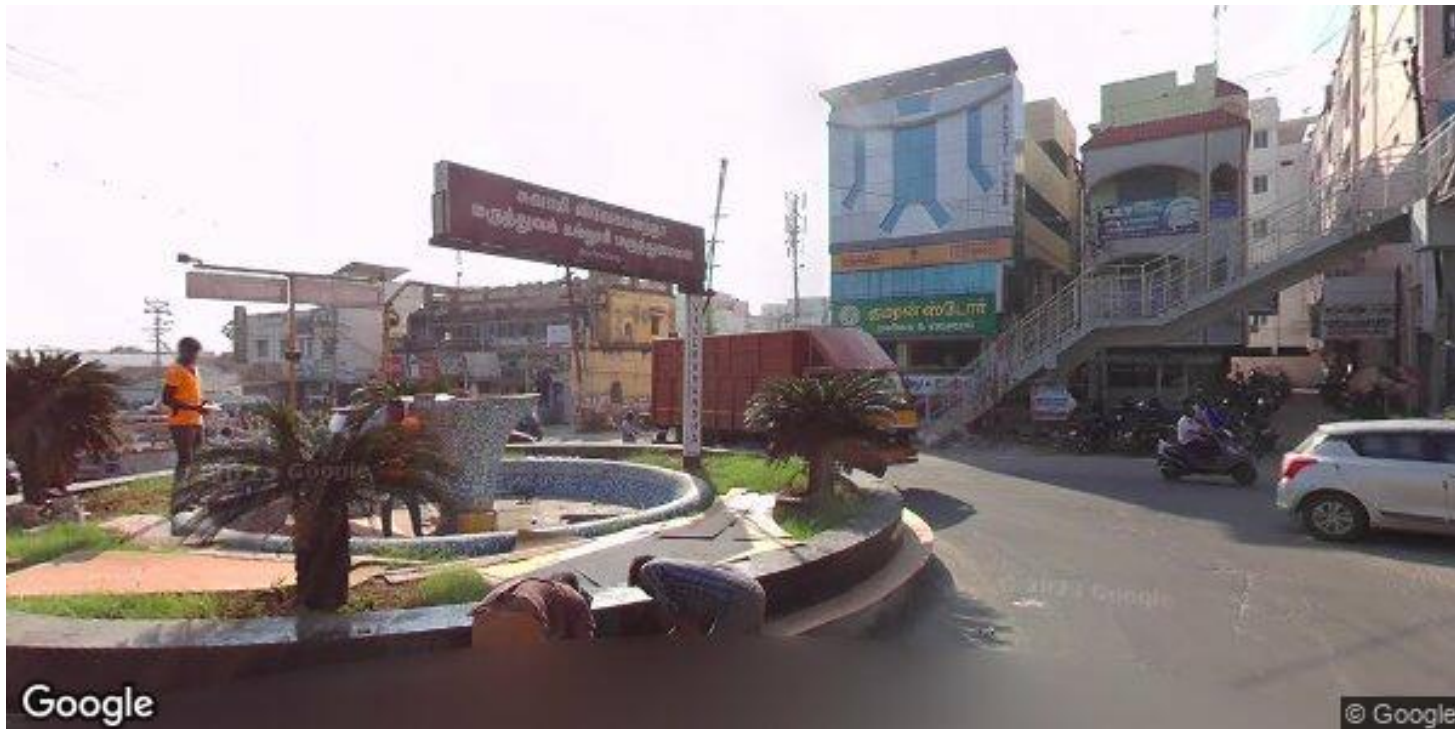
**Coordinates:** 11.38395, 77.89480

**Risk Type:** Roundabout

**Risk Level:** High

**Speed Limit:** 15 KM/Hr

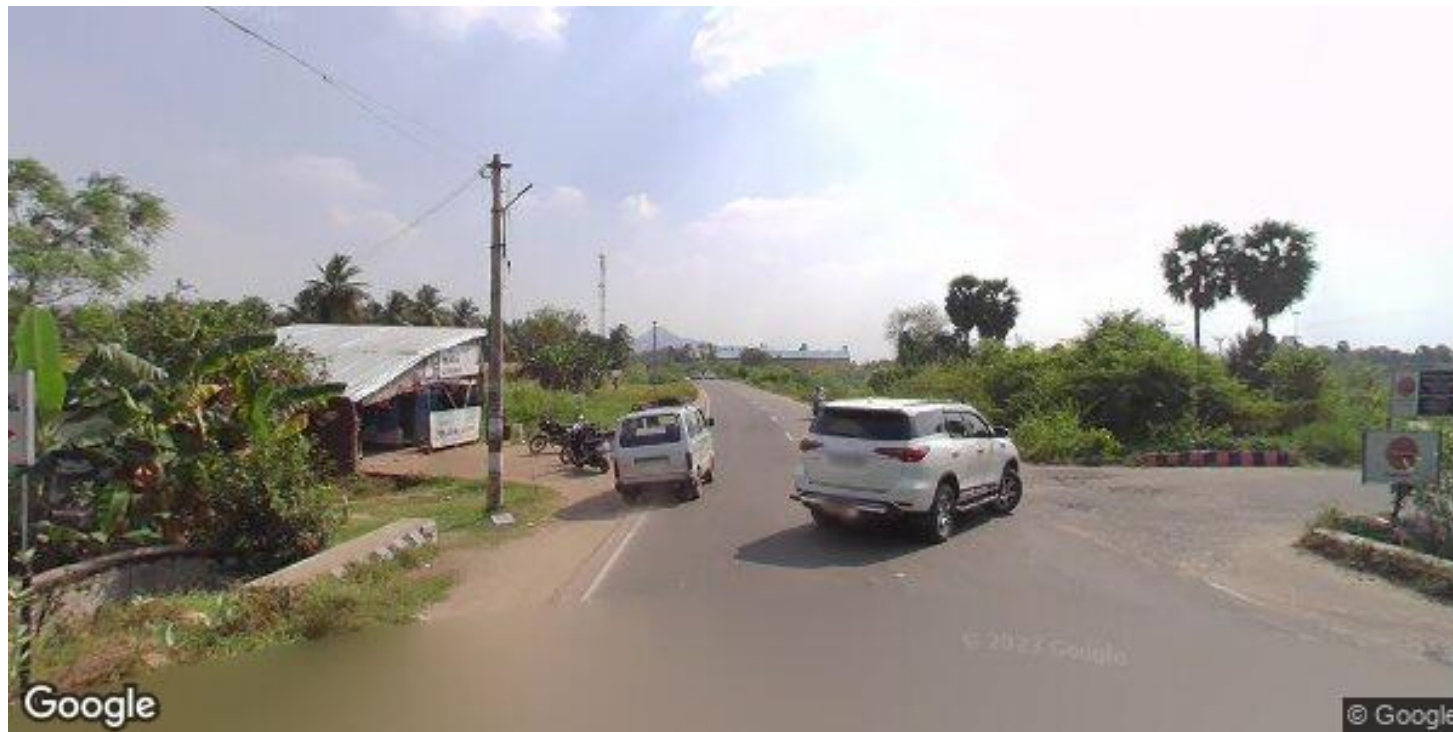
**Coordinates:** 11.44029, 77.87544

**Risk Type:** Blind Spot

**Risk Level:** Blind Spot

**Speed Limit:** 10 KM/Hr

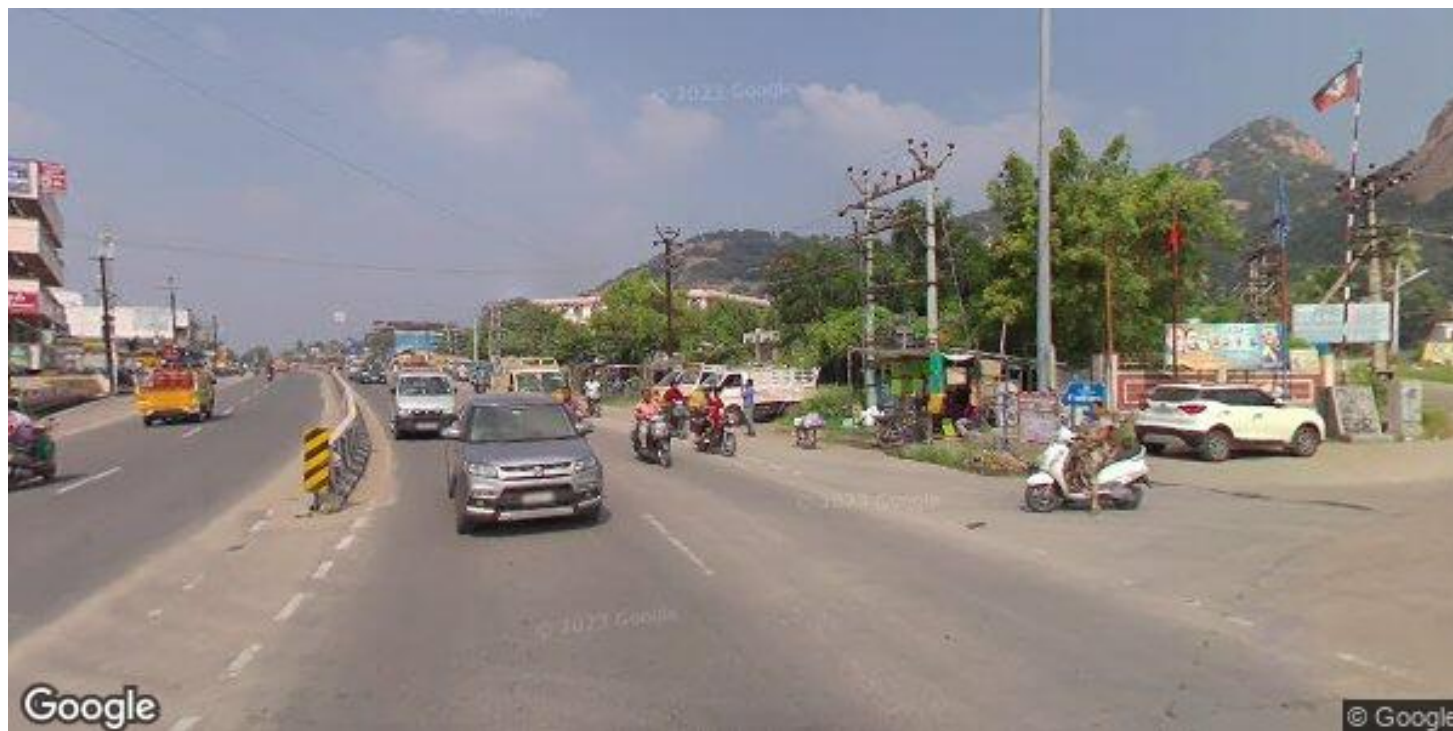
**Coordinates:** 11.39671, 77.88878

**Risk Type:** Turn

**Risk Level:** Medium

**Speed Limit:** 30 KM/Hr

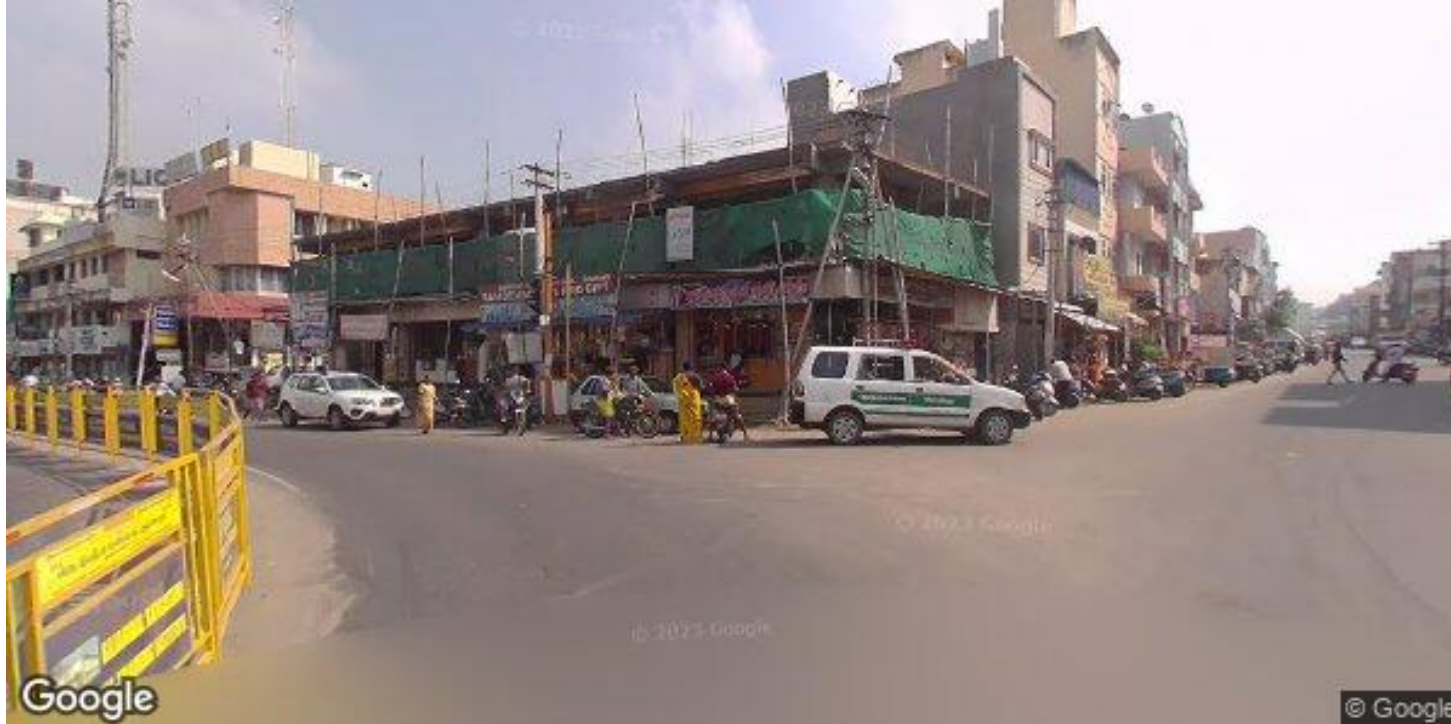
Coordinates: 11.37868, 77.89498

Risk Type: Turn

Risk Level: High

Speed Limit: 15 KM/Hr

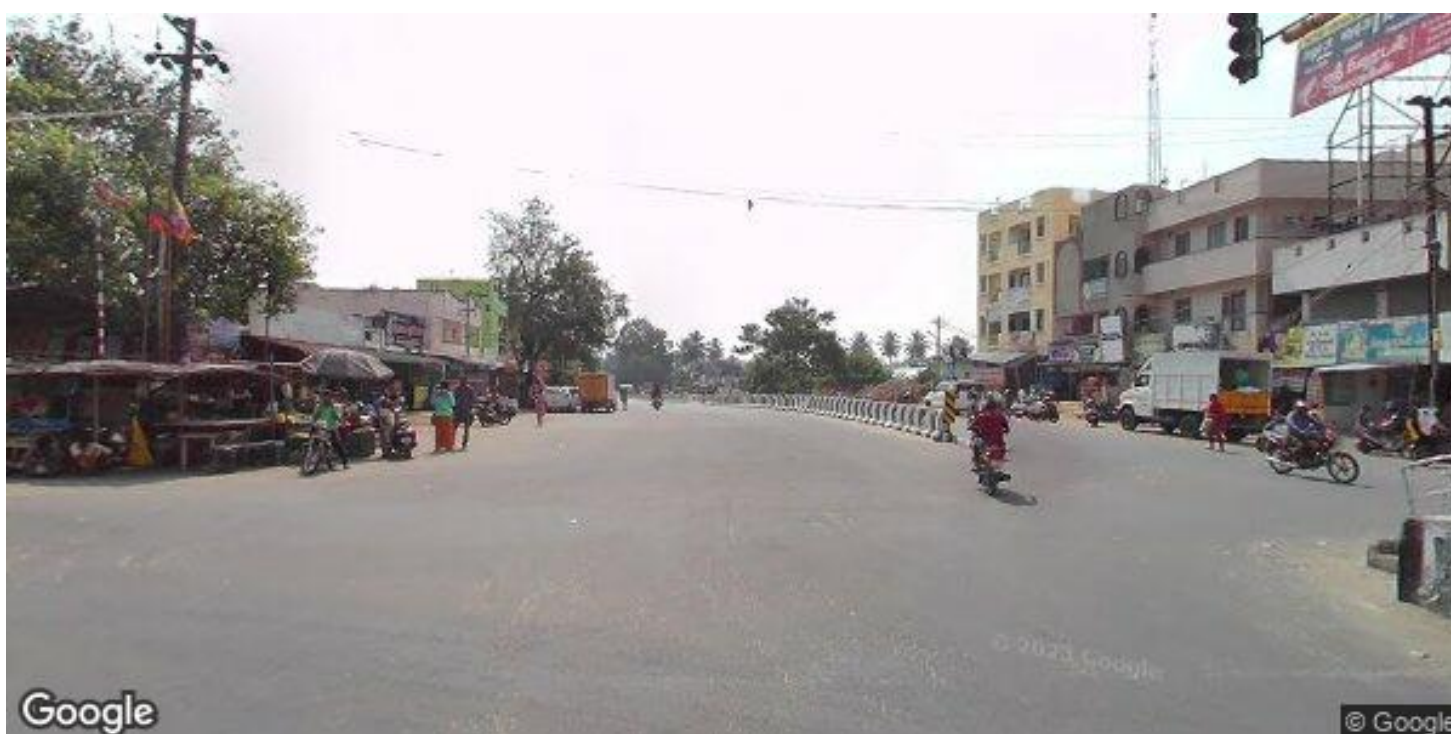
**Coordinates: 11.36604, 77.88887**

Risk Type: Turn

Risk Level: High

**Speed Limit: 15 KM/Hr**

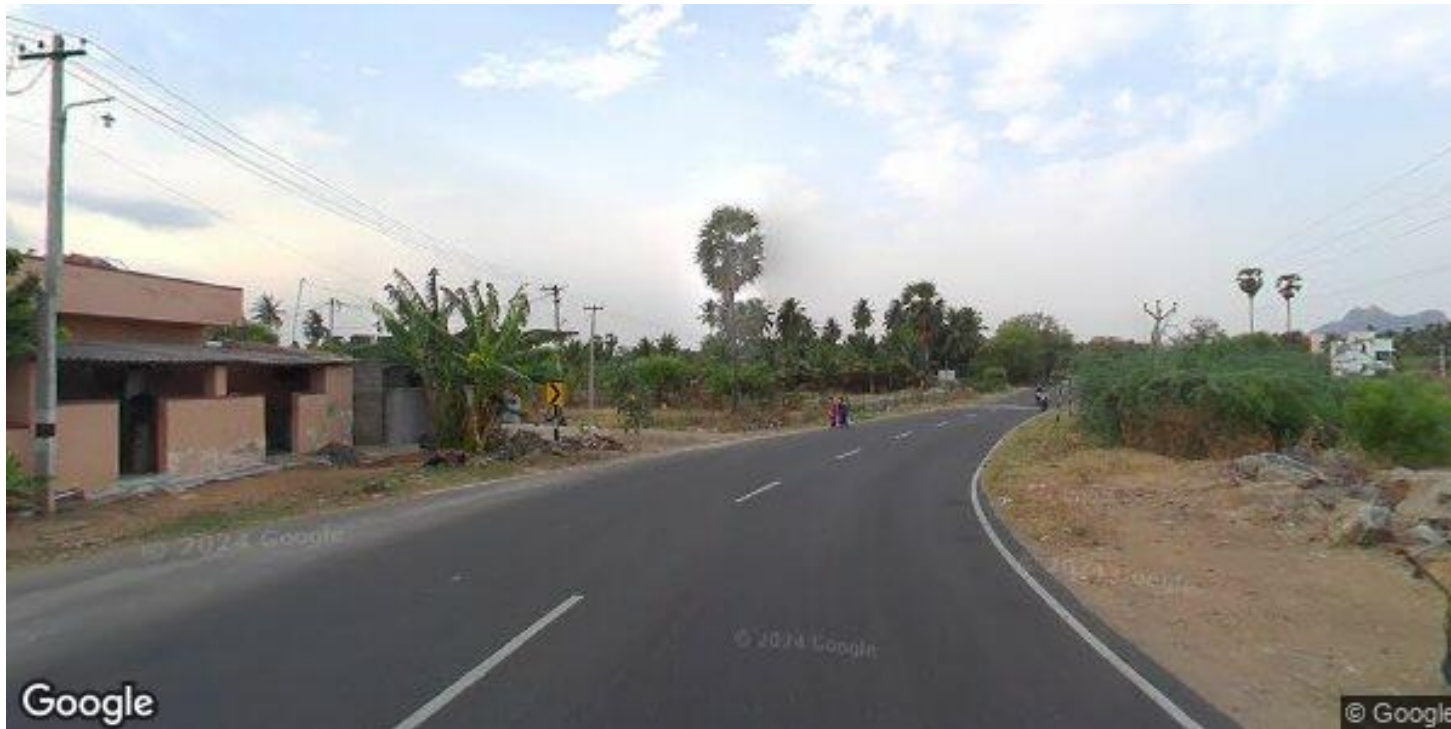
**Coordinates: 11.33882, 77.86218**

**Risk Type: Turn**

**Risk Level: Medium**

**Speed Limit: 30 KM/Hr**

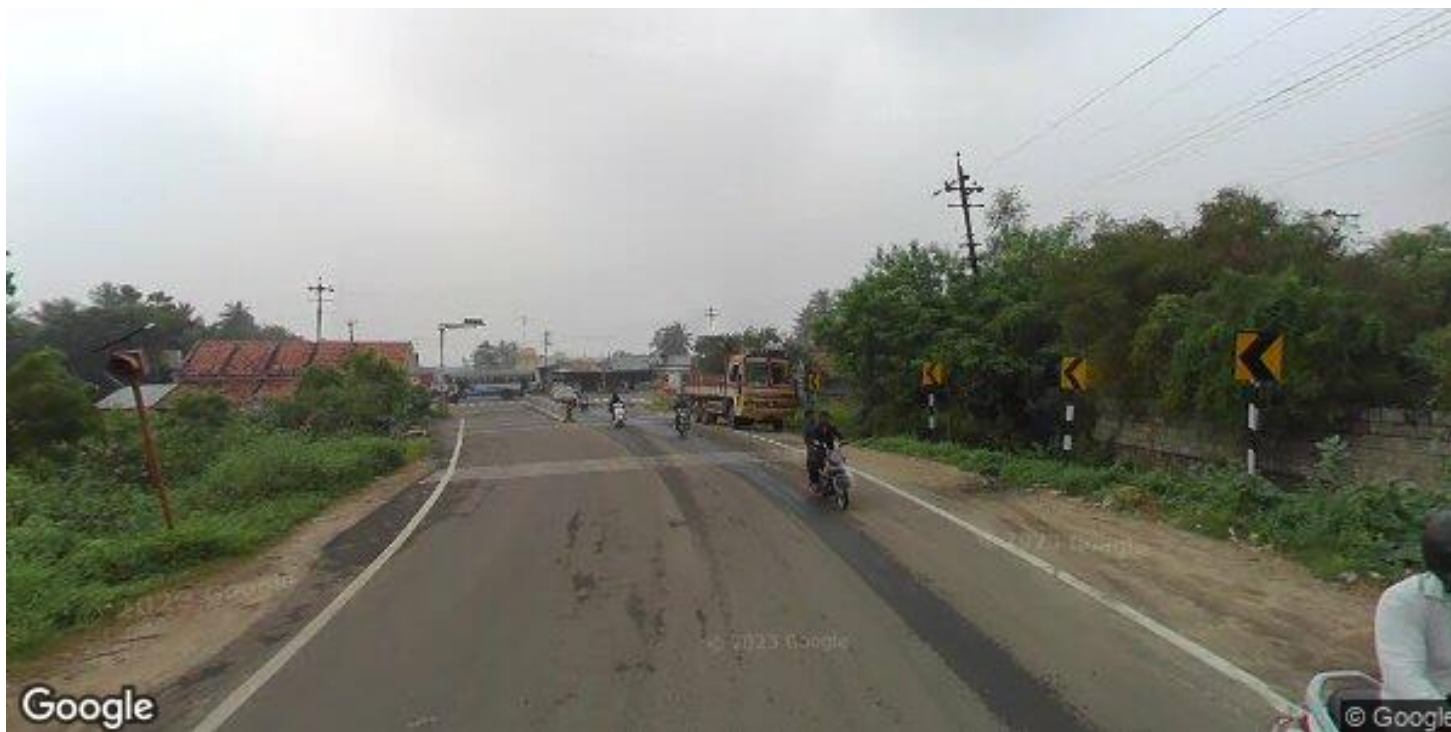
**Coordinates: 11.30970, 77.76705**

**Risk Type: Turn**

**Risk Level: Medium**

**Speed Limit: 30 KM/Hr**

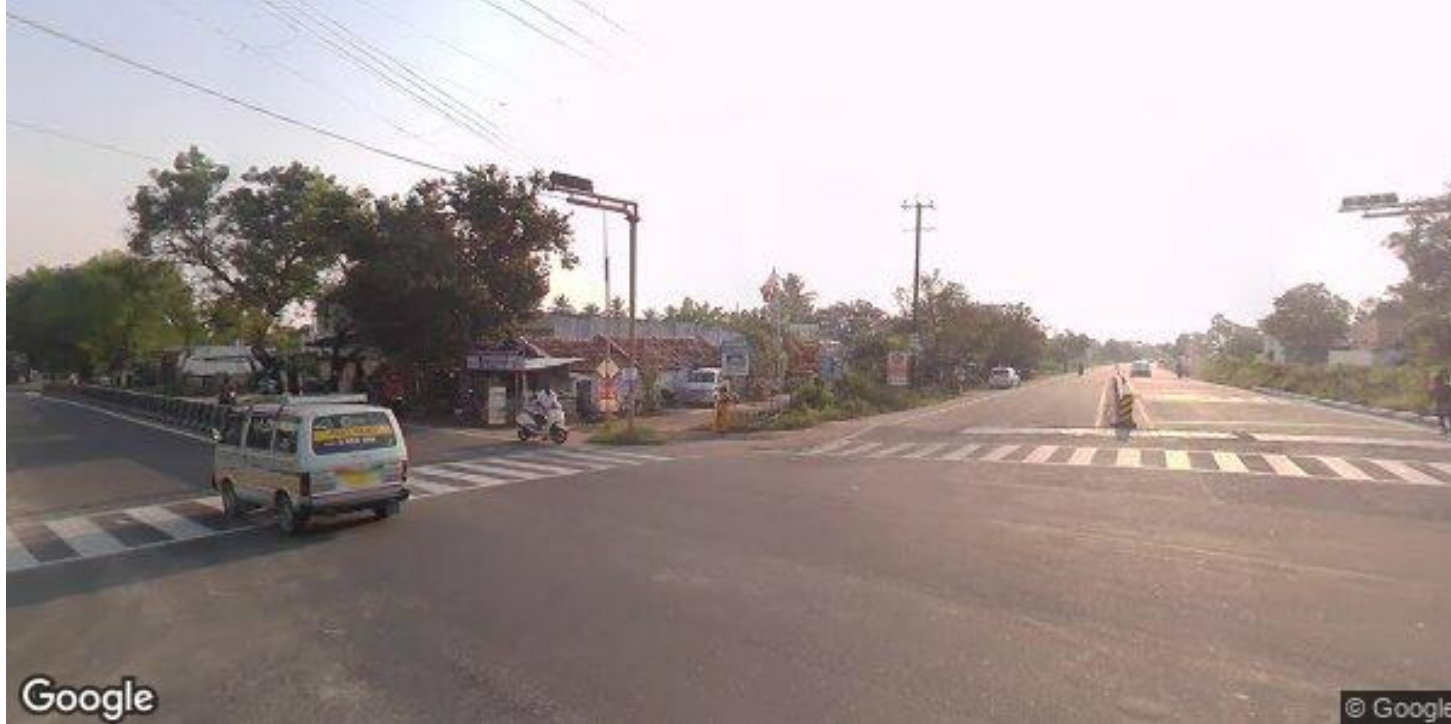
**Risk Type:** Turn  
**Risk Level:** High  
**Speed Limit:** 15 KM/Hr  
**Coordinates:** 11.29899, 77.75806

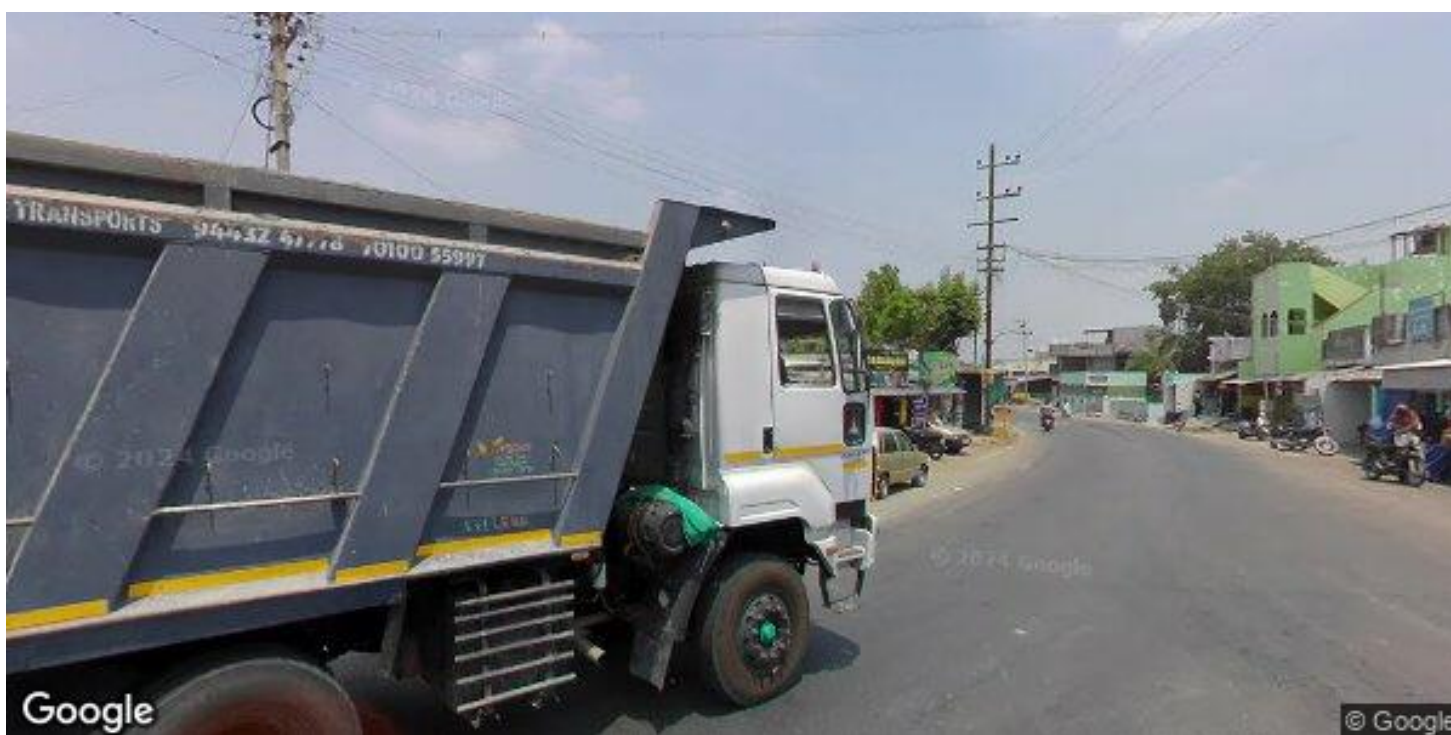
**Risk Type:** Turn  
**Risk Level:** Medium  
**Speed Limit:** 30 KM/Hr  
**Coordinates:** 11.18959, 77.77076

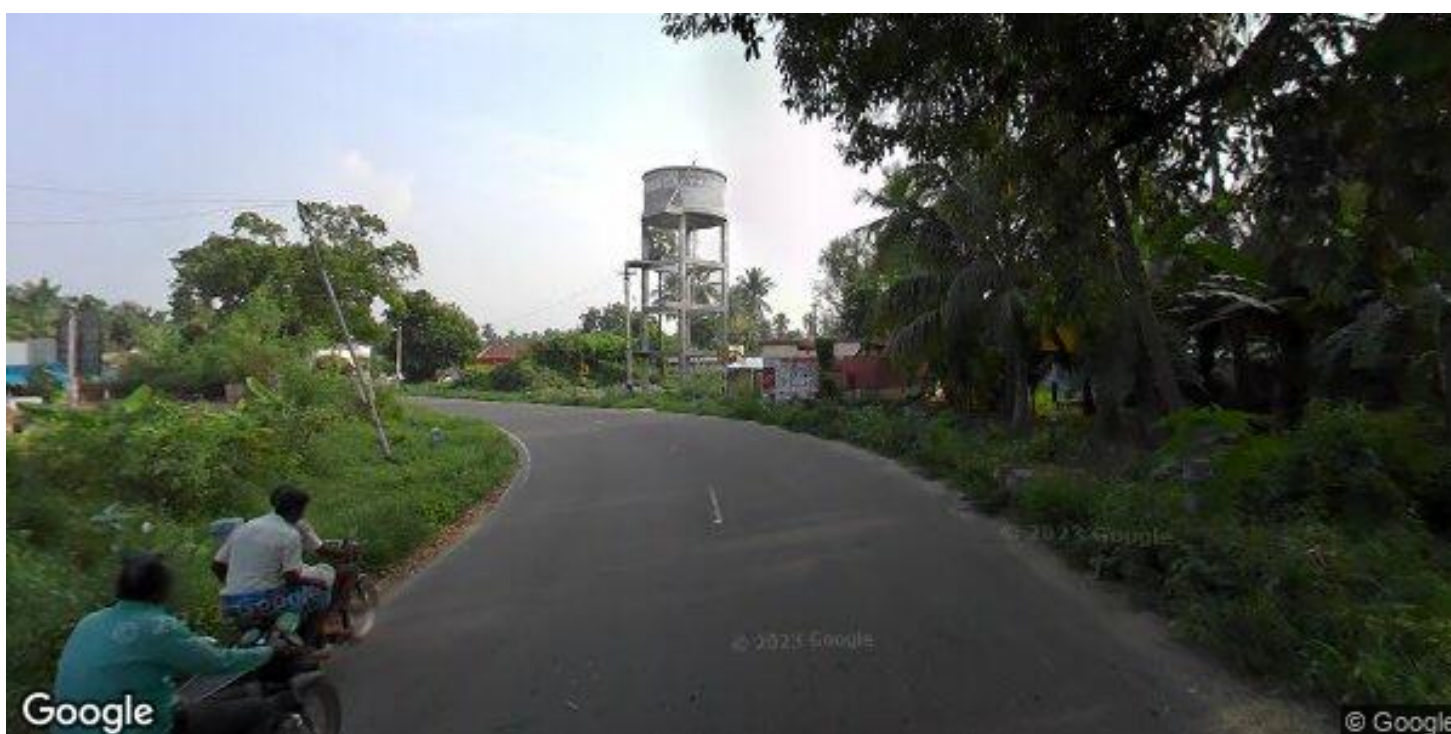
Coordinates: 11.16421, 77.77364

**Risk Type:** Turn  
**Risk Level:** Medium

Speed Limit: 30 KM/Hr

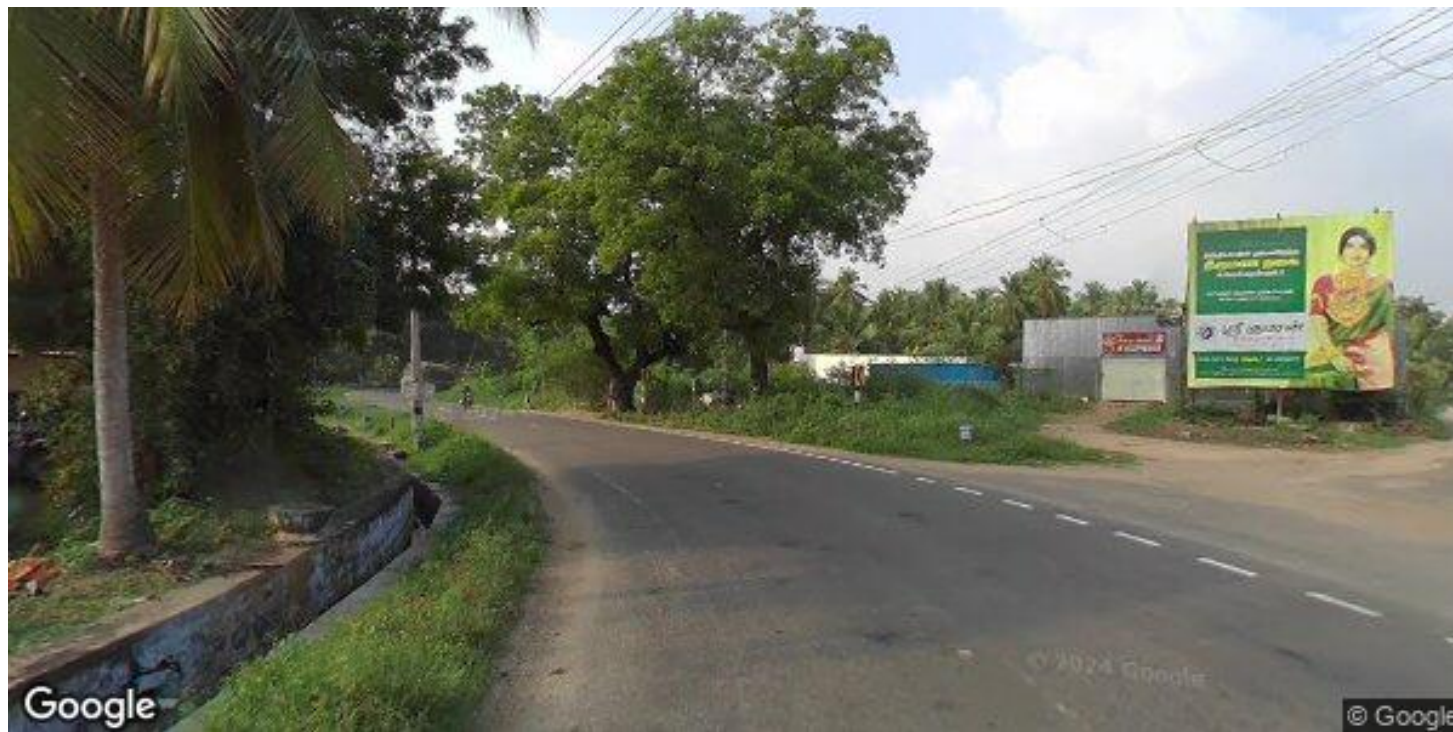
Coordinates: 11.16357, 77.77434

Risk Type: Turn

Risk Level: Medium

Speed Limit: 30 KM/Hr

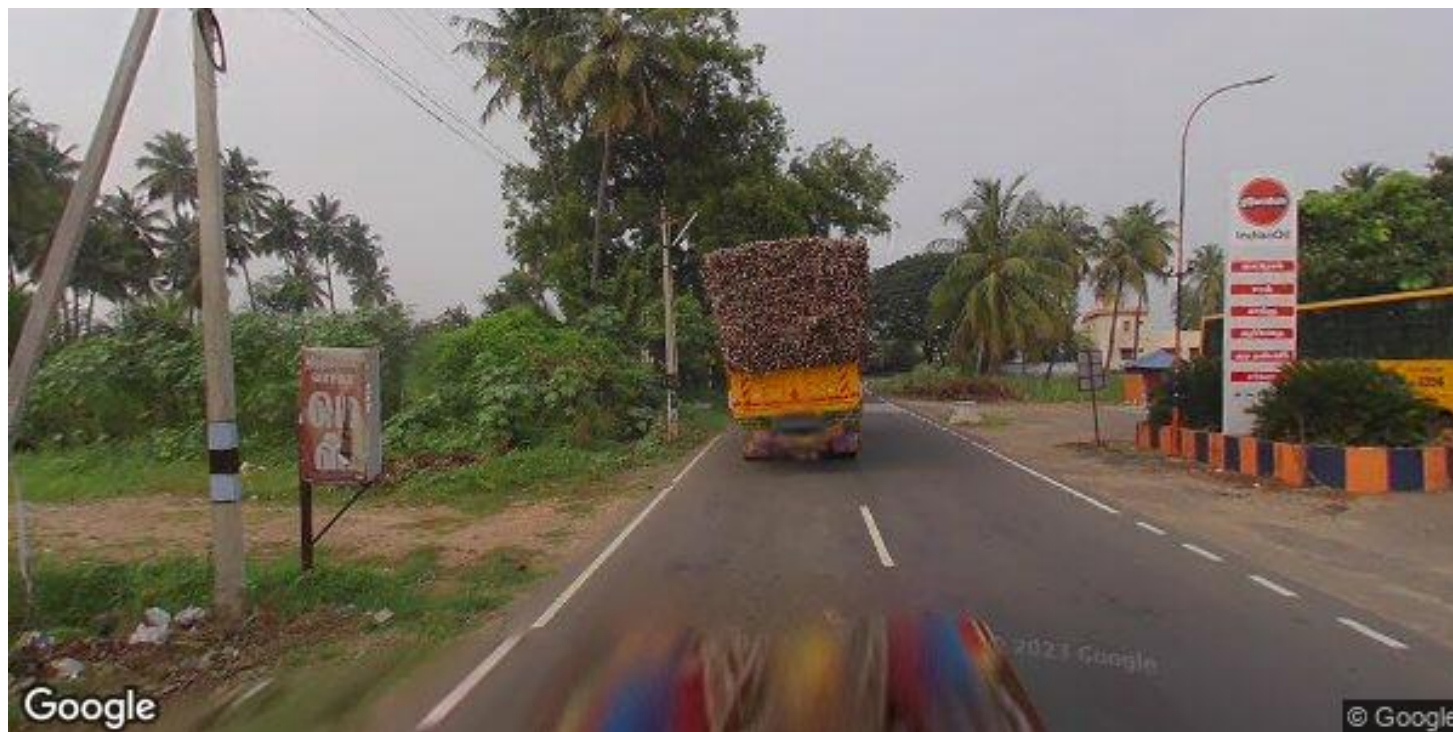
Coordinates: 11.11427, 77.75261

Risk Type: Blind Spot

Risk Level: Blind Spot

Speed Limit: 10 KM/Hr

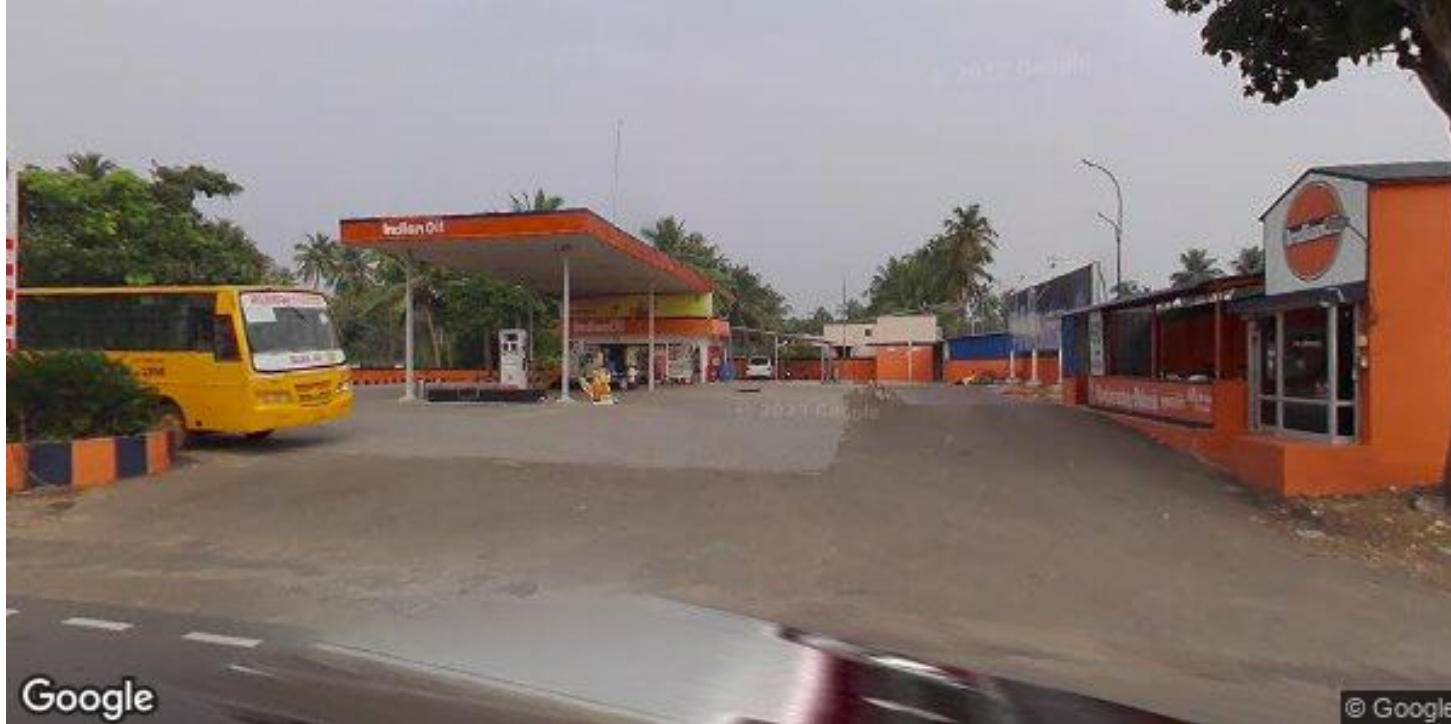
**Coordinates:** 11.11424, 77.75282

**Risk Type:** Turn

**Risk Level:** Medium

**Speed Limit:** 30 KM/Hr

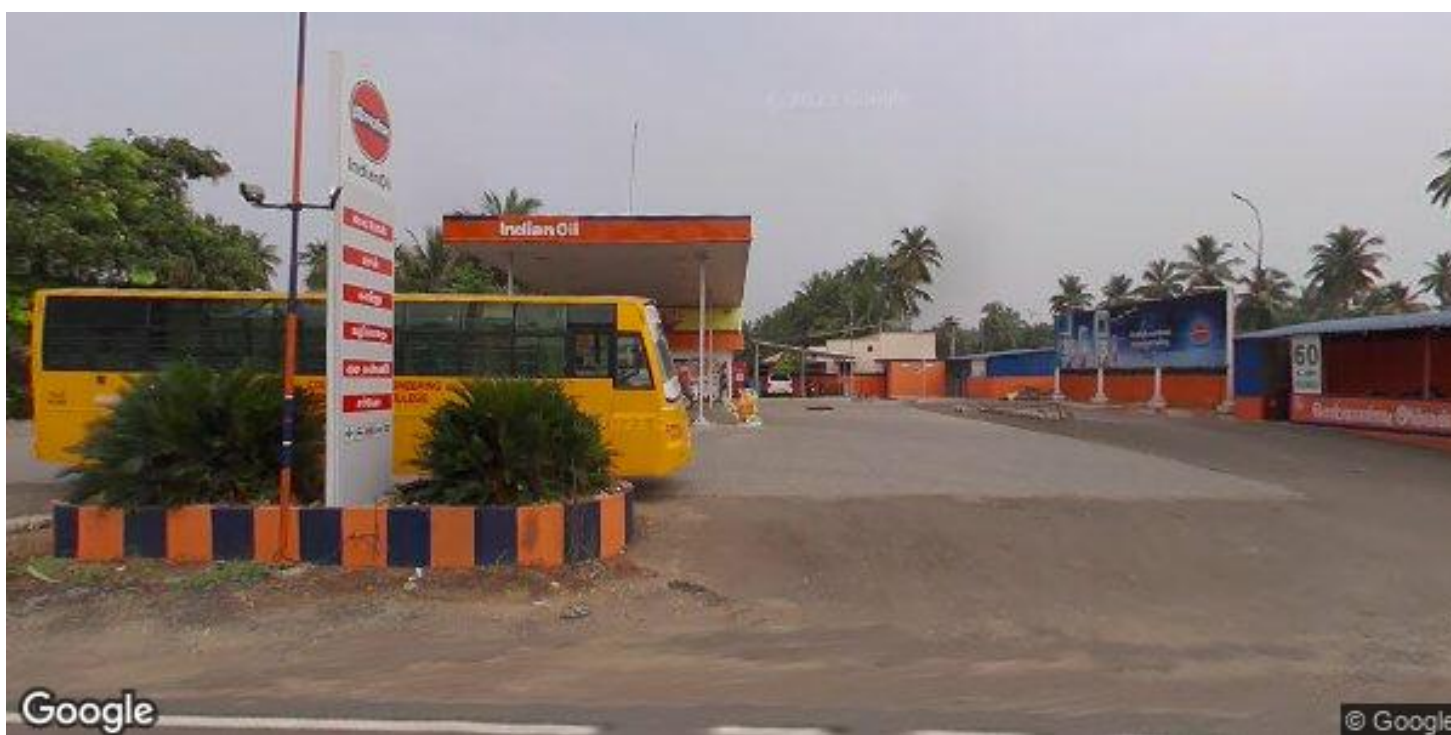
**Coordinates:** 11.11428, 77.75288

**Risk Type:** Turn

**Risk Level:** High

**Speed Limit:** 15 KM/Hr
