## JOURNEY RISK MANAGEMENT (JRM) STUDY

### Salem Terminal TO PALKARAR K. PONNU AGENCIES

**Route Analysis from CVQF+23W, Sangagiri to 438R+HQJ, Vallipuram - Palapatti Road**

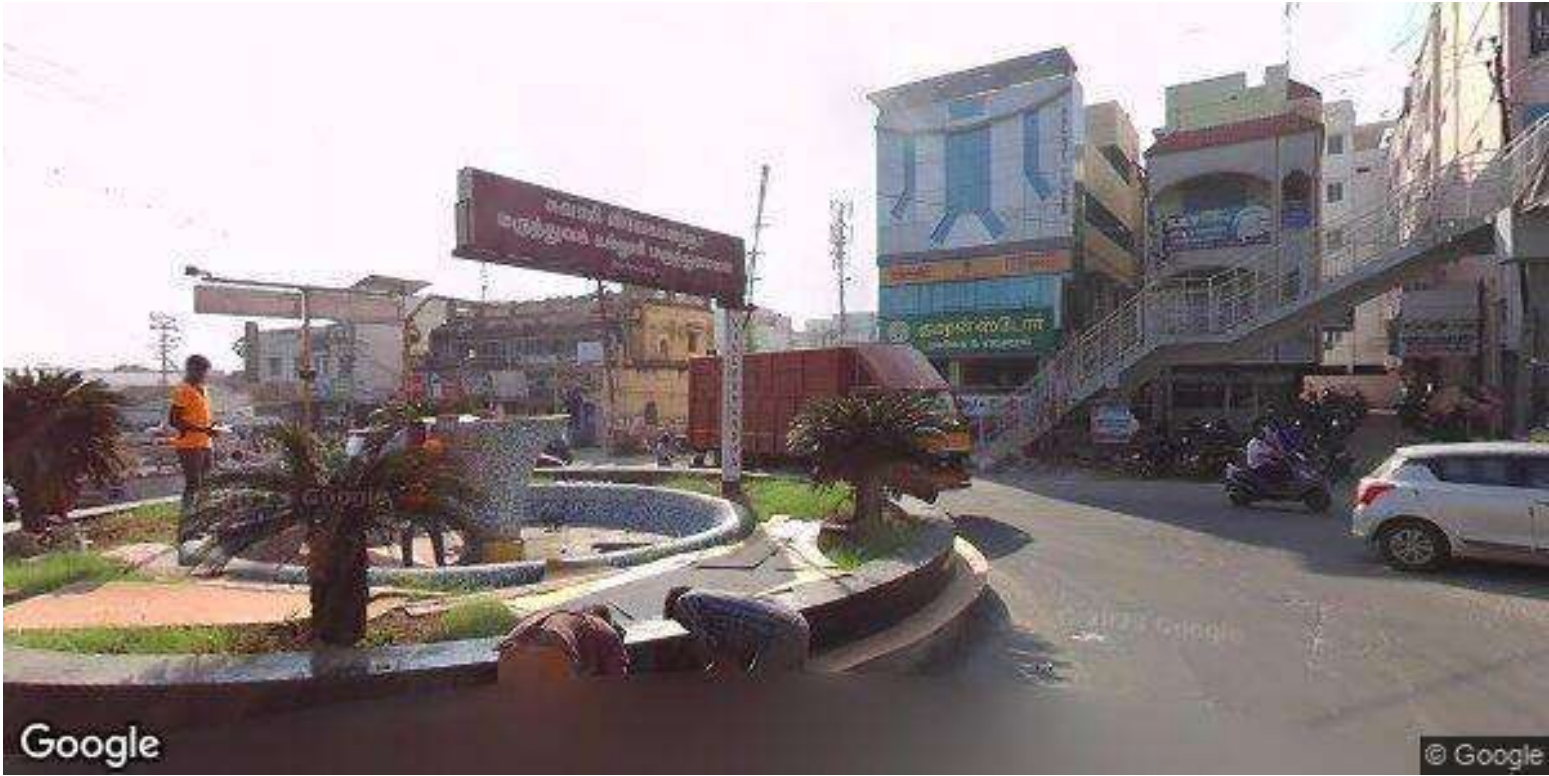
Coordinates: 11.38395, 77.89480

Risk Type: Roundabout

Risk Level: High

Speed Limit: 15 KM/Hr

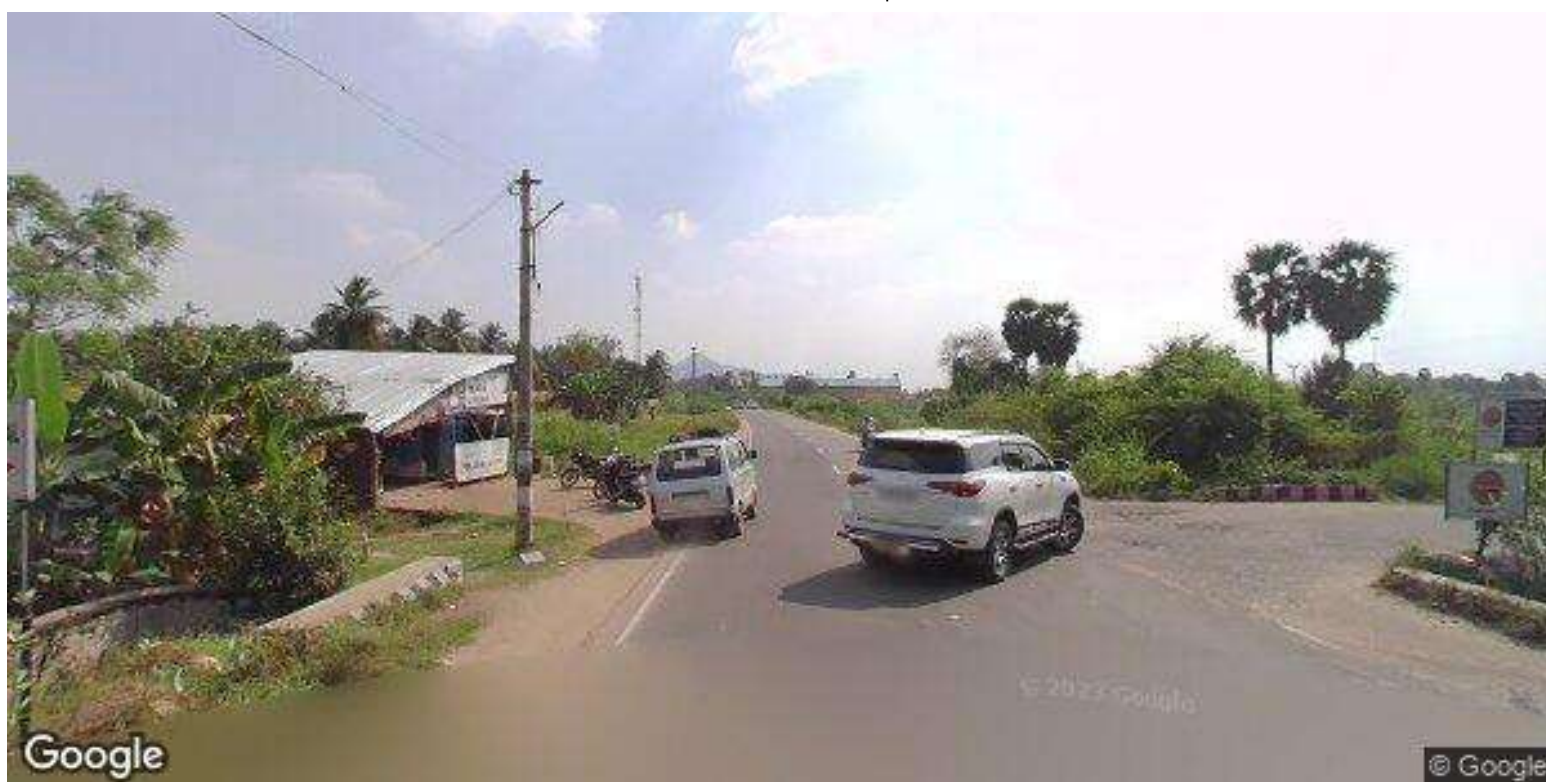
**Coordinates:** 11.44029, 77.87544

**Risk Type:** Blind Spot

**Risk Level:** Blind Spot

**Speed Limit:** 10 KM/Hr

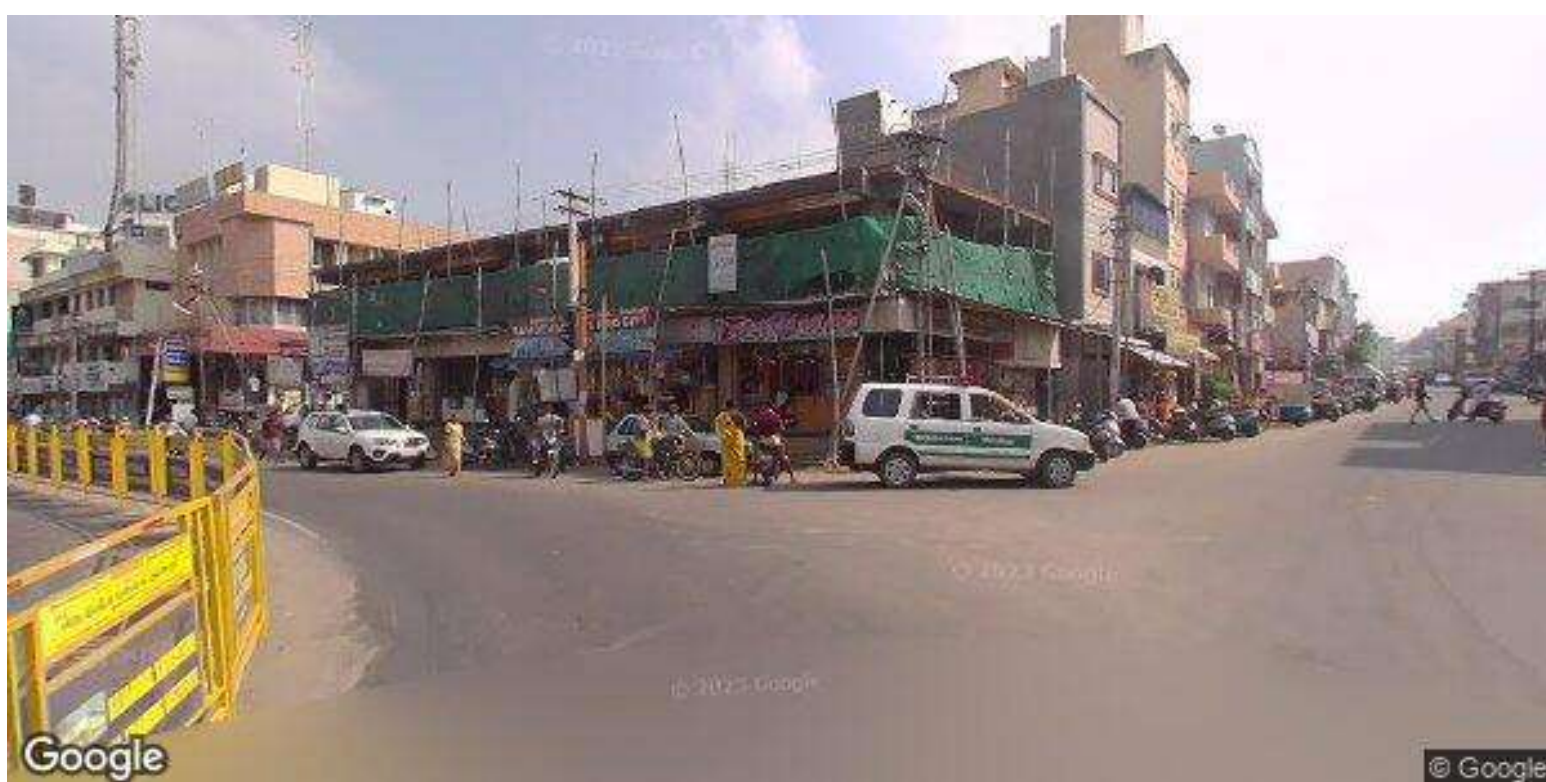
**Coordinates:** 11.37868, 77.89498

**Risk Type:** Turn

**Risk Level:** High

**Speed Limit:** 15 KM/Hr

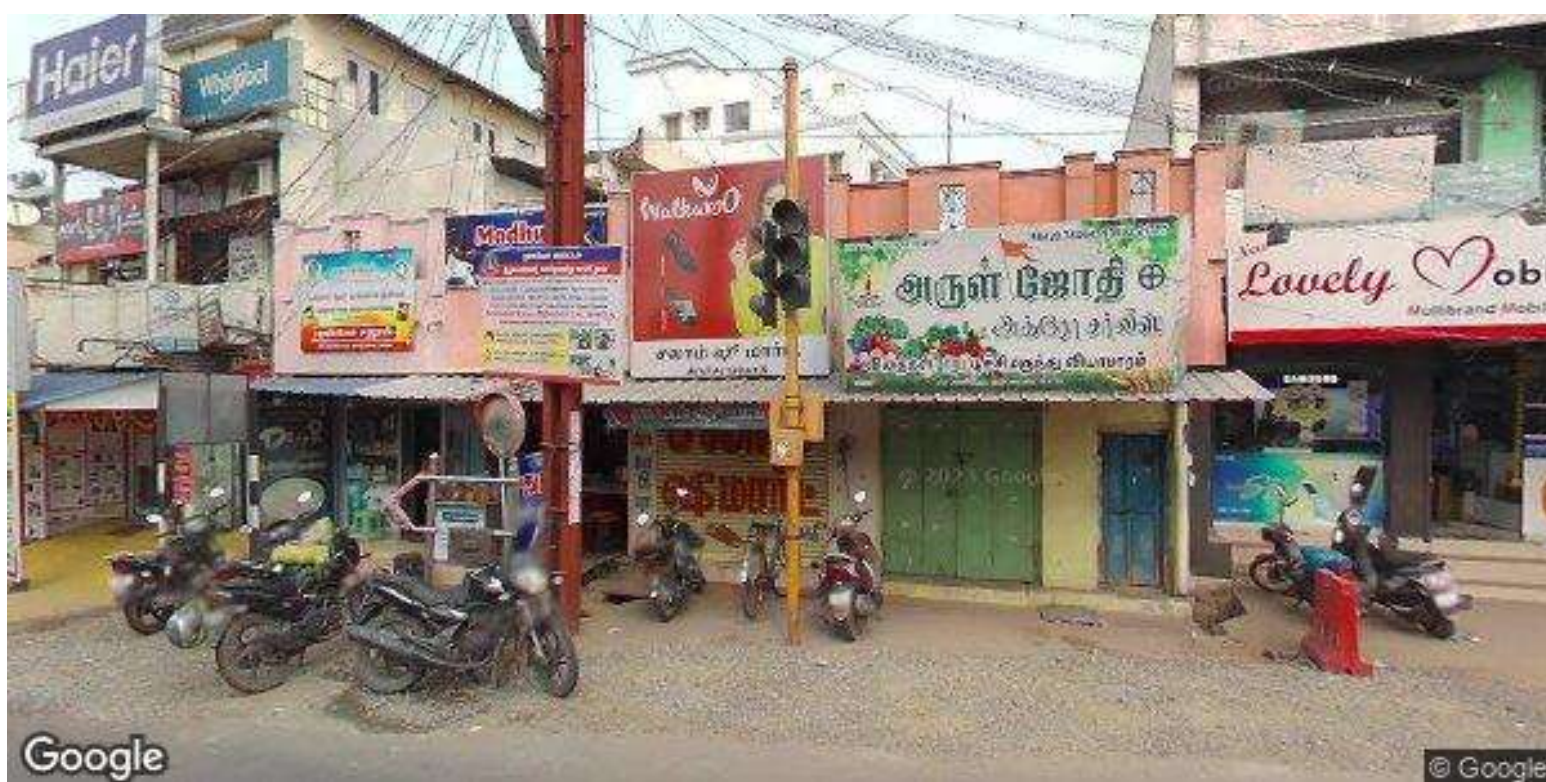
**Risk Type:** Turn  
**Risk Level:** High  
**Speed Limit:** 15 KM/Hr  
**Coordinates:** 11.37850, 77.89453

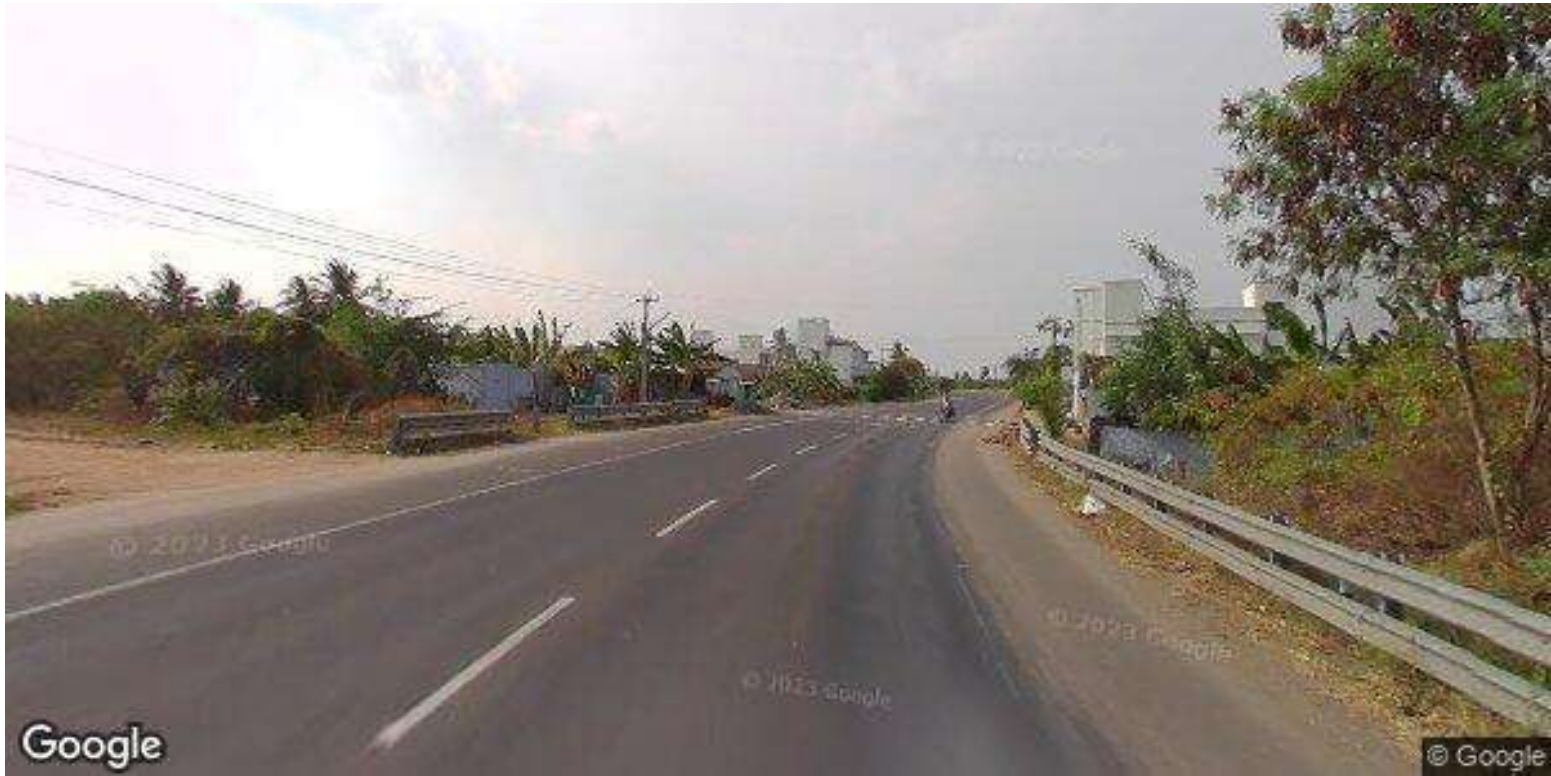
**Risk Type:** Turn  
**Risk Level:** Medium  
**Speed Limit:** 30 KM/Hr  
**Coordinates:** 11.16764, 78.01565

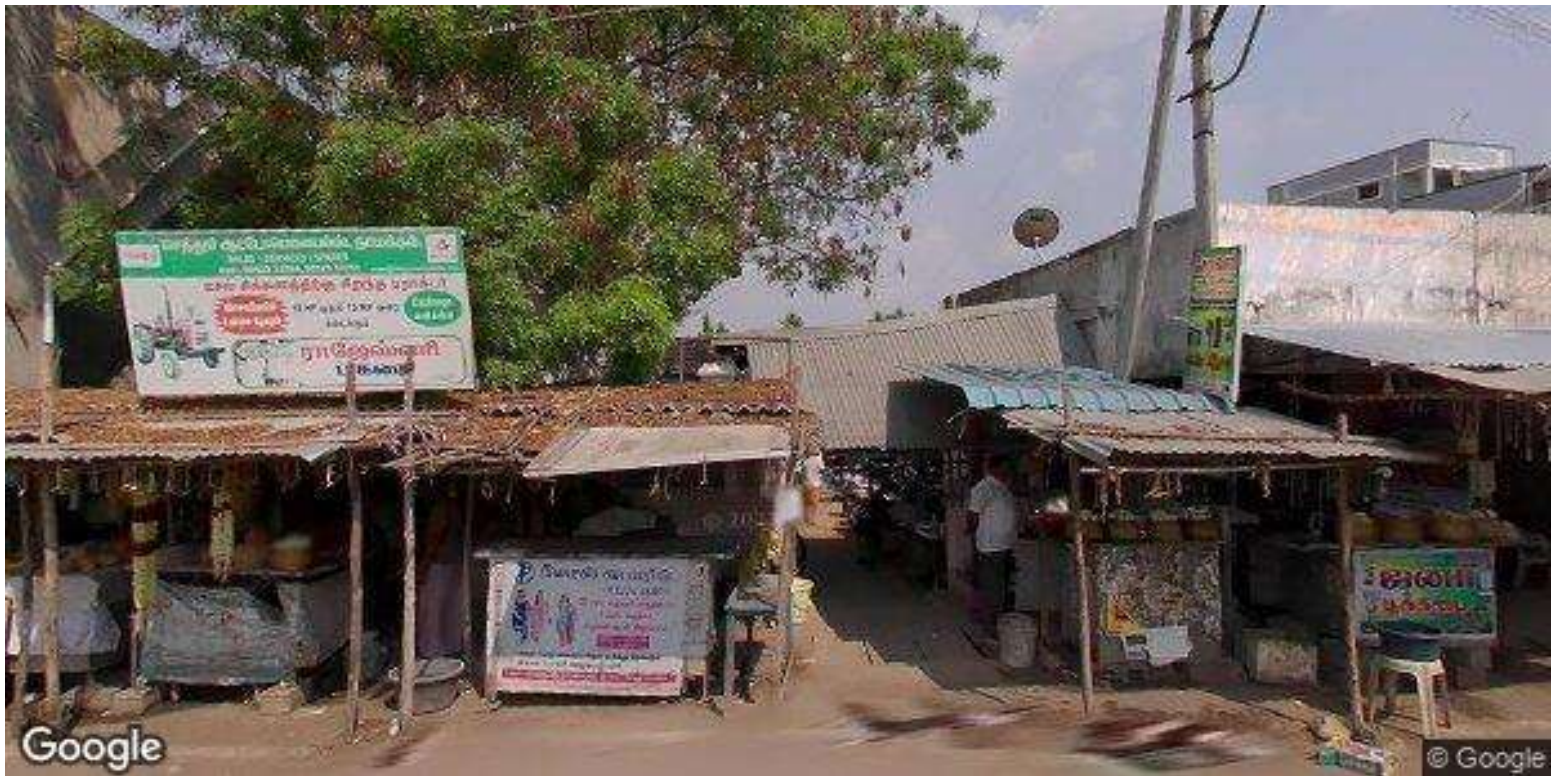
**Risk Type:** Blind Spot  
**Risk Level:** Blind Spot  
**Speed Limit:** 10 KM/Hr  
**Coordinates:** 11.15573, 78.02176

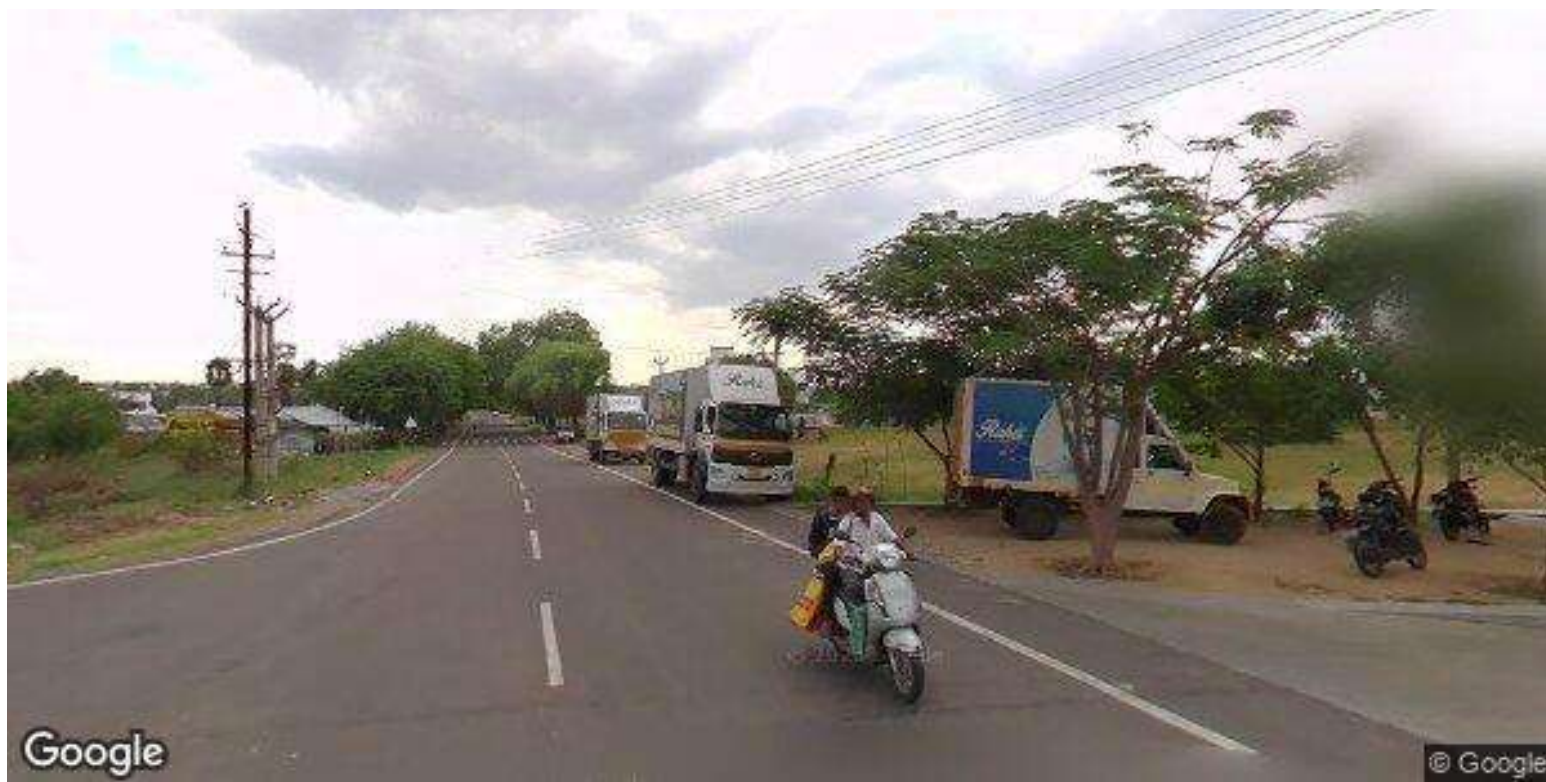
**Coordinates:** 11.16243, 78.02715

**Risk Type:** Turn

**Risk Level:** Medium

**Speed Limit:** 30 KM/Hr

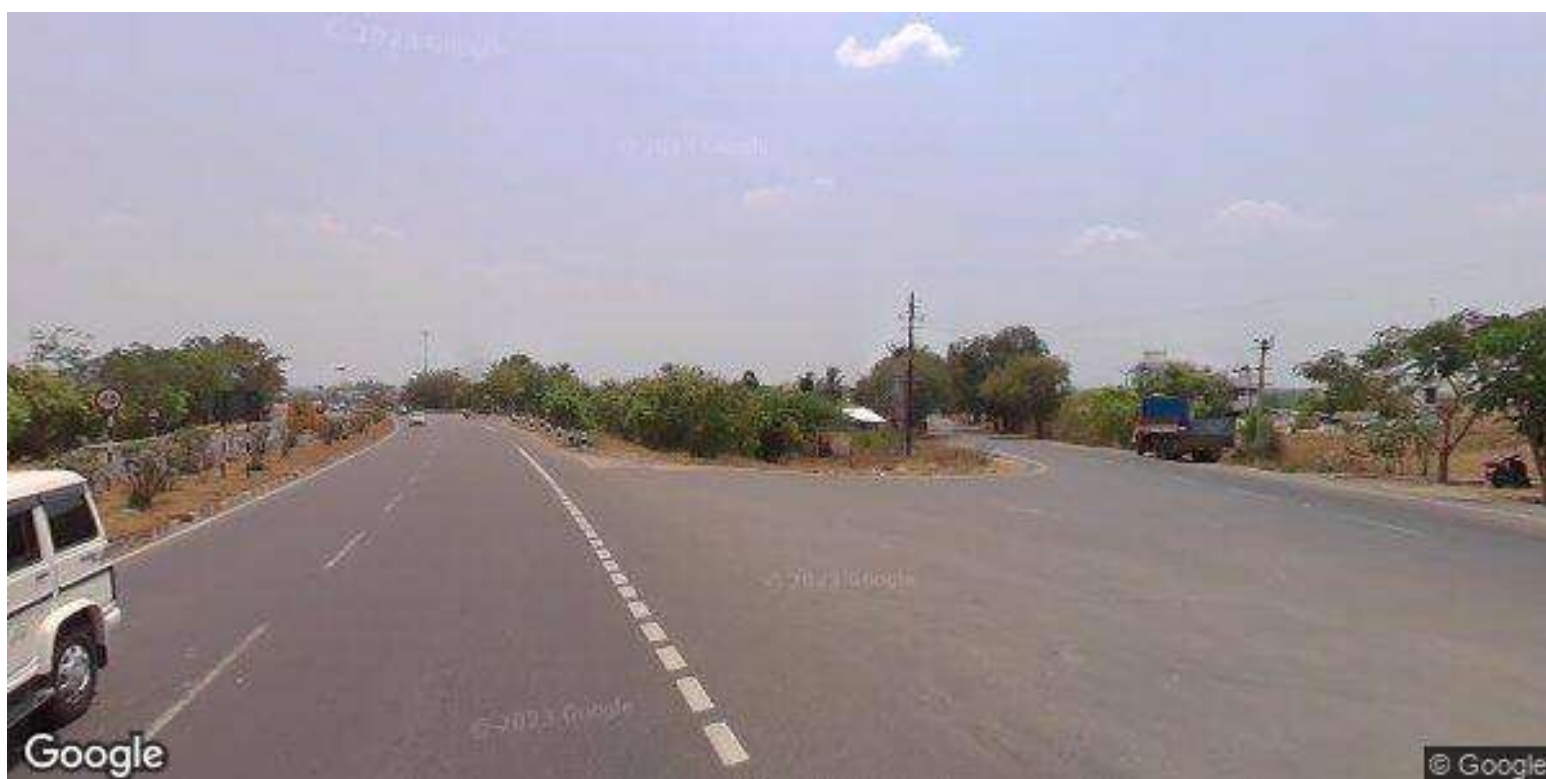
**Coordinates:** 11.16241, 78.02729

**Risk Type:** Turn

**Risk Level:** High

**Speed Limit:** 15 KM/Hr

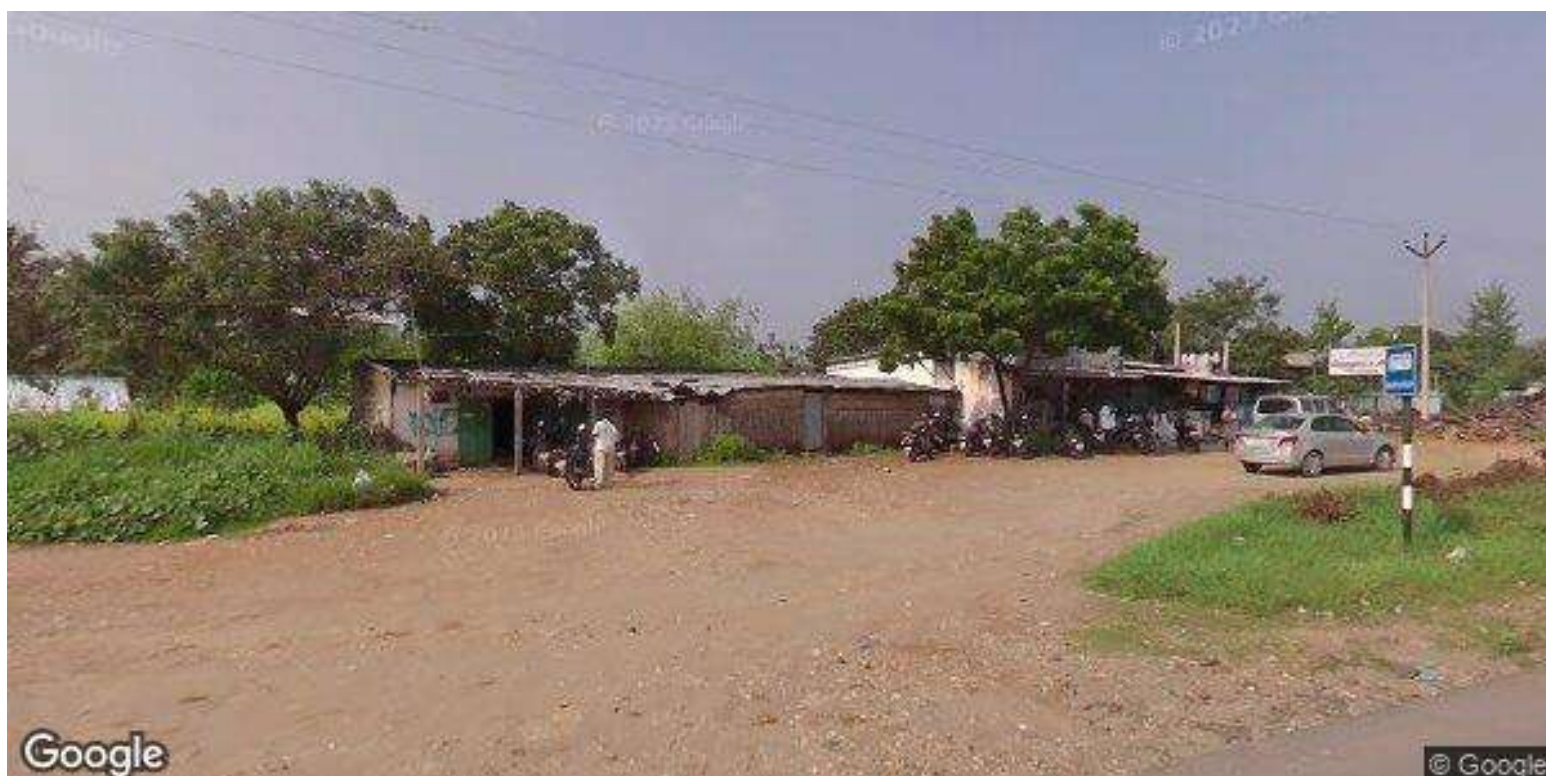
**Risk Type:** Turn  
**Risk Level:** High  
**Speed Limit:** 15 KM/Hr  
**Coordinates:** 11.17605, 78.05538

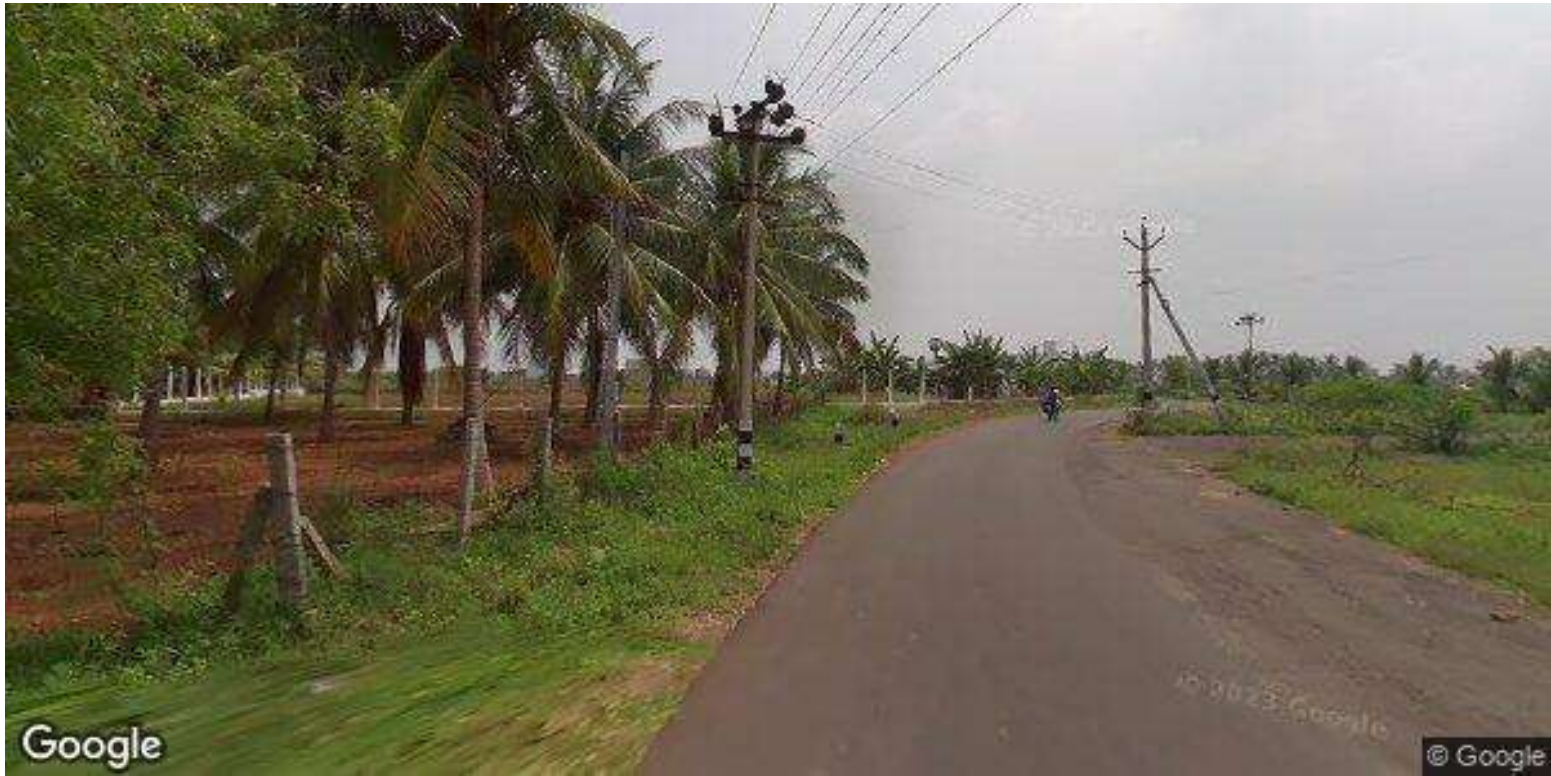
**Risk Type:** Turn  
**Risk Level:** Medium  
**Speed Limit:** 30 KM/Hr  
**Coordinates:** 11.17447, 78.05732

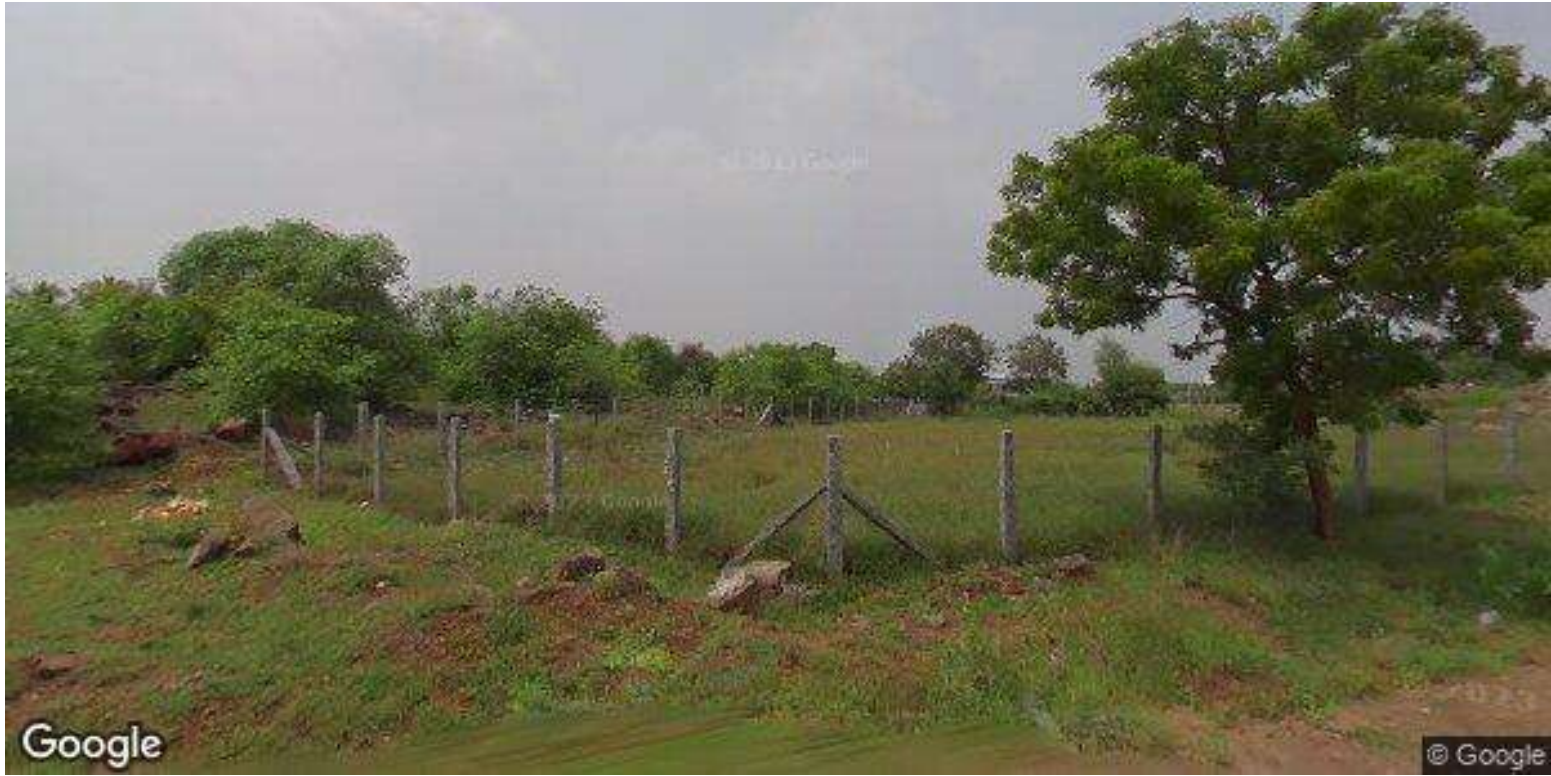
**Risk Type:** Turn  
**Risk Level:** Medium  
**Speed Limit:** 30 KM/Hr  
**Coordinates:** 11.17225, 78.05906

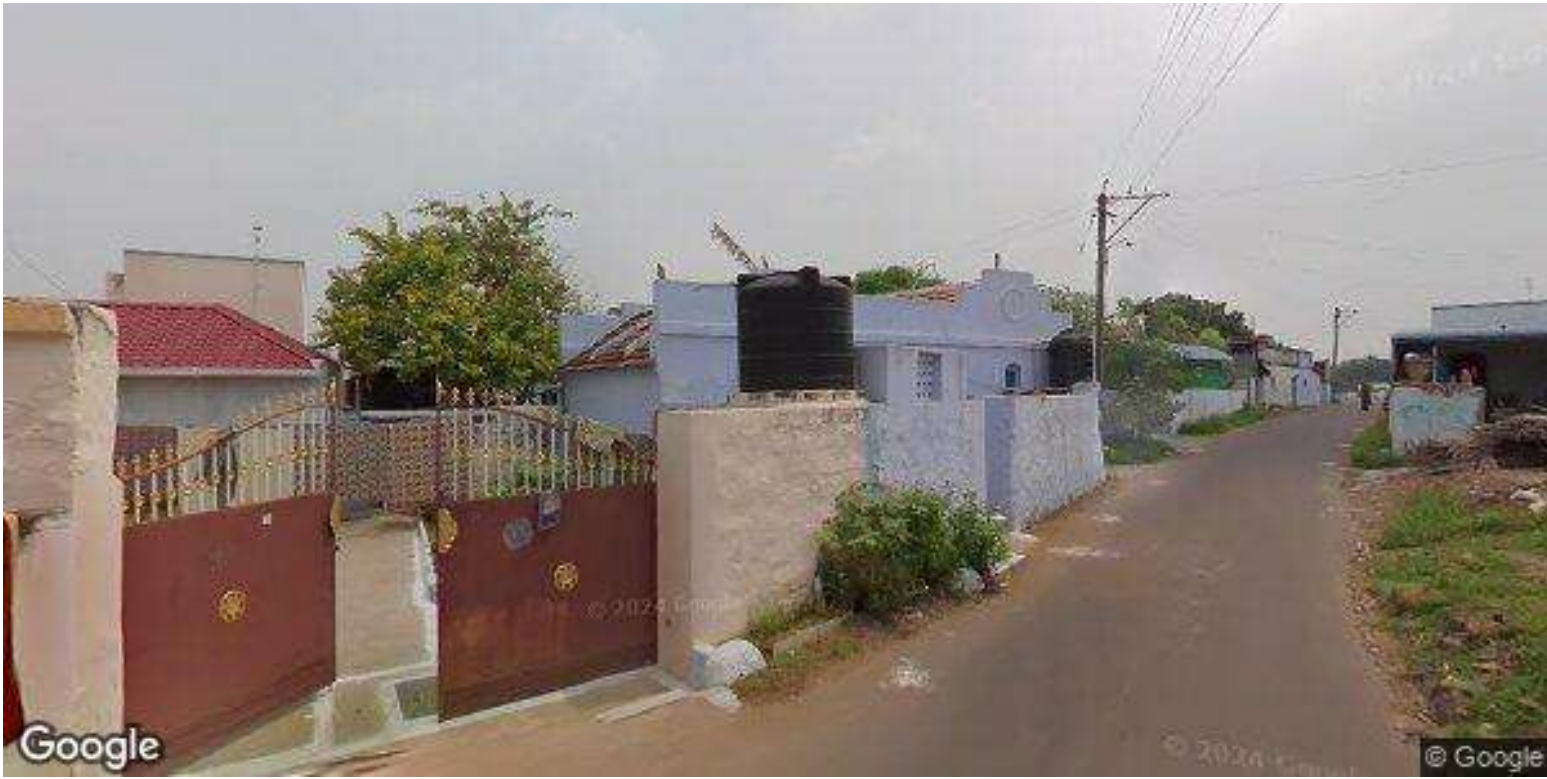
**Risk Type:** Turn  
**Risk Level:** Medium  
**Speed Limit:** 30 KM/Hr  
**Coordinates:** 11.16071, 78.06874

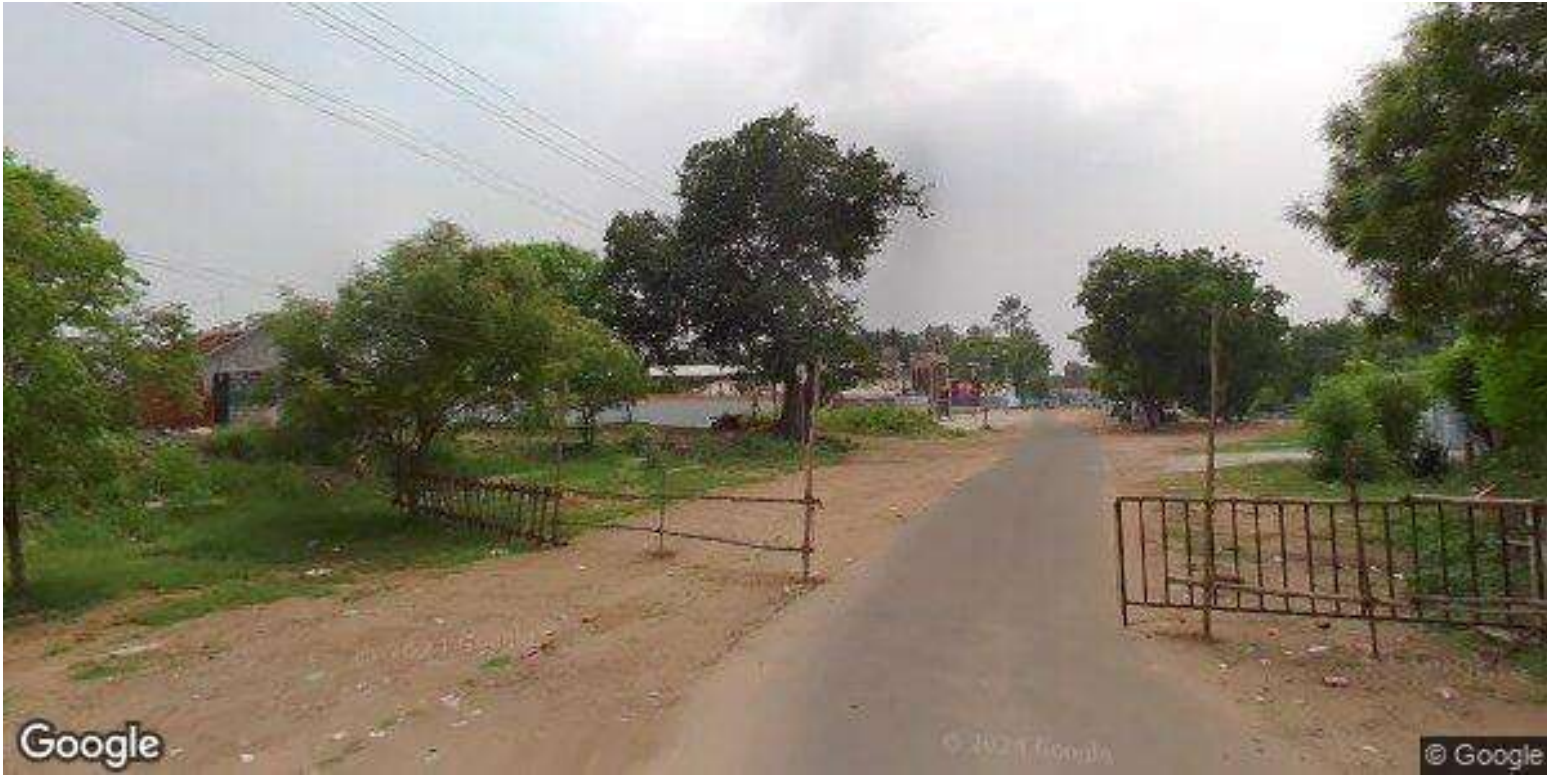
**Risk Type:** Turn  
**Risk Level:** Medium  
**Speed Limit:** 30 KM/Hr  
**Coordinates:** 11.15756, 78.07014

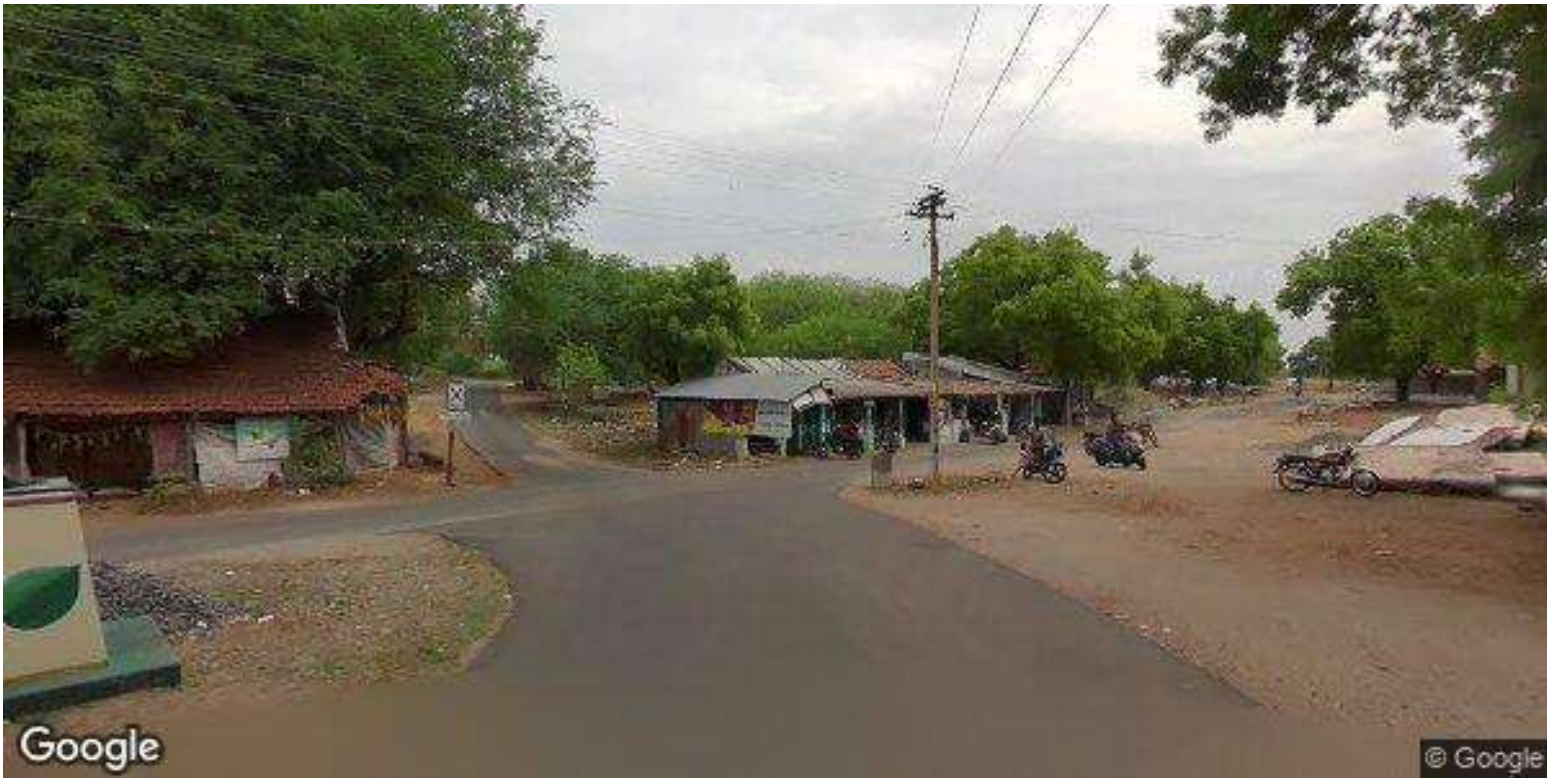
**Risk Type:** Turn  
**Risk Level:** Medium  
**Speed Limit:** 30 KM/Hr  
**Coordinates:** 11.15582, 78.07004

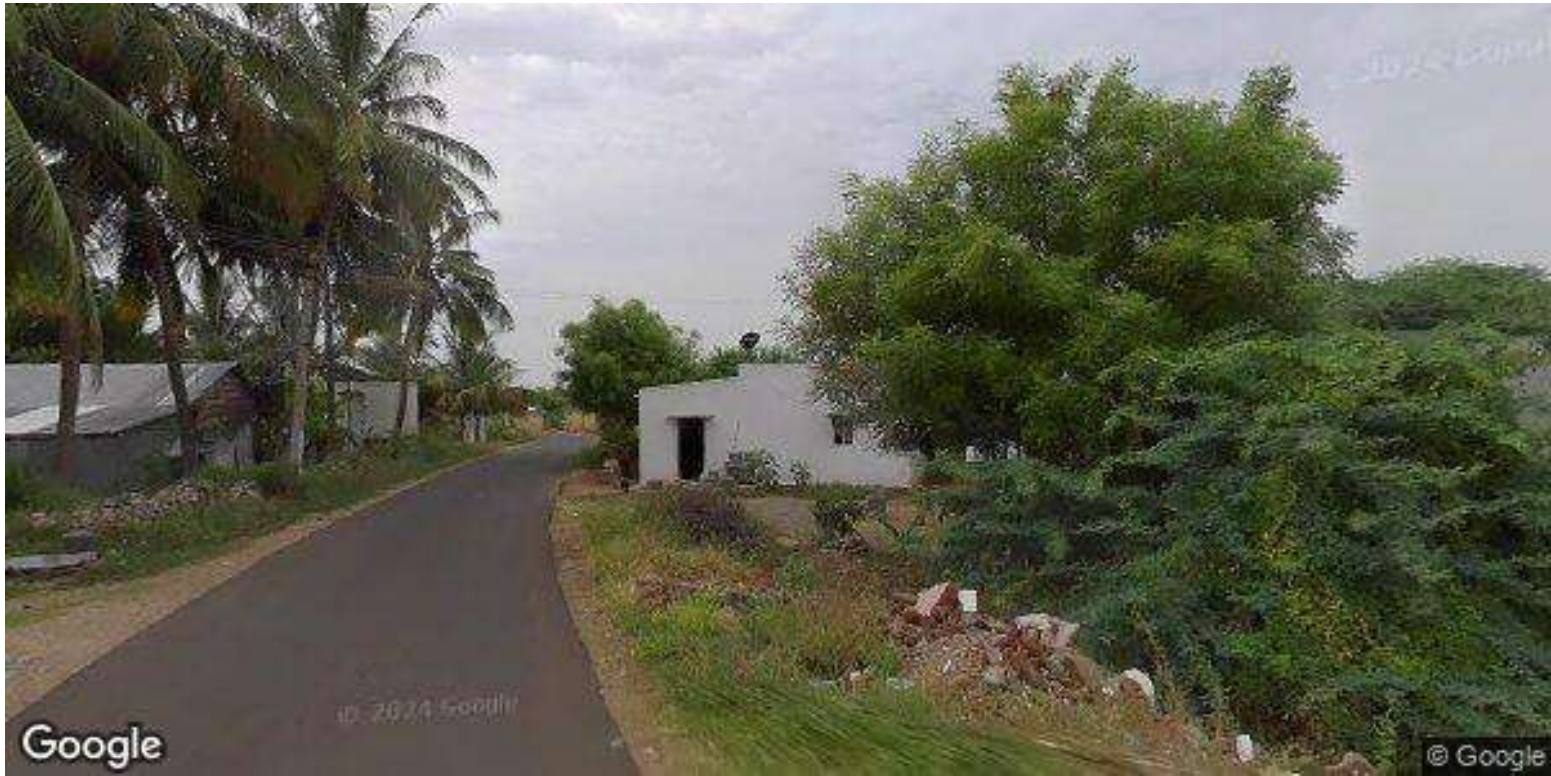
**Risk Type:** Turn  
**Risk Level:** Medium  
**Speed Limit:** 30 KM/Hr  
**Coordinates:** 11.15501, 78.07151

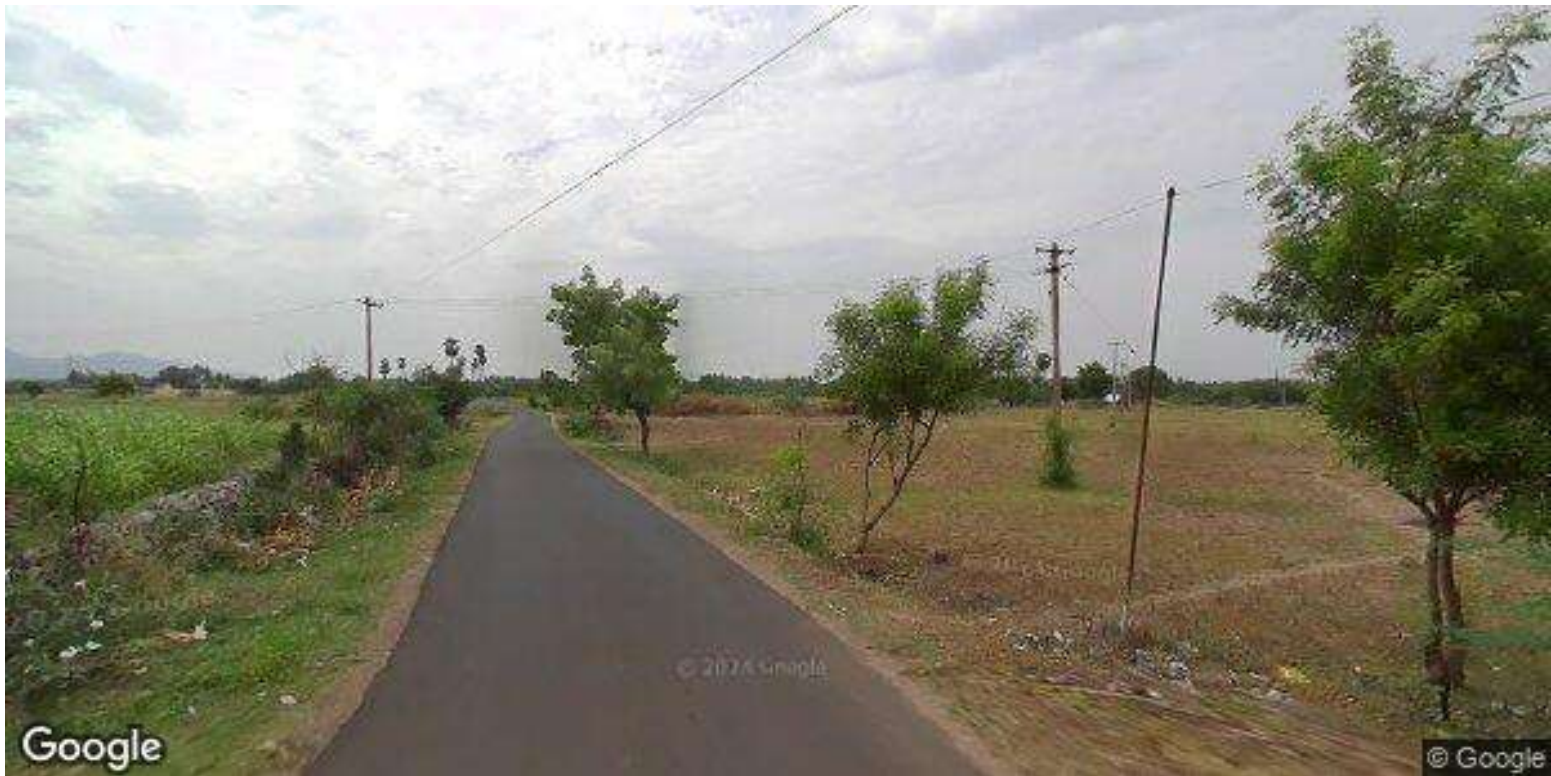
**Risk Type:** Turn  
**Risk Level:** Medium  
**Speed Limit:** 30 KM/Hr  
**Coordinates:** 11.15437, 78.07194

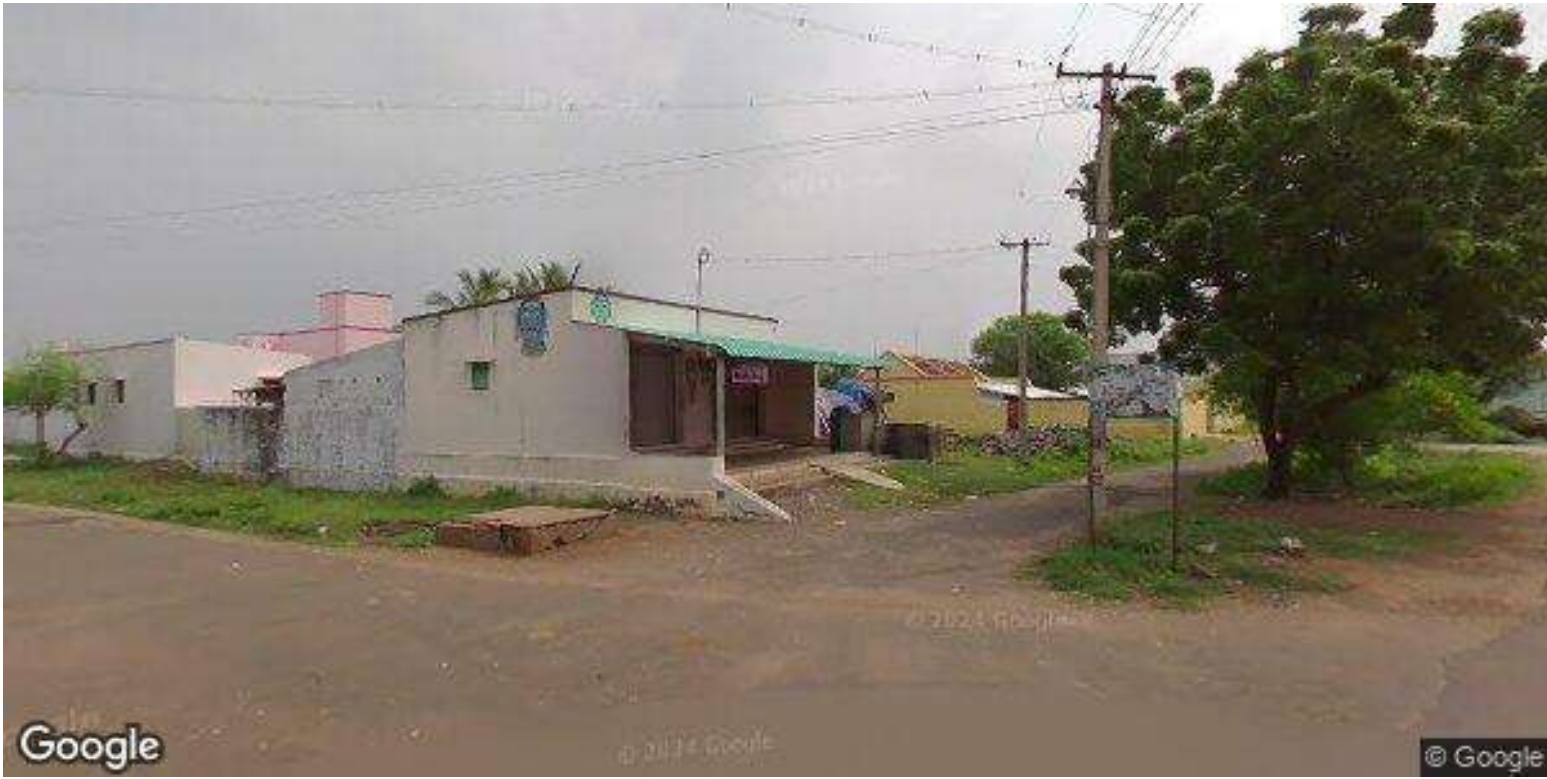
**Risk Type:** Blind Spot  
**Risk Level:** Blind Spot  
**Speed Limit:** 10 KM/Hr  
**Coordinates:** 11.15411, 78.07842

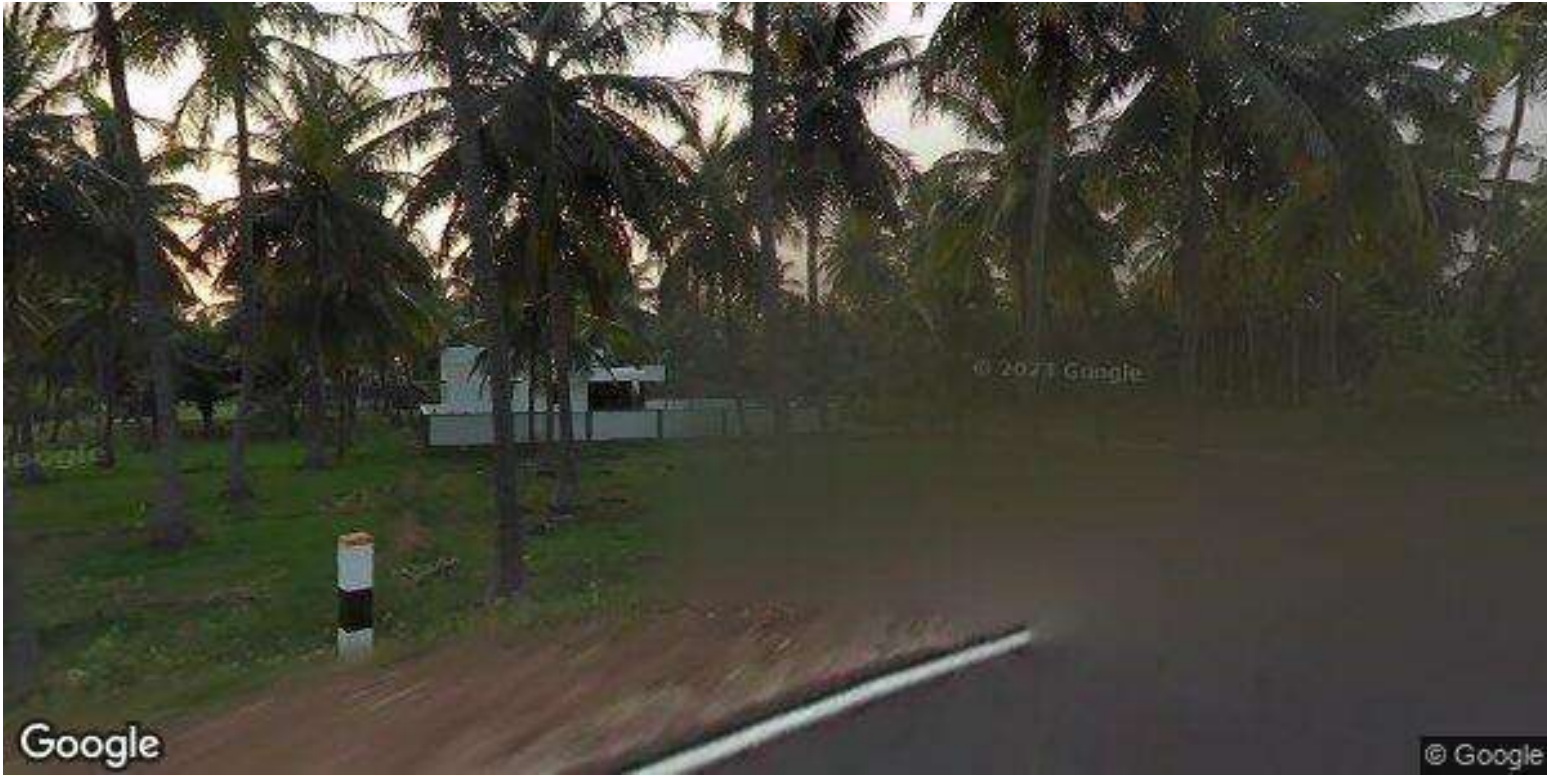
**Risk Type:** Turn  
**Risk Level:** High  
**Speed Limit:** 15 KM/Hr  
**Coordinates:** 11.14790, 78.07733
