## JOURNEY RISK MANAGEMENT (JRM) STUDY

### Salem Terminal TO PALKARAR K. PONNU AGENCIES

**Route Analysis from CVQF+23W, Sangagiri to 438R+HQJ, Vallipuram - Palapatti Road**

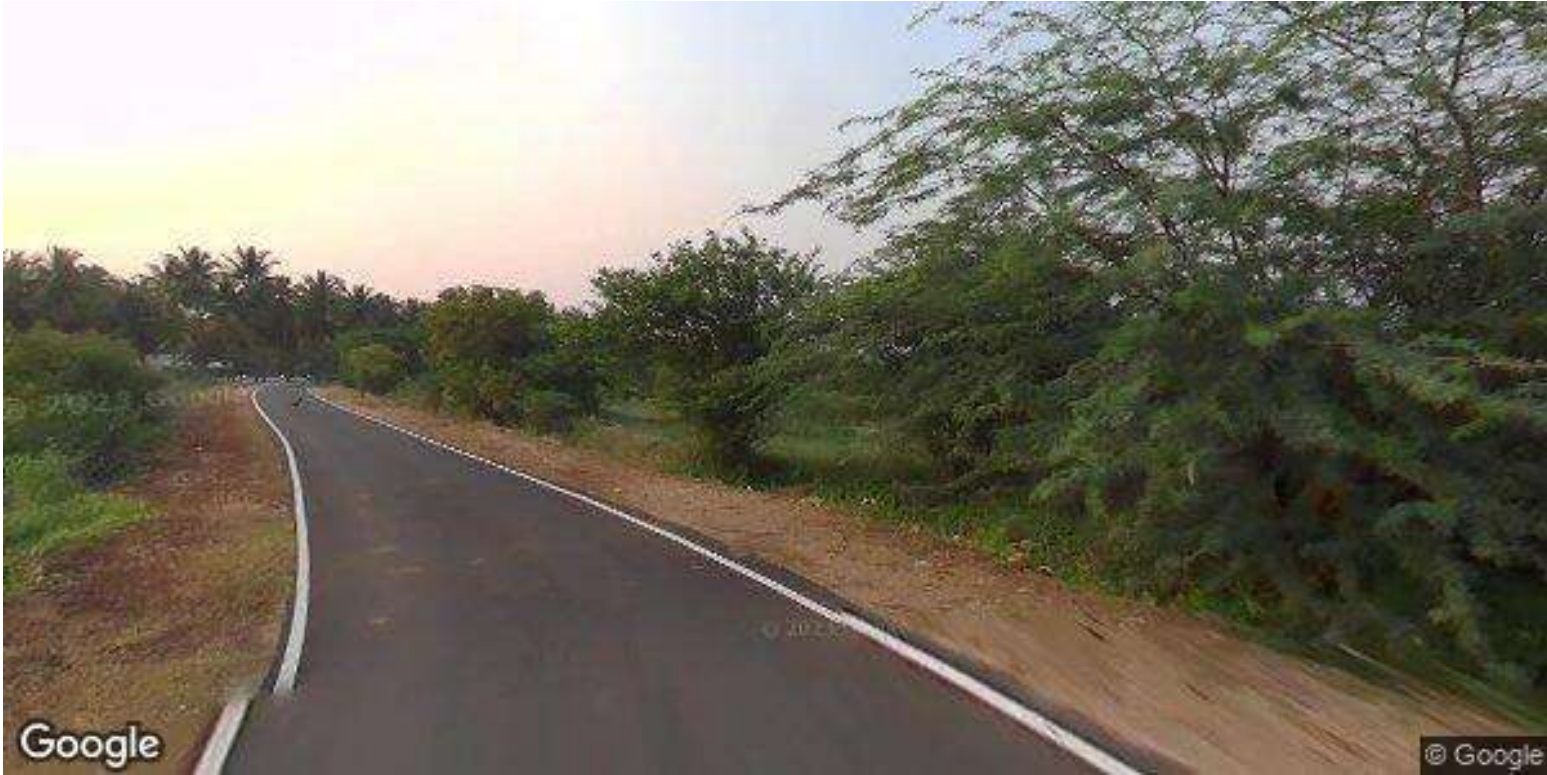
**Risk Type:** Turn  
**Risk Level:** Medium  
**Speed Limit:** 30 KM/Hr  
**Coordinates:** 11.14736, 78.07811

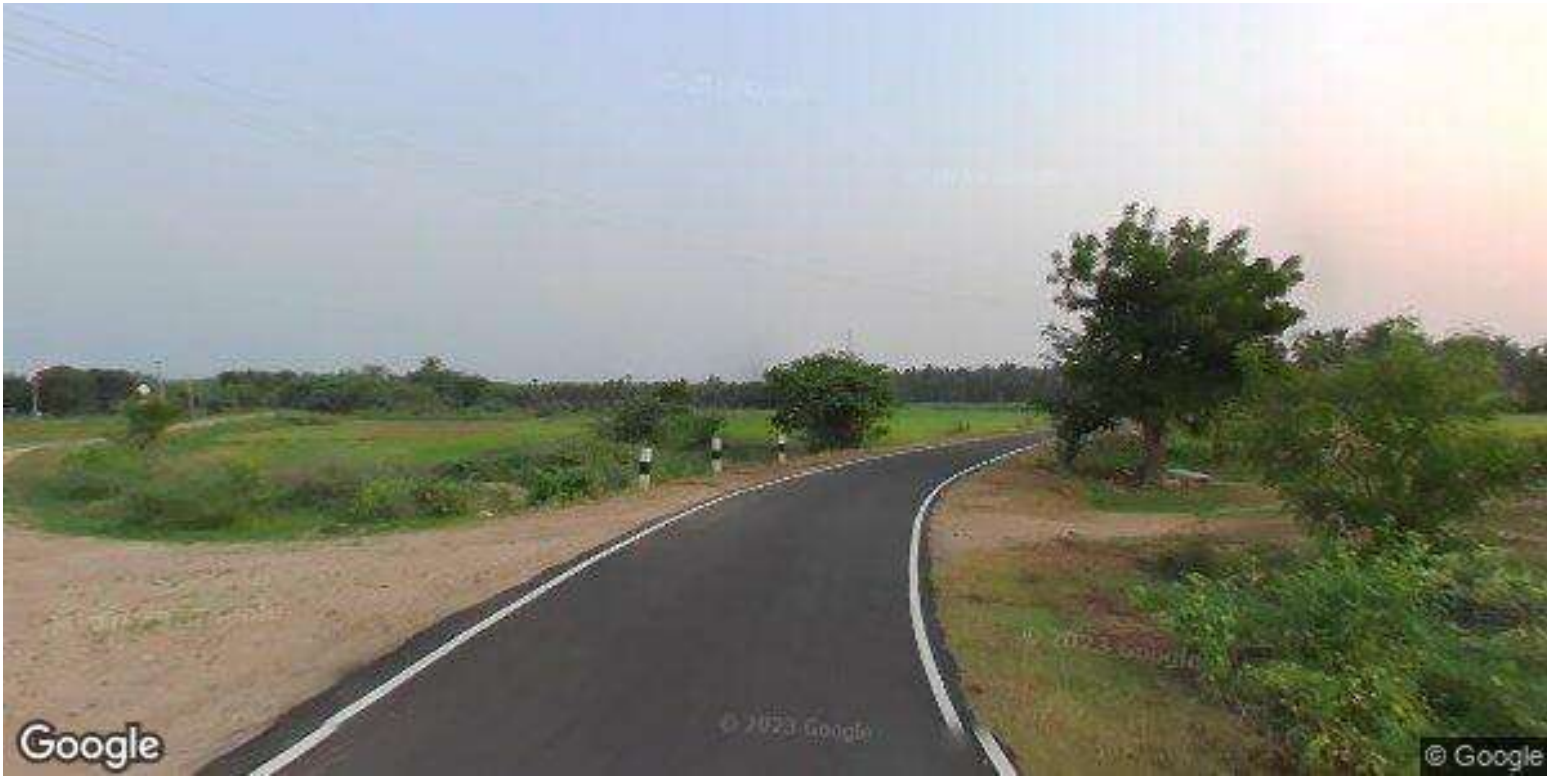
**Risk Type:** Turn  
**Risk Level:** Medium  
**Speed Limit:** 30 KM/Hr  
**Coordinates:** 11.14715, 78.07821

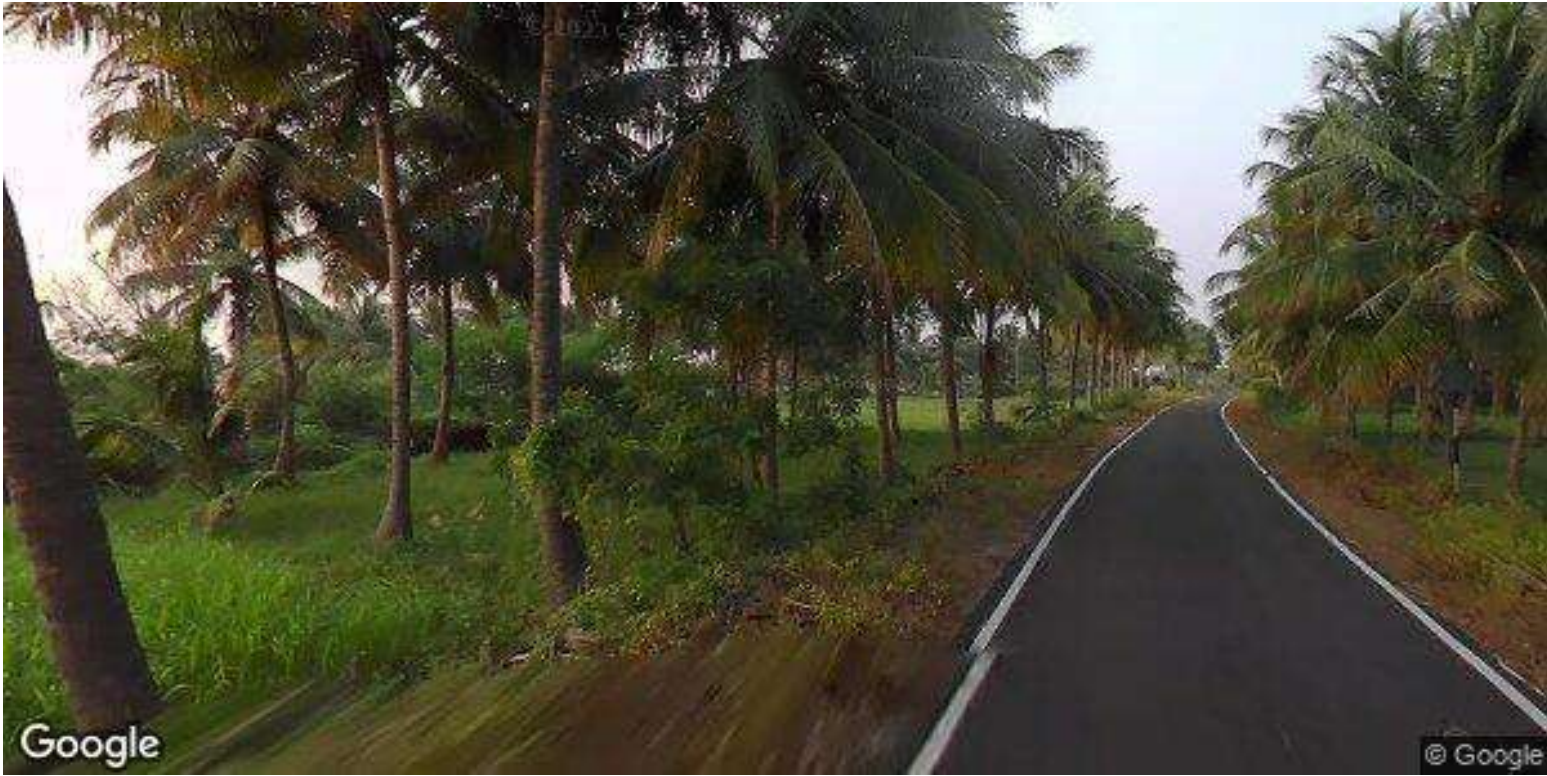
**Risk Type:** Turn  
**Risk Level:** Medium  
**Speed Limit:** 30 KM/Hr  
**Coordinates:** 11.14327, 78.07733

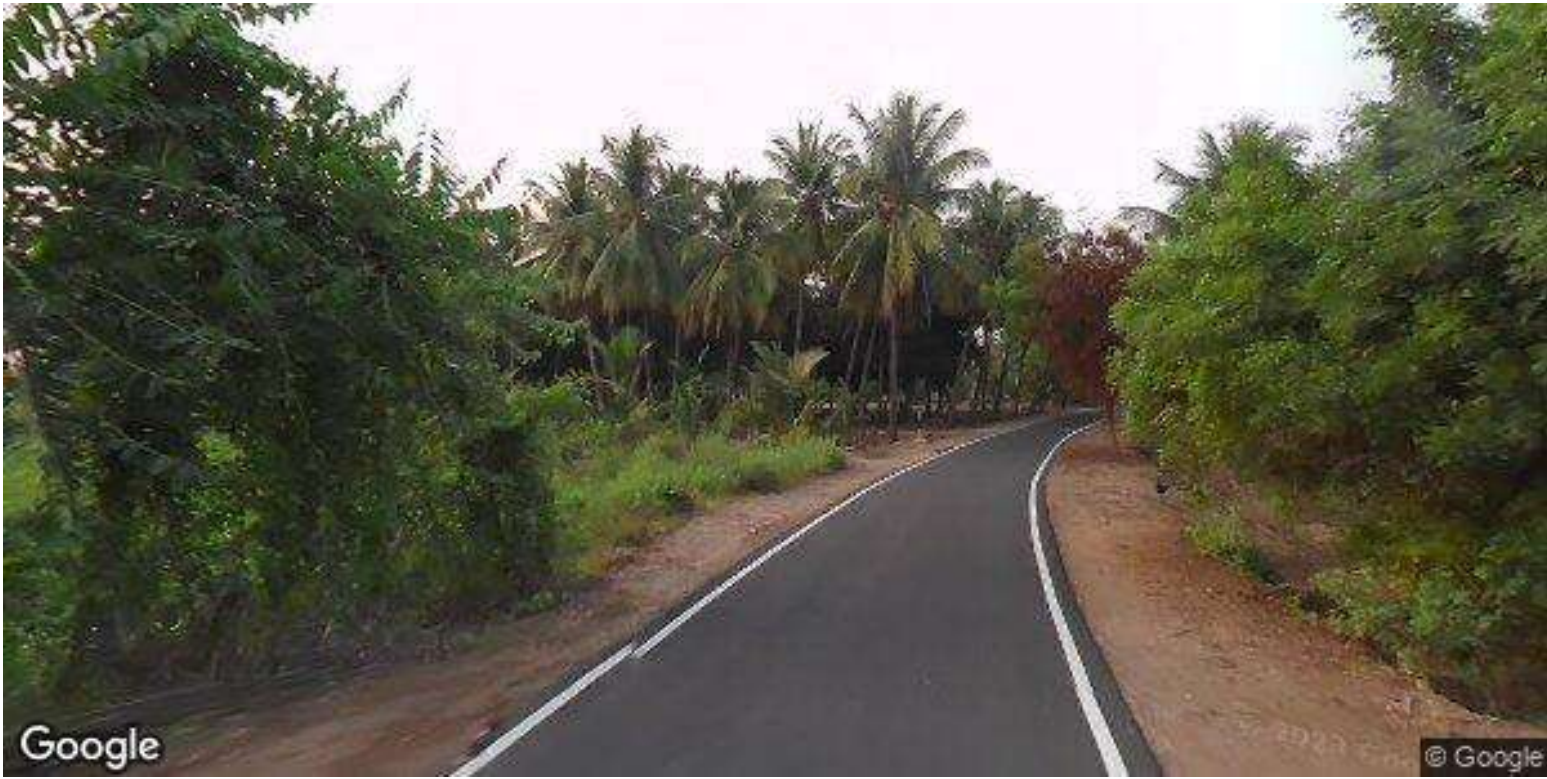
**Risk Type:** Turn  
**Risk Level:** Medium  
**Speed Limit:** 30 KM/Hr  
**Coordinates:** 11.13737, 78.07789

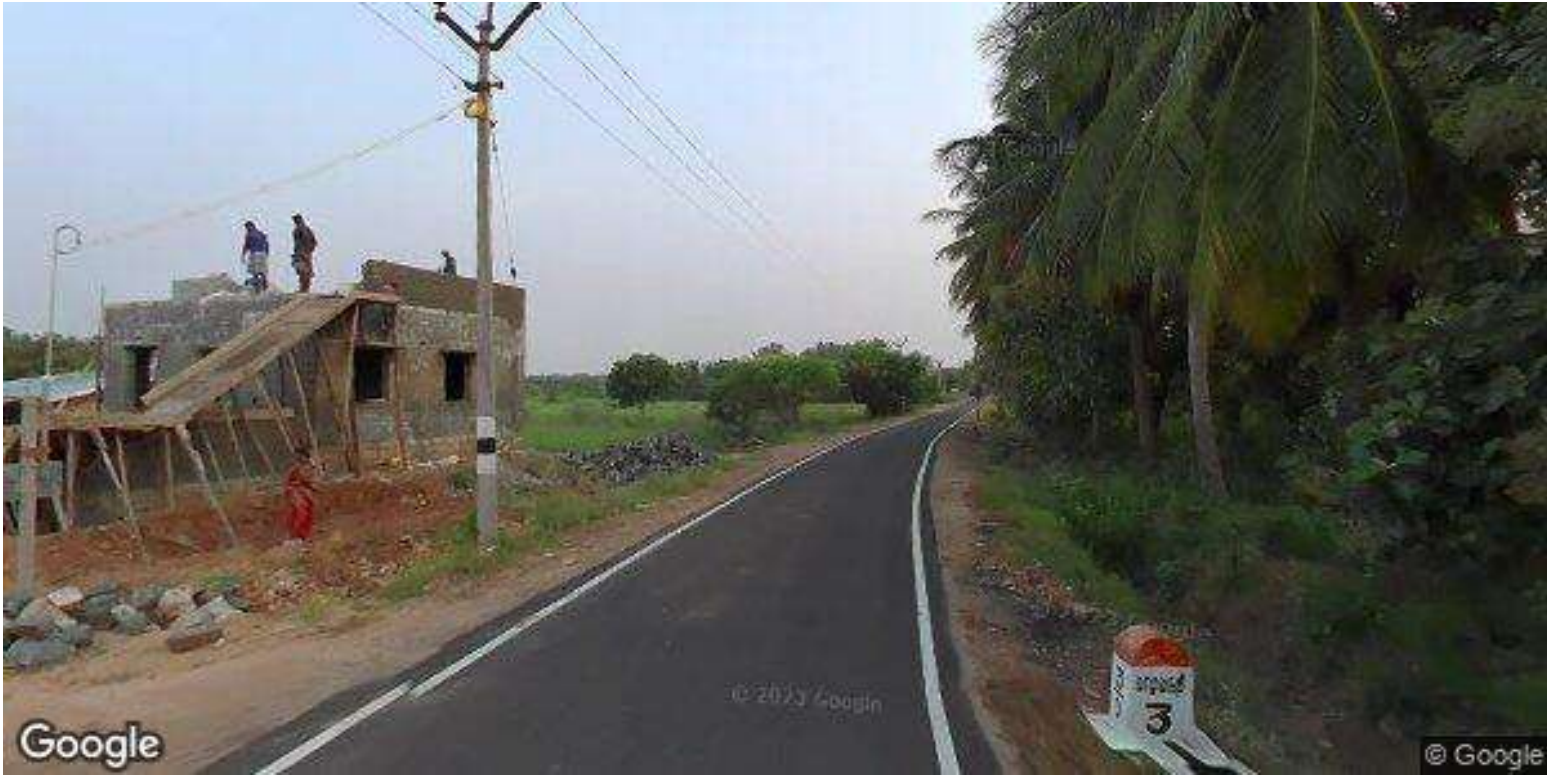
**Risk Type:** Turn  
**Risk Level:** Medium  
**Speed Limit:** 30 KM/Hr  
**Coordinates:** 11.13608, 78.07979

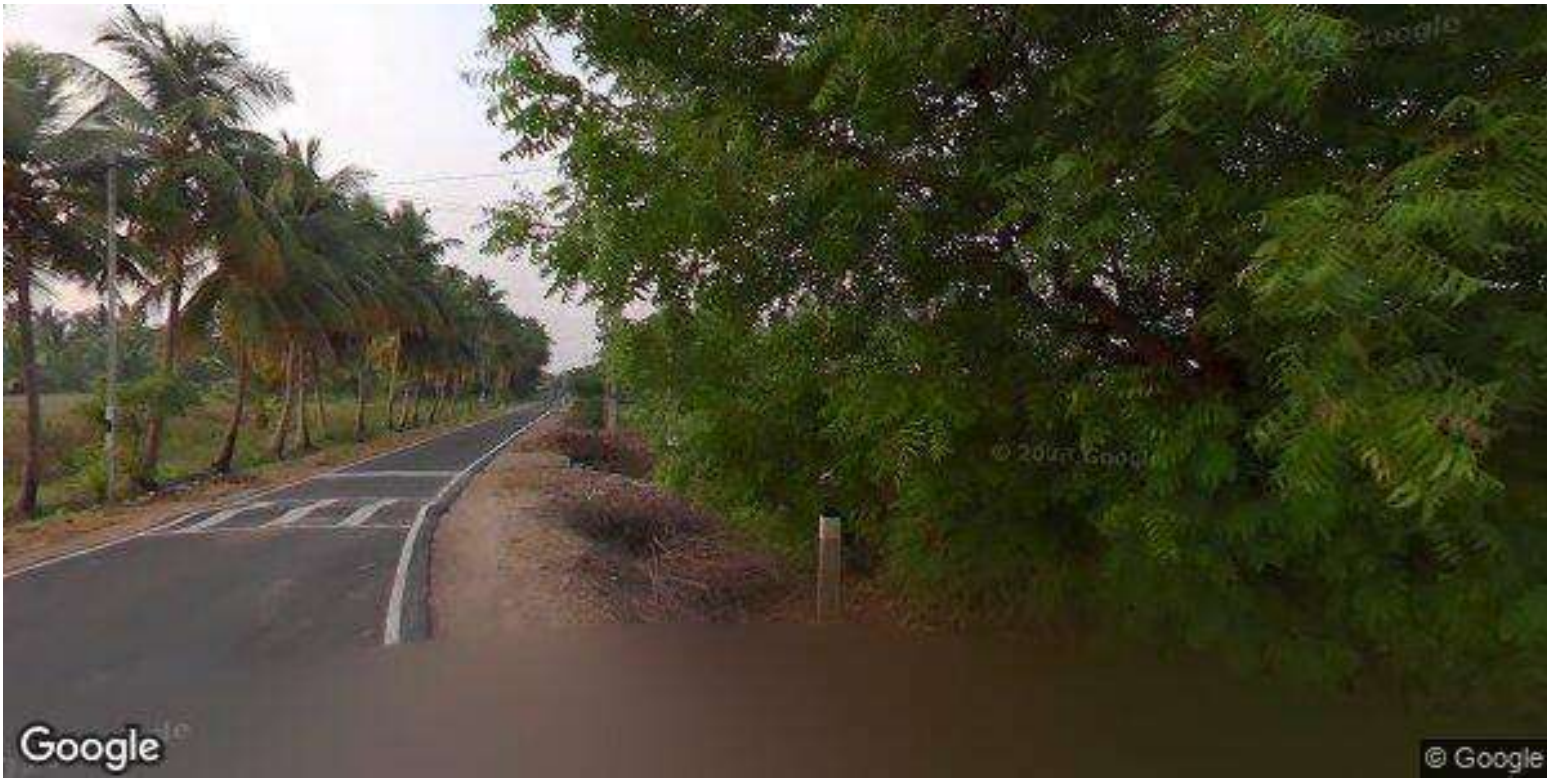
**Risk Type:** Blind Spot  
**Risk Level:** Blind Spot  
**Speed Limit:** 10 KM/Hr  
**Coordinates:** 11.13449, 78.08021

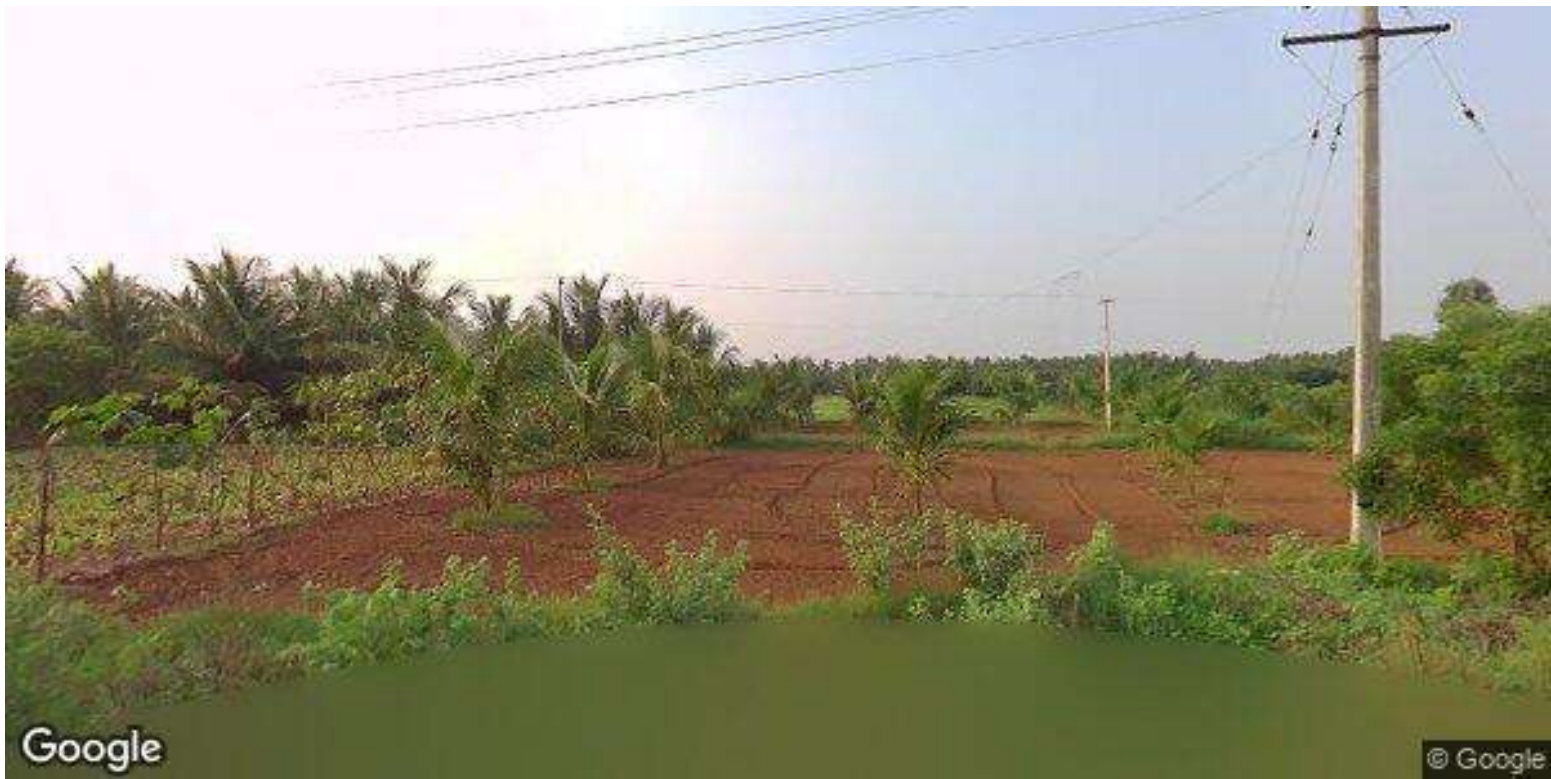
**Risk Type:** Turn  
**Risk Level:** High  
**Speed Limit:** 15 KM/Hr  
**Coordinates:** 11.13464, 78.08069

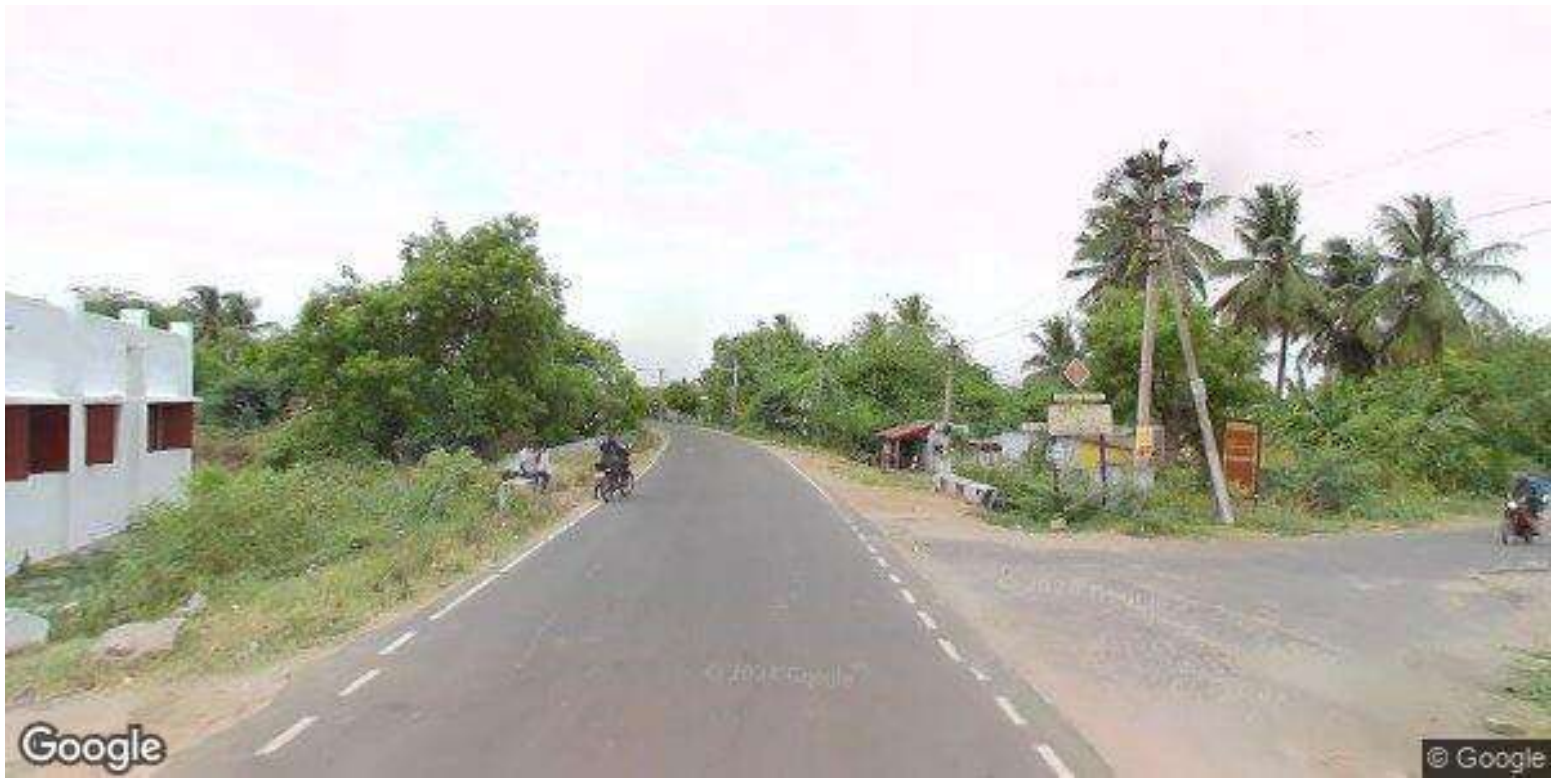
**Risk Type:** Turn  
**Risk Level:** High  
**Speed Limit:** 15 KM/Hr  
**Coordinates:** 11.11376, 78.09124

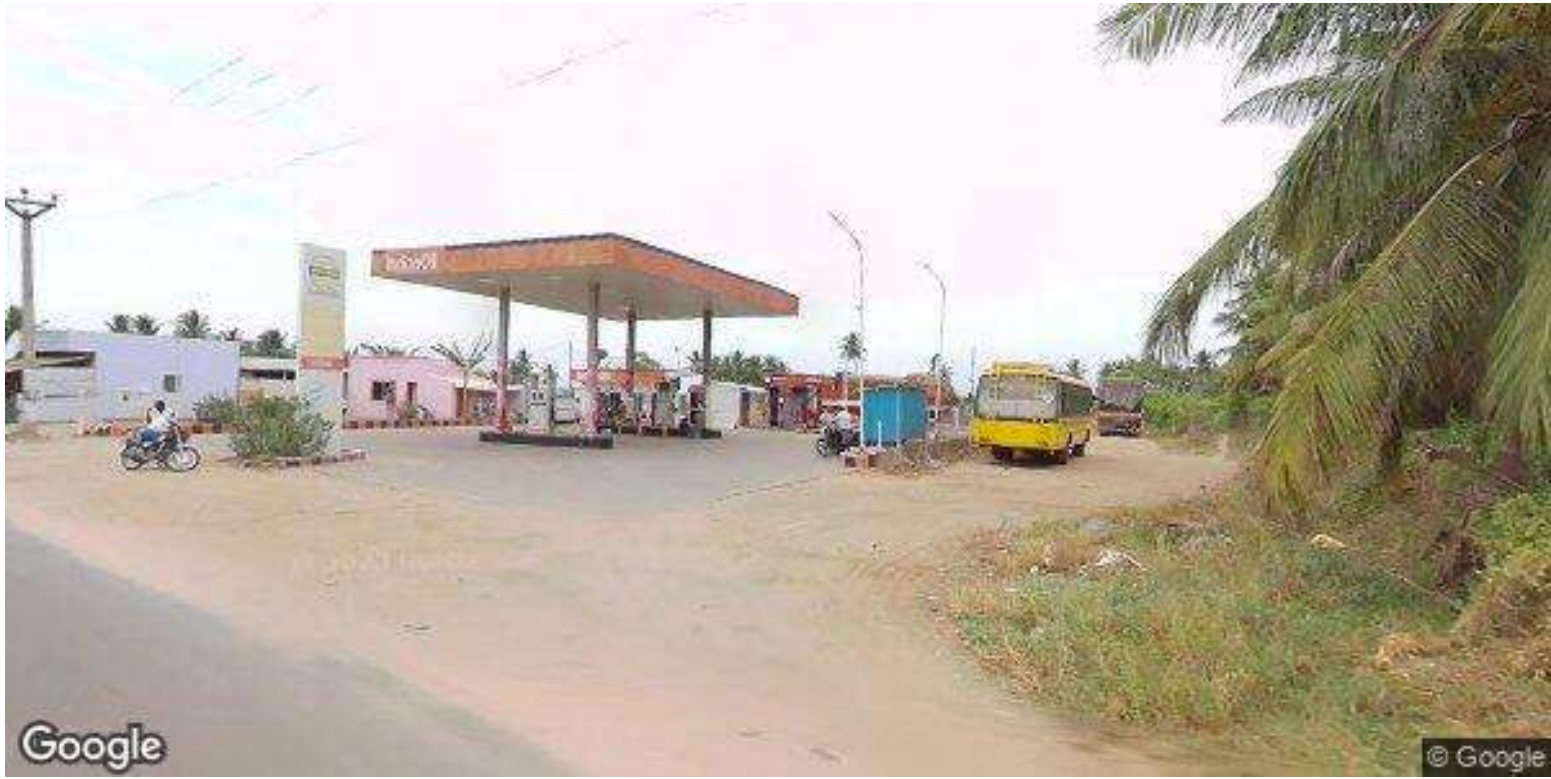
**Risk Type:** Blind Spot  
**Risk Level:** Blind Spot  
**Speed Limit:** 10 KM/Hr  
**Coordinates:** 11.11657, 78.09219
