# IndianOil

## JOURNEY RISK MANAGEMENT (JRM) STUDY

### Salem Terminal to NEHRU AGENCY

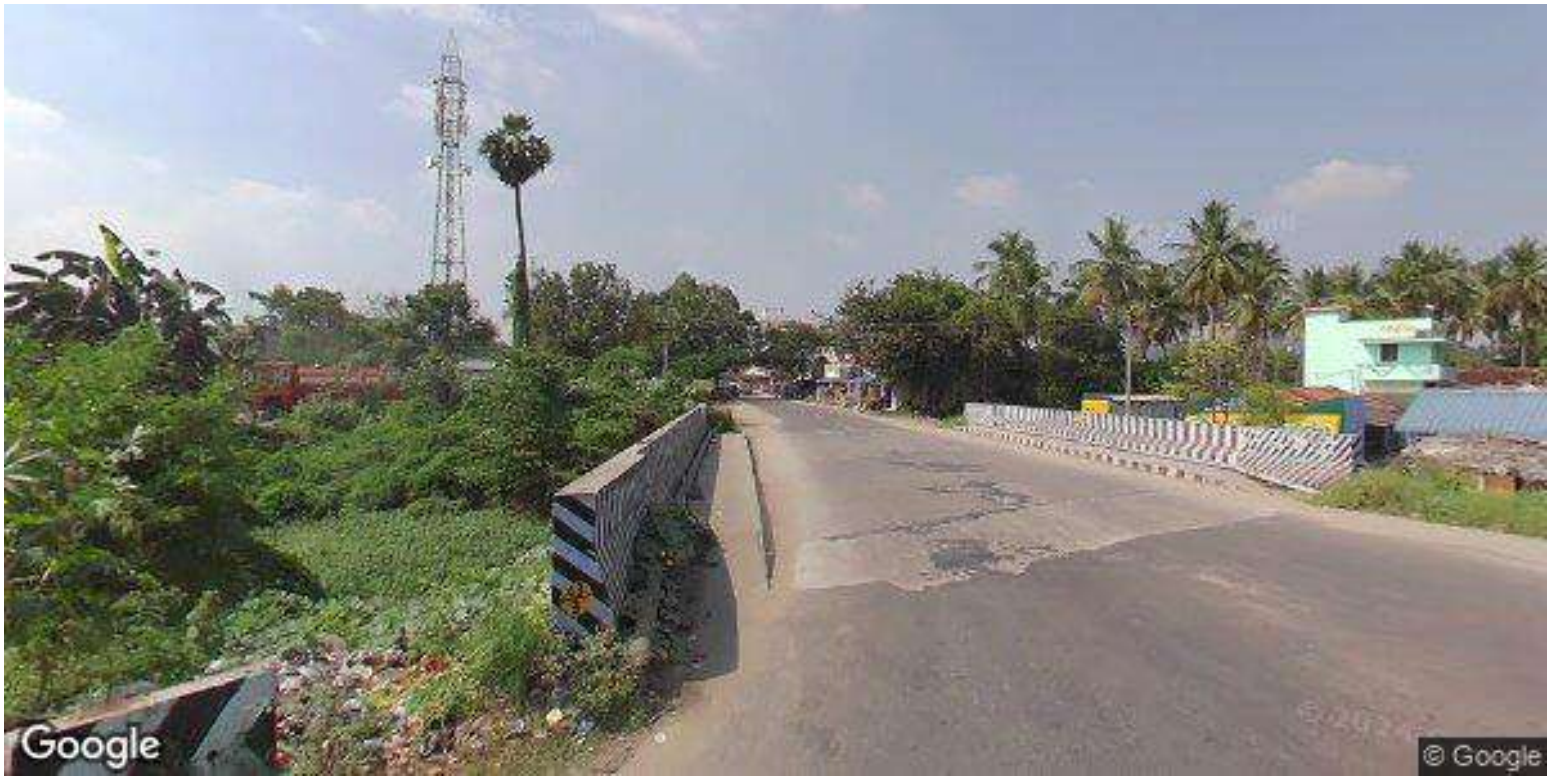
**Risk Type:** Turn  
**Risk Level:** High  
**Speed Limit:** 15 KM/Hr  
**Coordinates:** 11.44900, 77.87406

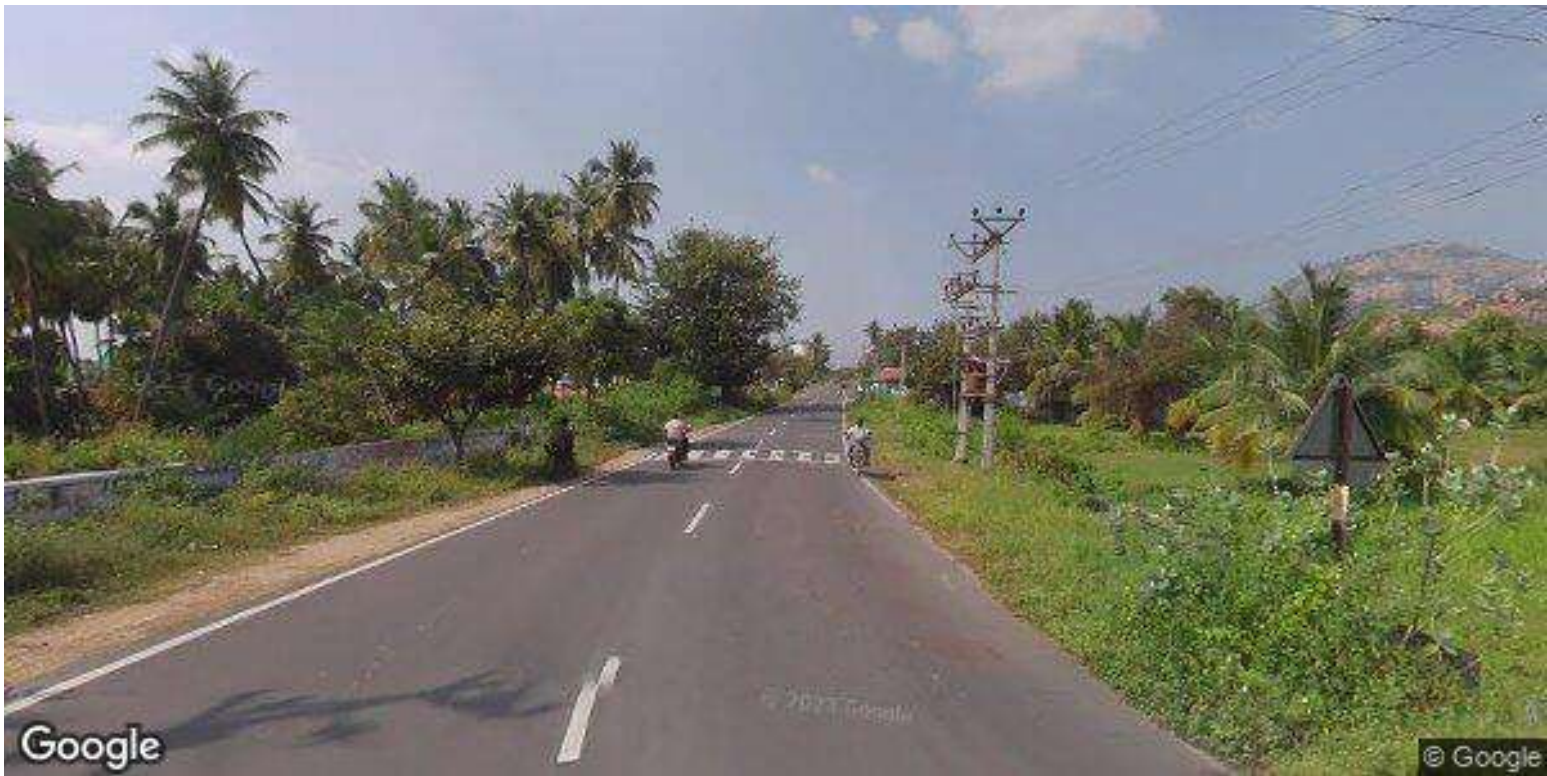
**Coordinates: 11.45352, 77.85698**

**Risk Type: Turn**

**Risk Level: High**

**Speed Limit: 15 KM/Hr**

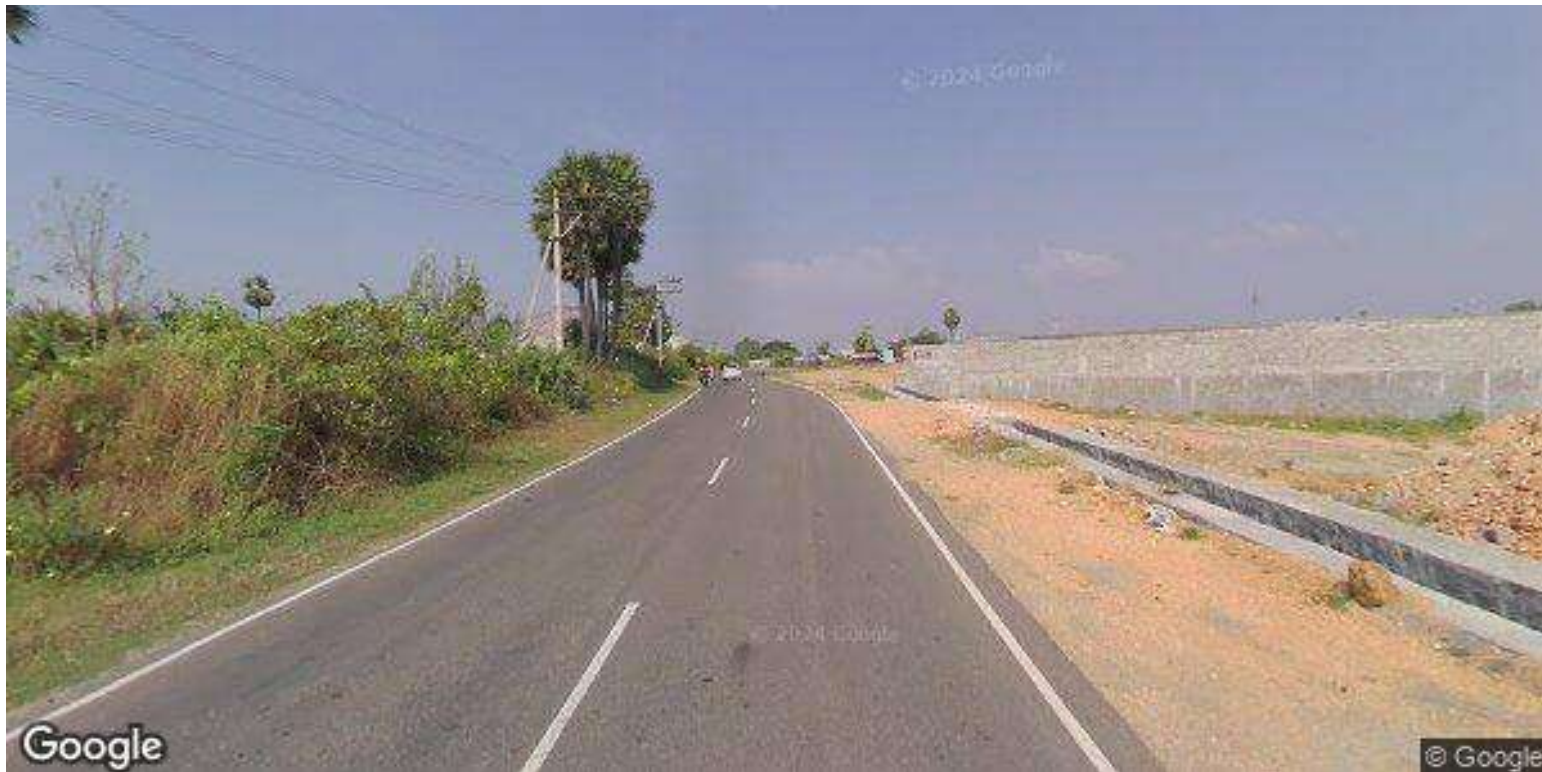
**Coordinates: 11.45764, 77.85219**

**Risk Type: Turn**

**Risk Level: Medium**

**Speed Limit: 30 KM/Hr**

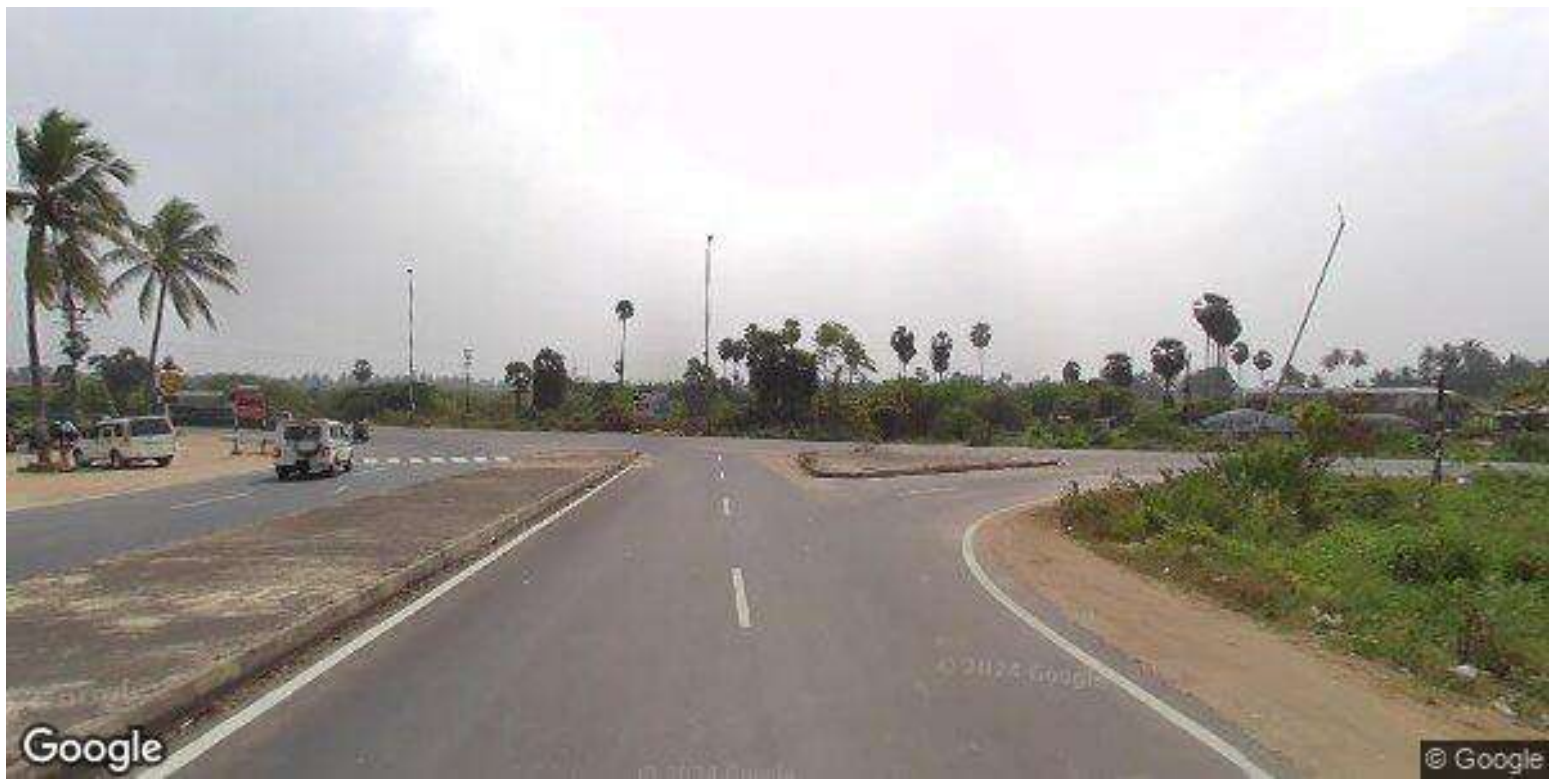
**Coordinates: 11.45571, 77.81702**

**Risk Type: Turn**

**Risk Level: High**

**Speed Limit: 15 KM/Hr**

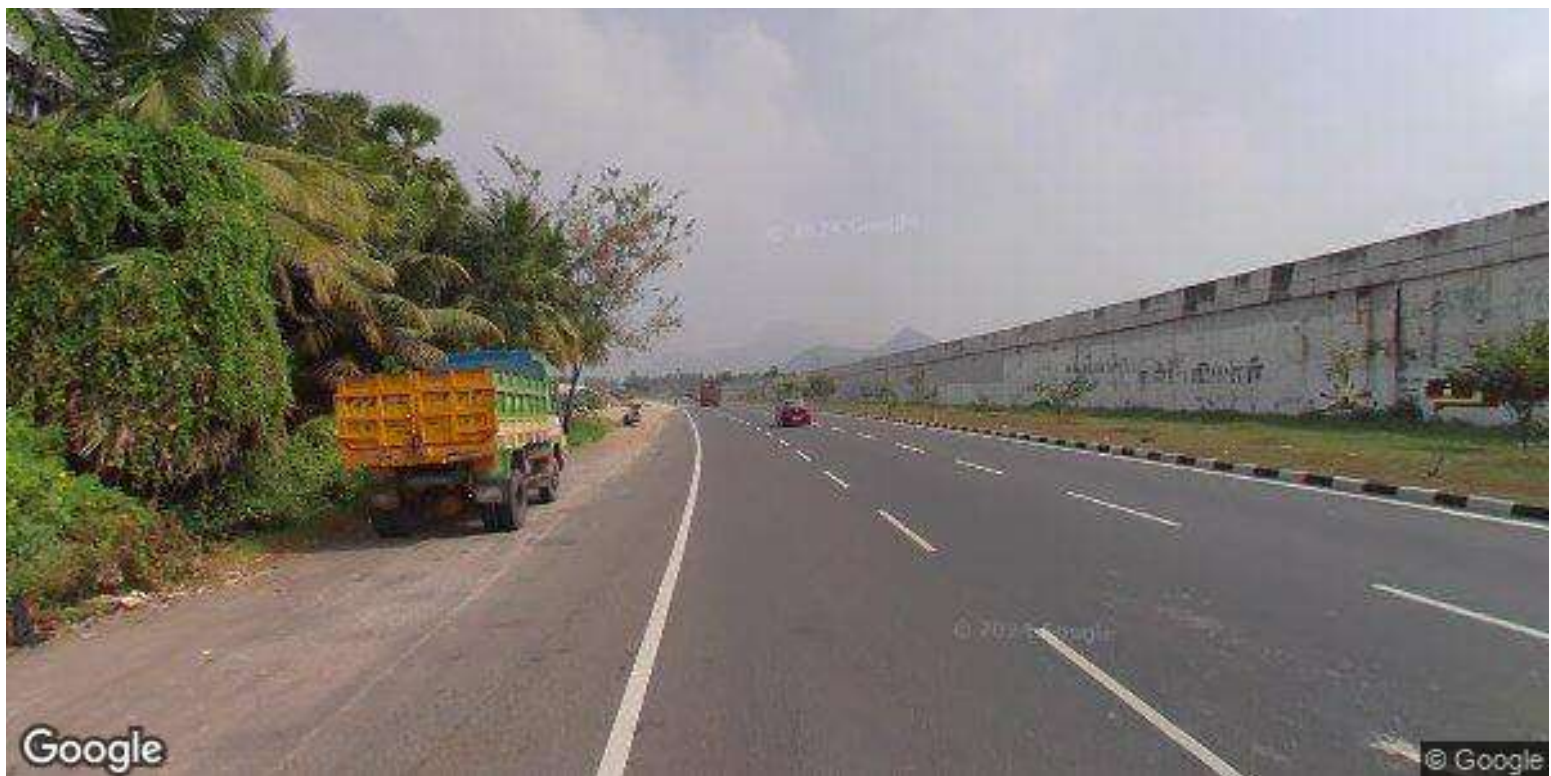
**Coordinates: 11.45654, 77.81706**

**Risk Type: Turn**

**Risk Level: Medium**

**Speed Limit: 30 KM/Hr**

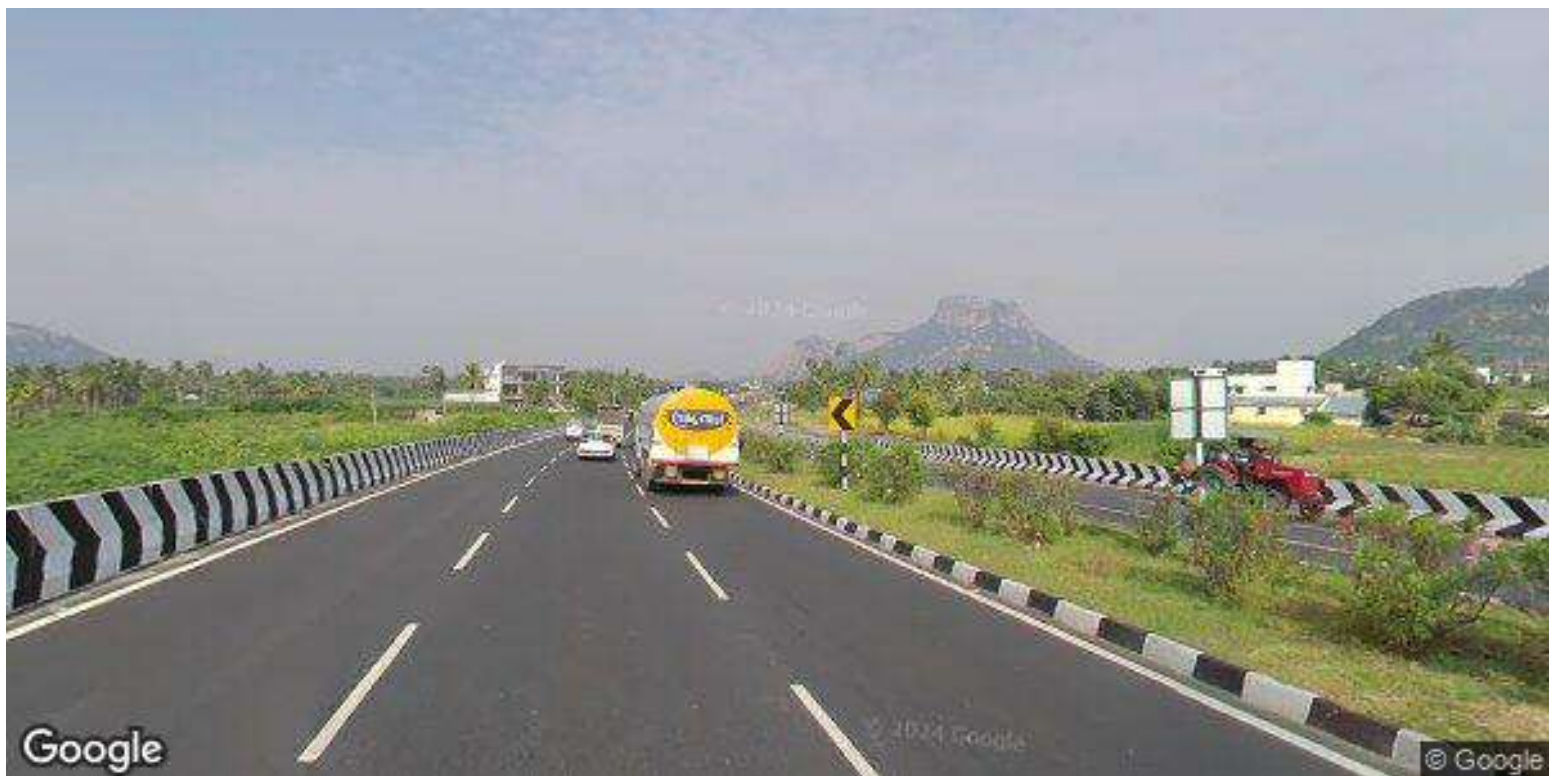
**Risk Type:** Turn  
**Risk Level:** Medium  
**Speed Limit:** 30 KM/Hr  
**Coordinates:** 11.46916, 77.82431

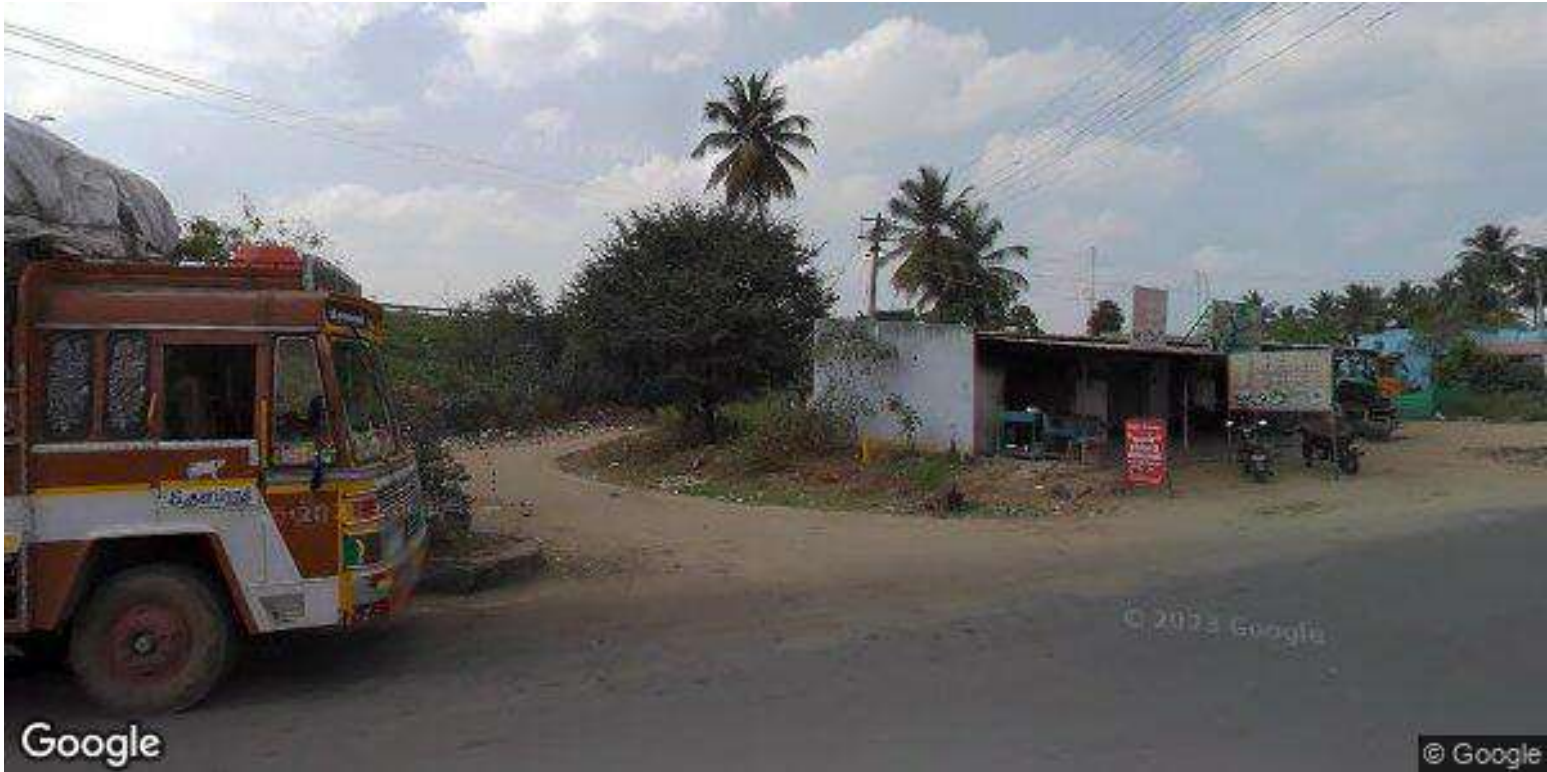
**Risk Type:** Blind Spot  
**Risk Level:** Blind Spot  
**Speed Limit:** 10 KM/Hr  
**Coordinates:** 11.49395, 77.88537

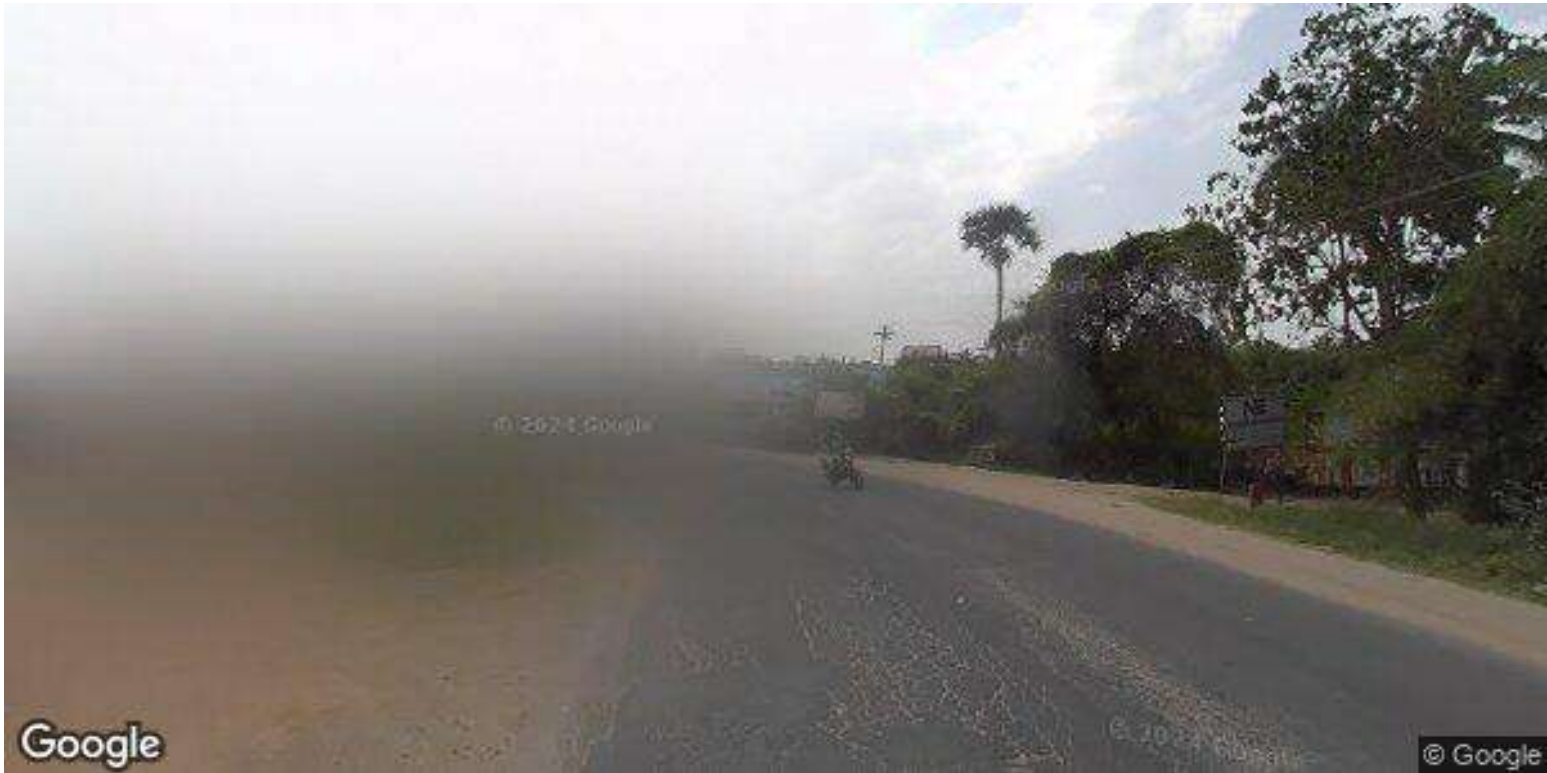
**Risk Type:** Turn  
**Risk Level:** High  
**Speed Limit:** 15 KM/Hr  
**Coordinates:** 11.49465, 77.88488

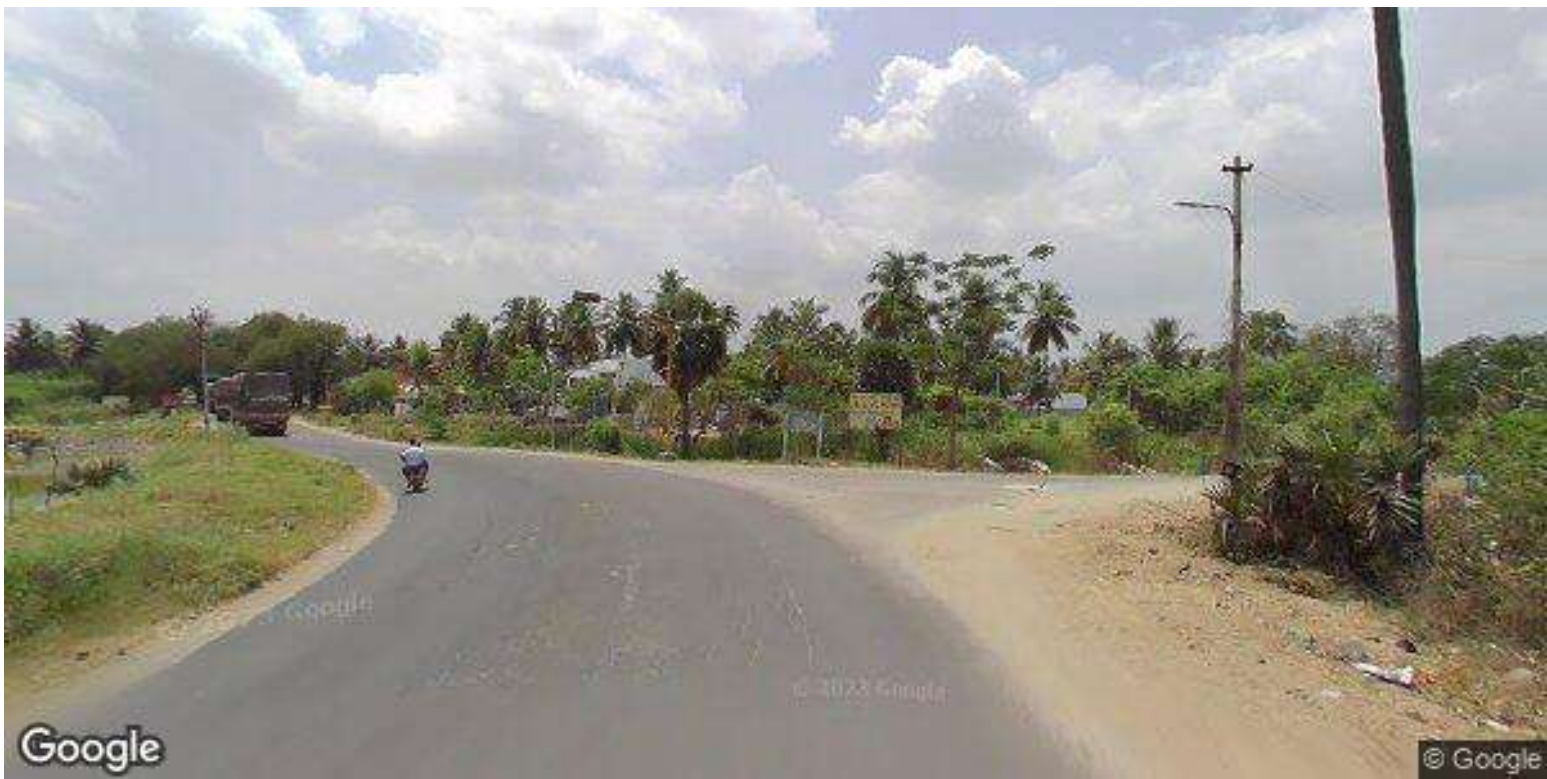
**Risk Type:** Turn  
**Risk Level:** Medium  
**Speed Limit:** 30 KM/Hr  
**Coordinates:** 11.56096, 77.89931

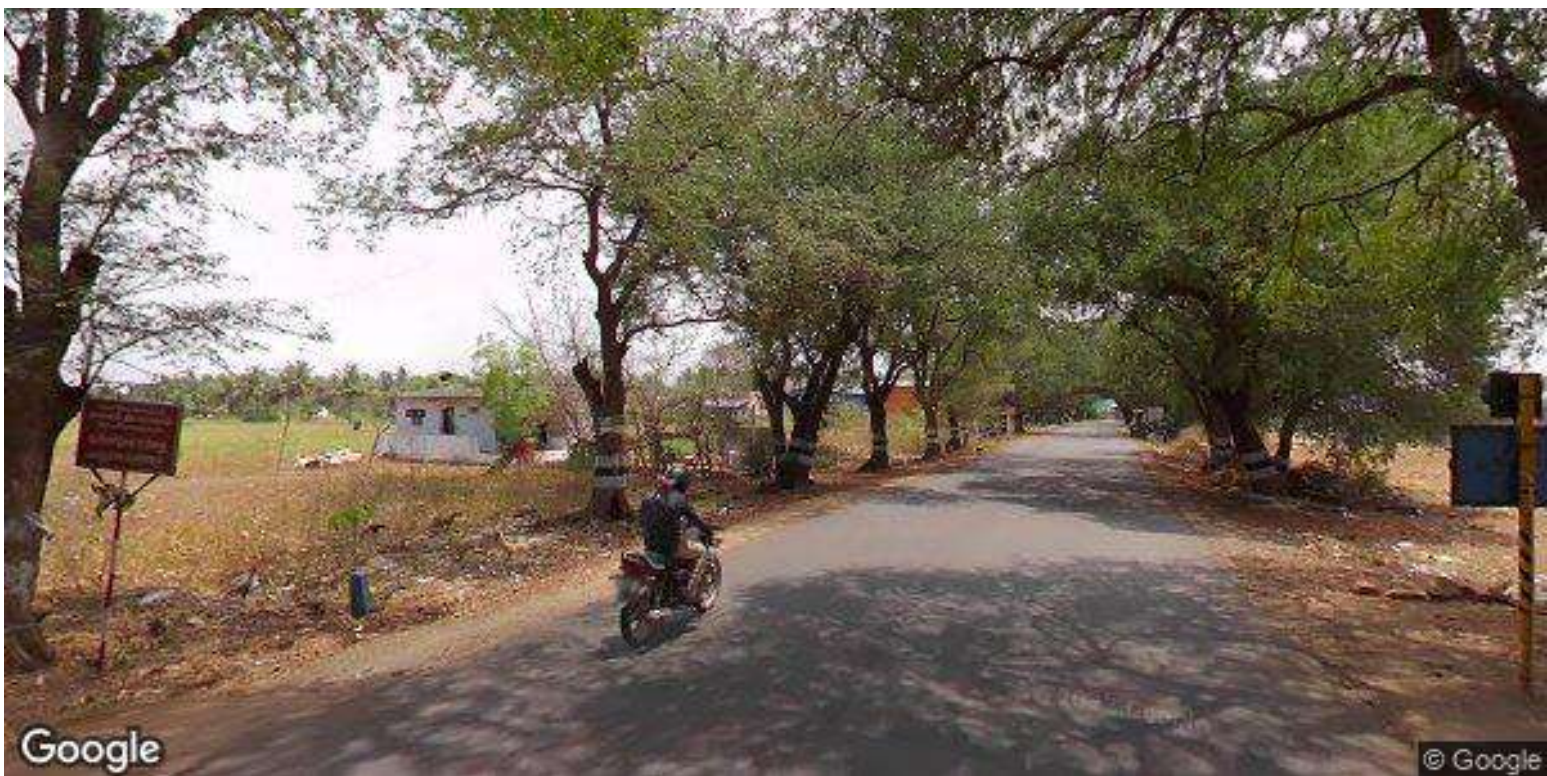
**Risk Type:** Turn  
**Risk Level:** Medium  
**Speed Limit:** 30 KM/Hr  
**Coordinates:** 11.57649, 77.90610

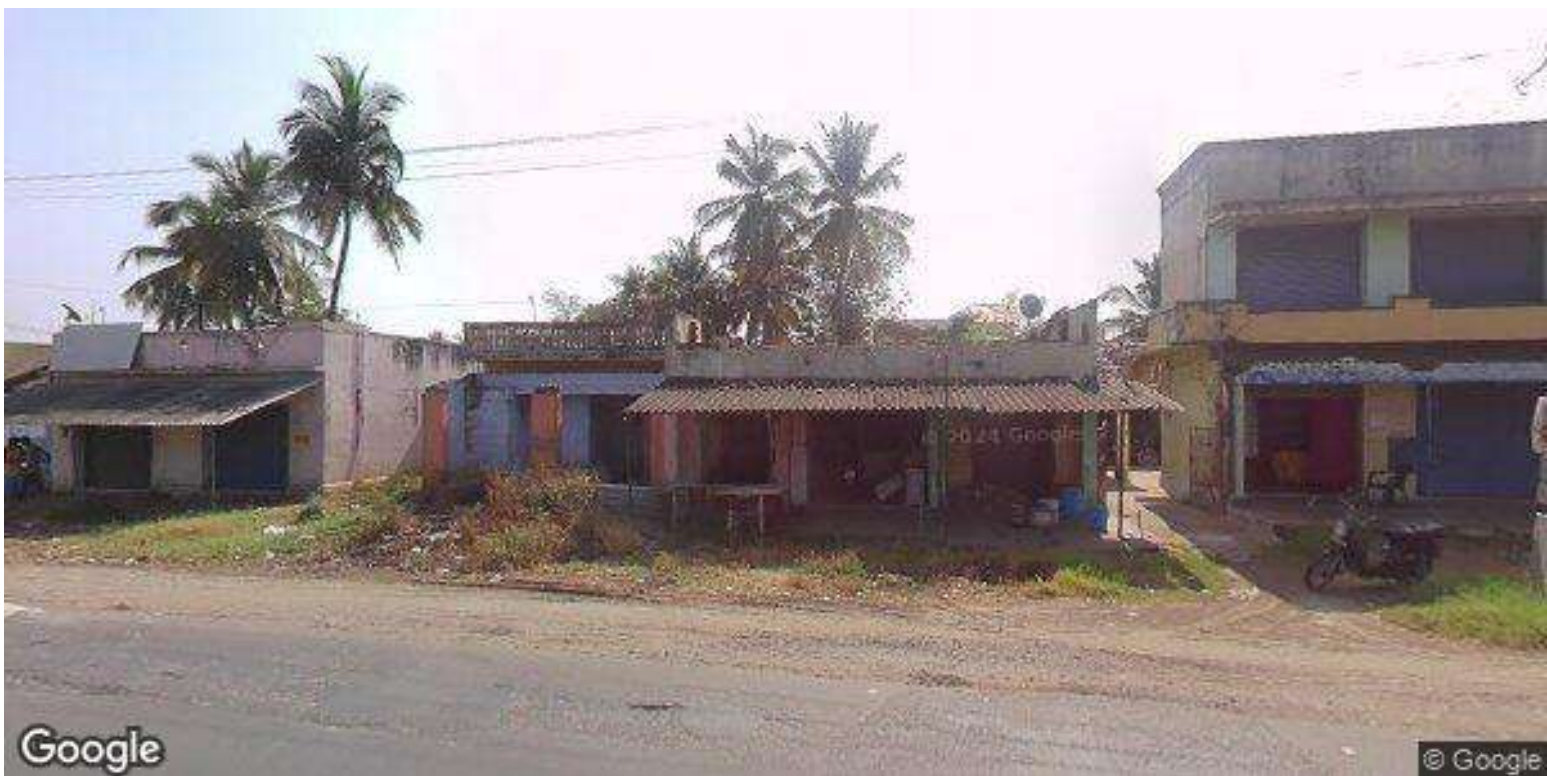
**Risk Type:** Turn  
**Risk Level:** Medium  
**Speed Limit:** 30 KM/Hr  
**Coordinates:** 11.59214, 77.90656

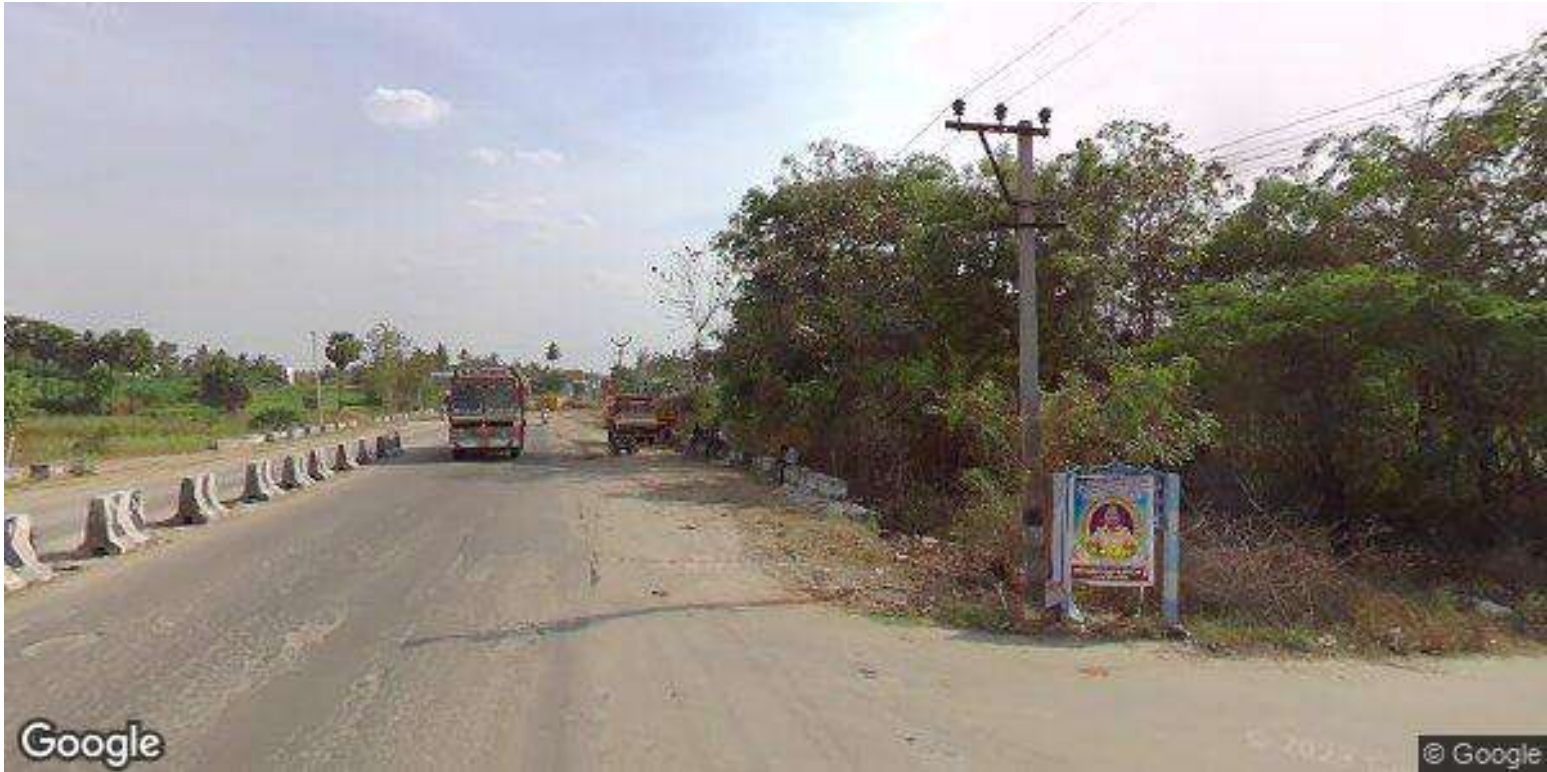
**Risk Type:** Turn  
**Risk Level:** Medium  
**Speed Limit:** 30 KM/Hr  
**Coordinates:** 11.63833, 77.94818

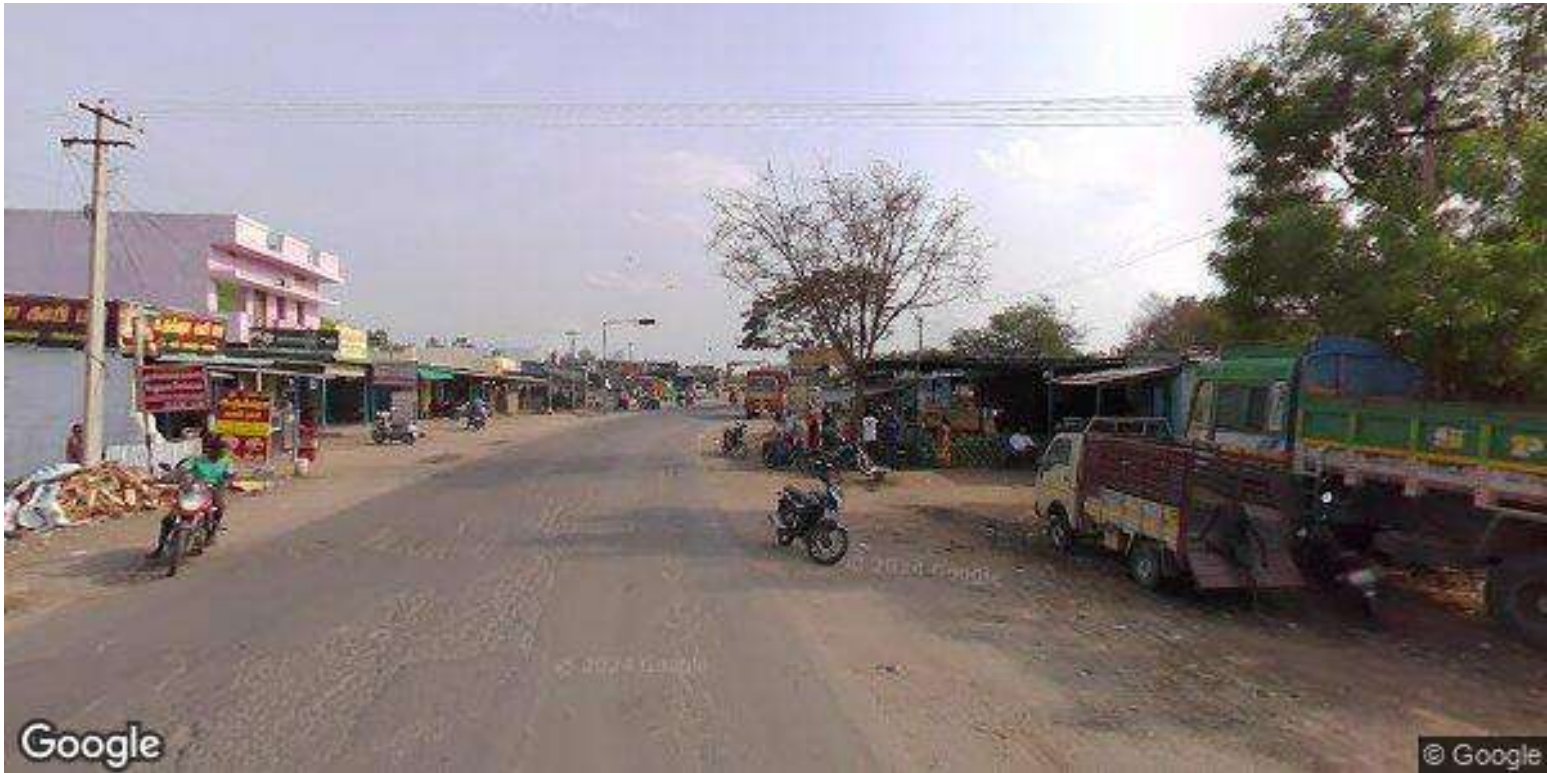
**Risk Type:** Turn  
**Risk Level:** High  
**Speed Limit:** 15 KM/Hr  
**Coordinates:** 11.64243, 77.95198

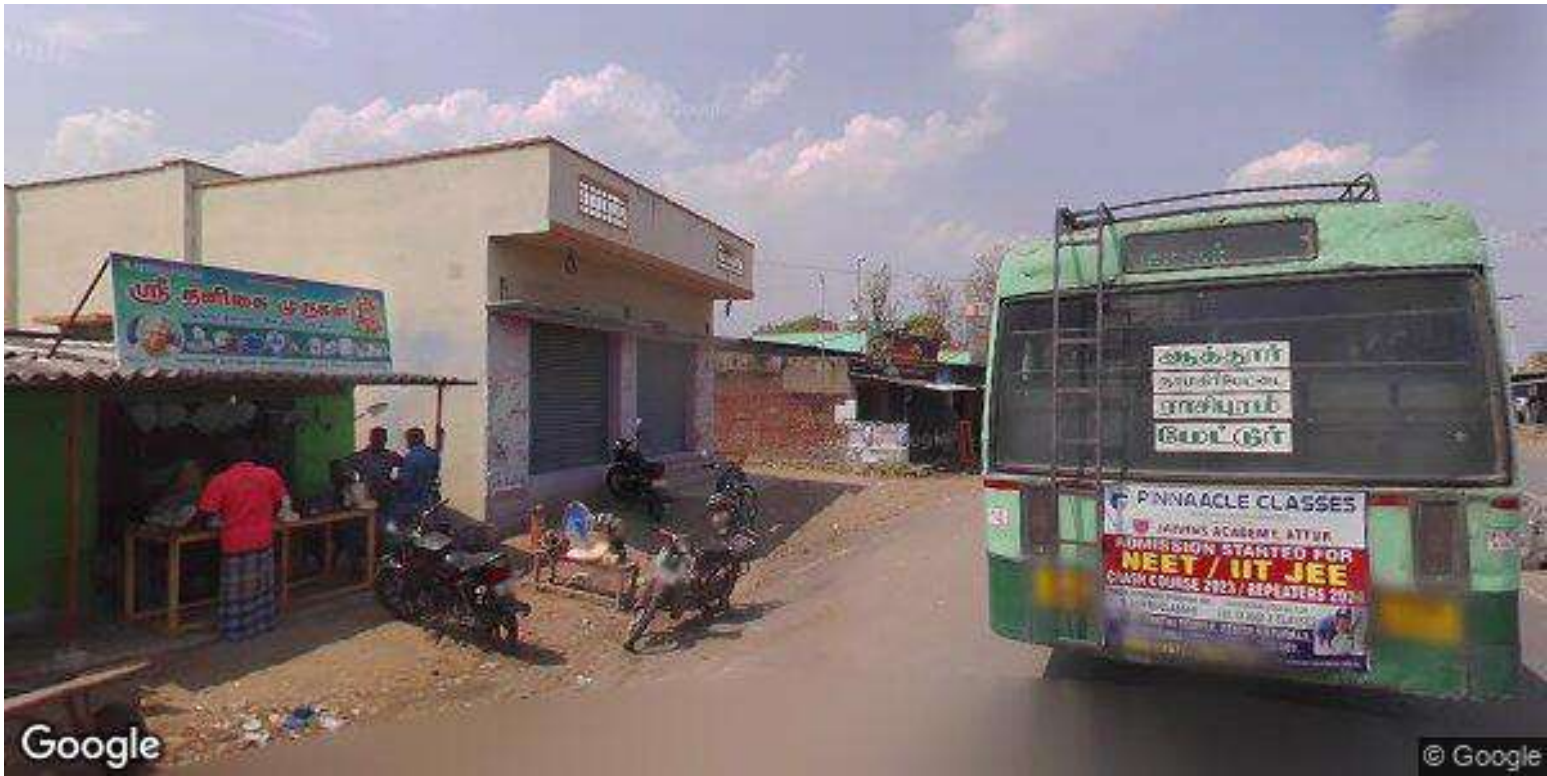
**Risk Type:** Turn  
**Risk Level:** Medium  
**Speed Limit:** 30 KM/Hr  
**Coordinates:** 11.64721, 77.95118

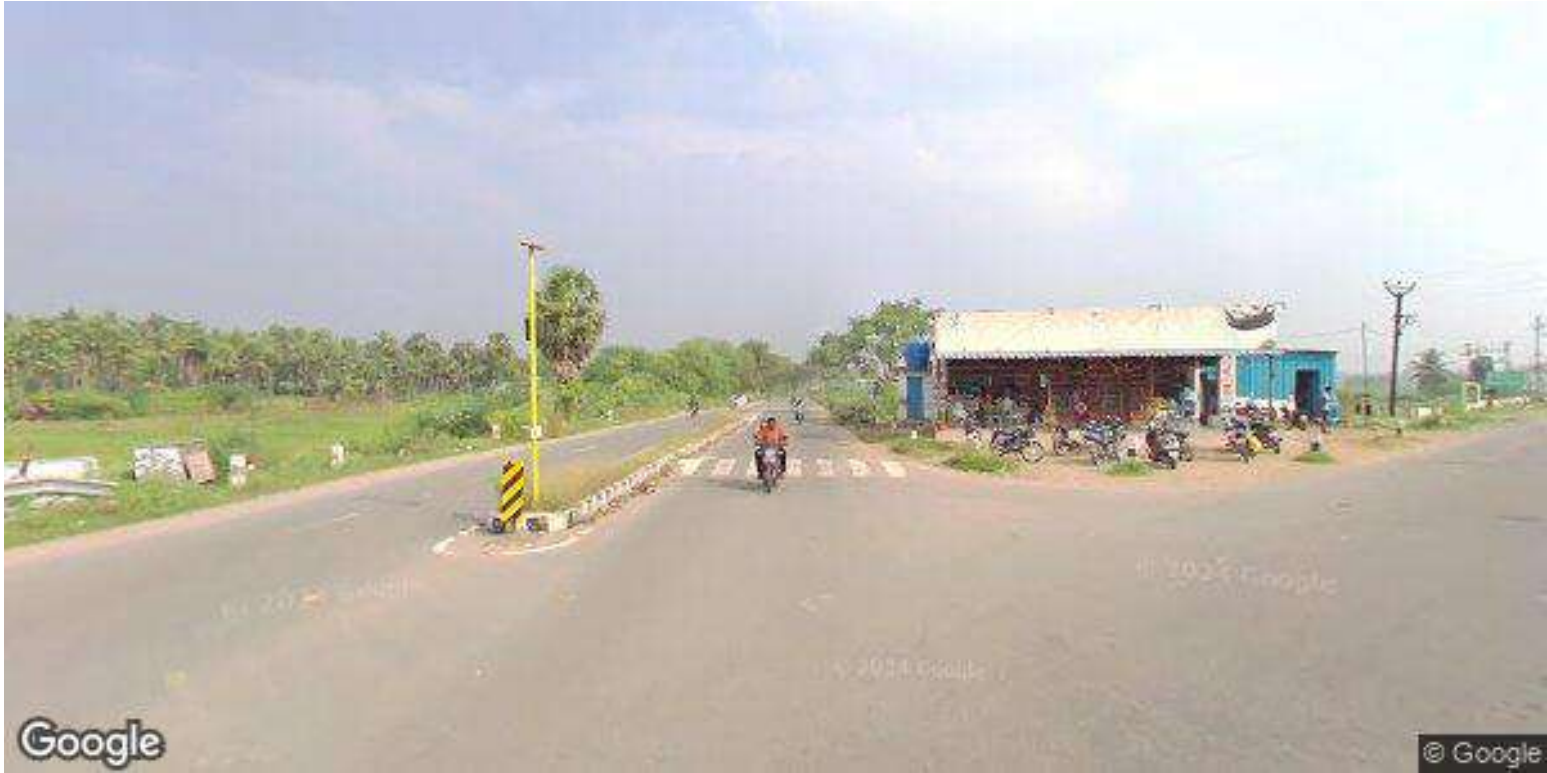
**Risk Type:** Turn  
**Risk Level:** Medium  
**Speed Limit:** 30 KM/Hr  
**Coordinates:** 11.67870, 77.96846

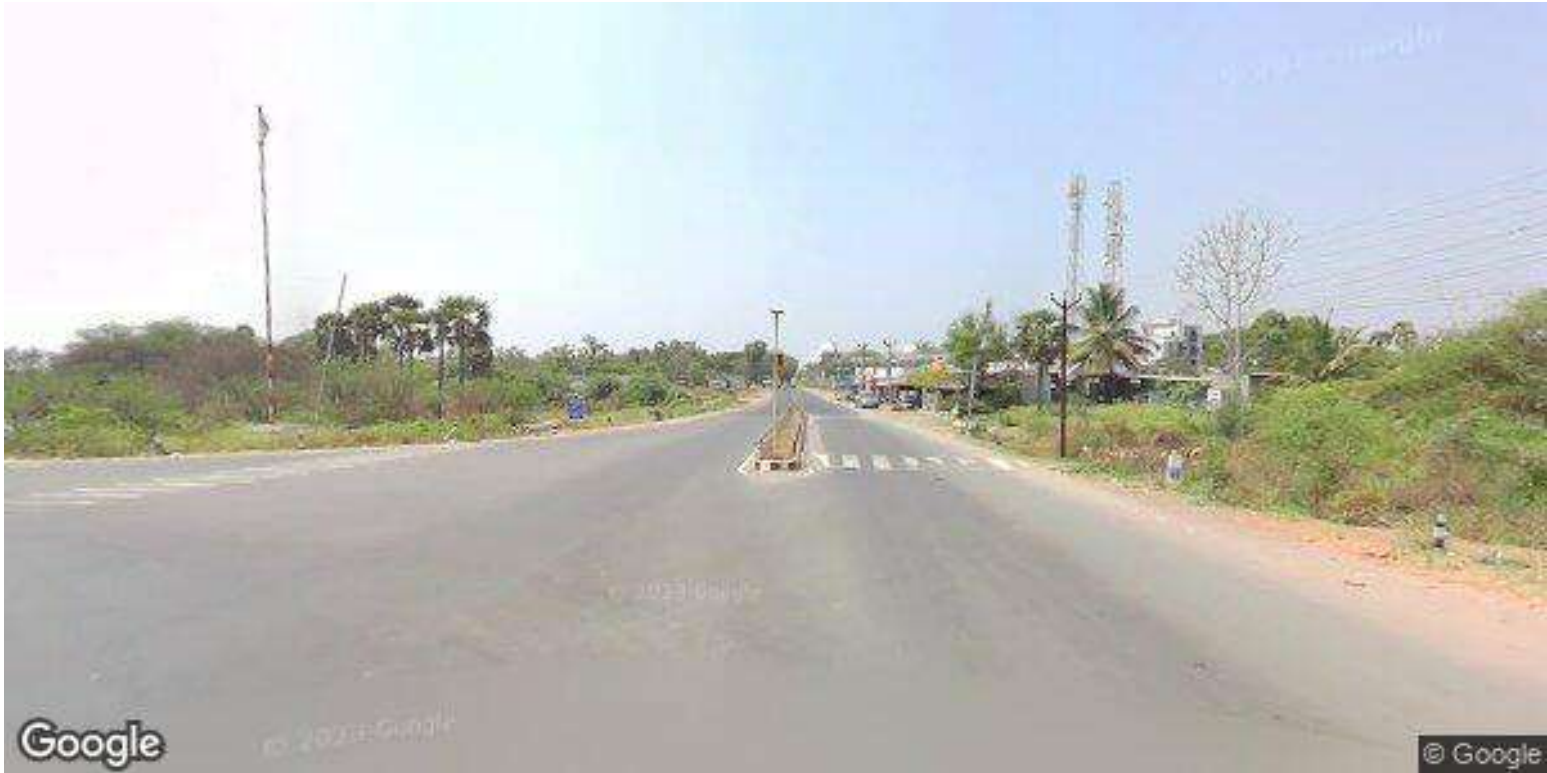
**Coordinates: 11.70227, 77.97864**

**Risk Type: Turn**

**Risk Level: High**

**Speed Limit: 15 KM/Hr**

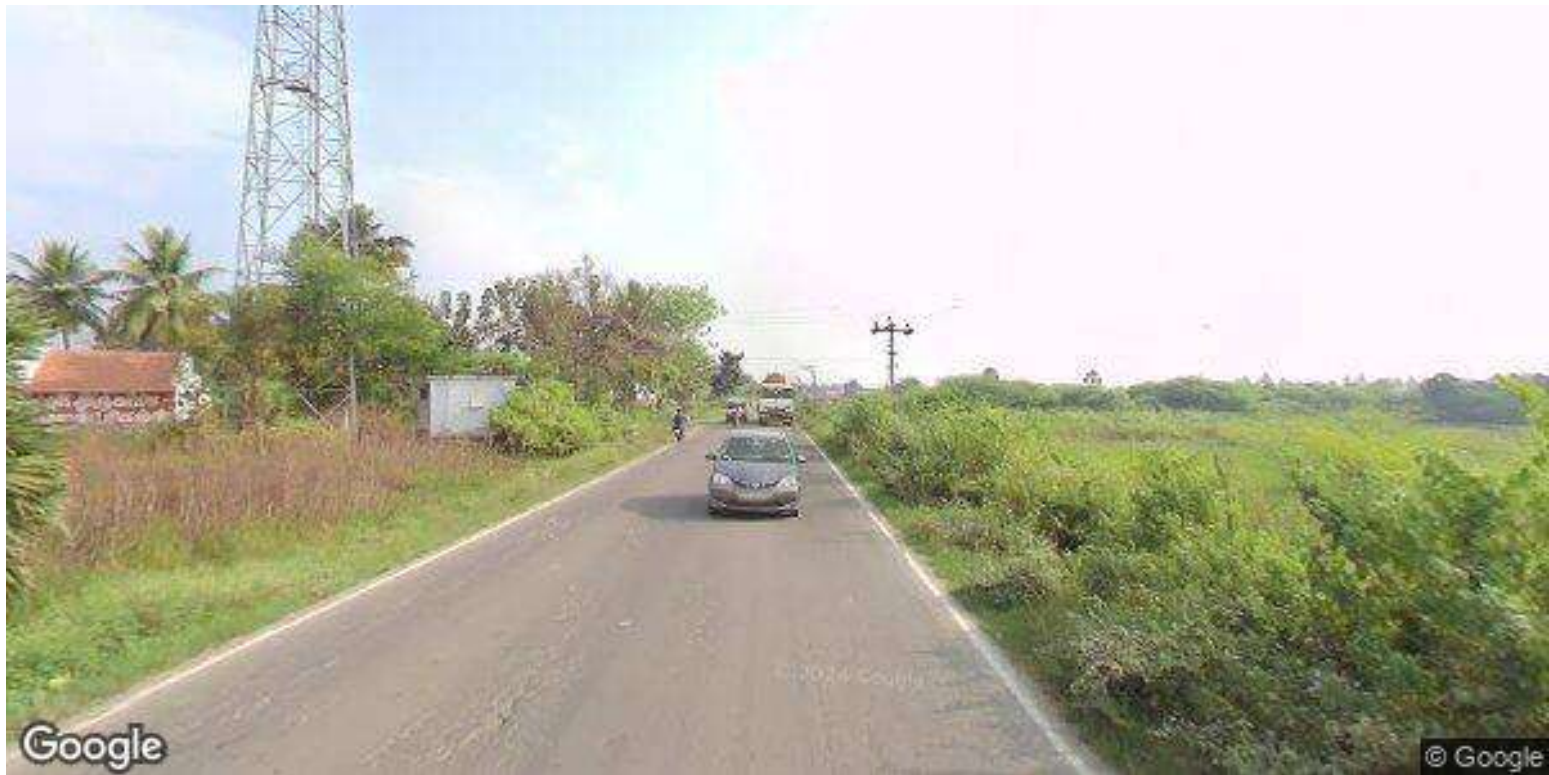
**Coordinates: 11.71416, 77.99604**

**Risk Type: Turn**

**Risk Level: Medium**

**Speed Limit: 30 KM/Hr**

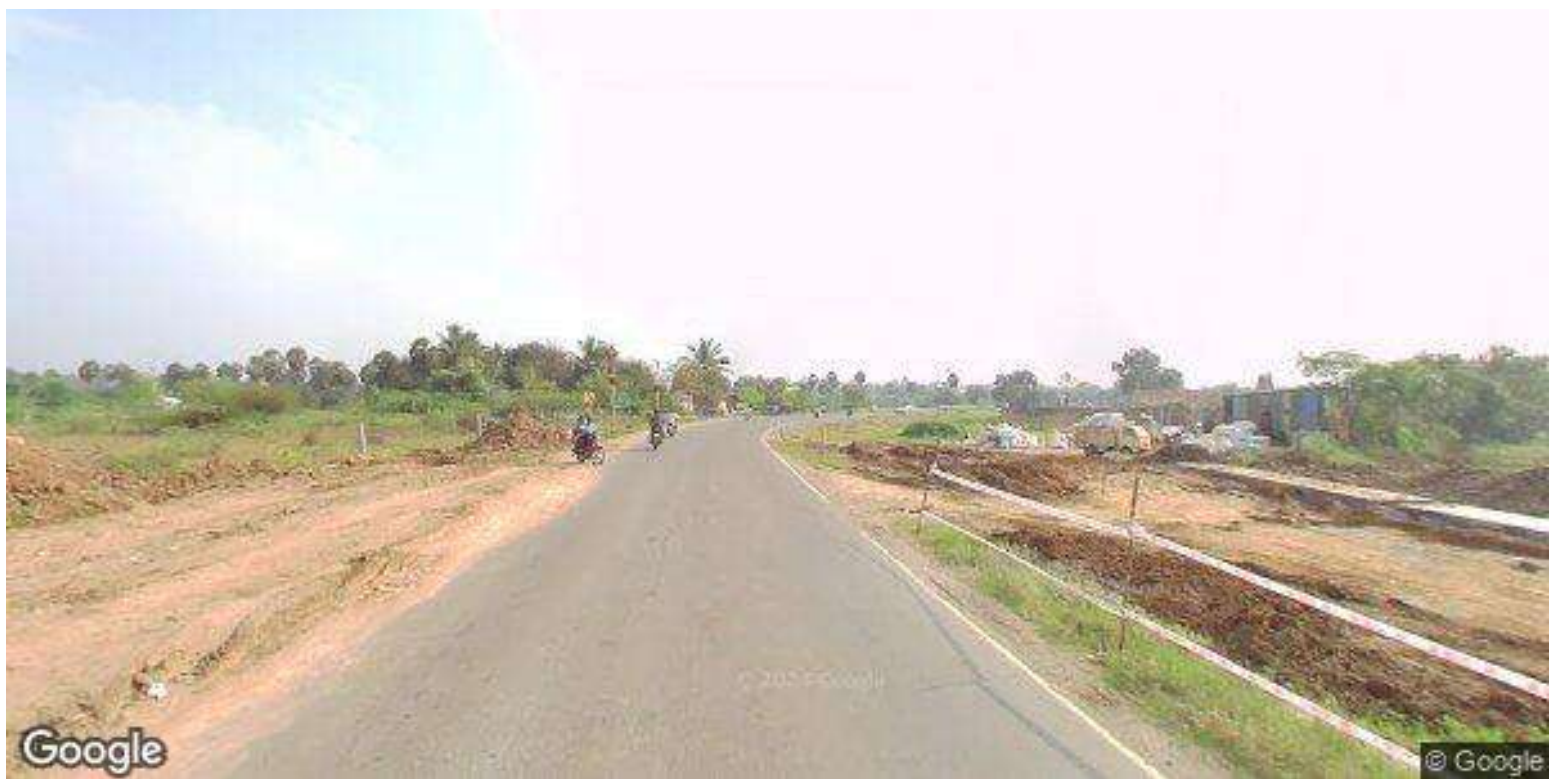
**Coordinates: 11.71715, 77.99969**

**Risk Type: Turn**

**Risk Level: Medium**

**Speed Limit: 30 KM/Hr**

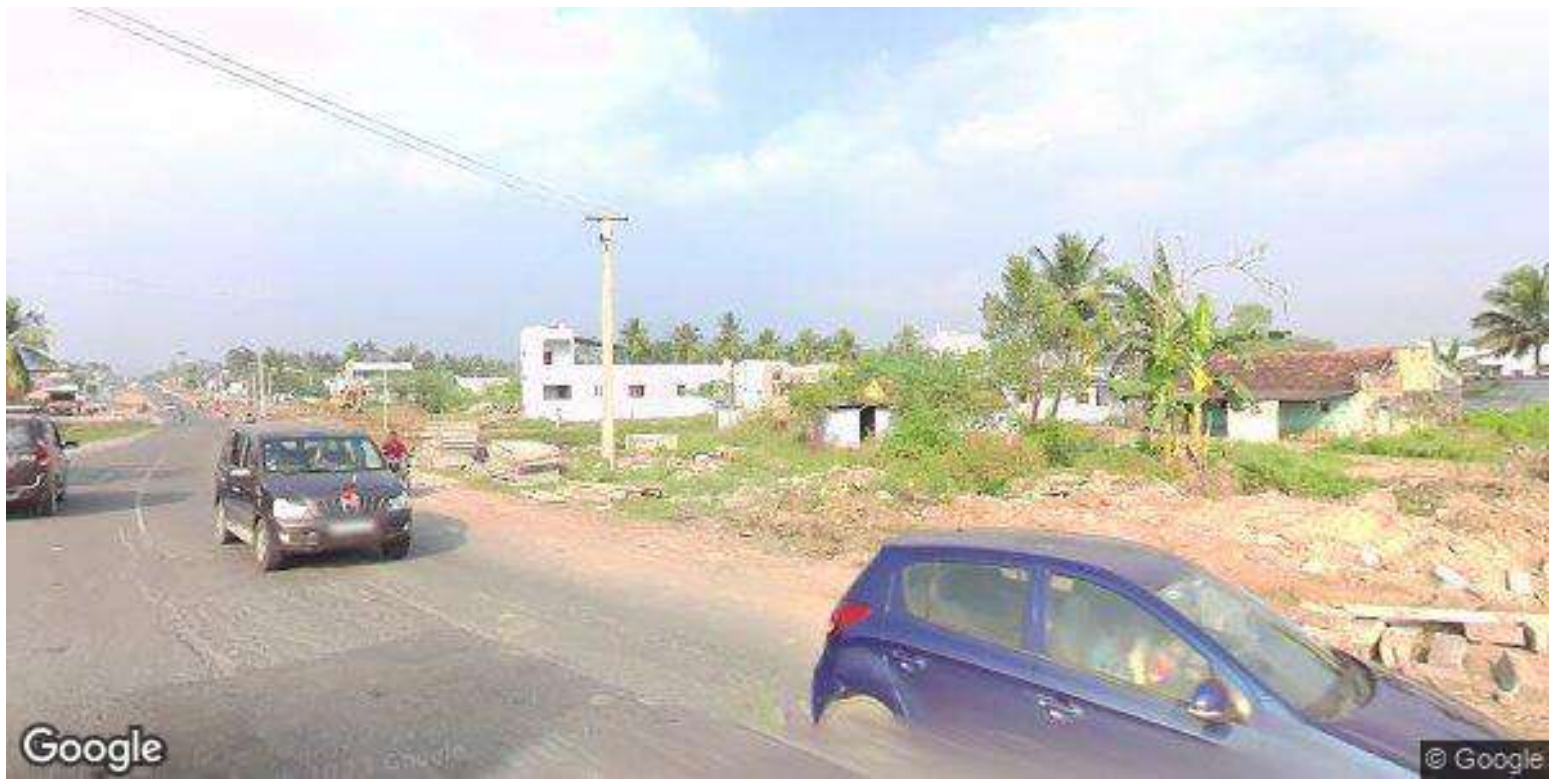
**Coordinates:** 11.71921, 78.01133

**Risk Type:** Turn

**Risk Level:** Medium

**Speed Limit:** 30 KM/Hr
