# IndianOil

## JOURNEY RISK MANAGEMENT (JRM) STUDY

### Salem Terminal to NEHRU AGENCY

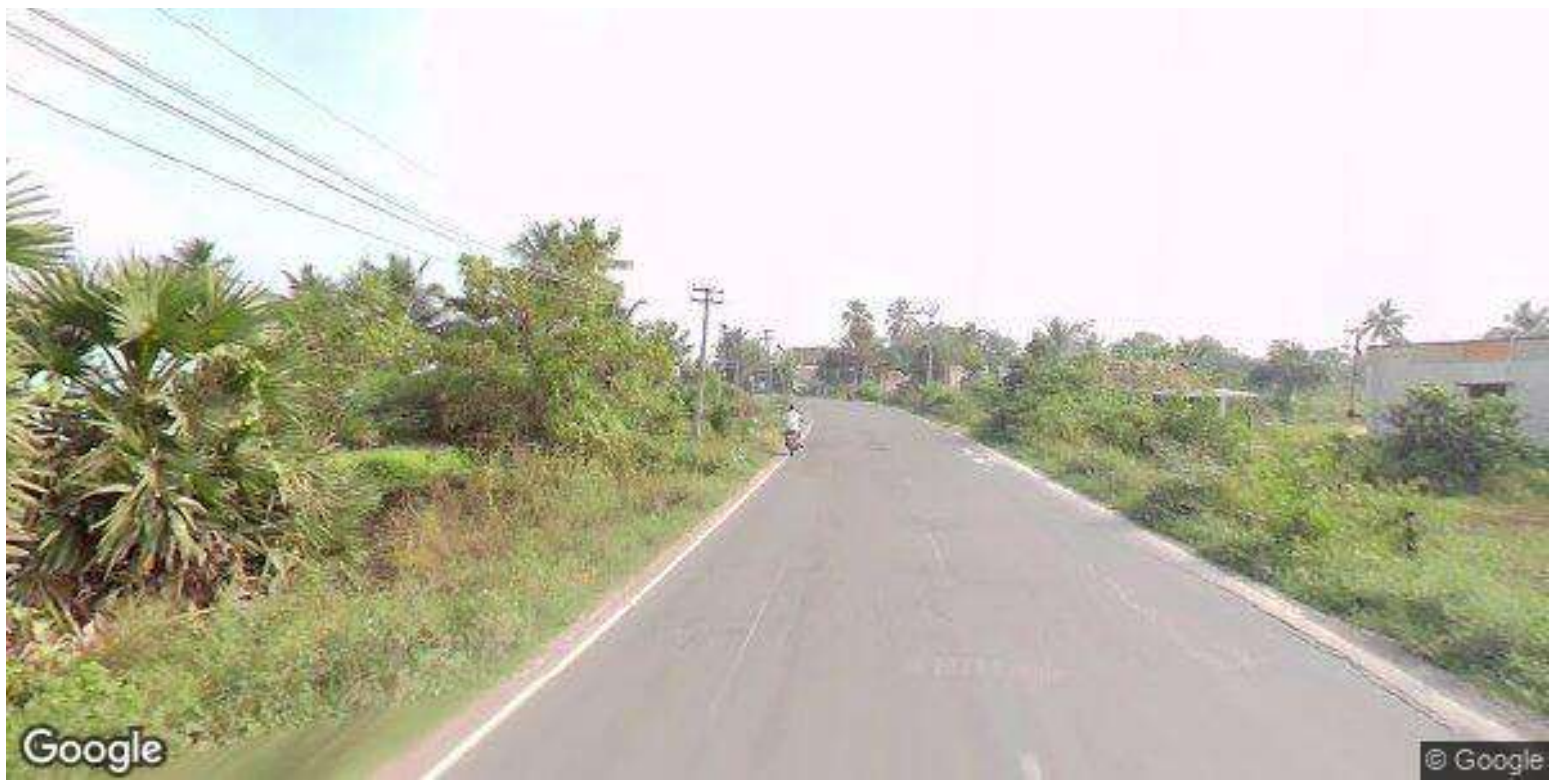
**Coordinates:** 11.72737, 78.02248

**Risk Type:** Turn

**Risk Level:** Medium

**Speed Limit:** 30 KM/Hr

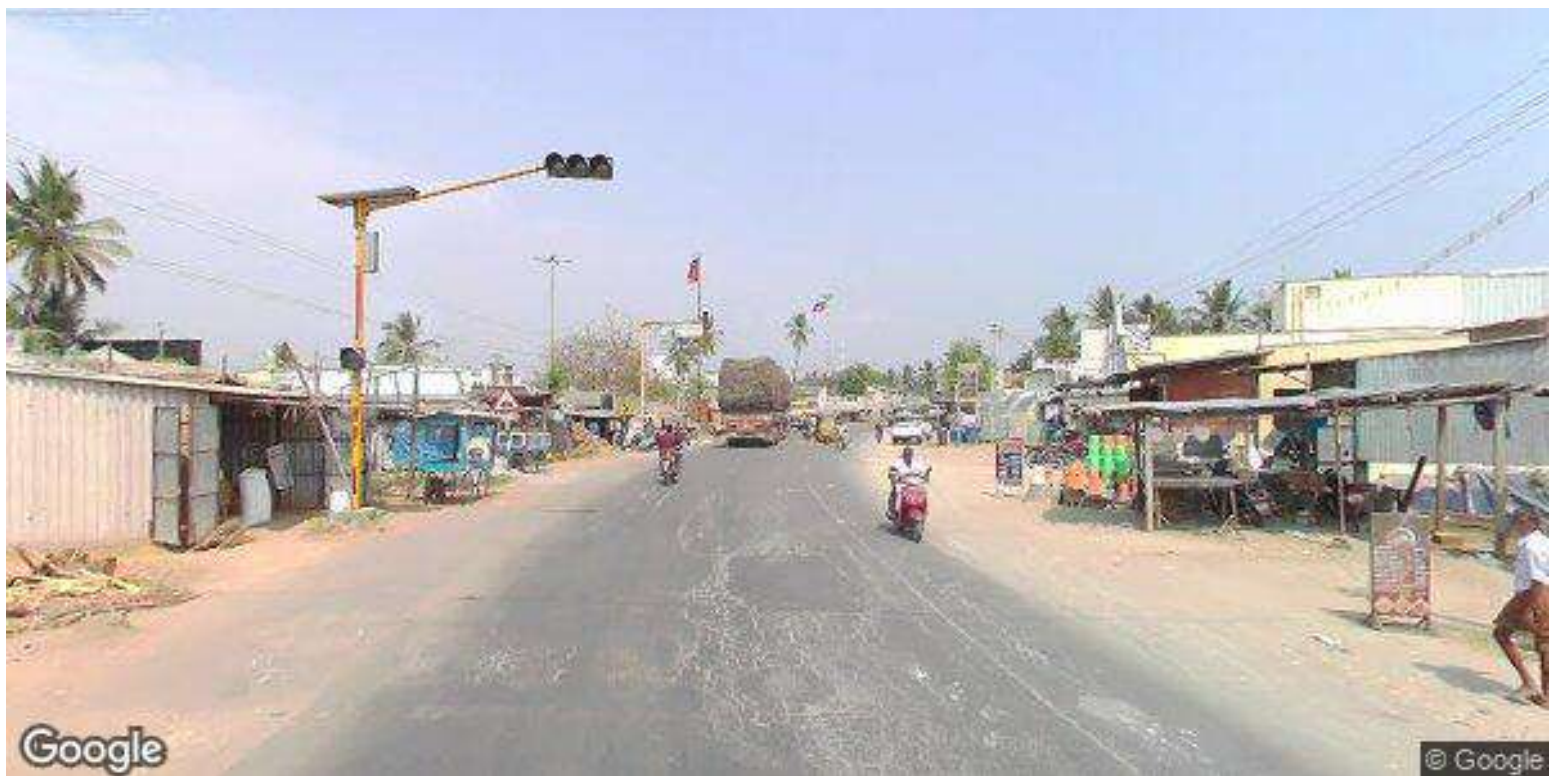
**Coordinates: 11.73775, 78.03465**

**Risk Type: Turn**

**Risk Level: High**

**Speed Limit: 15 KM/Hr**

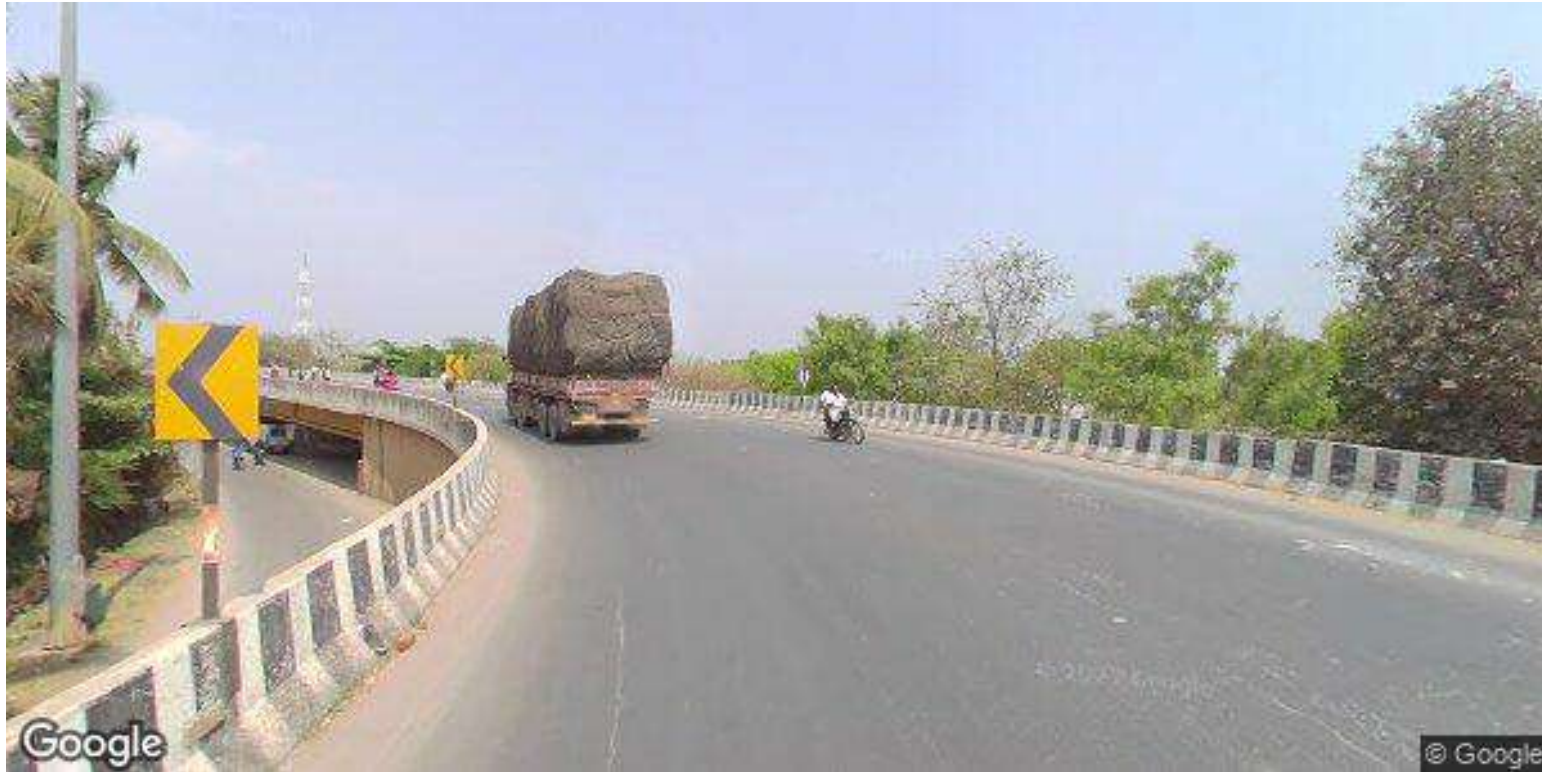
**Coordinates: 11.73651, 78.03878**

**Risk Type: Turn**

**Risk Level: High**

**Speed Limit: 15 KM/Hr**

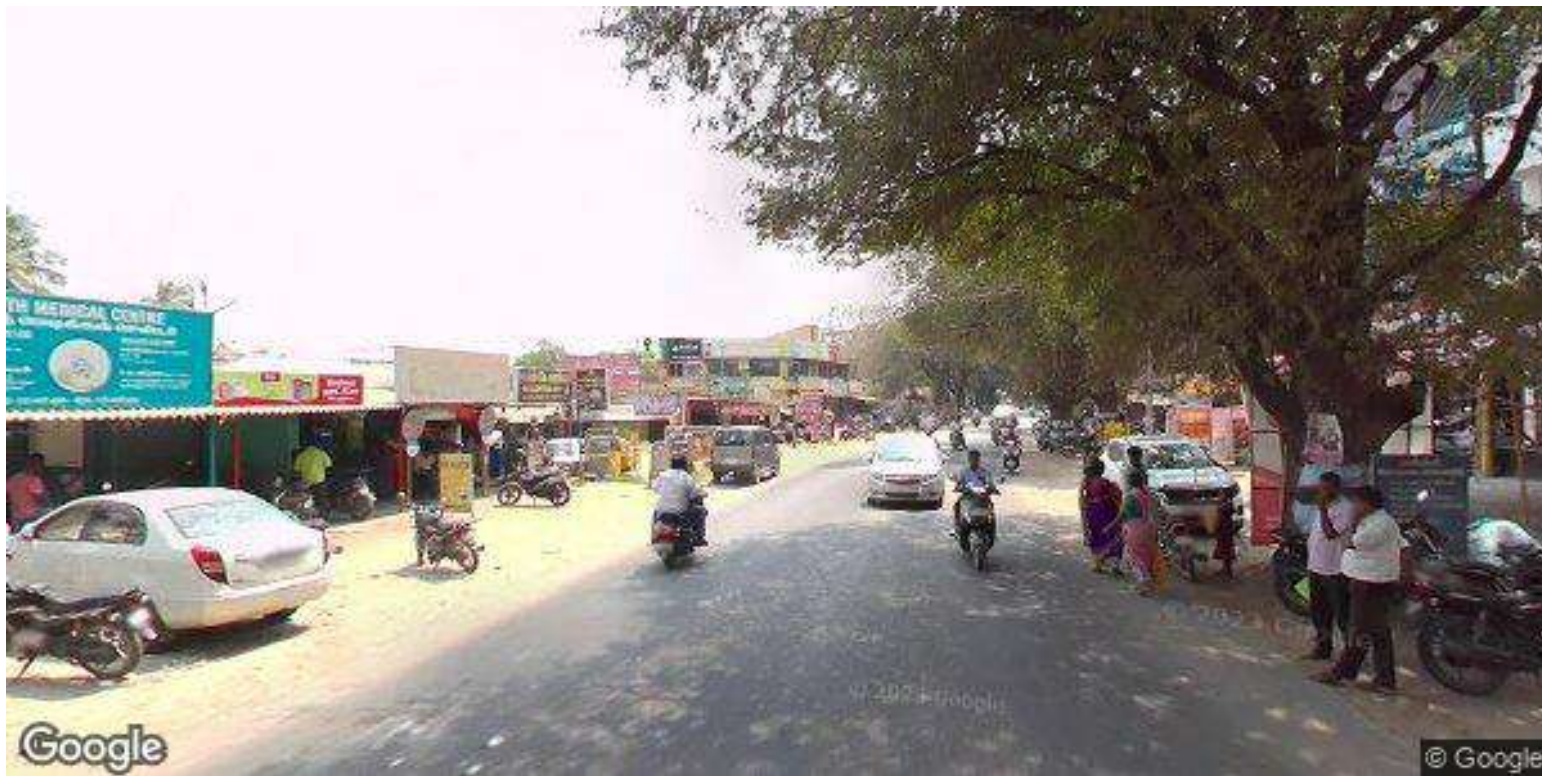
**Coordinates: 11.74189, 78.04660**

**Risk Type: Turn**

**Risk Level: High**

**Speed Limit: 15 KM/Hr**

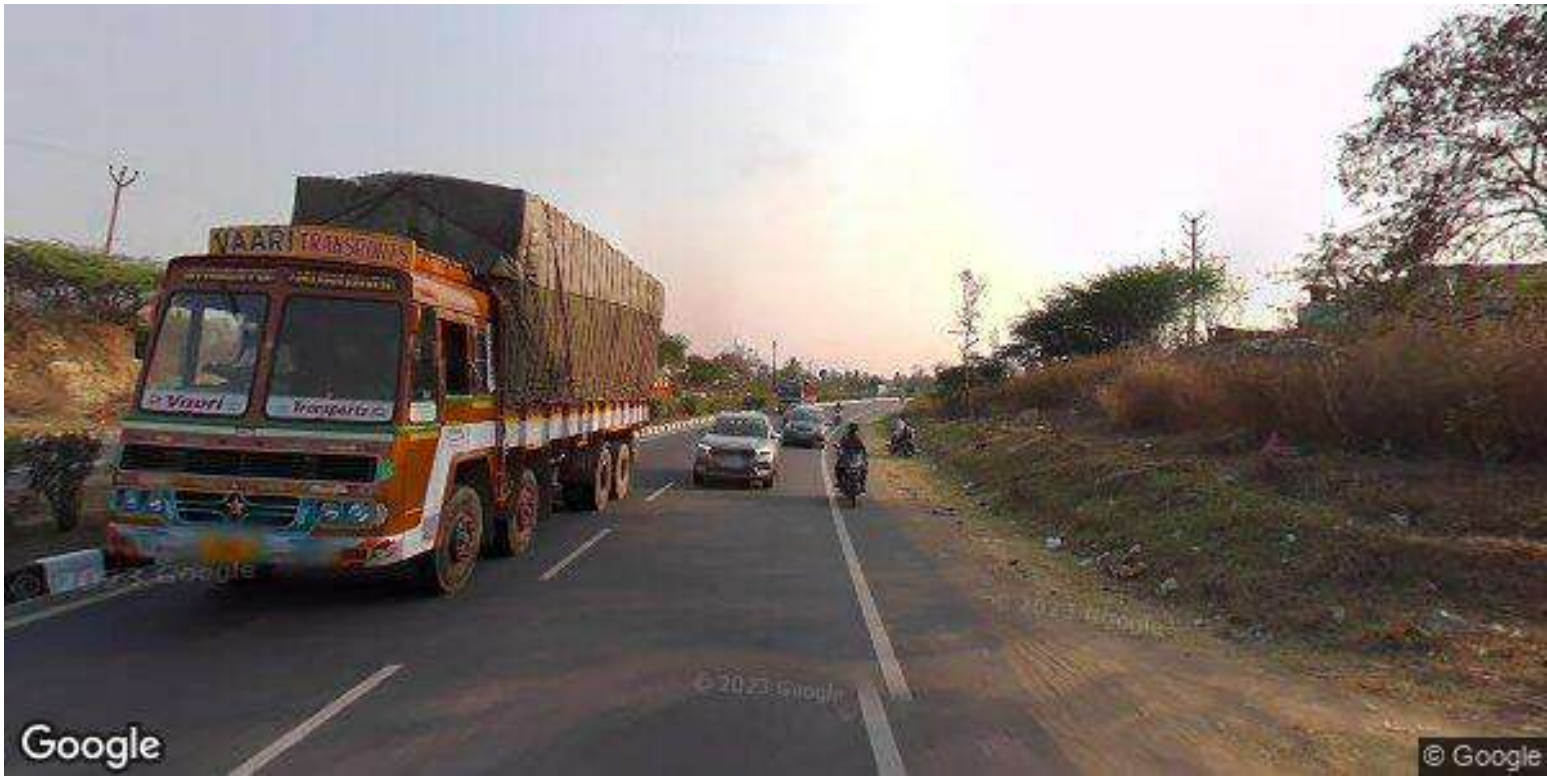
**Coordinates:** 11.78039, 78.05792

**Risk Type:** Turn

**Risk Level:** Medium

**Speed Limit:** 30 KM/Hr

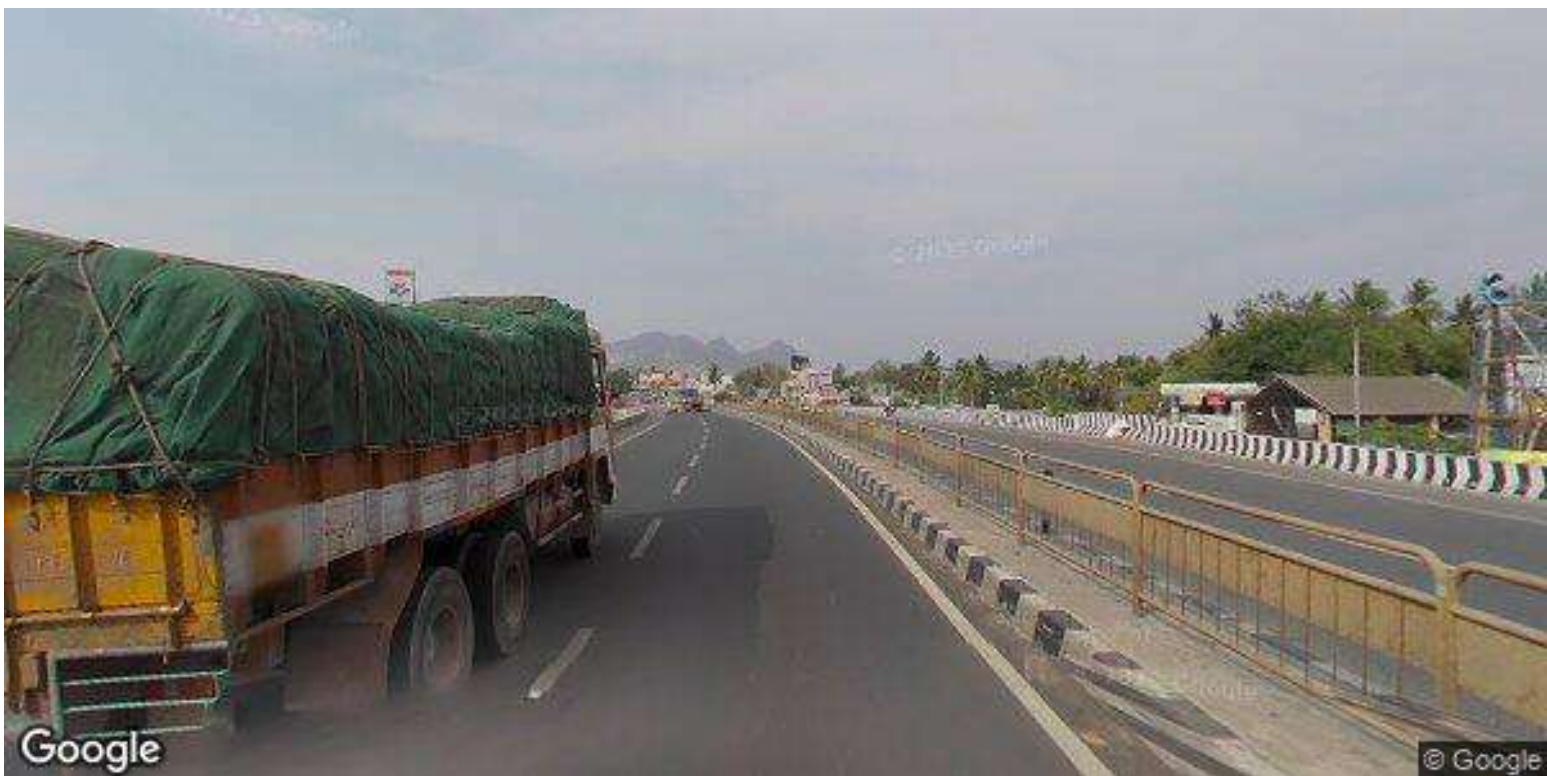
**Coordinates:** 11.86753, 78.08331

**Risk Type:** Turn

**Risk Level:** Medium

**Speed Limit:** 30 KM/Hr

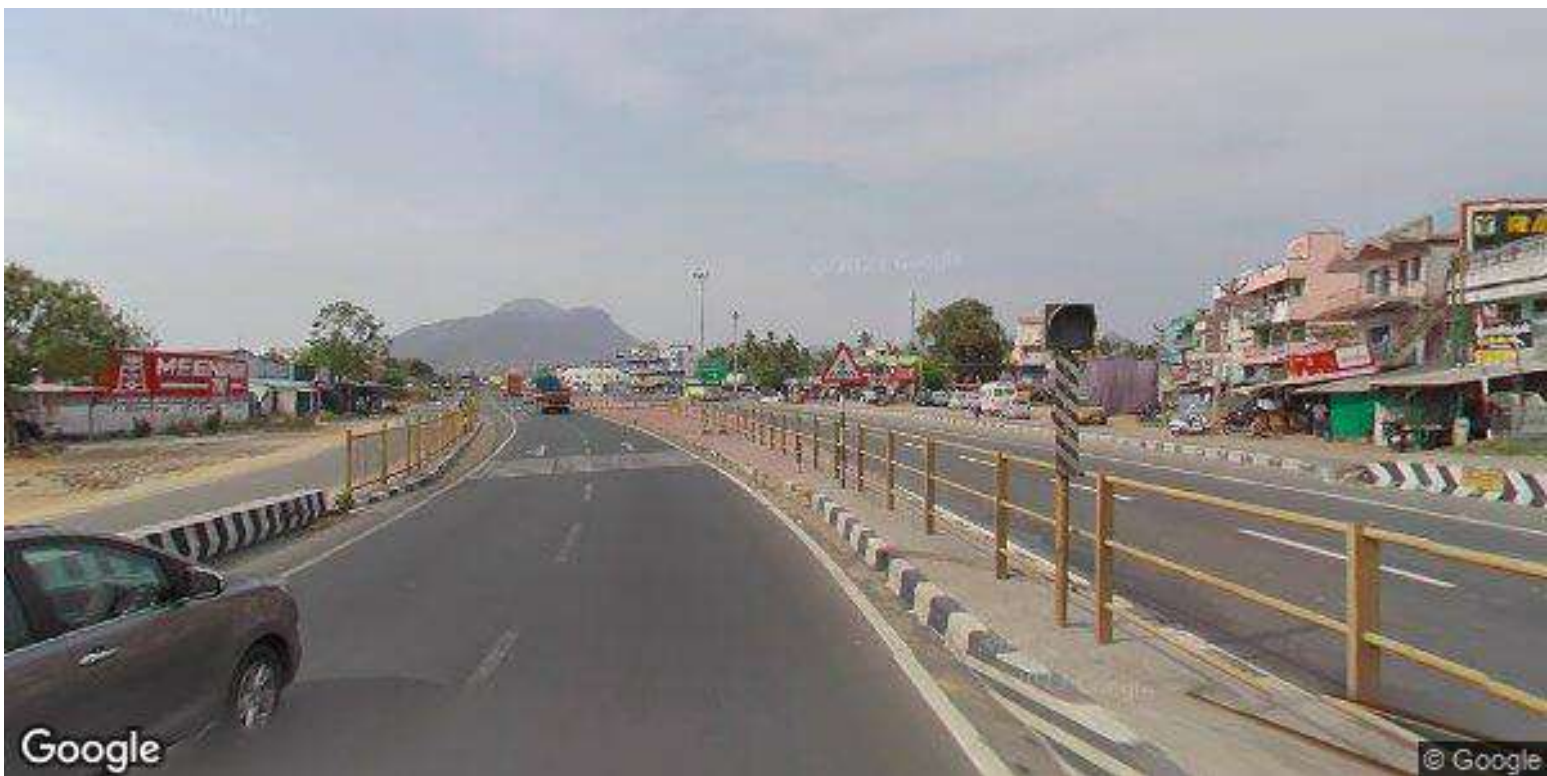
**Risk Type:** Turn  
**Risk Level:** Medium  
**Speed Limit:** 30 KM/Hr  
**Coordinates:** 11.86981, 78.08387

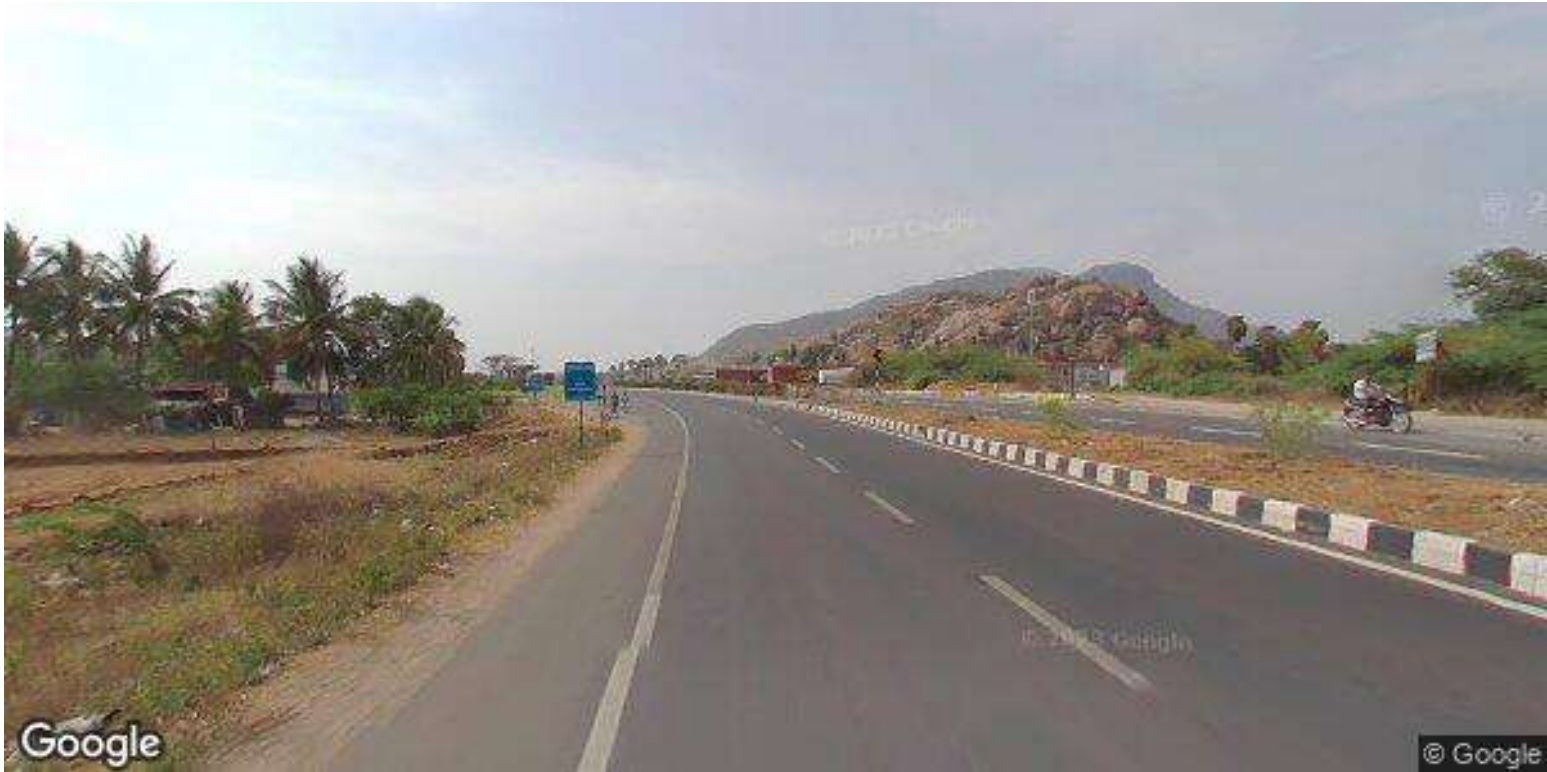
**Risk Type:** Turn  
**Risk Level:** Medium  
**Speed Limit:** 30 KM/Hr  
**Coordinates:** 11.88041, 78.08143

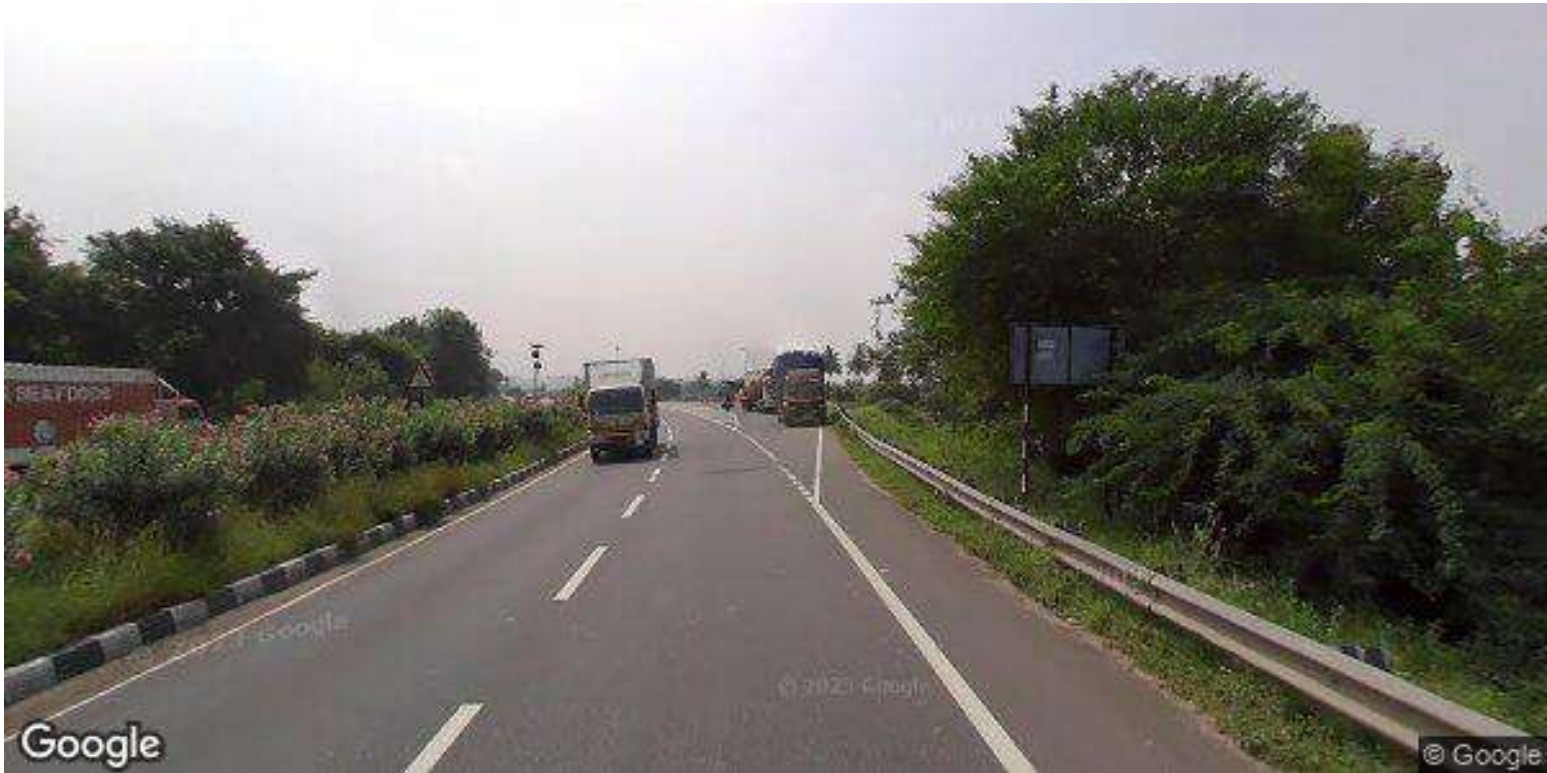
**Risk Type:** Turn  
**Risk Level:** Medium  
**Speed Limit:** 30 KM/Hr  
**Coordinates:** 11.91302, 78.05856

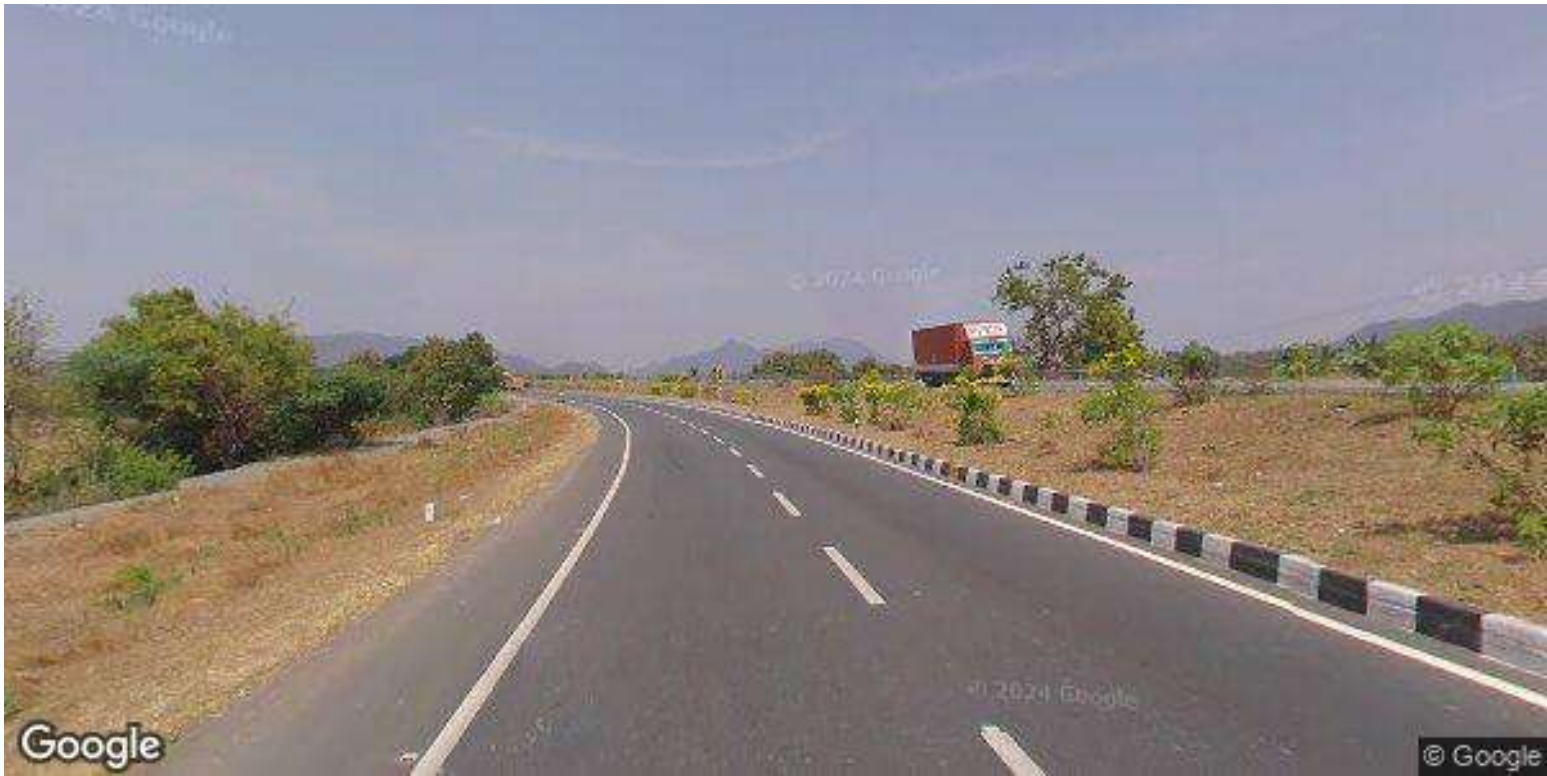
**Risk Type:** Turn  
**Risk Level:** Medium  
**Speed Limit:** 30 KM/Hr  
**Coordinates:** 11.92526, 78.06488

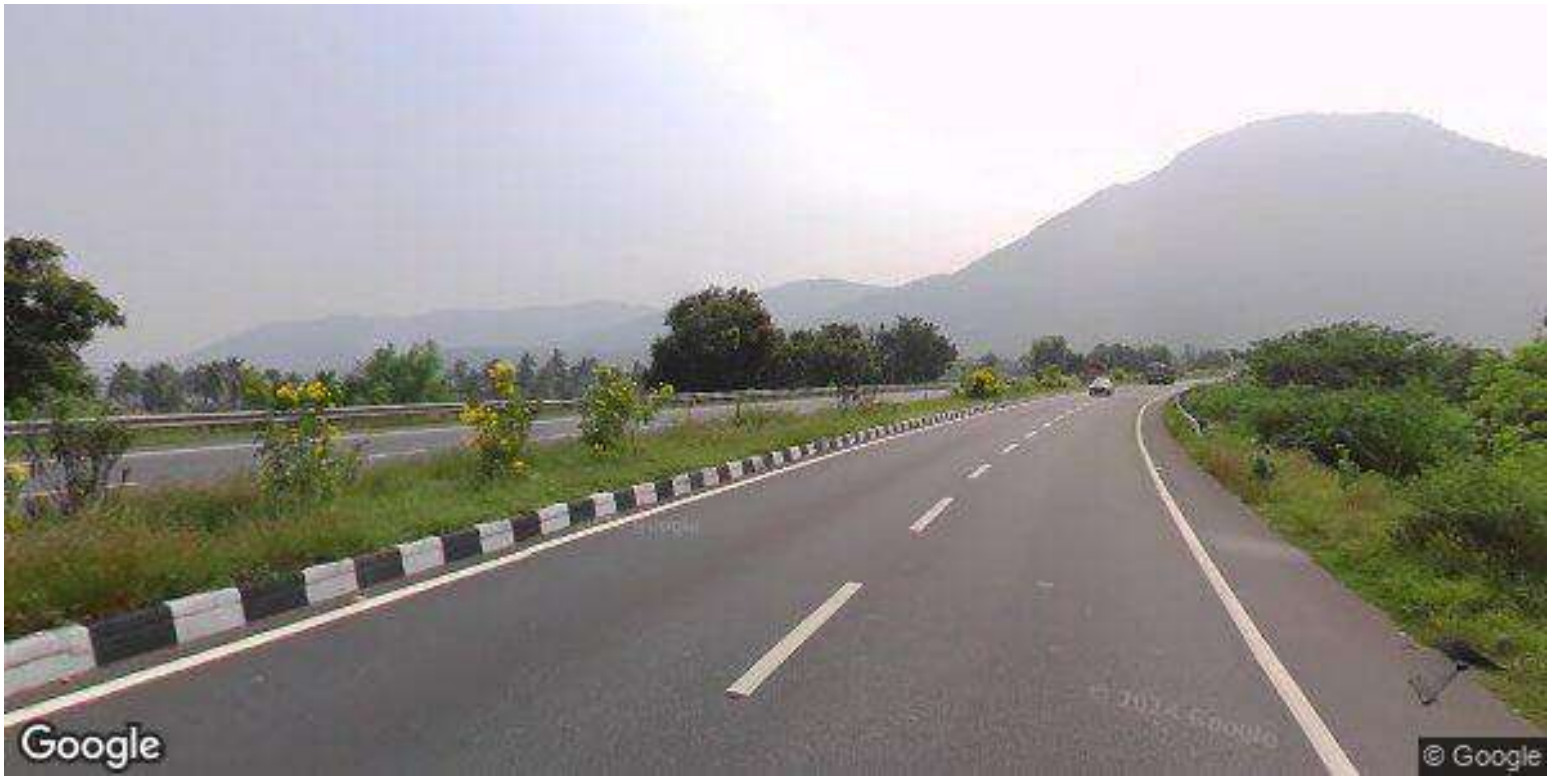
**Risk Type:** Turn  
**Risk Level:** Medium  
**Speed Limit:** 30 KM/Hr  
**Coordinates:** 11.93402, 78.06354

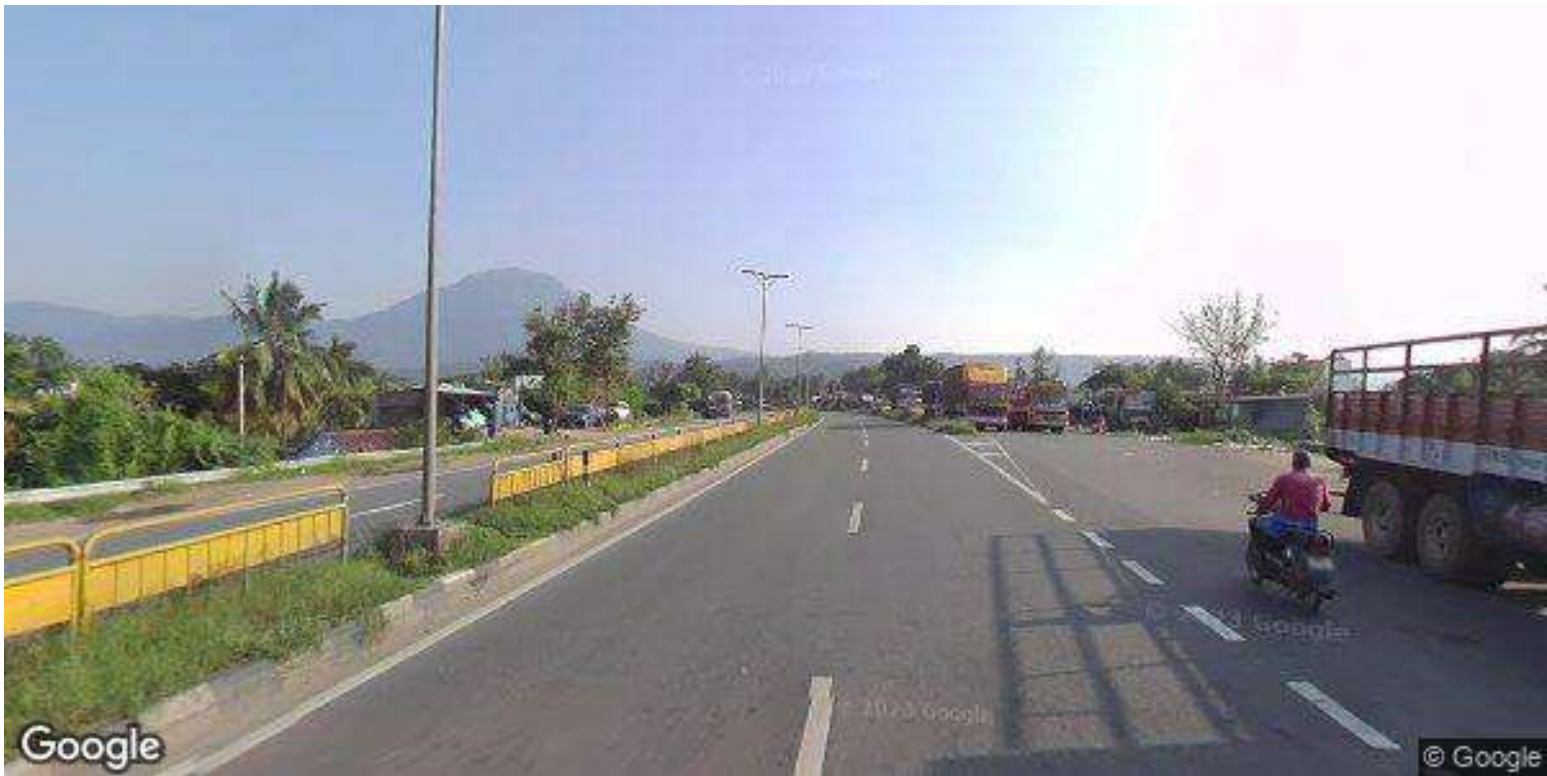
**Risk Type:** Turn  
**Risk Level:** Medium  
**Speed Limit:** 30 KM/Hr  
**Coordinates:** 11.94600, 78.04740

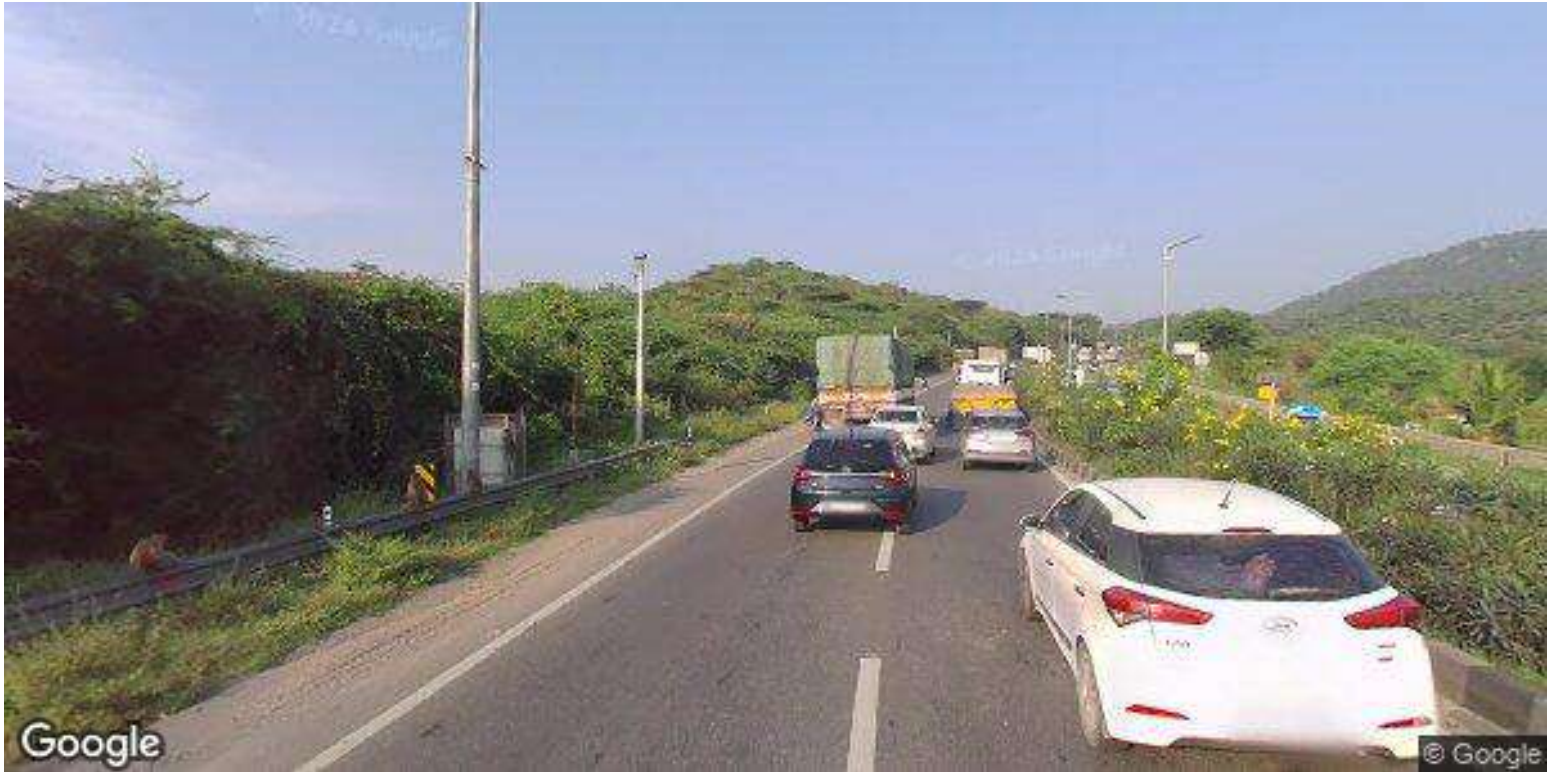
**Risk Type:** Turn  
**Risk Level:** Medium  
**Speed Limit:** 30 KM/Hr  
**Coordinates:** 11.95625, 78.04748

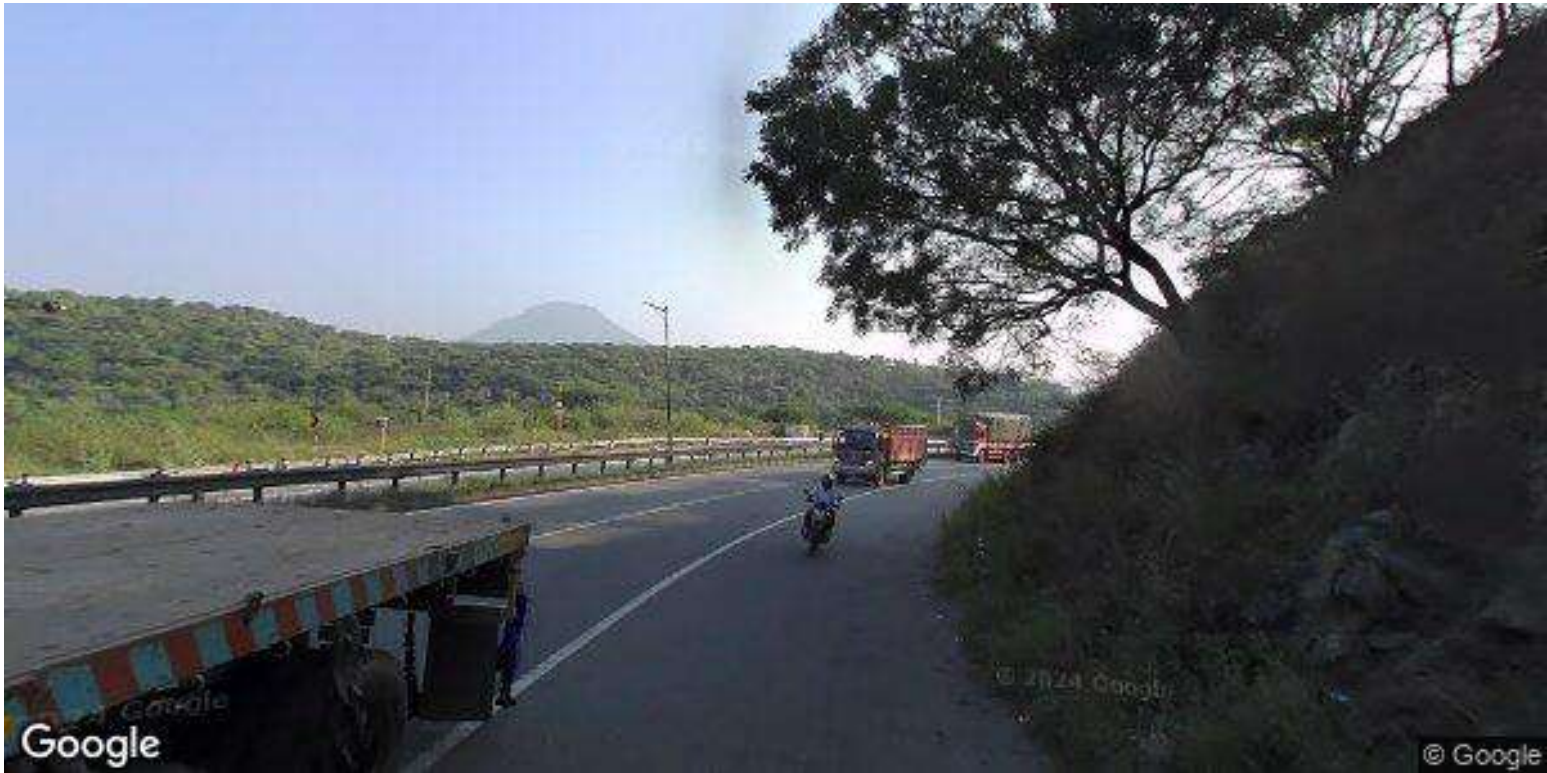
**Risk Type:** Turn  
**Risk Level:** High  
**Speed Limit:** 15 KM/Hr  
**Coordinates:** 11.95880, 78.04989

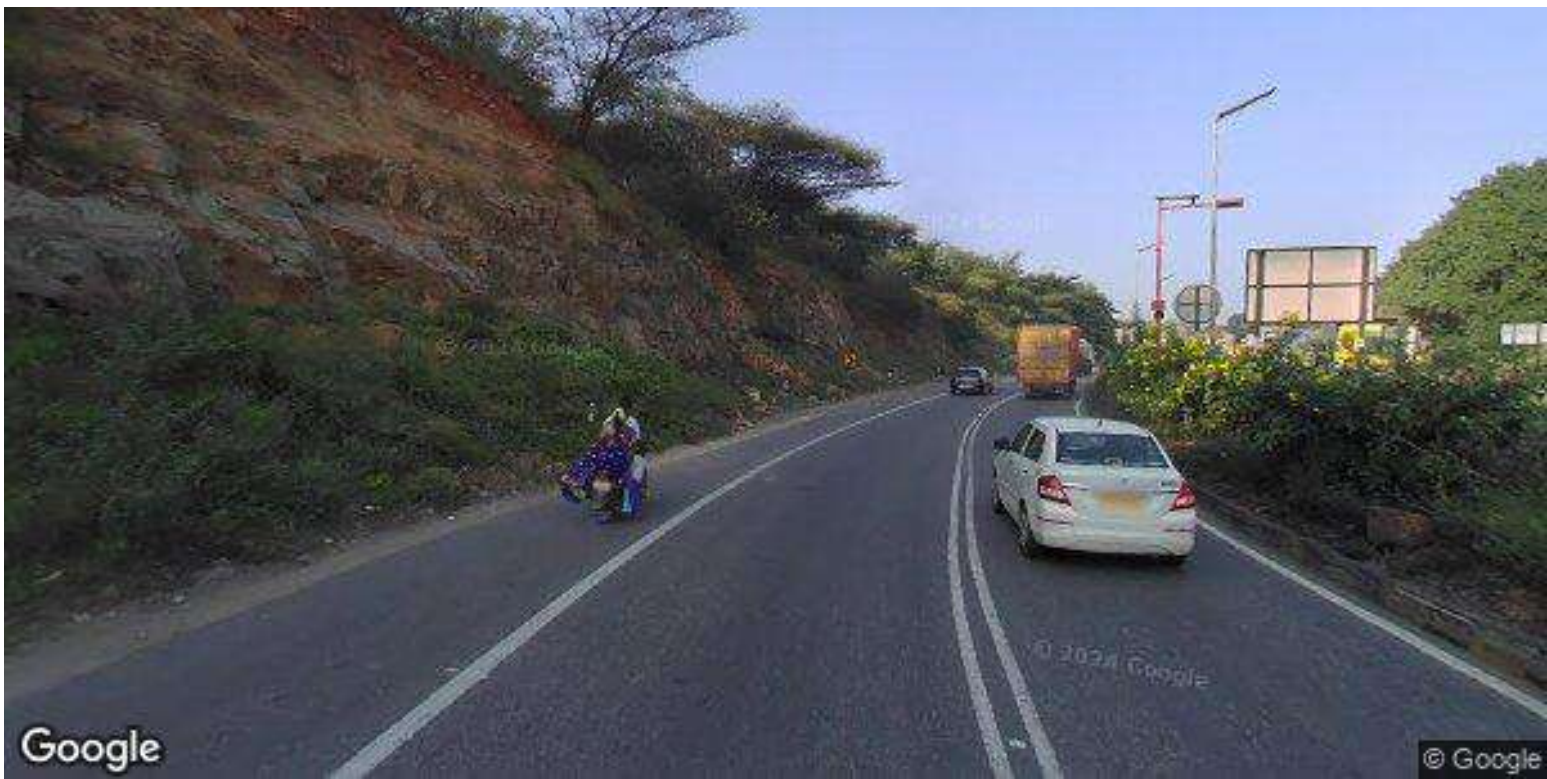
**Risk Type:** Turn  
**Risk Level:** High  
**Speed Limit:** 15 KM/Hr  
**Coordinates:** 11.96040, 78.04947

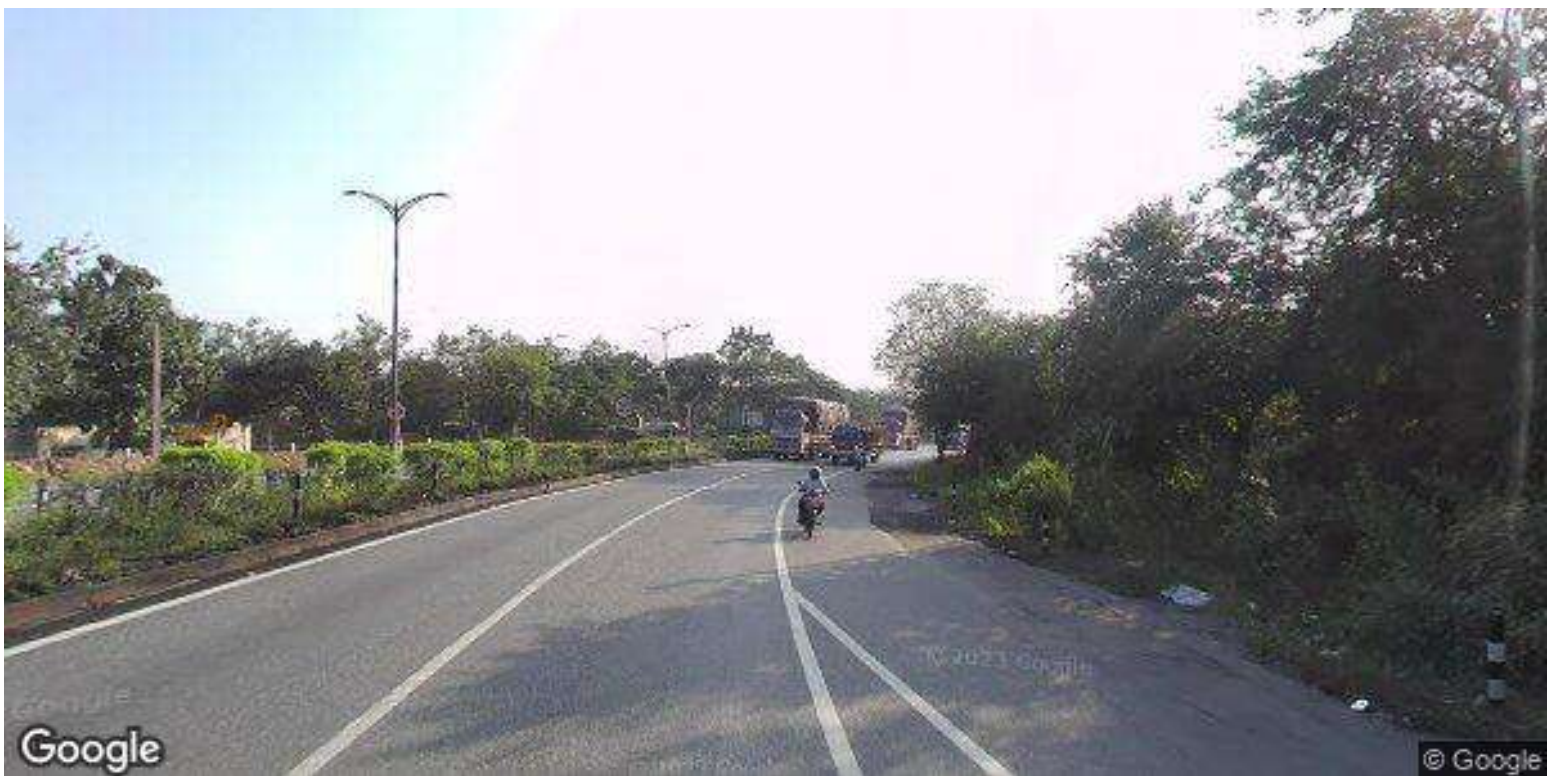
**Risk Type:** Turn  
**Risk Level:** High  
**Speed Limit:** 15 KM/Hr  
**Coordinates:** 11.96320, 78.05139

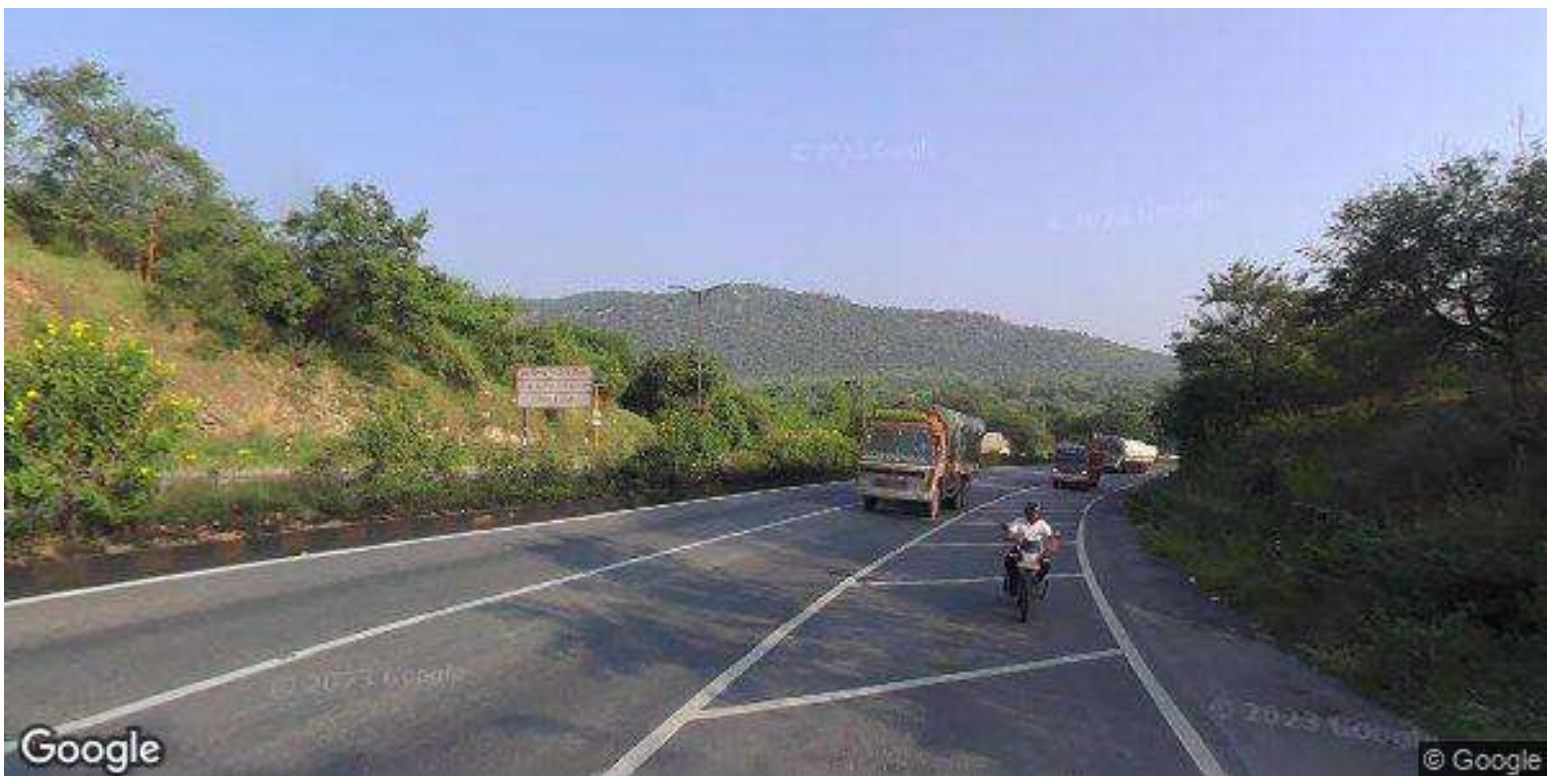
**Coordinates: 11.96463, 78.05077**

**Risk Type: Turn**

**Risk Level: Medium**

**Speed Limit: 30 KM/Hr**

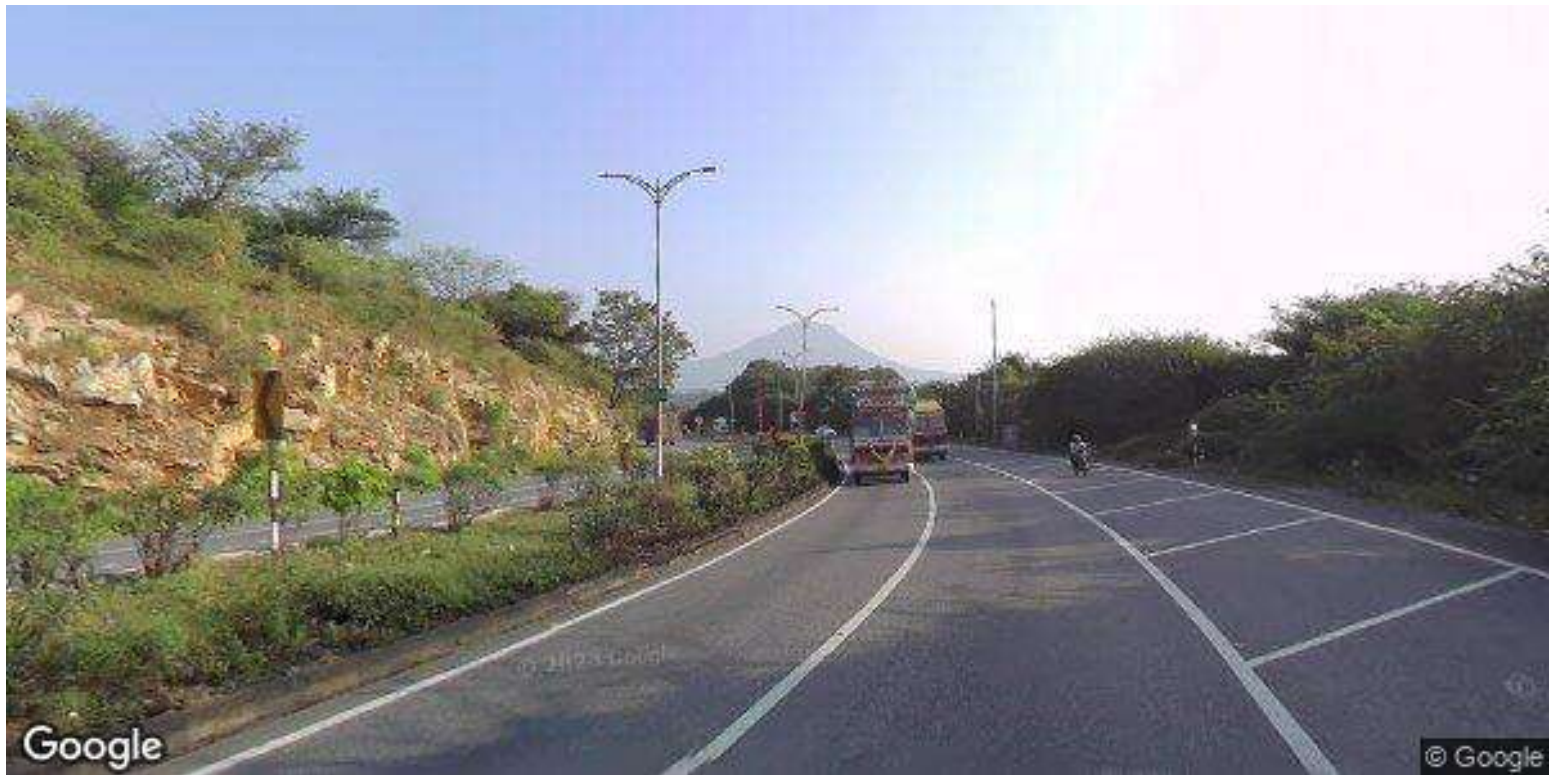
**Coordinates: 11.96597, 78.04920**

**Risk Type: Turn**

**Risk Level: High**

**Speed Limit: 15 KM/Hr**

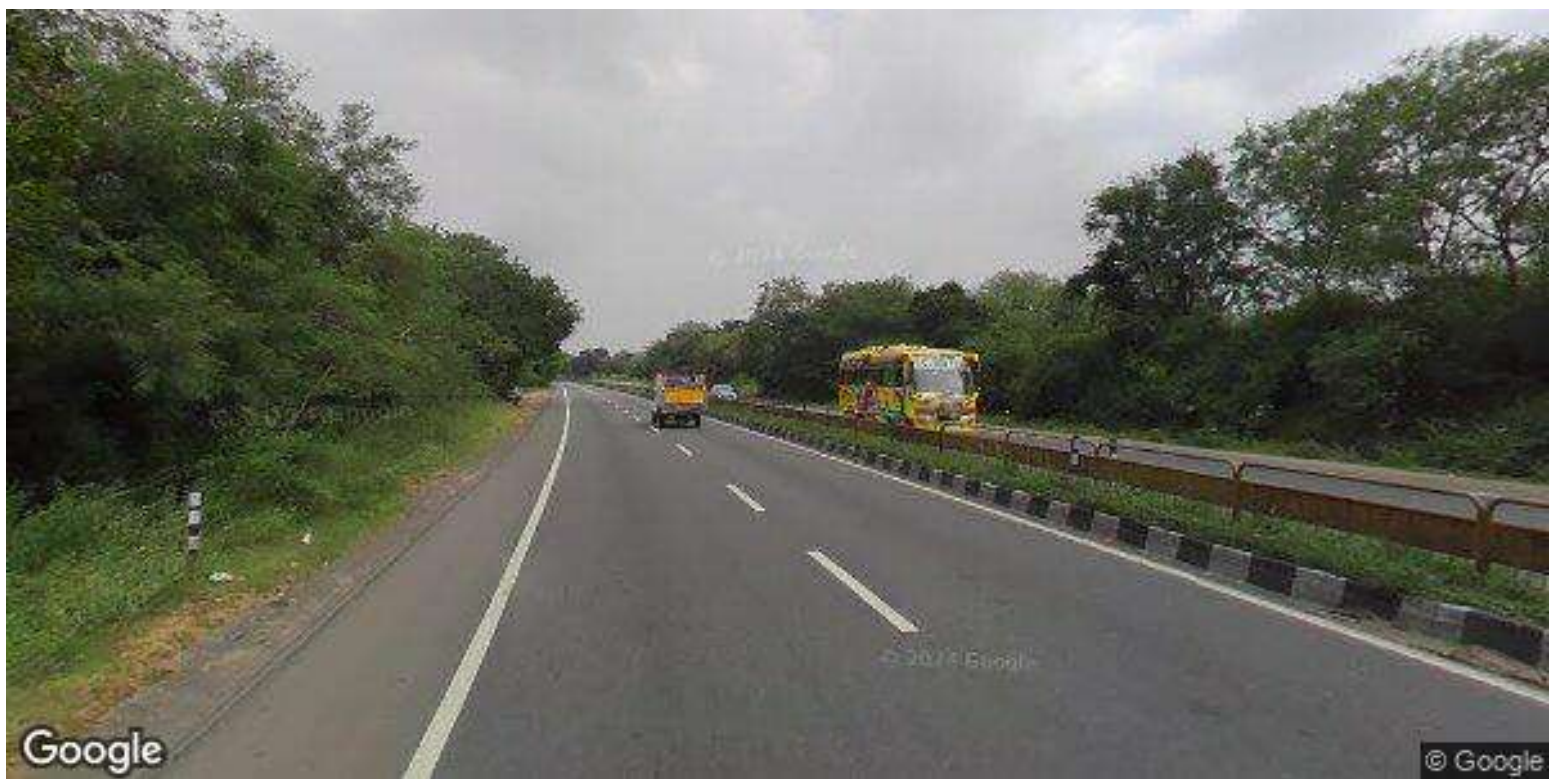
**Coordinates: 11.98504, 78.06287**

**Risk Type: Turn**

**Risk Level: Medium**

**Speed Limit: 30 KM/Hr**
