# IndianOil

## JOURNEY RISK MANAGEMENT (JRM) STUDY

### Salem Terminal to NEHRU AGENCY

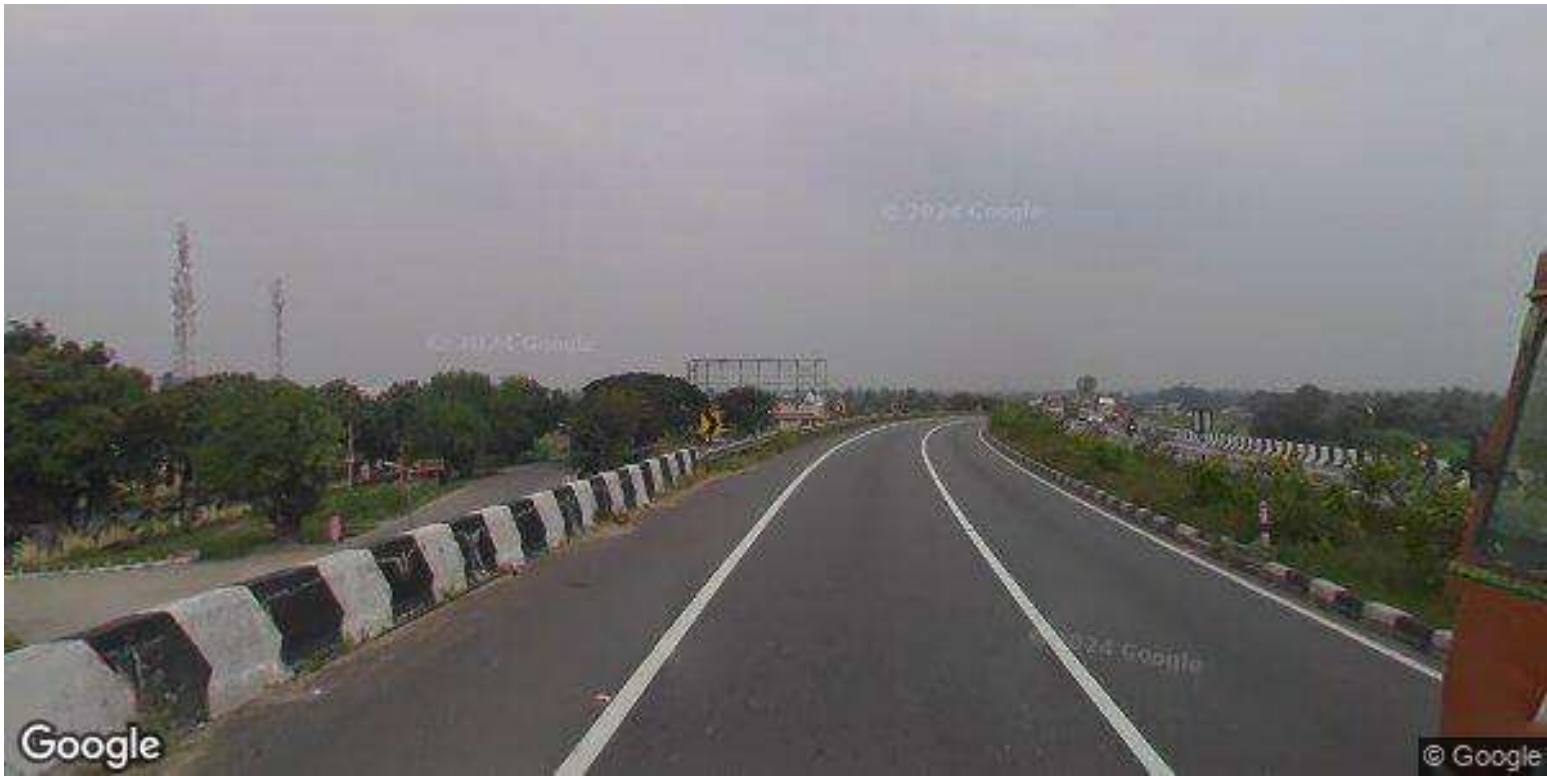
**Risk Type:** Turn  
**Risk Level:** High  
**Speed Limit:** 15 KM/Hr  
**Coordinates:** 12.24611, 78.19519

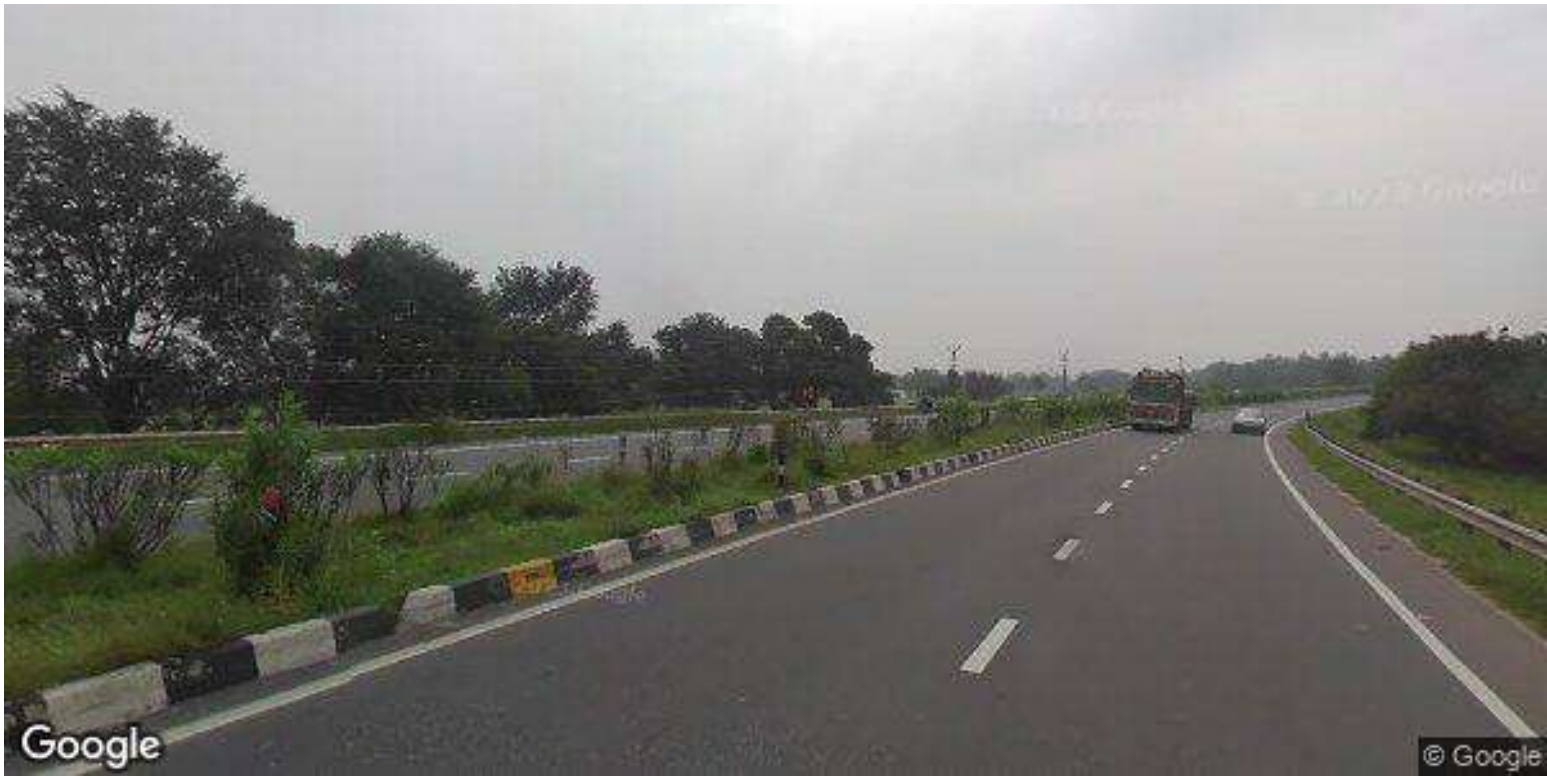
**Risk Type:** Turn  
**Risk Level:** Medium  
**Speed Limit:** 30 KM/Hr  
**Coordinates:** 12.25200, 78.20034

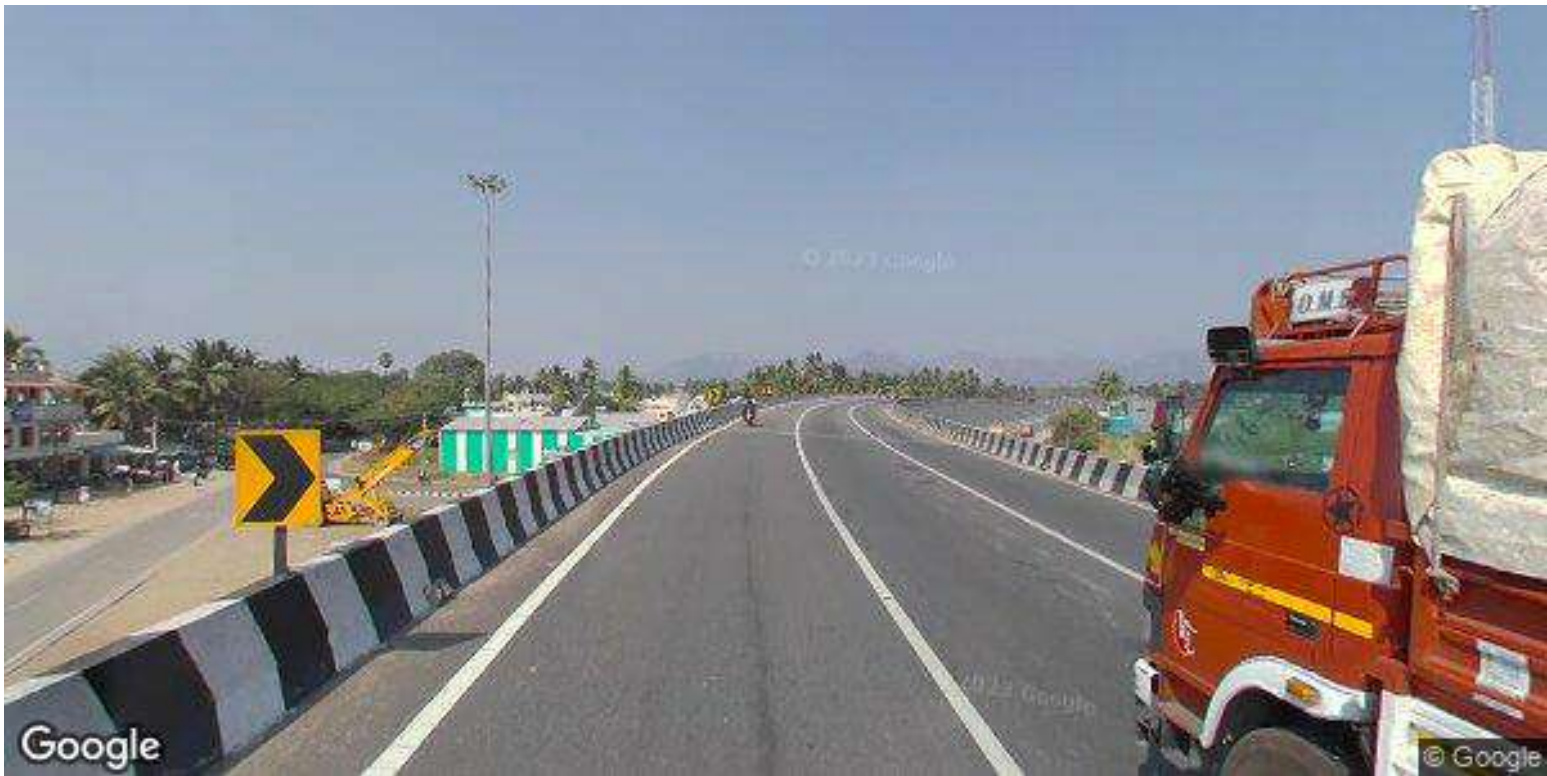
**Risk Type:** Turn  
**Risk Level:** High  
**Speed Limit:** 15 KM/Hr  
**Coordinates:** 12.40026, 78.21775

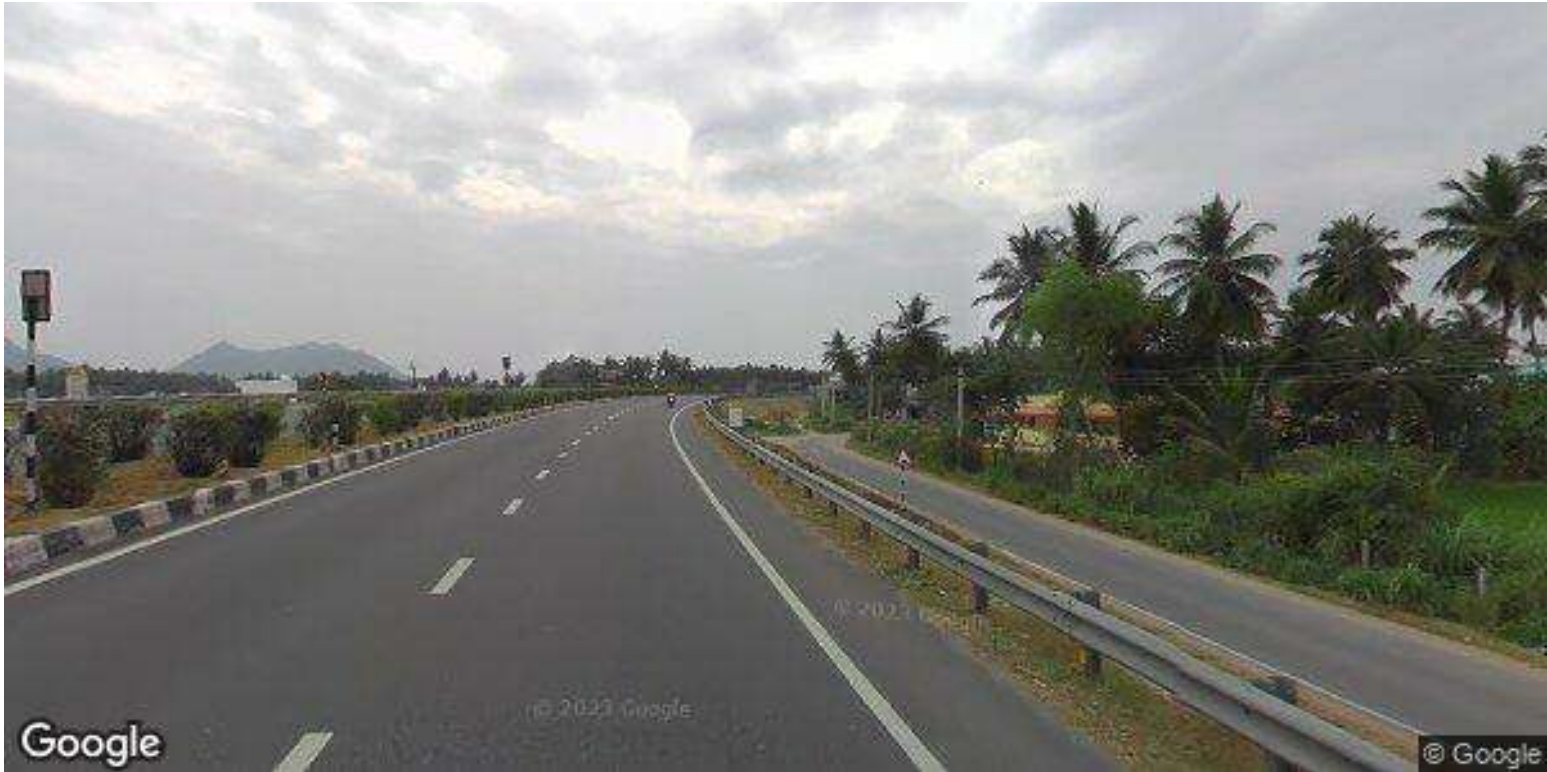
**Risk Type:** Turn  
**Risk Level:** Medium  
**Speed Limit:** 30 KM/Hr  
**Coordinates:** 12.40734, 78.22344

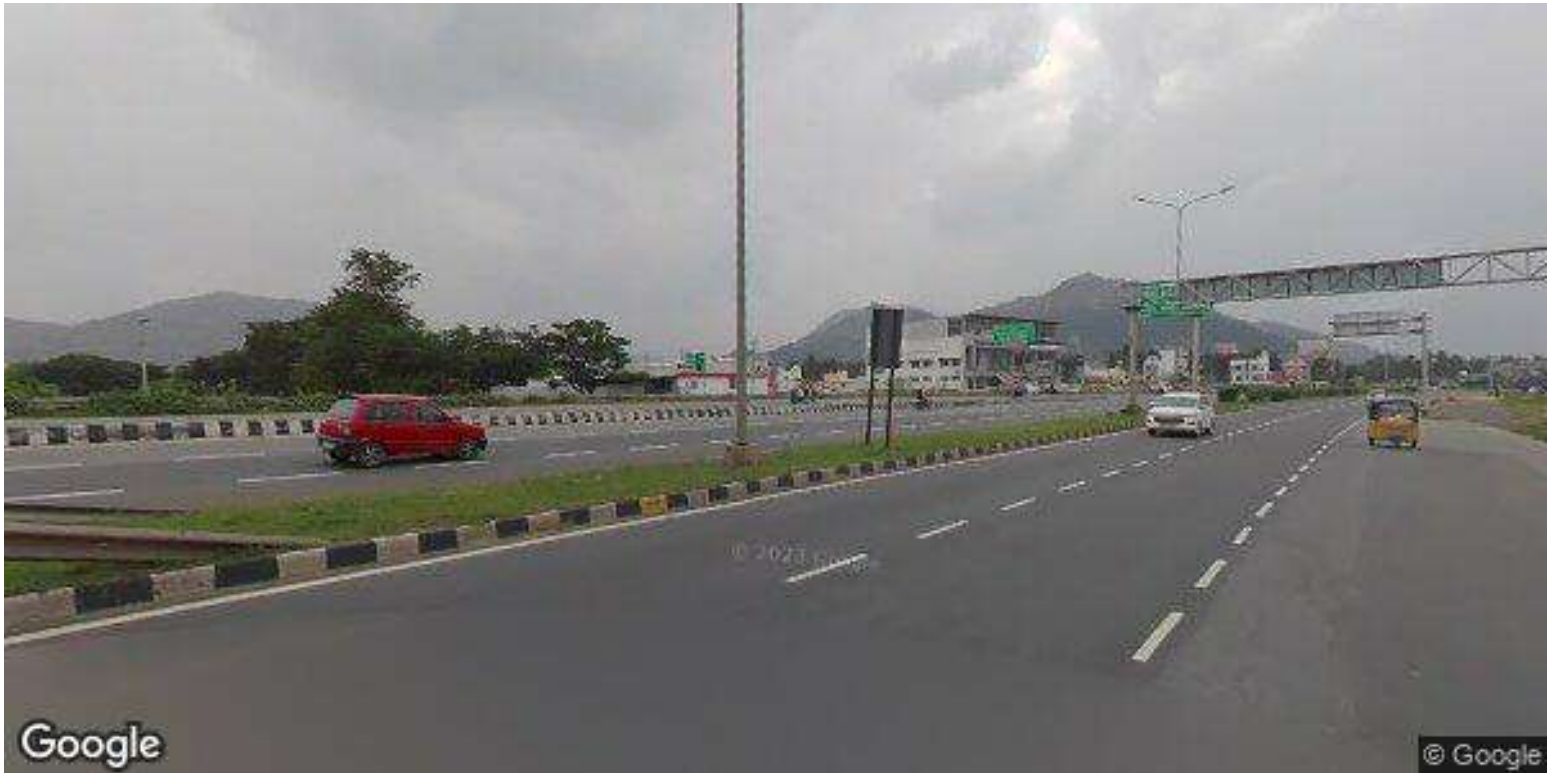
**Risk Type:** Turn  
**Risk Level:** Medium  
**Speed Limit:** 30 KM/Hr  
**Coordinates:** 12.50273, 78.22341

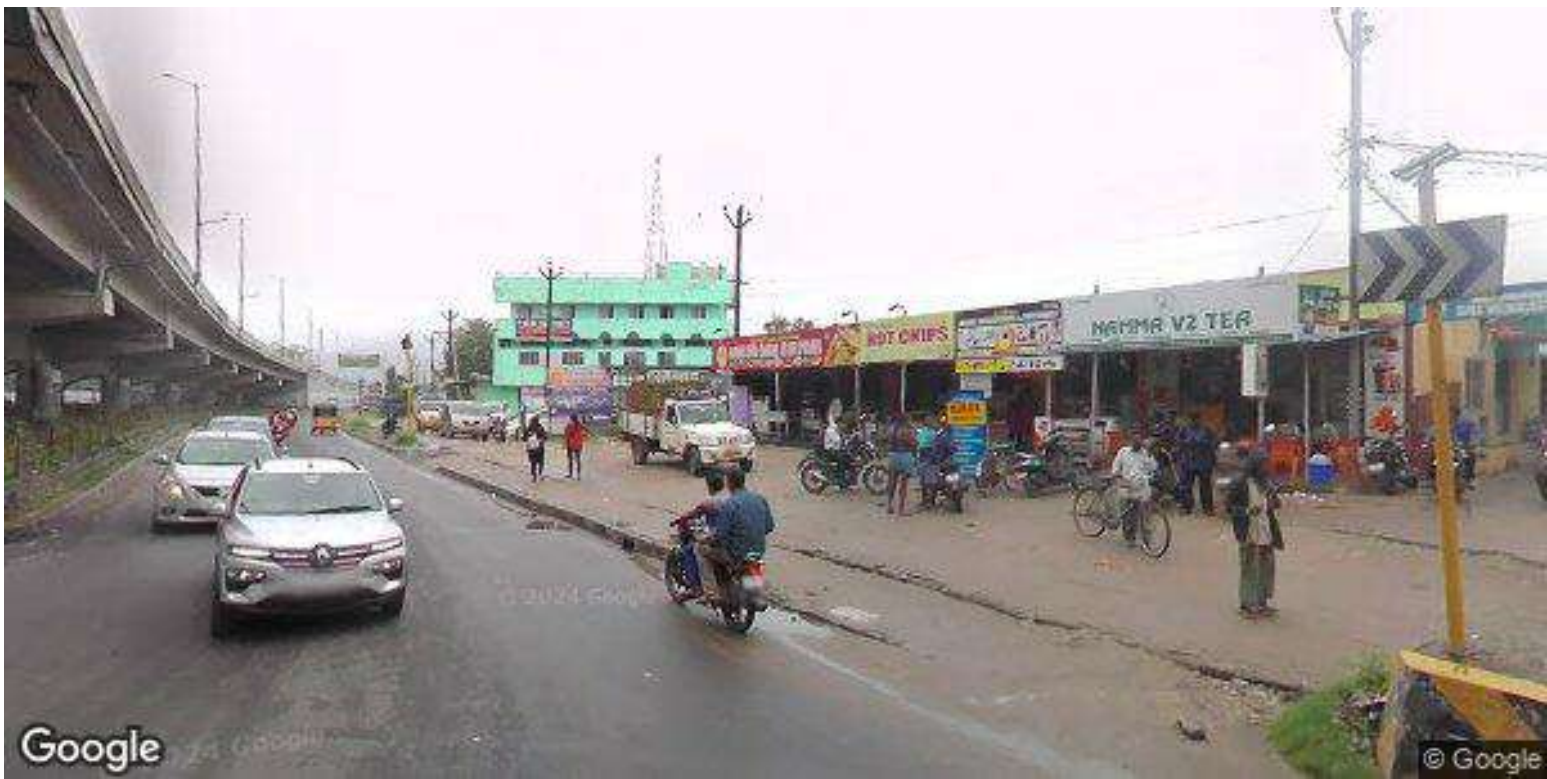
**Coordinates:** 12.50713, 78.22227

**Risk Type:** Turn

**Risk Level:** High

**Speed Limit:** 15 KM/Hr

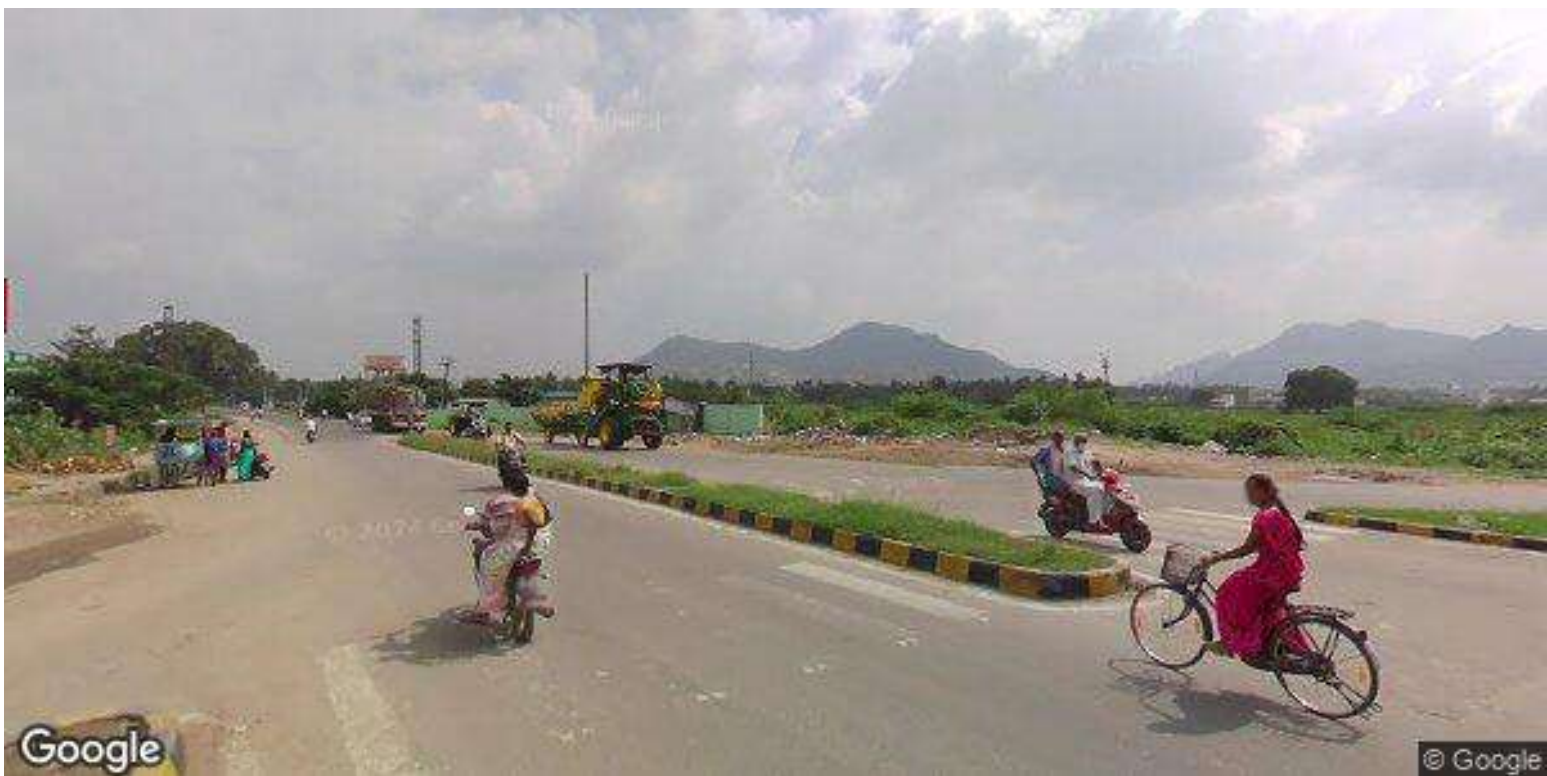
**Coordinates:** 12.51545, 78.23078

**Risk Type:** Turn

**Risk Level:** High

**Speed Limit:** 15 KM/Hr

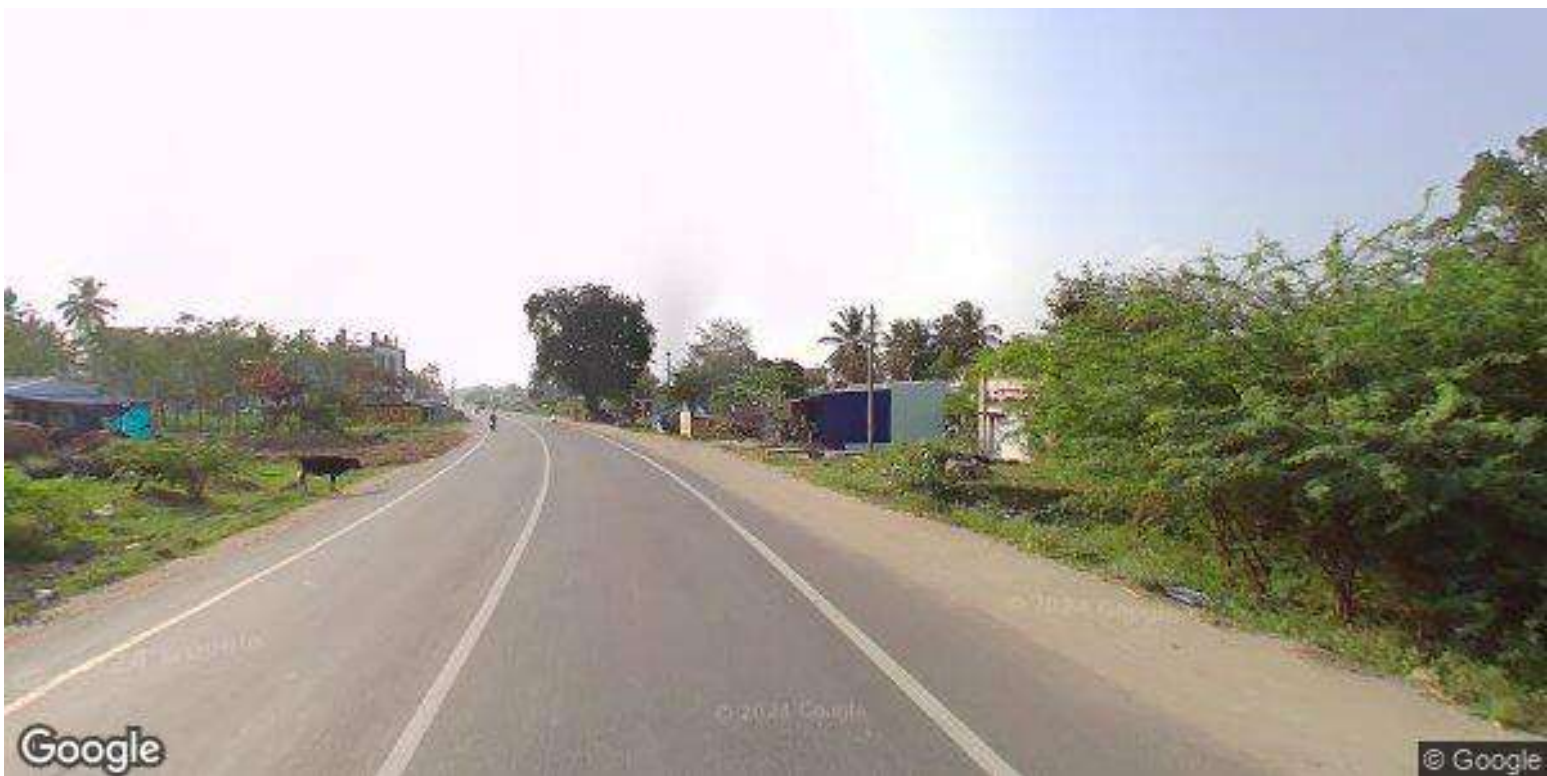
**Coordinates: 12.51540, 78.24086**

**Risk Type: Turn**

**Risk Level: Medium**

**Speed Limit: 30 KM/Hr**

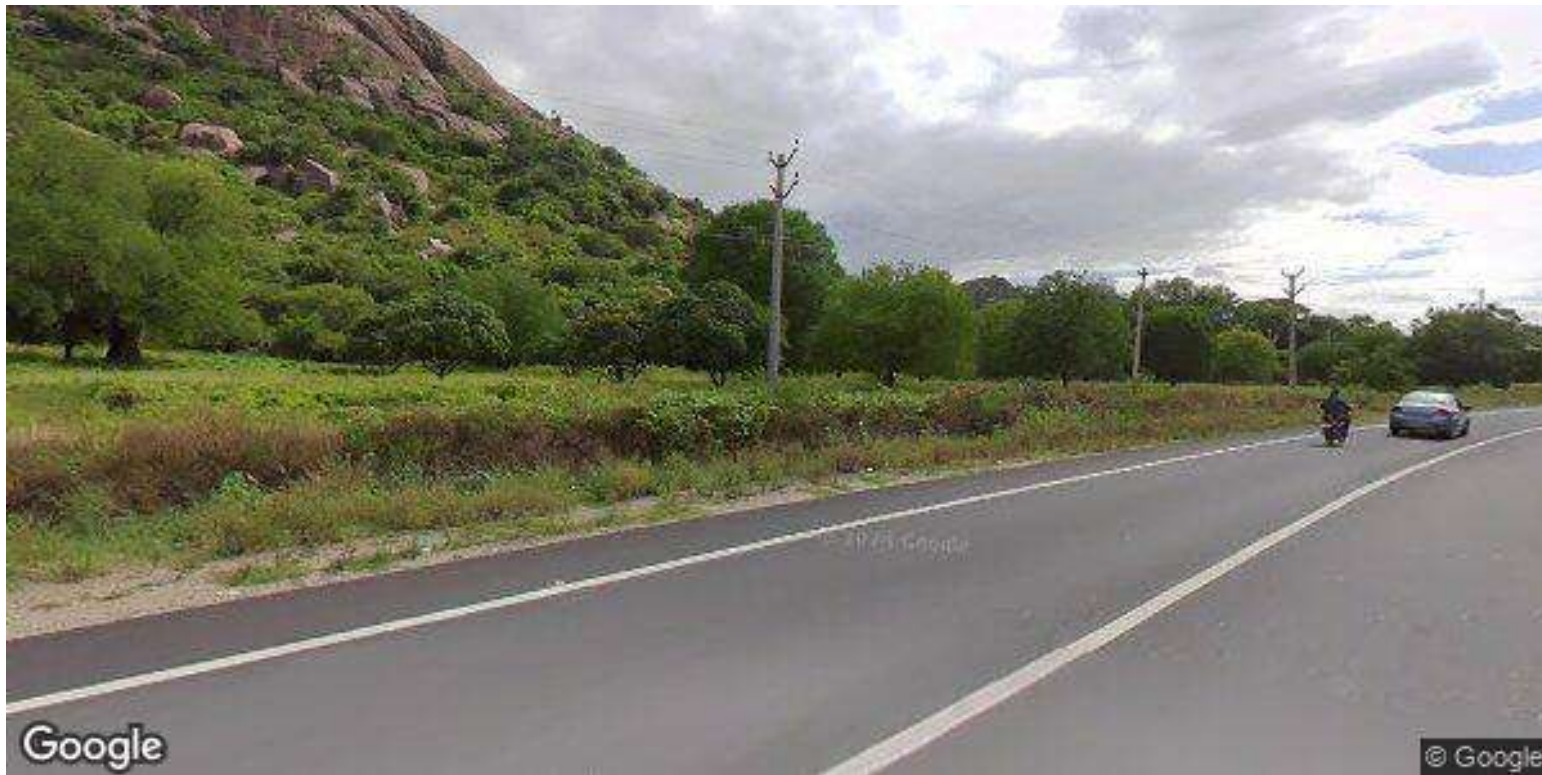
**Coordinates: 12.48218, 78.31195**

**Risk Type: Turn**

**Risk Level: Medium**

**Speed Limit: 30 KM/Hr**

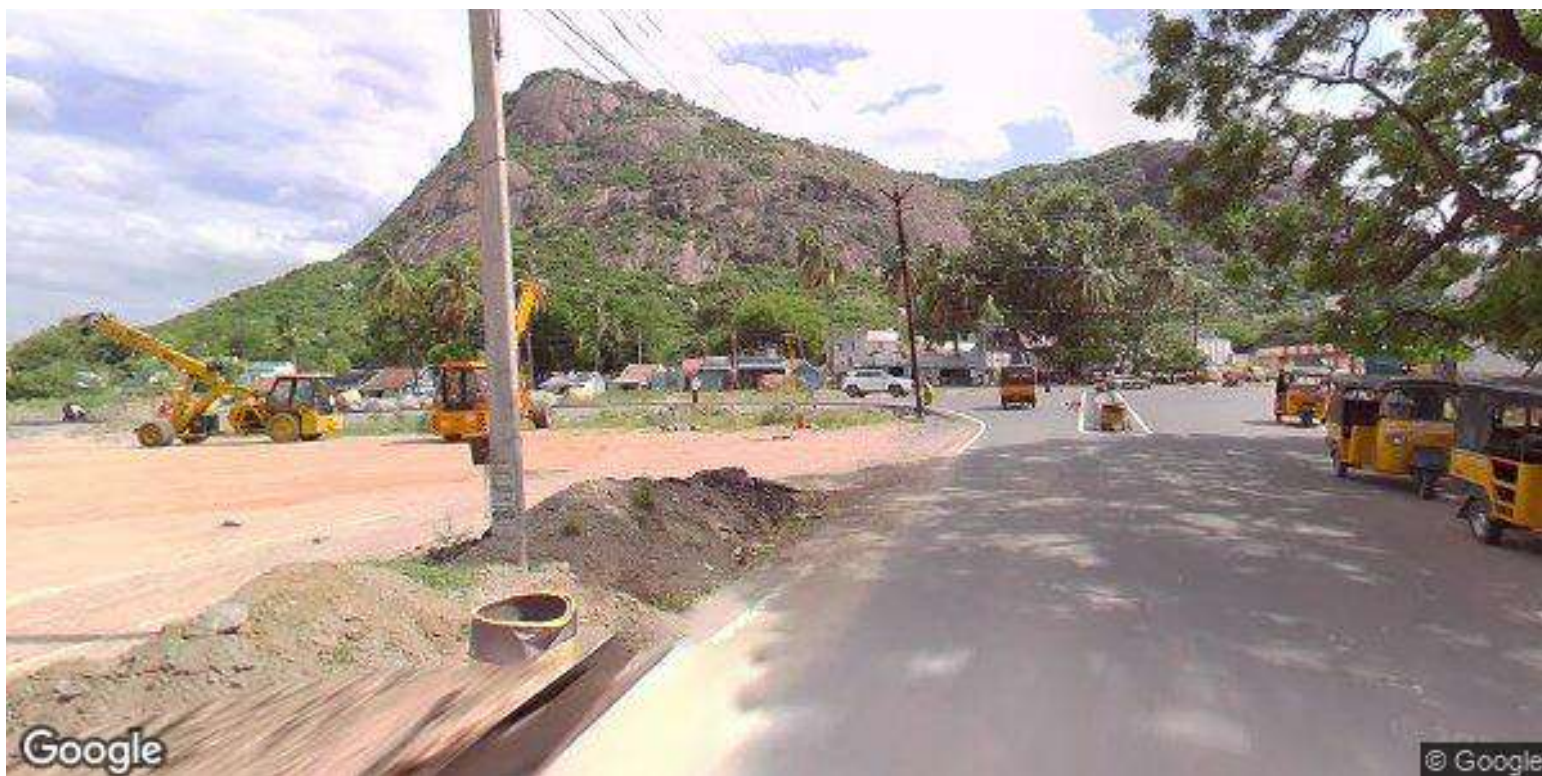
**Coordinates: 12.48382, 78.31736**

**Risk Type: Turn**

**Risk Level: Medium**

**Speed Limit: 30 KM/Hr**

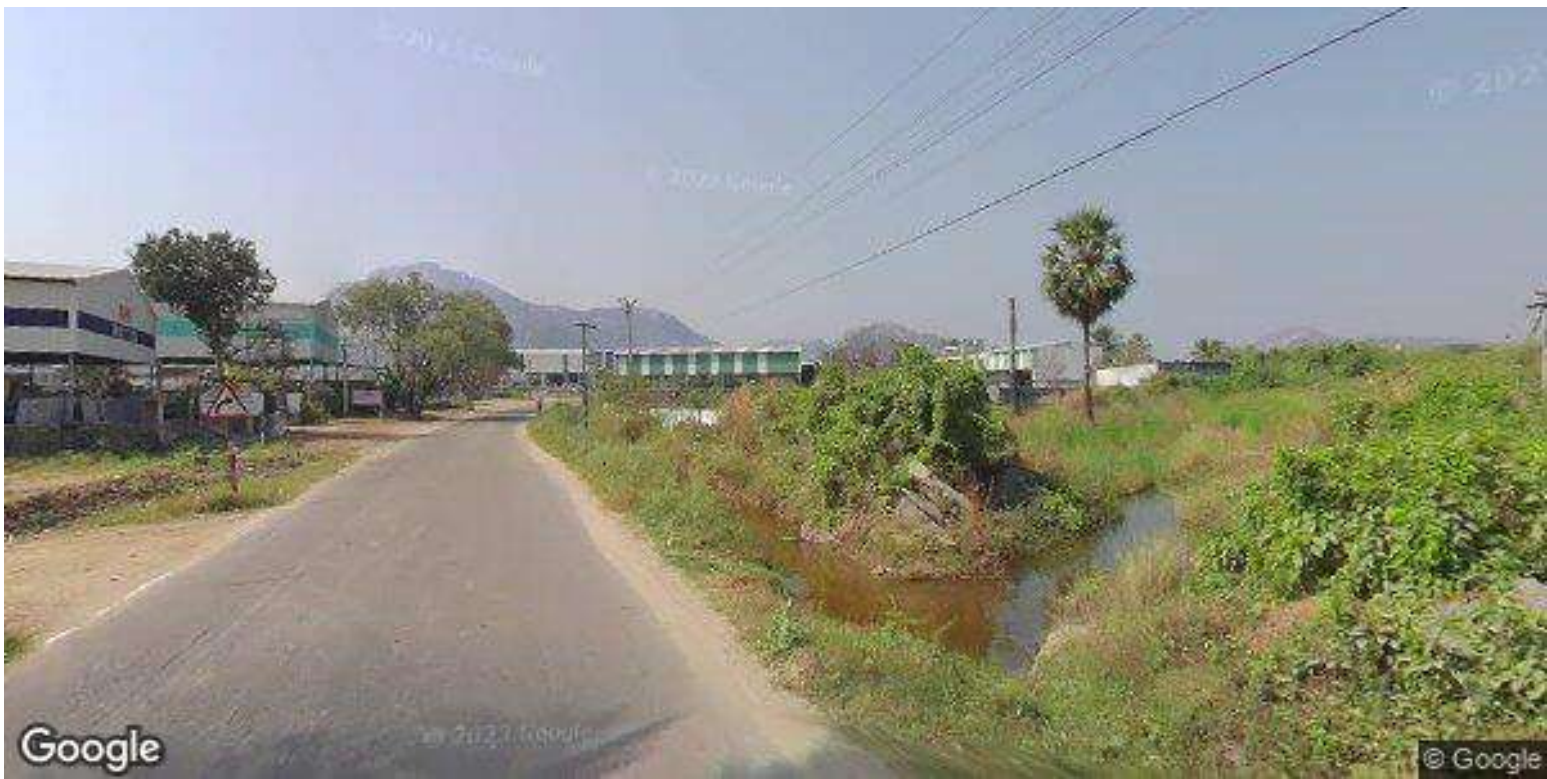
**Risk Type:** Turn  
**Risk Level:** Medium  
**Speed Limit:** 30 KM/Hr  
**Coordinates:** 12.49393, 78.32753

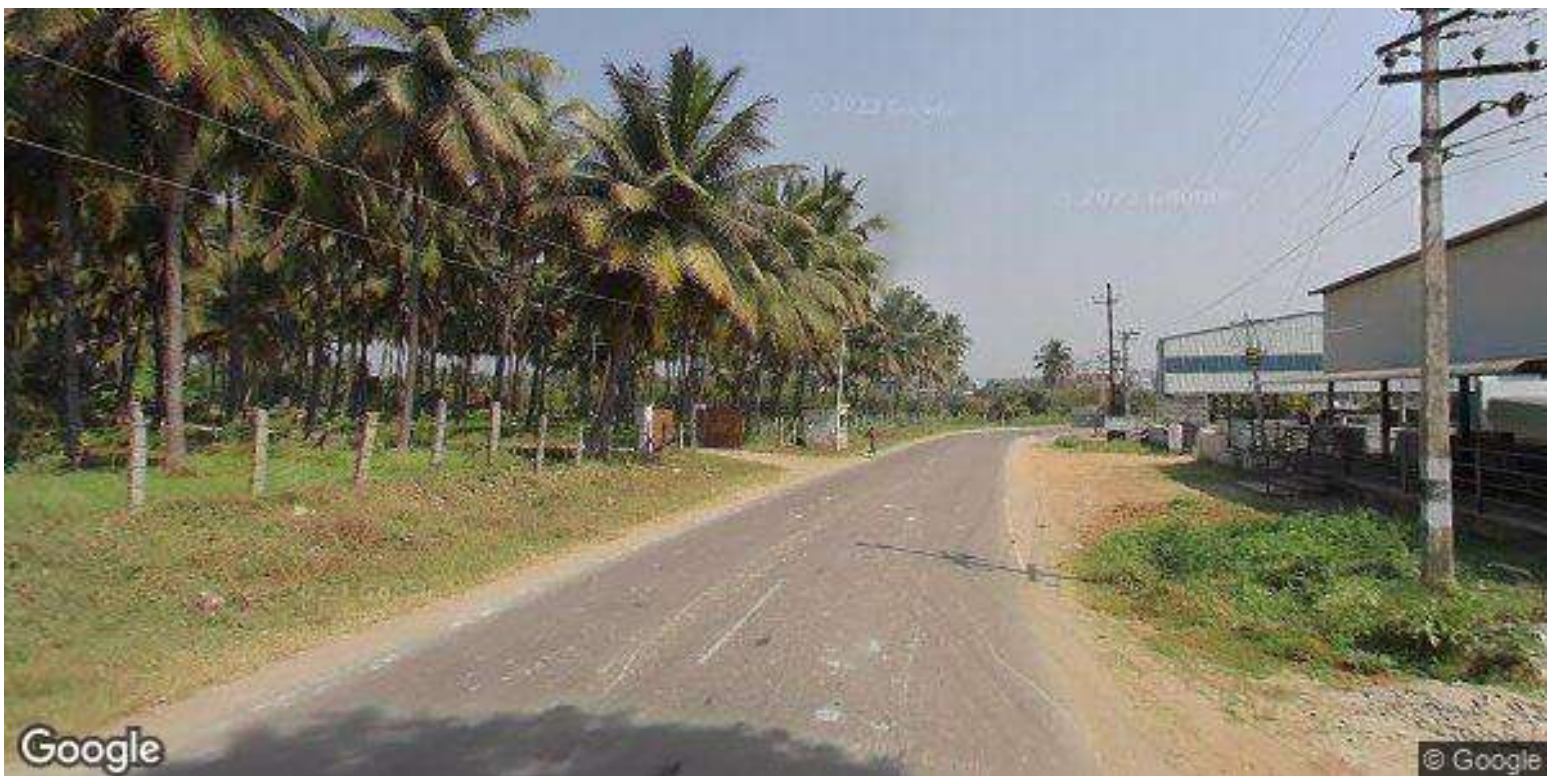
**Risk Type:** Turn  
**Risk Level:** Medium  
**Speed Limit:** 30 KM/Hr  
**Coordinates:** 12.49710, 78.32879

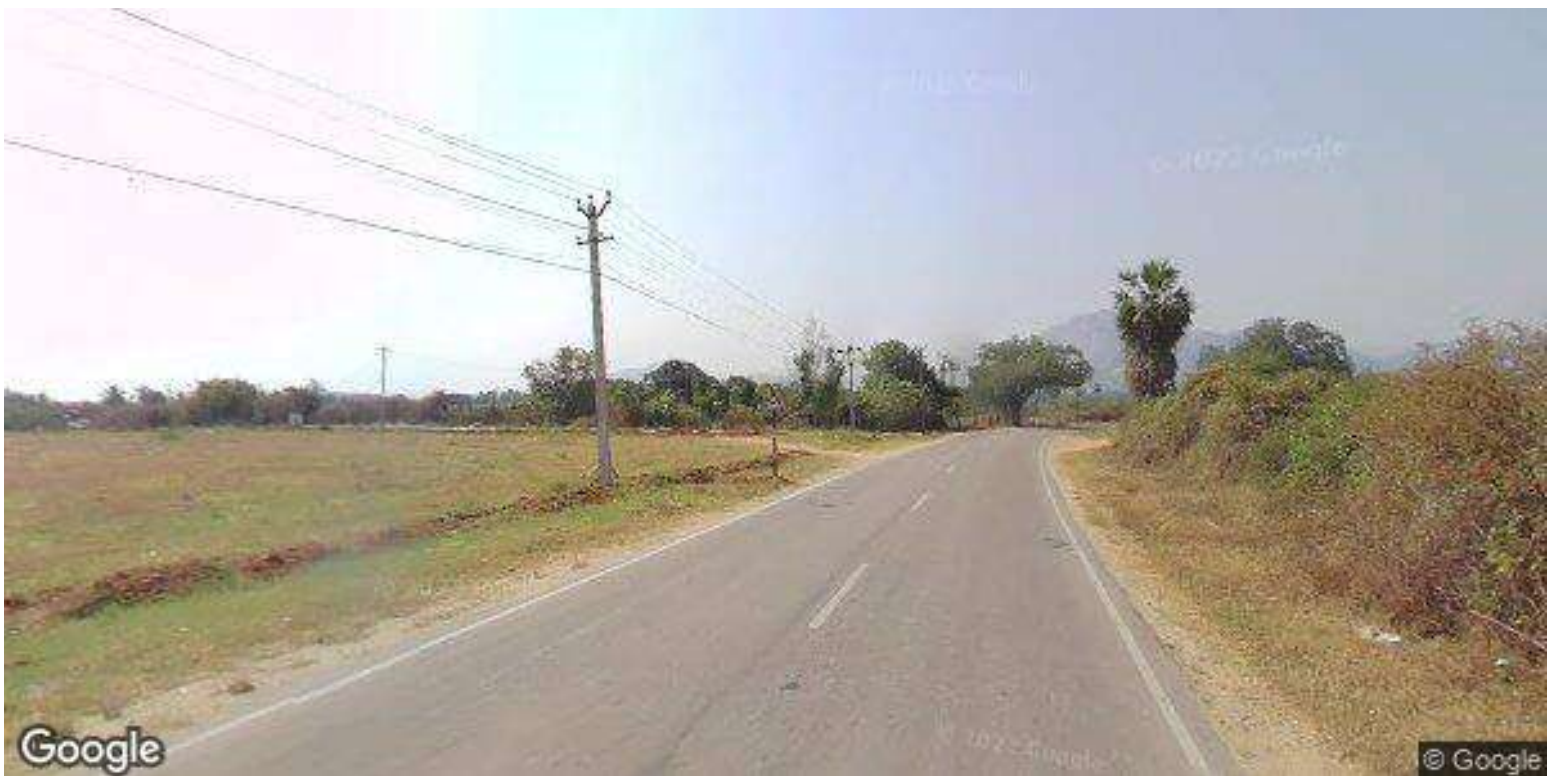
Coordinates: 12.50128, 78.33423

Risk Type: Turn

Risk Level: Medium

Speed Limit: 30 KM/Hr

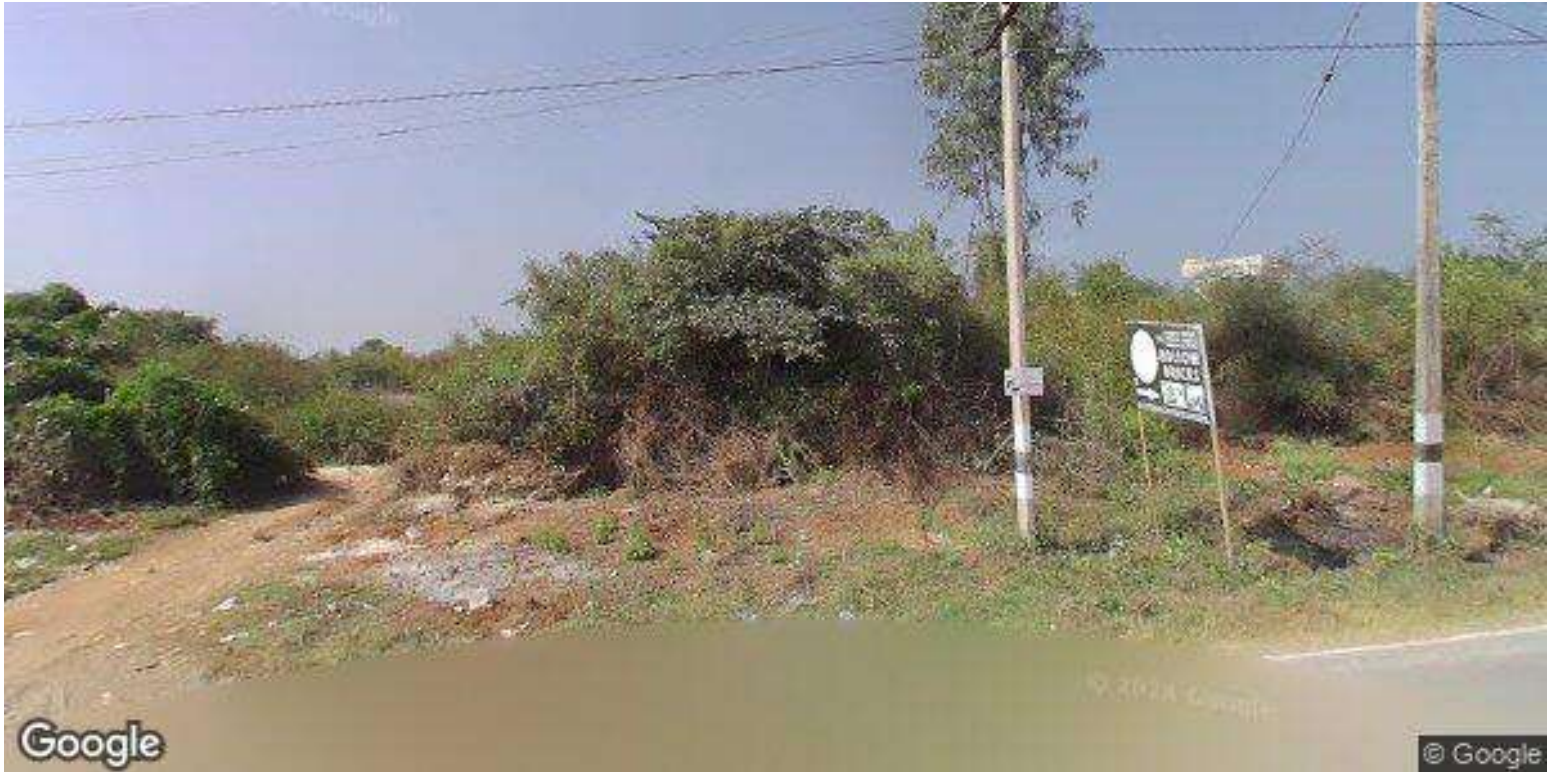
Coordinates: 12.52154, 78.34403

Risk Type: Turn

Risk Level: Medium

Speed Limit: 30 KM/Hr
