## JOURNEY RISK MANAGEMENT (JRM) STUDY

### Salem Terminal TO SELVI AGENCY

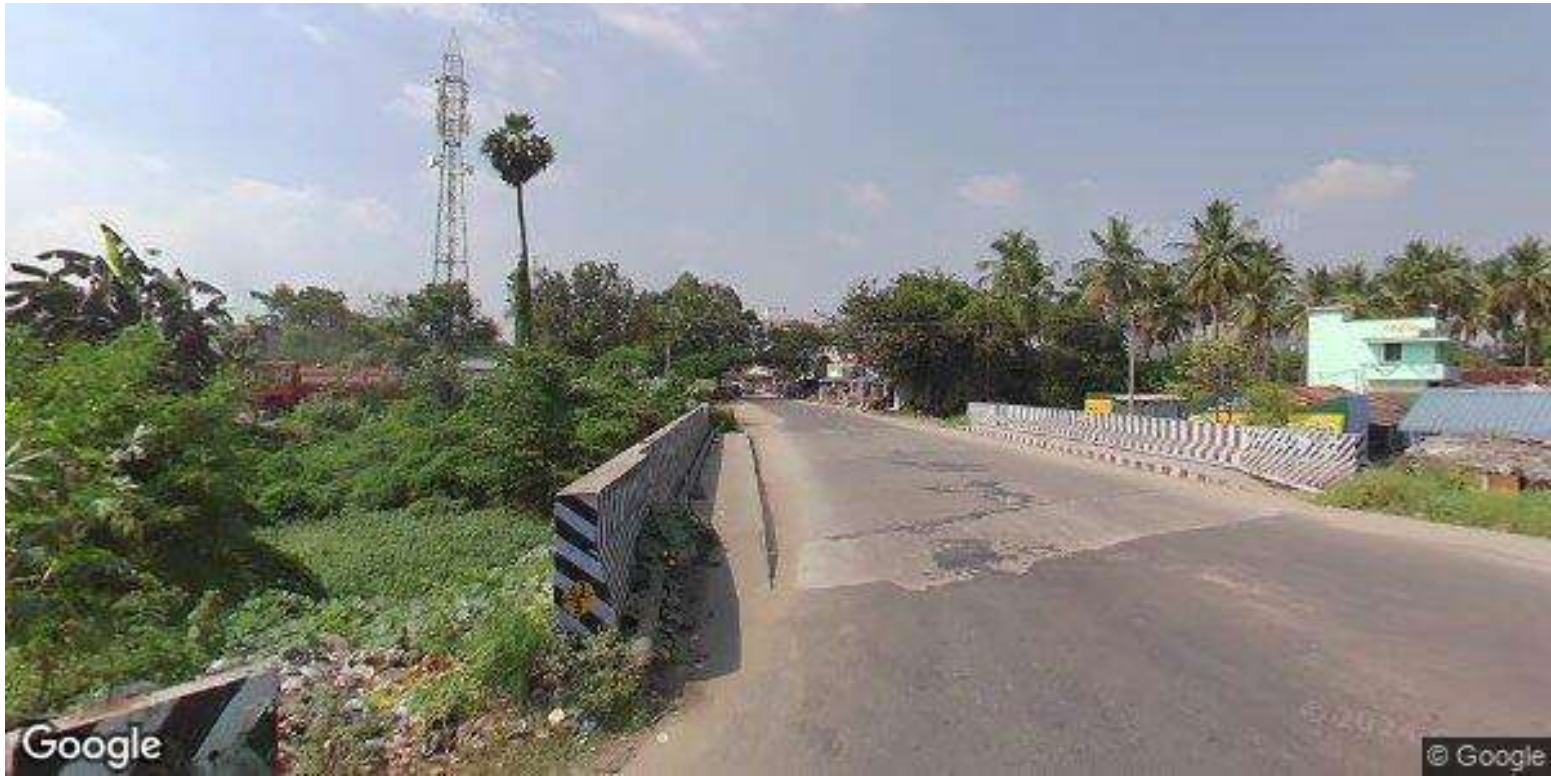
**Risk Type:** Turn  
**Risk Level:** Medium  
**Speed Limit:** 30 KM/Hr  
**Coordinates:** 11.44900, 77.87406

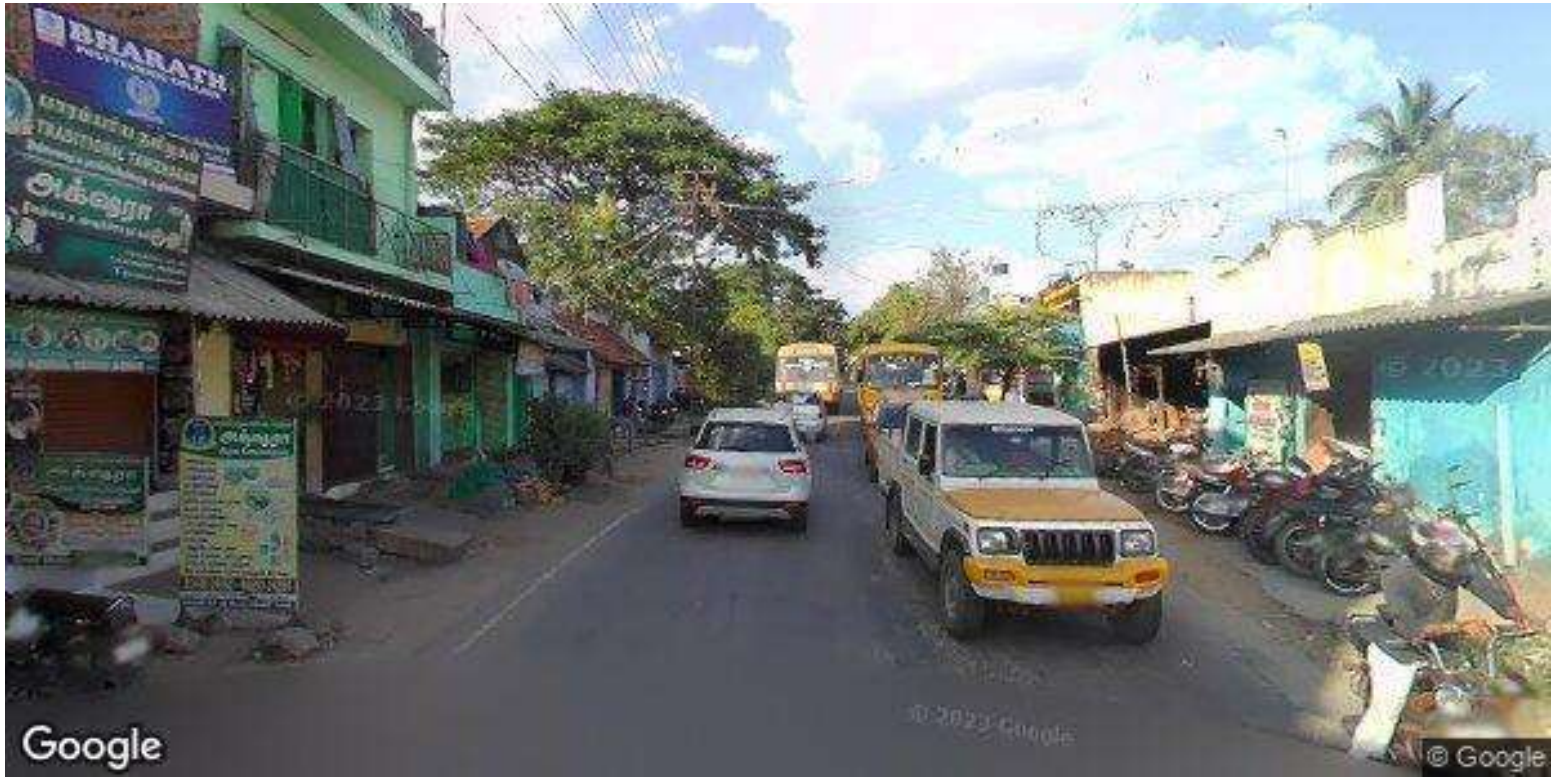
**Risk Type:** Turn  
**Risk Level:** High  
**Speed Limit:** 15 KM/Hr  
**Coordinates:** 11.45028, 77.87202

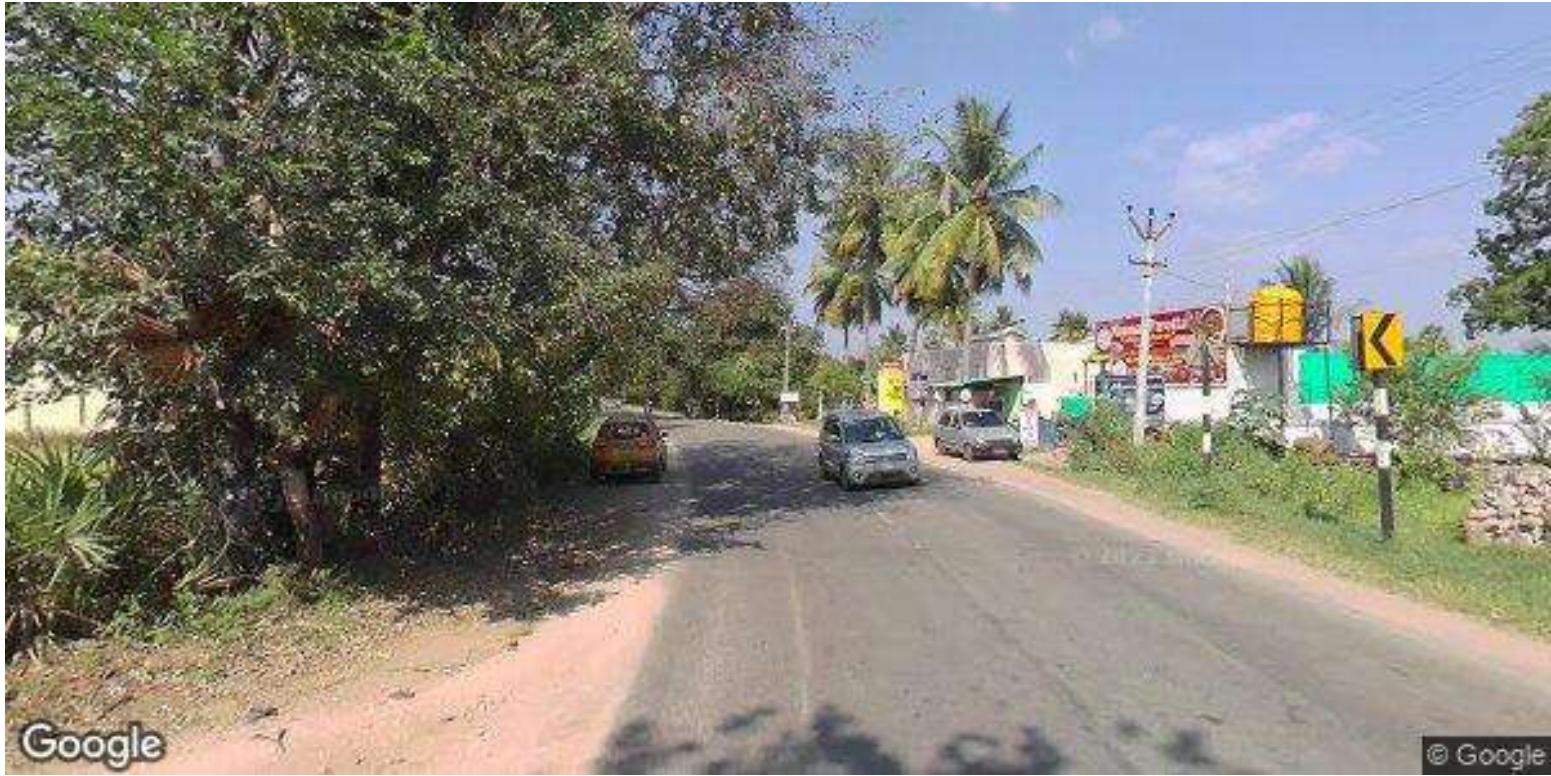
**Risk Type:** Turn  
**Risk Level:** Medium  
**Speed Limit:** 30 KM/Hr  
**Coordinates:** 11.45309, 77.87325

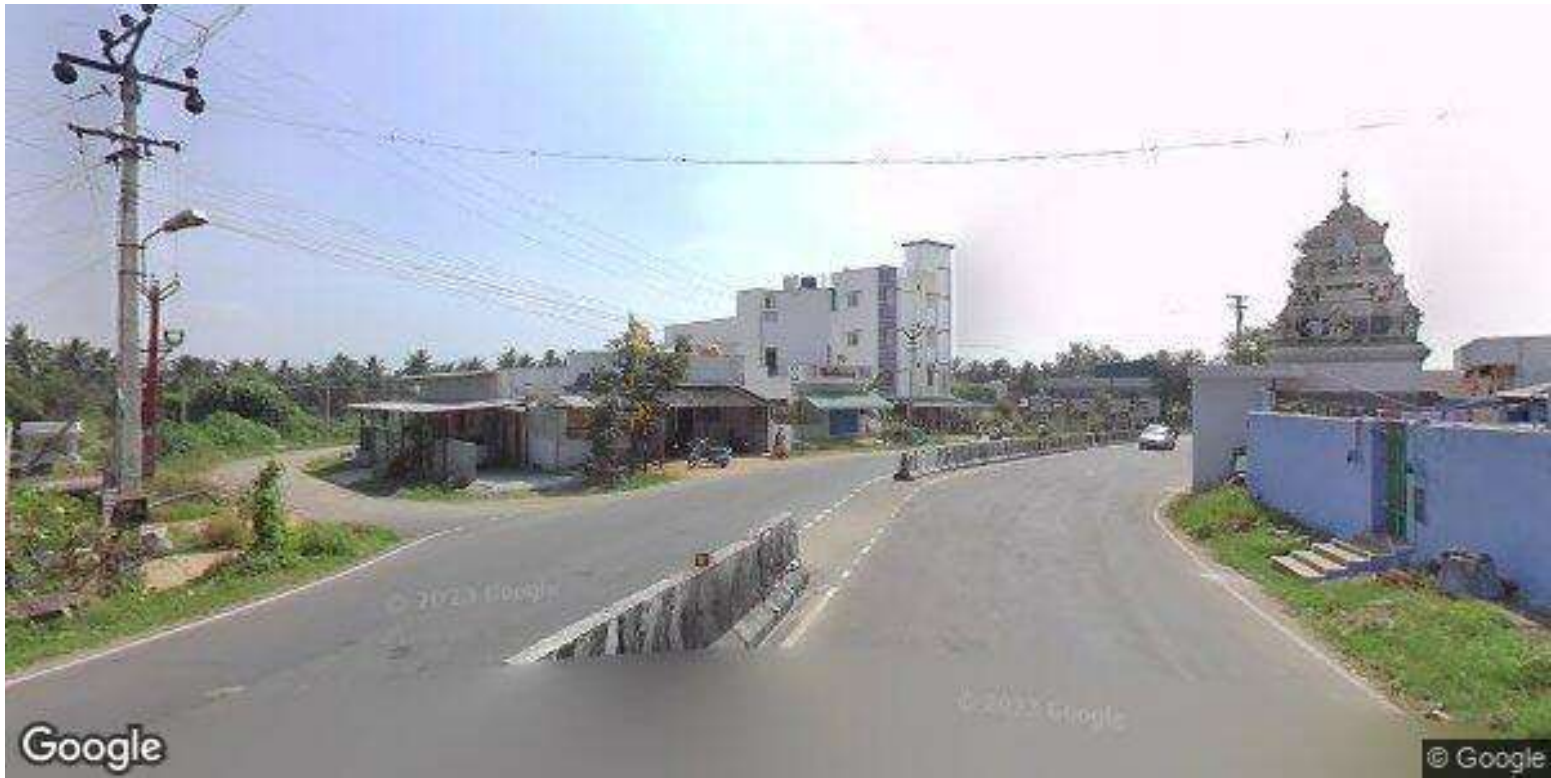
**Risk Type:** Turn  
**Risk Level:** Medium  
**Speed Limit:** 30 KM/Hr  
**Coordinates:** 11.46400, 77.87323

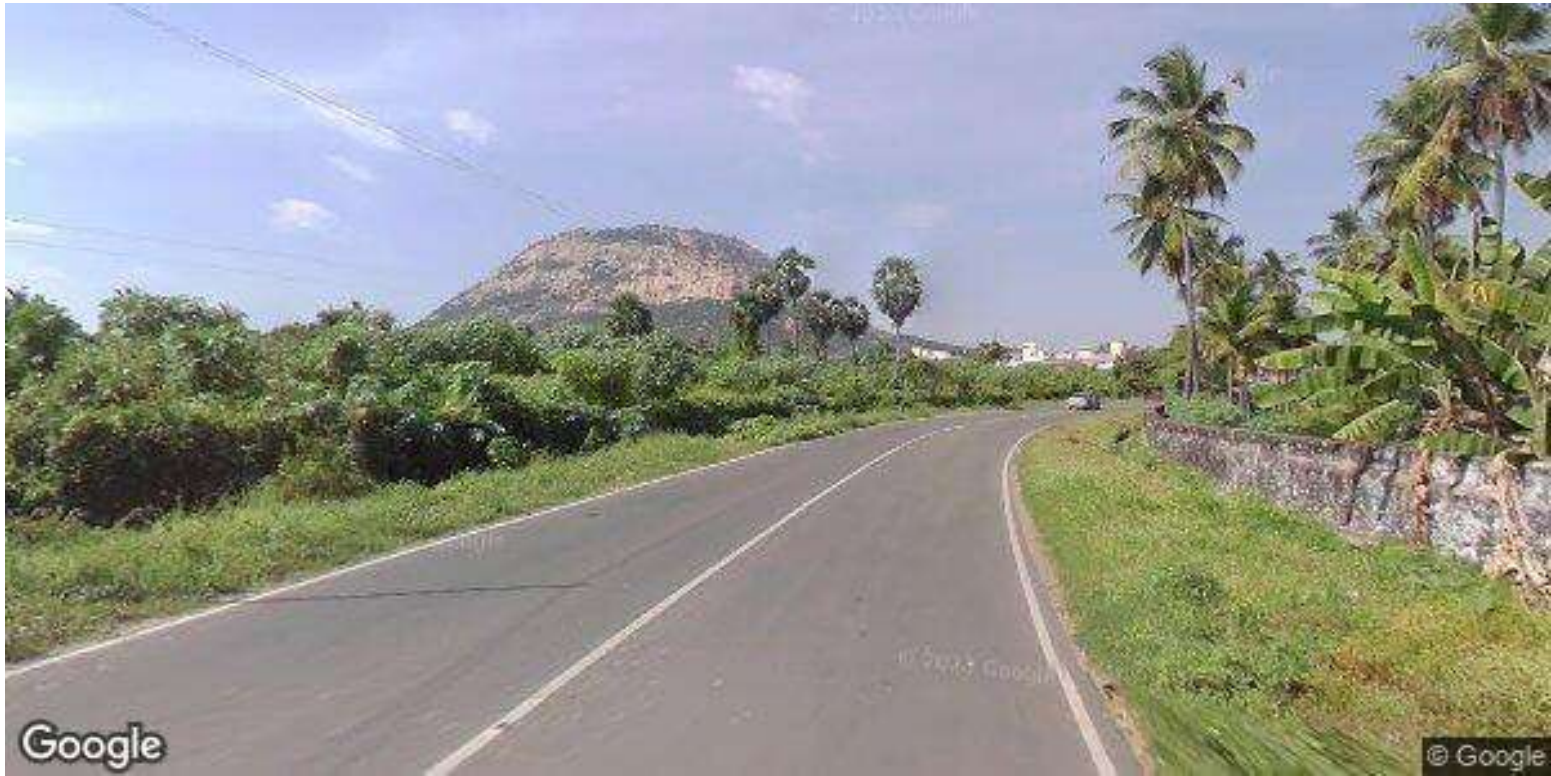
**Risk Type:** Turn  
**Risk Level:** Medium  
**Speed Limit:** 30 KM/Hr  
**Coordinates:** 11.46765, 77.87037

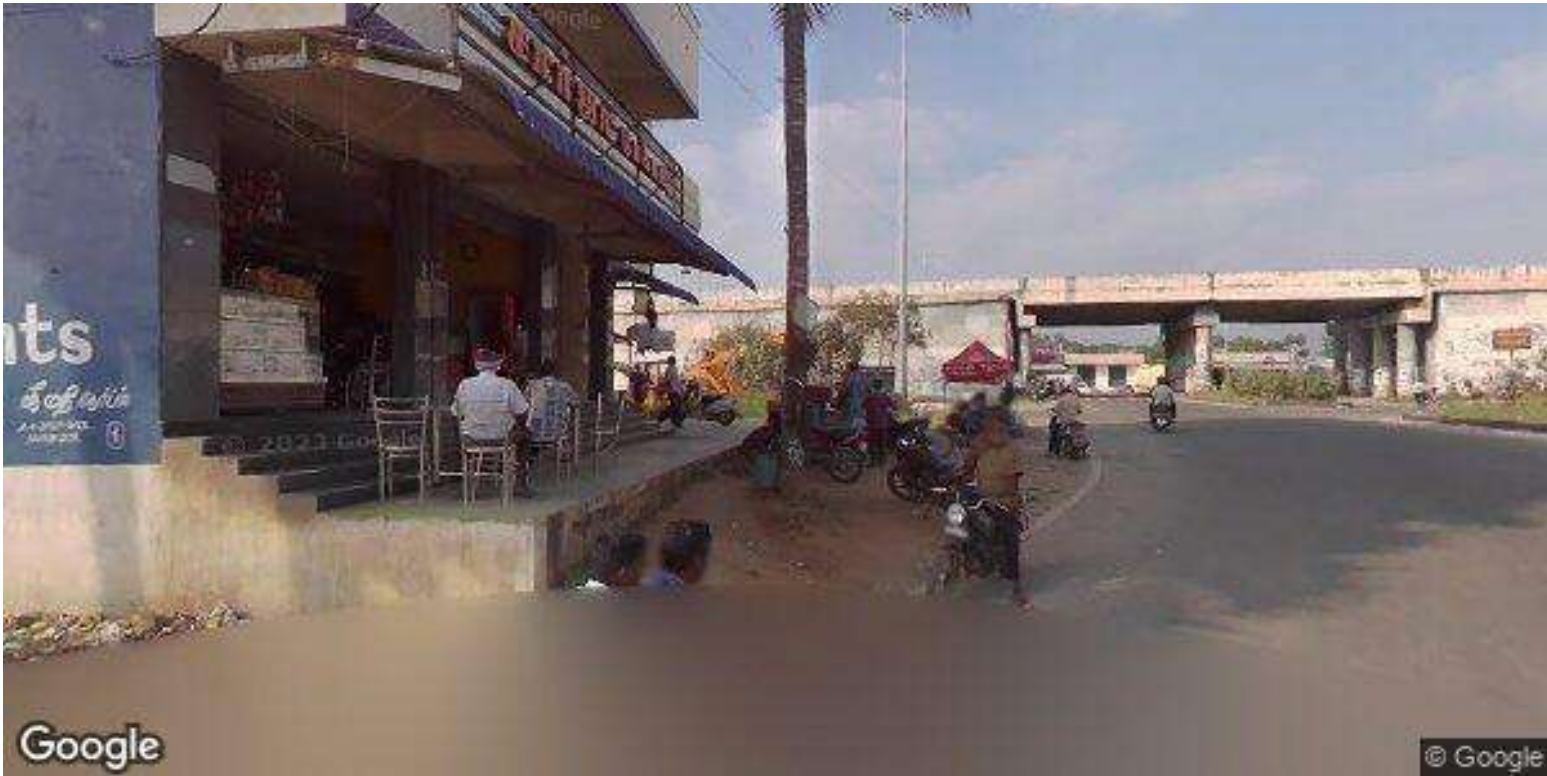
Risk Type: Turn  
Risk Level: High  
Speed Limit: 15 KM/Hr  
Coordinates: 11.49149, 77.89601

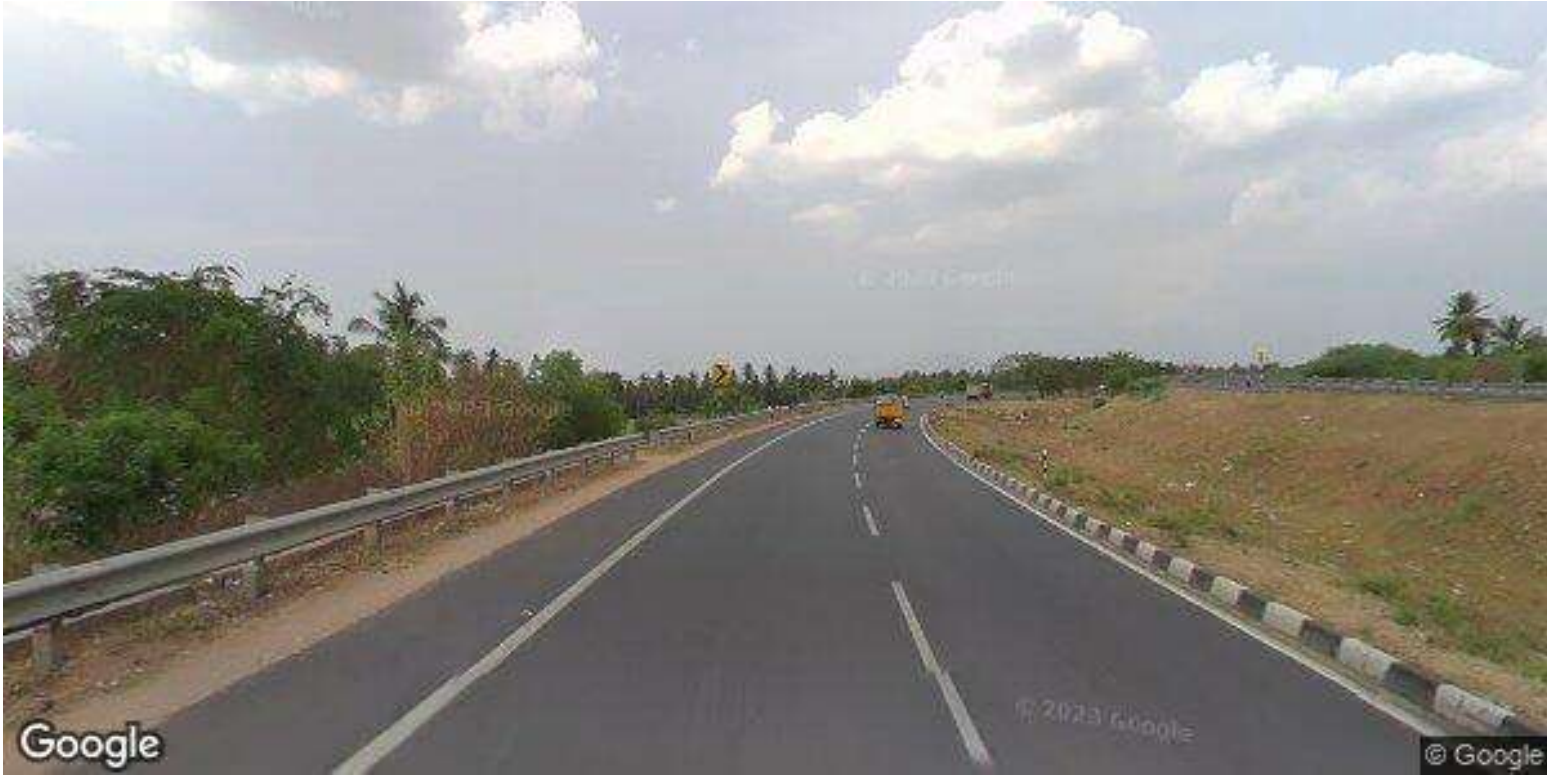
**Risk Type: Turn**

**Risk Level: Medium**

**Speed Limit: 30 KM/Hr**

**Coordinates: 11.53501, 77.95707**

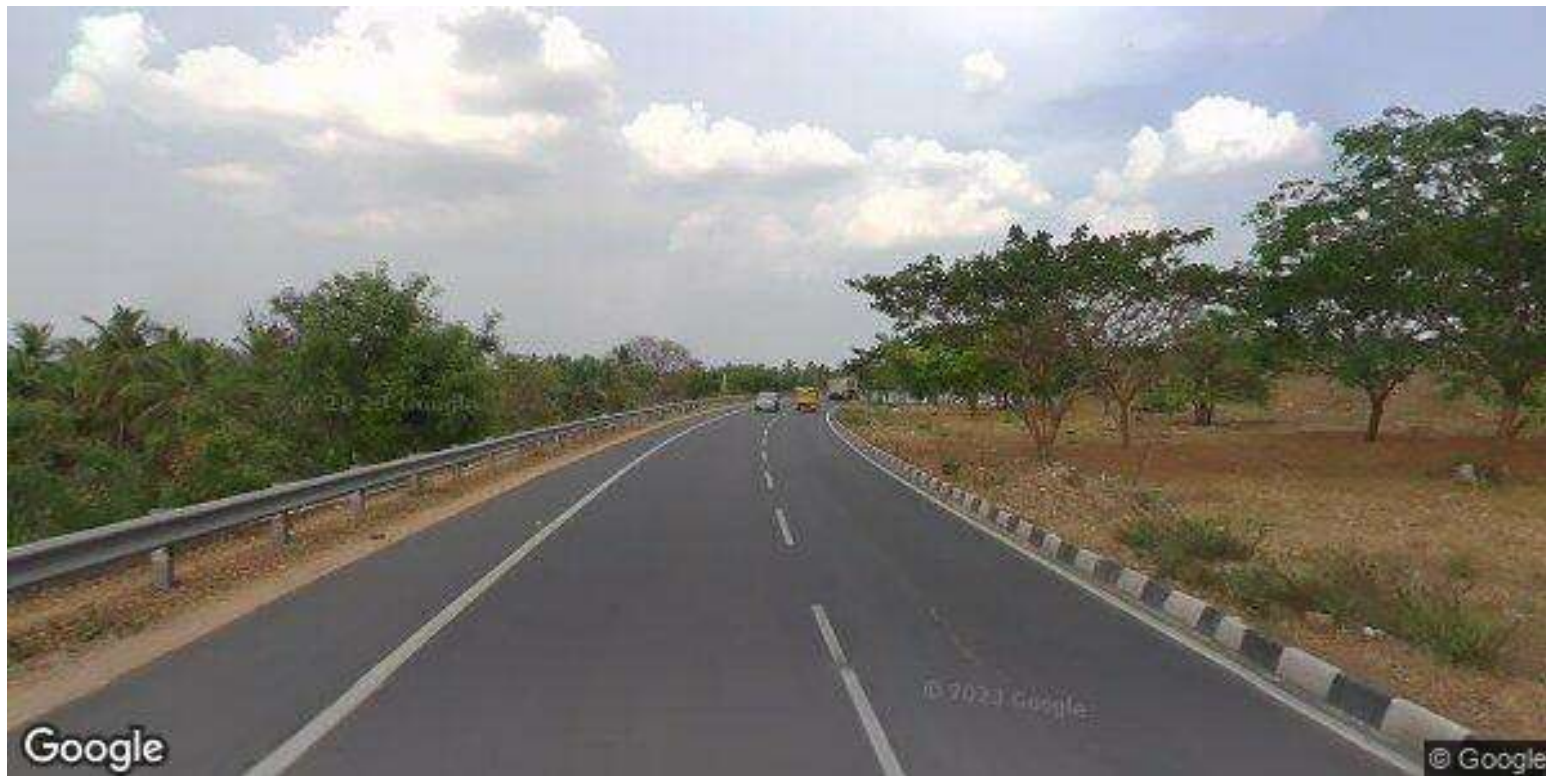
**Risk Type: Turn**

**Risk Level: Medium**

**Speed Limit: 30 KM/Hr**

**Coordinates: 11.53601, 77.95856**

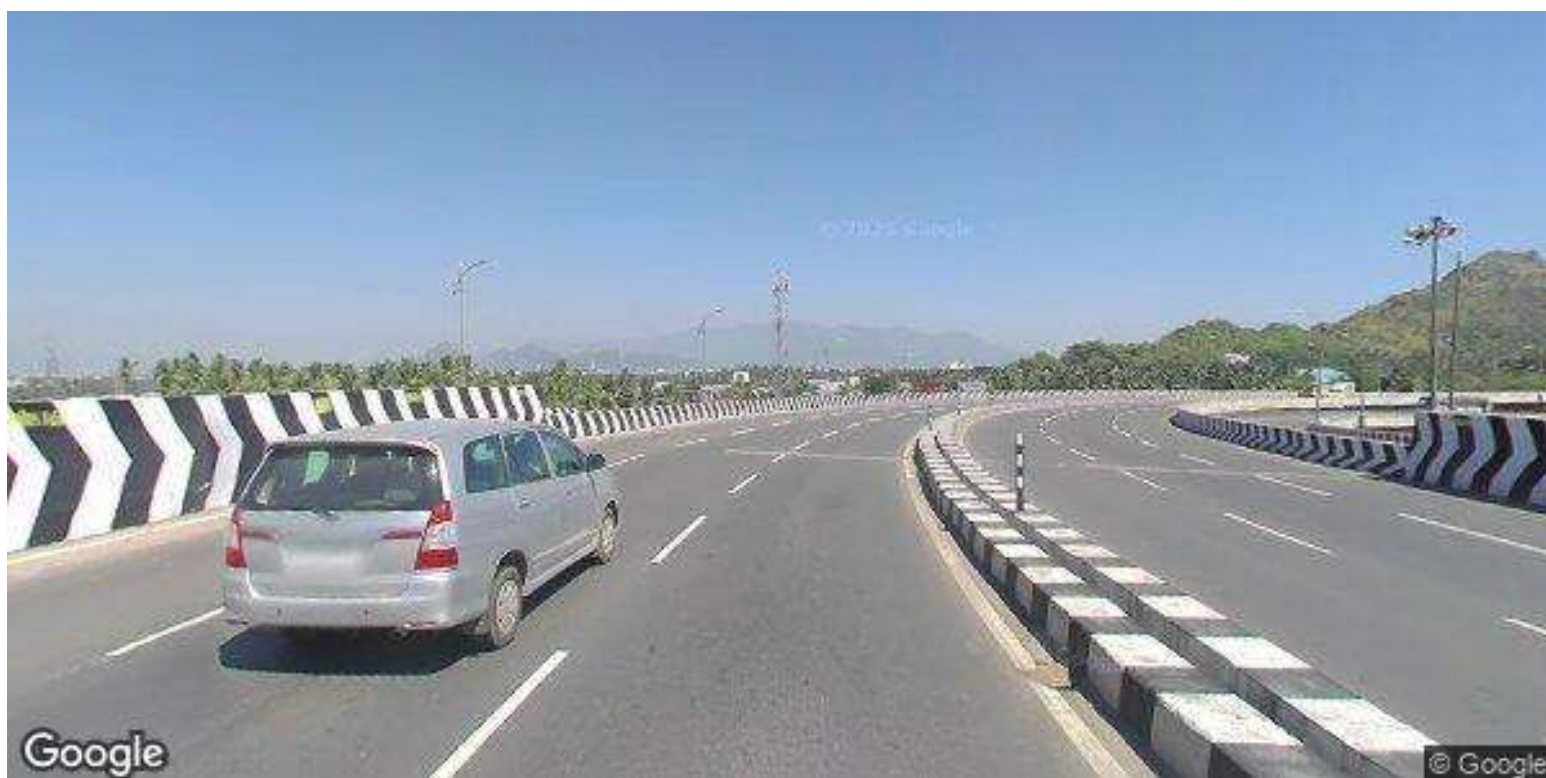
**Risk Type: Turn**

**Risk Level: Medium**

**Speed Limit: 30 KM/Hr**

**Coordinates: 11.64172, 78.11817**

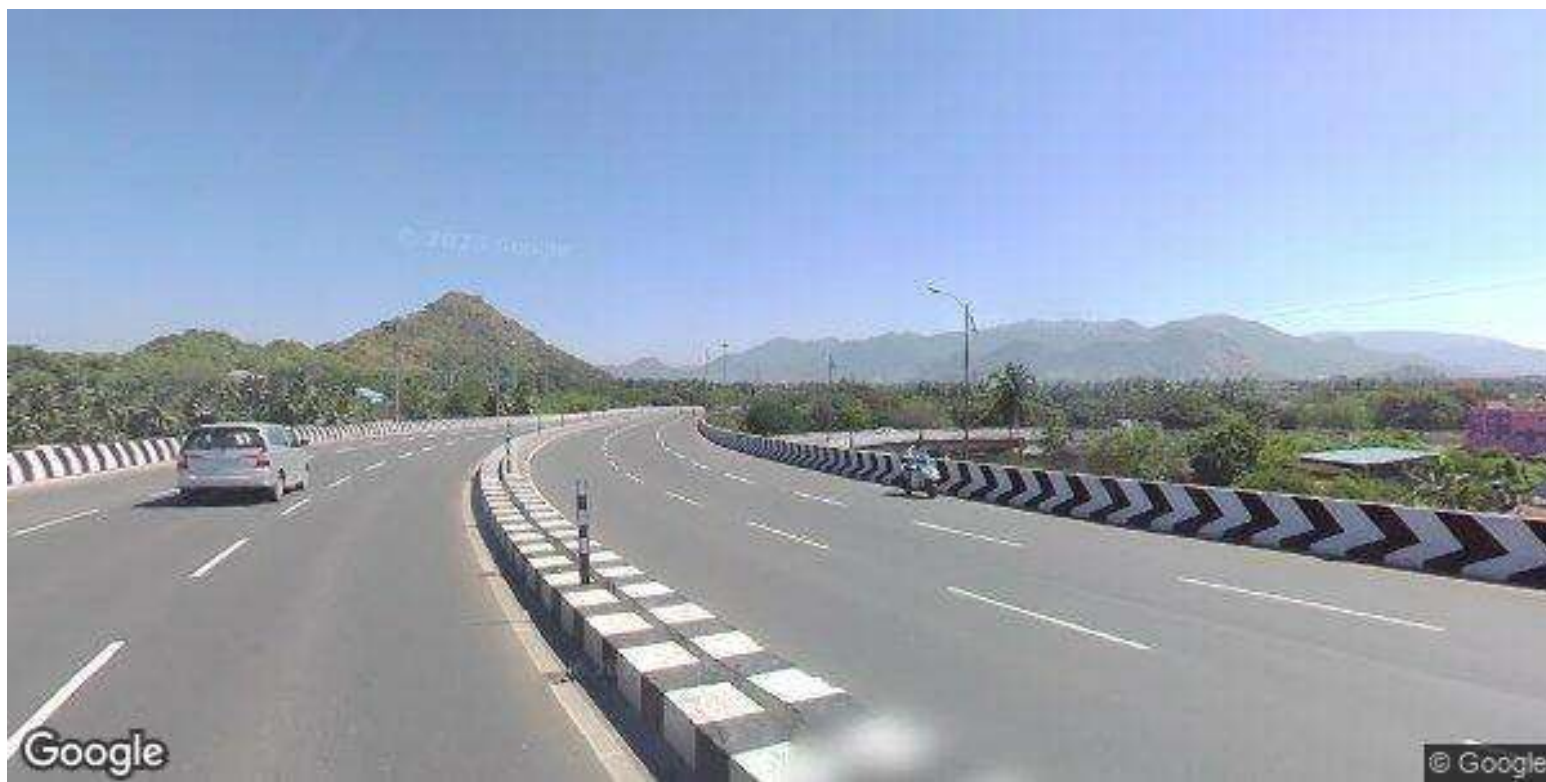
**Risk Type: Turn**

**Risk Level: Medium**

**Speed Limit: 30 KM/Hr**

**Coordinates: 11.64216, 78.11875**

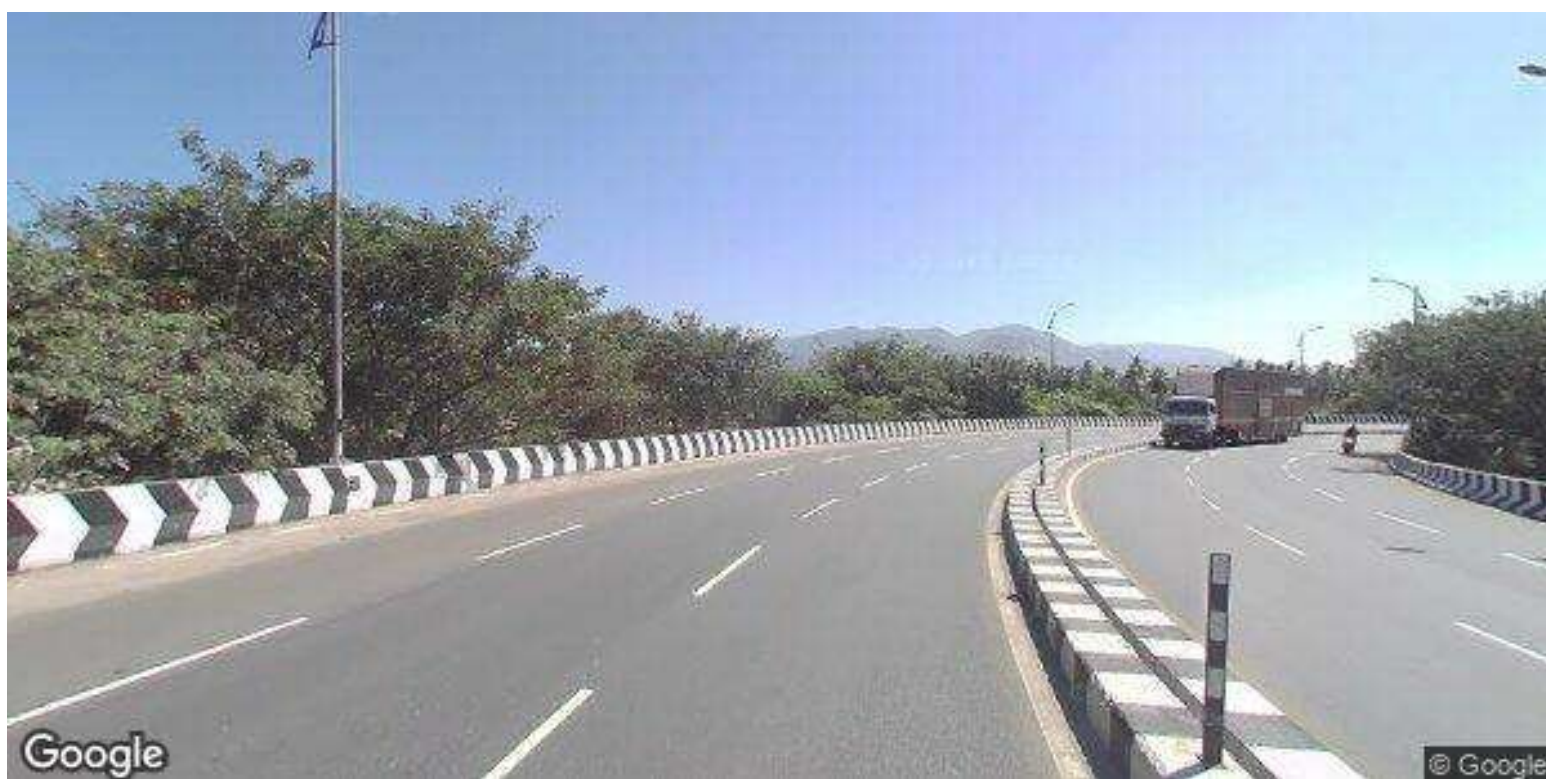
**Risk Type: Turn**

**Risk Level: High**

**Speed Limit: 15 KM/Hr**

**Coordinates: 11.64195, 78.12129**

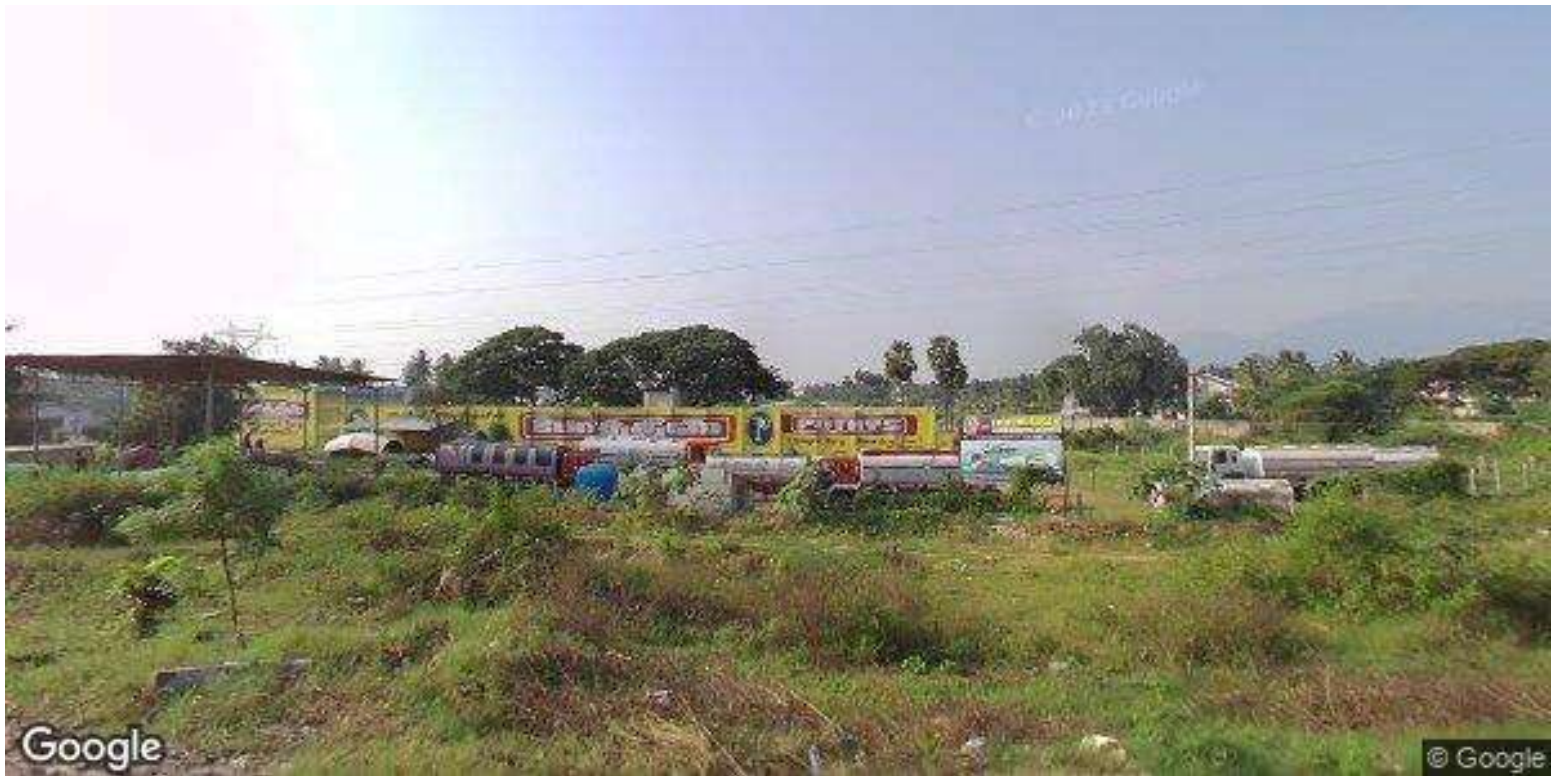
**Risk Type:** Turn  
**Risk Level:** Medium  
**Speed Limit:** 30 KM/Hr  
**Coordinates:** 11.65703, 78.20465

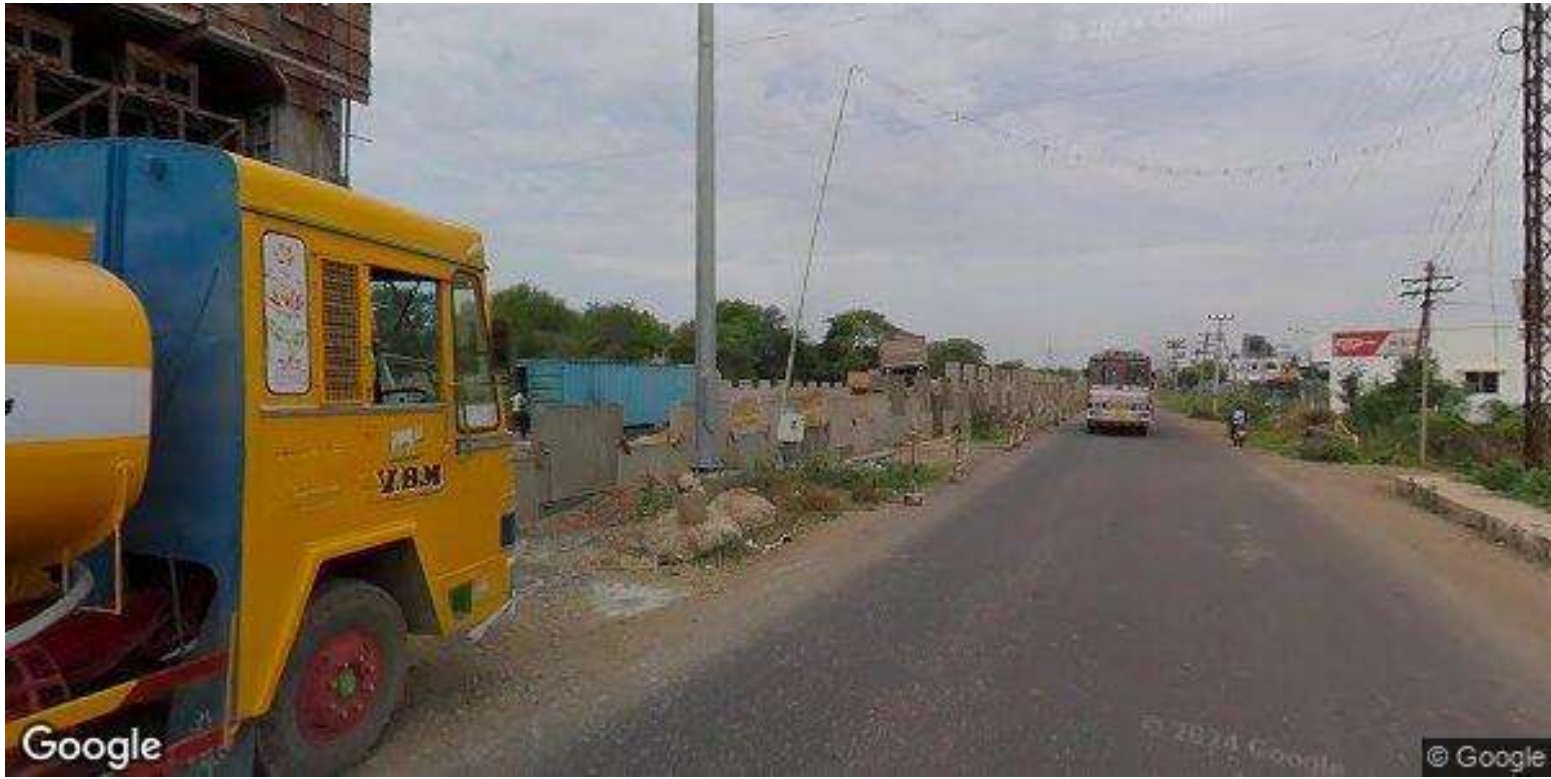
**Risk Type:** Turn  
**Risk Level:** High  
**Speed Limit:** 15 KM/Hr  
**Coordinates:** 11.58562, 78.74231

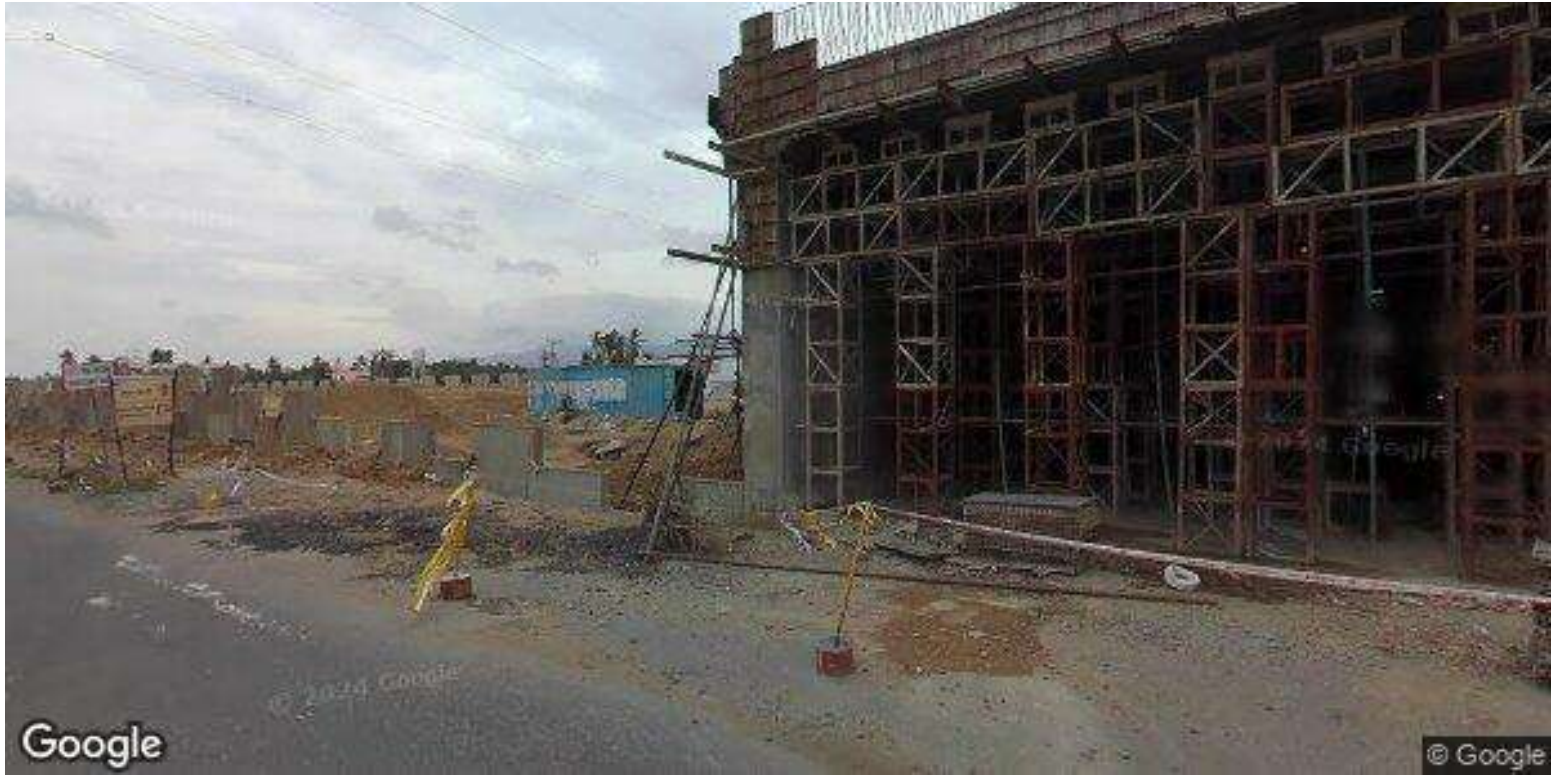
**Risk Type:** Turn  
**Risk Level:** High  
**Speed Limit:** 15 KM/Hr  
**Coordinates:** 11.58528, 78.74234

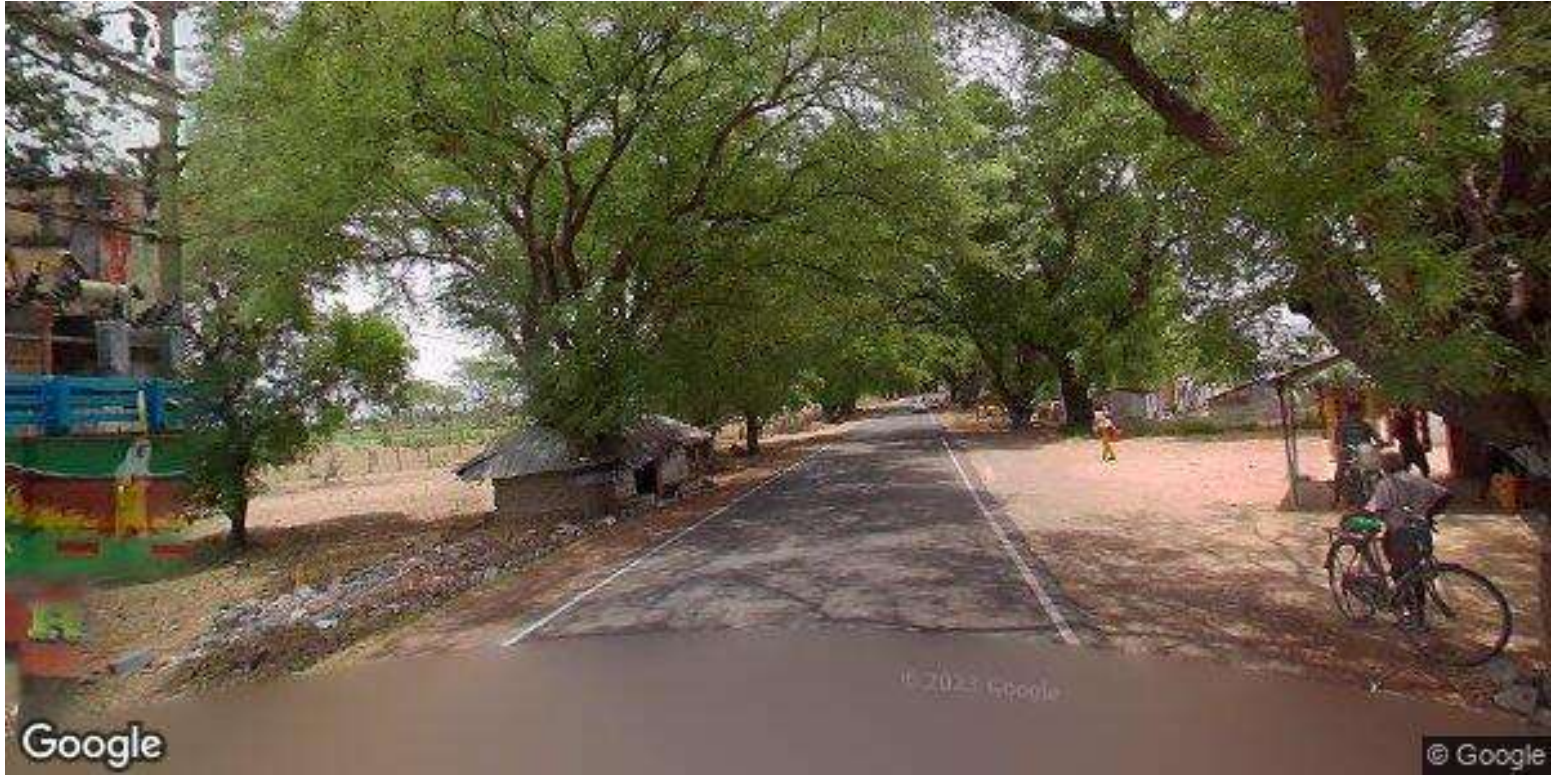
Risk Type: Turn

Risk Level: High

Speed Limit: 15 KM/Hr

Coordinates: 11.58553, 78.74952
