## JOURNEY RISK MANAGEMENT (JRM) STUDY

### Salem Terminal to SARADHA RANGANATHAN AGENCIES

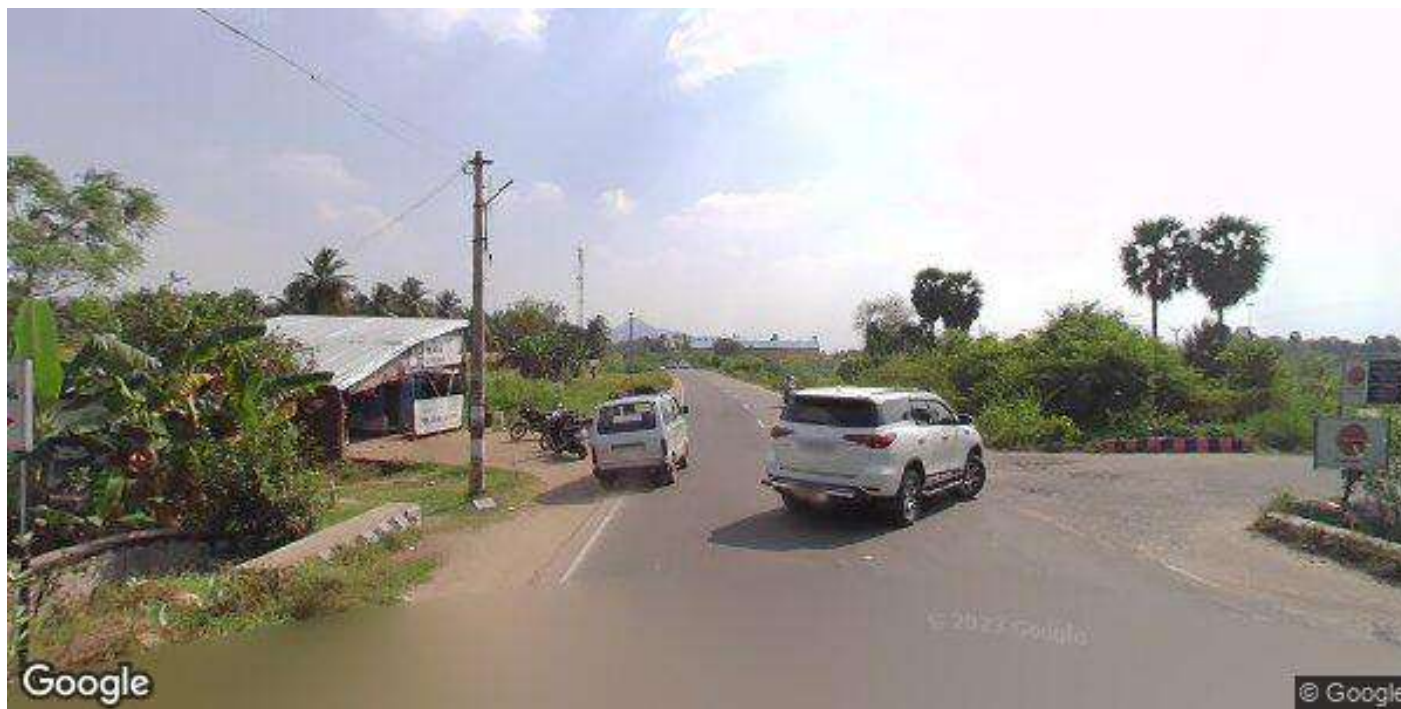
**Risk Type:** Turn  
**Risk Level:** High  
**Speed Limit:** 15 KM/Hr  
**Coordinates:** 11.44029, 77.87544

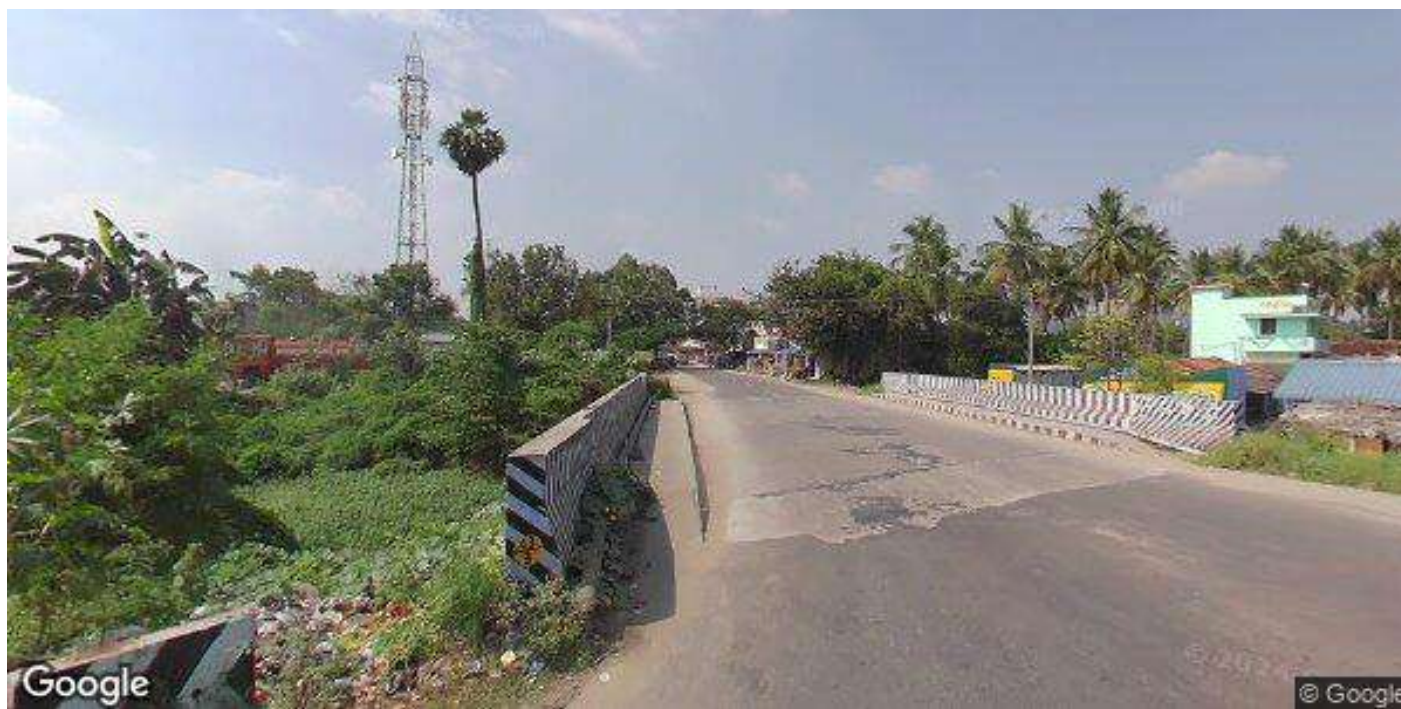
**Risk Type:** Turn  
**Risk Level:** Medium  
**Speed Limit:** 30 KM/Hr  
**Coordinates:** 11.44900, 77.87406

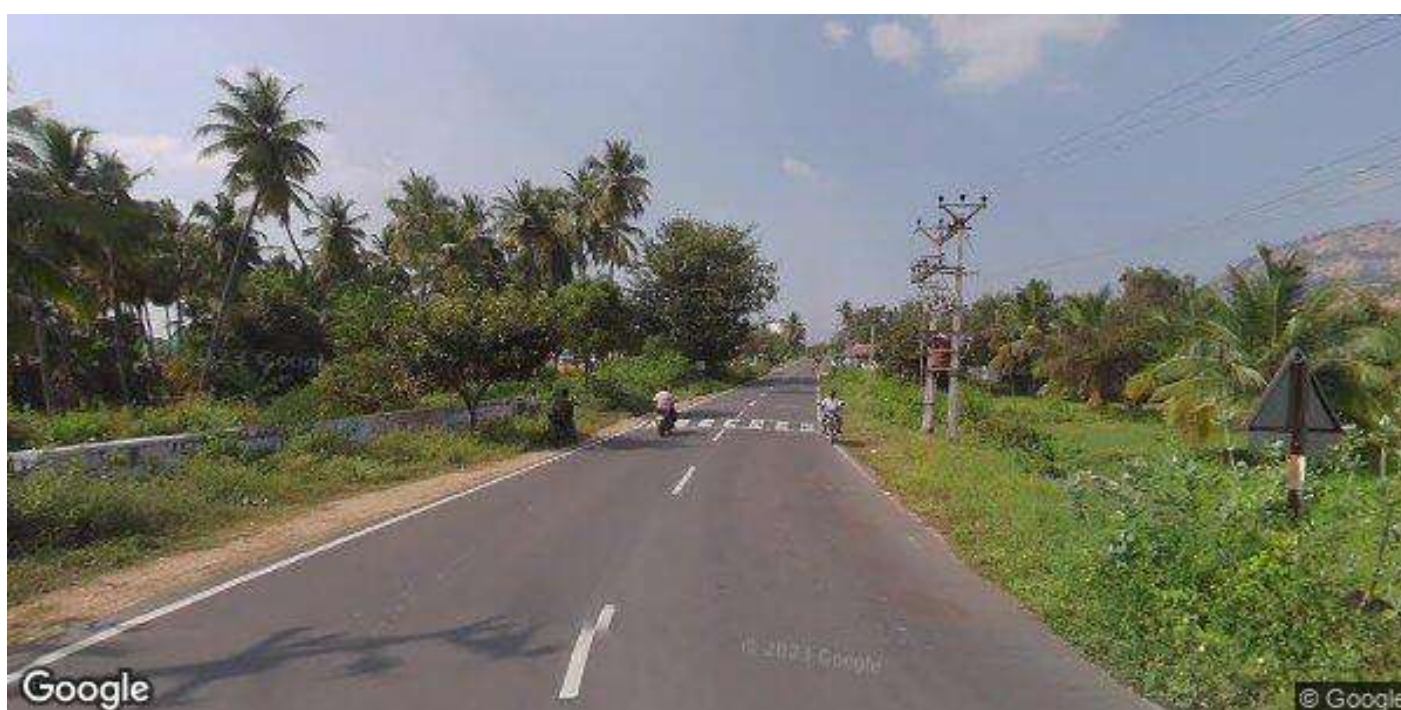
**Risk Type:** Turn  
**Risk Level:** High  
**Speed Limit:** 15 KM/Hr  
**Coordinates:** 11.45353, 77.85697

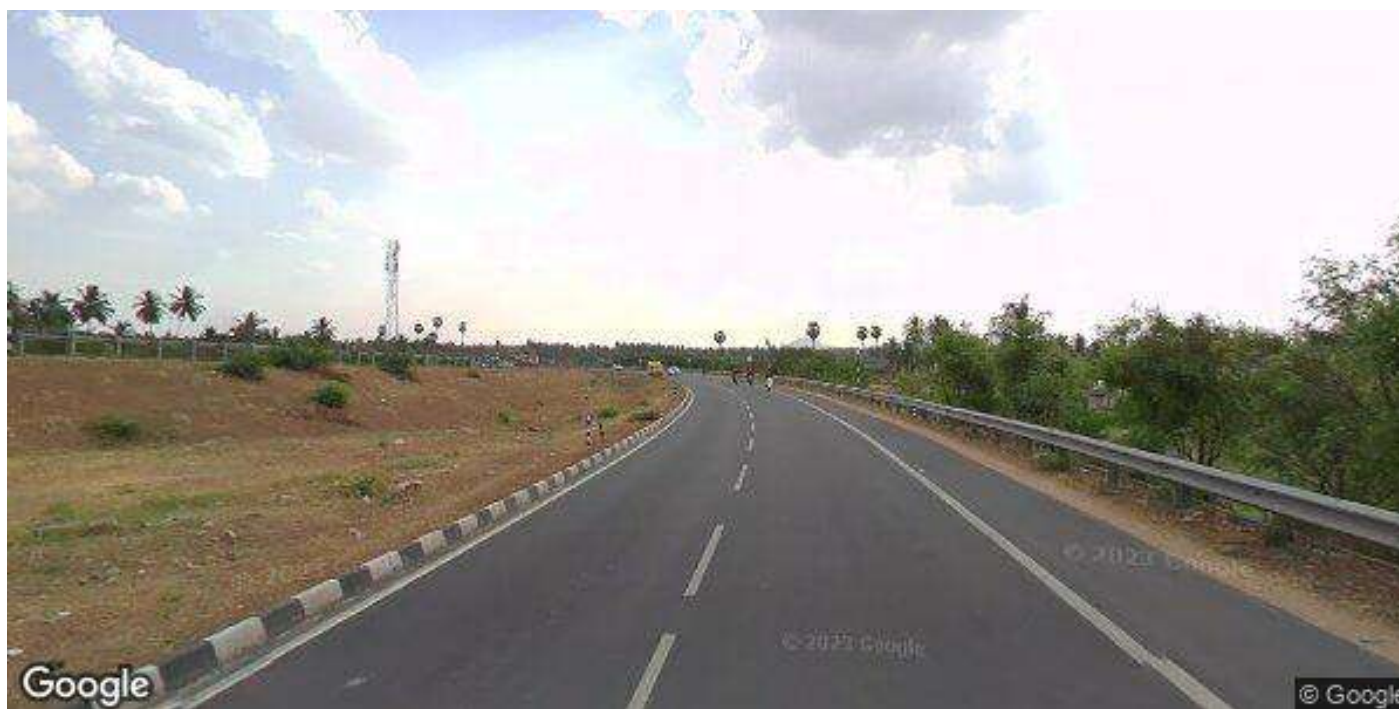
**Risk Type:** Turn  
**Risk Level:** Medium  
**Speed Limit:** 30 KM/Hr  
**Coordinates:** 11.53573, 77.95794

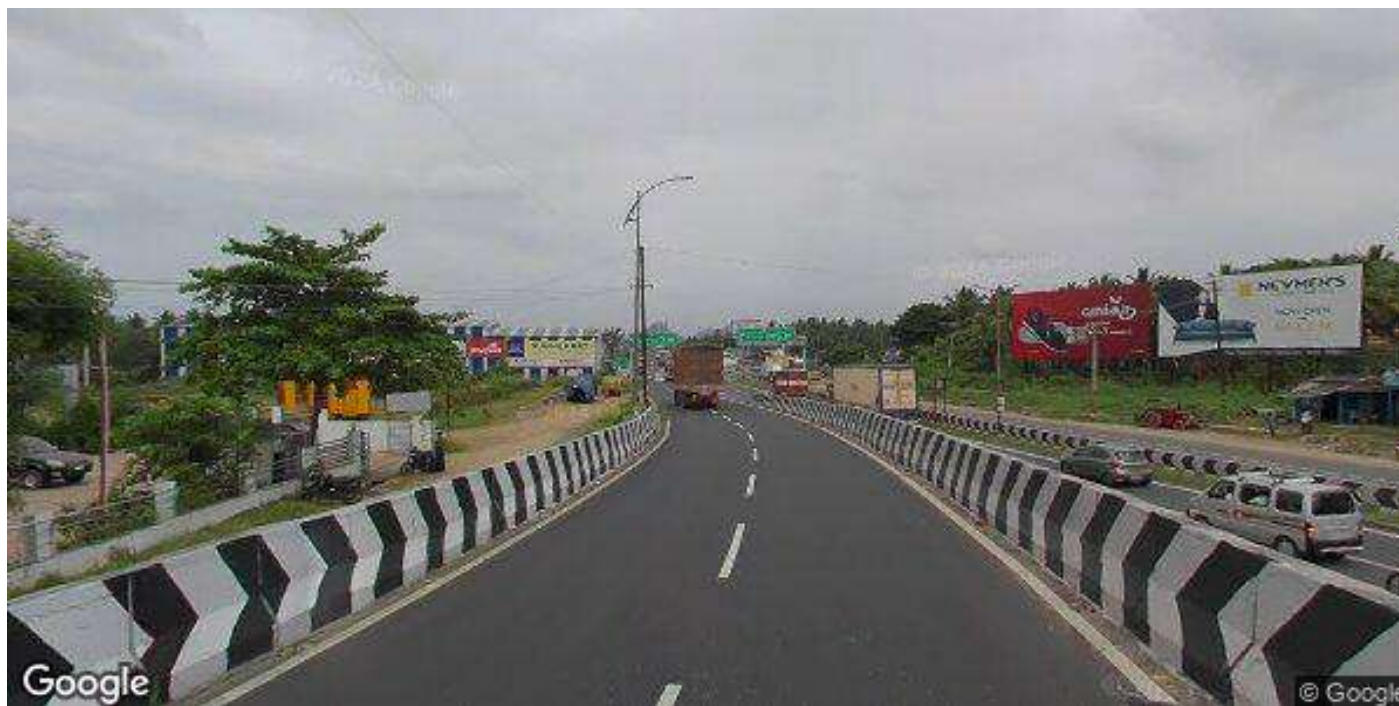
**Risk Type:** Turn  
**Risk Level:** Medium  
**Speed Limit:** 30 KM/Hr  
**Coordinates:** 11.64338, 78.11998

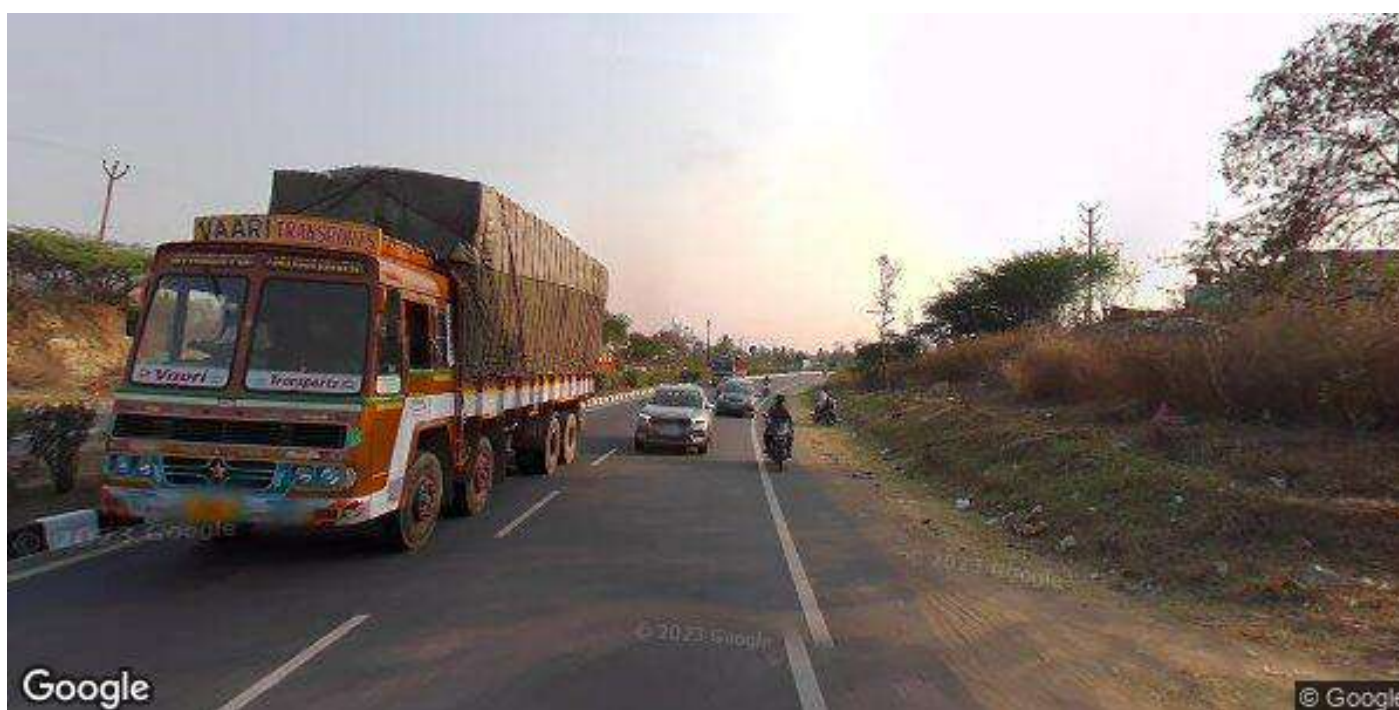
**Risk Type:** Turn  
**Risk Level:** Medium  
**Speed Limit:** 30 KM/Hr  
**Coordinates:** 11.78039, 78.05792

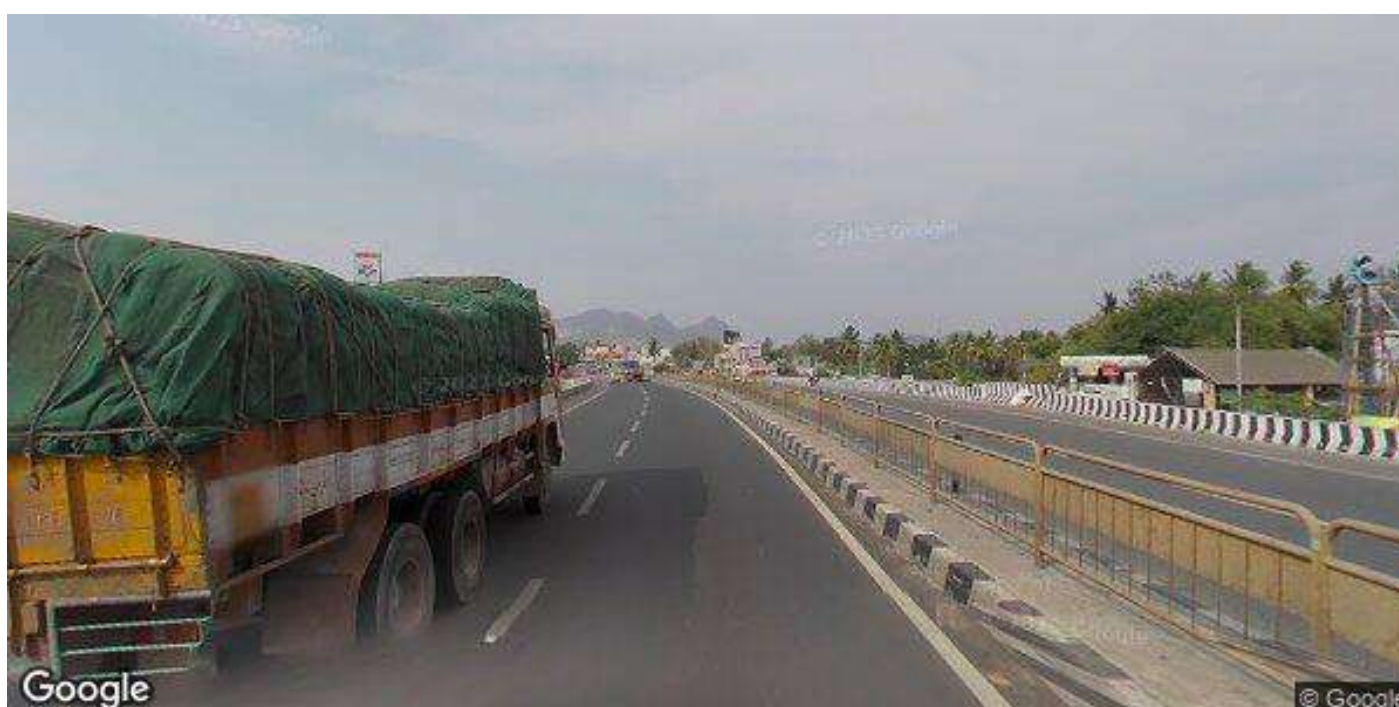
**Risk Type:** Turn  
**Risk Level:** Medium  
**Speed Limit:** 30 KM/Hr  
**Coordinates:** 11.86753, 78.08331

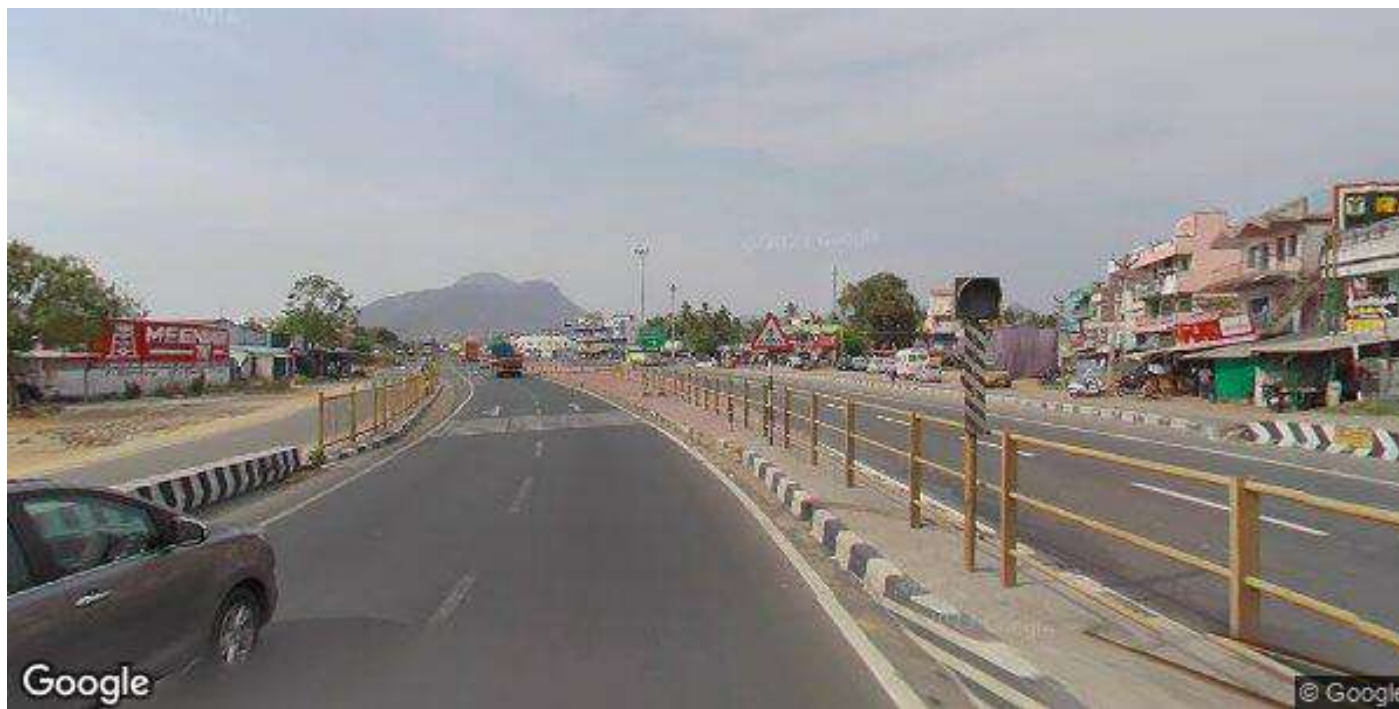
**Risk Type:** Turn  
**Risk Level:** Medium  
**Speed Limit:** 30 KM/Hr  
**Coordinates:** 11.86981, 78.08387

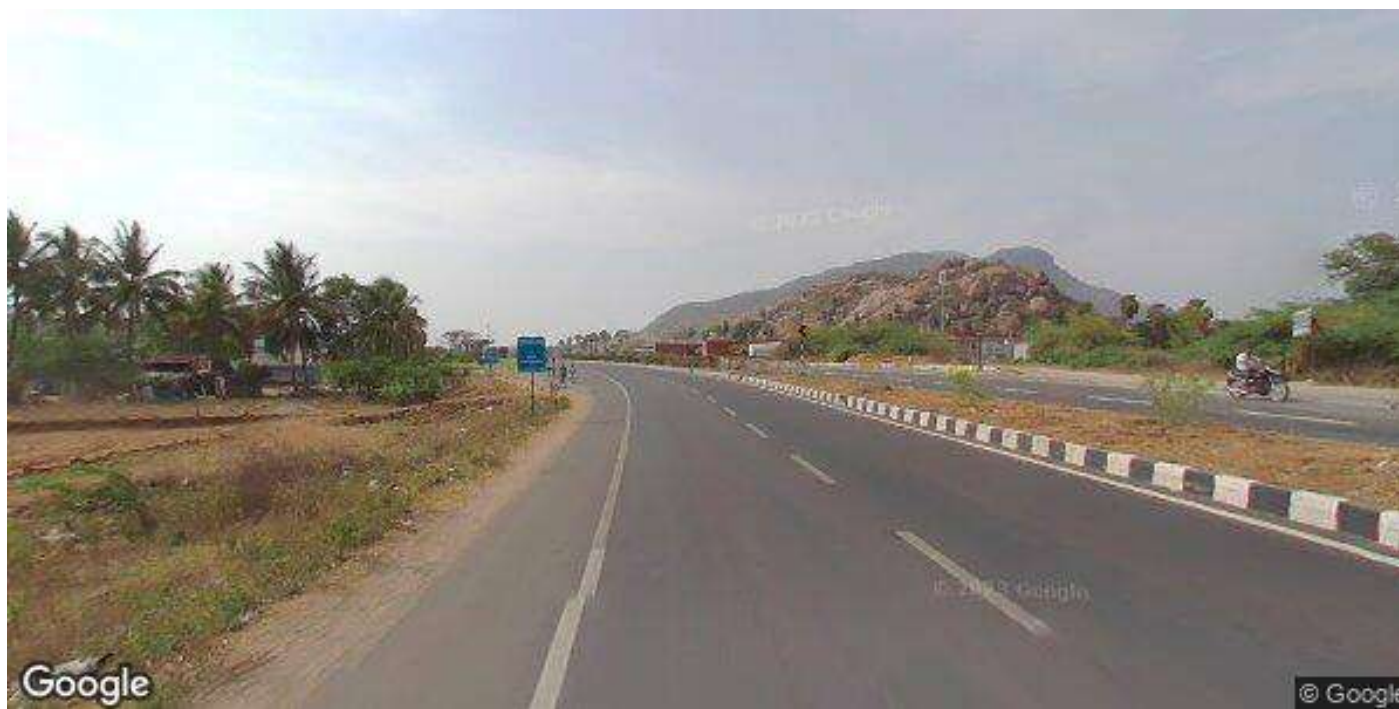
**Risk Type:** Turn  
**Risk Level:** Medium  
**Speed Limit:** 30 KM/Hr  
**Coordinates:** 11.88041, 78.08143

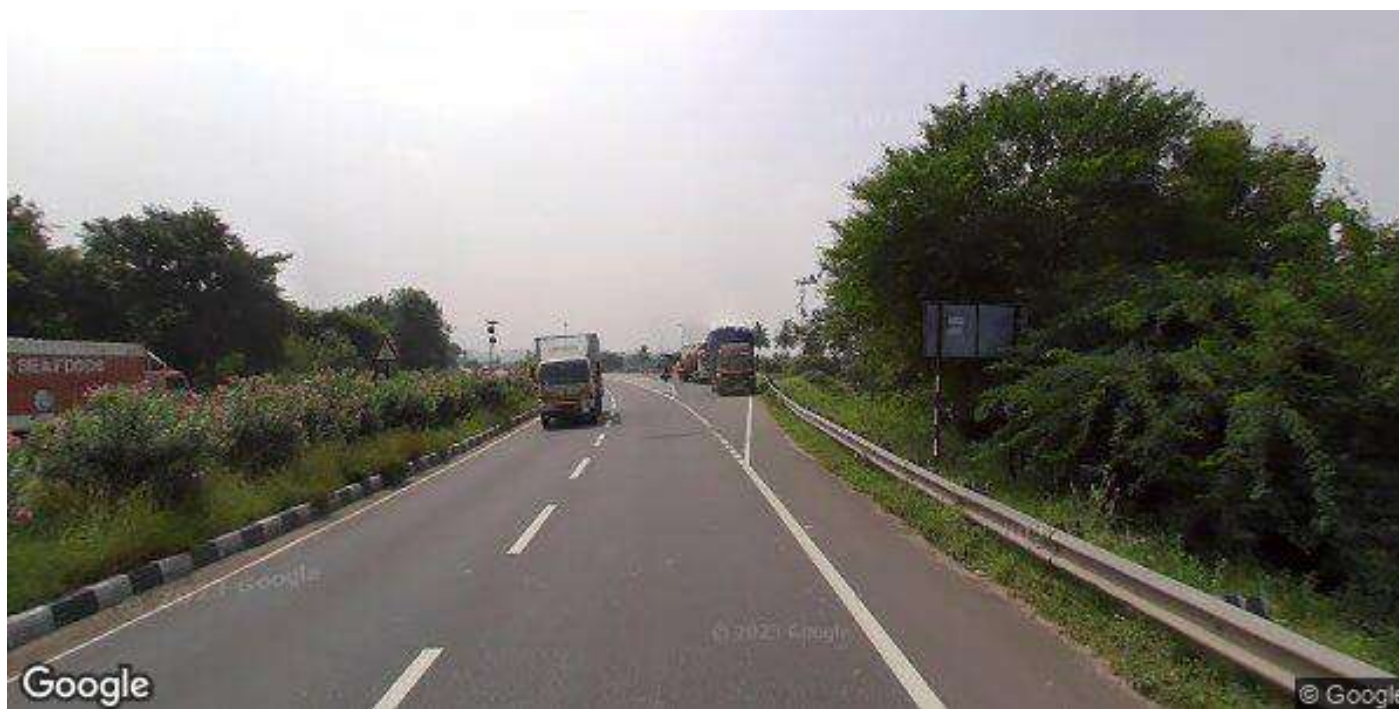
**Risk Type:** Turn  
**Risk Level:** Medium  
**Speed Limit:** 30 KM/Hr  
**Coordinates:** 11.91302, 78.05856

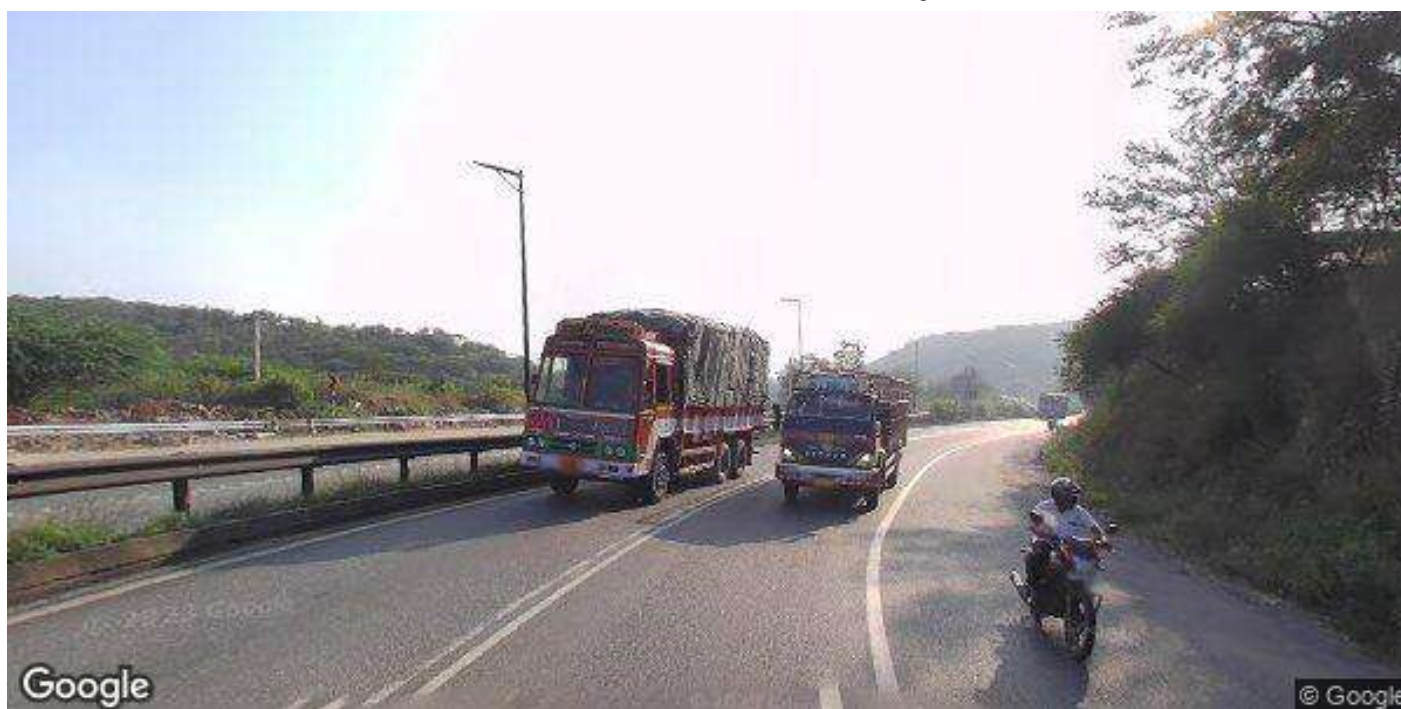
**Risk Type:** Turn  
**Risk Level:** High  
**Speed Limit:** 15 KM/Hr  
**Coordinates:** 11.95824, 78.04981

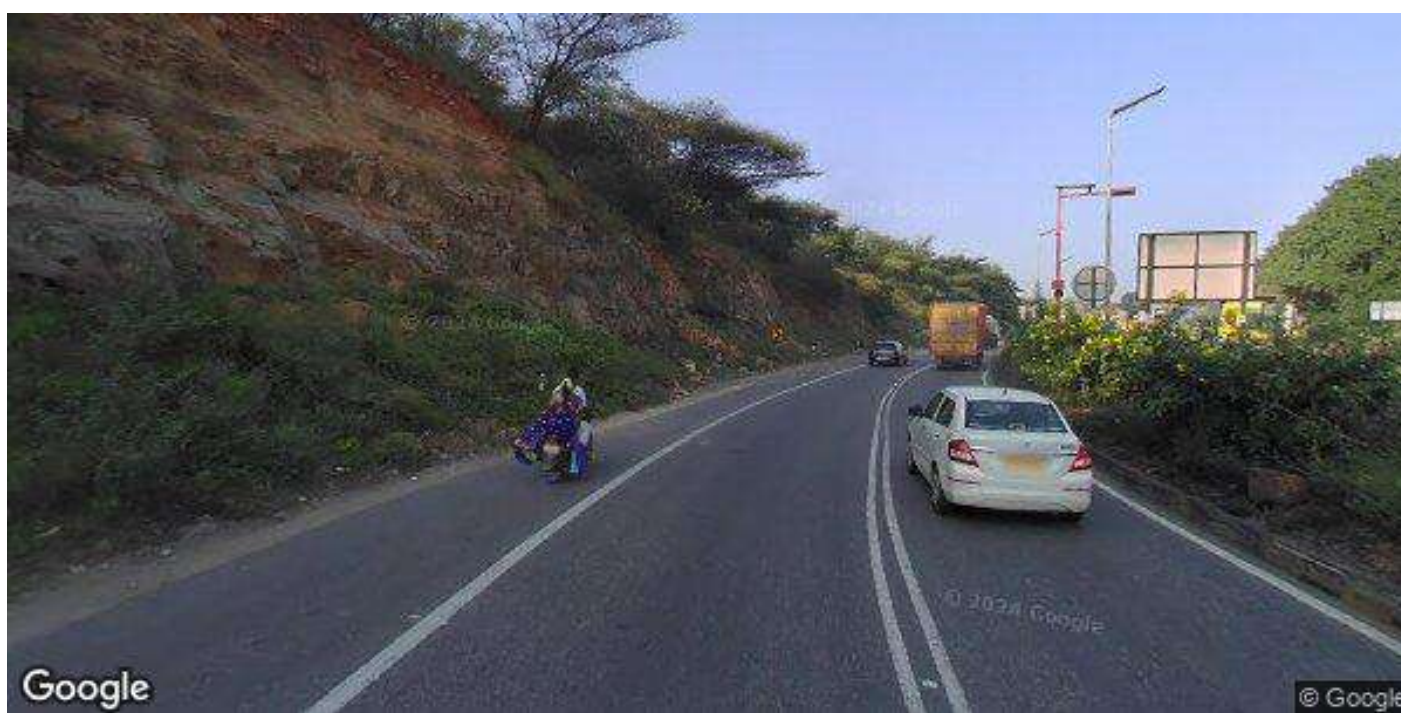
**Risk Type:** Turn  
**Risk Level:** High  
**Speed Limit:** 15 KM/Hr  
**Coordinates:** 11.96040, 78.04947

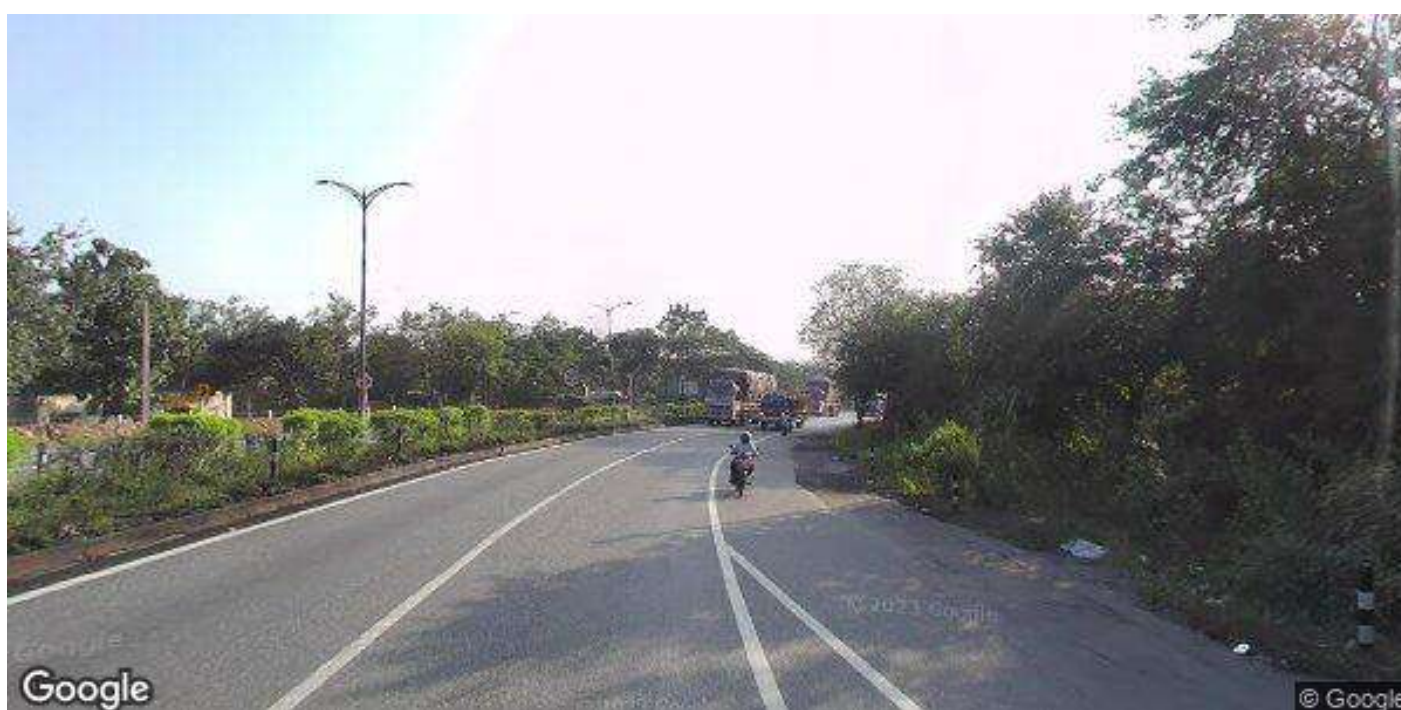
**Risk Type:** Turn  
**Risk Level:** Medium  
**Speed Limit:** 30 KM/Hr  
**Coordinates:** 11.96320, 78.05139

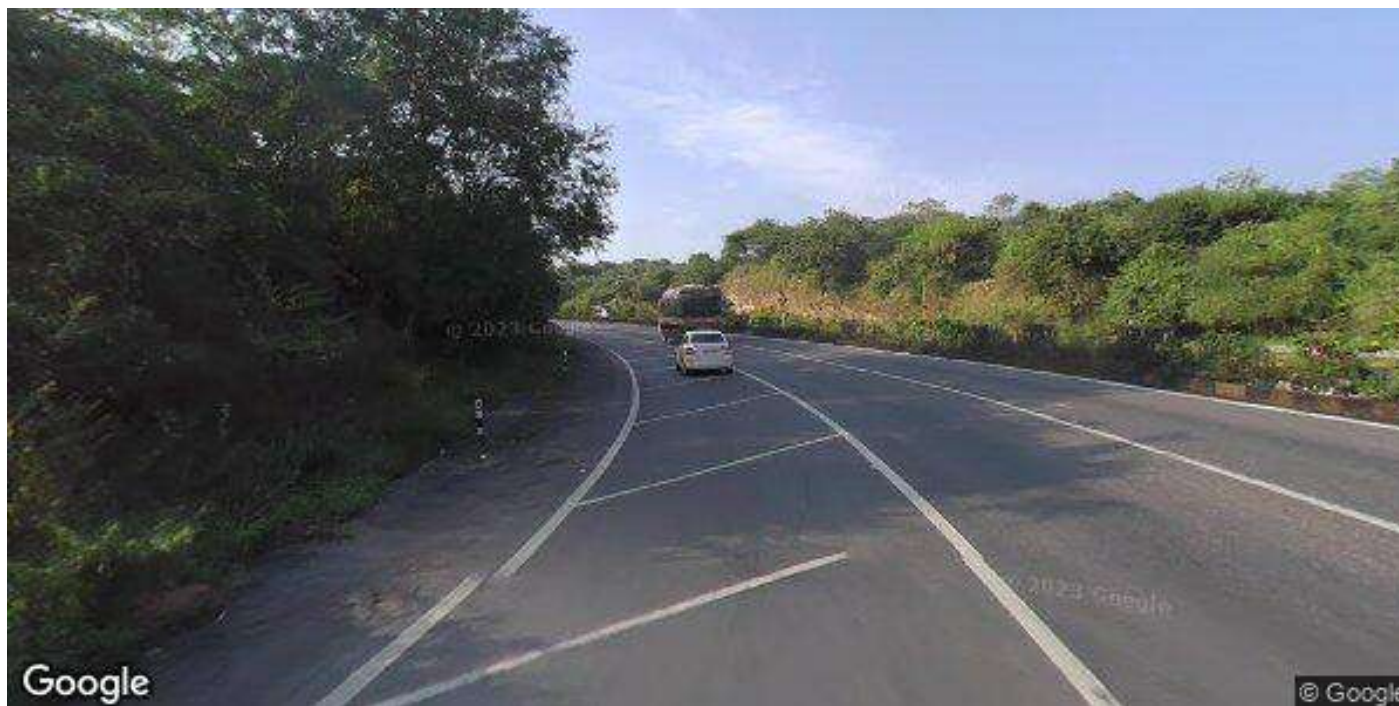
**Risk Type:** Turn  
**Risk Level:** Medium  
**Speed Limit:** 30 KM/Hr  
**Coordinates:** 11.96401, 78.05134

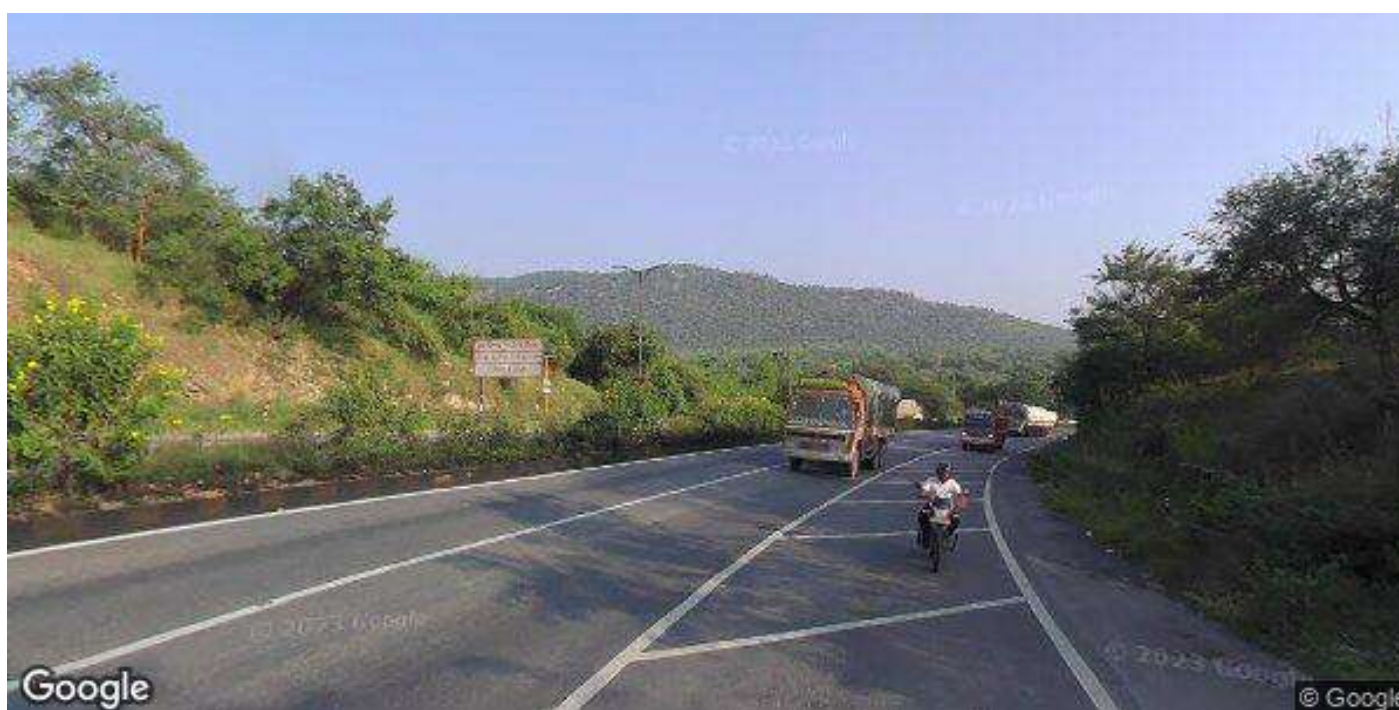
**Risk Type:** Turn  
**Risk Level:** Medium  
**Speed Limit:** 30 KM/Hr  
**Coordinates:** 11.96463, 78.05077

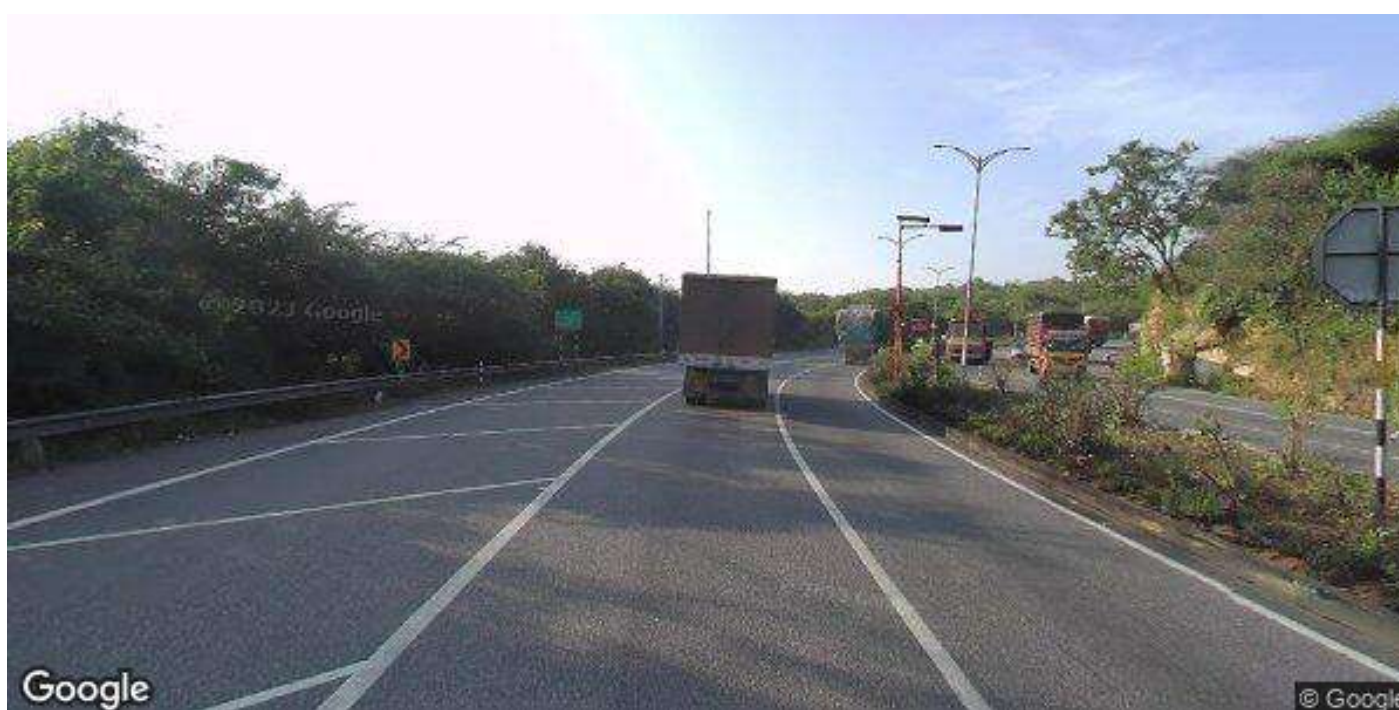
**Risk Type:** Turn  
**Risk Level:** Medium  
**Speed Limit:** 30 KM/Hr  
**Coordinates:** 11.96504, 78.04975

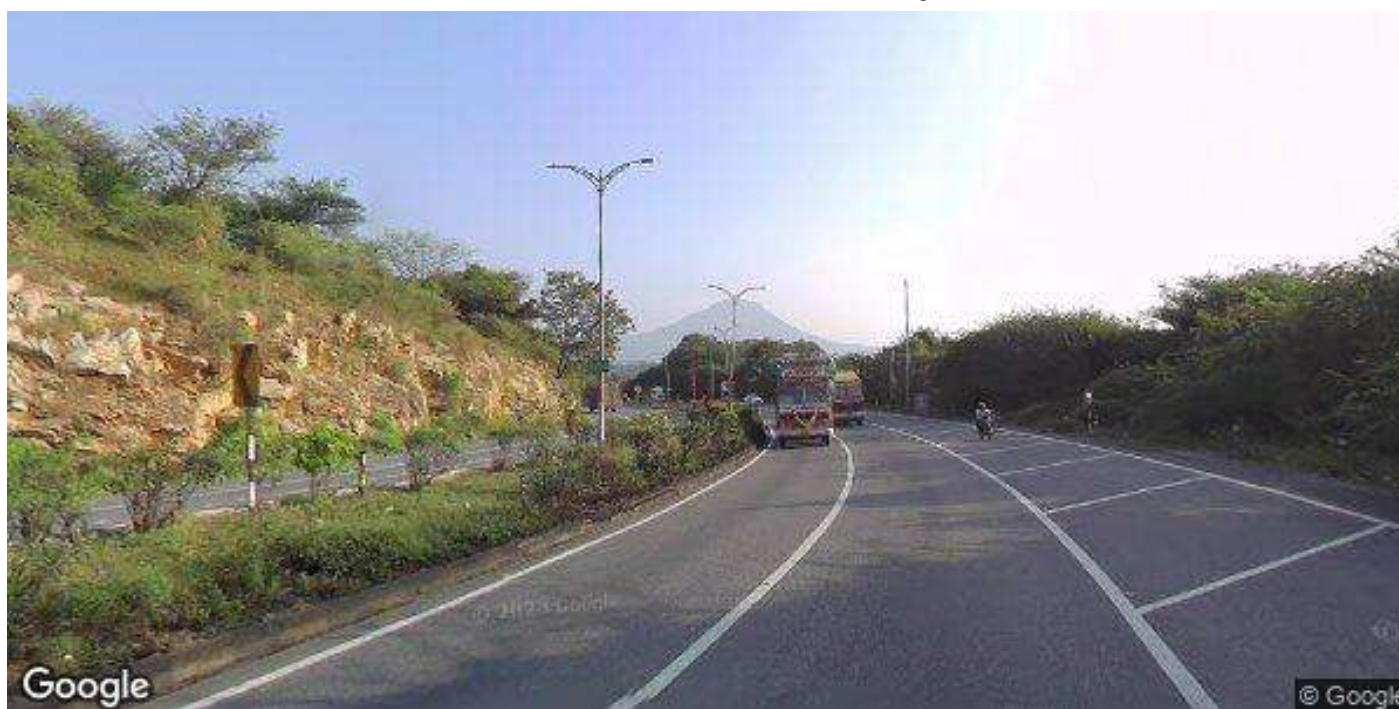
**Risk Type:** Turn  
**Risk Level:** High  
**Speed Limit:** 15 KM/Hr  
**Coordinates:** 11.96597, 78.04920

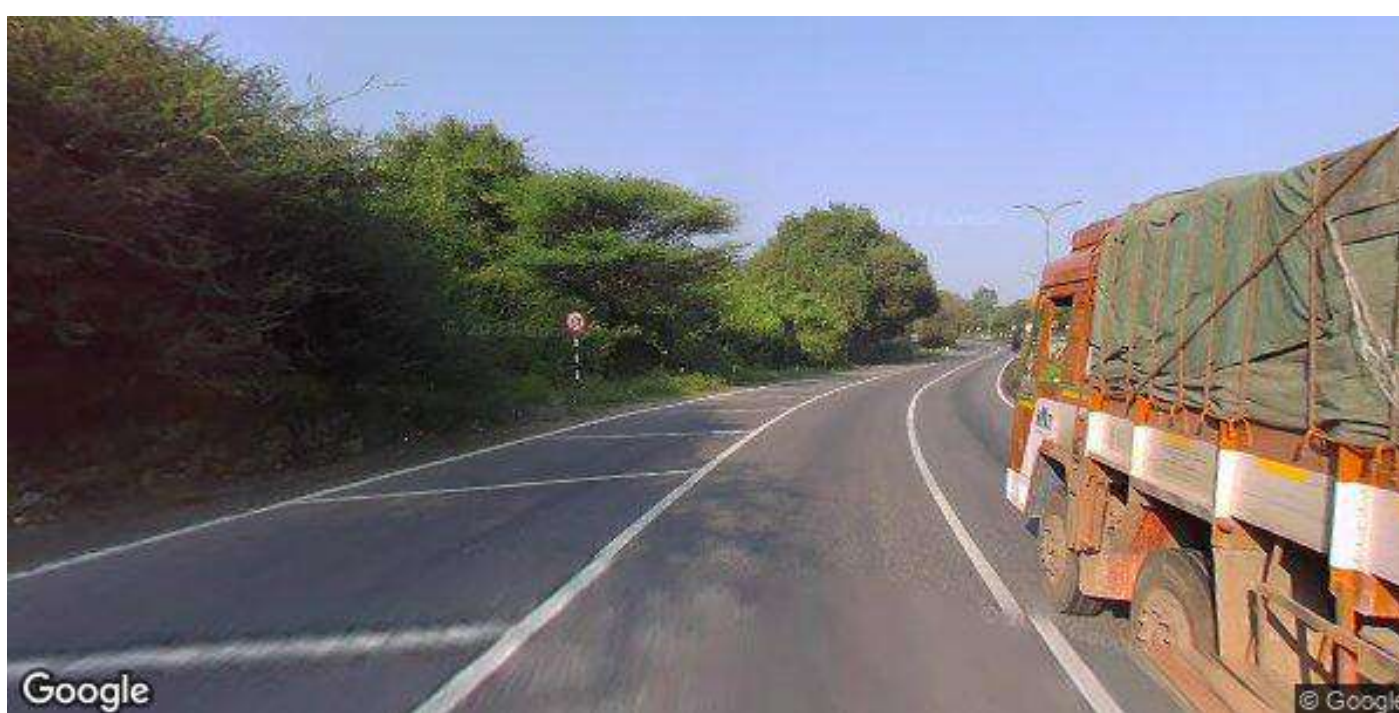
**Risk Type:** Turn  
**Risk Level:** Medium  
**Speed Limit:** 30 KM/Hr  
**Coordinates:** 11.96679, 78.04942

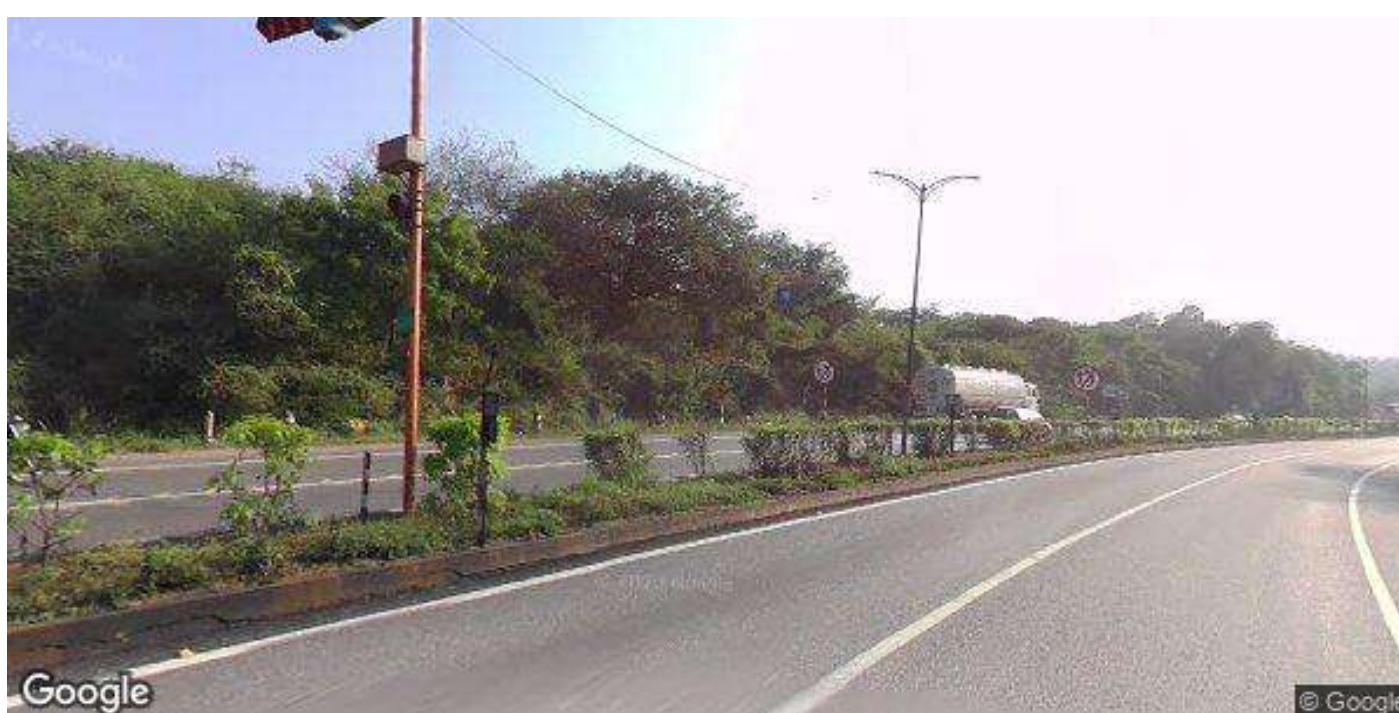
**Risk Type:** Turn  
**Risk Level:** Medium  
**Speed Limit:** 30 KM/Hr  
**Coordinates:** 11.96804, 78.05080

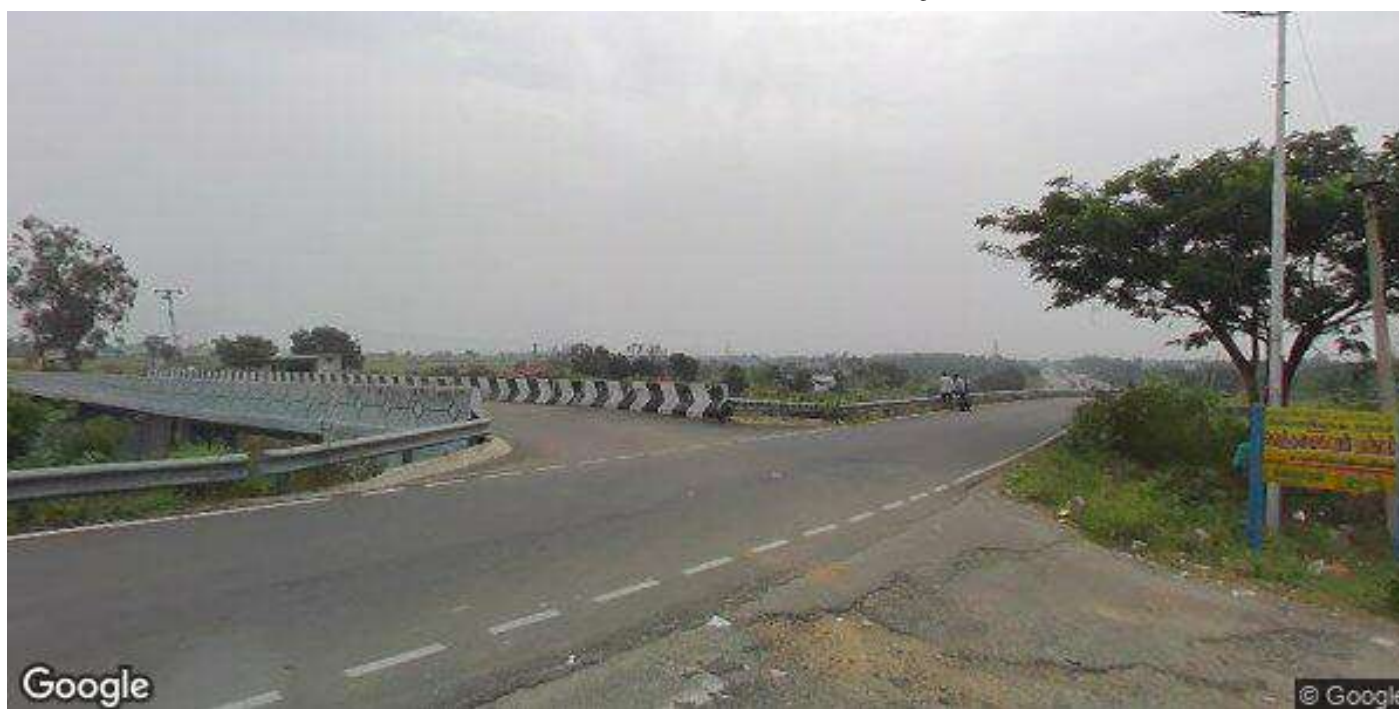
**Risk Type:** Blind Spot  
**Risk Level:** Blind Spot  
**Speed Limit:** 10 KM/Hr  
**Coordinates:** 12.09202, 78.11459

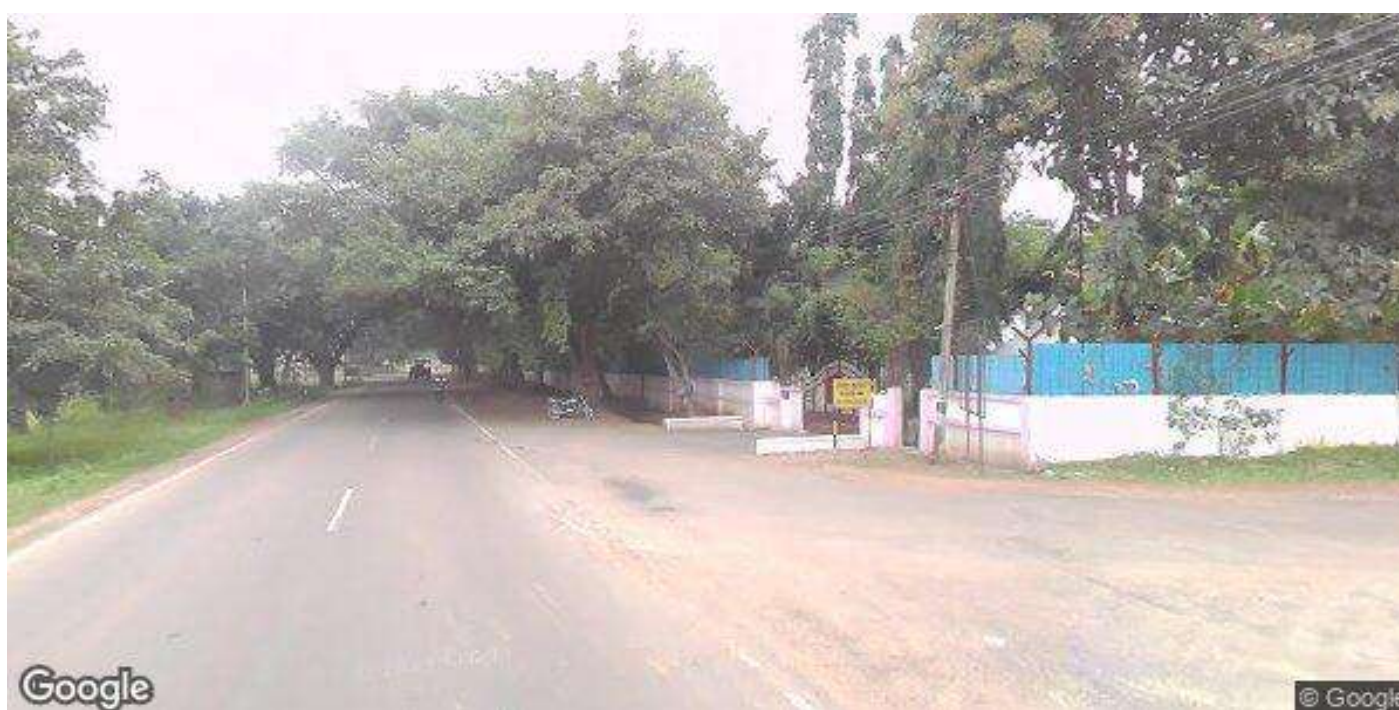
**Risk Type:** Turn  
**Risk Level:** High  
**Speed Limit:** 15 KM/Hr  
**Coordinates:** 12.08780, 78.12237

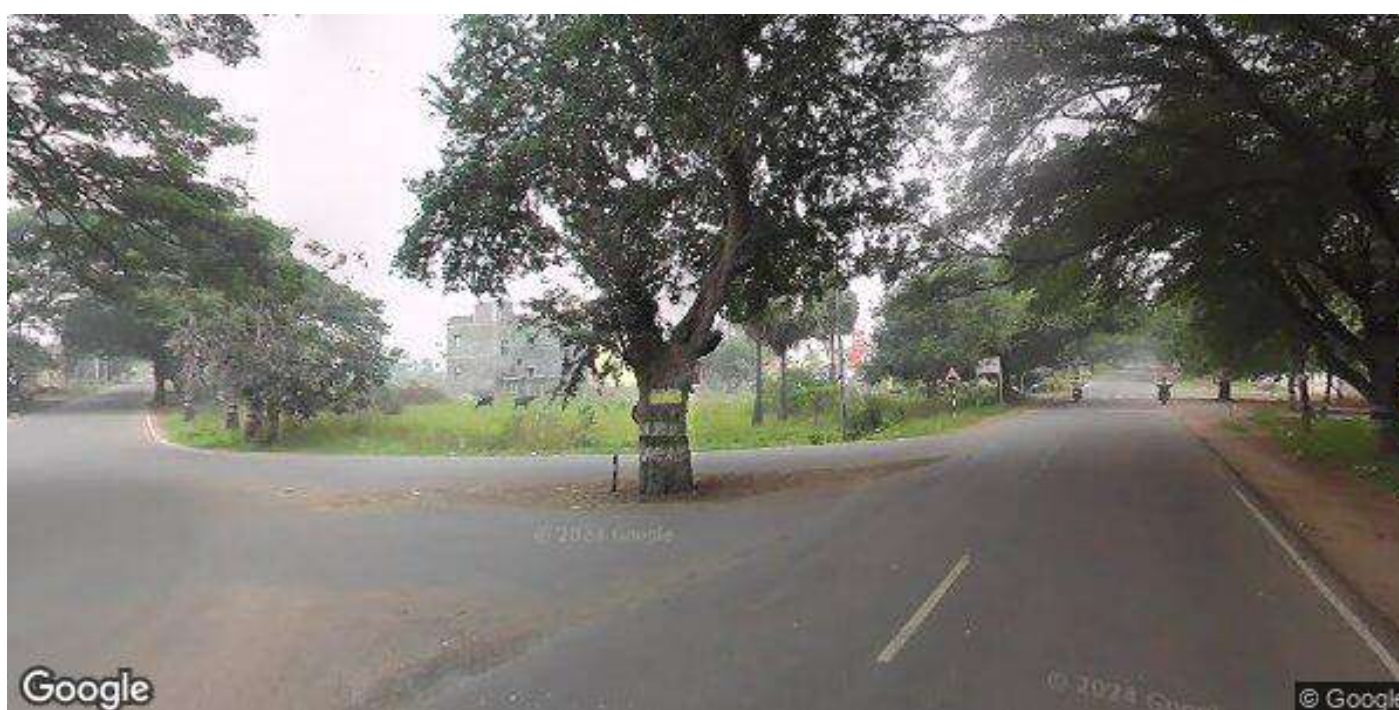
**Risk Type:** Turn  
**Risk Level:** High  
**Speed Limit:** 15 KM/Hr  
**Coordinates:** 12.08688, 78.12234
