## JOURNEY RISK MANAGEMENT (JRM) STUDY

### Salem Terminal to SARADHA RANGANATHAN AGENCIES

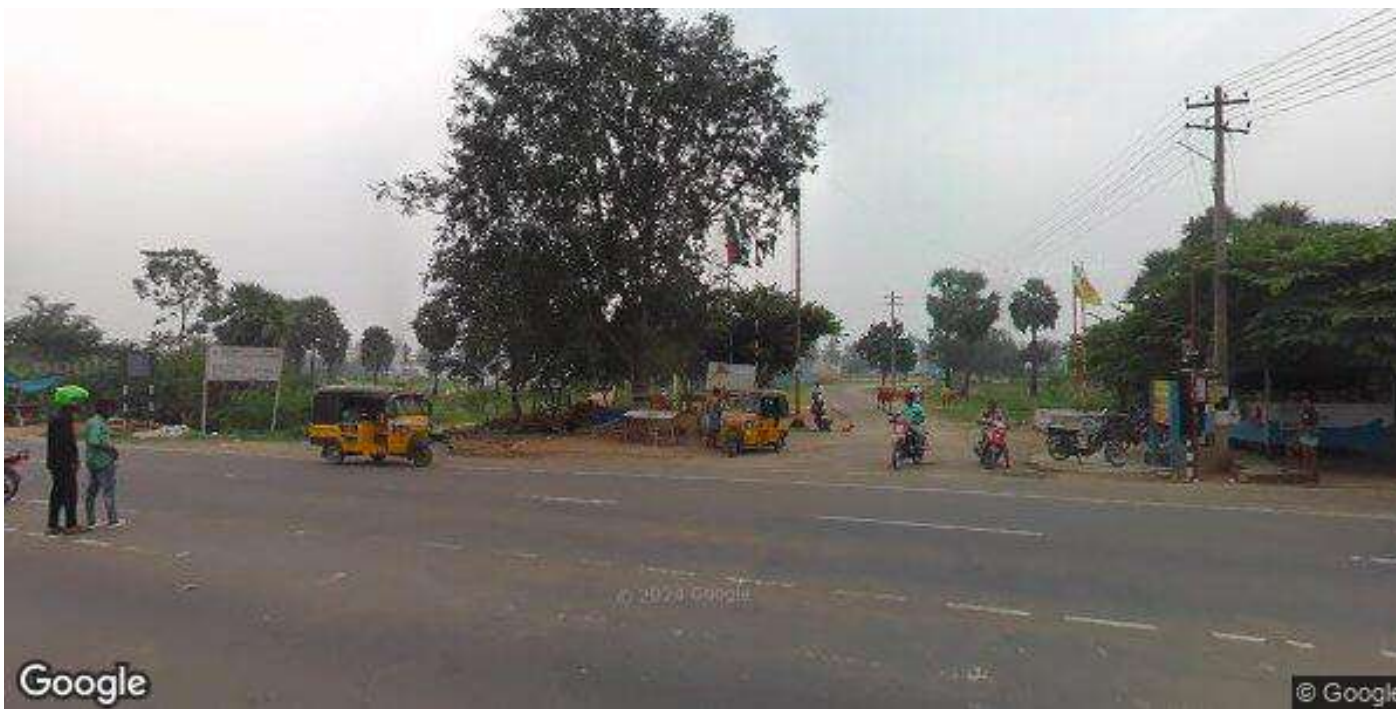
**Risk Type:** Turn  
**Risk Level:** High  
**Speed Limit:** 15 KM/Hr  
**Coordinates:** 12.08464, 78.12765

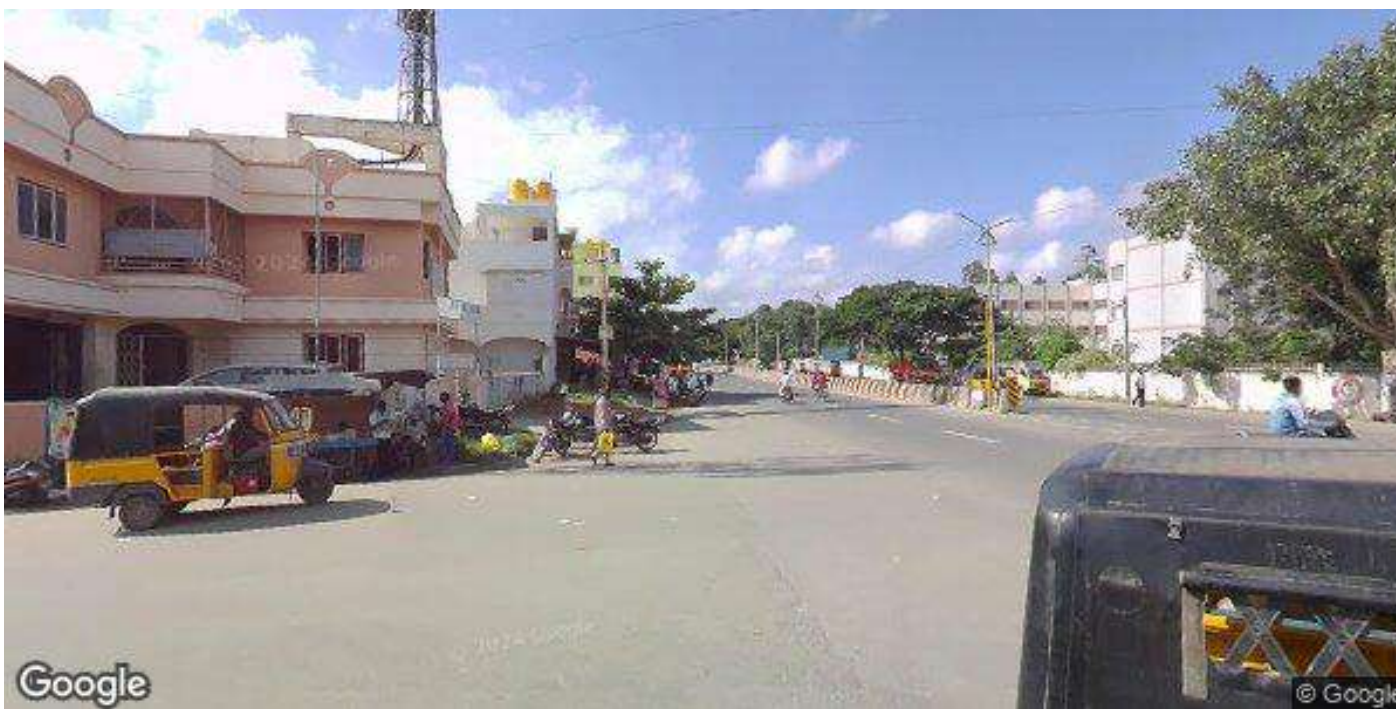
**Risk Type:** Turn  
**Risk Level:** High  
**Speed Limit:** 15 KM/Hr  
**Coordinates:** 12.10313, 78.14568

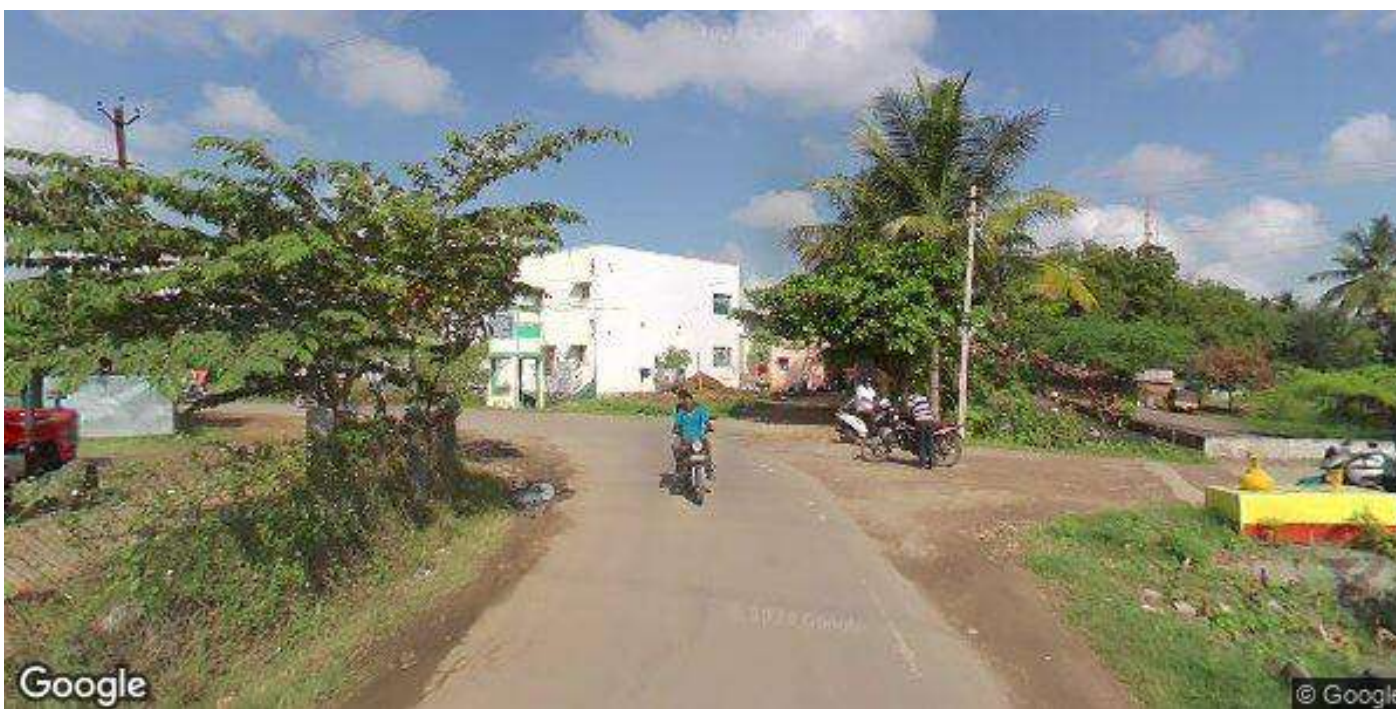
**Risk Type:** Turn  
**Risk Level:** Medium  
**Speed Limit:** 30 KM/Hr  
**Coordinates:** 12.10166, 78.14834

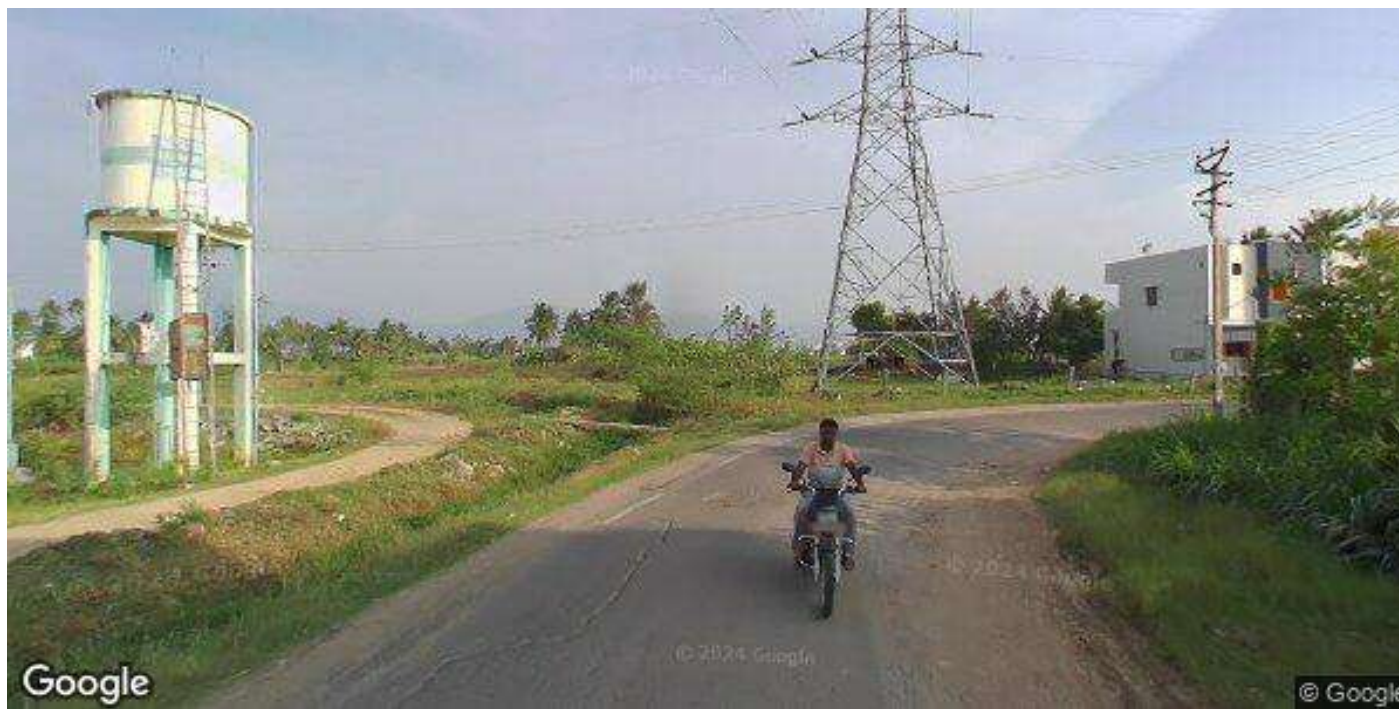
**Risk Type:** Turn  
**Risk Level:** High  
**Speed Limit:** 15 KM/Hr  
**Coordinates:** 12.09975, 78.14984

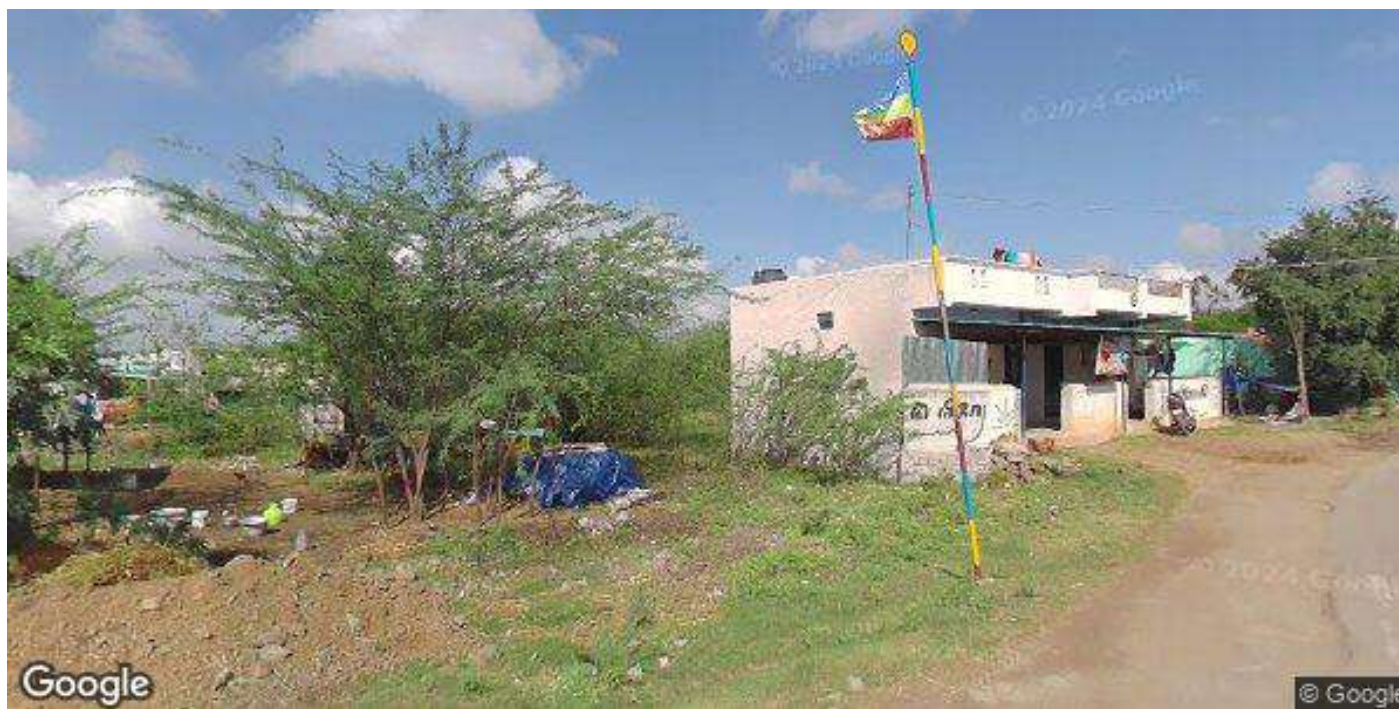
**Risk Type:** Turn  
**Risk Level:** High  
**Speed Limit:** 15 KM/Hr  
**Coordinates:** 12.09643, 78.14897
