# IndianOil

## JOURNEY RISK MANAGEMENT (JRM) STUDY

### Salem Terminal to LR AGENCIES

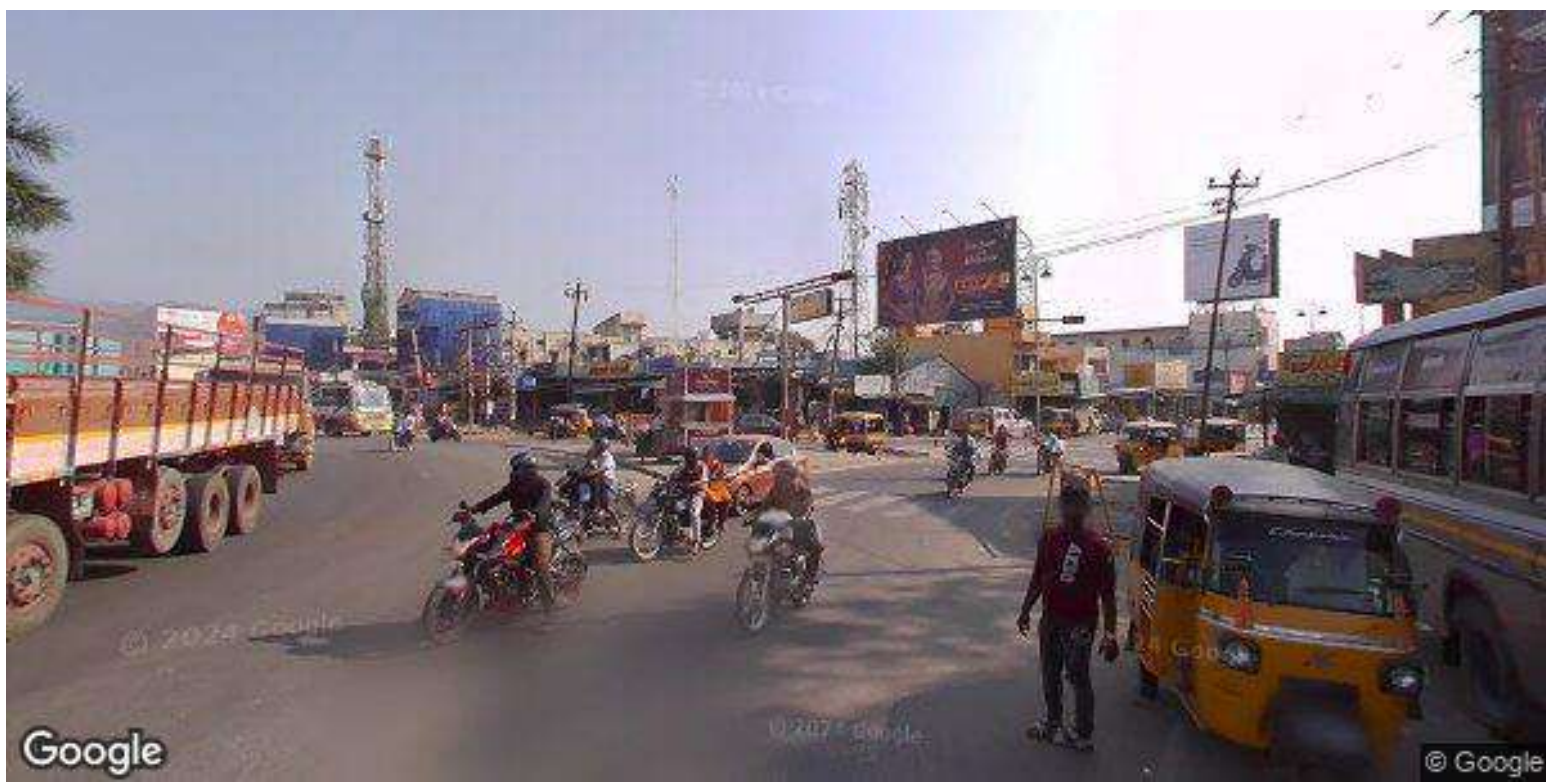
**Coordinates:** 11.63266, 78.12699

**Risk Type:** Roundabout

**Risk Level:** High

**Speed Limit:** 15 KM/Hr

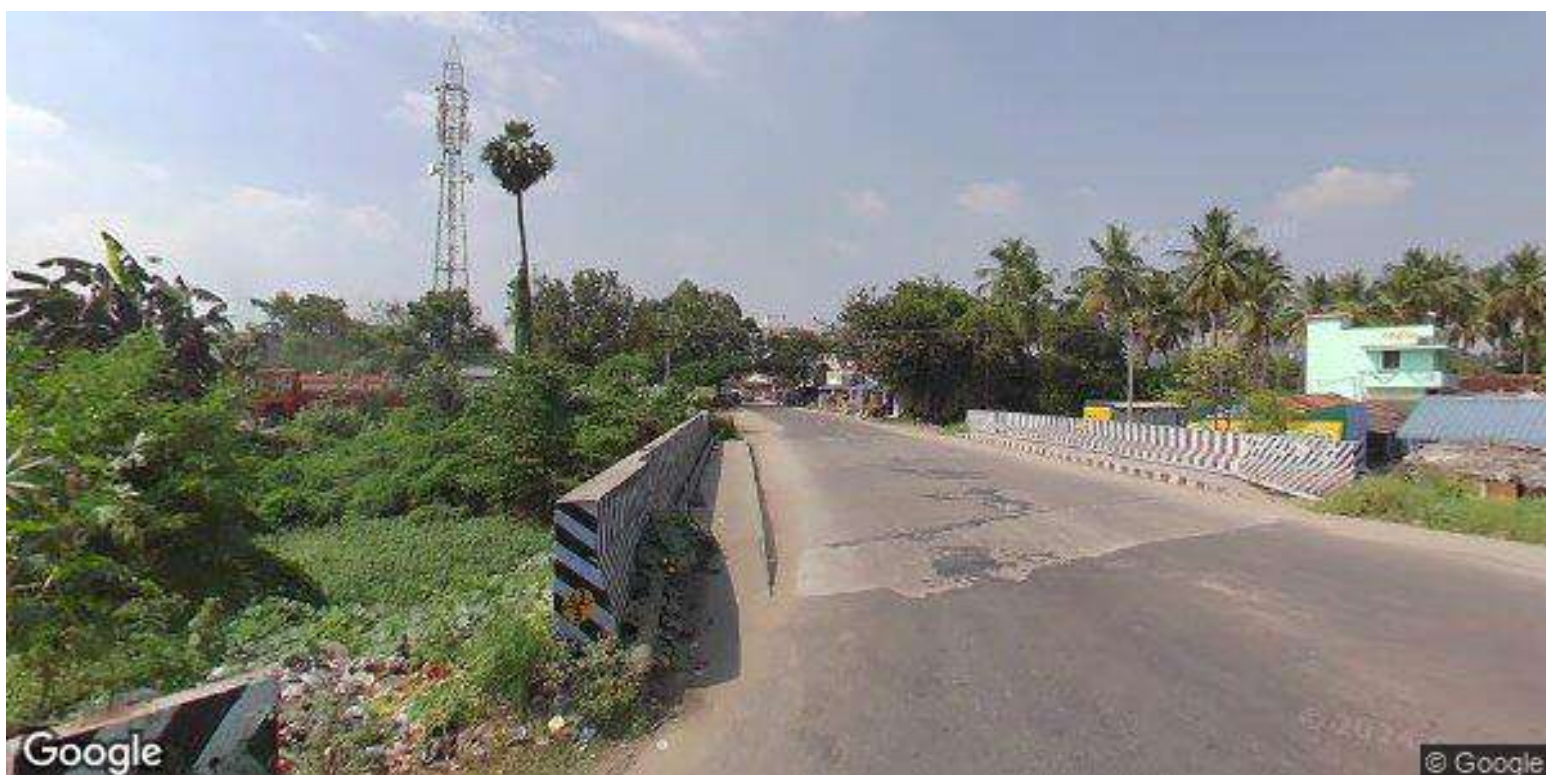
**Risk Type:** Turn  
**Risk Level:** Medium  
**Speed Limit:** 30 KM/Hr  
**Coordinates:** 11.44900, 77.87406

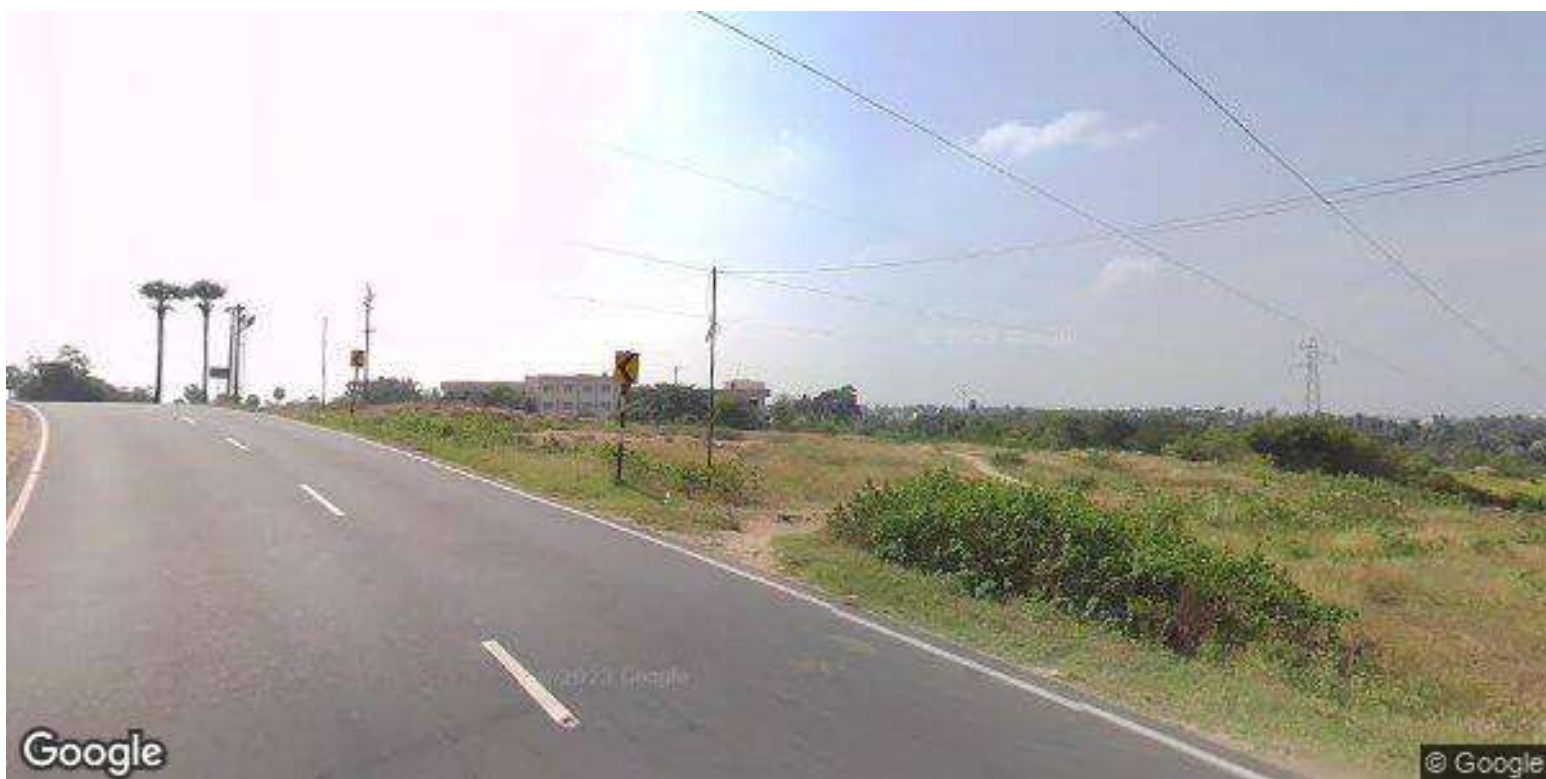
**Coordinates:** 11.46048, 77.85036

**Risk Type:** Turn

**Risk Level:** Medium

**Speed Limit:** 30 KM/Hr

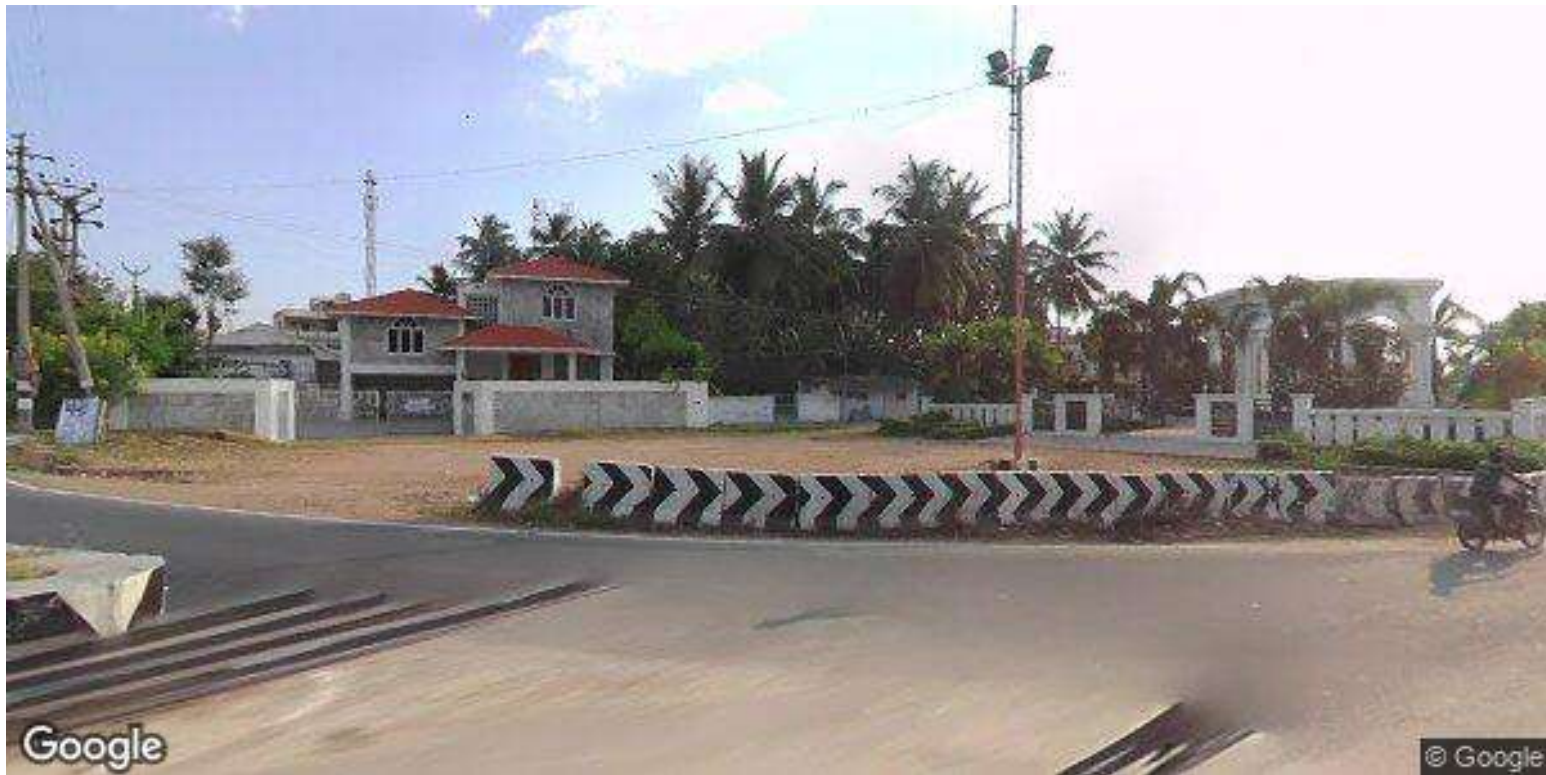
**Coordinates: 11.46314, 77.84928**

**Risk Type: Turn**

**Risk Level: Medium**

**Speed Limit: 30 KM/Hr**

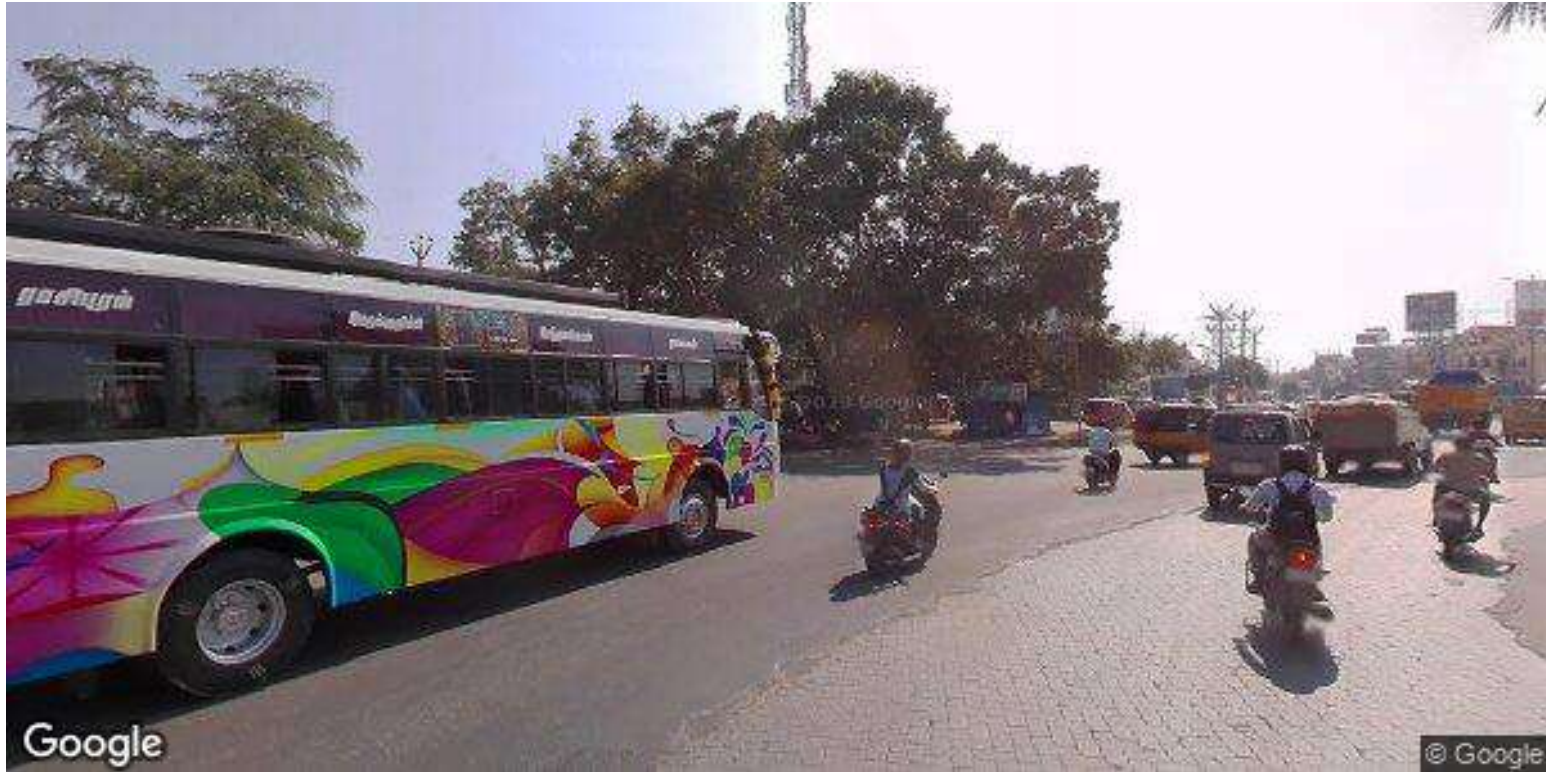
**Risk Type:** Turn  
**Risk Level:** High  
**Speed Limit:** 15 KM/Hr  
**Coordinates:** 11.63300, 78.12746

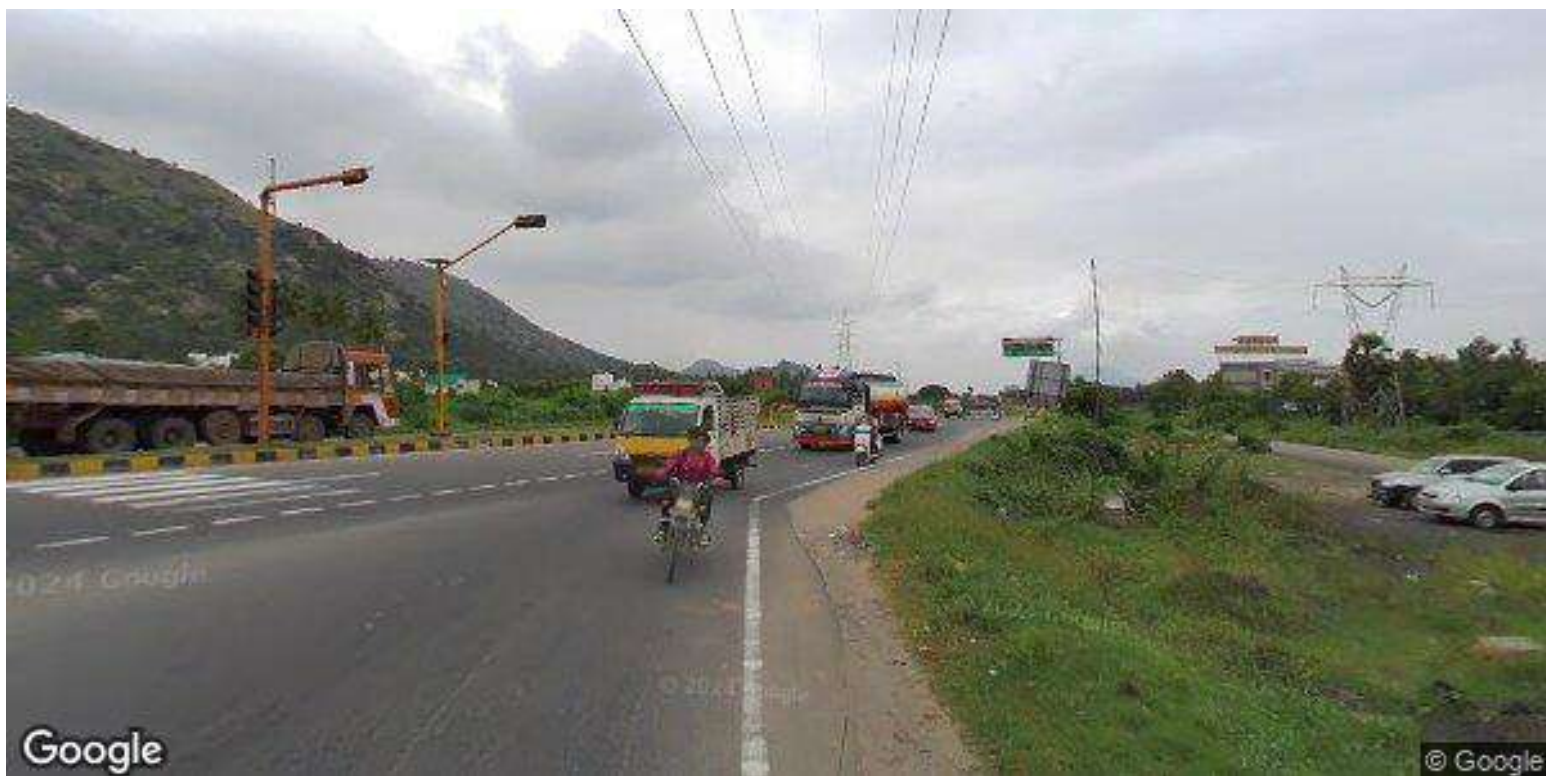
**Risk Type:** Turn  
**Risk Level:** Medium  
**Speed Limit:** 30 KM/Hr  
**Coordinates:** 11.65627, 78.20215

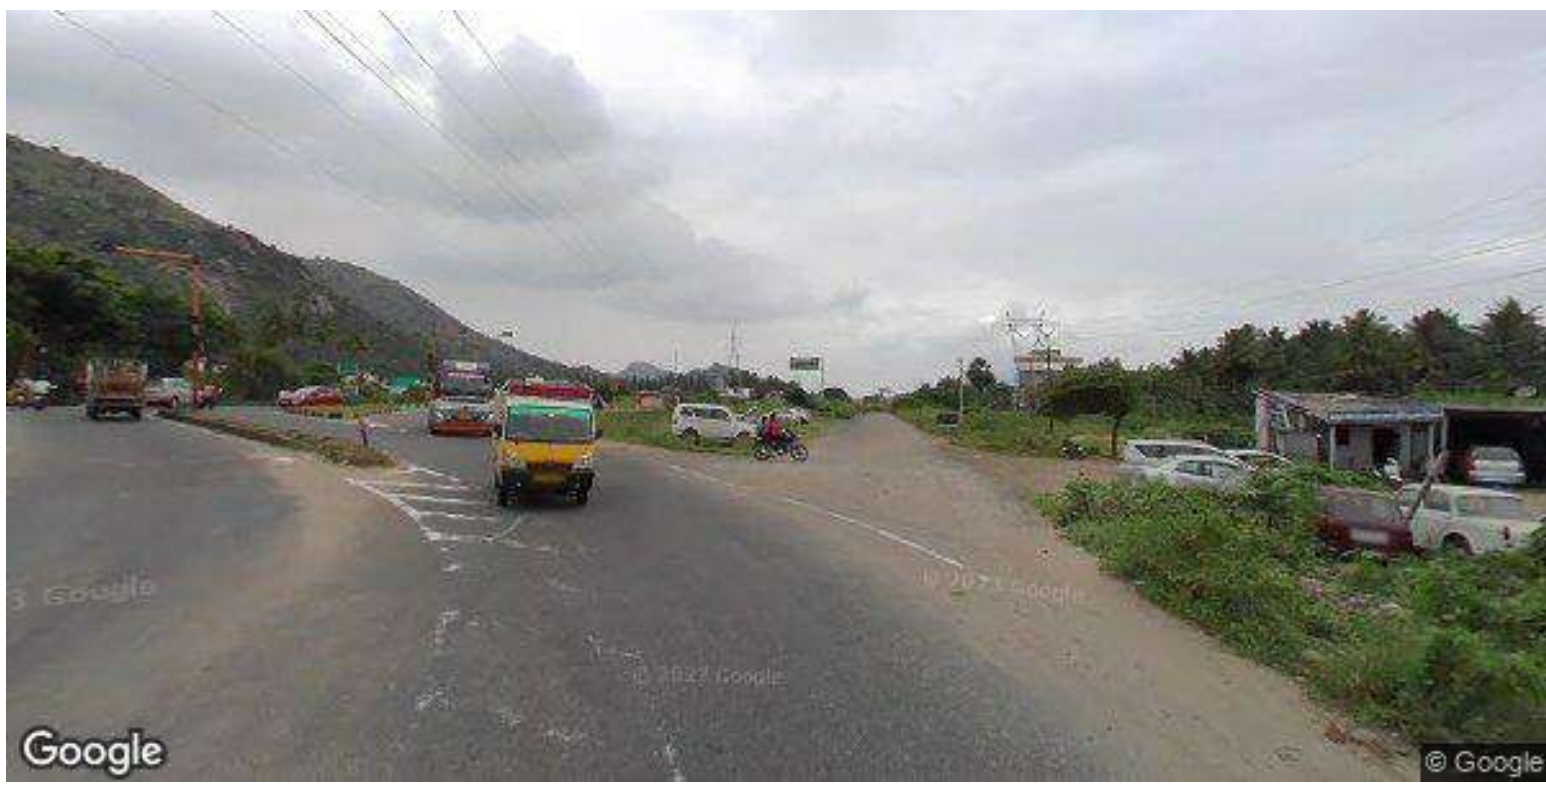
**Coordinates:** 11.65664, 78.20240

**Risk Type:** Turn

**Risk Level:** Medium

**Speed Limit:** 30 KM/Hr

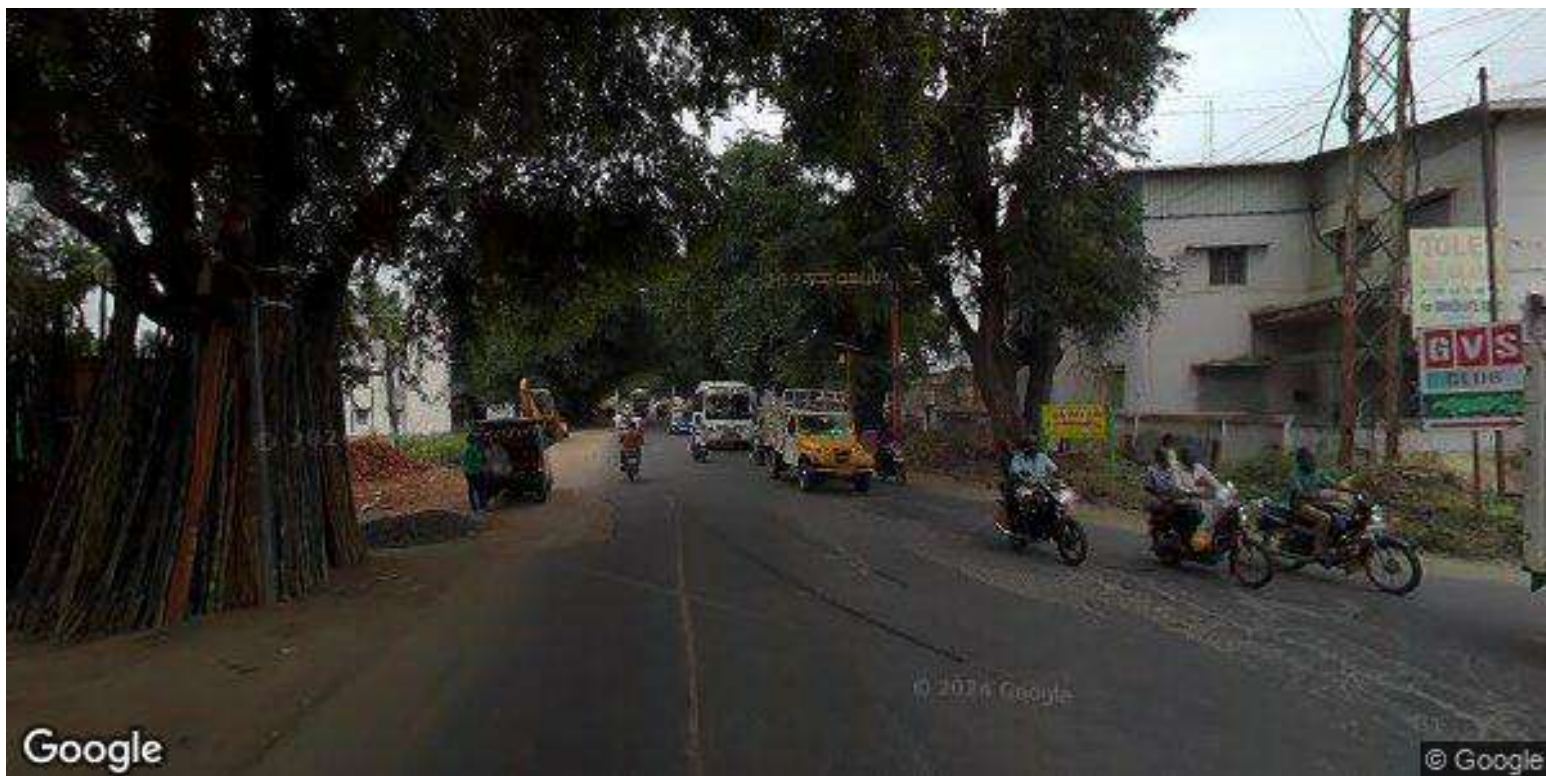
**Coordinates:** 11.66380, 78.20648

**Risk Type:** Turn

**Risk Level:** High

**Speed Limit:** 15 KM/Hr

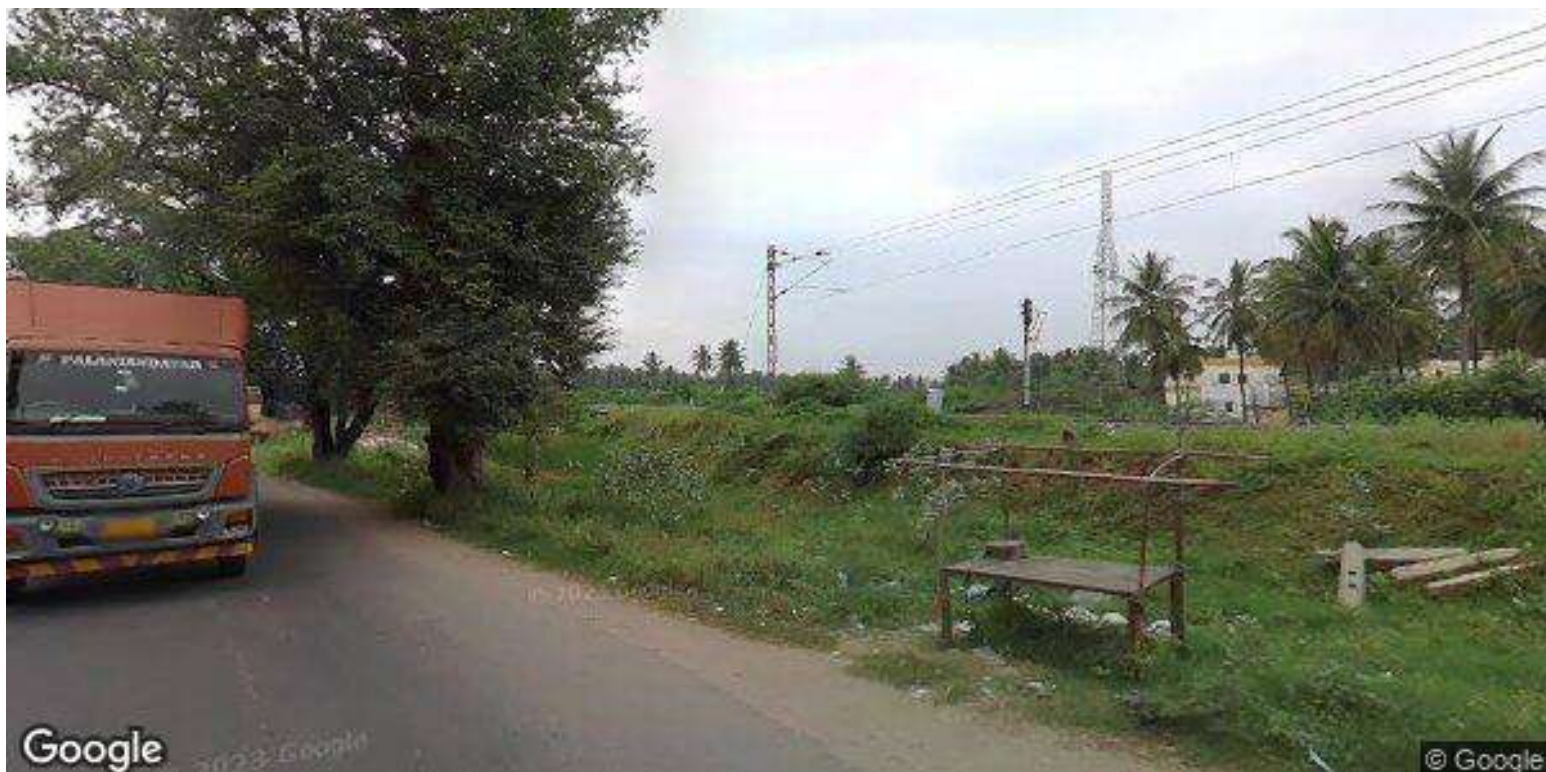
**Coordinates: 11.67128, 78.22971**

**Risk Type: Turn**

**Risk Level: Medium**

**Speed Limit: 30 KM/Hr**

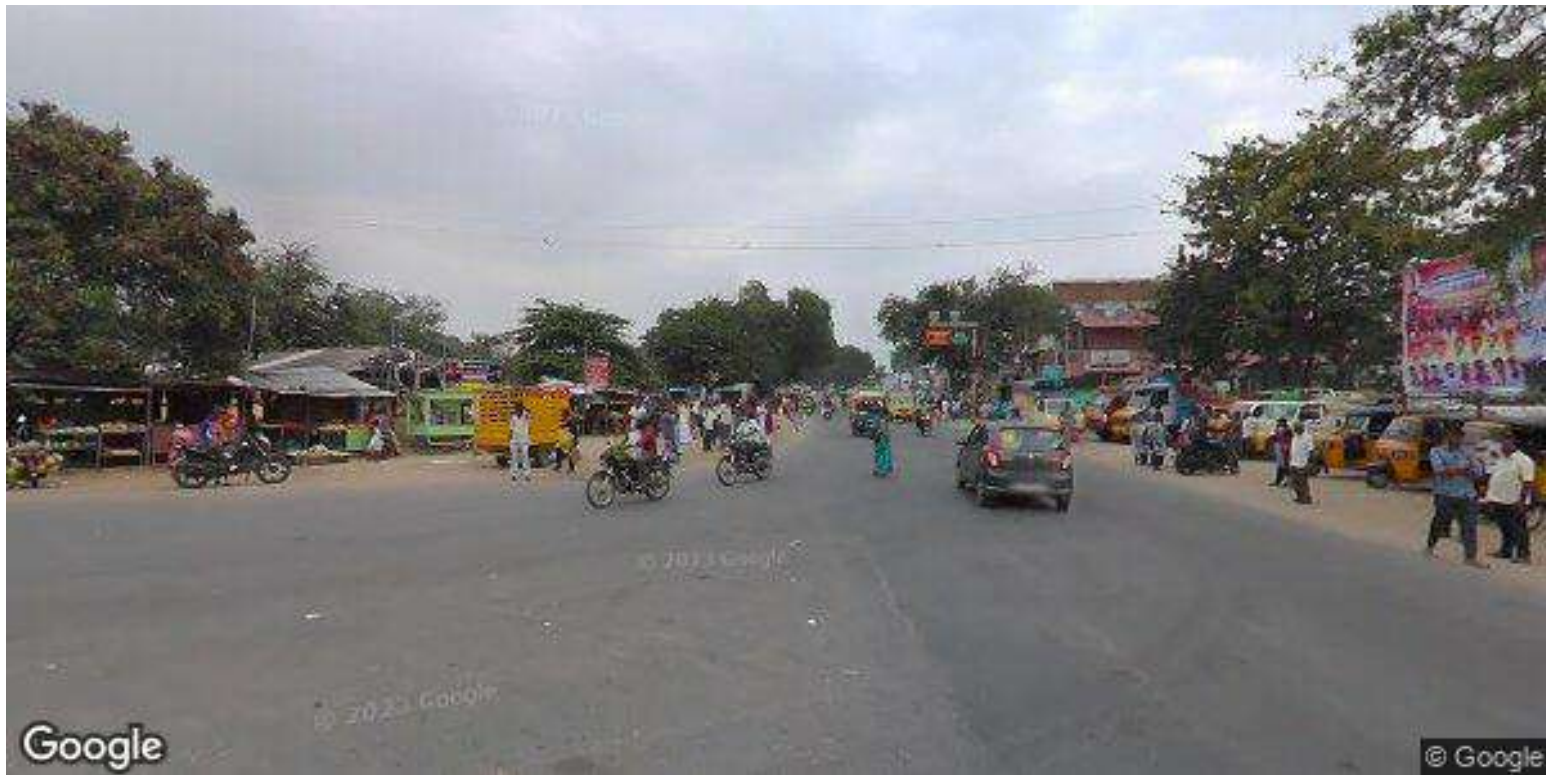
**Coordinates: 11.67111, 78.23134**

**Risk Type: Turn**

**Risk Level: High**

**Speed Limit: 15 KM/Hr**

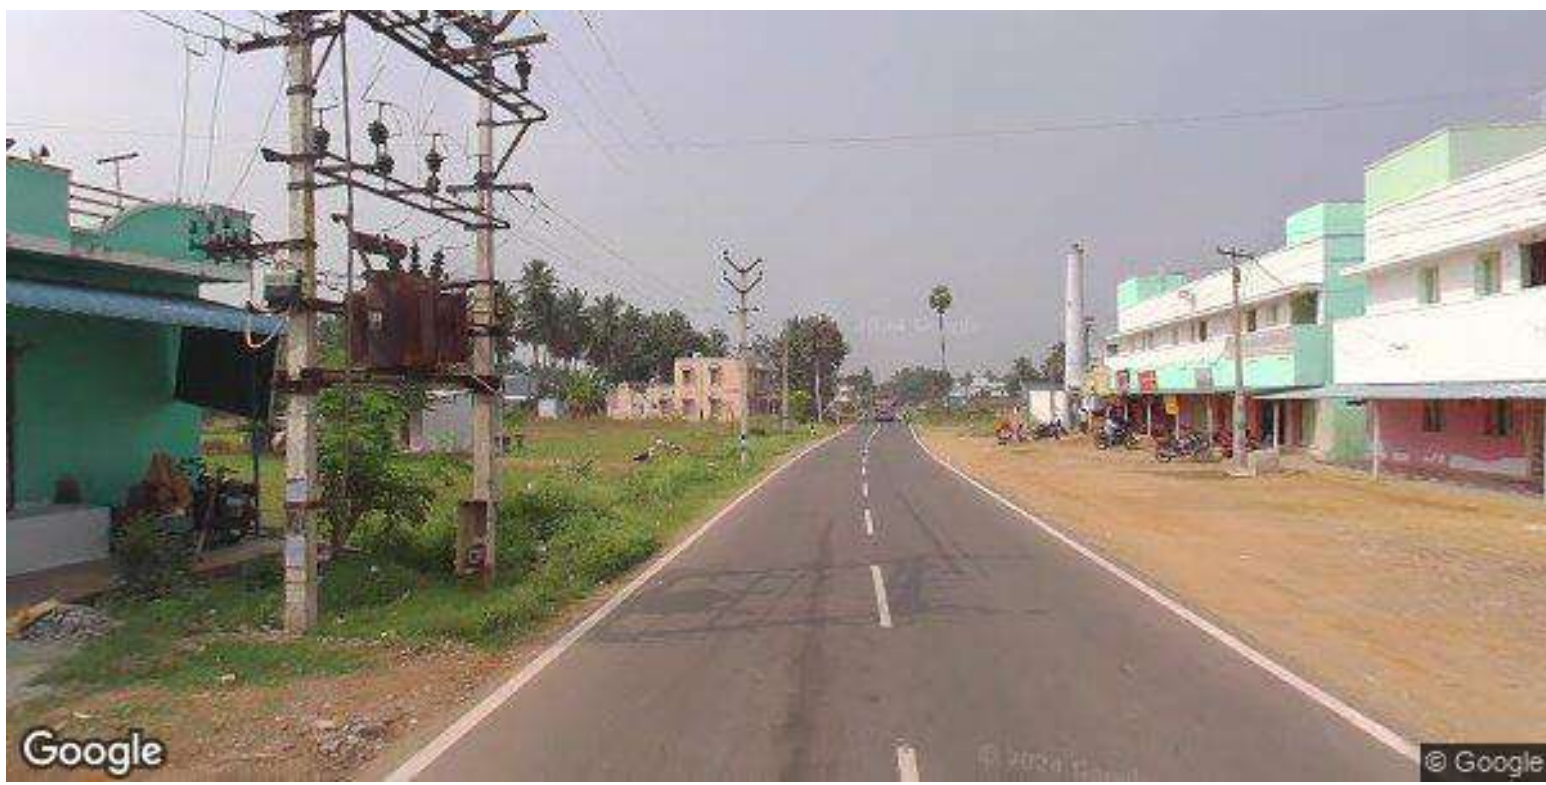
**Coordinates:** 11.67666, 78.24906

**Risk Type:** Turn

**Risk Level:** Medium

**Speed Limit:** 30 KM/Hr

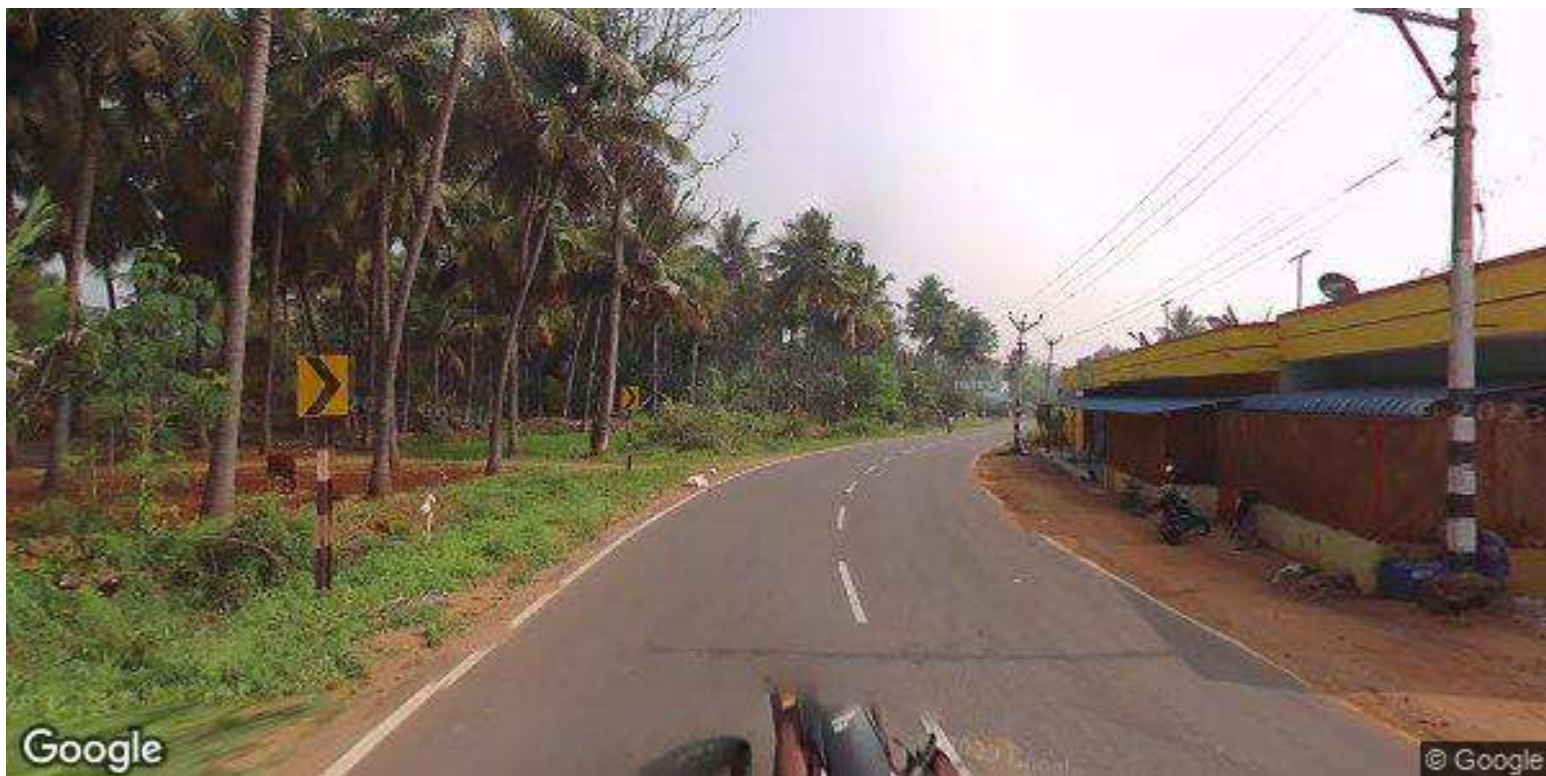
**Coordinates:** 11.68494, 78.26198

**Risk Type:** Turn

**Risk Level:** Medium

**Speed Limit:** 30 KM/Hr

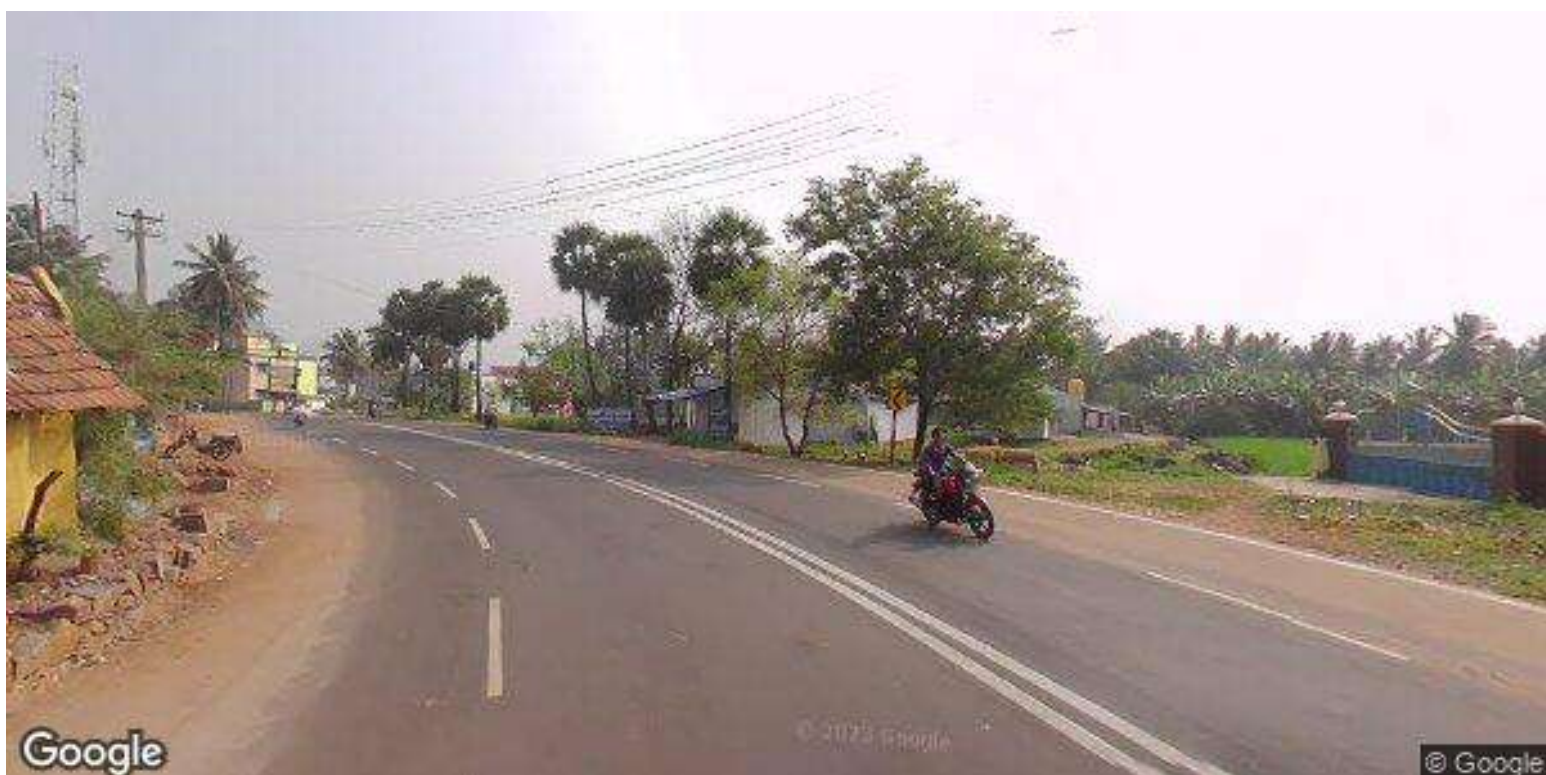
**Risk Type:** Turn  
**Risk Level:** Medium  
**Speed Limit:** 30 KM/Hr  
**Coordinates:** 11.68551, 78.26771

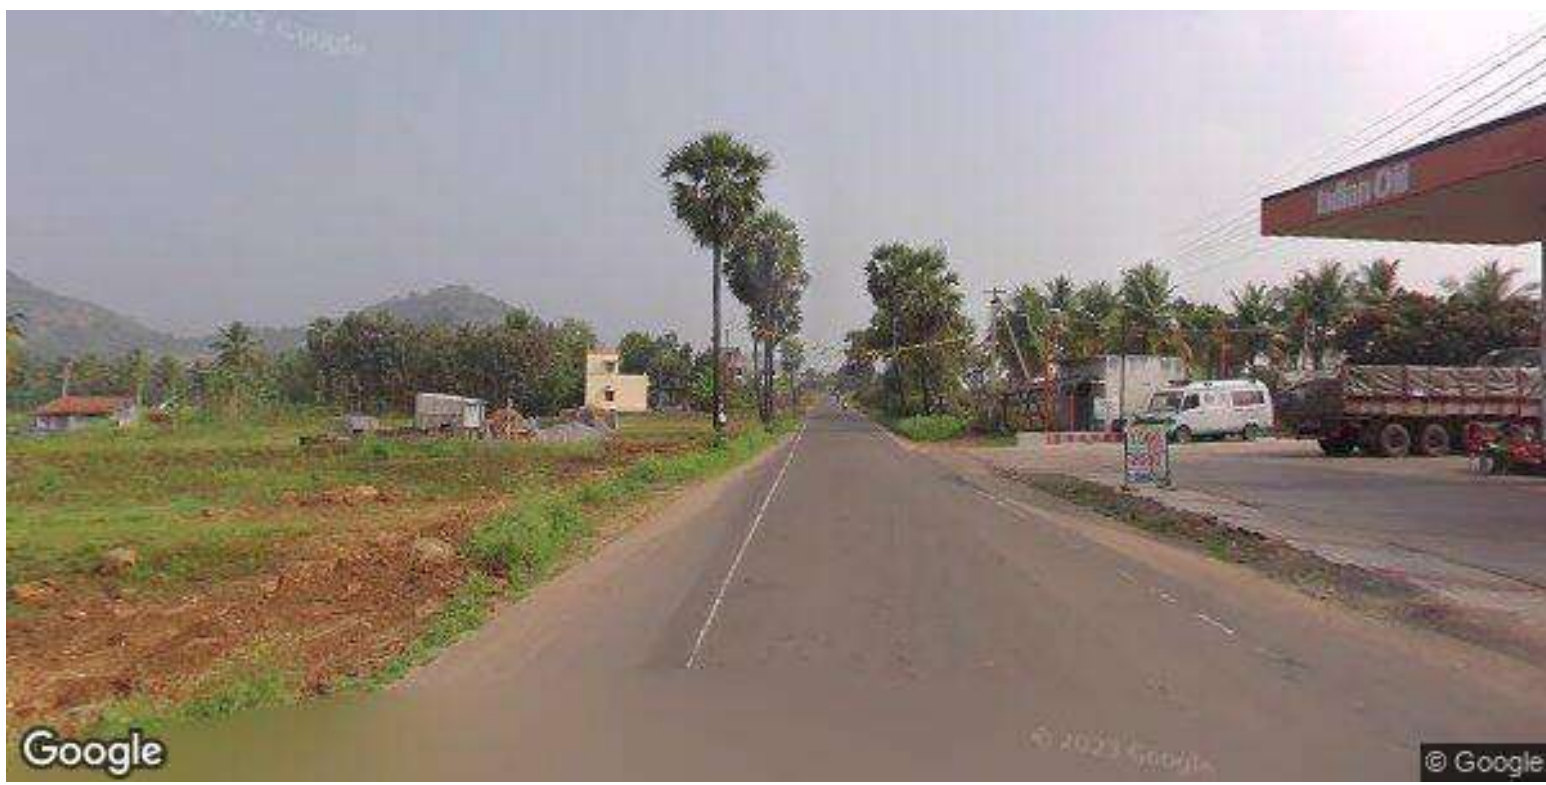
**Coordinates:** 11.68904, 78.29460

**Risk Type:** Turn

**Risk Level:** High

**Speed Limit:** 15 KM/Hr
