## **JOURNEY RISK MANAGEMENT (JRM) STUDY**

### **Salem Terminal To SRI BALAGANAPATHI AGENCIES**

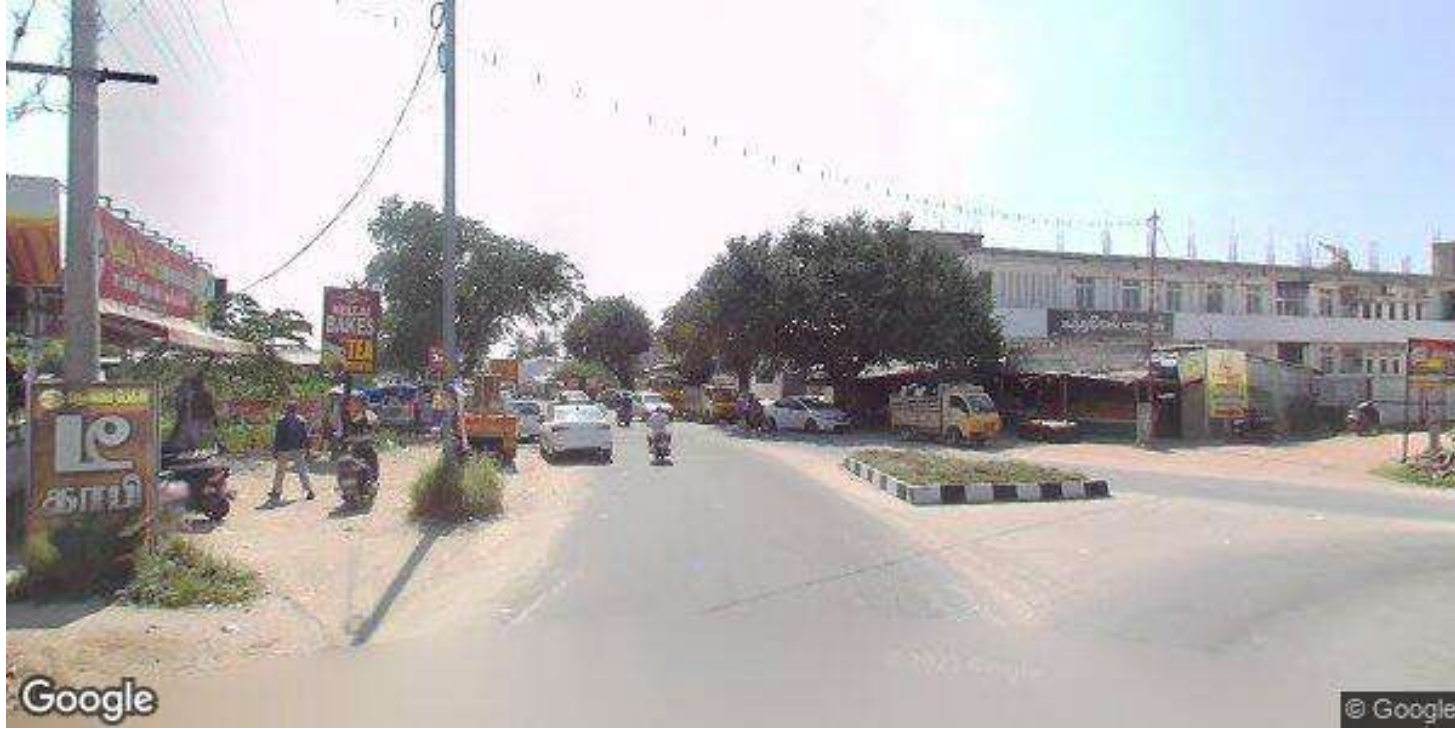
**Coordinates:** 11.17250, 77.26863

**Risk Type:** Roundabout

**Risk Level:** High

**Speed Limit:** 15 KM/Hr

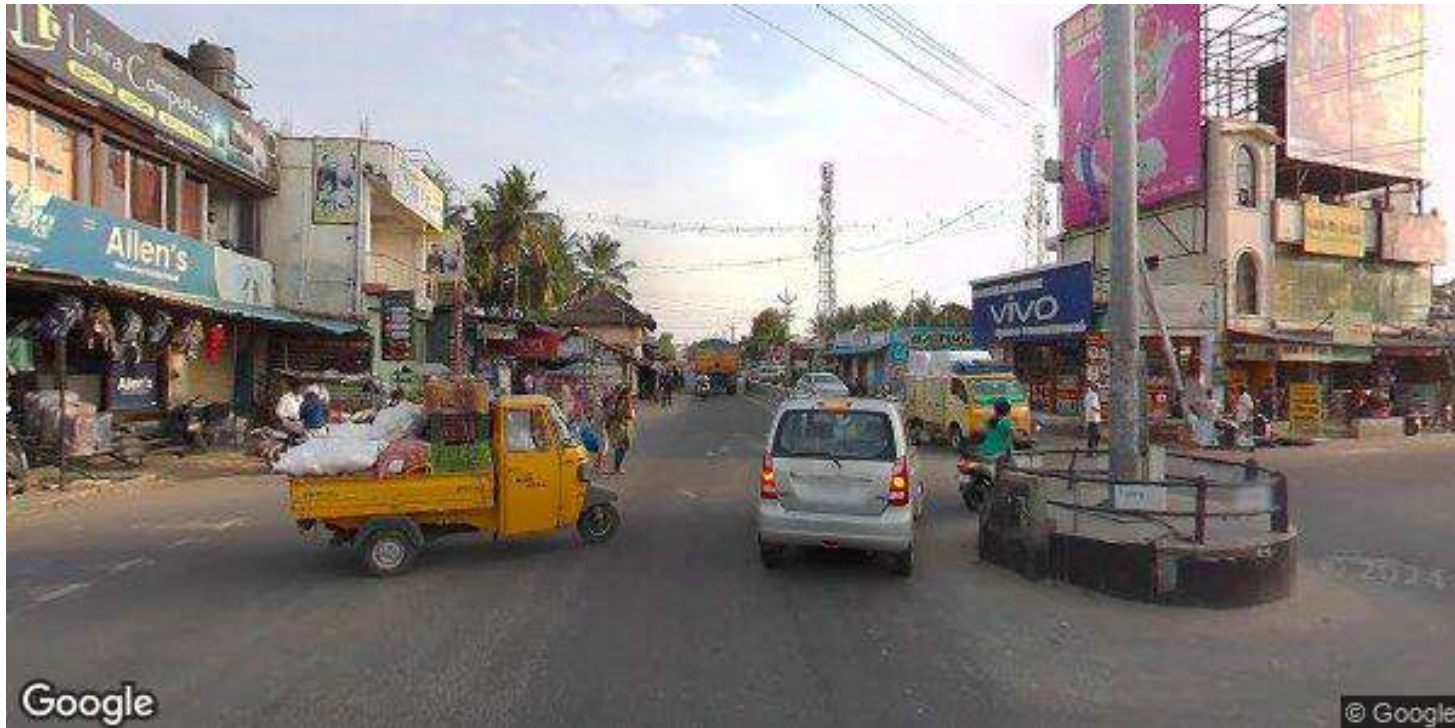
**Coordinates:** 11.10249, 77.27146

**Risk Type:** Roundabout

**Risk Level:** High

**Speed Limit:** 15 KM/Hr

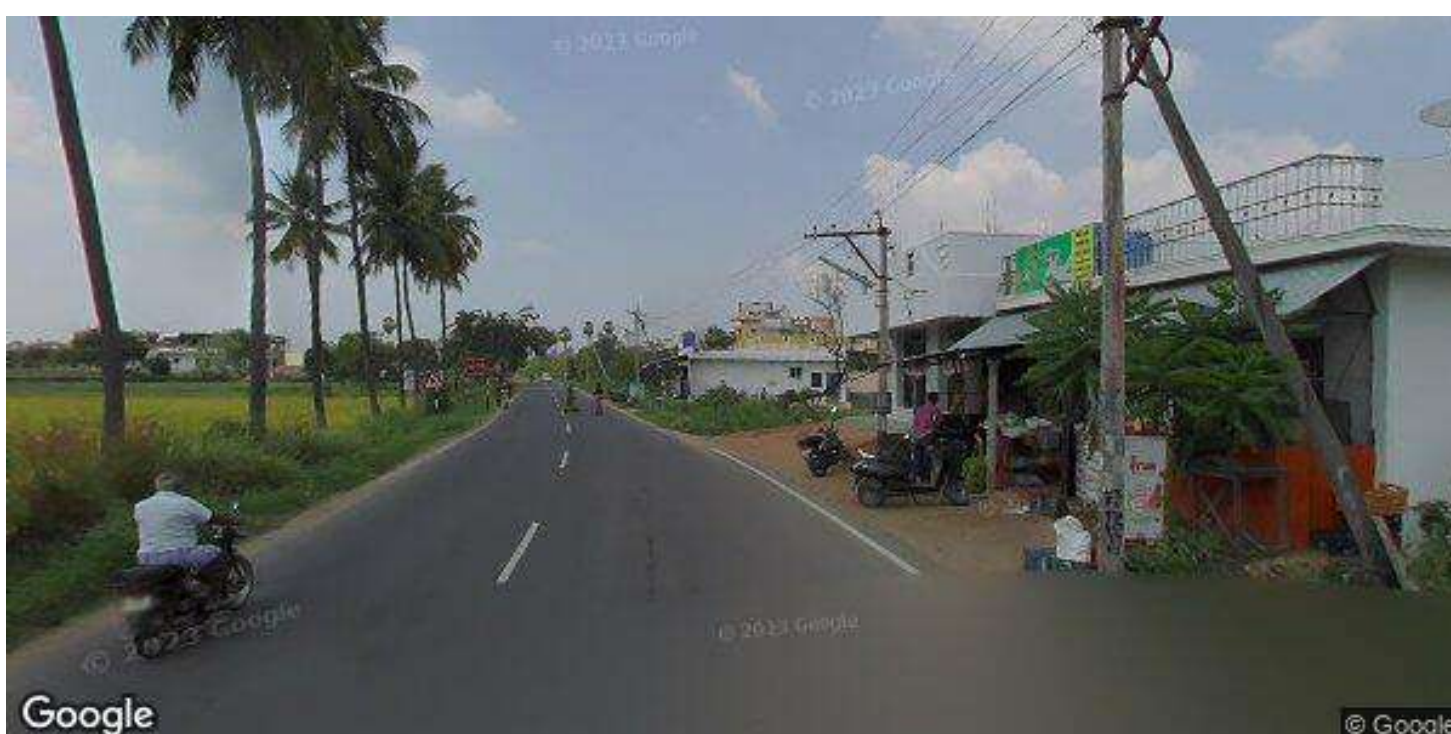
**Coordinates: 11.45127, 77.86734**

**Risk Type:** Turn  
**Risk Level:** Medium

**Speed Limit: 30 KM/Hr**

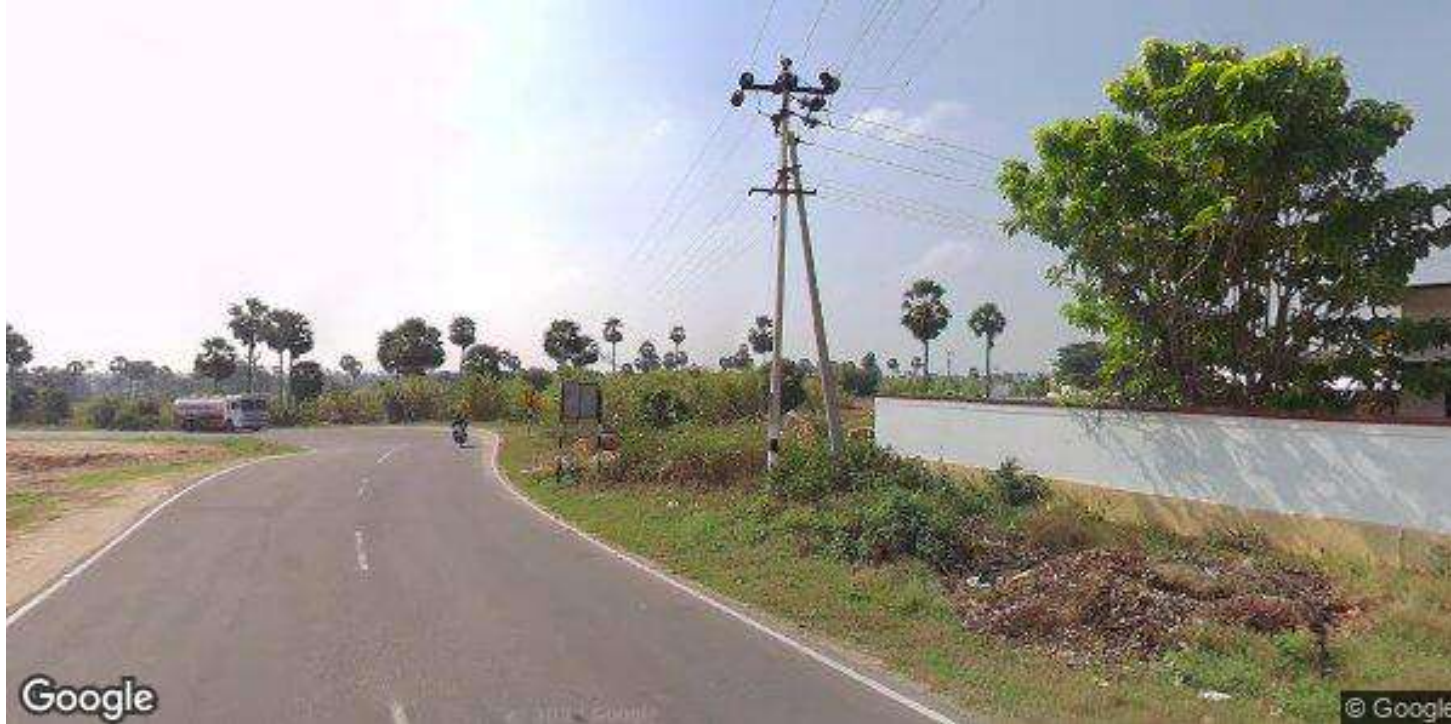
**Coordinates:** 11.45889, 77.85136

**Risk Type:** Turn

**Risk Level:** Medium

**Speed Limit:** 30 KM/Hr

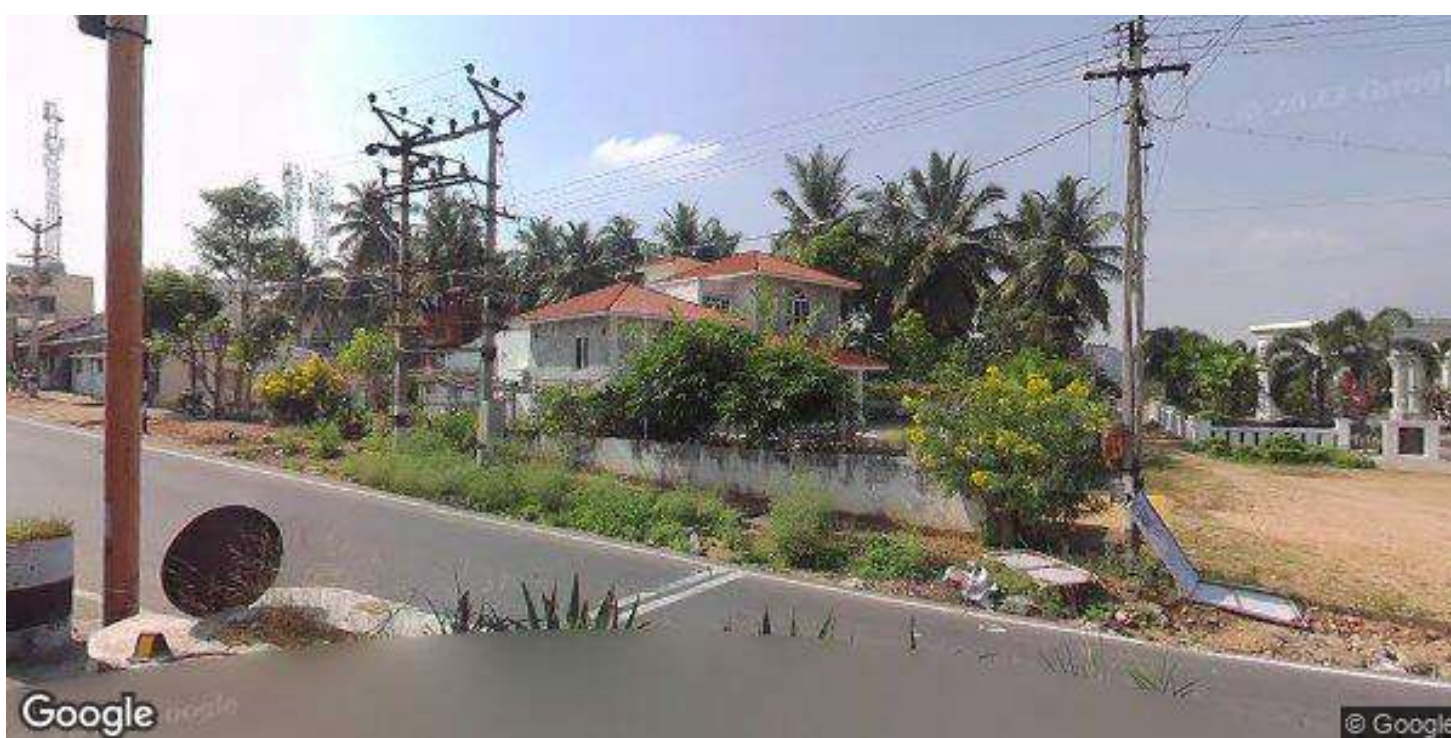
**Coordinates:** 11.46303, 77.84945

**Risk Type:** Turn

**Risk Level:** High

**Speed Limit:** 15 KM/Hr

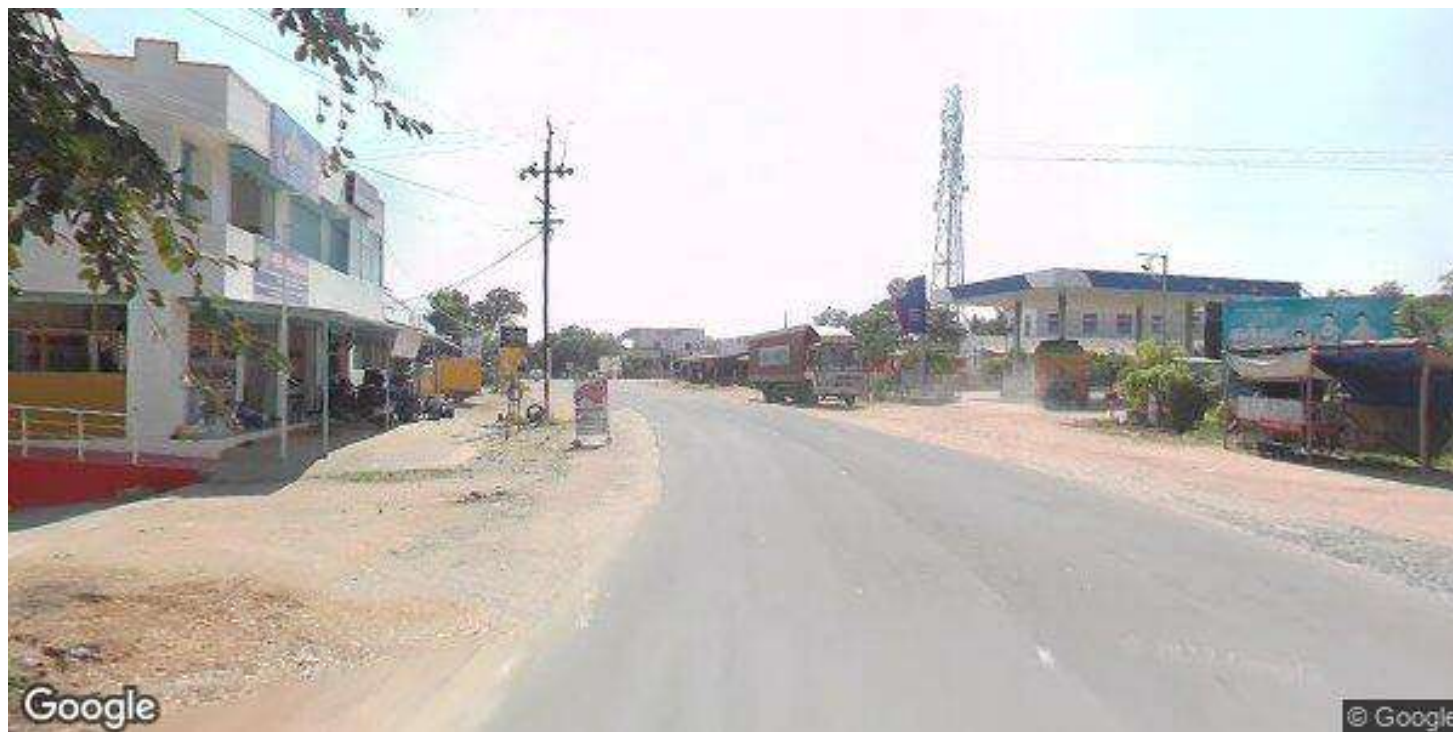
**Coordinates: 11.16875, 77.26763**

**Risk Type: Turn**

**Risk Level: Medium**

**Speed Limit: 30 KM/Hr**

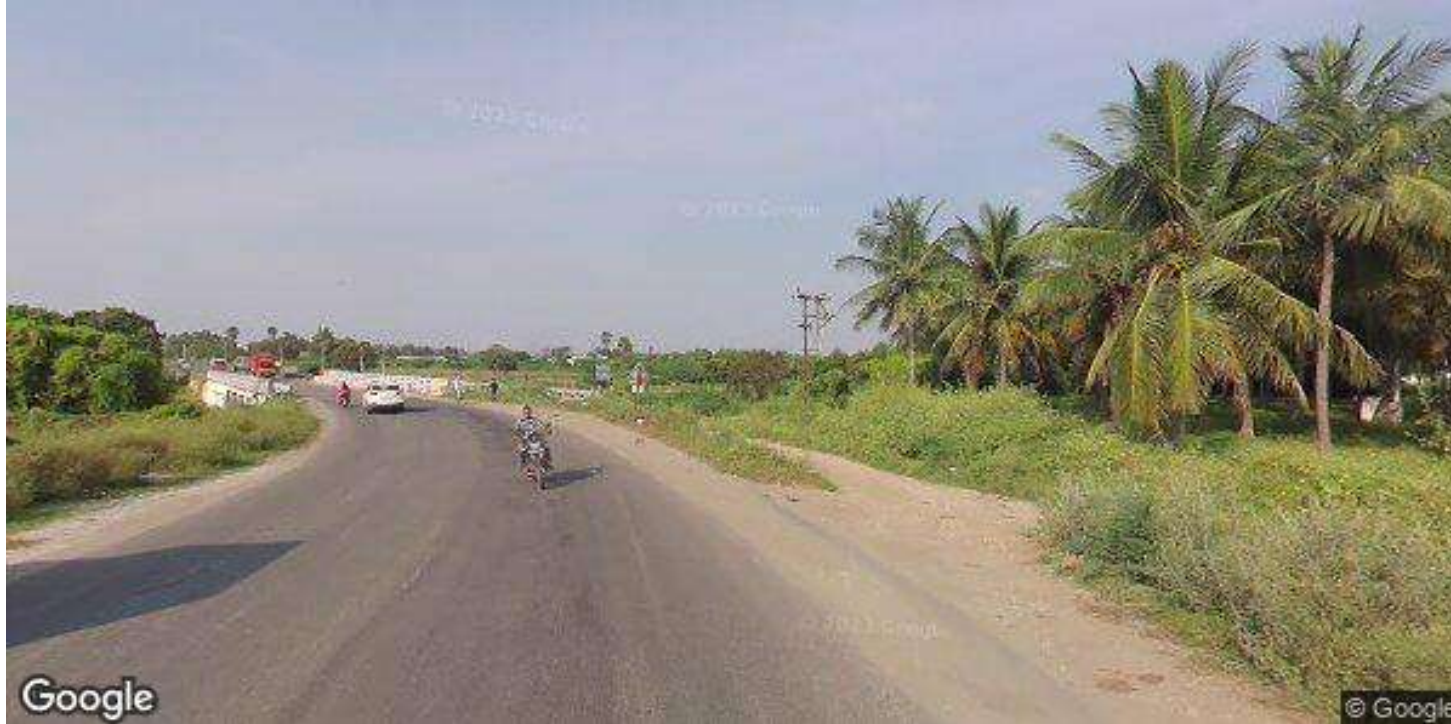
**Risk Type:** Turn  
**Risk Level:** Medium  
**Speed Limit:** 30 KM/Hr  
**Coordinates:** 11.10874, 77.27131

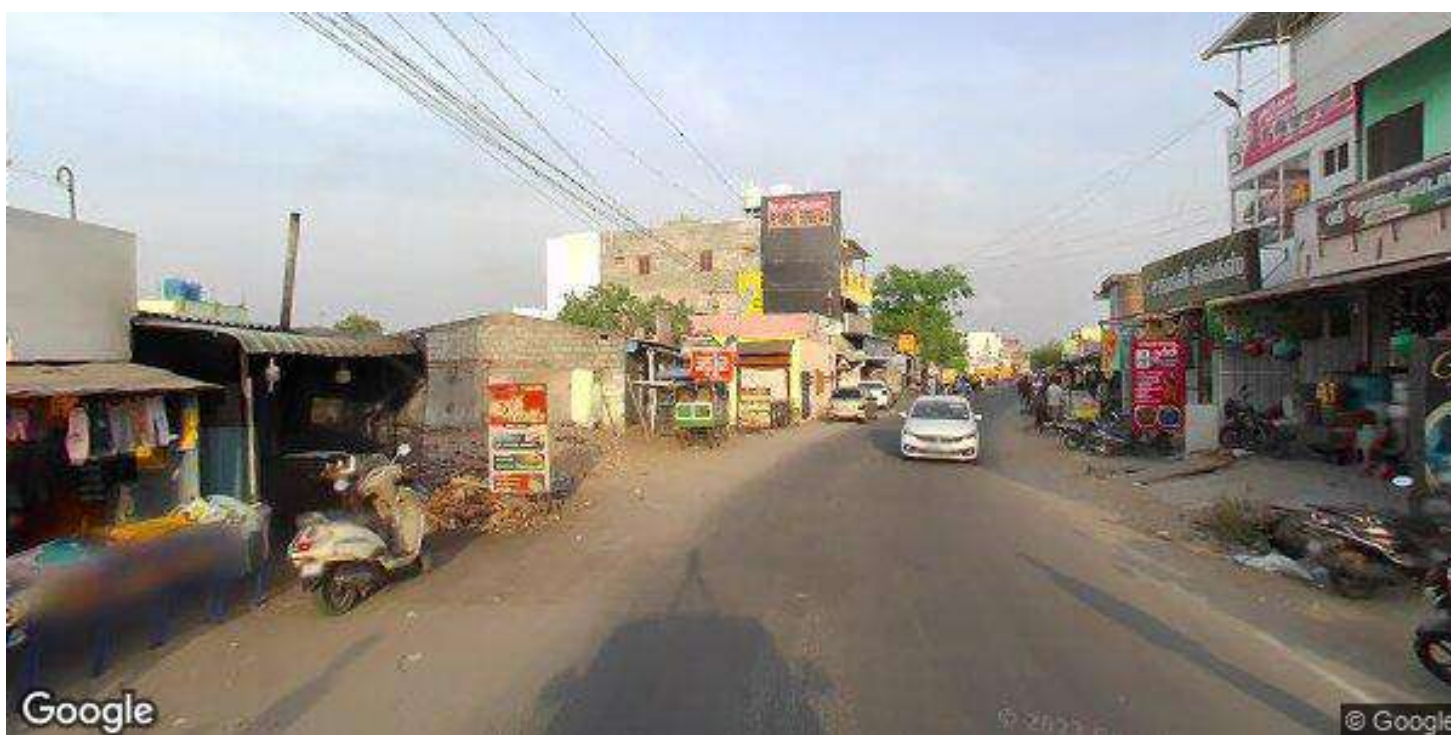
**Risk Type:** Turn  
**Risk Level:** Medium  
**Speed Limit:** 30 KM/Hr  
**Coordinates:** 11.10258, 77.27231

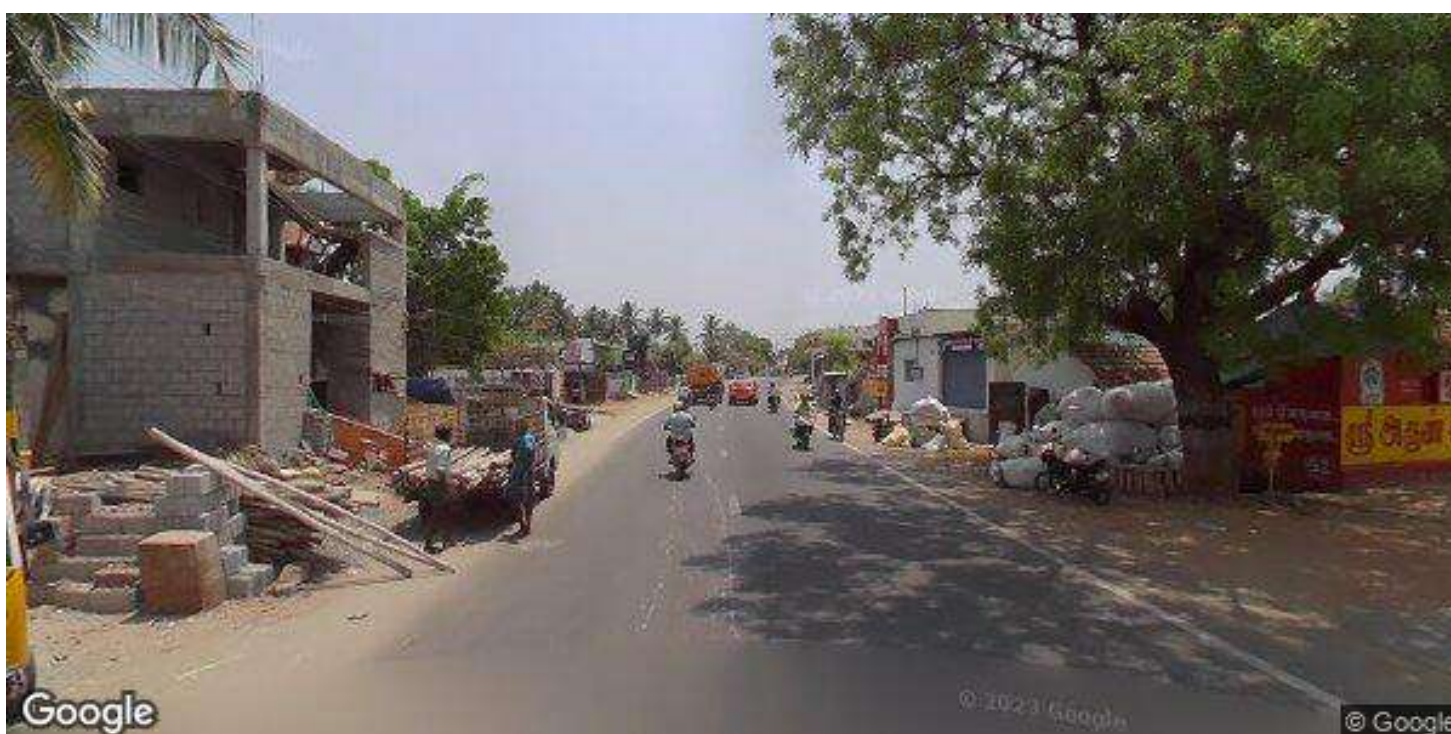
**Risk Type:** Turn  
**Risk Level:** High

**Speed Limit: 15 KM/Hr**  
**Coordinates: 11.10213, 77.28783**
