# IndianOil

## JOURNEY RISK MANAGEMENT (JRM) STUDY

### Salem Terminal TO DR NGP MOTOR AGENCY

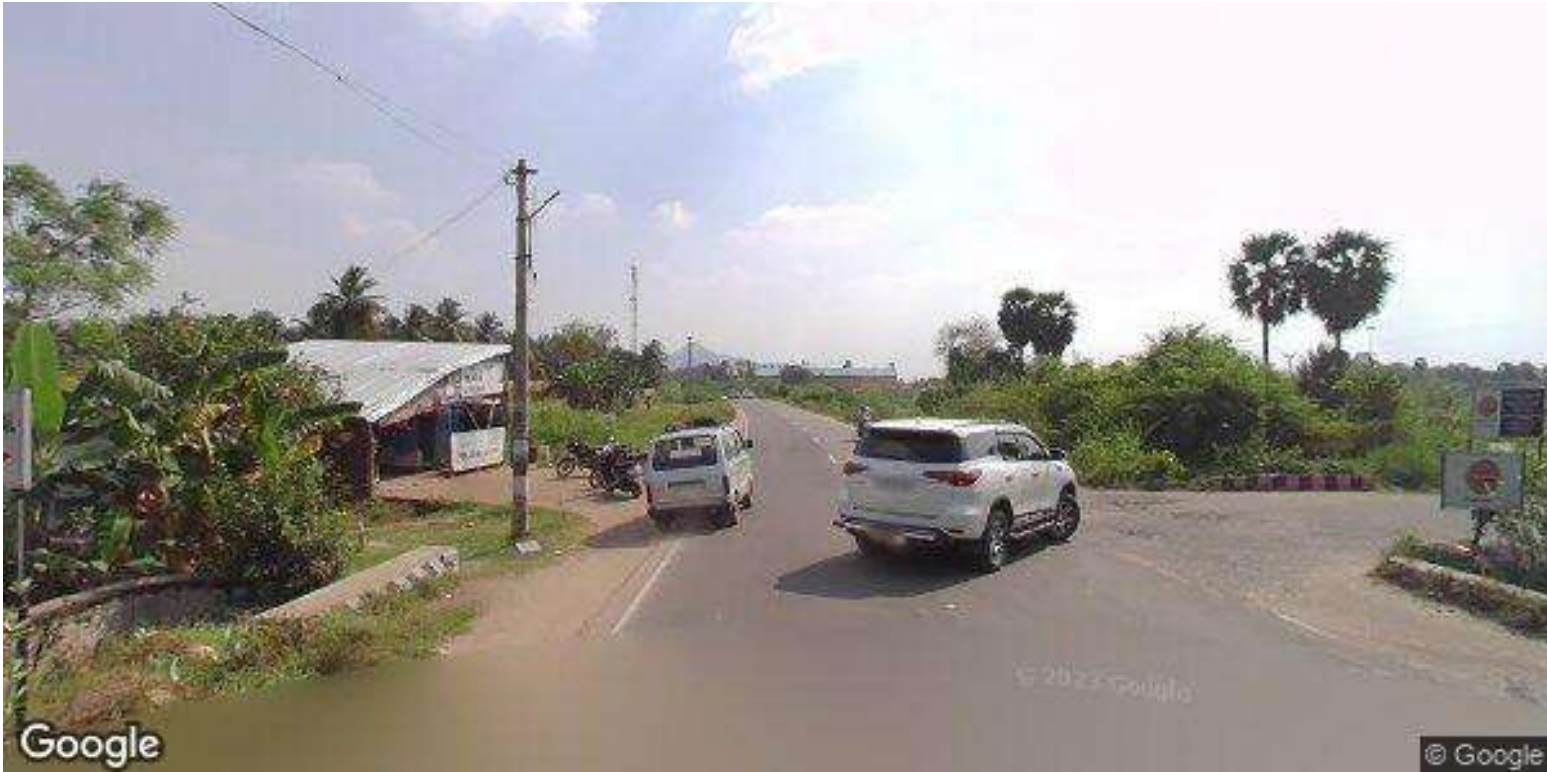
Coordinates: 11.44029, 77.87544

| | Risk Type | Risk Level | Coordinates | Speed Limit |
|---|---|---|---|---|
| 2 | Turn | High | 11.44029, 77.87544 | 15 KM/Hr |

Risk Type: Turn

Risk Level: High

Speed Limit: 15 KM/Hr

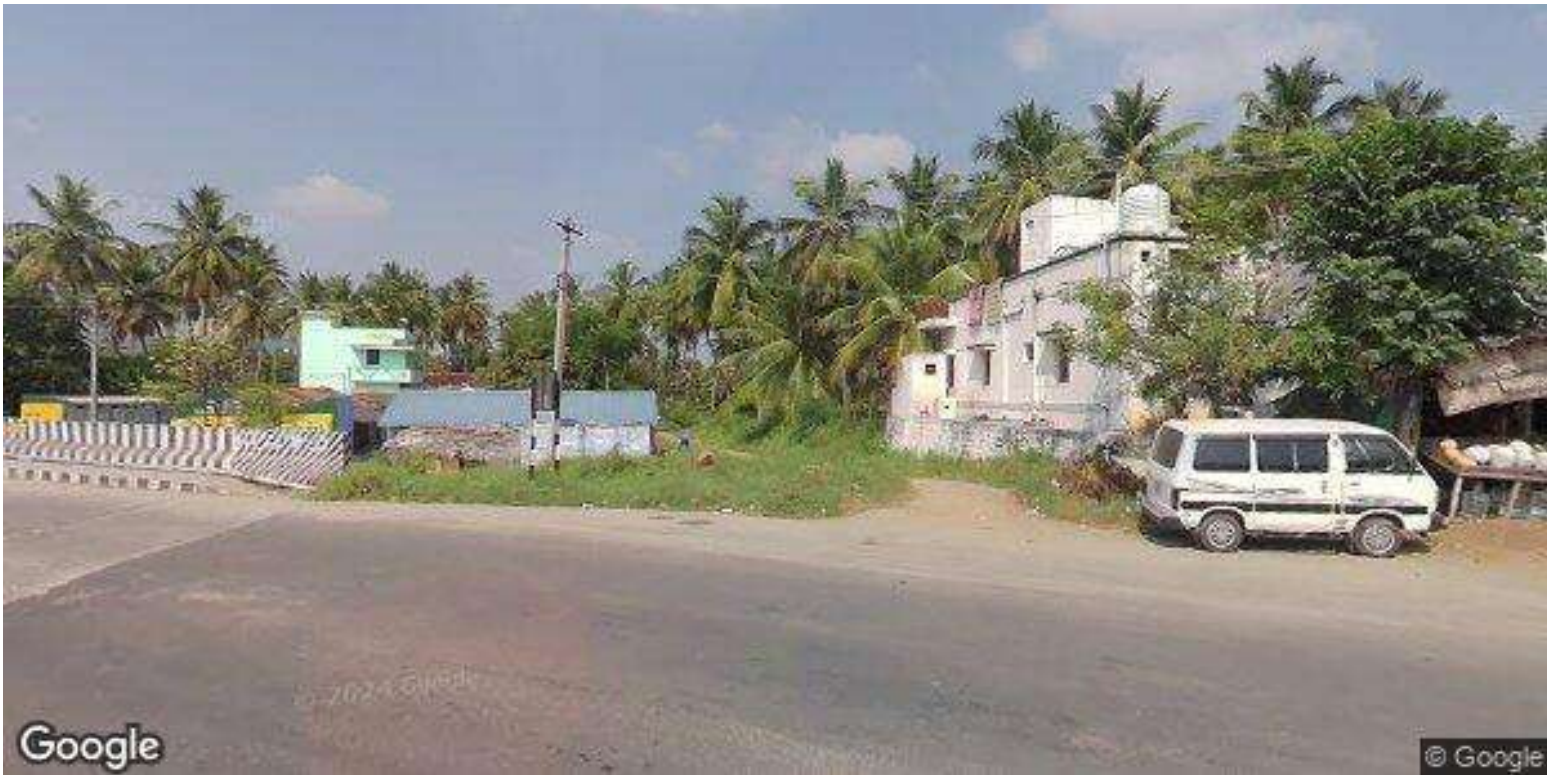
| | Risk Type | Risk Level | Coordinates | Speed Limit |
|---|---|---|---|---|
| 3 | Turn | Medium | 11.44898, 77.87410 | 30 KM/Hr |

**Risk Type:** Turn  
**Risk Level:** Medium  
**Speed Limit:** 30 KM/Hr  
**Coordinates:** 11.44898, 77.87410

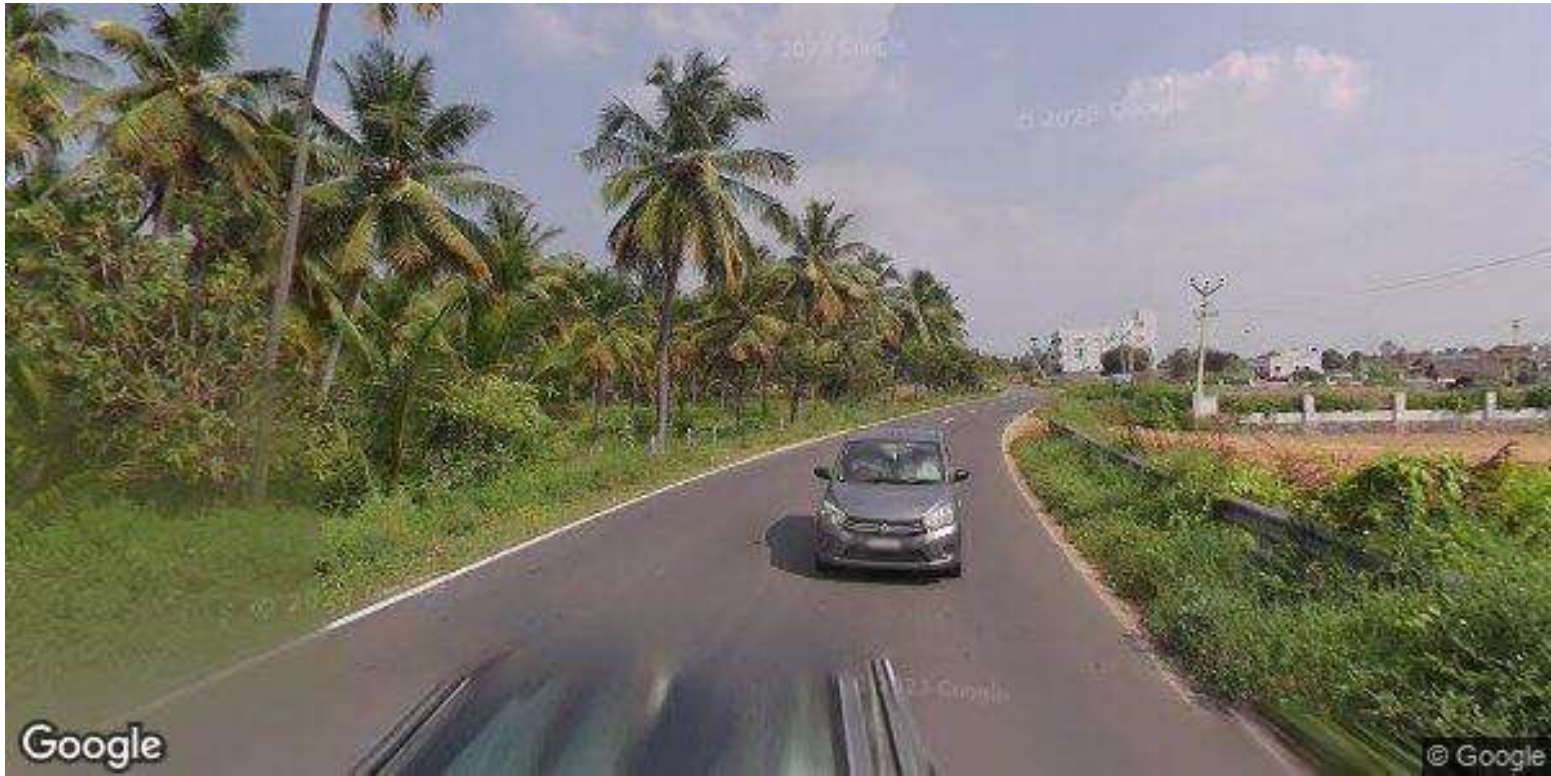
| | Risk Type | Risk Level | Coordinates | Speed Limit |
|---|---|---|---|---|
| 4 | Turn | Medium | 11.45357, 77.85789 | 30 KM/Hr |

**Risk Type:** Turn  
**Risk Level:** Medium  
**Speed Limit:** 30 KM/Hr  
**Coordinates:** 11.45357, 77.85789

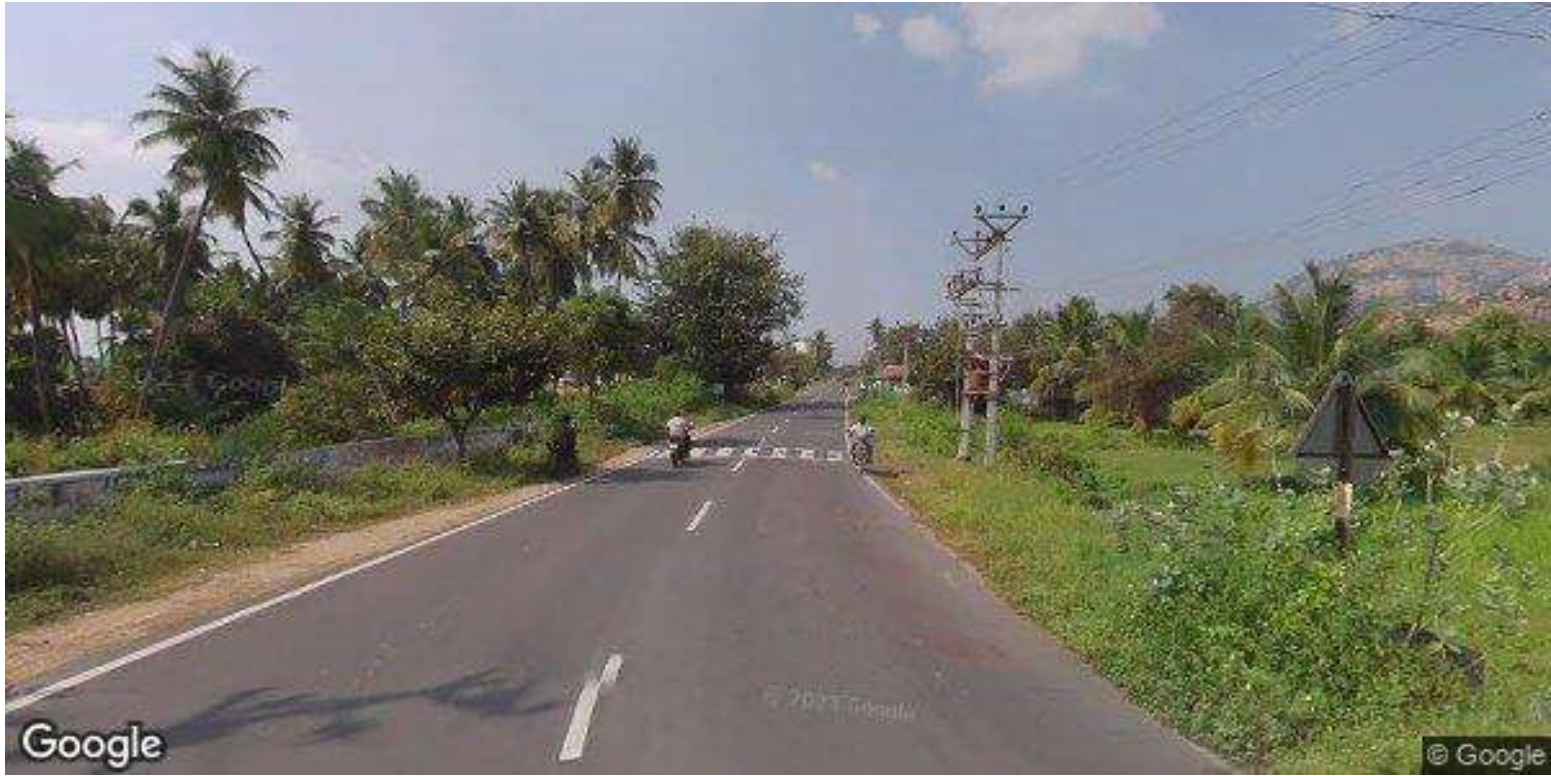
| | Risk Type | Risk Level | Coordinates | Speed Limit |
|---|---|---|---|---|
| 5 | Turn | Medium | 11.45352, 77.85698 | 30 KM/Hr |

**Risk Type:** Turn  
**Risk Level:** Medium  
**Speed Limit:** 30 KM/Hr  
**Coordinates:** 11.45352, 77.85698

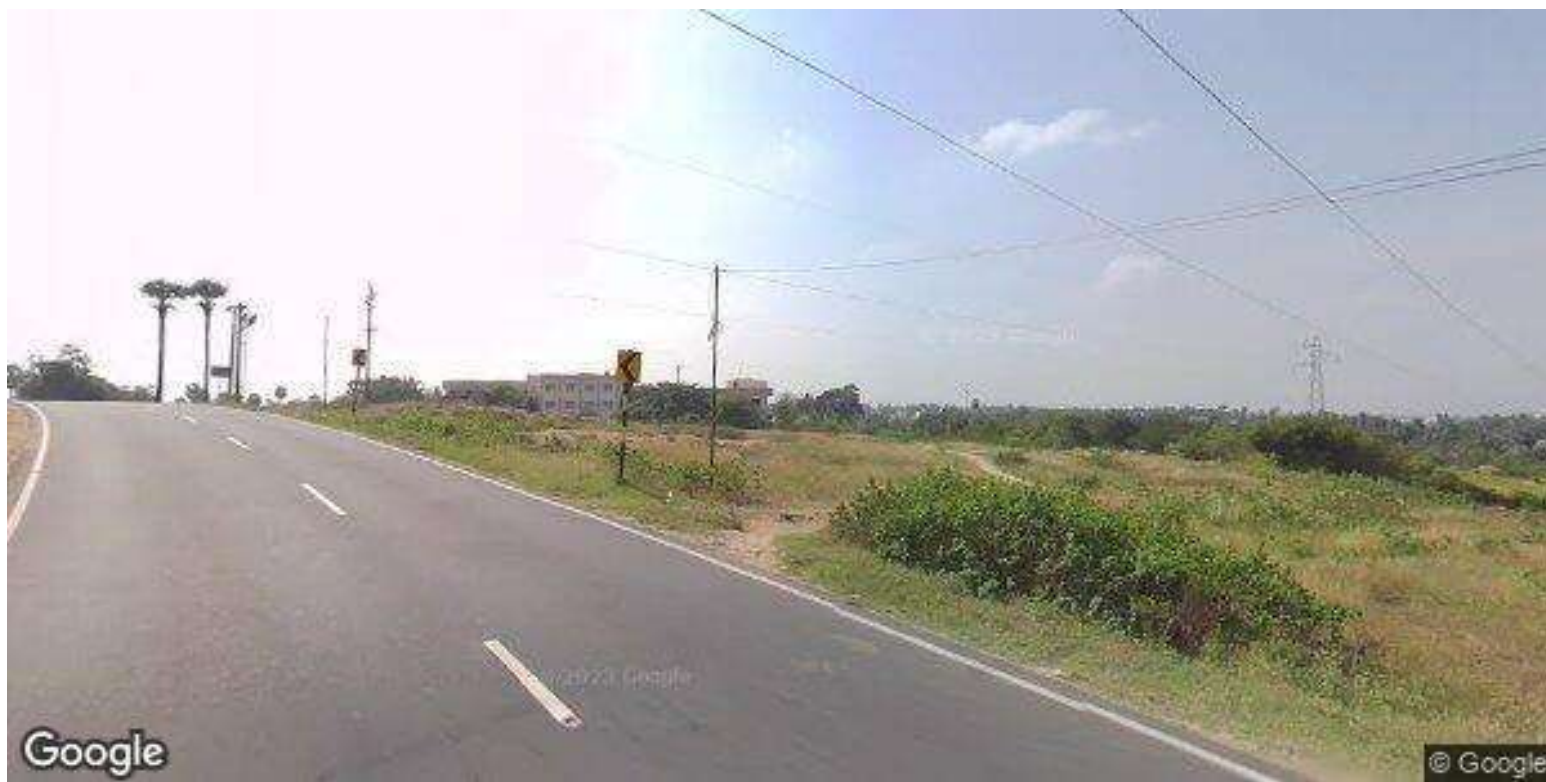
**Coordinates:** 11.46048, 77.85036

| | Risk Type | Risk Level | Coordinates | Speed Limit |
|---|---|---|---|---|
| 6 | Turn | Medium | 11.46048, 77.85036 | 30 KM/Hr |

**Risk Type:** Turn

**Risk Level:** Medium

**Speed Limit:** 30 KM/Hr

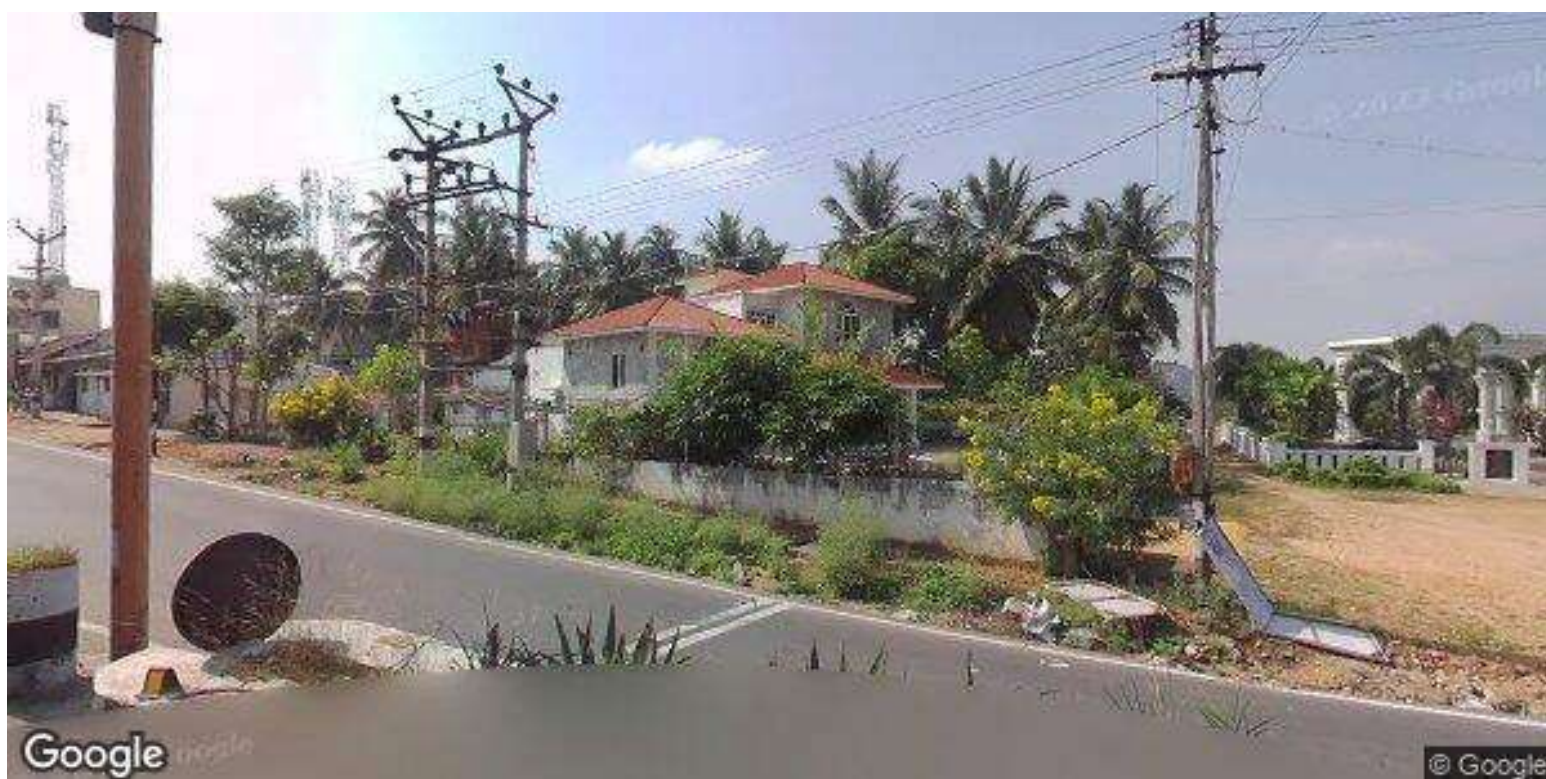
**Coordinates:** 11.46303, 77.84945

| | Risk Type | Risk Level | Coordinates | Speed Limit |
|---|---|---|---|---|
| 7 | Turn | Medium | 11.46303, 77.84945 | 30 KM/Hr |

**Risk Type:** Turn

**Risk Level:** Medium

**Speed Limit:** 30 KM/Hr

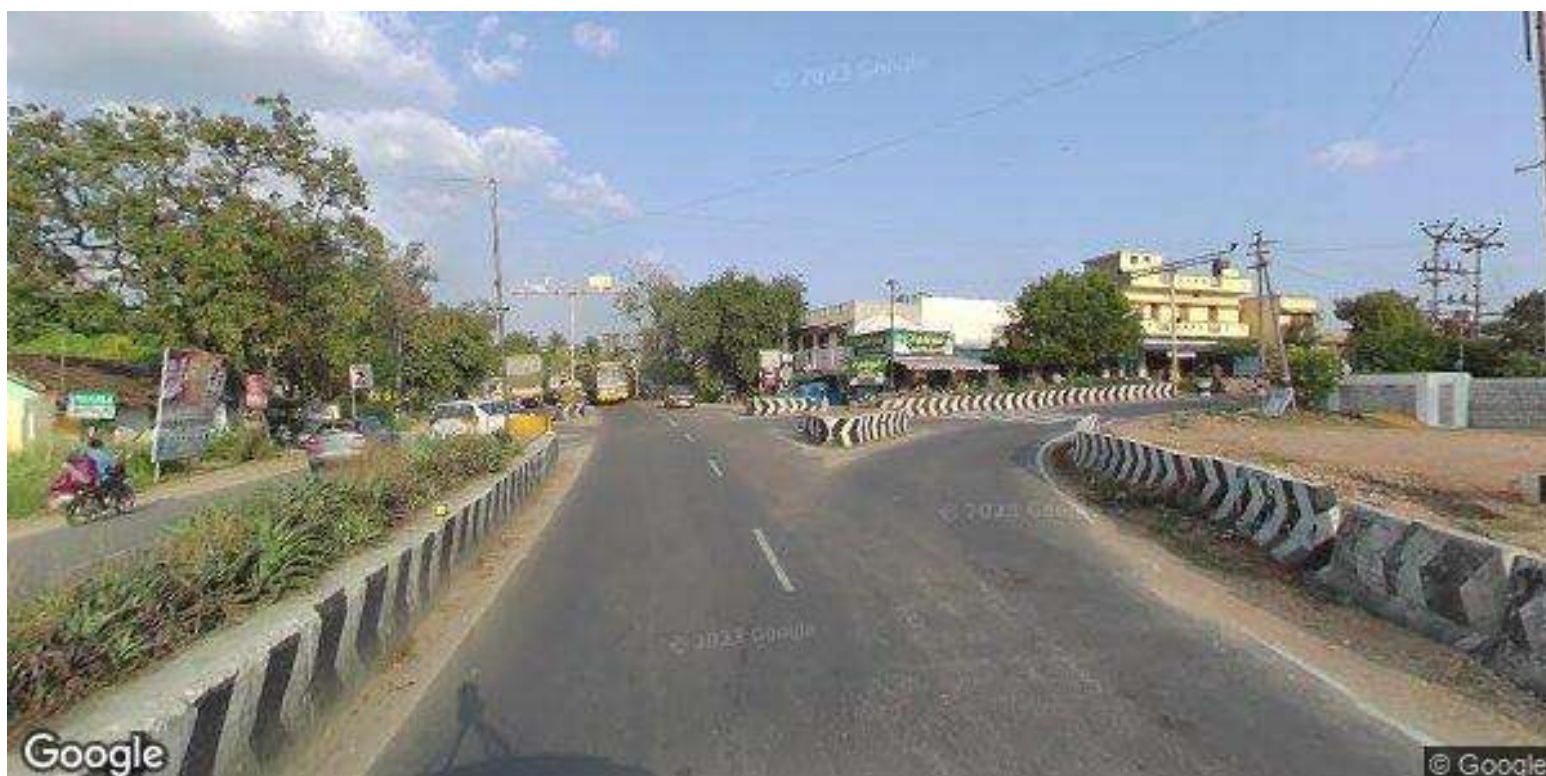
| | Risk Type | Risk Level | Coordinates | Speed Limit |
|---|---|---|---|---|
| 8 | Turn | Medium | 11.46318, 77.84913 | 30 KM/Hr |

**Risk Type:** Turn  
**Risk Level:** Medium  
**Speed Limit:** 30 KM/Hr  
**Coordinates:** 11.46318, 77.84913

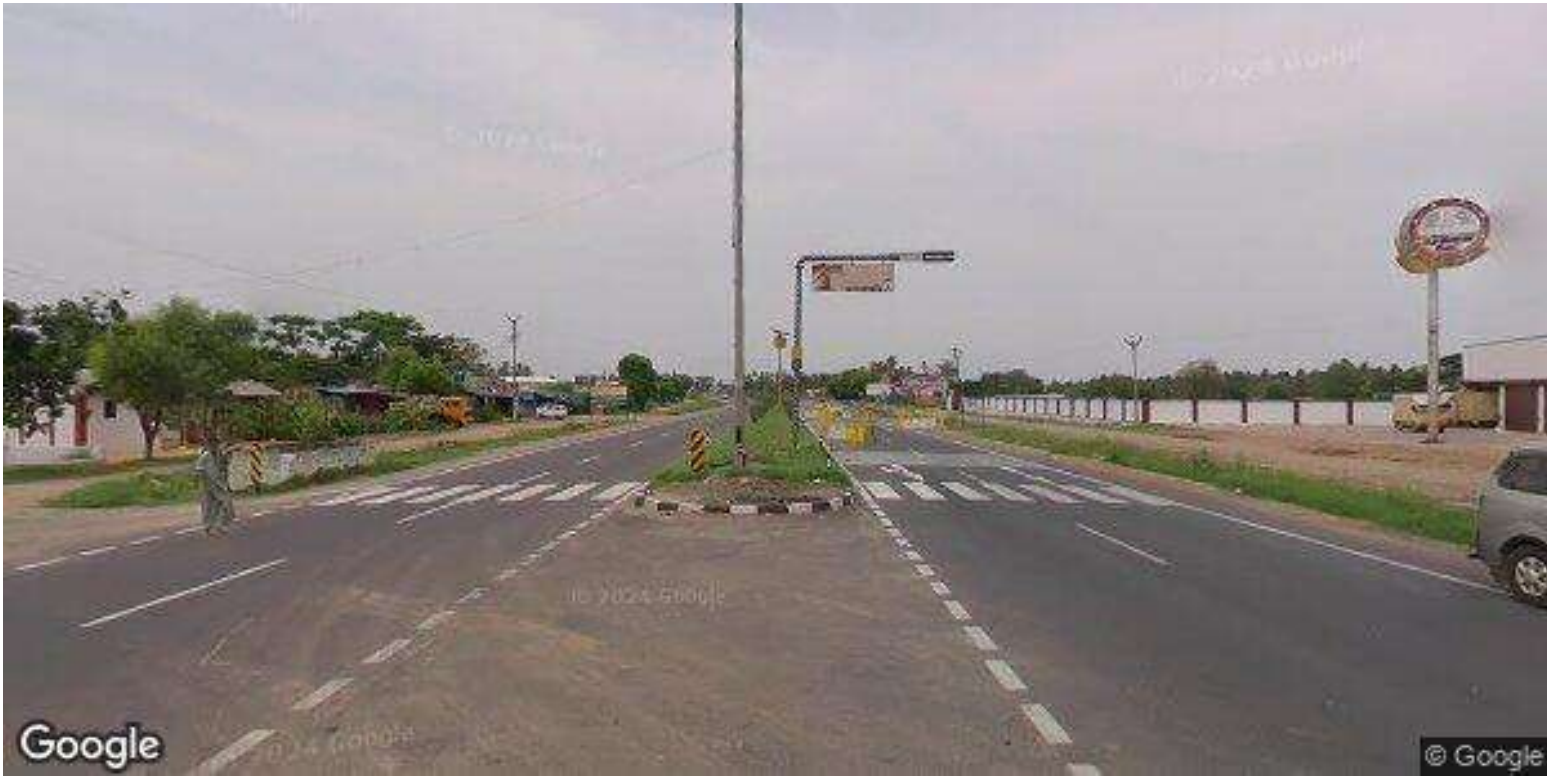
| | Risk Type | Risk Level | Coordinates | Speed Limit |
|---|---|---|---|---|
| 9 | Turn | High | 11.34315, 77.63670 | 15 KM/Hr |

**Risk Type:** Turn  
**Risk Level:** High  
**Speed Limit:** 15 KM/Hr  
**Coordinates:** 11.34315, 77.63670

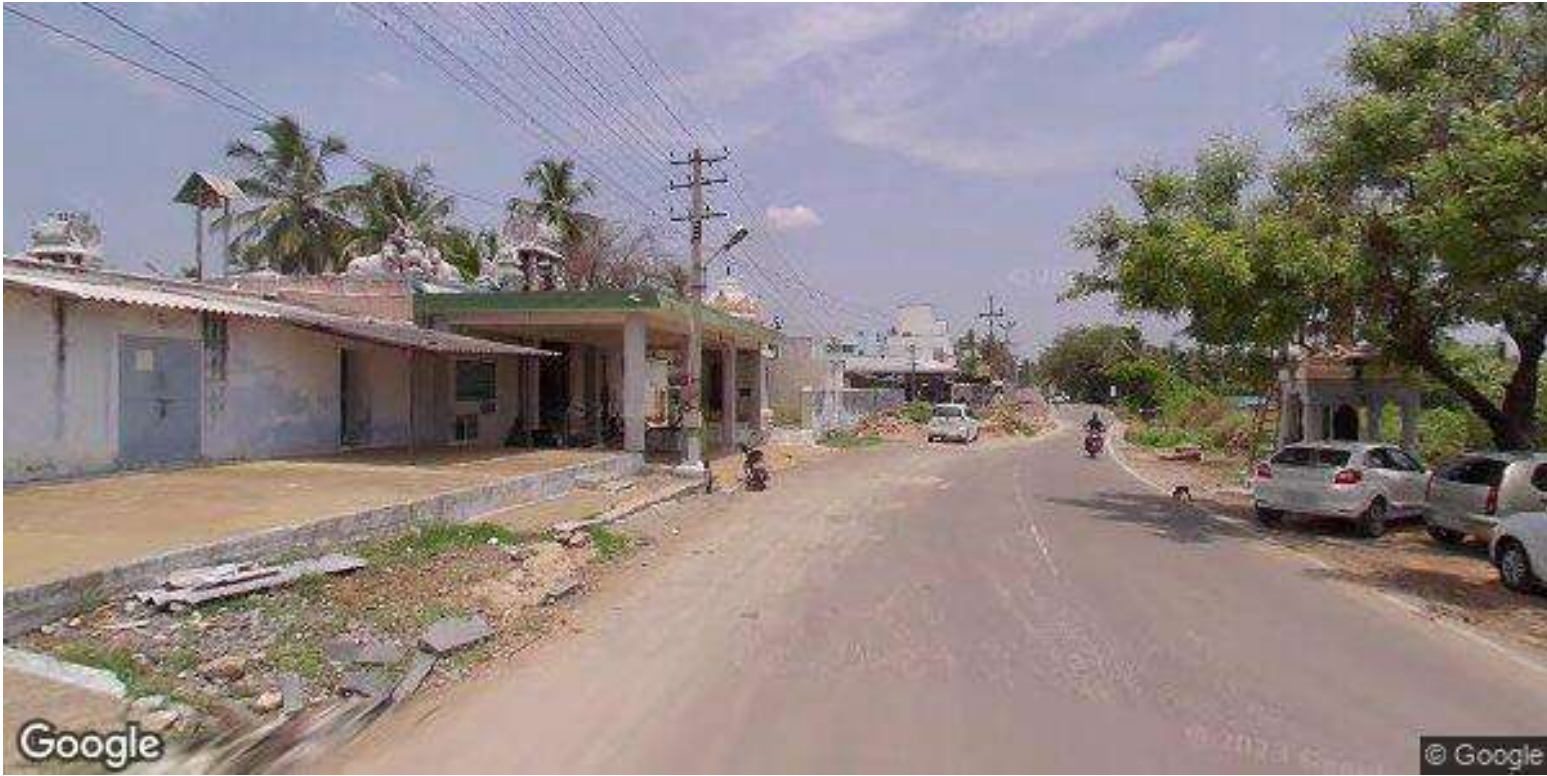
| | Risk Type | Risk Level | Coordinates | Speed Limit |
|---|---|---|---|---|
| 10 | Turn | High | 11.33890, 77.63610 | 15 KM/Hr |

**Risk Type:** Turn  
**Risk Level:** High  
**Speed Limit:** 15 KM/Hr  
**Coordinates:** 11.33890, 77.63610

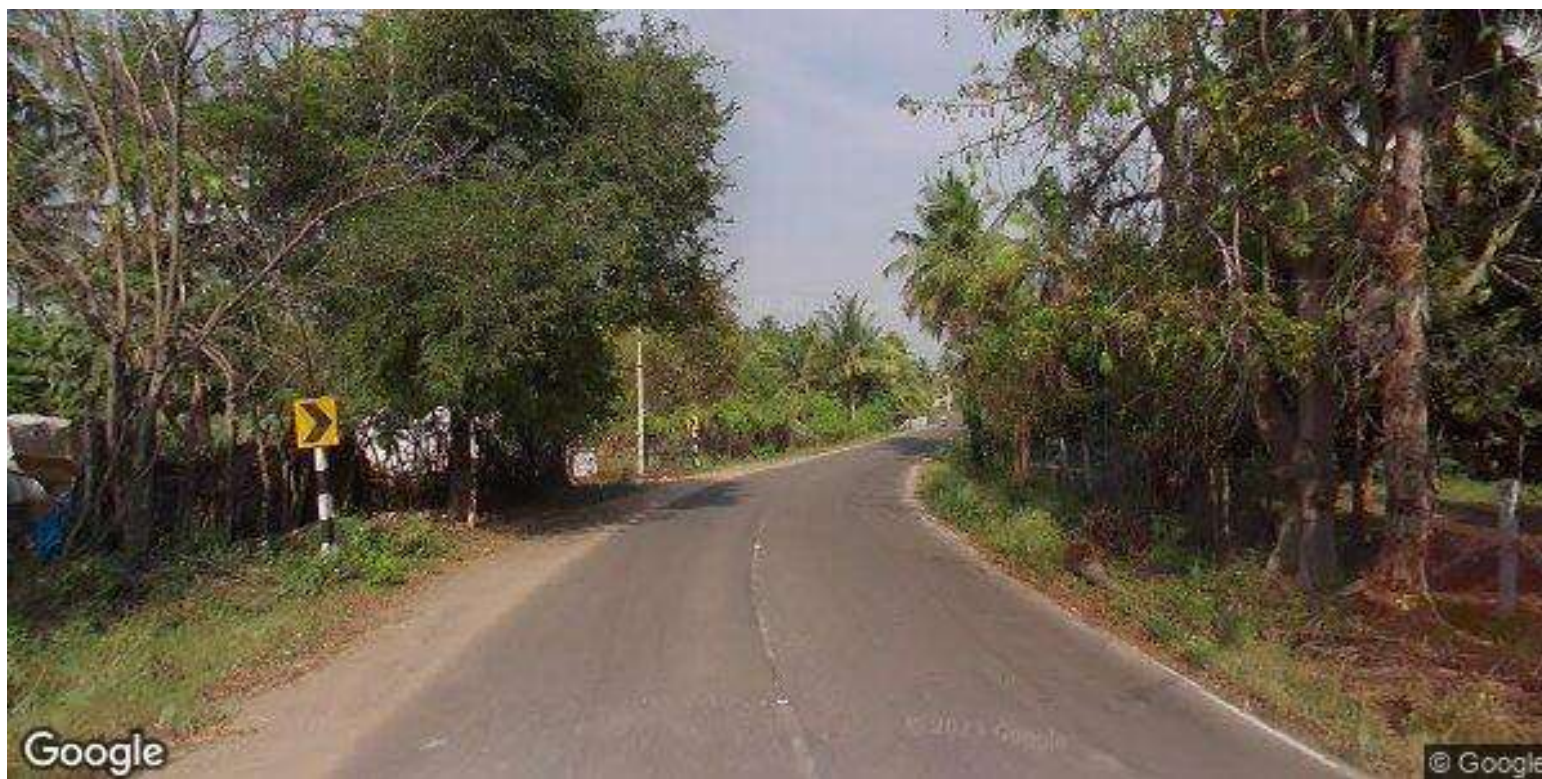
**Coordinates:** 11.34241, 77.61957

| | Risk Type | Risk Level | Coordinates | Speed Limit |
|---|---|---|---|---|
| 11 | Turn | Medium | 11.34241, 77.61957 | 30 KM/Hr |

**Risk Type:** Turn

**Risk Level:** Medium

**Speed Limit:** 30 KM/Hr

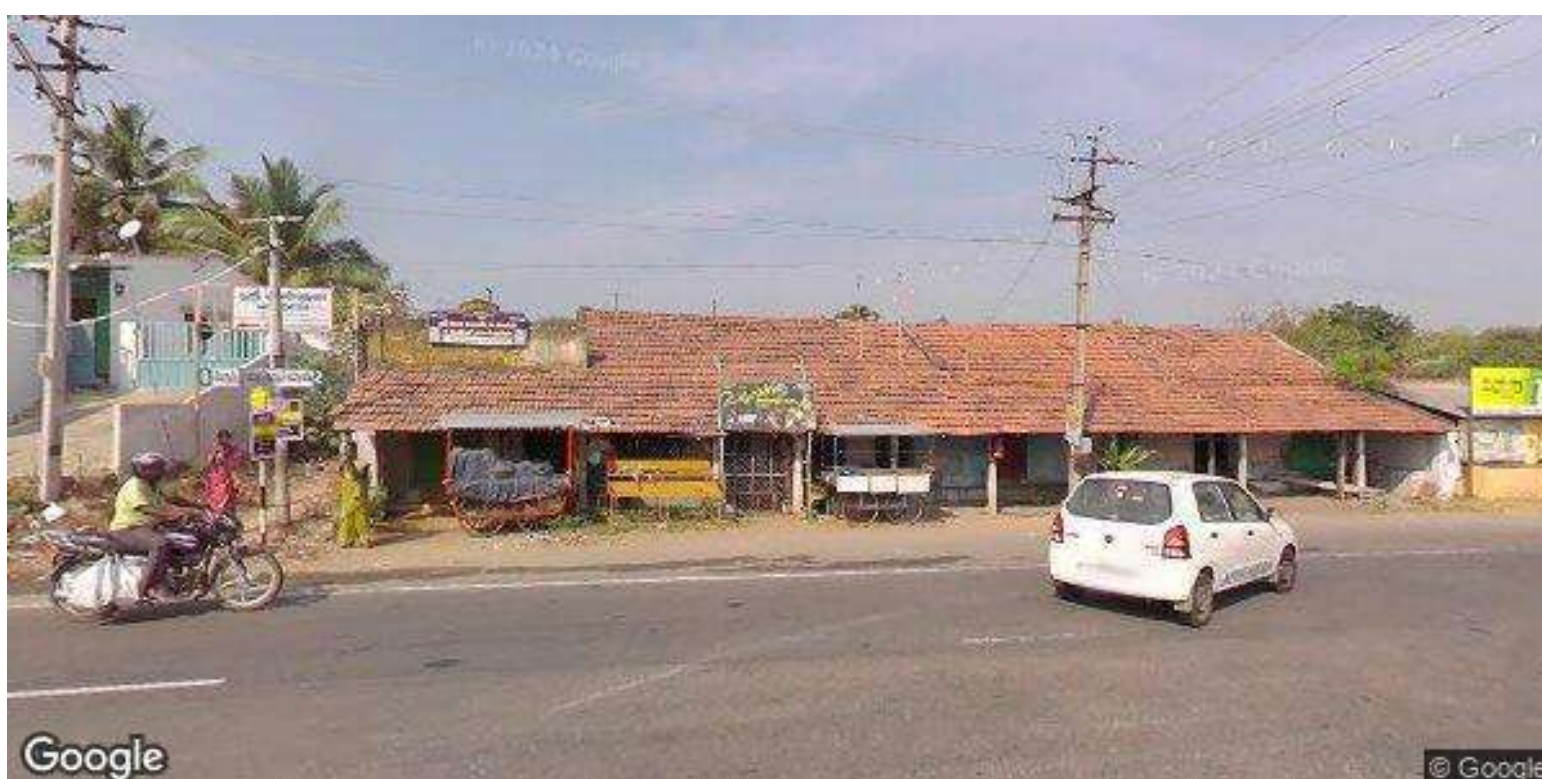
**Coordinates:** 11.34865, 77.59559

| | Risk Type | Risk Level | Coordinates | Speed Limit |
|---|---|---|---|---|
| 12 | Turn | High | 11.34865, 77.59559 | 15 KM/Hr |

**Risk Type:** Turn

**Risk Level:** High

**Speed Limit:** 15 KM/Hr

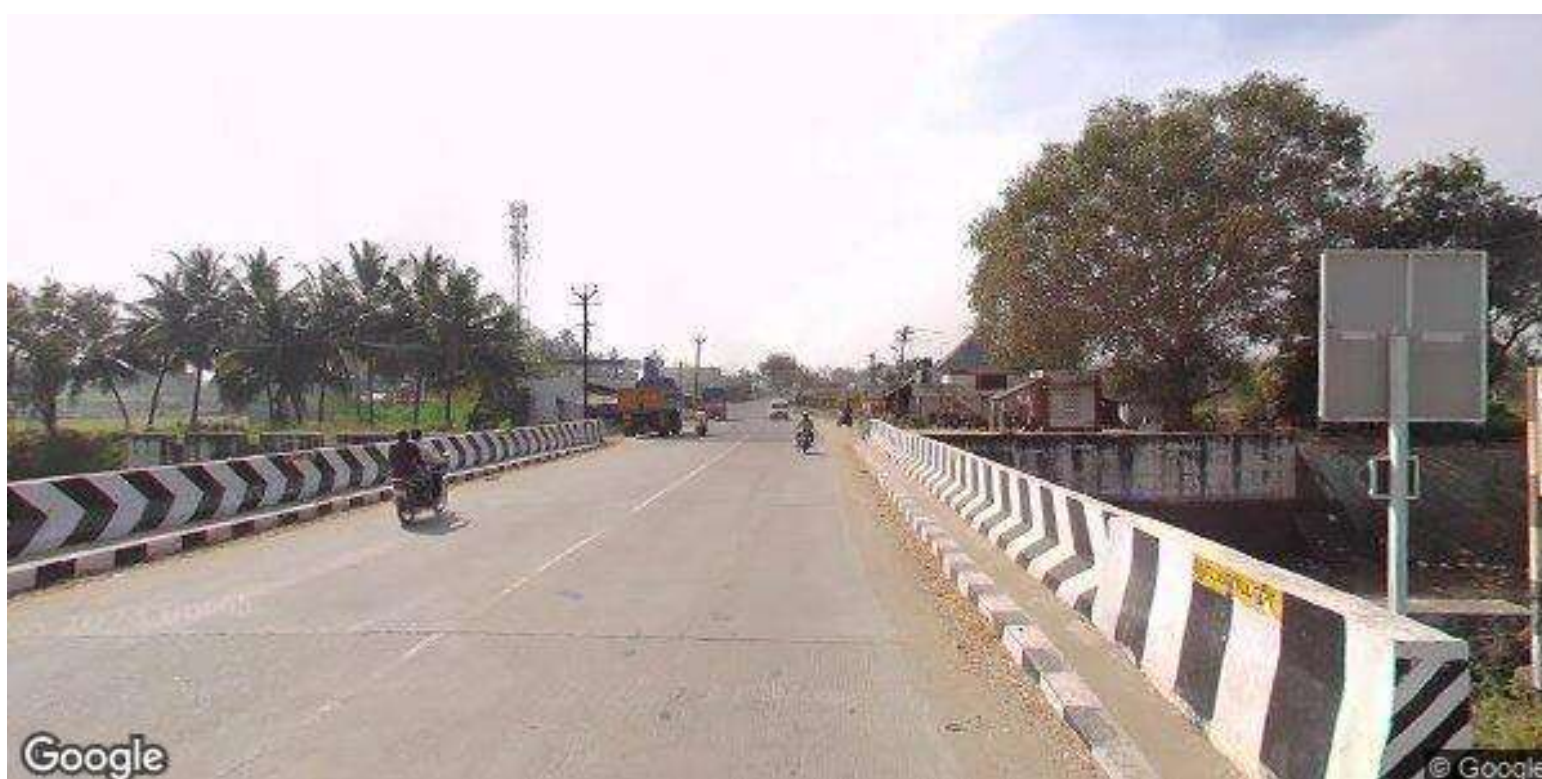
**Coordinates: 11.35150, 77.59493**

| | Risk Type | Risk Level | Coordinates | Speed Limit |
|---|---|---|---|---|
| 13 | Turn | Medium | 11.35150, 77.59493 | 30 KM/Hr |

**Risk Type: Turn**

**Risk Level: Medium**

**Speed Limit: 30 KM/Hr**

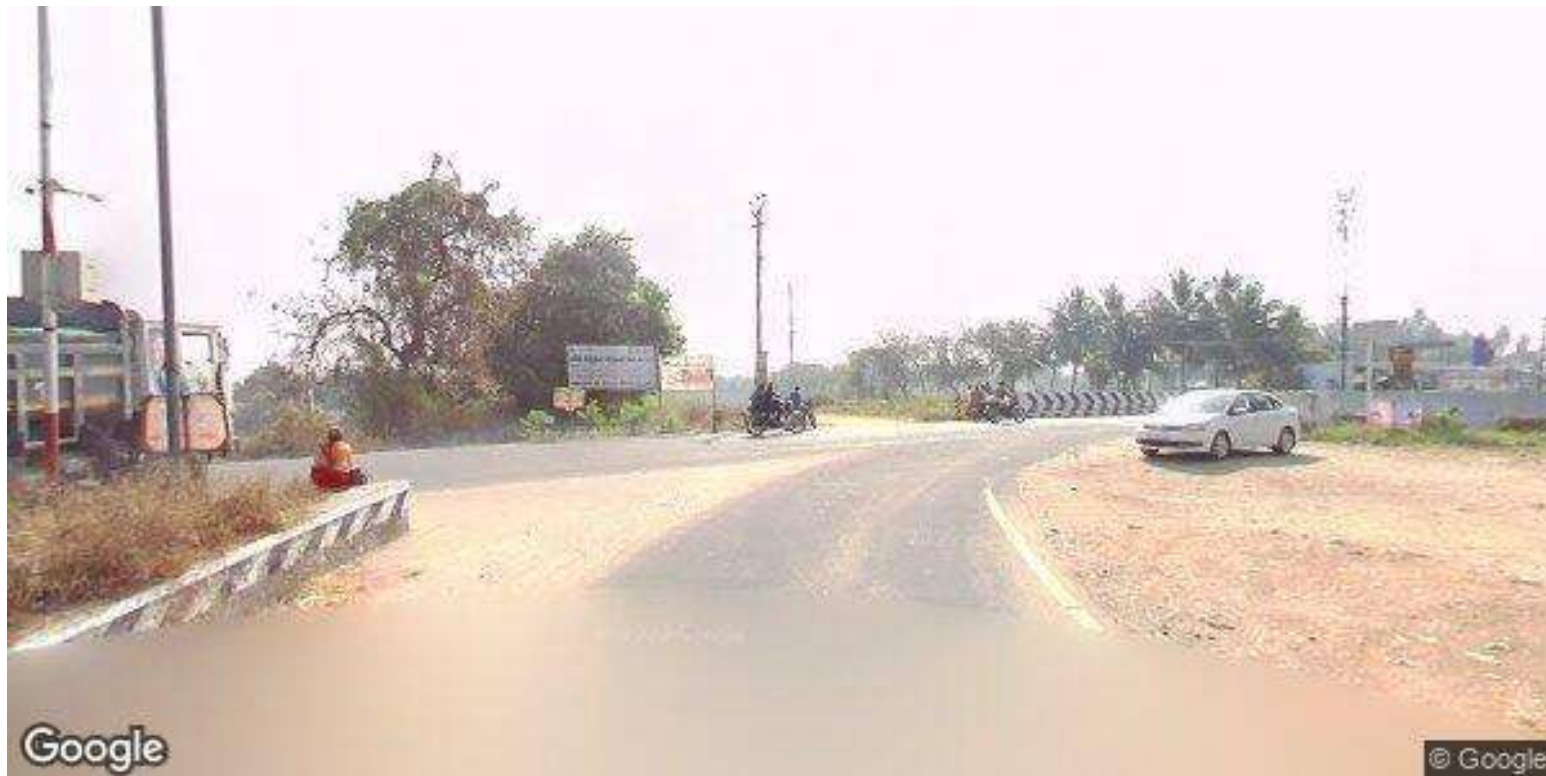
**Coordinates: 11.35165, 77.59474**

| | Risk Type | Risk Level | Coordinates | Speed Limit |
|---|---|---|---|---|
| 14 | Turn | Medium | 11.35165, 77.59474 | 30 KM/Hr |

**Risk Type: Turn**

**Risk Level: Medium**

**Speed Limit: 30 KM/Hr**

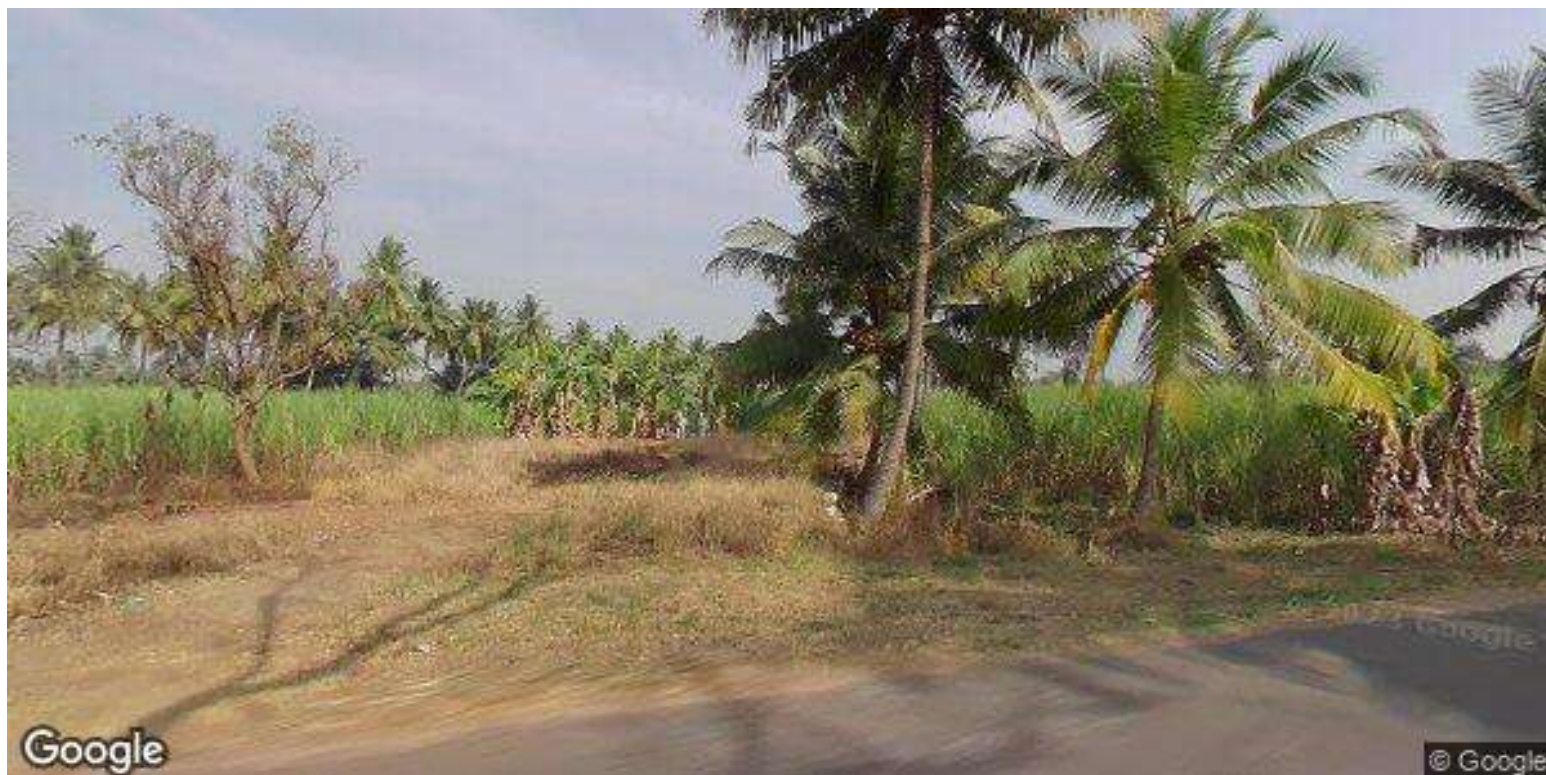
**Coordinates: 11.35209, 77.57382**

| | Risk Type | Risk Level | Coordinates | Speed Limit |
|---|---|---|---|---|
| 15 | Turn | Medium | 11.35209, 77.57382 | 30 KM/Hr |

**Risk Type: Turn**

**Risk Level: Medium**

**Speed Limit: 30 KM/Hr**

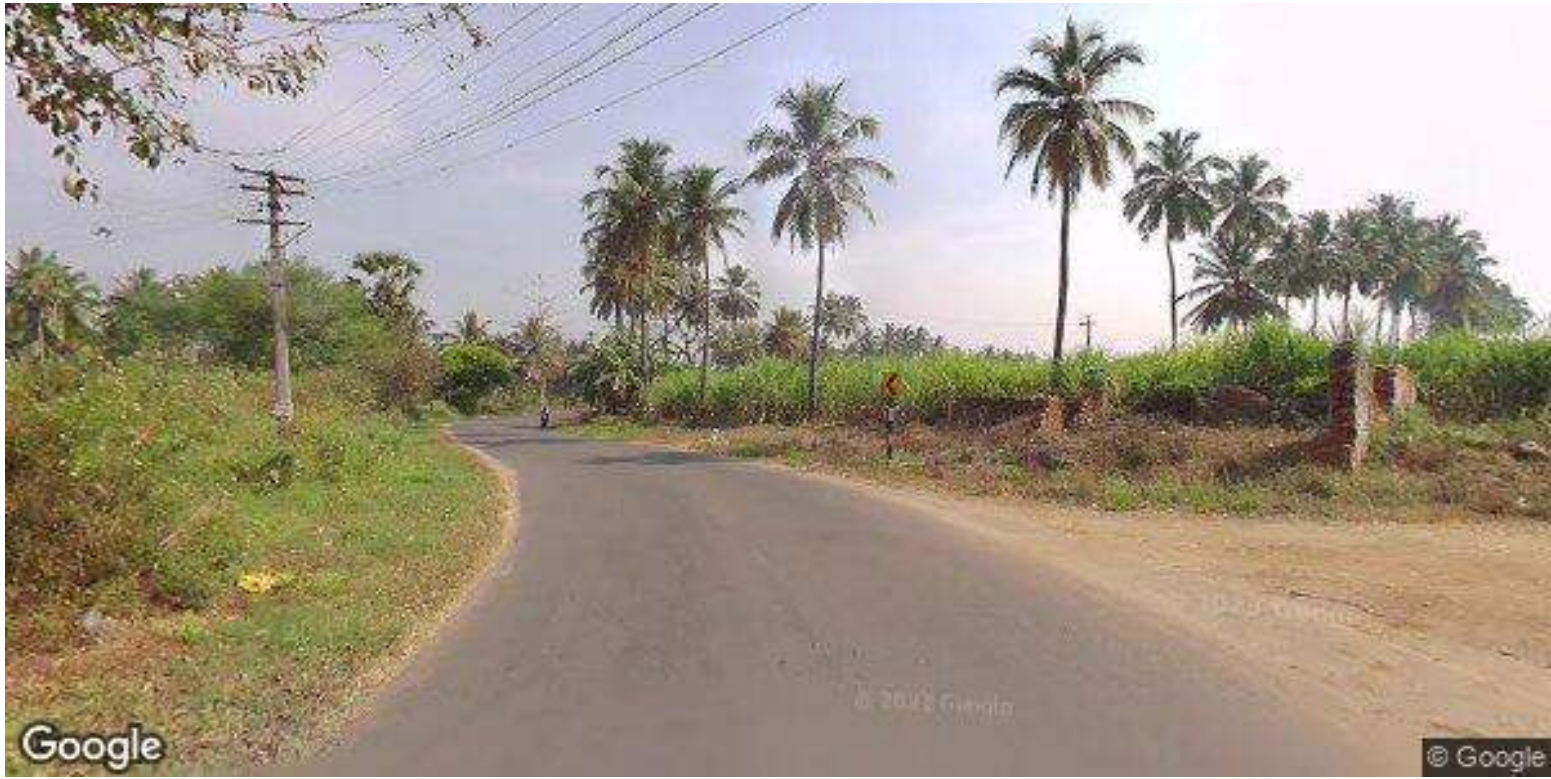
| | Risk Type | Risk Level | Coordinates | Speed Limit |
|---|---|---|---|---|
| 16 | Turn | Medium | 11.35106, 77.57318 | 30 KM/Hr |

**Risk Type:** Turn  
**Risk Level:** Medium  
**Speed Limit:** 30 KM/Hr  
**Coordinates:** 11.35106, 77.57318

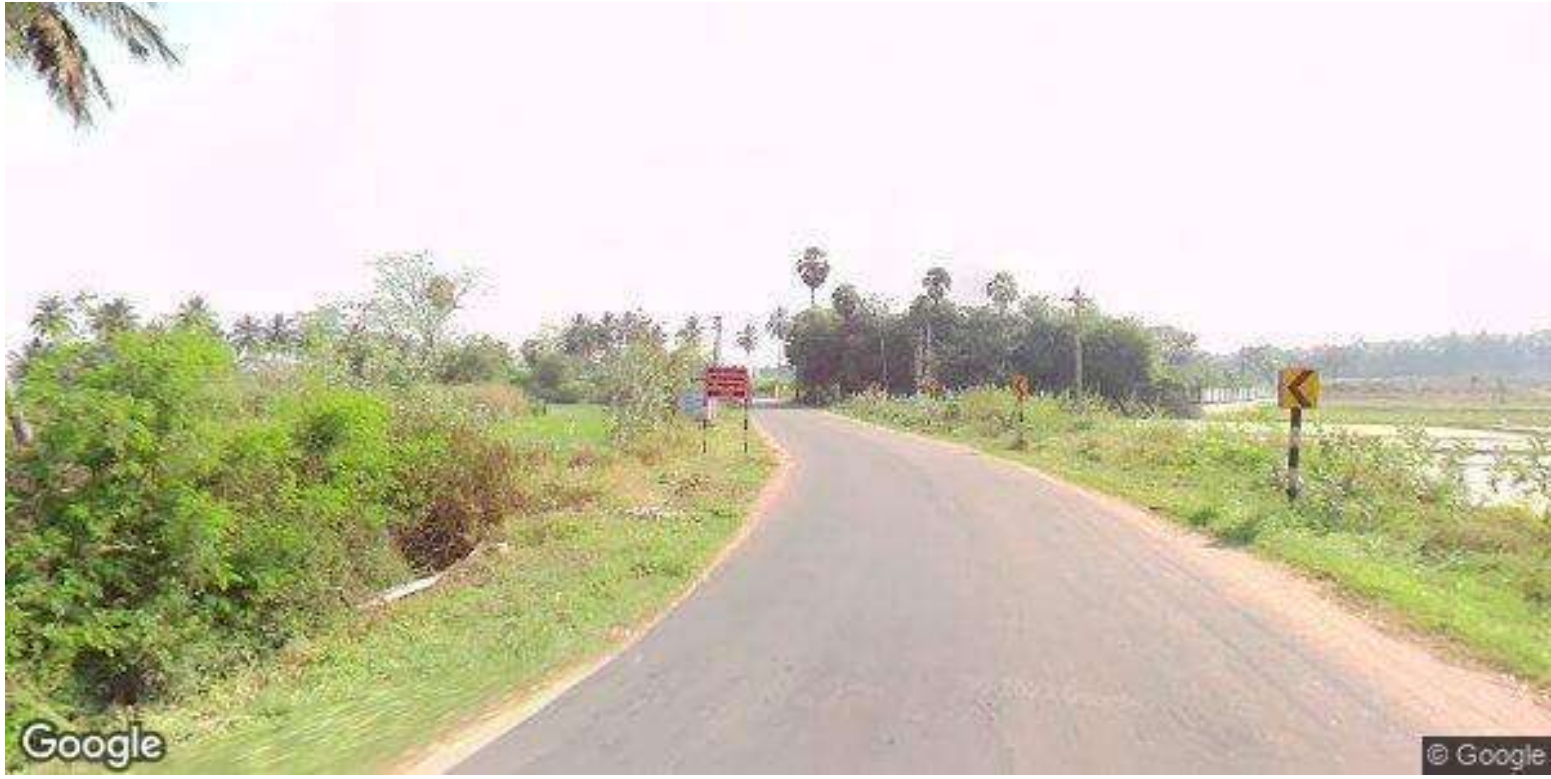
| | Risk Type | Risk Level | Coordinates | Speed Limit |
|---|---|---|---|---|
| 17 | Turn | Medium | 11.35049, 77.57222 | 30 KM/Hr |

**Risk Type:** Turn  
**Risk Level:** Medium  
**Speed Limit:** 30 KM/Hr  
**Coordinates:** 11.35049, 77.57222
