## **JOURNEY RISK MANAGEMENT (JRM) STUDY**

### **Salem Terminal To SRI MAHA FUELS**

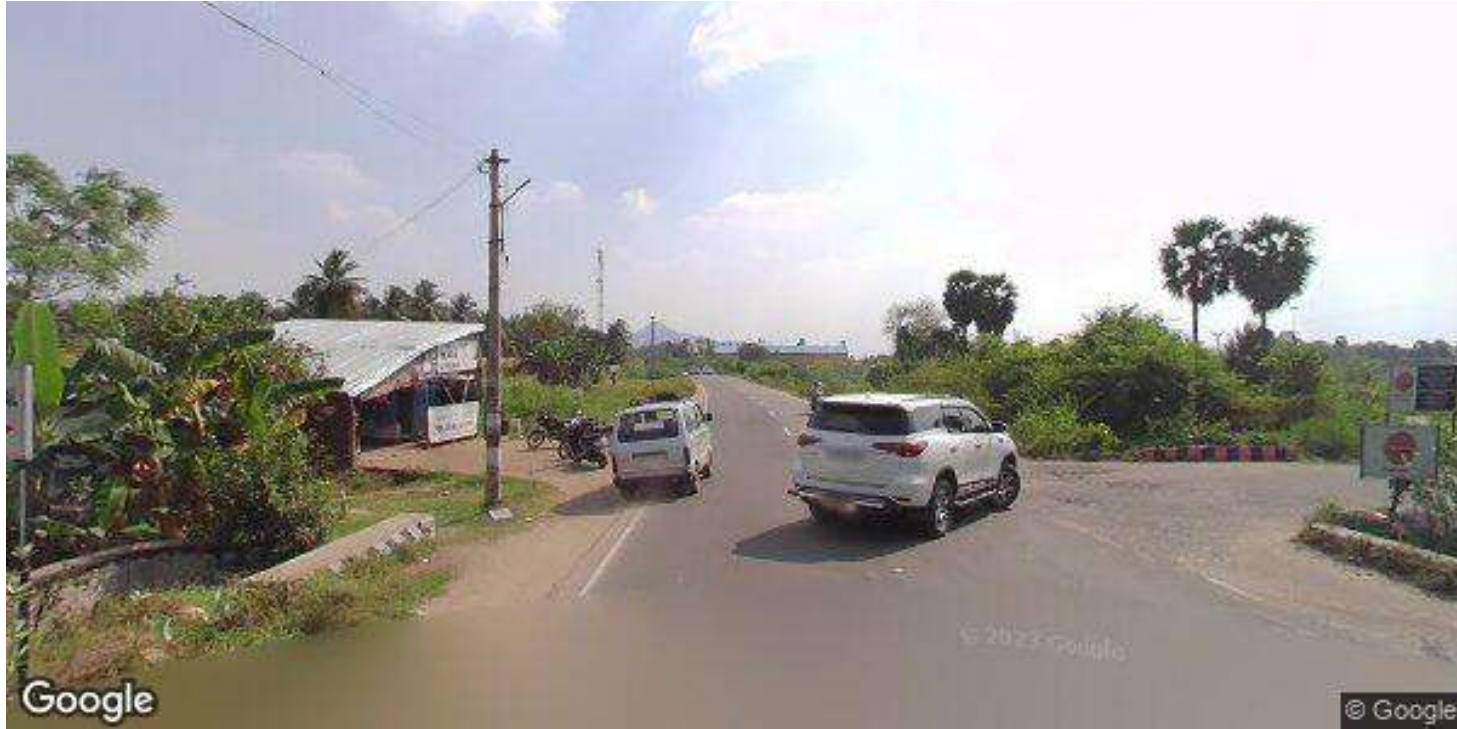
**Coordinates:** 11.44029, 77.87544

**Risk Type:** Turn

**Risk Level:** High

**Speed Limit:** 15 KM/Hr

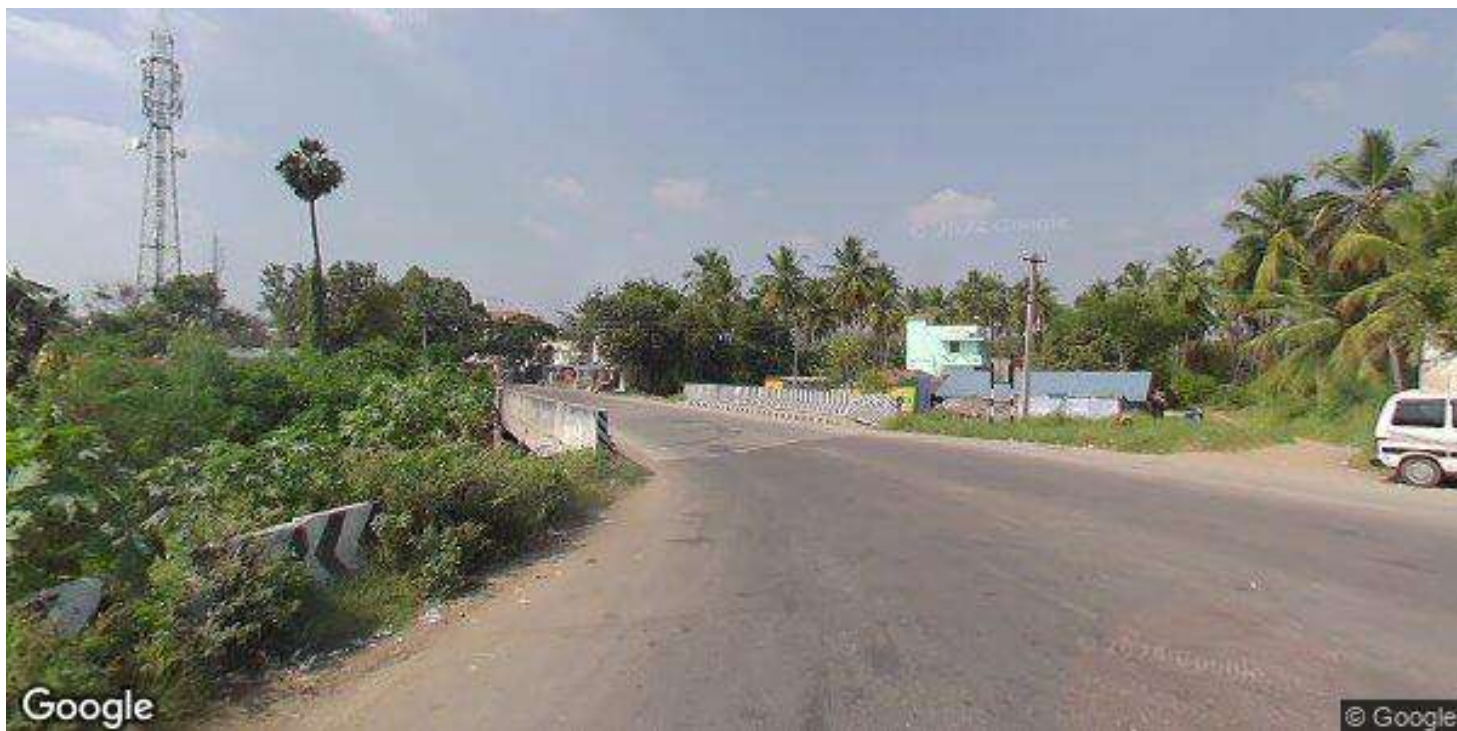
**Coordinates:** 11.44893, 77.87413

**Risk Type:** Turn

**Risk Level:** High

**Speed Limit:** 15 KM/Hr

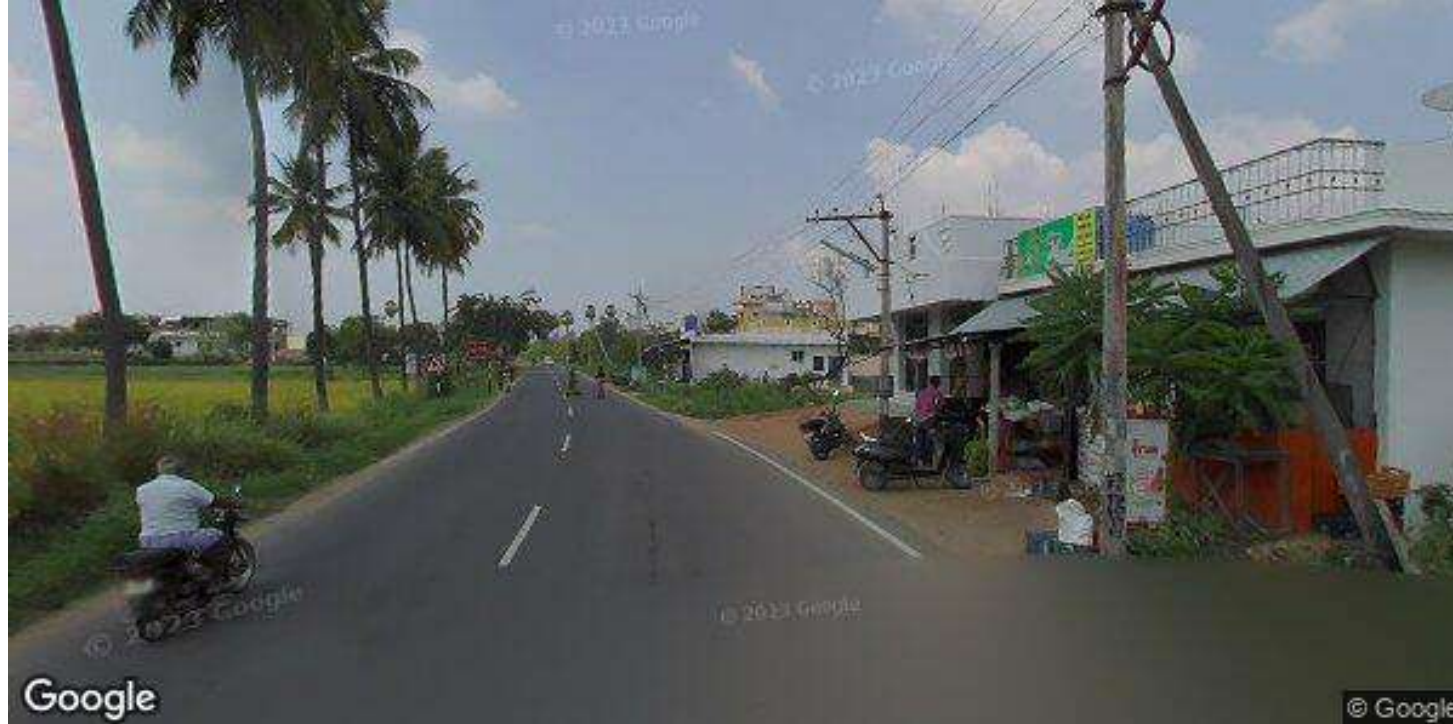
**Coordinates:** 11.45127, 77.86734

**Risk Type:** Turn

**Risk Level:** Medium

**Speed Limit:** 30 KM/Hr

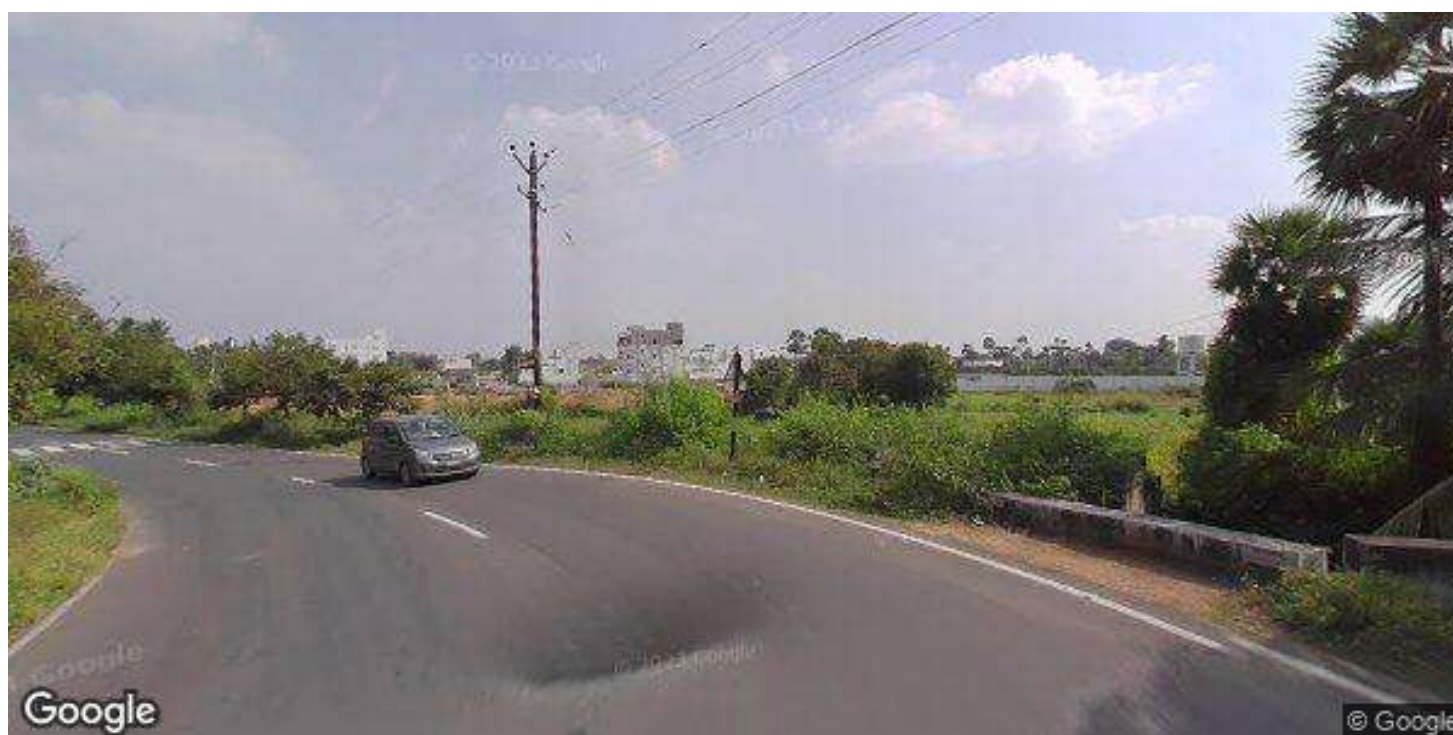
**Coordinates:** 11.45350, 77.85700

**Risk Type:** Turn

**Risk Level:** High

**Speed Limit:** 15 KM/Hr

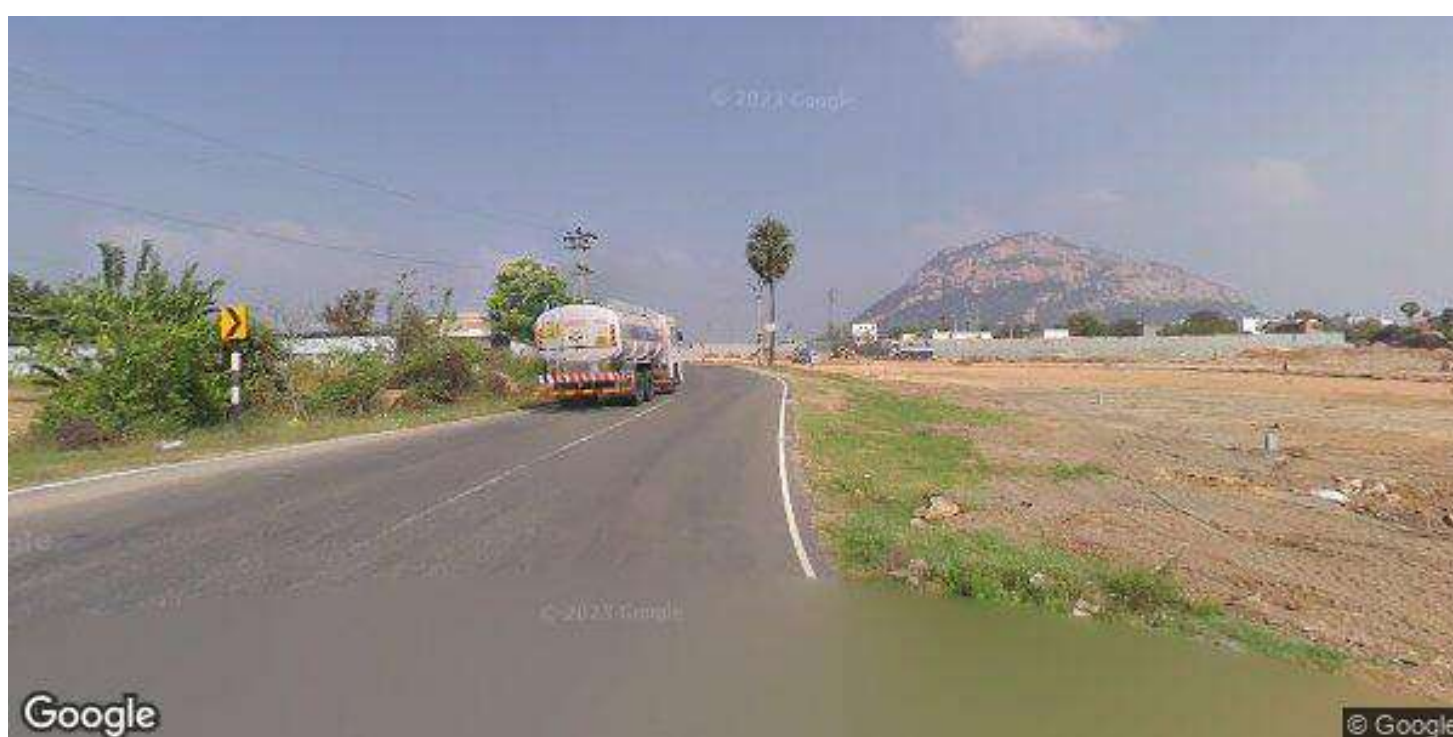
**Coordinates: 11.45845, 77.85141**

**Risk Type:** Turn

**Risk Level:** Medium

**Speed Limit: 30 KM/Hr**

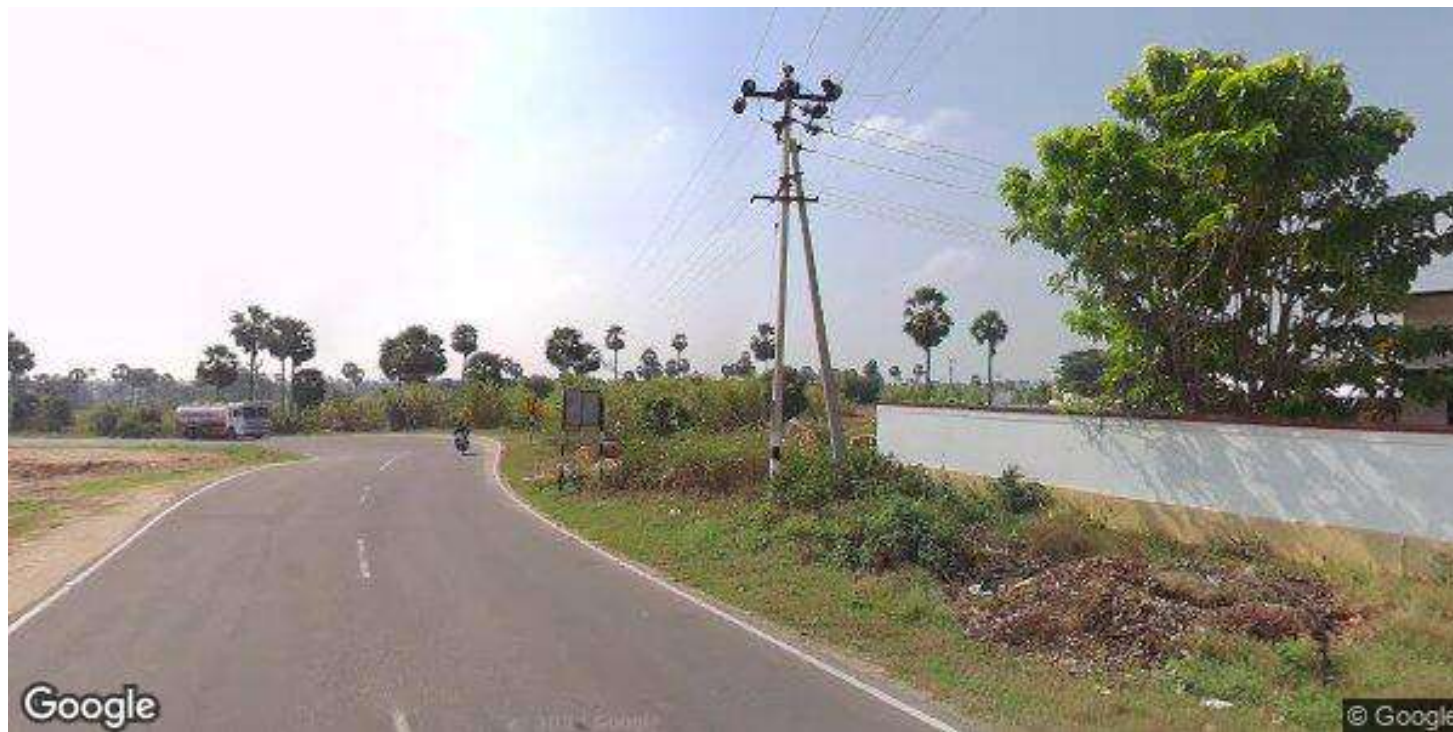
**Coordinates: 11.45889, 77.85136**

**Risk Type: Turn**

**Risk Level: Medium**

**Speed Limit: 30 KM/Hr**

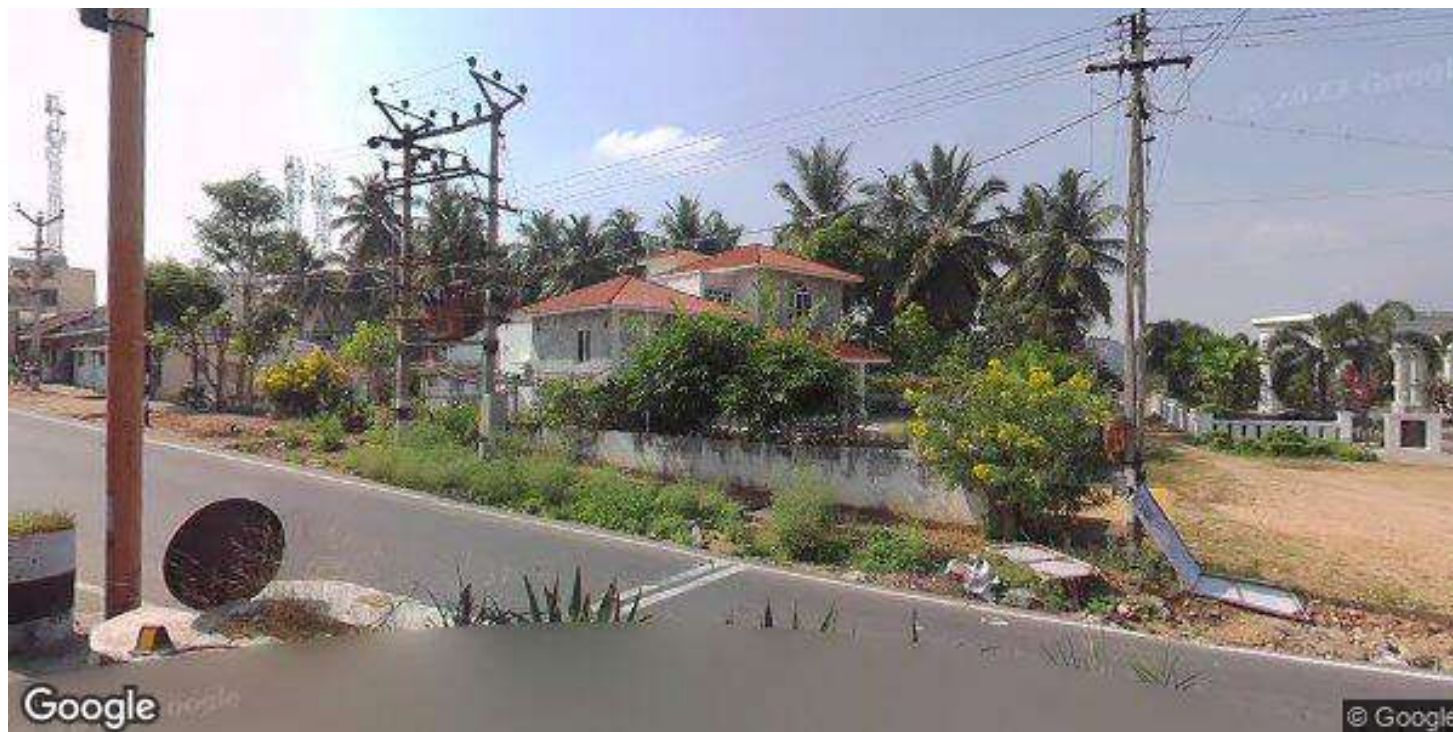
**Coordinates: 11.46303, 77.84945**

**Risk Type: Turn**

**Risk Level: High**

**Speed Limit: 15 KM/Hr**

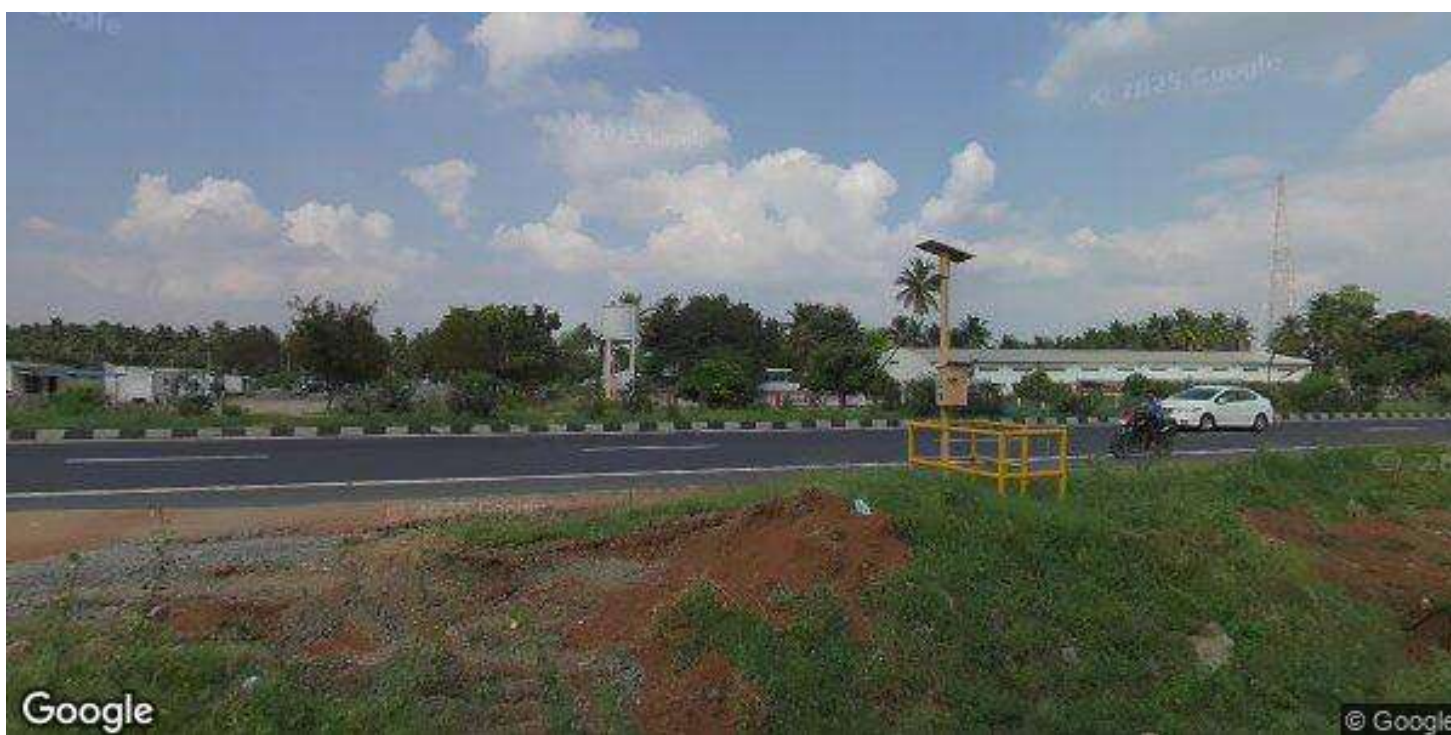
**Risk Type:** Turn  
**Risk Level:** Medium  
**Speed Limit:** 30 KM/Hr  
**Coordinates:** 11.29141, 77.58266

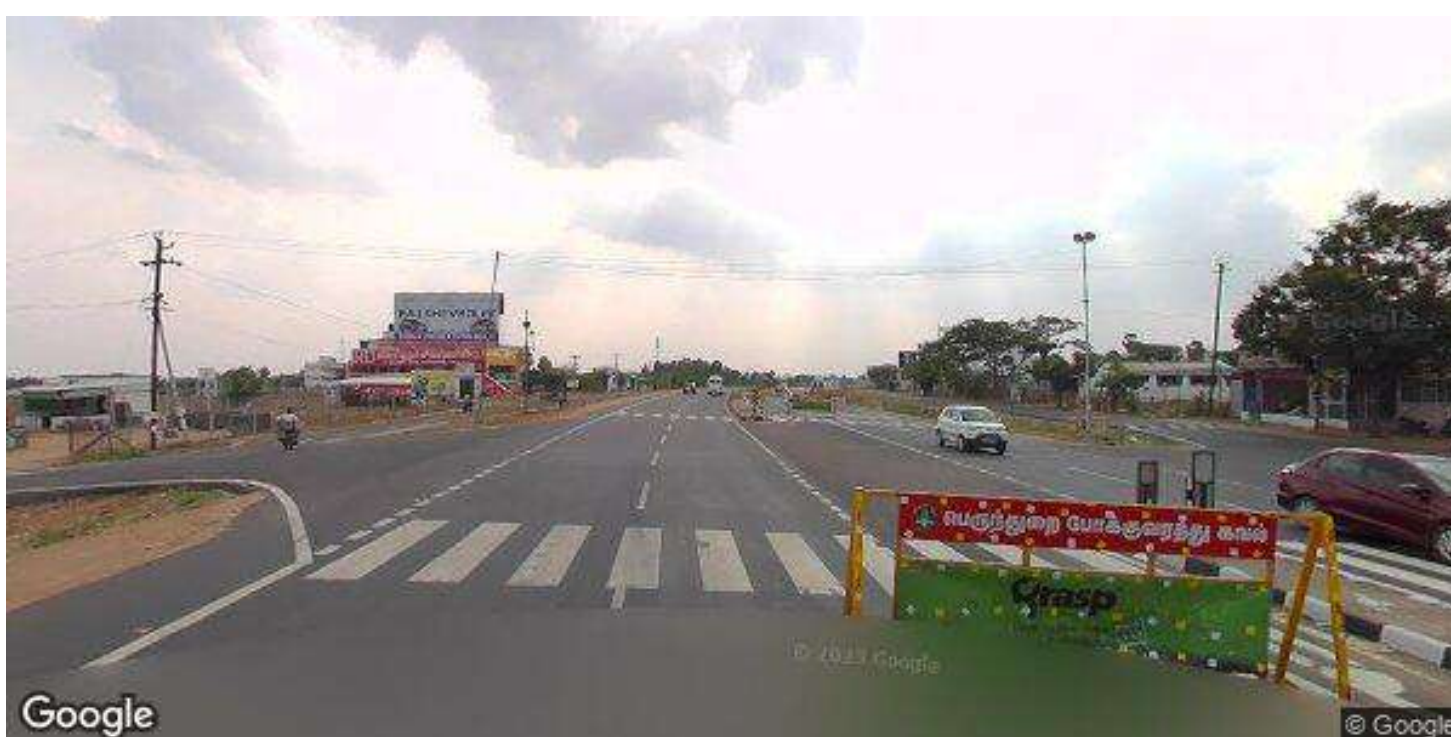
**Coordinates: 11.23724, 77.50686**

**Risk Type:** Turn  
**Risk Level:** Medium

**Speed Limit: 30 KM/Hr**

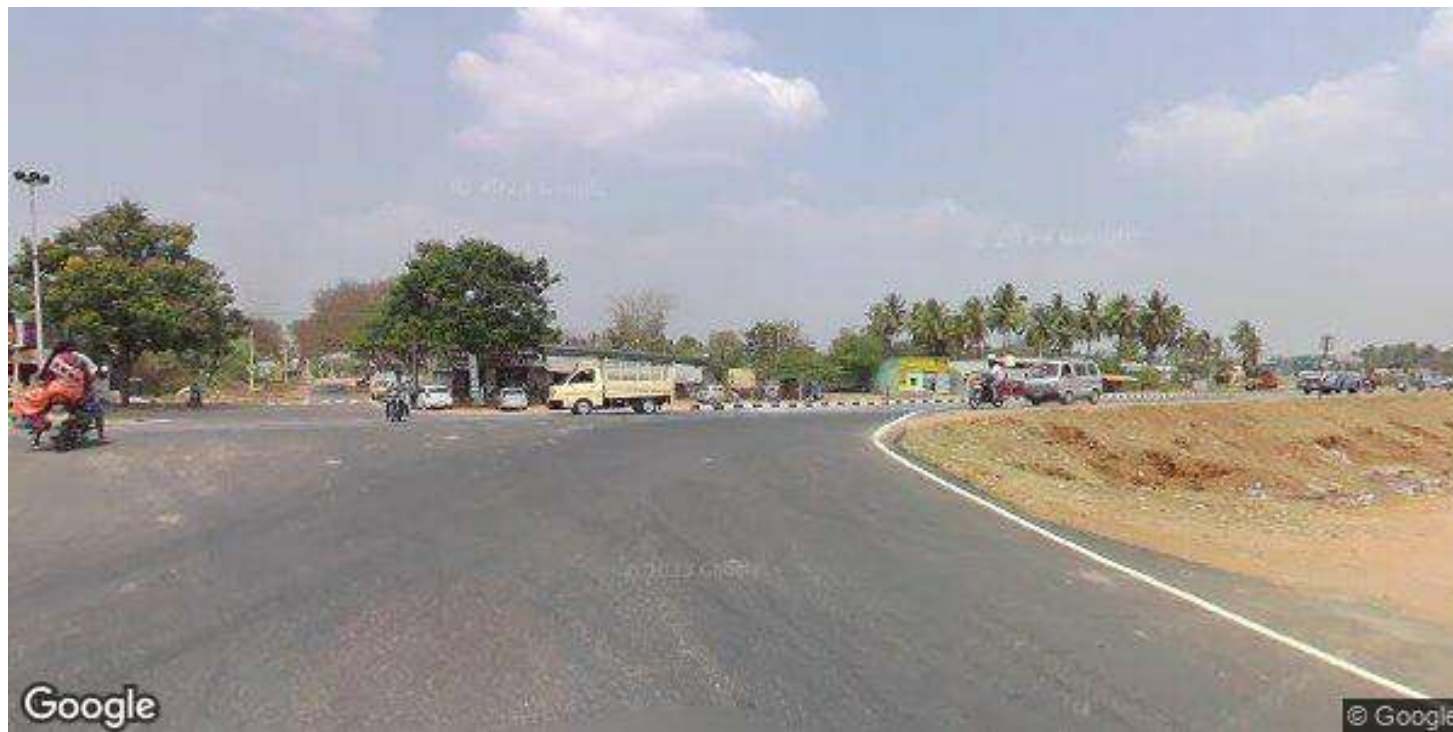
**Coordinates: 11.23704, 77.50676**

**Risk Type: Turn**

**Risk Level: High**

**Speed Limit: 15 KM/Hr**

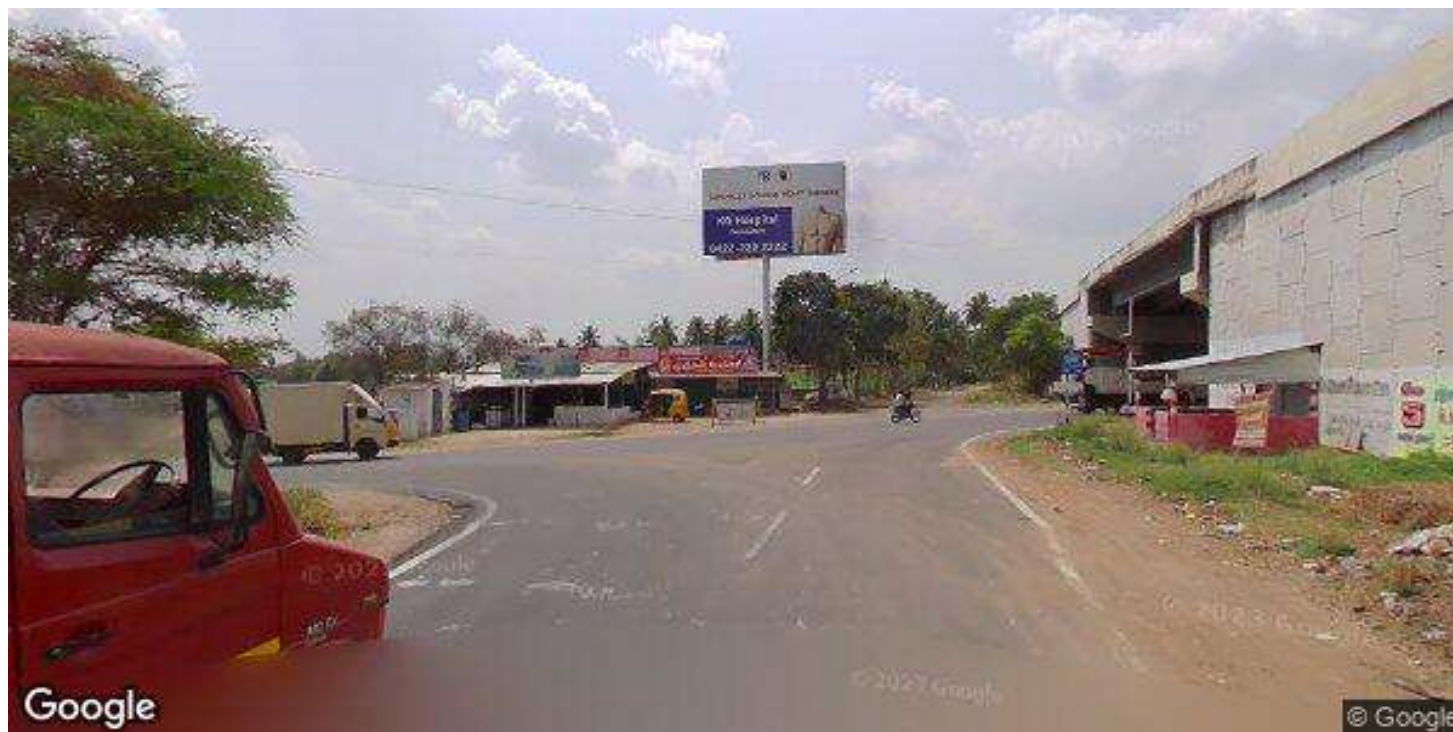
**Coordinates: 11.23685, 77.50236**

**Risk Type: Turn**

**Risk Level: Medium**

**Speed Limit: 30 KM/Hr**

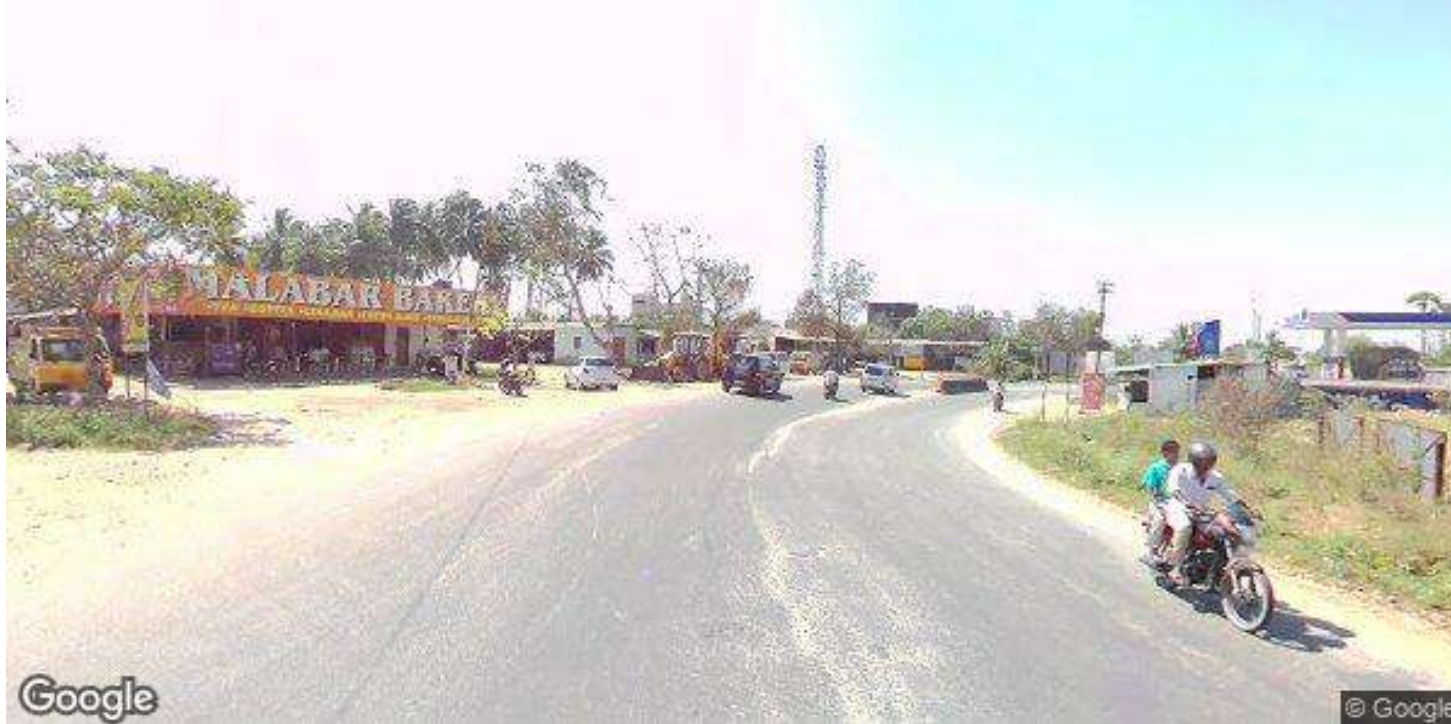
**Risk Type:** Turn  
**Risk Level:** High  
**Speed Limit:** 15 KM/Hr  
**Coordinates:** 11.23675, 77.50215

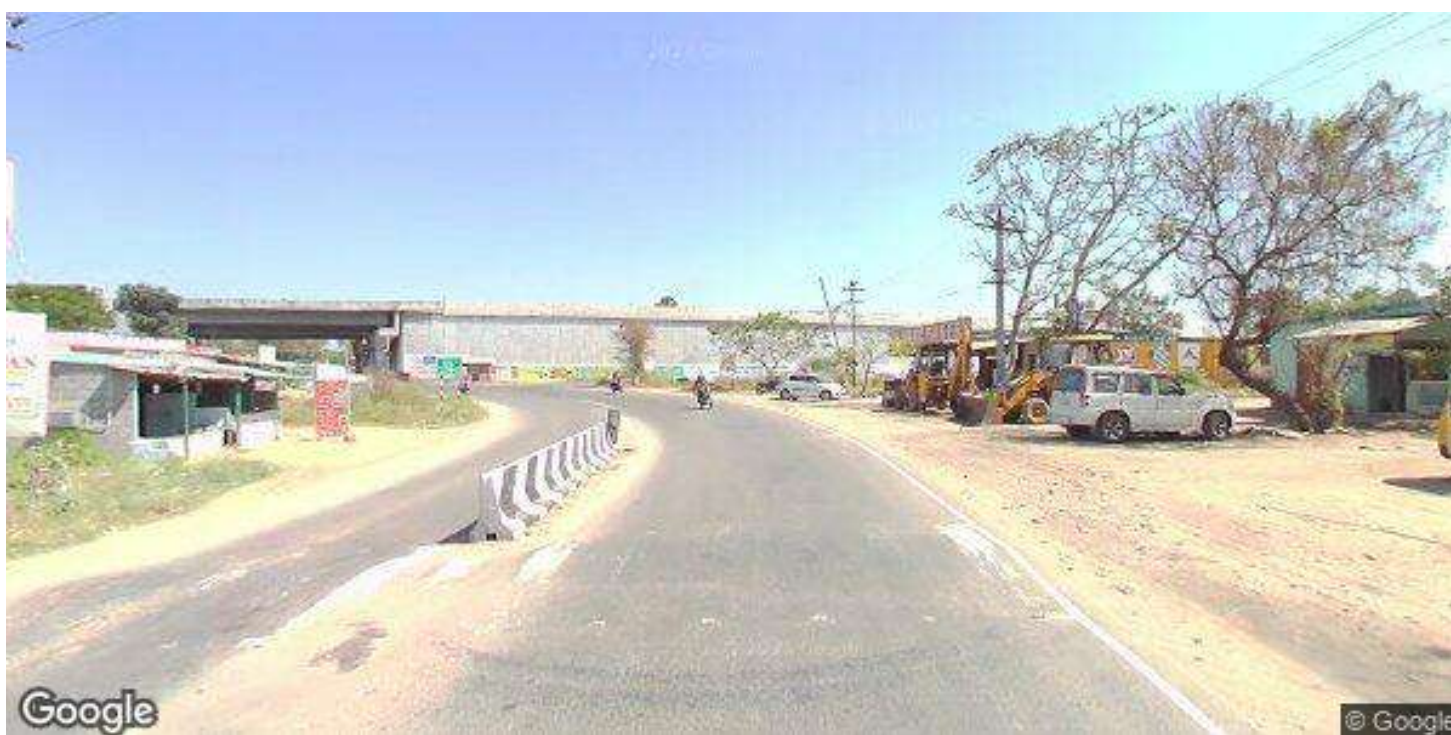
**Risk Type:** Turn  
**Risk Level:** Medium  
**Speed Limit:** 30 KM/Hr  
**Coordinates:** 11.23622, 77.50210

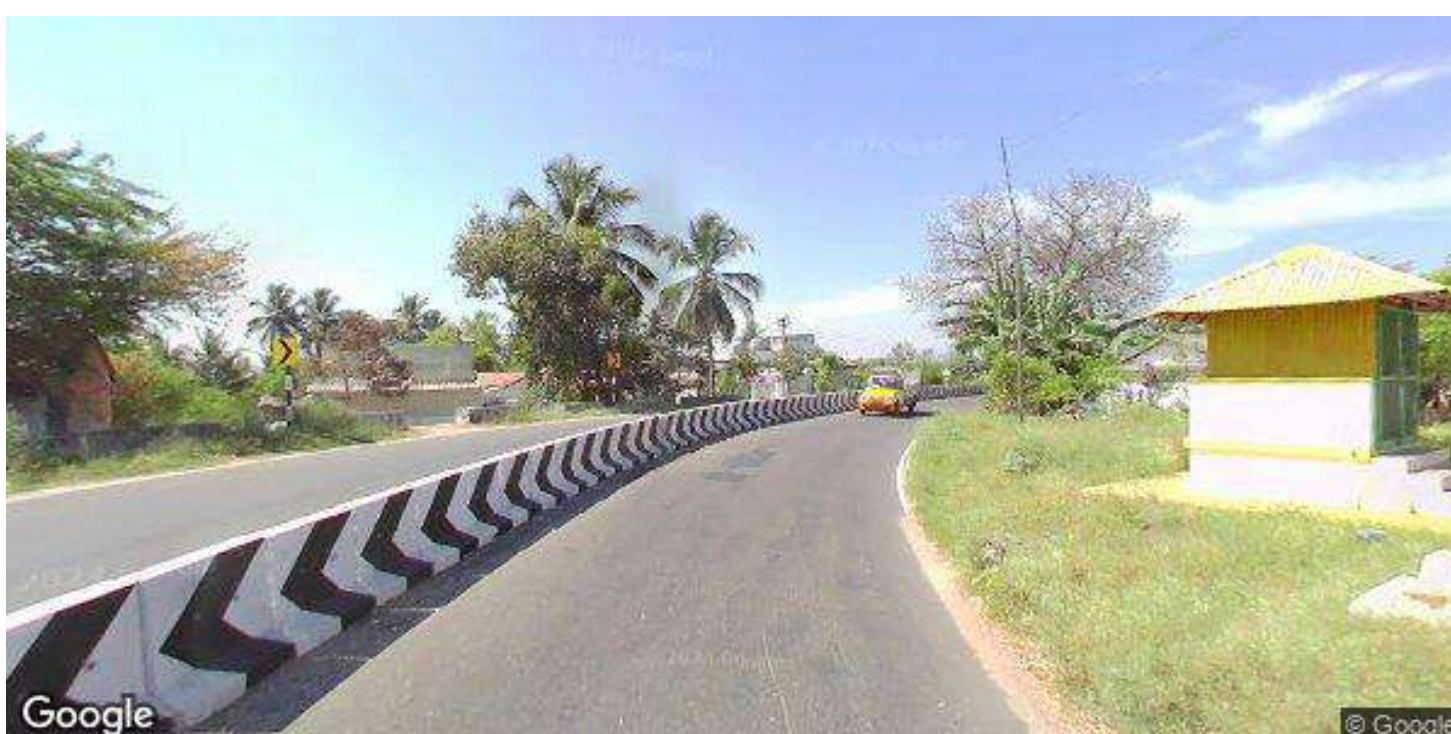
**Coordinates: 11.23396, 77.50105**

**Risk Type:** Turn  
**Risk Level:** Medium

**Speed Limit: 30 KM/Hr**

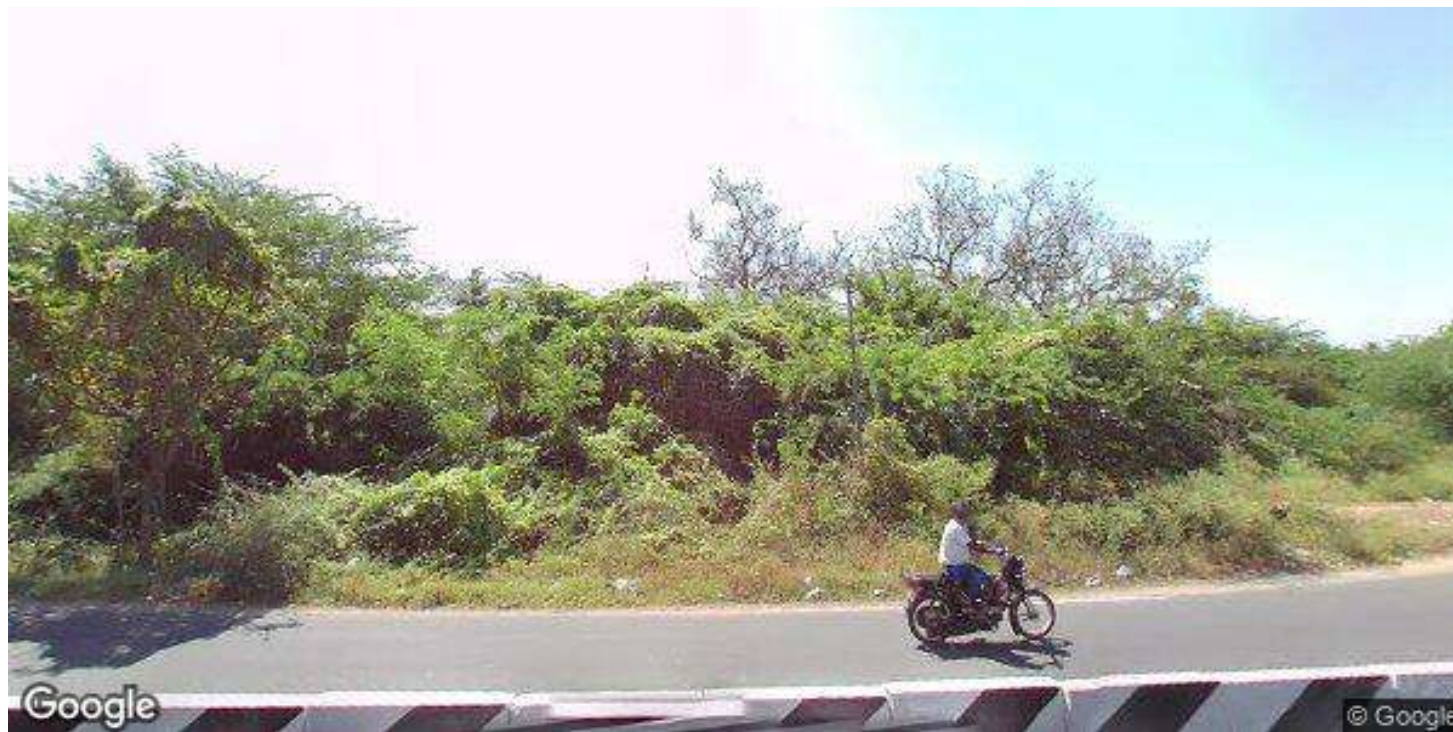
**Coordinates: 11.23329, 77.49966**

**Risk Type: Turn**

**Risk Level: Medium**

**Speed Limit: 30 KM/Hr**

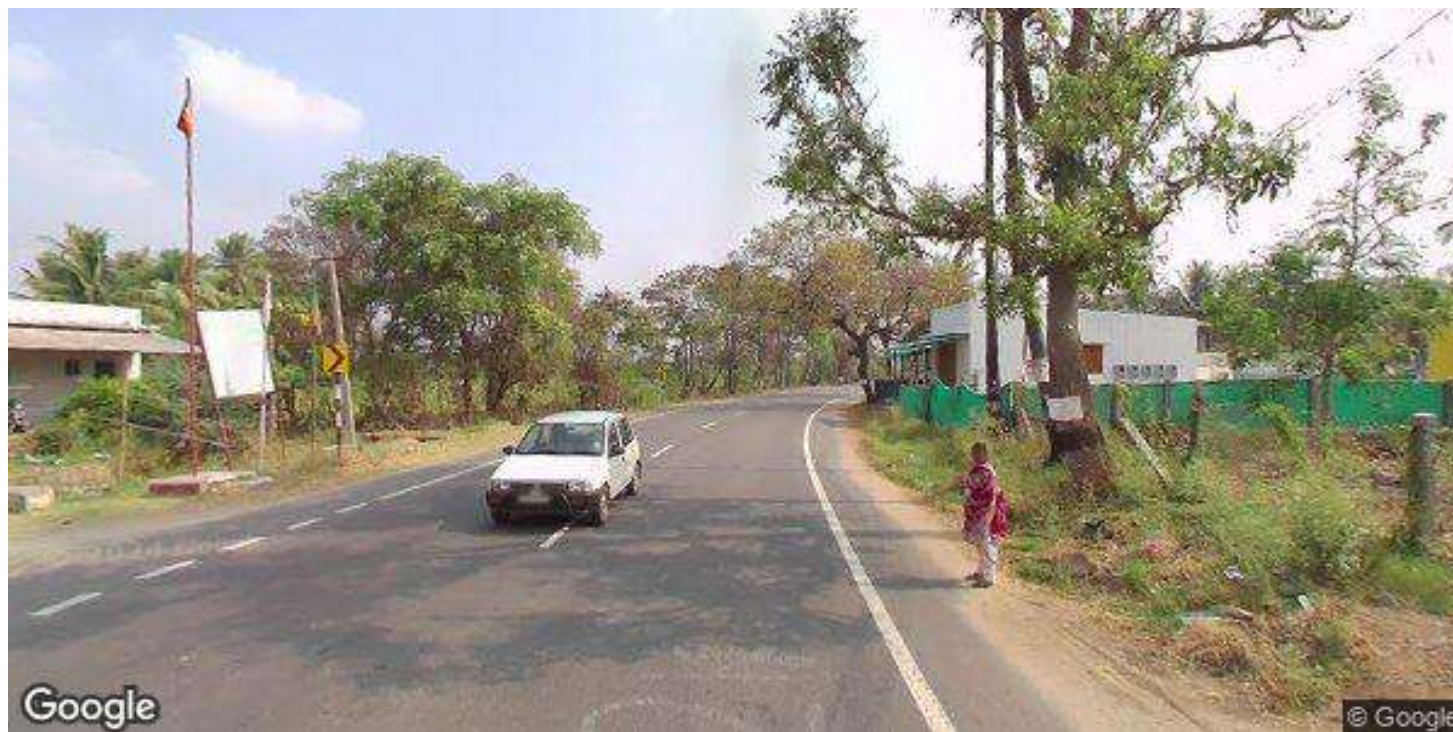
**Coordinates: 11.18329, 77.46249**

**Risk Type: Turn**

**Risk Level: Medium**

**Speed Limit: 30 KM/Hr**

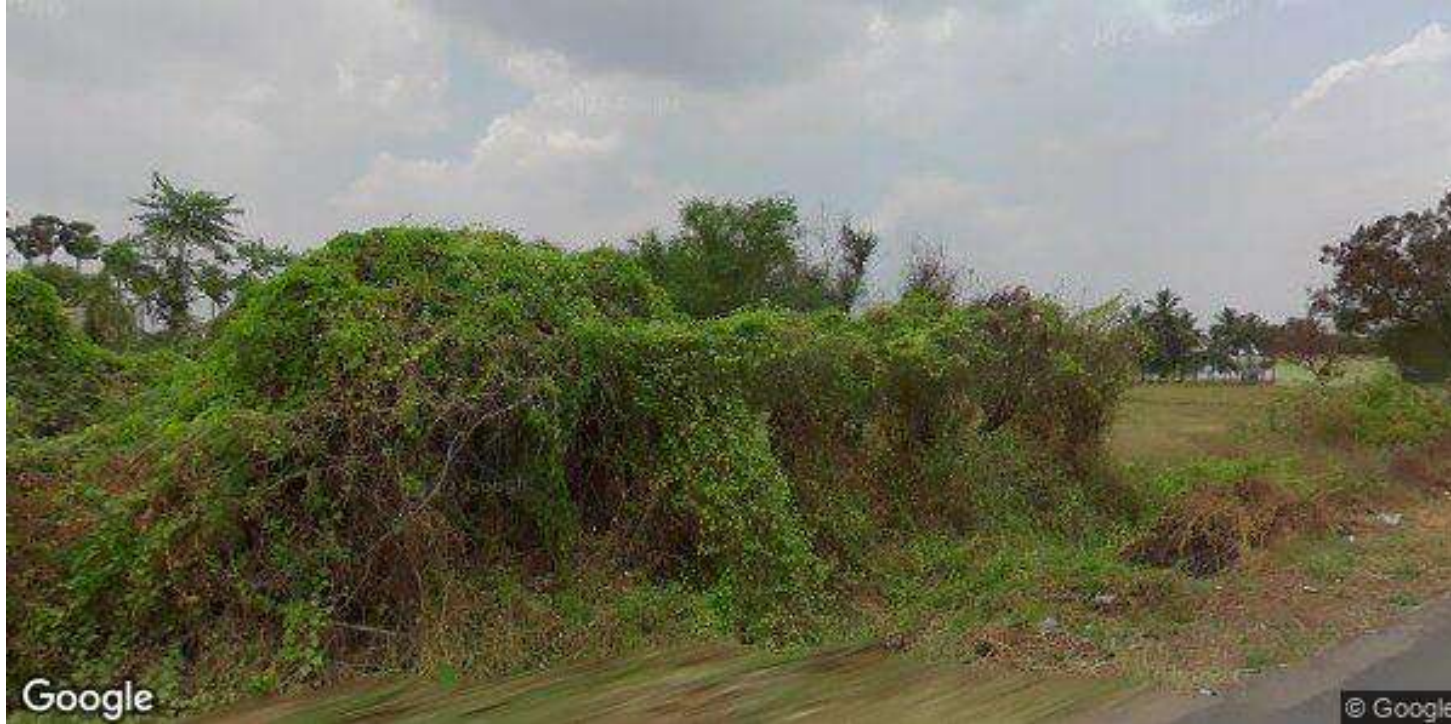
**Coordinates:** 11.17851, 77.46169

**Risk Type:** Turn

**Risk Level:** Medium

**Speed Limit:** 30 KM/Hr

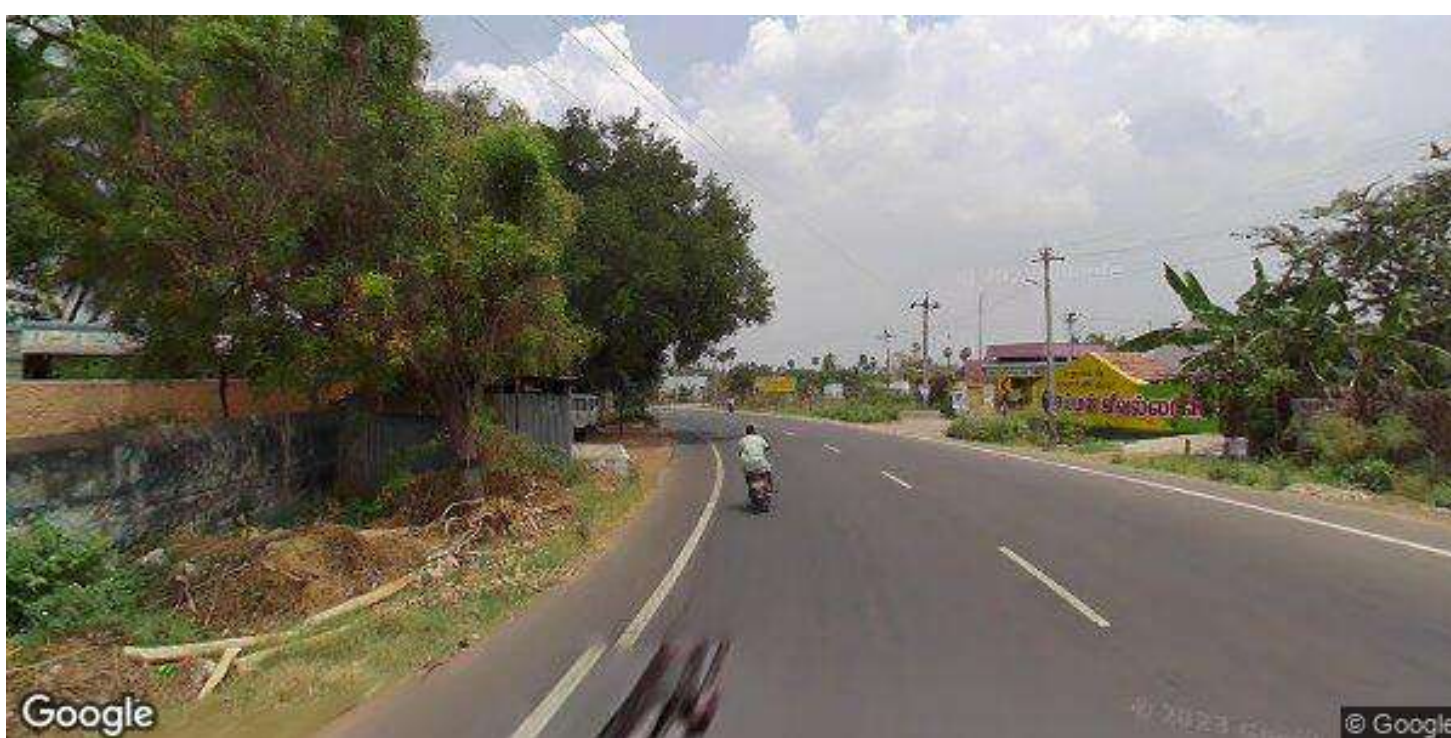
**Coordinates:** 11.17497, 77.45961

**Risk Type:** Turn

**Risk Level:** Medium

**Speed Limit:** 30 KM/Hr

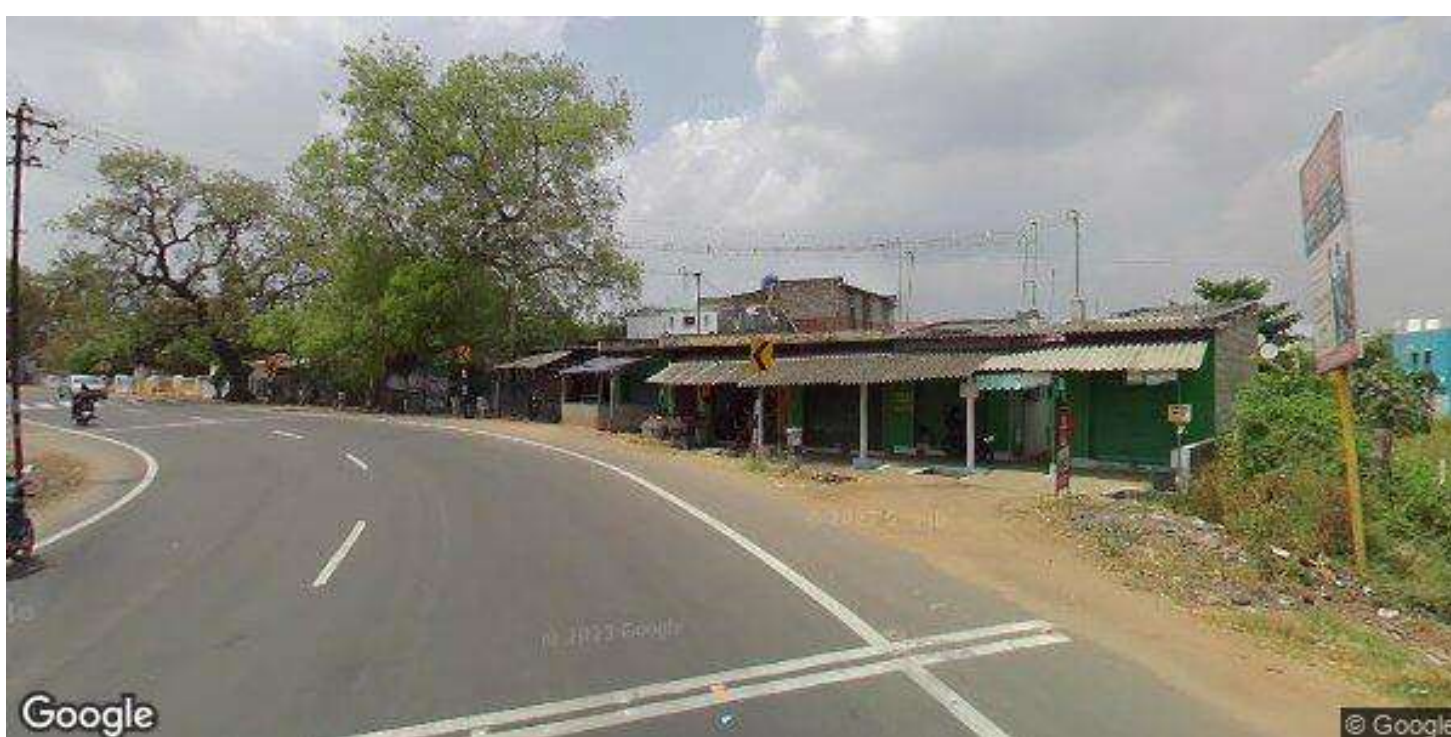
**Coordinates: 11.17383, 77.45750**

**Risk Type:** Turn

**Risk Level:** Medium

**Speed Limit: 30 KM/Hr**

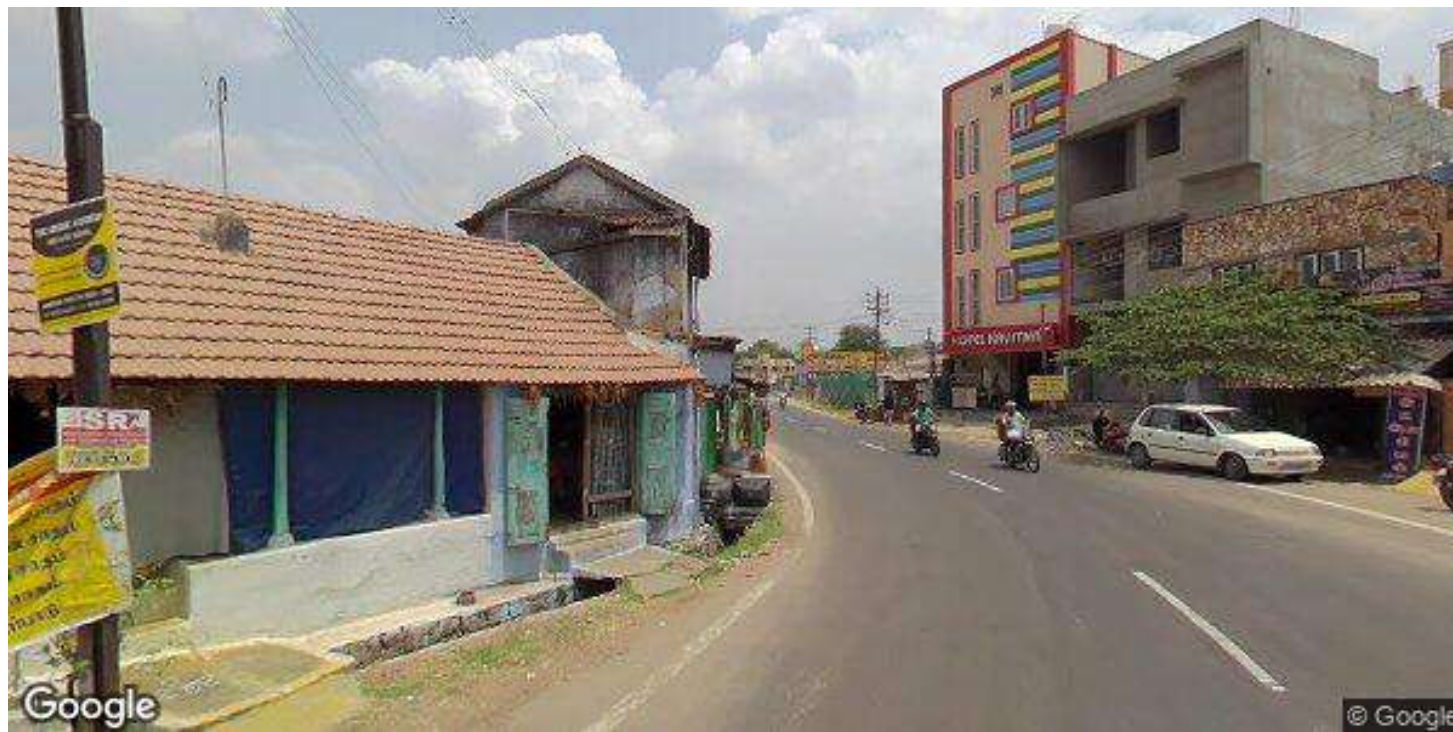
**Coordinates: 11.17133, 77.45590**

**Risk Type: Turn**

**Risk Level: Medium**

**Speed Limit: 30 KM/Hr**

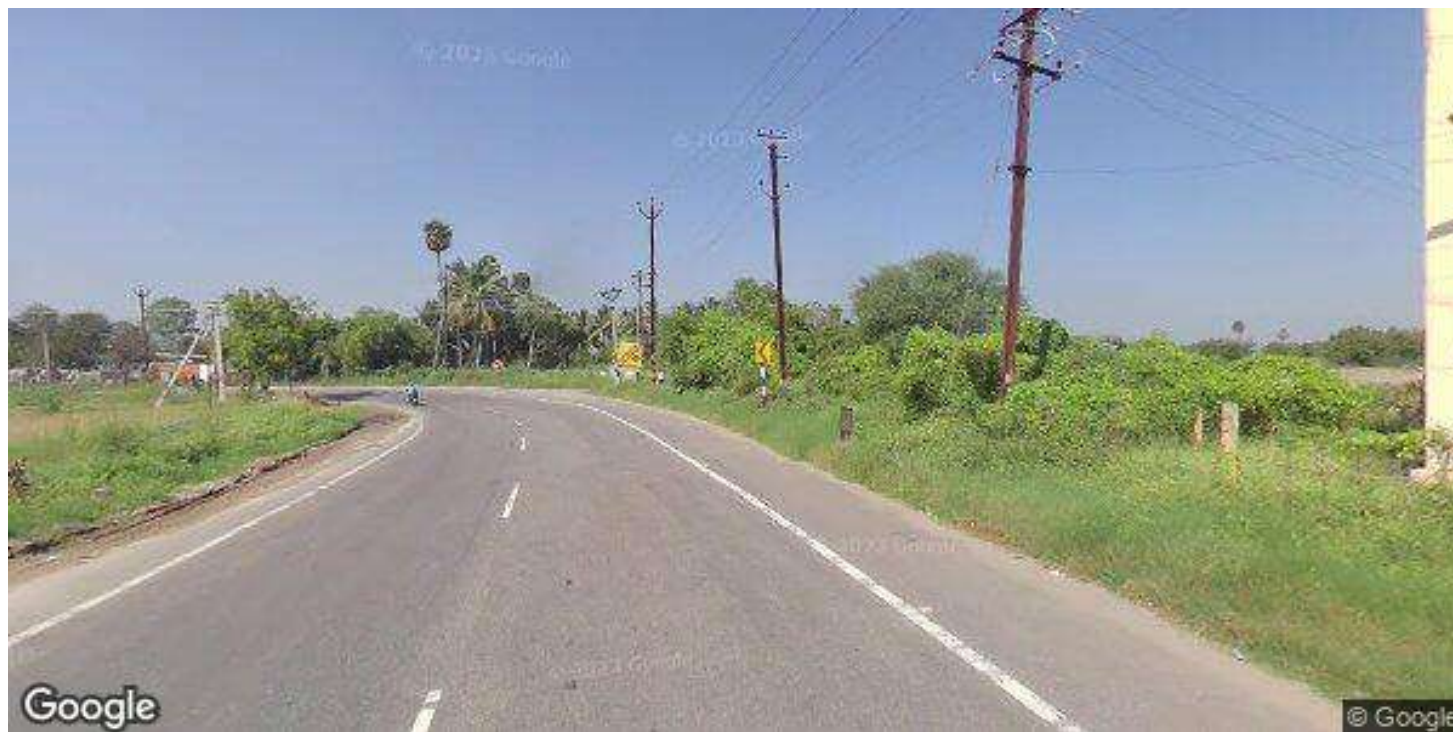
**Coordinates: 11.16959, 77.44438**

**Risk Type: Turn**

**Risk Level: Medium**

**Speed Limit: 30 KM/Hr**
