## **JOURNEY RISK MANAGEMENT (JRM) STUDY**

### **Salem Terminal To SRI MAHA FUELS**

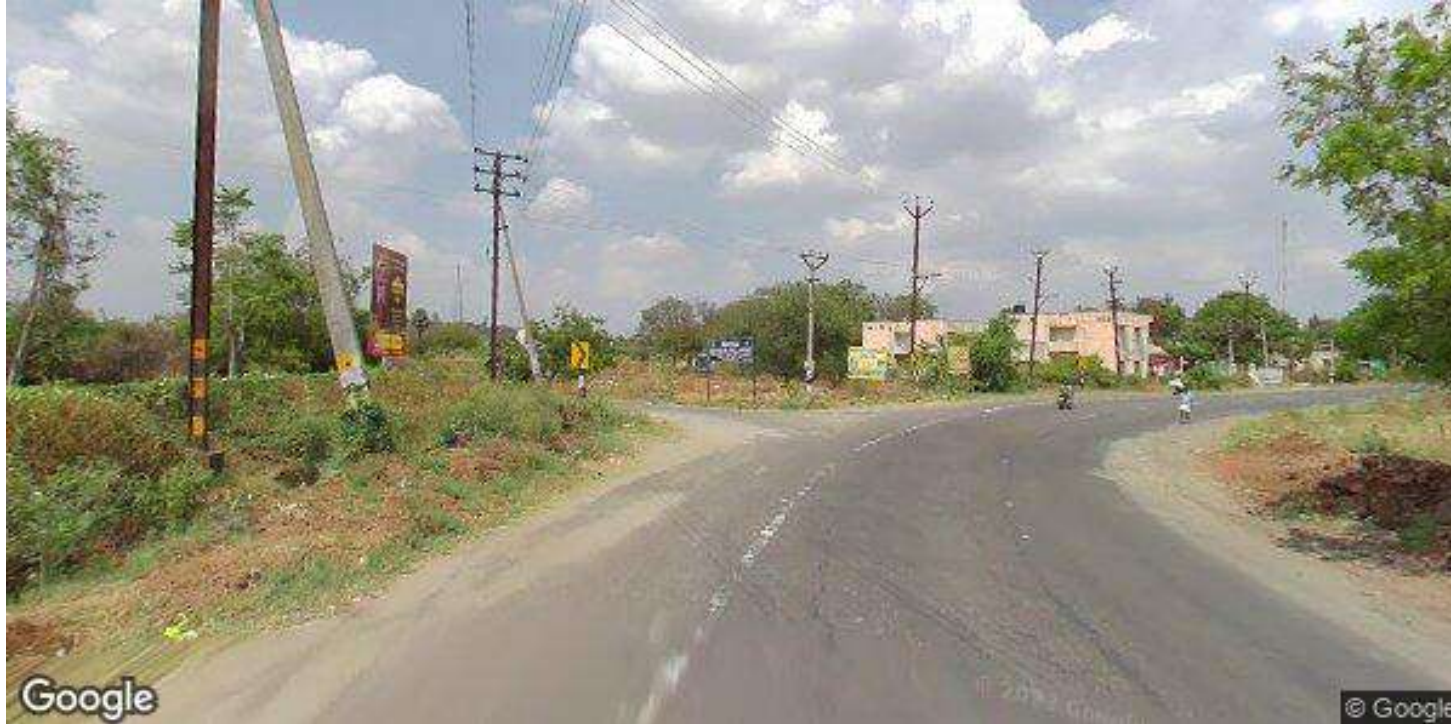
**Coordinates:** 11.16950, 77.44376

**Risk Type:** Turn

**Risk Level:** Medium

**Speed Limit:** 30 KM/Hr

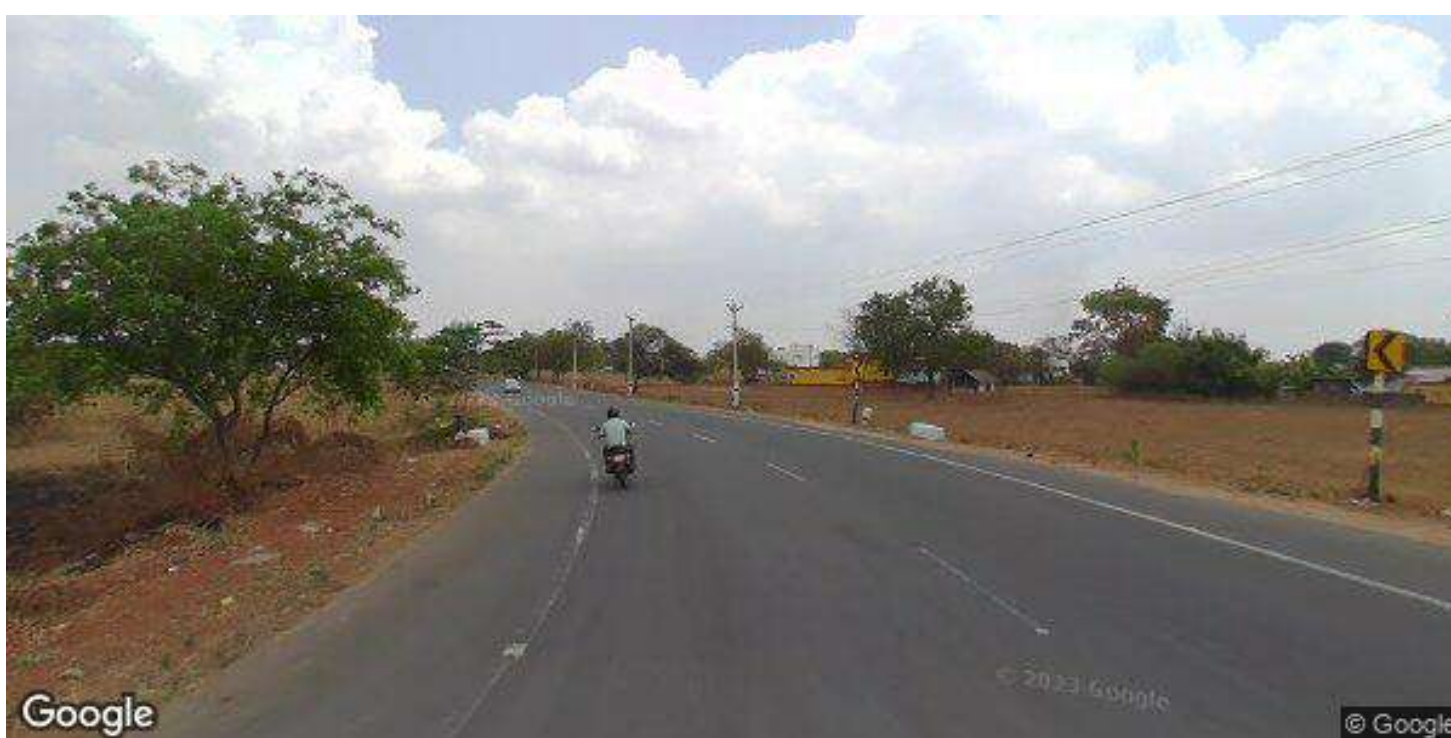
**Coordinates:** 11.16381, 77.43700

**Risk Type:** Turn

**Risk Level:** Medium

**Speed Limit:** 30 KM/Hr

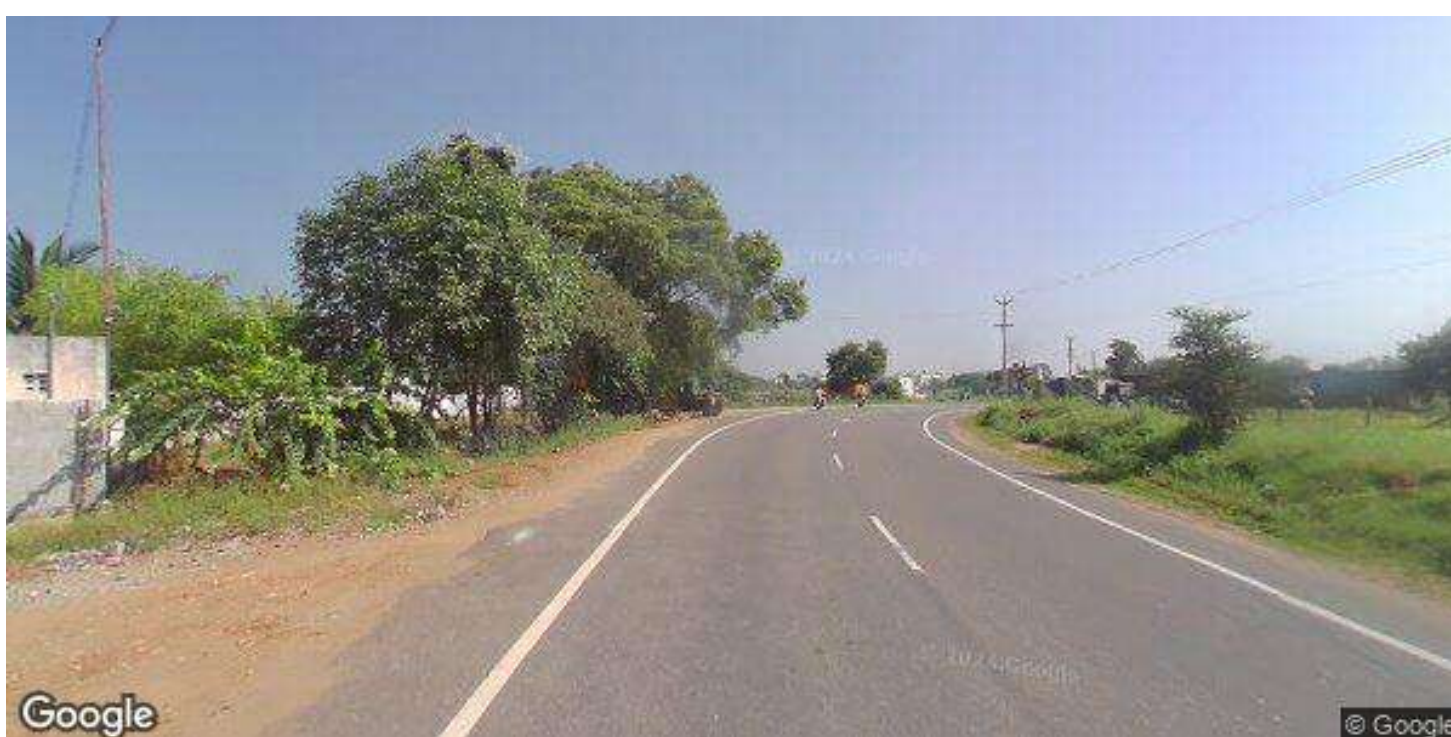
**Coordinates: 11.16259, 77.43103**

**Risk Type:** Turn

**Risk Level:** Medium

**Speed Limit: 30 KM/Hr**

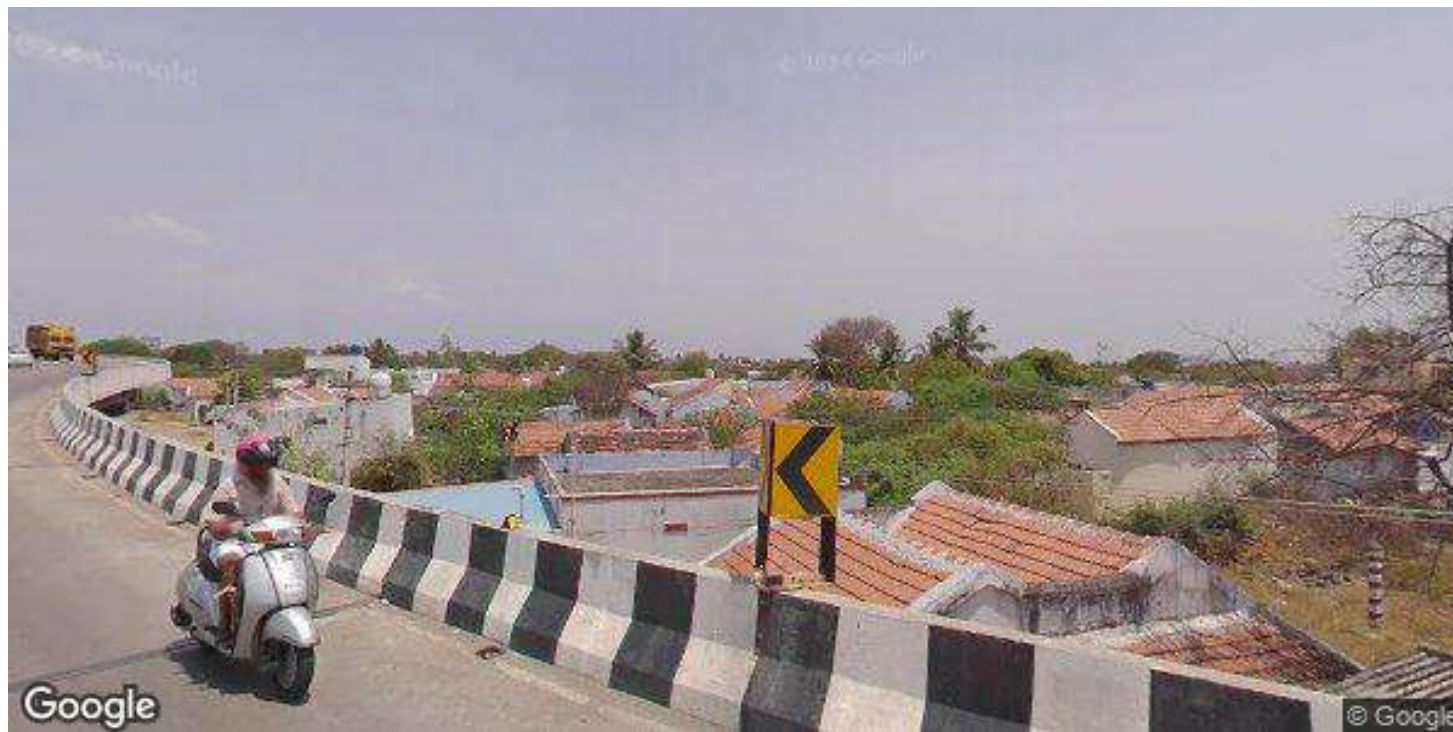
**Coordinates: 11.15161, 77.42320**

**Risk Type: Turn**

**Risk Level: Medium**

**Speed Limit: 30 KM/Hr**

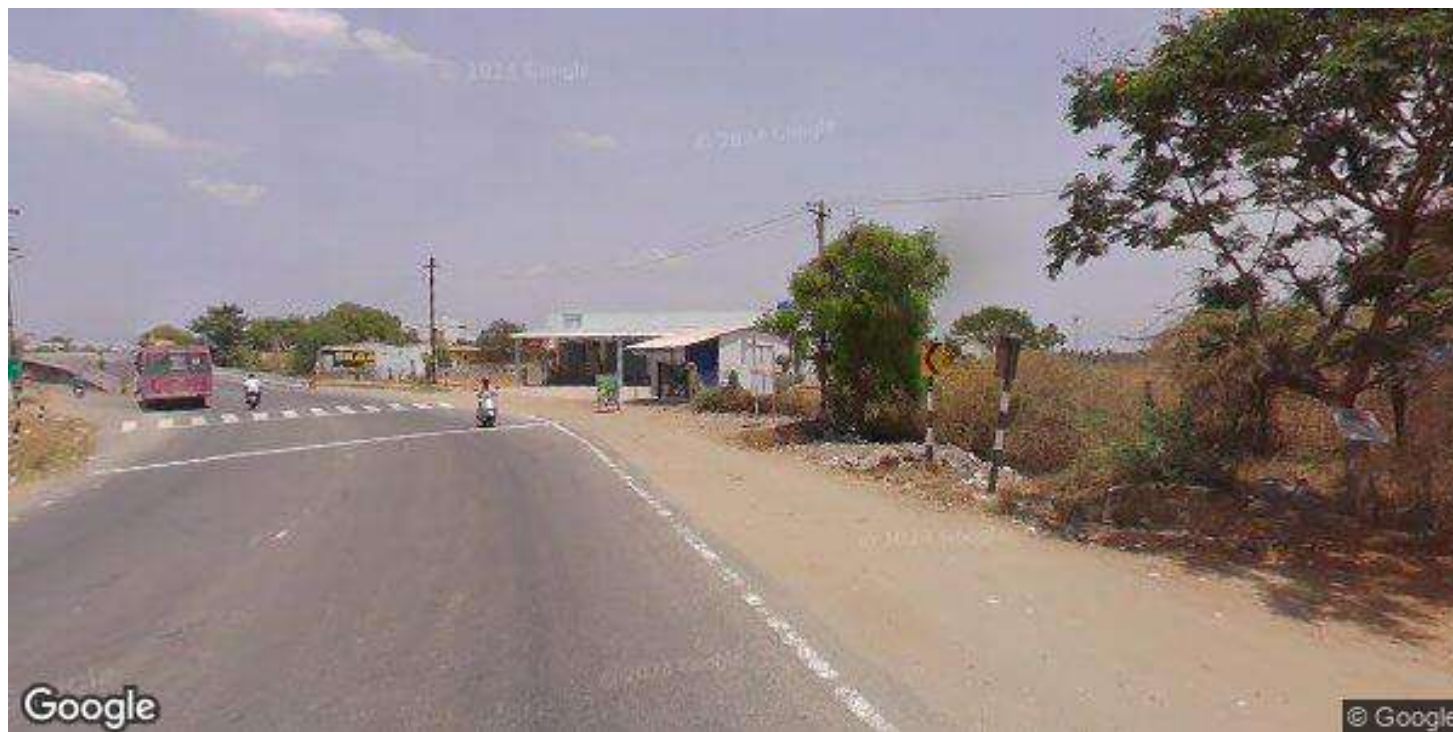
**Coordinates: 11.14985, 77.42215**

**Risk Type: Turn**

**Risk Level: Medium**

**Speed Limit: 30 KM/Hr**

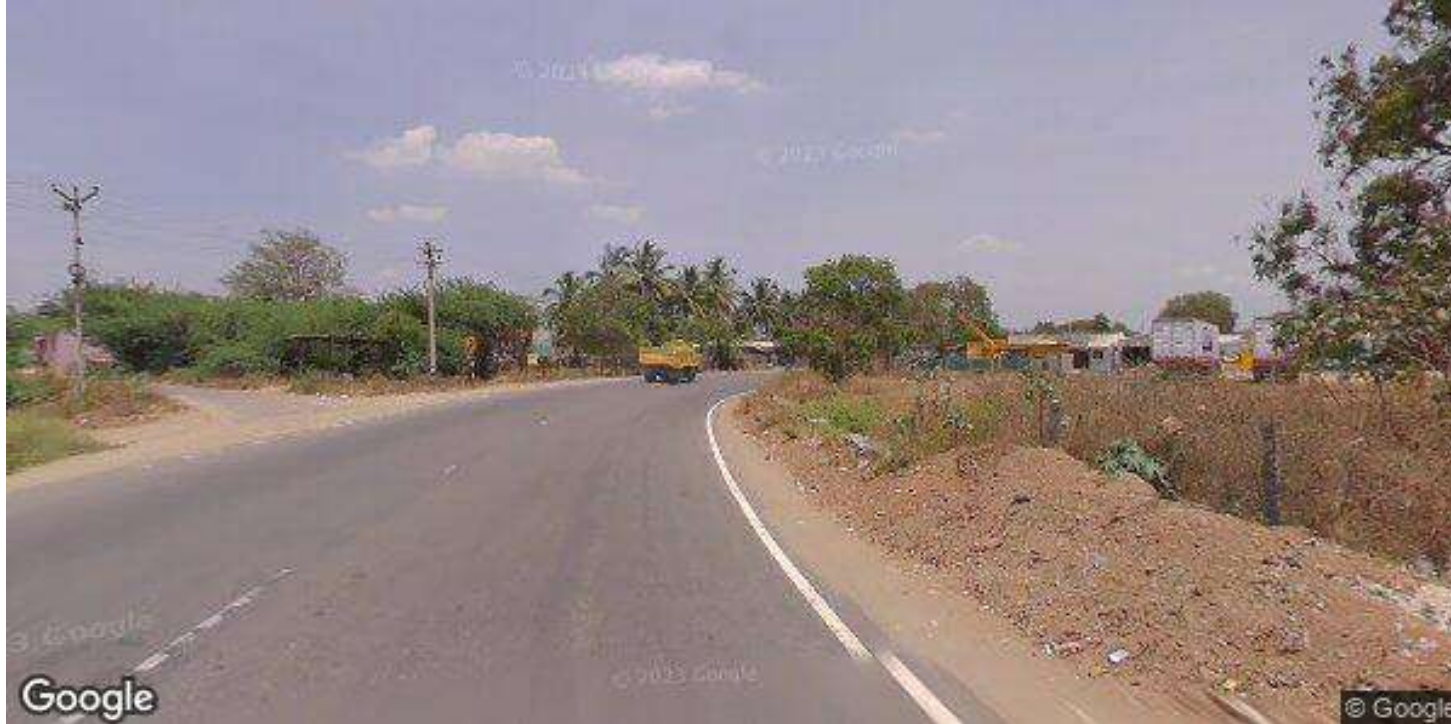
**Coordinates:** 11.14892, 77.42022

**Risk Type:** Turn

**Risk Level:** Medium

**Speed Limit:** 30 KM/Hr

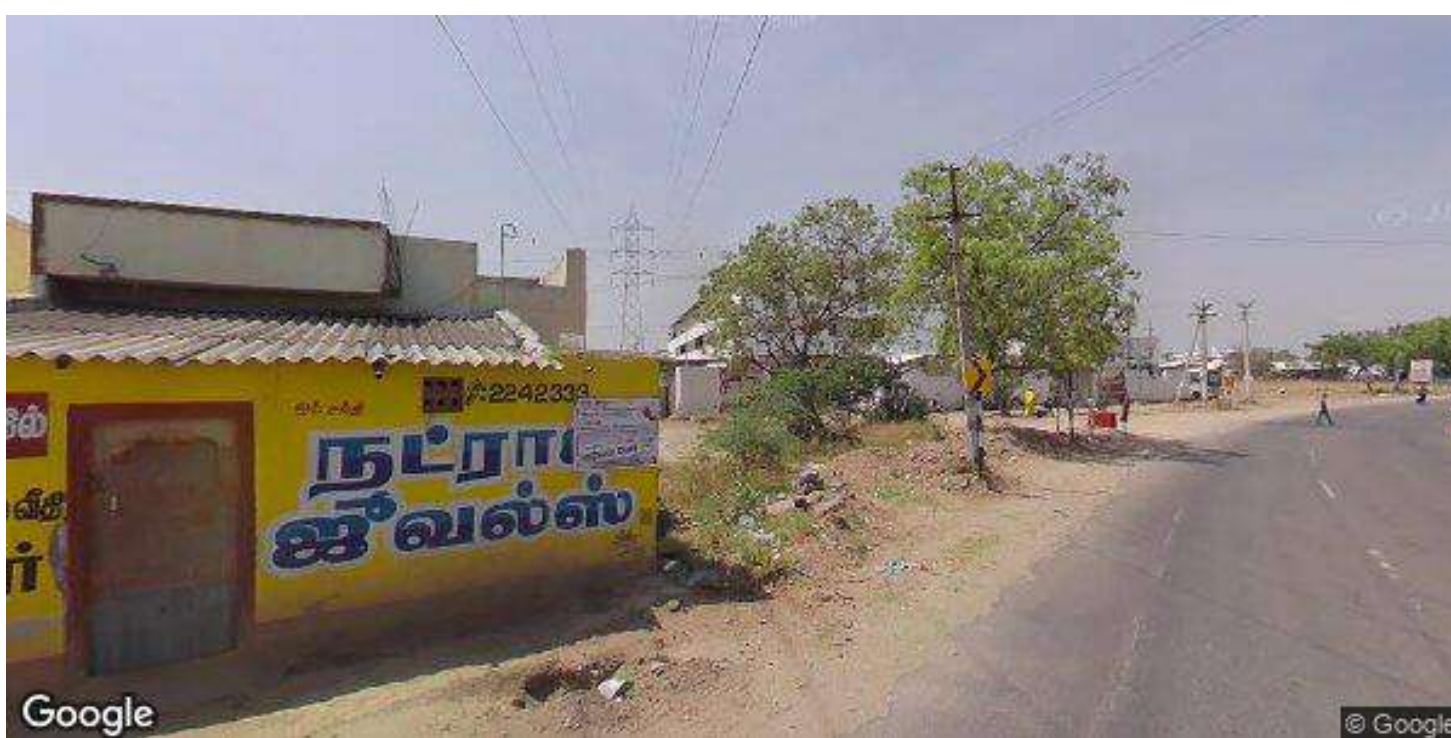
**Coordinates:** 11.13578, 77.41299

**Risk Type:** Turn

**Risk Level:** Medium

**Speed Limit:** 30 KM/Hr

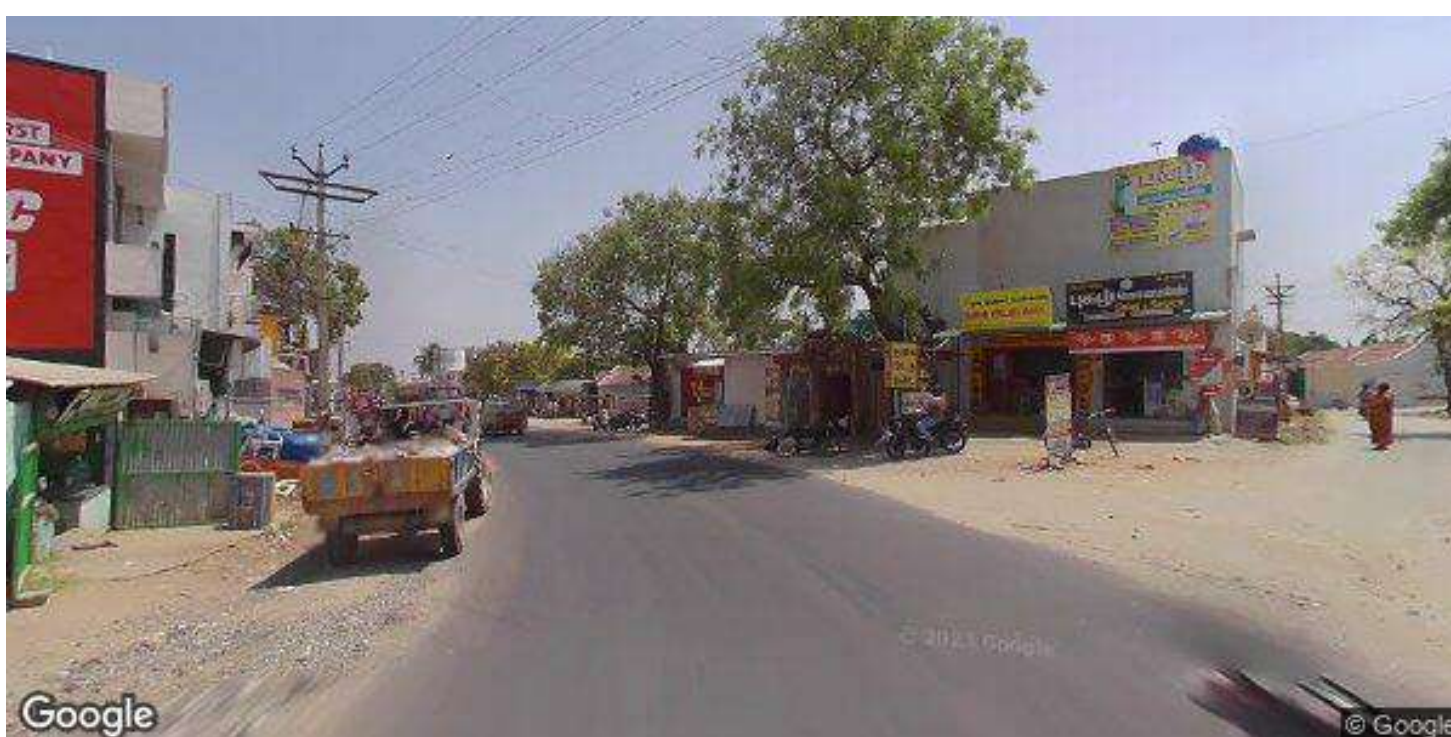
Coordinates: 11.13007, 77.40331

**Risk Type:** Turn

**Risk Level:** Medium

Speed Limit: 30 KM/Hr

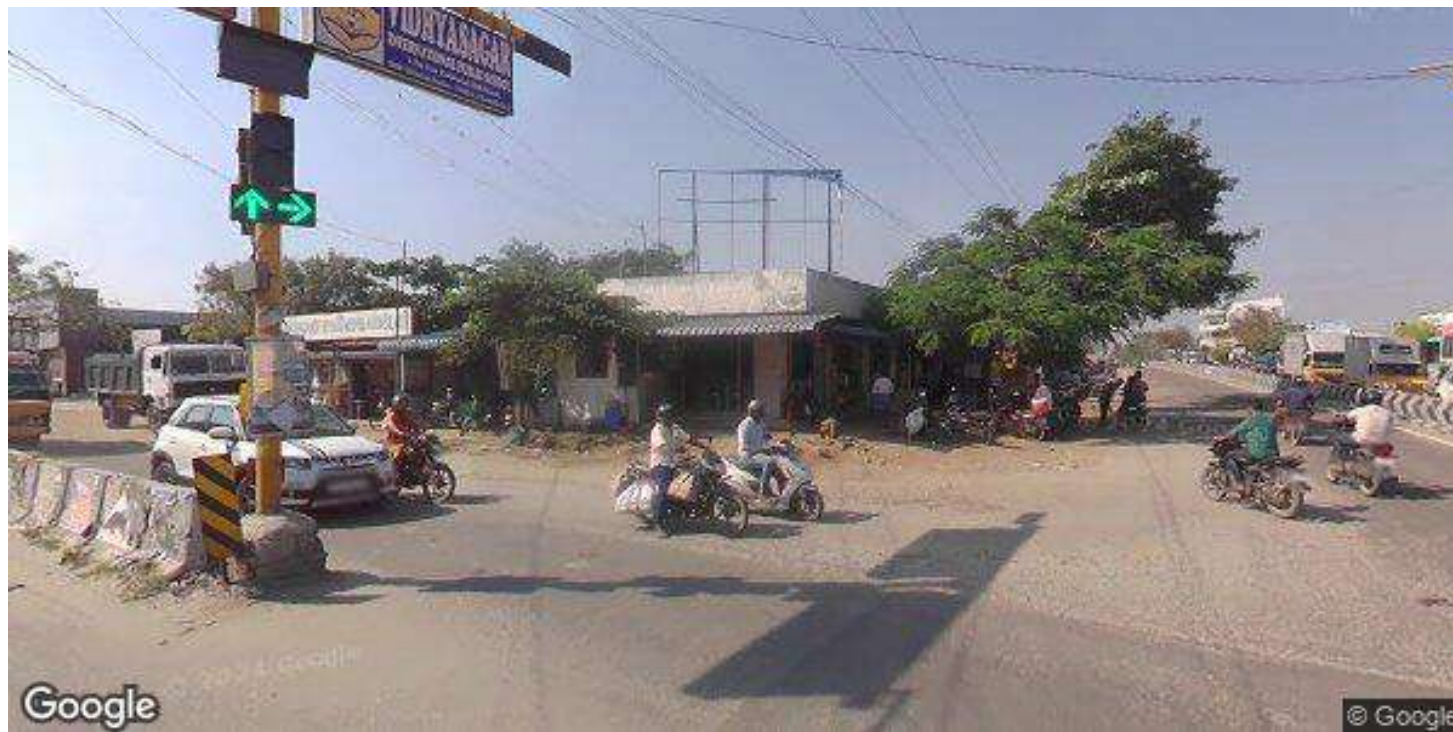
Coordinates: 11.12775, 77.39347

Risk Type: Turn

Risk Level: High

Speed Limit: 15 KM/Hr

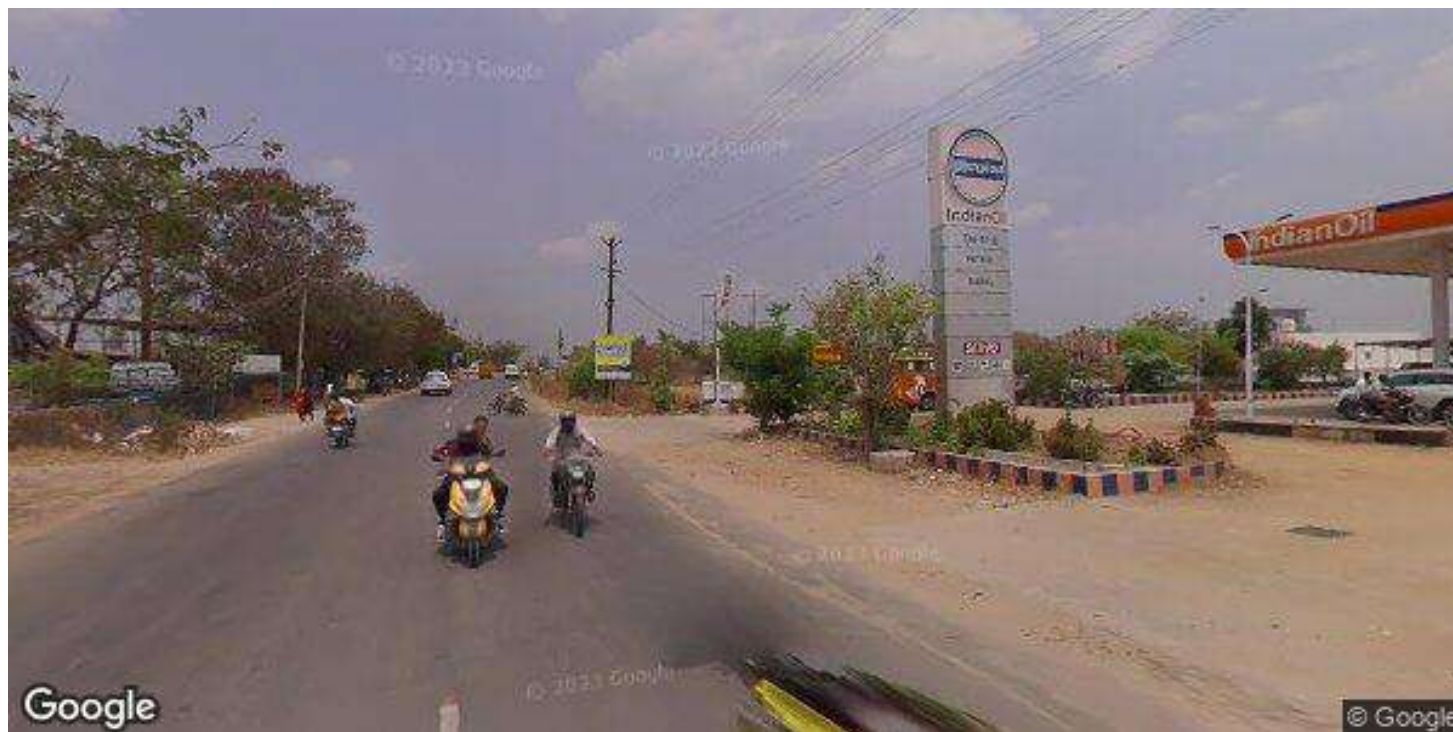
Coordinates: 11.12333, 77.39381

Risk Type: Blind Spot

Risk Level: Blind Spot

Speed Limit: 10 KM/Hr
