# IndianOil

## JOURNEY RISK MANAGEMENT (JRM) STUDY

### Salem Terminal TO SURYA FUEL AGENCIES

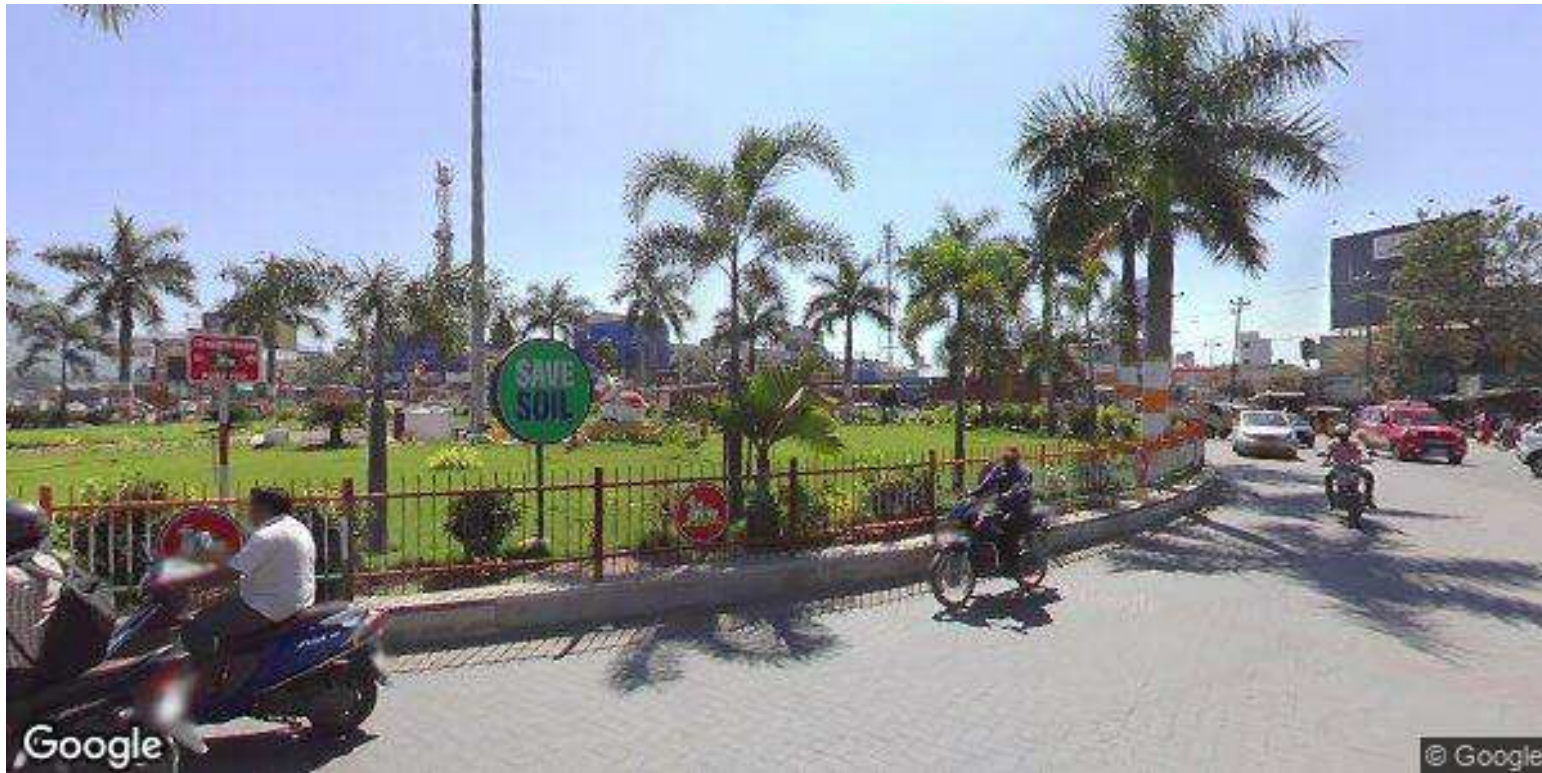
**Coordinates:** 11.63303, 78.12713

**Risk Type:** Roundabout

**Risk Level:** High

**Speed Limit:** 15 KM/Hr

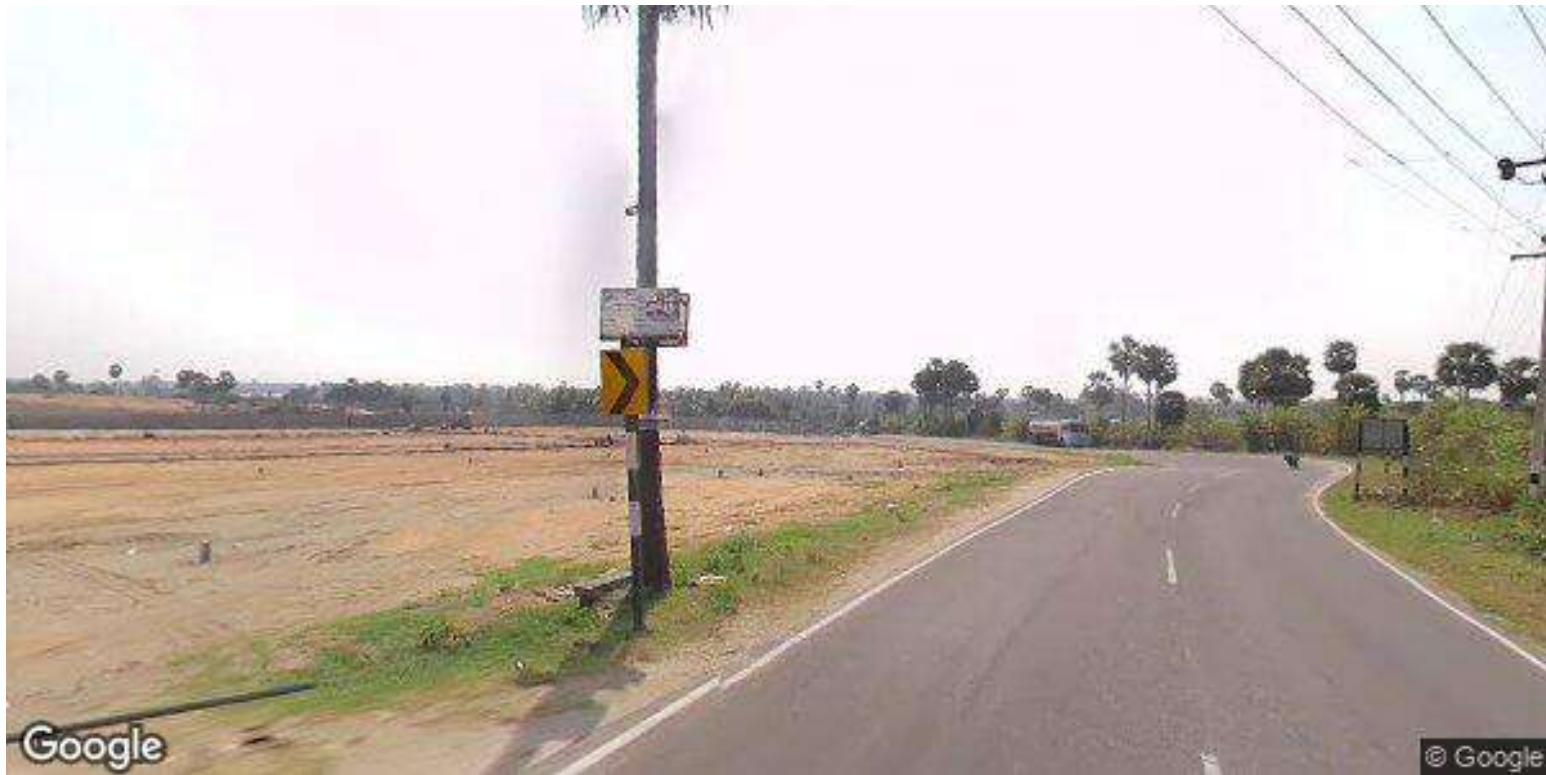
**Coordinates:** 11.45898, 77.85135

**Risk Type:** Turn

**Risk Level:** Medium

**Speed Limit:** 30 KM/Hr

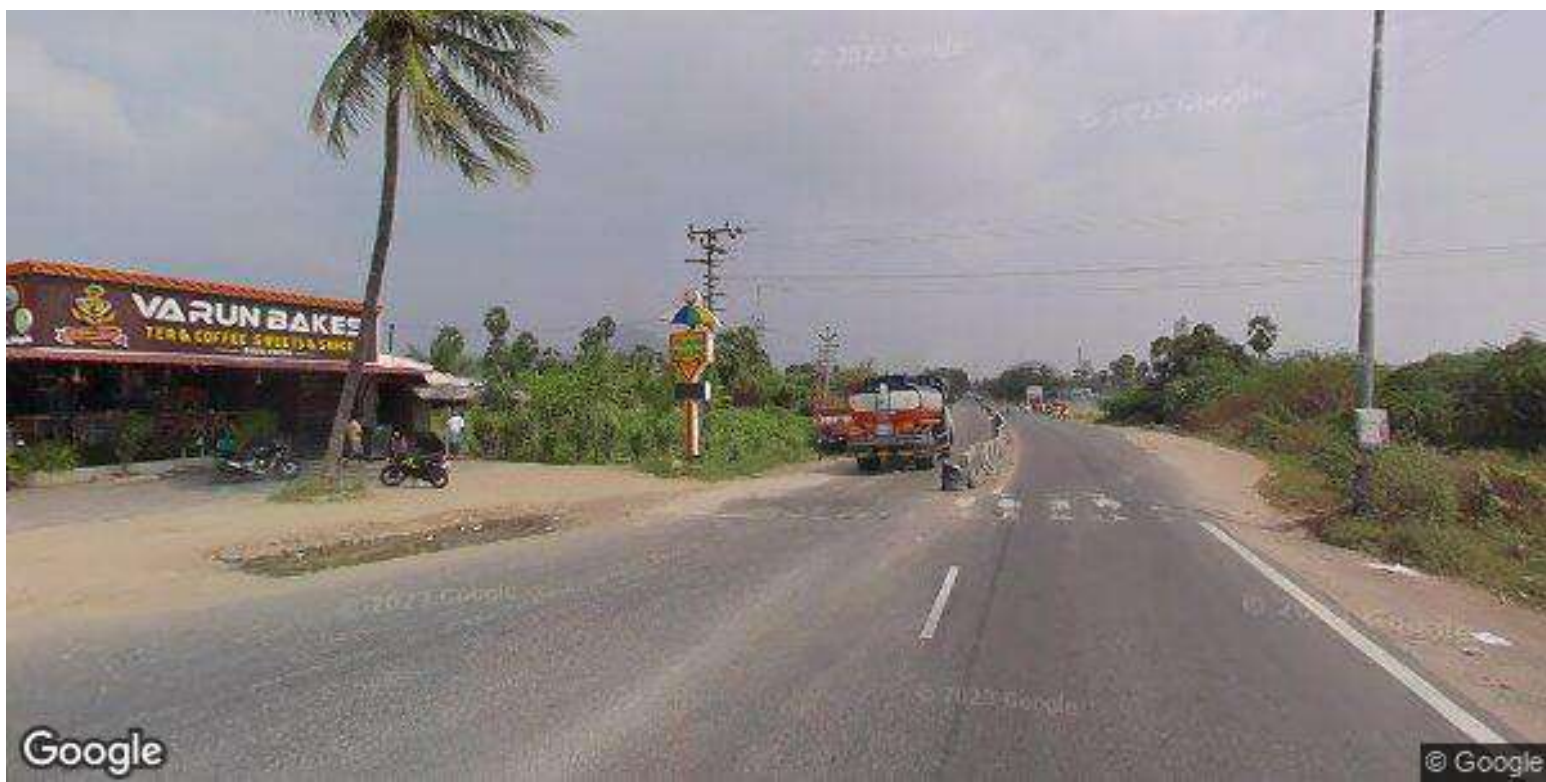
**Coordinates:** 11.45543, 77.81740

**Risk Type:** Turn

**Risk Level:** Medium

**Speed Limit:** 30 KM/Hr

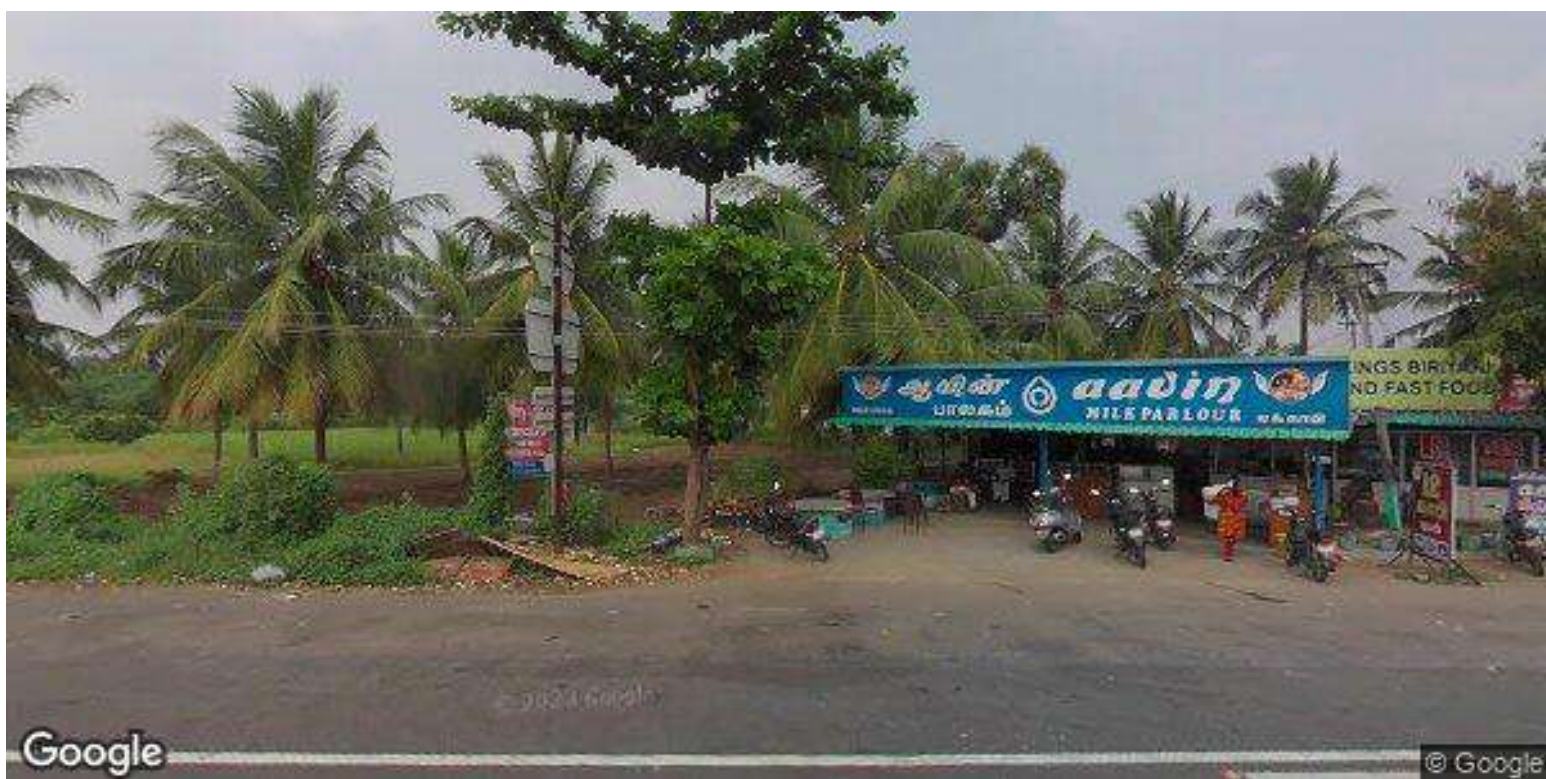
**Coordinates:** 11.45631, 77.81668

**Risk Type:** Turn

**Risk Level:** High

**Speed Limit:** 15 KM/Hr

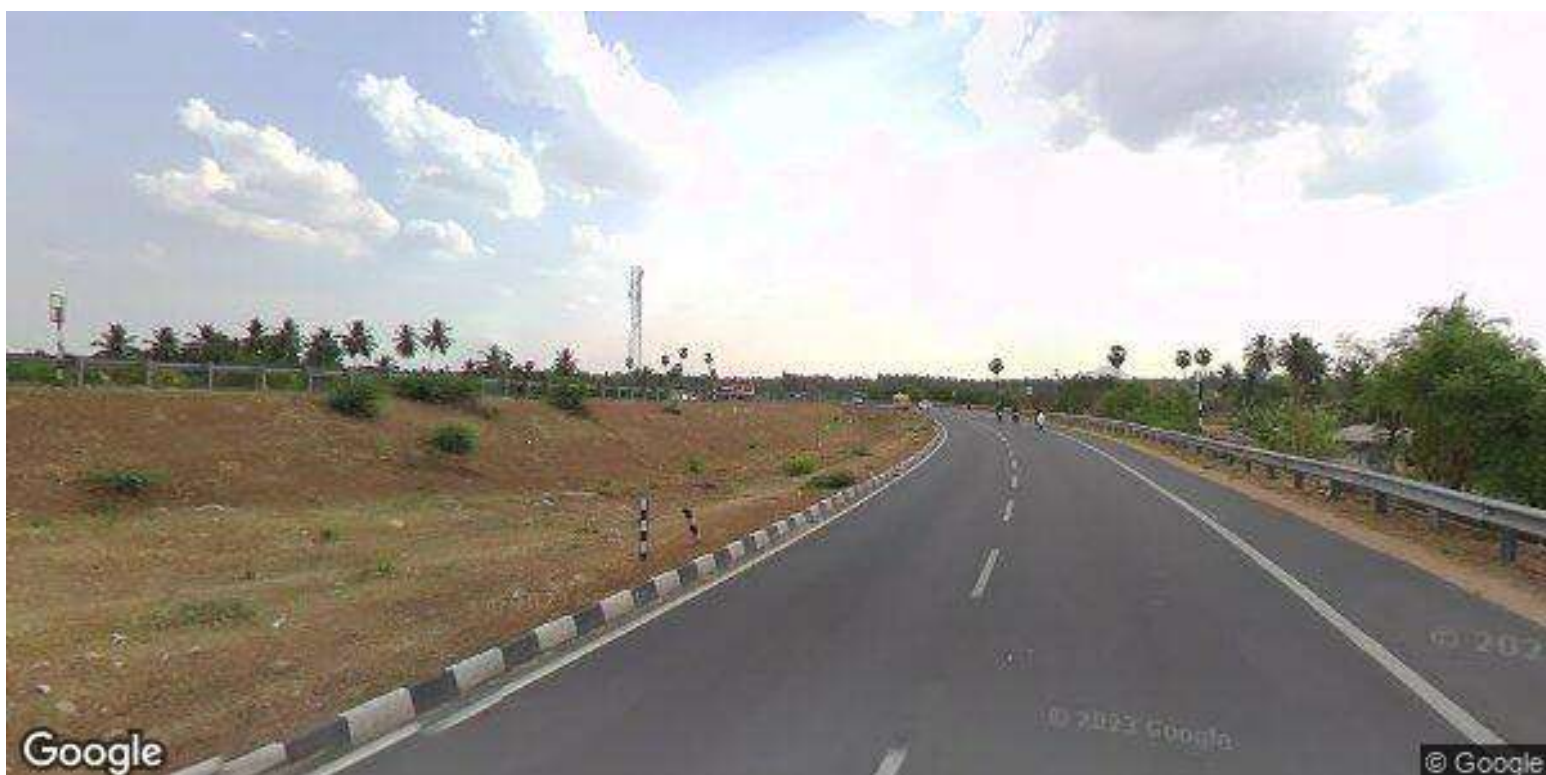
**Risk Type:** Turn  
**Risk Level:** Medium  
**Speed Limit:** 30 KM/Hr  
**Coordinates:** 11.53569, 77.95787

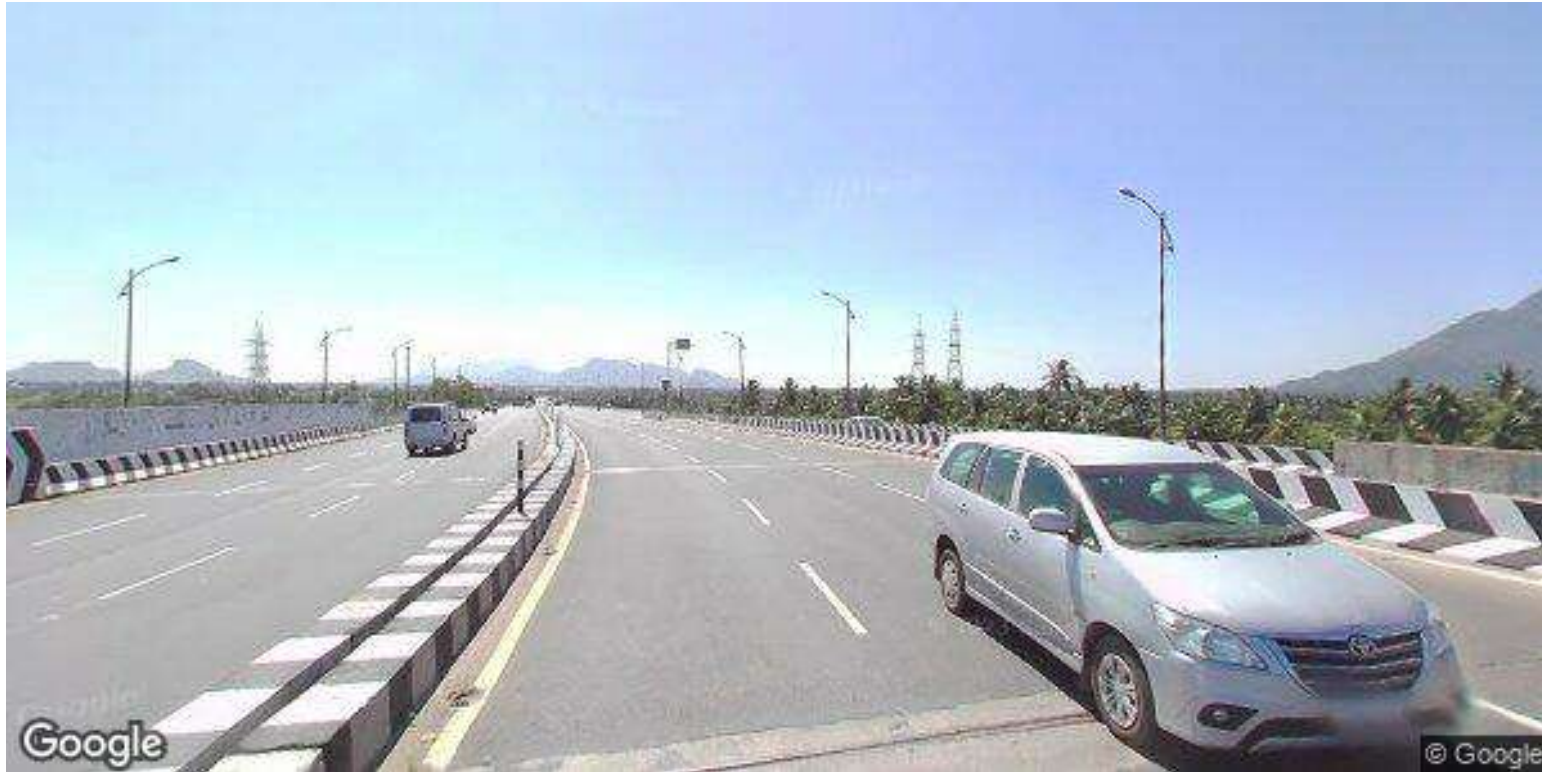
**Risk Type:** Turn  
**Risk Level:** Medium  
**Speed Limit:** 30 KM/Hr  
**Coordinates:** 11.64120, 78.11797

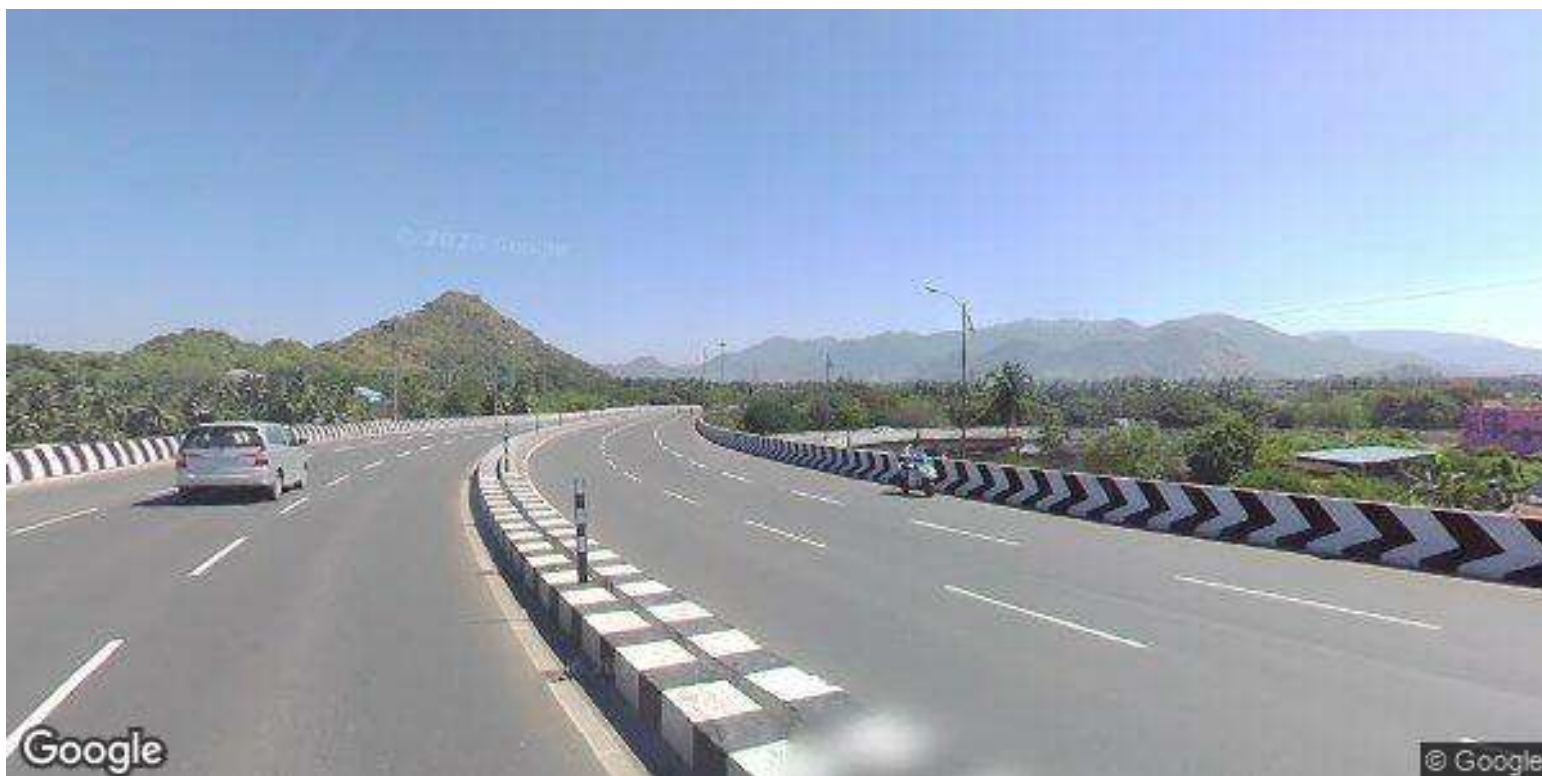
**Risk Type:** Turn  
**Risk Level:** High  
**Speed Limit:** 15 KM/Hr  
**Coordinates:** 11.64216, 78.11875

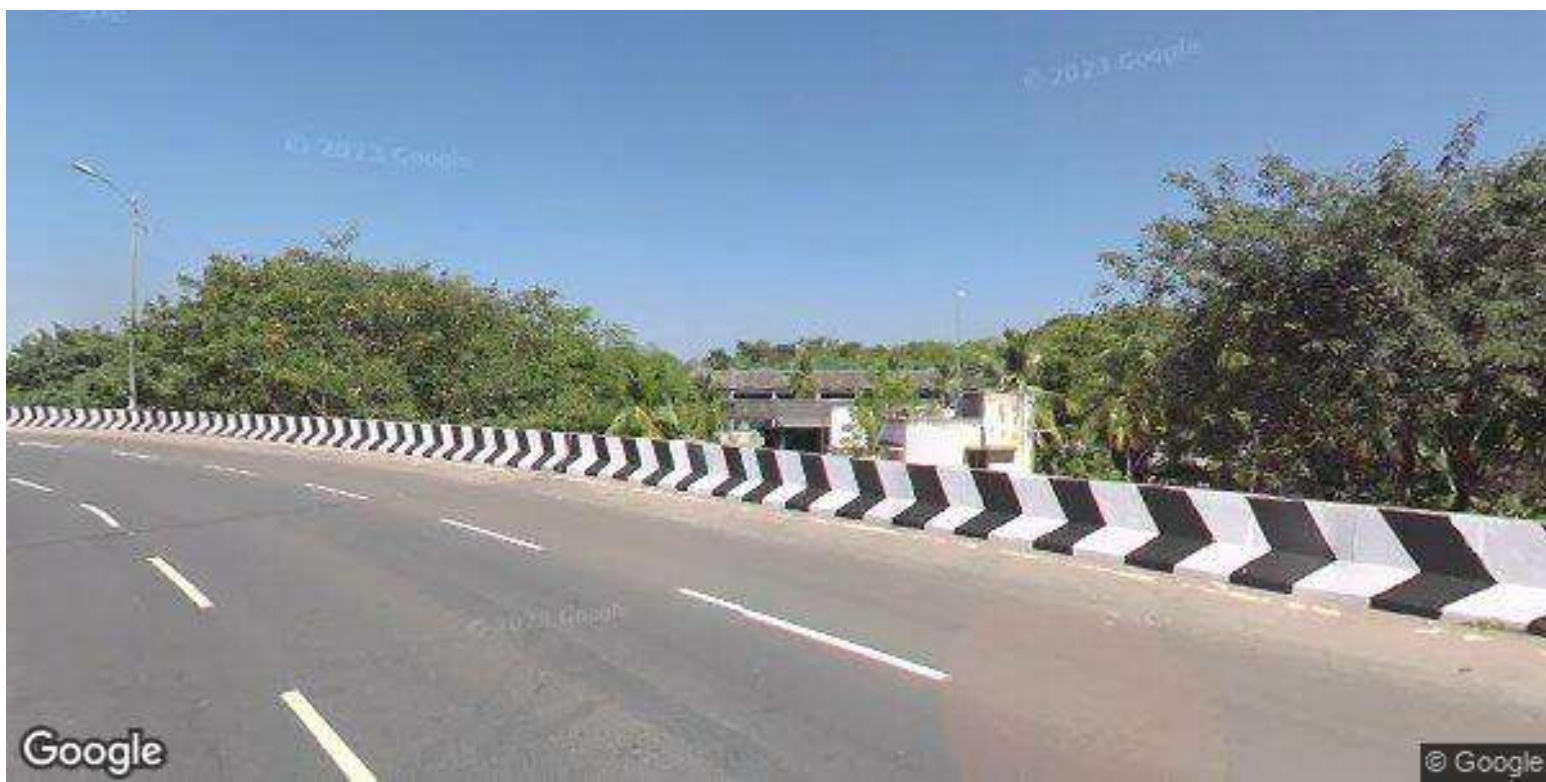
**Coordinates:** 11.64162, 78.12160

**Risk Type:** Turn

**Risk Level:** High

**Speed Limit:** 15 KM/Hr

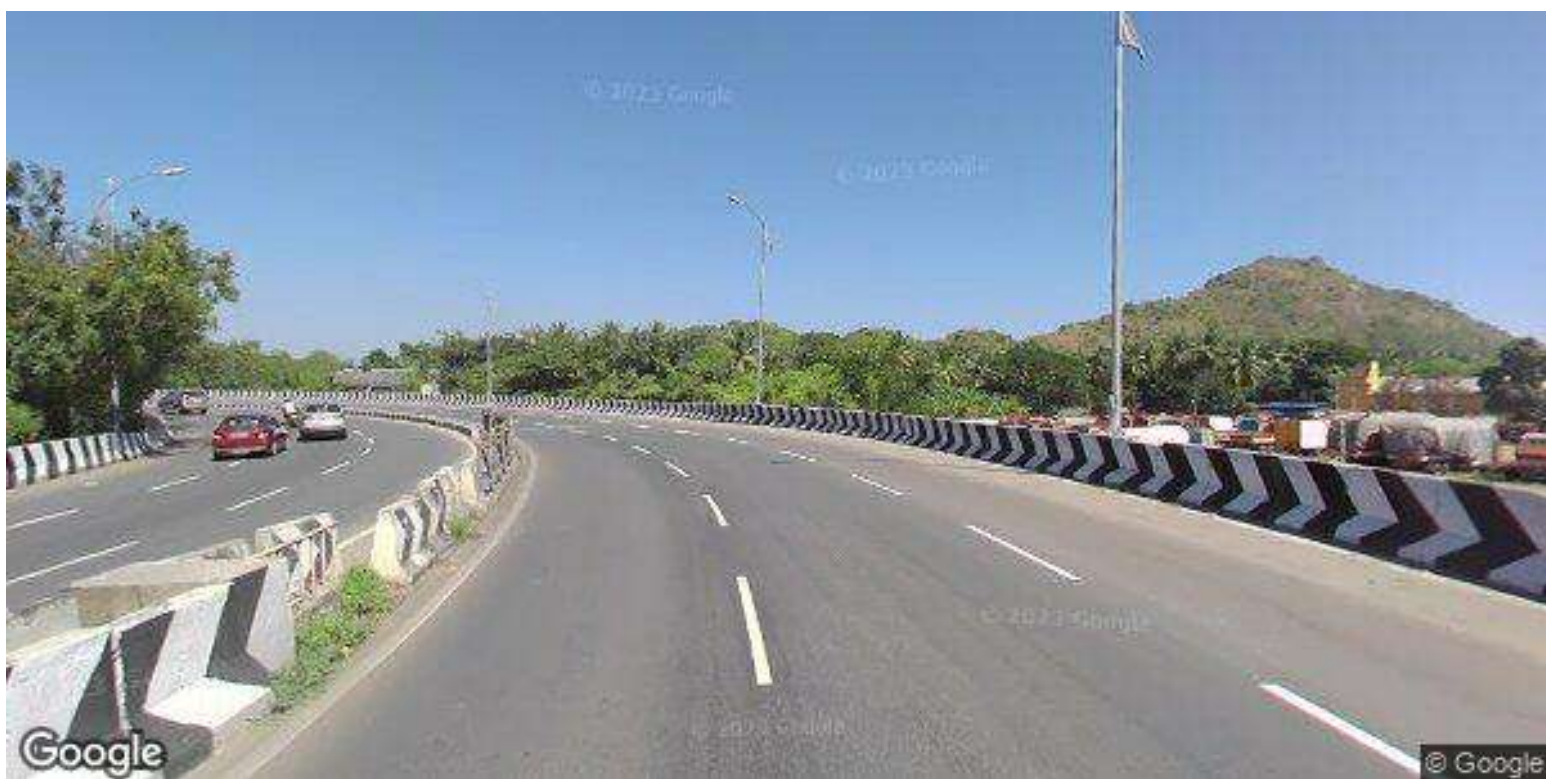
**Coordinates:** 11.64087, 78.12157

**Risk Type:** Turn

**Risk Level:** Medium

**Speed Limit:** 30 KM/Hr

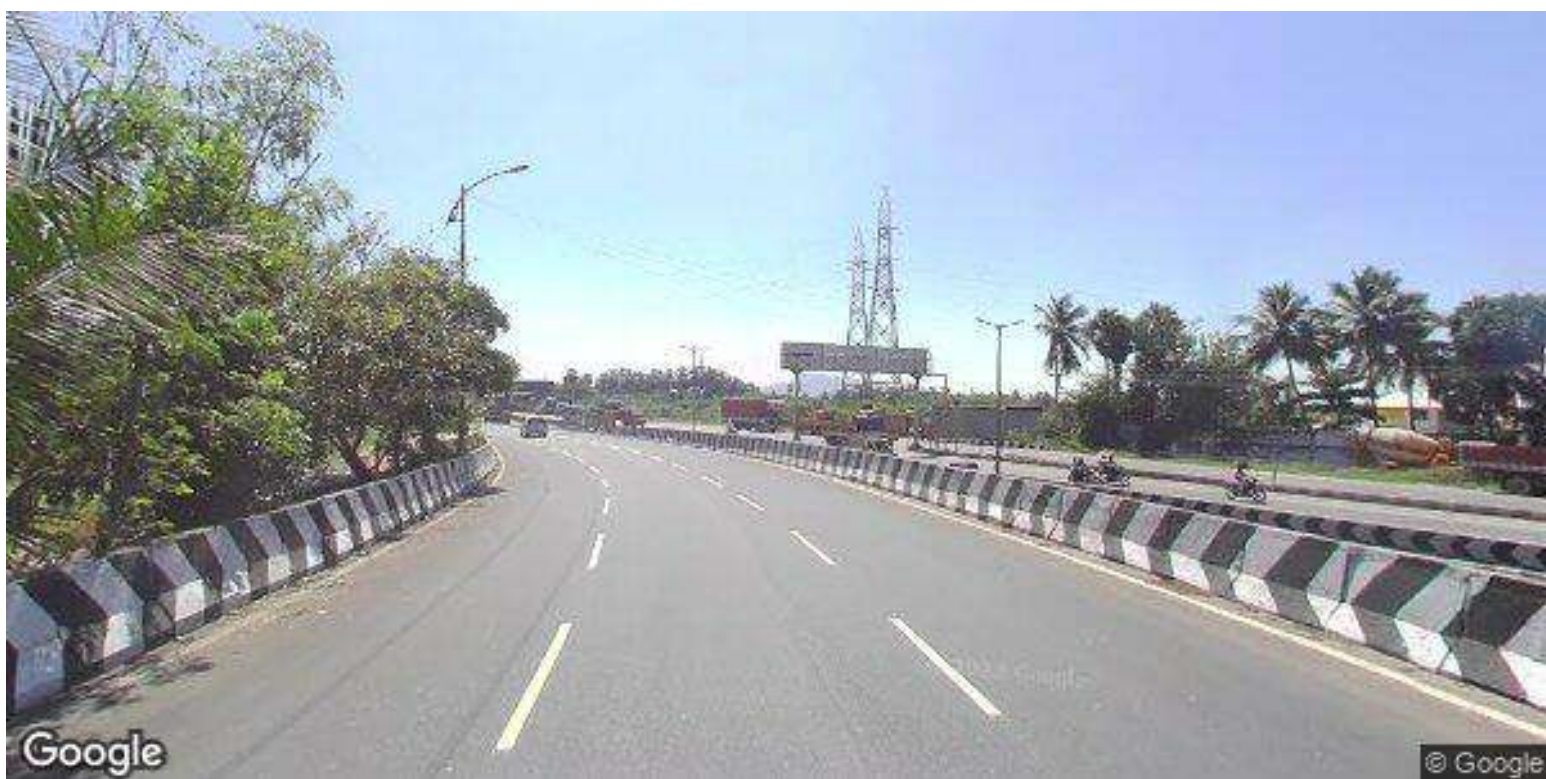
**Risk Type:** Turn  
**Risk Level:** High  
**Speed Limit:** 15 KM/Hr  
**Coordinates:** 11.63948, 78.12081

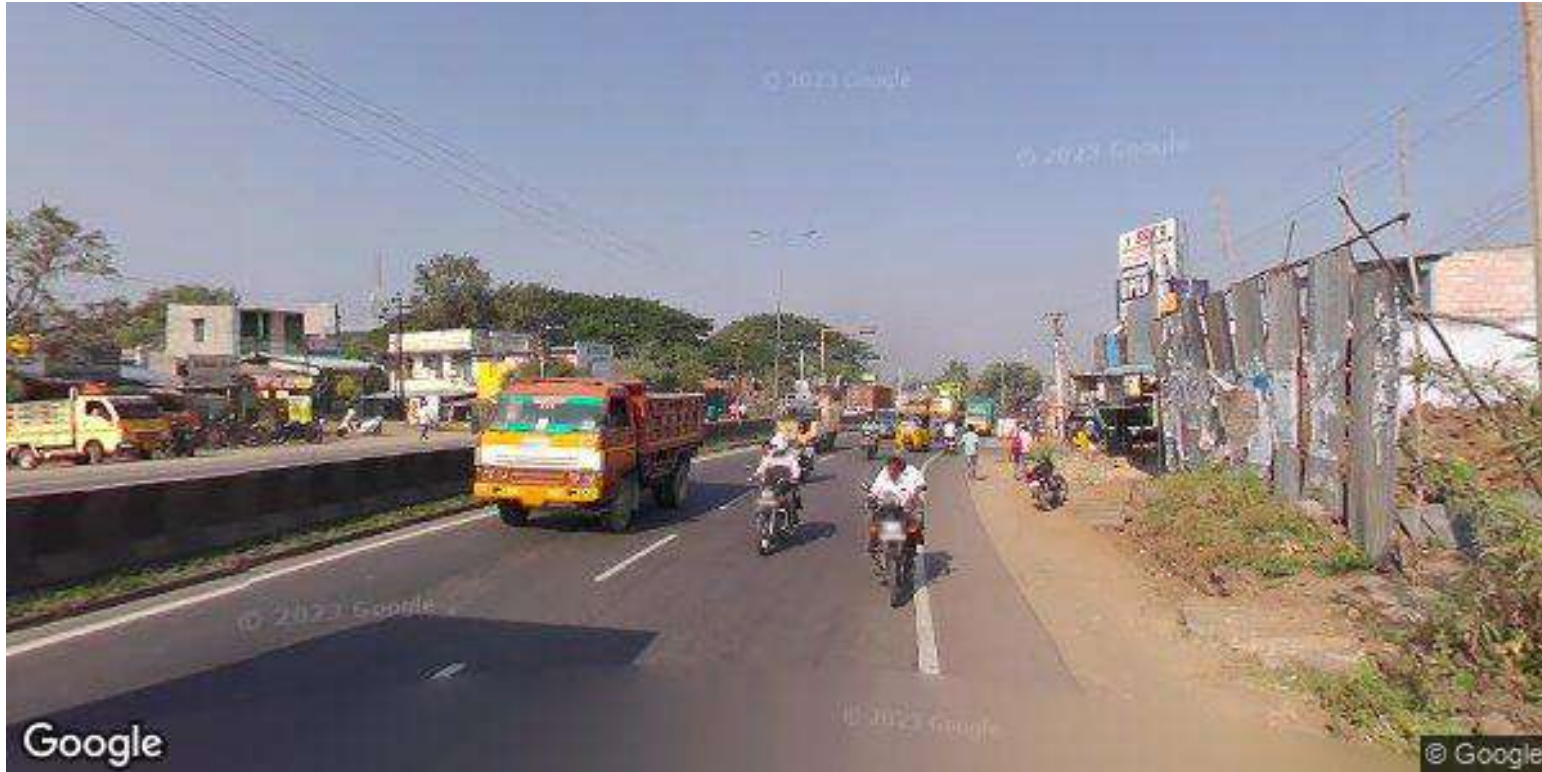
**Risk Type:** Turn  
**Risk Level:** Medium  
**Speed Limit:** 30 KM/Hr  
**Coordinates:** 11.62821, 78.13348

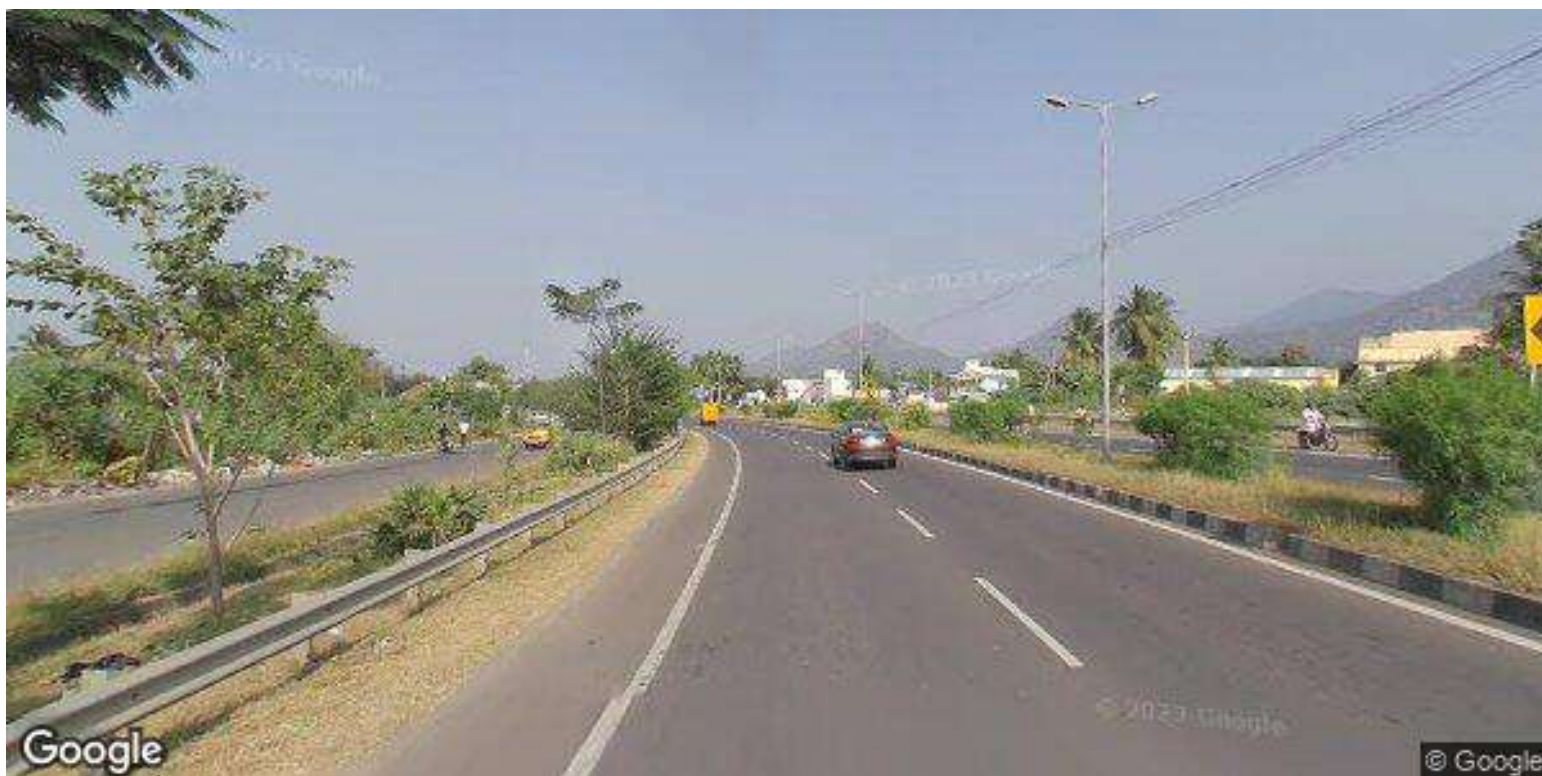
**Risk Type:** Turn  
**Risk Level:** Medium  
**Speed Limit:** 30 KM/Hr  
**Coordinates:** 11.62836, 78.16483

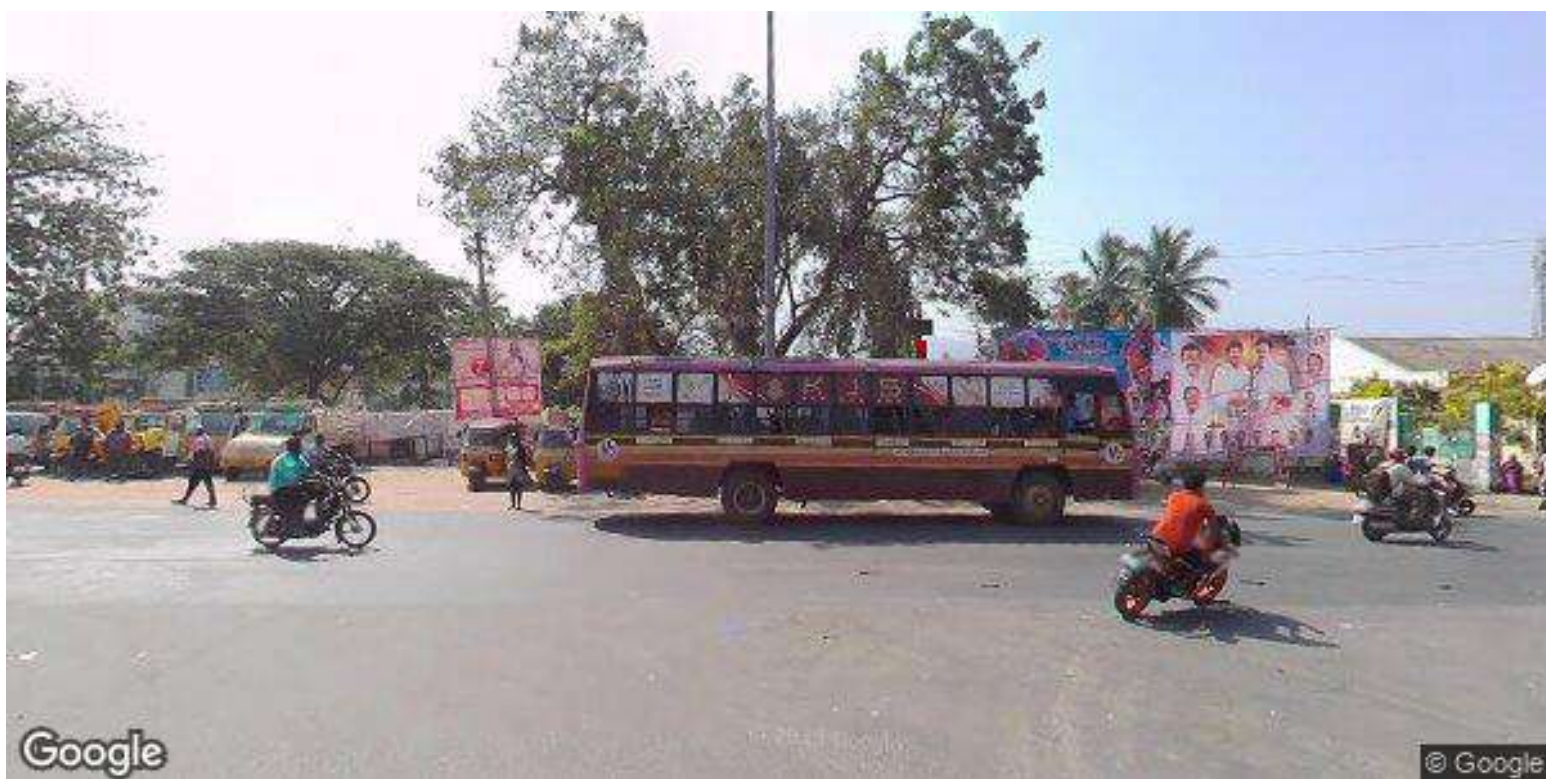
**Coordinates:** 11.67120, 78.23136

**Risk Type:** Turn

**Risk Level:** High

**Speed Limit:** 15 KM/Hr

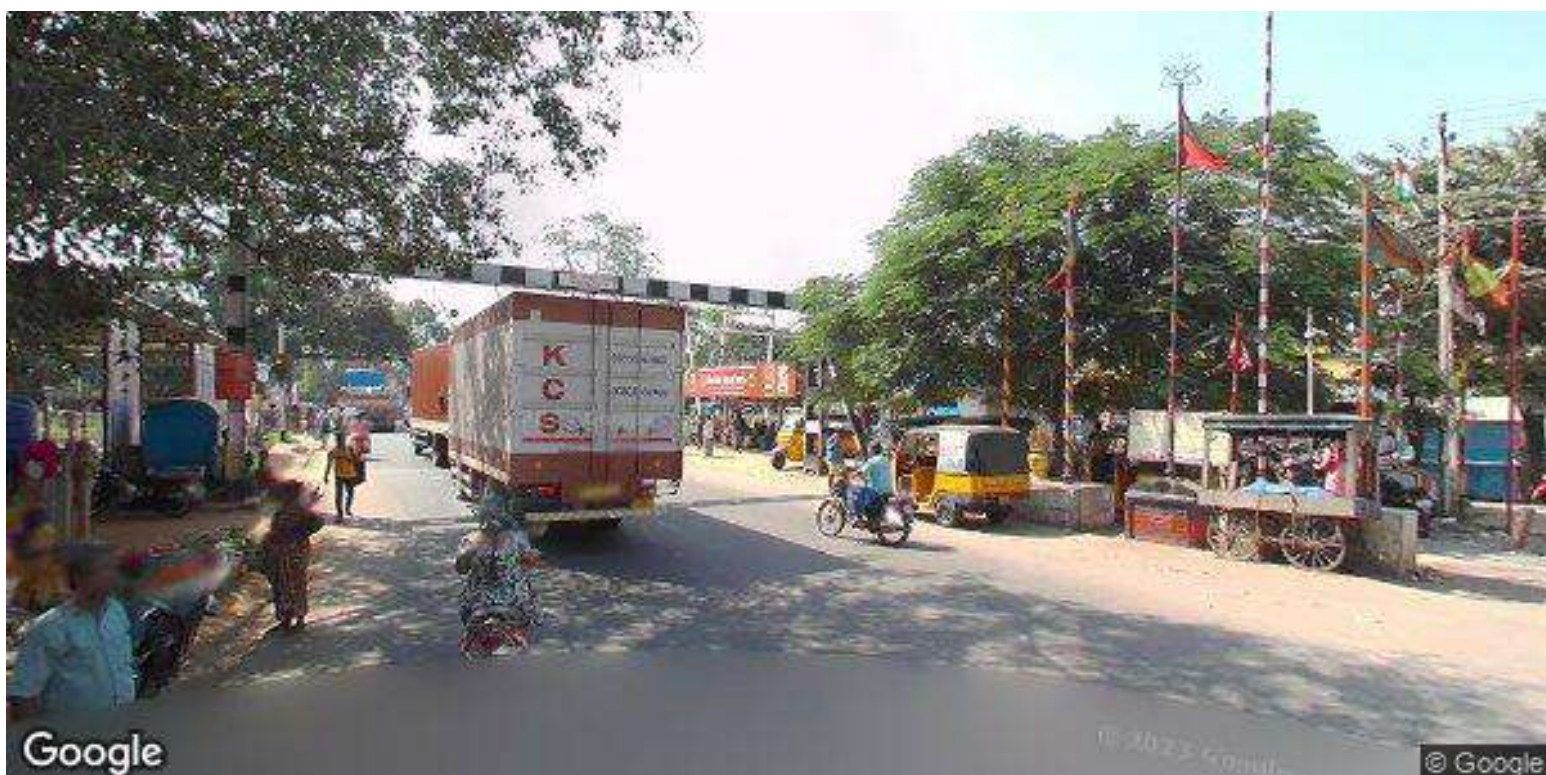
**Risk Type:** Turn  
**Risk Level:** High  
**Speed Limit:** 15 KM/Hr  
**Coordinates:** 11.67190, 78.23144

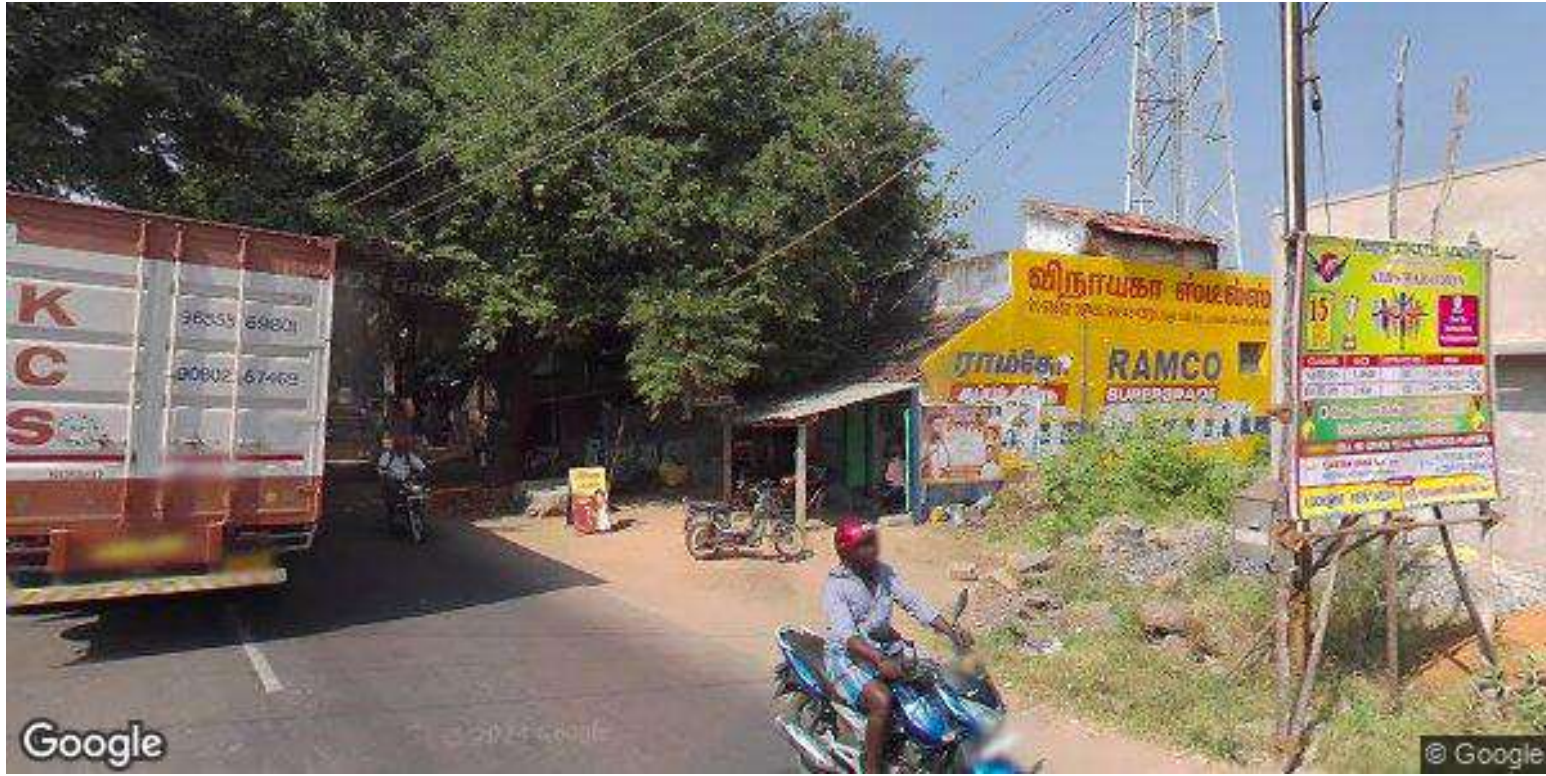
**Risk Type:** Turn  
**Risk Level:** Medium  
**Speed Limit:** 30 KM/Hr  
**Coordinates:** 11.67429, 78.23896

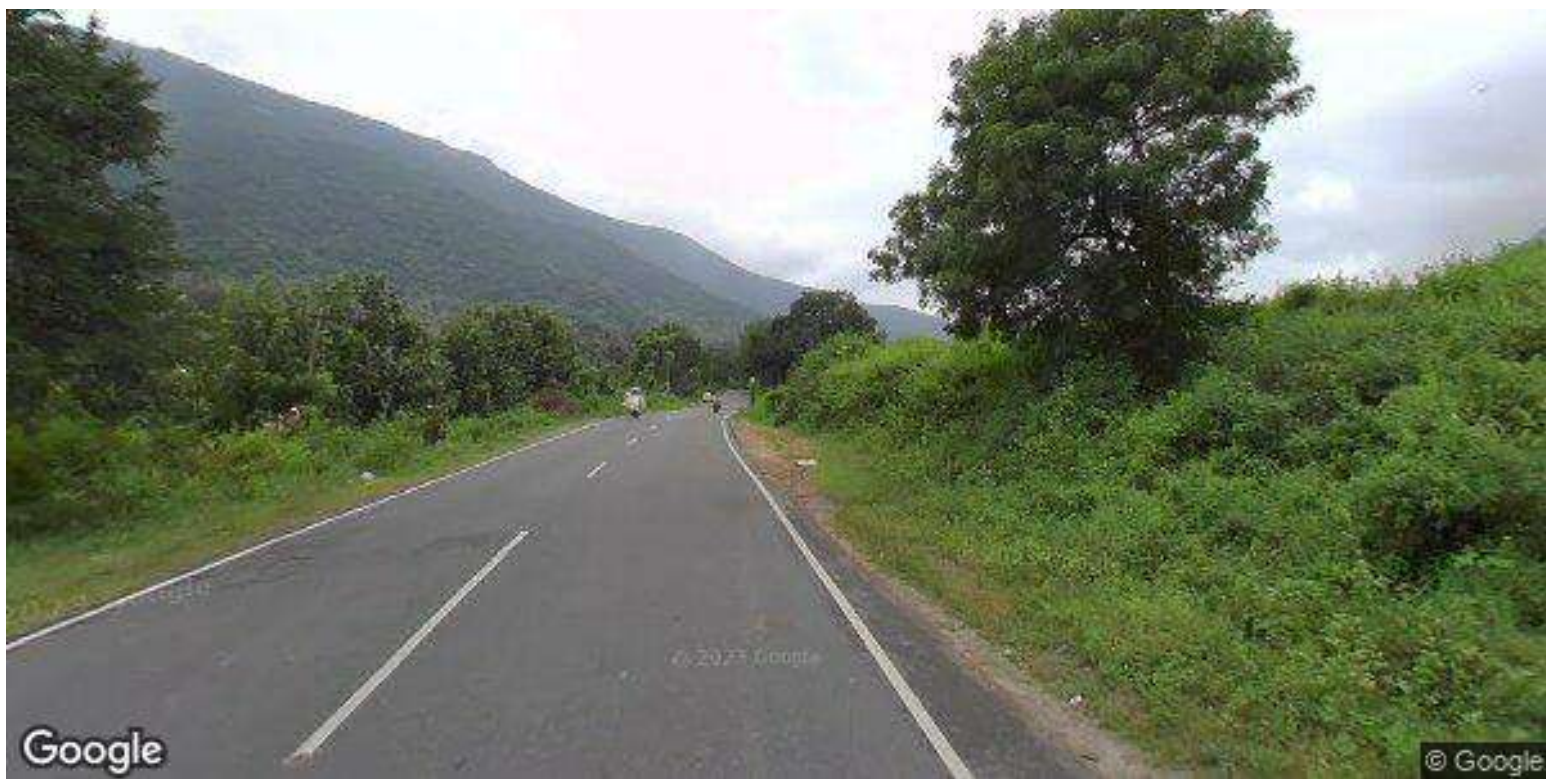
**Risk Type:** Turn  
**Risk Level:** Medium  
**Speed Limit:** 30 KM/Hr  
**Coordinates:** 11.80416, 78.33319

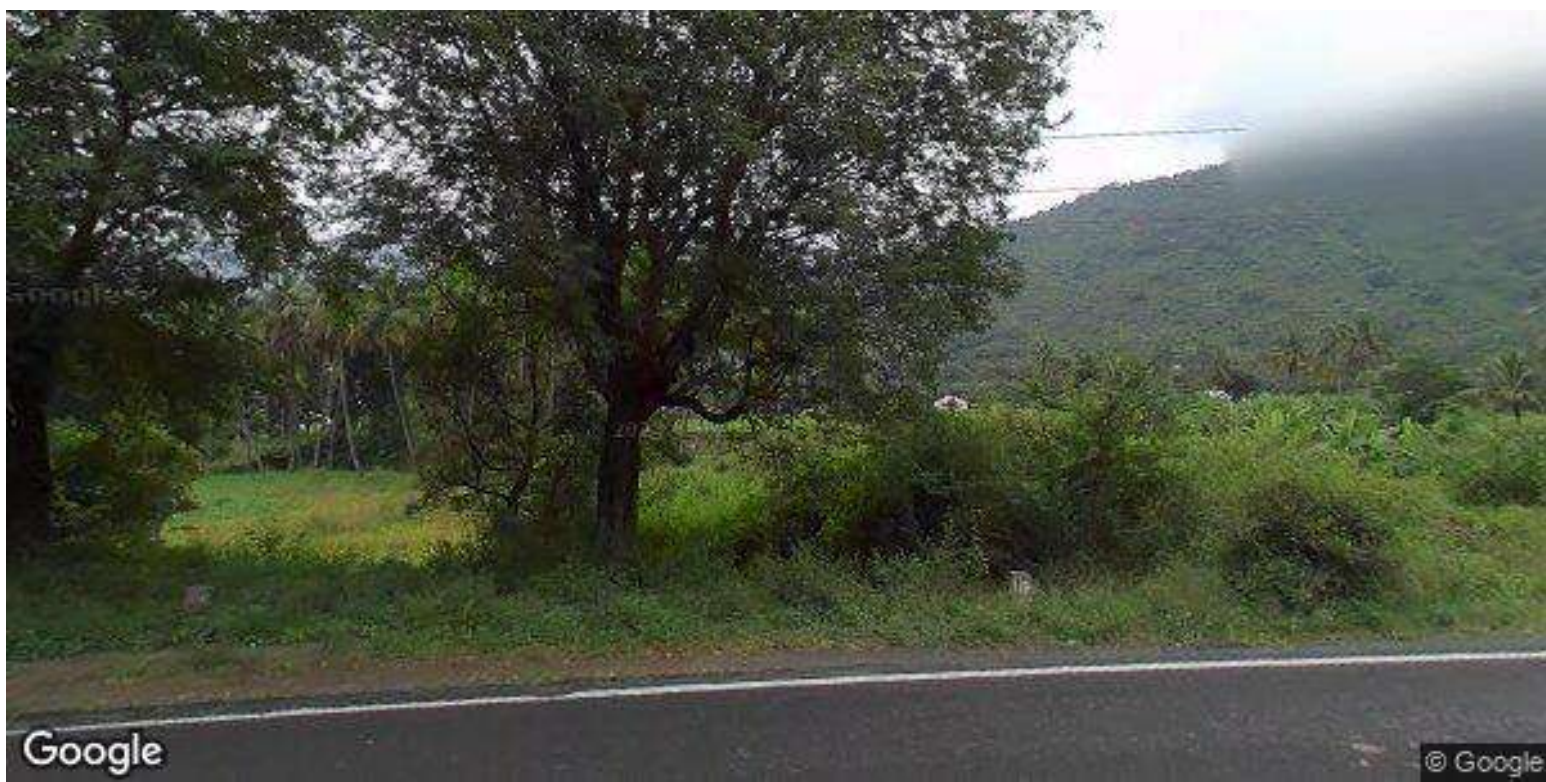
**Coordinates:** 11.81219, 78.34077

**Risk Type:** Turn

**Risk Level:** Medium

**Speed Limit:** 30 KM/Hr

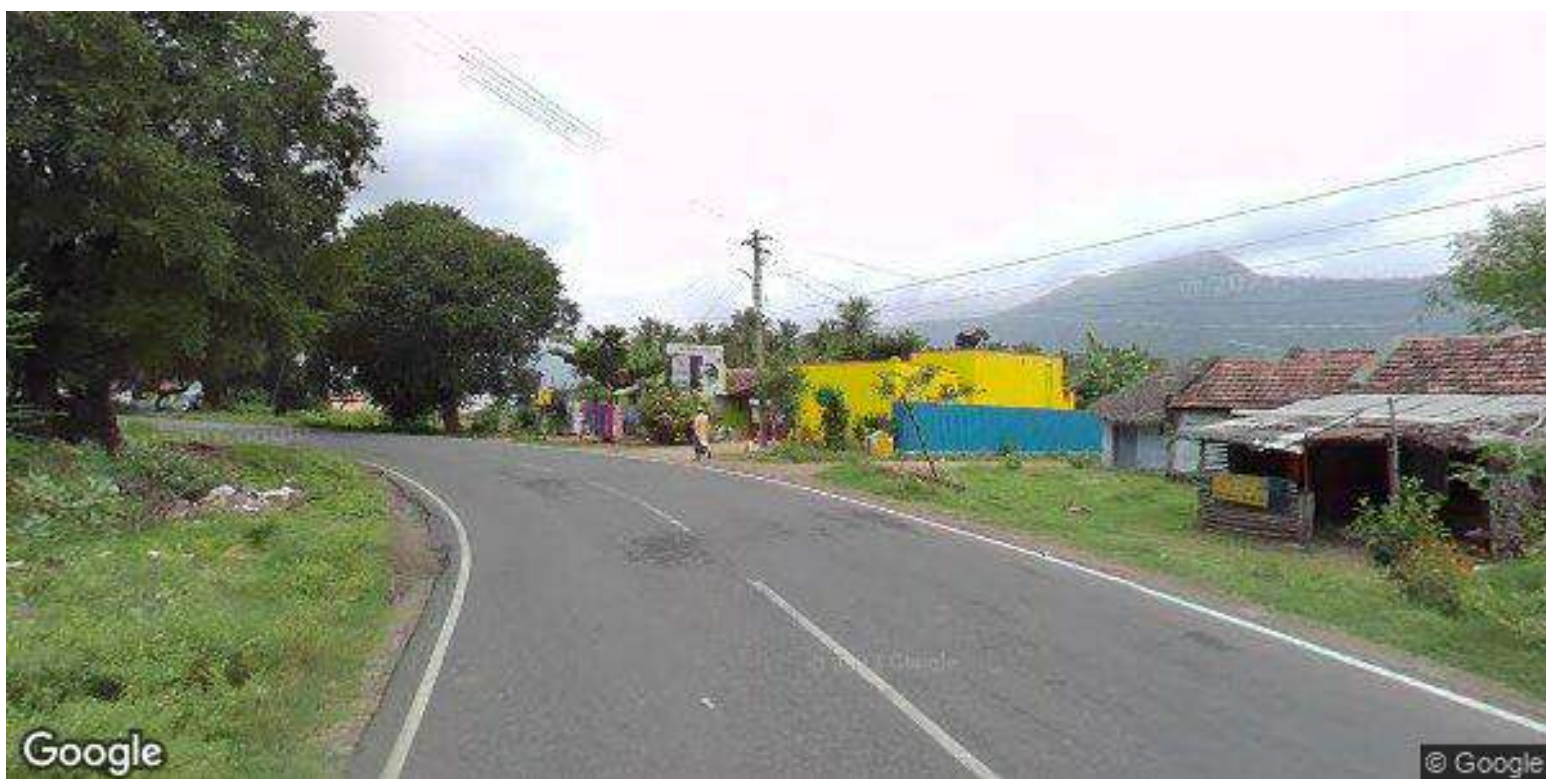
**Coordinates:** 11.83472, 78.35285

**Risk Type:** Turn

**Risk Level:** Medium

**Speed Limit:** 30 KM/Hr

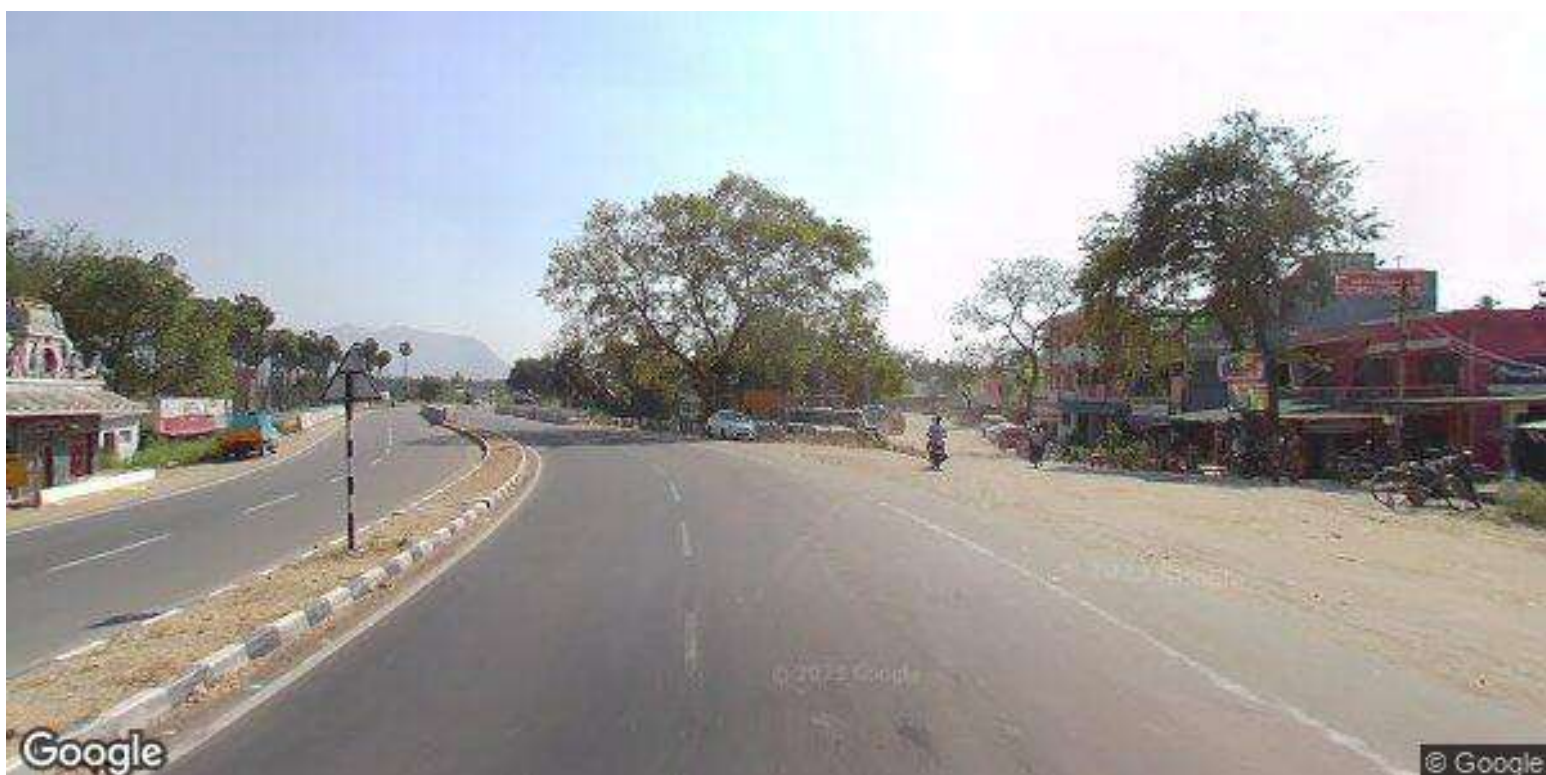
**Risk Type:** Turn  
**Risk Level:** Medium  
**Speed Limit:** 30 KM/Hr  
**Coordinates:** 11.99572, 78.44559
