# IndianOil

## JOURNEY RISK MANAGEMENT (JRM) STUDY

### Salem Terminal TO SURYA FUEL AGENCIES

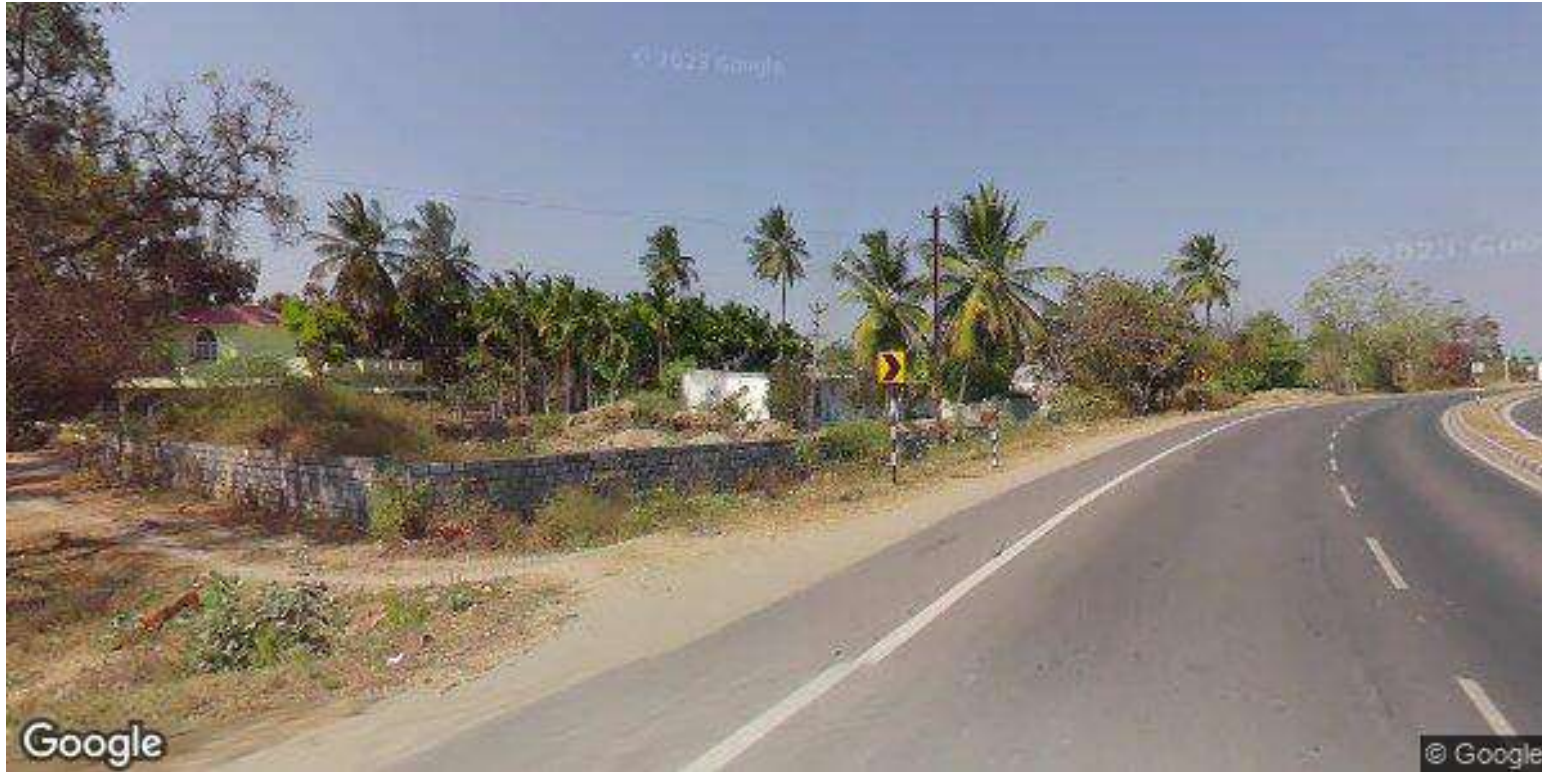
**Risk Type:** Turn  
**Risk Level:** Medium  
**Speed Limit:** 30 KM/Hr  
**Coordinates:** 12.01548, 78.45650

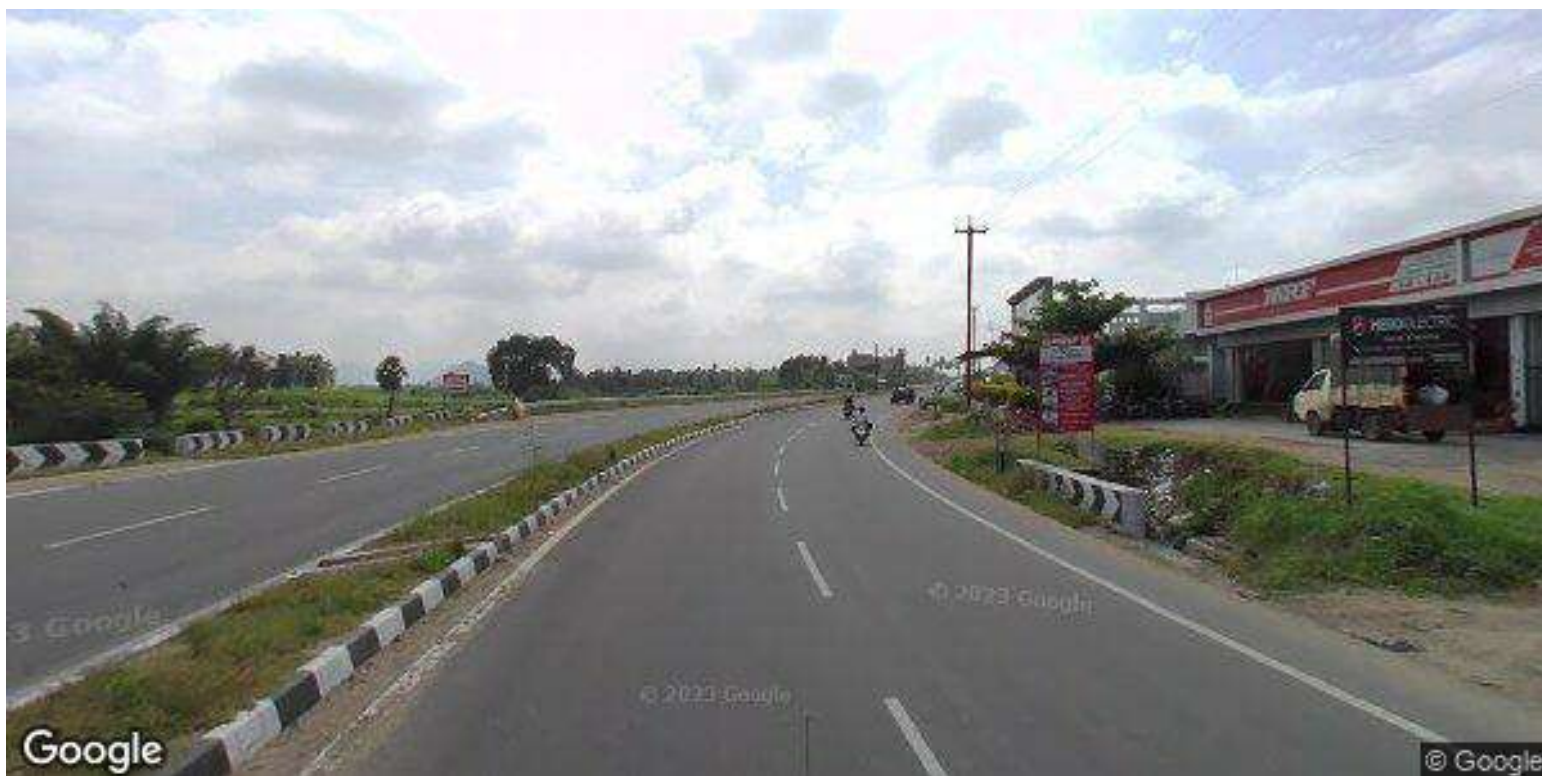
**Risk Type:** Turn  
**Risk Level:** Medium  
**Speed Limit:** 30 KM/Hr  
**Coordinates:** 12.04309, 78.48361

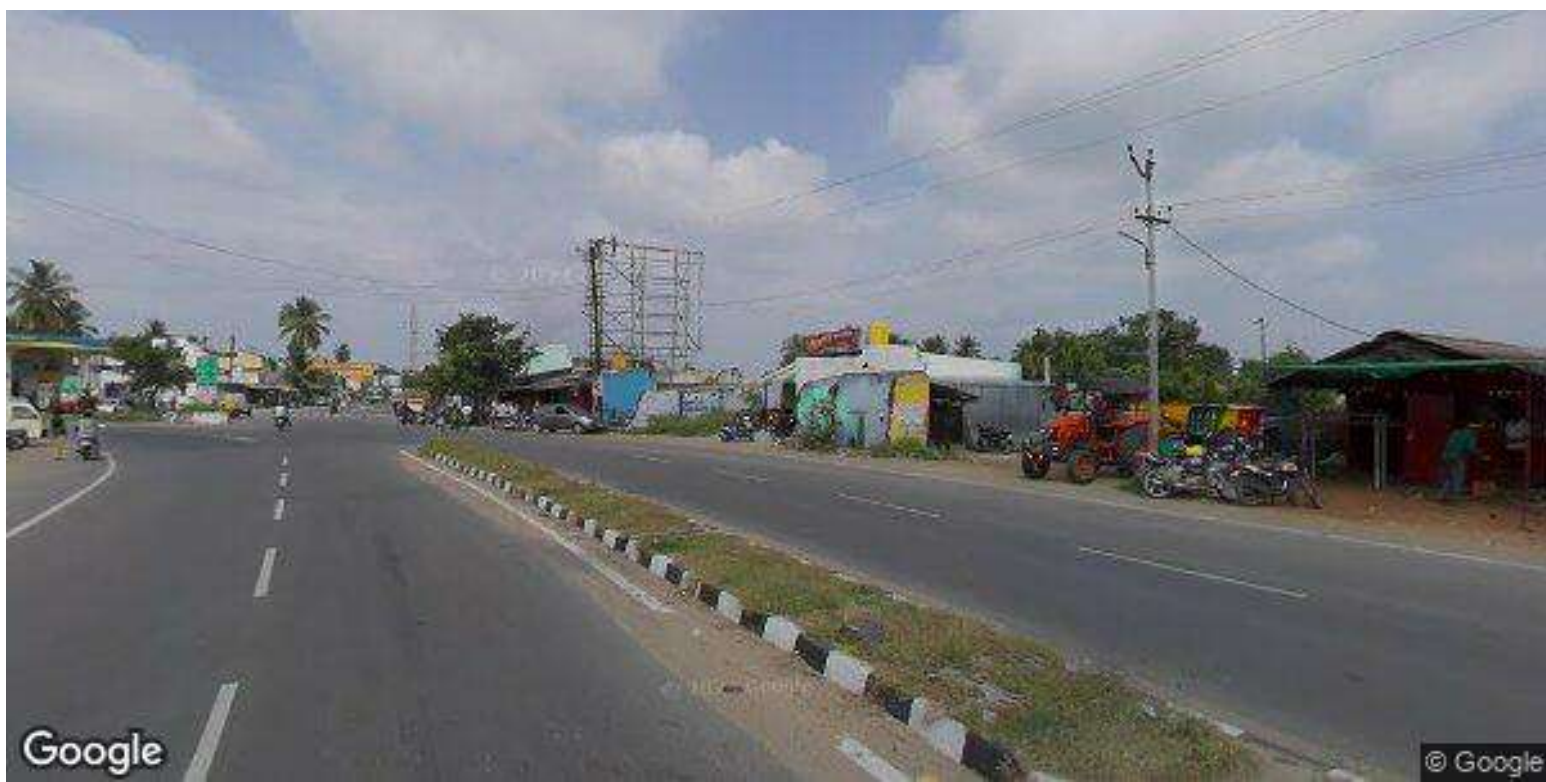
**Coordinates:** 12.04429, 78.48380

**Risk Type:** Turn

**Risk Level:** Medium

**Speed Limit:** 30 KM/Hr

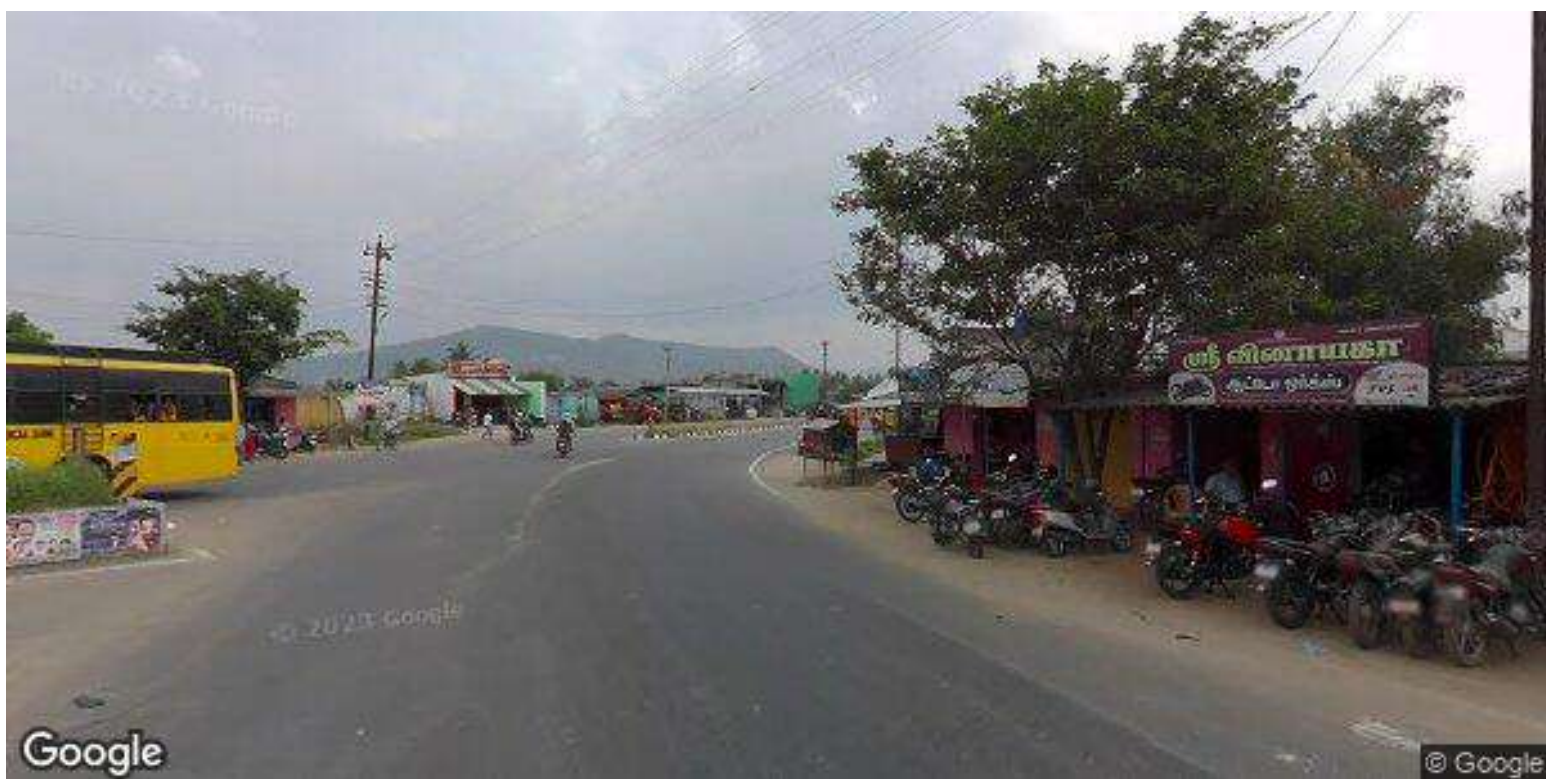
**Coordinates:** 12.04490, 78.48355

**Risk Type:** Turn

**Risk Level:** Medium

**Speed Limit:** 30 KM/Hr

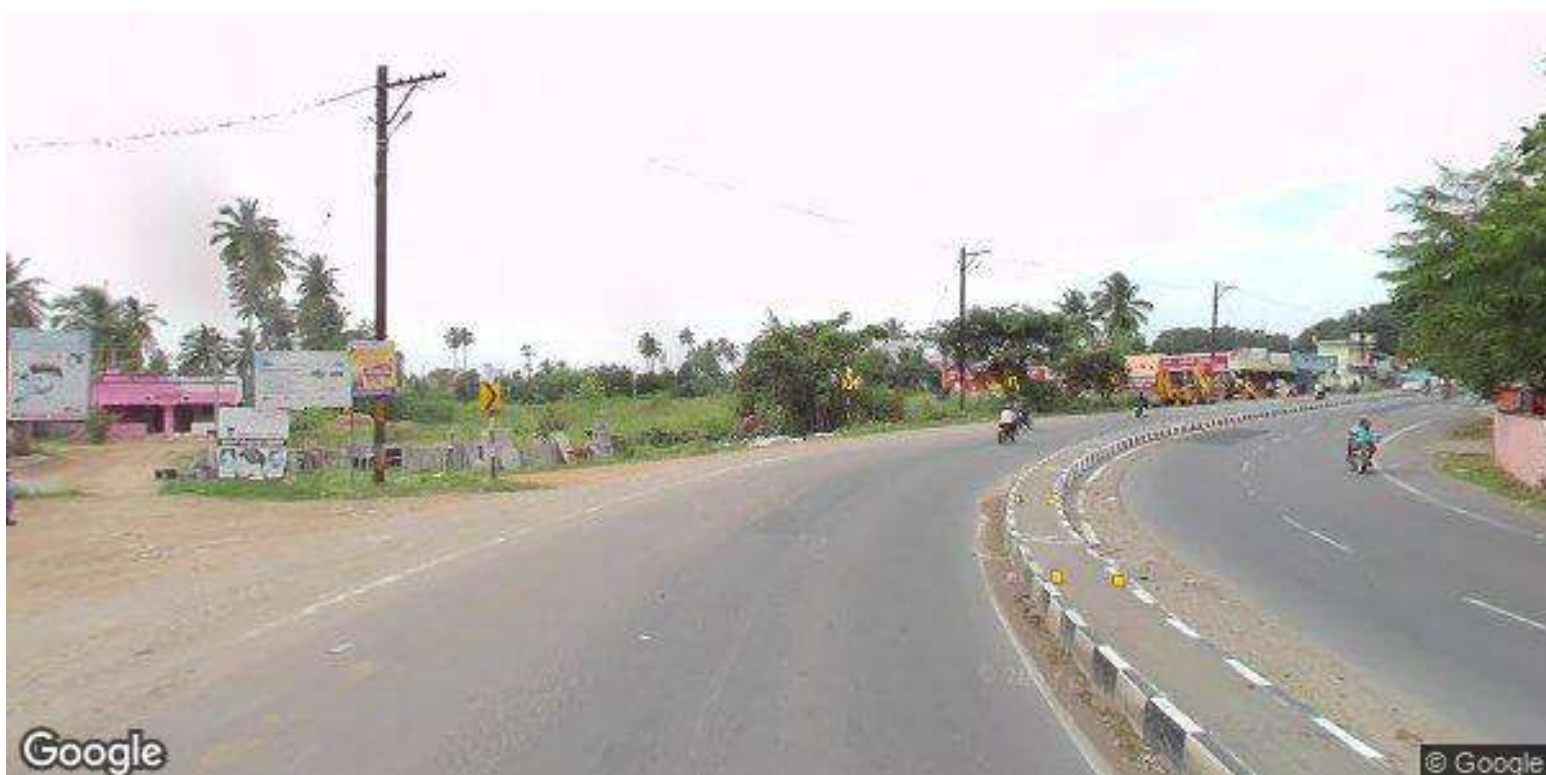
**Coordinates: 12.04984, 78.47480**

**Risk Type: Turn**

**Risk Level: High**

**Speed Limit: 15 KM/Hr**

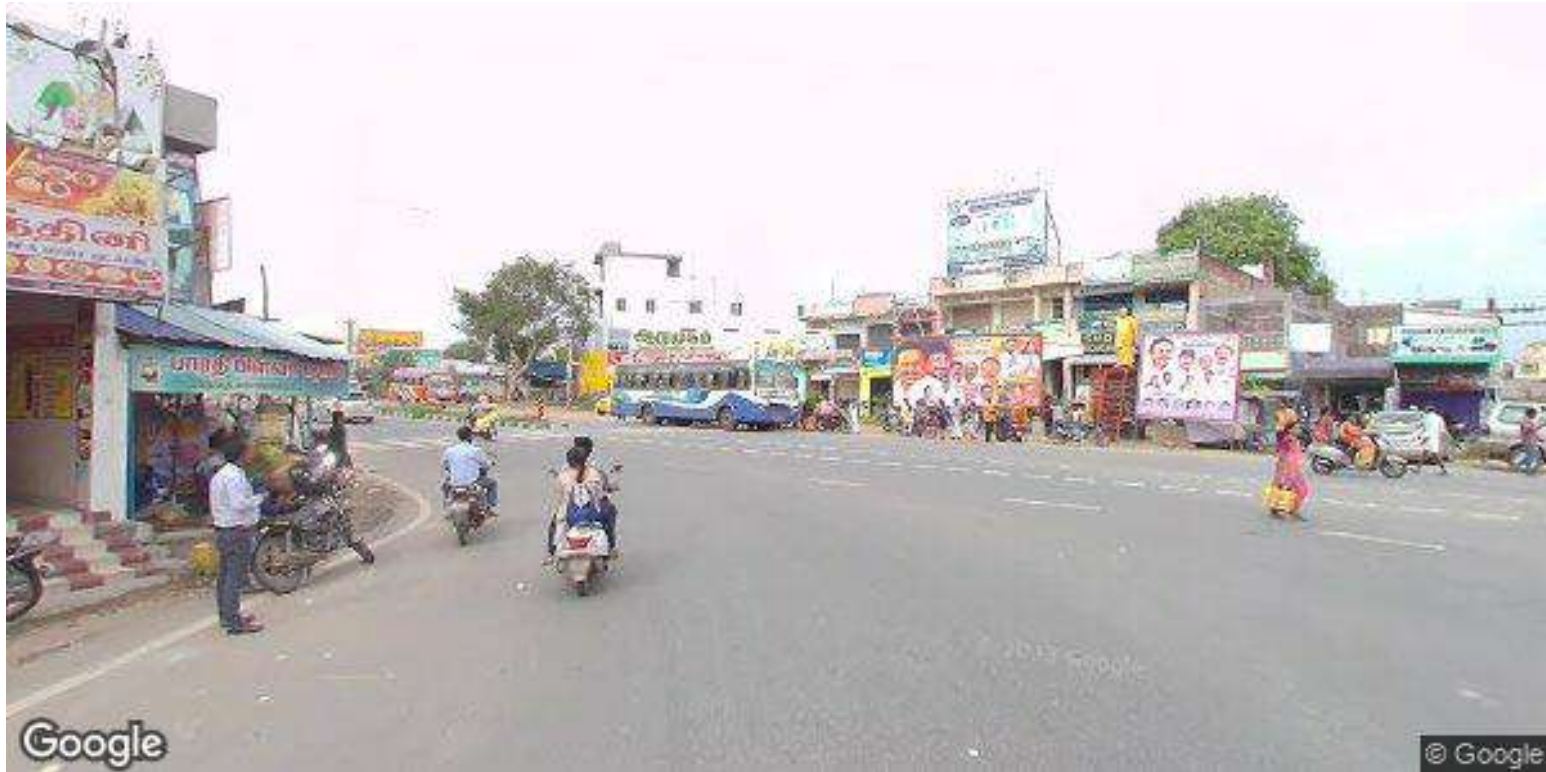
**Coordinates: 12.06014, 78.47787**

**Risk Type: Turn**

**Risk Level: High**

**Speed Limit: 15 KM/Hr**

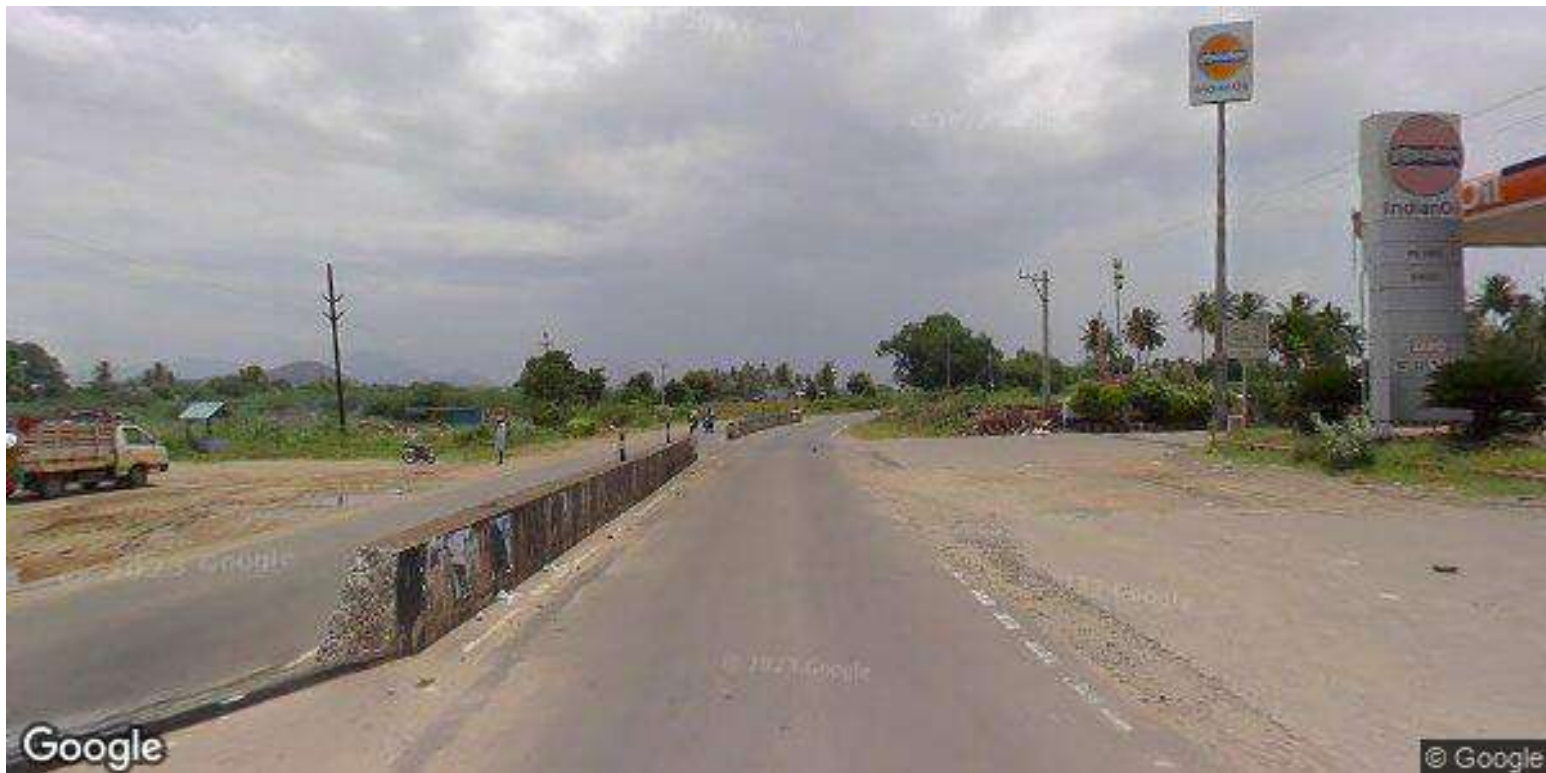
**Coordinates: 12.11584, 78.40337**

**Risk Type: Turn**

**Risk Level: High**

**Speed Limit: 15 KM/Hr**
