# IndianOil

## **JOURNEY RISK MANAGEMENT (JRM) STUDY**

### **Salem Terminal to THIRUKUMARAN PRAVEEN FUELS**

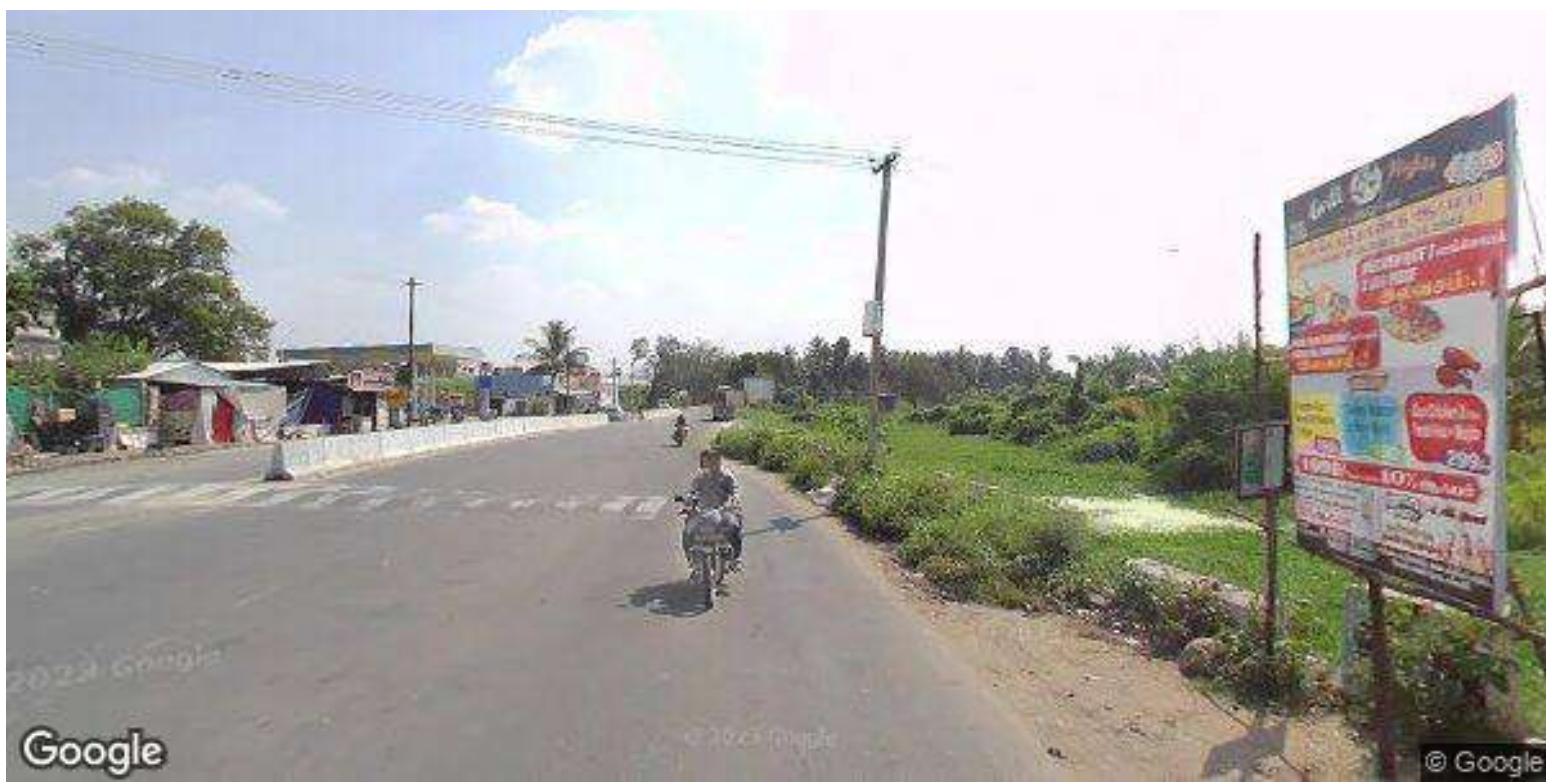
**Coordinates:** 11.44861, 77.87429

**Risk Type:** Blind Spot

**Risk Level:** Blind Spot

**Speed Limit:** 10 KM/Hr

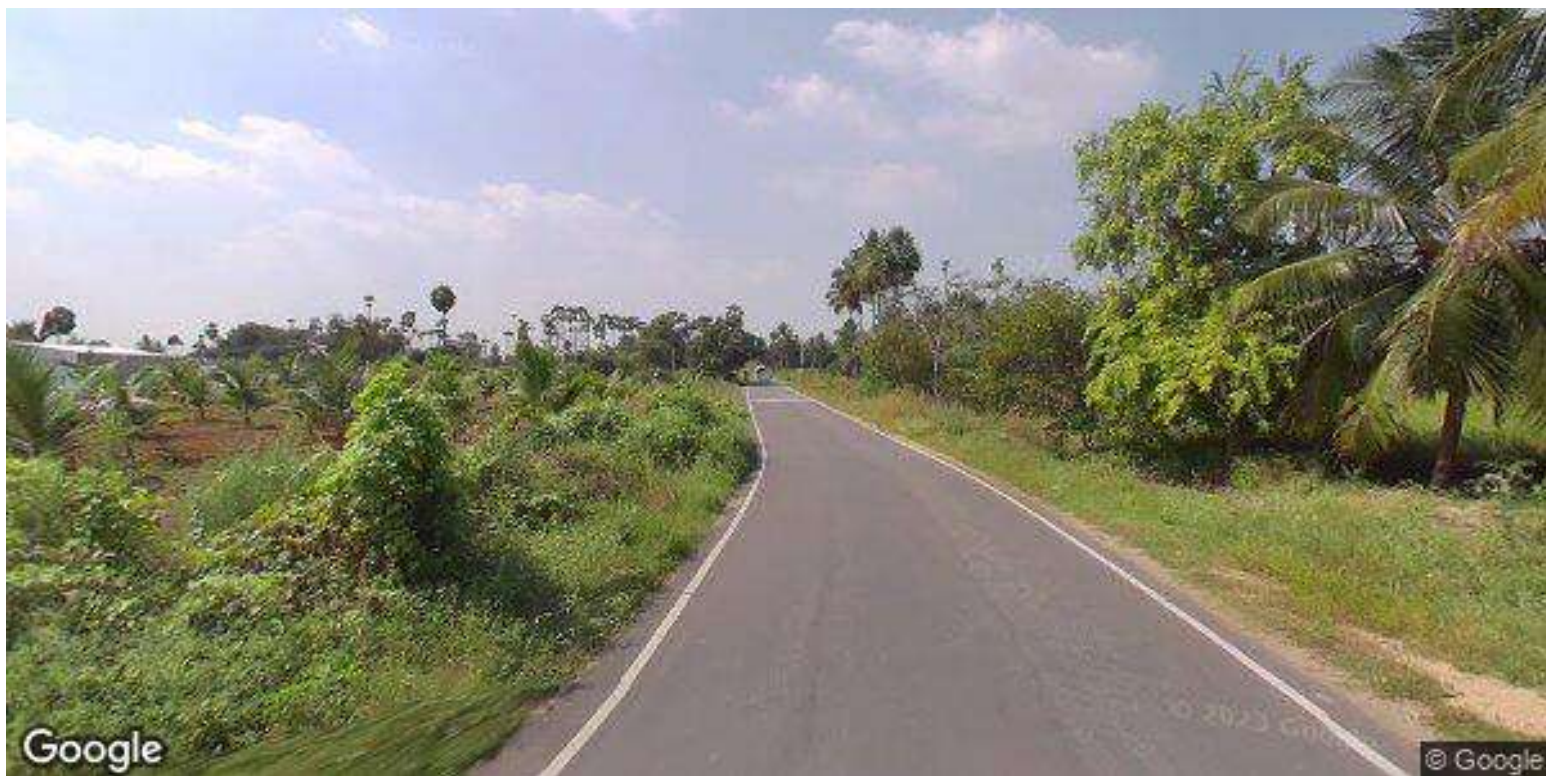
**Coordinates:** 11.44194, 77.90923

**Risk Type:** Turn

**Risk Level:** Medium

**Speed Limit:** 30 KM/Hr

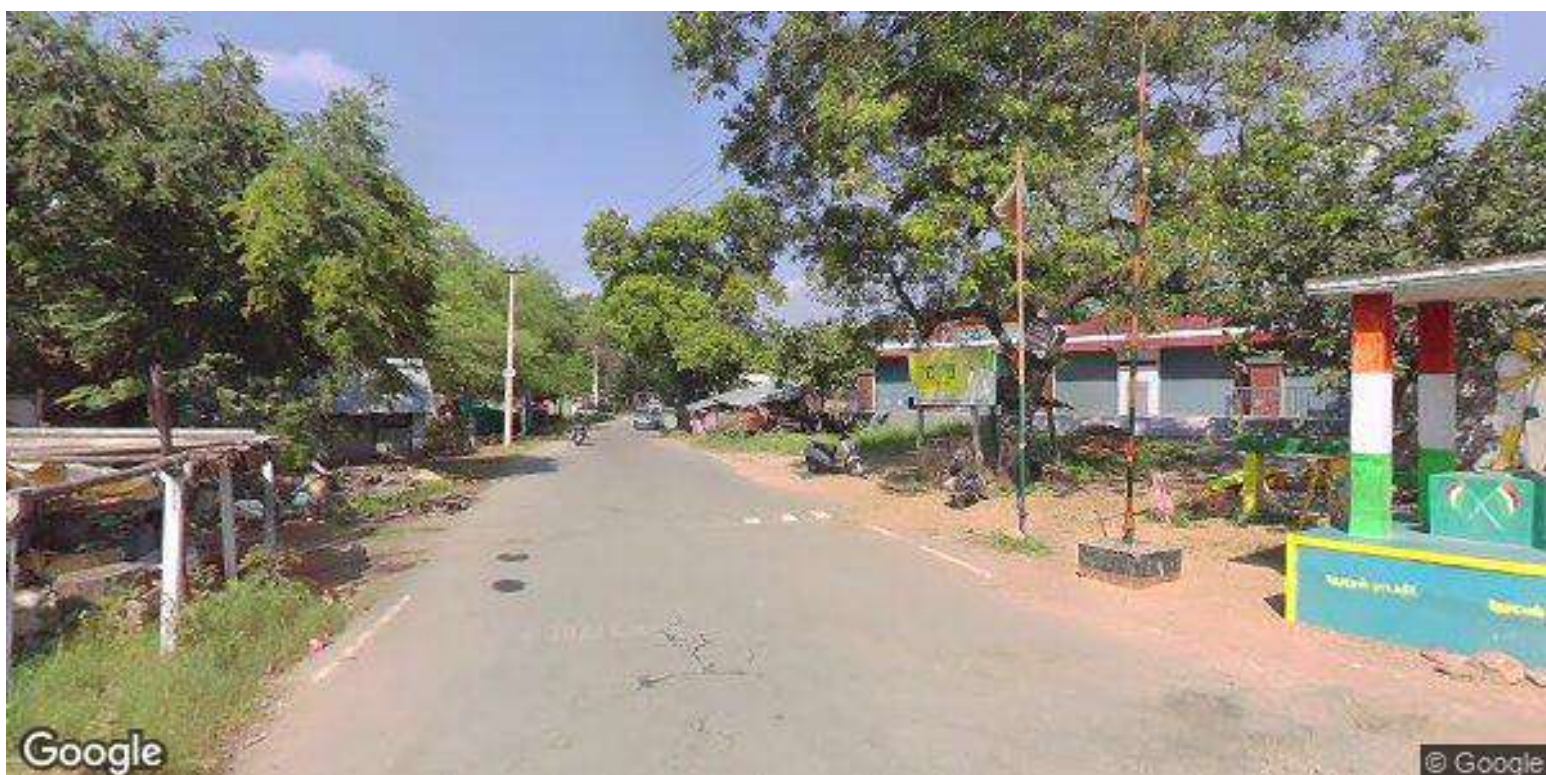
**Risk Type:** Blind Spot  
**Risk Level:** Blind Spot  
**Speed Limit:** 10 KM/Hr  
**Coordinates:** 11.43673, 77.91703

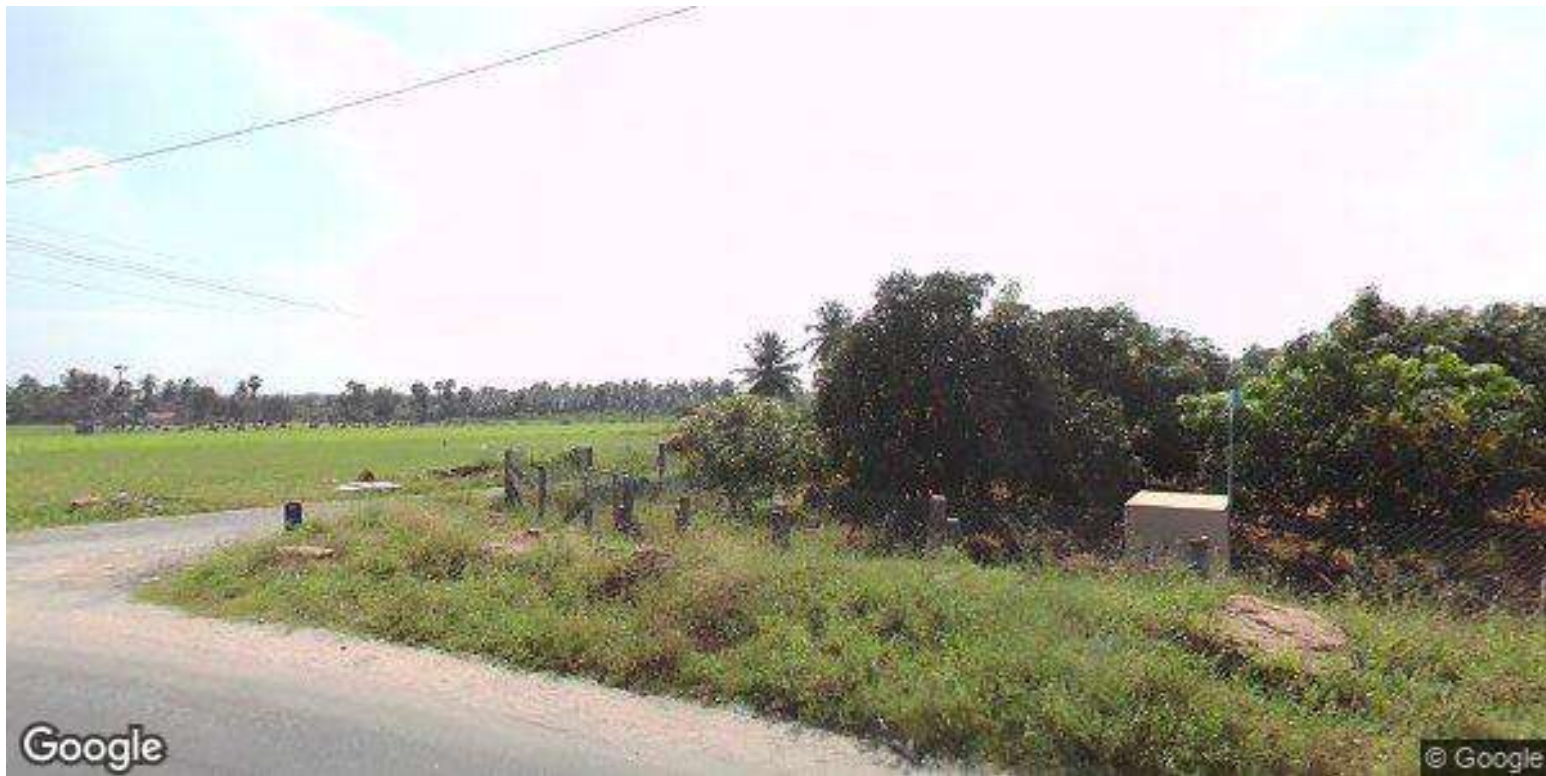
**Risk Type:** Turn  
**Risk Level:** Medium  
**Speed Limit:** 30 KM/Hr  
**Coordinates:** 11.43931, 77.92291

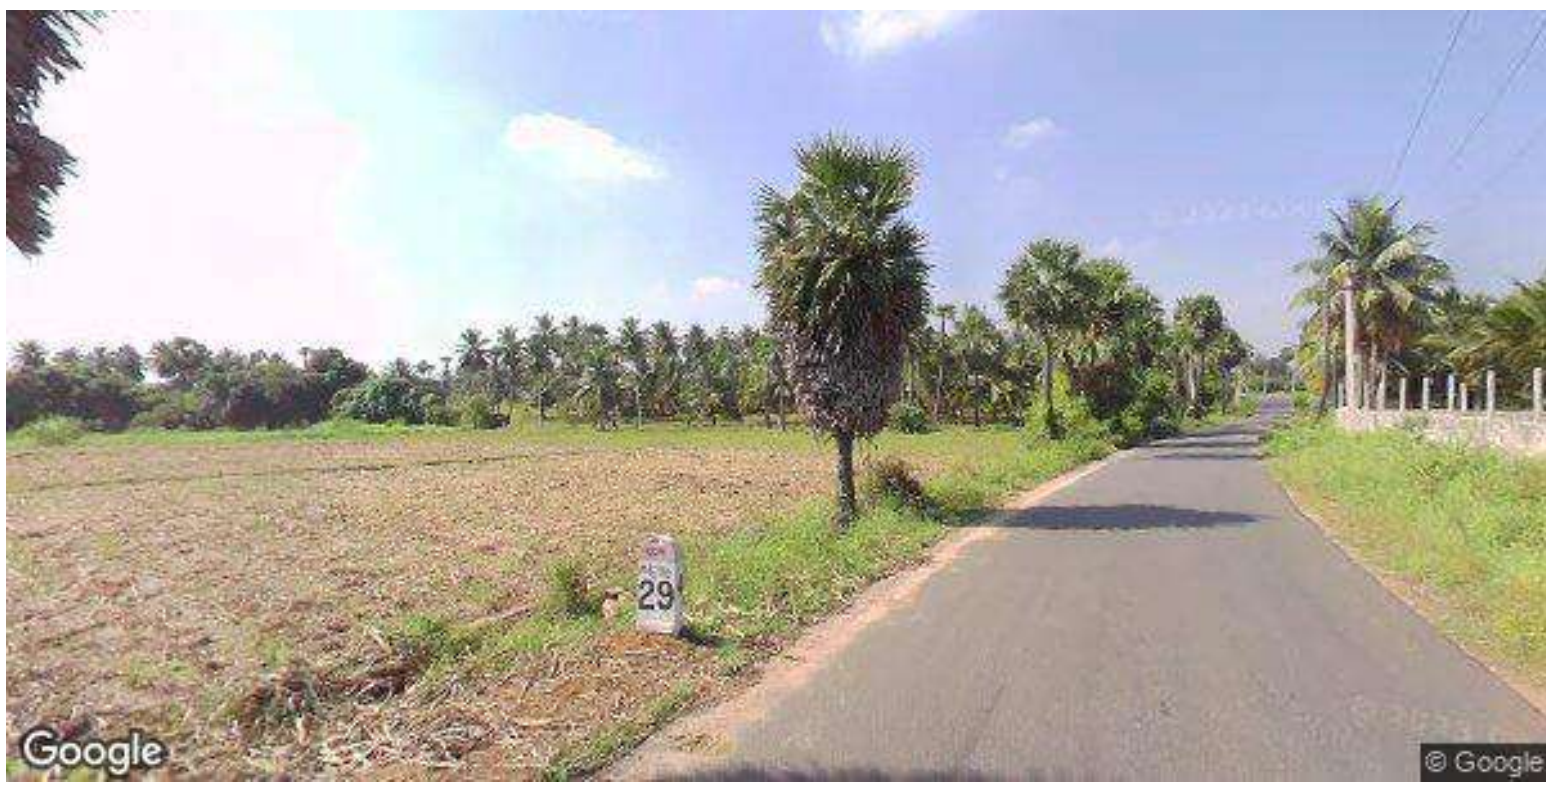
**Coordinates:** 11.43982, 77.93018

**Risk Type:** Turn

**Risk Level:** Medium

**Speed Limit:** 30 KM/Hr

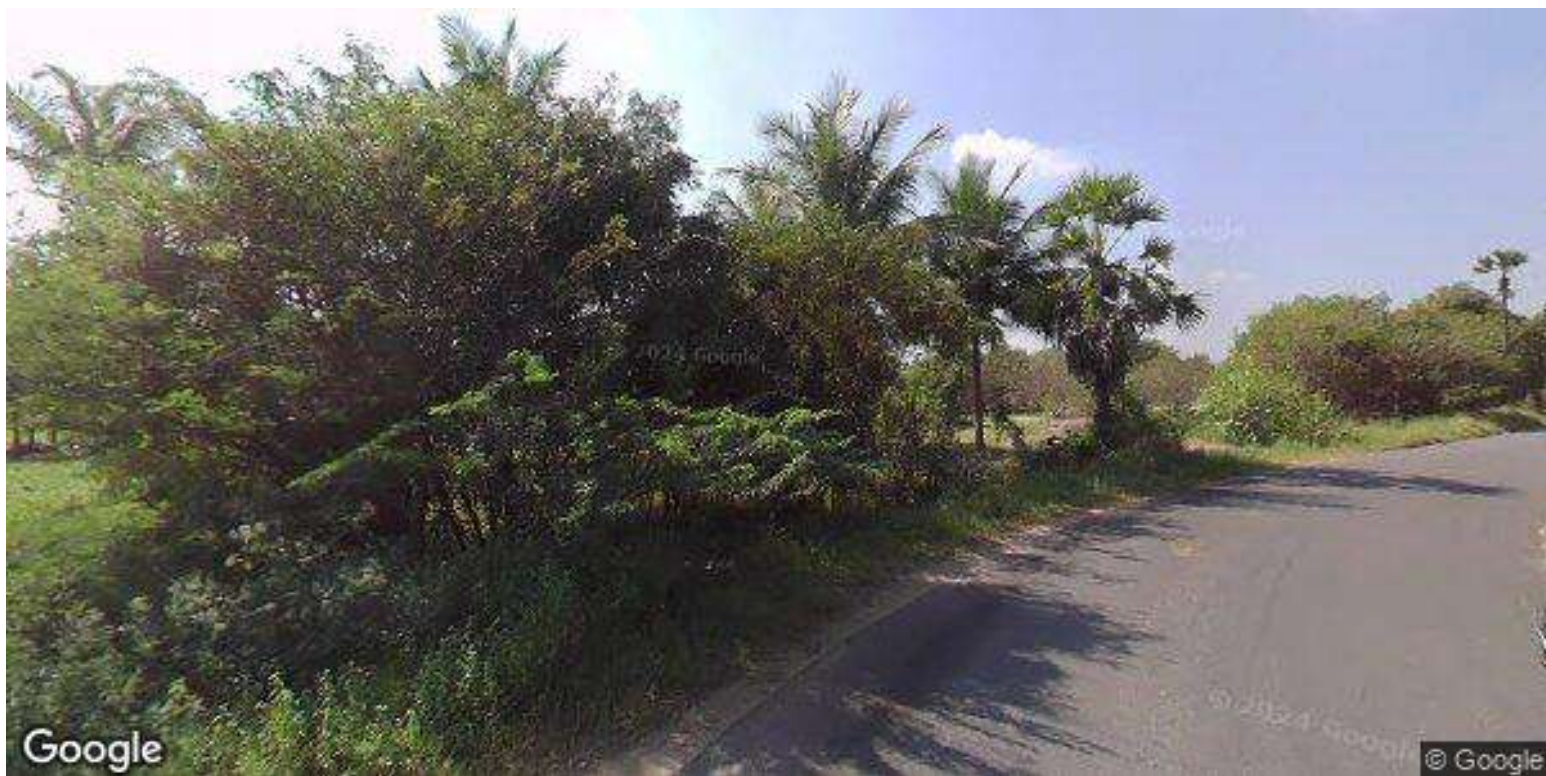
**Coordinates:** 11.44080, 77.93220

**Risk Type:** Turn

**Risk Level:** Medium

**Speed Limit:** 30 KM/Hr

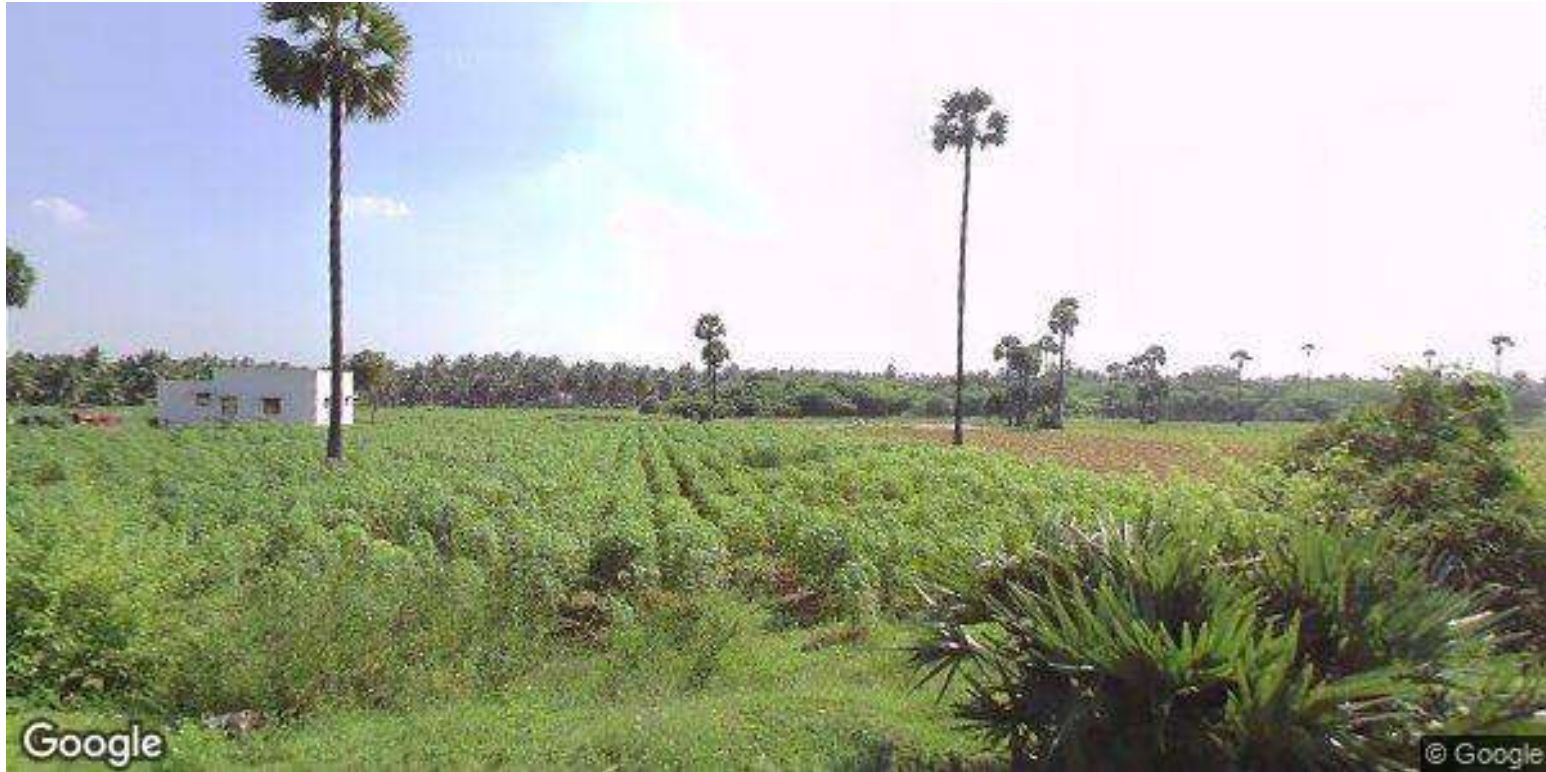
**Risk Type:** Turn  
**Risk Level:** Medium  
**Speed Limit:** 30 KM/Hr  
**Coordinates:** 11.44175, 77.93249

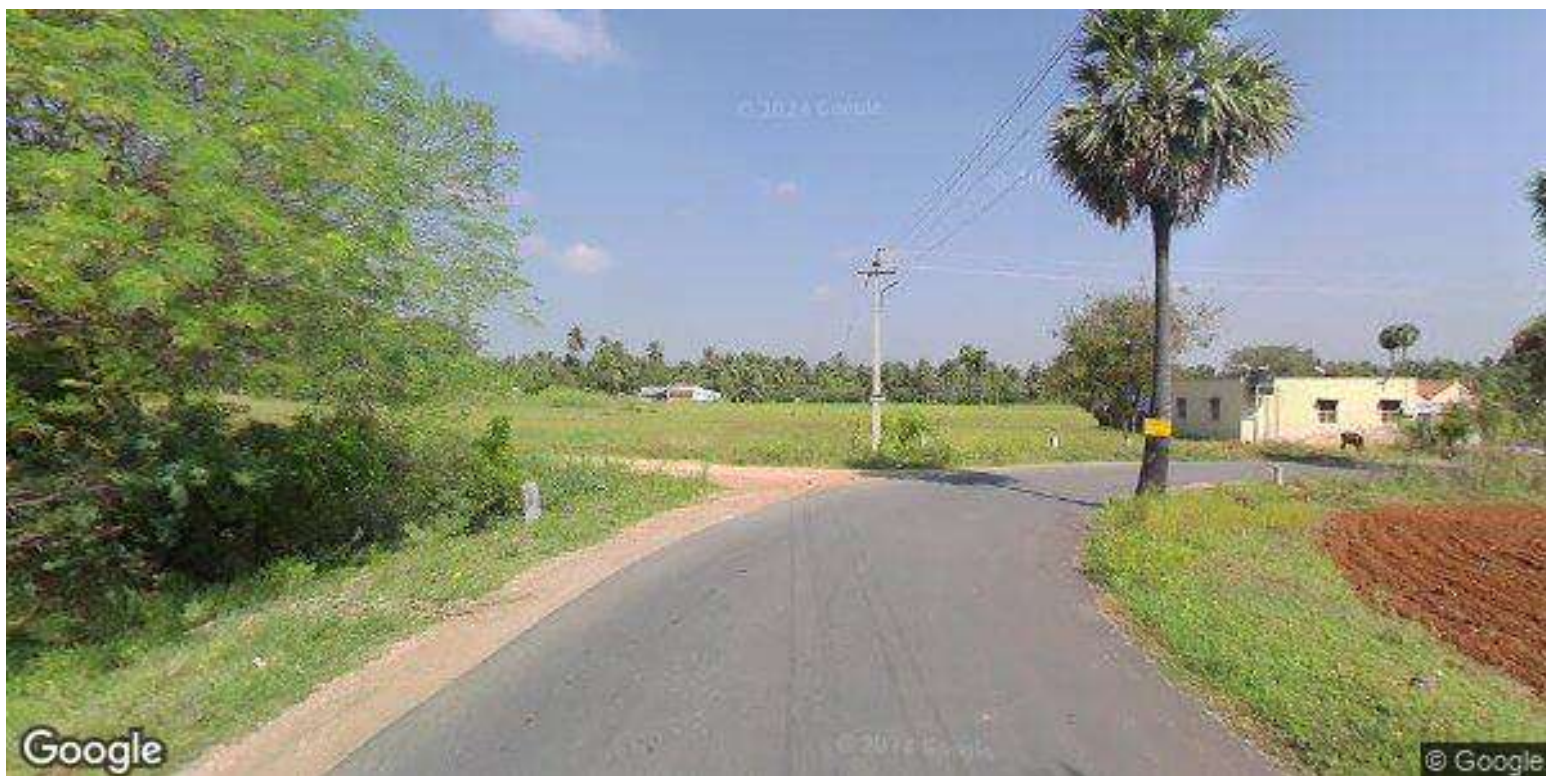
**Risk Type:** Turn  
**Risk Level:** Medium  
**Speed Limit:** 30 KM/Hr  
**Coordinates:** 11.44234, 77.93242

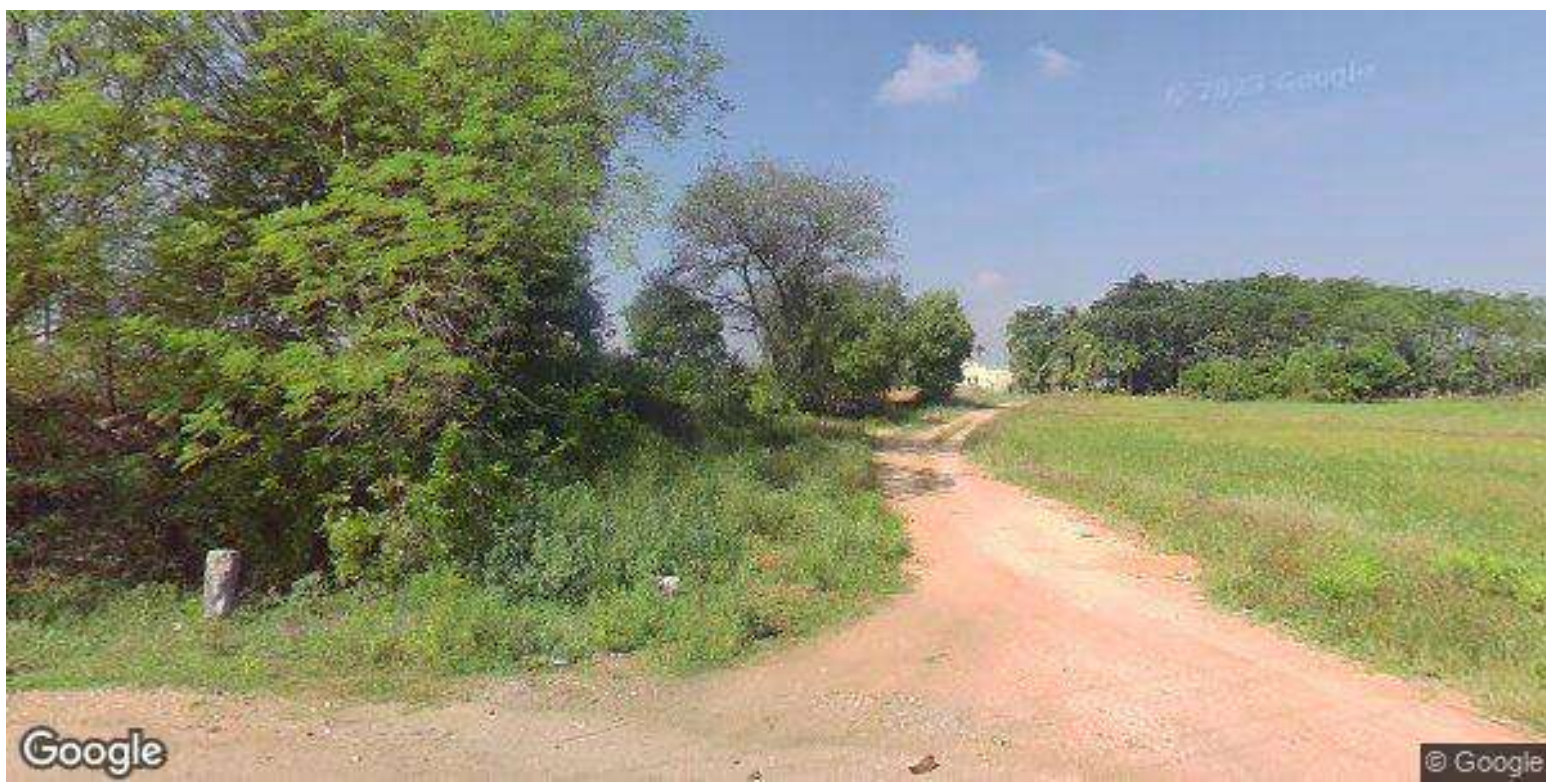
**Risk Type:** Turn  
**Risk Level:** High  
**Speed Limit:** 15 KM/Hr  
**Coordinates:** 11.44248, 77.93247

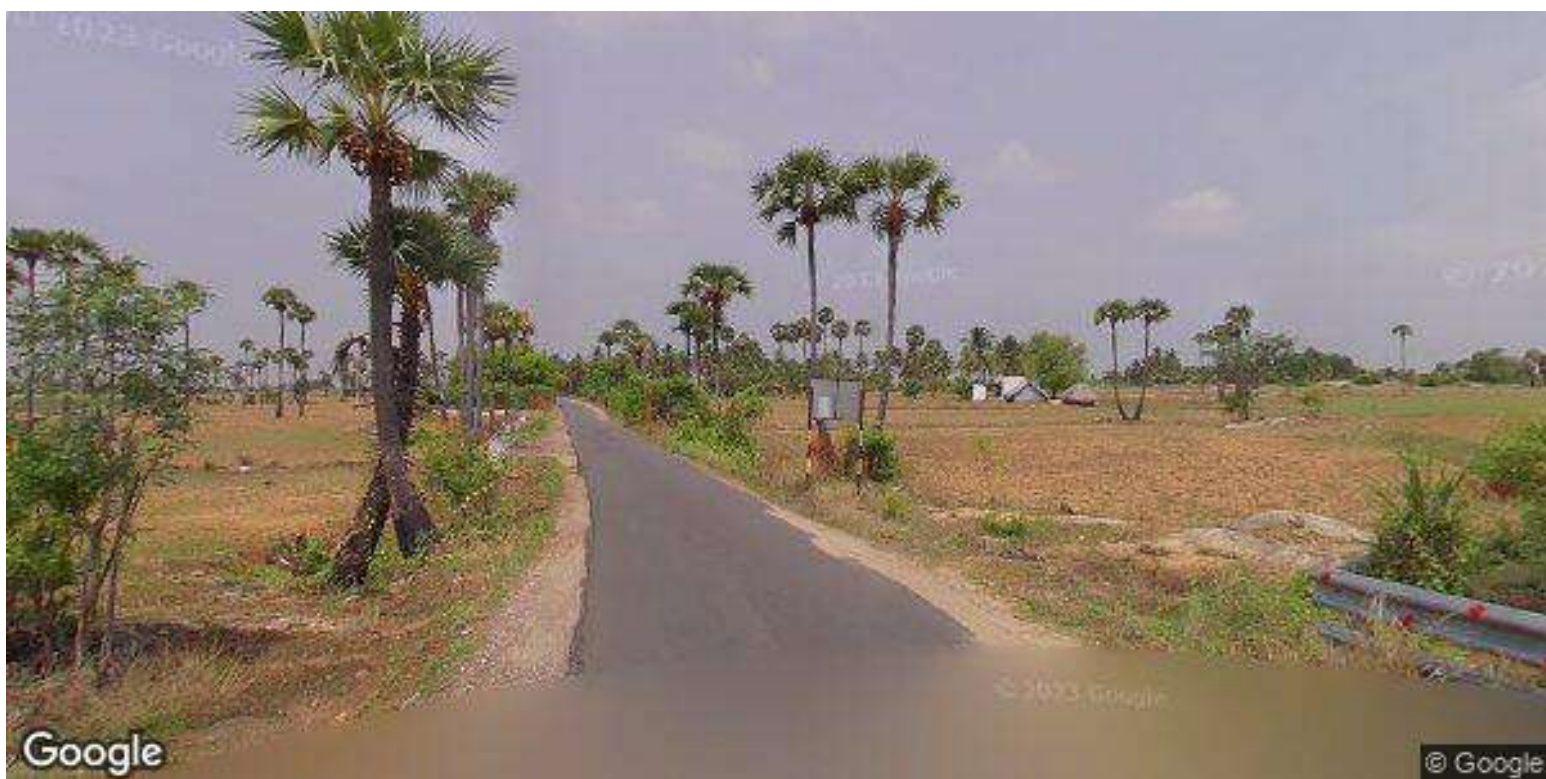
**Risk Type:** Turn  
**Risk Level:** Medium  
**Speed Limit:** 30 KM/Hr  
**Coordinates:** 11.44547, 77.95309

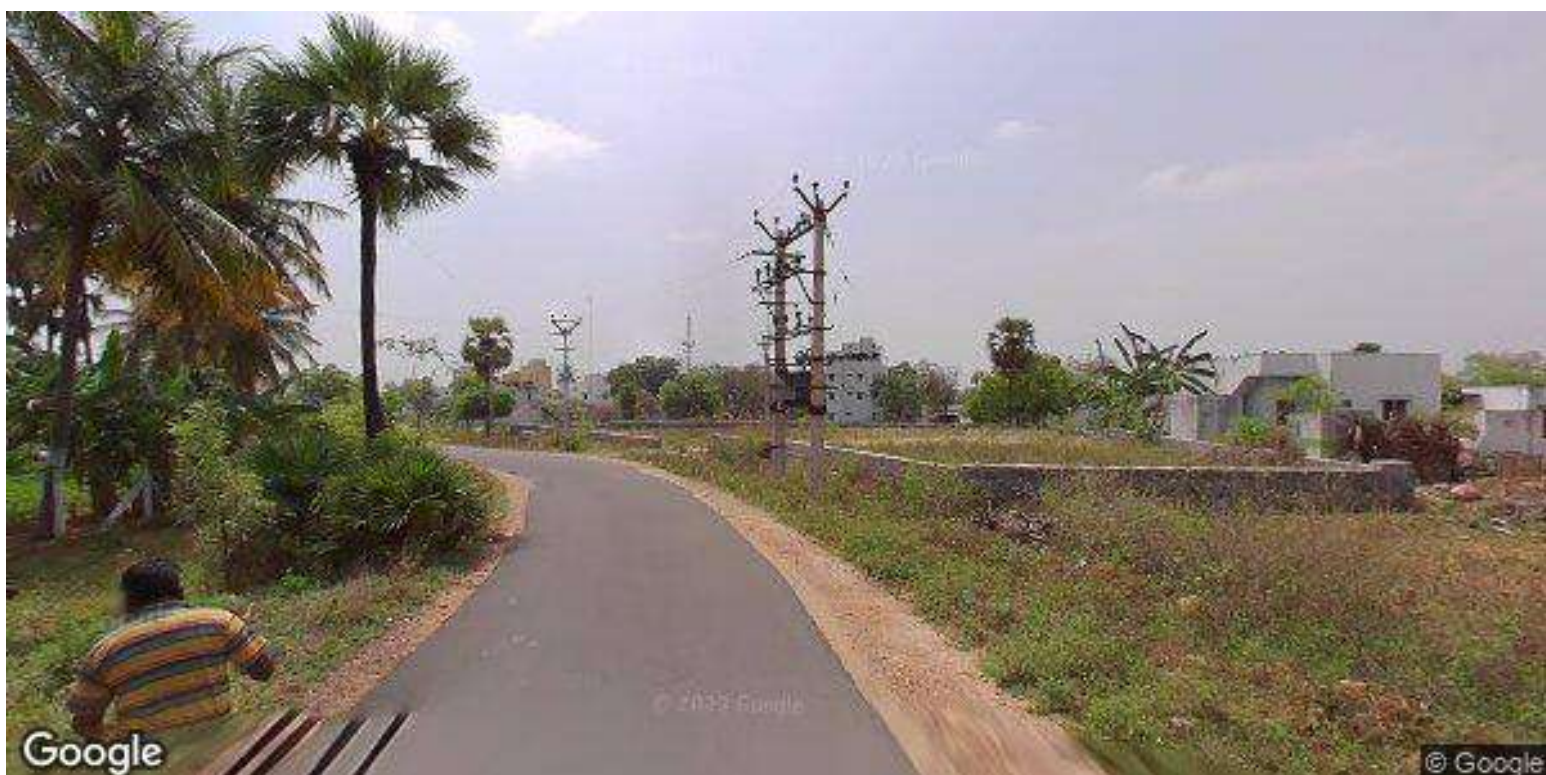
**Coordinates:** 11.44370, 77.96020

**Risk Type:** Turn

**Risk Level:** Medium

**Speed Limit:** 30 KM/Hr

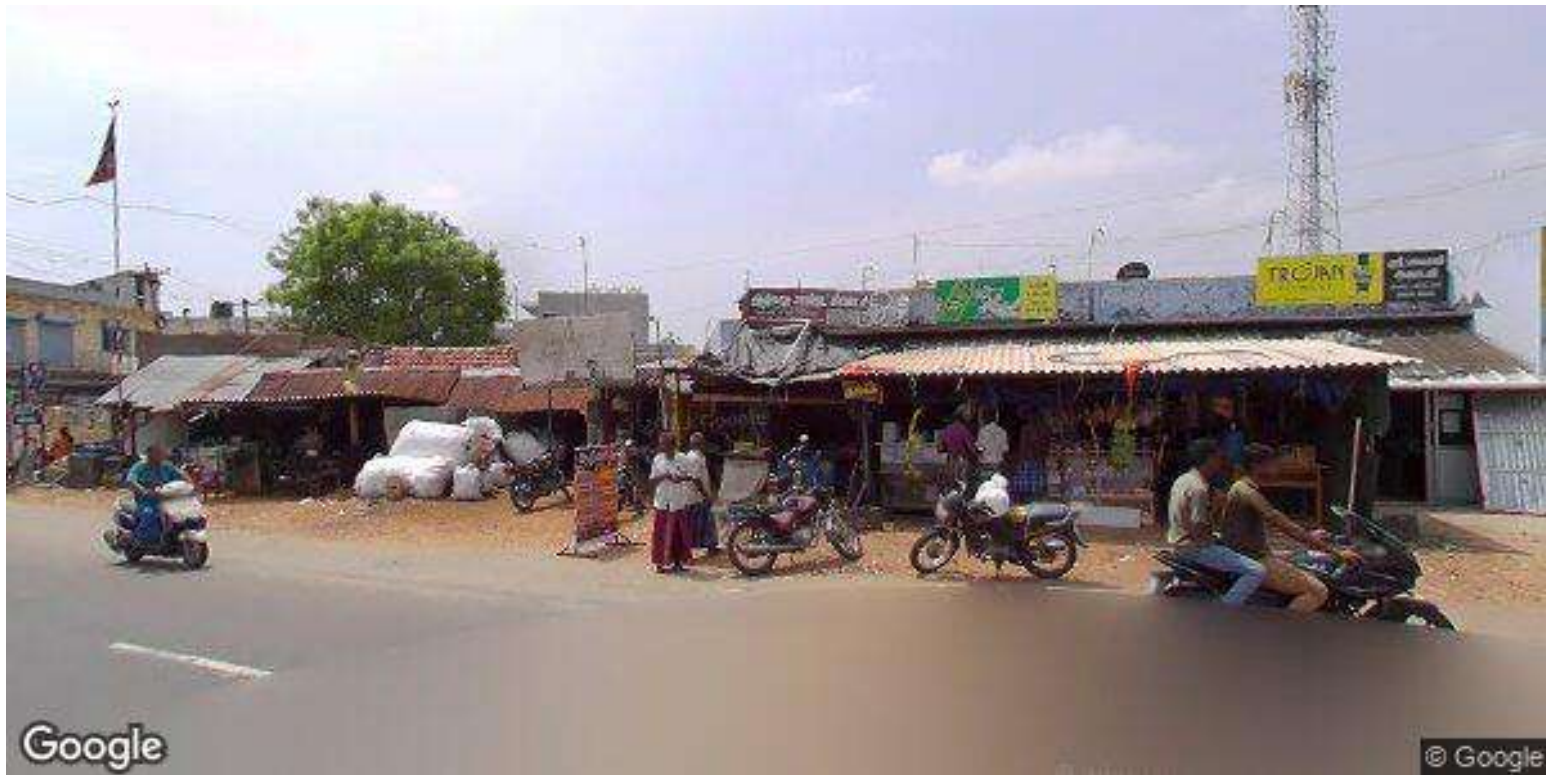
**Coordinates:** 11.44387, 77.96283

**Risk Type:** Turn

**Risk Level:** High

**Speed Limit:** 15 KM/Hr

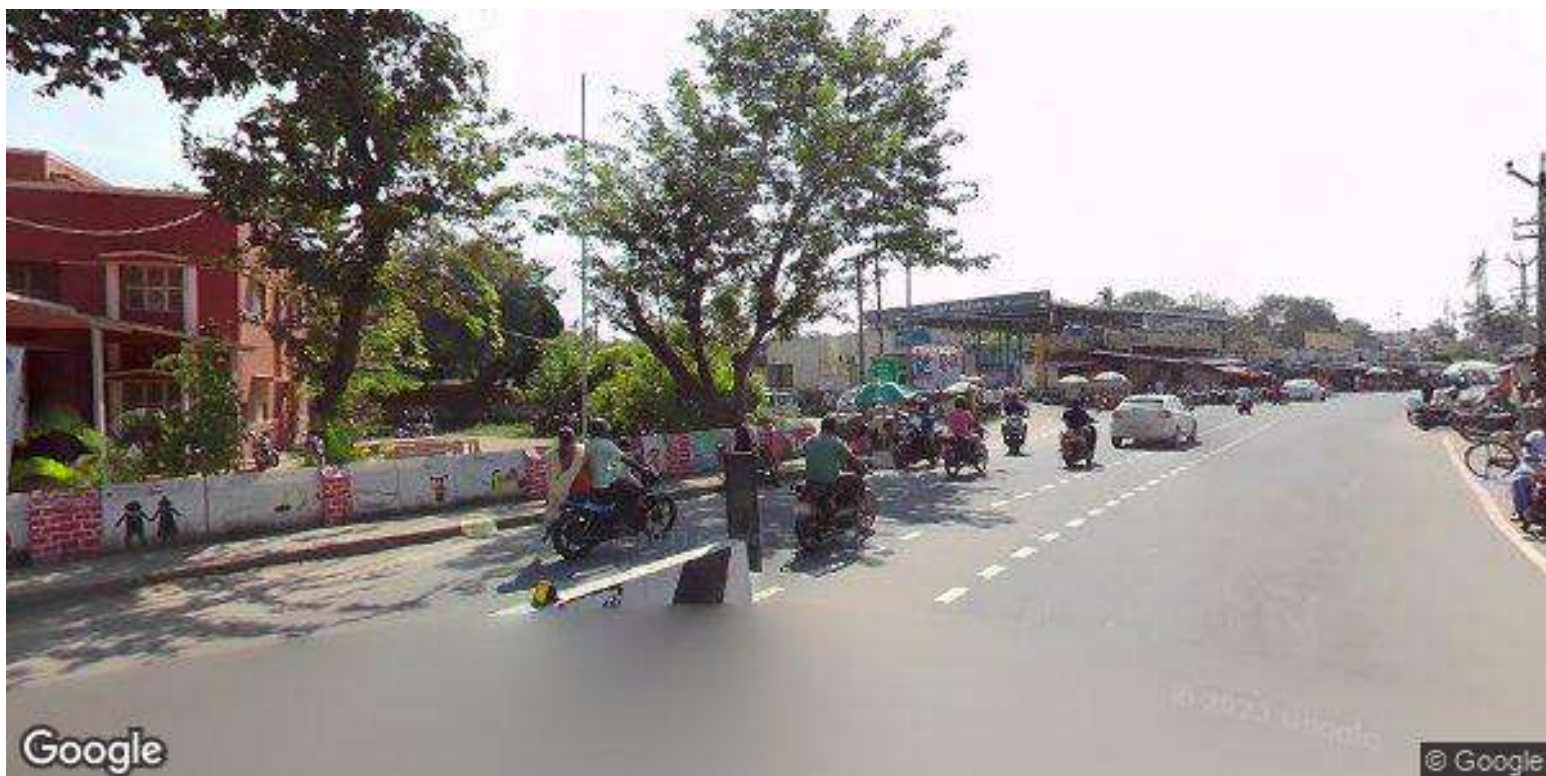
**Coordinates:** 11.53168, 78.05072

**Risk Type:** Turn

**Risk Level:** Medium

**Speed Limit:** 30 KM/Hr

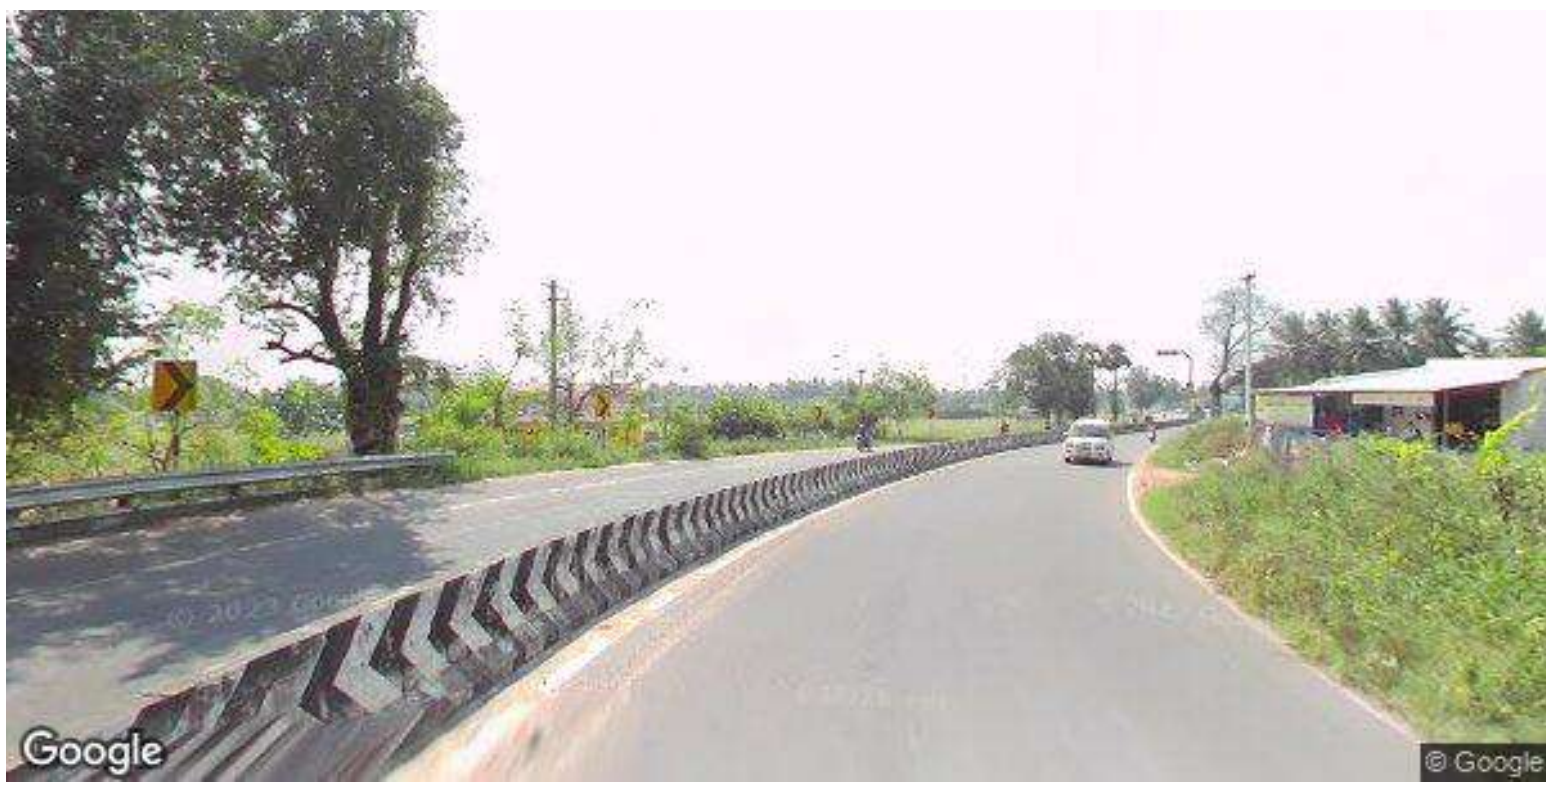
**Coordinates:** 11.54862, 78.06397

**Risk Type:** Turn

**Risk Level:** Medium

**Speed Limit:** 30 KM/Hr

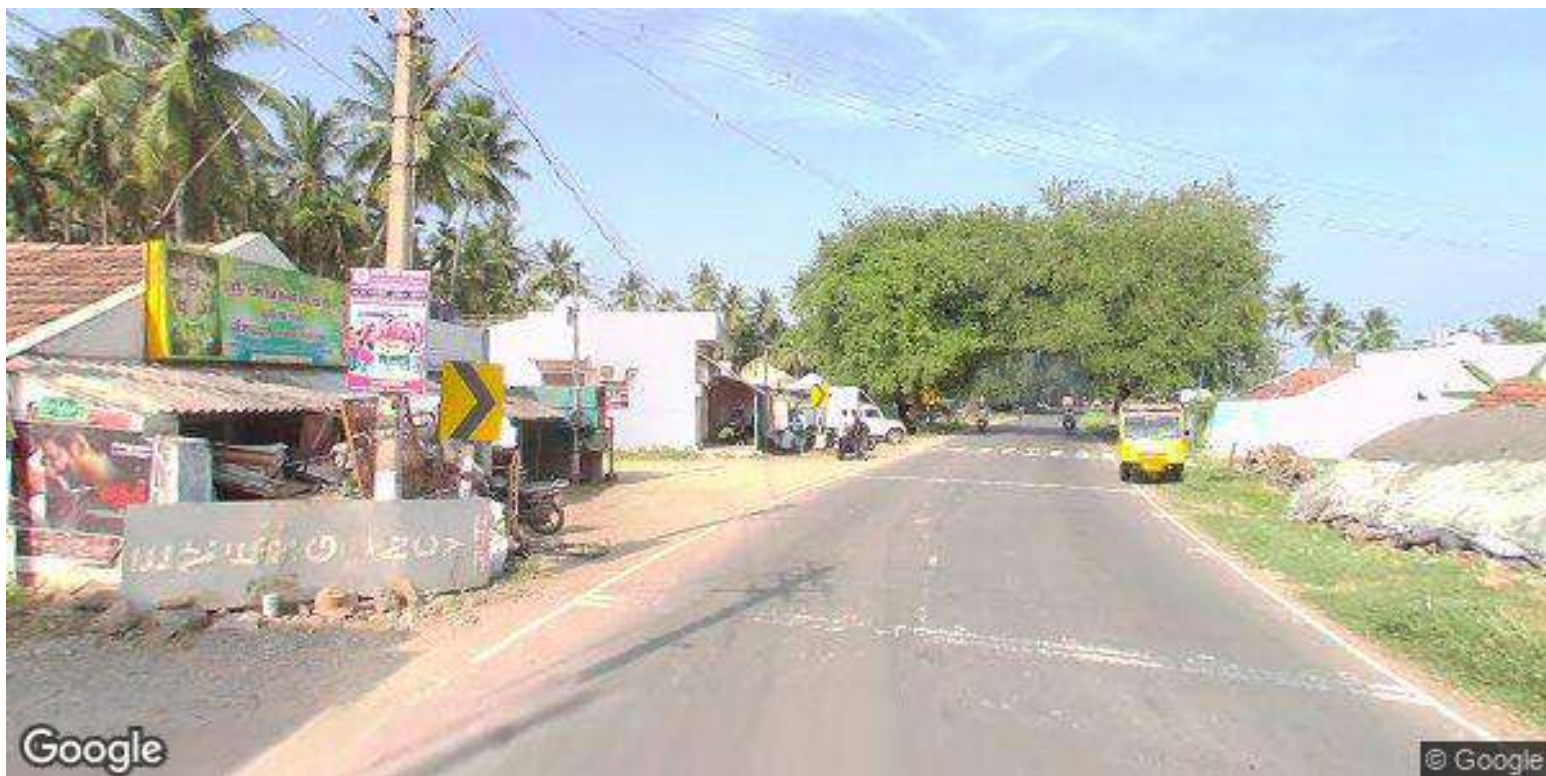
**Coordinates:** 11.57645, 78.07293

**Risk Type:** Blind Spot

**Risk Level:** Blind Spot

**Speed Limit:** 10 KM/Hr
