# IndianOil

## JOURNEY RISK MANAGEMENT (JRM) STUDY

### Salem Terminal to ASHWIN AUTOMOBILES

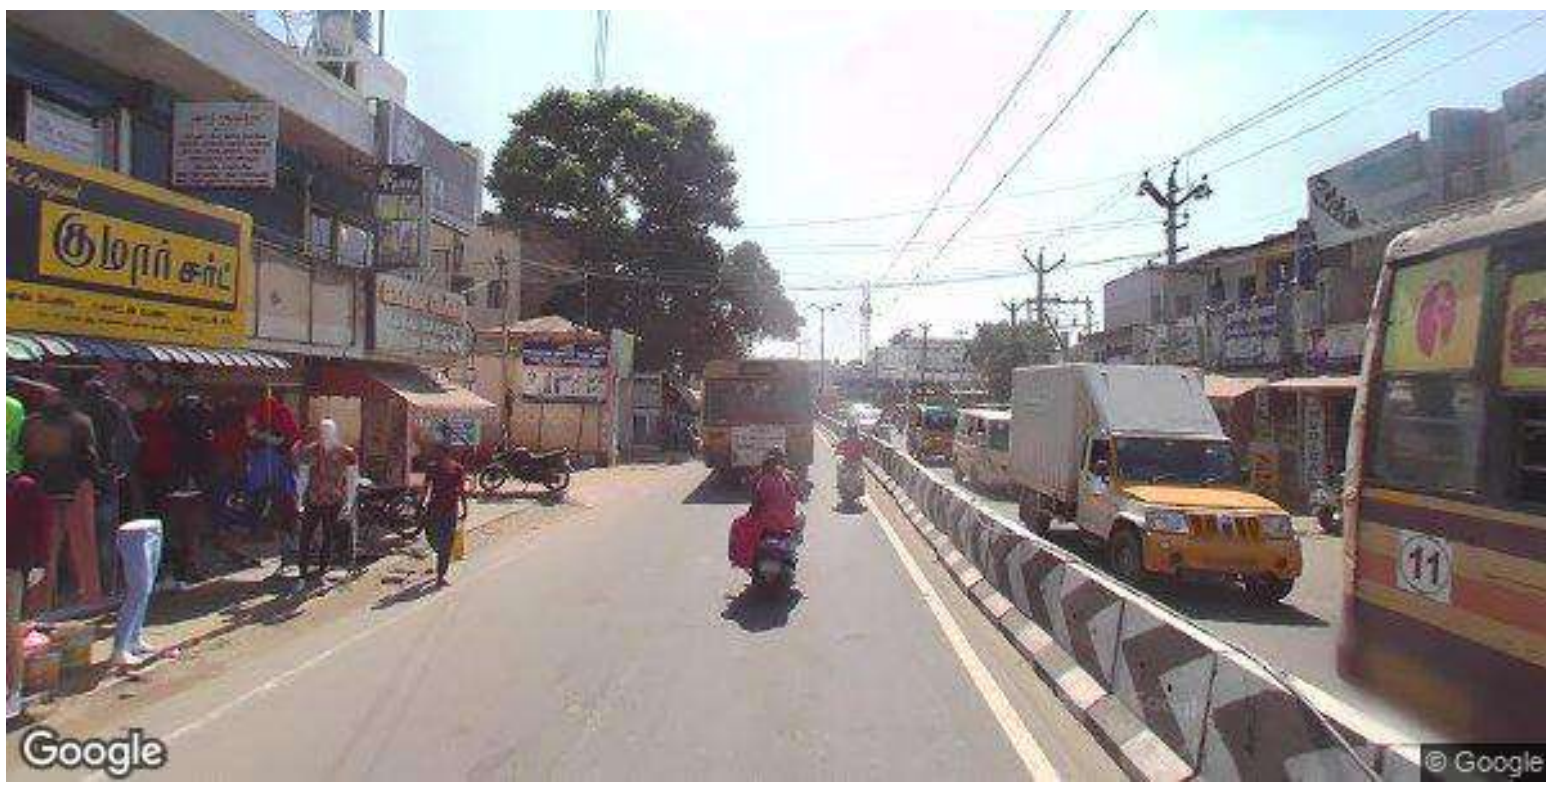
**Coordinates:** 11.1328729, 77.3421741

**Risk Type:** U-Turn

**Risk Level:** High

**Speed Limit:** 10 KM/Hr

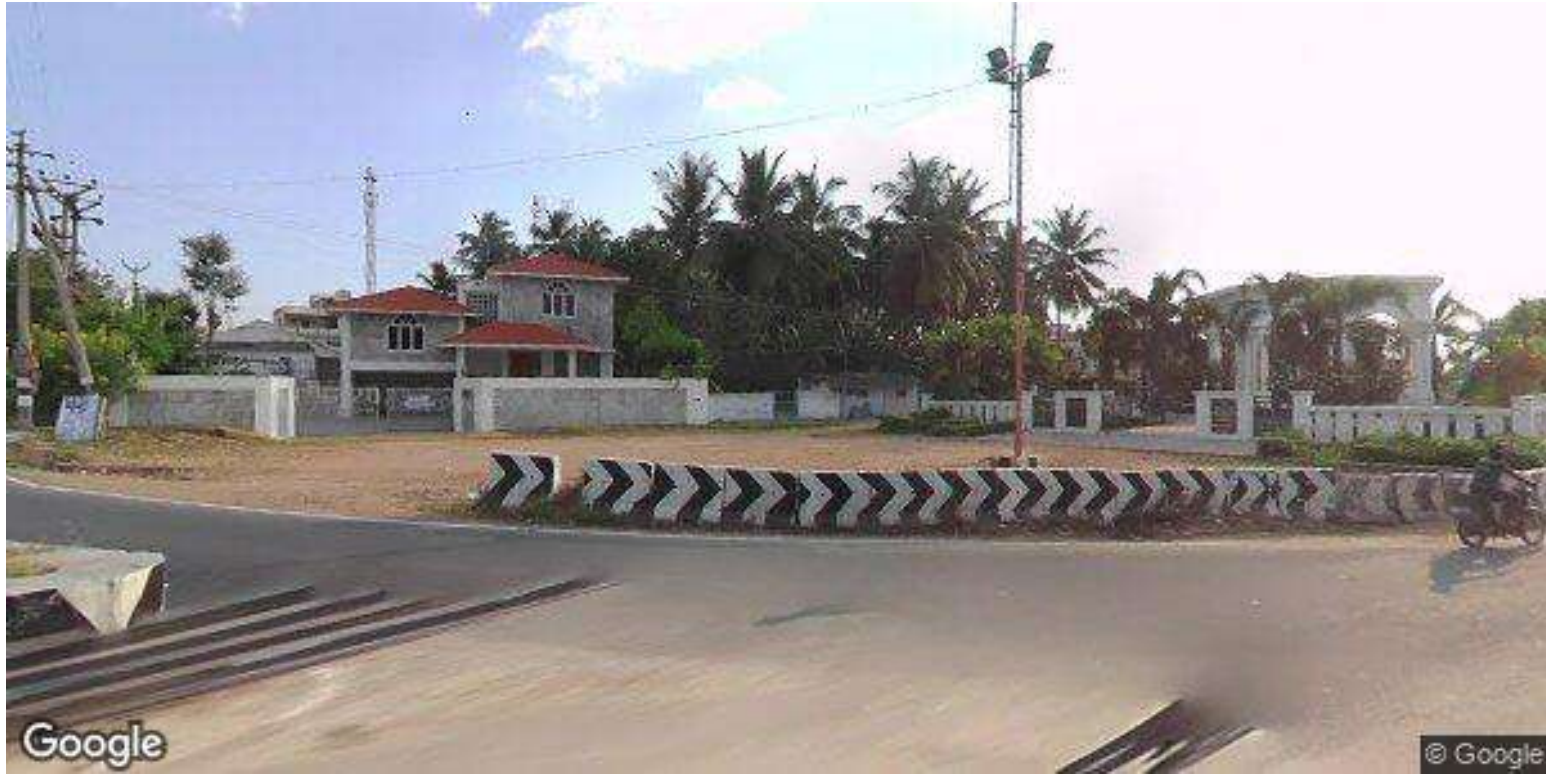
**Coordinates:** 11.46314, 77.84928

**Risk Type:** Turn

**Risk Level:** Medium

**Speed Limit:** 30 KM/Hr

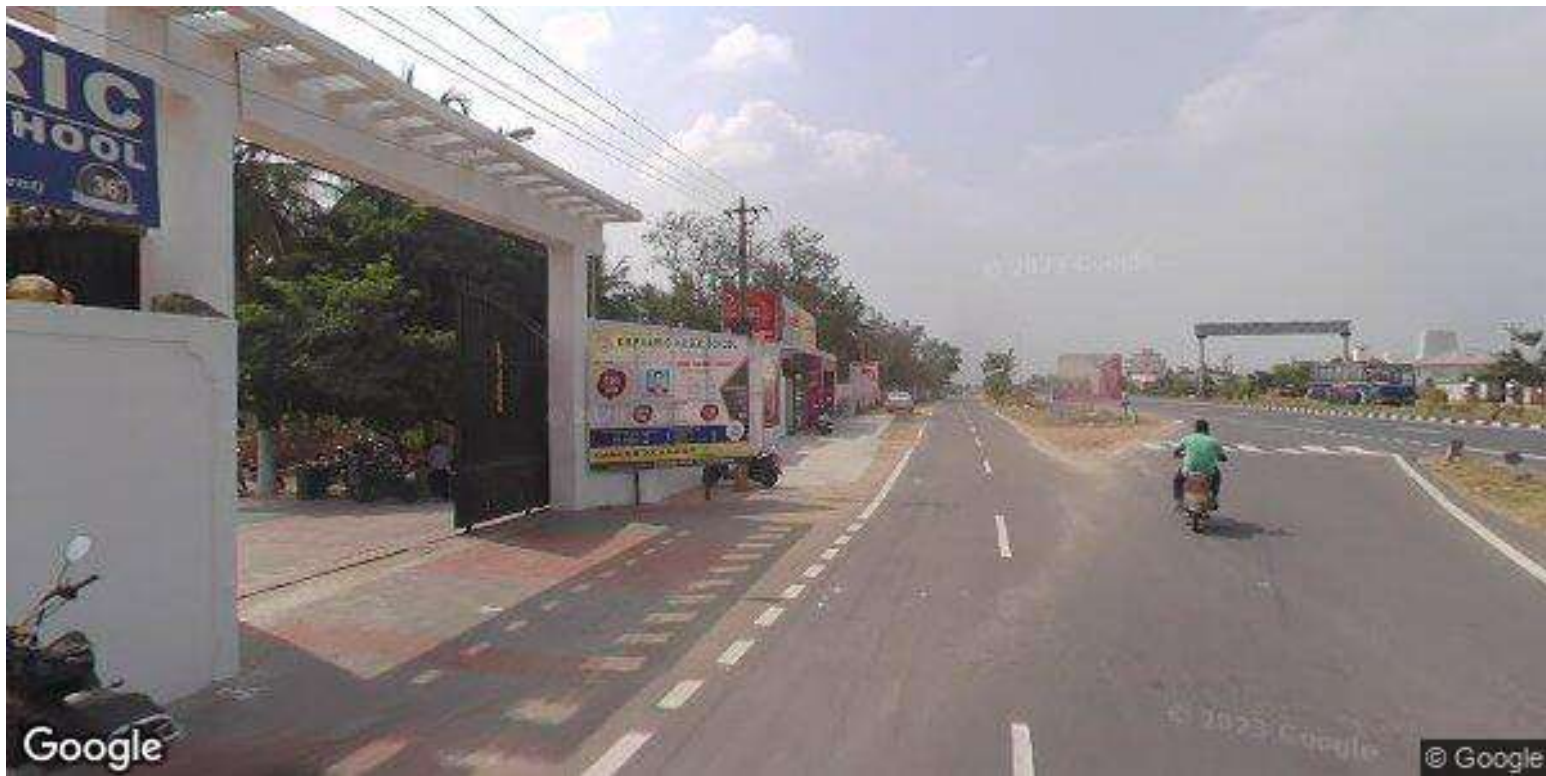
**Coordinates:** 11.45509, 77.81383

**Risk Type:** Turn

**Risk Level:** Medium

**Speed Limit:** 30 KM/Hr

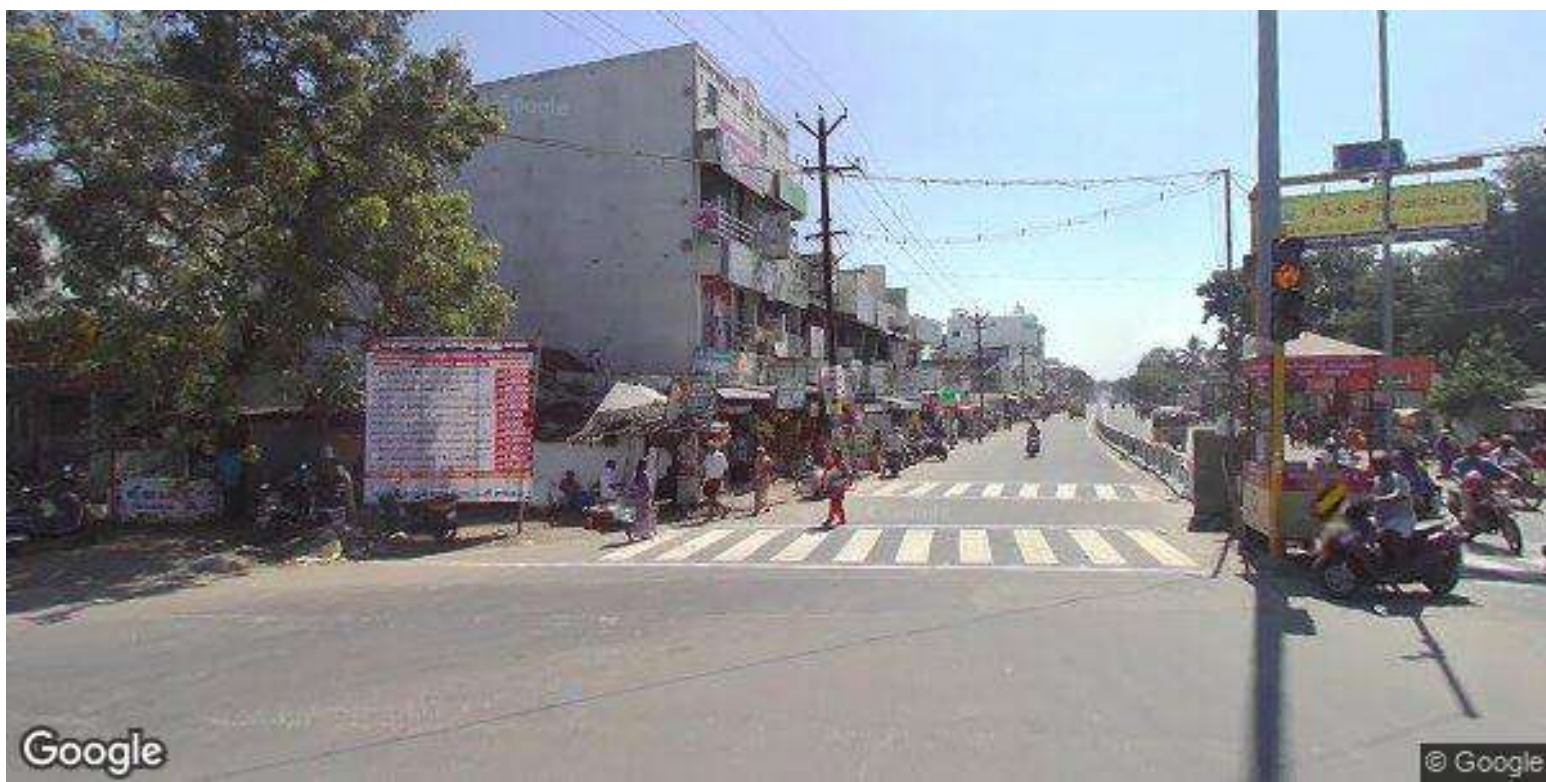
**Coordinates:** 11.20728, 77.35914

**Risk Type:** Turn

**Risk Level:** High

**Speed Limit:** 15 KM/Hr

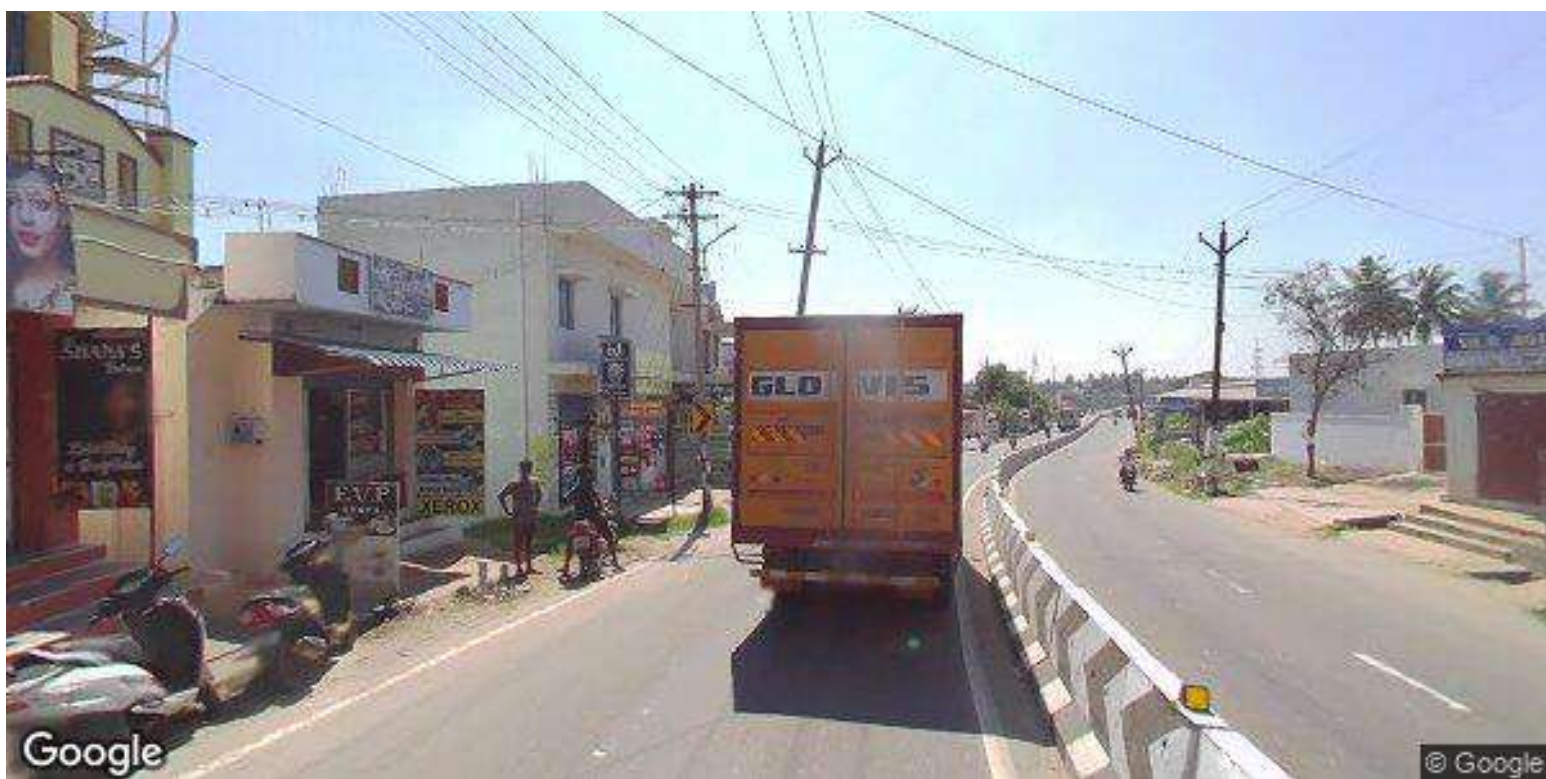
**Coordinates:** 11.20246, 77.35895

**Risk Type:** Turn

**Risk Level:** Medium

**Speed Limit:** 30 KM/Hr

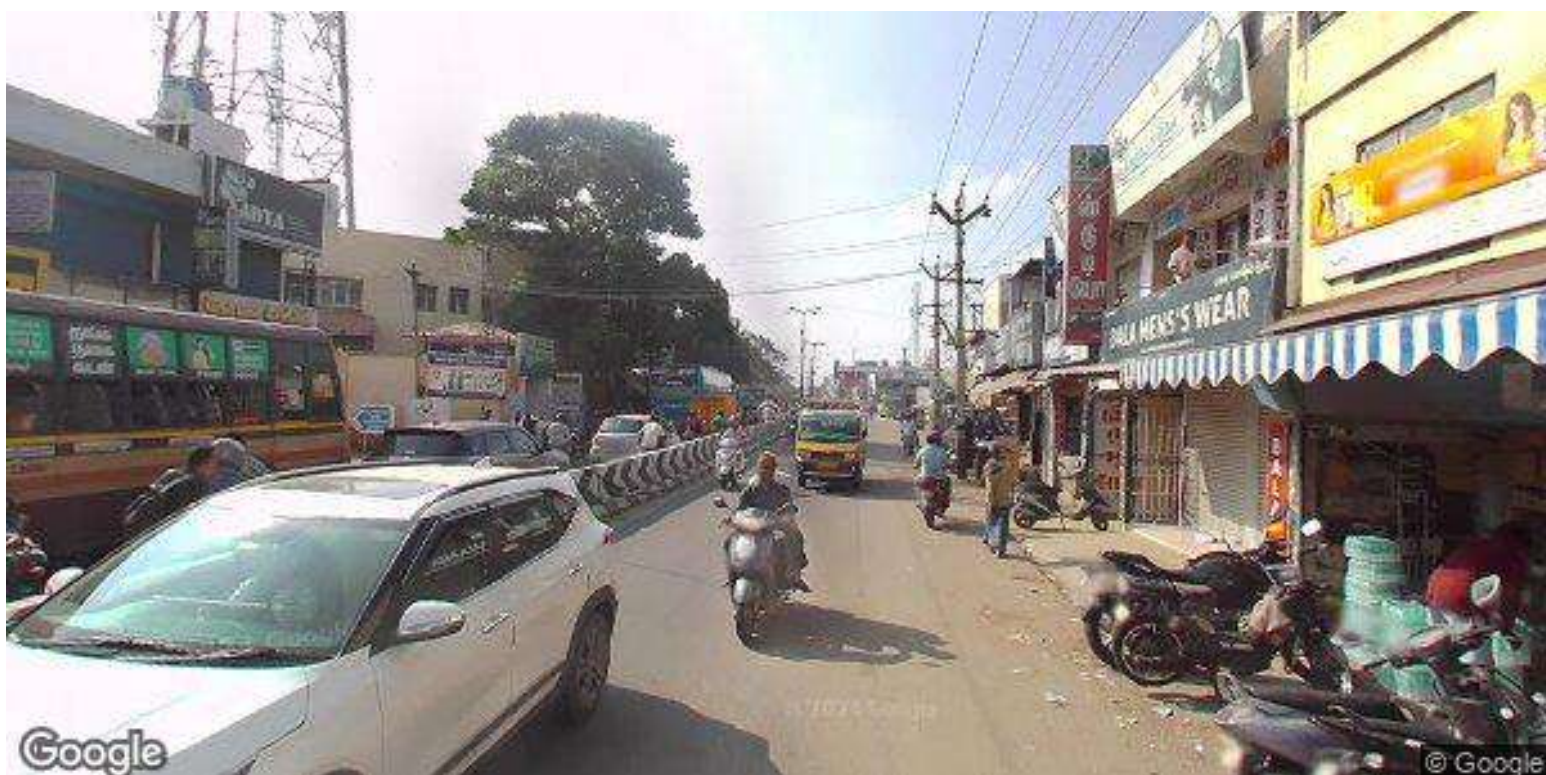
**Coordinates:** 11.13289, 77.34212

**Risk Type:** Blind Spot

**Risk Level:** Blind Spot

**Speed Limit:** 10 KM/Hr
