# IndianOil

## JOURNEY RISK MANAGEMENT (JRM) STUDY

### Salem Terminal to ARUNA FUEL AGENCIES

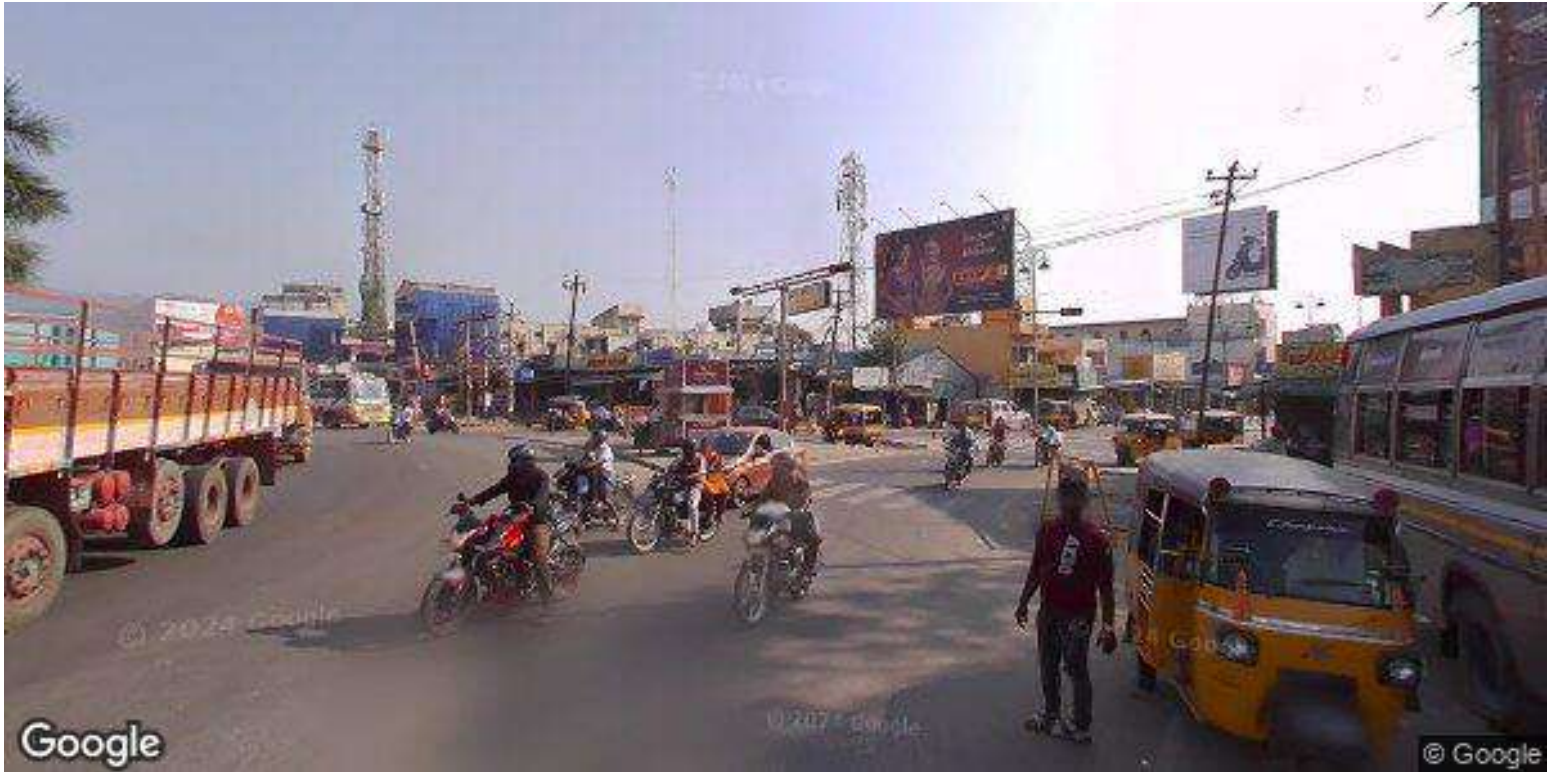
**Risk Type:** Roundabout  
**Risk Level:** High  
**Speed Limit:** 15 KM/Hr  
**Coordinates:** 11.63266, 78.12699

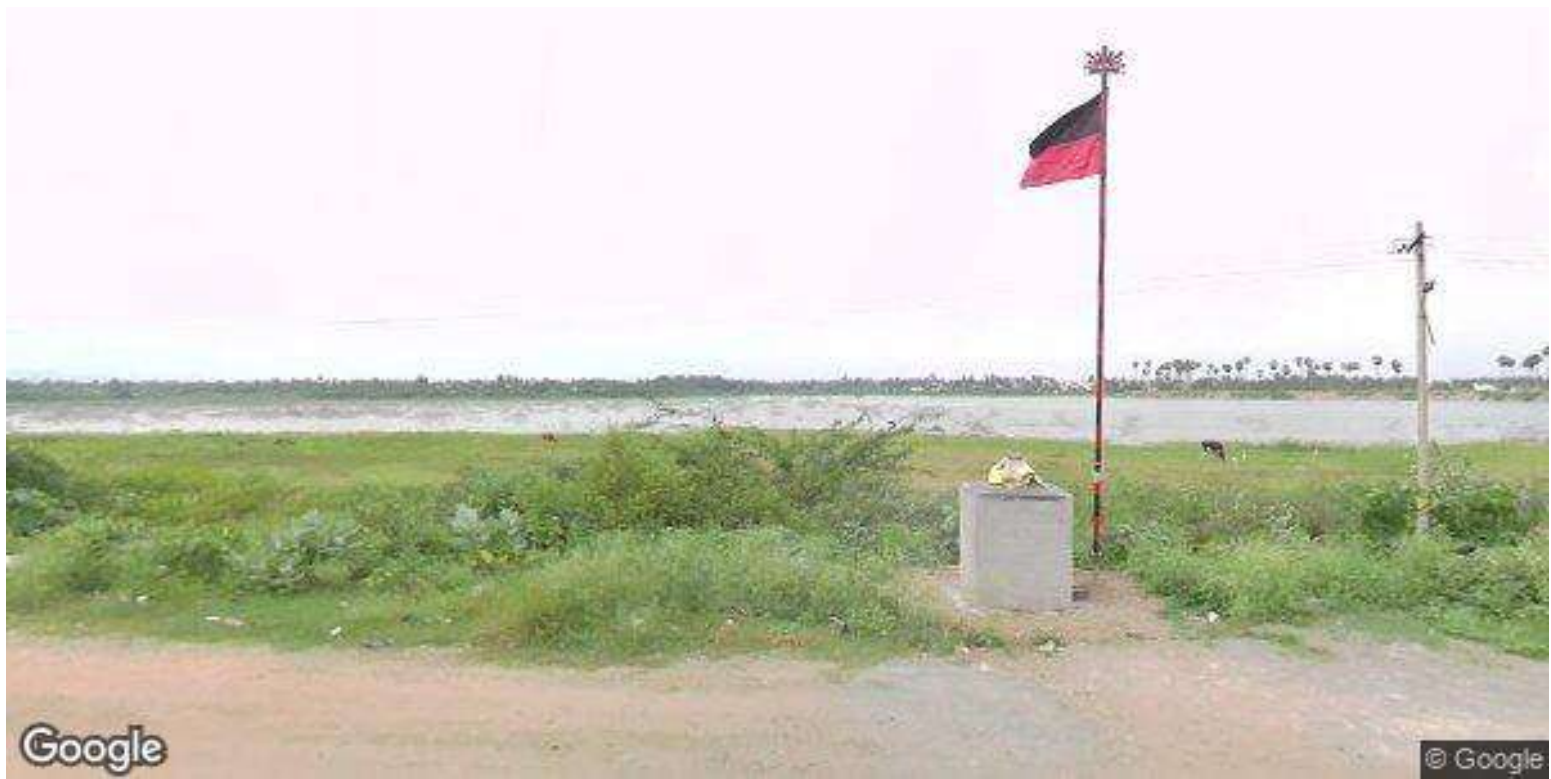
**Risk Type:** U-Turn

**Risk Level:** High

**Speed Limit:** 10 KM/Hr

**Coordinates:** 12.0372299, 78.47784910000001

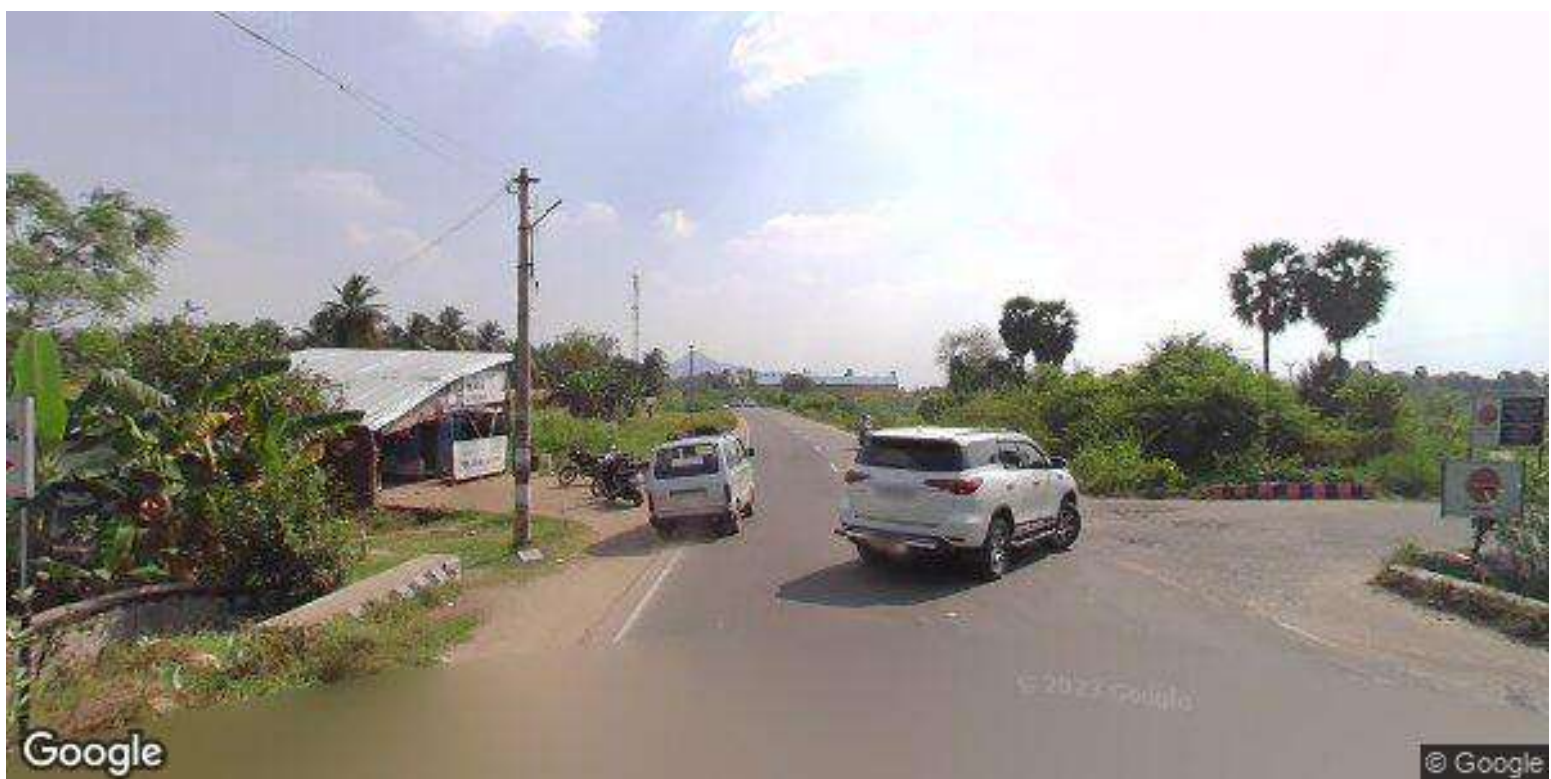
**Risk Type:** Turn

**Risk Level:** High

**Speed Limit:** 15 KM/Hr

**Coordinates:** 11.44029, 77.87544

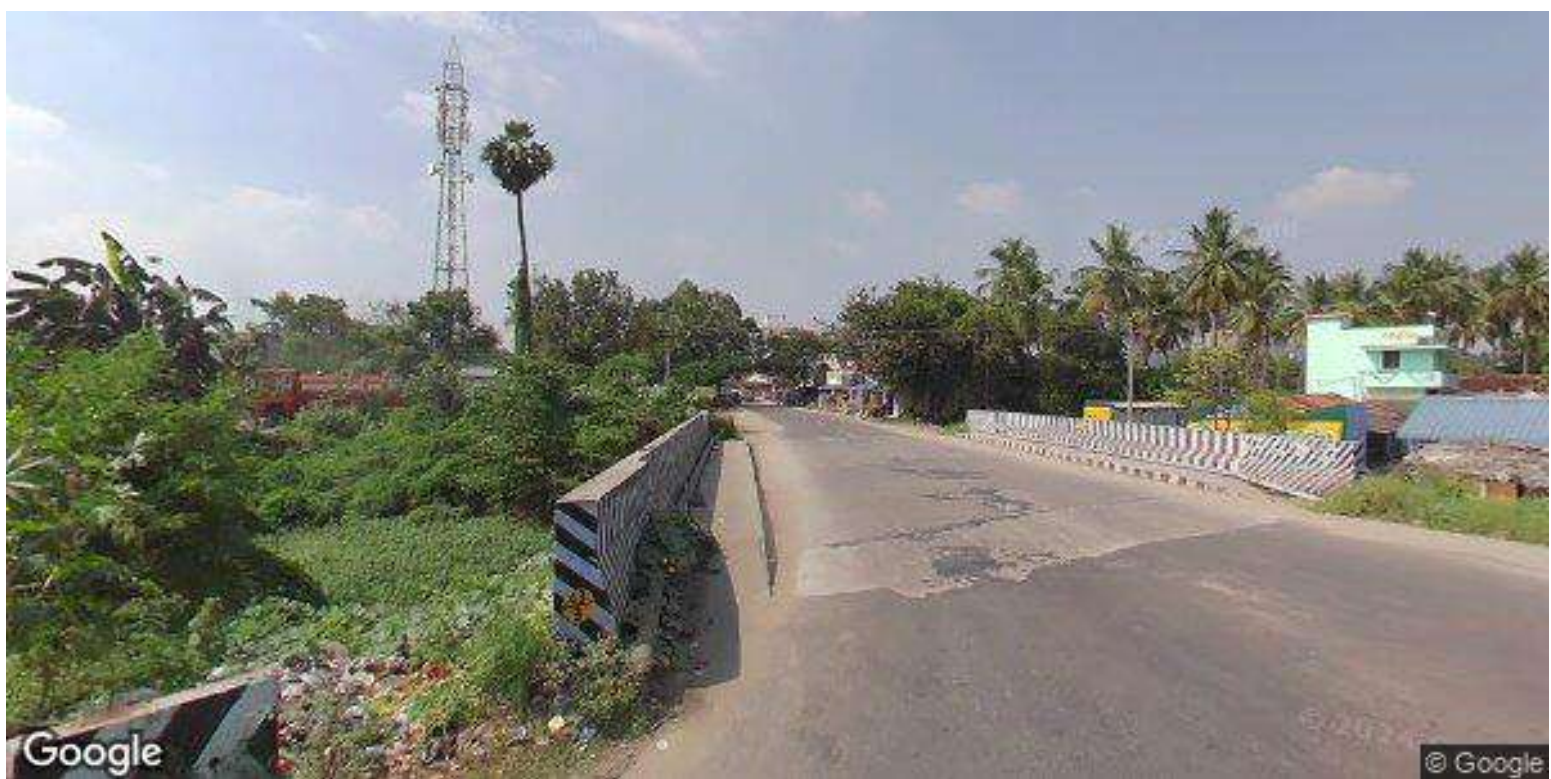
**Risk Type: Turn**

**Risk Level: Medium**

**Speed Limit: 30 KM/Hr**

**Coordinates: 11.44900, 77.87406**

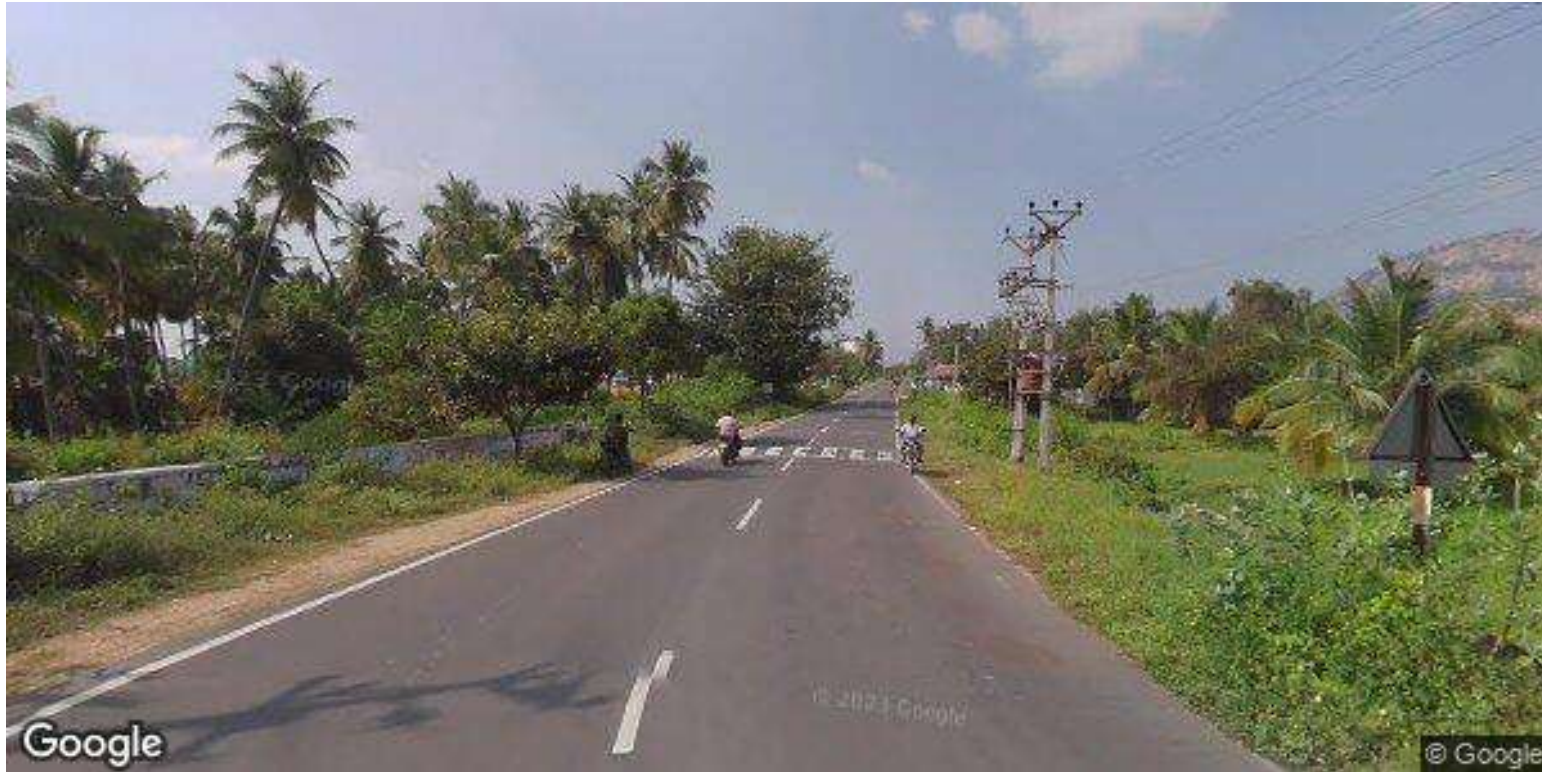
**Risk Type: Turn**

**Risk Level: High**

**Speed Limit: 15 KM/Hr**

**Coordinates: 11.45353, 77.85697**

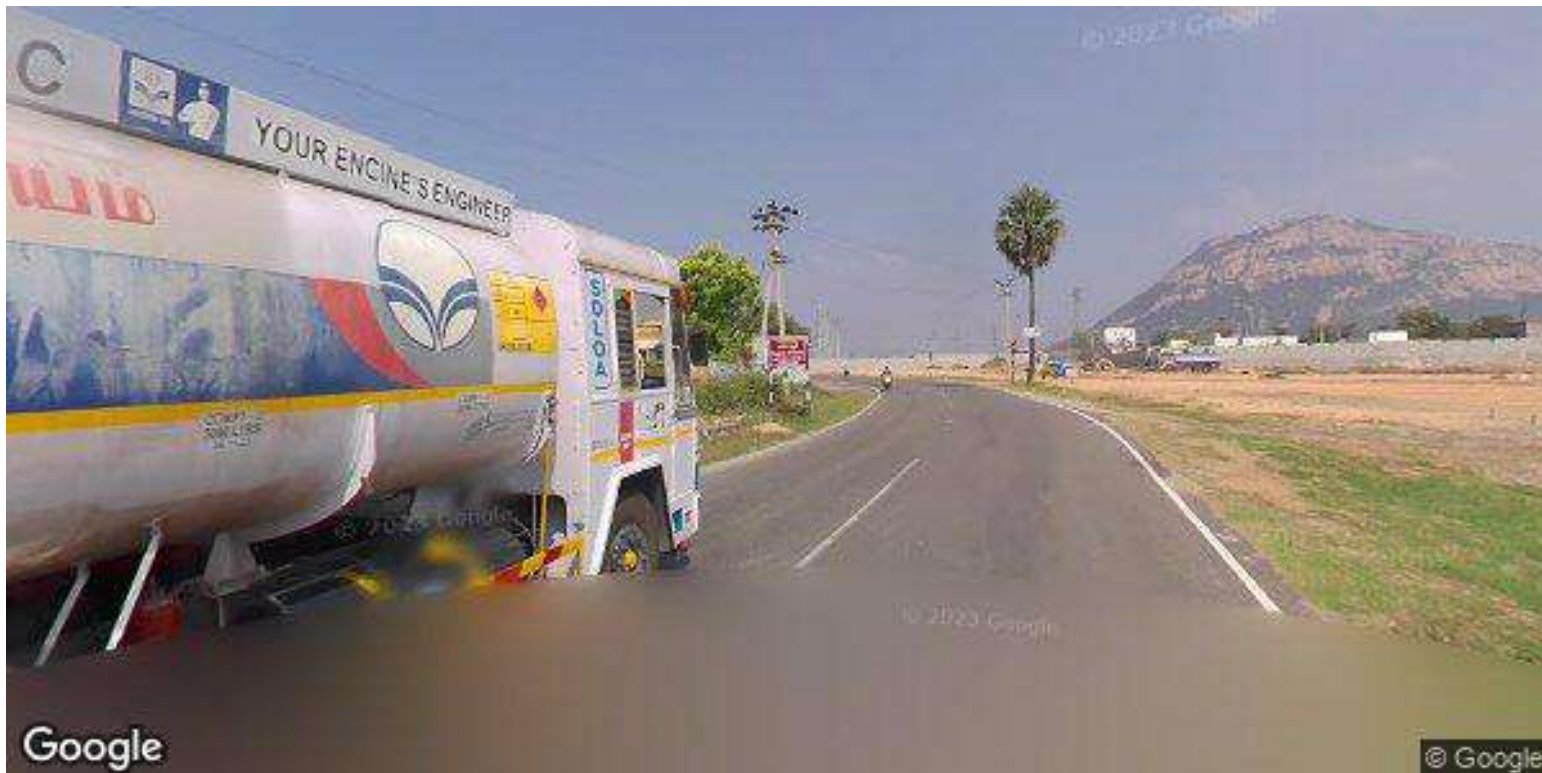
**Risk Type: Turn**

**Risk Level: Medium**

**Speed Limit: 30 KM/Hr**

**Coordinates: 11.45853, 77.85139**

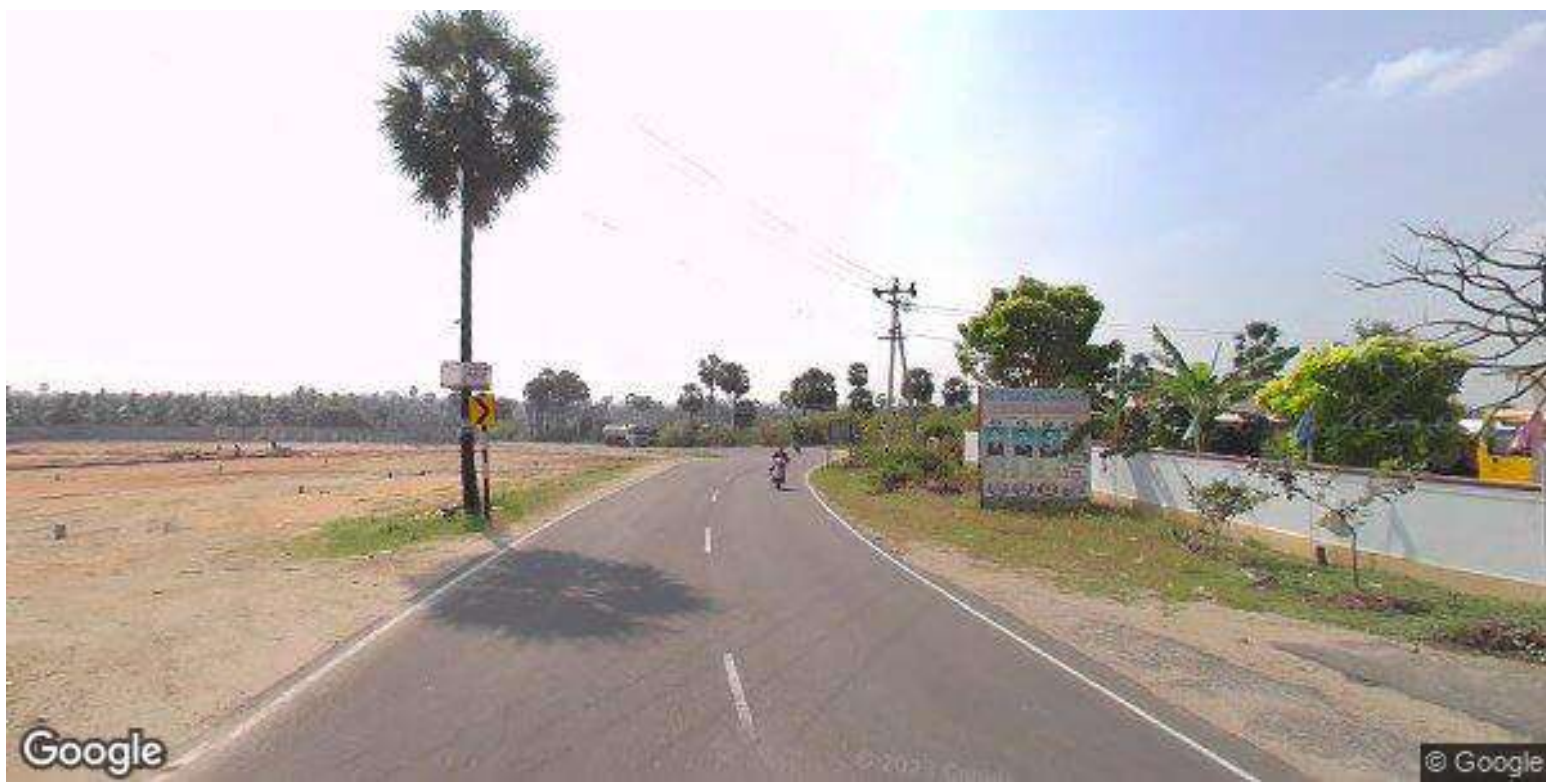
**Risk Type:** Turn

**Risk Level:** Medium

**Speed Limit:** 30 KM/Hr

**Coordinates:** 11.45906, 77.85132

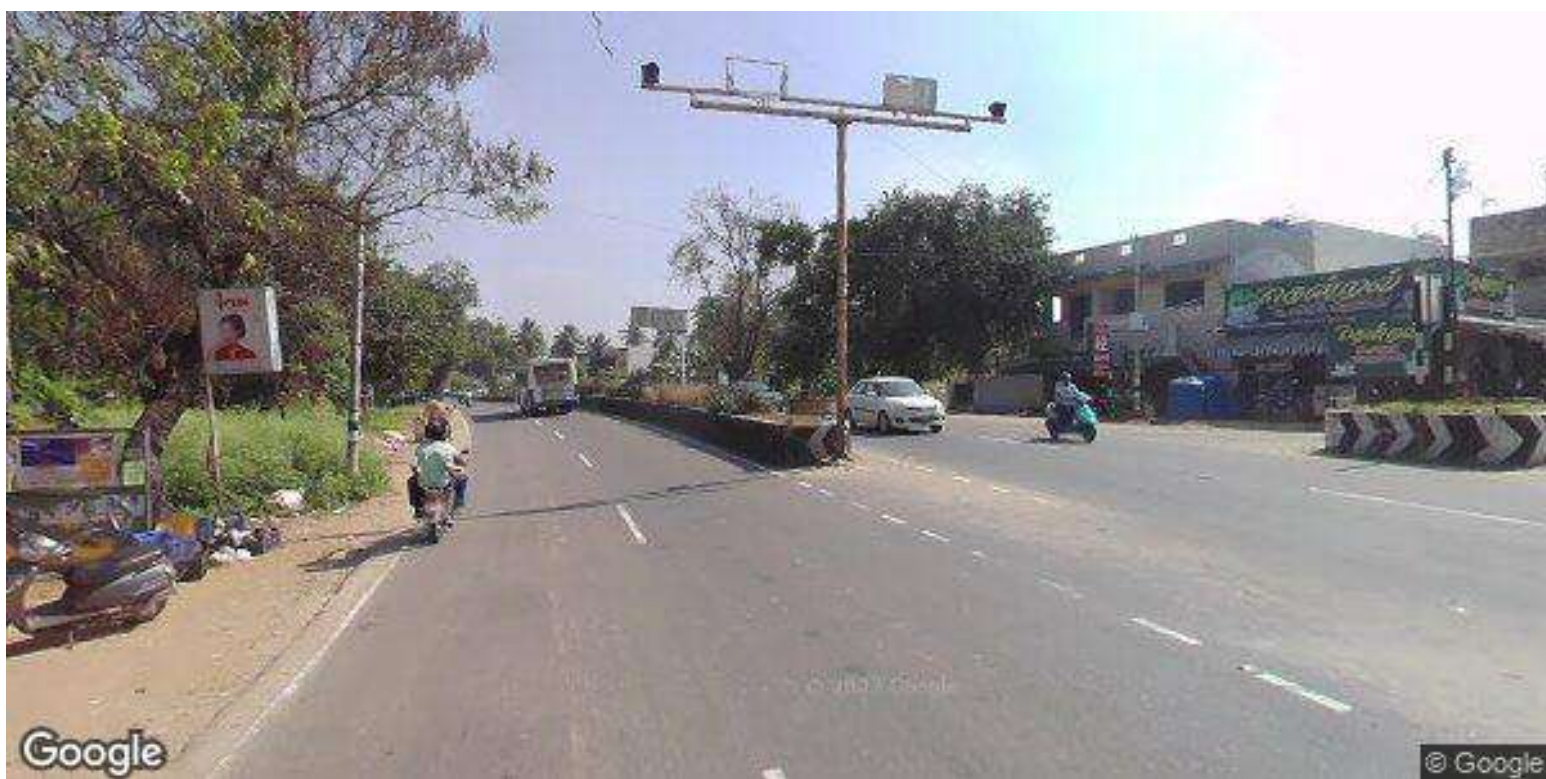
**Risk Type:** Turn

**Risk Level:** High

**Speed Limit:** 15 KM/Hr

**Coordinates:** 11.46332, 77.84935

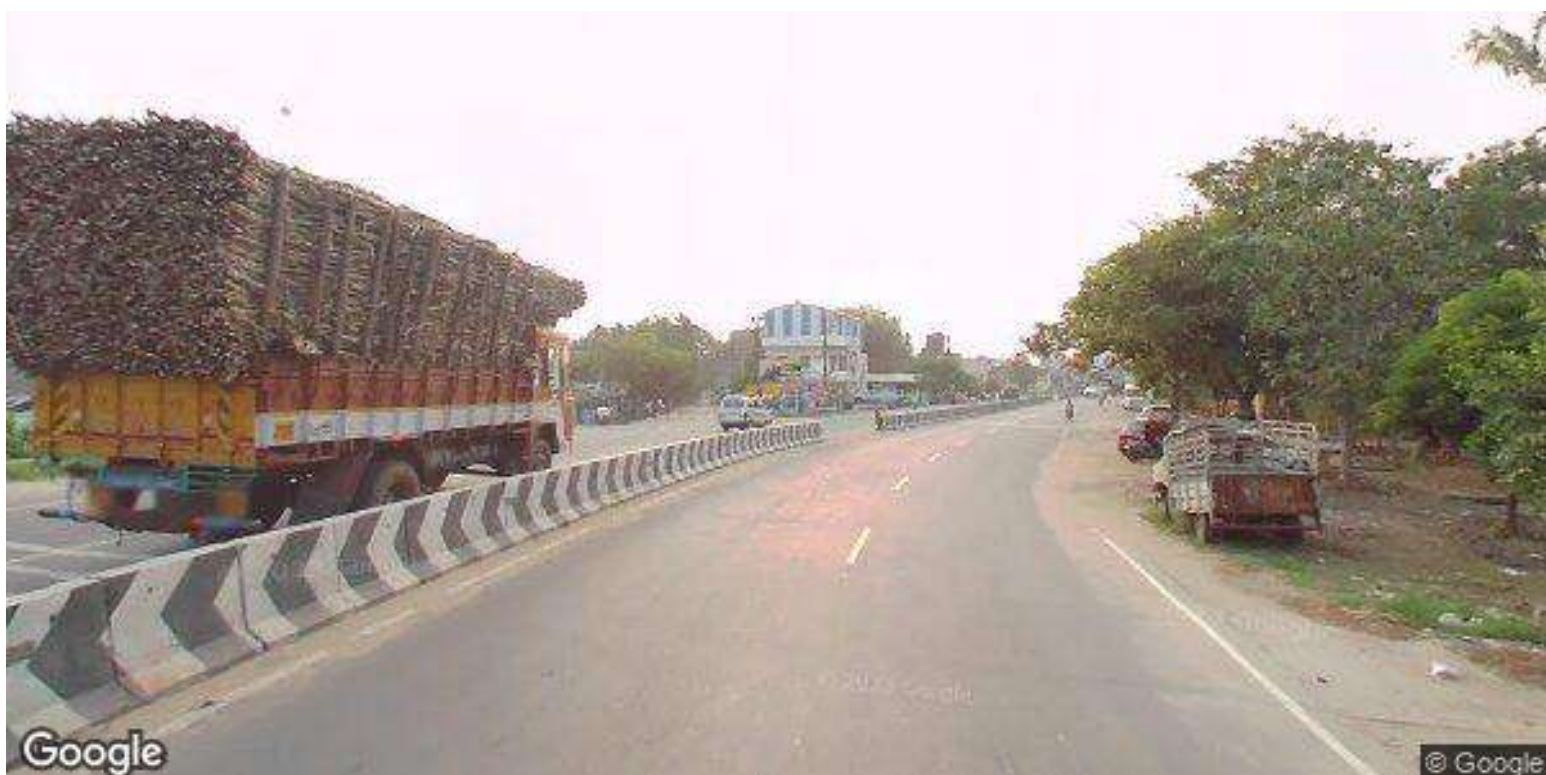
**Risk Type: Turn**

**Risk Level: Medium**

**Speed Limit: 30 KM/Hr**

**Coordinates: 11.47358, 77.86766**

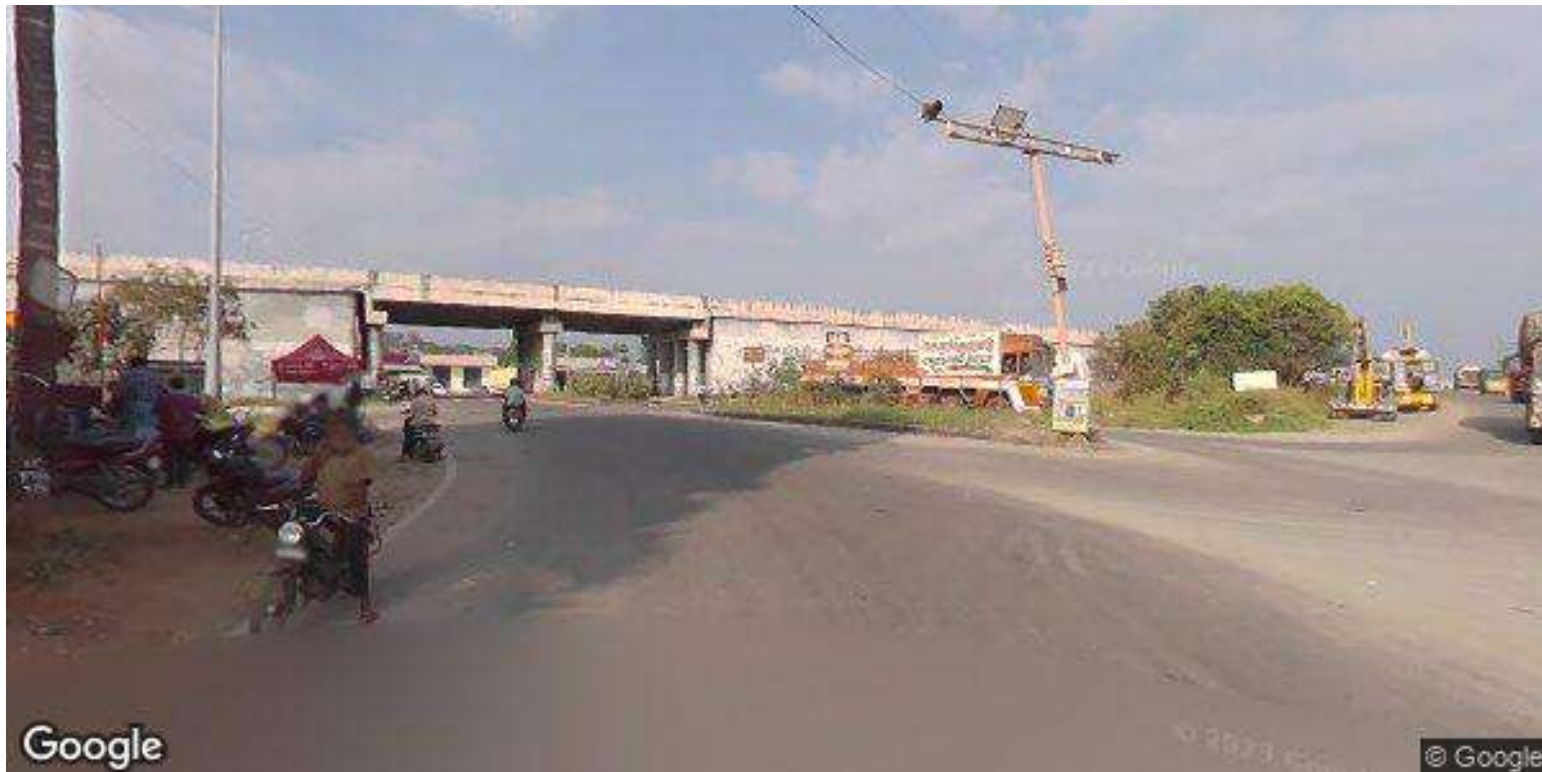
**Risk Type: Turn**

**Risk Level: High**

**Speed Limit: 15 KM/Hr**

**Coordinates: 11.49150, 77.89602**

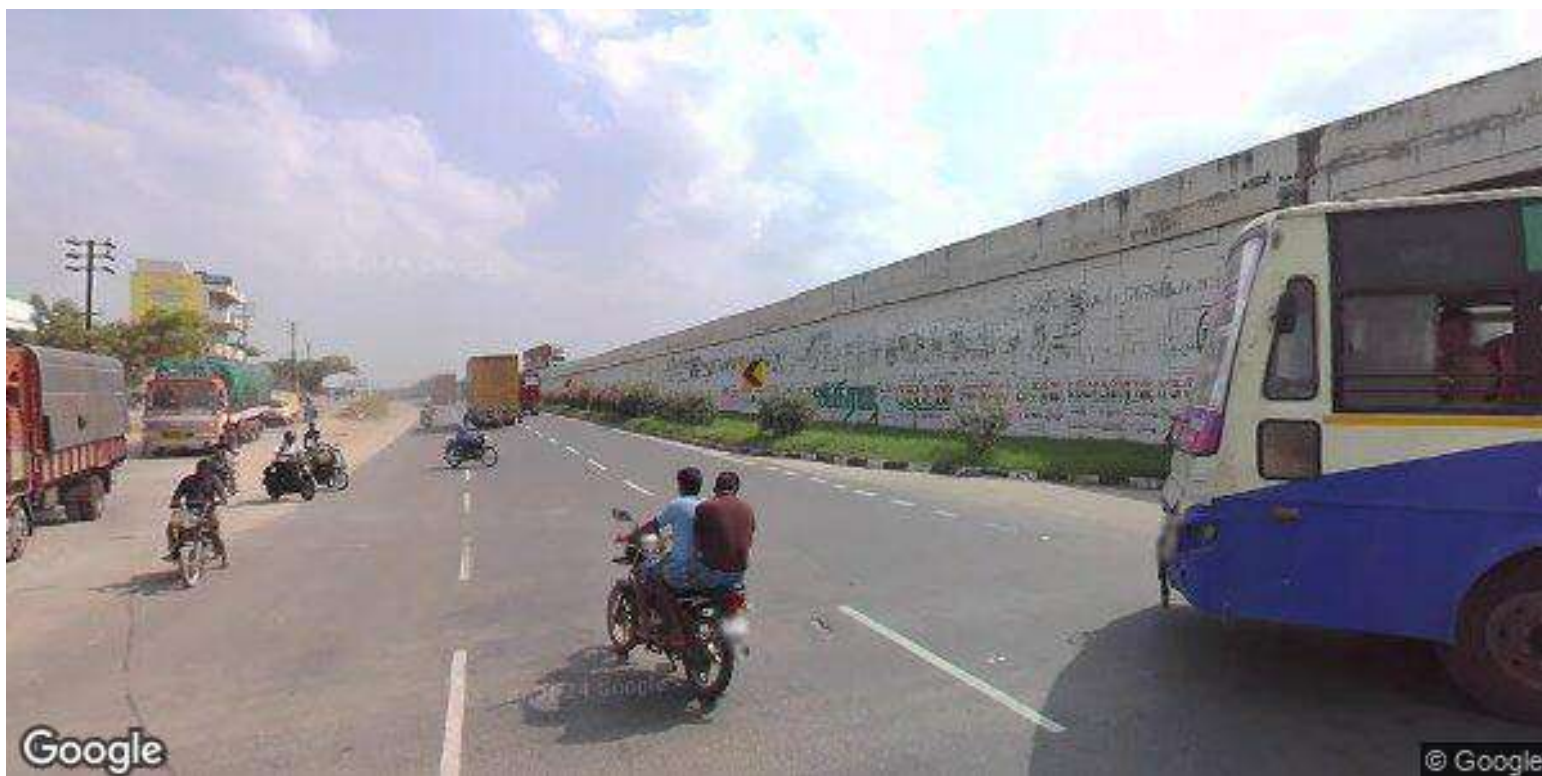
**Risk Type: Turn**

**Risk Level: High**

**Speed Limit: 15 KM/Hr**

**Coordinates: 11.49224, 77.89611**

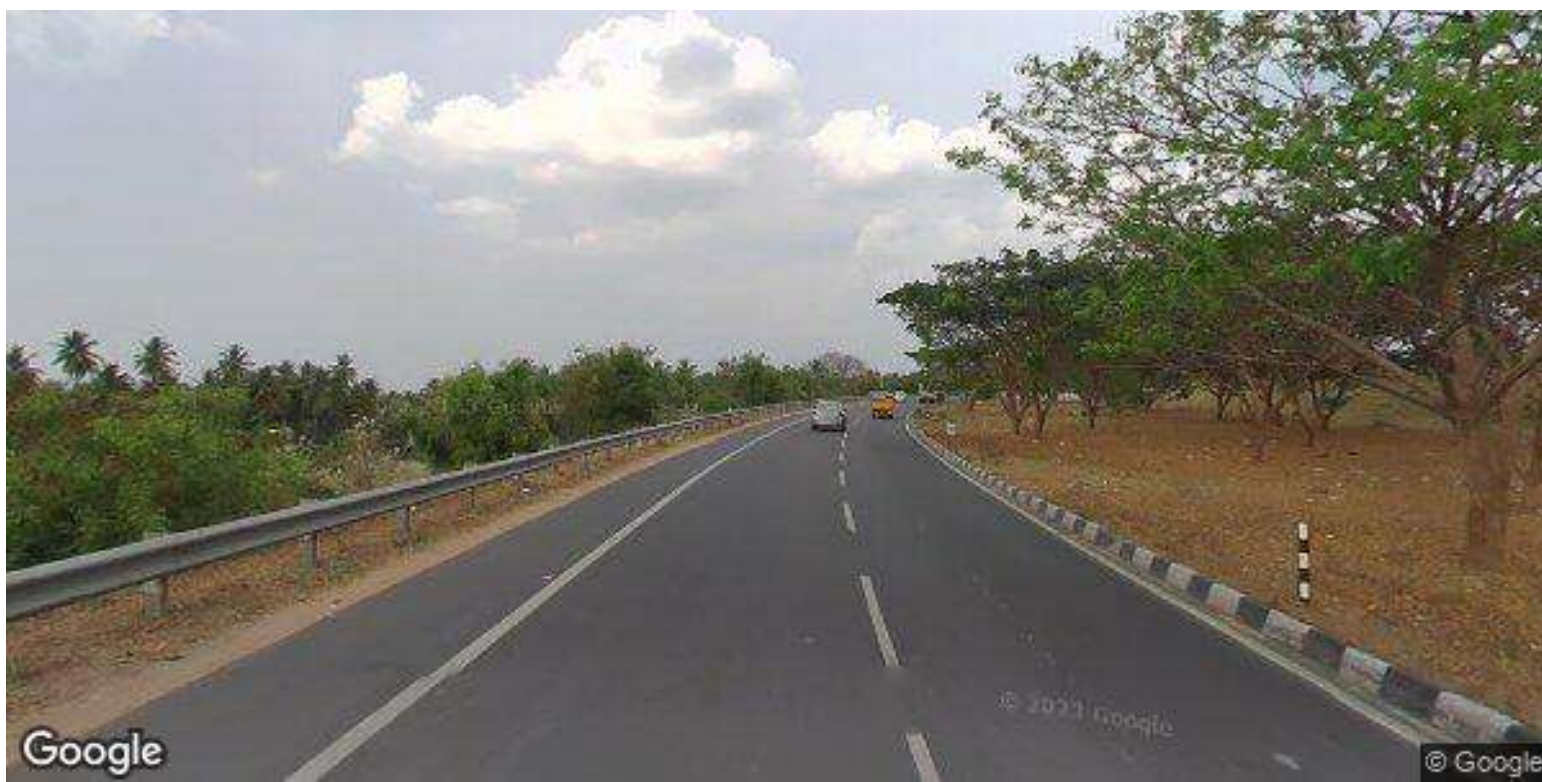
**Risk Type:** Turn

**Risk Level:** Medium

**Speed Limit:** 30 KM/Hr

**Coordinates:** 11.53584, 77.95814

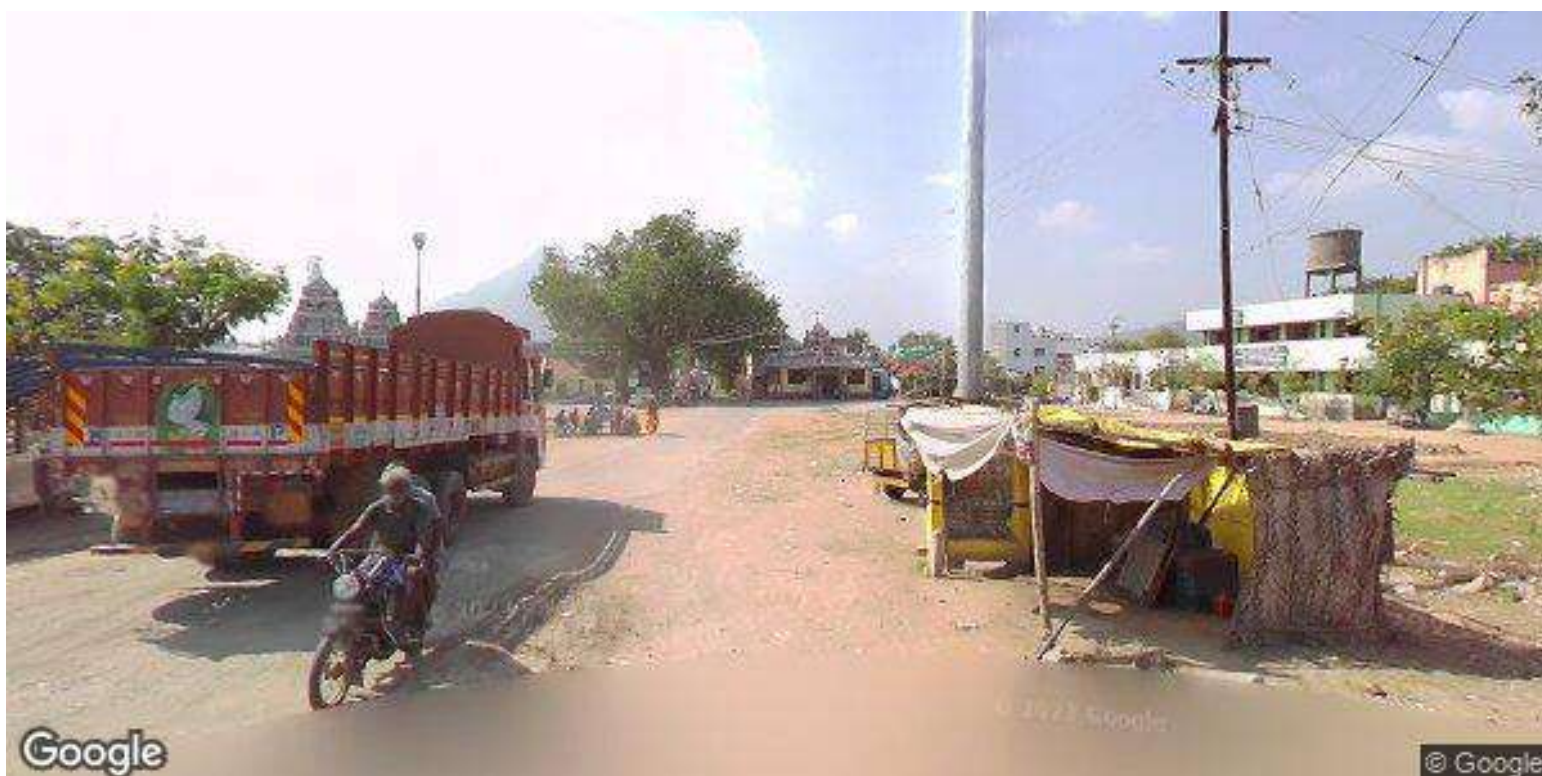
**Risk Type:** Blind Spot

**Risk Level:** Blind Spot

**Speed Limit:** 10 KM/Hr

**Coordinates:** 11.62145, 78.10740

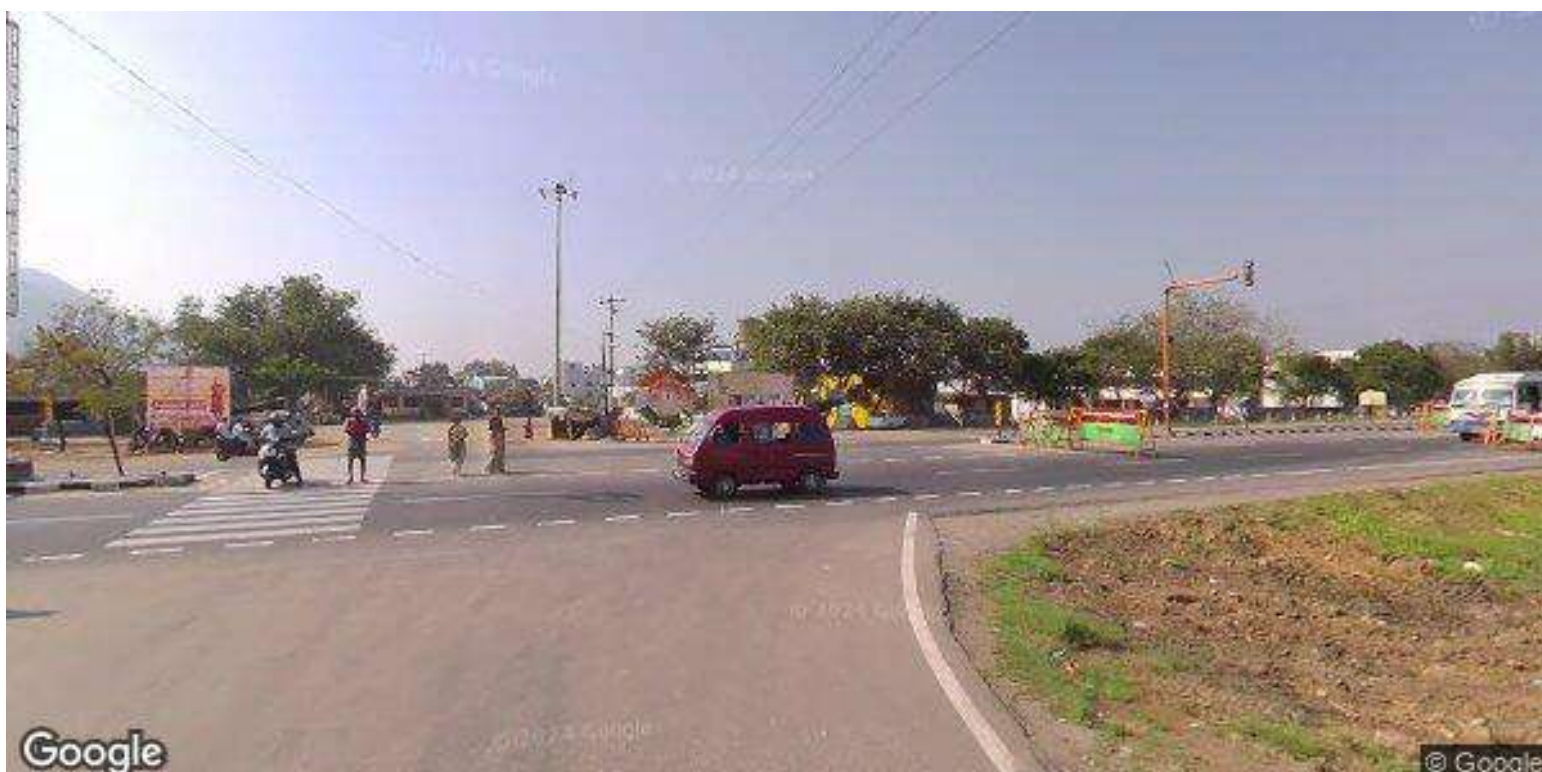
**Risk Type: Turn**

**Risk Level: High**

**Speed Limit: 15 KM/Hr**

**Coordinates: 11.62130, 78.10776**

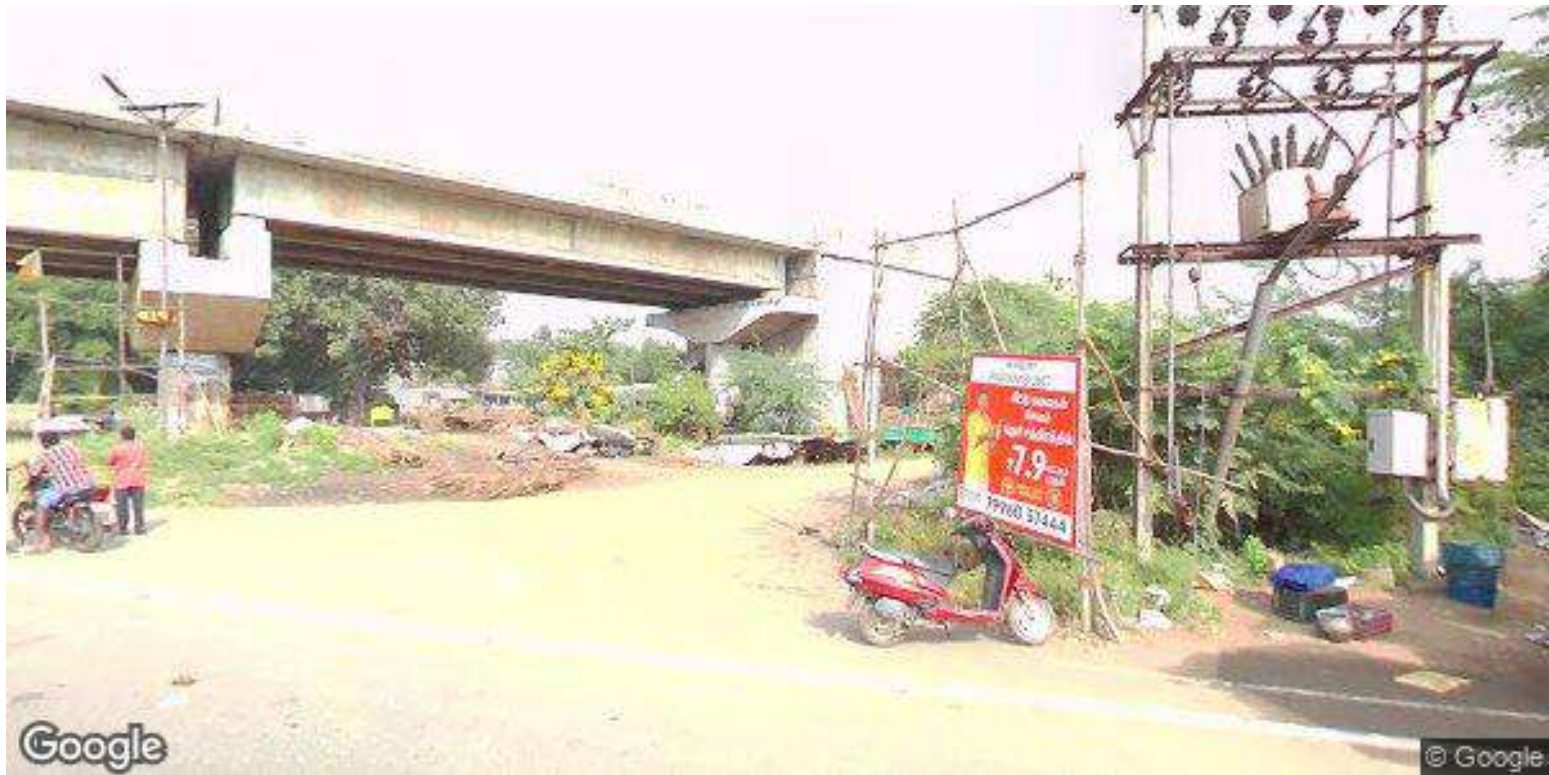
**Risk Type: Blind Spot**

**Risk Level: Blind Spot**

**Speed Limit: 10 KM/Hr**

**Coordinates: 11.61235, 78.10438**

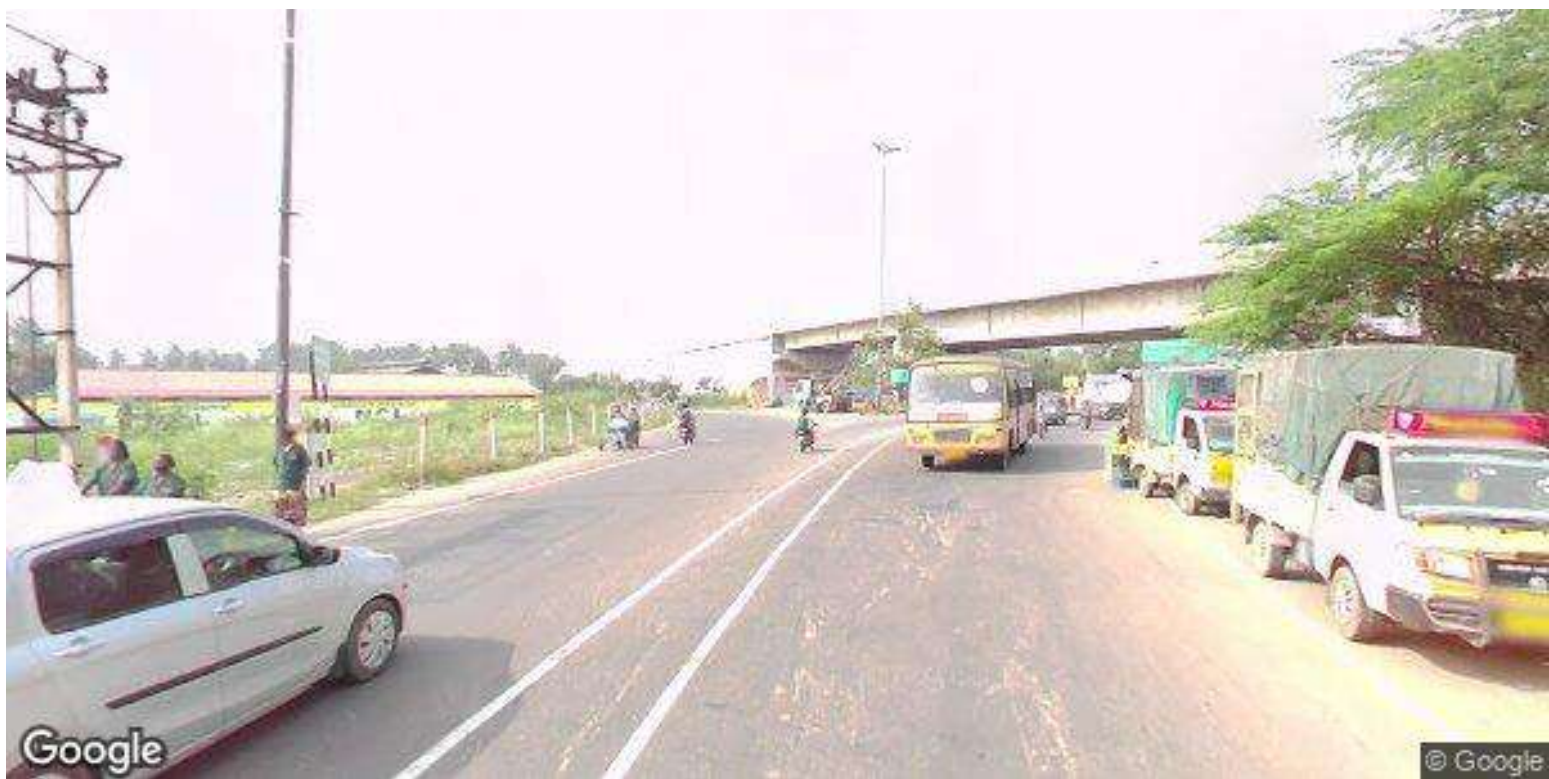
**Risk Type: Turn**

**Risk Level: Medium**

**Speed Limit: 30 KM/Hr**

**Coordinates: 11.61224, 78.10469**

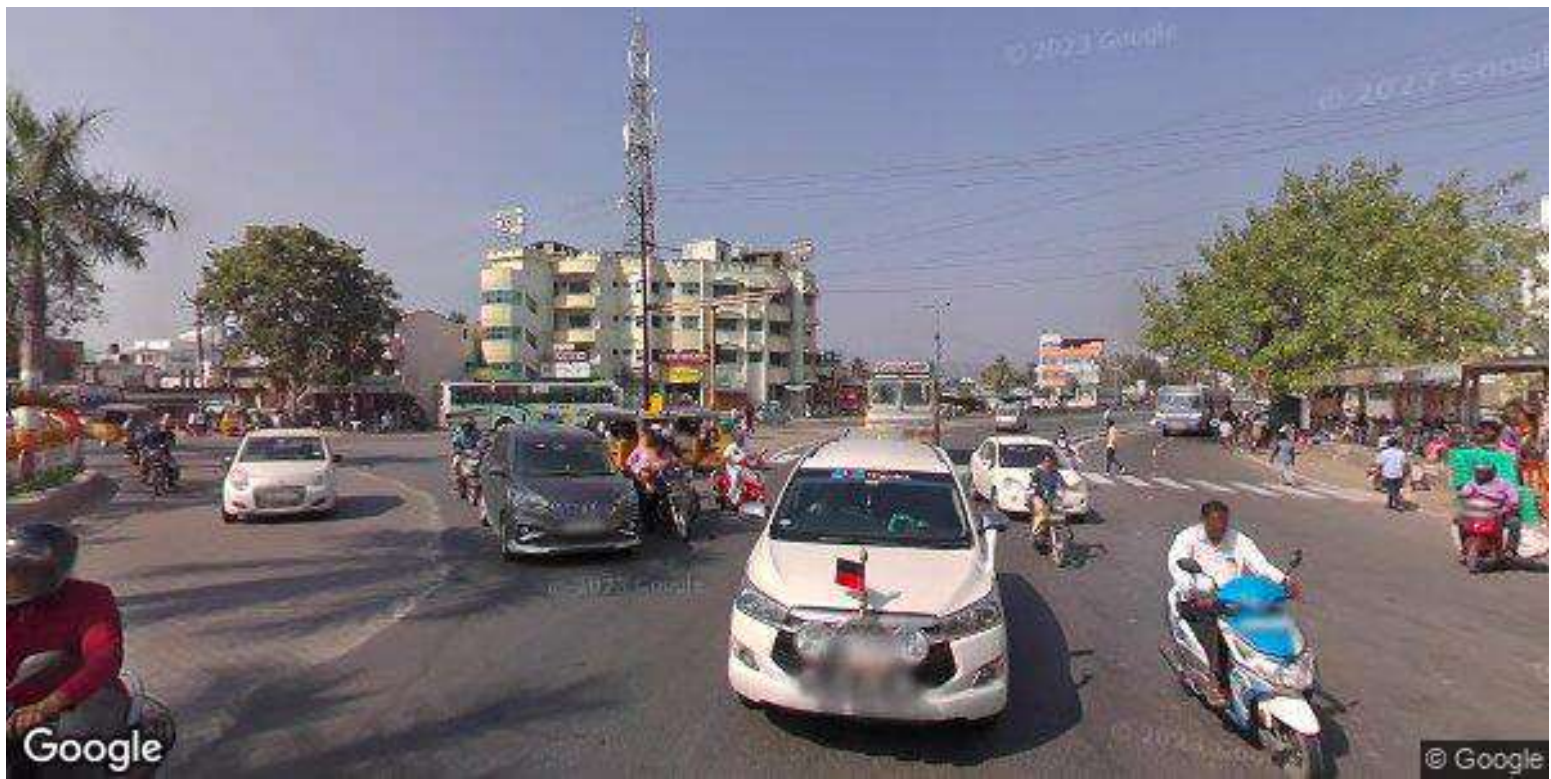
**Risk Type:** Blind Spot  
**Risk Level:** Blind Spot  
**Speed Limit:** 10 KM/Hr  
**Coordinates:** 11.63306, 78.12722

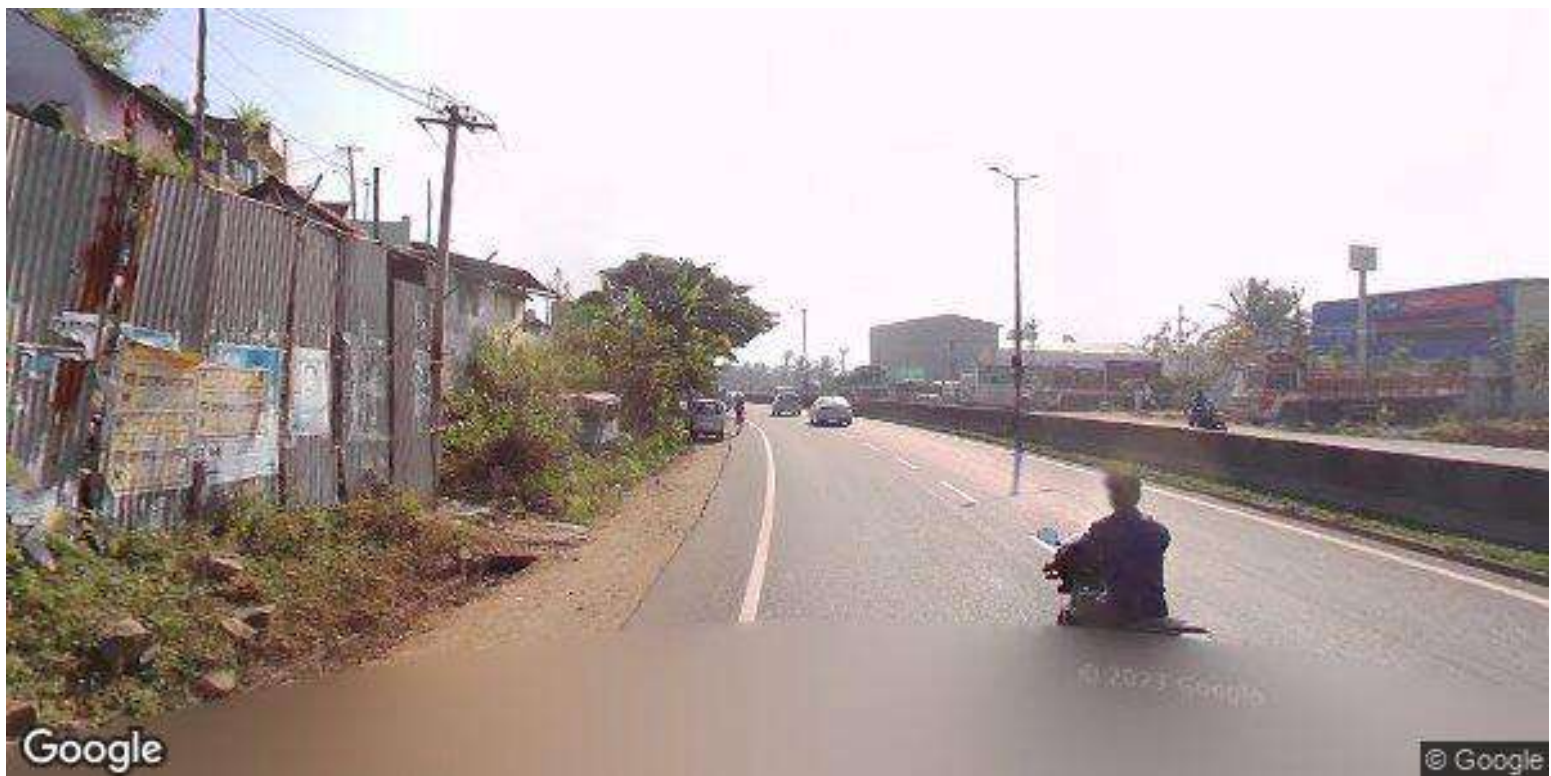
**Risk Type:** Turn  
**Risk Level:** Medium  
**Speed Limit:** 30 KM/Hr  
**Coordinates:** 11.62826, 78.13337

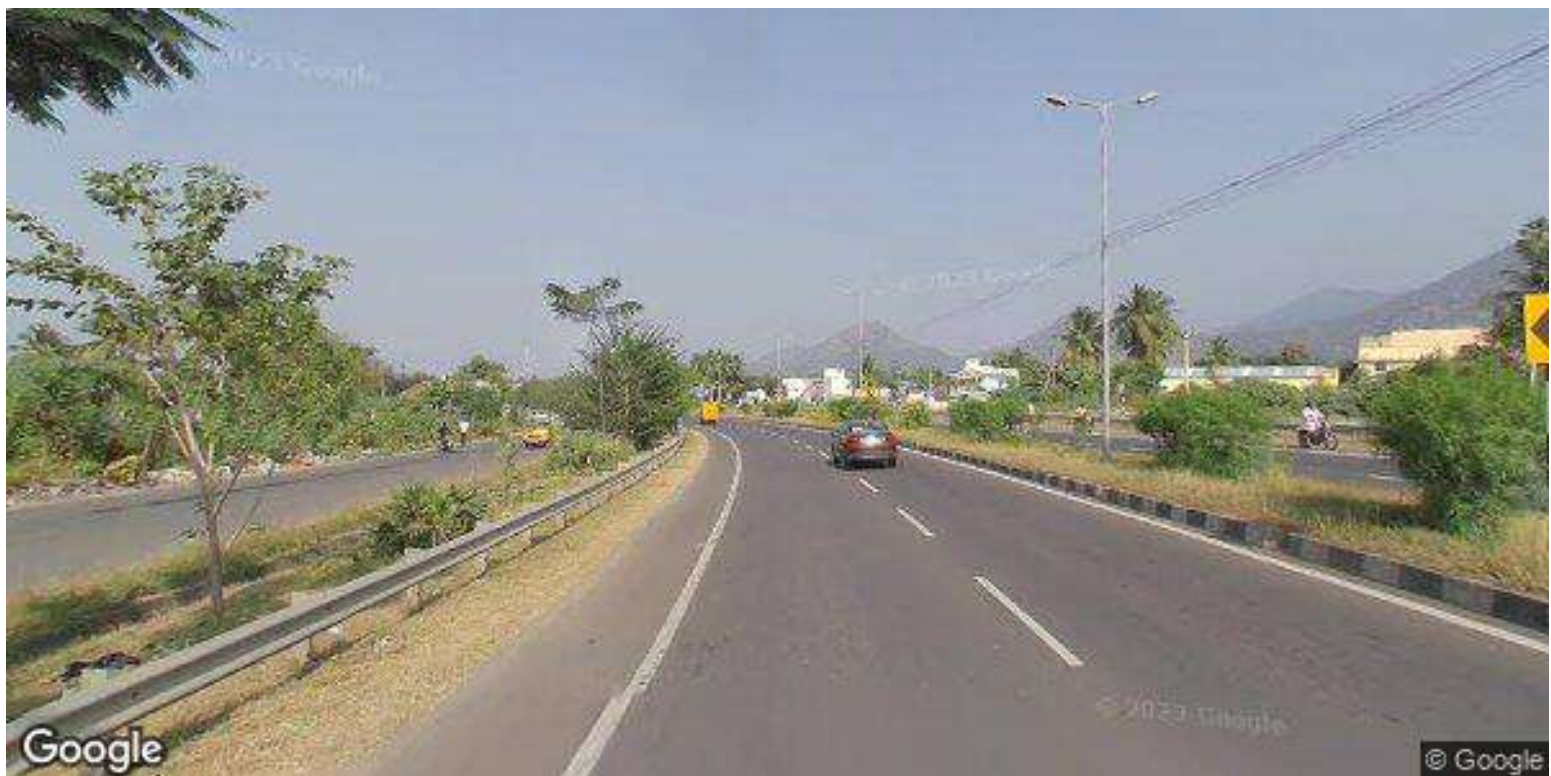
**Risk Type:** Turn  
**Risk Level:** Medium  
**Speed Limit:** 30 KM/Hr  
**Coordinates:** 11.62836, 78.16483
