# IndianOil

## JOURNEY RISK MANAGEMENT (JRM) STUDY

### Salem Terminal to ARUNA FUEL AGENCIES

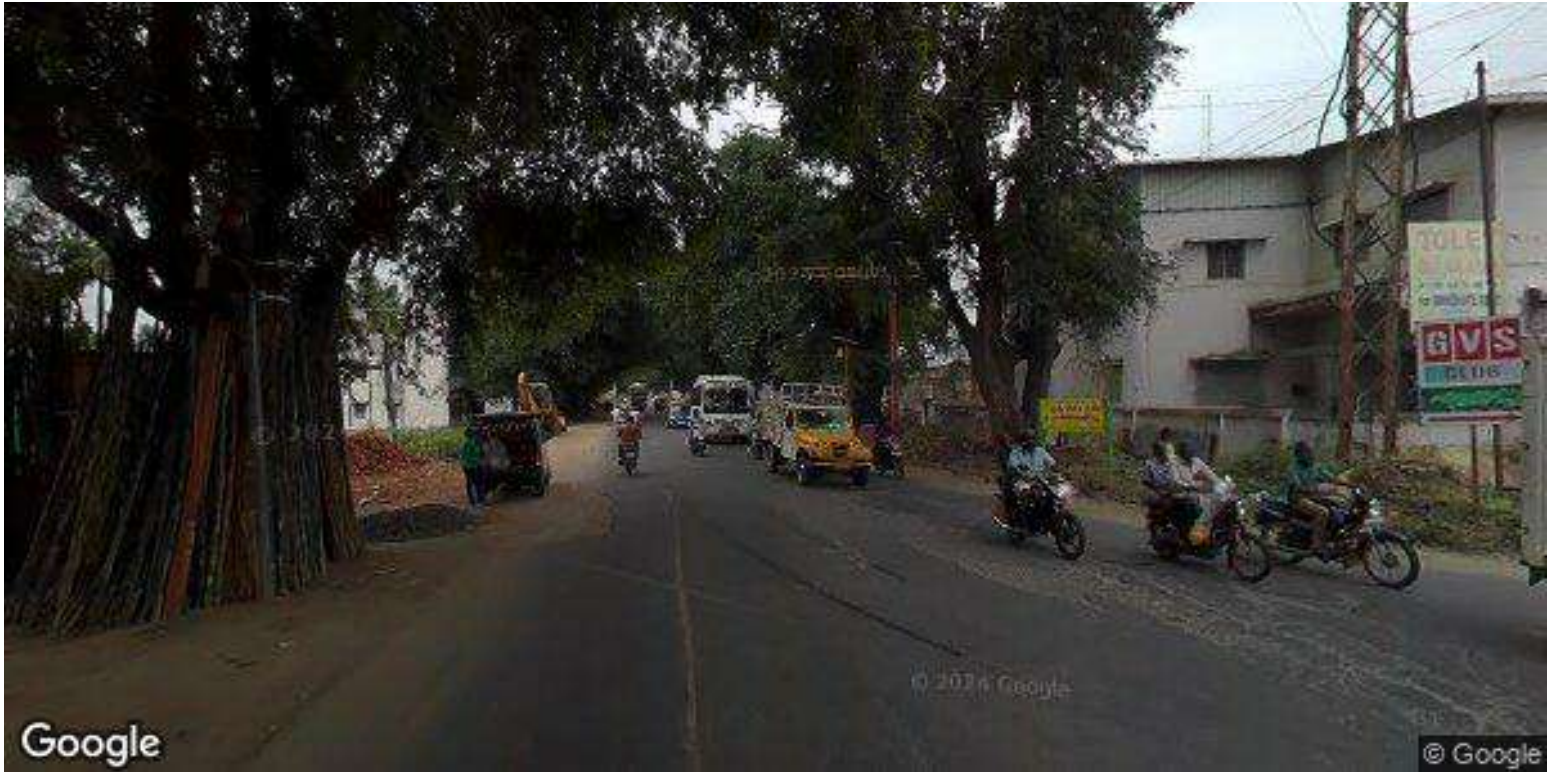
**Risk Type:** Turn  
**Risk Level:** High  
**Speed Limit:** 15 KM/Hr  
**Coordinates:** 11.66380, 78.20648

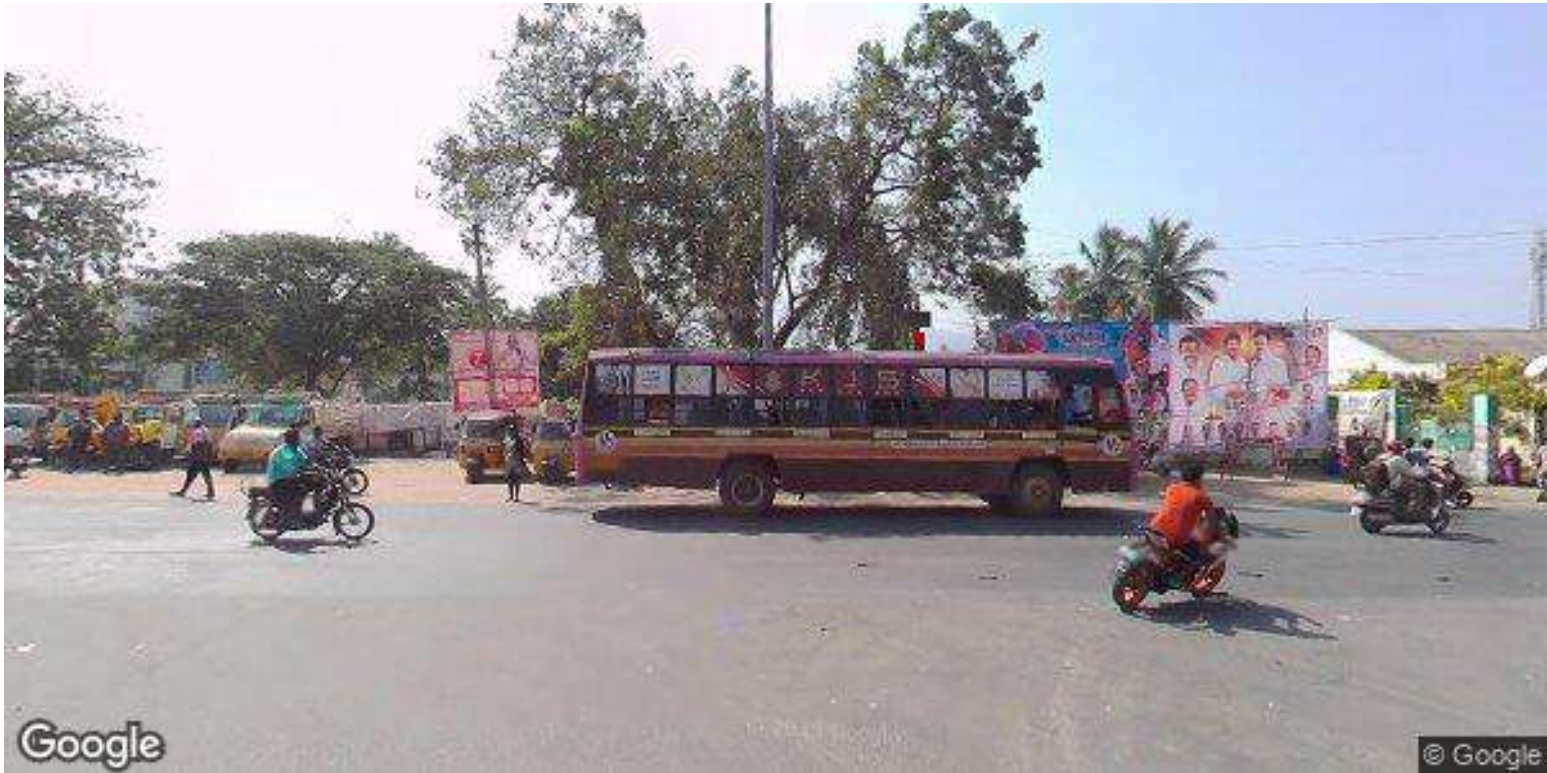
**Risk Type:** Turn  
**Risk Level:** High  
**Speed Limit:** 15 KM/Hr  
**Coordinates:** 11.67120, 78.23136

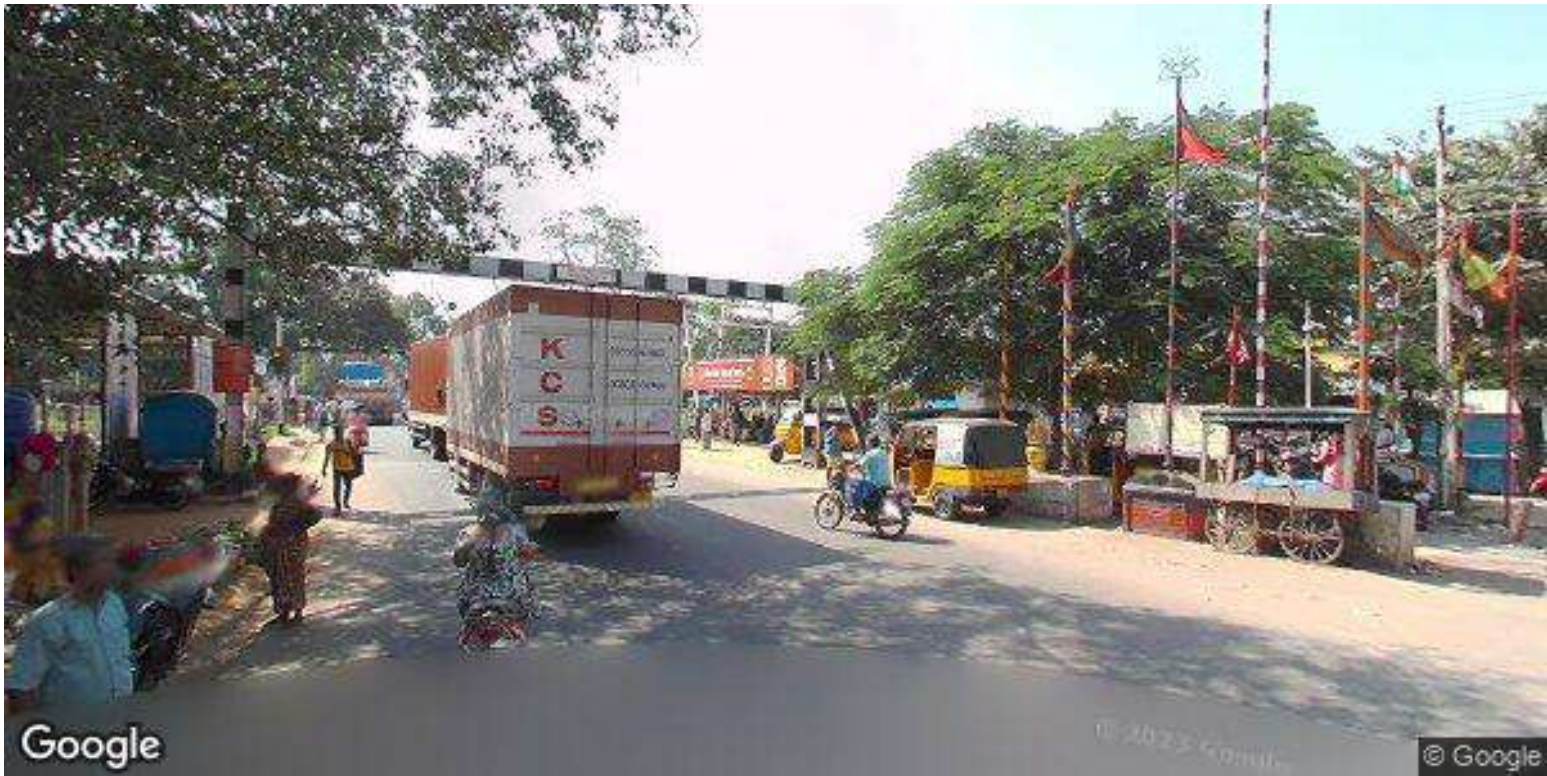
**Risk Type:** Turn  
**Risk Level:** High  
**Speed Limit:** 15 KM/Hr  
**Coordinates:** 11.67190, 78.23144

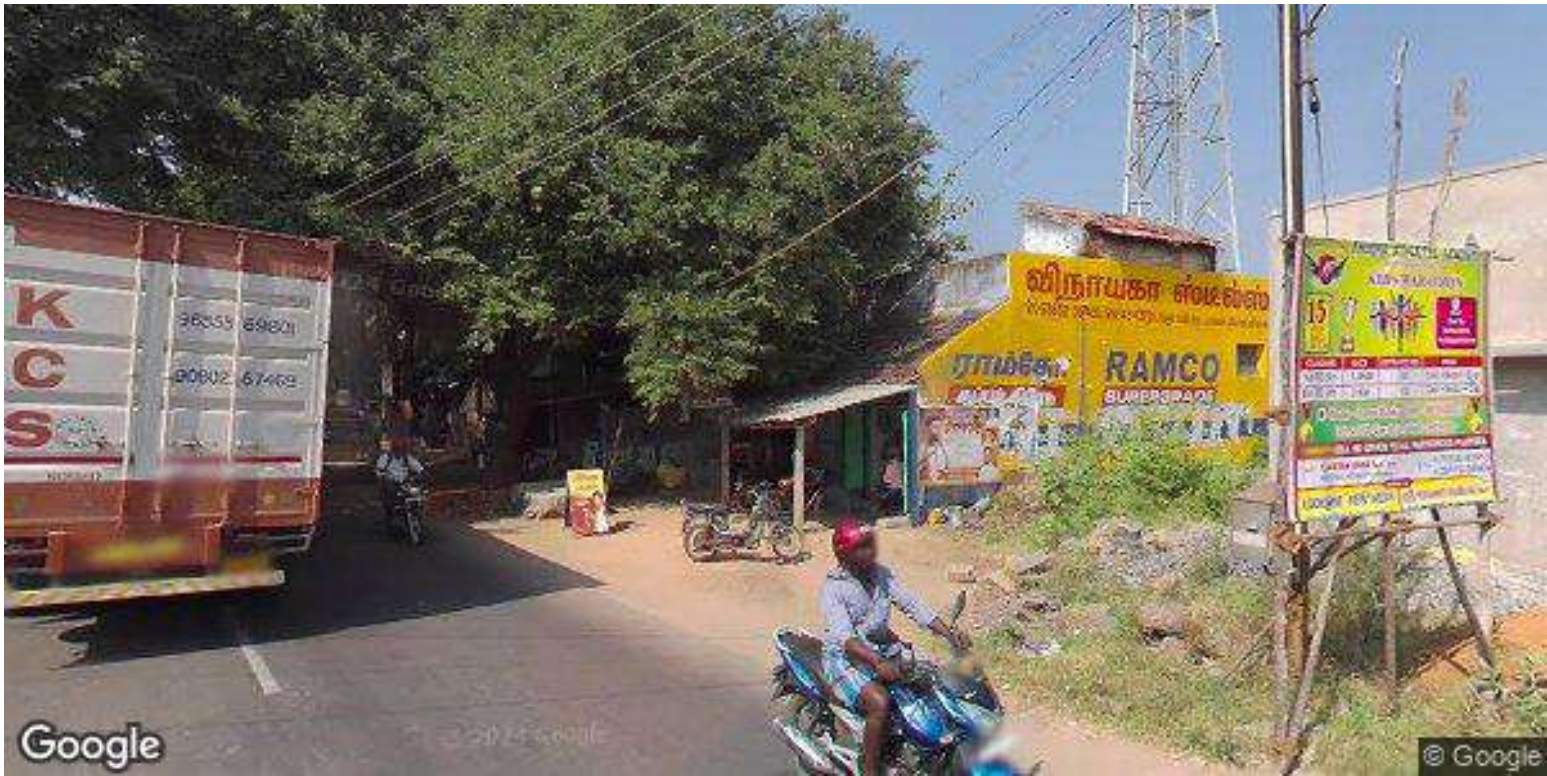
**Risk Type:** Turn  
**Risk Level:** Medium  
**Speed Limit:** 30 KM/Hr  
**Coordinates:** 11.67429, 78.23896

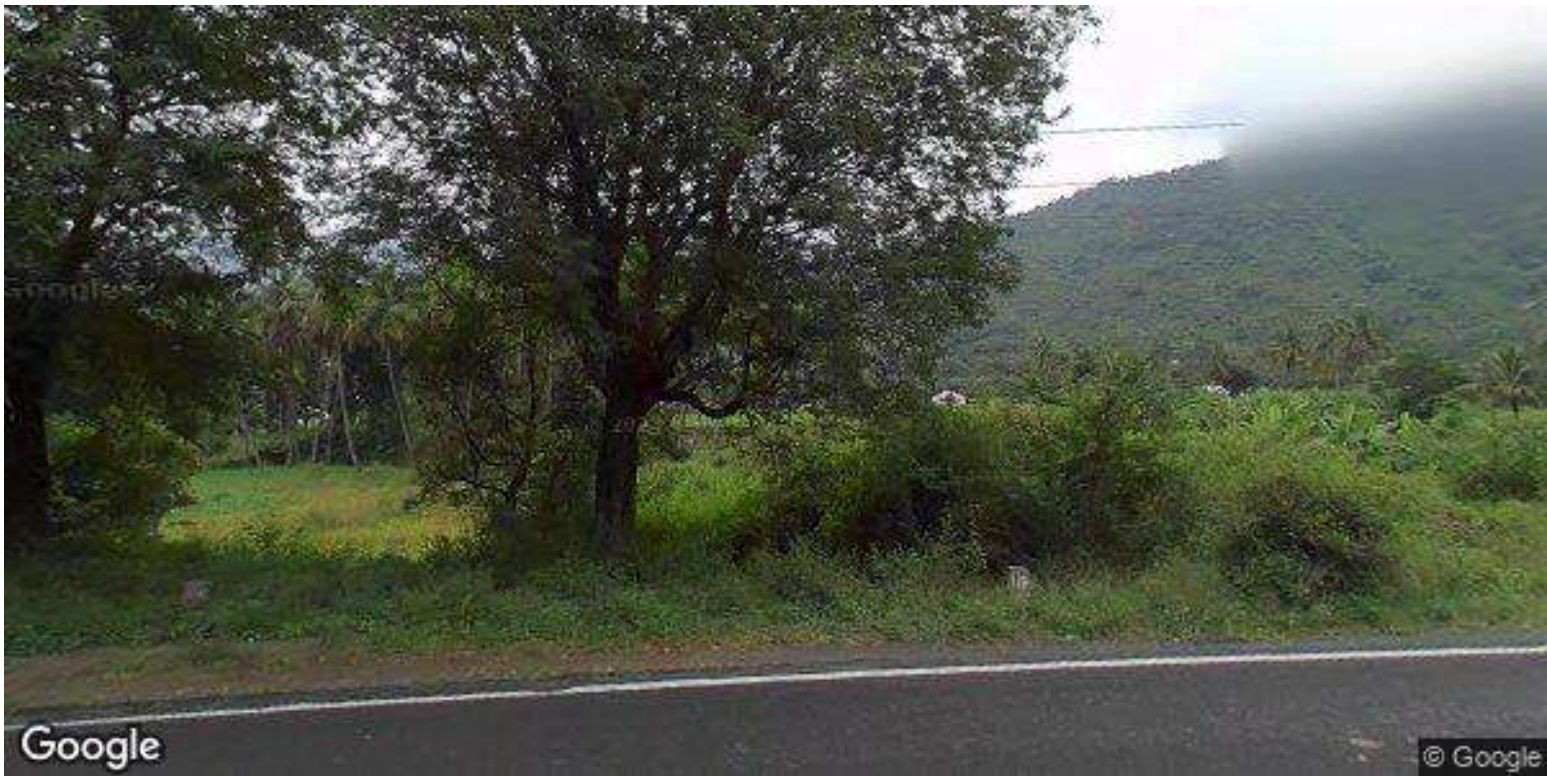
**Risk Type: Turn**

**Risk Level: Medium**

**Speed Limit: 30 KM/Hr**

**Coordinates: 11.81219, 78.34077**

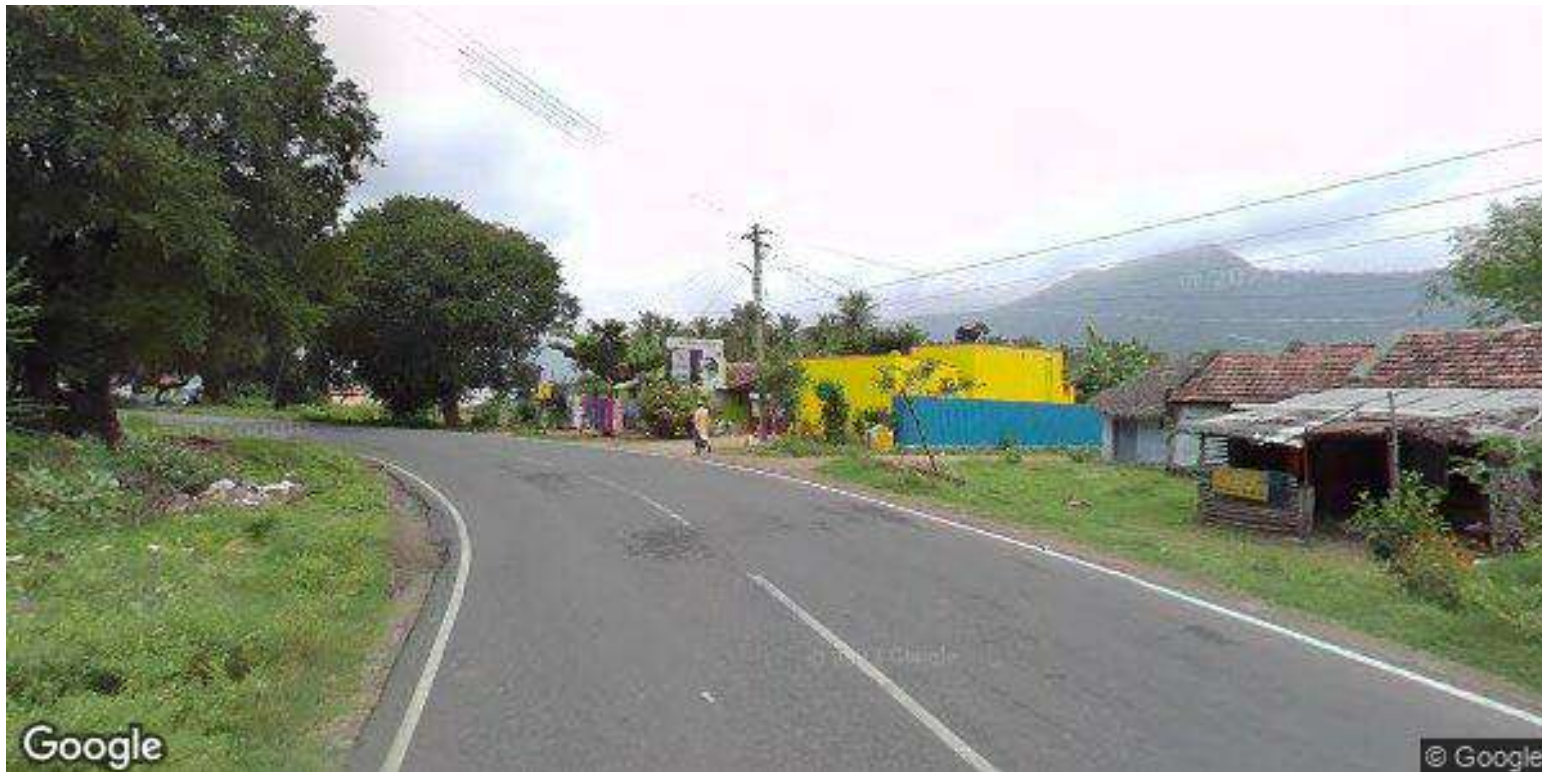
**Risk Type: Turn**

**Risk Level: Medium**

**Speed Limit: 30 KM/Hr**

**Coordinates: 11.83472, 78.35285**

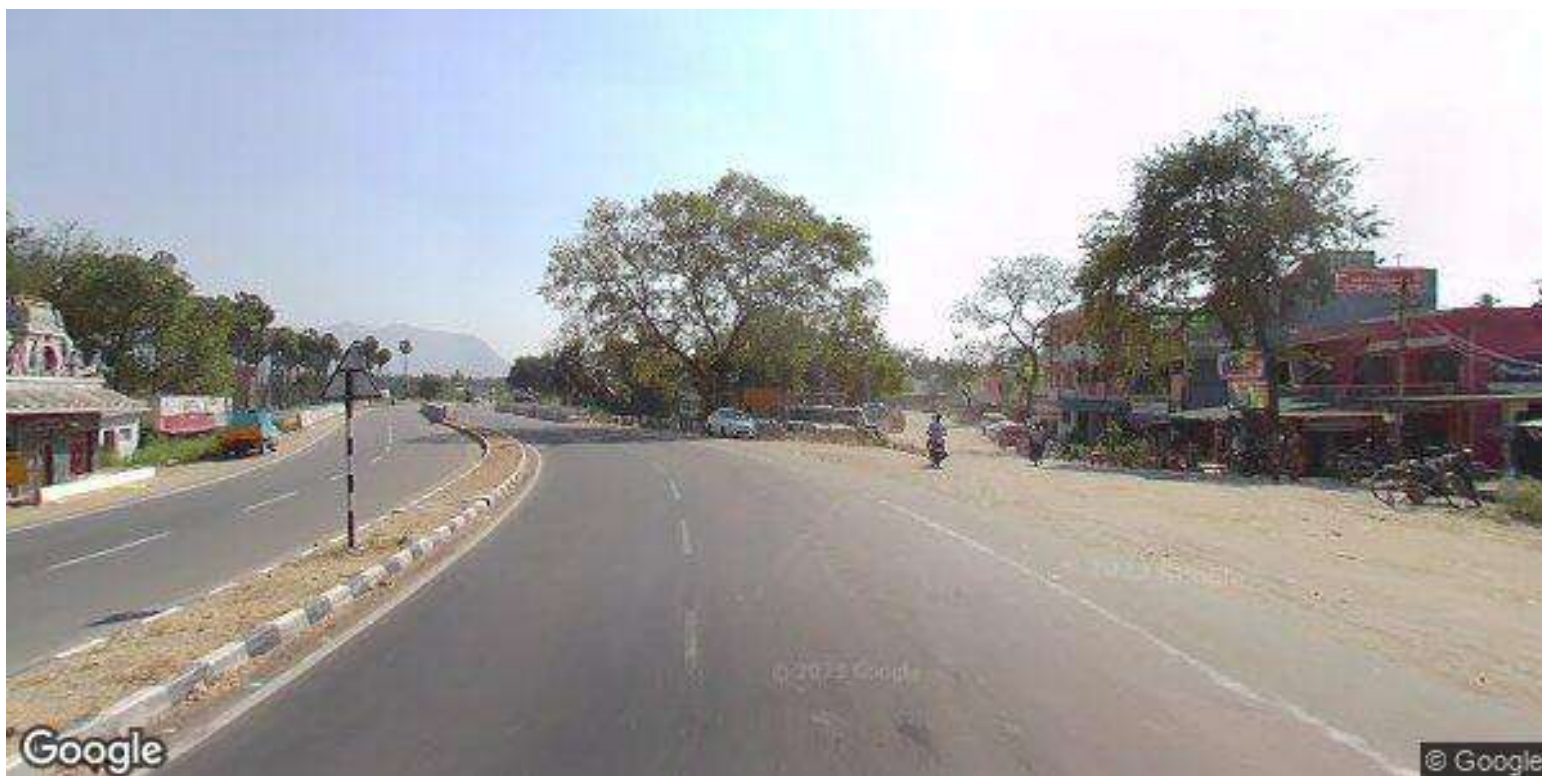
**Risk Type: Turn**

**Risk Level: Medium**

**Speed Limit: 30 KM/Hr**

**Coordinates: 11.99572, 78.44559**

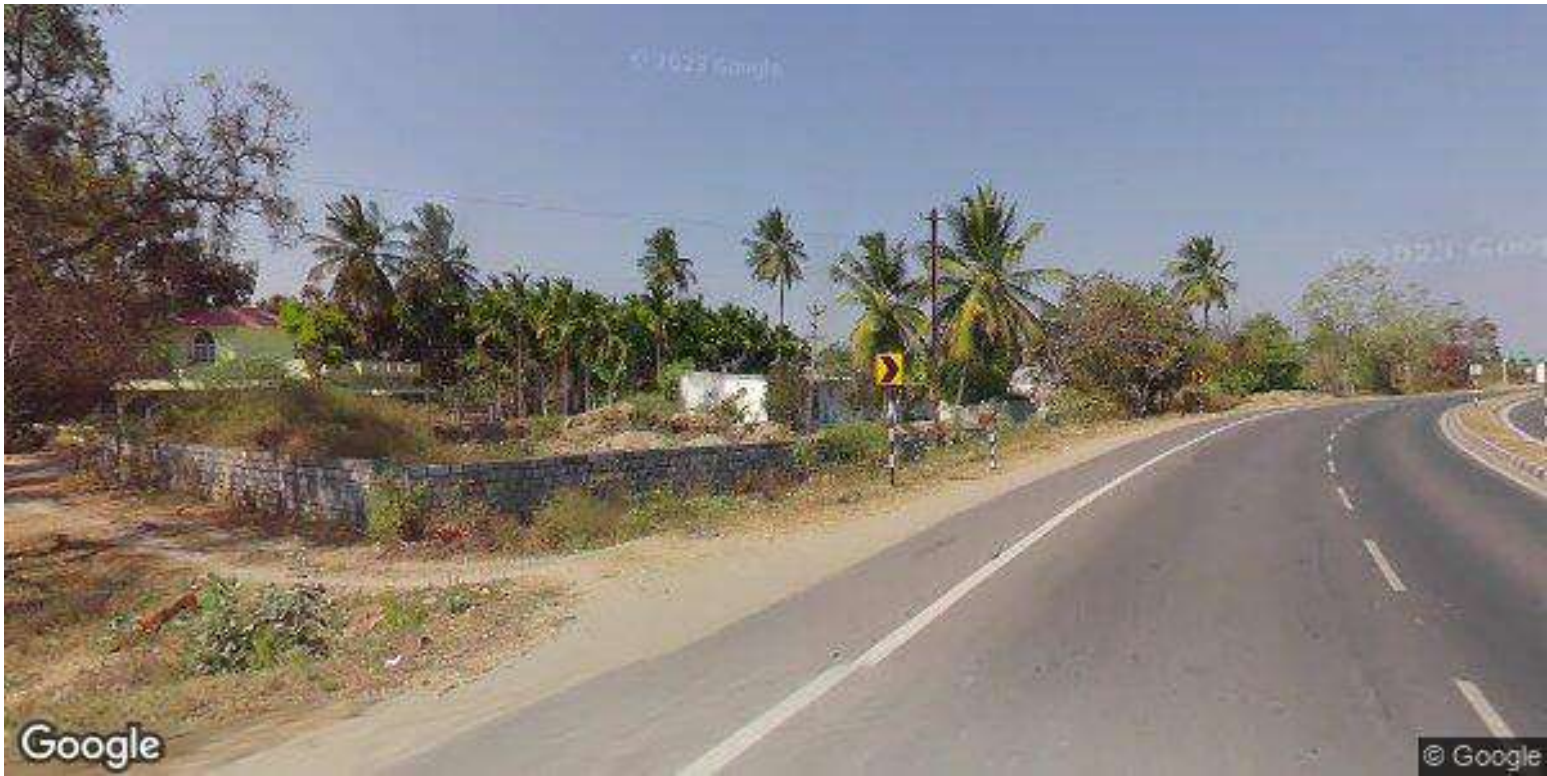
**Risk Type:** Turn  
**Risk Level:** Medium  
**Speed Limit:** 30 KM/Hr  
**Coordinates:** 12.01548, 78.45650

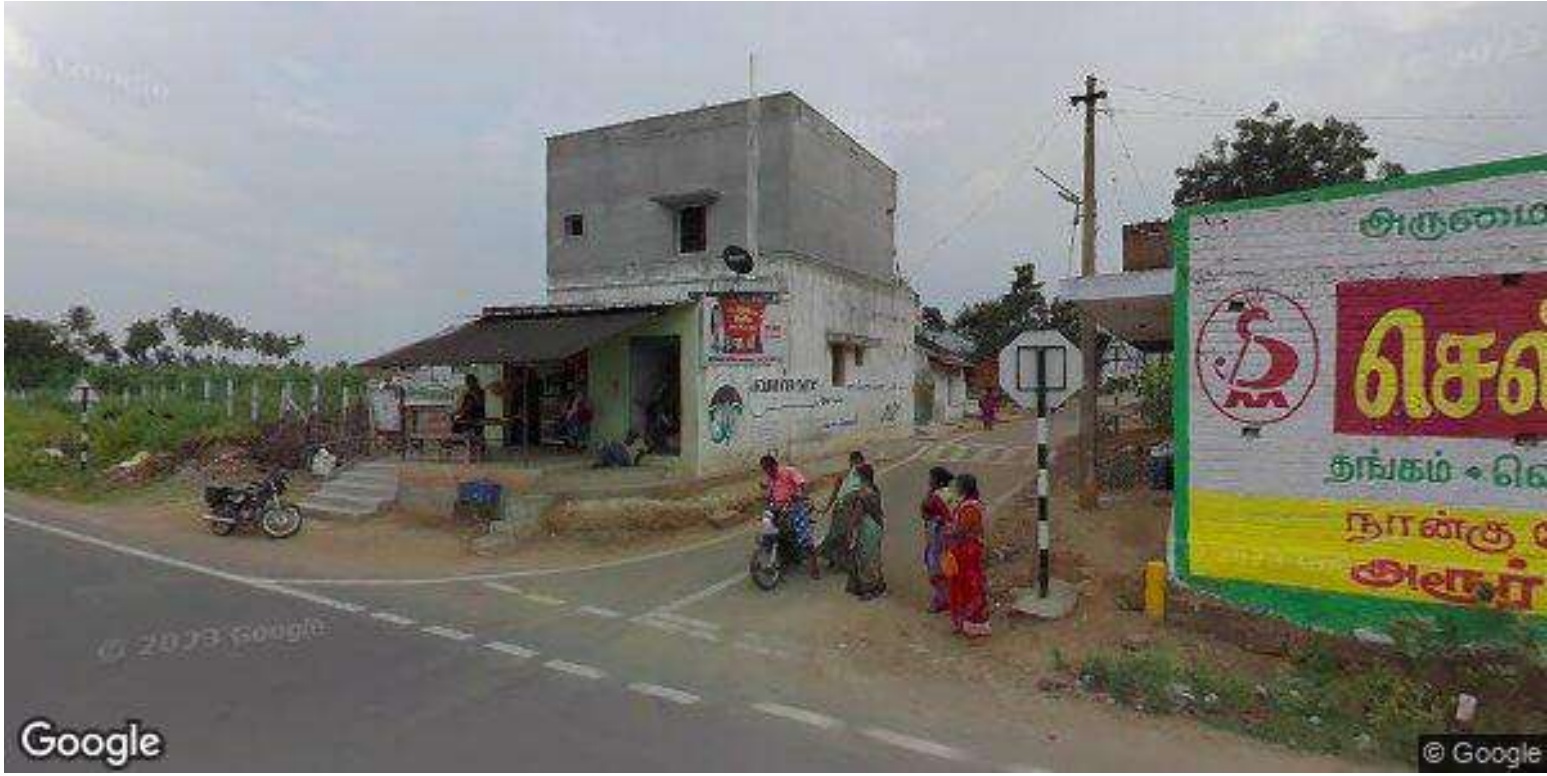
**Risk Type:** Blind Spot  
**Risk Level:** Blind Spot  
**Speed Limit:** 10 KM/Hr  
**Coordinates:** 12.03717, 78.47794
