# IndianOil

## JOURNEY RISK MANAGEMENT (JRM) STUDY

### Salem Terminal TO SWASAN FILLING STATION

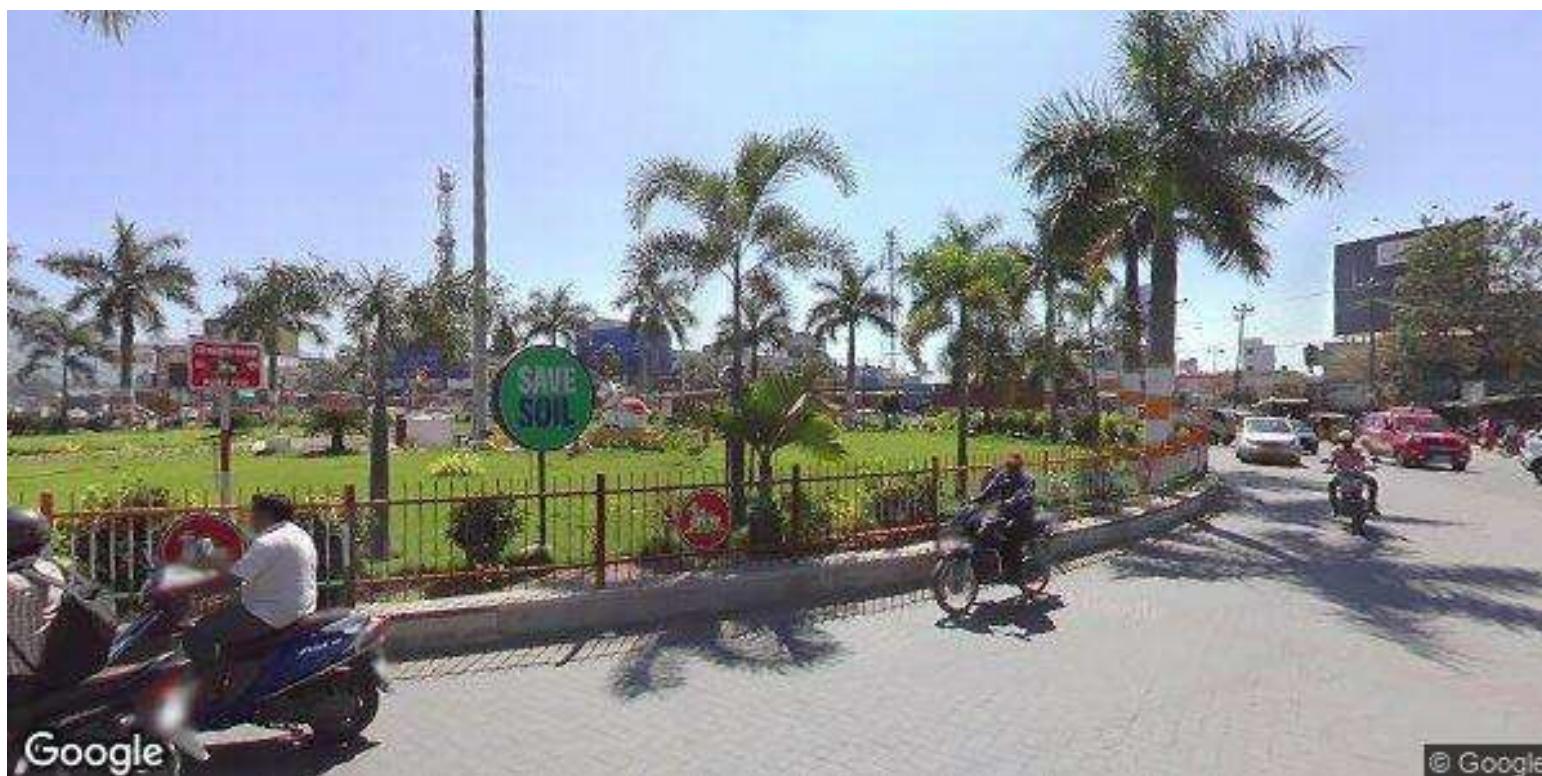
**Coordinates:** 11.63303, 78.12713

**Risk Type:** Roundabout

**Risk Level:** High

**Speed Limit:** 15 KM/Hr

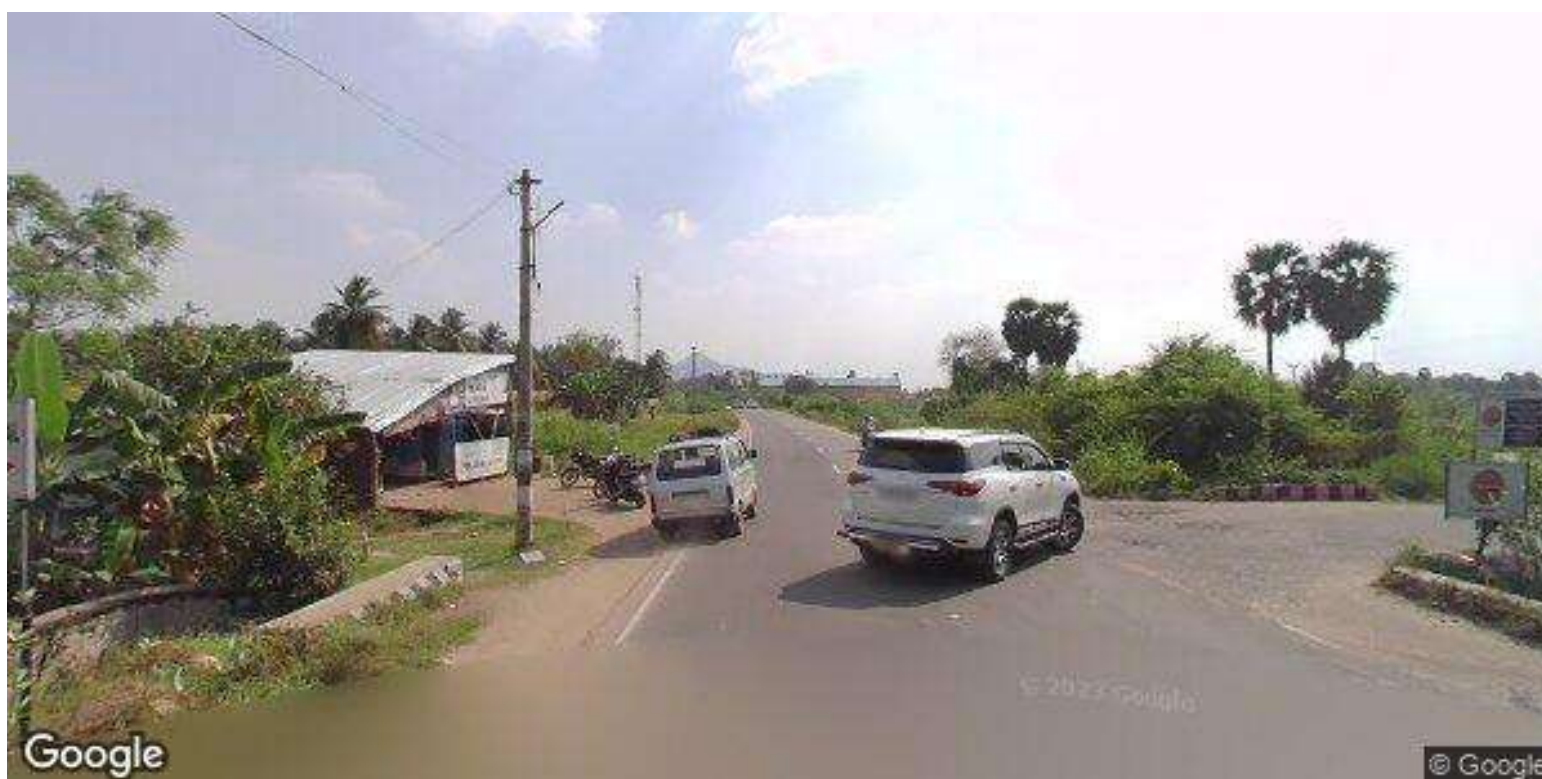
**Coordinates:** 11.44029, 77.87544

**Risk Type:** Turn

**Risk Level:** High

**Speed Limit:** 15 KM/Hr

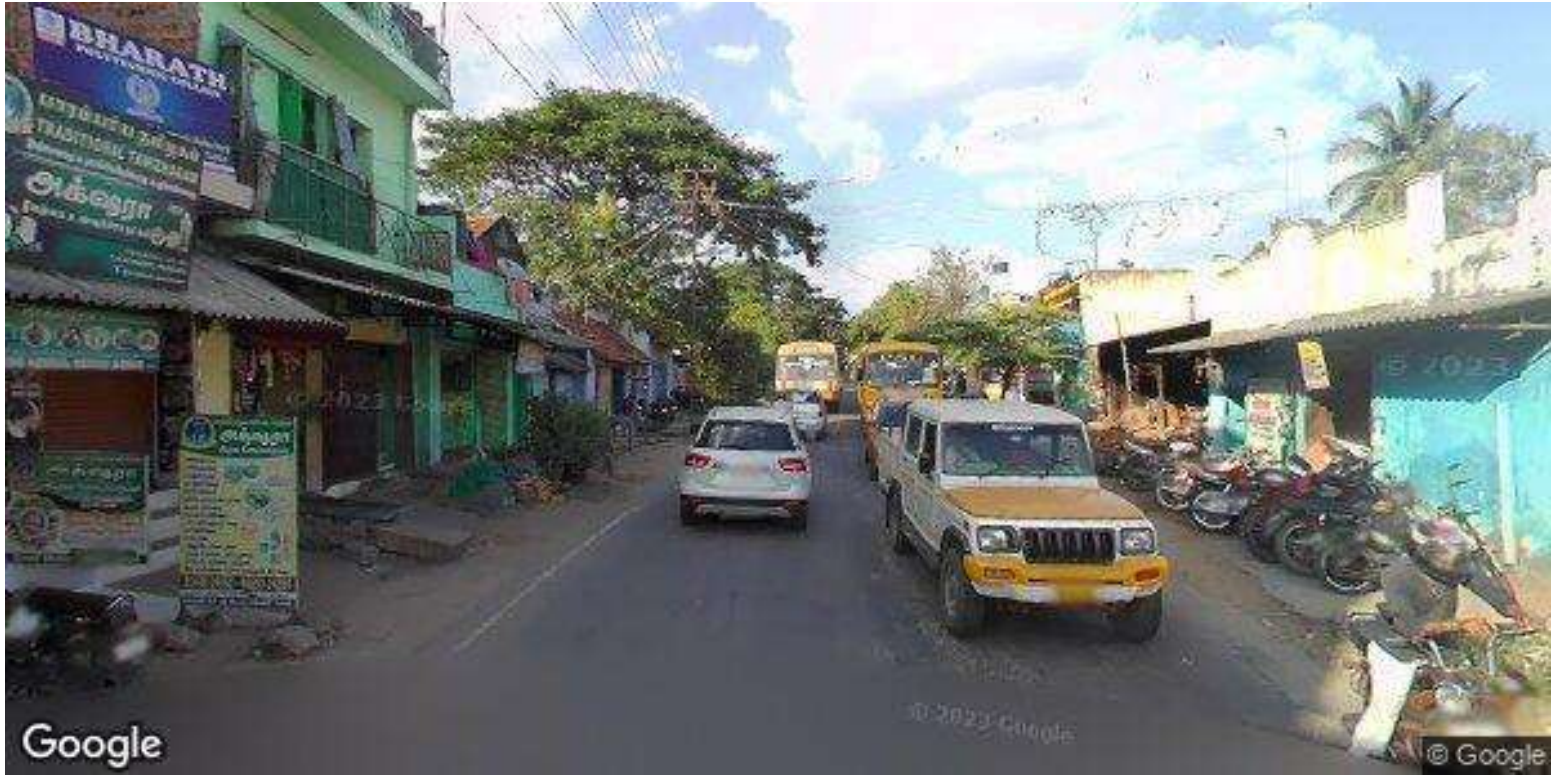
Risk Type: Turn  
Risk Level: Medium  
Speed Limit: 30 KM/Hr  
Coordinates: 11.45028, 77.87202

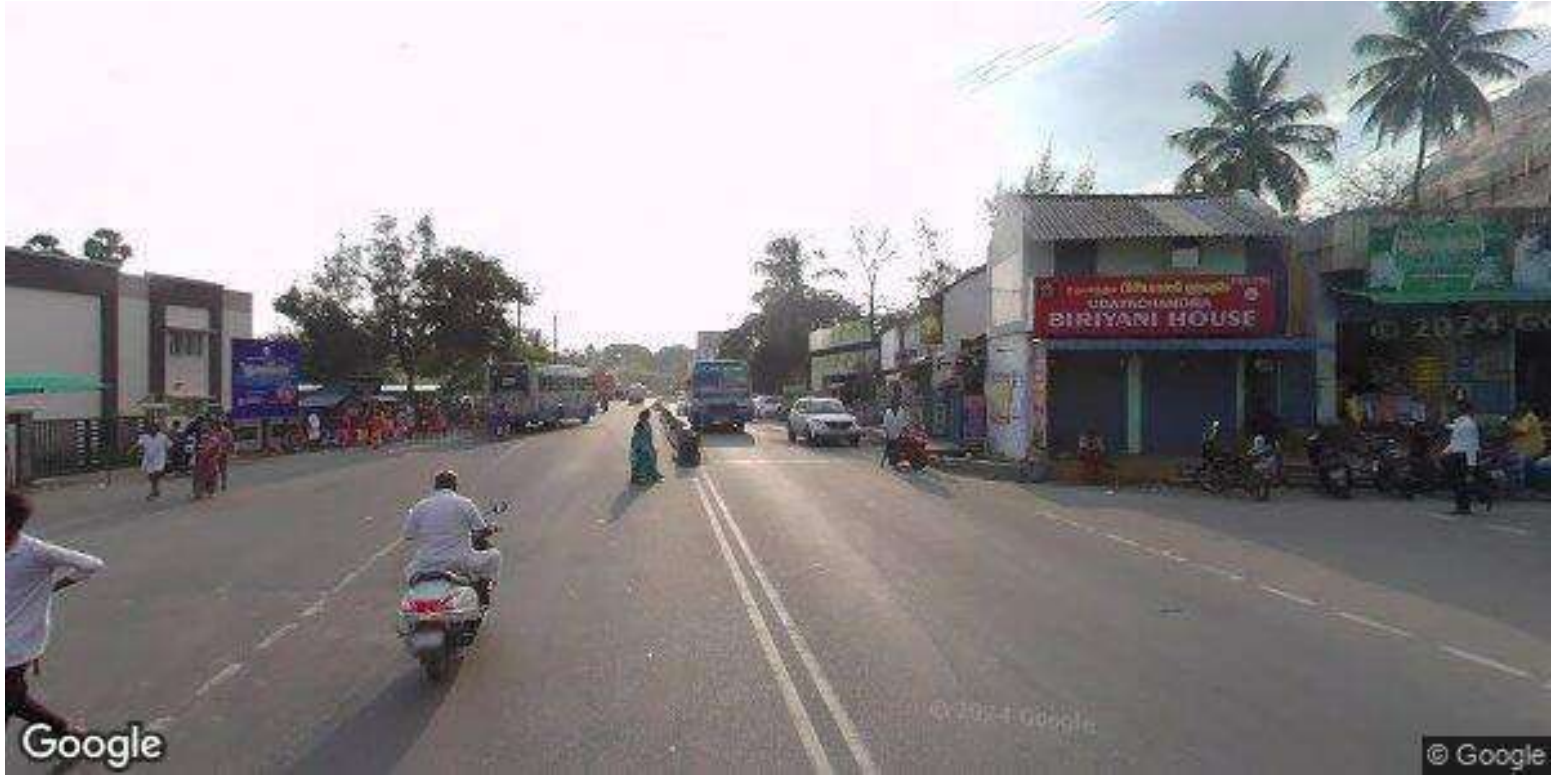
**Risk Type:** Turn  
**Risk Level:** High  
**Speed Limit:** 15 KM/Hr  
**Coordinates:** 11.47403, 77.86841

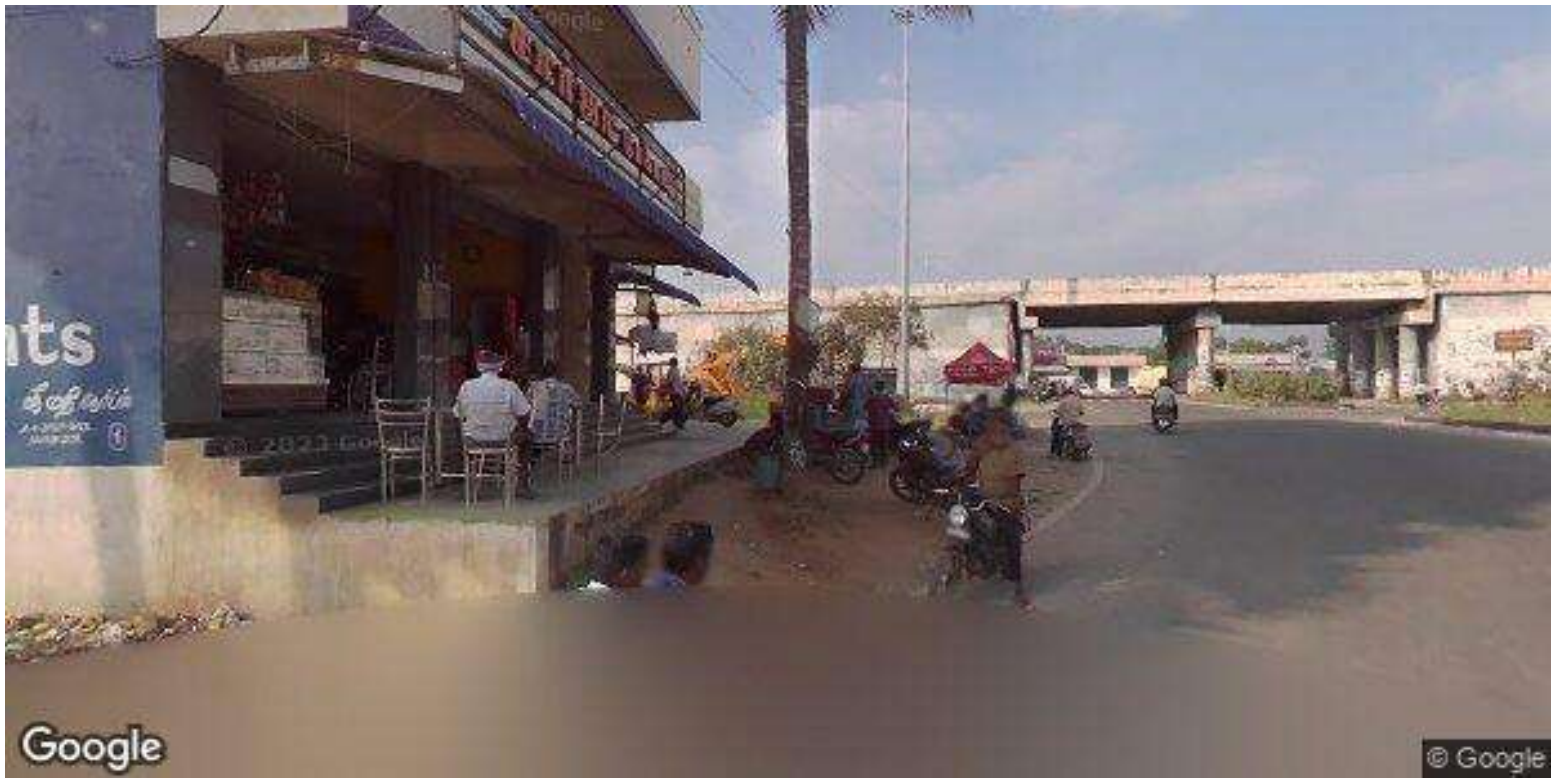
**Risk Type:** Turn  
**Risk Level:** High  
**Speed Limit:** 15 KM/Hr  
**Coordinates:** 11.49149, 77.89601

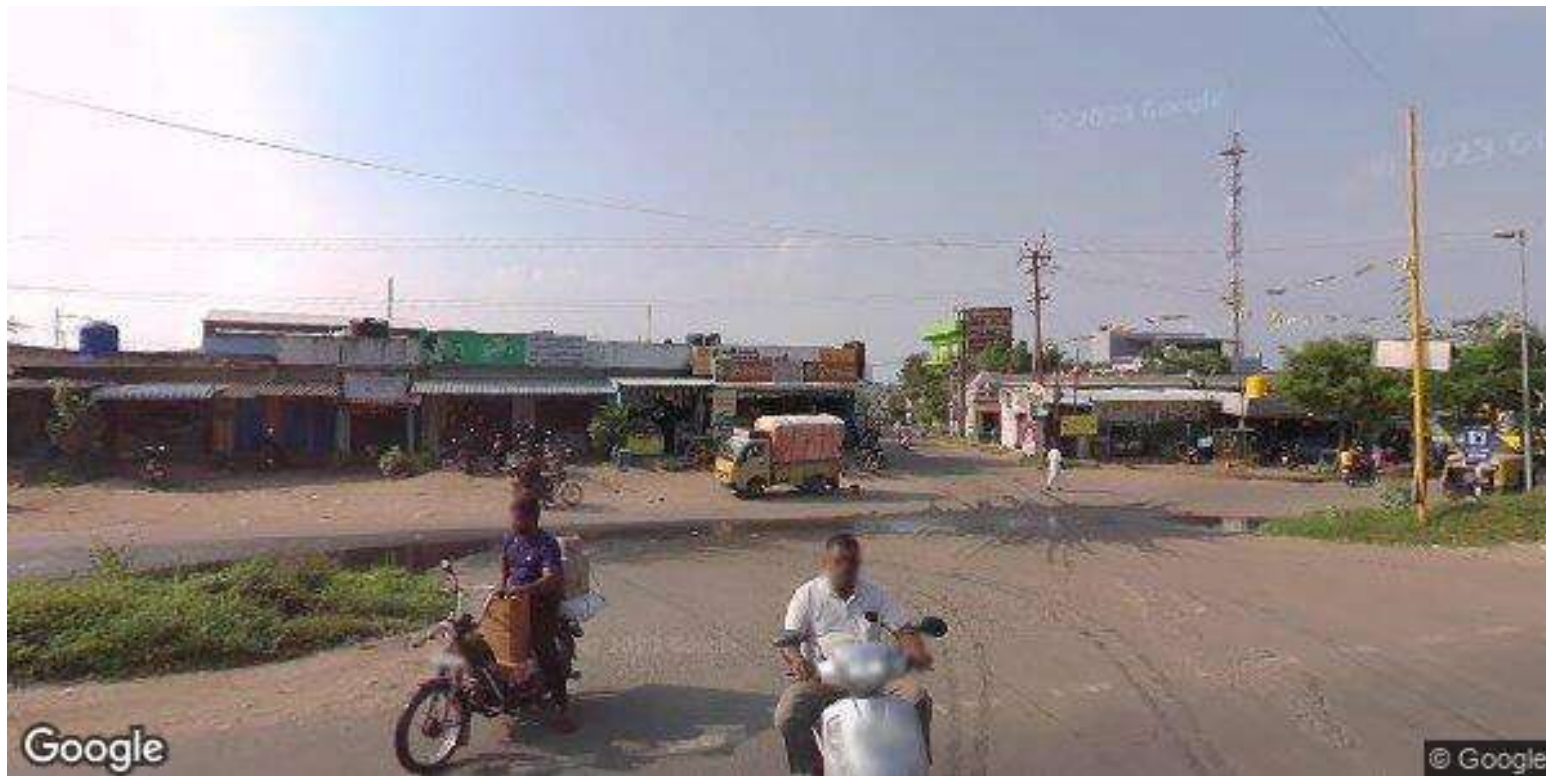
**Coordinates: 11.63219, 78.16753**

**Risk Type: Blind Spot**

**Risk Level: Blind Spot**

**Speed Limit: 10 KM/Hr**

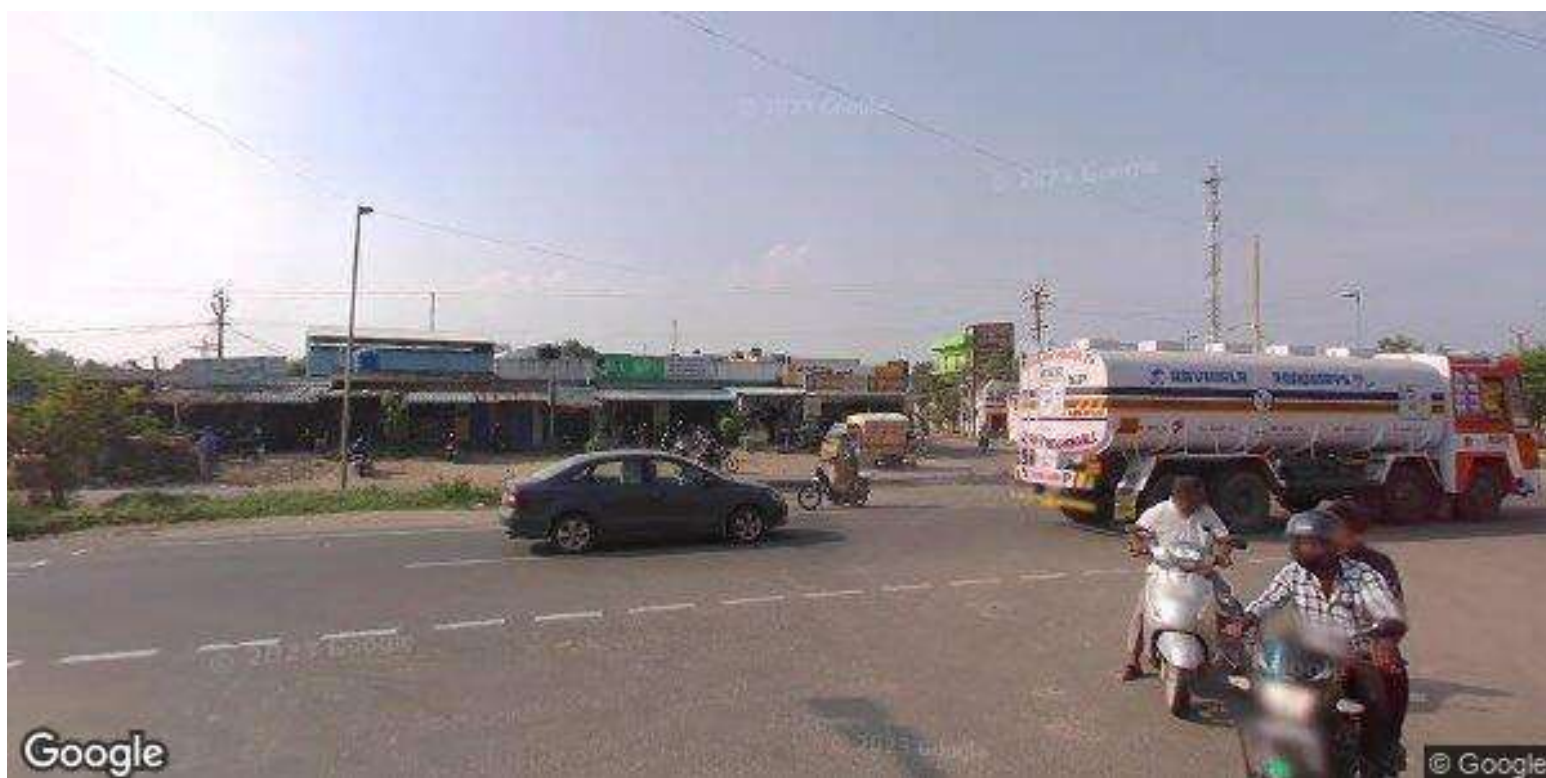
**Coordinates: 11.63211, 78.16762**

**Risk Type: Turn**

**Risk Level: High**

**Speed Limit: 15 KM/Hr**

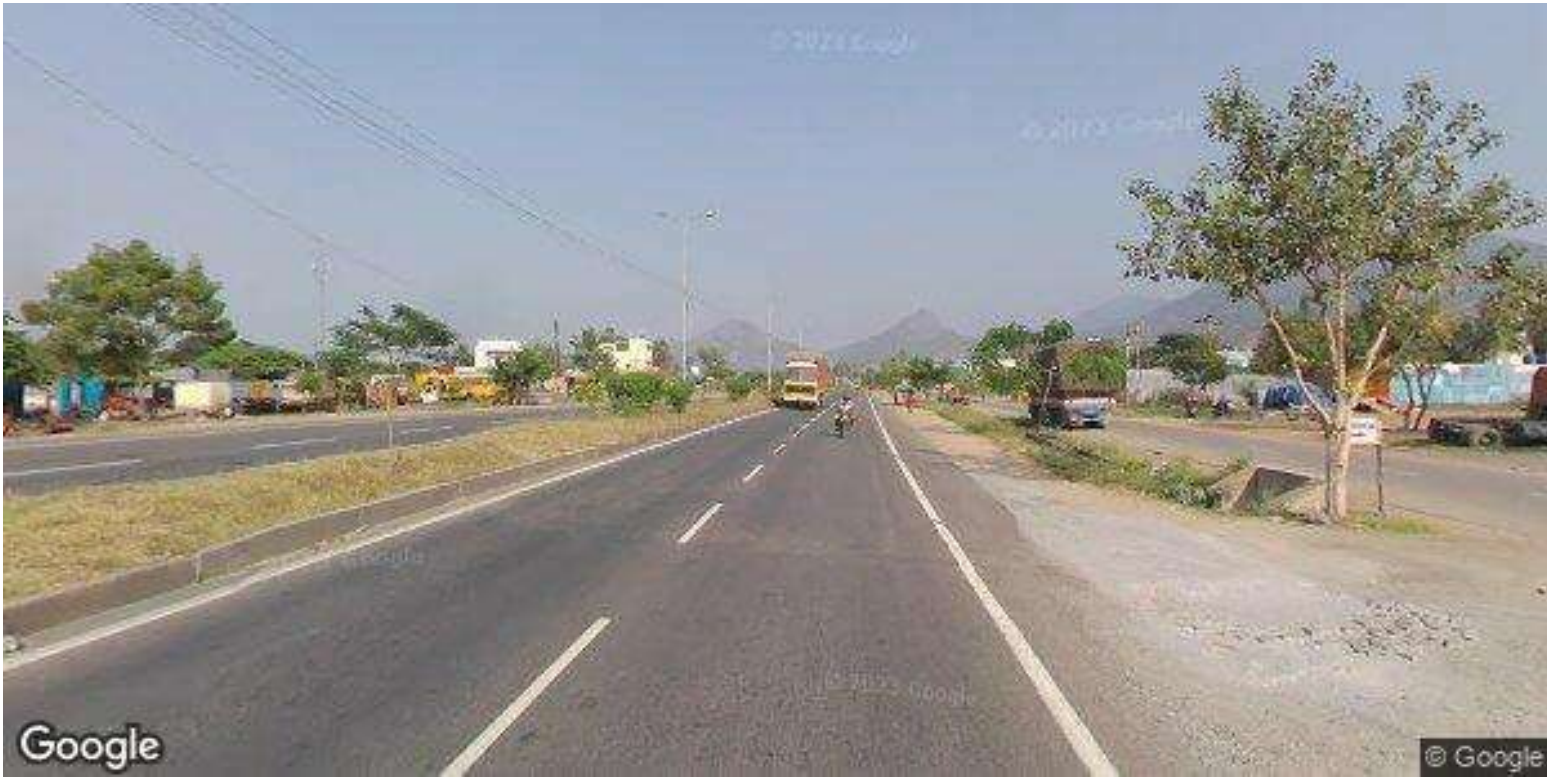
**Risk Type:** Blind Spot  
**Risk Level:** Blind Spot  
**Speed Limit:** 10 KM/Hr  
**Coordinates:** 11.62746, 78.16194

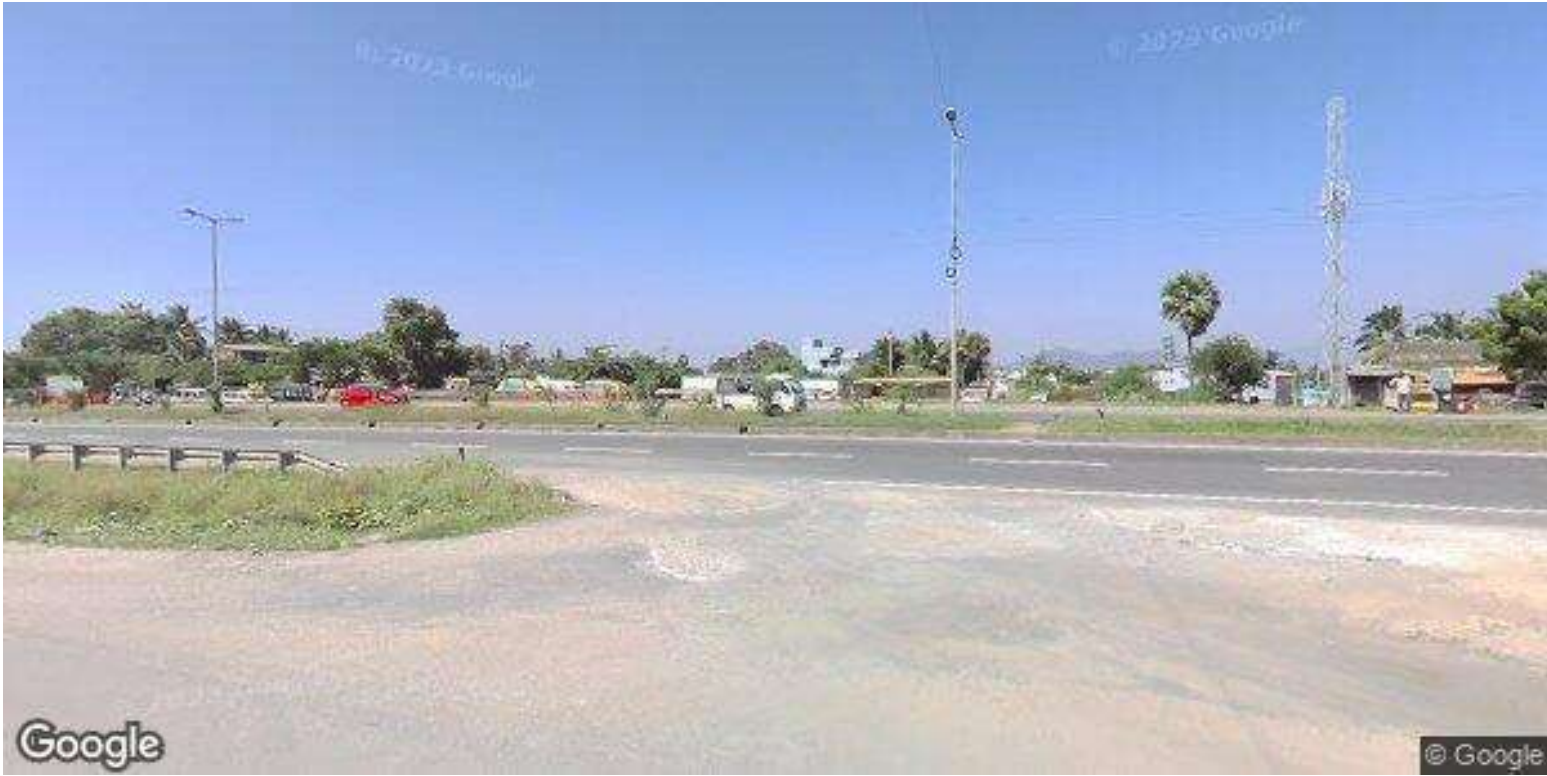
**Risk Type:** Blind Spot  
**Risk Level:** Blind Spot  
**Speed Limit:** 10 KM/Hr  
**Coordinates:** 11.62732, 78.16198

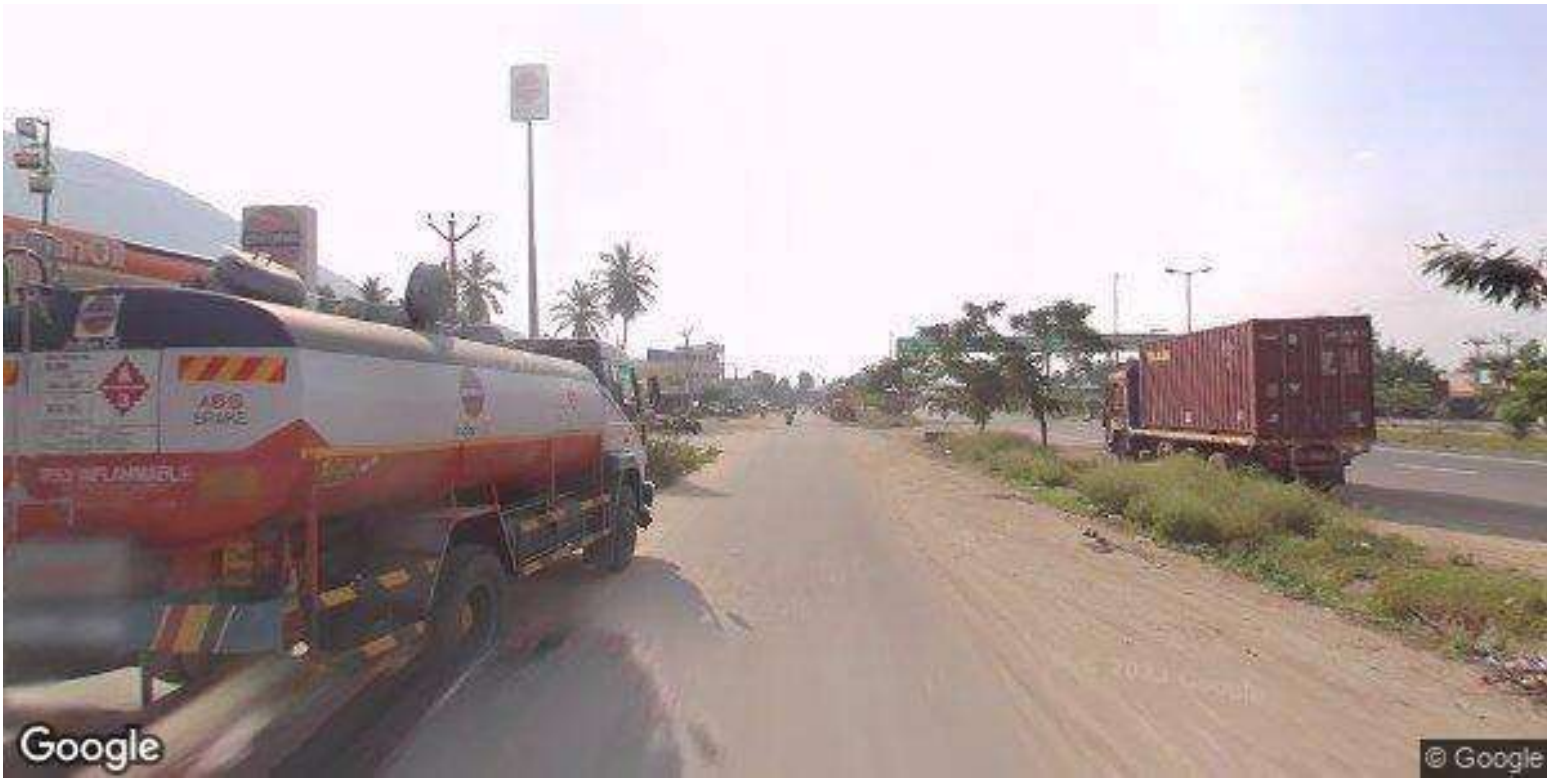
Coordinates: 11.62564, 78.15656

Risk Type: Turn

Risk Level: High

Speed Limit: 15 KM/Hr

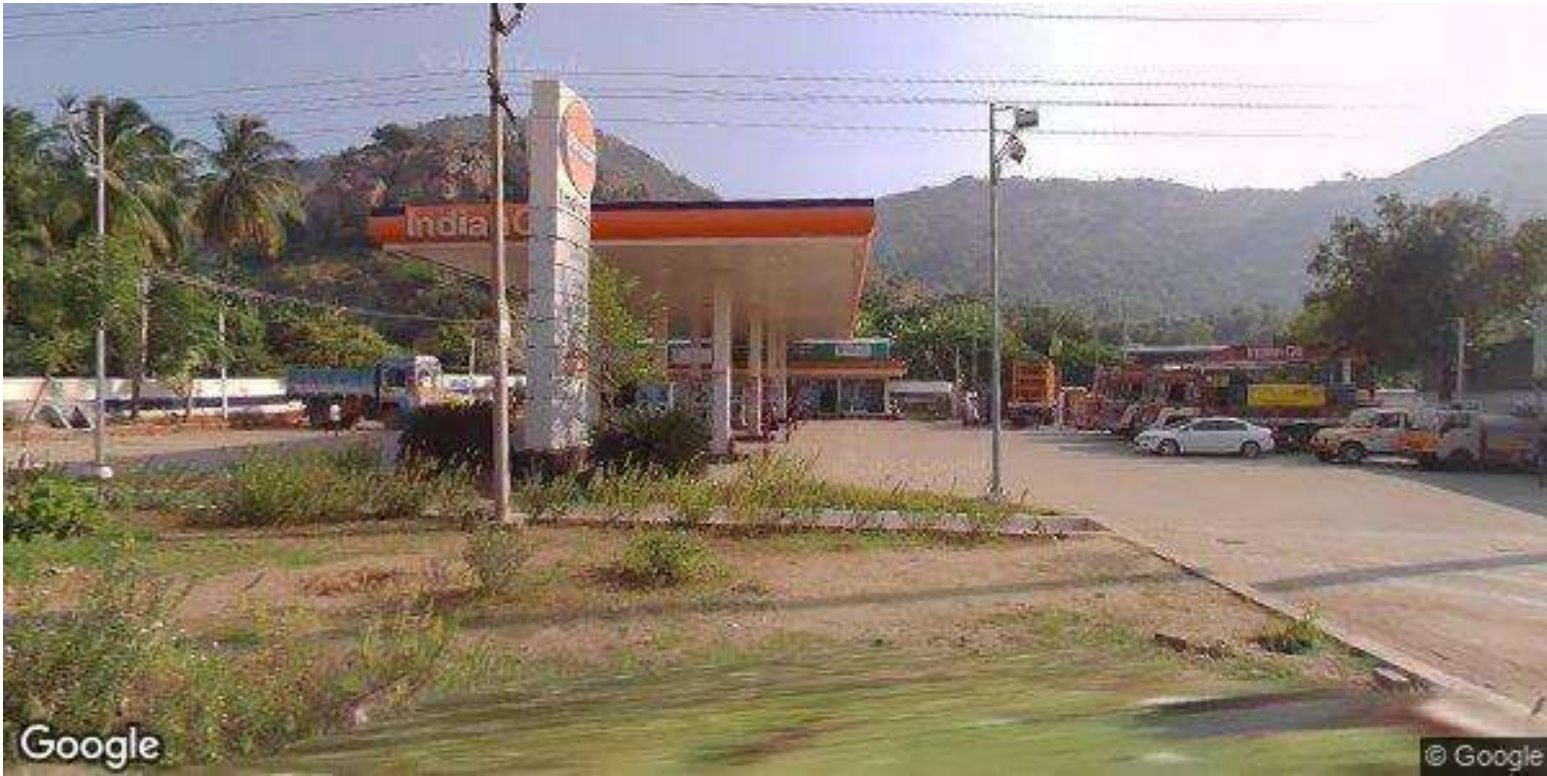
Coordinates: 11.62522, 78.15646

Risk Type: Turn

Risk Level: High

Speed Limit: 15 KM/Hr
