## **JOURNEY RISK MANAGEMENT (JRM) STUDY**

### **Salem Terminal To SRI KUPPANNA PETROLIUM**

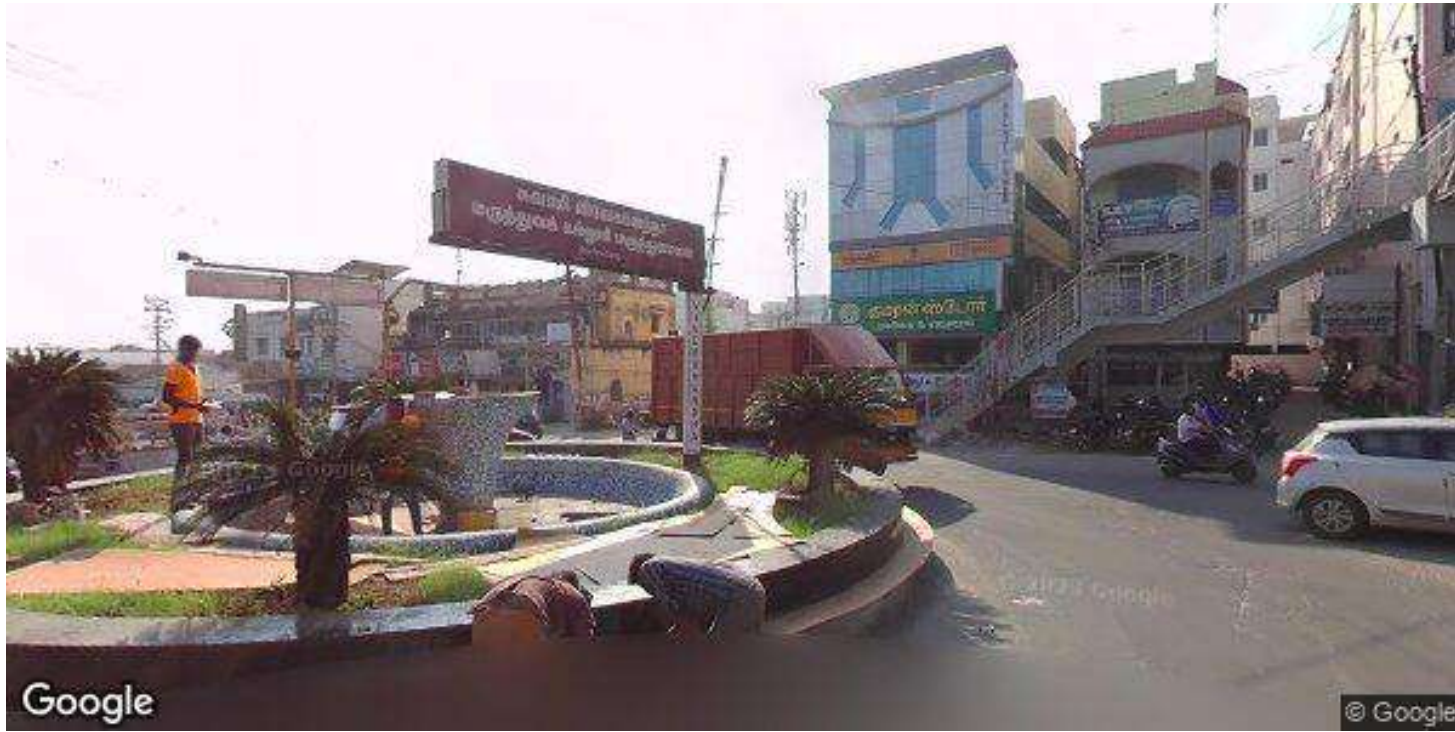
**Coordinates:** 11.38395, 77.89480

**Risk Type:** Roundabout

**Risk Level:** High

**Speed Limit:** 15 KM/Hr

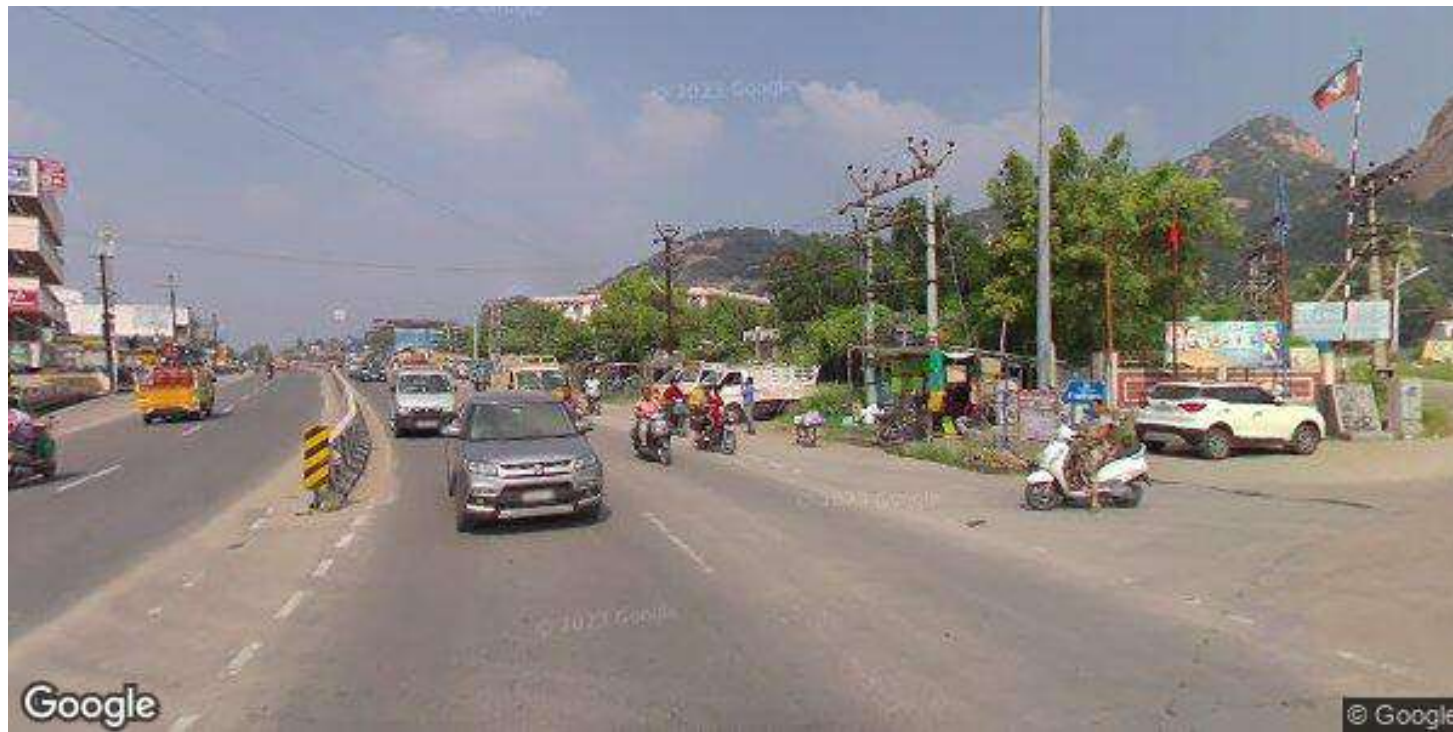
**Risk Type:** Turn  
**Risk Level:** Medium  
**Speed Limit:** 30 KM/Hr  
**Coordinates:** 11.39671, 77.88878

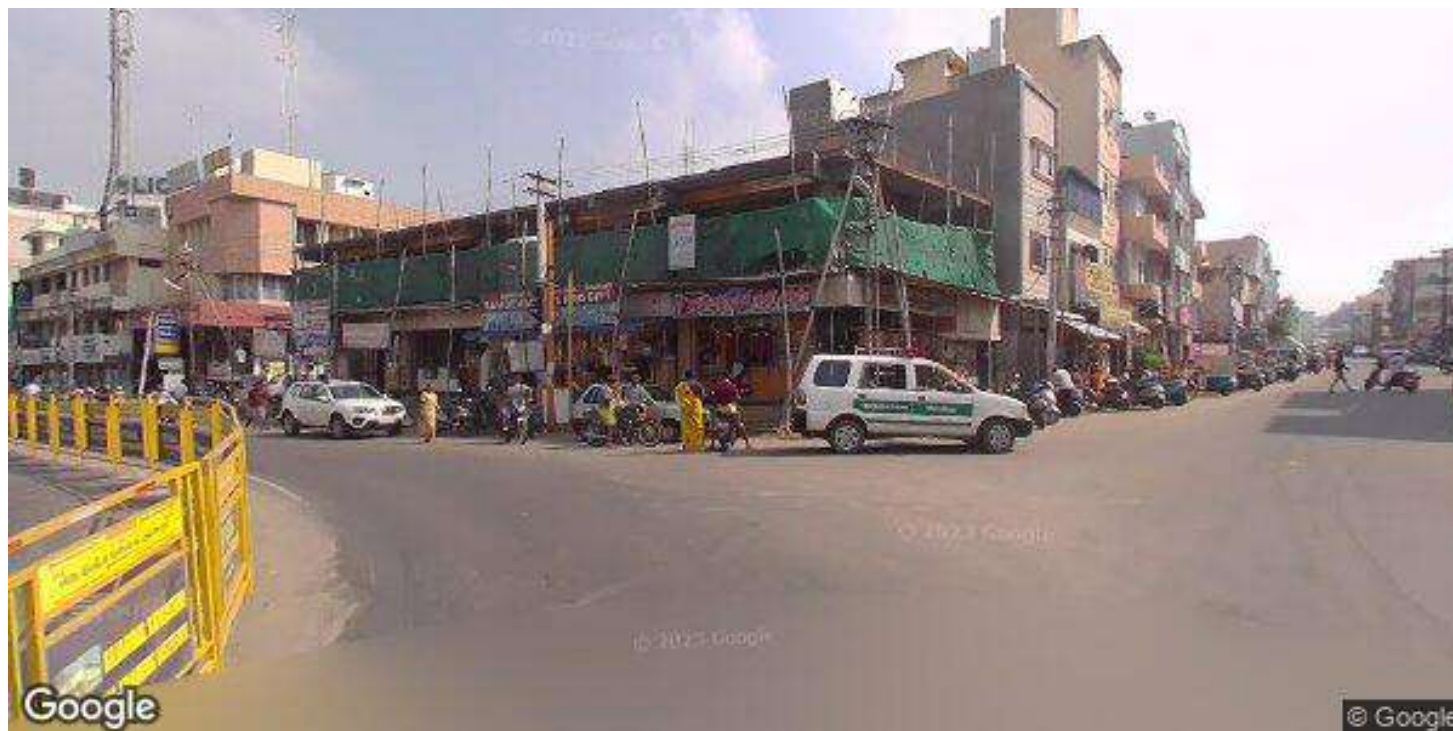
**Risk Type:** Turn  
**Risk Level:** High  
**Speed Limit:** 15 KM/Hr  
**Coordinates:** 11.37868, 77.89498

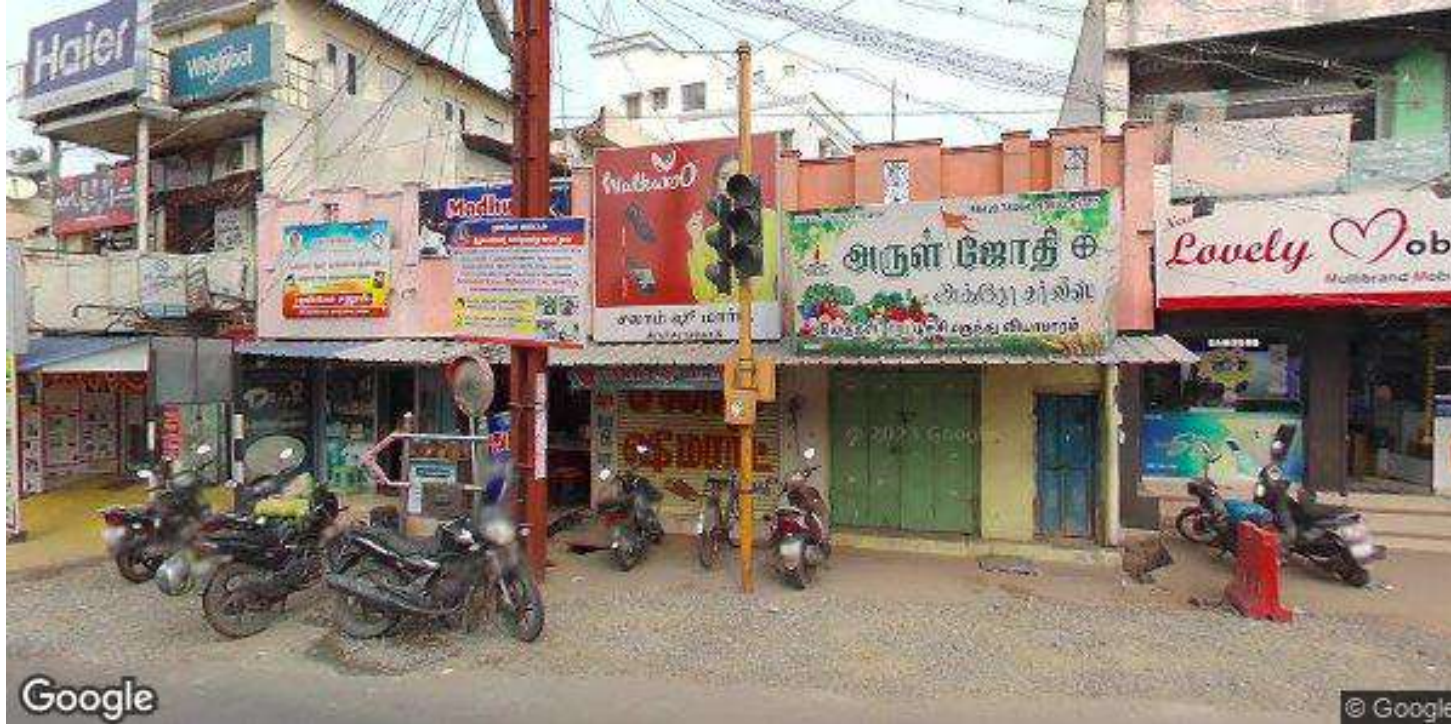
Coordinates: 11.37850, 77.89453

Risk Type: Turn

Risk Level: High

Speed Limit: 15 KM/Hr

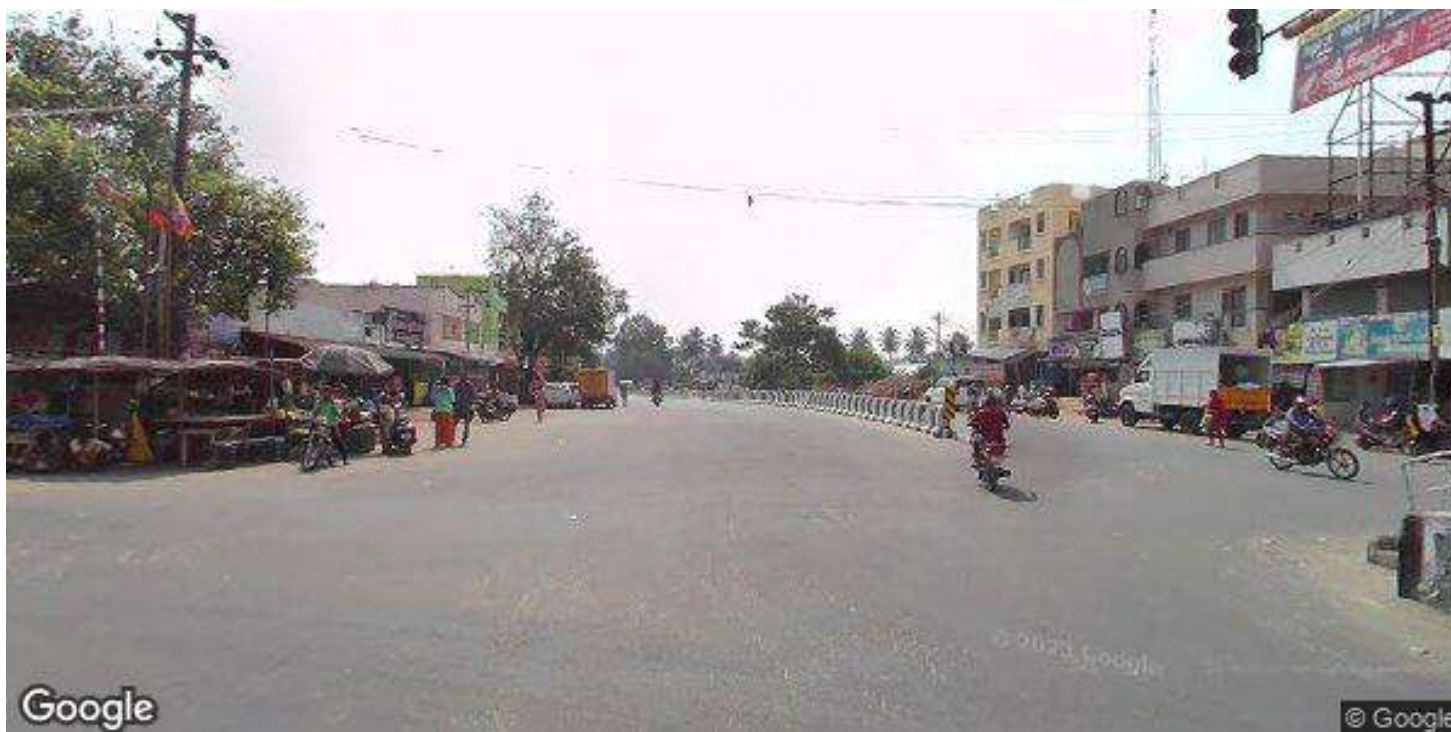
Coordinates: 11.36604, 77.88887

Risk Type: Turn

Risk Level: High

Speed Limit: 15 KM/Hr

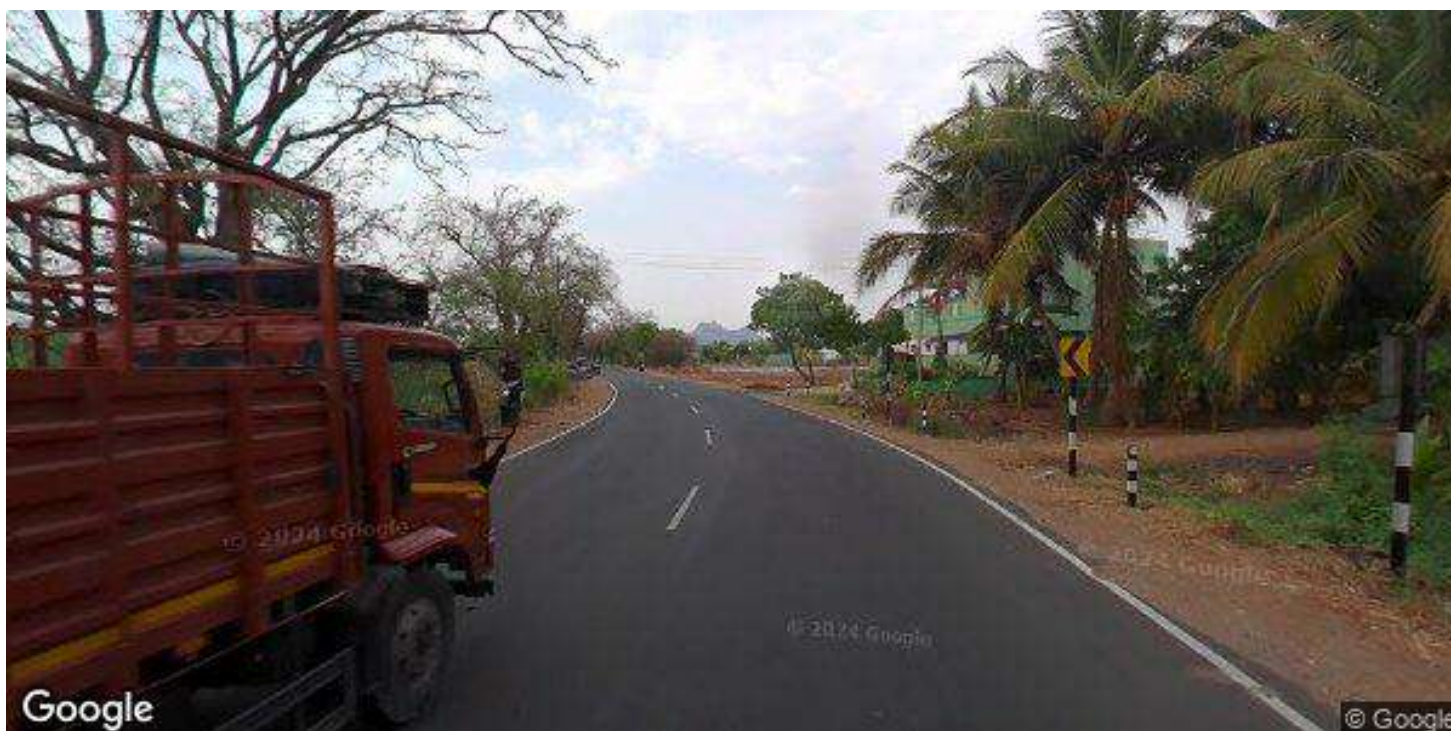
**Coordinates: 11.34105, 77.86426**

Risk Type: Turn

Risk Level: Medium

**Speed Limit: 30 KM/Hr**

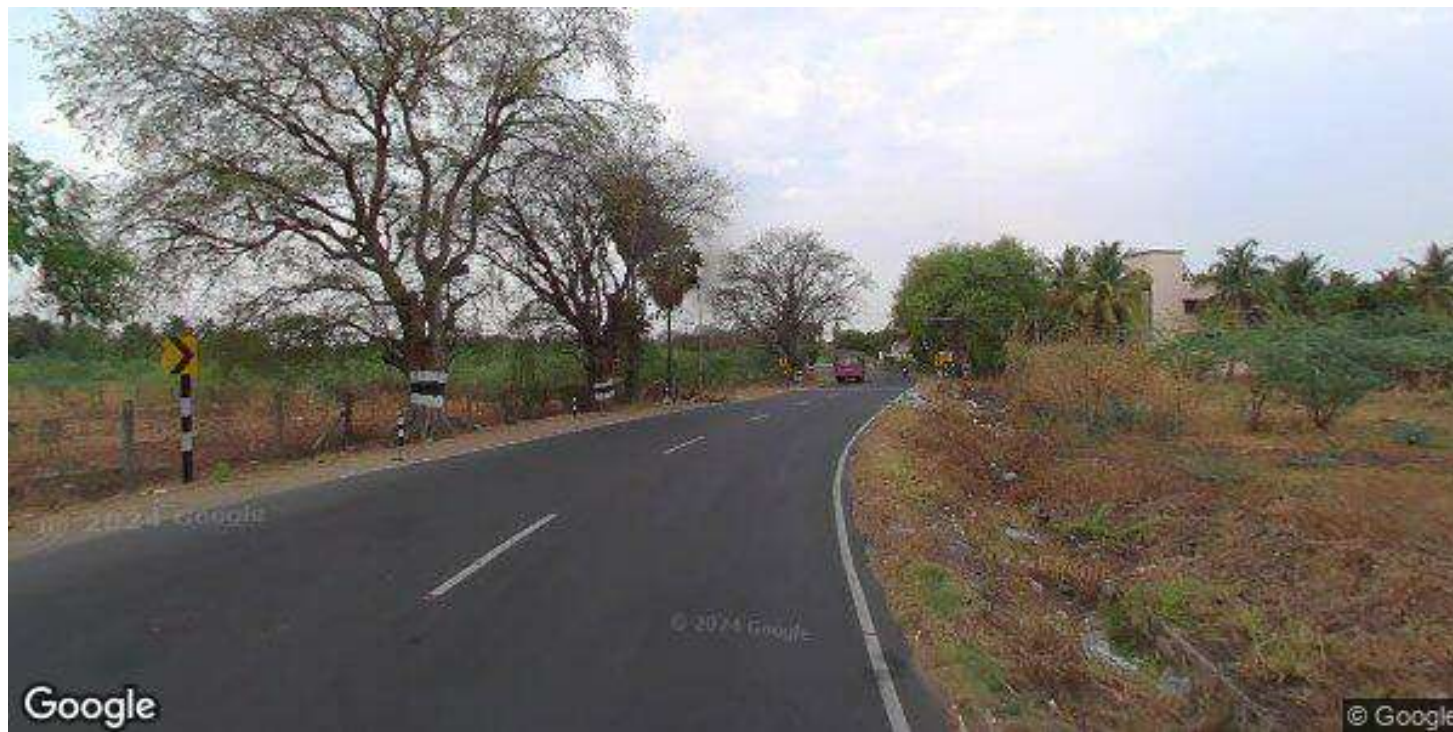
**Coordinates: 11.34074, 77.86356**

**Risk Type: Turn**

**Risk Level: Medium**

**Speed Limit: 30 KM/Hr**

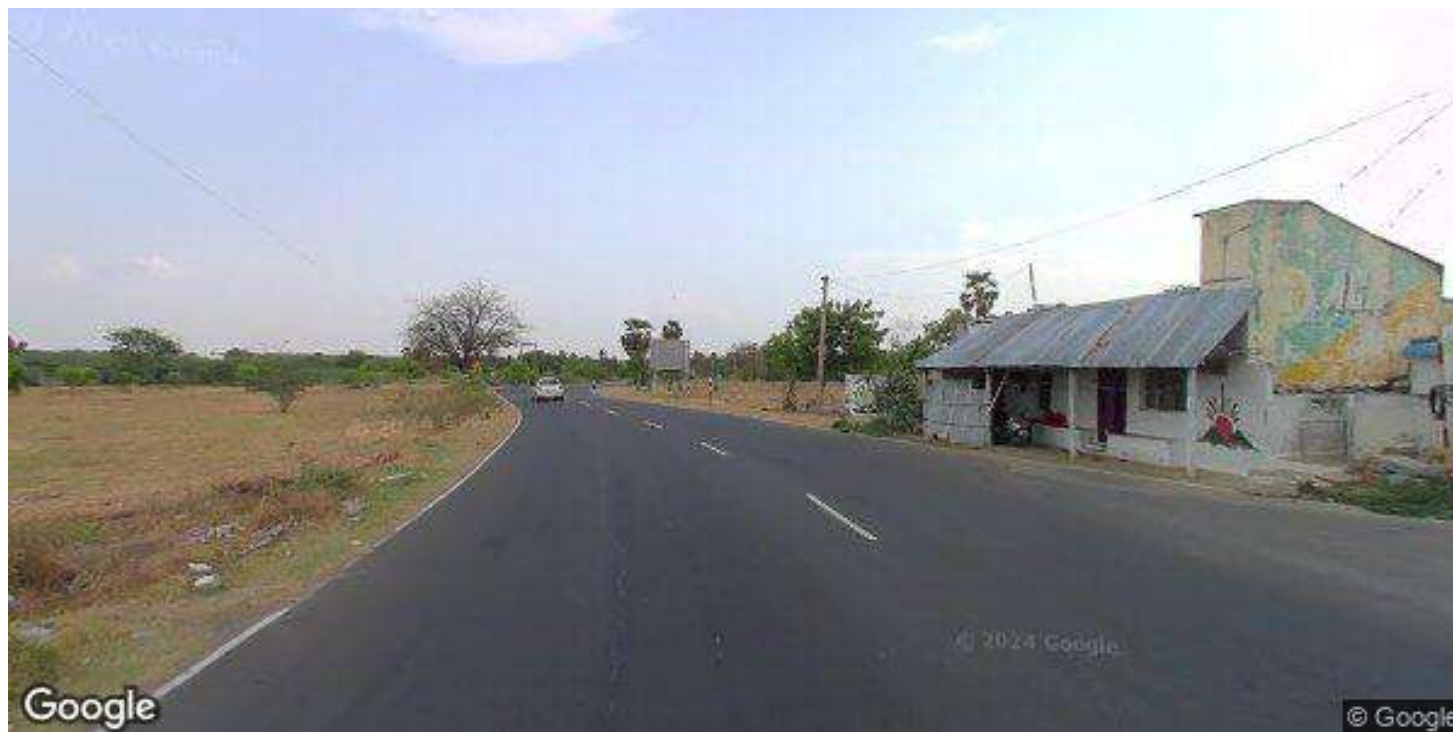
**Coordinates: 11.33865, 77.86216**

**Risk Type: Turn**

**Risk Level: Medium**

**Speed Limit: 30 KM/Hr**

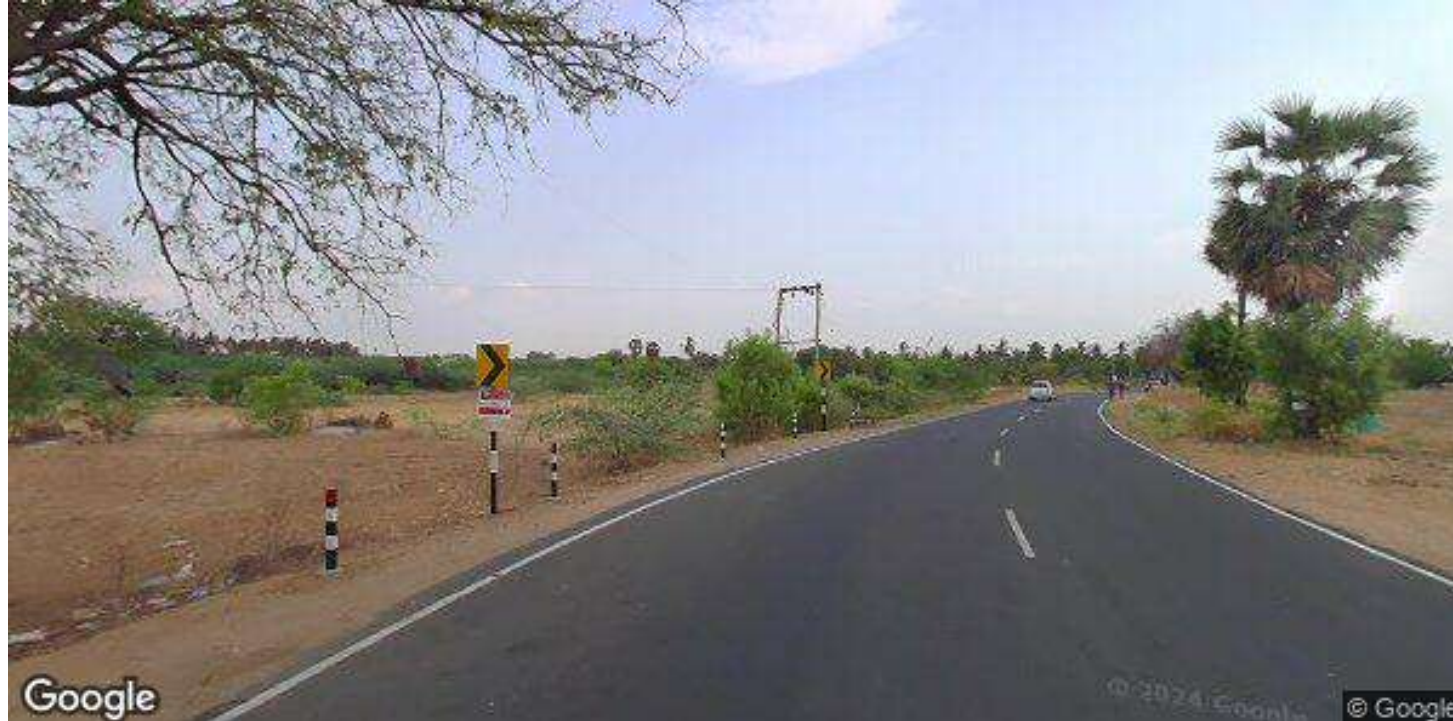
**Risk Type:** Turn  
**Risk Level:** Medium  
**Speed Limit:** 30 KM/Hr  
**Coordinates:** 11.33794, 77.86235

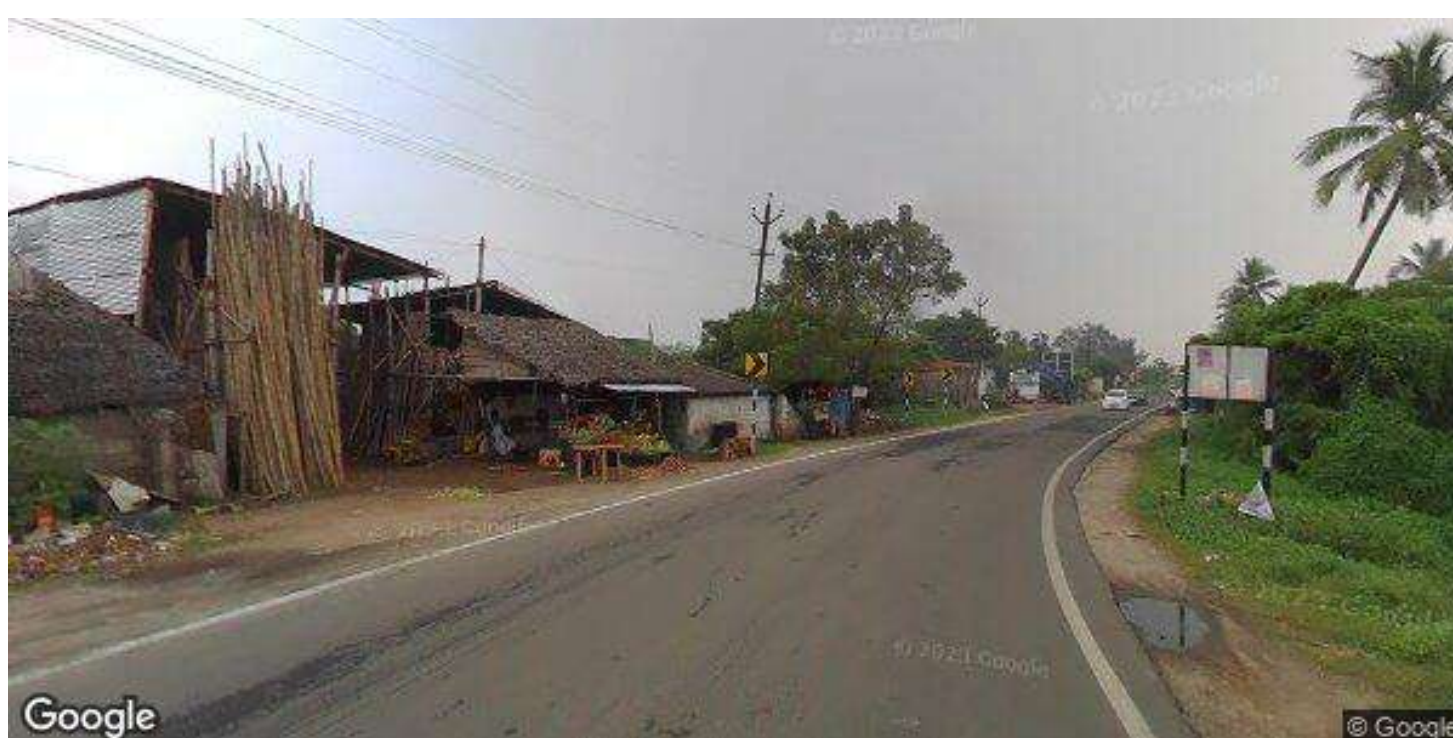
**Risk Type:** Turn  
**Risk Level:** Medium  
**Speed Limit:** 30 KM/Hr  
**Coordinates:** 11.30968, 77.76701

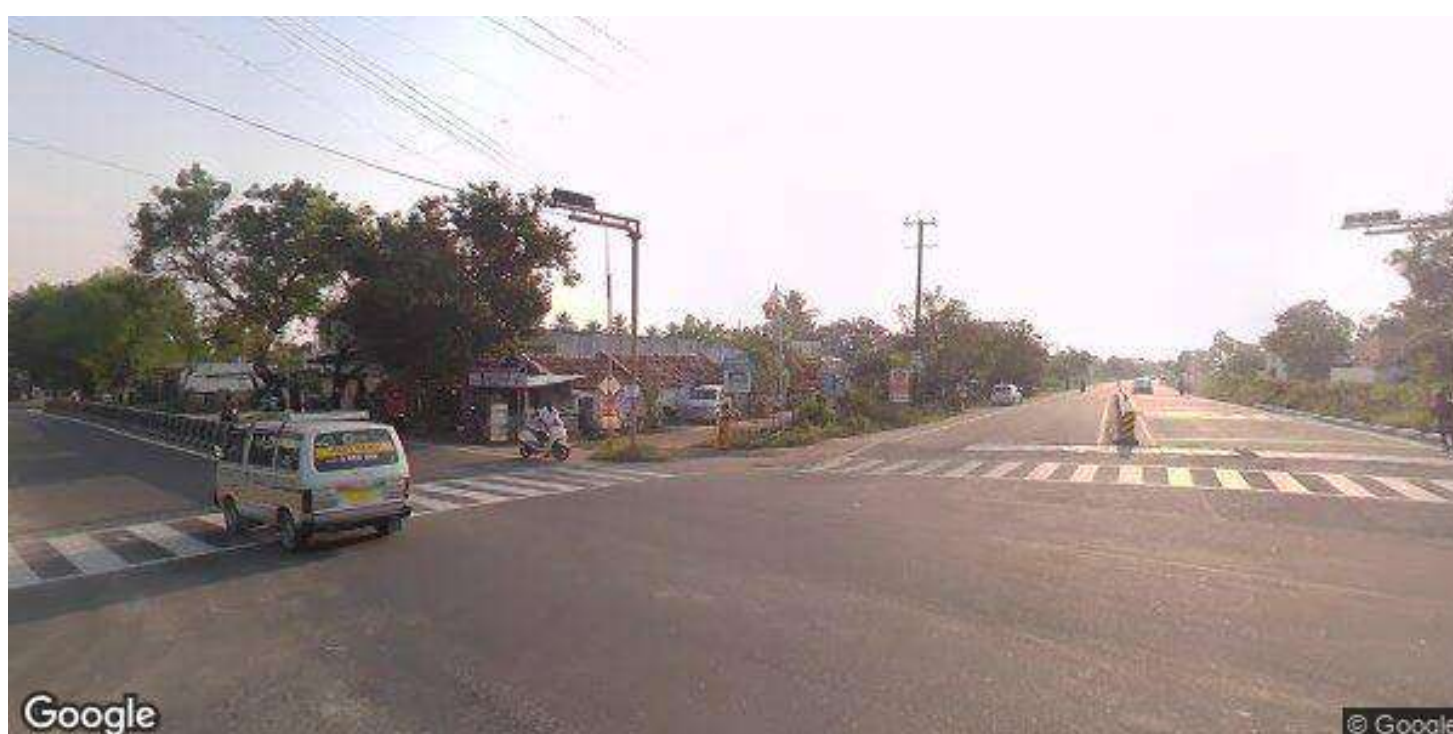
**Coordinates: 11.29899, 77.75806**

**Risk Type:** Turn  
**Risk Level:** High

**Speed Limit: 15 KM/Hr**

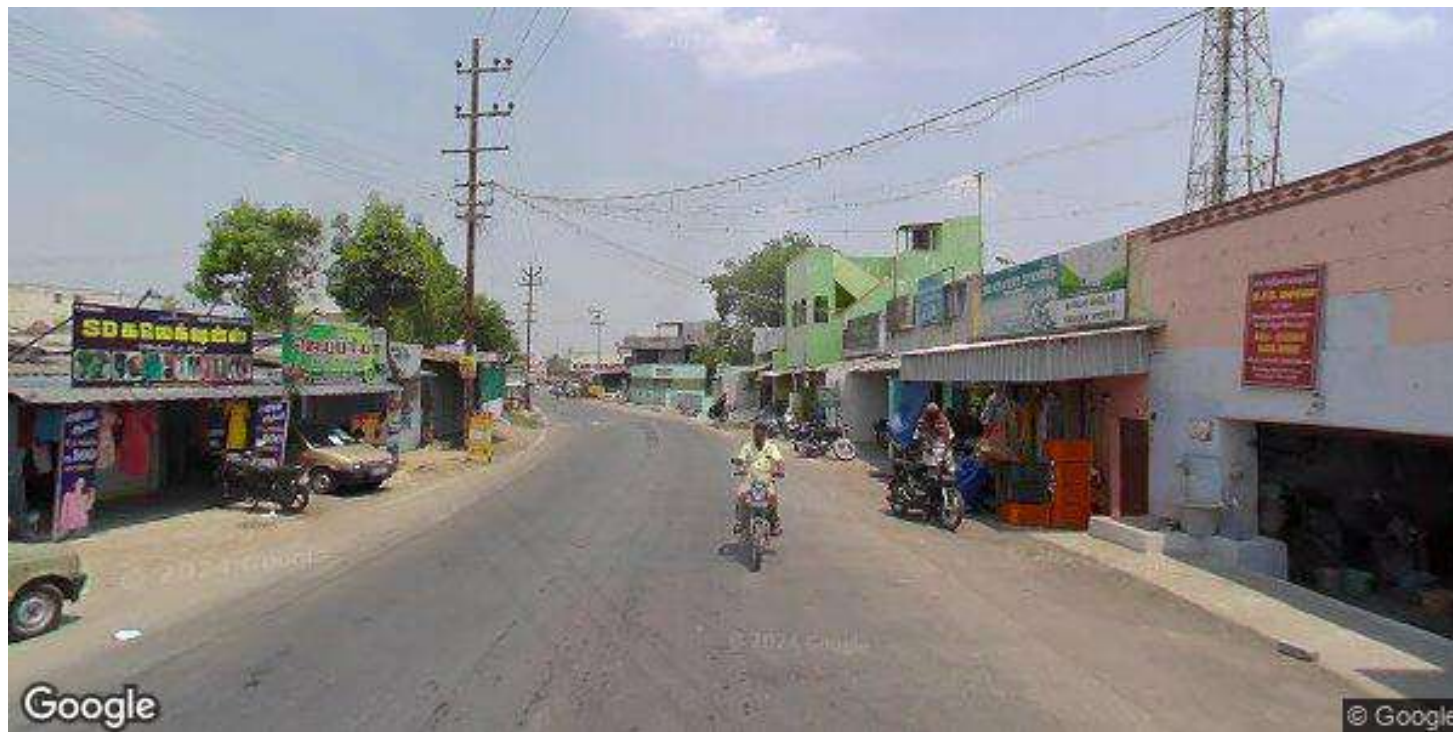
**Coordinates: 11.18947, 77.77076**

**Risk Type: Turn**

**Risk Level: Medium**

**Speed Limit: 30 KM/Hr**

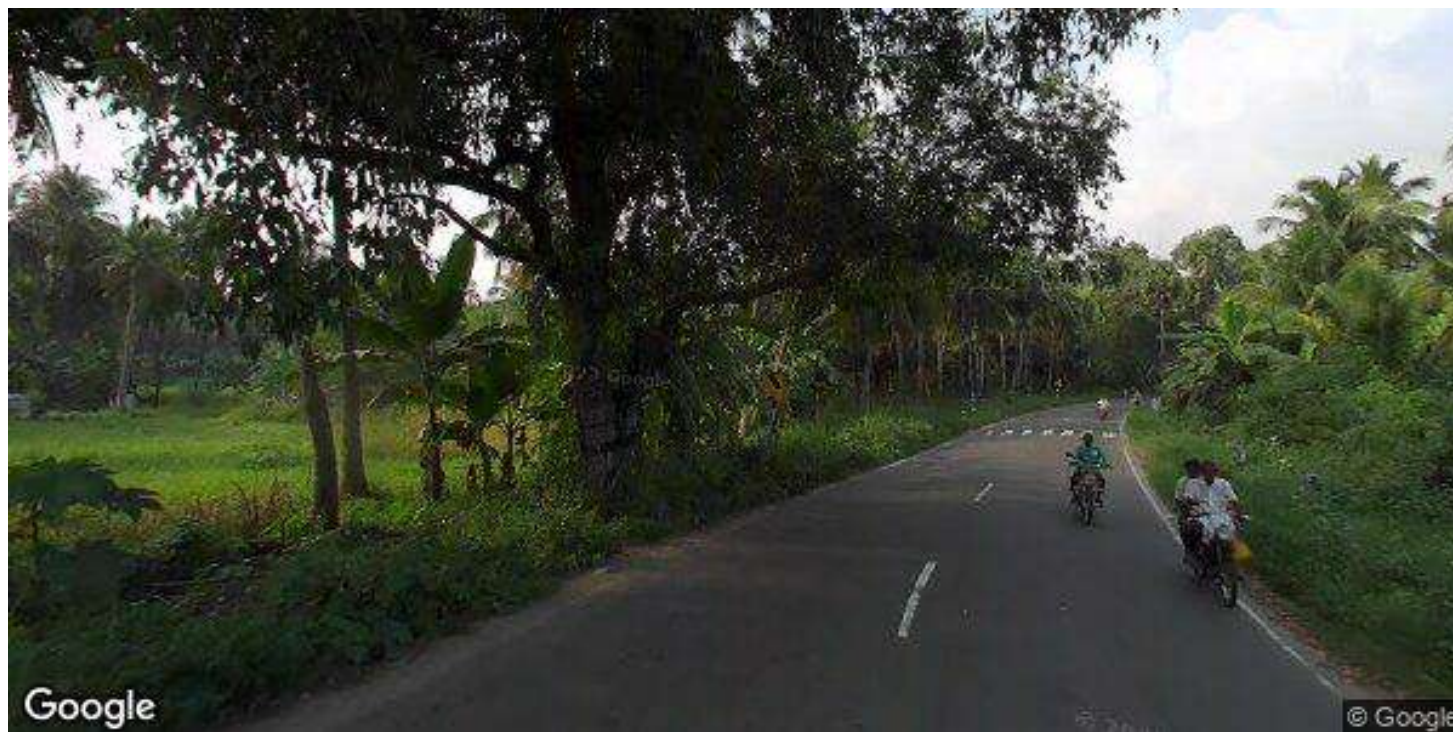
**Coordinates: 11.16419, 77.77365**

**Risk Type: Turn**

**Risk Level: Medium**

**Speed Limit: 30 KM/Hr**

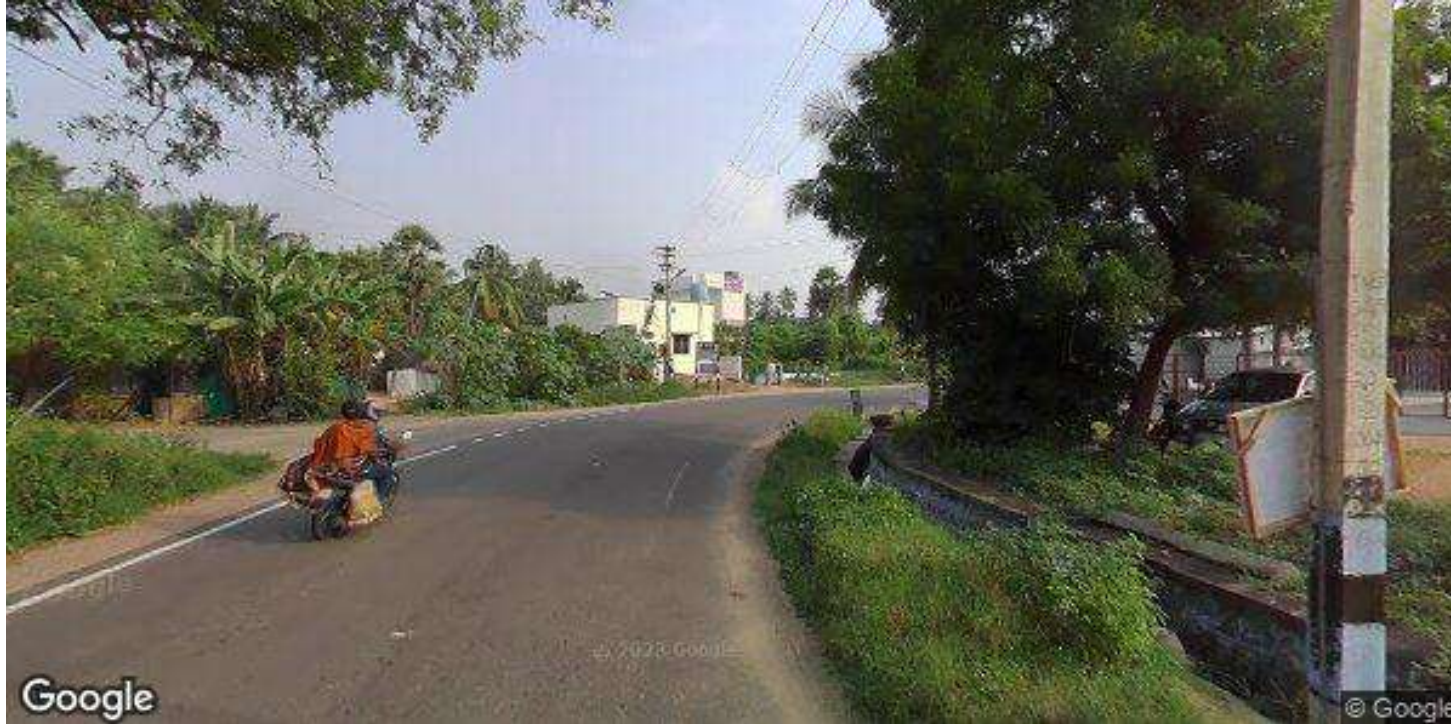
**Risk Type:** Turn  
**Risk Level:** Medium  
**Speed Limit:** 30 KM/Hr  
**Coordinates:** 11.16377, 77.77421

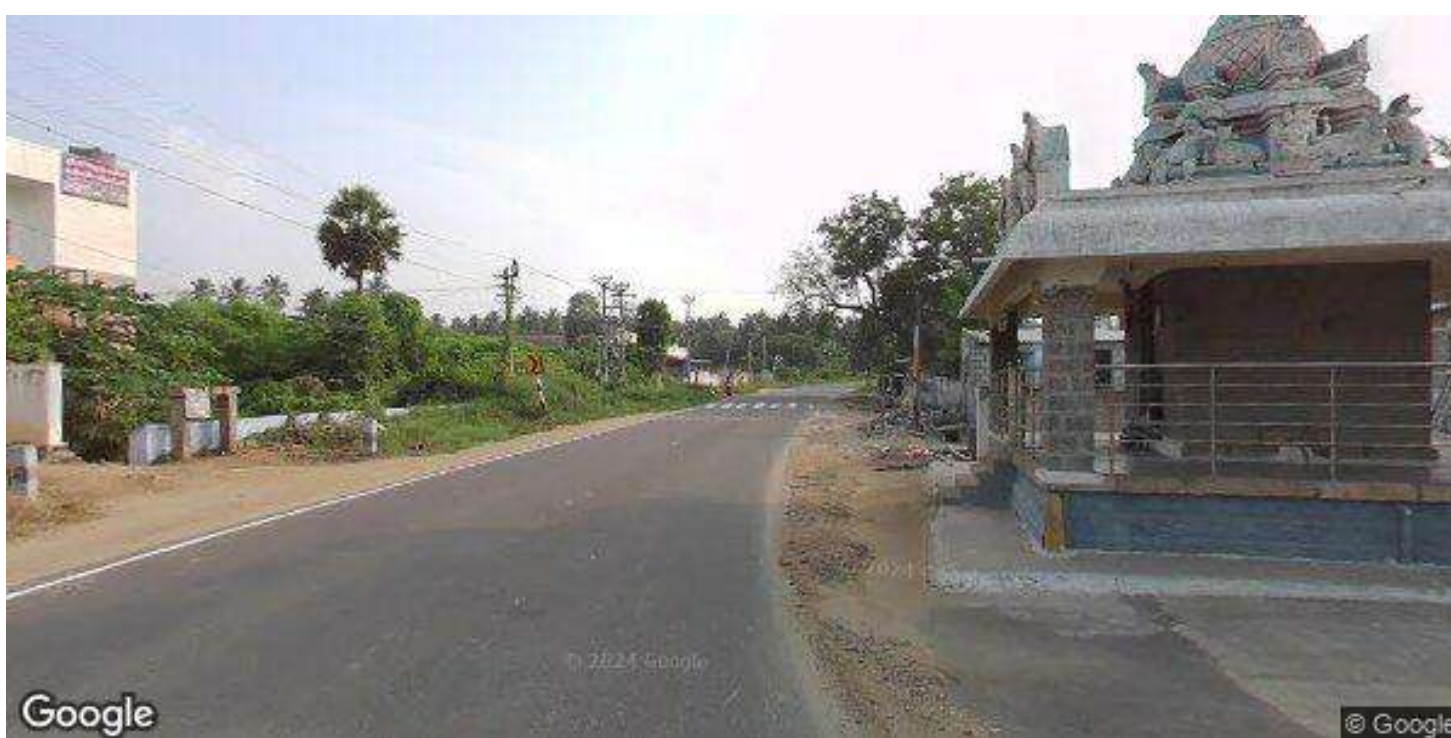
**Risk Type:** Turn  
**Risk Level:** Medium  
**Speed Limit:** 30 KM/Hr  
**Coordinates:** 11.16354, 77.77435

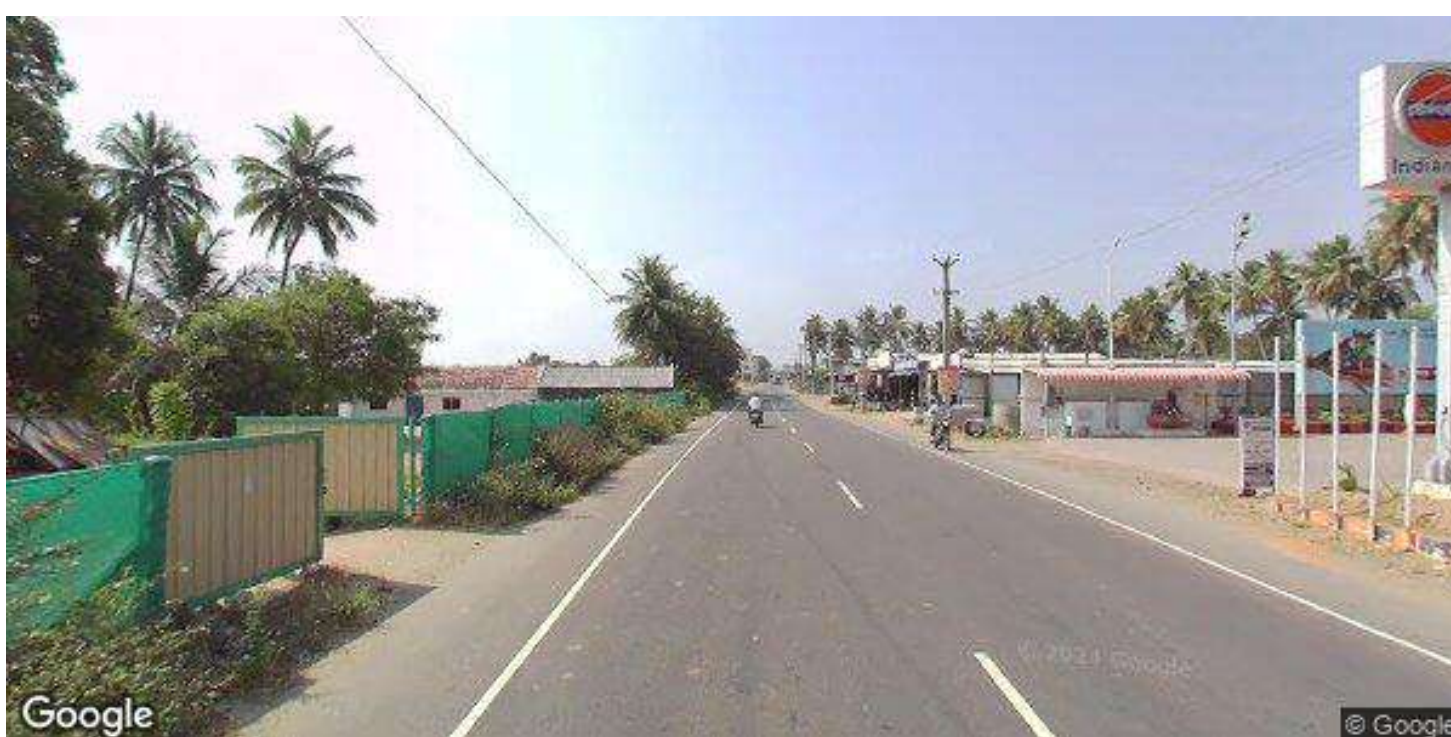
**Risk Type:** Turn  
**Risk Level:** High

**Speed Limit: 15 KM/Hr**  
**Coordinates: 11.05276, 77.73776**
